**Historic building recording
at Thornbrook House
Stoke Mandeville, Buckinghamshire
March 2021**

Report No. 21/039

Historic building recording at Thornbrook House Stoke Mandeville, Buckinghamshire March 2021

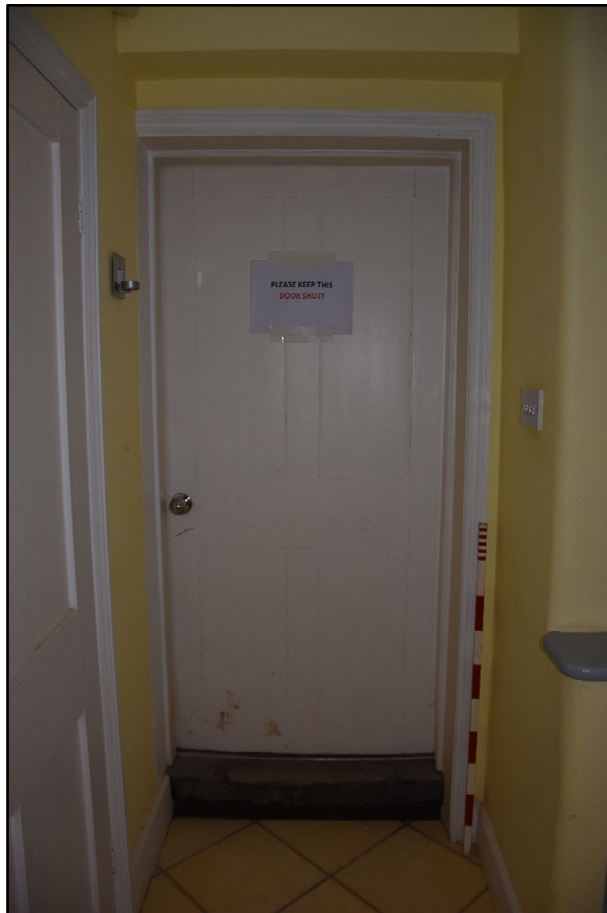
Door from GF01 into GF07, looking east Fig 47

The current kitchen is housed in various parts of the rear extensions and leads into the rear corridor of GF08. The door from the entrance hall is a plain four-panelled example with a brass doorknob and lock case (Fig 47). There is a step down into this space which has a modern tile floor, plain skirting and modern fixtures and fittings. It can be subdivided for ease of description.

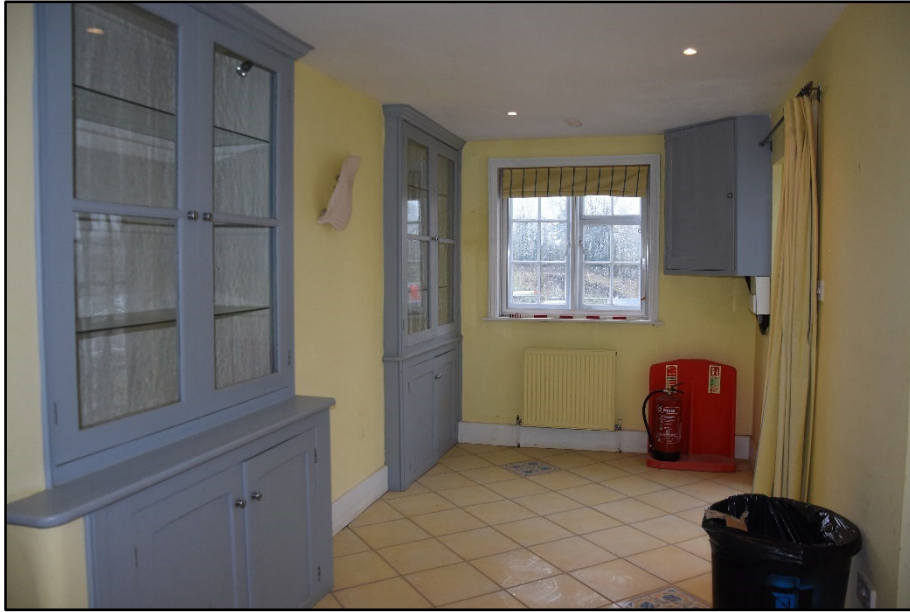
Southern area of GF07, looking south Fig 48

To the south this area is housed in the rear extension seen externally and was consistent with the main range, but had a lower roof form. Here the rear of the chimney stack to GF05 is visible and is flanked by two fitted dressers with lower cupboard and upper shelving we have seen elsewhere (Fig 48). To the south wall is a window within a moulded frame and secondary glazing. The moulding to the glazing bars suggests

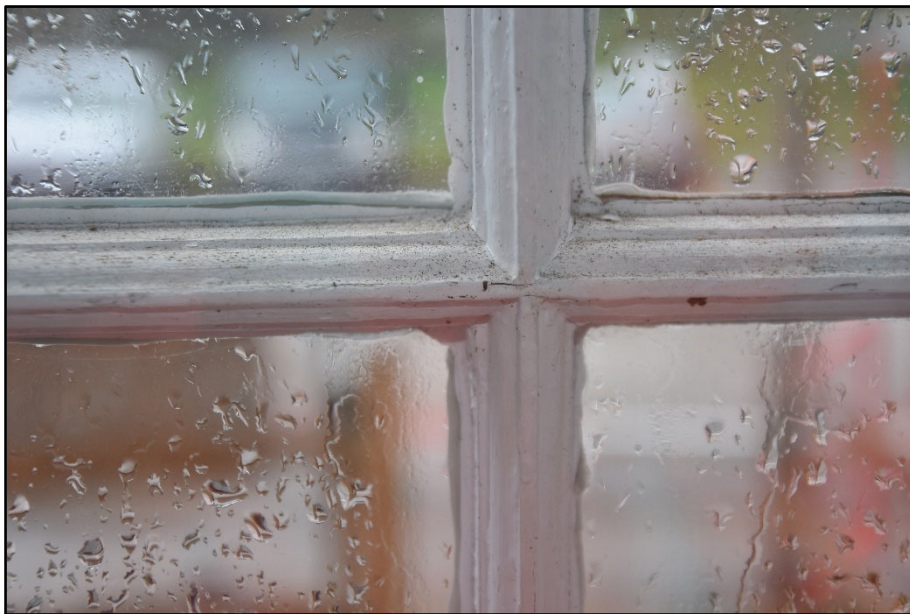
Moulded glazing bars to the window in GF07, looking south-west Fig 49

some age (Fig 49), and the handles are the reeded examples with some Art Deco influence (Fig 50). To the west wall is a set of French doors, which are entirely modern (Fig 51).

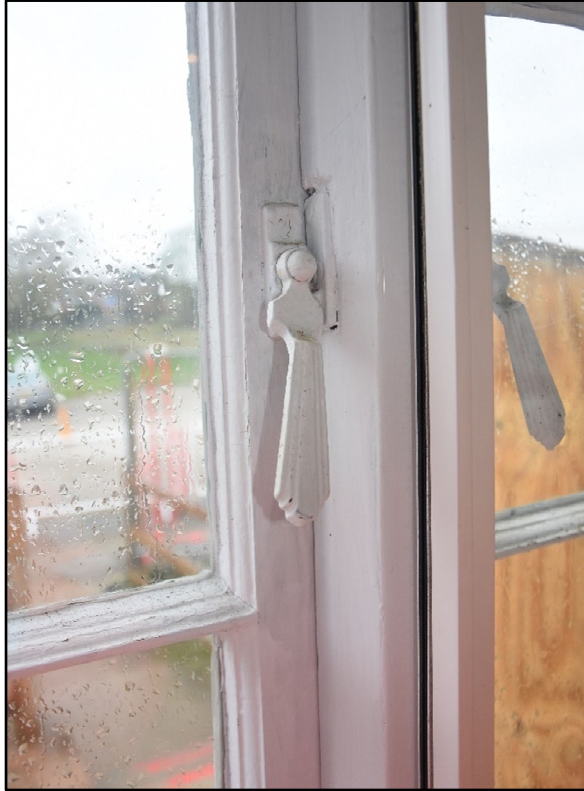
Decorative window catches in GF07, looking south-west Fig 50

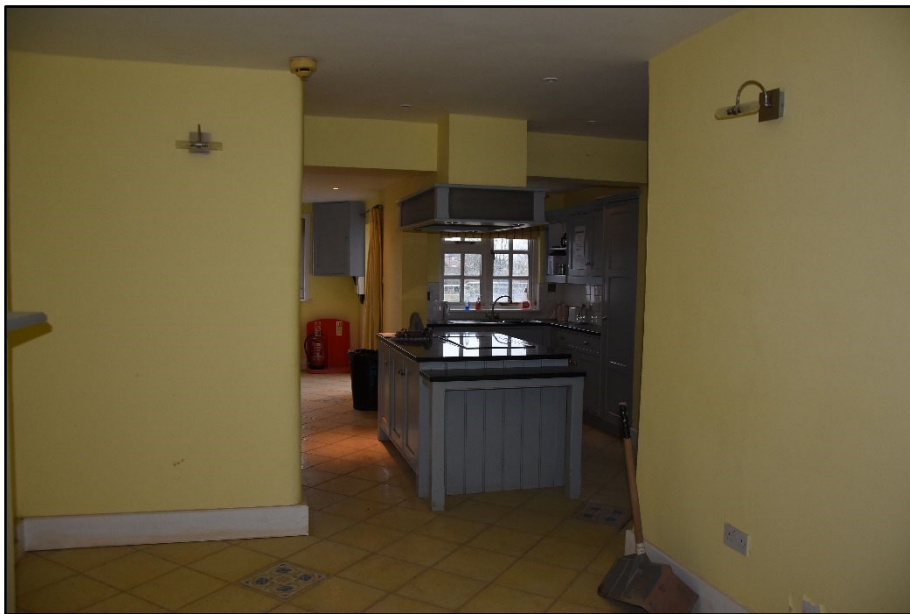
Central area of GF07, looking south-west Fig 53

The actual kitchen area is housed opposite the door from the entrance hall and appears to be within a separate rear extension (Fig 52). A boiler cupboard protrudes into the space and retains curved edges, which is of interest. A four-panel plain door with modern handle gives access. Kitchen cupboards and an island fill the space otherwise but overhead a downstand suggests this area straddles two phases of rear development (Fig 53). A modern window lies to the south.

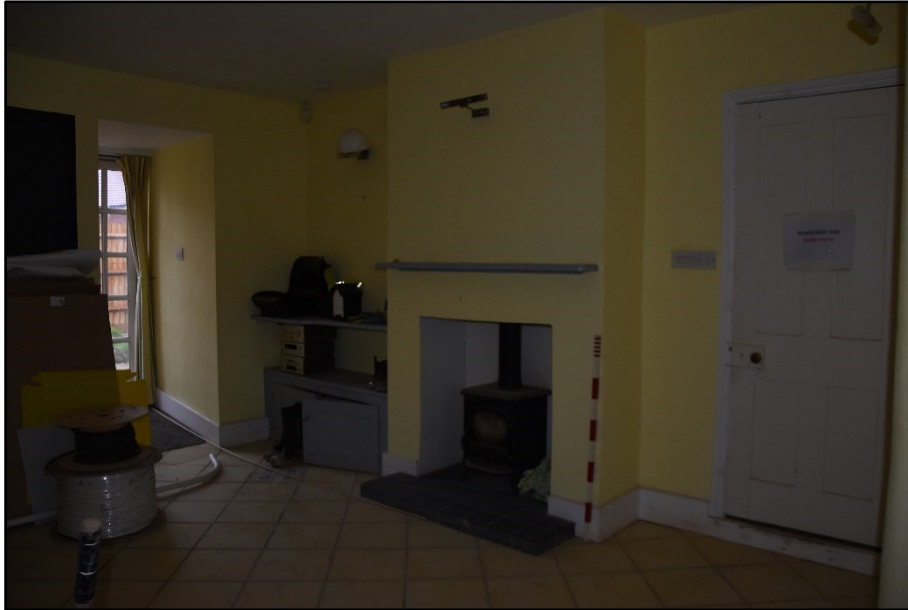
Northern area of GF07, looking north-east Fig 54

To the north of the kitchen a separate area gives access into the parlour (GF03) and access to the exterior. This space has a chimney stack with stove to the east wall to the rear of the stack seen in GF03 (Fig 54). There is a high shelf above and a raised tile hearth. To the south the door providing access is a plain four-panel example with doorknob and lock case. To the north of the stack is a low fitted cupboard and shelf. To the north a sloped corridor gives access to the modern multi-pane door seen externally. Also in this short corridor section is a louvred door giving access to a small cupboard.

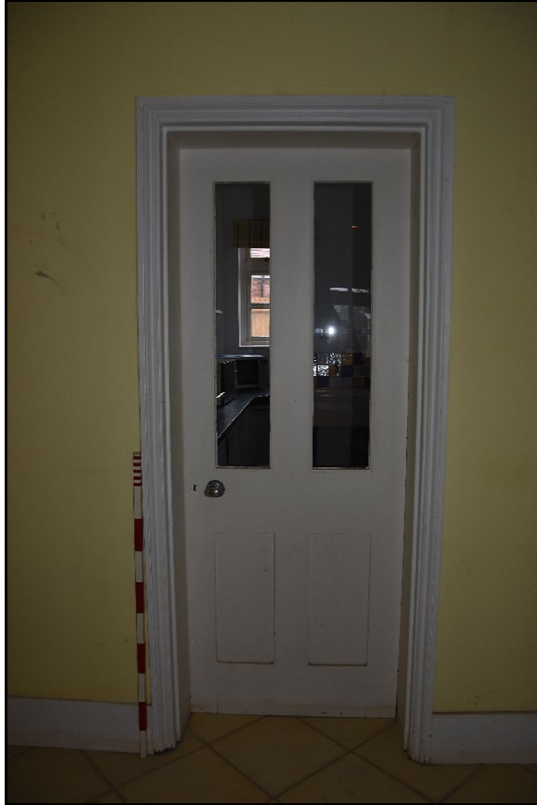
Door to GF09 from GF08, looking north Fig 55

This room is accessed from the rear hall via a four-panelled door (Fig 55). The door has two upper glazed panels and two lower recessed panels. There is a modern doorknob present. The room has modern fittings and fixtures consistent with a secondary kitchen/preparation area, including in the north-east corner a ceramic butler sink (Fig 56). The window on the north wall is modern with modern stay bar to the upper casement.

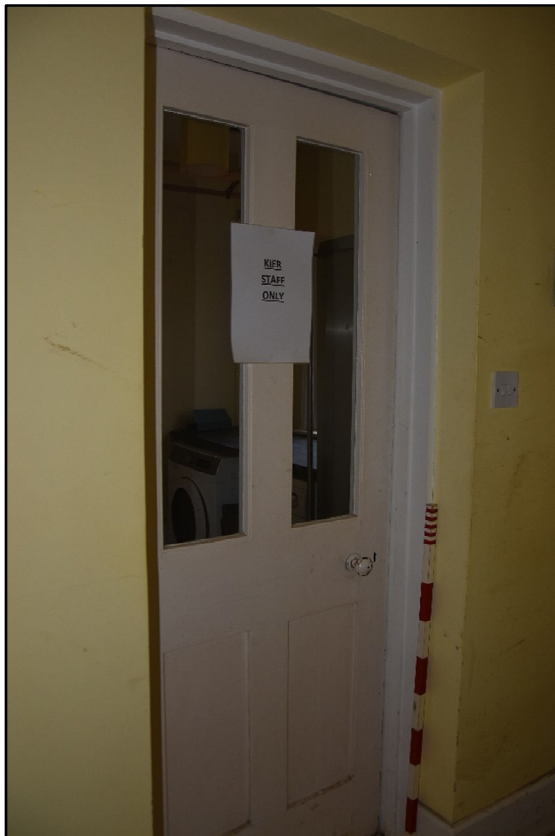
Door to GF10 from GF08, looking south-west Fig 57

Like GF09 this room is accessed via a four-panelled door with upper glazed panels and lower recessed panels (Fig 57). There is a doorknob and keyhole, there is a lock case to the rear. The room has a tiled floor, simple skirting and plaster walls painted yellow (Fig 58). There is a suspended clothes rack hanging from the ceiling. The window to the west wall seen externally has modern catches and a decorative stay bar (Fig 59). The glazing bars are robust but lack mouldings.

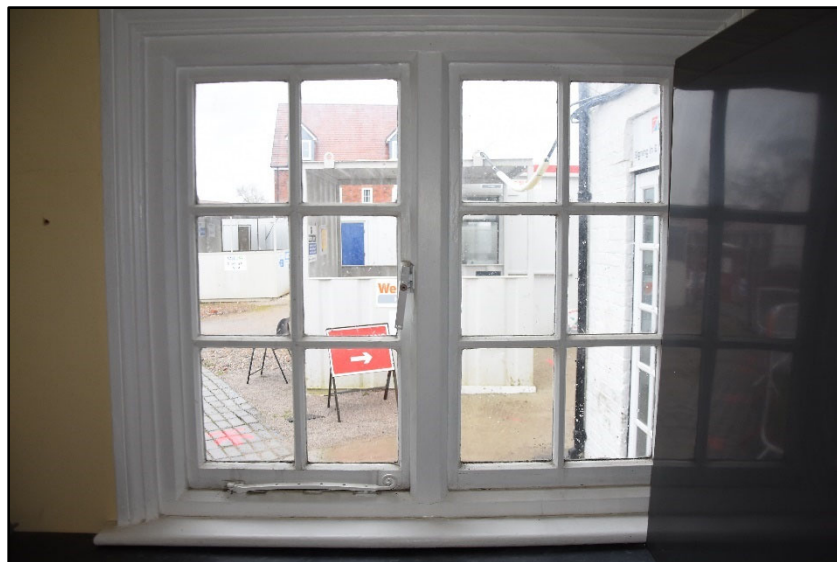
Window in GF10, looking west Fig 59

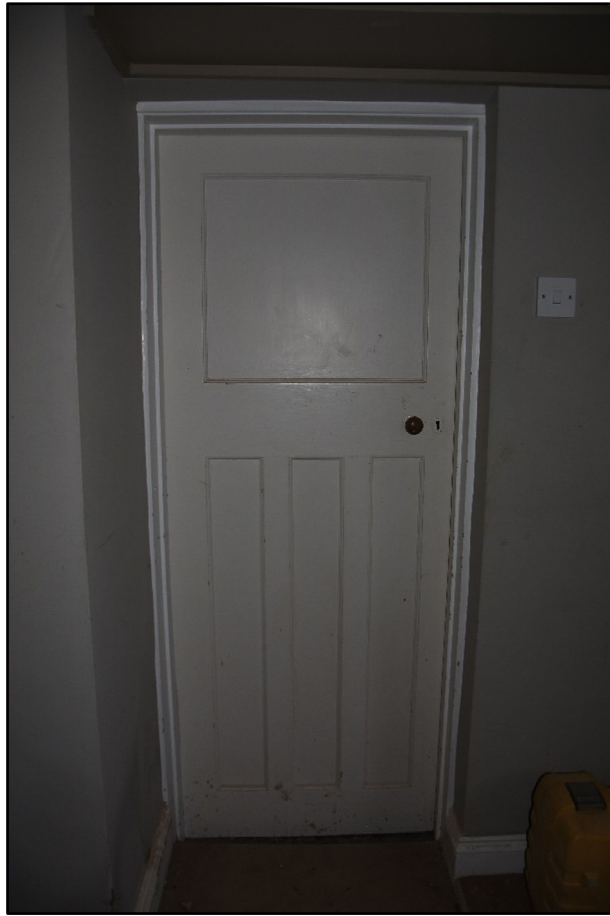
Door to GF12, in GF11, looking north-west Fig 64

This room is accessed via a short corridor from the rear hall. The door is four-panelled and the same form as seen elsewhere in this area (Fig 62). There is a small step up into this room that has a carpeted floor and is fairly plain in decoration. The window to the north wall has the reeded catches and stay bars as seen elsewhere on the ground floor (Fig 63). To the west an early 20th-century door gives access into GF12 (Fig 64). This door has one large square upper panel and three elongated lower panels.

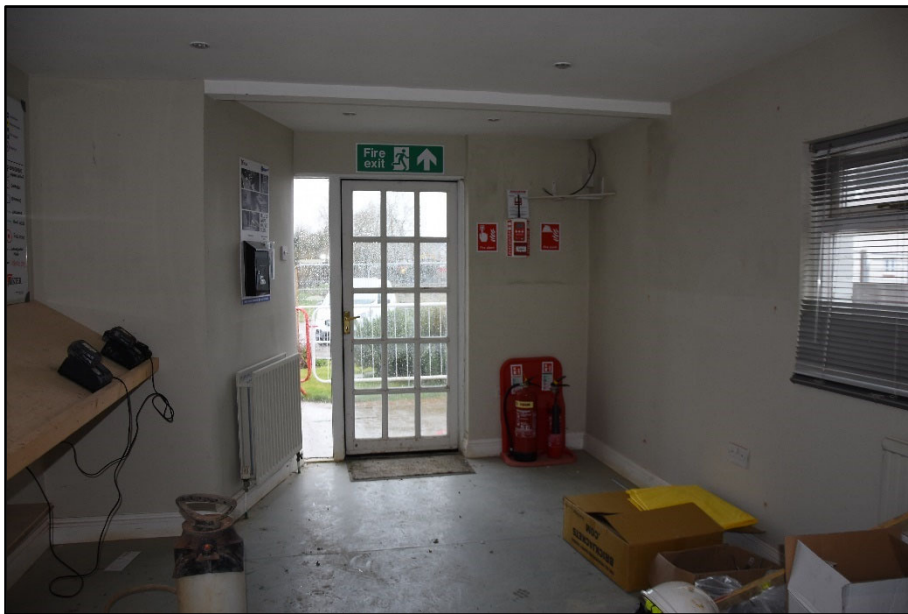
Interior of GF12, looking south-west Fig 66

To the south the south-east corner cuts into the room to accommodate the wind lobby seen externally. The multi-pane door and side light here are modern (Fig 66).

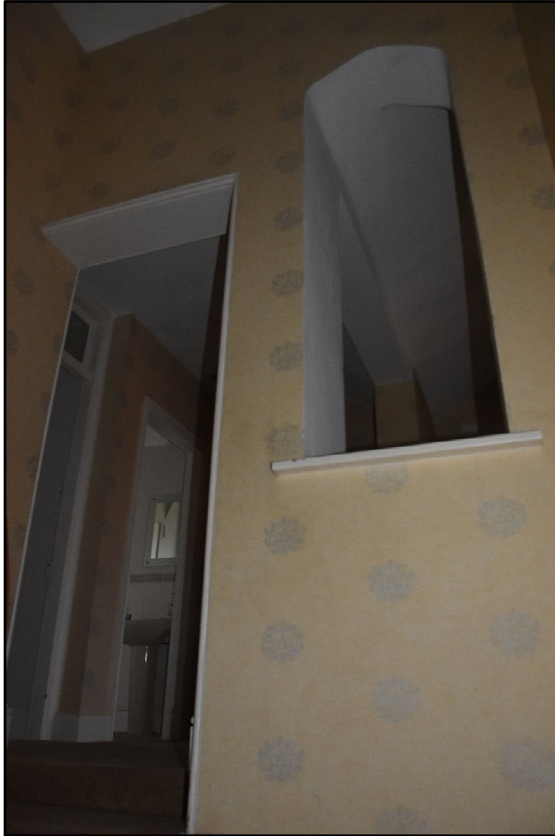
Area above the stairs looking west towards FF07 Fig 69

The staircase from the entrance hall is the only access onto the first floor. As the winder turns back to the east there is a quarter-landing. Further steps to the east access the rooms over the main range (Fig 68), and to the west where the original exterior wall has been pushed access is given through into the rear ranges (Fig 69).

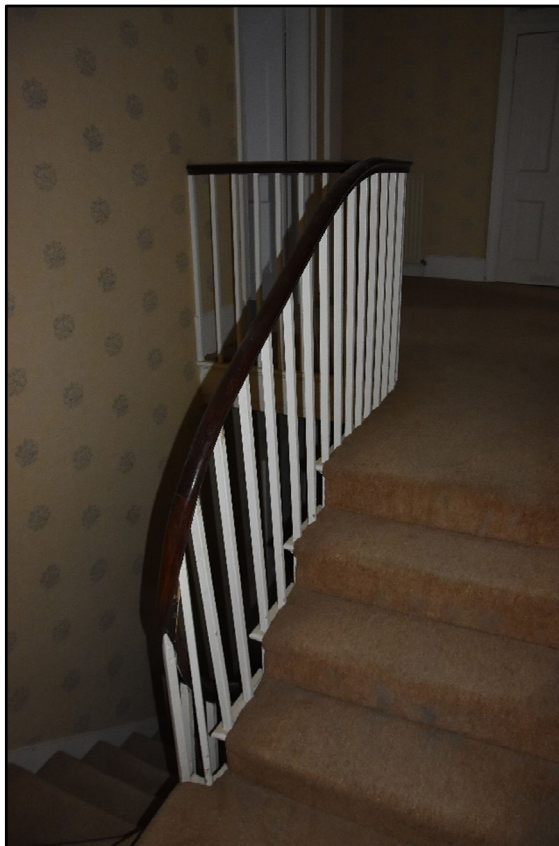
Section of balustrade in FF01, looking east Fig 70

The landing in the main range is an open area reached by several steps from the half-landing. The balustrade returns sharply to the east rising with the stairs and then returning into the north wall (Fig 70). There are five doors here to four bedrooms and a linen closet.

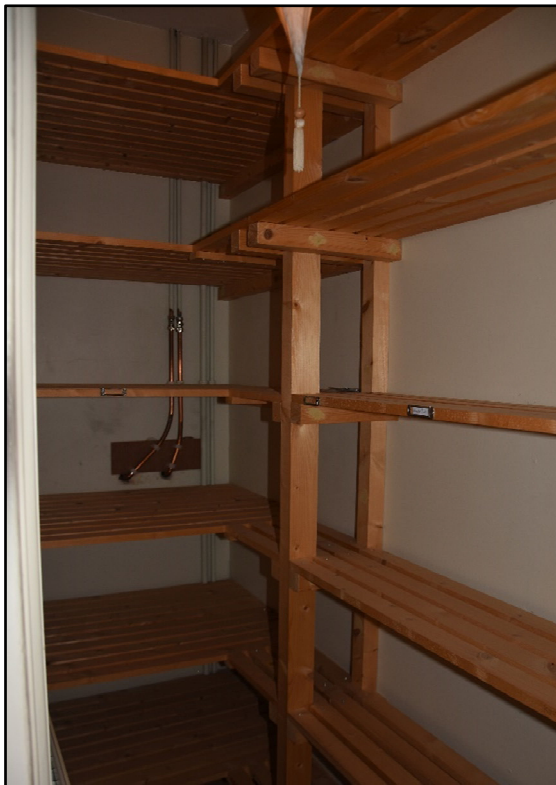
Interior of FF01a, looking north Fig 72

The door to the linen closet lies on the east wall and is of the same form as elsewhere. The only distinction is a single over light above, and upper and lower louvred panels for ventilation (Fig 71). This is likely the fifth bedroom described in the sales particulars of 1879, potentially later the bathroom, but has been subdivided to provide FF03 with an ensuite. It is currently used as a storage cupboard with modern shelving (Fig 72).

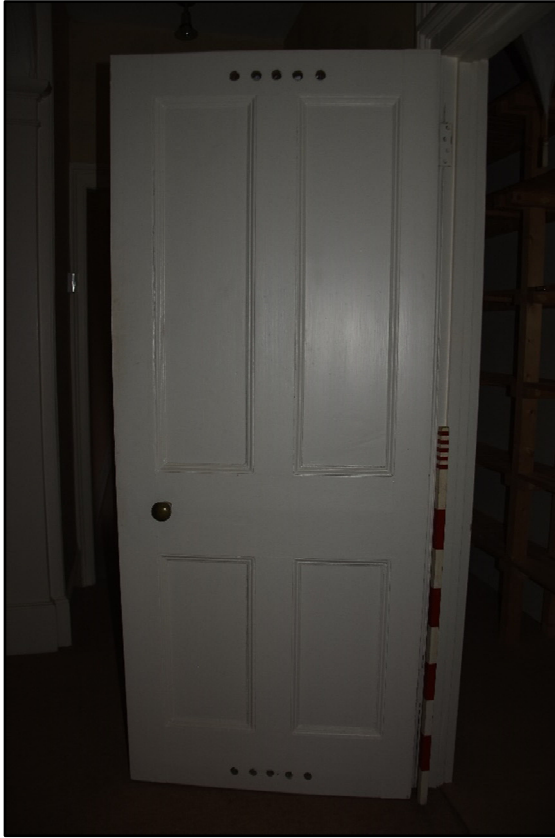
Rear of the door to FF01a, looking north Fig 73

The rear of the door is plain, but the upper and lower rails are pierced by a series of circular holes (Fig 73). These are likely an early ventilation system before the plastic panels were added to the door. The interior of the cupboard is plain but of note is a moulded skirting which does not return along the east wall (Fig 74). Instead, the skirting runs into the wall and can be seen within the adjoining bathroom of FF04.

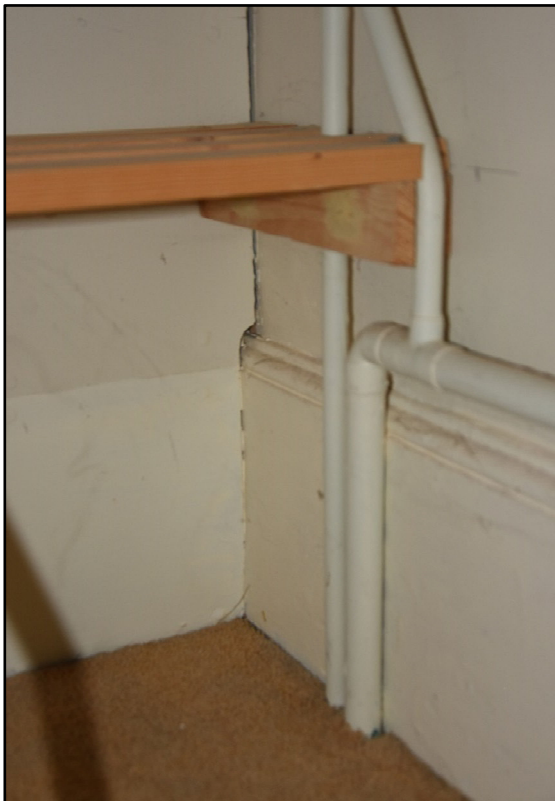
Detail of inserted east wall in FF01a cut around original skirting, looking south-east Fig 74

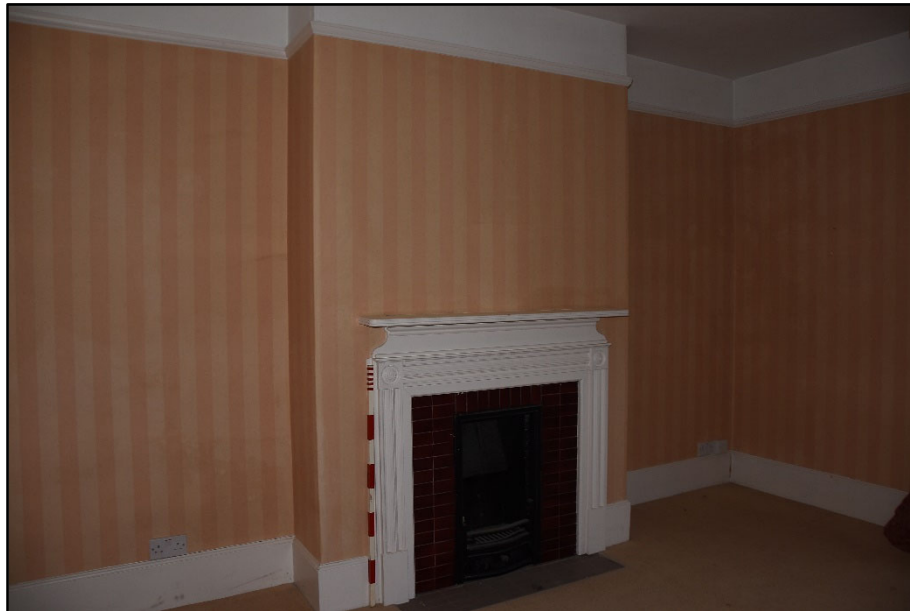
Interior of FF02, looking north-east Fig 75

The rear of the door from the landing is plain with its original doorknob. The room is decorated with a high skirting, a moulded picture rail and wallpapered walls (Fig 75). The ceiling is plastered and plain, there is no cornice.

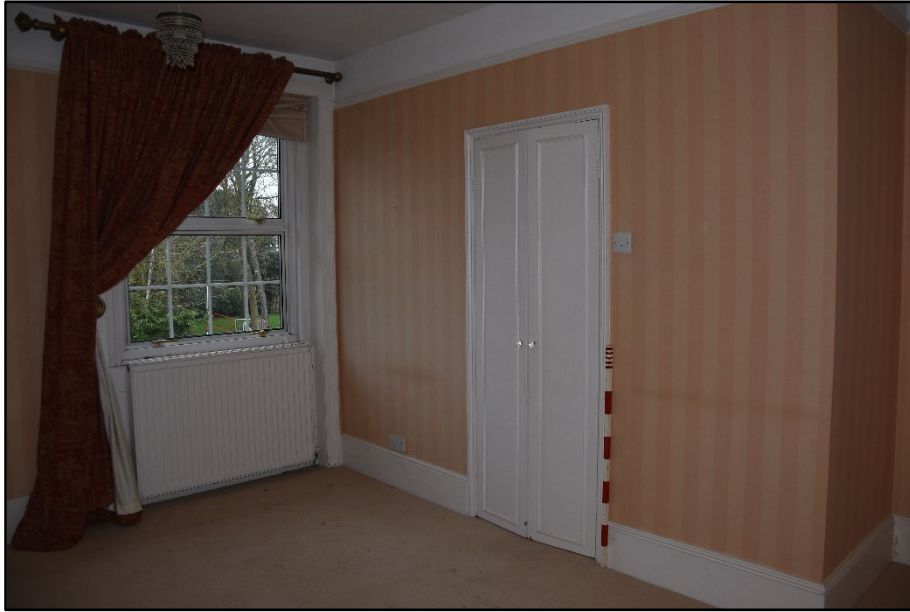
Interior of FF02, looking south-west Fig 76

To the east is a single window within a recess with moulded surround. The window is a modern replacement (Fig 76).

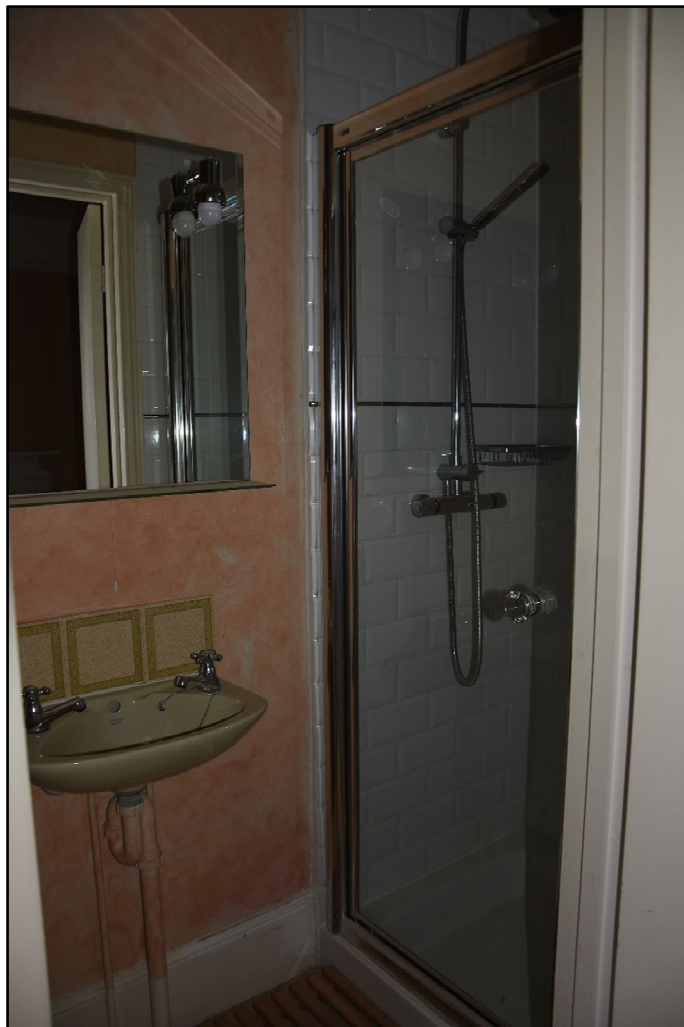
Interior of FF02a, looking south-west Fig 77

On the south wall part of the room has been subdivided to create an en-suite. The double doors giving access sit within a moulded frame and have modern handle. Each door is slender in width and has a moulded panel in the style of bolection moulding. The skirting appears to continue uninterrupted but the moulding either side of the access door differs in profile. However, there is no obvious interruption in the picture rail. Within the bathroom the skirting is present, wallpaper decorates the walls and the fittings are all modern, perhaps of mid-20th century date (Fig 77).

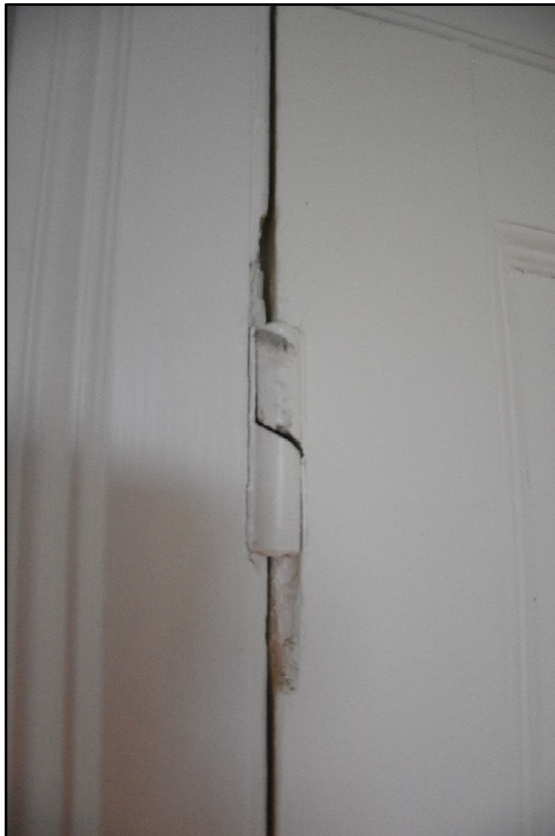
Swivel hinges on the door to FF03, looking north Fig 78

The door from the landing sits in the moulded frame with a doorknob and a lock case. It is on swivel hinges which differs from other doors seen elsewhere (Fig 78). The room has skirting and plastered walls to a plain ceiling, there is no evidence of a picture rail. The skirting is moulded along the north wall but is much plainer along the south.

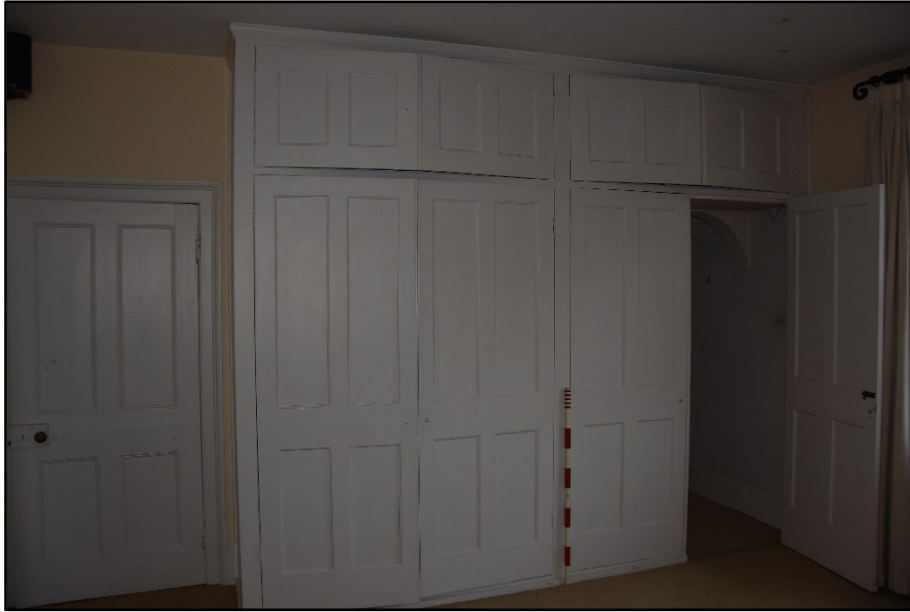
Fitted cupboards in FF03, looking north-east Fig 79

Along the north wall is a series of fitted wardrobes and cupboards which reach from floor to ceiling (Fig 79). The furthest eastern door gives access into the en-suite (FF04) housed within the former bathroom likely given access from the landing. This is described in more detail below. The fitted wardrobes have plainly recessed doors on barrel hinges and have had their handles removed. There is little of interest inside them but of note the skirting continues along the north wall.

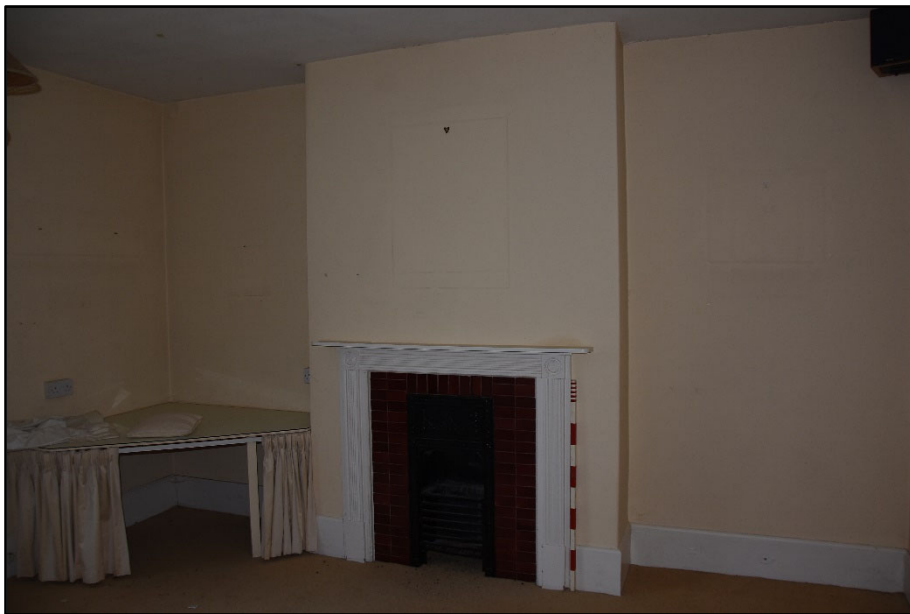
Fireplace in FF03, looking south-east Fig 80

On the south wall a chimney stack has a matching fireplace to that in FF02 (Fig 80). The hearth has been carpeted over, and the surround is simpler. The south-east corner of the room has a low corner shelf with curtains.

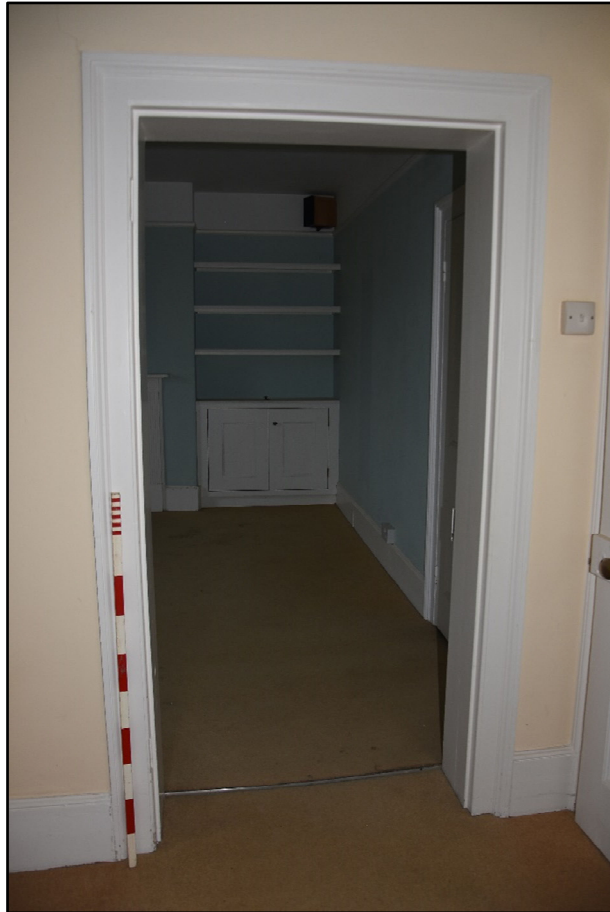
Doorway between FF03 and FF05, looking north-west Fig 81

The west wall retains a doorway to the adjoining FF05 bedroom, this has a moulded door frame, but the door has not survived (Fig 81).

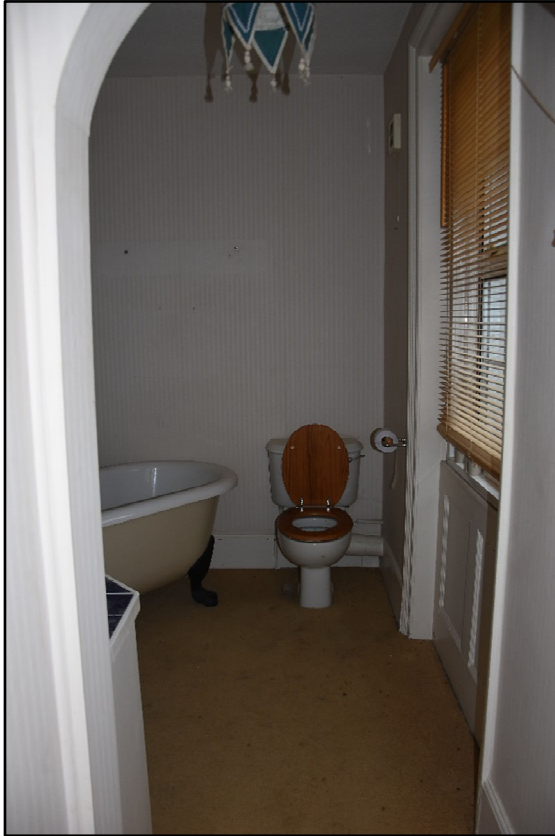
Interior of FF03a, looking north Fig 82

As described above this bathroom is given access through the wardrobes in FF03, but presumably was once joined with FF01a to form a larger room. There is a semi-circular arch where the wall would have been pushed through (Fig 82).

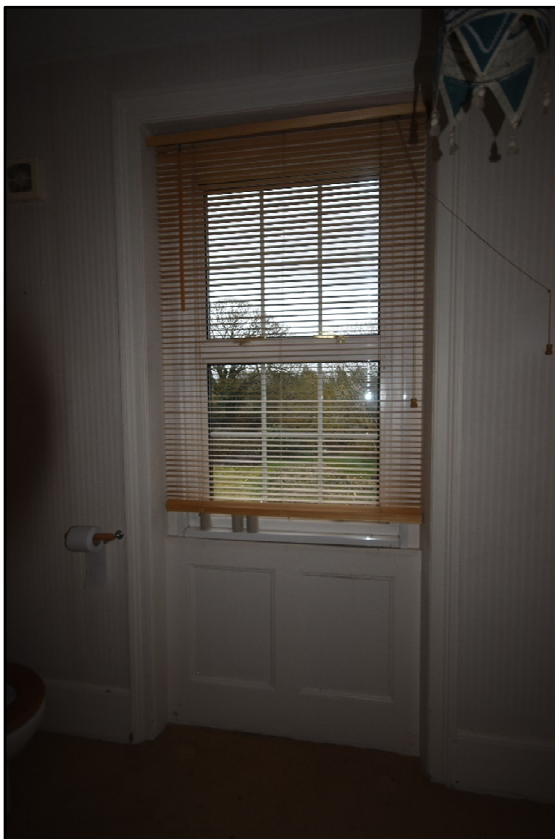
Window in FF03, looking south-east Fig 83

To the east wall a modern window sits in a simple recess with moulded frame, matching those to FF02 and FF03 (Fig 83). Below the window, where the other examples are obscured by modern radiators, are two moulded and recessed panels.

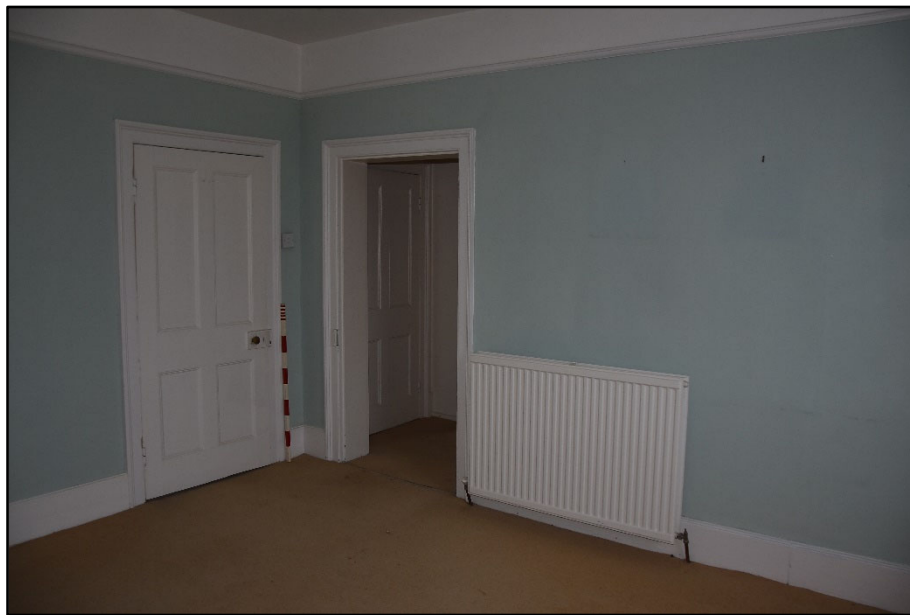
Interior of FF05, looking north-east Fig 84

This room is accessed from the main landing and from the adjoining Magnolia bedroom to the east. The rear of the door from the landing has a lock case and doorknob, and swivel hinges are visible (Fig 84). The door surround from FF03 retains part of a lock case, but the door has been lost.

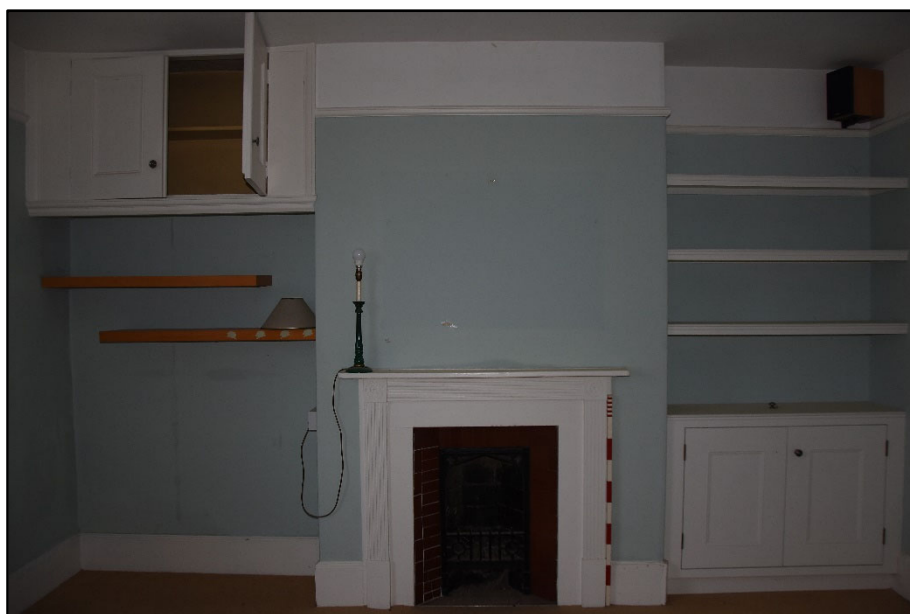
Interior of FF05, looking north-west Fig 85

The room retains its high skirting, picture rail and fireplace to the west, which matches that seen in FF03 next door. The chimney stack projects into the room and has fitted cupboards and shelves either side (Fig 85). The cupboards have moulded panelled doors and modern knobs.

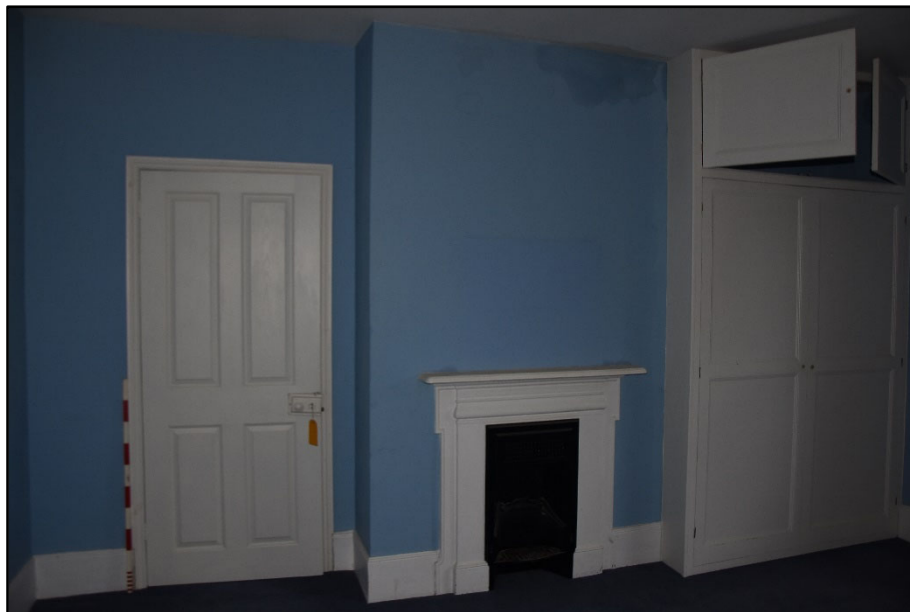
Interior of FF06, looking north-west Fig 86

To the west a chimney stack retains a simple timber surround and cast-iron grate (Fig 86). To the south a door gives access into FF09, housed in a rear extension. This door has four fielded panels, a simple moulded surround and a lock case. To the north of the stack the space is filled with fitted cupboards, the knobs have been removed. The cupboard doors have moulded and recessed panels.

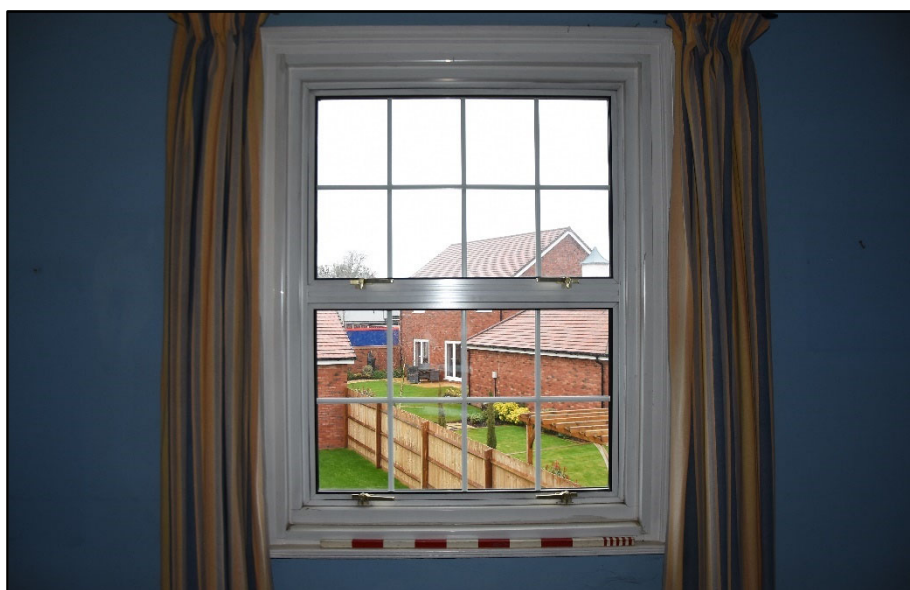
Window in FF06, looking north-east Fig 87

The window to the north (Fig 87) is modern and sits in a moulded surround with similarities to that seen in FF05.

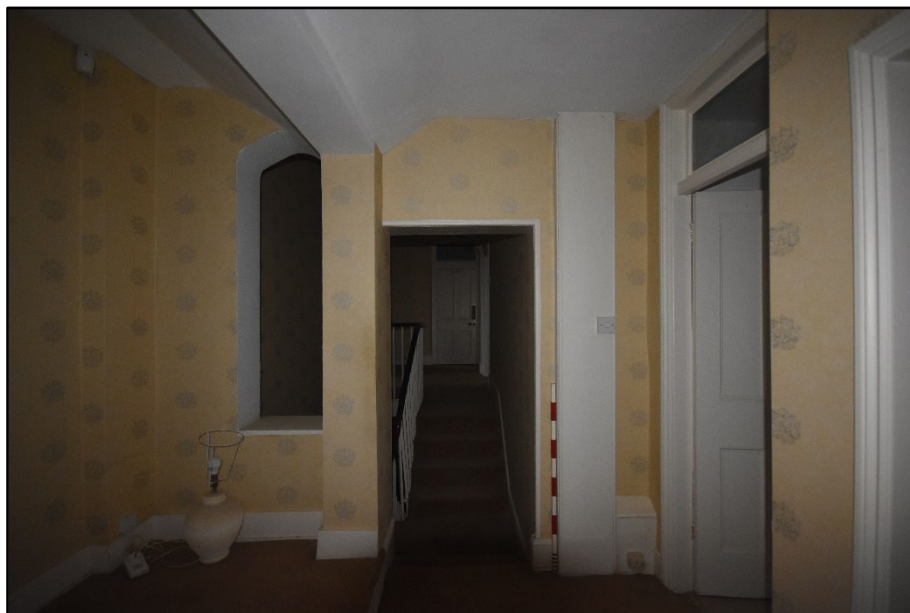
East wall of FF07, looking west Fig 88

The east wall (Fig 88) retains the simple recess from the main landing, as well as a boxed-out pilaster presumably for the running of services which has a small moulding to the corners. To the north is an alcove, open to the stairs, with ogee-arch. It is narrow and has a simple timber shelf.

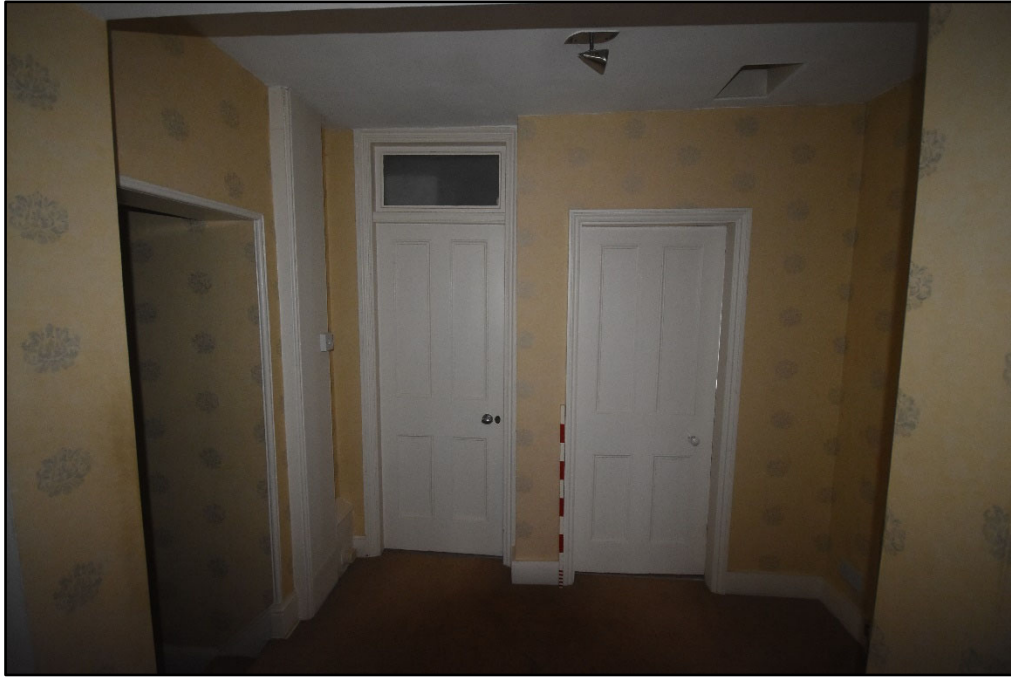
South wall of FF07, looking south-west Fig 89

The south wall houses the two doors giving access into the bathroom (FF08) and WC (FF08a) (Fig 89). That to the bathroom is within a moulded surround which is simpler than the examples to the main landing, and seen on the ground floor, within the main range. The door is of four moulded panels with modern doorknob. There is a glazed over light above. The door to the WC also sits in a moulded surround and is of the same form with Bakelite-style doorknob.

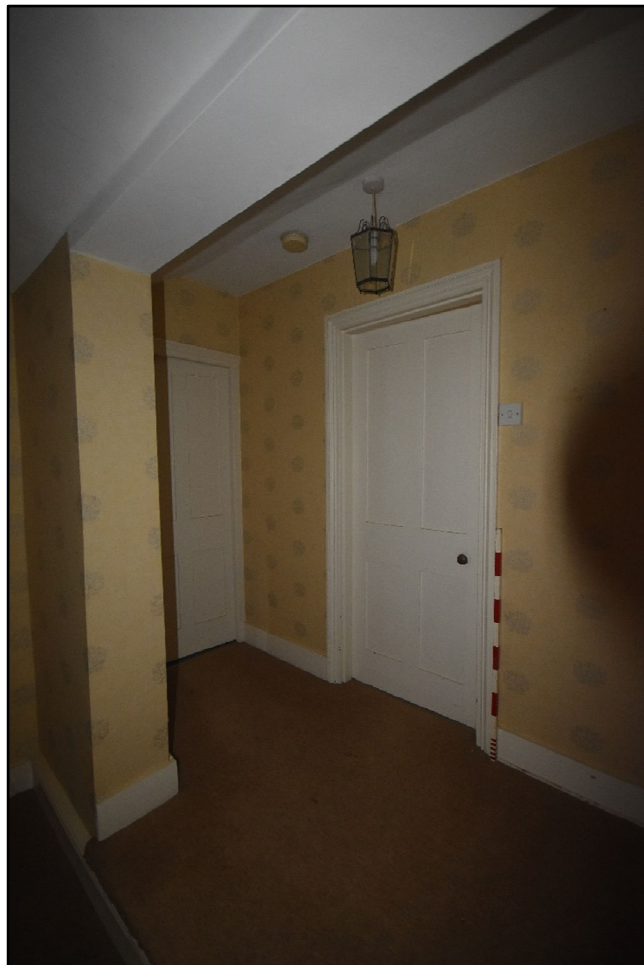
Area to the north of FF07, looking north Fig 90

The north wall (Fig 90) is plain but for the door to the Beige bedroom described below (FF09). The surround is moulded but the four panels are simply recessed. To the west the door to the master suite is of the same form (FF10-13).

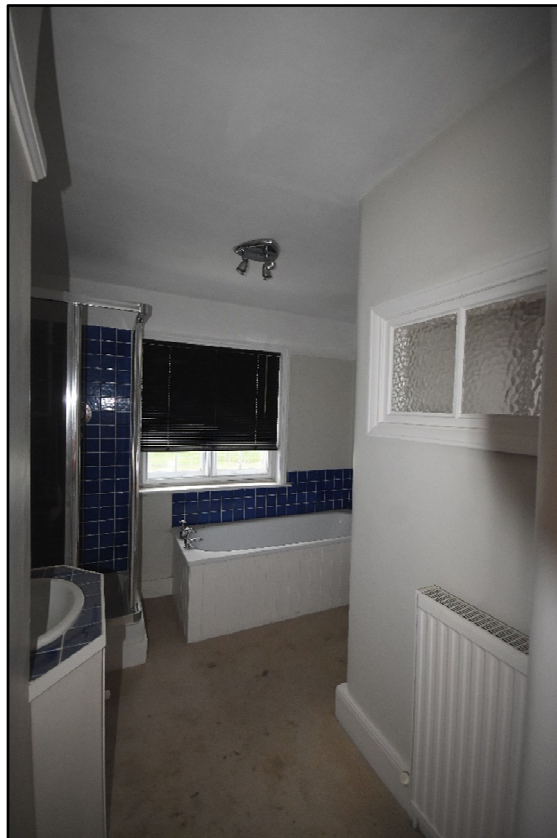
Interior of FF08, looking south-west Fig 91

The bathroom has a modern skirting but the walls and ceiling are plain (Fig 91). There is carpet to the floor and the fittings are all modern. The door from the rear landing has moulded panels with a modern doorknob and historic lock case (Fig 92). A glazed window gives light to the WC adjacent and has two-lights of frosted glass within a moulded frame. A window to the south has modern handles and stay bars but sits in a moulded frame. The glazing bars have a slender ovolo-moulding, suggesting some age.

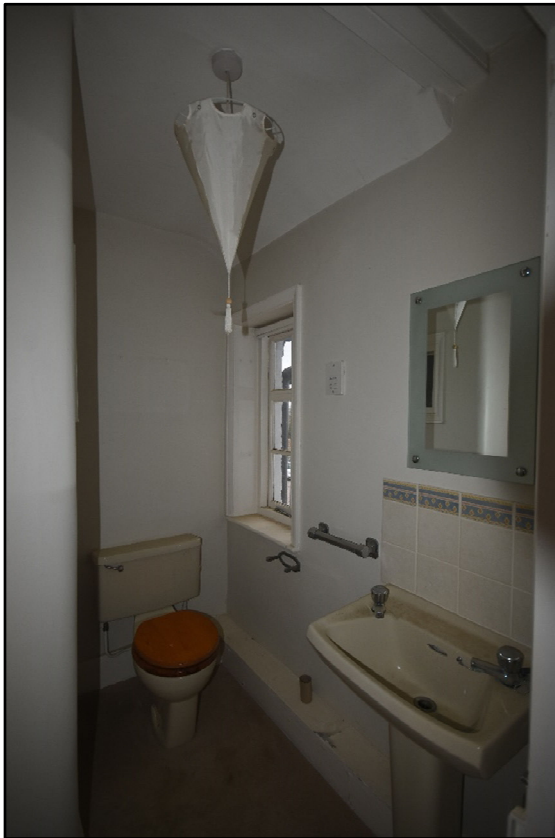
Interior of FF08a, looking south Fig 93

The adjacent WC has modern fittings but has a single recessed window in moulded surround (Fig 93). This window has modern handle and stay bar but retains moulded glazing bars.

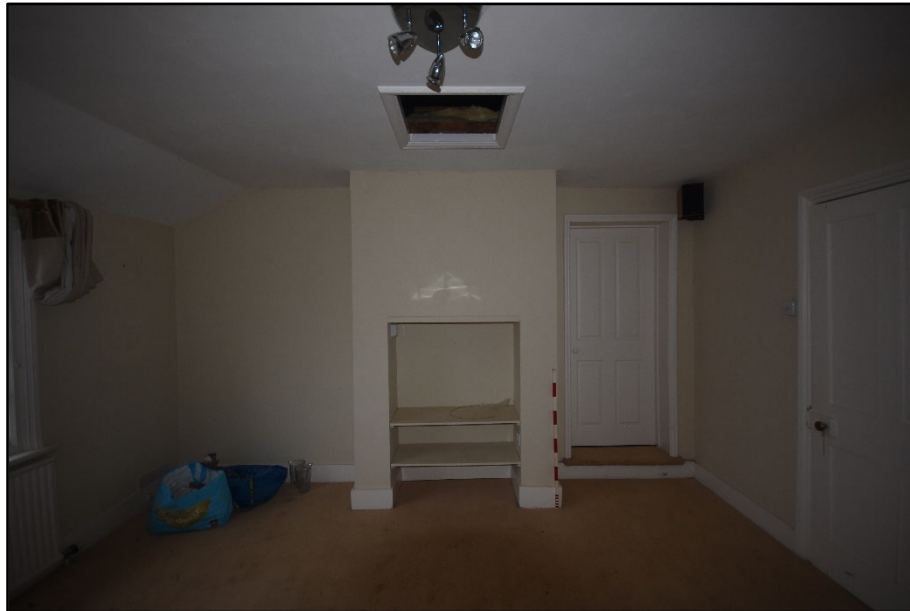
Interior of FF09, looking south-east Fig 94

Accessed from the adjoining Blue bedroom (FF06), and the rear landing (FF07), this room is fairly plain in decoration (Fig 94). The skirting is plain in profile and there is no picture rail or cornice, nor a decorative fire surround. This room is housed partly in the roof space of this range, with a sloping ceiling to the north. There is a roof hatch in this space that is described in more detail below.

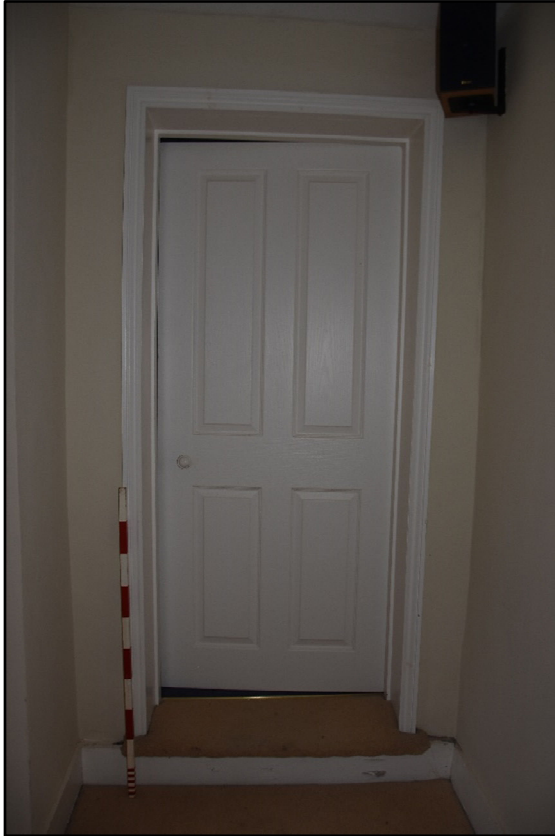
Door from FF06 into FF09, looking south-east Fig 95

The rear of the door from FF06 has four fielded panels and a doorknob and sits in a recess with moulded surround (Fig 95). From FF06 there is a step down in floor level. The door from the landing to the south has four recessed panels and a lock case with doorknob (Fig 96).
