**Historic building recording
at Thornbrook House
Stoke Mandeville, Buckinghamshire
March 2021**

Report No. 21/039

Historic building recording at Thornbrook House Stoke Mandeville, Buckinghamshire March 2021

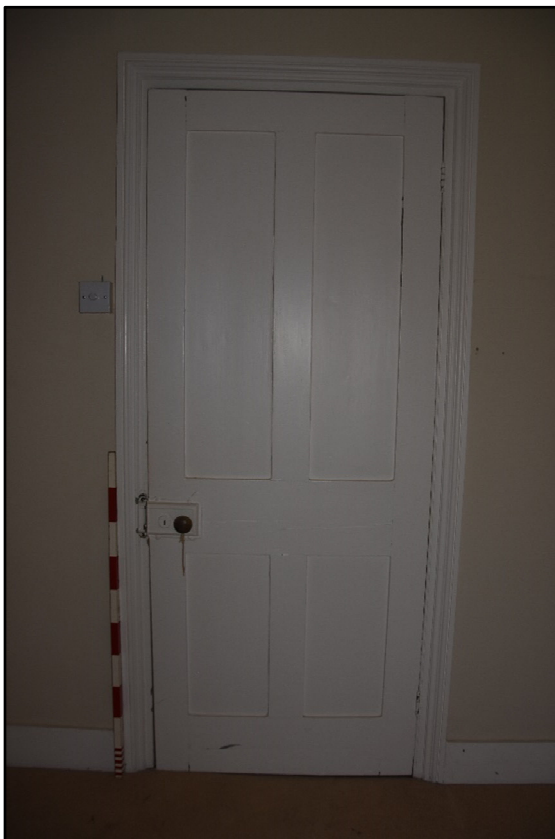
Door from FF07 into FF09, looking south-west Fig 96

The rear of the door from FF06 has four fielded panels and a doorknob and sits in a recess with moulded surround (Fig 95). From FF06 there is a step down in floor level. The door from the landing to the south has four recessed panels and a lock case with doorknob (Fig 96).

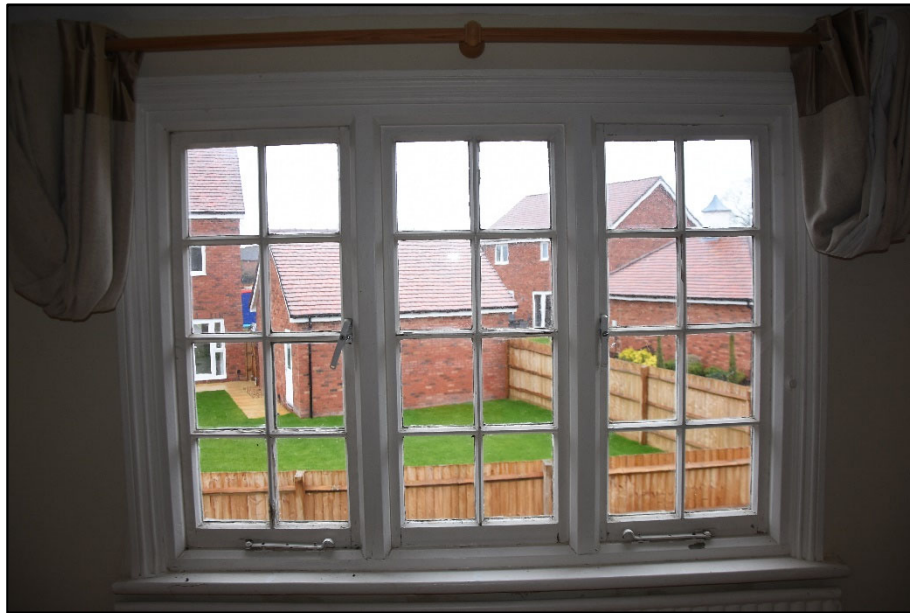
Window in FF09, looking north-east Fig 97

The window to the north sits in a moulded surround but has modern handles and stay bars (Fig 97). The glazing bars are simply chamfered.

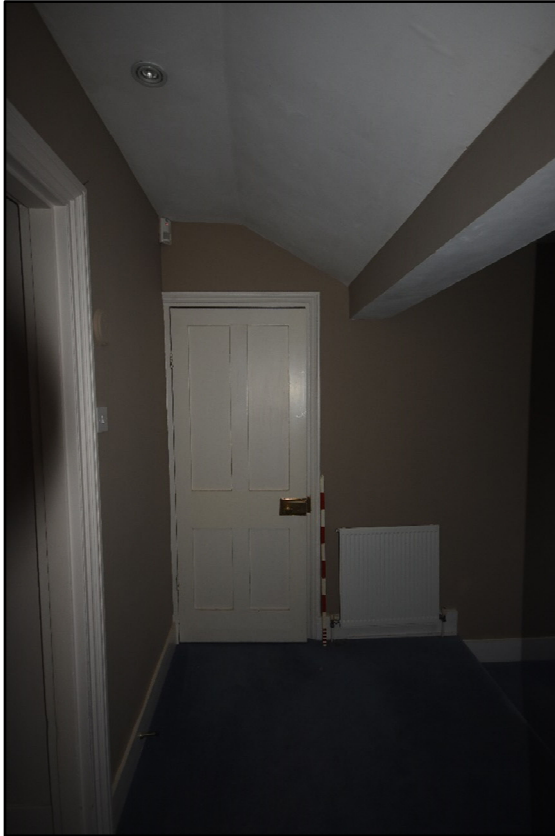
Door from FF07 into FF10, looking south-east Fig 98

The lobby is accessed directly from the rear landing through the door described above (Fig 98). The rear has four plain recessed panels with a brass lock case and doorknob, all set within a moulded surround. There is a plain skirting but otherwise there is no decorative elements present.

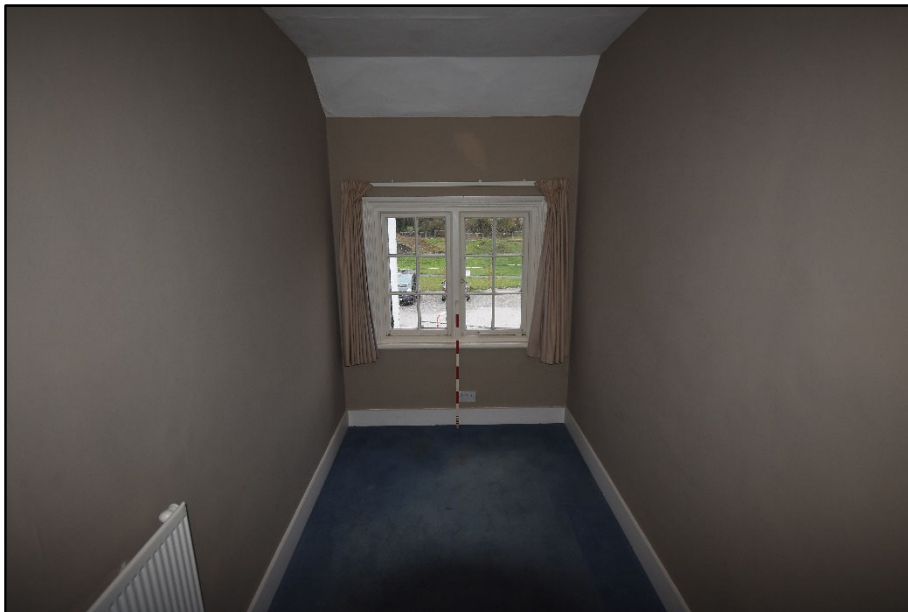
South area of FF10, looking south-west Fig 99

The room straddles two rear ranges as seen on the rear landing with the same downstand and sloped ceiling to each side. The floor is carpeted and steps down to the south (Fig 99). Along this south wall is a window within a moulded surround. The glazing has a chamfered profile and are slender. There is a catch handle of interest and a stay bar to the west casement.

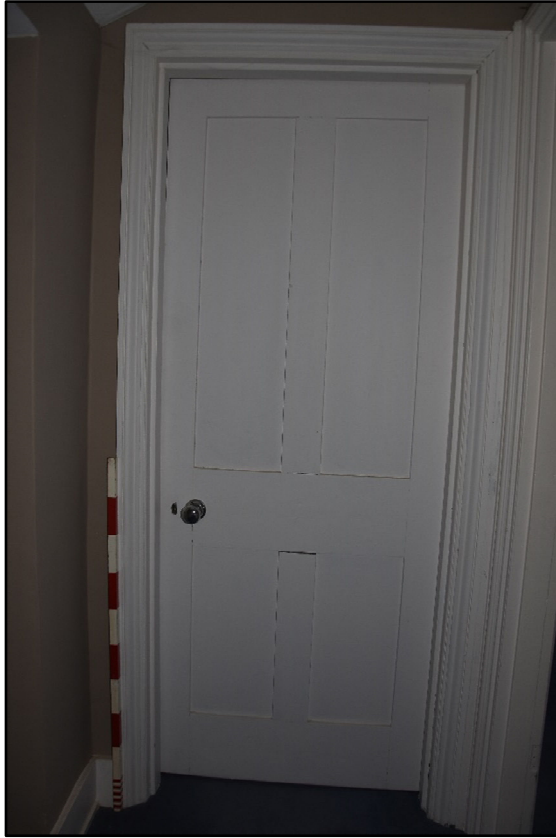
Door to FF11 from FF10, looking north-west Fig 100

To the north of the room there is a moulded doorway through to the bedroom (FF12) the door has been lost, and a door to the bathroom (FF11). The door to the bathroom is of four plain recessed panels with modern doorknob and key plate (Fig 100).

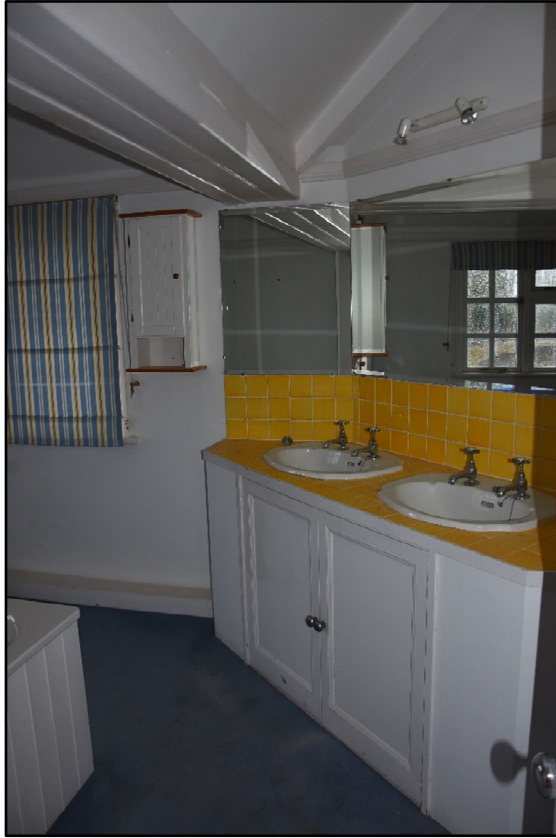
Interior of FF11, looking north-west Fig 101

The room has modern fittings and fixtures and is carpeted with little decoration (Fig 101). The rear of the door from the lobby has a modern lock case and doorknob that has clearly replaced a historic example (Fig 102). A window to the west has a moulded surround with chamfered glazing bars and a catch and stay bar matching that to the lobbies window described above (FF10) (Fig 103). To the south a mid 20th-century window lies in a moulded surround with stay bars and catches (Fig 104).

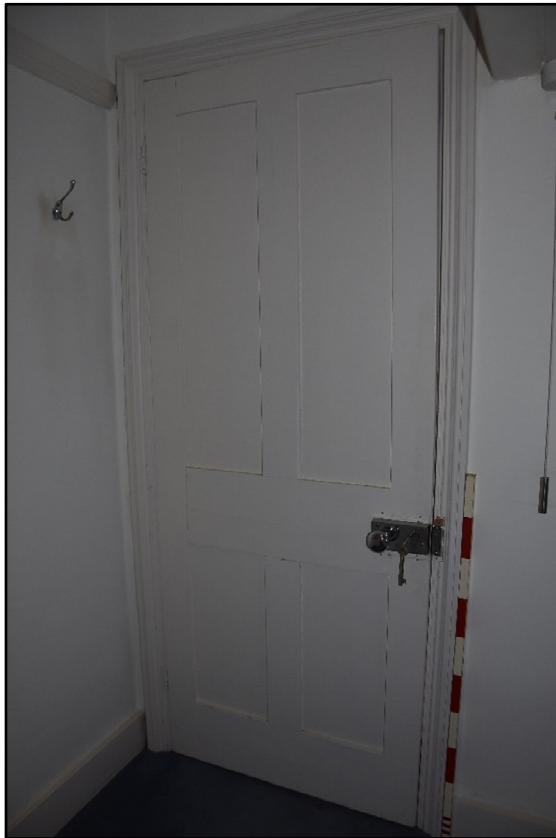
Rear of the door in FF11 from FF10, looking east Fig 102

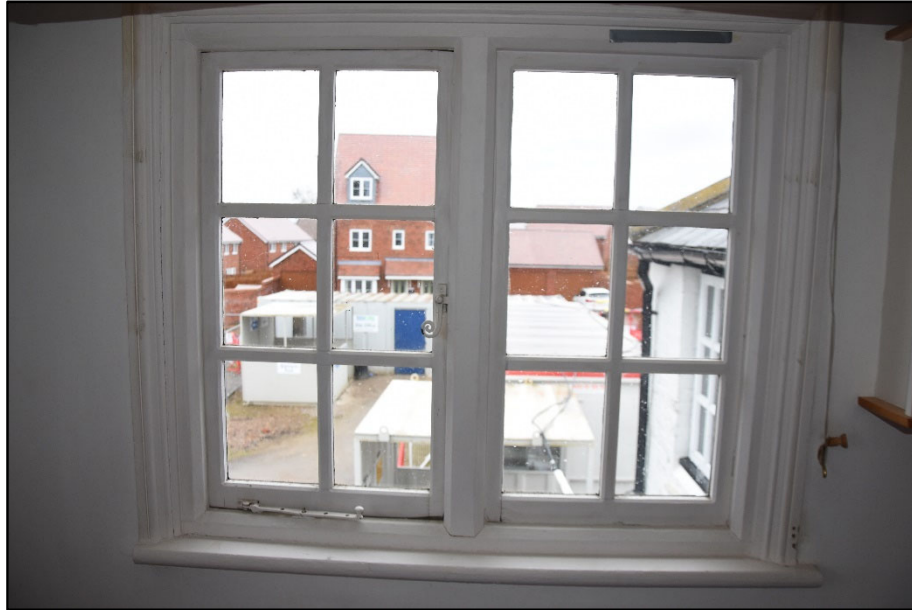
Window in FF11, looking north-west Fig 103

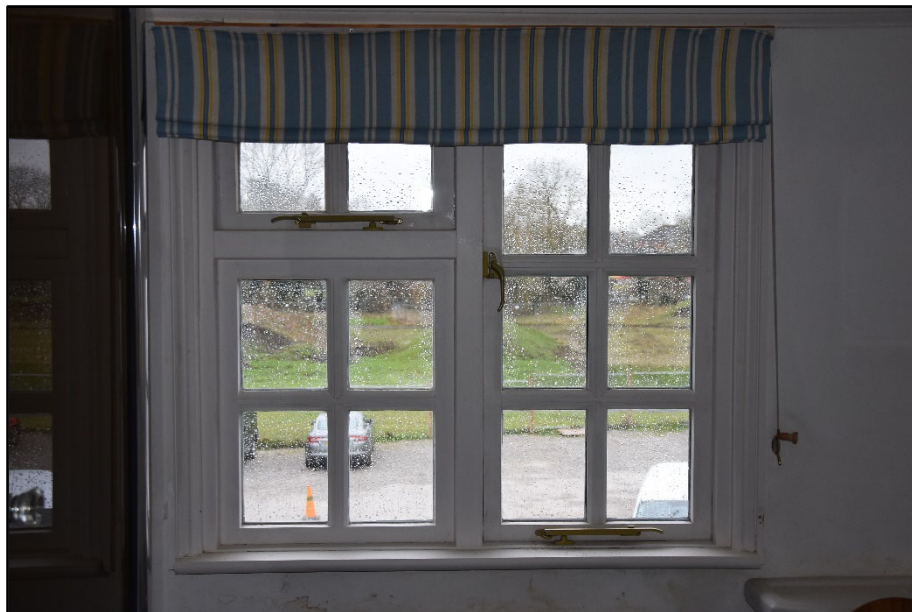
Window in FF11, looking south-west Fig 104

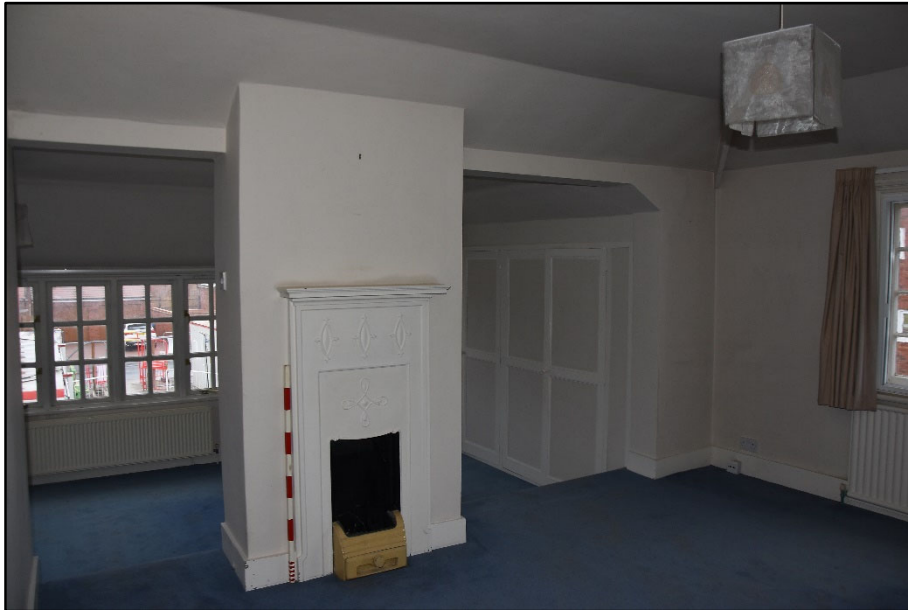
Interior of FF12, looking north-west Fig 105

Accessed only from FF10 this room is similarly decorated with a simple skirting and plain walls (Fig 105). There is a sloped ceiling to the north and west in line with the roof pitch above. A rafter is visible to the north-west to match that seen in FF11.

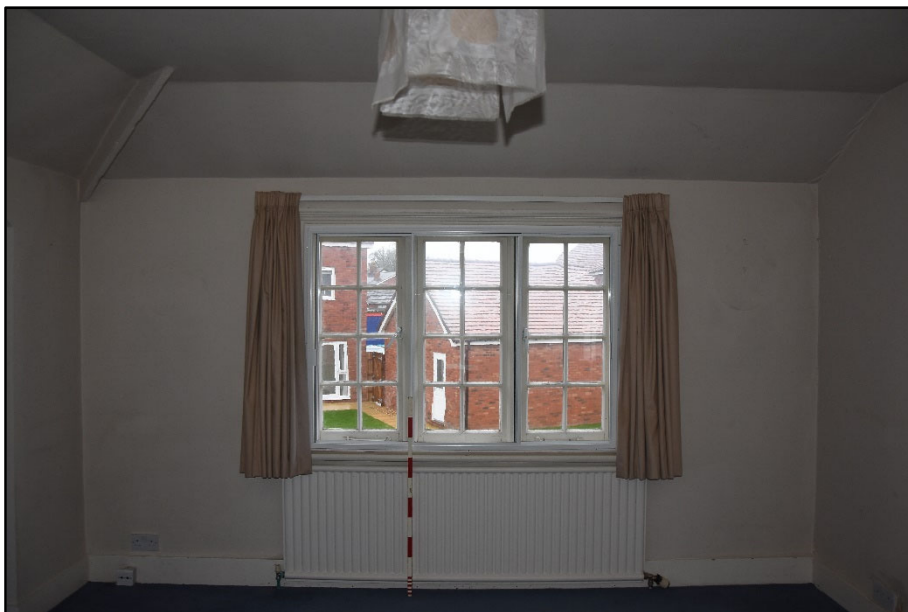
Window on the north wall of FF12, looking north-east Fig 106

To the north is a single window in moulded surround and secondary glazing. The catches and stay bars are modern (Fig 106). The glazing bar profile is simply chamfered.

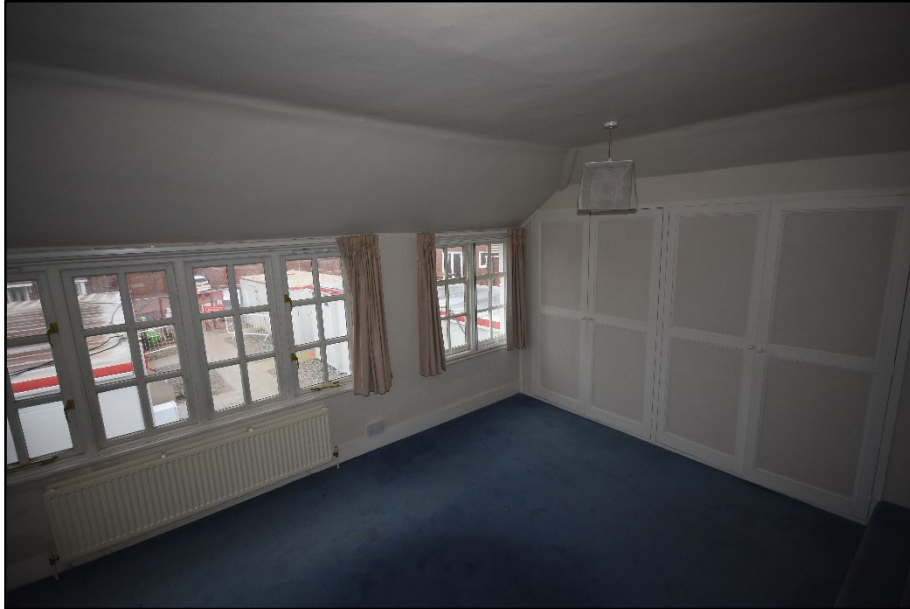
Interior of FF13, looking north Fig 107

Accessed only from FF12 this room is decorated in the same manner as the other rooms within this area. Formerly the dressing room there are fitted wardrobes to the north wall (Fig 107). The room is partly housed in the roof space with sloped ceilings to the west, south and north.

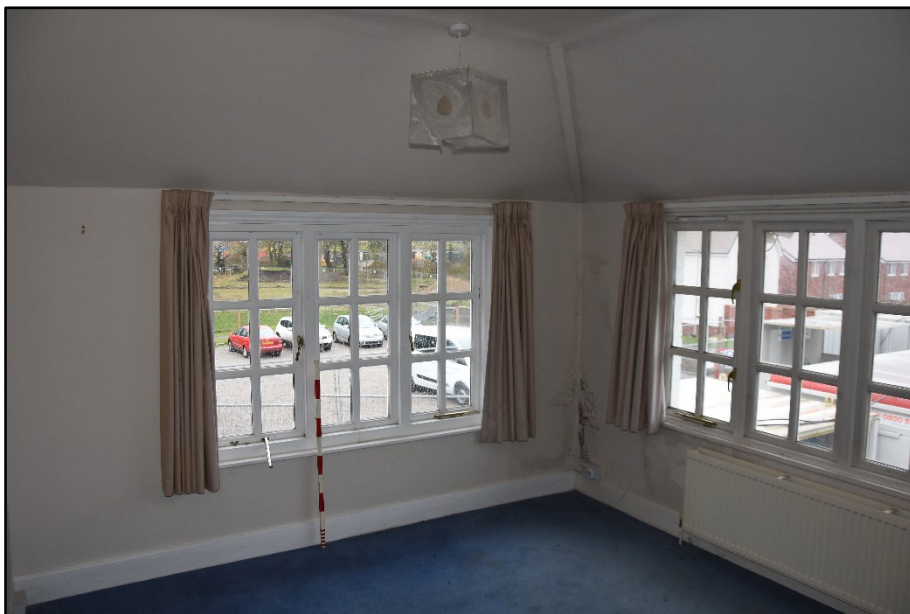
Interior of FF13, looking south-west Fig 108

There is a single window to the south wall in a simple moulded frame (Fig 108). The glazing bars are robust with a simple chamfer in profile. The catch and stay bars are

modern. To the west there are two windows. The southern window is of the same style as the window to the south wall. The window to the north has slender moulded glazing bars and a moulded surround.

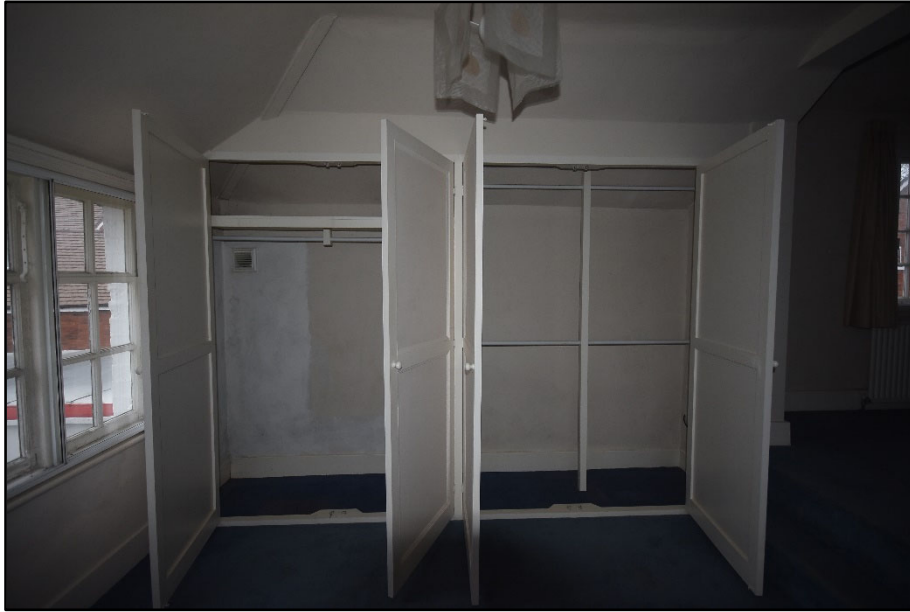
Interior of the cupboards in FF13, looking north-east Fig 109

The cupboards to the north are modern and the skirting can be seen within them. The rafter to the north-west is also visible within, continuing towards the outer corner of the room (Fig 109).

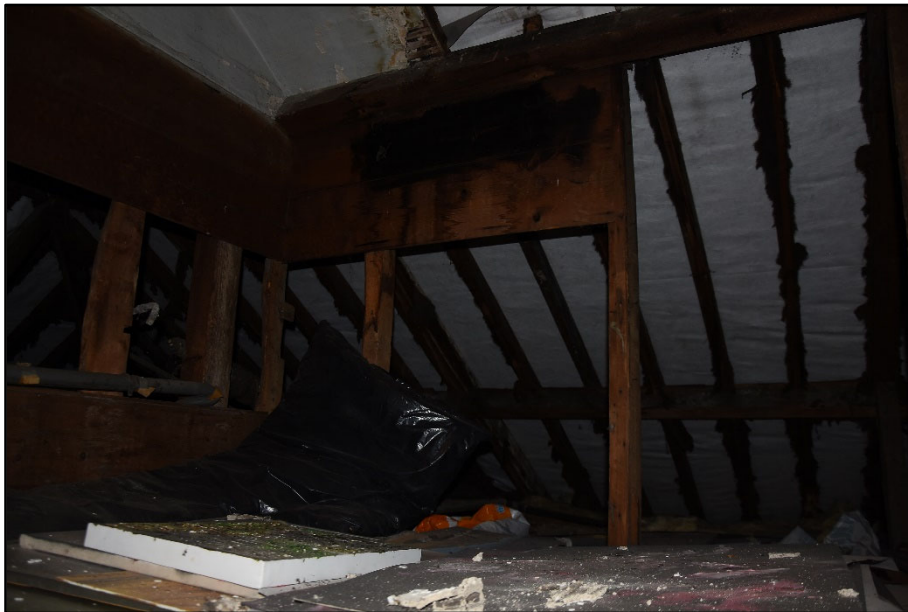
Formerly boarded attic space over the main range, looking west Fig 111

The roof hatch in FF01 provides access into the roof over the main range. It rises into the central area of the roof. This appears to have once been boarded and used for storage and confirms the sales particulars of 1879 entry as having attic space (Fig 111). Walls have been created using posts and timber boards. Above this the roof pitch exposes lath and plaster used to seal the area. This may have been here from the outset. There is a boarded roof light to the north (Fig 112).

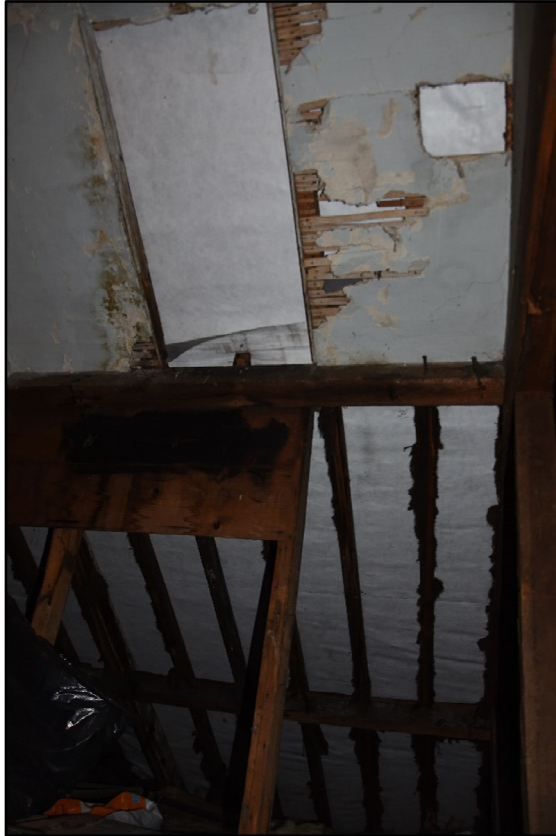
Lath and plaster around a former roof light, looking west Fig 112

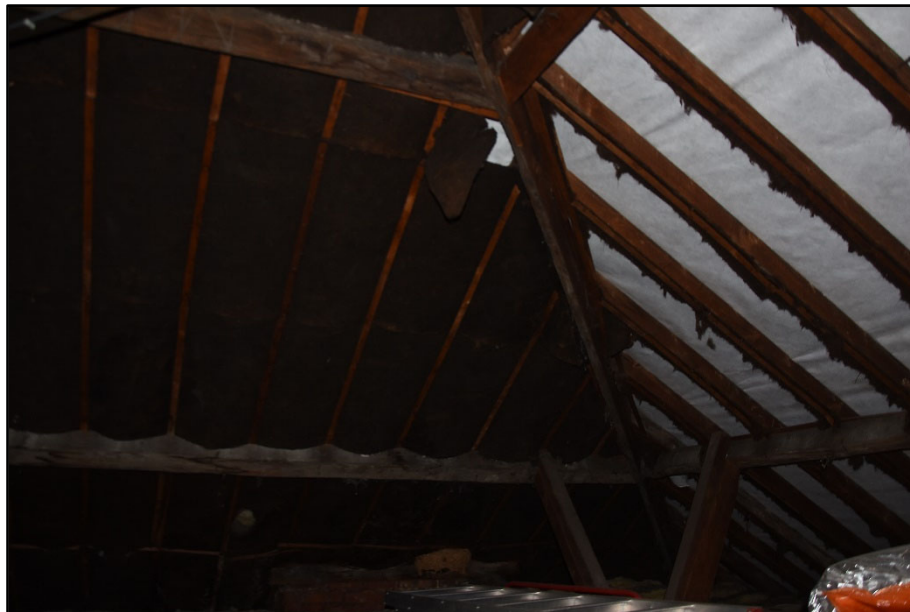
Roof structure over the main range, looking north-east Fig 113

The construction comprises a series of regularly spaced rafters and jack rafters which rise to meet the hip rafters. There are two purlins over which the rafters rise. To the corners the lower purlins are supported by two raking struts, and there is a central support along each elevation (Fig 113). The rafters show evidence of a felt covering, which has mostly now been removed but survives to the northern pitch.

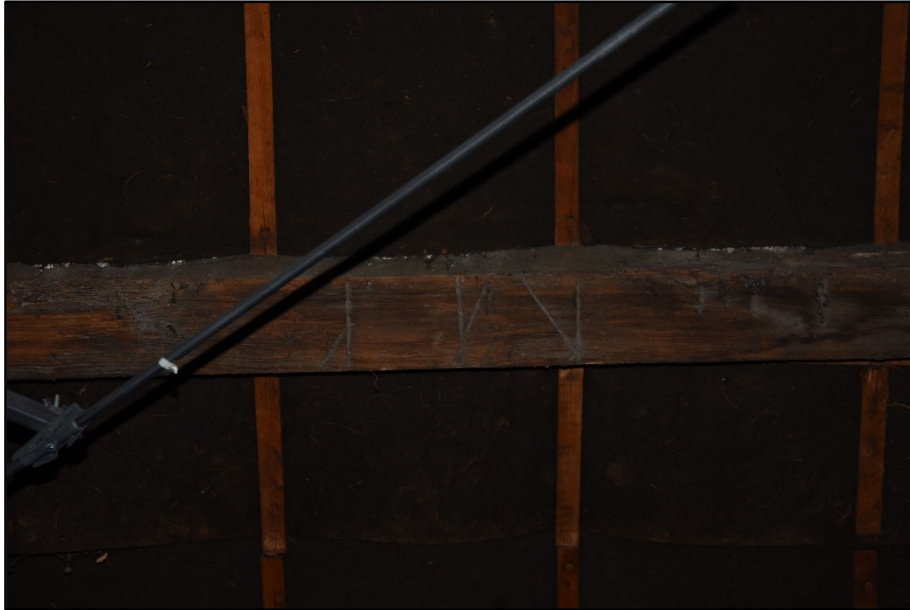
Fig 114

Suspected Baltic mark in the roof structure over the main range, looking north

There is one example of a carpentry mark, thought to be a Baltic bracking mark, to the upper purlin opposite the hatch (Fig 114).

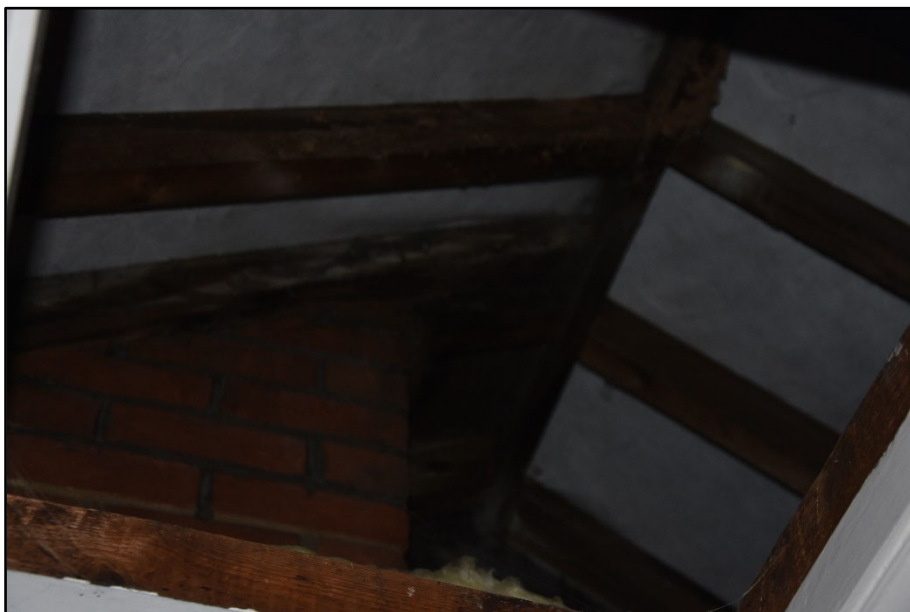
Roof structure over the rear range, accessed from FF09, looking east Fig 115

From a roof hatch in FF09 the roof of one of the rear ranges is visible. It could only be viewed from within the room, so information is limited. The brick stack rising through the roof can be seen (Fig 115). This accommodated the fireplaces in FF06 and FF09 presumably. The roof structure that was visible comprised softwood rafters rising to a ridgeboard. It appeared regular and the scantling was cleanly cut, presumably mechanically sawn.
