# PETERBOROUGH CATHEDRAL VAULT OF THE CROSSING TOWER

# A STUDY OF THE LATE FOURTEENTH-CENTURY TIMBER FRAME

Historical Analysis & Research Team Reports and Papers 82 2003

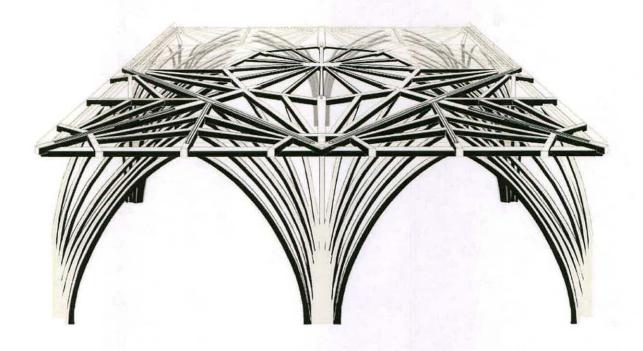
Figure 2
Perspective view of vault framing

Late-C14th timbers

Late-C19th replacement timbers
