THE OLD RECTORY,
UFFORD
CAMBRIDGESHIRE

A Report on the Historical Development of the House

Susie Barson and Richard Bond

Reports and Papers No. 44

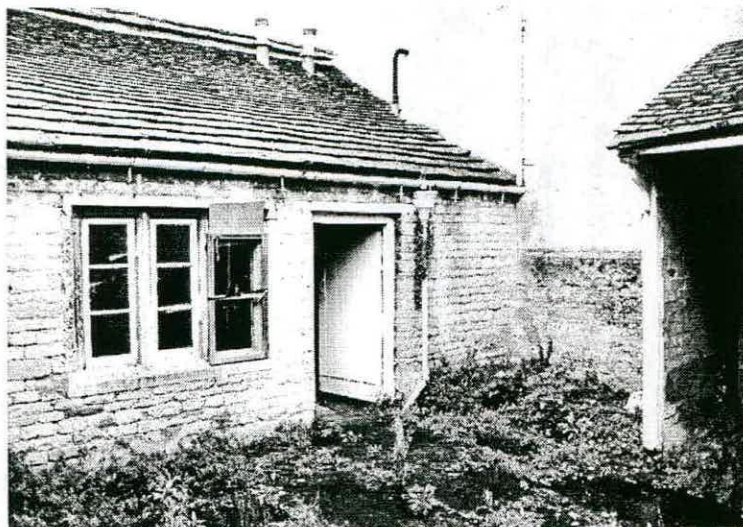
Figure 7 Single-storey addition at west end of house

At the west end of the house in the front (south) wall of the cellar is a mullion and transom window with ovolo-moulded stone cross members. At ground floor level, towards the north (rear) end of the exterior side wall of the same wing is another three-light stone window with ovolo-moulded mullions. The window is set a high level, possibly to avoid an extension or lean-to on this side of the house (*Figure 6*). Adjoining the west wing is a later single-storey structure (the plinth of the cross wing being continuous along the entire length of the wall) aligned N-S, i.e. at right angles to the west wall of the wing. This is probably a later 17th century addition - possibly a brewhouse - which, like the wing itself, also includes an ovolo-moulded stone window in its south front wall.

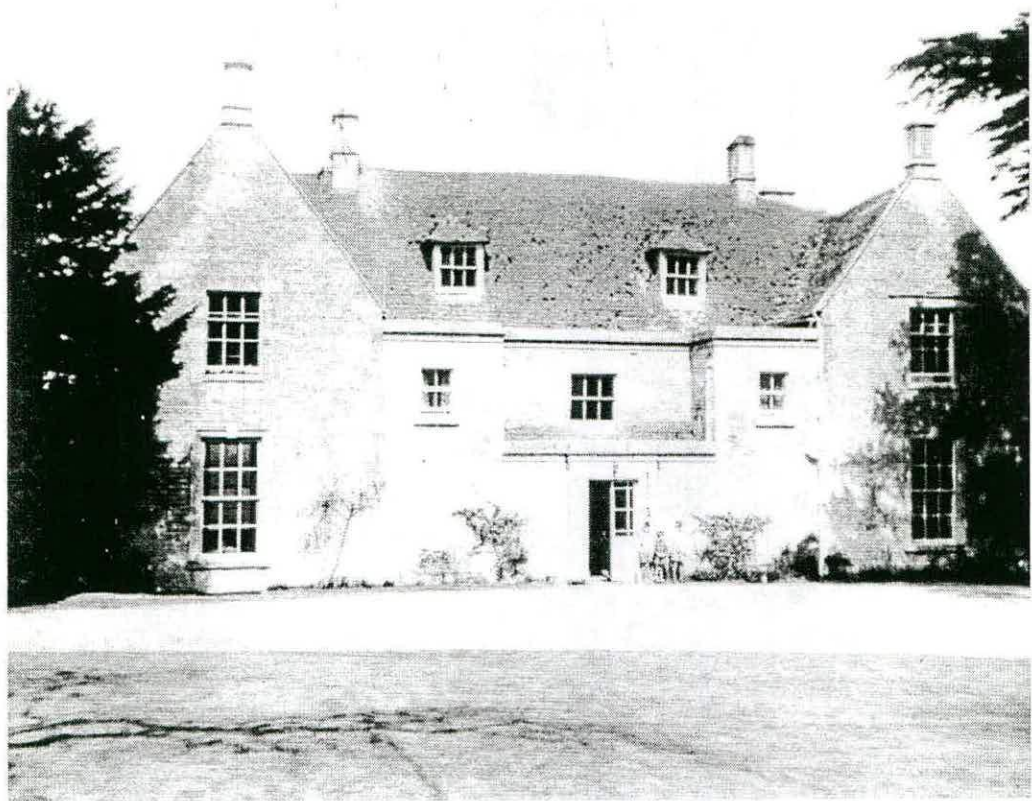
Figure 19 Photograph of south front of house taken in 1958

Some time between 1817 (faculty plans) and 1958 (the date of a photograph taken of the south front) the front wall of the hall range was taken down and rebuilt on a new alignment further outwards to create a symmetrical, balanced composition with the cross wings. At the centre of the wall at first floor level, the earlier (presumably medieval) wall line was maintained to create a central recess above the main entrance (Figure 19).

The south front has undergone significant changes since photographs were taken in 1958 (Figure 19). The area in the central part of the house on the first floor has been infilled to create a small room, which gives

out through French windows onto a projecting stone porch. (The original door contained double doors, with glazed panels and marginal lights on the upper part). Flanking the porch are new window openings to increase the light into the lateral passage and entrance hall beyond.
