The Church of St George,
Castle Way, Hanworth,
London Borough of Hounslow

*Notes on the medieval and early nineteenth century
church*

Historical Analysis & Research Team

Reports and Papers 40

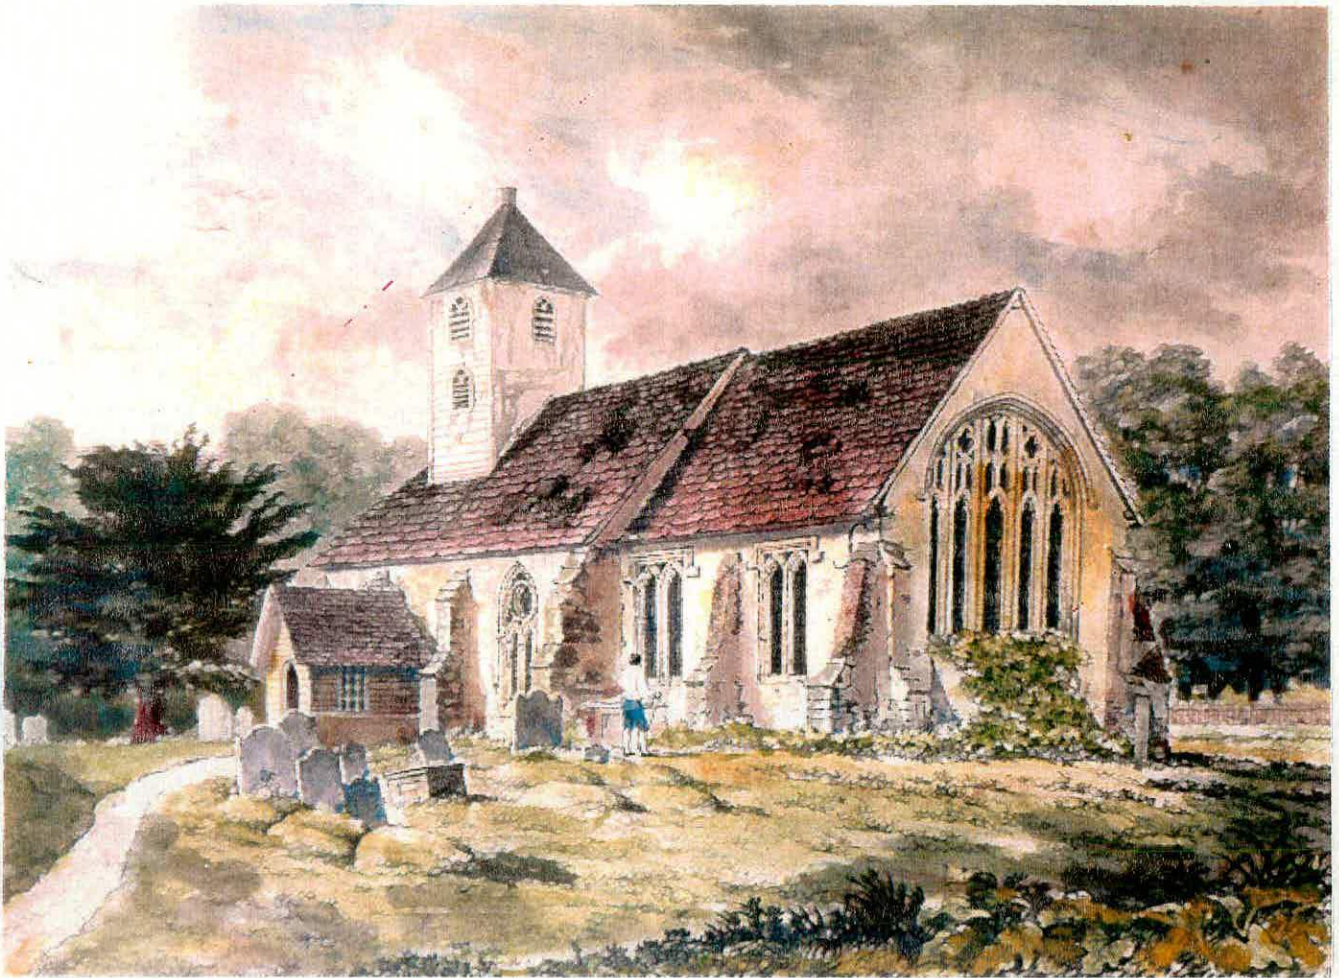
Figure 2, an aquatint on paper of the church viewed from the south east by Joseph Charles Barrow, 1790, engraved by George Isham Parkyns and published by Joseph Charles Barrow (Guildhall Collection)

According to the historical views (Figure 2 to Figure 4), four buttresses divided the south wall of the medieval nave into three bays. In the present arrangement, five buttresses divide the nave into four bays. If the medieval foundations and bay divisions were retained, then the nave was extended by one bay at the east end. There is, however, no discernible break in the construction of the present south wall of the nave to indicate that only the east bay dates from the extension. The whole of the south wall of the nave therefore appears to be of one build, which dates from or post-dates the eastward extension of the medieval nave.

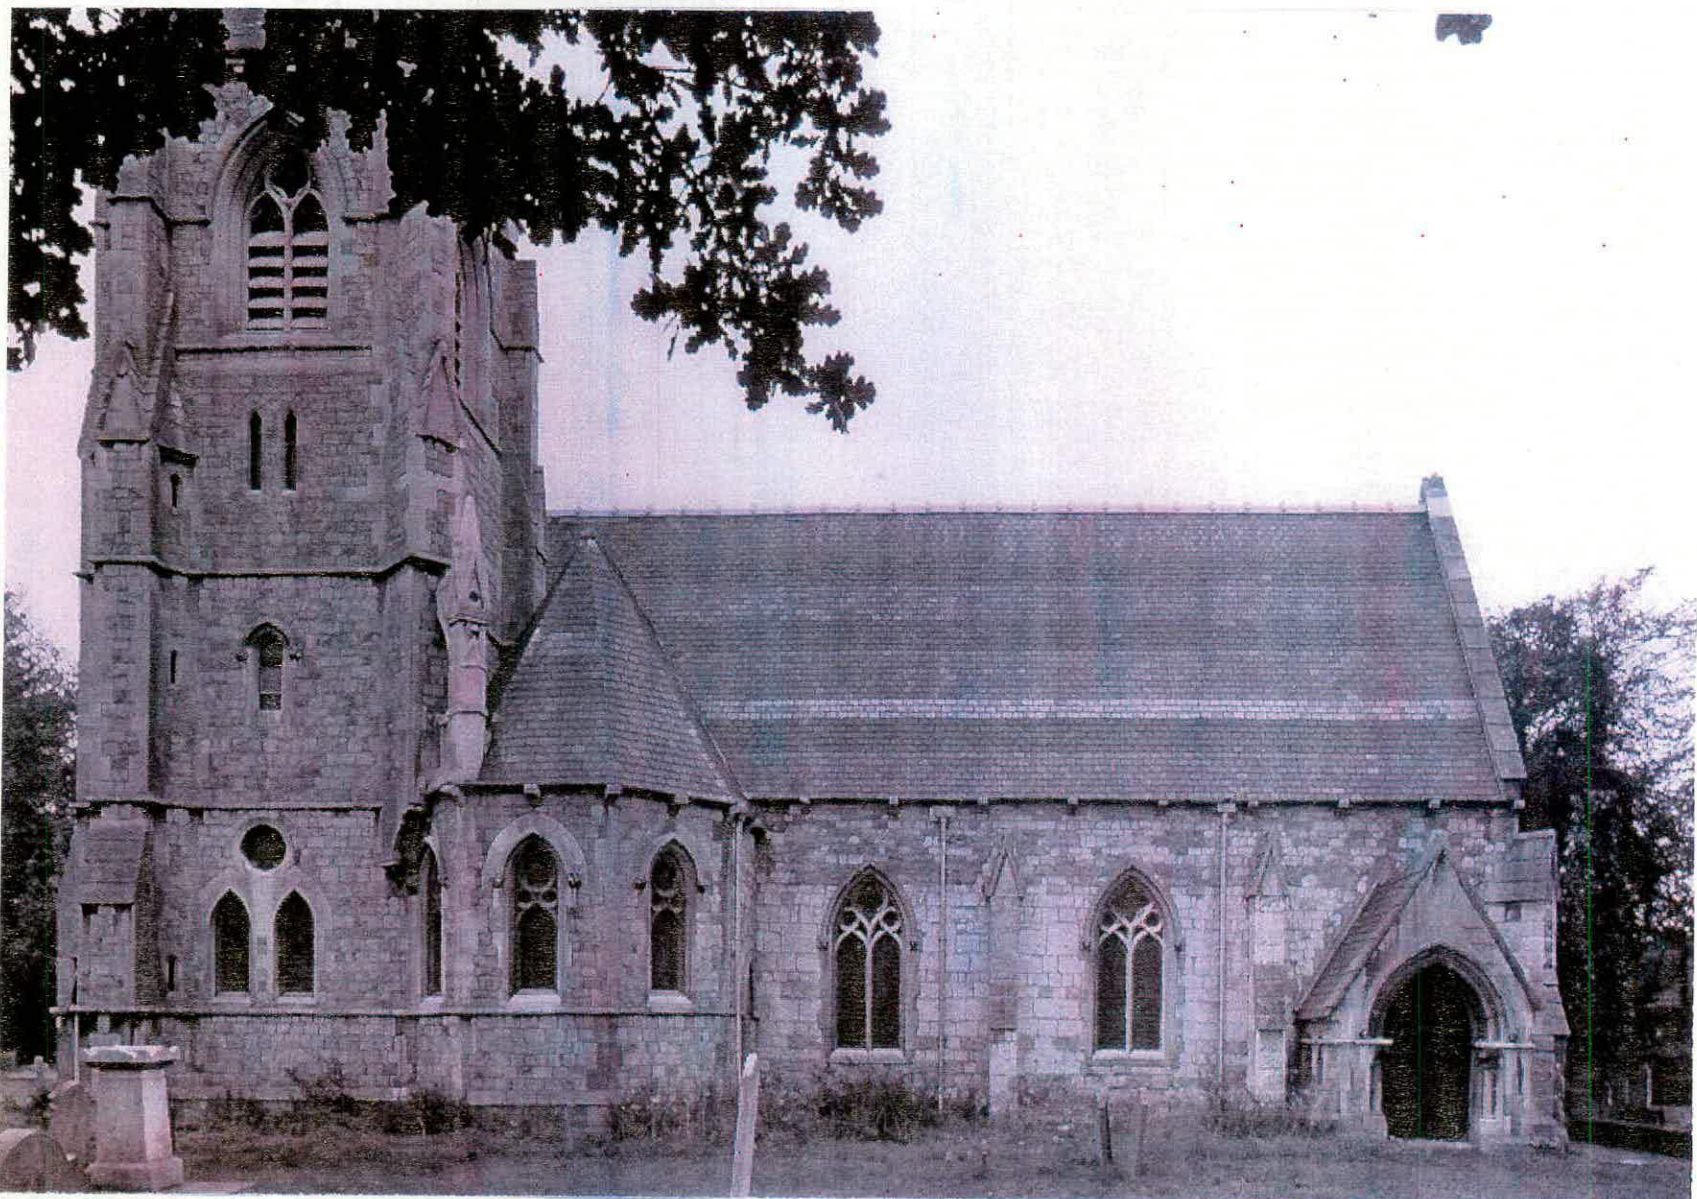
Figure 11, the north elevation of the church, 1991 (photograph English Heritage)

The two types of construction evident in the north and south walls of the nave (Figure 10 and Figure 11) suggest two discrete phases of building activity even though it is argued in this report that in their present context, both derive from Wyatt's rebuild of the early nineteenth century. The two groups of building material may well however relate to two phases within the construction of the medieval church. The ragstone probably derives from the fourteenth century nave and the ashlar from the chancel, which, based on its windows probably dates from the fifteenth century.

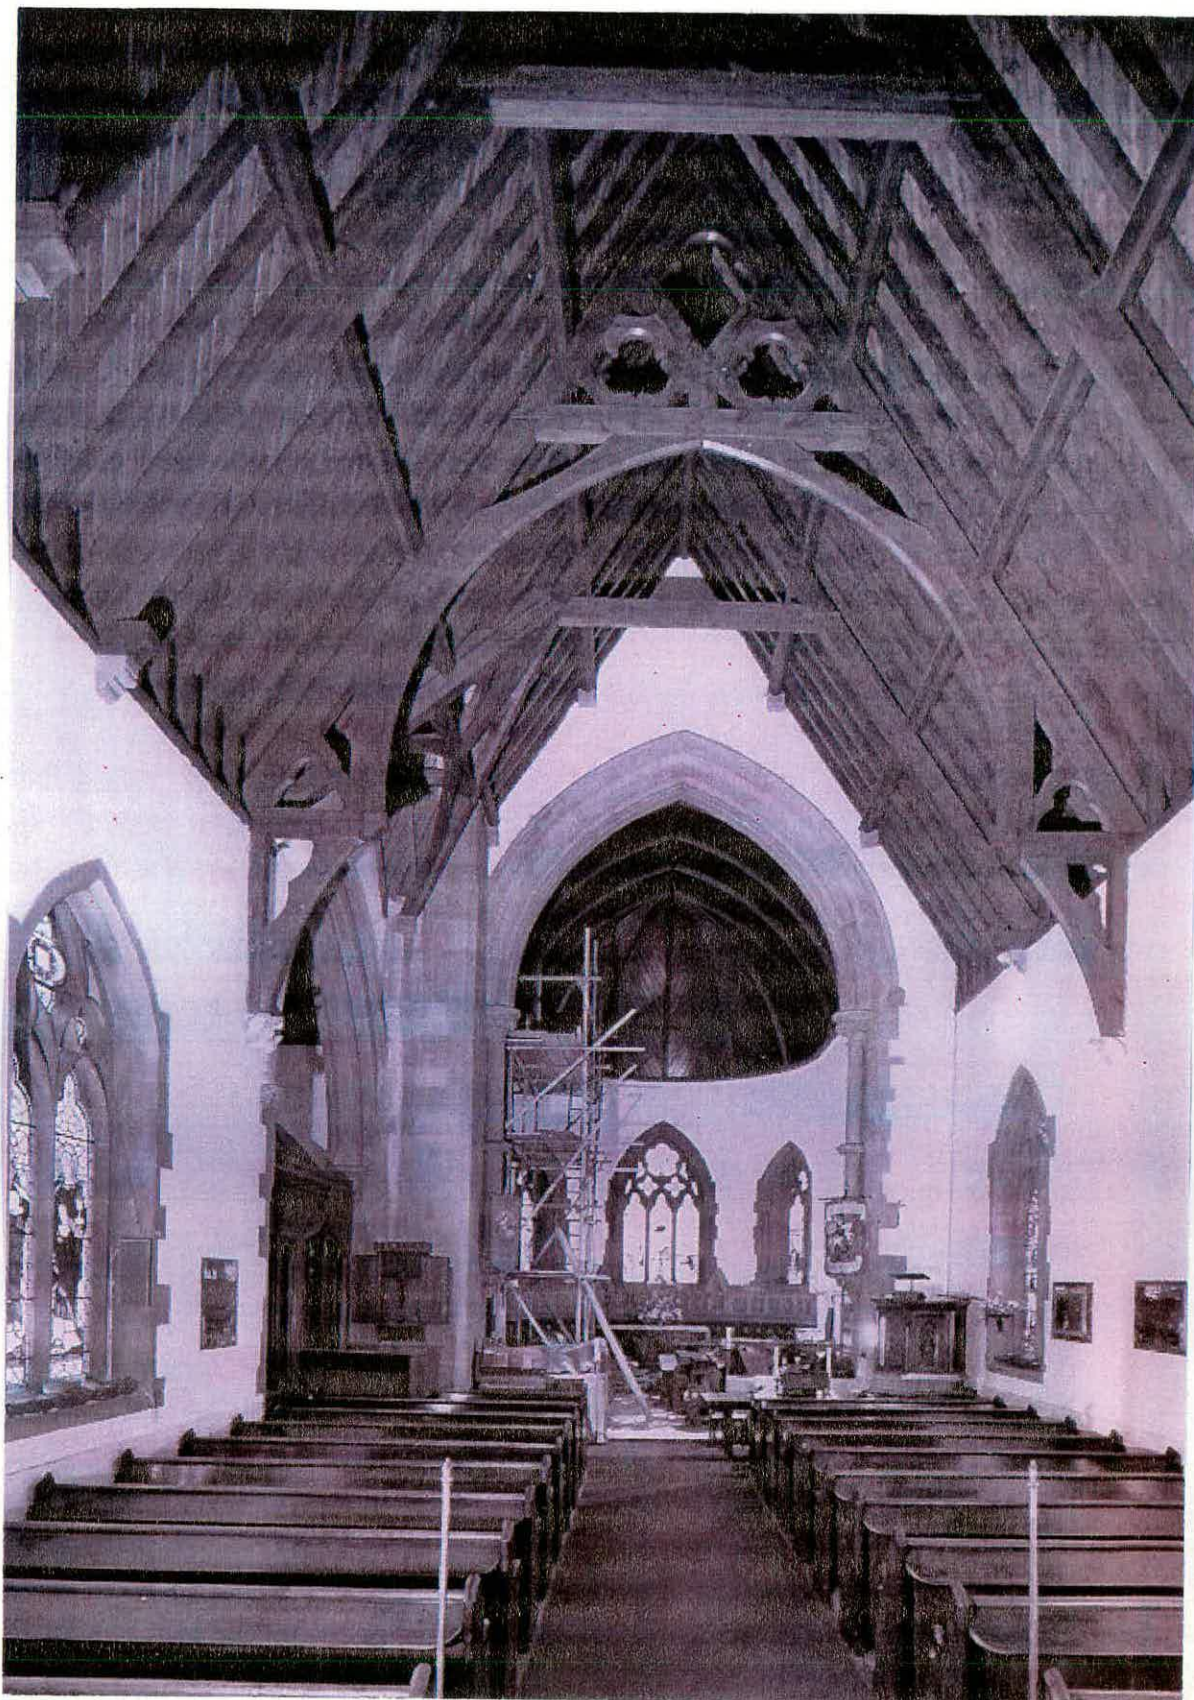
Figure 13, the interior of the nave looking west, 1991 (photograph English Heritage)

The present roof above the nave could be described as a hammerbeam (Figure 13). This is how Wyatt's roof was described in 1853 and, consequently, it remains to be demonstrated that this roof is by Teulon. First, the roof structure above Teulon's addition of the 'north transept' appears to be consistent with that above the nave. Second, the design, although not particularly impressive as an example of Victorian Gothic from the 1860s, is bolder than any known to be by James Wyatt. The use of large cusps, trefoils and a simple chamfered section contributes to this boldness. Wyatt's hammerbeam roof above the entrance hall to Fonthill, for example, was much more Perpendicular in style with trefoil head panels above the collar. And thirdly, the rebuilding of the upper parts of the nave south and west walls appears to present an identifiable phase distinct from Wyatt's work. It therefore seems reasonable to attribute the roof to Teulon. Wyatt's church was capped with a crenellated parapet, which it seems Teulon removed. He would also have avoided the use of render. In rebuilding the upper parts of the nave, it seems he attempted to match the existing wall surfaces to north and south. The timber structure of the roof is uniform throughout, so it seems unlikely that he would have reused any of Wyatt's timbers. The reason for the replacement of the roof was probably to do with the pitch. The Ecclesiological aesthetic of the 1860s required a steeper pitch than that which Wyatt adopted. This much is evident from the Rev Spering's description of the church. That Wyatt's roof was less steeply pitched than Teulon's chancel roof can be seen in Teulon's north elevation (Figure 6). It is not clear, however, how Teulon intended to manage the junction between the two roofs. It was perhaps this problem, in combination with the desired aesthetic, which prompted the replacement of Wyatt's roof (Figure 16).
