New Sedgwick Gunpowder Works,
Cumbria:
an archaeological
and architectural survey

SURVEY REPORT

Archaeological Investigation Report Series AI/19/2003

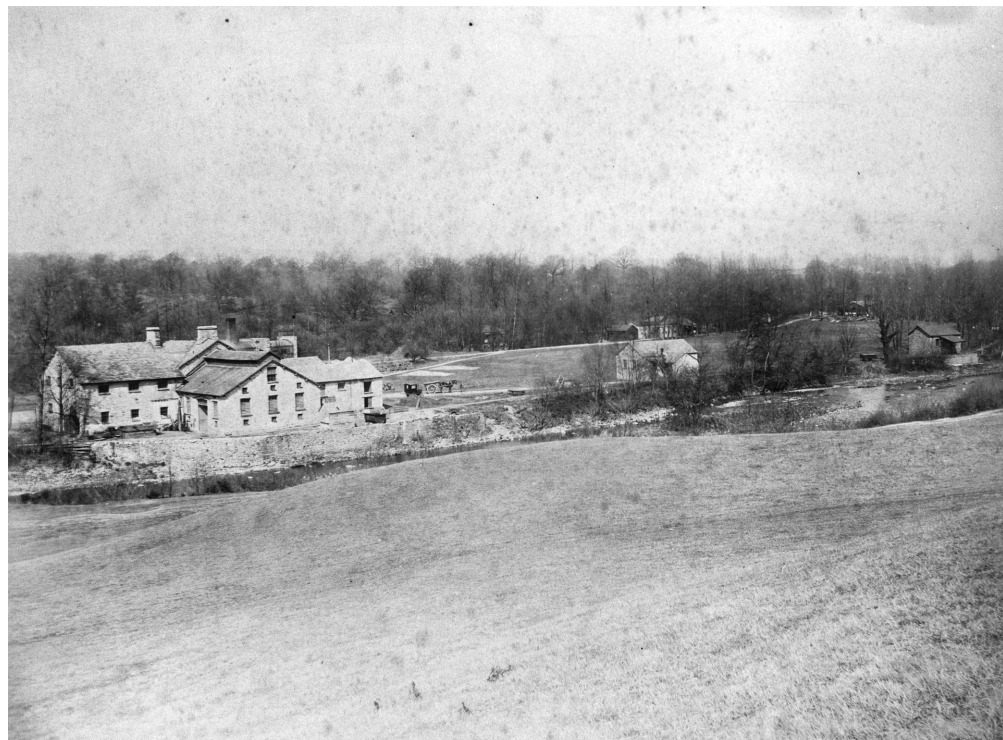
Figure 8.
View from the east showing the saltpetre refinery complex and other buildings in the main part of the works, by J H Hogg (one of 'the 1873-1875 photographs'). (NMR: AA022282, reproduced by permission of David Willacy)

house which was built after the first glaze house blew up in 1903. Two photographs in this collection are much earlier and were taken by J H Hogg of Kendal, probably between 1873 and 1875. One of them (Fig 8) is of particular importance because it is a view across the main part of the works from the east and shows buildings such as the saltpetre house which no longer survive. This photograph also provides its own internal dating evidence because it shows the heading house erected in 1873 and the powder press house which blew up in 1875 (the replacement press house was built at a new location). The other photograph (Fig 9) is of the unlicensed area at the southern end of the works and buildings, such as the clock tower above the turbine house, are visible. In this report these images will be referred to as the 1873-1875 photographs.

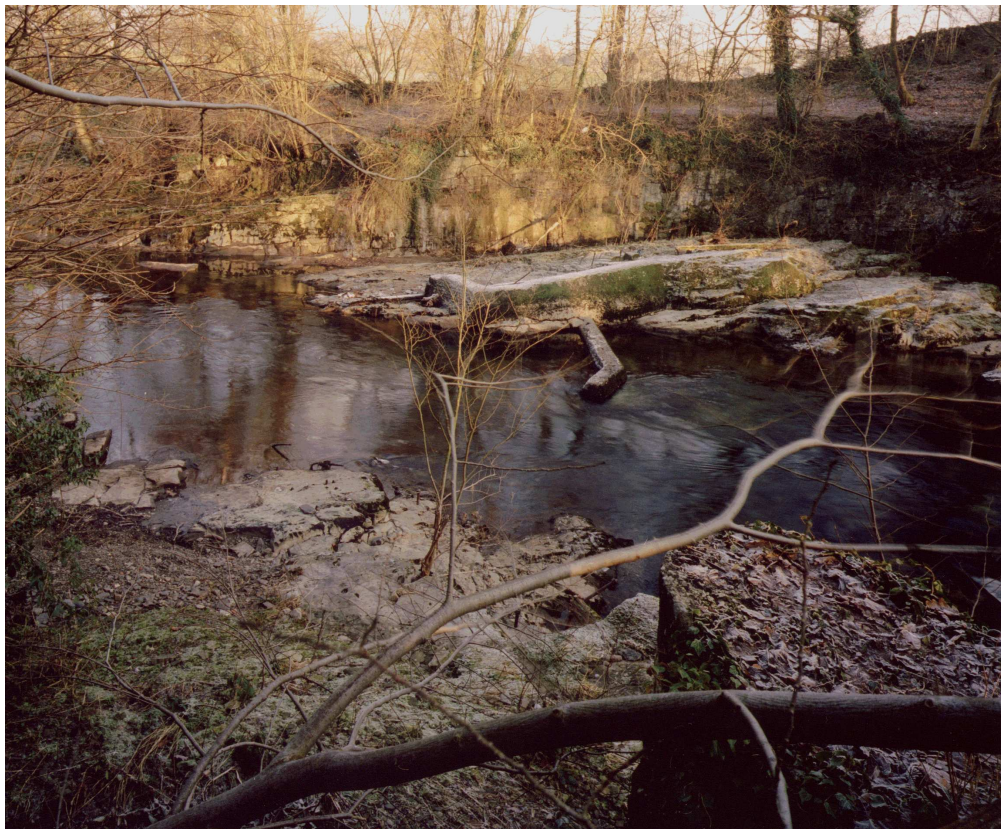
Figure 11.
*The weir and fish pass
from the south west.*
(NMR: AA012908)

remains of a fish pass also survive and consist of a concrete wall, 'L'-shaped in plan, extending from the rocky shelf into the river on the south side of the weir (Fig 11). Below and coming off the southern side of the main wall is a second but much smaller concrete wall, also angled towards one end. According to Davies-Shiel (*pers comm*) there was fierce litigation concerning the weir because the riparian owner on the east bank of the Kent did not want the weir to abut his land and hence the eastern side was designed as a fish ladder. The weir at the nearby Basingill Works also had a fish pass (Hunt and Goodall 2002, 14). On the edge of the riverbank, near the entrance to the leat, are traces of the western side of the 'V'-shaped weir consisting of iron bolts, some with nuts still attached, set in bedrock together with remains of timbers, one of which protrudes from a concrete housing. Iron rods are also visible north of the leat entrance but it is not clear how these related to the weir. No doubt the 'V'-shaped weir was repaired or refurbished from time to time, so all the surviving features may not be contemporary. A short distance south of the remains of this weir at least two iron rods protrude from the riverbed, but it was not possible to record their positions due to the depth of the water. They appear to be associated with a line across the river where the water seems to break - perhaps these features are related to the original straight weir.

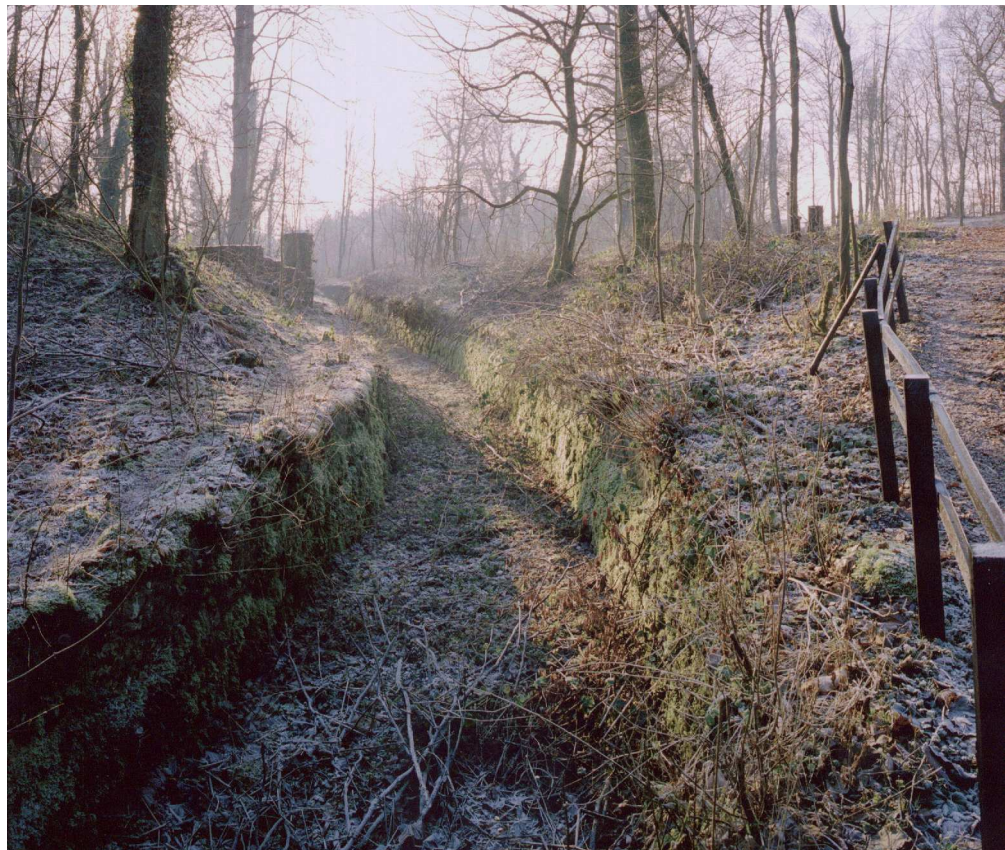
Figure 12.
The main leat looking south from near the incorporating mills (blast walls of green charge house visible above on left). (NMR: AA012871)

The leat was designed to make maximum use of the head of water by means of a series of enlargements and constrictions in its width at a number of places along its course, thereby ensuring a sufficient flow of water at key points. The leat is 3.5m wide until just before it reaches incorporating mills 1 to 6 where it broadens, in effect forming a small mill pond to feed the wheel. It narrows to 2.5m beyond the incorporating mills (Fig 12) and then swells slightly beside the entrance to the turbine pit of the preparing house, again forming a

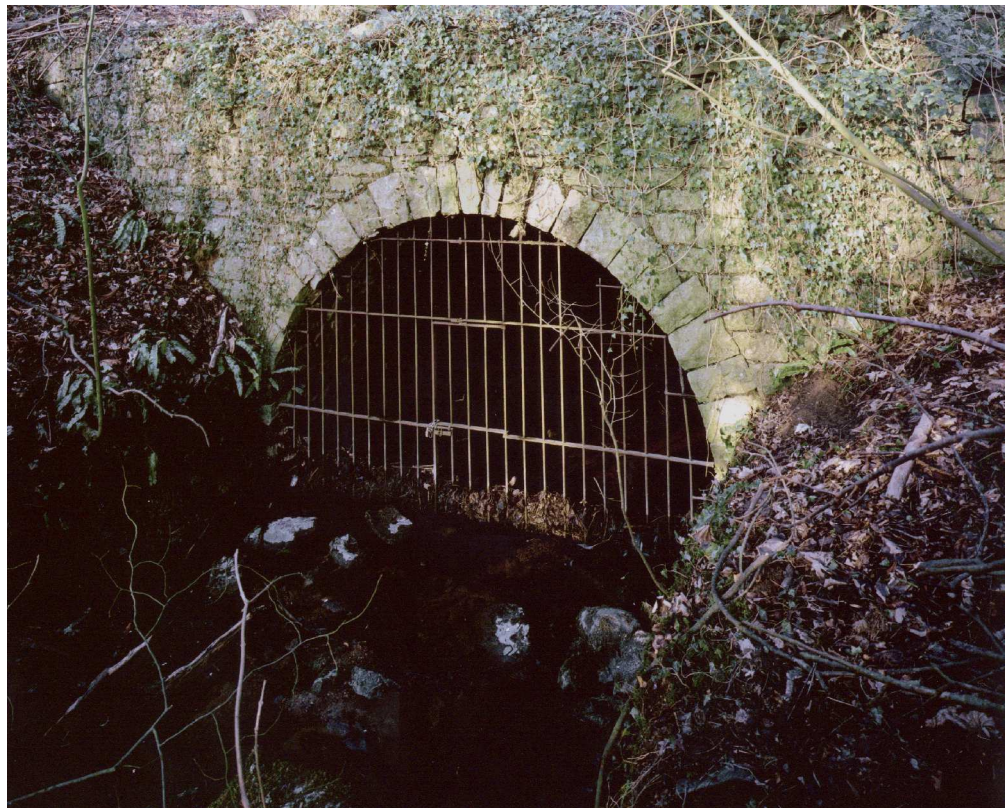
Figure 13.
*The arched exit of the
main tailrace from the
south east.*
(NMR: AA012903)

The return of spent water to the River Kent from the various process houses was also carefully managed. The first glaze house and later the new glaze house and reel house were situated close enough to the riverbank for the used water to be discharged straight into the Kent via a very short tailrace from each building. However, the coming house was located some distance from the river and spent water from its turbine house entered a culverted tailrace that was constructed east of and probably parallel to the main leat. Further to the south, tributary tailraces from both the incorporating mills and the preparing house joined this underground channel. The preparing house was situated on the western side of the leat, which meant that in order to gain access to the main tailrace, spent water from the turbine pit of the preparing house must have been routed in a culvert underneath the leat. The main tailrace emerges from underground in the face of the river terrace on which the works is built, some 30m to the south east of the former preparing house, and extends as an open channel for 30m to the river. It exits the terrace through a monumental arched entrance, 3.9m wide and 2.5m high, which is flush with a coursed revetment wall above (Fig 13). The interior of the culvert was not investigated for safety reasons, and to prevent access iron railings have in recent years been erected across the entrance. However, it is still possible to look into the southern part of the culvert through the arched entrance, and this reveals a tunnel-like channel curving gently to the east, while on its western side the opening of the tailrace from the preparing mill is also visible. A photograph from this location and showing these underground features is reproduced in Tyler (2002, 217). The sides of

the outflow channel leading from the arched entrance to the river are strongly revetted in stone at the river's edge to a maximum height of 2m.

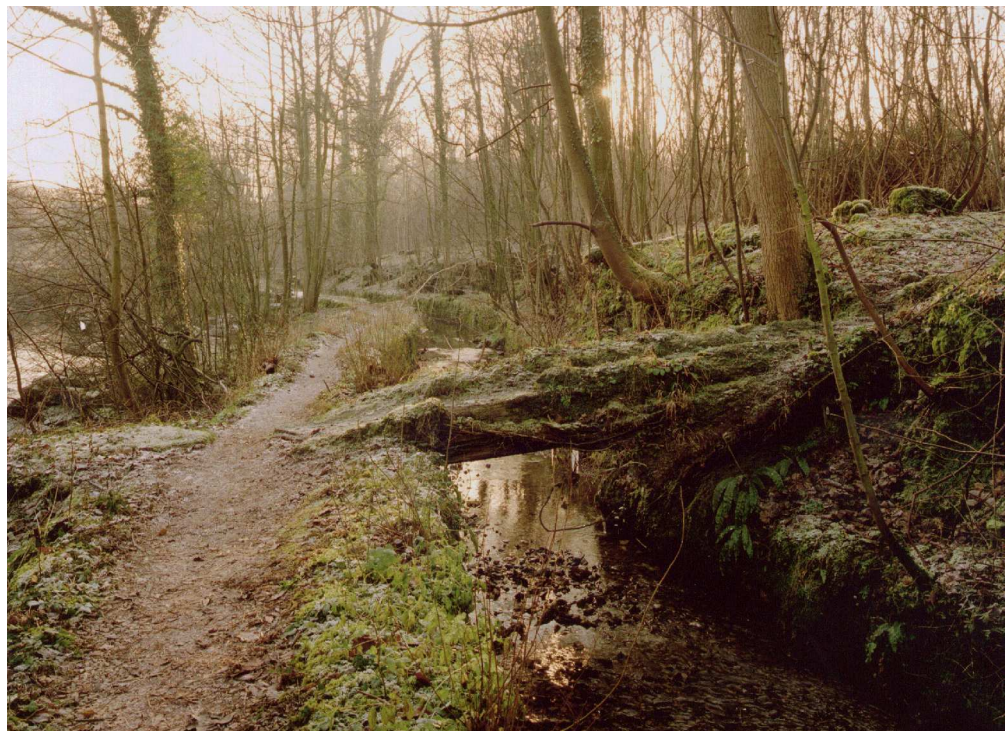
Figure 14.
*The aqueduct
and main leat
from the north.*
(NMR: AA012923)

By 1912 (Ordnance Survey 1914b) the stream at the northern end of the site was prevented from draining into the main leat as a result of the construction of a small aqueduct which carried the water across the leat to the riverbank (Fig 14). The aqueduct still survives and appears to be made of timbers held together with iron bolts; it measures about 1.1m wide overall. The sides and base of the water channel that it carried are thickly encrusted with limescale - any structural details are thus masked. The reason for the aqueduct is uncertain. It may have been simply to stop stream water undermining the revetment wall of the leat and to formalise the drainage path of the steam here. It could also have been an attempt to stop lime-rich water entering the leat and furring up the workings of turbines or other machinery. In this respect it may be relevant that its construction seems to coincide with that of the

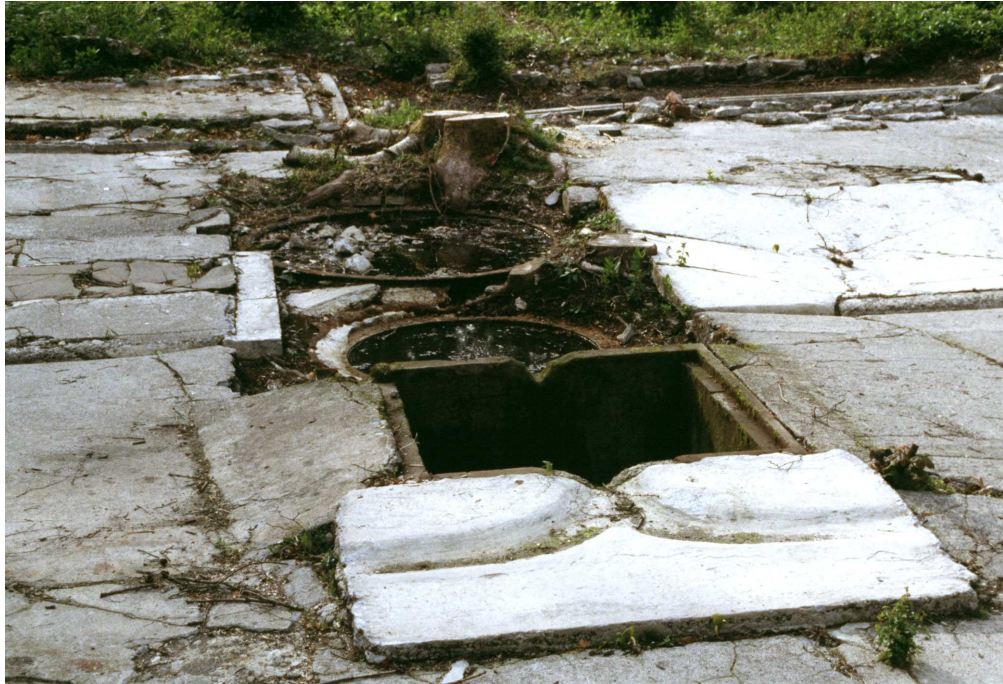
Figure 15.
*The tank and cast -
 iron basins in the floor
 of the saltpetre
 refinery, from the
 south east.
 (NMR: DP001578,
 reproduced by
 permission of
 Christopher Dunn)*

Towards the end of 2002, by which time the EH survey had been completed in the field, the National Trust cleared the leaf mould and felled the saplings growing over the site of the refinery block. This revealed the floor to be surfaced with either large flagstones or areas of concrete. Immediately north west of the central tank clearance exposed a slightly lowered area in the floor (the north-east and south-west concrete edges were recorded by the EH survey) in which are sunk two large cast-iron basins that form a line with the tank (Fig 15). The furthest (upper) basin from the tank is at a slightly higher level than its companion (as is the rest of the floor in the north-west part of the refinery) and measures 1.9m across

although, like the other (lower) basin, its upper part may have been truncated when the refinery was demolished; the lower basin is 1.7m in diameter. EH revisited this part of the site in January 2003, but on this occasion the basins were full of frozen water so it was not possible to record their depths, but they may be fairly shallow. They were still visible as surface features as late as 1977 when Davies-Shiel photographed this part of the site. Perhaps they are the basal elements of the two large pans in the refinery mentioned in Faulkner's notebook (see section 4.1 above). The clearance also exposed a number of channels, about 0.15 in width and depth, in the floor that may have transported liquid to or from the tank and basins (or have collected spills). There is one on either side of these latter features set some 2.2m in from the south-west and north-east walls of the building to which they are parallel. Arms extend at right angles from both channels towards the bifurcated groove on the south-east lip of the tank and also towards the lower basin; near the latter one has the remnants of a cast-iron trough in it. The floor at the north-west end of the building contains eight square post sockets, each about 0.2m across and 0.05m deep, arranged in two groups and separated by the upper basin. They must relate to former structures and each group contains four sockets spaced about 1.9m apart and forming a square. A vertical cast-iron pipe, 0.11m in diameter, protrudes through the floor near the northernmost group. A short channel is also visible in the floor beyond the south-west group of sockets and near the north-west wall of the refinery to which it is parallel; it seems to link up with a series of other channels exposed immediately outside (north west) this part of the building where clearance has also revealed fragmentary walls and a concrete floor. None of these recently exposed features have been added to the EH plan.

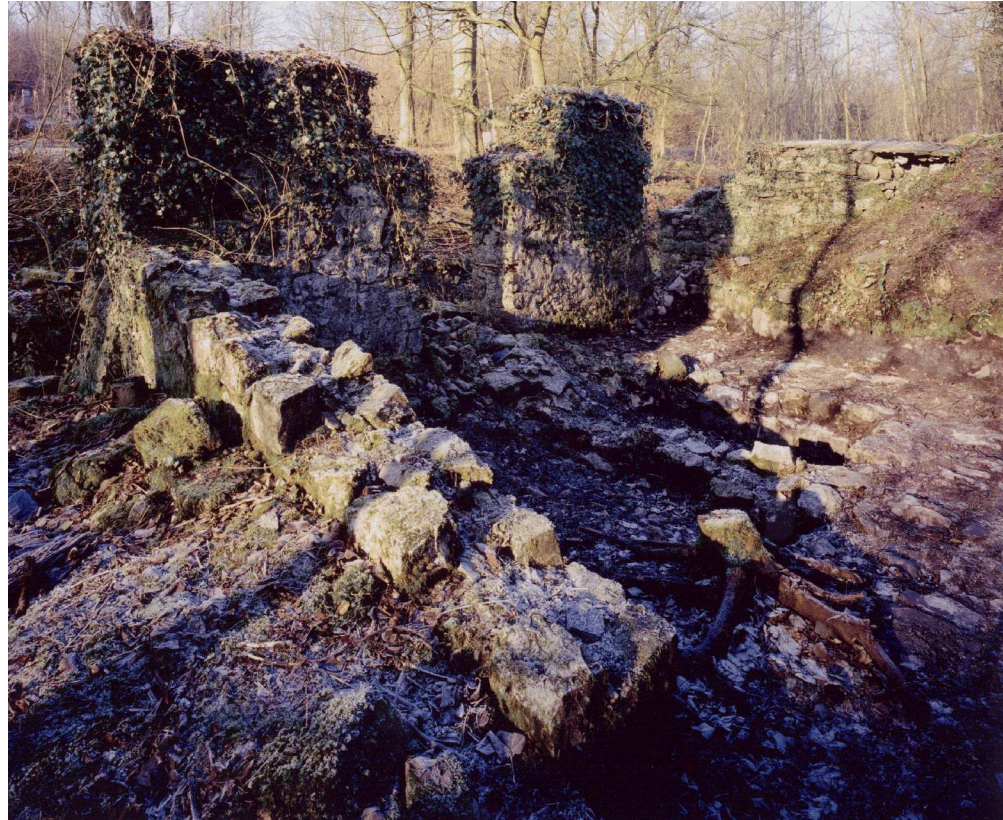
Figure 16.
*The site of the green
 charge house from the
 south east.*
 (NMR: AA012875)

The charge house proper no longer survives but the three blast walls and blast bank revetment that surrounded it are well preserved (Fig 16). The building was presumably of timber and was cut into (or partly enclosed by) the south-western end of an earthen blast bank, a maximum of 4.8m high but which gradually tapers away to the south. Immediately adjacent to the charge house, the cutting into the blast bank is revetted with stone to a height of 1.1m. At its west end the revetment butts against a short blast wall (the northern blast wall)

of coursed rubble, orientated east to west and measuring 3.6m long, 1.9m high and 0.6m wide. Another blast wall (the western blast wall) lies to the south of the west end of the northern blast wall and is separated from the latter by a 1.2m wide gap. It seems quite likely that the inner face of the western blast wall formed one side of the charge house, which must have butted up against it. This blast wall is 2.6m high and 0.6m wide and has the remains of a doorway in its centre that presumably allowed entry to the building from the tramway. The lintel and stonework above the doorway has recently collapsed. The northern end of the wall exhibits a curious form of construction because its upper part has been built on top of a crudely formed buttress. The latter, together with the curving course of the revetment of the blast bank, has the effect of reducing the width of the gap between the ends of the western and northern blast walls - a surprising feature if this gap also served as an entrance. An iron hook fixed into the end of the wall above the buttress also survives. At the southern end of this blast wall there is a butt joint where another wall (the southern blast wall), orientated east to west, joins it on the east. This third blast wall is also 0.6m wide and now tapers (west to east) from 1.3m to 0.5m in height. At the east it terminates before reaching the revetment wall of the blast bank providing a 1.9m wide entrance into the area occupied by the east end of the charge house.

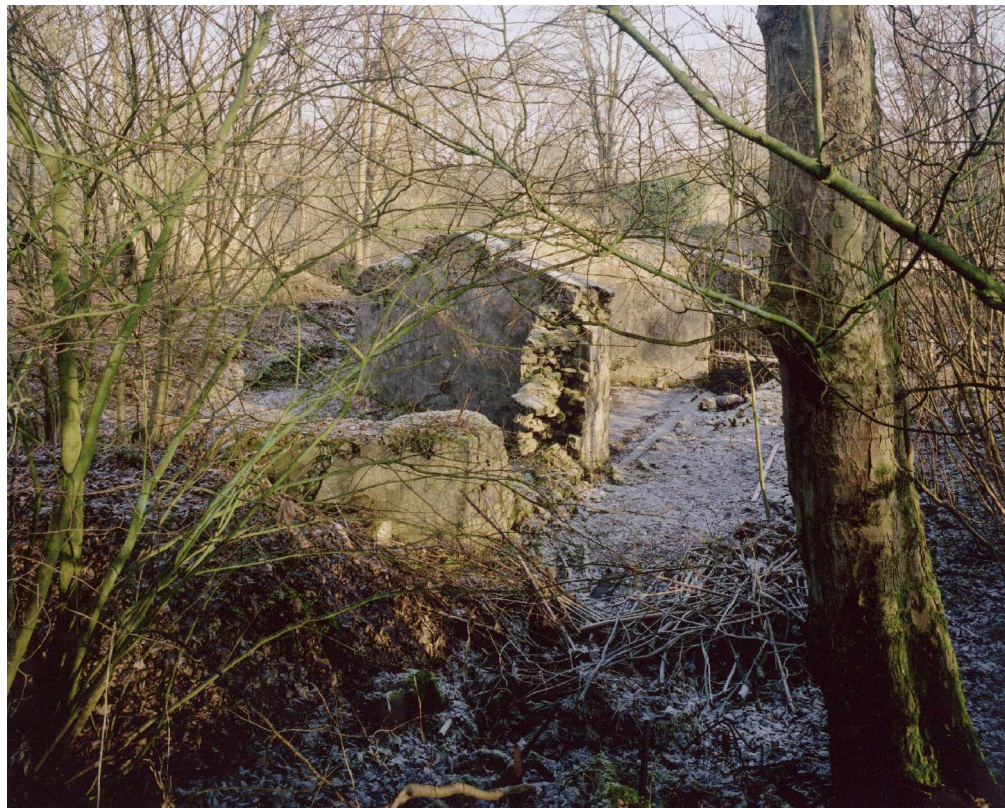
Figure 18.
*Incorporating mills 1-3
from the west with
waterwheel house and
other mills in
background
(chamber of mill 1 in
left foreground almost
completely obscured
by dumping).
(NMR: AA012884)*

Incorporating mills 1-6 (6) (Fig 18)

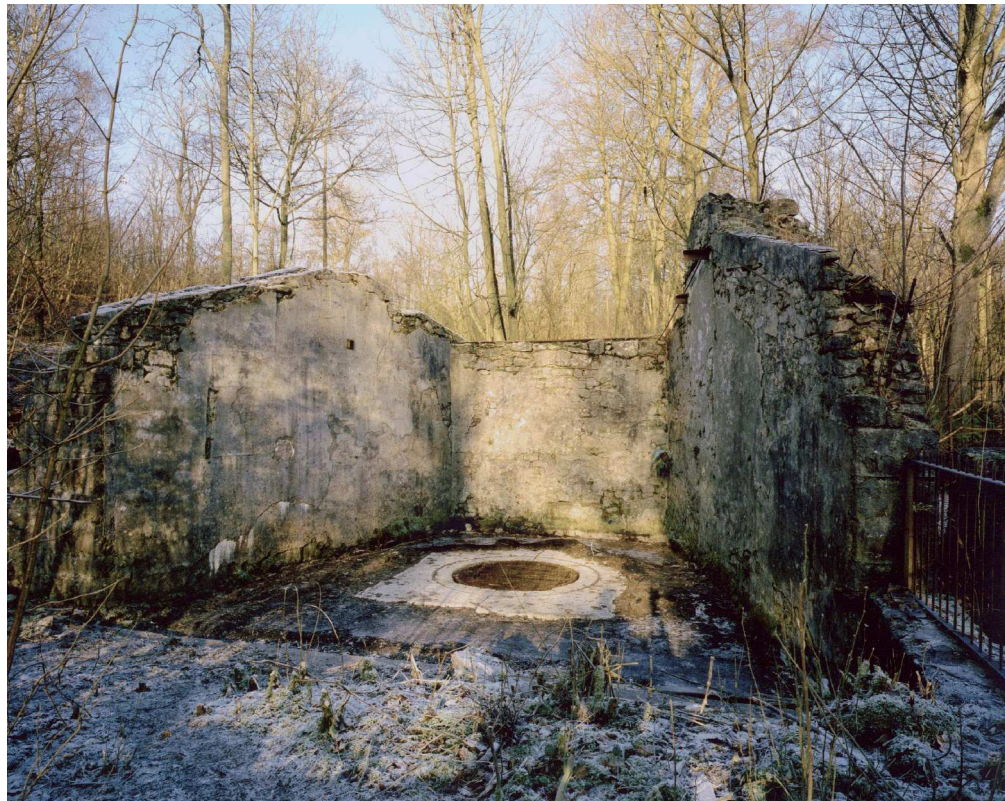
Figure 20.
*Incorporating mill 3,
general view from
south.
(NMR: AA012870)*

The chamber of mill 3 is the only one to retain significant evidence of the former roof (Fig 20). Embedded in the inner face of the east wall are the sawn-off ends of two purlins of 'L'-shaped angle iron, one at the apex of the roof, the other supporting the north slope, and two purlins of 'T'-section angle iron, one mid-way down the south slope, the other close to its base. The opposite end of the last of these purlins survives in the opposing side wall of mill 3. Sitting on the purlins in the east wall is a wrought-iron rafter in two lengths, one per slope, which overlap at the apex. The rafters are iron rods with expanded and pierced terminals at both ends and double-pierced expansions over the mid-span ridge purlins. The pierced holes were for wrought iron hook-ended bolts which secured them to the purlins. The iron purlins must have spanned the chamber, but how many iron rafters there were is uncertain, but the combined purpose of this ironwork was to support the roof covering. Fragments of iron sheeting projecting from the north slope of the east wall, above the iron purlins, may be weathering to prevent rainwater seeping in at the junction between the roof and the wall. At the rear of the chambers, the wall top continues the slope of the former roof.

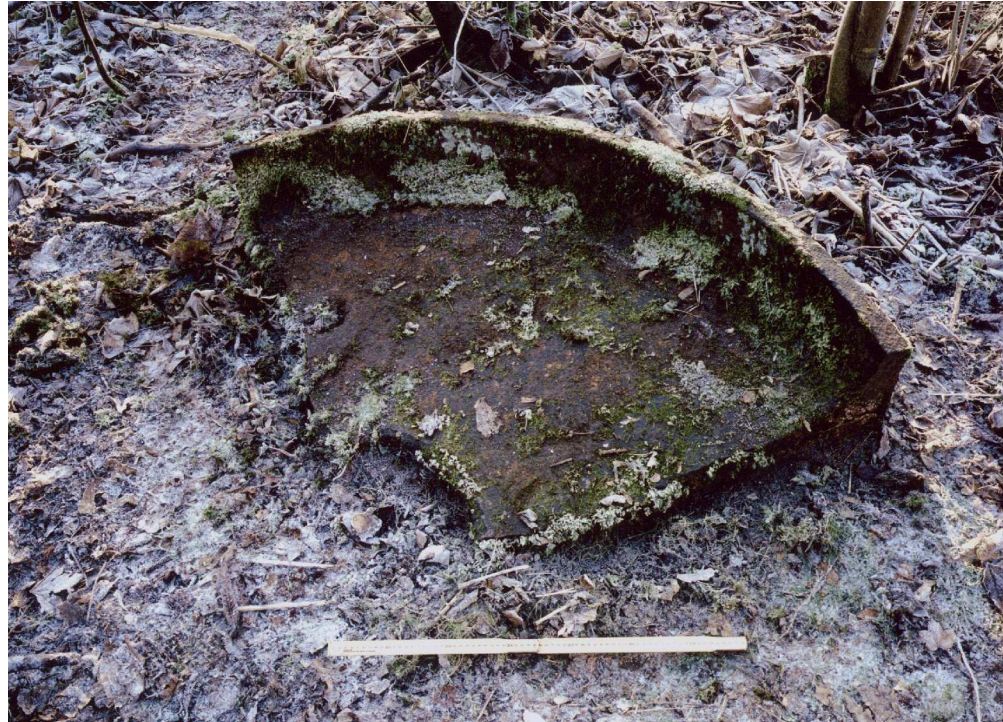
Figure 22.
Detail of iron edge-
runner fragment
outside waterwheel
house of early range
of incorporating mills.
(NMR: AA 012876)

The six incorporating mills each housed an edge-runner mill which was set in a cast-iron housing bolted to a substantial stone base and powered from below (Fig 21). A large fragment of one of the iron edge-runners lies to the south of the waterwheel house (Fig 22); when complete this edge-runner must have measured about 2.24m in diameter. The interiors of the chambers of mills 3, 4 and 5 have been cleared, and in both 3 and 4 the massive limestone flags which form the base can be seen. Six flags form each base and around the central hole there is a groove for the base of the edge-runner mill which was secured by being screwed down to four iron bolts set in the flags. The flags are overlain in both chambers by black ash floors which must once have run up to the machinery. In mill 4 this floor overlies an original concrete floor. It is possible, however, that the ash floors are simply deposits from the wood which was stacked in the mills and burnt when the licensed area was made safe following closure of the works in 1935 (see James Guy's recollections at the end of section 4.2 above). The interior of mill 5 (and possibly also mill 6) has a concrete

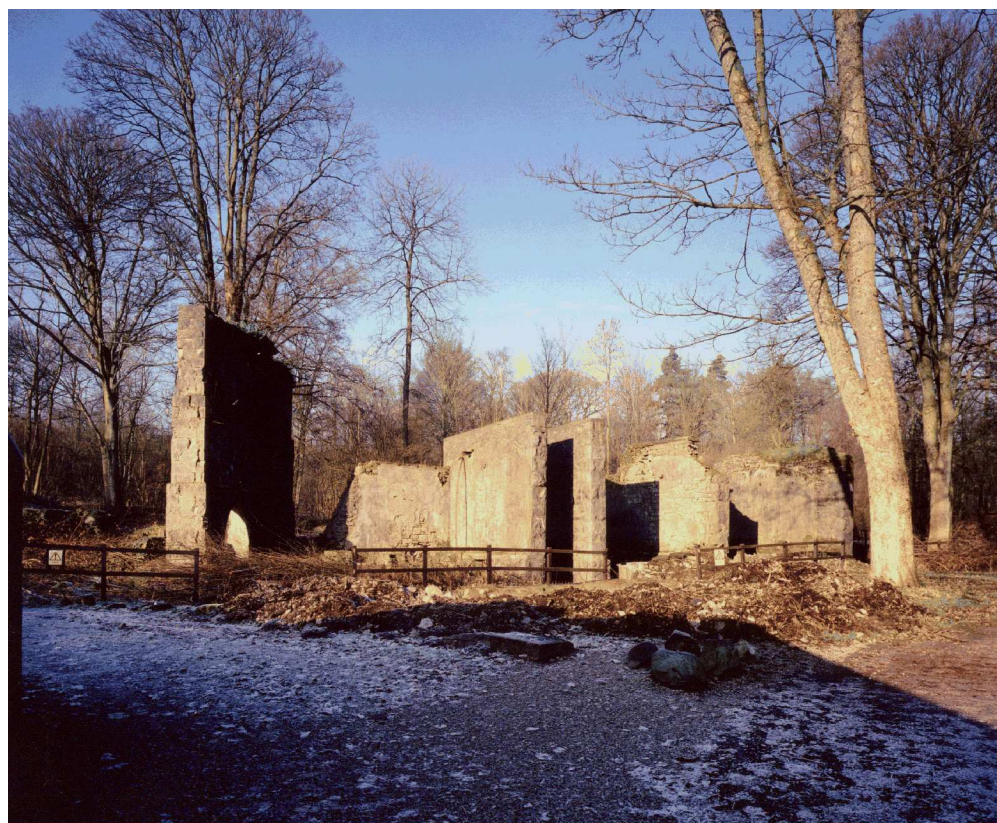
Figure 24.
*Blast wall (left) and
incorporating mills
7,8 and 9 from the
south east.
(NMR: AA 012873)*

Incorporating mills 7-9 (7) (Figs 24 and 25)

Separating the original and later mill groups is a stone blast wall, rising above the height of the mills. It is shown on both the 1898 and 1914 editions of the OS 25" map, and also on the site plan of 1903-12. Constructed in three tiers for stability, access between mills was maintained via a skewed archway through it which was aligned with the north wall of incorporating mills 1-6.

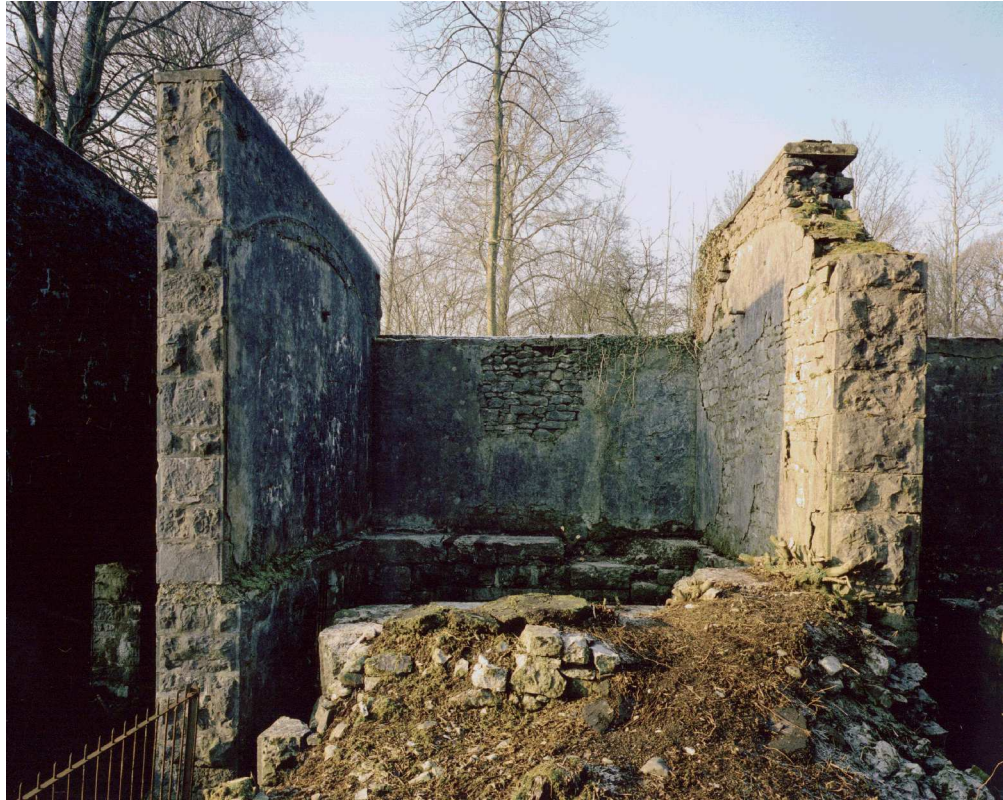
Figure 26.
*Incorporating mill 8
 from the east.*
 (NMR: AA012895)

Incorporating mills 7 and 8 (Fig 26) are built of rock-faced rubble, the stones at the corners with distinctive dressed-back edges, but as with the earlier incorporating mills they survive in a state of disrepair with some of their walls lost although they retain a little more evidence of their roofs. The chambers of the mills are rectangular in plan and face to the south east. The side and rear walls are of differing thickness, the walls also stepping back at the level of the now largely lost internal floors. The masonry within each chamber was plastered up to a vertical edge close to the front, which will have had a flimsy covering. The side walls of the two mills rose to flat tops; stone coping with chamfered edges survives on the north-east

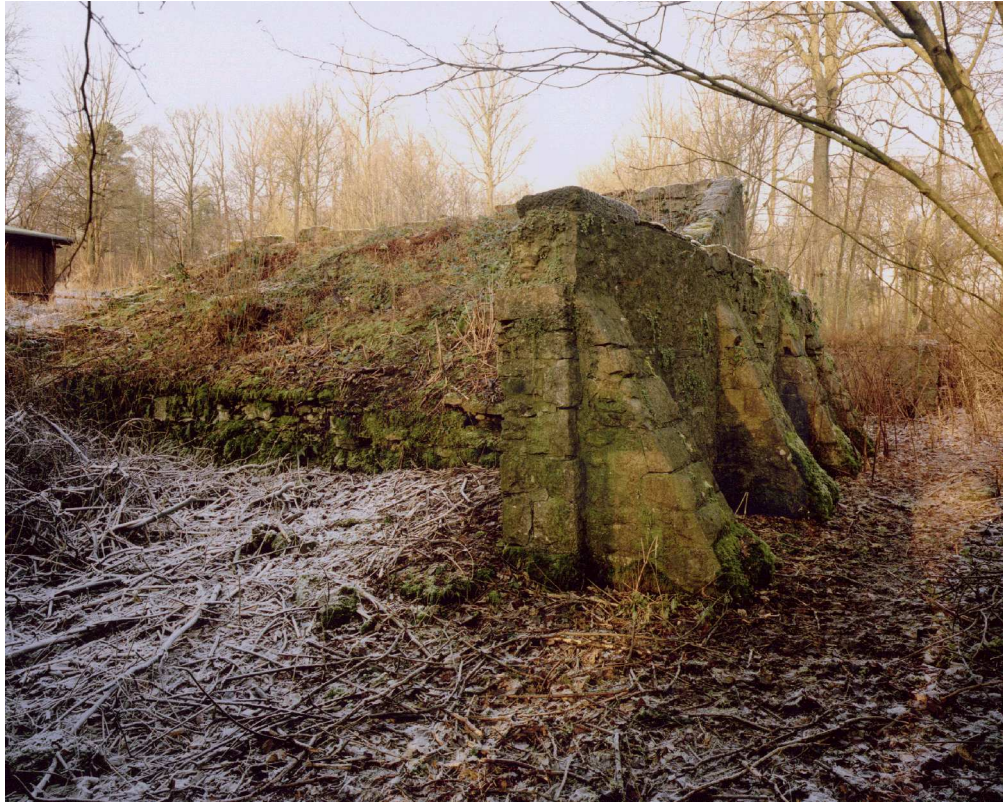
Figure 27.
*Blast bank between
first powder press
house and corning
house , from the
south east.
(NMR: AA012916)*

The powder press house was initially situated adjacent to the corning house. Field evidence indicates that the overall area occupied by these buildings had been excavated to form a broad depression in which to site them, presumably to help contain the effects of any explosions. In places this lowered area, especially where the natural slope of the valley side has been cut into, is over 2m deep; it is revetted principally to the south, west and north where the excavation is deepest. A massive blast bank crosses the central part of the lowered area west-north-west to east-south-east and rises above the other revetment walls (Fig 27). The feature is original, appearing on the first edition OS 25" map but has undergone modification. The structure is trapezoidal in section and comprises a huge earthen bank contained by a series of revetment walls. The eastern and western ends of the bank are revetted with a gabled wall; the eastern one has been strengthened by a secondary stone wall, itself supported by later stone buttresses. The northern side of the bank was originally contained by a stone wall with a batter, the top of the wall protruding above the summit of

the bank and thus forming a slight parapet. Against this wall is a second revetment wall, this one vertical, which is slightly lower than the original leaving a narrow terrace along the upper edge of the blast bank. On the southern side, the earth bank slopes down more gradually until it meets a less substantial revetment wall, 1.1m high. This represents a later broadening of the blast bank that up to 1912 (Ordnance Survey 1914a) appears not to have extended beyond the line of the revetment walls at either end. There was a 'truckman's shelter' built against the blast bank at the time of the 1903 glaze house explosion (Explosives Inspectorate 1903, 5).

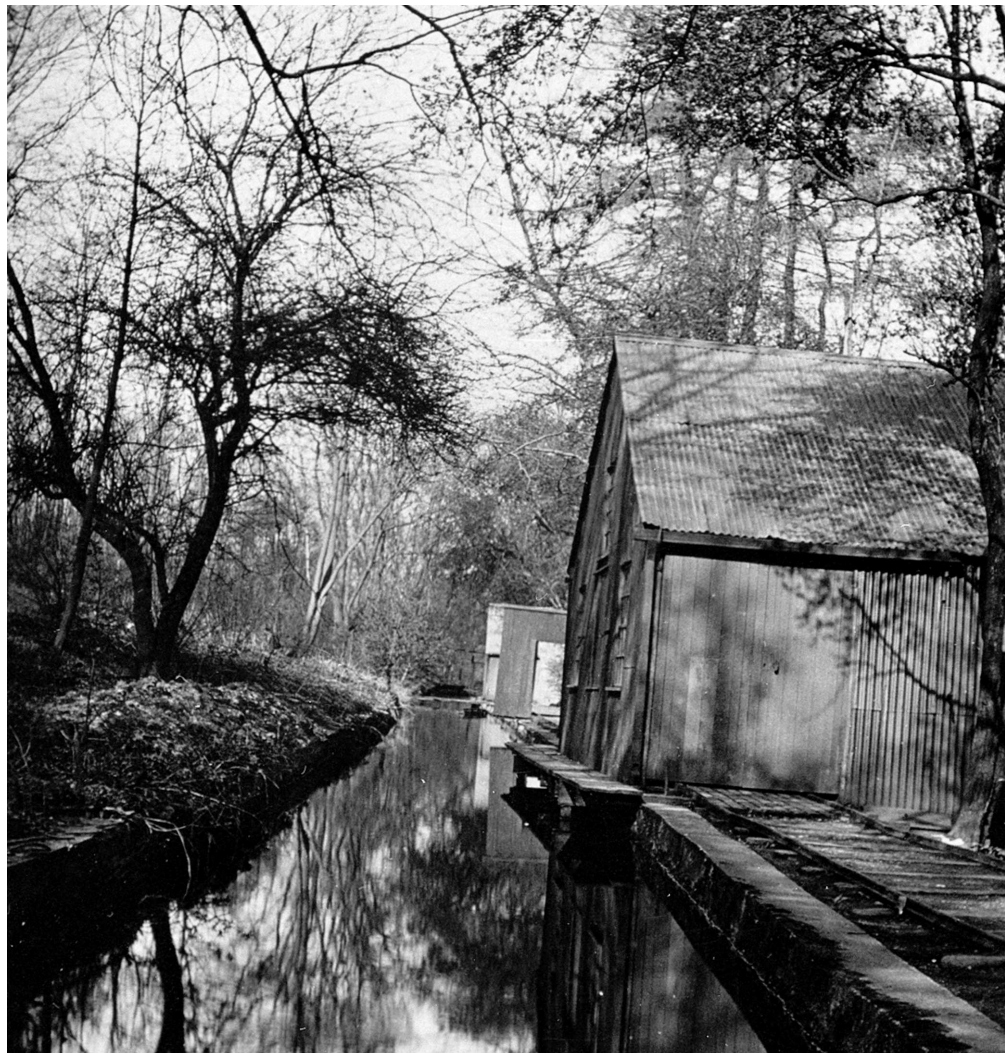
Figure 28.
Western end of the
corning house
(probably in the
late 1920s), from
the south west.
(NMR: AA035276,
reproduced by
permission of
David Willacy)

west. One of the photographs in the Willacy Collection appears to be of the north-western end of the corning house and probably dates to the late 1920s (Fig 28). It shows the end of a timber-framed building, gabled approximately south-east to north-west, with corrugated iron sheets used for both walls and roof. In the end gable wall two windows are visible at ground floor level with a third one above them in the gable apex. The tramway is visible entering the building near its corner through a sliding door of vertical boards; presumably this is the 'upper door' referred to by the Explosives Inspectorate (1903, 5). A timber walkway suspended above the main leat gave access around the north-west end of the building. The MMB and Explosives Inspectorate (1903, 5) indicate that internally the corning house was on two levels with a short tramway on the upper floor used for taking the pressed cake from the main tramway to near the corning machine. When the MMB was produced the corning machine was of the Hastie type and had been installed in 1903, presumably when the corning house was rebuilt after the explosion which also destroyed the first glaze house. It, like its predecessors (*Westmorland Gazette*, 4 April 1903), was powered by turbine. The pressed cakes were broken up into smaller pieces by hand and then passed through a series of rollers with the powder, now in grain form, landing on the sieves of the scry or separator that was situated on the lower floor. A doorway in the east wall of the corning house provided access to this floor (Explosives Inspectorate 1903, 5).

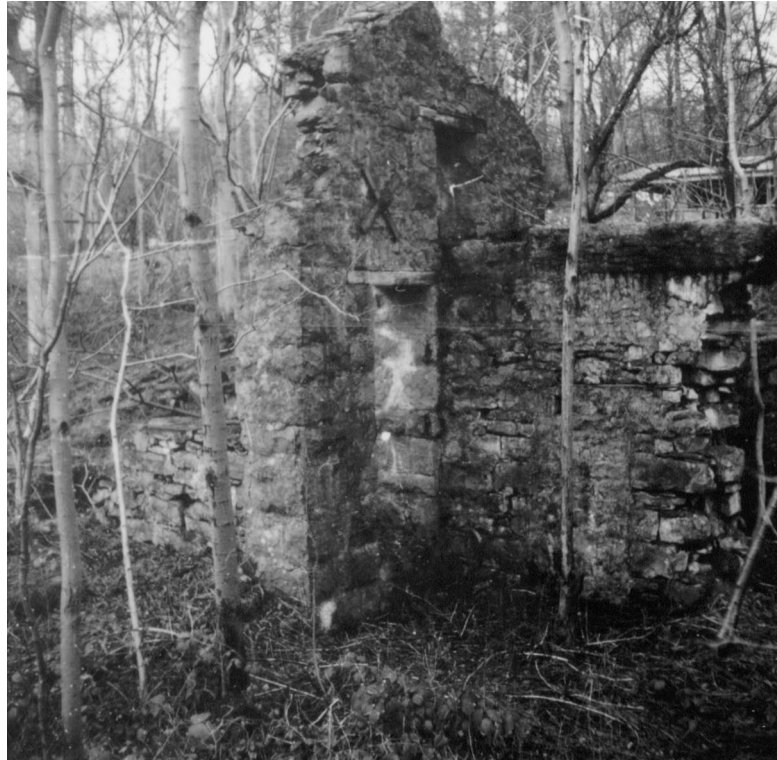
Figure 29.
The north-east end of
the turbine house
(which provided power
for the corning
machine) in 1977.
(Reproduced by
permission of the
National Trust)

A rectangular walled structure containing a turbine pit in its southern half is the site of the turbine house. The site was made safe in 1977 when the north-east wall was lowered and the south-western and south-eastern walls, which no longer survived, were partly rebuilt to prevent visitors to the caravan park accidentally falling into the turbine pit, which is 3.3m deep and 2.5m in diameter. The date of the work together with the initials DC MW MG DH are inscribed in the concrete capping on top of the south-east wall. The turbine was of the vertical type and was housed in a pit that received water from the main leat via the feeder channel. The arrangement of the turbine house over the pit is similar to that housed in the clock tower (see section 6.2.9 below). Water from the feeder channel entered the turbine house through an arched opening spanning most of the north-west side of the structure and must have entered the circular turbine pit via a wooden pentrough. Despite later blocking part of the arch is still visible in the north-west wall. The pit is not central to the building, which would have meant that water was directed at its northern half. The north-east wall survives to a height of 2.4m and is 0.6m wide; a doorway that allowed access to the machinery pierces it. This entrance now has a concrete lintel across its top that was presumably inserted during consolidation in 1977. Rusticated stone blocks are visible around the doorway and at the north-east corner of the building while dribbles of pitch on some of the stones suggest that the turbine house had a felt and pitch roof. It is possible

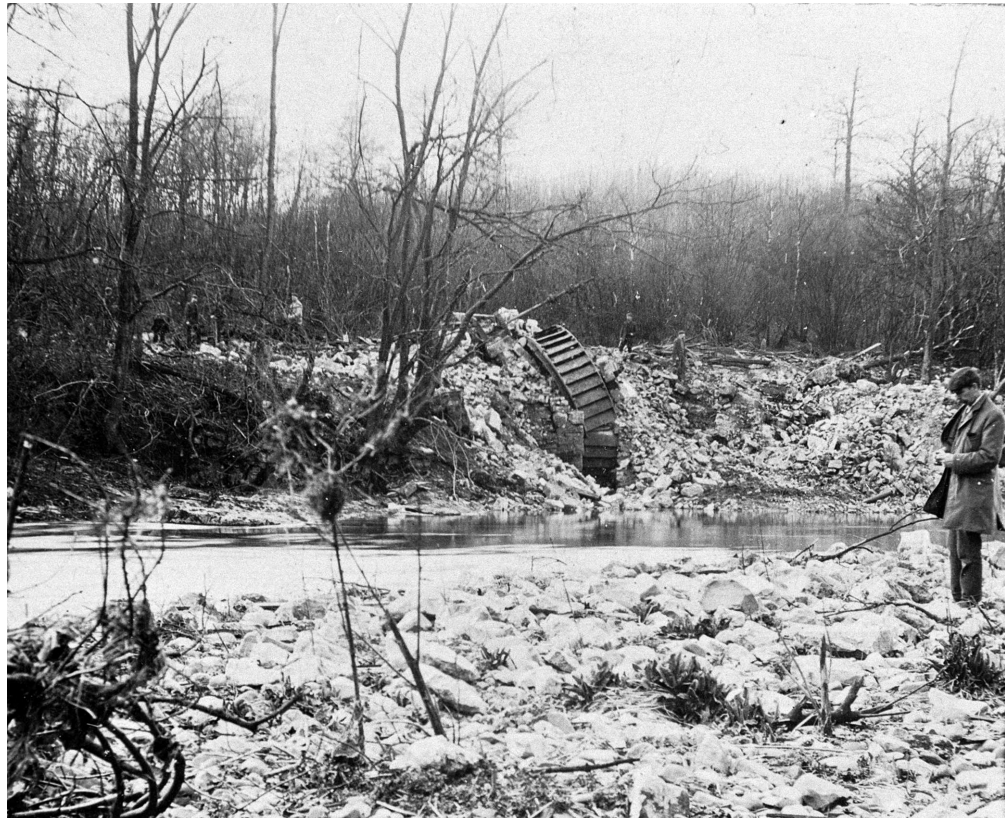
Figure 30.
The ruins of the glaze house after the explosion in 1903, from the east. (NMR: AA 035281, reproduced by permission of David Willacy)

On 30 March 1903 the glaze house was wrecked by a serious explosion that blew two of the workmen to pieces, injured a number of others, destroyed the corning house and damaged several other buildings (*Westmorland Gazette*, 4 April 1903). A photograph of the remains of the glaze house after this event is reproduced by Tyler (2002, 218) and there is a similar photograph taken from a slightly different angle in the Willacy Collection (Fig 30). They

show the glaze house reduced to a spread of rubble with the lower part of the waterwheel still in its wheel pit but with its upper section broken off; damaged and severed branches on the adjacent trees are also evidence of the ferocity of the blast. The report by the Explosives Inspectorate into the incident gives details of the building as it existed at the time of the explosion. It confirms the general layout as shown on the second edition of the OS 25" map and notes that the northern compartment, 25 ft (7.6m) by 11ft (3.3m), contained two glazing barrels and the southern one, 28 ft (8.5m) by 13 ft (3.9m), four glazing barrels and four glazing reels. The southern compartment was built of stone on its northern, eastern and southern sides, up to a height of about 5ft (1.5m), the drive shafts and gearing being carried along the tops of these walls. The rest of the building was of timber 'formed with a double skin' and the roof was covered with tarred felt (Explosives Inspectorate 1903, 4).

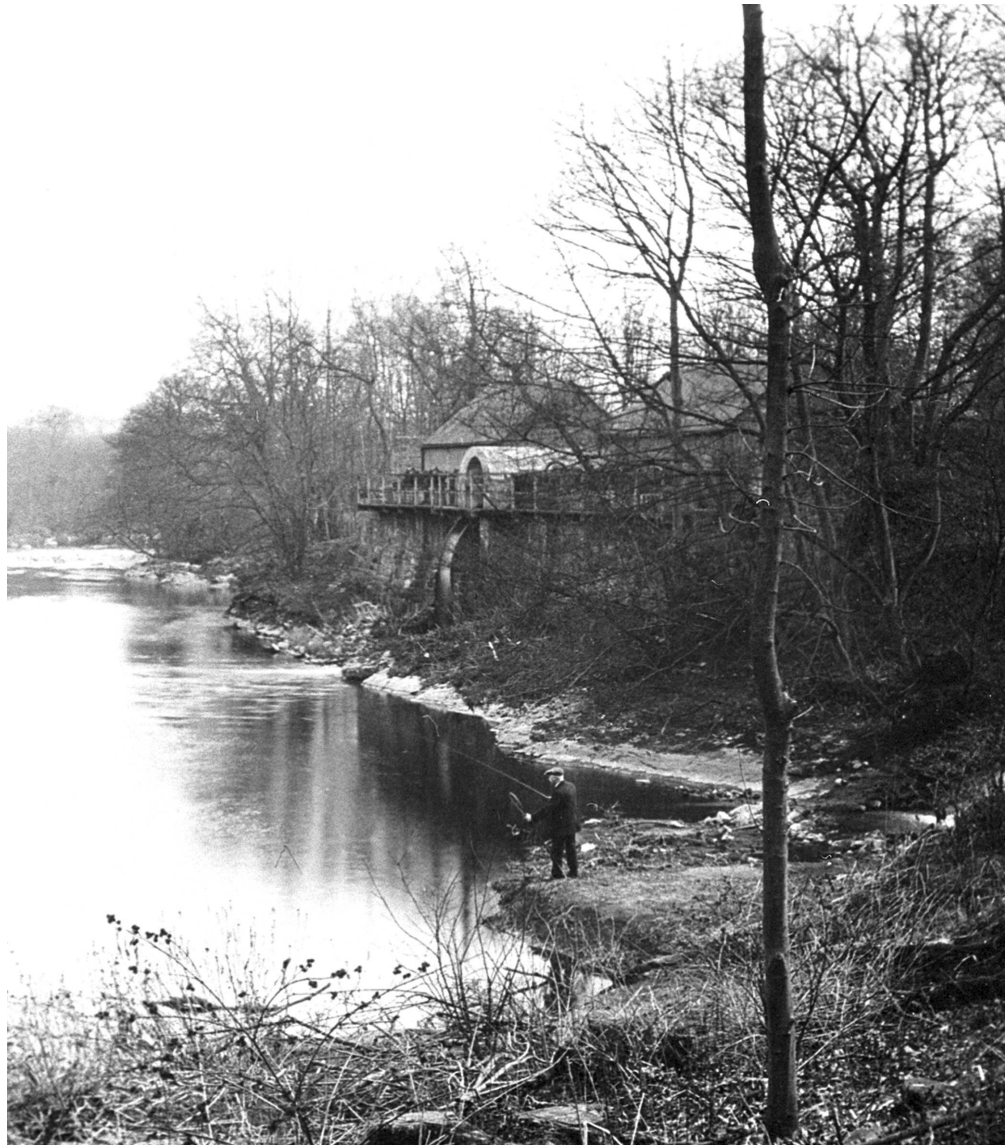
Figure 31.
Thomas Faulkner fishing with the new glaze house in the background (probably in the late 1920s), from the north. (NMR: AA035274, reproduced by permission of David Willacy)

Two photographs of the new glaze house are known to exist, both taken looking towards the site from the north. One was published in 1929 (Imperial Chemical Industries 1929, 343) and was recently reproduced by Tyler (2002, 218). The second photograph is in the Willacy Collection and is of Thomas Faulkner fishing in the River Kent with the new glaze house visible in the background (Fig 31). This photograph is particularly informative because it was taken when the leaves were off the trees so that both compartments are clearly visible. Each was a separate single-storey rectangular structure gabled north-west to south-east. Both sat on top of a large platform whose north-eastern side rose high above the river and was revetted with stone walling. A timber walkway projected out towards the river from near the top of the revetment and the side facing the river had safety railings to prevent accidents.

The wheel pit pierced the centre of the revetment and the large waterwheel that it held is clearly visible protruding well out in front of the revetment. The arched tunnel-like waterwheel house above it shows up as being very white indicating that it was of concrete construction.

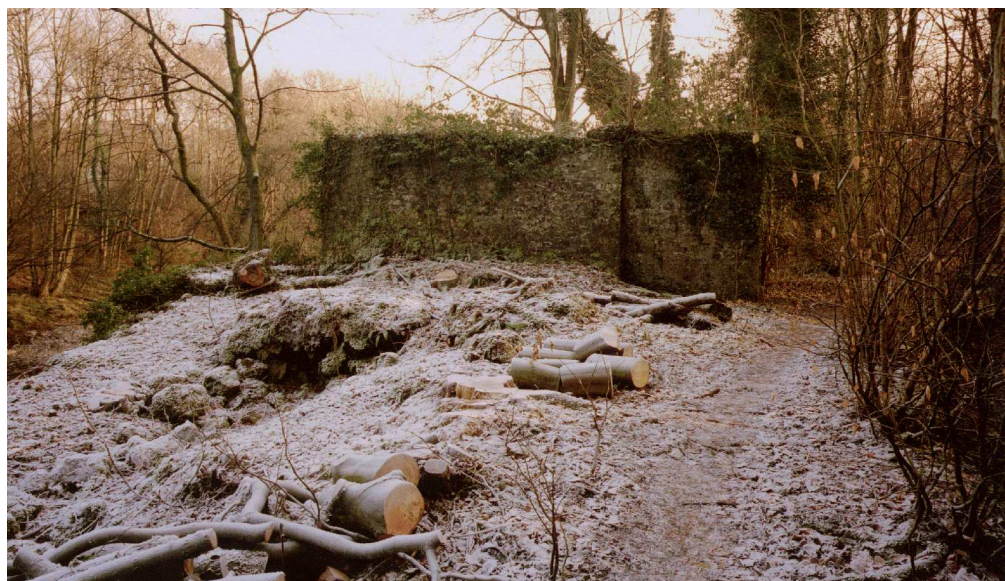
Figure 32.
The southern compartment and revetted blast bank of the new glaze house, from the north west. (NMR: AA012918)

The two blast banks that flanked the glaze house, one at either end, are well preserved and are about 2.7m high. A stone wall with a slight batter revets the inner face of each blast bank and the ends are also revetted (Fig 32). The lower part of the revetment wall corner at the south-west end of the southern blast bank has a deep chamfer to facilitate access to the glaze house. The course of the tramway on the south west side of the compartments is also still traceable with a number of timber sleepers still in their original positions. These
