New Sedgwick Gunpowder Works,
Cumbria:
an archaeological
and architectural survey

SURVEY REPORT

Archaeological Investigation Report Series AI/19/2003

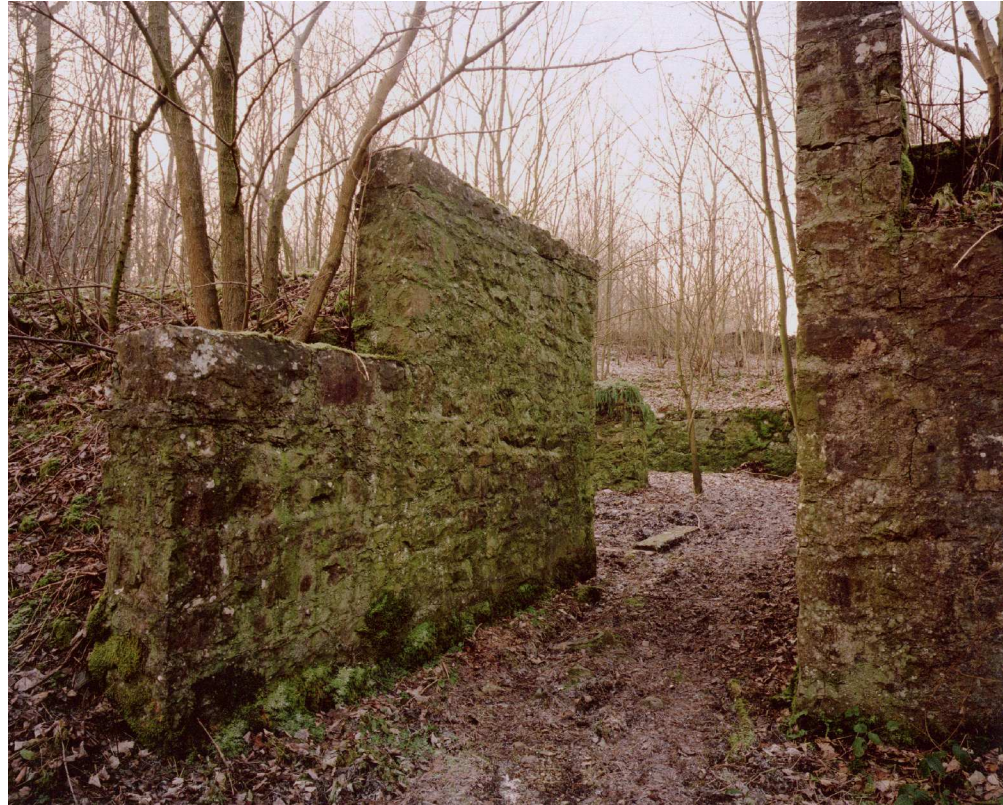
Figure 33.
*The entrance to the
new stove house,
from the east.*
(NMR: AA012910)

Although the superstructures (presumably of timber or corrugated iron) of the drying houses have been destroyed, there is still much surviving evidence of the stove house site itself. The vertically sided rectangular depression (with its revetment walls) is well preserved; it measures about 14m (north-west to south-east) by 12m and is up to 2.8m in depth. The interior is divided into two rectangular compartments by a cross-wall, 8m long and 1.9m high, which butts against the revetment wall of the south-west side of the depression. There was a drying building in each of these compartments and partial clearance of the floor of the south-eastern compartment in autumn 2000 by National Trust volunteers exposed the foundations of the north-east end of the larger of the two drying houses. A number of concrete plinths are visible, each measuring 0.35m wide; they form the footprint of a building, about 5.5m wide, with a short porch about 2.7m deep at its north-east end. The porch appears to have been modified over time because the porch on the 1914 edition of the OS map, like the one depicted at the other drying building, is much longer extending across the whole of the space between the end of the drying house and the revetment wall that bounded the north-east side of the depression. The entrance passage leading into the depression is also well preserved, it is 2.2m wide and flanked by tall revetment walls (Fig 33). On the lower south-east side of the depression, some of the original material dug out was mounded

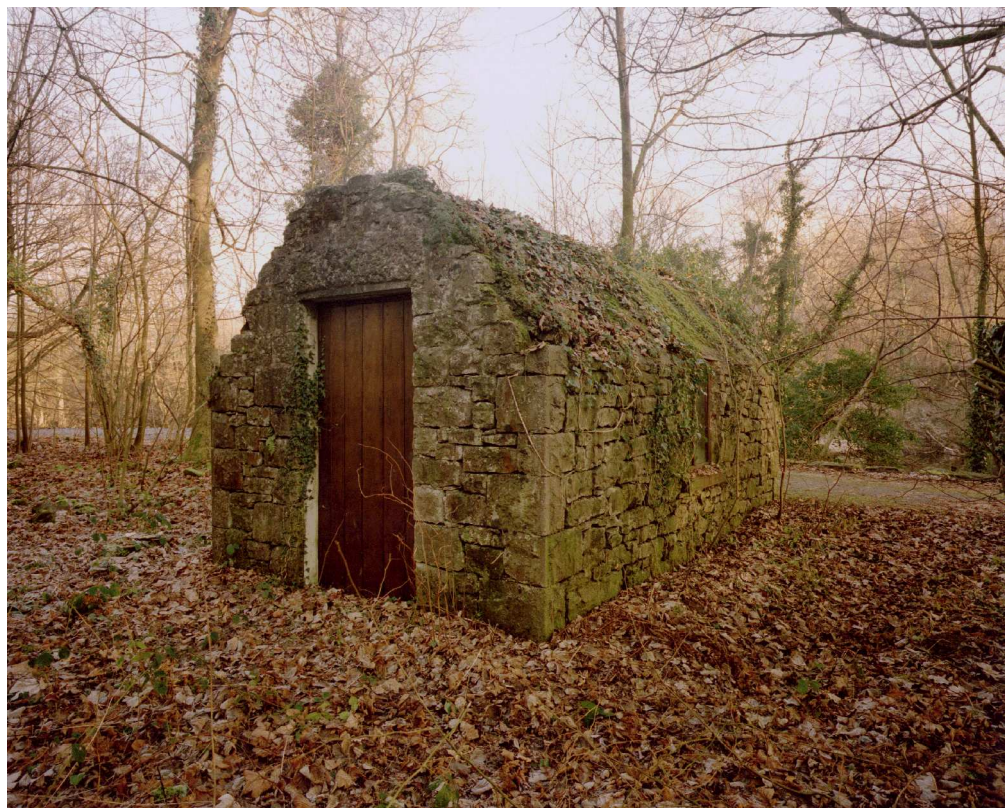
Figure 34.
The electric motor house from the west.
(NMR: AA012927)

The electric motor house has rubble walls, roughly coursed except at the corners, which are of squared rubble with quoins. The doorway in the north-west gable wall has sides of squared blocks which support a substantial rusticated, rectangular stone lintel. The single window opening in the south-west wall has a stone sill and the base of the roof forms the lintel. About half way along the north-east wall there is a smooth rectangular area of concrete, 0.6m by 0.45m, with bolts or fixing straps at the corners. Presumably this once held a plate or piece of machinery, perhaps connected with the transfer of drive from the electric motor to the mechanical separator in the dust house. Its lower half is perforated by two metal pipes, centrally placed and one above the other (about 0.2m apart), whose ends are almost flush with the concrete surface; each is 3.5cms in overall diameter. The gable walls, 2.6m high, to south east and north west are raised to form a small parapet above the

This small, single-storey stone building, rectangular in plan and measuring 6.8m by 3.1m with 1.7m high side walls, was erected during the last years of the 19th century (Fig 34). It is not shown on the second edition of the OS 25" map revised in 1896 but is depicted on the site plan of 1900 on which it is numbered 32 and labelled 'Shed for electric motor'. It is similarly described and numbered on the site plan of 1903-12 and also appears on the 1914 edition of the OS map; on this map a footpath is shown leading away from it towards the cartridge press pump house. Electricity for the motor may well have been generated at the latter.

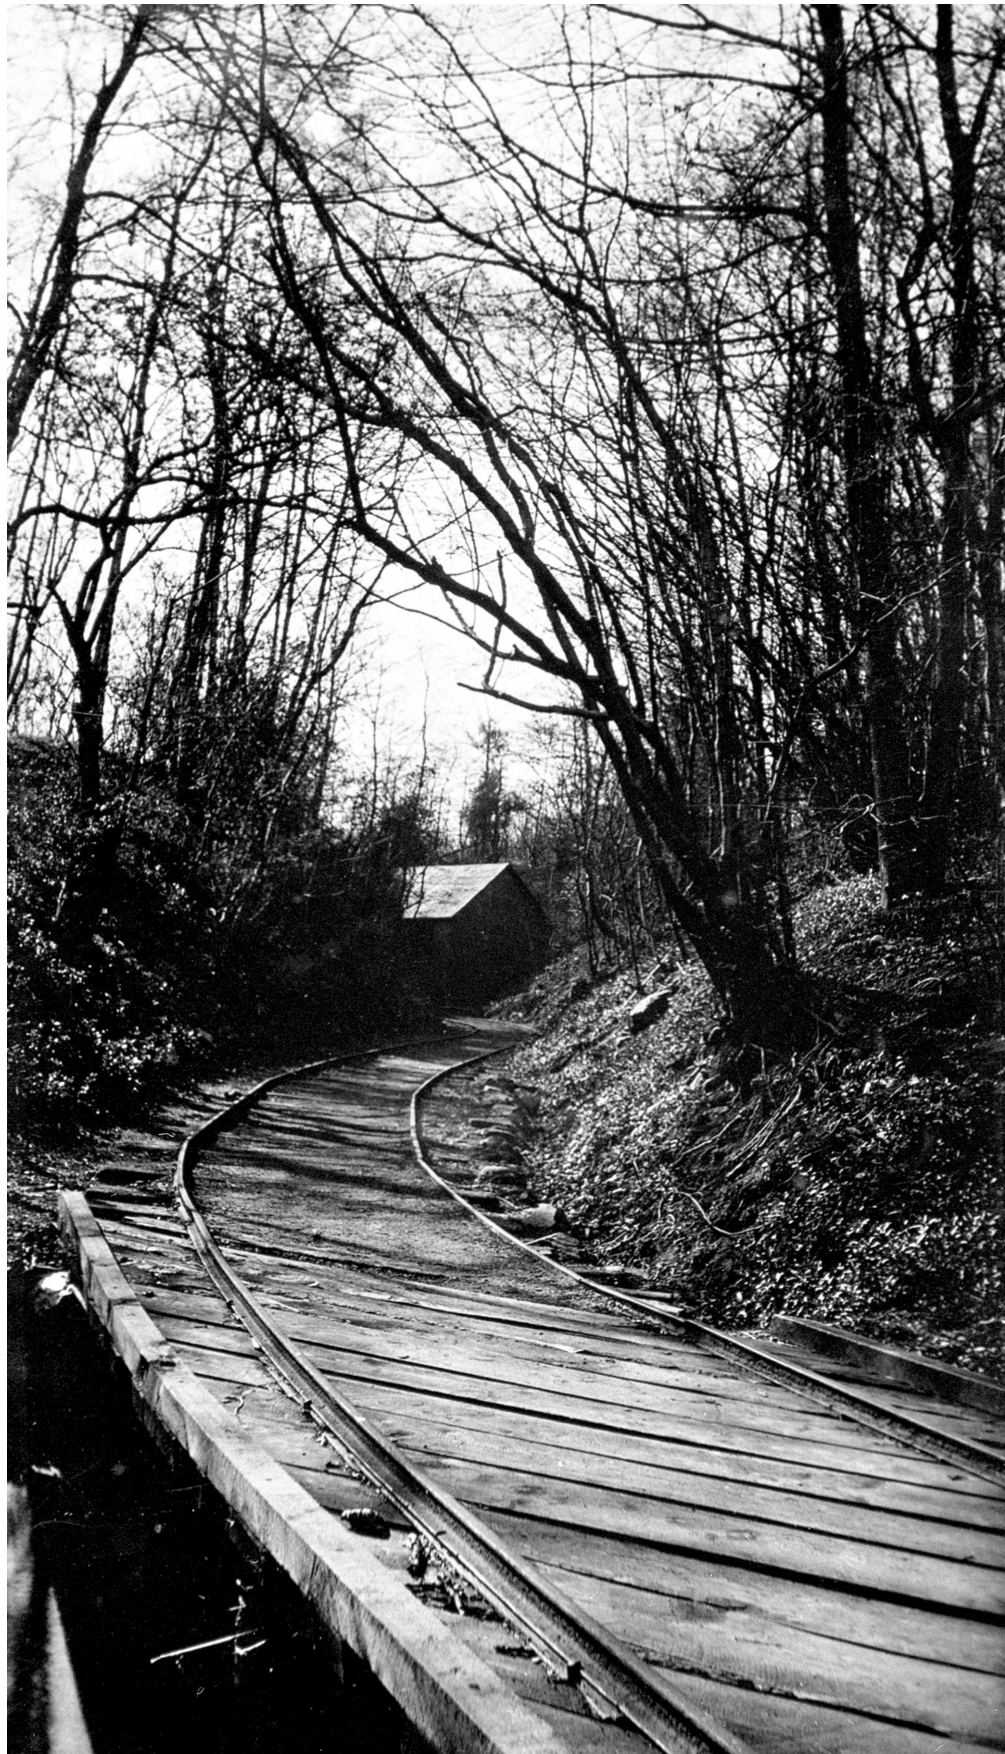
Figure 35. Cartridge compressing house 2 and the tramway (probably in the late 1920s) from the east. (NMR: AA035275, reproduced by permission of David Willacy)

The building no longer survives but earthwork remains indicate that it stood on a raised platform cut into the rising ground to the north west. On the south east the platform is revetted with stone to a height of 0.4m above the base of the cutting. The former is about 6.5m long by 4.5m and is subdivided into two parts by a crudely fashioned cross-wall up to 0.7m high. This wall may be nothing to do with the cartridge compressing house and probably relates to the use of this part of the site for ammunition storage during World War II. Immediately east of the platform a square feature, partly embanked, has been dug into the side of the cutting and is almost certainly the site of an ammunition dump. A similar feature is also visible near the entrance to the cutting on its southern side, some 8m west of the main leat.

There is a photograph looking up the cutting, probably taken in the late 1920s, in the Willacy Collection (Fig 35). The north-east end of the compressing house is just visible in the background. It was a single-storey affair gabled north-east to south-west, with a pitched roof (probably of timber) lightly covered by what looks like felt. In the foreground the tramway is visible crossing the main leat by means of a plank bridge. The gauge was quite wide and the flat-bottomed rails were held in position by track spikes. The sides of the cutting were supporting bushes, saplings and trees when the photograph was taken and, apart from becoming more rampant, the vegetation was still much the same when EH surveyed the cutting in 2002.

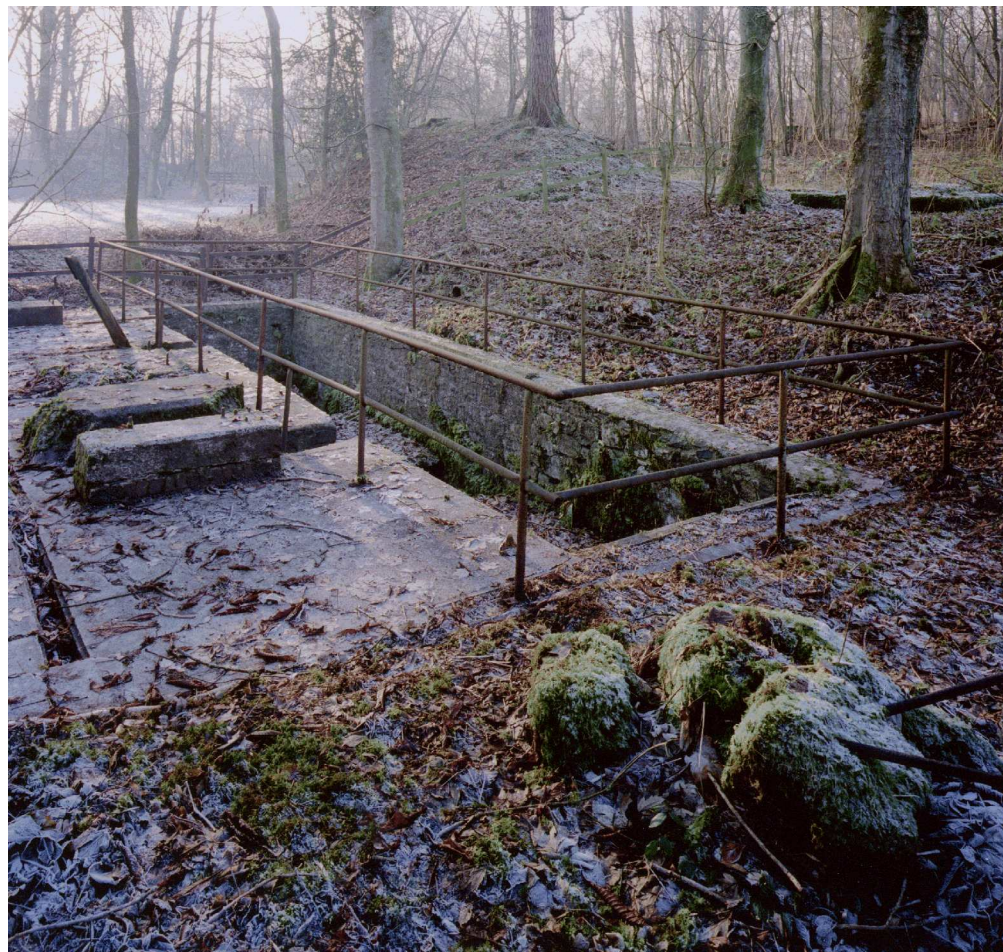
Figure 36.
Cartridge press pump
house and near-by
blast bank from the
north east.
(NMR: AA012904)

Each pit held a turbine and the slight difference in layout may reflect the point from which each was supplied with water and also the chronological development of the pump house;

The surviving remains indicate that the extended pump house was built in a depression dug into ground that rises about 2.2m above the pump house on the north west. The superstructure no longer survives but was presumably timber framed and clad in wood or corrugated iron. The rectangular floor area is well preserved and measures 11m by 6m and is divided longitudinally into two parts; the one to the south east was the machine floor and the other to the north west was the turbine area (Fig 36). This second area consists of a stone-edged pit, rectangular in plan, and about 10.1m long, 2.4 m wide and 1.3m deep. Tubular iron railings have been erected around it to keep people out. Three smaller rectangular pits, about 1.2m deep, are spaced out at intervals in its bottom and, apart from the northernmost one (foreshortened slightly at the south-east), span the full width of the bottom. The bottom of the northernmost pit has collapsed into the main tailrace of the works which carried used water back to the river; its arched roof is just visible.

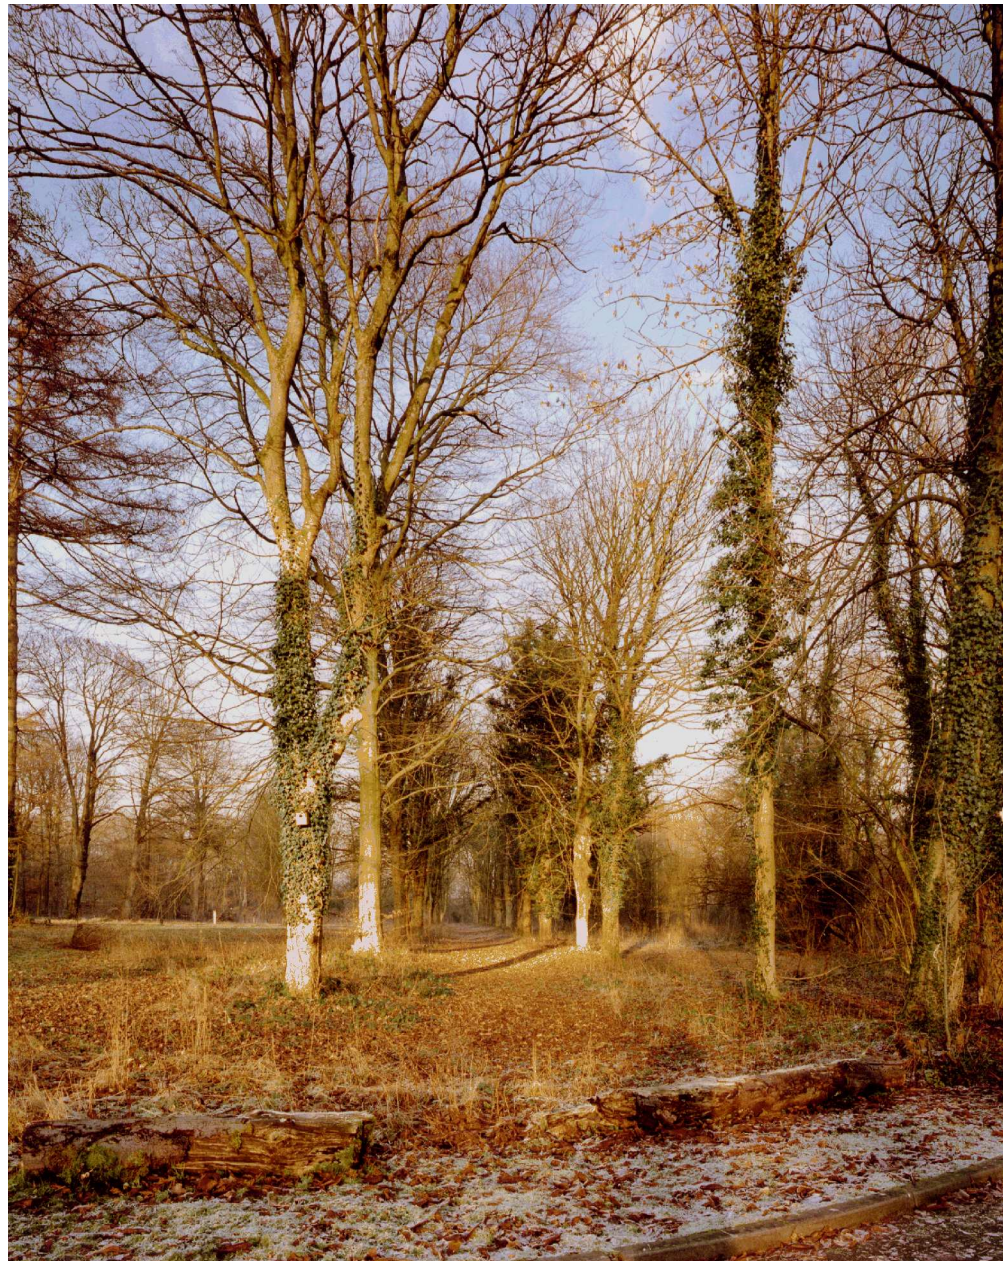
Figure 37.
*The proofing range
from the south.*
(NMR: AA012928)

with the main leat situated about 60m to the west (Fig 37). Near its northern end the avenue is joined by a second but much shorter cross-avenue and together they produce a cruciform plan that dominates the central manufacturing area. The proofing range is laid out so that its southern end opened on to the space between the saltpetre refinery complex and the charcoal store. The date of the range is uncertain: it does not appear on the 1873-1875 photographs (at that time the central area appears to have been an open grassy space), nor is it shown on the second edition of the OS 25" map (revised 1896), but it is depicted on the 1914 edition (revised 1912). On this map the trees making the cruciform plan are shown rather schematically and not individually, which may indicate that they had yet to become well established. A similar proofing range, dating to the latter half of the 19th century, existed at the Oare Gunpowder Works in Kent and was lined with Wellingtonias (Cocroft 2000). There is no practical reason for the cruciform plan but local tradition has it that the trees were planted as a memorial to those killed in World War I. The cartographic evidence

Both avenues still survive; the trees are of sycamore (with the exception of a horse chestnut and copper beech at or near the southern end of the long avenue) and are planted about 6m apart (probably representing an original planting space of 20ft). A number have died or been felled but the National Trust have replaced some with saplings. Sycamore was probably chosen because it is fast growing, while the choice of two different species of trees at the southern end suggests a desire to create an ornamental approach. Apart from at the northern end, the trees of the long avenue have been planted on a pair of low banks, one on either side of the avenue, which stand to a height of 0.3m. The interior of the avenue between the banks has been roughly surfaced with coal-derived clinker. No evidence for embanking or surfacing is visible in the short avenue suggesting that it had a purely ornamental or commemorative function. Burrowing animals (or World War II activity) have probably created a large amorphous hollow within the eastern part of this avenue, 0.4m deep. A separate length of bank is visible just beyond the eastern side of the long avenue near its southern end. Its function is uncertain, but its proximity to the avenue and similar form to the banks of the latter raises the possibility of it being the remnants of an even earlier proofing range.

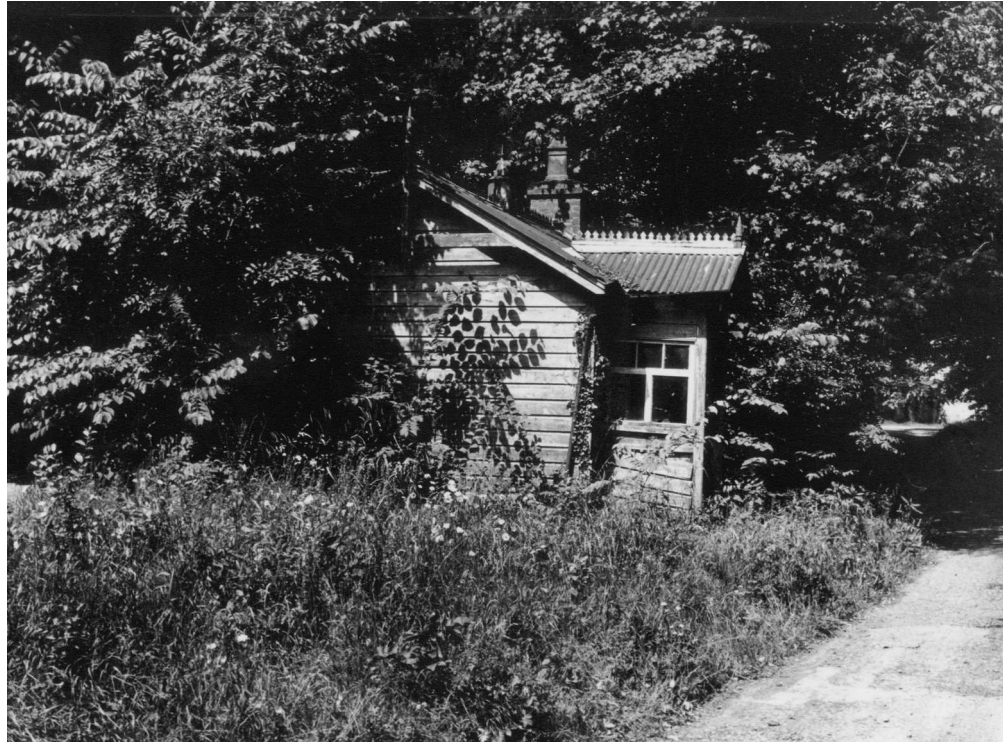
Figure 38.
*The proofing house in
 1977, from the south.*
 (Reproduced by
 permission of the
 National Trust)

The proofing house was situated 40m north of the works entrance in the unlicensed area. It first appears on the 1914 edition of the OS 25" map (revised 1912) and survived until 1977 when it was demolished during alterations for the caravan park. On the map it measures just over 4m long and slightly less in width. The proofing house, although obscured by vegetation, is visible on National Trust photographs of the works dated 1977 (Fig 38). They show a single-storey affair whose sides were clad with tongue and groove boarding and entered on the east through a porch with a window on its south side. The porch roof, gabled west to east, was covered in corrugated iron sheet and was embellished with a decorative metal ridge crest and (at its east end) a finial. The main roof was gabled north to south with a pointed finial at each end of the ridge. A brick chimney stack with a ceramic chimney pot is visible at the north end of the building indicating that it had a fireplace.

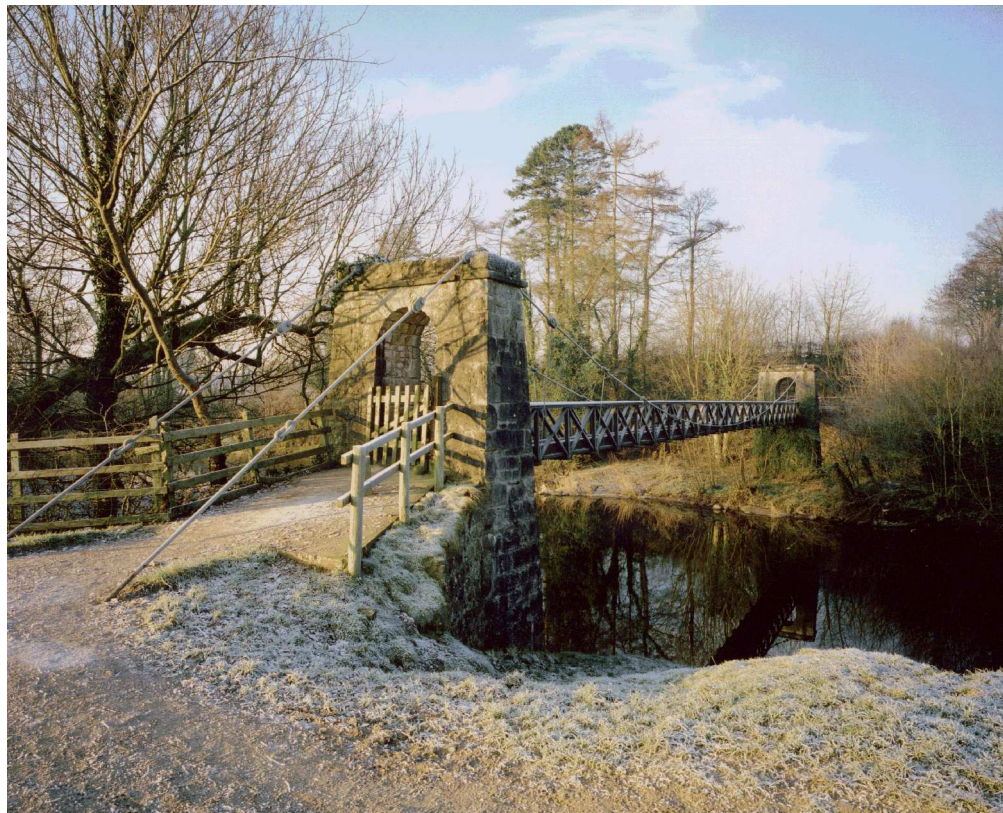
Figure 39.
*The suspension
footbridge across the
River Kent, from the
north east.
(NMR: AA012831)*

in October 1874 during a flood (*Westmorland Gazette*, 7 August 1875). The bridge was rebuilt (work probably started soon after the flood) by Francis James Willacy as a suspension bridge (Fig 39) which (according to his great grandson (David Willacy)) is reputed to contain suspension rods reused from an earlier bridge in Scotland. The suspension bridge may have been better suited to the wide river crossing and thus less vulnerable to damage than the earlier wooden bridge. By 1982 the suspension bridge was in need of restoration and this was undertaken in 1988; on reopening in April 1989, the ribbon across the bridge was cut by Mrs Thomas Hornyold-Strickland of Sizergh Castle (*Westmorland Gazette*, 14 April 1989).

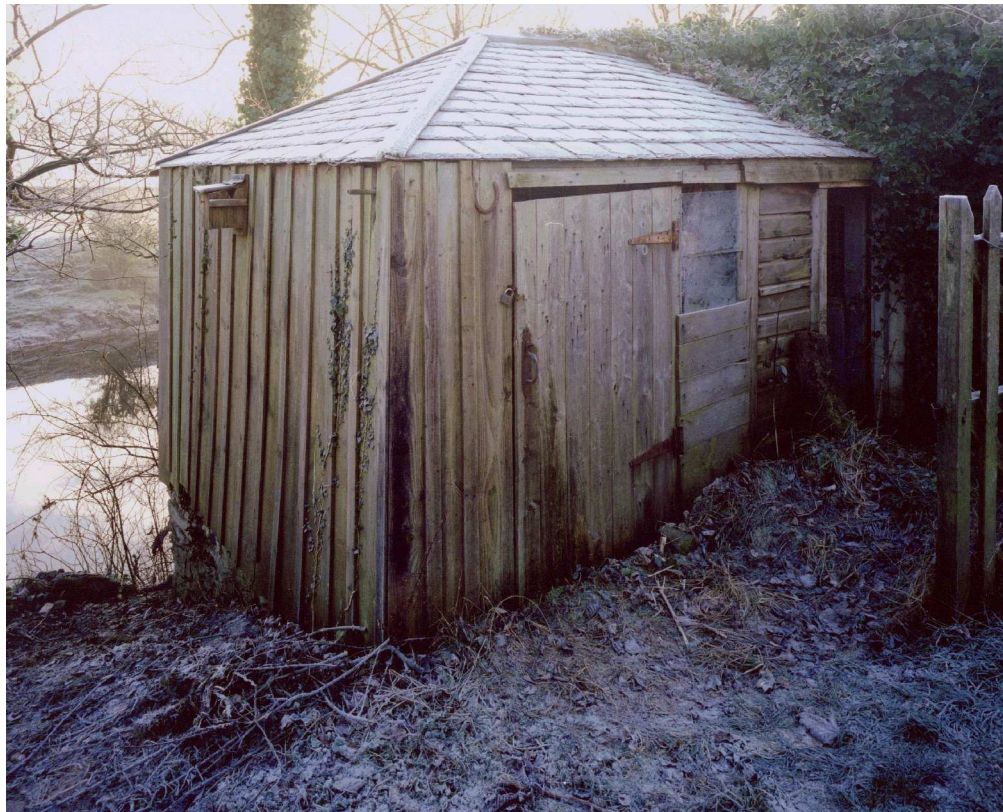
Figure 40.
*The clocking-in shed
from the north west.
(NMR: AA012833)*

The clocking-in shed (Fig 40), a small timber-clad building immediately inside the entrance to the works, was erected after 1912 (Ordnance Survey 1914a). It is built upon a stone-revetted platform with a concrete floor. The shed is divided by a brick wall into two compartments; the smaller one to the south was used for storing the work's bicycle and the main compartment contained the clock and two opposing racks for the 'IN' cards and the 'OUT' cards (James Willacy, *pers comm*).

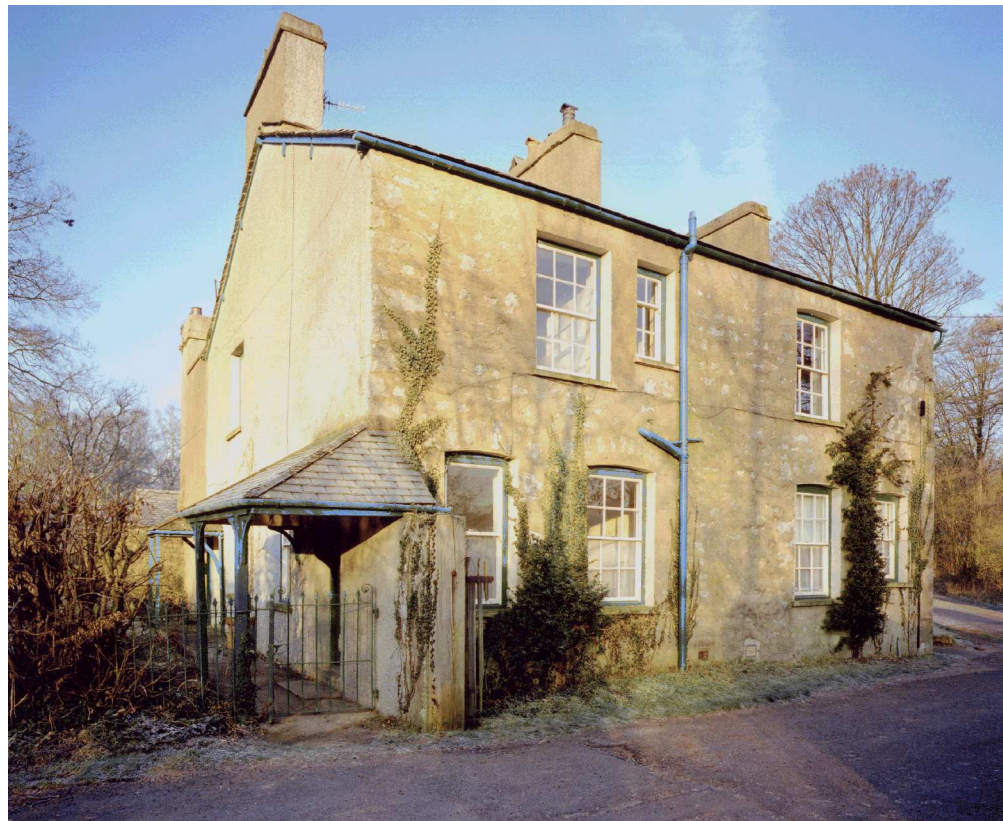
Figure 41.
*The gate house from
the south east.
(NMR: AA012835)*

The gate house (Fig 41), now numbers 1 and 2 'Gate House Cottage', formed part of the original gunpowder works and is shown on the first edition of the OS 25" map (surveyed 1857). The building, as its name implies, stands at the entrance to the site, and its substantial size and internal arrangement indicate that it was built to combine the functions of gate house and foreman's house (confirmed by James Willacy). The positioning of the foreman's house beside the main entrance meant that the foreman was ideally located to supervise and control people and traffic entering or leaving the works. The building was slightly extended before the OS map revision of 1896 and was divided into two cottages after the works closed.

The original building of 1857 had a two-storey main block, gabled to north and south, with a narrow wing, two storeys high over a cellar, and with a single-pitch roof, projecting from the rear south-west corner. By 1896, when revision for the second edition of the OS 25" map took place, a gabled single-storey extension had been added to the rear of the house, abutting the original wing, and a free-standing gabled single-storey outbuilding had been erected behind the wing, and a small addition, since demolished, had been added to the front. The house and the additions are built of coursed rubble, the east elevation of the house retaining the slobbered mortar which must have characterised its original appearance, the other walls having later, denser render. The roofs are all slated.

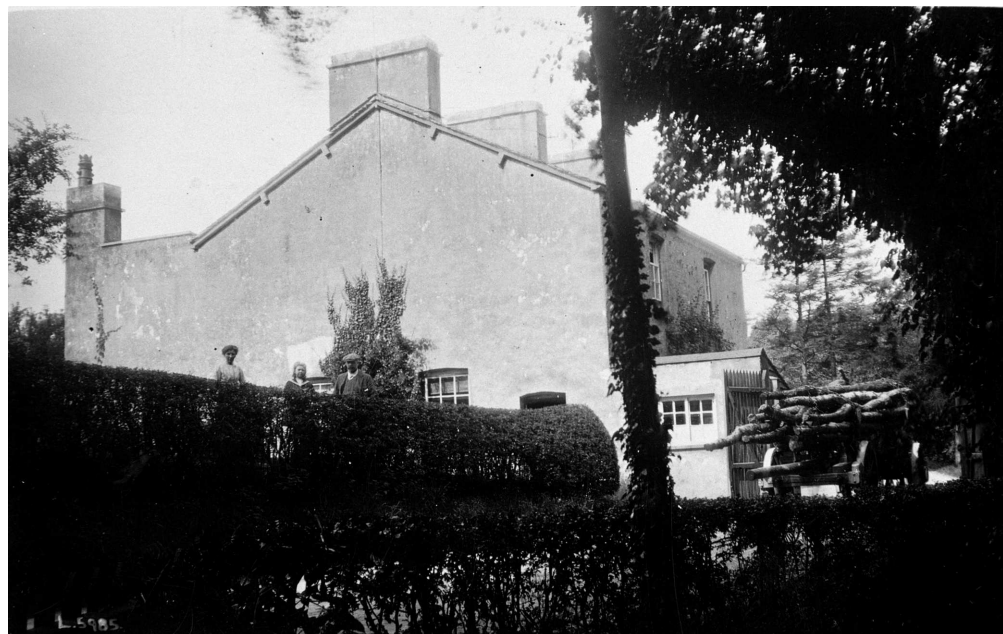
Figure 42.
The gate house and
weighbridge office
(probably in the late
19th or very early 20th
century) from the
south.
(NMR: AA035270,
reproduced by
permission of
David Willacy)

The house has two original front doorways in its south gable wall, one into the front room, the other into the rear room, both reached from a path which opened from the roadway immediately in front of the gates which controlled access into the site. Of the two doorways into the house, both are now covered by open timber porches with slated roofs, that at the front opened into a single room which must have been intended as a general office which, in conjunction with the later office associated with the weighbridge, controlled and recorded people and the delivery of raw materials and the despatch of gunpowder. A doorway (later

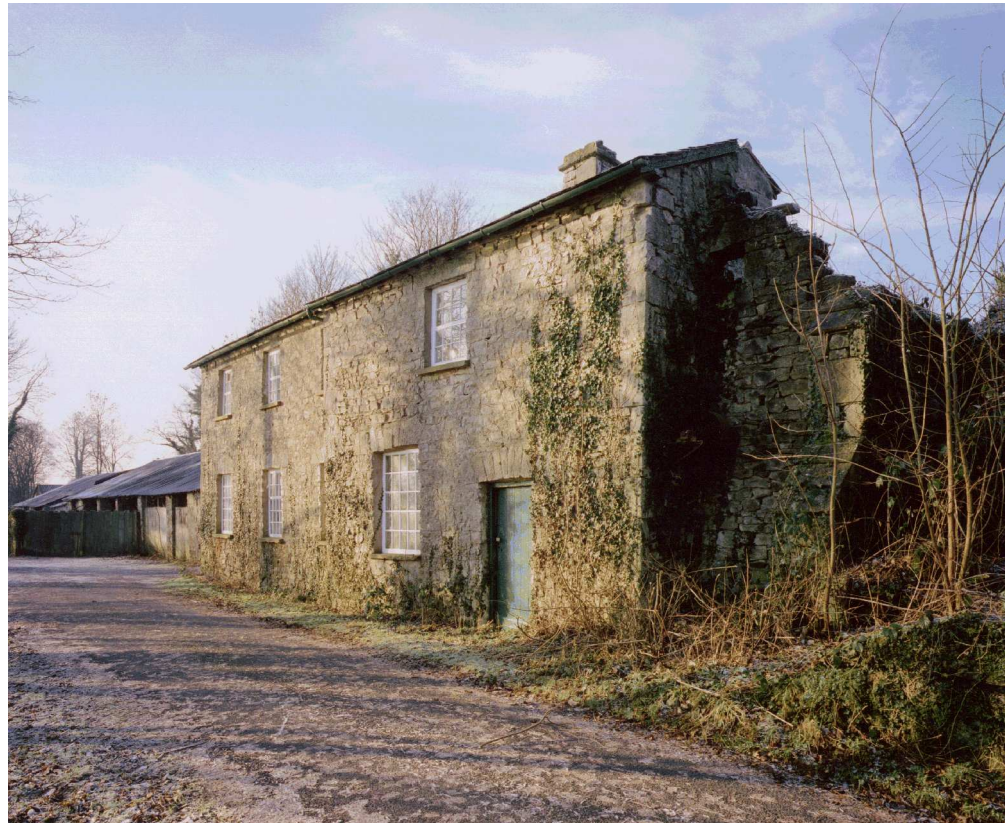
Figure 44.
*The new saw mill,
 watch house and
 turbine house from the
 north east.*
 (NMR: AA012852)

The cooper's yard includes a water-powered saw mill, machine shop and cooper's shop which were built as part of the original gunpowder works and are shown on the first edition of the OS 25" map surveyed in 1857. A new saw mill, incorporating a watch house and a clock tower above the turbine house (Fig 44), were built to architect's drawings dated 1859. The second edition of the OS map shows that by 1896 (when it was revised) further extensions had been added. These include what was probably a joiners shop, built as an extension of the original saw mill complex, and a building within the angle of the two saw mills - this last

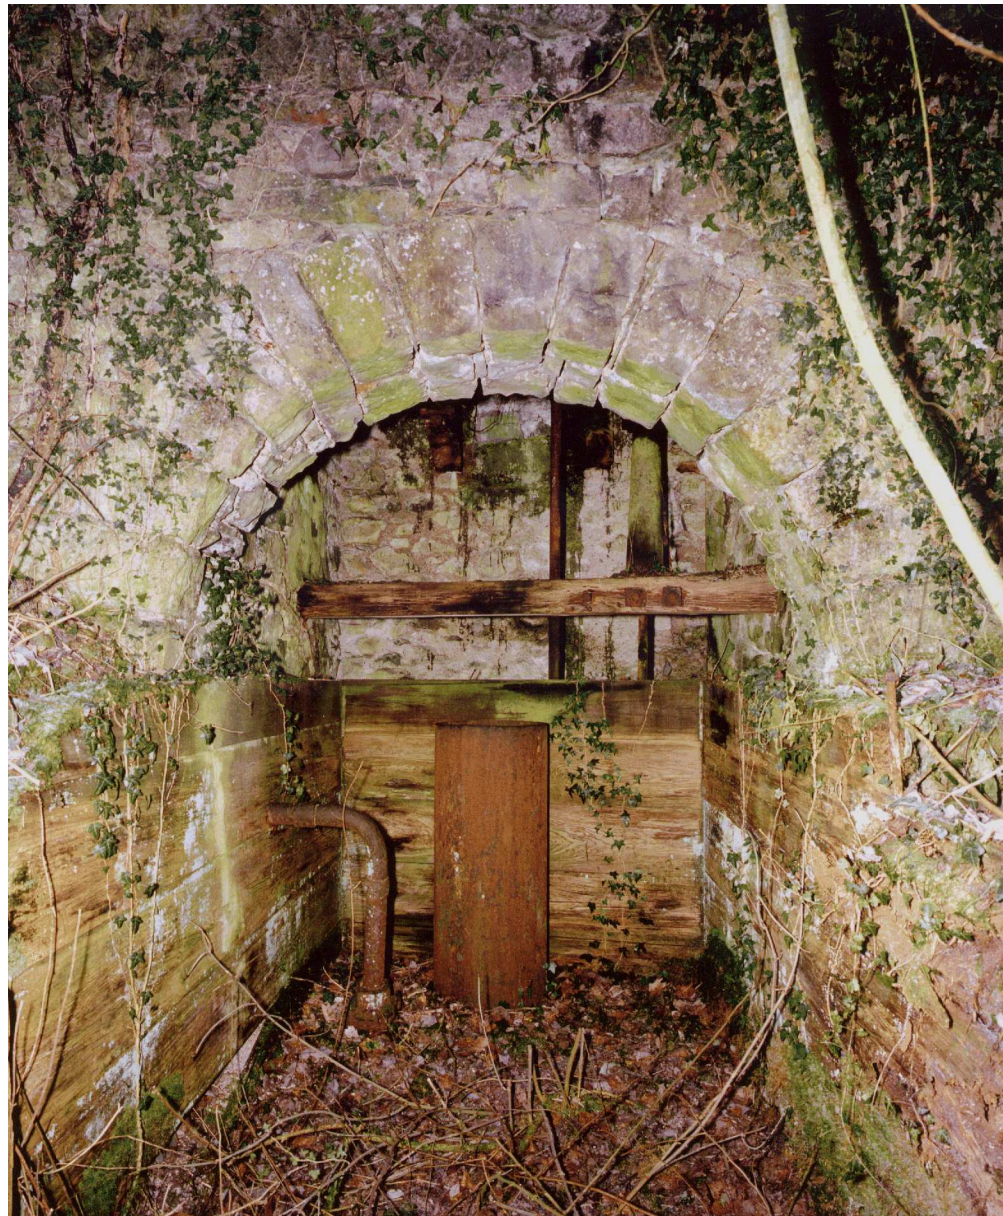
Figure 45.
Detail of the new saw mill showing the arched opening from the main leat into the turbine house which served the cooperage, from the north east. (NMR: AA012853)

The turbine house, called the 'Water Wheel House' on the architects plans of 1859 (see below), is depicted on them as a square structure built against the north end of the east gable wall of the saw mill. The main leat entered it from the north east (Fig 45), through what appears to have been a grated opening, driving a turbine wheel which is not depicted on the plan, which itself powered a vertical shaft with bevel wheels transferring the drive to a shaft along the saw mill. The turbine pit, called the 'Wheel Case' on the 1859 drawings, is circular in section, stone-lined, and now contains a later water turbine.

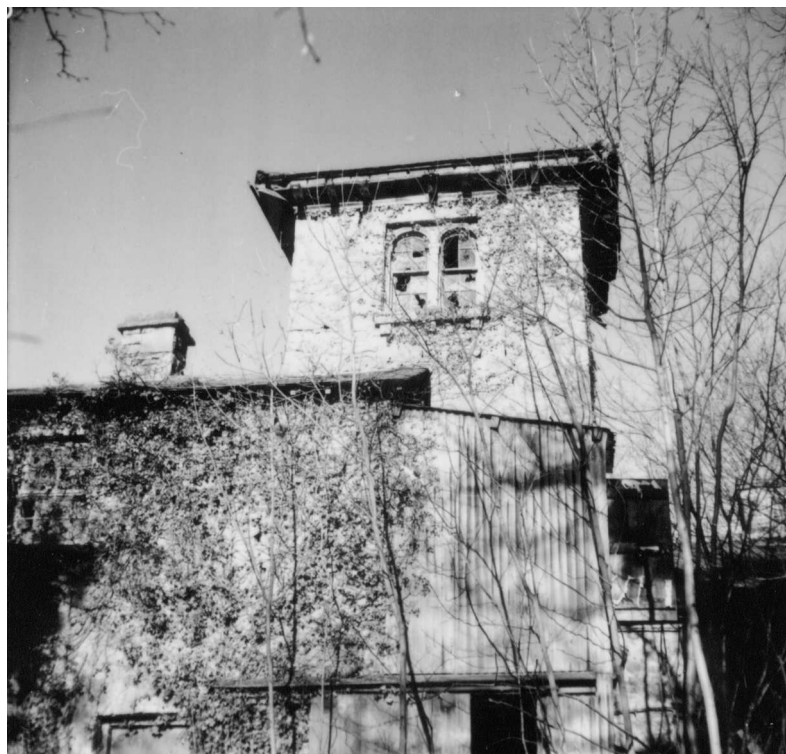
Figure 46.
*The clock tower
above the turbine
house in 1977 before
partial demolition,
from the east.
(Reproduced by
permission of the
National Trust)*

clockwise or anticlockwise to achieve these results. Turning the wheel activated a worm gear on the shafts. The clock tower which was raised above the turbine house is square in plan, Italianate in detailing, and had a shallow pyramidal roof with oversailing eaves and an oval ball finial. The clock chamber was entered, as the 1859 architect's drawings show, through a doorway in its south wall reached from a staircase at the north end of the first floor of the new saw mill. The doorway is now blocked, and the stairs have been removed. A two-light east window lit the clock chamber, and the north wall housed a clock which was set within a shaped, decorative ashlar surround. The Italianate detailing was decorative, but the clock was an important feature on the site. The clock tower was largely demolished in 1977 but the National Trust (Fig 46) and Davies-Shiel took photographs, prior to its demolition. The National Trust photograph also shows that at some time a narrow corrugated iron structure, with a sloping roof, was built against the east wall of the clock tower/turbine house; it is also visible from the north on one of the photographs taken by Miss Gardner in c1945. Perhaps also relevant to the saw mills is a reference in Faulkner's notebook to a 'Trent dynamo' at the 'S Mill'.

The new saw mill is built in the local vernacular tradition, but the architect made a feature of one of the component parts of his new building, the clock tower above the heightened turbine house. The turbine house, with its round-arched entrance from the main leat, dates from 1857, rose to the height of the buttress and housed the central drive shaft which was powered from the turbine and had bevel gears into both the original and the new saw mills. The existing turbine, shaft and the mechanism to adjust the flow of water to the turbine were probably installed around 1920 (see section 6.2.1) by Gilbert Gilkes & Company (who in 1928 became Gilbert Gilkes & Gordon (Crocker 2000, 96)). The control mechanism was operated by turning a cast iron wheel which projects into the north-east corner of the original saw mill. The wheel is cast with the name 'GILKES' and place 'KENDAL', and the instructions 'OPEN' and 'CLOSE', accompanied by arrows indicating that the wheel should be turned

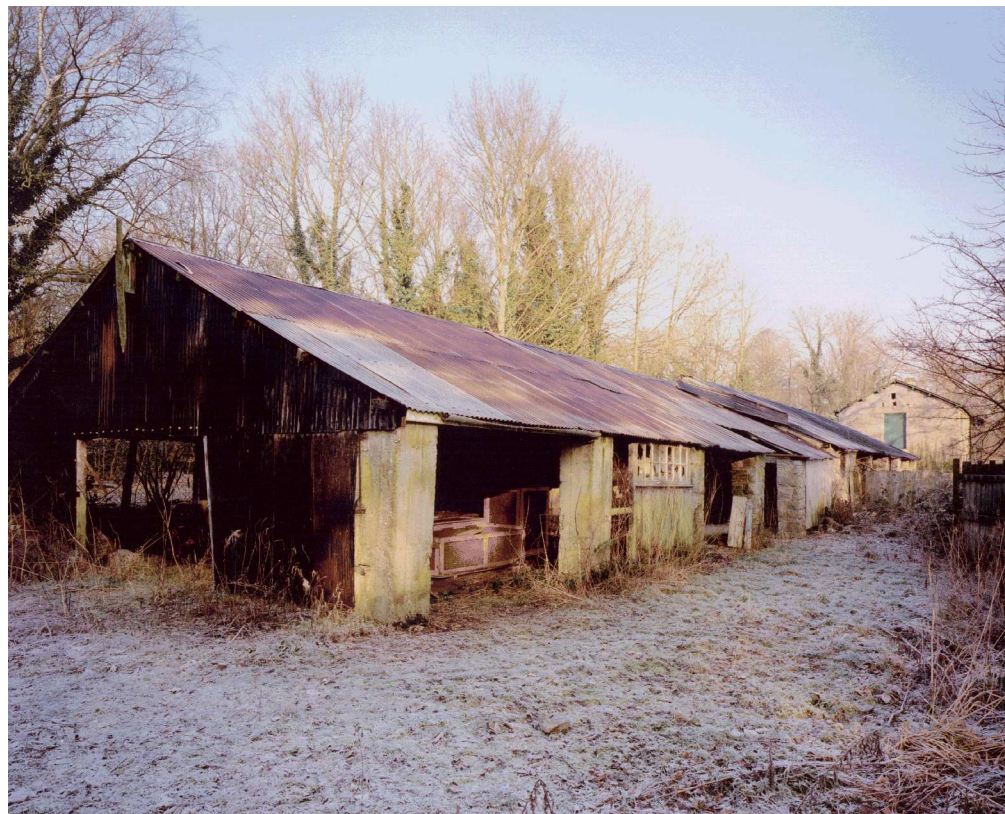
Figure 47.
*The open-fronted
shed from the
south south east.
(NMR: AA012848)*

The original part of the open-fronted shed, as just noted, is at the north end. Six bays long, gabled to north and south, and built of stone rubble with good quoins, it has a corrugated iron roof that must replace slates. The six-bay long open front has four wide central bays flanked by narrower end bays, the five stone rubble piers which separate the bays each supporting the end of a roof truss. The gable walls, which have corner returns at the front,

Three deep slit vents in the rear wall of the north half of this part of the shed, each one set centrally within a bay, appear to be secondary. Originally 1.4m deep, their lower two-thirds since blocked, they each have external timber lintels, and the masonry on either side of them in many cases shows signs of disturbance caused by their insertion. The vents have a stepped inner splay, some retaining timber planks which may have allowed them to be closed off. There is a further insertion at this end of the shed in the form of a small rectangular opening low down in the north gable wall, close to the rear corner. This has an external timber lintel as well as some bricks in its side wall: it is now blocked and its purpose is uncertain. The south end bay has been partitioned off from the rest of the interior by a timber partition of upright planks. The narrow room so created has a lath and plaster ceiling with a small hatch mid-way back, and the original open front has been narrowed by the insertion of a rubble wall to create a doorway with a ledge and batten door. The five king-post trusses of the shed are modern, like their corrugated iron covering. The shed floor is of earth.

The first south extension of the shed is identical in width to the original part but is slightly less tall. It has a three-bay wide, open front with stone piers and rubble rear and gable end walls. The piers are of rock-faced rubble with dressed back corners, a feature found on incorporating mills 7 and 8, which date from the late 1860s. The enlargement of the shed could be part of the expansion of the site initiated after the change of ownership in 1864. The rear wall has three slit vents which rise to the underside of the timber wallplate but internally have stone heads, and the apex of the south gable wall has a smaller slit vent with a stone lintel. The roof has been replaced, almost certainly during World War II; it is supported on a pair of king-post trusses bearing the graffiti 'Aug 43' and 'Clayden/Docherty/Ross/Mills/Scully'. Its roof, covered with corrugated iron sheeting, was renewed when the second extension was built (see below). A cut-out in the sheeting in the front of the central bay created extra headroom for waggons using the shed. The shed floor is of earth.

The open-fronted shed, south of the cooperage, was built in three stages, and although the earliest of these, at the north end, is not shown on the first edition of the OS 25" map (surveyed 1857), it was probably built shortly after that map was surveyed in order to serve the newly-established gunpowder works. One of the 1859/1860 sketch maps shows what must be the first phase of the shed as an open rectangle with a cross through it (CRO(K) WDB/35/779), confirming its early date. The second edition of the OS 25" mapping (revised 1896) depicts the building with its first extension; the second extension is likely to date from the military occupation of the site during World War II. The shed is not labelled on the site plans of 1900 and 1903-12, but it is likely that carts used by the works were housed in part of it, and timber stored in the rest of it. On the plan in Crocker and Crocker (1992, 9) the building is annotated 'Fire Engine, Stables, etc.' but the identification is not based on historic sources.

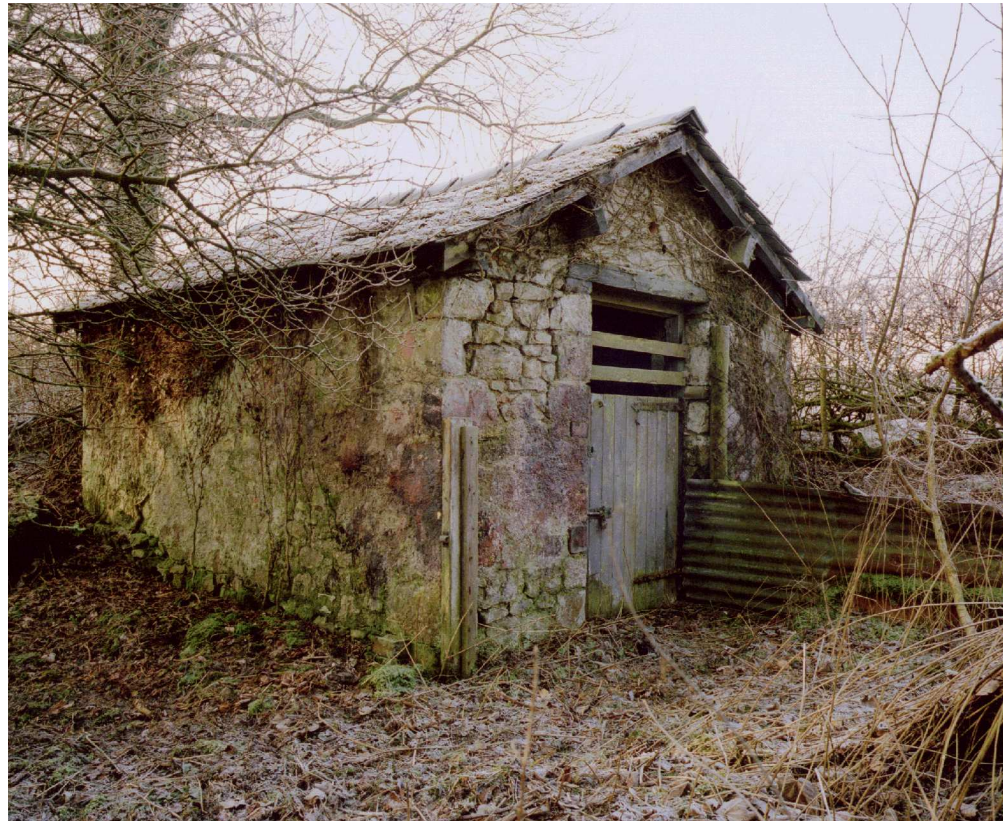
Figure 48.
*The small stable to
the west of the
cooperage, from the
north east.
(NMR:AA012847)*

A small stable (56) (identification confirmed by James Guy), shown on the second and 1914 editions of the OS 25" map, is situated beside the western perimeter of the unlicensed area to the west of the cooperage (Fig 48). It has been well-maintained and appears to have been in use until fairly recently. Measuring 4.2m by 3.3m, it is built of rubble with roughly dressed quoins and a single doorway in its north-eastern end. The gabled roof is of slate. The interior is rendered and subdivided into two stalls.

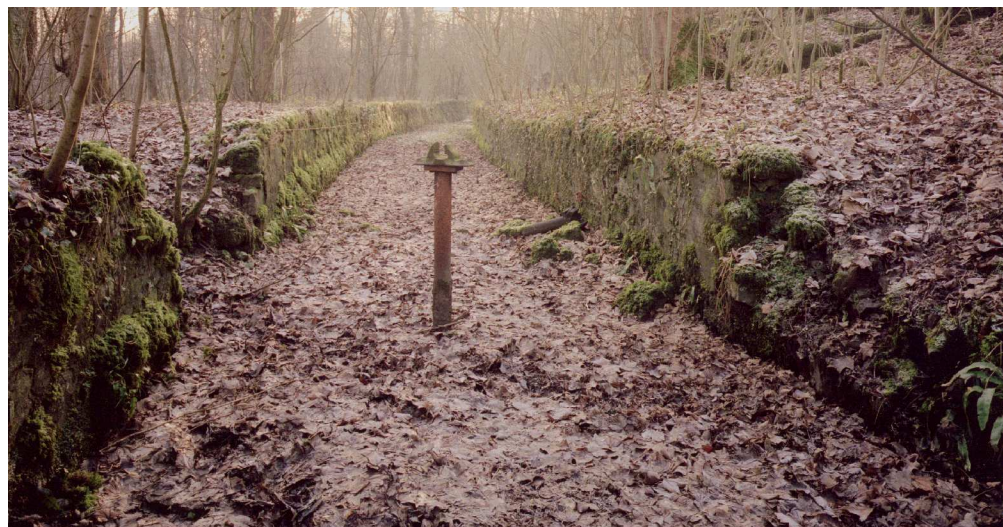
Figure 49.
Remains of the tramway crossing over the main leat between the new stove house and the reel house, from the north.
(NMR : AA012921)

in order for the junction to work efficiently a waggon turntable was probably installed where the lines crossed. This new line crossed the main leat and ran in a northerly direction to the new stove house and beyond to the reel house which entailed another crossing of the leat. This crossing may have been a rather rickety affair and the surviving evidence indicates that two iron pipes, with standard gauge rail chairs fitted to their tops, were set vertically into the base of the leat (Fig 49). The chairs presumably held longitudinal timbers that supported the track bed. One of the pipes has fallen over but the other is still upright.

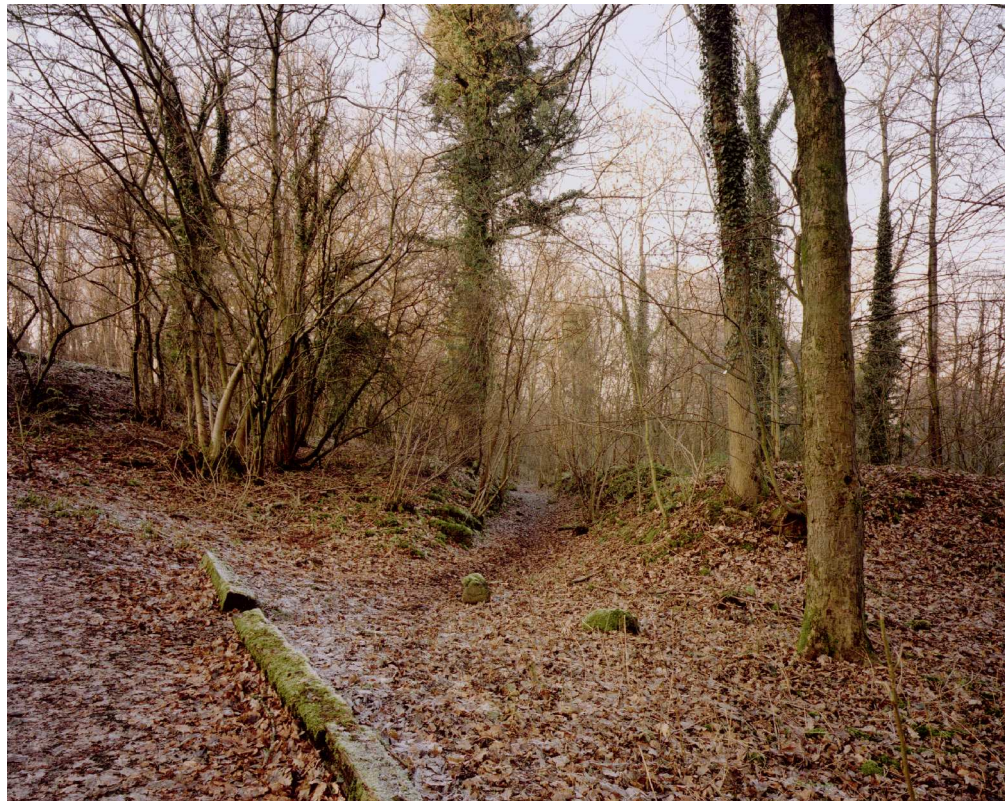
Figure 50.
*The tramway cutting
south west of the new
glaze house, from the
south east.*
(NMR: AA012926)

Returning to the southern end of the new line, after crossing the leat it entered a 55m long straight cutting on its way to the new stove house. This survives as a substantial earthwork (Fig 50) cut into the lower part of the valley side and measures about 4.2m across and up to 1.4m deep. In places it has been cut into the bedrock and some of the excavated material has been heaped up on the east side of the cutting, presumably to provide blast protection from the adjacent new glaze house. At its south end this bank merges with a well-formed short blast bank that extends east to west from the cutting to the edge of the main leat; it is about 1.7m high and its east end has been revetted with stone to prevent collapse into the leat. This section of the tramway may have been re-used in World War II, suggesting that either it was not lifted when the works closed or that it was re-laid after the outbreak of hostilities. The evidence for this comes from the siting of former munition dumps whose arrangement in the vicinity of the cutting and new stove house suggests a relationship of some sort with the route of the tramway. Indeed several dumps were rather awkwardly placed on the narrow space between the main leat and the bank on the eastern side of the cutting (the west end of their platforms are cut into the bank confirming that they post-date the cutting). The bank was breached in a couple of places to give access to them and it is difficult to see how these features were serviced unless a tramway was being used.
