New Sedgwick Gunpowder Works,
Cumbria:
an archaeological
and architectural survey

SURVEY REPORT

Archaeological Investigation Report Series AI/19/2003

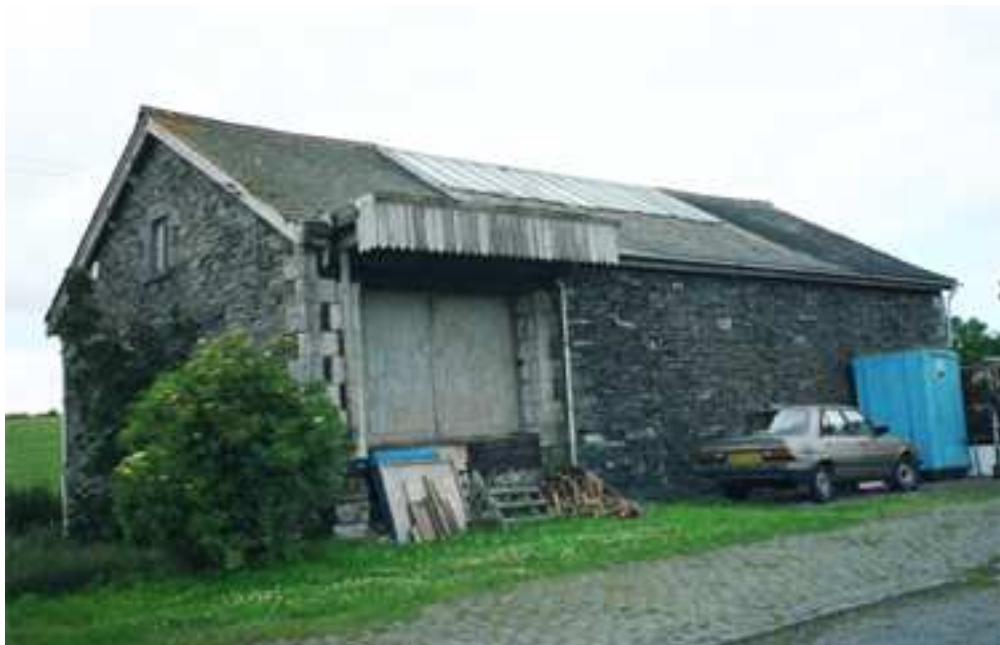
Figure 52.
The gunpowder
warehouse at
Hincaster Junction,
from the east.
(NMR: DP001584,
reproduced by
permission of
Christopher Dunn)

same means. Transport between the warehouse and New Sedgwick was by horse and cart, but latterly a motor van was used for the gunpowder (Halliwell 1964). The warehouse still survives and is situated at NGR SD 5121 8481 on privately owned land beside the present West Coast mainline railway (Fig 52). The building is currently used as a farm implement shed but before this part of the interior was converted into a small office. The single-storey building measures 14.8m by 7.4m, walls are of coursed slate rubble with limestone quoins. There are windows in each gable end with stone jambs, sills and lintels. It has a slate roof with large skylights in the central area and the interior of the building has a raised floor. In the northern wall there is a large double sliding door accessed by a ramp, but this appears to be a later insertion. In the southern end of the east wall is an original loading bay, with a decorative wooden canopy that faced on to the siding; the track of the later has been lifted.

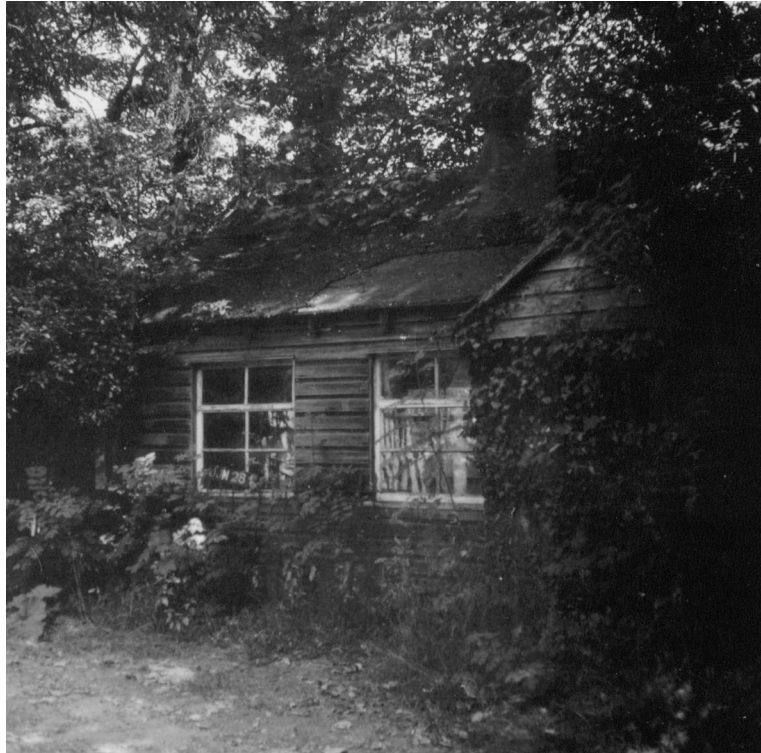
Figure 53.
The World War II guard house at the entrance to New Sedgwick in 1977, from the west. (Reproduced by permission of the National Trust)

Immediately outside and to the east of the entrance to the gunpowder works are the foundations of what was probably the guard house for the depot. No building is shown at this location on any of the maps or site plans produced during the life of the works so the remains are unlikely to relate to the gunpowder industry. However, a very dilapidated building was photographed here by Davies-Shiel (reproduced in Tyler (2002, 216)) and the National Trust (Fig 53) during the late 1970s. The single-storey timber building had sides clad in tongue and groove boarding and a felt-covered roof gabled north to south; a large ventilator-like feature with a cylindrical top was centrally situated on the roof ridge. There was a window in the centre of the southern end and two windows and a porch (with a gabled roof) on the west side. The building was situated on the edge of the riverbank which here falls steeply

down to the to the water's edge. All that survives are nine shuttered concrete pillars, no longer all upright, whose tops would have provided a level base at road level for the floor of the building.

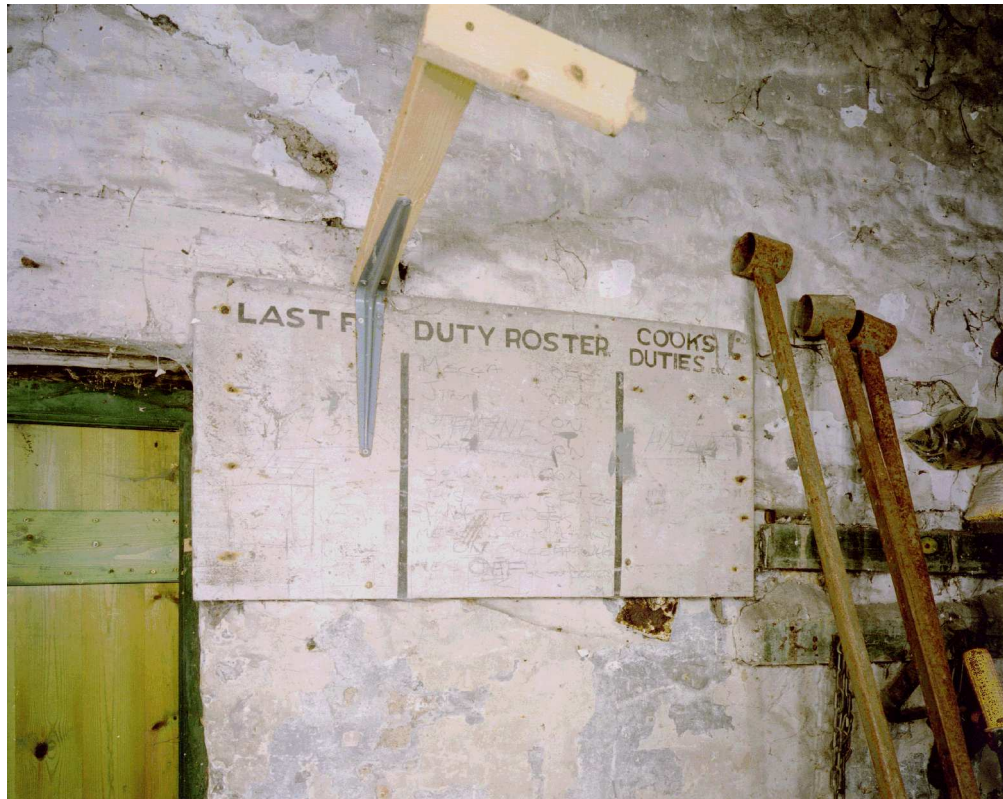
Figure 54.
Duty roster board on
west wall of World
War II cookhouse.
(NMR: AA012938)

During World War II the machine shop at the western end of the saw mill was converted into a cookhouse, a long, low, cast-iron range, set in a brick casing, being built against the east wall. The range has an open fire flanked by two ovens, the doors of which are cast with the words COOKING and ROASTING. Smoke from the range was led up a pipe that rose in front of the wall behind the range and then passed through a hole mid way up it into a flue within its thickness. The hole in the wall survives, but not the pipe. A notice board by the door in the gable end wall is of wartime date, having columns headed LAST F., DUTY ROSTER and COOKS DUTIES ETC (Fig 54).

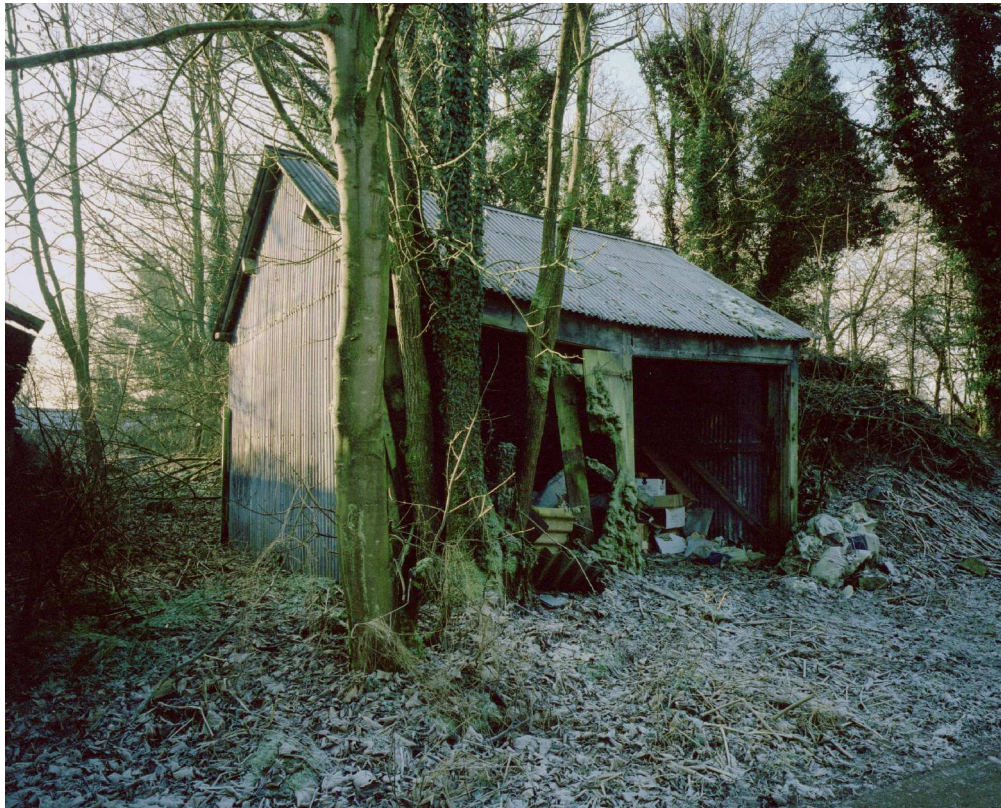
Figure 55.
World War II storage
shed to west of open -
fronted shed,
from the north east.
(NMR: AA012860)

A single-storey shed (Fig 55), with timber framing, and clad in corrugated iron is situated immediately south of the coopeage on the site of an earlier gunpowder building (see section 6.2.9 above). The floor is of solid concrete and the building has double doors indicating that it was able to accommodate reasonably wide loads.

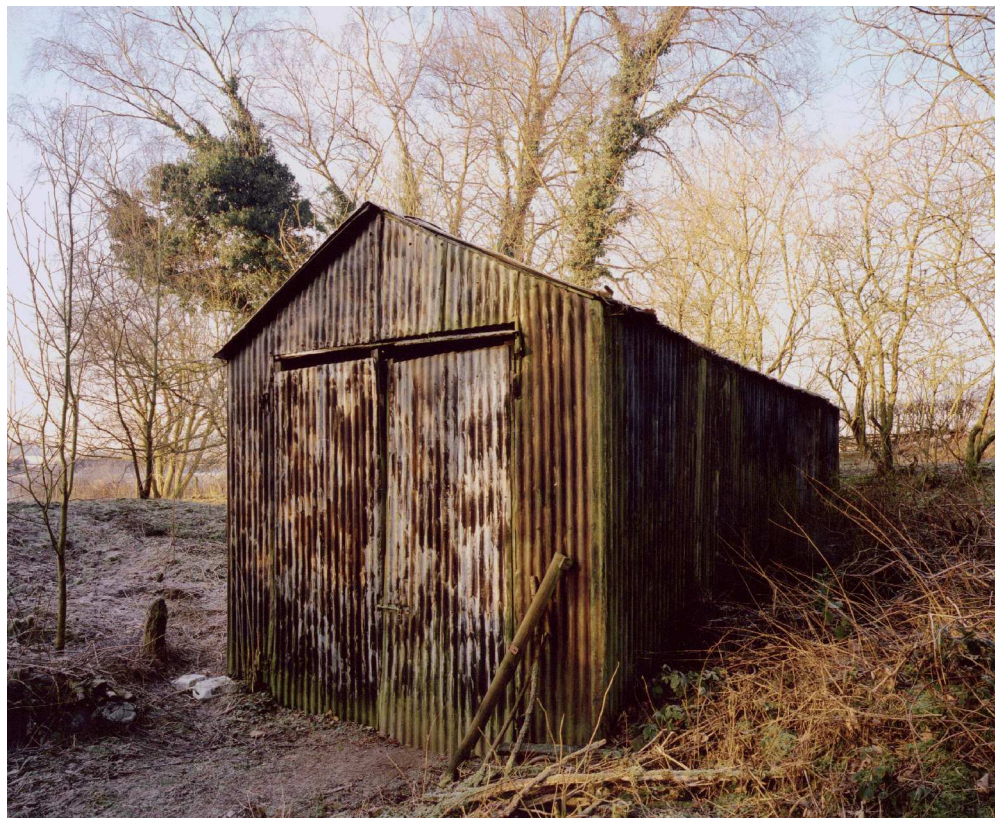
Figure 56.
*World War II garage
north west of the gate
house, from the east.*
(NMR: AA012837)

The garage was constructed on the site of an earlier gunpowder building (see section 6.2.9 above). The garage (Fig 56) is a timber-framed single-storey affair with a corrugated iron exterior and internal timber cladding. In the floor is a timber-lined inspection pit. The collapsed remains of a lean-to extension, also of corrugated iron, lie beside the southern side of the main structure. A concrete base, 2m square, is situated beside the front of the garage to the north and was constructed in the 1970s. According to a local informant it was the site of a dog kennel (a low headstone, situated a short distance to the north, marks the site of a dog's grave).

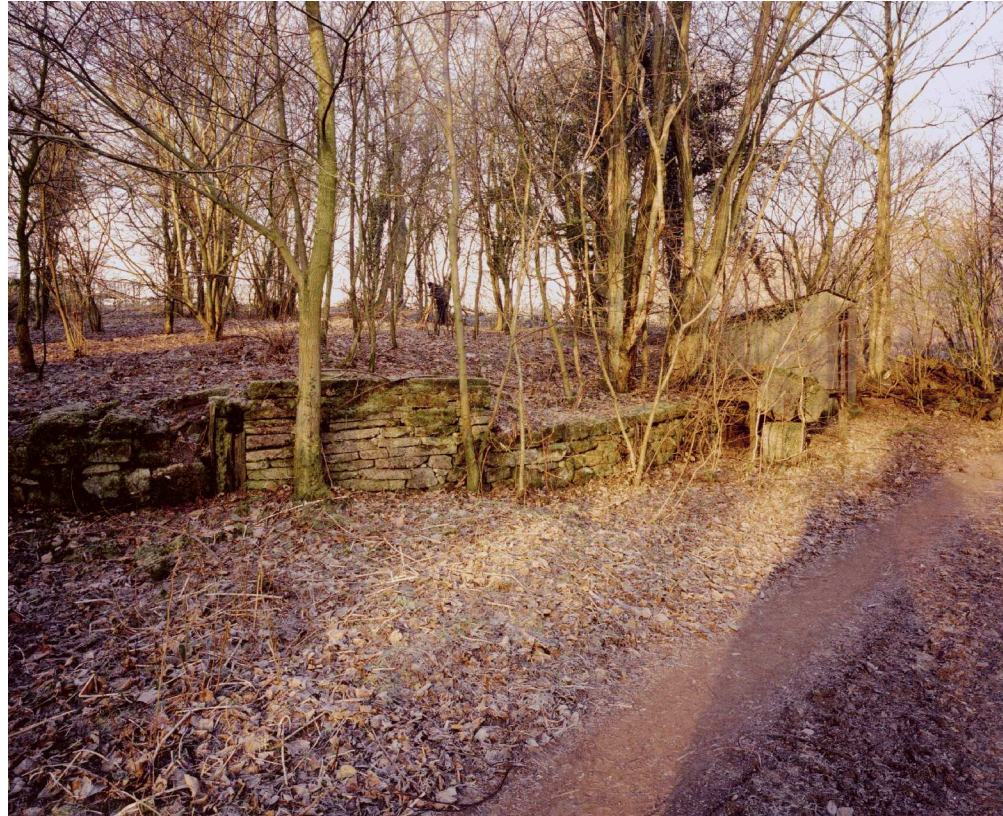
Figure 57.
*World War II loading
platform and hut to
rear of open-fronted
shed, from the south
south east.
(NMR: AA012840)*

A loading platform is situated near the western edge of the track to the rear of the open-fronted shed (Fig 57). Its front is revetted with walling made from broken concrete slabs and stone; it is 1.1m high, 1.8m deep and also contains timber in its construction. A small, single-storey concrete hut, with a single-pitch roof of corrugated iron and a recently replaced door, is situated at one end of it.
