ARCHAEOLOGICAL  
INVESTIGATIONS

NATIONAL TRUST  
SEATON DELAVAL HALL  
NORTHUMBERLAND

on behalf of  
The National Trust

NAA 20/92  
May 2021

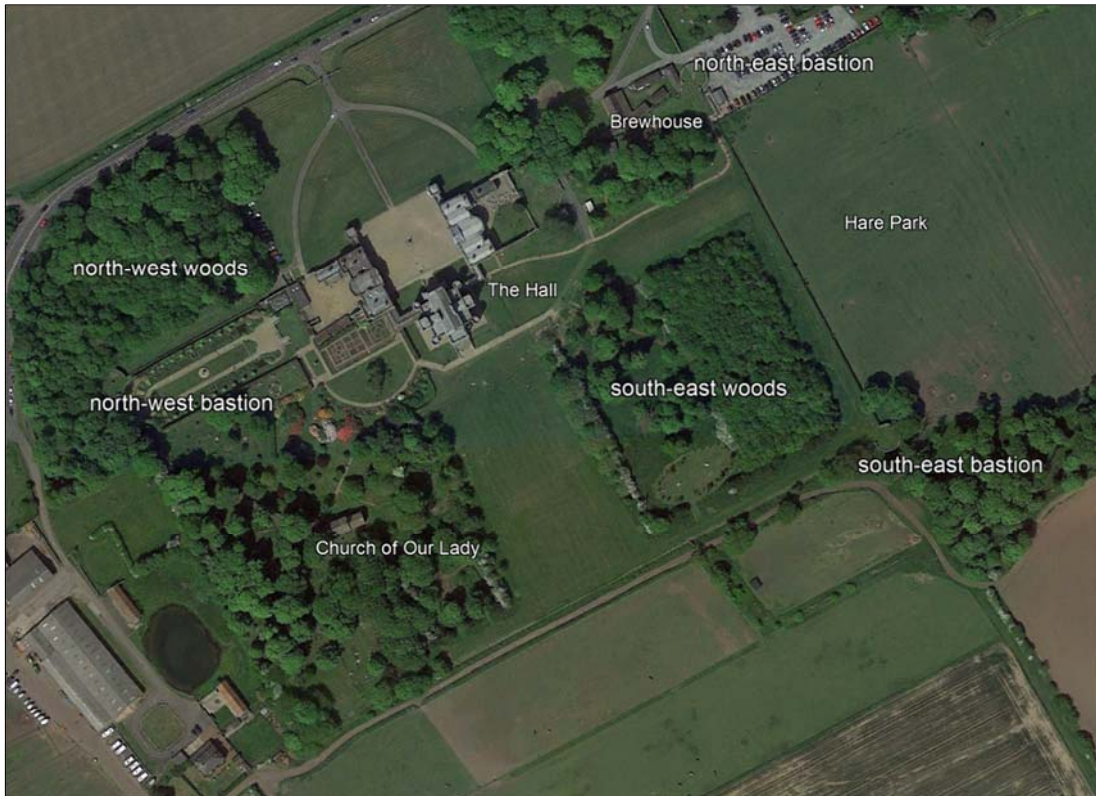
*Figure 3: aerial photograph of key areas discussed in report. Image © Google 2018 5/27/2018.*

- 2.3 The Pleasure Grounds form part of a wider parkland estate, and at project commencement comprised blocks of mixed woodland interspersed with areas of open lawn, the most significant of which are to the north, east and south of the Hall providing long views and vistas both to and from the mansion (Fig. 3). The former Pleasure Grounds mainly lay to the south of the Hall, enclosed on three sides by the ha-ha. Much of this area (that which is owned by the National Trust) is now gardens and mixed

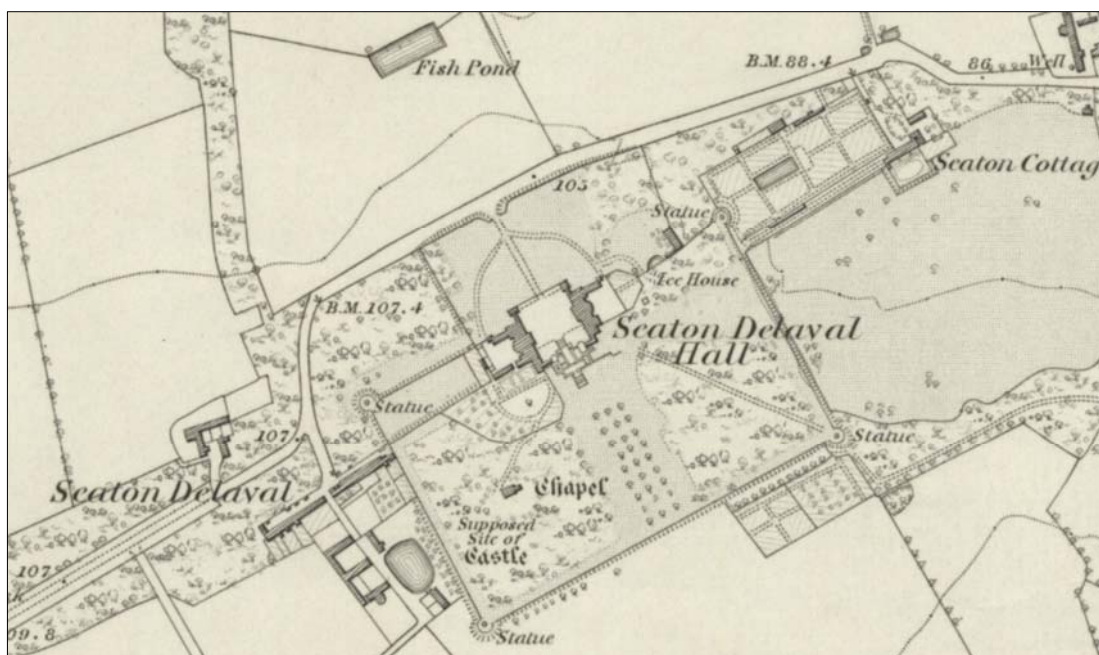
Figure 6: 1860 First Edition six-inch OS map.

- 3.25 The First Edition OS map, surveyed in 1855, shows the remains of the Hall following the fire and the Central Hall is depicted as unroofed (Fig. 6). A new garden is shown laid out to the south-west of the building, to the rear of the potting shed. Associated with this is a D-shaped enclosure that survives in the layout today. A block of trees, set in three rows, is shown occupying the south lawn, although later maps suggest that this was a short-lived planting scheme.
- 3.26 The Second and Third Edition maps, published in 1897 and 1922 (Fig. 7 and Fig. 8), show a considerable degree of tree felling inside the bastion enclosure, breaking up the formal edges of the woodland blocks. The Church of Our Lady became the parish church in 1891 and in association with this the area around the church was given to the Parish and cleared to establish the graveyard.

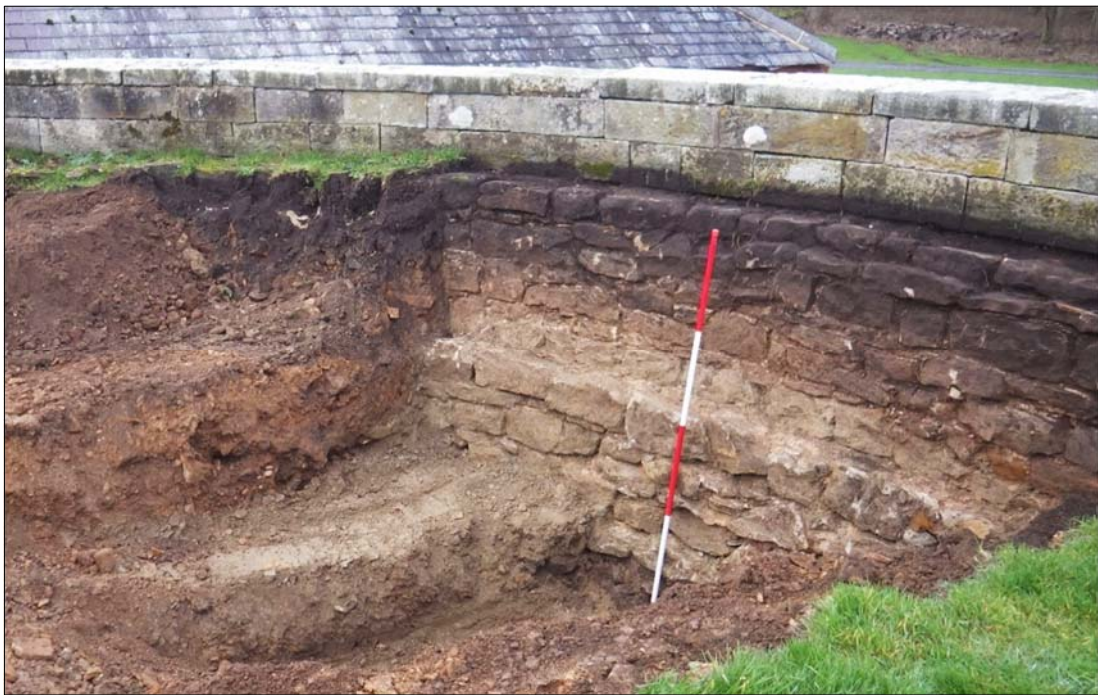
*Plate 1: interior face of wall 22 with infill 28 and 29 visible (facing north).*

exposed, hand-excavated and recorded as the work progressed. This provided evidence of the sequence of construction (Plate 1). Once the sequence of deposition had been established, and the absence of any intermediate structural features confirmed, much of the interior fill of bastion was removed by the contractor under archaeological supervision.

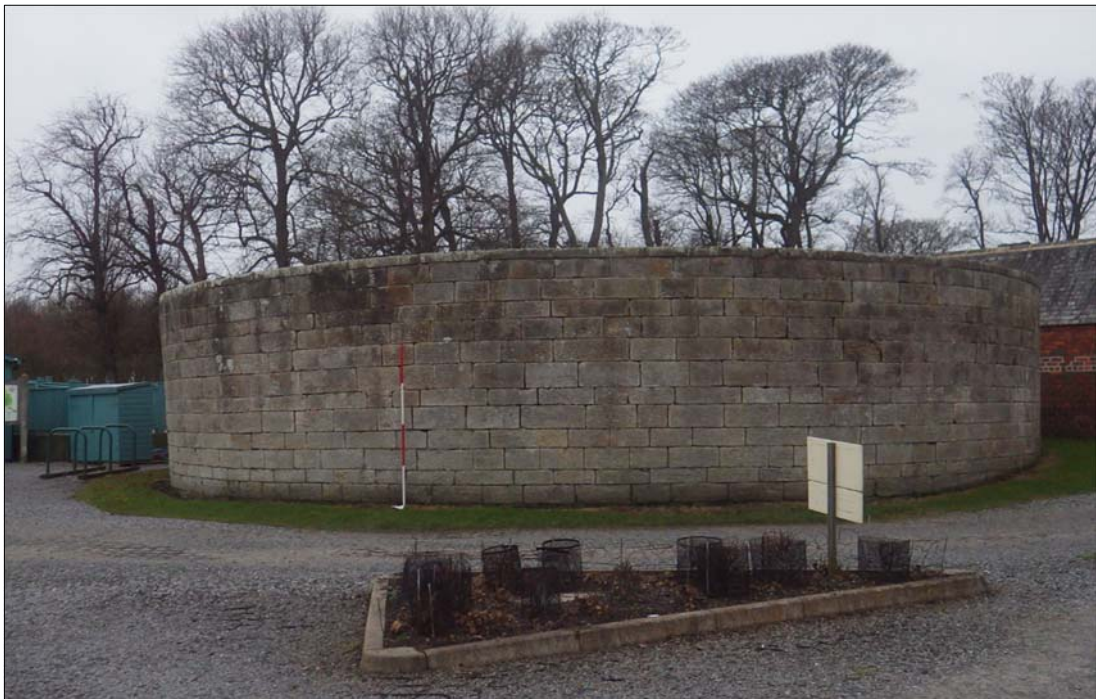
*Plate 2: external face of north-west bastion, facing south-east.*

- 8.3 The exterior face of the bastion was c.3m high and was constructed of regularly coursed small ashlar. This was roughly hammer-dressed and bonded with a creamy-white lime mortar. The structure was topped with rectangular sandstone coping (Plate 2).
- 8.4 The evidence suggested that, prior to construction, the ground around the bastion was stripped of all topsoil and subsoil down to the natural underlying clay. The structure was then erected from ground level in three stages comprising: (a) foundations, (b) mid-section, and (c) ashlar upper section with sandstone copings (Plate 1). The foundation course was c.1.2m wide and constructed of large, coursed sandstone blocks that were partially mortared and bedded onto the natural glacial clay. Redeposited clay (29) was packed both behind and into the interstices between the stonework to provide additional support (Plate 3).

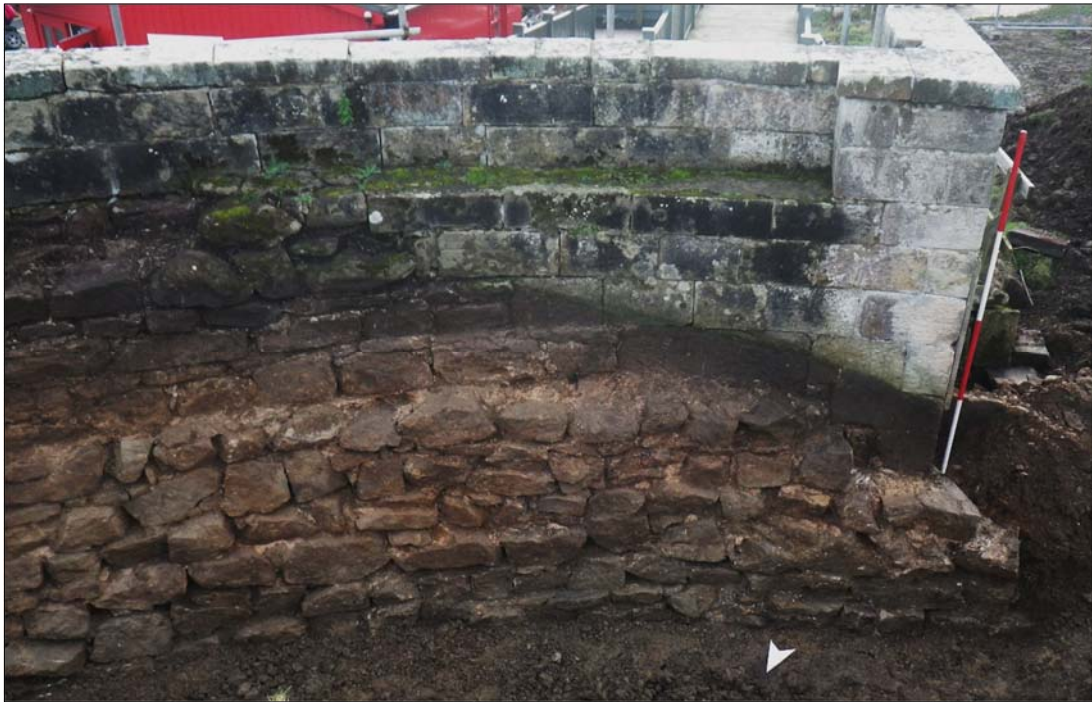
*Plate 3: stepped construction courses within the entrance to the bastion, with ashlar courses at and above the turfline.*

- 8.5 The mid-section was stepped c.0.25m in from the face of the foundation course below. It stood c.1.00m high and, like the foundations, most of it was constructed of coursed rectangular blocks, the exception being at each end of the bastion where small ashlar were used (Plate 3). This indicated that the majority of the masonry was always intended to be concealed below ground with only the two ends exposed. The upper section of the wall was stepped 0.3m in from the face of the mid-section and comprised two courses of regularly coursed small ashlar, matching the external face of the structure.

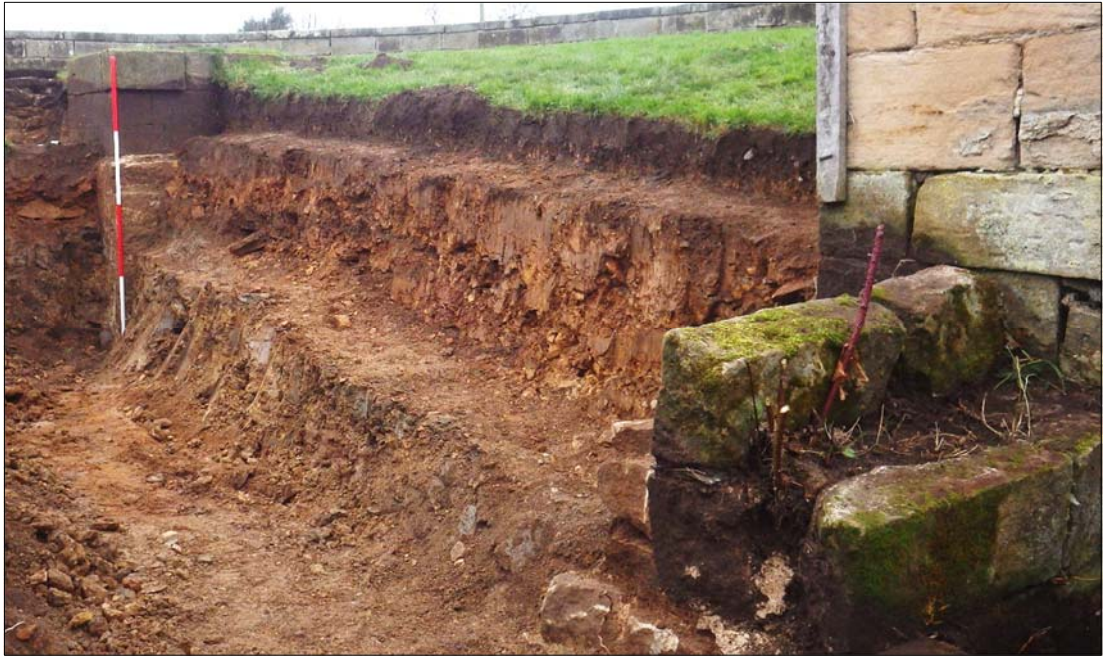
*Plate 4: stepped excavation of Trench 2 with statue plinth **24** on the left and retaining wall **25** in the foreground (facing north).*

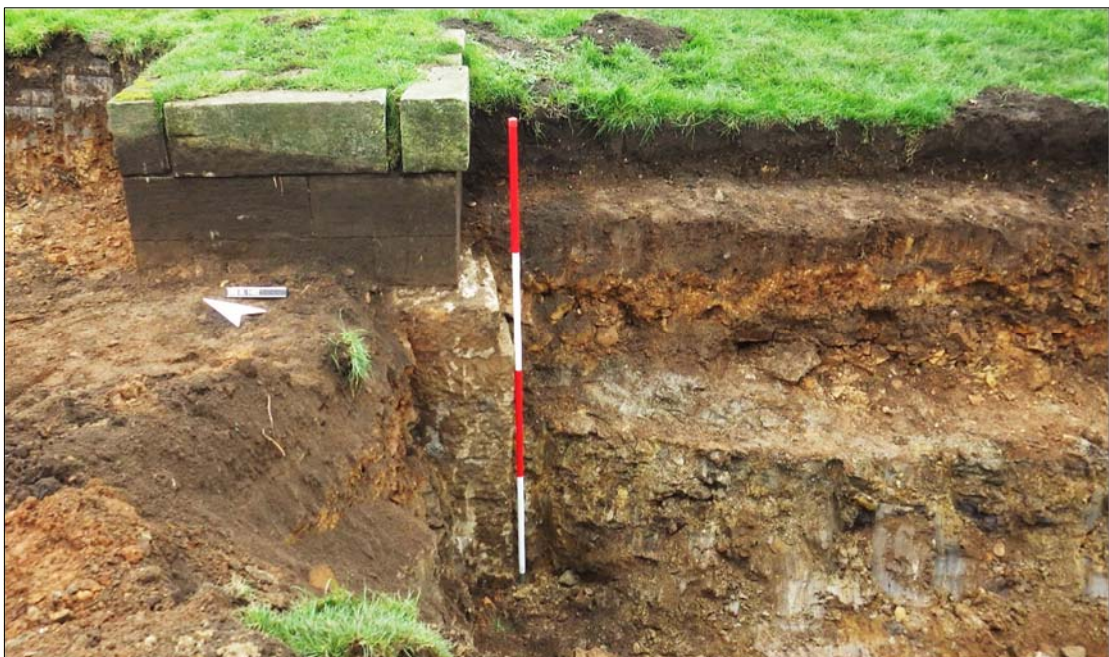
*Plate 5: excavation through the infill of the bastion with exposed statue plinth **24** (facing east).*

- 8.9 The central statue plinth comprised three courses of dressed ashlar, set above a foundation of heavily mortared rubble sat on a base of sandstone. The foundation measured c.1.3m deep and was deeper than those for the surrounding bastion wall, extending down into the natural clay (Plate 5).

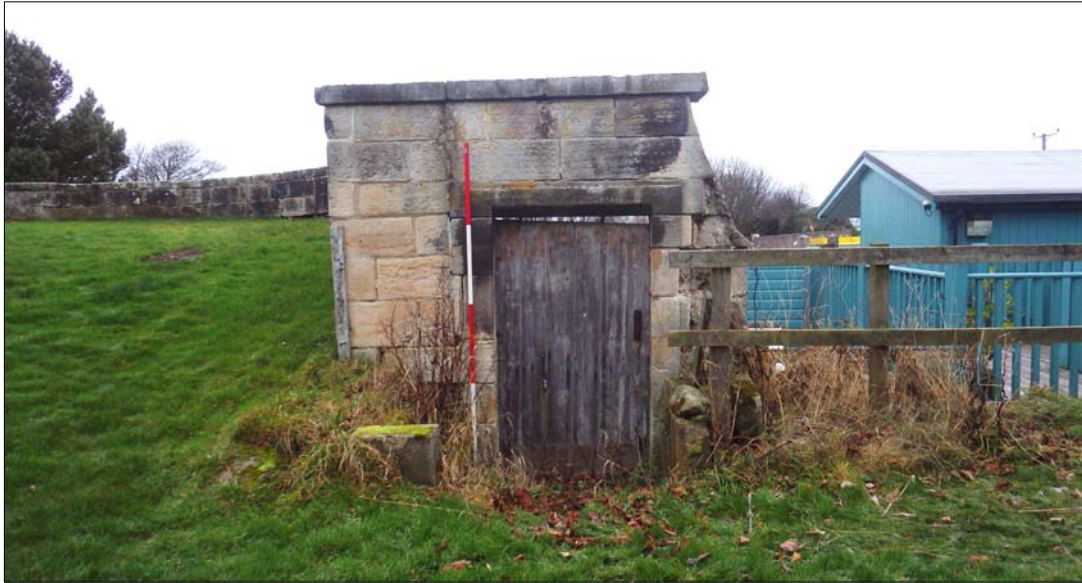
*Plate 6: gateway 23 prior to excavation showing the slope of the bastion bank.*

Pleasure Grounds into the walled garden. The ha-ha wall at its northernmost end was the same height as the bastion, and clearly abutted its external face. Both structures were capped with the same type of sandstone coping stones (Plate 6). Immediately south of gateway, the wall sloped down to an external height of 0.8m above modern ground level and had lost most of its coping stones. It continued south-south-east to form the eastern boundary of the pleasure garden enclosure (Plates 7–8; Fig. 9).

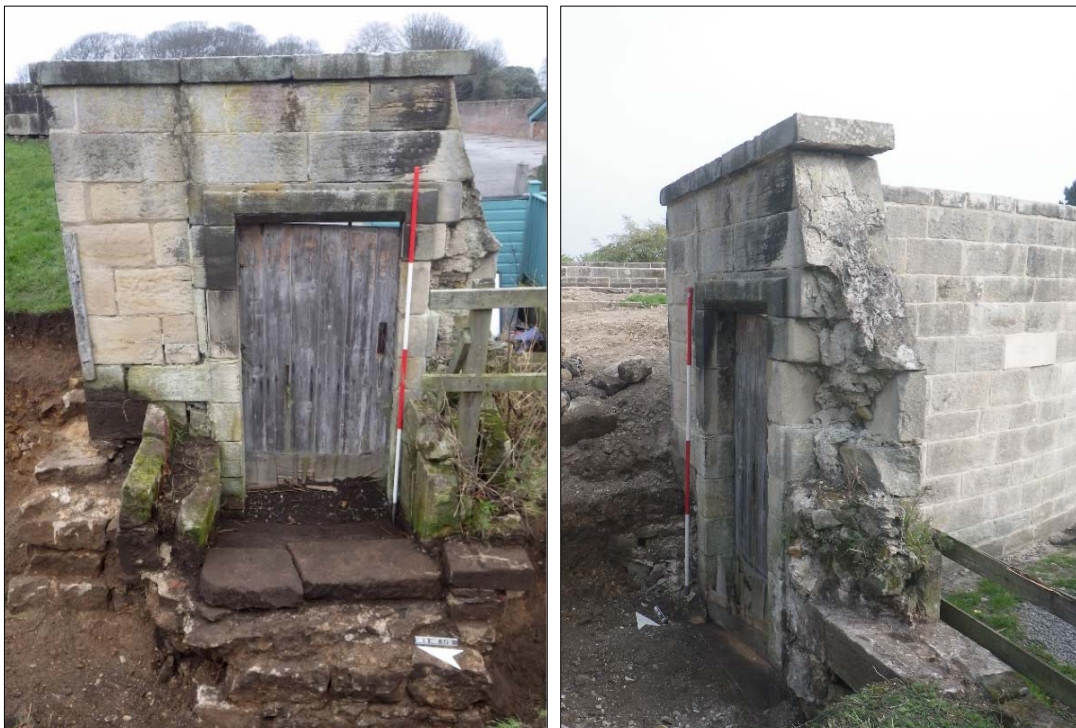
*Plates 7, 8: (left) gateway 23 with step 31 and retaining wall 25 during primary excavation; (right) full extent of gateway exposed prior to renovation.*

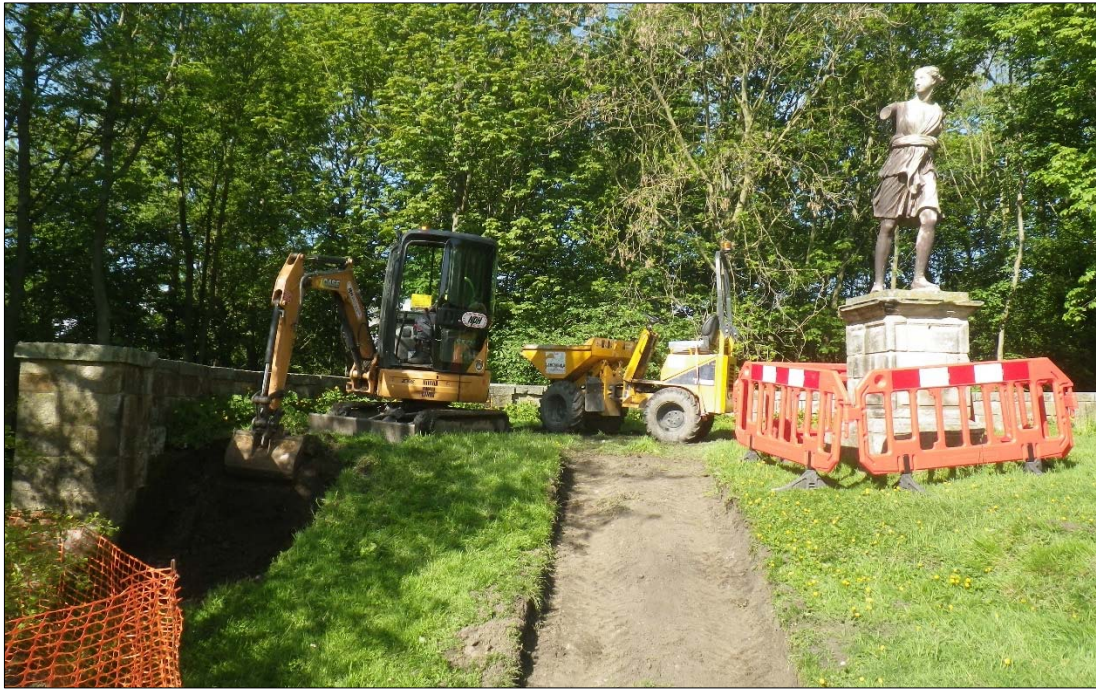
*Plate 9: initial machine excavation and removal of soil within the north-west bastion.*

- 8.13 The north-west bastion was similar in size to the north-east bastion, and shared the same type of construction (Plates 9 and 10).
- 8.14 A small rubber-tracked excavator removed the infill around the interior of the bastion, taking great care not to disturb the statue. Soils in the interior were reduced by a depth of 1.2m, and the internal face of the masonry was cleared by hand by the archaeologist (Plate 10). The nature of the infill was similar to that observed in the north-east bastion and consisted of heavily compacted crushed stone rubble with mixed sands and clays (218). This material contained no finds. The reduction in the required depth of excavation meant that only the upper ashlar course of the internal wall face was exposed (219). This was repaired and consolidated prior to the reinstatement of internal landscaping.

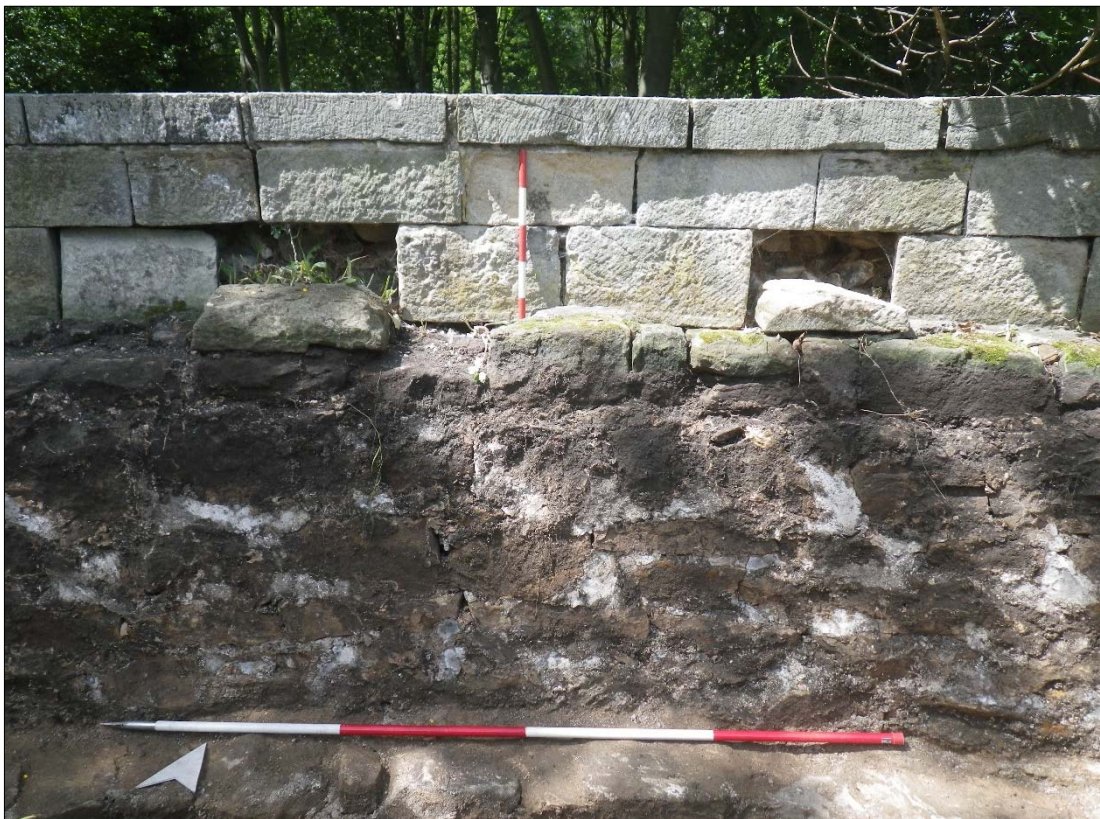
*Plate 10: interior face of the north-west bastion after hand clearance, with weather damage to the ashlar courses and foundation plinth in the base of the trench.*

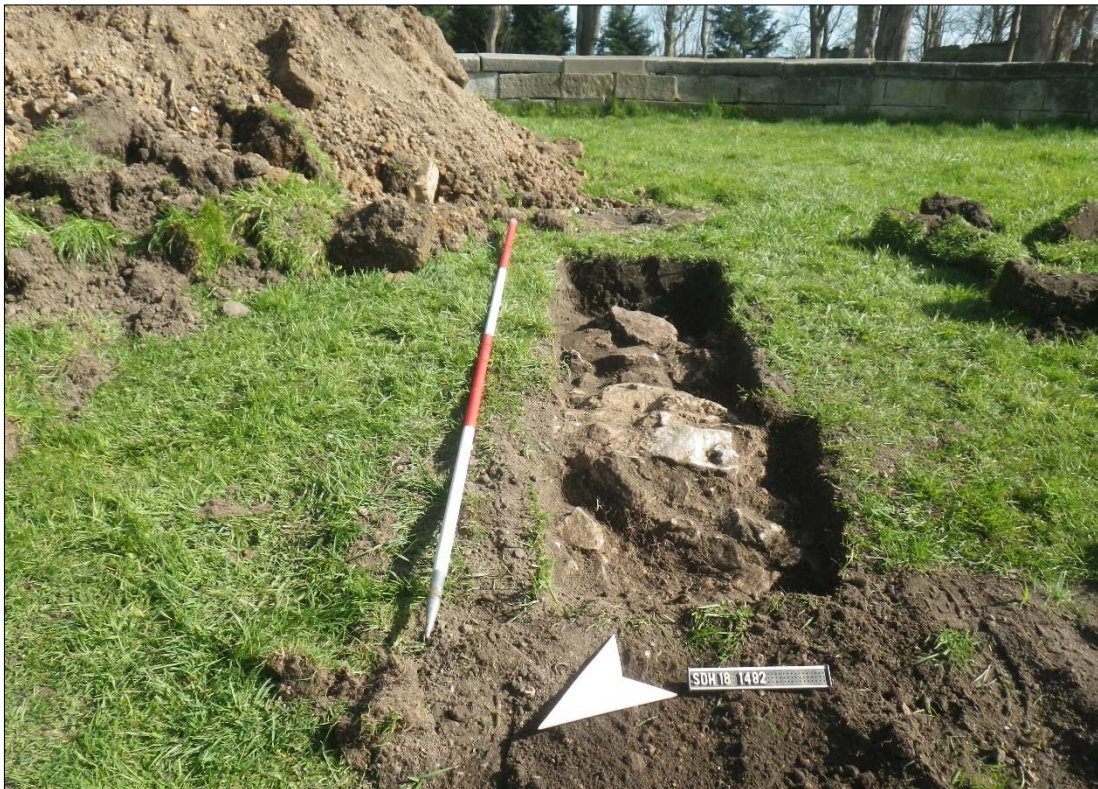
*Plate 11: rubble deposit 220 in the centre of the south-east bastion.*

- 8.15 The interior of the south-east bastion was excavated in a similar manner to that of the north-west, except for the addition of a small hand-excavated trench in the centre to investigate the apparent absence of a statue plinth. This measured 2m by 0.5m and was excavated to a depth of 0.2m beneath the topsoil, revealing an area of disturbed rubble (220) marking the probable location of the former plinth. Investigation stopped at the required depth of intervention and no worked masonry or foundations were recorded at this depth (Plate 11).

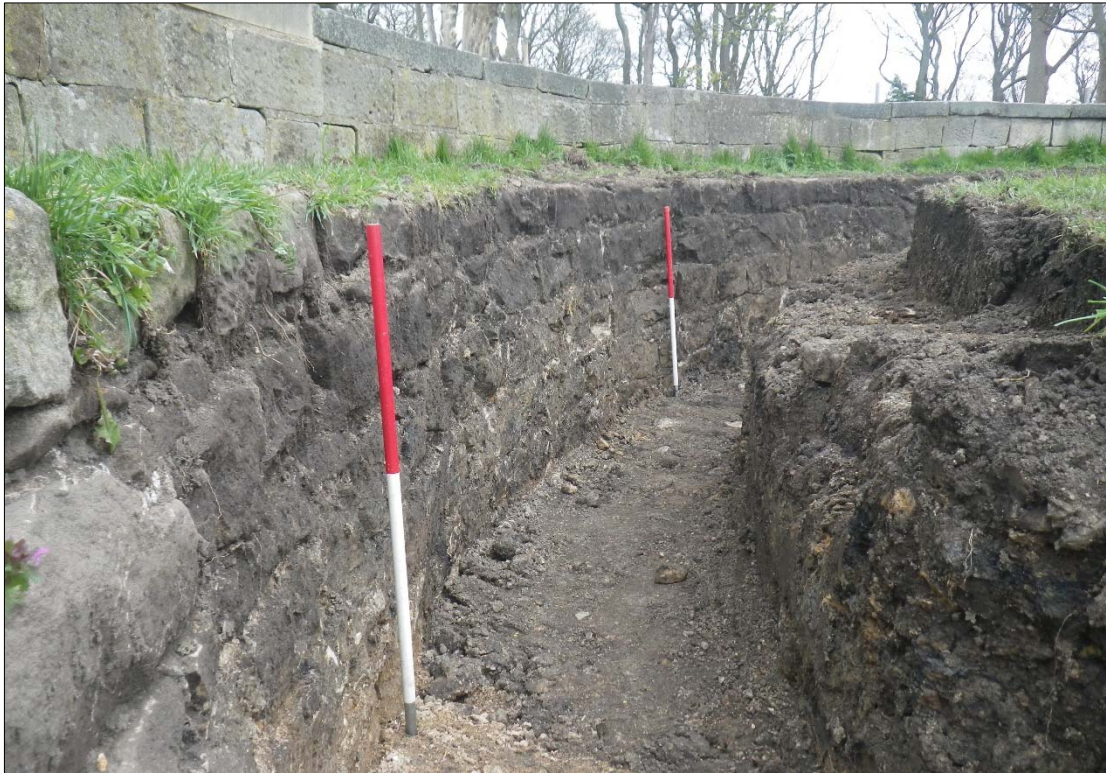
*Plate 12: interior face of the south-east bastion following excavation and hand cleaning.*

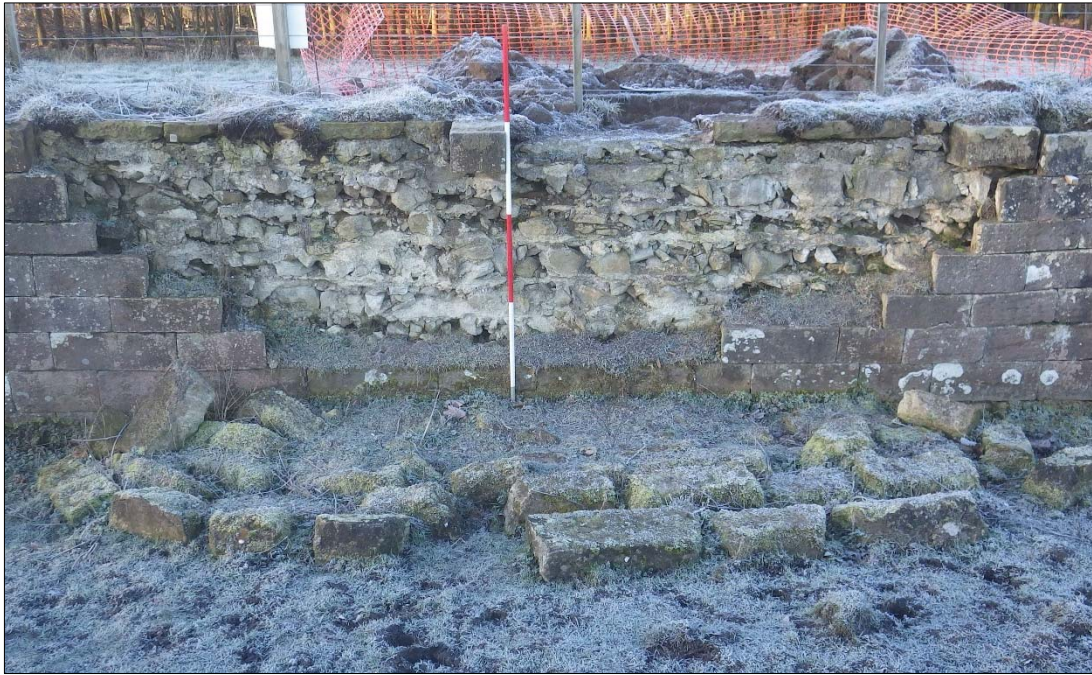
*Plate 13: southeast-facing section of wall 34 with collapsed ashlar facing and heavily mortared rough-coursed inner face exposed. Investigation test pit just visible to the rear.*

- 8.21 The ha-ha wall (34) was faced with hammer-dressed ashlars, measuring 0.3m wide by 0.25–0.3m high and up to 0.7m in length, behind which were courses of roughly squared and heavily mortared sandstone blocks and rubble (35) (Plate 13). The ditch was typically 1m deep with the outer edge of the cut c.3m from the wall face. The level of the interior of the ha-ha'd enclosure was on average 1m above that of the surrounding landscape.

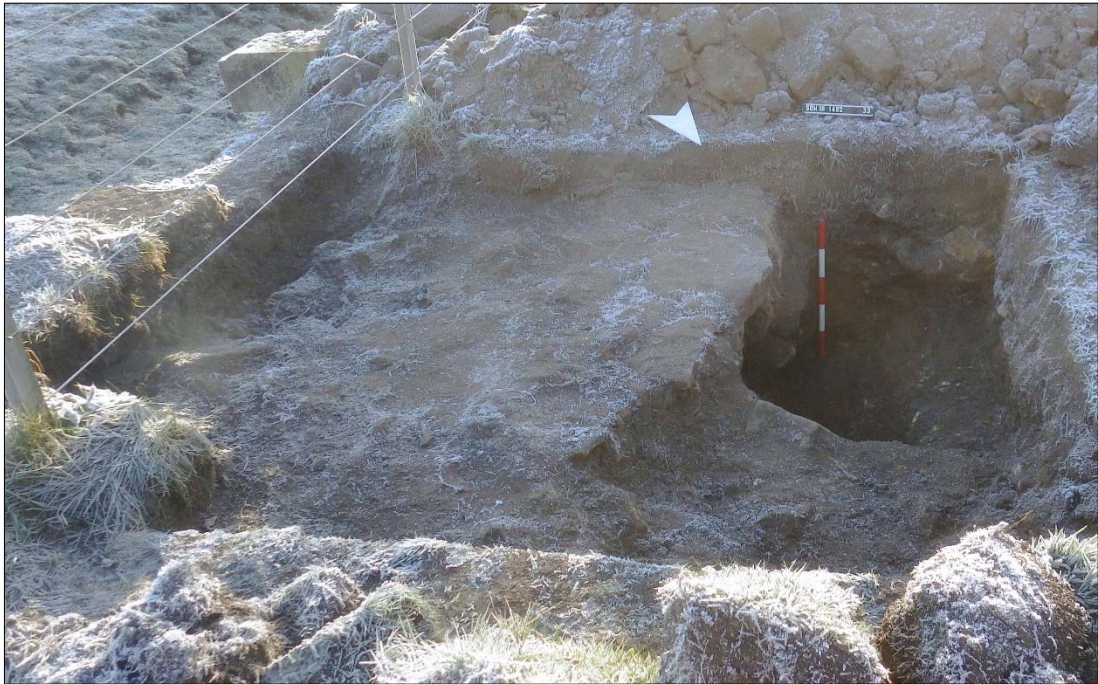
*Plate 14: test pit behind the ha-ha, with small evaluation of the backfill 35.*

backfill was then removed, revealing a possible linear cut (33) situated c.1.7m from the inner face of the wall. This was partially excavated (Plate 14).

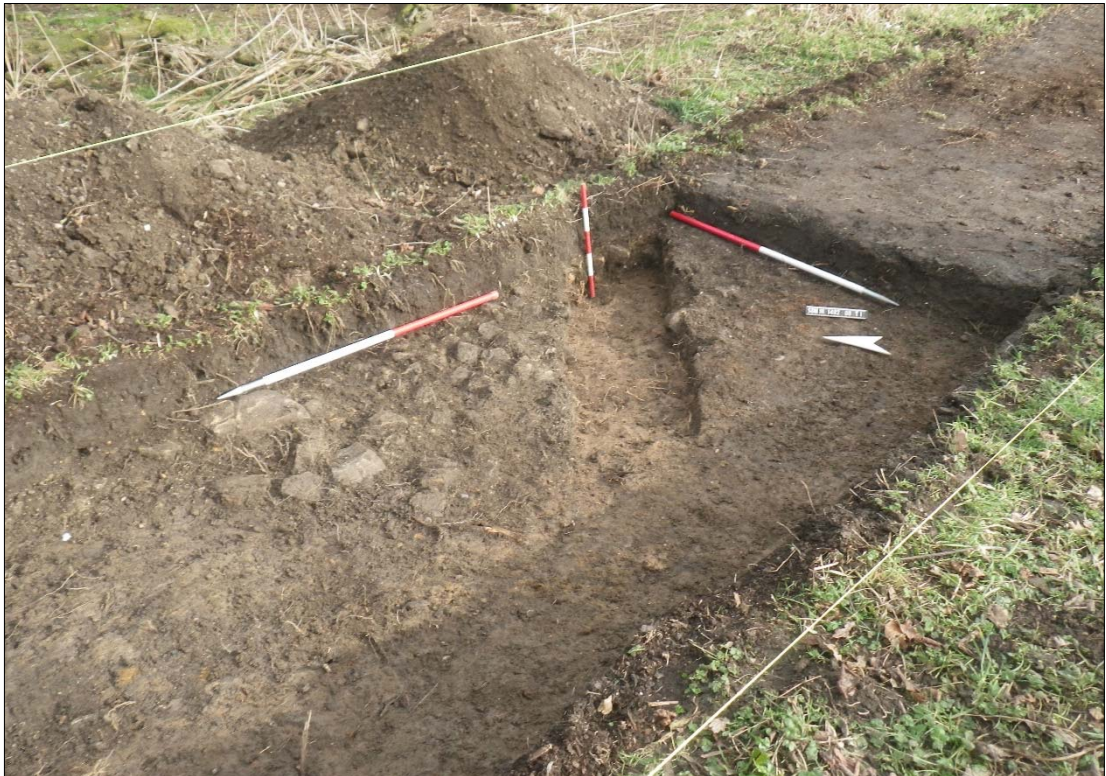
*Plate 15: linear stone deposit 55 running across the line of the alignment of the current pathway in T1.*

- 8.32 Trenches 2 and 3 were located to investigate a possible earthwork identified on the 2017 LiDAR survey (Fig. 11, AW). This was visible on the surface as a slight embankment where T3 cross the existing pathway. After machining off the topsoil, the area was hand cleaned and excavated to expose a stony deposit (55) at the south-eastern end of the trench (Plate 15). This lay in a shallow hollow following the line of the bank and running at an angle to the existing path. The deposits comprised small angular stones heavily compacted into a dark silt, up to 0.2m deep, which formed a distinct edge. Deposit 55 sat directly above the natural subsoil (60).

- 8.33 Both T1 and T2 contained similar compacted stone deposits that may have formed a bedding layer for an earlier trackway visible on the LiDAR (Fig. 11, AN), which remained partially discernible on the ground.

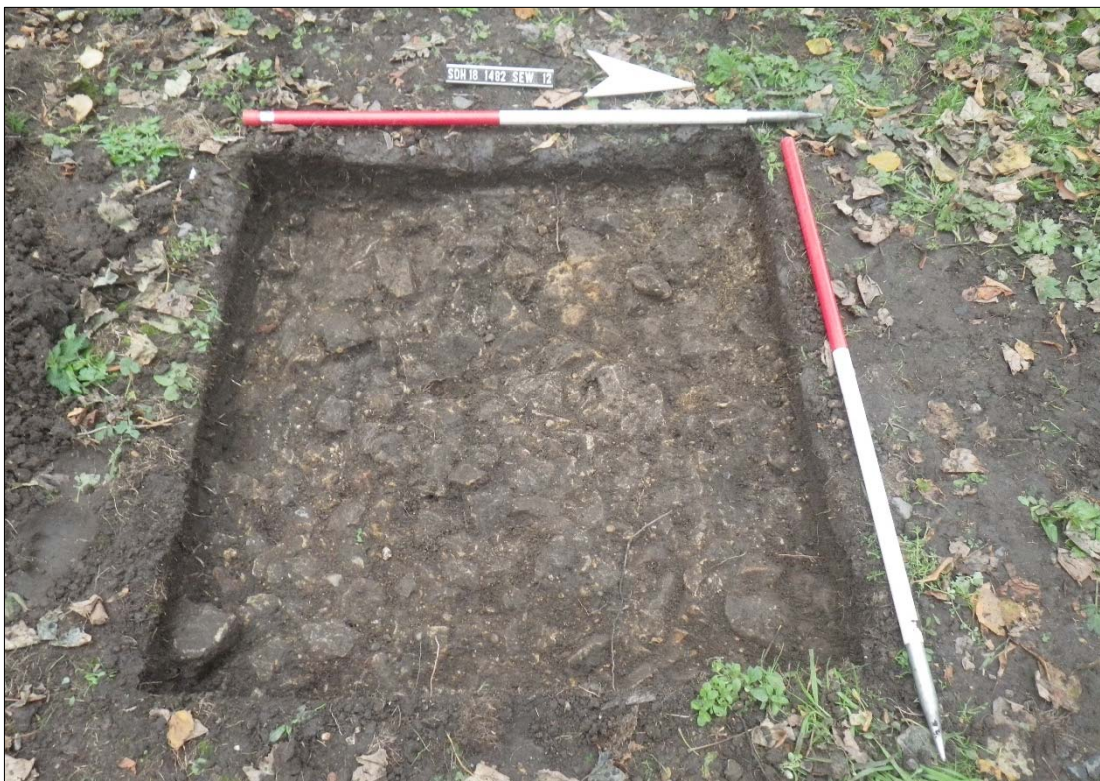
*Plate 16: stone deposit 86 directly beneath a thin layer of topsoil in TP12.*

8.37 Three pits (TP 12, 13, 17; Fig. 10) contained a thick deposit of angular stones lying directly on subsoil (Plate 16). These were clustered in the north-west area of the woods, in close proximity to the line of the modern pathway. The compaction of the layer suggested deliberate surfacing and may relate to an old footpath or track running north-west to south-east. This would have been located to the south-west of the modern path, although a precise alignment could not be determined given the limited scope of the excavations. However, no feature is shown in this location on any of this historic mapping, and finds of 19th- to 20th-century date, recovered from a humic soil (87) sealed beneath the stony surface in TP13, suggest the path was probably modern in date. The same surface was also seen in MP3 and MP4 (see below).

8.38 TP12 was a 1m<sup>2</sup> trench excavated to a depth of 0.5m (Plate 15). Directly beneath 0.14m of topsoil (80) was a 0.15m-thick layer of compacted stones (86), which in turn overlay 0.3m of subsoil (81). Deposit 86 equated with context 55 recorded in the earlier trial trenches (TT1–3).

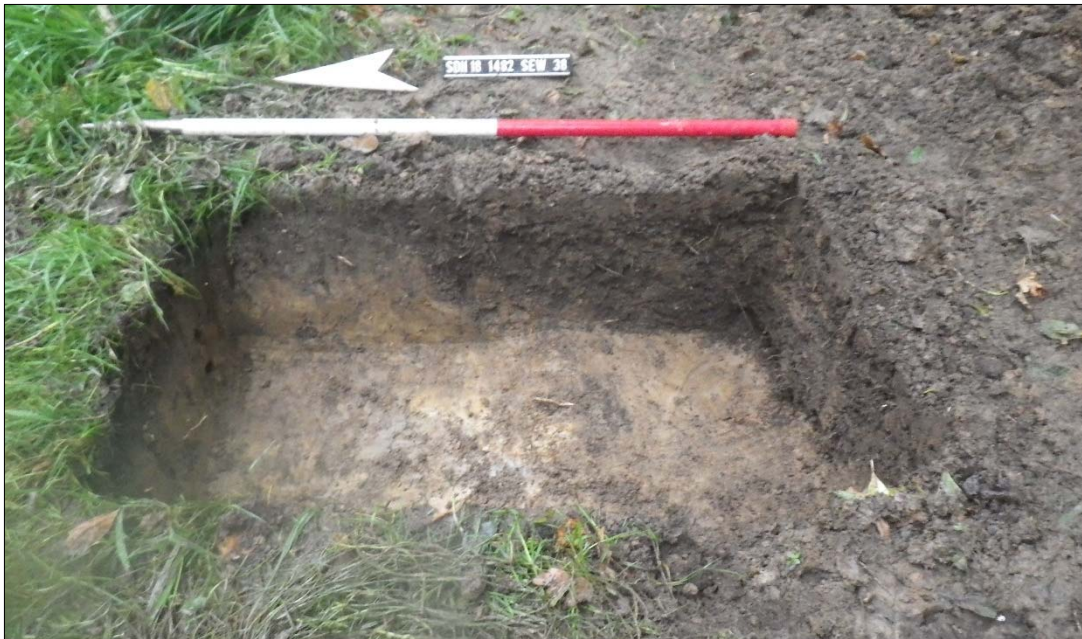
*Plate 17: woodland landscape feature 171 in TP38.*

- 8.41 TP38 was a 1m<sup>2</sup> test pit located in towards the centre of the south-east woods. This was excavated to a depth of 0.4m. It contained a linear feature (**171**) identified directly beneath woodland turf, which appeared to be aligned south-east to north-west, cut into natural clay (**82**) and infilled with root-disturbed topsoil (**80**). The ditch had a shallow U-shaped profile and was 0.38m deep in the excavated area (Plate 17). This may have provided drainage for the diagonal path shown on the LiDAR (Fig. 11, AN) connecting with south-east bastion. This path was reinstated as part of the Curtain Rises landscape works.

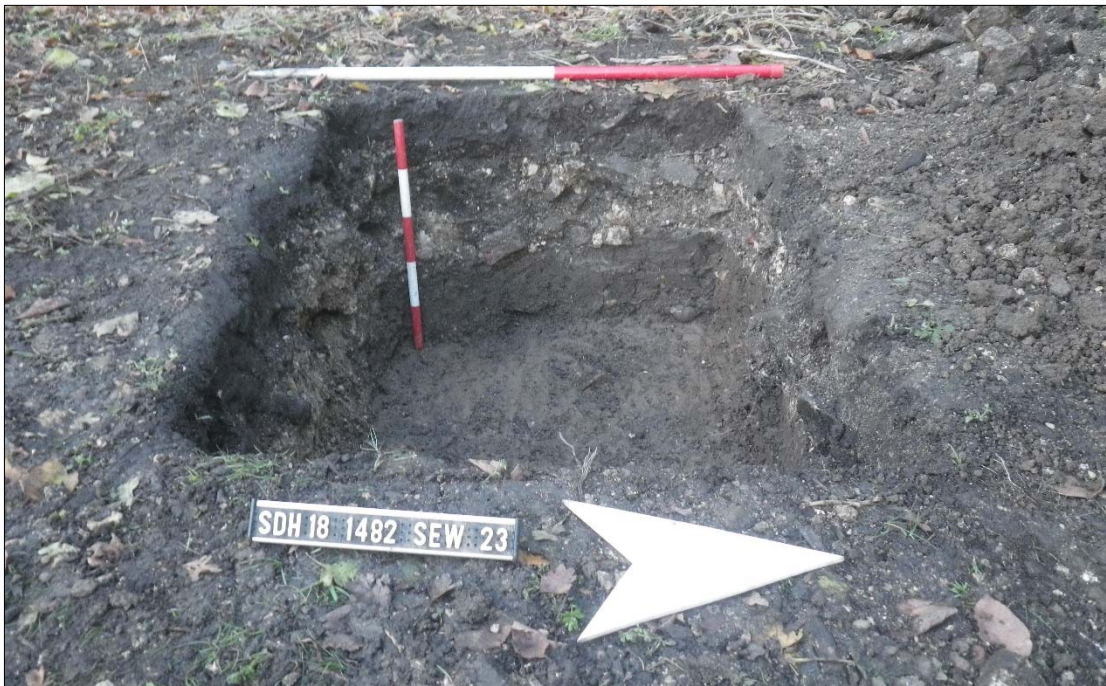
*Plate 18: dumping and consolidation layer 93 in TP23.*

- 8.43 Three test pits were excavated in a line close to the north-western boundary of the woods (TP23–24; Fig. 10), all of which contained brick and stone rubble deposits. These were probably associated with relatively recent attempts to consolidate water-logged ground in this area after the failure of field drainage for the south portico lawn, to the west.

- 8.44 TP21, the northernmost test pit, measured 0.5m by 1m and was excavated to a depth of 0.55m. Below the woodland turf was a rubble levelling and consolidation layer (88), up to 0.2m thick, dumped over 0.2m of buried subsoil (81).
- 8.45 TP23 was a 0.8m by 1.1m test pit excavated to a depth of 0.55m. Below the woodland turf was a rubble levelling and consolidation layer (93) up to 0.3m thick, dumped over slope of buried subsoil (81) (Plate 18).
- 8.46 TP24 was a 1m<sup>2</sup> trench excavated to a depth of 0.6m. Below the woodland turf was a rubble levelling and consolidation layer (89) up to 0.2m thick, dumped over compacted silty clay (91), which was capped by a level deposit of angular sandstone fragments (90).

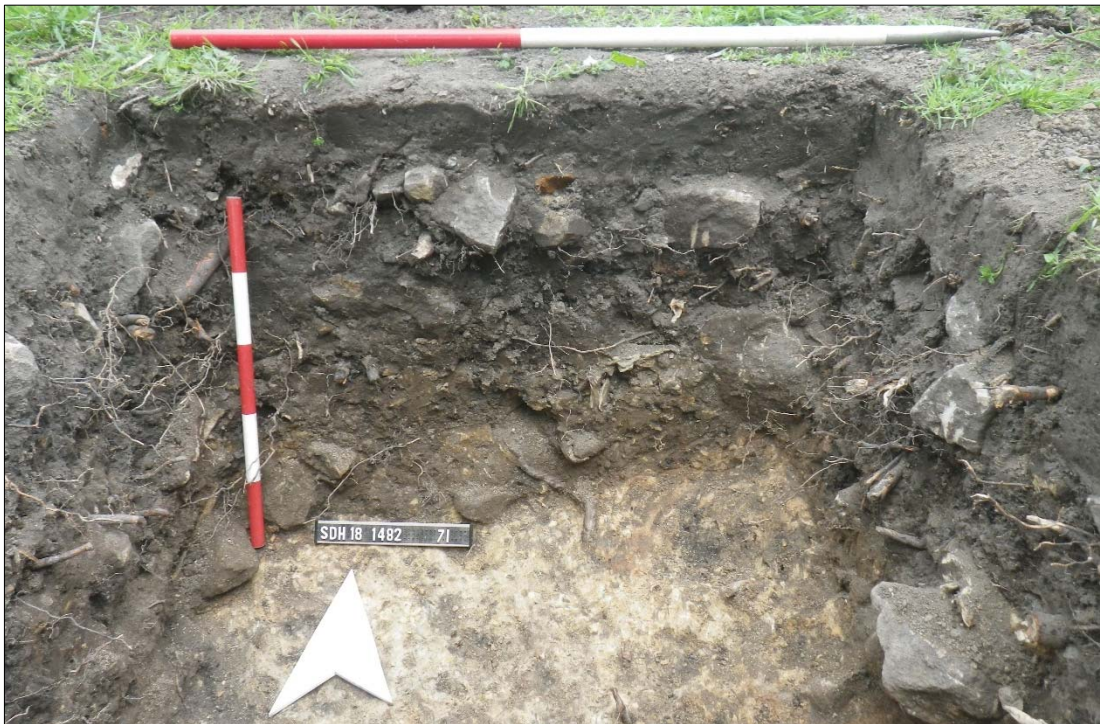
*Plate 19: feature 71 filled by buried soil 70 and cobbled layer 69 visible in section.*

- 8.52 TT1 was a 1m<sup>2</sup> trench excavated to a depth of 0.6m. At the base was a linear hollow (71) which was at least 0.2m deep, running roughly north–south along the line of the slope of the local ground surface. This was filled by a light brown clayey-sand with small, rounded pebbles (70), which was a possible early soil horizon. The pronounced slope at the base of the trench ran counter to the gradient of the present ground surface and,

due to the disparity in height and alignment, cut **71**. This was probably the result of human agency rather than natural accumulation (Plate 19).

- 8.53 Deposit **70** was sealed by a layer (0.05–0.15m thick) of compacted angular stones bedded into a dark grey silty-sand (**69**) up to 0.3m thick. Above was a 0.1m layer of topsoil (**68**).

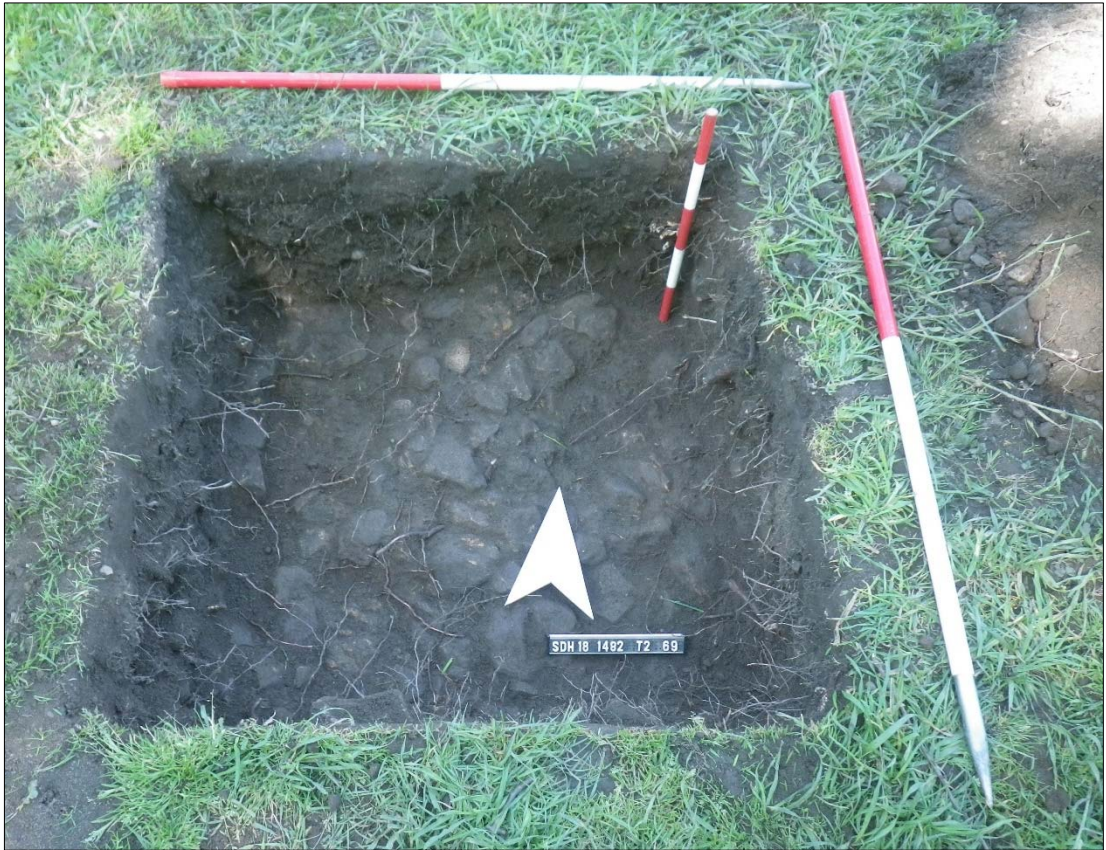
*Plate 20: stone surface 69 beneath the topsoil in TT2.*

- 8.54 TT2 was a 1m<sup>2</sup> trench excavated to a depth of 0.55m, located at the base of the incline beneath TT1, meaning stony layer **69** was observed at significant depth below the current ground level (Plate 19) and was bedded directly onto natural sandstone. At the base of TT2 a shallow, but pronounced, linear hollow (**72**) was recorded in the north-west corner, running counter to the gradient of the present ground surface.

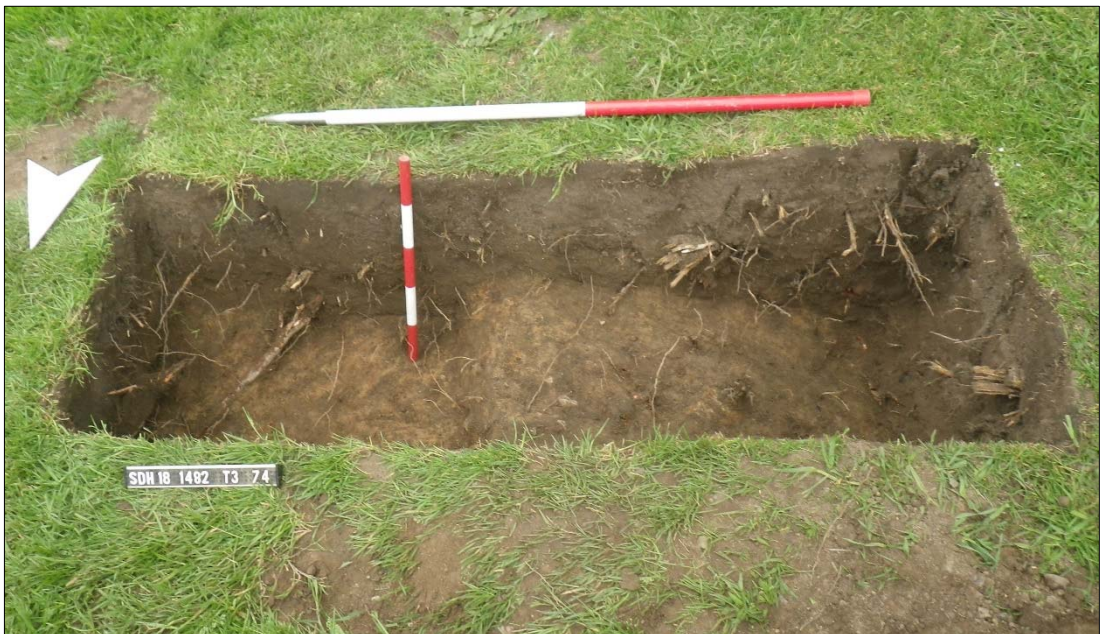
*Plate 21: step 74 cut into the root-disturbed natural clay in TT3, with slope of possible furrow 75 in the west.*

8.56 TT3 was a 1.5m by 0.6m trench excavated to a depth of 0.55m, located 10m west of the ha-ha wall, to the south of the proposed pathway. It was aligned north-east to south-

west, and excavated to investigate an anomaly on the LiDAR survey which presented on the ground as slight change in ground-level running parallel to the ha-ha. A possible earthwork, feature **74**, was evident as a small but vertical 0.2m step in the natural sandy clay, with a flat surface to the east (Plate 20).

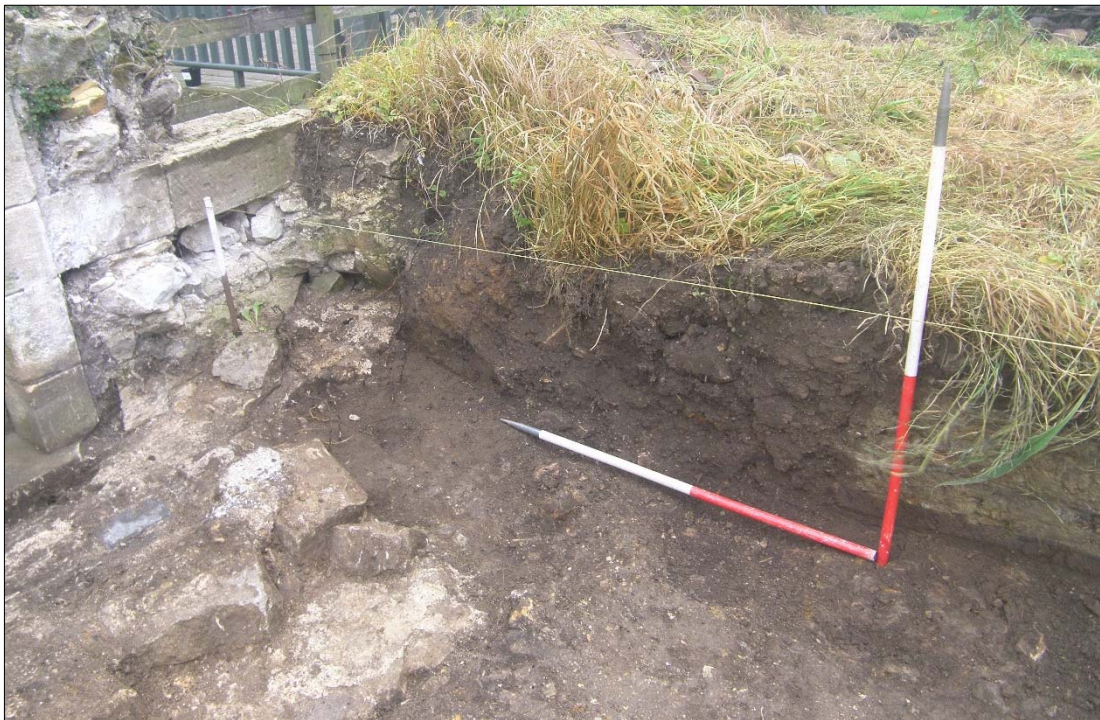
*Plate 22: ditch 151 and foundation trench 148, with steps 31/145 on the left.*

- 8.62 The north-eastern edge of feature 151 was cut by construction trench 148 for the ha-ha wall 34/146. At this location, immediately south-south-east of gateway 23, the wall survived to an external height of 0.8m above modern ground level, although it had lost its coping stones. On the inner face of the wall, the upper course of stone facing was supported below ground level by a constructed mass of mortared-stone rubble at least 0.47m wide and more than 0.6m high. Behind this, the construction trench had been backfilled with orange-brown clay (150) containing some lumps of dark brown soil. This deposit was dissimilar to the natural clay at this location and presumably had been brought from another source.

- 8.63 Against the back of the ha-ha structure the clay was overlain by a wedge of greyish brown soil (149), probably filling of shrinkage and subsidence of deposit 150, combined with effects of localised movement in the ha-ha wall. These deposits were sealed by c.0.15m of modern topsoil and turf 147.
- 8.64 There was a c.0.75m difference in the modern ground levels to either side of the ha-ha. In order to provide transition between these differing levels, a rectangular mass of

masonry immediately inside the gateway formed the base of a short flight of three or four steps (**145**); recorded as feature **31** during the excavation of Trench 1 in AWP 4. Part of the construction cut for this structure survived at its north-western side. This was vertical-sided and located 0.28m from stonework **145**. It was filled with loose, voided, small sandstone rubble and mortar fragments. It cut clay **150**, indicating that the steps were a secondary addition to the ha-ha.
