ARCHAEOLOGICAL  
INVESTIGATIONS

NATIONAL TRUST  
SEATON DELAVAL HALL  
NORTHUMBERLAND

on behalf of  
The National Trust

NAA 20/92  
May 2021

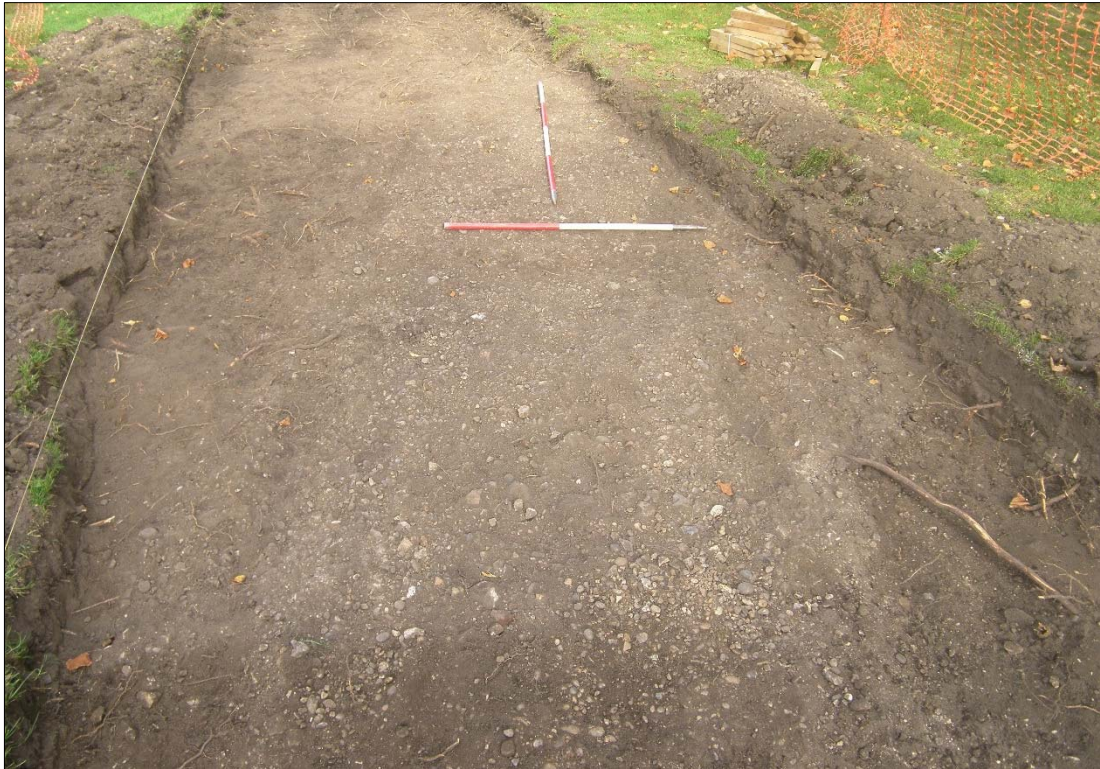
*Plate 23: wheel-ruts in pathway surface **158** at the south-east end of the trench.*

8.65 Approximately 68m south-west of gateway **28**, towards the top of the incline south-west of the Brewhouse complex and adjacent to the ice-house (Fig.10, P5), a wide former path surface (**158**) was exposed beneath the modern topsoil. This ran east to west, crossing the excavated area at a shallow angle (Plate 22) and was observed continuing for c.11.5m within the footprint of the new access path (Fig. 10). Surface **158** comprised small pebbles and pea-grit, together with occasional larger rounded stones, set in a matrix of mid-brown sandy clay, and measured up to 2.6m wide. It was fairly level along its course, although cambered along its northern and southern edges. Where excavated, larger unshaped stones along the edges of the surface may be the remains of kerbing, although too little of this was exposed to be certain.

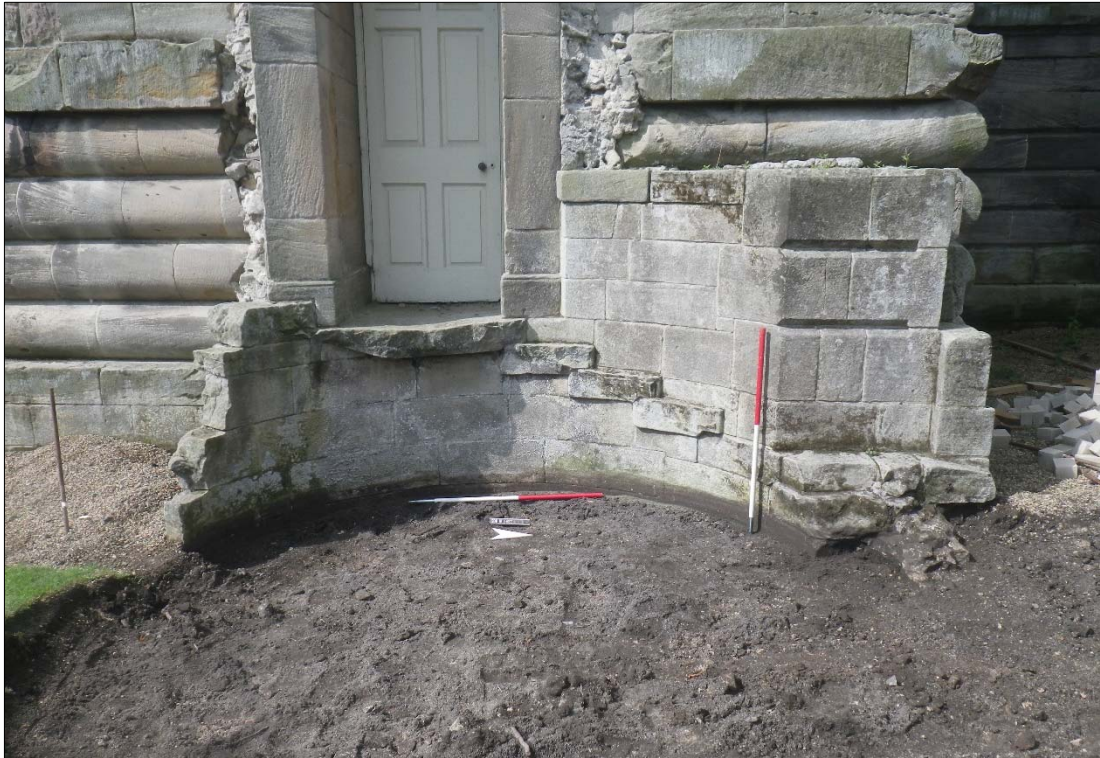
*Plate 24: removal of turf in the stairwell of the south-east range prior to installation of gravelled area.*

- 8.70 Further monitoring by NAA was conducted during the installation of the promenade walk. Within the footprint of the spiral staircase that formerly served the western end of the lost south-east range, the existing turf was removed by hand and replaced with gravel to delineate the extents of the stairwell and create a passing-space along the path (Plate 24). Along the eastern edge of the Central Hall building the base of the pre-existing ditch had been disturbed by modifications to the Hall drainage, including the installation of a substantial gravelled soak-away. Archaeological monitoring conducted in this area during installation of the drainage had exposed wall footings associated with the lost wing (Solstice 2018) but these lay below the impact level of the new pathway. No other archaeological remains or features were encountered during the promenade walk monitoring works.

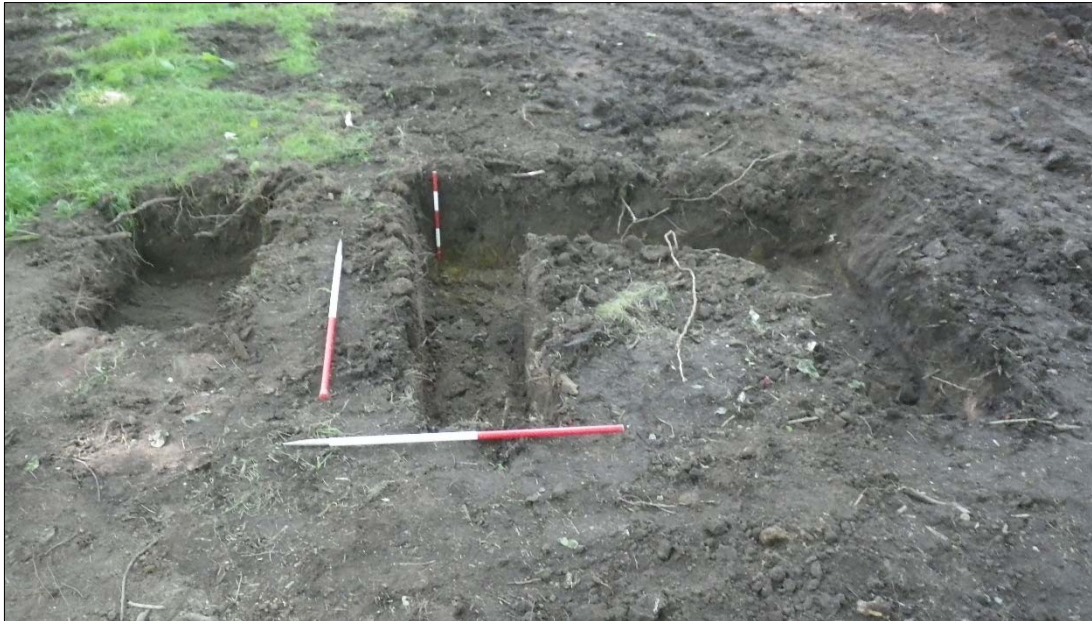
*Plate 25: foundation trenches for the playground equipment in the north-west woods.*

- 8.76 The foundation trenches for the play equipment followed the specific footprint of each structure (Fig. 2). These were generally 0.5m-square postholes at a depth of 0.5–0.6m and they were partially excavated by machine using a 0.3m toothless bucket and then aligned and squared by hand. The more complex structures required the excavation of slot trenches 0.5m wide and 0.5m deep. These were machine-excavated through a thick layer of coarse sandy-silt and loam (61). Beneath this, a mid-brown sandy clay subsoil was visible in the base of a few of the trenches. Excavation stopped at the required

impact level (0.5–0.6m) without reaching the underlying natural substrata (Plate 25). No archaeological features or deposits were encountered.
