WATCHING BRIEF REPORT

**THE BARN AT BYERS GARTH**

**SHERBURN**

**CO. DURHAM**

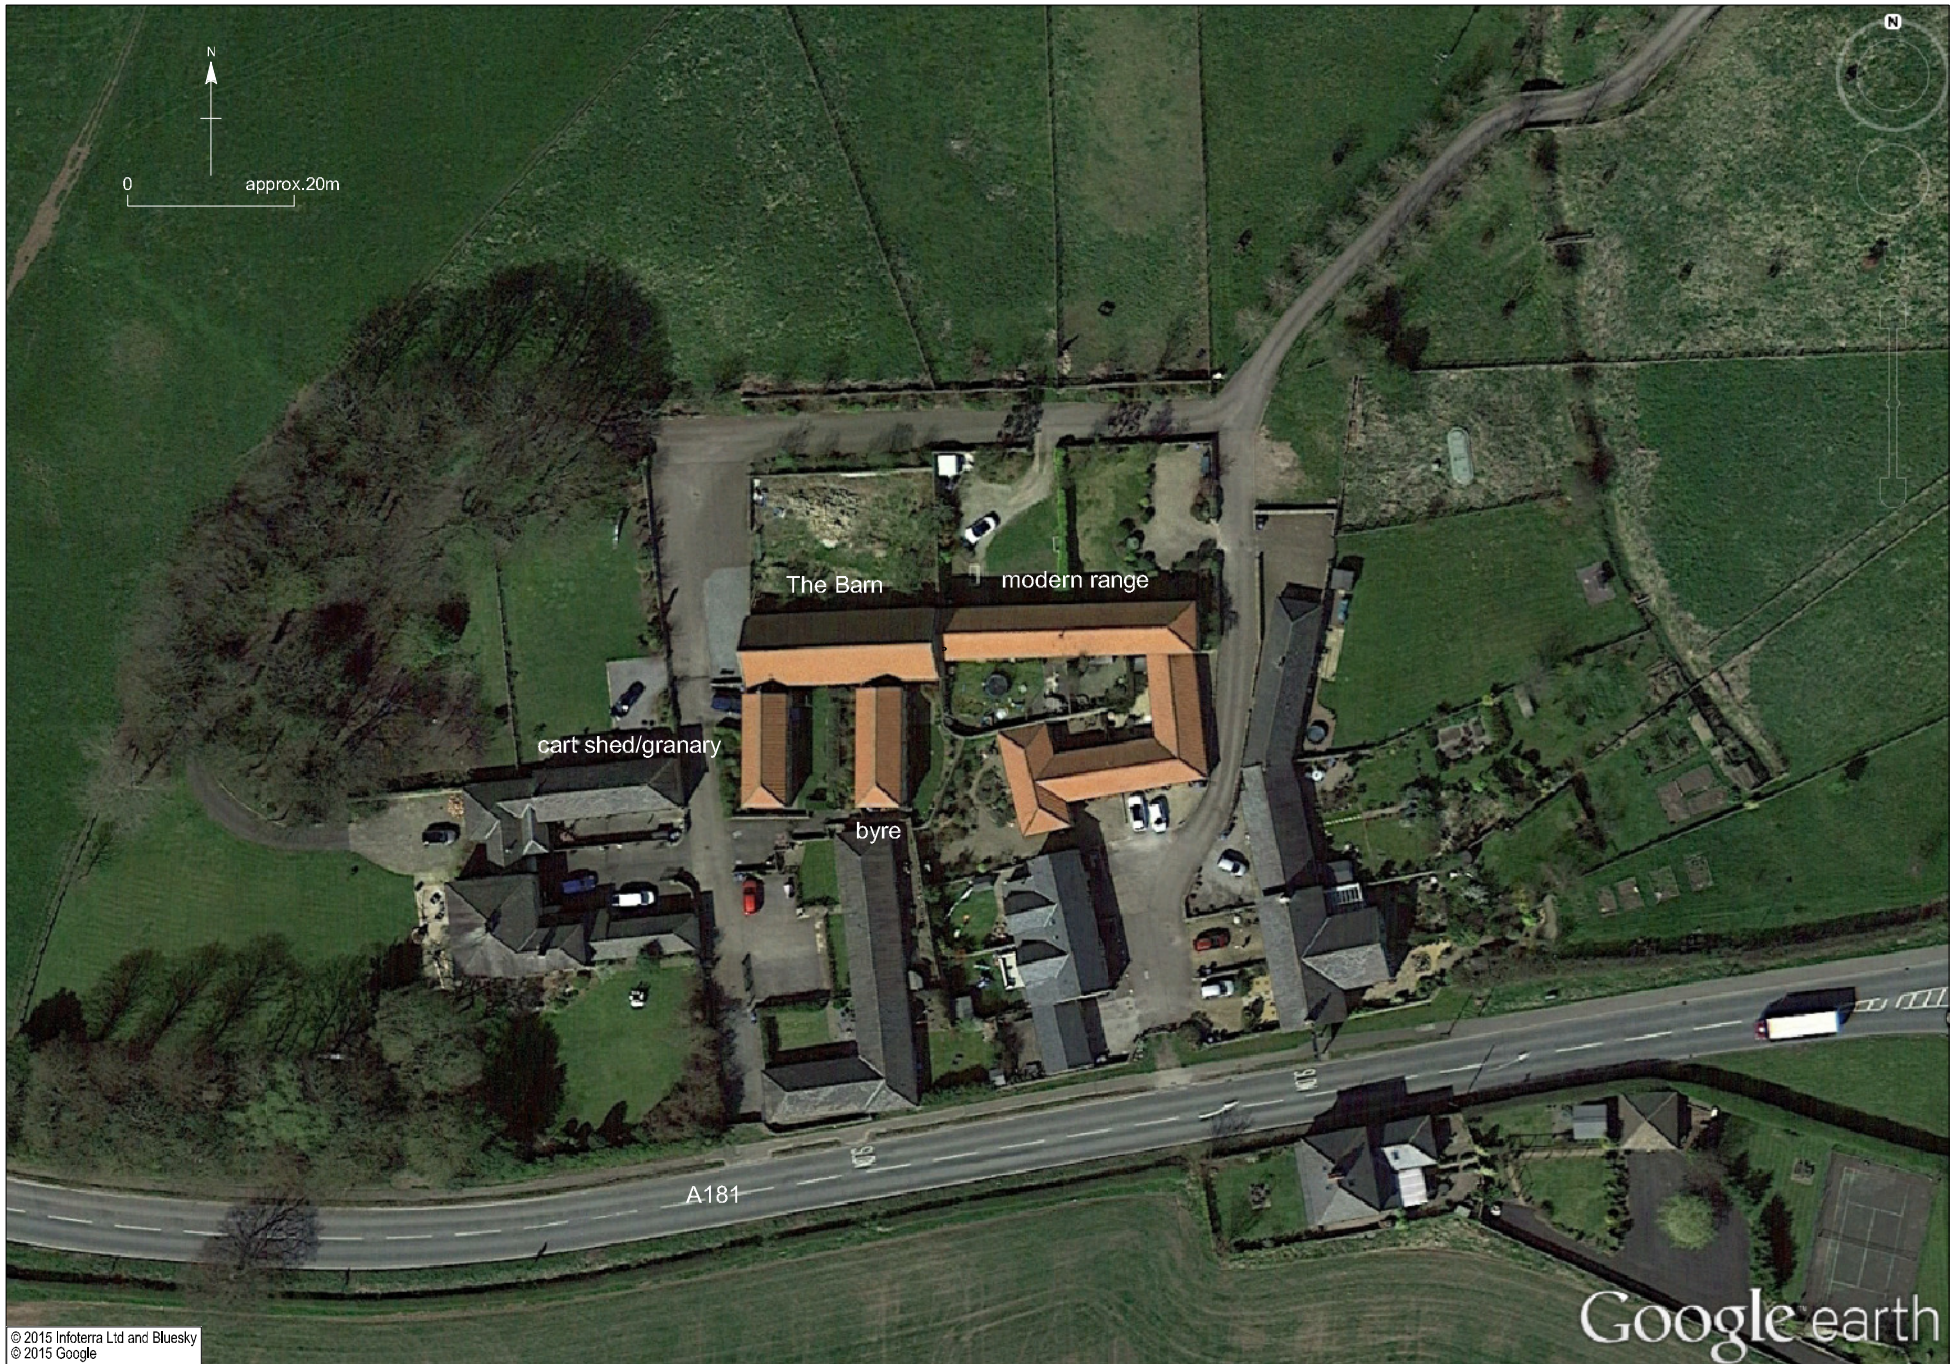
*Figure 2*

*Byers Garth Barn, Sherburn: detailed site location showing The Barn and associated buildings*

2.1 The barn at Byers Garth lies approximately 0.8km to the south-east of Sherburn Hospital, 1.5km to the south of Sherburn Village and approximately 6km east of Durham (NZ 317 409). The barn was accessed via the main Byers Garth development entrance off Mill Lane. It was situated 40m north-east of the Byers Garth farmhouse, bordering the northern boundary of the former farm complex (Figure 2).
