ARCHAEOLOGICAL
MONITORING REPORT

WITTON CASTLE LPG
WITTON-LE-WEAR
COUNTY DURHAM

prepared for
Witton Castle Country Park Ltd

NAA 22/03
February 2022

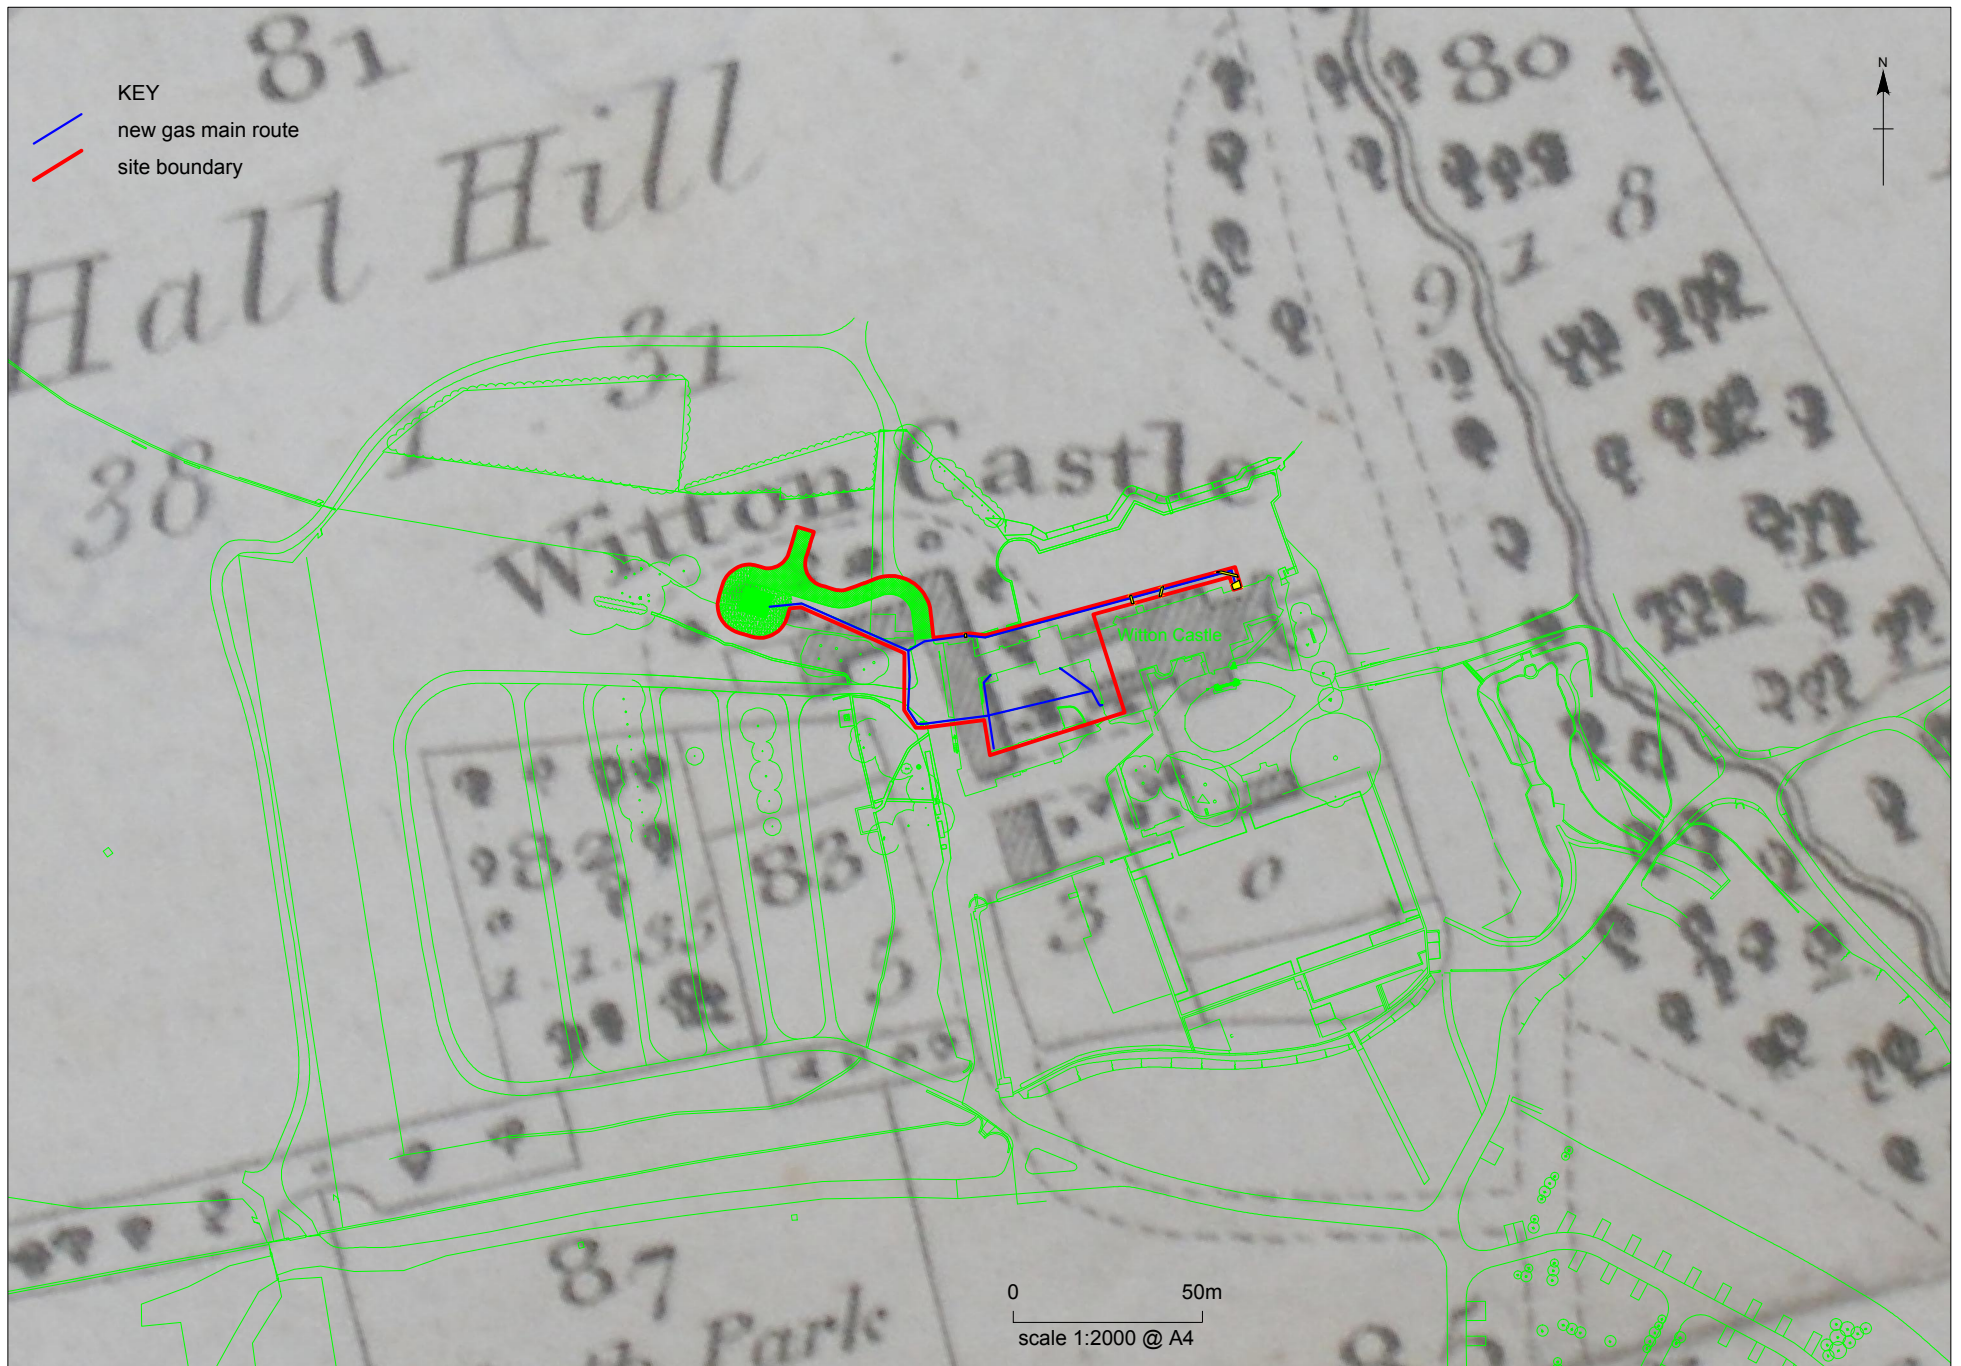
Witton Castle, Witton-le-Wear: modern survey (green) overlain on 1816 estate plan (best fit)

- 3.5 The Plan of Witton Castle Estate produced to accompany the sale of the castle in 1816, provides the earliest detailed layout of the castle and park complex (Durham University Library DHC 11/VI/107) (Fig. 3). This plan depicts the layout of the castle buildings after

- 6.5 Deposit **02** continued beneath the topsoil throughout the North Area of the pipe trench but decreased in depth from west to east. Towards the west end of the north area, deposit **02** sealed a north to south wall foundation (**07**; Fig. 3 and Plate 4). The wall foundation measured c.1.7m wide and comprised a single course of dressed sandstone with a rubble core. No bonding material was observed. Considering the location and alignment of wall **07**, it most likely represented the eastern wall of an L-shaped range of buildings that were once present in this area, as illustrated on the 1816 estate plan (Fig. 3). No other components of this range of buildings were encountered during trenching.

- 7.2 The location and alignment of wall **07** correspond to the eastern wall of the detached L-shaped range of buildings shown on the 1816 plan (Fig. 3), which was demolished during a programme of alterations undertaken in the 1820s and 1830s.

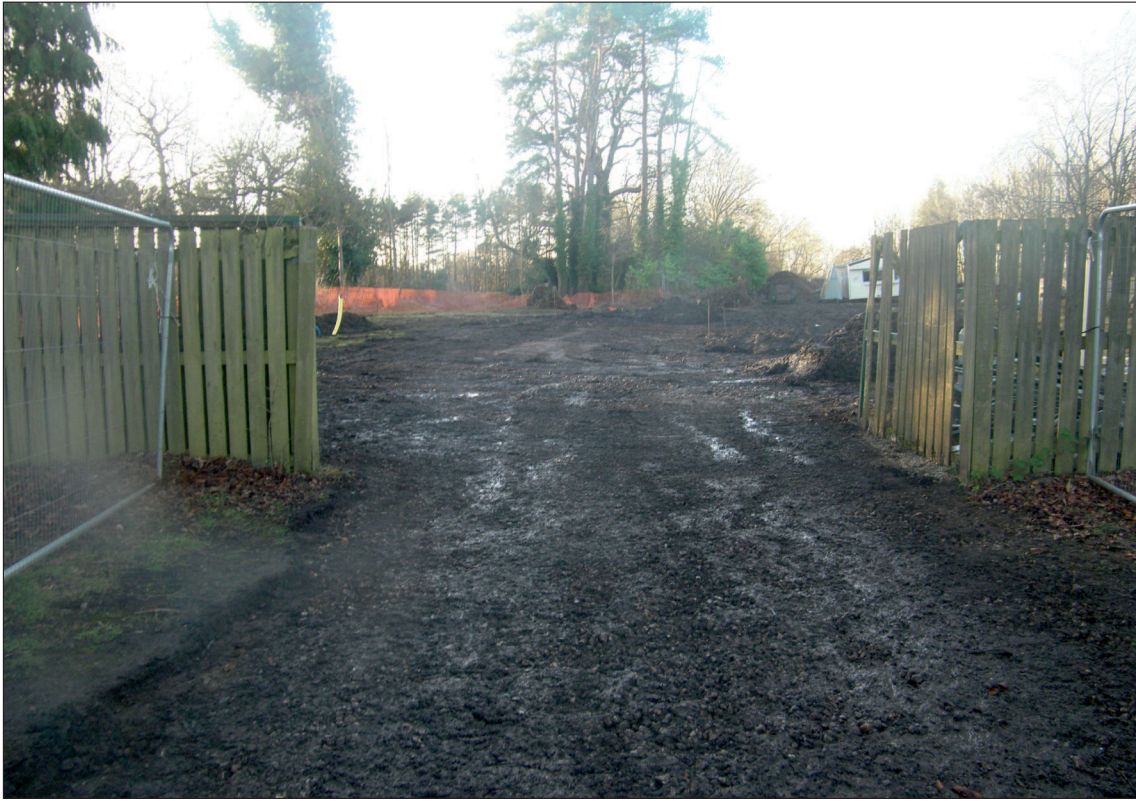
Plate 1

*Witton Castle, Witton-le-Wear: access road and
LPG compound, looking west*

The LPG Compound and Access Road (Plate 1)

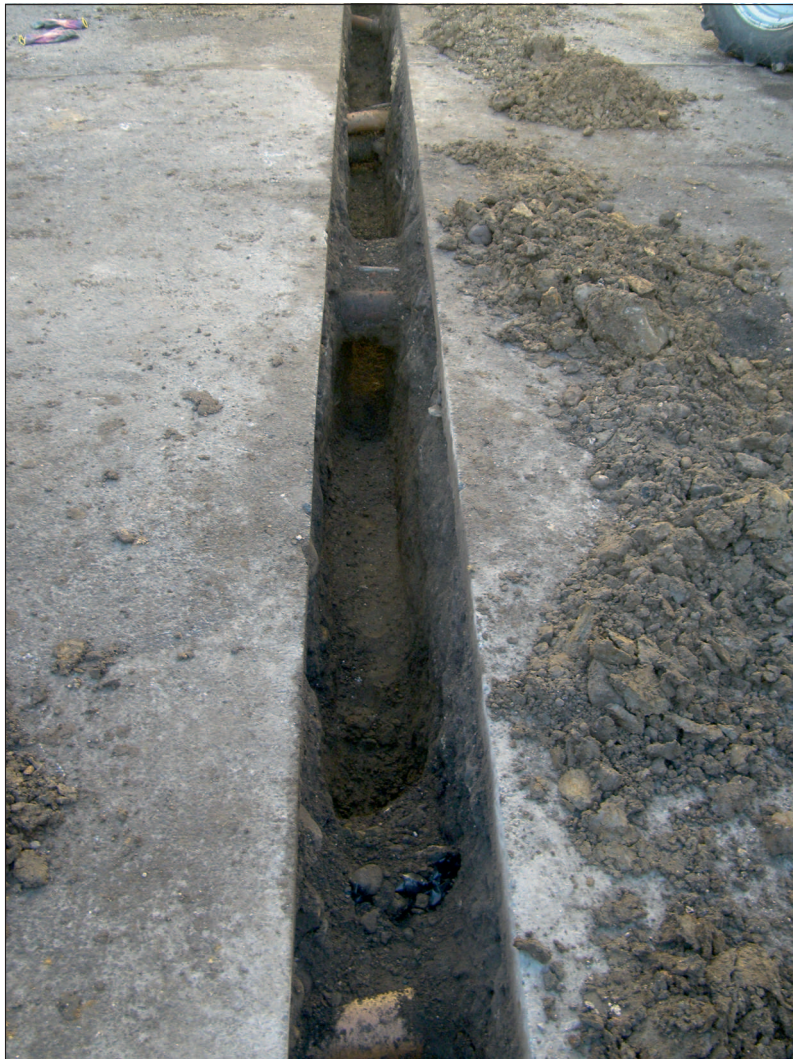
Plate 2

*Witton Castle, Witton-le-Wear: trench
within the courtyard, looking north*

The Courtyard (Plate 2)

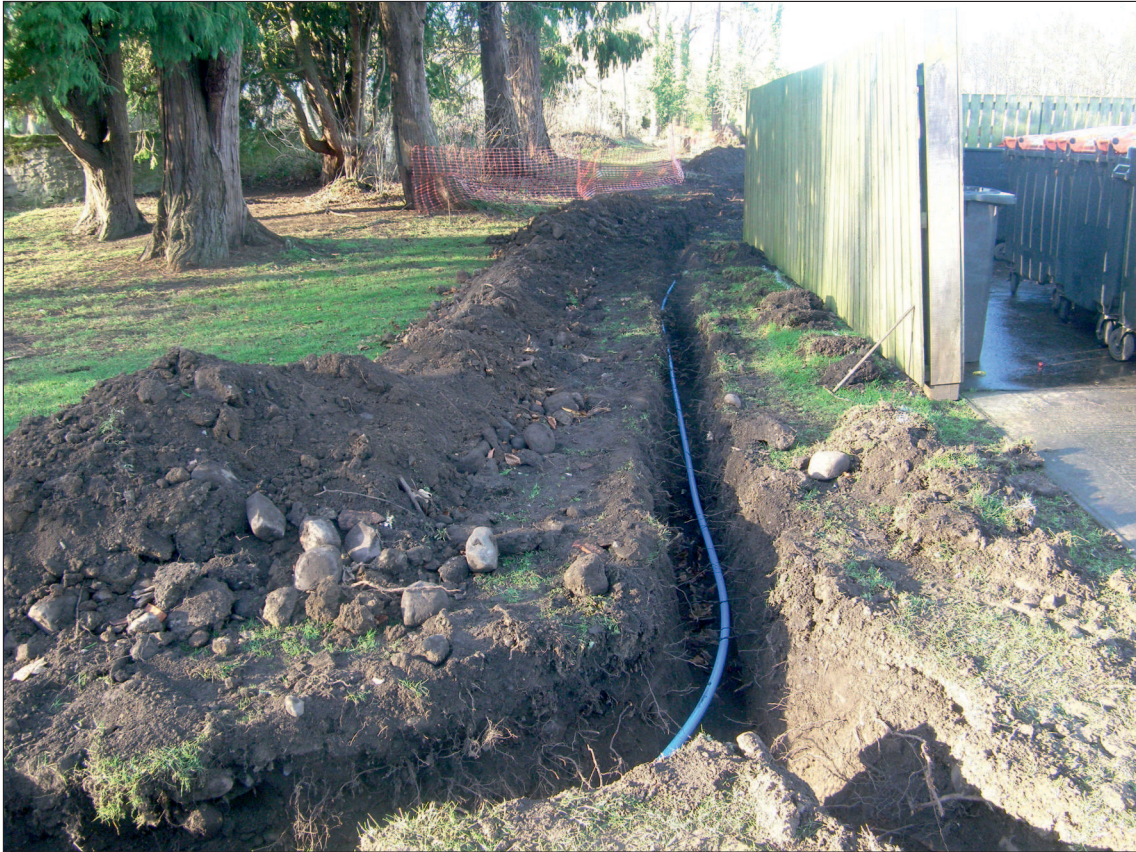
Plate 3

Witton Castle, Witton-le-Wear: the West Area, looking west

The West Area (Plate 3)

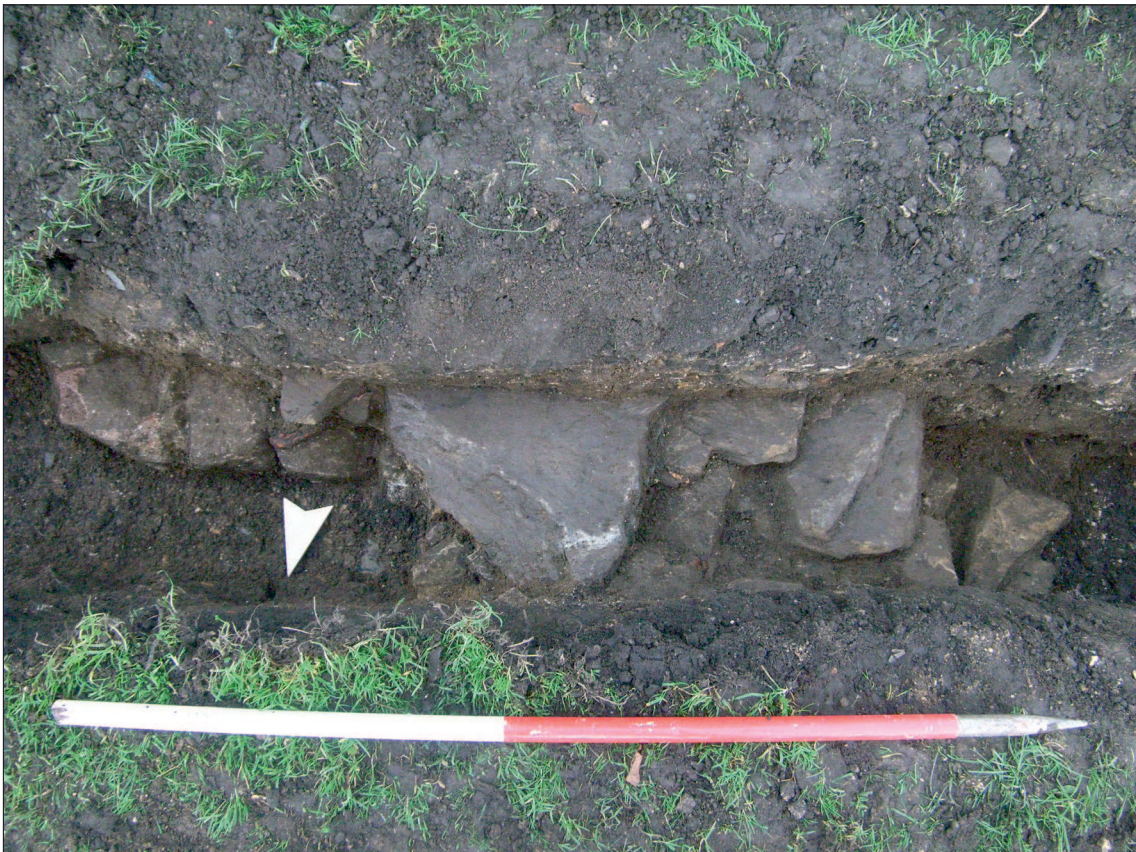
Plate 4

Witton Castle, Witton-le-Wear: wall 07, looking south

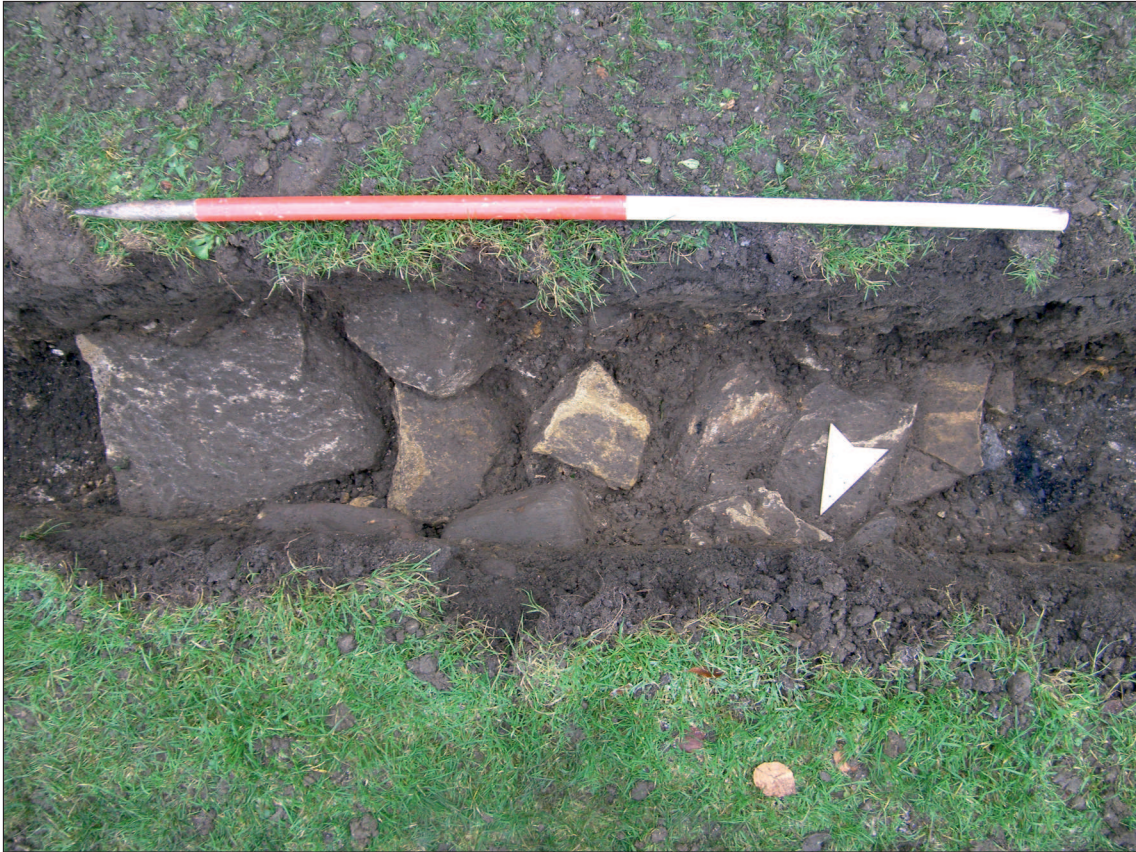
Plate 5

Witton Castle, Witton-le-Wear: wall 06, looking south

- 6.6 A north-northwest to south-southeast wall (**06**) was exposed c.43m to the east of wall **07**. Wall **06** was 2.2m wide and comprised sandstone facing stones with a rubble core (Plate 5). Traces of lime mortar were observed on the upper surface of the facing stones. The wall was overlain by dark ashy deposit (**03**), which was present for the full length of the trench located inside the bastion (Plate 6). Deposit **03** contained a particularly high concentration of burnt material around wall **06**. Wall **06** represented the remains of a previously unknown structure, and given its robust dimensions and location relative to the north elevation of the existing castle buildings, it is likely that it represented a building or defensive structure, rather than a less substantial feature such as a garden wall.

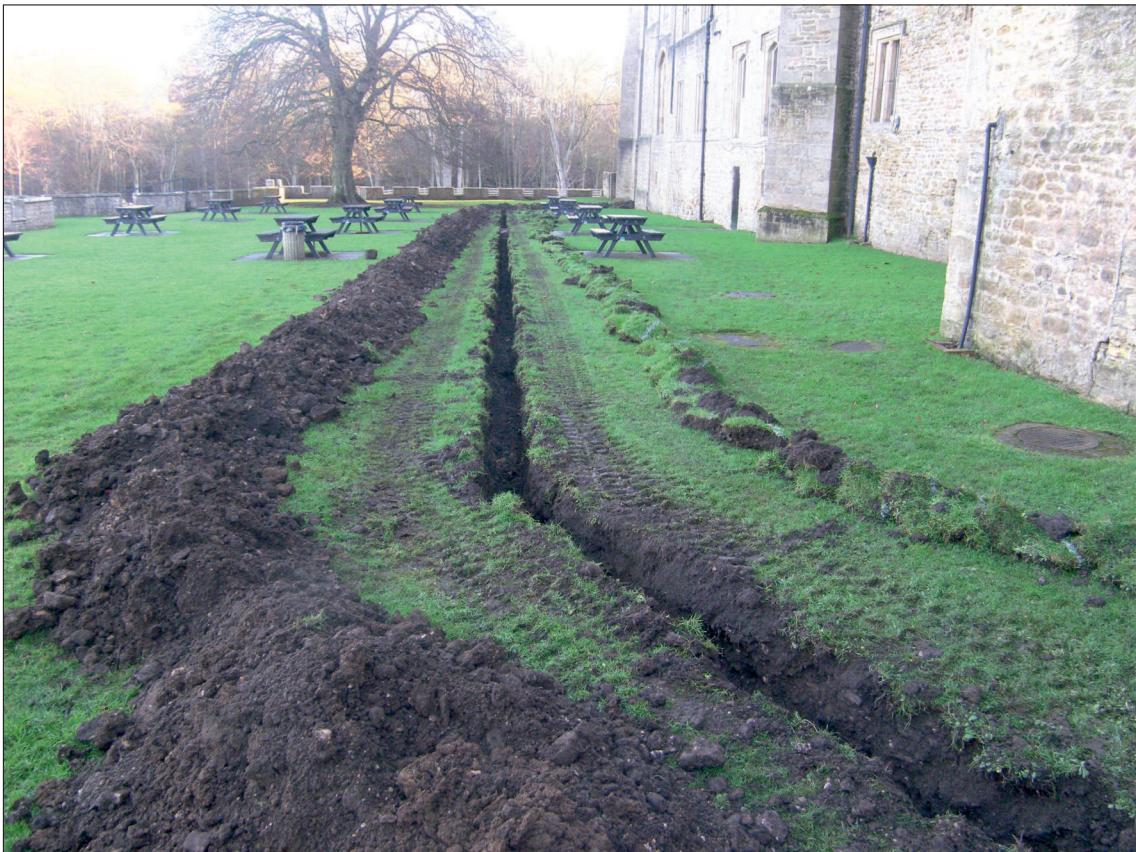
Plate 6

*Witton Castle, Witton-le-Wear: the North Area
within the Bastion, looking east*

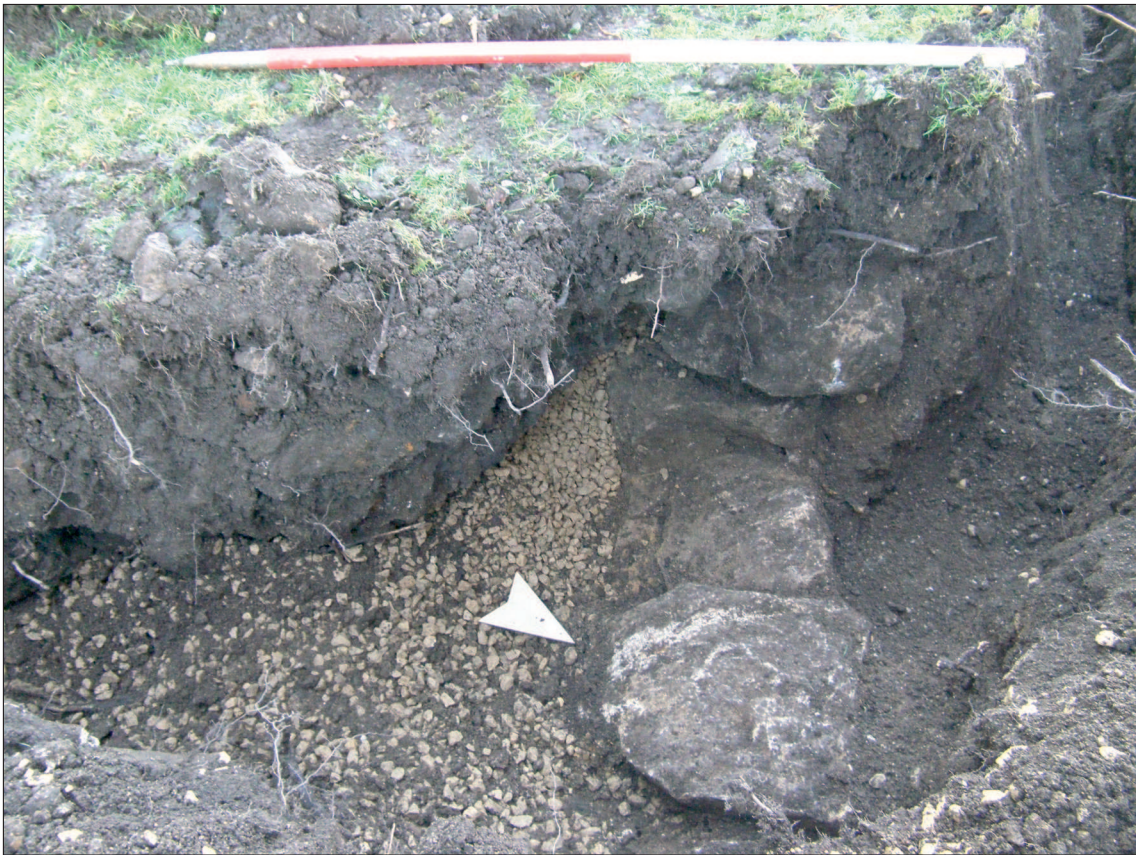
Plate 7

Witton Castle, Witton-le-Wear: wall 08, looking west

- 6.7 Another wall (**08**) was located at the east end of the pipe trench. Wall **08** was aligned north-west to south-east and comprised unbonded laminar sandstone blocks that survived to three courses (0.45m) high. The wall was overlain by deposit **03** and had been cut by a modern east to west aligned drain (Plate 7).

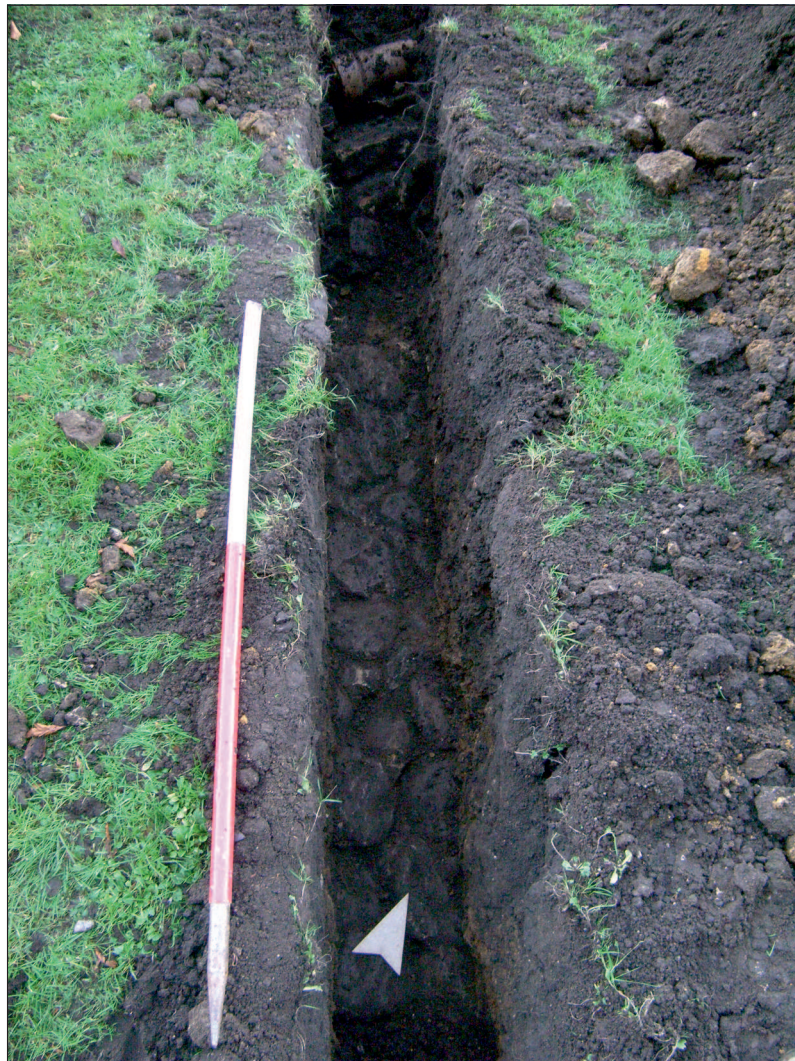
Plate 8

Witton Castle, Witton-le-Wear: cobbled surface 04, looking north-west

- 6.8 A cobbled surface (**04**) was exposed between wall **08** and the existing castle wall. Surface **04** consisted of densely packed rounded riverine cobbles and was exposed for 1.8m. It was cut and did not continue beyond a modern service trench at its north edge (Plate 8). Cobbled surface **04** was overlain by deposit **03** and its depth corresponded to the required construction depth, therefore it was retained in situ.

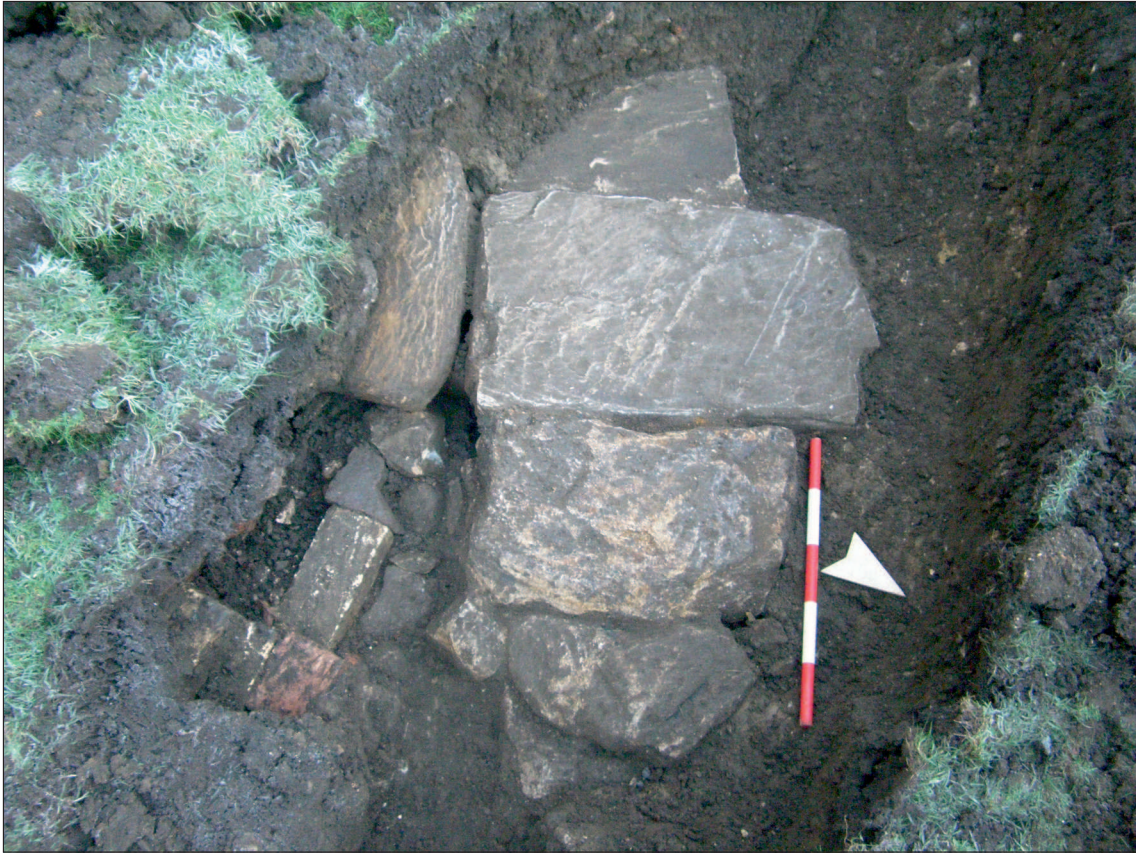
Witton Castle, Witton-le-Wear: culvert 05, looking south-west
