NEW ELECTRICAL SUPPLY TO
CARRIAGE HOUSE.
REPORT ON ARCHAEOLOGICAL
MONITORING

SEATON DELAVAL HALL,
NORTHUMBERLAND

prepared for
The National Trust

NAA 21/93
October 2021

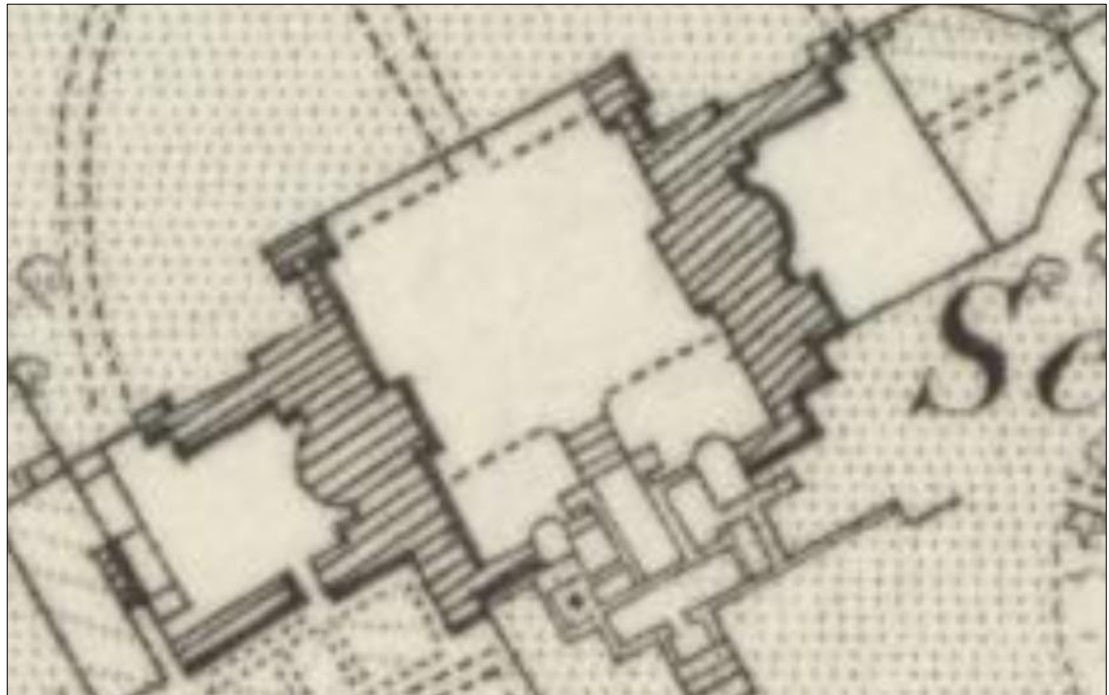
Figure 5: extract from 1860 six-inch First Edition map showing the East Wing and the Carriage House.

appears on the six-inch First Edition Ordnance Survey (OS) map of 1860 (surveyed 1858) (Fig. 5). Given the likely low level of investment in the estate following the 1822 fire, the Carriage House was probably constructed sometime between 1816 and 1822. The front (north) façade of the Carriage House was designed to match that of the north-west range of the West Wing, giving symmetry to the complex (Fig. 5). On the south side, a set of three carriage doors open into the enclosed stable yard.

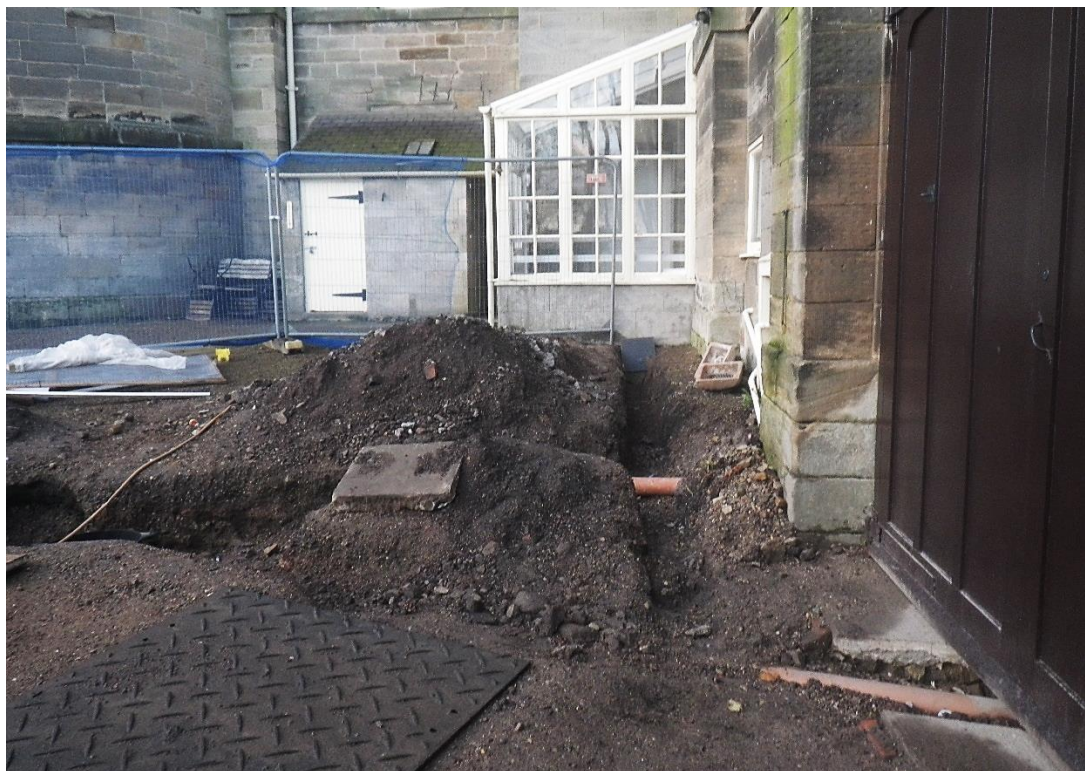
Plate 1: electrical cable trench during excavation (and realignment of drainage in the stable yard), looking south-west. The lean-to structure is in the background.

6.2 A 12m-long trench was hand excavated by the client's contractor, extending east from the electrical distribution board in the East Wing passage, through a lean-to lobby to connect with an existing drainage route before entering the Carriage House (Fig. 2; Plates 1 and 2). Prior to excavation, a strip of the modern, red-tiled, flooring within the lean-to lobby was carefully lifted and set aside for later reinstatement. A section was then cut through the underlying cast-concrete floor in the lobby and north passage to accommodate the 0.30m-wide cable trench.

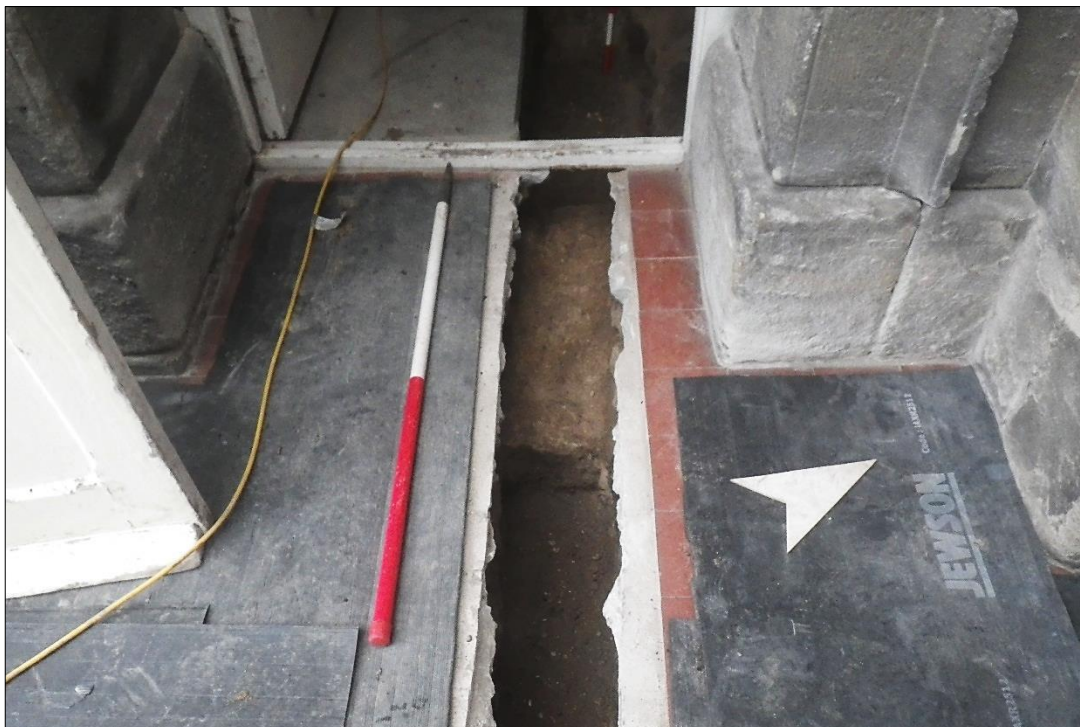
Plate 2: ceramic tiling and concrete floor in the lean-to structure and passage with wall footing 1000 visible beneath.

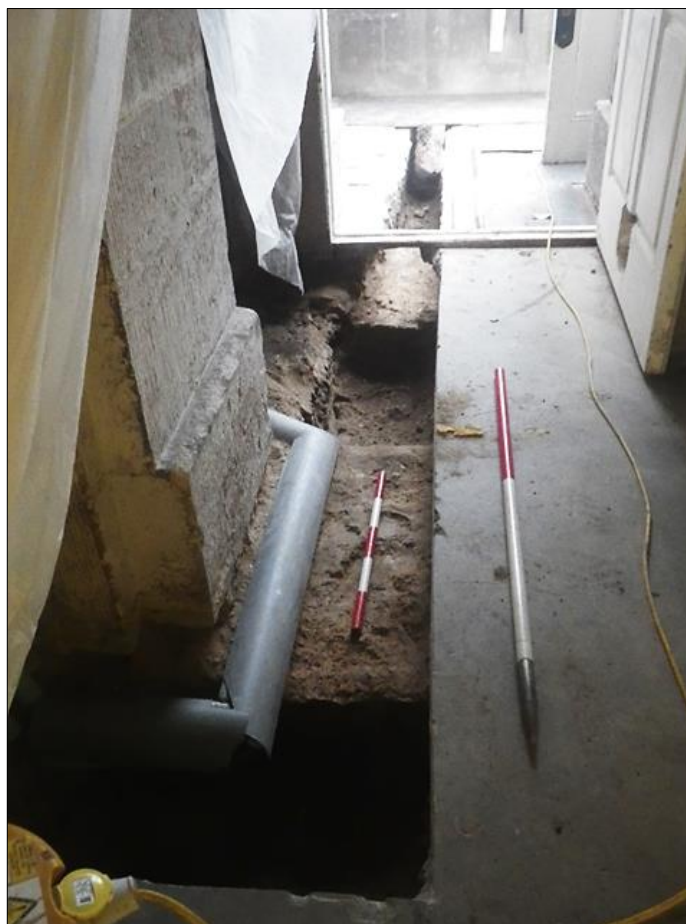
Plate 3: wall footings 1001 and 1002 in the East Wing north passage, with modern electrical cabling on the left of the photograph.

- 7.3 Two walls of heavily mortared sandstone masonry (**1001** and **1002**), measuring 1m wide and set c.2m apart, were identified forming a continuous foundation course running uninterrupted beneath the doors of the East Wing passage (Plate 3).

- 7.4 The wall footings were each two-courses high, standing to c.0.25m, and bedded on a heavily compacted layer of crushed sandstone mixed with small clay lenses (**1008**). This material also filled the gap between the two walls, where the deposit was up to 25cm thick. Equivalentents to both of these features were recorded in association with the south passage during the May 2019 excavations in the stable yard – wall footings **66** and levelling deposit **196** (NAA 2021, 122–5).

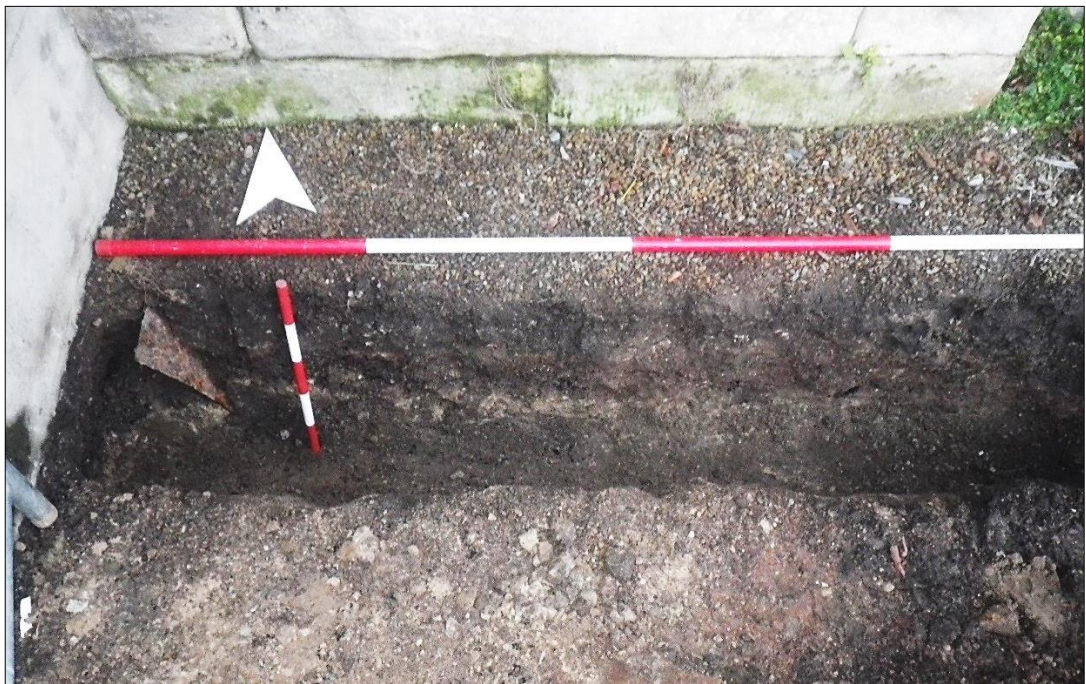
*Plate 4: ash deposit **1006** with crushed sandstone gravel **1007** visible in the base of trench.*

(Plate 5). Visible striations within this deposit suggest a continuous process of ash dumping and levelling within the yard. Both deposits **1006** and **1007** included no datable finds, perhaps suggesting deliberate dumping of a suitable material rather than domestic refuse.

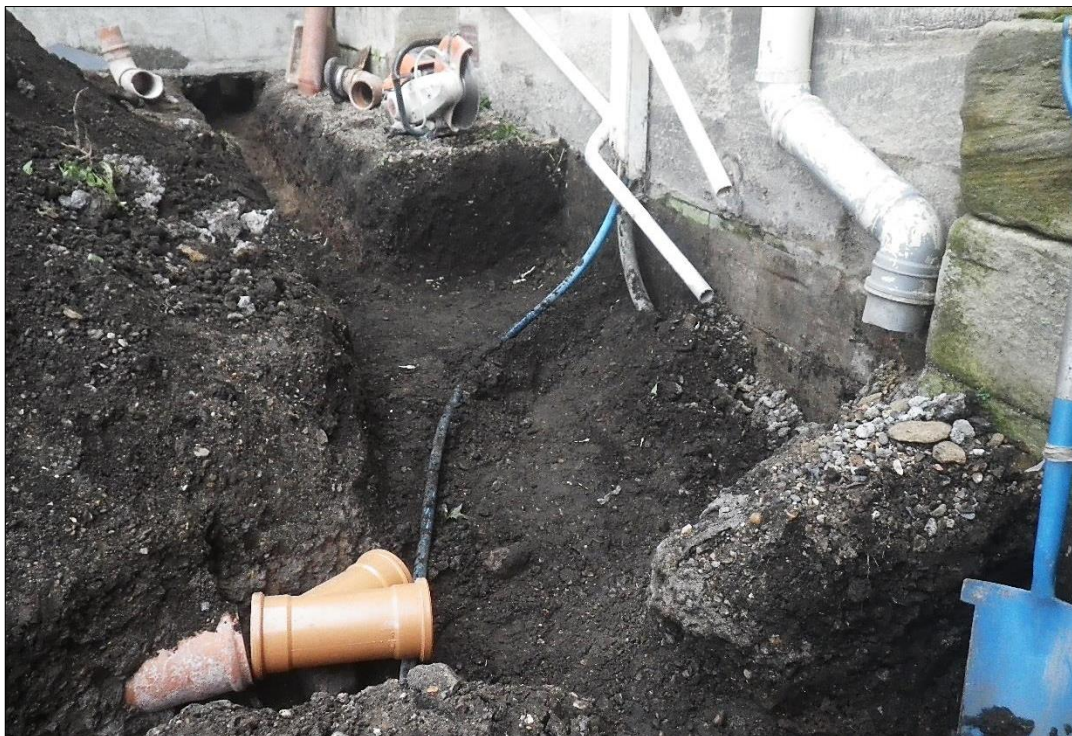
Plate 5: deposits in the stable yard after removal of disturbed modern deposits, with natural sandstone visible beneath the lean-to wall, looking west.
