St. Mary's Church, Shipley, West Sussex Report on a Recording Brief 2nd May 2003

A recording brief, carried out in the graveyard of St.Mary's Church as part of drainage works, revealed evidence for a possible precinct wall to the Templar Preceptory known to have existed on the site. The presence of building rubble suggested that some further remains may lie within the area of the drainage works, but that these would lie below the depth of 0.5m reached as part of this project.

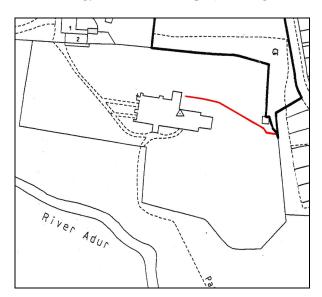
Fig.2 Plan of St.Mary's Church, showing location of drain trench in red. © Crown copyright. All rights reserved. License number: AL100036068.

- 2. The drain trench was to have run due east from the vestry to the east boundary of the churchyard. However due to the presence of grave stones, and the desirability of the drain empting into the surrounding ditch at a more southerly point, the eventual site of the trench was that shown in **Fig.2**.
- 3. The second change to the methodology as set out in the project design, was that it was found to be unnecessary to supervise the enlargement of the sump, since it evolved merely widening the aperture through a stone slab and re-use of an existing drain.

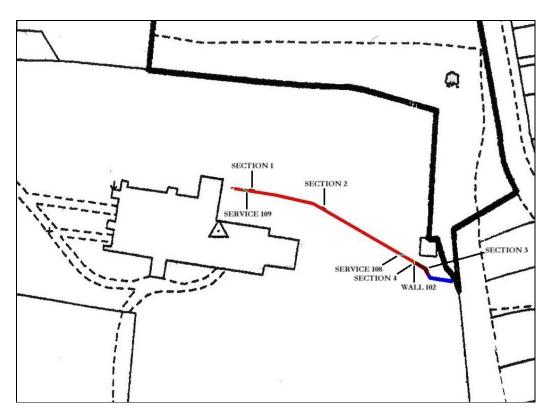
Fig.3 Plan of drain trench. The red indicates layer 101, brown layer 104 and blue 105. © Crown copyright. All rights reserved. License number: AL100036068

1. The drain trench ran approximately east-west for 45 metres until it reached the edge of the ditch which surrounds the modern churchyard on its north and east sides. The trench was 0.25m wide and varied slightly in depth along its length, from between 0.4m to 0.5m. Level readings taken along the trench reveal a drop in height of 0.69m from its west end to section 3, and a further drop of 0.48m from section 3 to the edge of the churchyard.

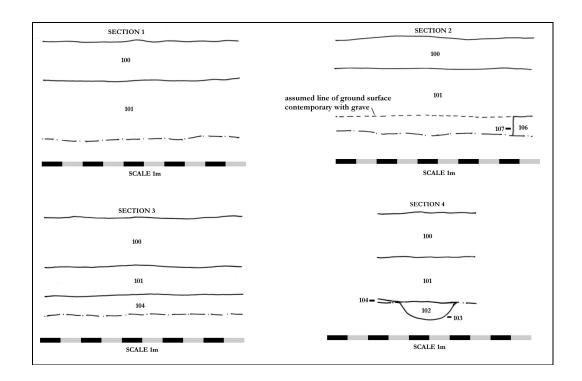
Fig.5 Sections 1-4, all are south facing with the exception of section 4, which faces north.

3. Four sections were drawn along the line of the trench to illustrate the nature of the deposits described above. Section 1, at the west end of the trench, revealed only two layers, the modern topsoil (100) and the underlying mixed clay deposit (101). Section two, to the east, showed the same two layers, but with what appears to be a grave cut (107) dug through part of deposit (101). Section 3, located where the clay layer (104) appeared, reveals three deposits, the overlying topsoil (100), the mixed clay later (101) and underlying these the clean clay (104). Section 4, place over the white mortar (102), shows the same sequence of layer as section 3, but with the cut (103) for the mortar dug through the clean clay (104) and underlying the mixed clay (101).

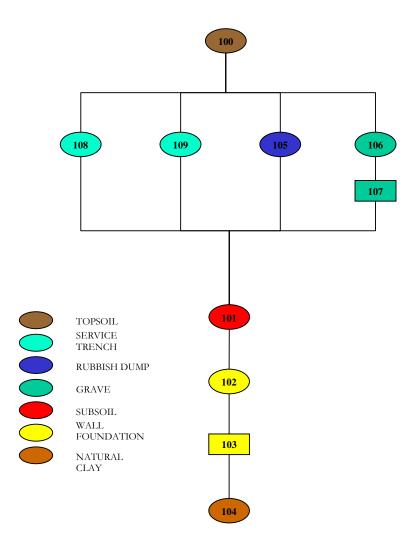
Fig.6 Harris matrix of all contexts found within drain trench. The earliest deposits are at the base of the matrix, the latest at the top

1. As seen in **Fig.6**, the earliest deposit revealed by this recording brief was the clean clay (**104**), which is likely to be the undisturbed Weald clay. Dug into this at an unknown date is the cut for the mortar deposit (**102**). Only a very limited area of this feature was visible, due to the small width of the drain trench, however it does appear to be running approximately north-south, parallel to the ditch to the east. It seems likely that it represent all that is left of the foundations for a wall. It is tempting to see this wall as once extending along the inside of the encircling ditch for its entire length, but from such a limited excavation this can be no more than speculation.

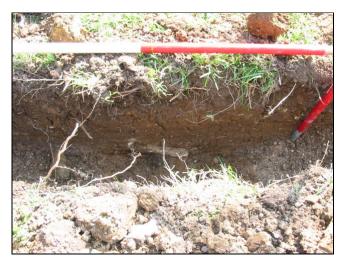
Fig.7. Photograph showing the remains of the wall foundations 102, looking south. The extreme narrowness of the trench made it difficult to get good photographs of any of the sections.

- 4. The only evidence recovered from the recording brief has been the wall foundation (102) discovered close to eastern ditch, which may represent the remains of a demolished precinct wall to the Preceptory, and the building rubble thrown up by grave digging in the mixed clay layer (101) that may indicate the remains of structures existing below the base of the drain trench. The only way of proving these conjectures would be by much more extensive excavation, down to a depth of at least 1m in the more central parts of the graveyard.

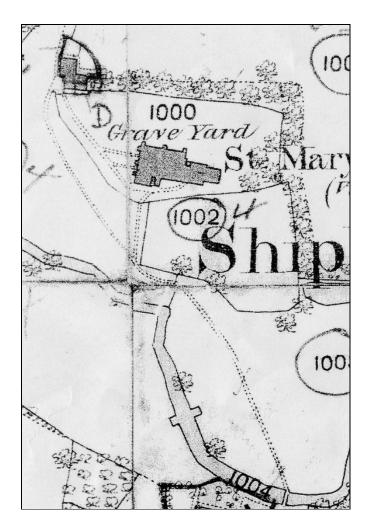
Fig.8 $1^{\rm st}$ Edition OS 1:2500 map, showing Shipley church. The kink about half way up the eastern ditch probably marks where its has been in-filled to the south.

5. Aside from the two modern service trenches (108 & 109), the only other feature in the drain trench was a dump of modern rubbish at its extreme east end. This consisted almost entirely of broken urns and vases from grave displays. The area is still used for the dumping of rubbish. It would appear from the lack of any visible Weald clay (104) at this point, that this rubbish is filling in a dip in the ground level. It seems probable from examining the alignment of the ditch which lies to the east, that it was originally wider at this point, and such rubbish dumping has narrowed it to its present width. The 1st Edition OS 1:2500 map of Shipley indicates that the ditch had already been partially in-filled by the end of the 19th century.
