An Archaeological Watching Brief at Bank Park, Warrington, Cheshire. Site Code 151 Final Report

Prepared for Golden Gates Housing Trust

This report describes the results of an archaeological watching brief at Bank Park, Warrington. The project took place in advance of the construction of a new office block on the site. The watching brief was specifically targeted at monitoring the excavation of an area on the eastern side of the site relating to a building identified as a former water management feature.

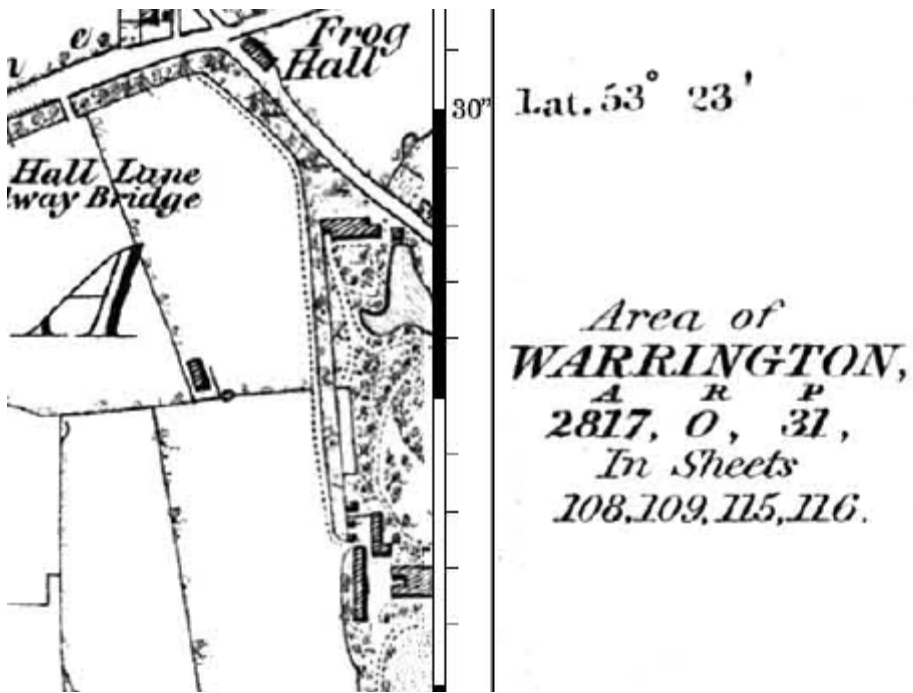
Fig. 2. Part of The OS 6 in to the Mile Sheet 115 published 1849. Not to scale.

The watching brief was confined to the site of a rectangular building sited immediately adjacent to the northern edge of a fishpond, both features are shown on historic mapping of the area, first appearing on the 1st Edition 6in to the Mile Survey of 1849 (Figs 2 and 3).

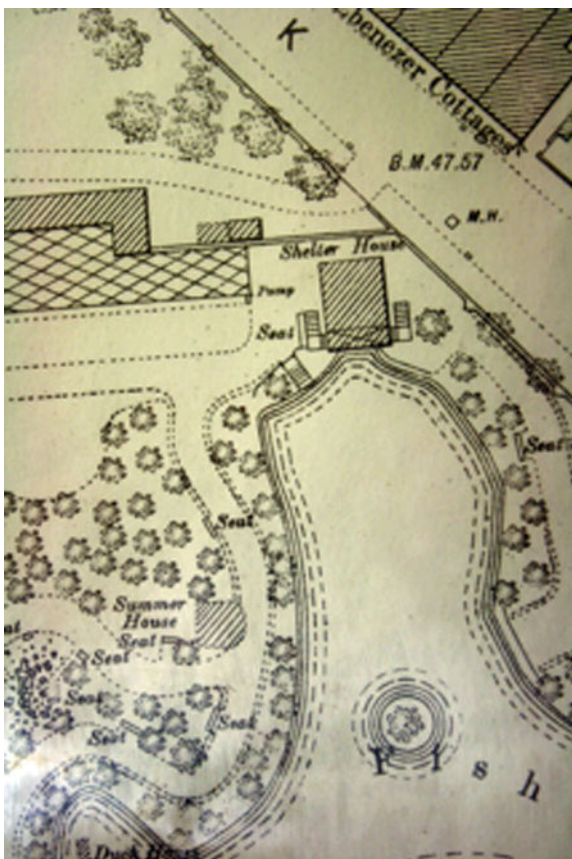
Fig. 3. Part of a survey of Warrington dated 1888. Image supplied by Warrington Archaeological and Historical Society. Not to scale.

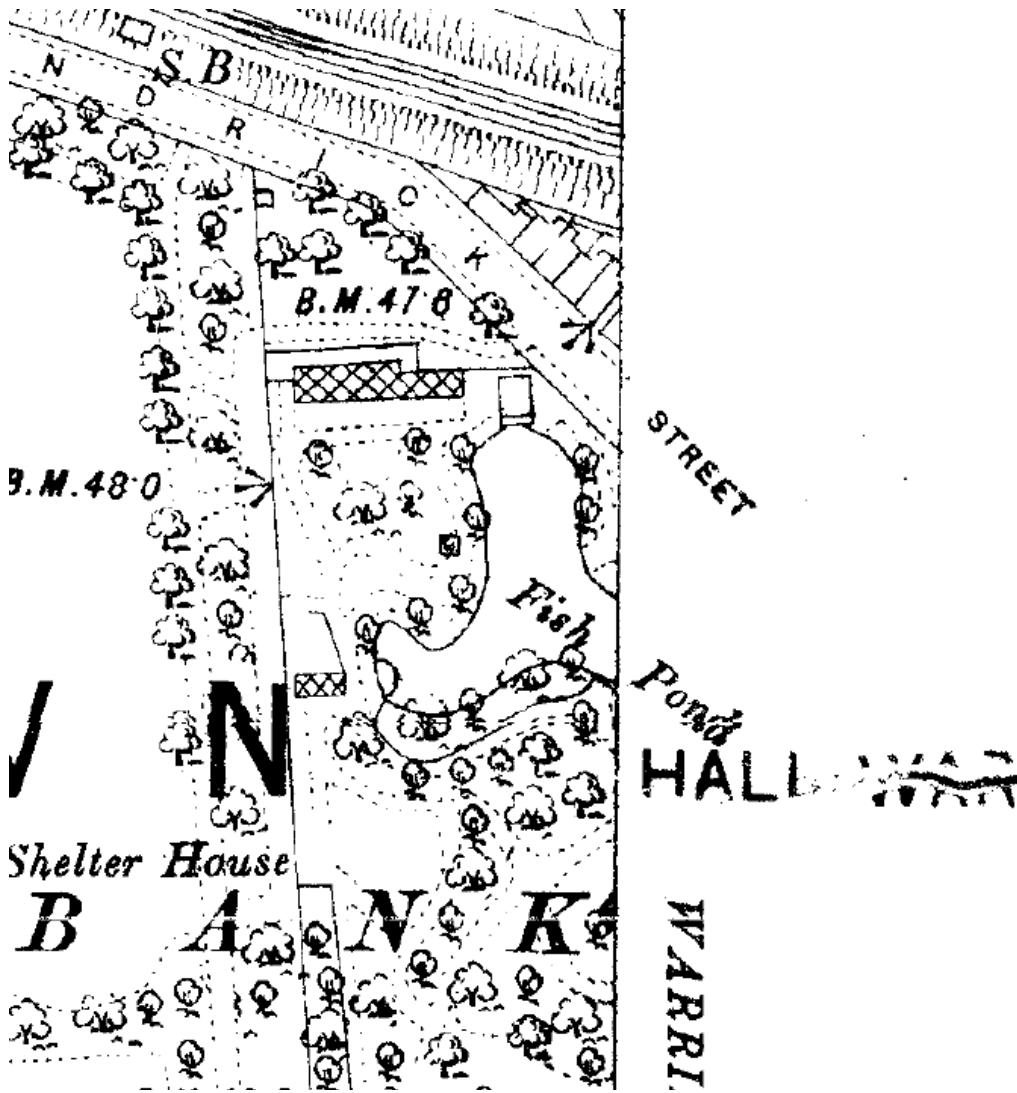
Fig. 4. Part of the OS 25 in to the Mile Sheet CXV.4 published 1893. Not to scale.

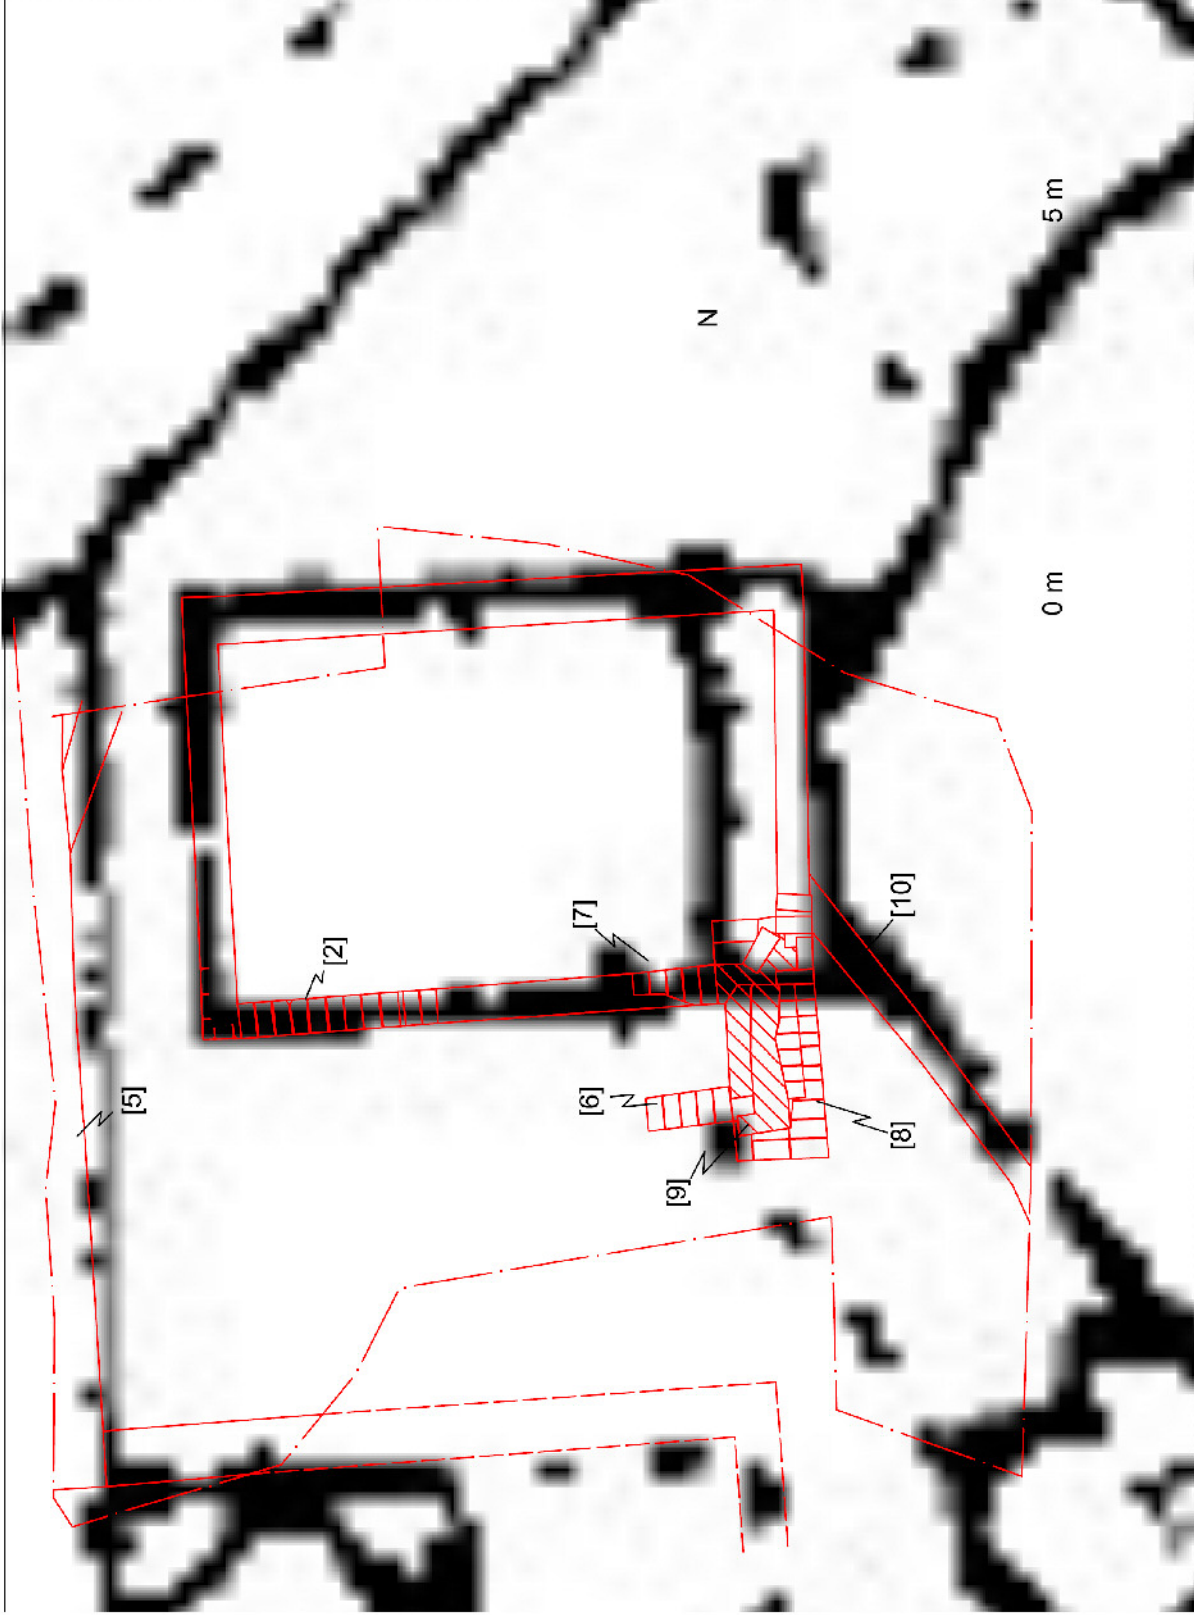
Fig. 6. Excavated features superimposed onto 1893 OS (Fig. 4). Note that the seats shown on Fig. 3 and which correspond with contexts 6,7, 8 and 9 do not appear on the 1893 edition.

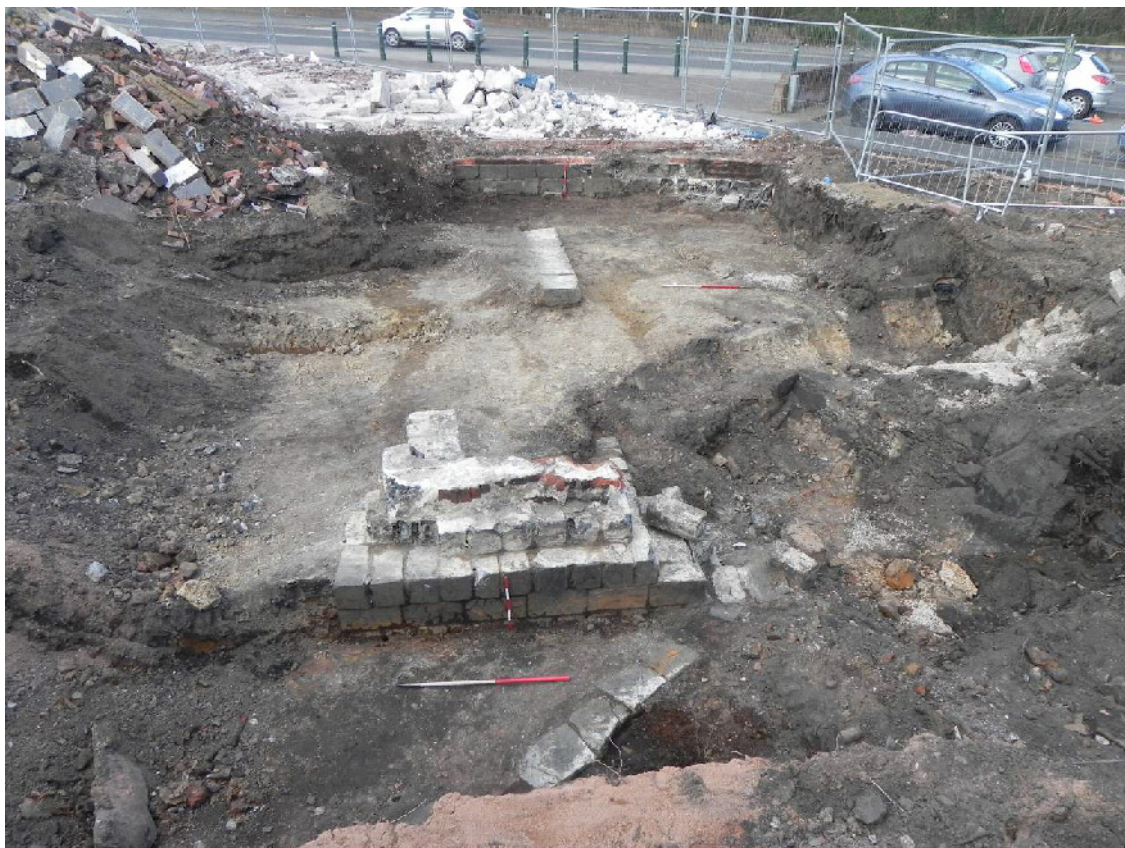
Plate 1. Area of excavation after the removal of context 1 showing slag block foundations and northern extent of the fishpond marked by curving line of blocks at the foreground. View from the south.

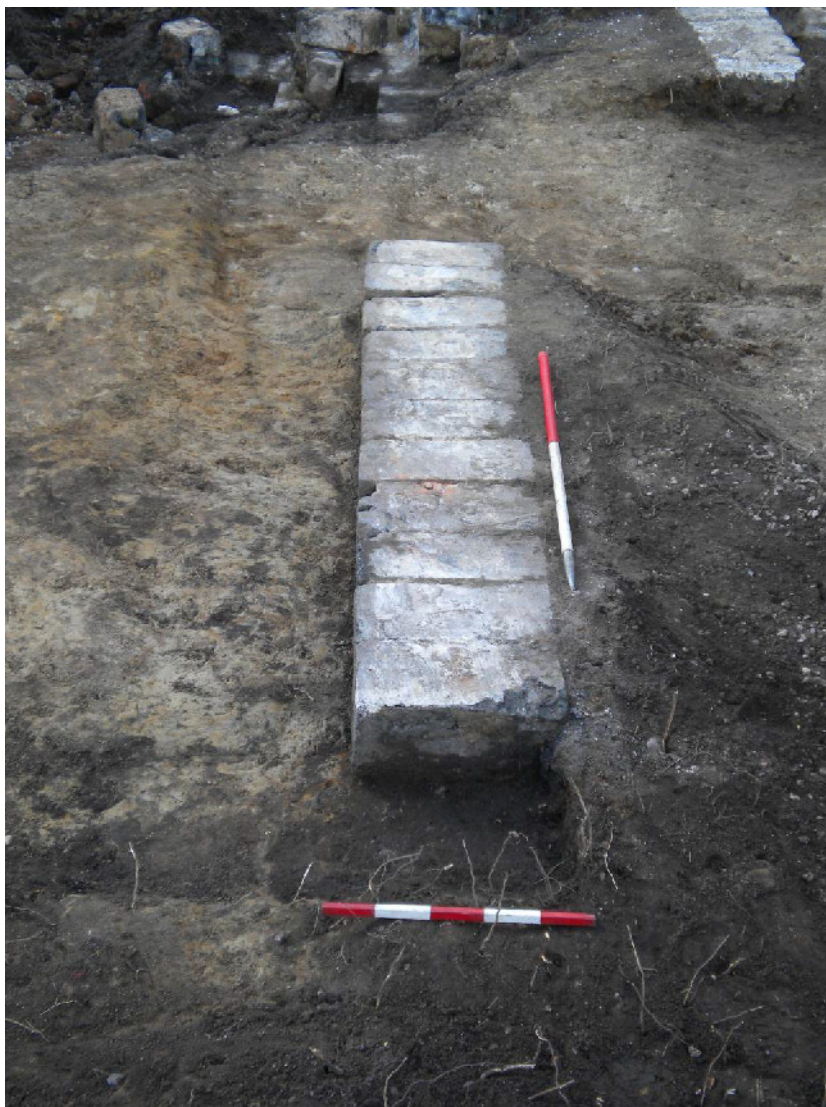
Plate 2. North – south aligned slag block foundation, context 2, showing shallow cut 12 at northern end. From the north.

A line of slag blocks, context 2, was aligned north – south across the northern section of the excavation. This feature measured 2.45 m (length) by 0.20 m (width) by 0.23 m (depth) and consisted of a single course of 11 blocks laid directly into natural sandy clay, context 11 (Plate 2). The blocks were made of copper slag cast into a rectangular mould and were very dense. The matt black external surface had been chipped showing a black, glassy, fine grained vesicular structure with a dark green colour showing some streaks of green, corrosion product. The blocks were generally of a uniform size c. 0.46 m (length) by 0.20 m (width) by 0.23 m (depth) and were bonded using a fine grained, off-white sandy lime mortar with no inclusions. One block at the northern end had been accidentally removed during machining revealing the traces of an 'L' shaped cut or impression for the foundation, context 12, which measured c. 2.90 m (length) by 1.00 – 0.47 m (width) by 0.23 m (depth).

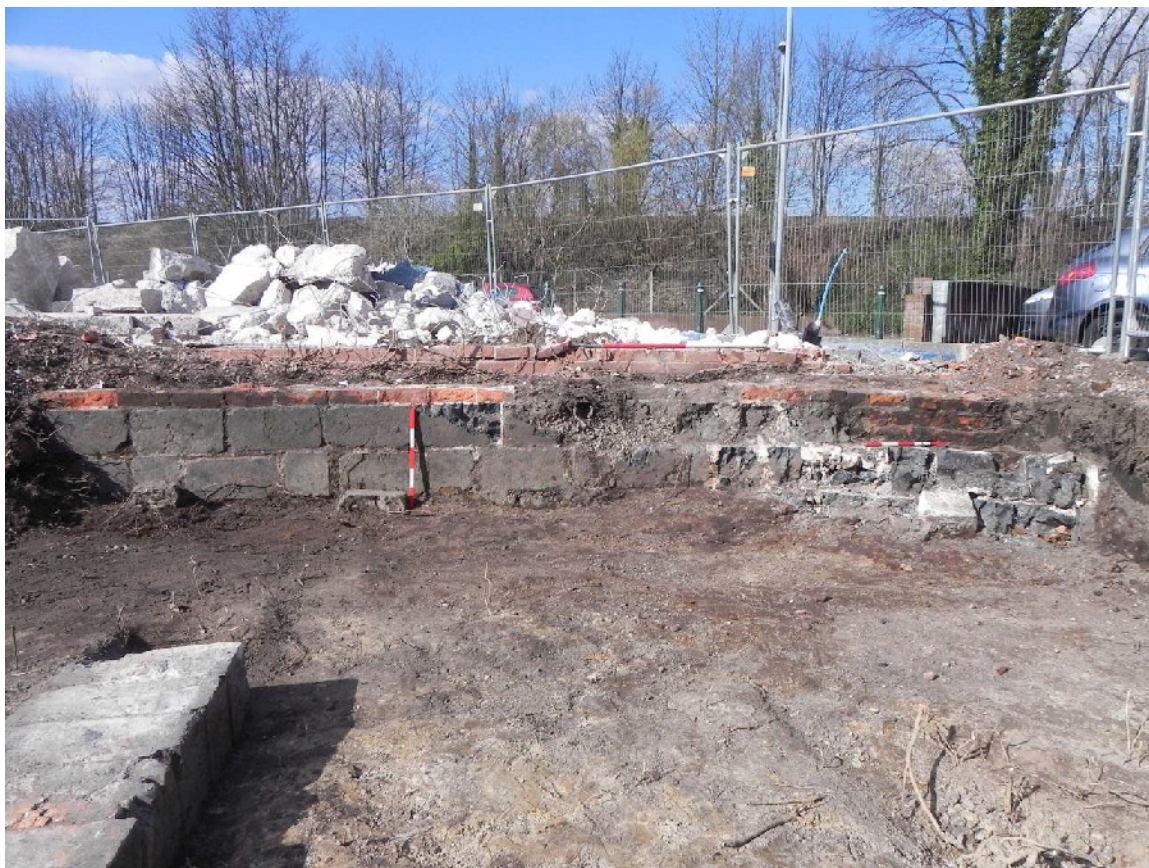
Plate 3. Wall foundations exposed in northern trench section, north of context 2.
From the south.

To the north of context 2, a series of wall foundations were visible in the northern trench section (Plate 3). The demolished remains of a building constructed c. 1980 lay directly behind the trench section and a soil in-fill 0.15 m wide separated these from brick and slag block foundations 4 and 5 to the south (Plate 4).

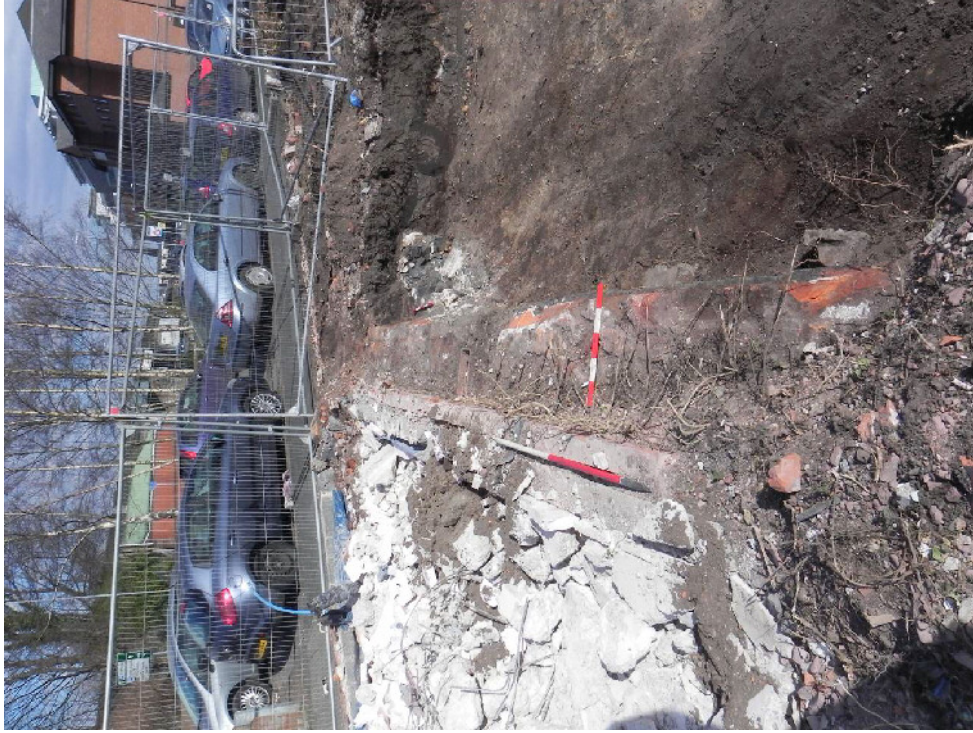
Plate 4. Wall foundations exposed in northern trench section showing demolished 1980s concrete slab to the north with line of modern brick foundations directly in front, context 3, and wall foundations, contexts 4 and 5, running parallel. From the west.

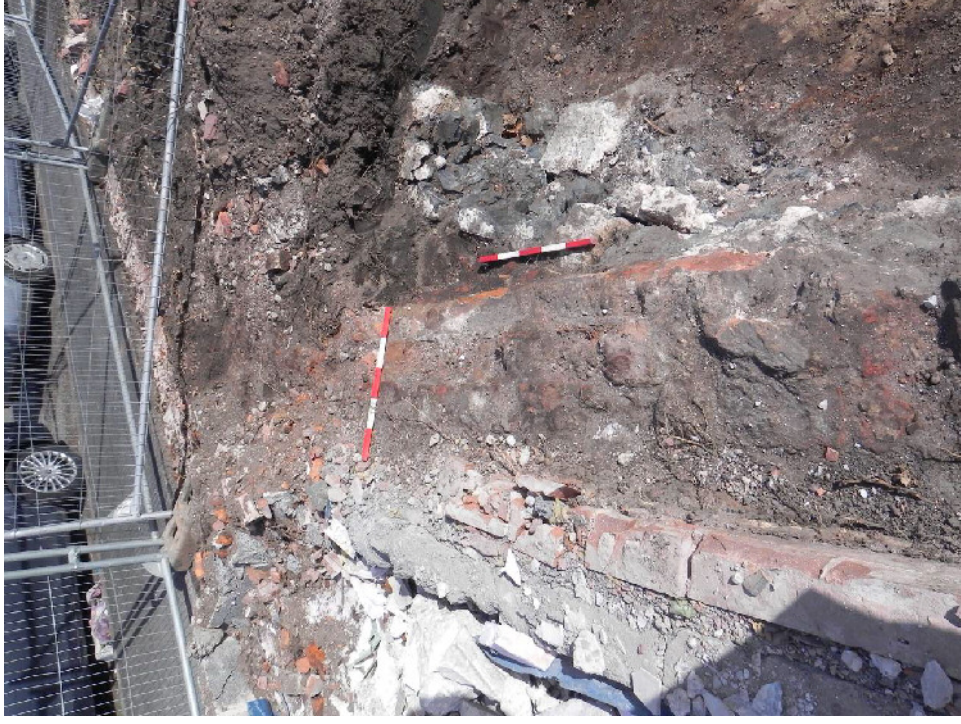
Plate 5. Context 4 brickwork shown running towards site boundary while underlying slag block foundations, context 5, turns diagonally running into eastern trench section. From the west.

The slag block foundation (context 5) ran on the same alignment as wall 4 before turning at its eastern end in a south-easterly direction, across the north-east corner of the trench, into the east trench section (Plate 5). The three course slag block foundation was similarly constructed to contexts 2 and 8 with overall measurements of 9.70 m (length) by 0.70 m (width) by 0.40 m (depth).

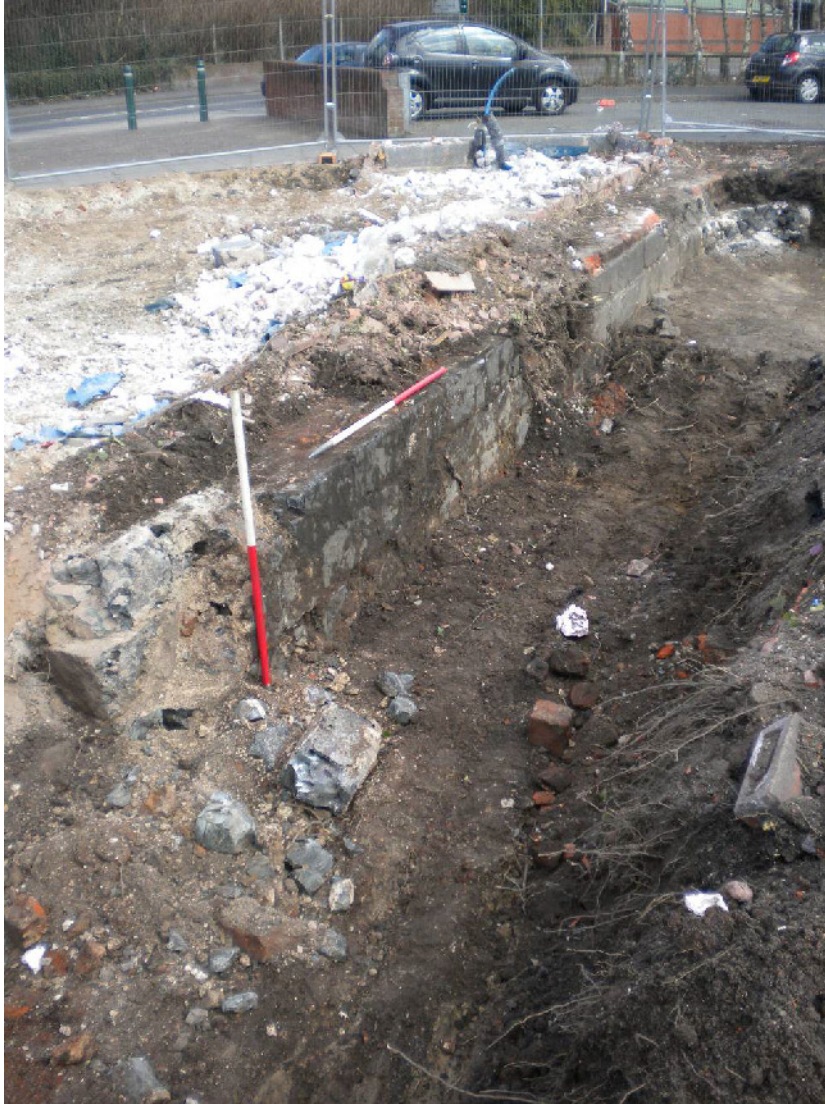
Plate 6. Trench along western extent of context 5 showing drain pipe damage mid-section. From the south-west.

At the western end of context 5 a red brick return wall ran south for approximately 3 m. A modern drain was seen in northern section cutting through both foundation walls 4 and 5 (Plate 6). This brick wall was only observed in the temporary trench section but was six courses deep measuring 0.50 m width (east – west) below 0.30 m of rubble in-fill context 1 and tarmac (Plate 7). The date of the wall was unclear but was thought to have formed the western wall to the building shown on historic OS mapping.

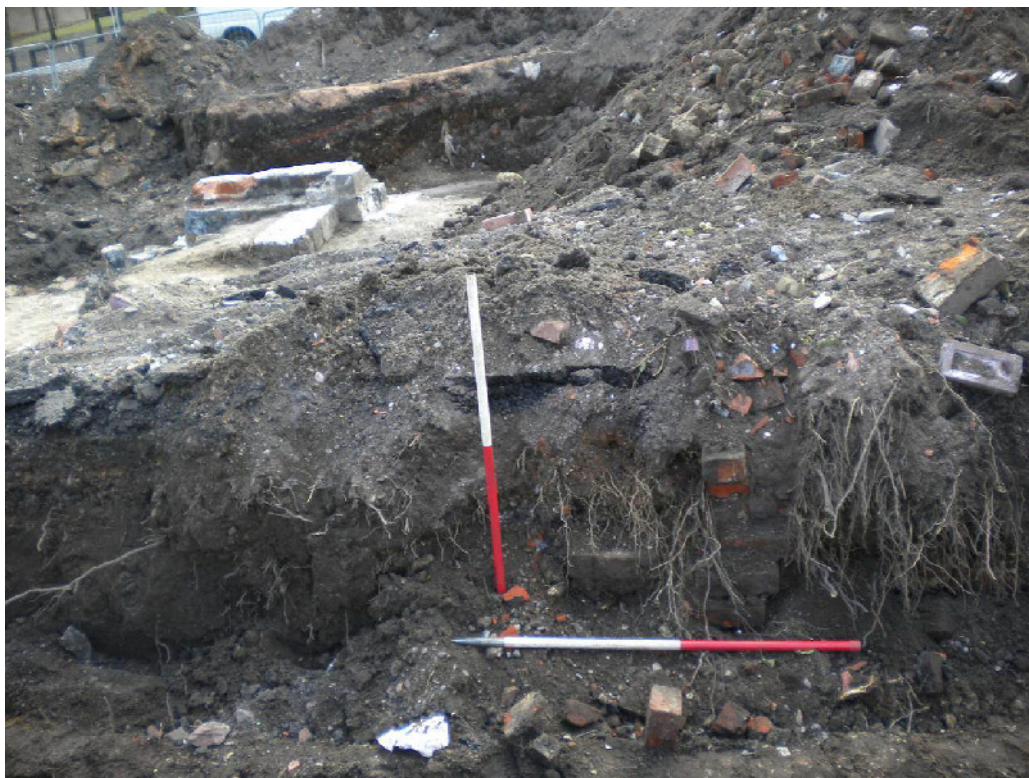
Plate 7. Brick return wall running south from west end of context 5 seen in temporary trench section below tarmac and rubble in-fill deposits. From the north.

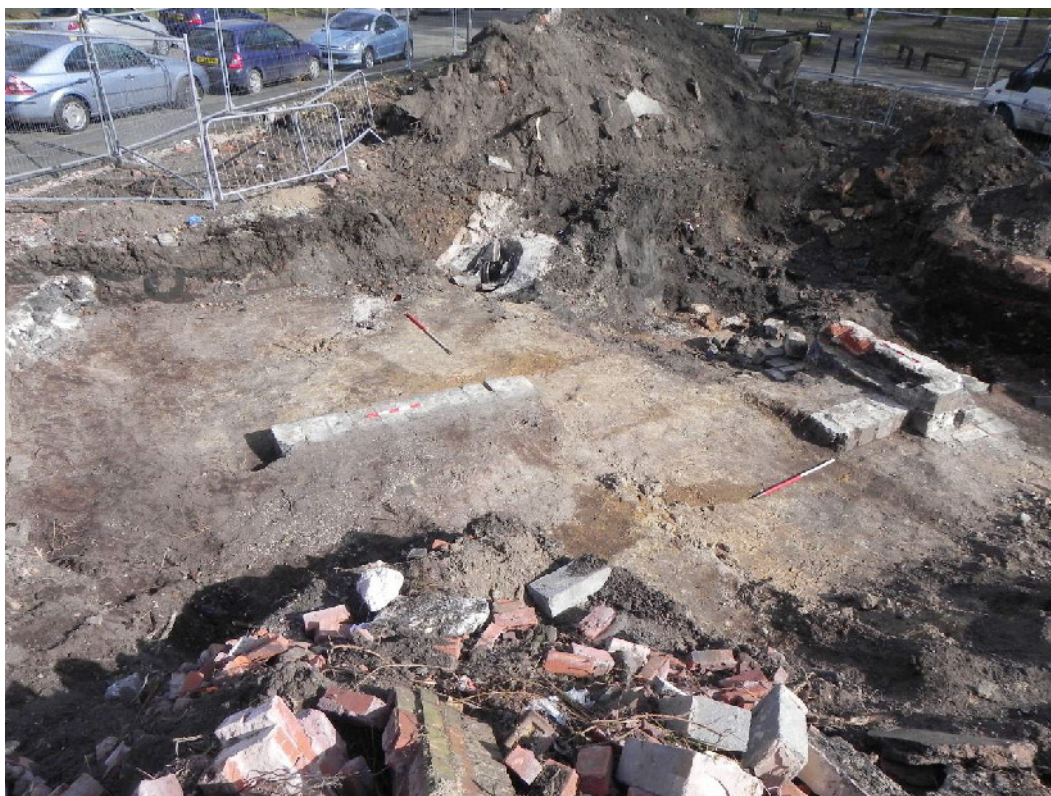
Plate 8. Group of foundations 6, 7, 8 and 9 to the south showing alignment with single line context 2. From the north-west.

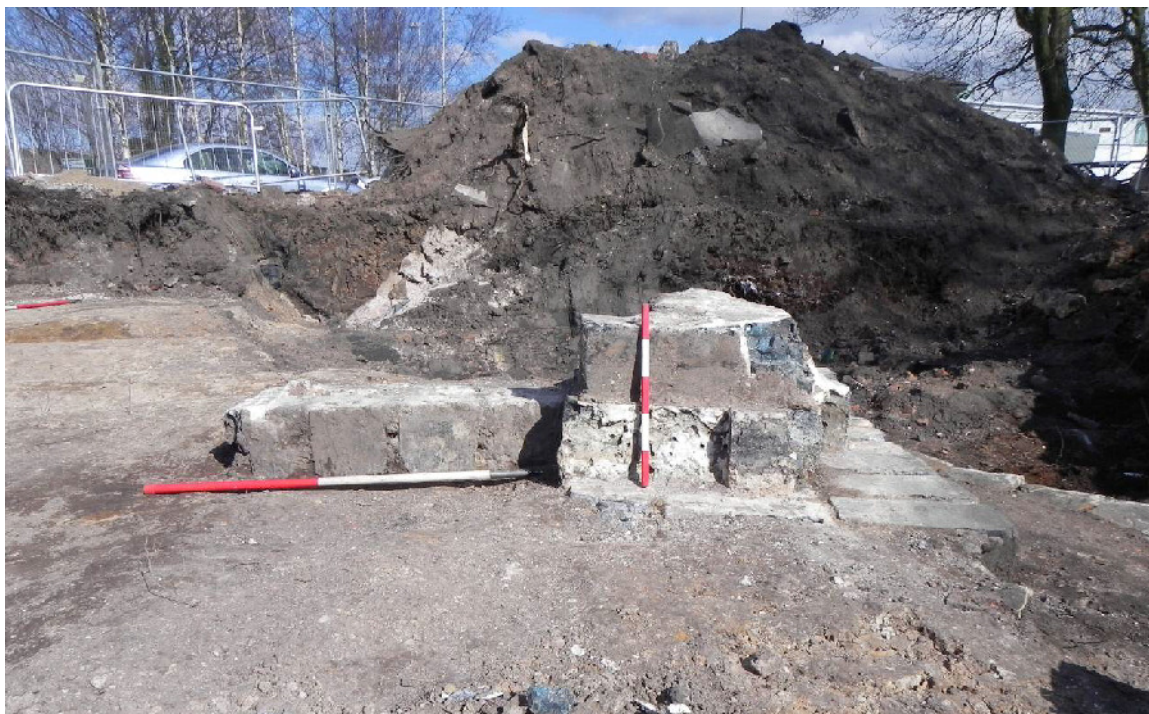
Plate 9. Side view showing context 6 to the north butted against main foundation block 8. From the west.

Context 6 butted against foundation 8 to the west and consisted of one course of four copper slag blocks, similar in shape and size to those described in context 2 (Plate 9). The foundation measured 1.05 m (length) by 0.45 m (width) by 0.22 m (depth). The bonding material, an off-white lime mortar, was also the same consistency as that described in context 2. It appeared to form part of an external wall to the building.

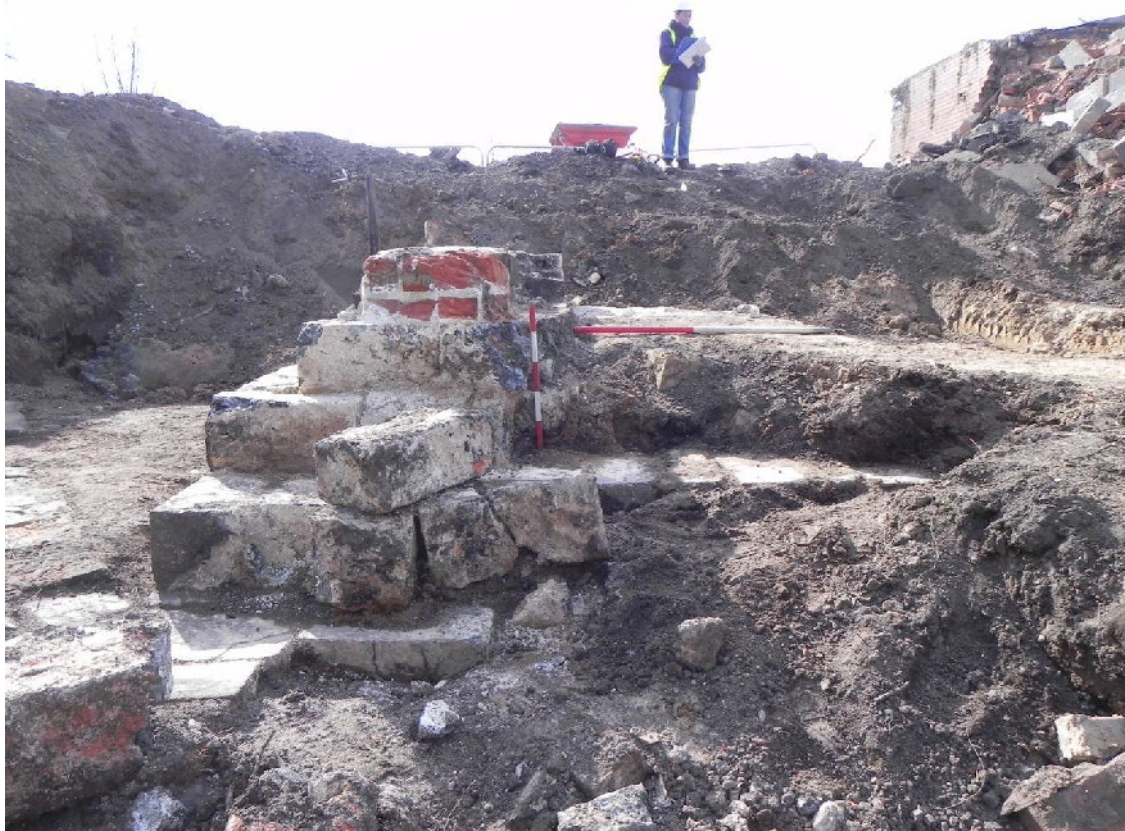
Plate 10. Side view showing context 7 running northwards from main foundation block 8, note sunken lower level compared with context 6 in previous plate 10. From the east.

Context 7 also butted against context 8 and ran parallel with context 6 but at a lower level, by c. 0.45 m (Plate 10). The foundation was constructed with the same materials as context 6 but consisted of five slag blocks. It measured 1.10 m (length) by 0.43 m (width), the depth was not visible, and possibly formed part of an internal wall to the building.

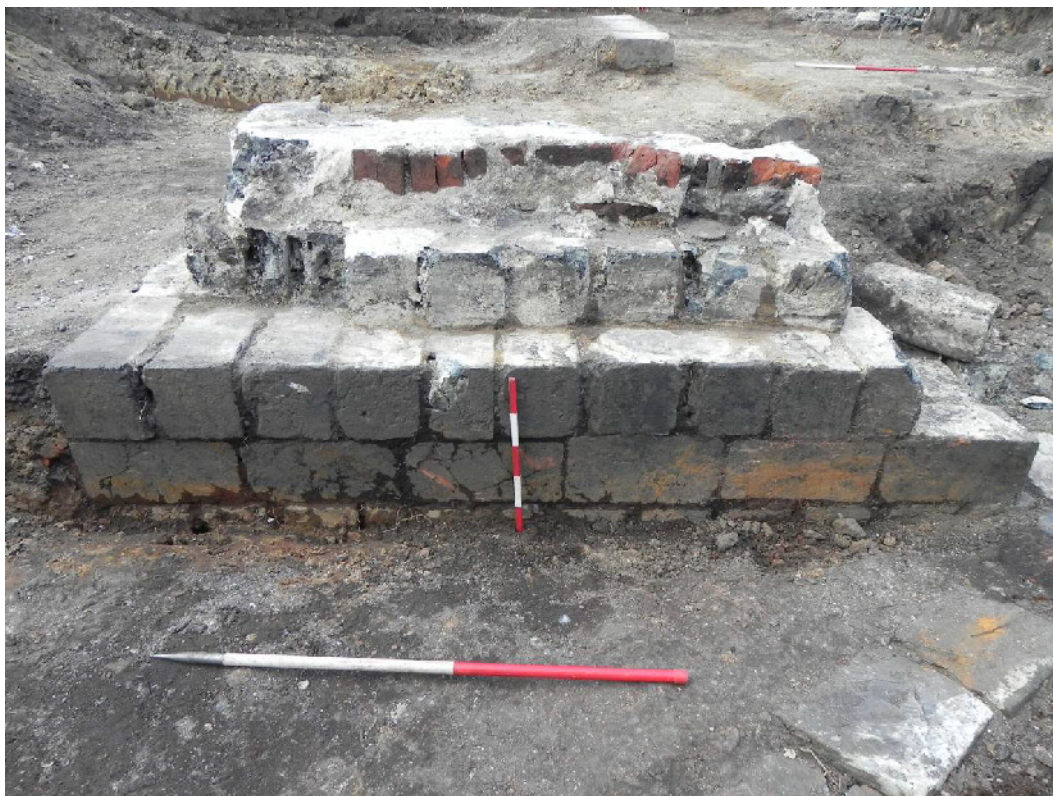
Plate 11. Stepped, rectangular foundation block showing contexts 8 and 9, external facing. From the south.

(width) by 0.75 – 1.00 m (depth) and was constructed with the same materials as context 2 (Plates 11 and 12). Context 8 appeared to continue eastwards towards the western trench section, where one *in situ* slag block was visible in section (Plate 13), but had been disturbed and cut through by a late 20th century drainage pipe heading north-easterly towards a man-hole.

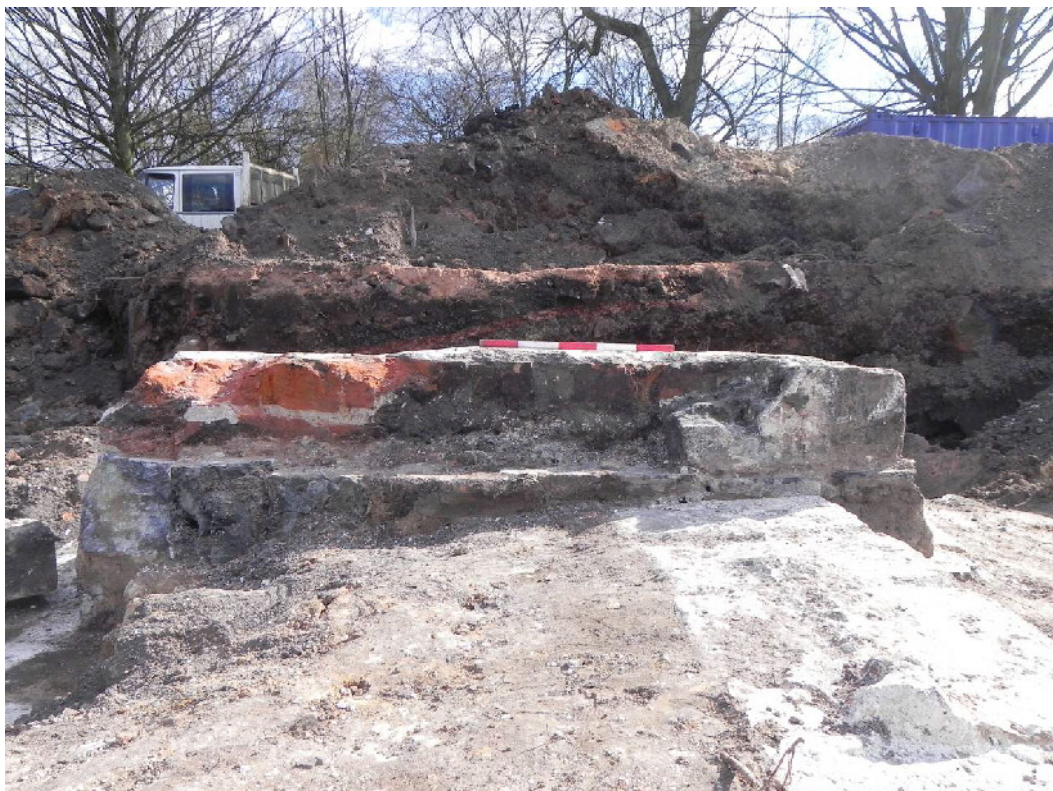
Plate 12. Stepped, rectangular foundation block showing contexts 8 and 9, internal facing and context 6 in foreground heading northwards. From the north.

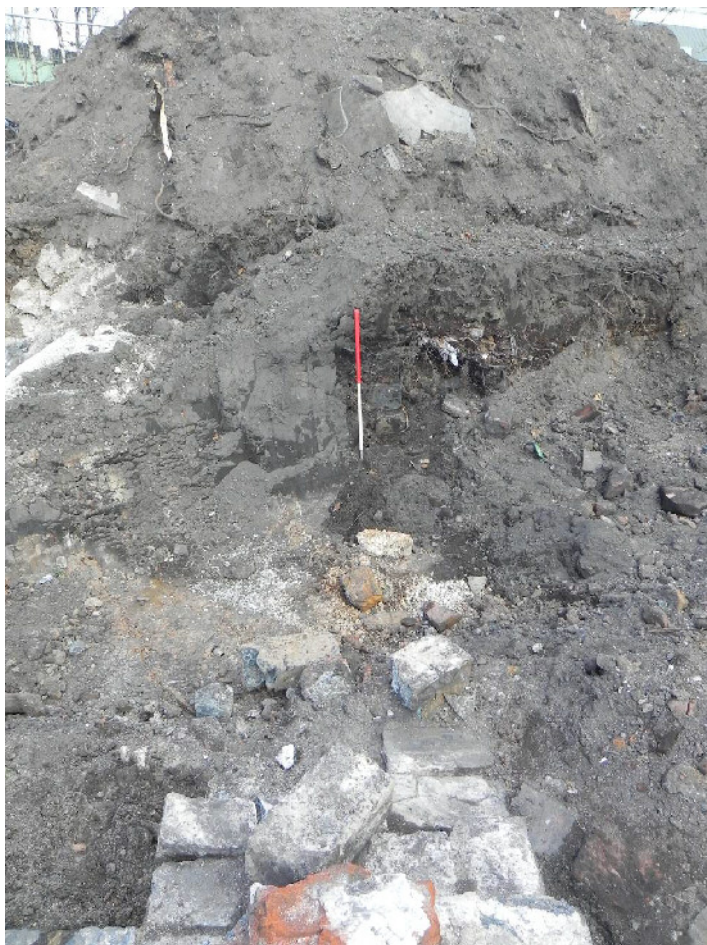
Plate 13. Continuation of wall foundation 8 showing damage by drainage system mid-section and *in situ* slag block in far eastern trench section (marked by ranging rod). From the west.

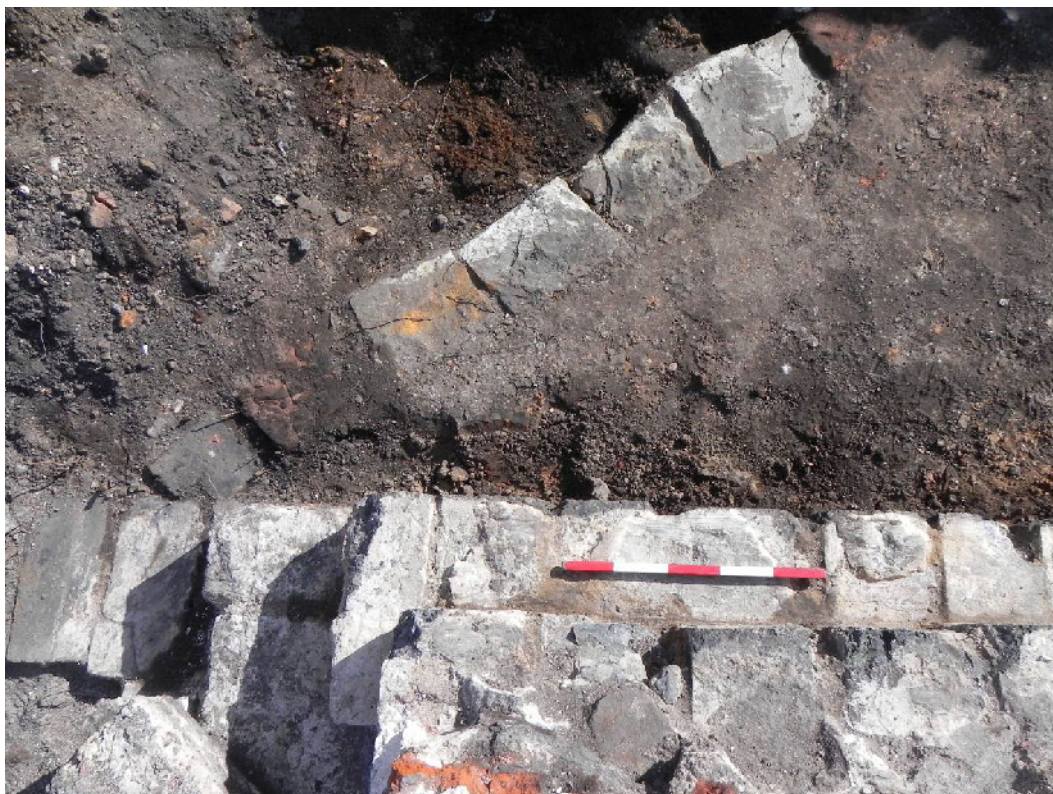
Plate 14. Plan view showing curved line of stone blocks context 10 marking northern extent of in-filled fishpond, overlooked by foundation block context 8.

Context 10 was the top of a curving line of eight coping stones marking the northern extent of the in-filled fishpond shown on historic mapping. It was at a depth of c. 1.30 m below ground level, running in a roughly south-west to north-east direction. The north-eastern end was truncated at the junction with slag block foundation, context 8 (Plate 14) and measured 4.10 m in length by 0.38 m width, the depth of the stones was not ascertained. Each block varied in size and were a mix of five granite, two sandstone and one slag blocks, no bonding material was visible. A series of tipping deposits were observed in the trench section directly above the pond in-fill and context 10 (Plate 15) but were not recorded in any further detail due to the inclusion of modern plastic debris and other rubbish.

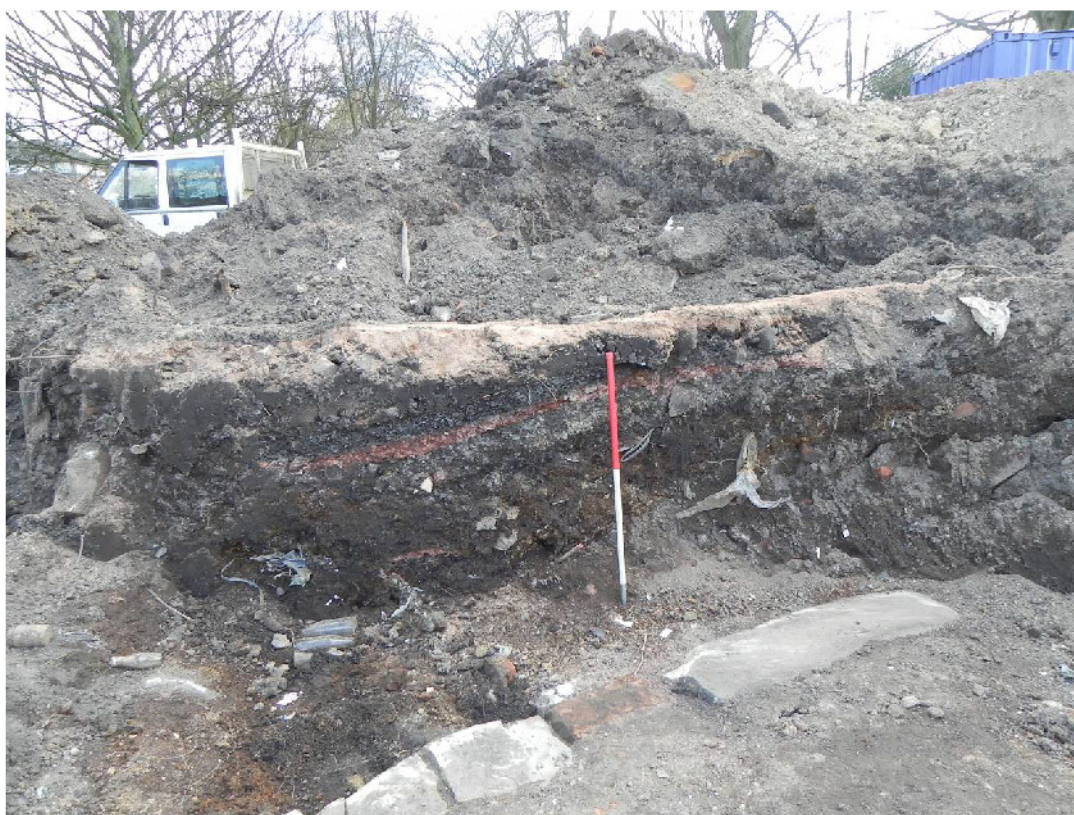
Plate 15. Tipping deposits shown in southern trench section overlying in-filled fishpond. From the north.
