The Sunken House Young Roots Project West Stow Anglo-Saxon Village, Suffolk

WSW 136/ESF 23265
Volume 2 – Appendices
SACIC Report No. 2016/004
Author: Rob Brooks
© SACIC

Volume 2 - Appendices

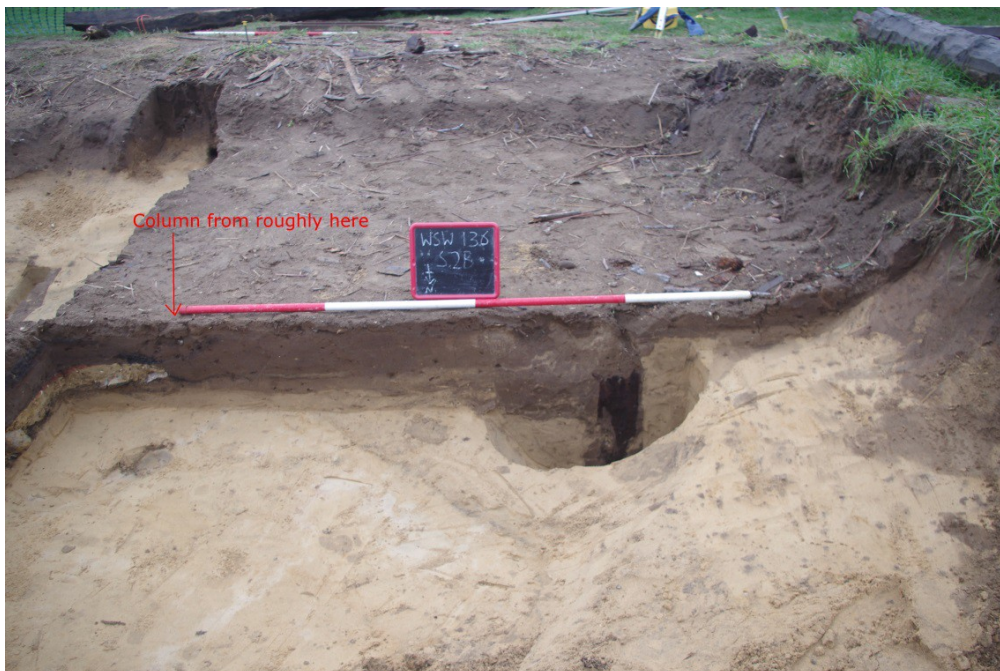
Field photo, supplied by Anna West, of sunken hut floor at West Stow. Thin section column picked out chalky daub and charcoal from the remains of the constructed hearth/floor and charcoal concentration.

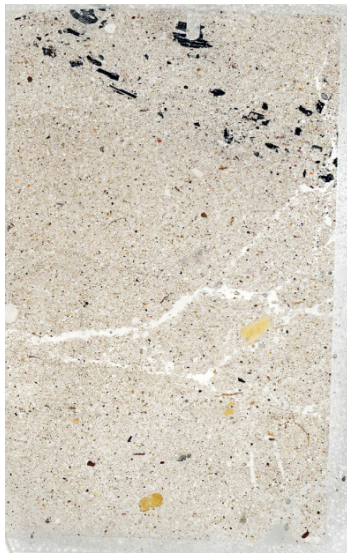
Fig. 28: Scan of M136B, mainly a sand fill with sloping layer of charcoal and burnt minerals. Frame width is ~50mm.

0224 (M136B): Very dominant mainly coated sands with clean, and an example of grey chalky loam and very few black organic channel fills, with very few fine gravel (max 5mm), are present (Fig 8). An example of a wood splinter, rare to many burnt mineral grains, rare woody roots, and rare to abundant fine and coarse wood charcoal (sloping layer with max 6mm-size examples), were noted (Figs 9-10). There are many likely sesquioxide coated grains, many thin burrows, and occasional very thin mainly organic excrements (pellets).

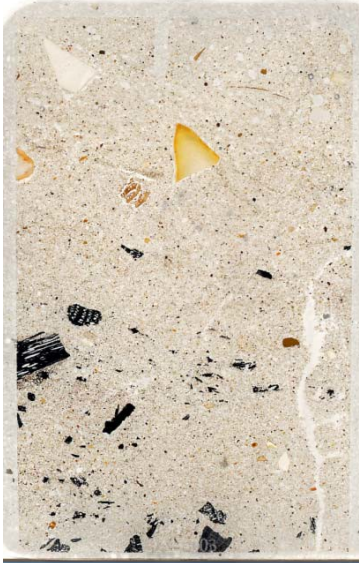
Fig. 31: Scan of Fig M136A, with charcoal-rich 0224 below flint and burnt flint-rich 0218. Frame width is ~50mm.
