# Landguard Point Radar Tower Connection Felixstowe, Suffolk

**FEX 337**

Archaeological Monitoring Report  
SACIC Report No. 2017/004  
Author: M. Sommers  
© SACIC

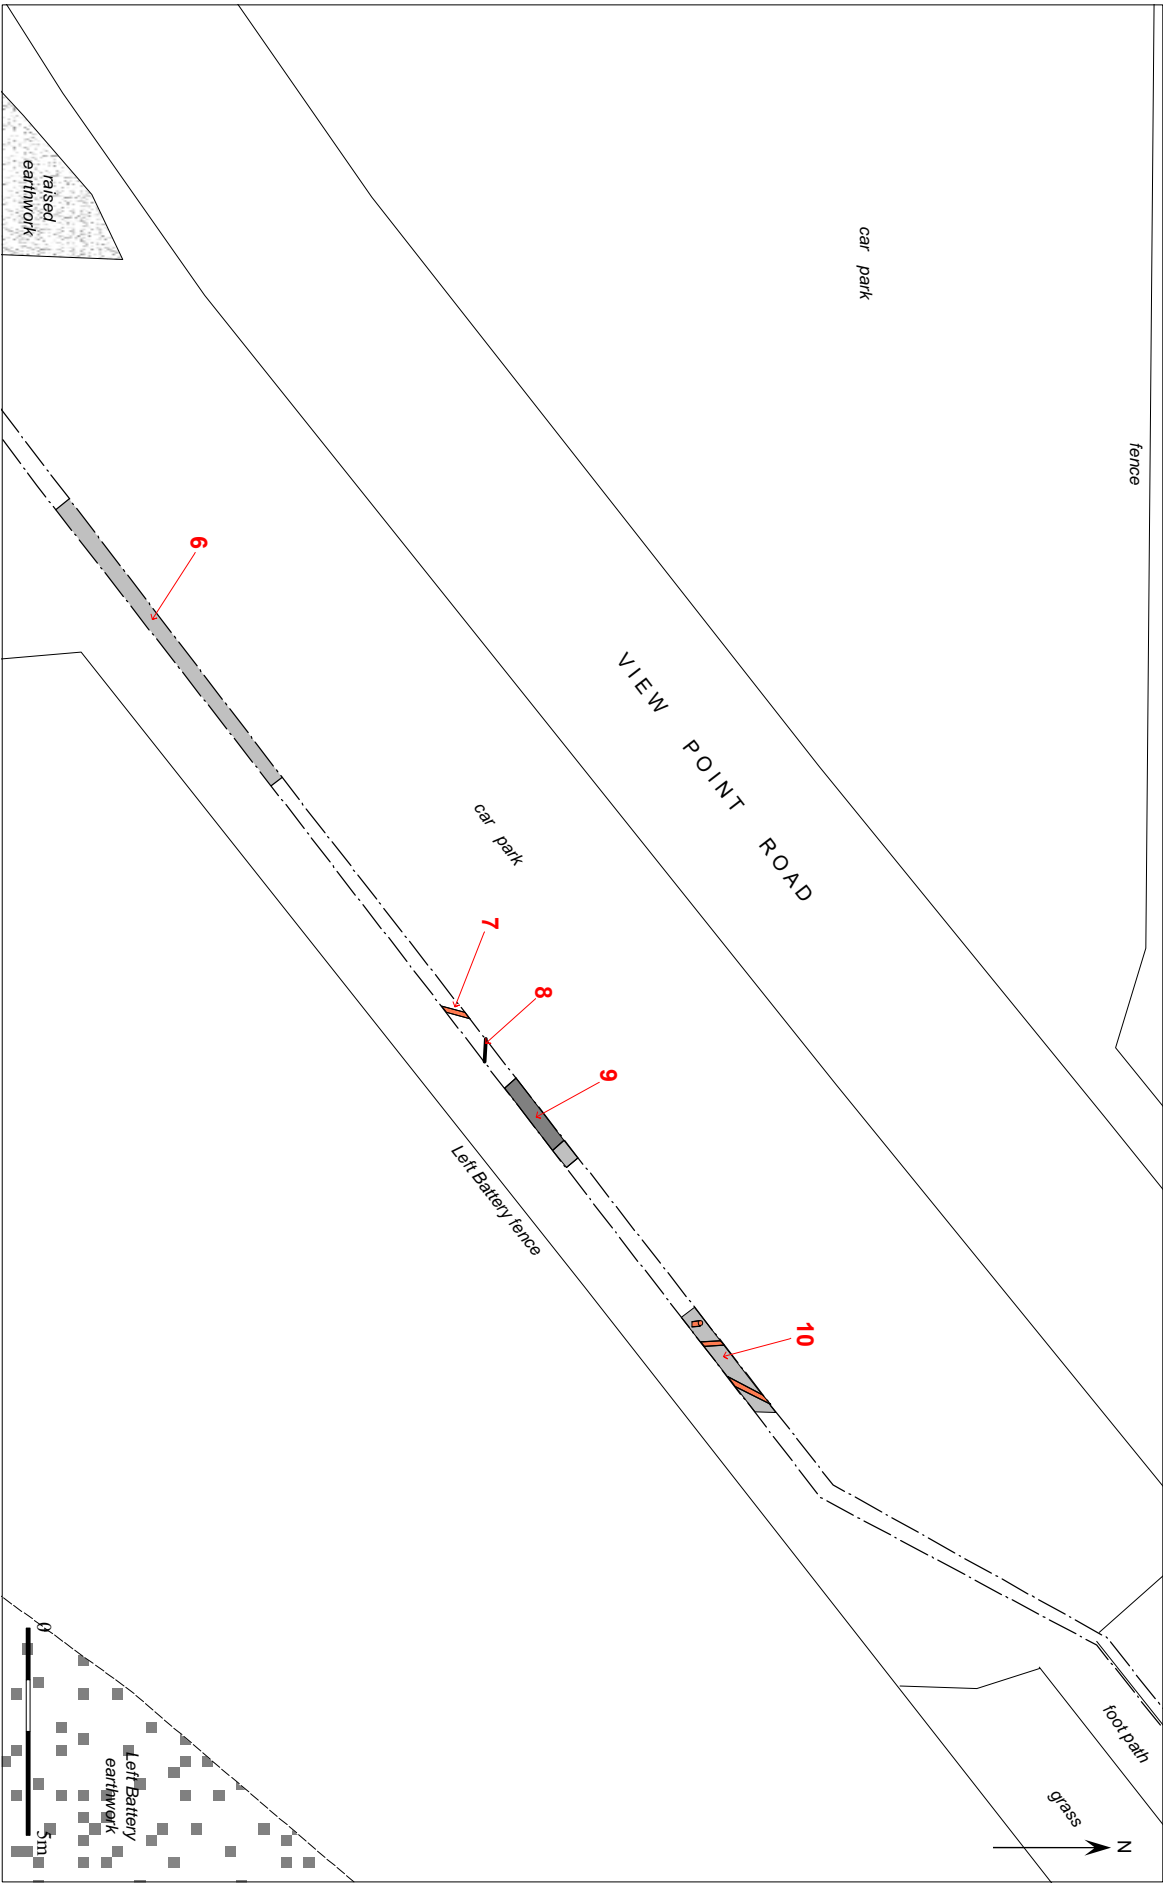
Figure 4. Location of Items 6 to 10

**Item 6** (fig. 4) consisted of an area of hardstanding or roadway (plate 9). It comprises a subbase of moderate sized fragments of a mudstone (?septaria), c. 0.2m thick overlain by c. 0.08m thick layer of rammed yellow sand and gravel which in turn was overlain by a c. 0.07m layer of rammed dark brown sand and gravel. This lay around 0.15 to 0.20m below the present ground surface. *Clearly a well constructed area of hardstanding, possibly part of an earlier roadway.*

**Item 7** (fig. 4) A salt-glazed pipe, c. 0.12m in diameter, aligned roughly north-south at a depth of approximately 0.6m (plate 10). Not entirely clear but appeared to have a slight fall to the north. *Foul water drain from the Left Battery?*

**Item 9** (fig. 4) An area of concrete with brick fragments, mostly frogless, soft reds (plate 11). It measured 1.8m in width, 0.2m in thickness and lay approximately 0.2m below the present ground surface. To install the service duct it was necessary to break out a slot through this feature. This revealed a length of loose bricks along southeast edge of the trench (plate 12), some of which could have potentially been part of an *in-situ* wall or brick surface, particularly towards the northeast (plates 13 and 14) although no obvious mortar was visible. The bricks appeared to be a mixture of hard frogged pink bricks (similar to flettons), measuring 220mm by 110mm by 80mm, and a slightly darker pink brick branded with the name 'National Heather' within a frog (plate 15); these were larger at 230mm by 110mm by 80mm. *Part of a small structure probably associated with the Left Battery. The bricks suggest a 20th century date with 19th century bricks being re-used in the concrete forming the base.*

**Item 10** (fig. 4) comprised a series of three salt-glazed pipes, c. 0.12m in diameter, on varying alignments and set into a mass of concrete with brick fragments at a depth of c. 0.2m below the present ground surface (plate 16). Two of the pipes ran at angles

across the width of the excavated trench whilst the third turned to form a vertical pipe, which was broken off. It was necessary to cut a slot with a breaker through these pipes and the concrete in order to install the service duct. *Drainage associated with a former toilet block to the rear of the Left Battery?*

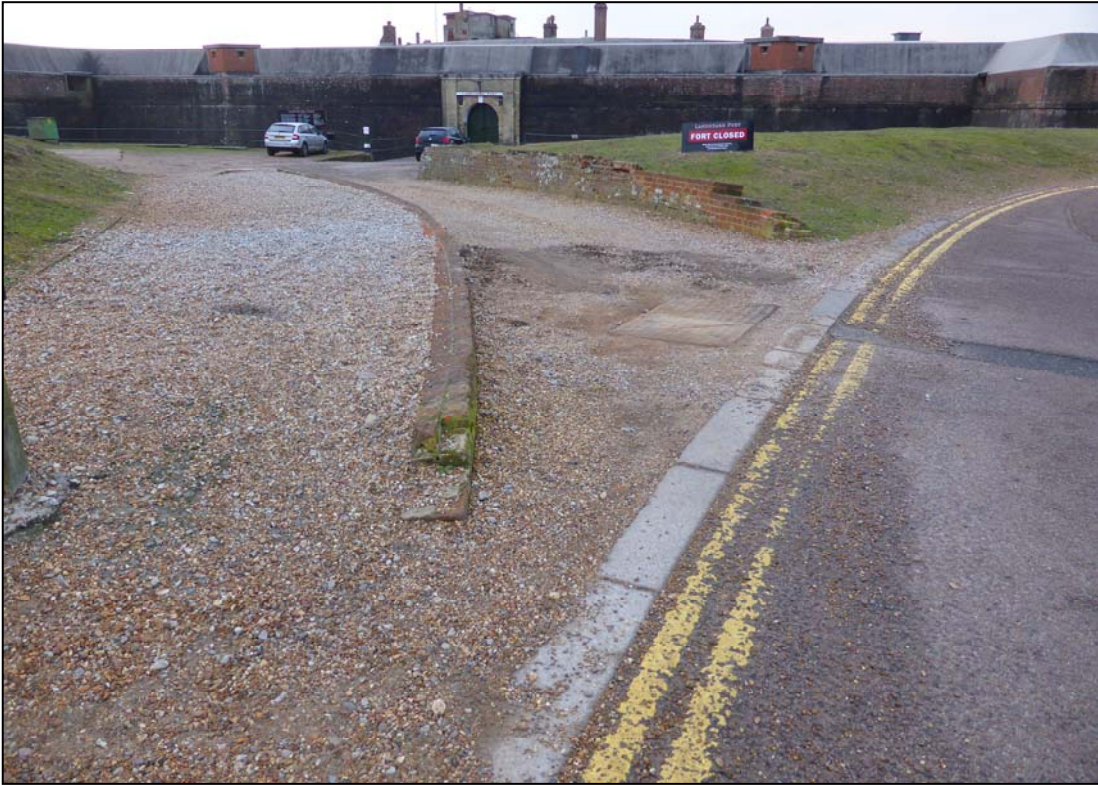
Plate 1. General view of the start point of the service duct showing the fort entrance chicane and the existing manhole, with its cover in place (camera facing SW)

The first feature encountered, **Item 1** (fig. 3), was a low, curving brick wall that formerly retained a now denuded earthwork that formed part of the fort's defences (plate 1). The upper courses of the brickwork have been recently rebuilt to make the feature more prominent as an aid to the interpretation of this defensive feature (a deliberate deviation

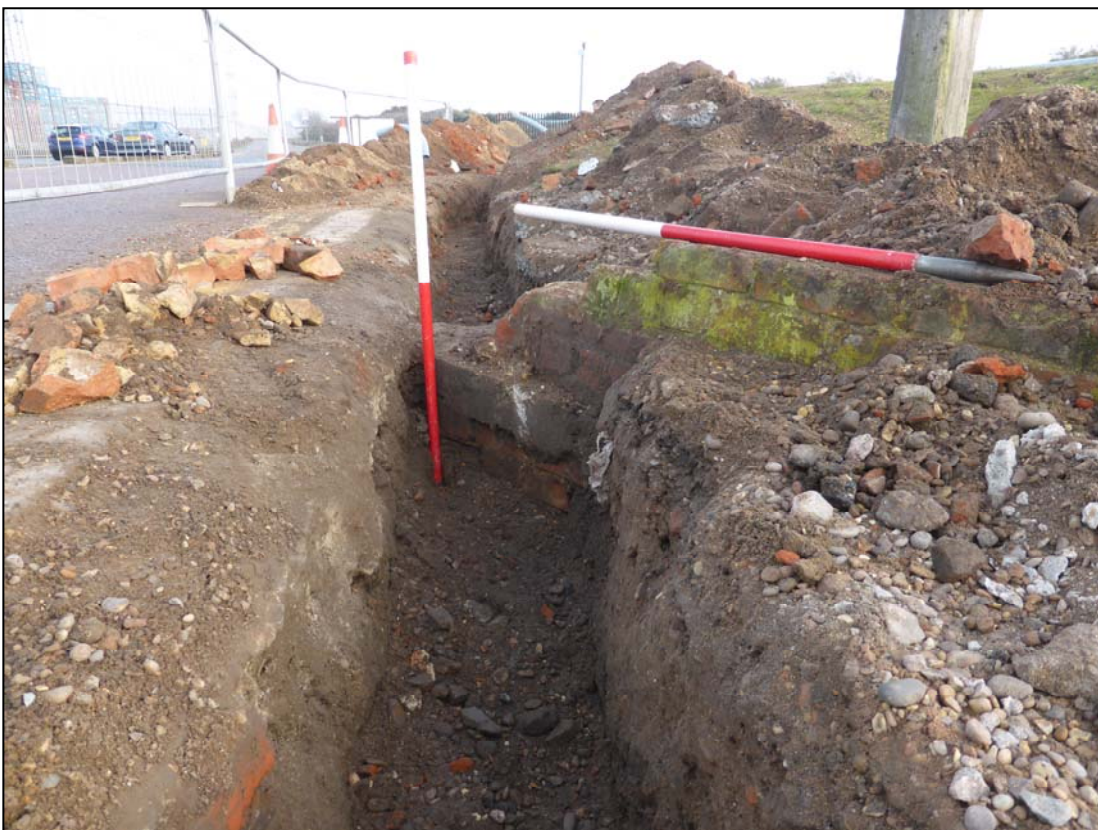
Plate 2. End of chicane wall (Item 1) exposed by excavated trench (camera facing NE)

of the road designed to prevent direct fire on the fort's entrance). The service duct passed under the wall through an existing tunnel. The appearance of the below ground portions the wall suggested it had been previous altered/rebuilt in association with earlier service works (plate 2).

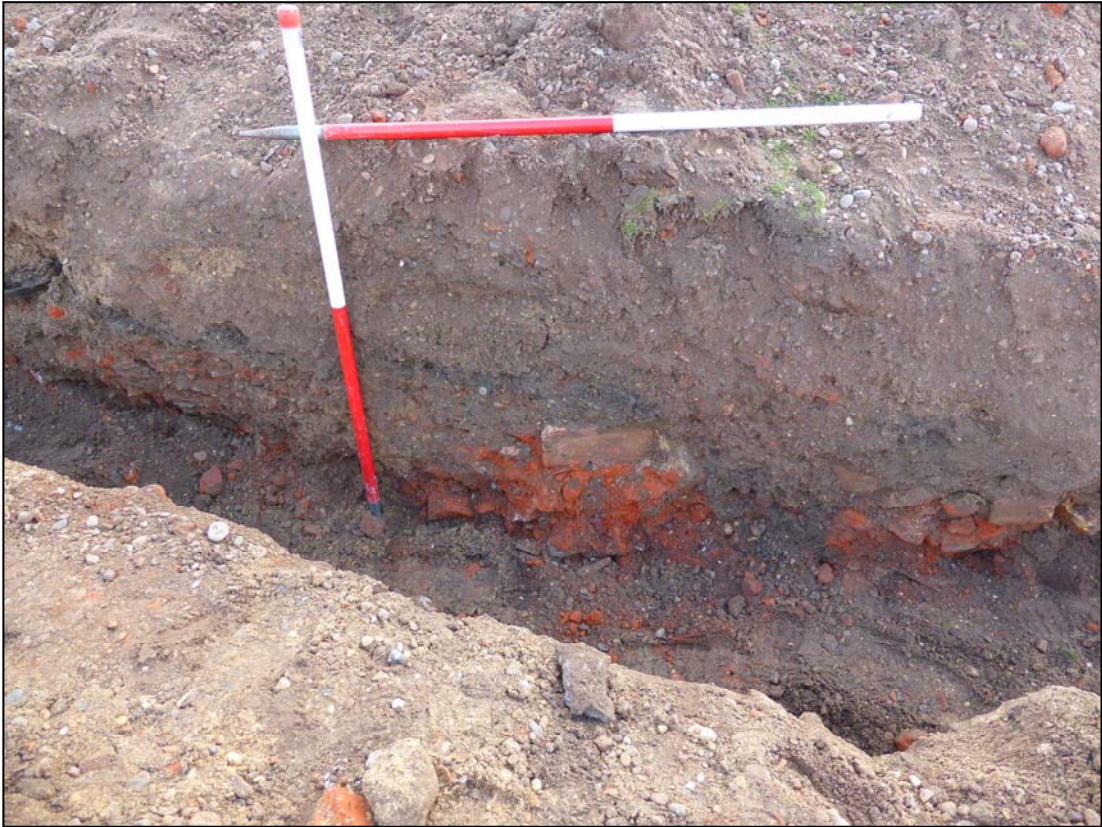
Plate 3. Item 2, as seen in the southern edge of the excavated trench

**Item 2** (fig. 3) comprises a section of possibly *in-situ* brickwork (plate 3) and an area of brick rubble visible on the southeast side of the trench. The brick rubble consisted of broken soft red bricks with little apparent mortar. Associated with this was at a pair of horizontally placed bricks set on edge. This were of a hard pink fabric, measured 220mm by 105mm by 65mm, with a frog but no branding. A 20th century date for this item is suggested by the bricks. *Possibly the remains of a manhole associated with drainage of other services?*

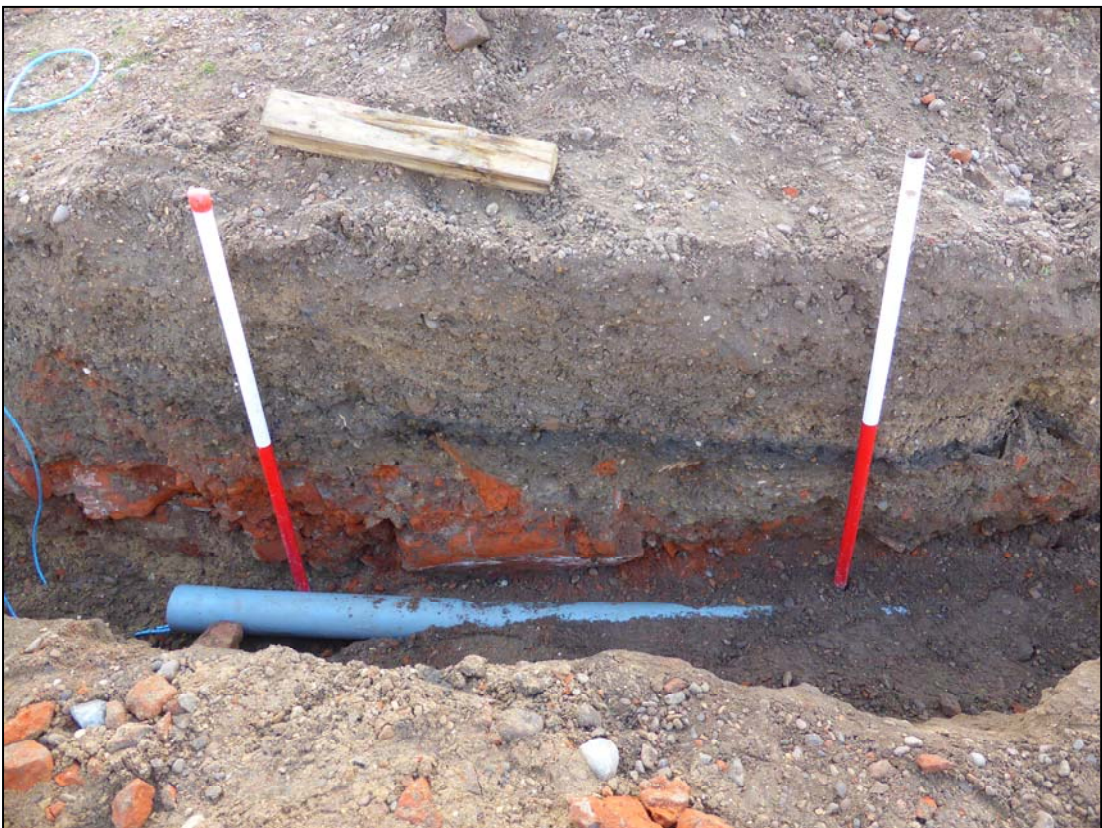
Plate 4. Item 3, as seen in the southern edge of the excavated trench

**Item 3** (fig. 3) was located c.2.5m to the northeast and comprised a further section of *in-situ* brickwork within an area of brick rubble (plates 4 and 5). The bricks consisted of frogless, soft reds (?mm by 105mm by 65mm) cemented with a pale creamy white mortar. *Remains of a wall of unknown purpose that presumably continues to the southeast. The bricks suggest a 19th century date for this structure.*

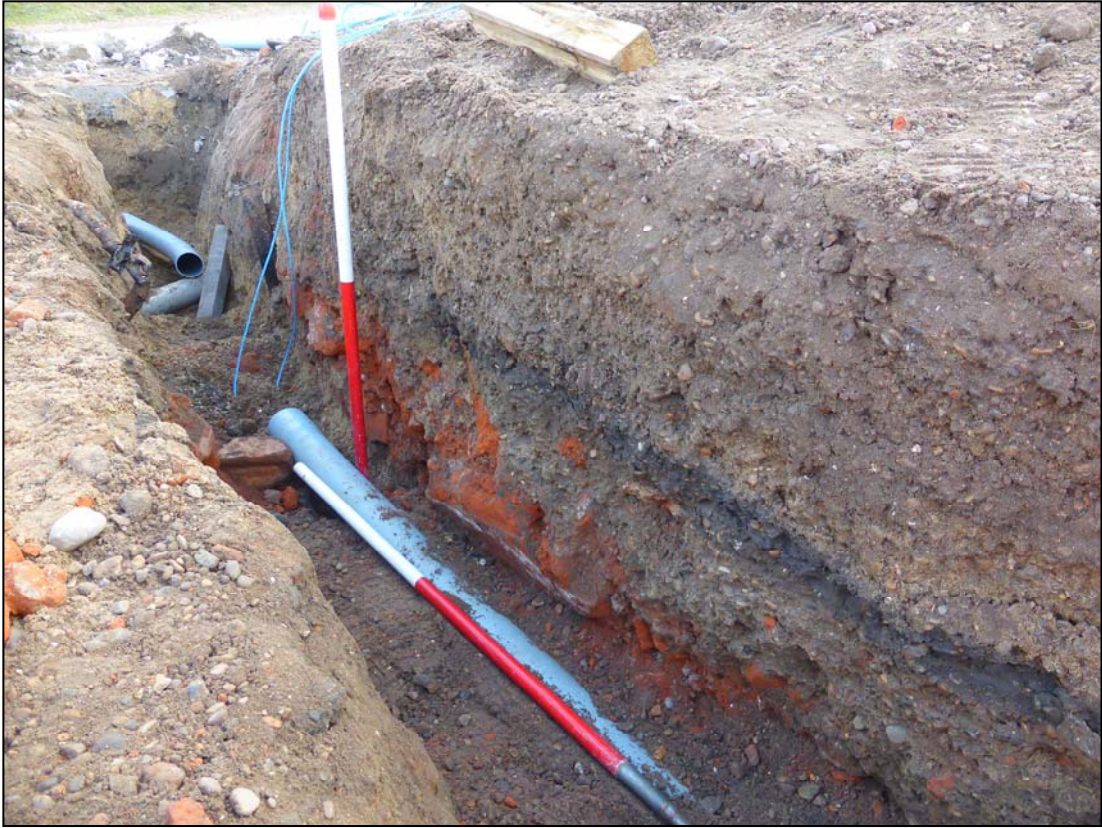
Plate 5. Item 3 (with Item 4 beyond), as seen in the southern edge of the trench. Also a former surface (visible as a dark layer in the exposed section)

The service trench continued to the east, cutting into the toe of a raised, flat-topped earthwork. In this area the trench was cut into made ground deposits of a dirty grey silty sand with occasional small fragments of red brick and tile. A horizontal layer of dark sand and gravel was visible at the base of the earthwork (*a former surface?*), at a level coincidental with, or just the below, the adjacent ground surface (visible in plates 3, 4 and 5). It was not visible beyond a section of brickwork (Item 3).

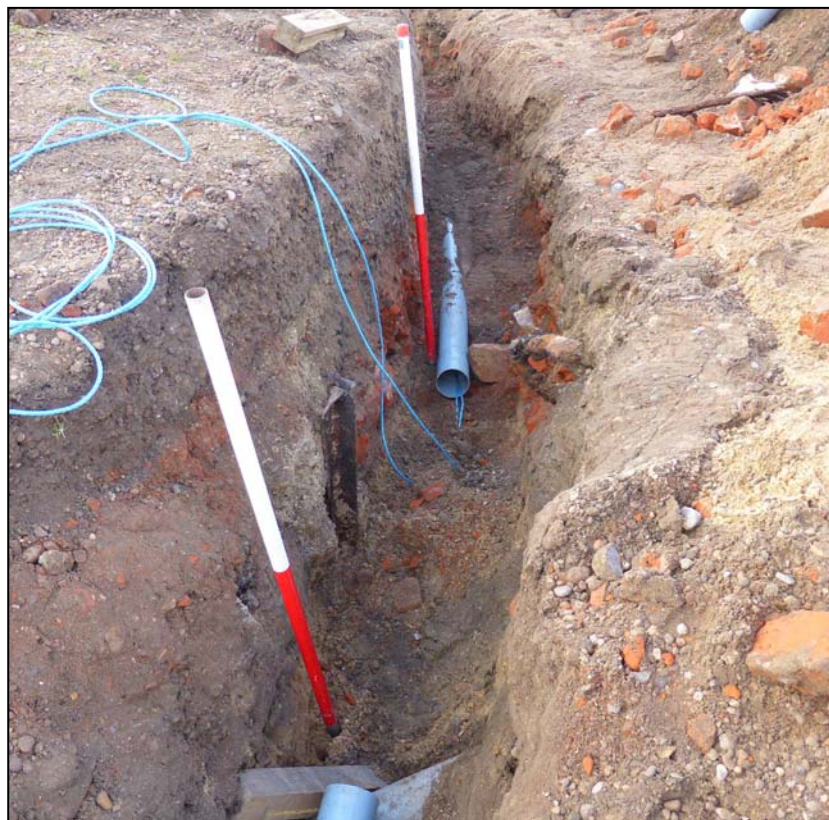
Plate 6. Item 4, with Item 3 beyond (camera facing W)

**Item 4** (fig. 3) A length of angle-iron set upright in concrete (plate 6, also visible in plate 5). Marks the eastern extent of the brick rubble associated with item 3. *Part of a fence or a signpost?*

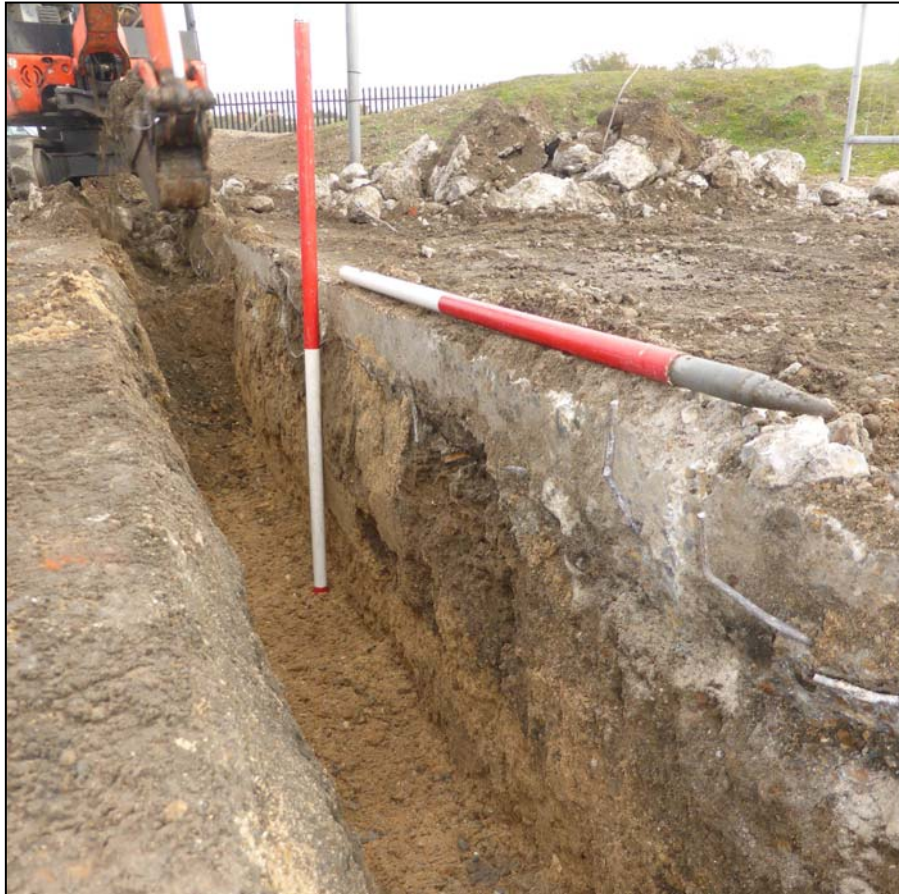
Plate 7. Cross section through concrete haul road (camera facing E)

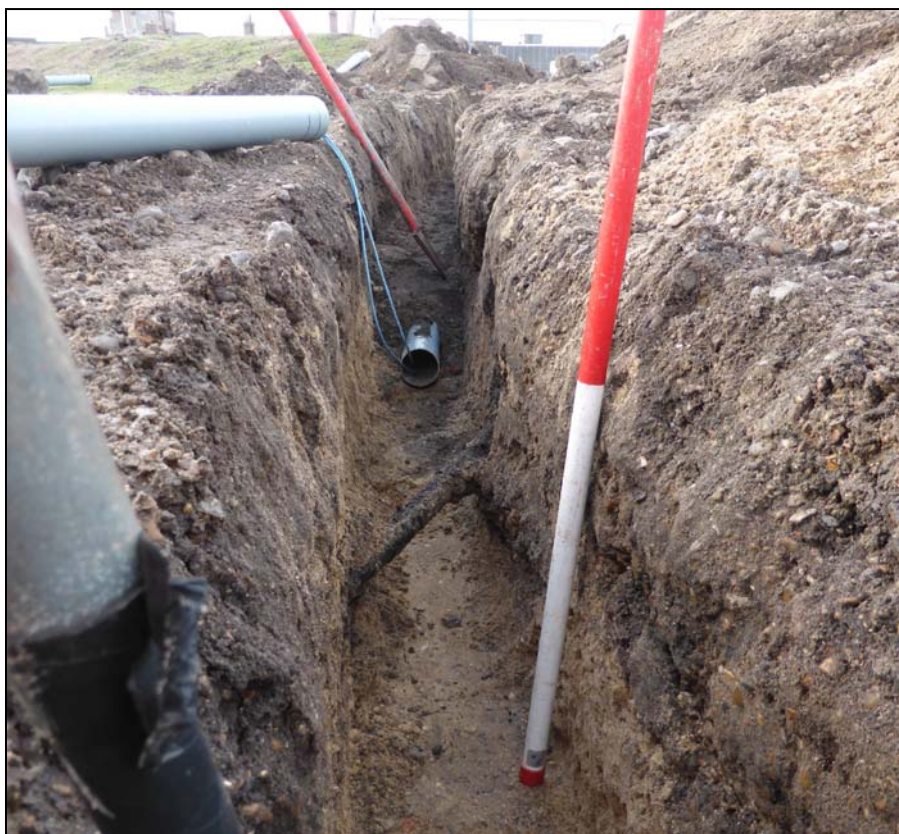
Plate 8. Item 5 (electric cable) running across the excavated trench (camera facing SW)

**Item 5** (fig. 3) A length of redundant ?electric cable ran diagonally across the trench on an east - west alignment (plate 8), towards the back of the Left Battery. *Part of the electrical supply to the Left Battery?*

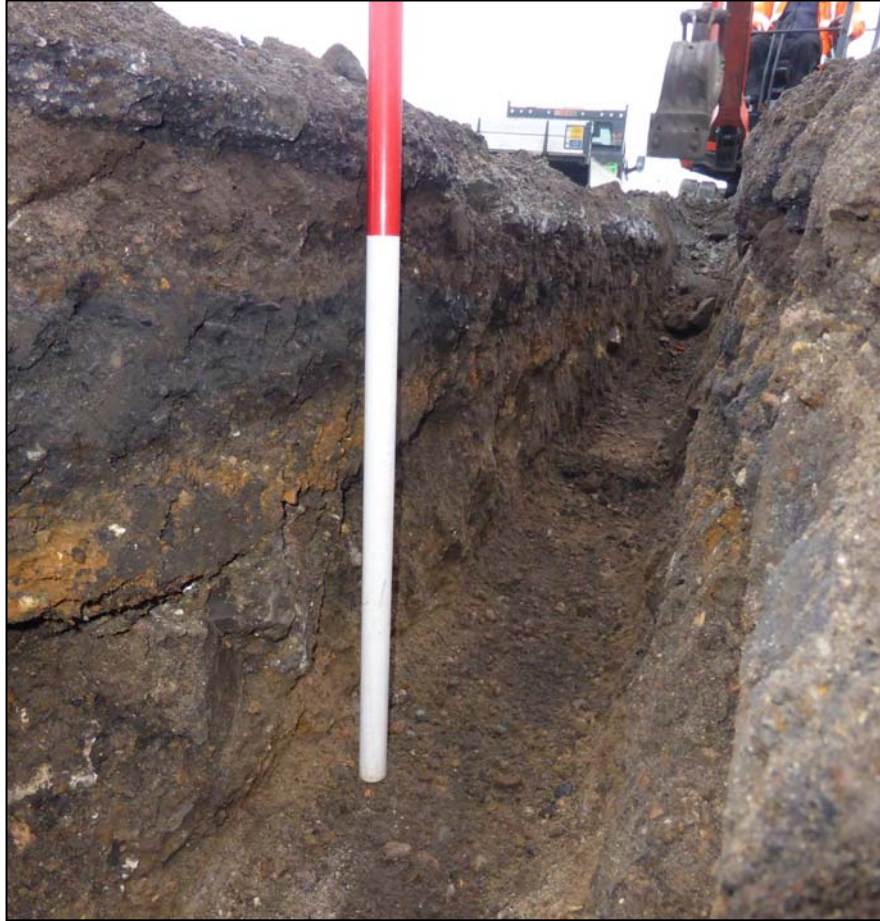
Plate 9. Item 6, make-up of surface visible in NW edge of trench (camera facing NE)

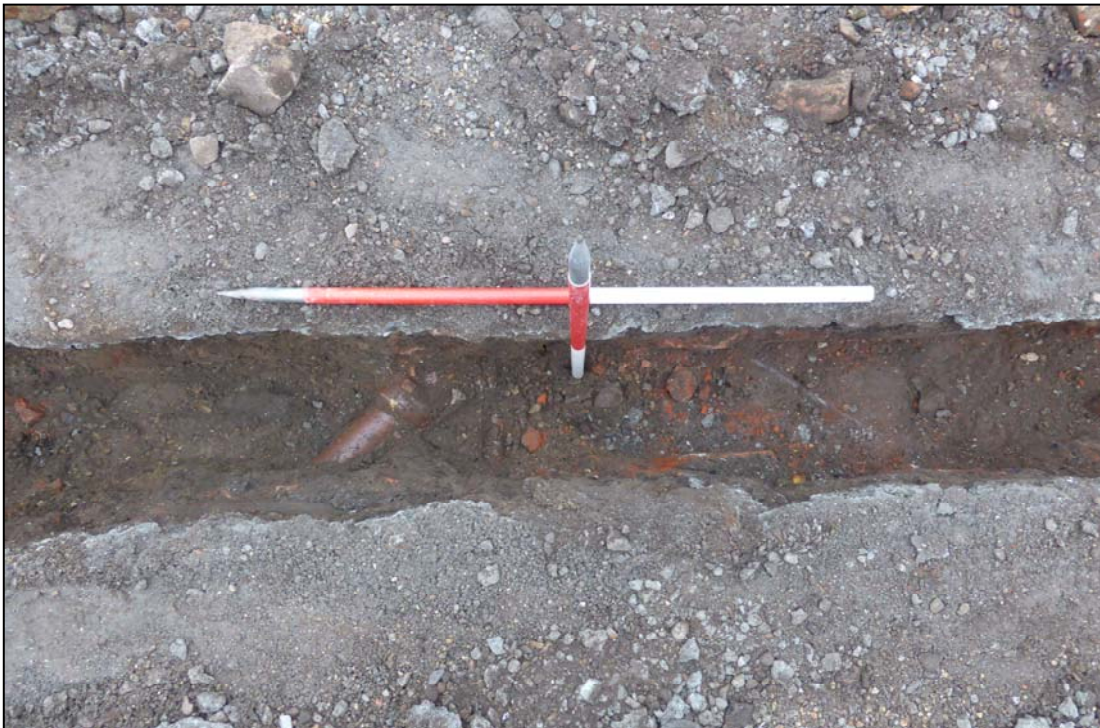
Plate 10. Items 7 (salt-glazed pipe) and 8 (steel pipe) visible on base of trench

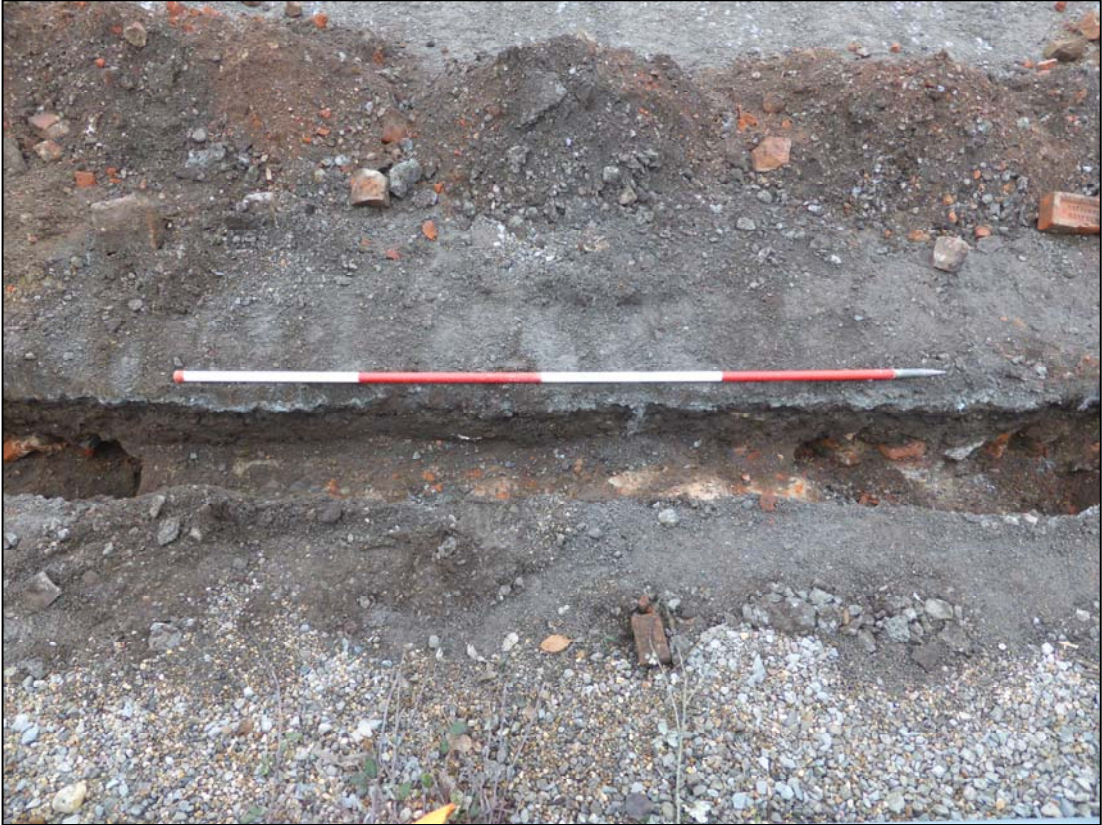
Plate 11. Item 9, area of concrete with brick fragments visible on base of trench

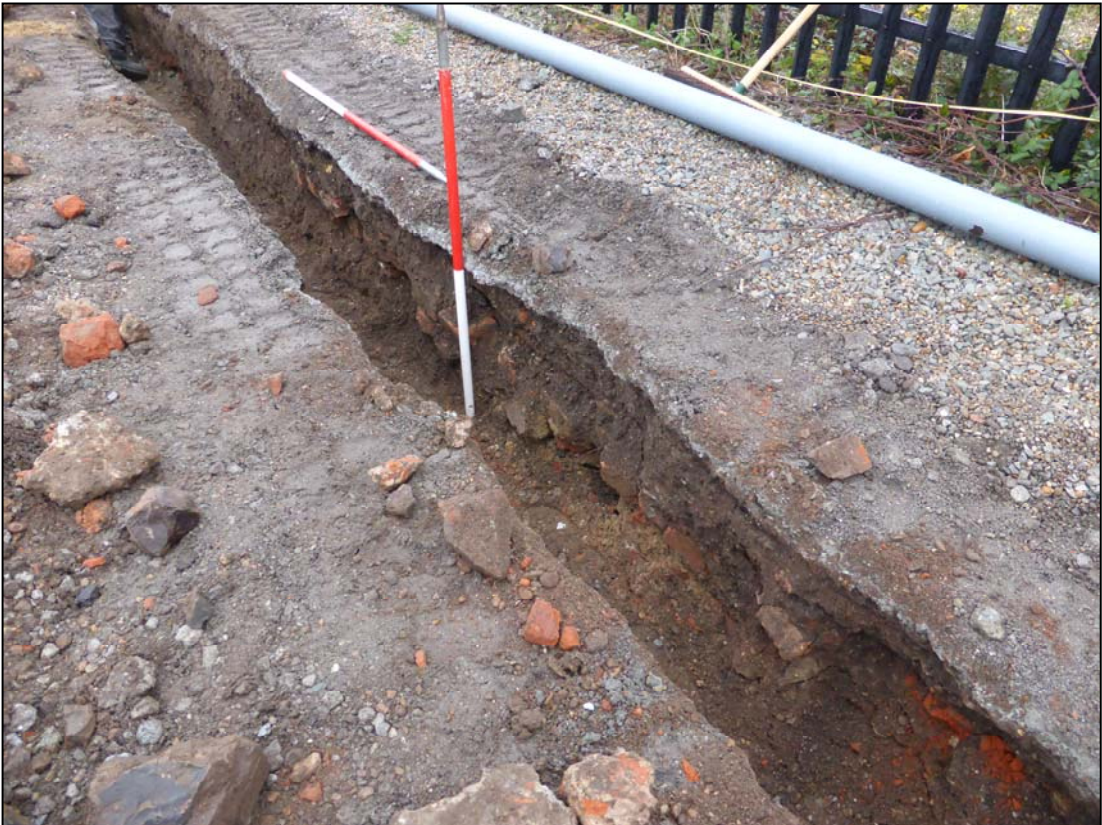
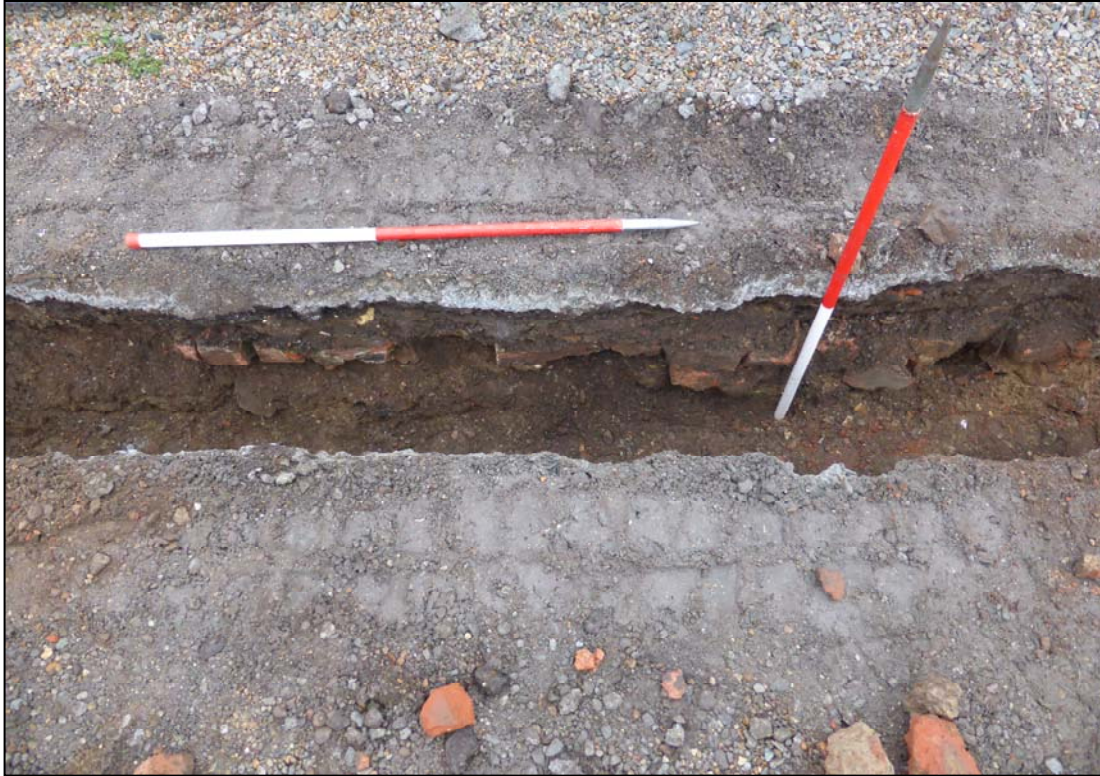
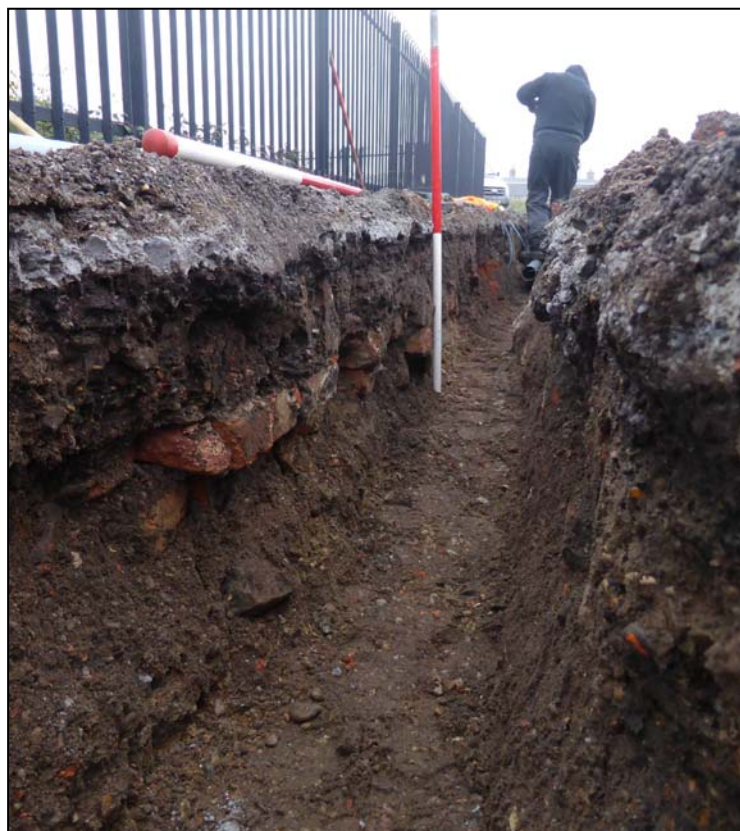
Plate 12. Item 9, after breaking out (camera facing E)

Plate 13. Item 9, after breaking out, showing possible wall or brick surface in SE edge of trench

Plate 14. Item 9, after breaking out, showing possible wall or brick surface in SE edge of trench (camera facing SW)

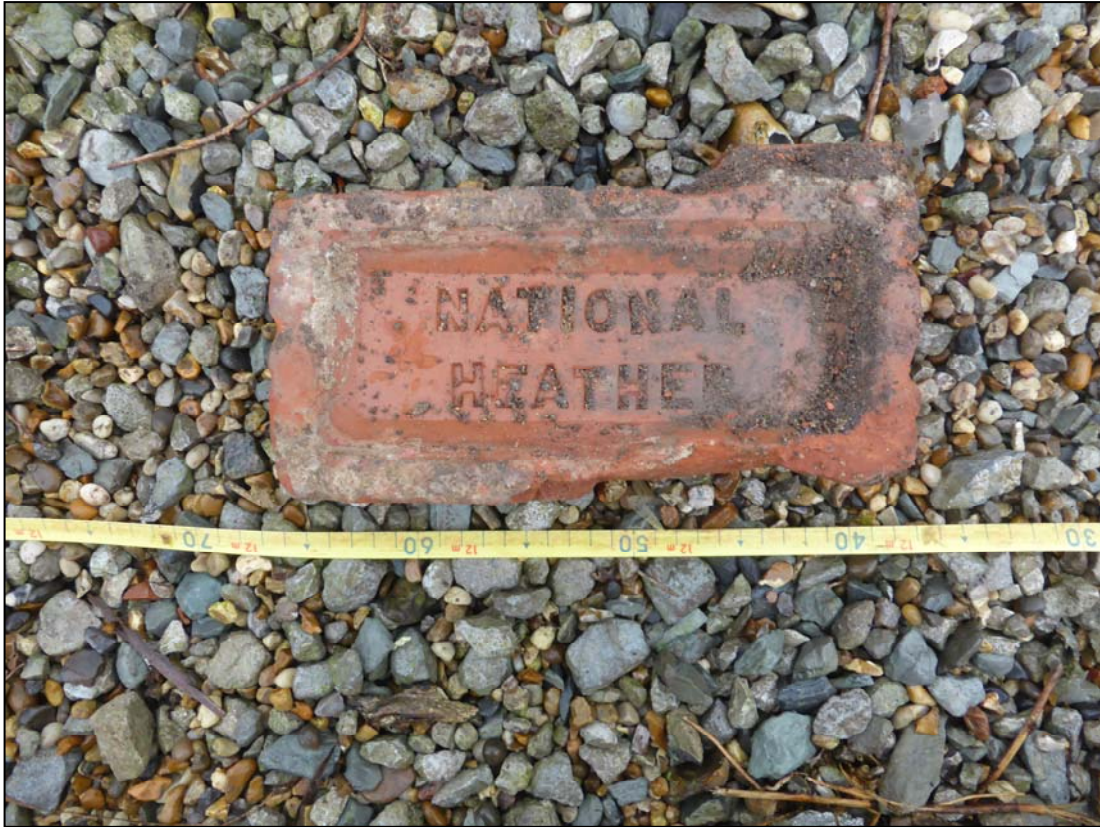
Plate 15. Sample of brick recovered from Item 9

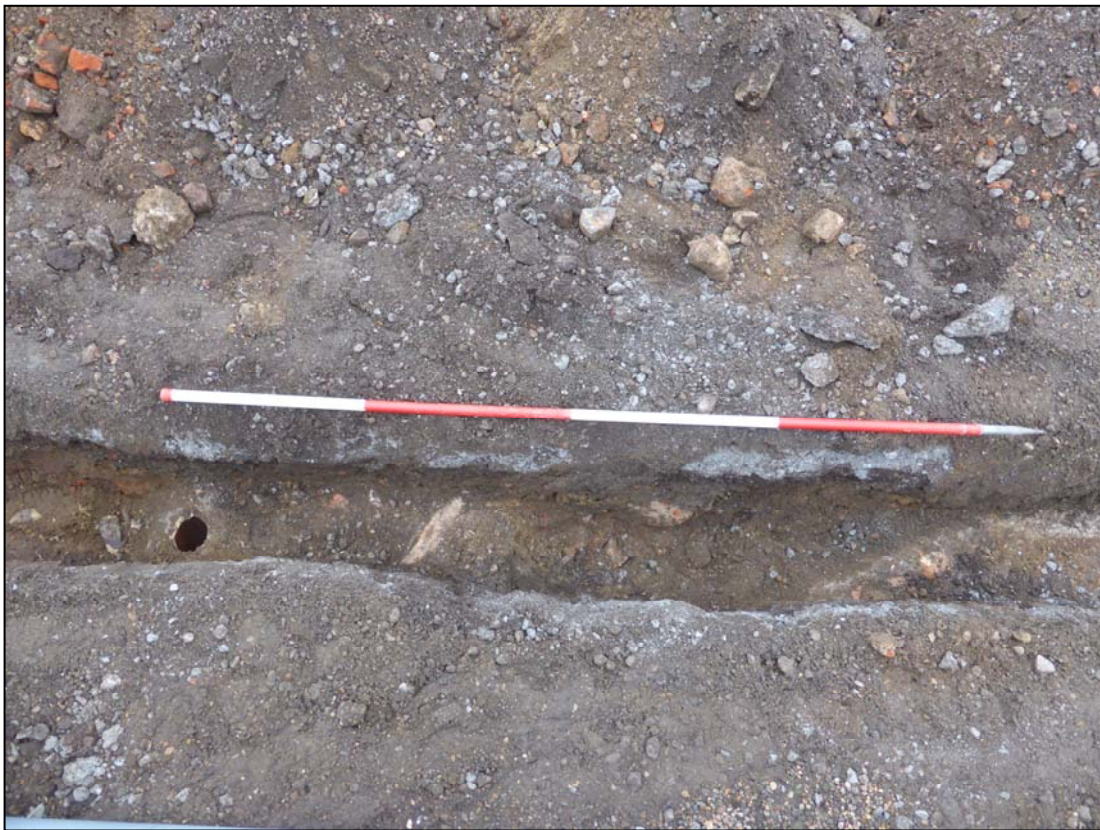
Plate 16. Item 10, salt-glazed drainage pipes set in a concrete mass (NW to top of image)

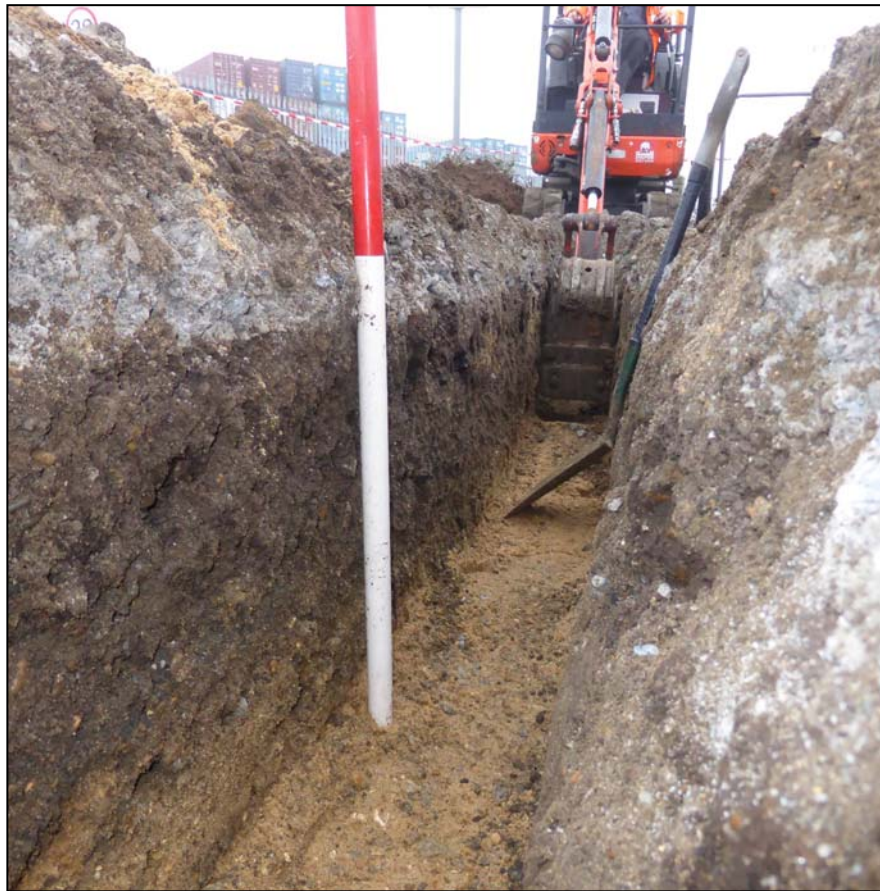
Plate 17. General view of made ground deposits, as seen in section (camera facing N)

It should be noted that for the entire length of the Left Battery the excavated trench was cut through made ground deposits of dark grey-brown silty sand and gravel within which numerous small fragments of brick and tile were noted. This was presumably related to the construction of the battery. The deposit continued beyond the base of the excavated trench although towards the northeast end of the battery a bright yellow sand and gravel was occasional exposed on the base (plate 17). Occasional small pieces of glazed, 19th century or later ceramics were also present along with undiagnostic clay pipe stems. A number of artefacts of possible interest were exposed during the trench excavation. These were photographically recorded before being returned to the trench upon its backfilling. They are as follows:

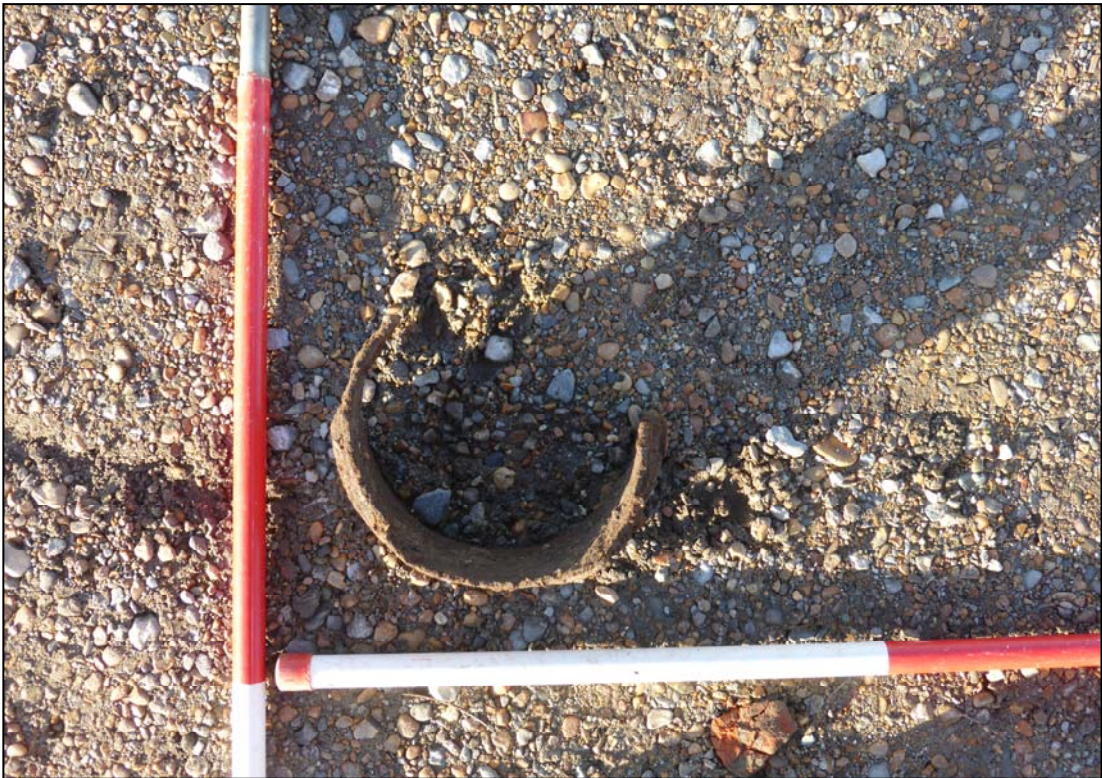
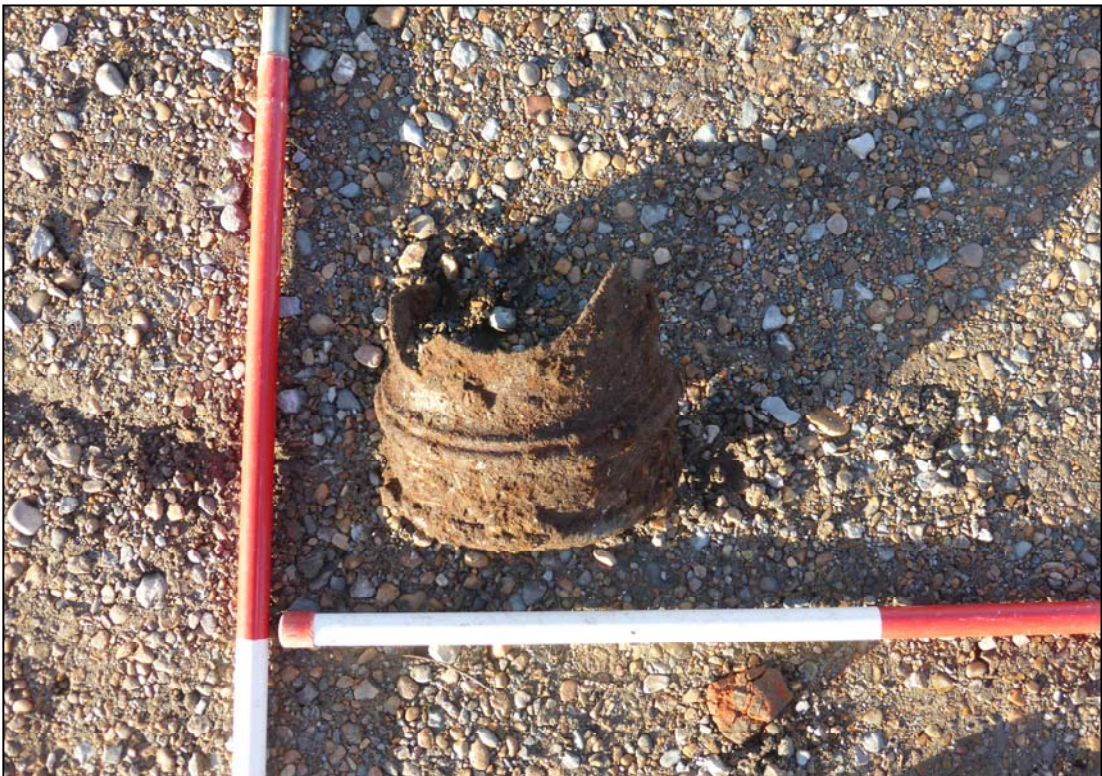
Plate 19. Fragment of cast iron vessel recovered from trench in vicinity of Left Battery

Plate 20. Fragment of cast iron vessel recovered from trench in vicinity of Left Battery, angled to show profile

Fragment of a cast-iron. Presumably part of a circular vessel, possibly a cooking pot or a small stove (plates 19 and 20);

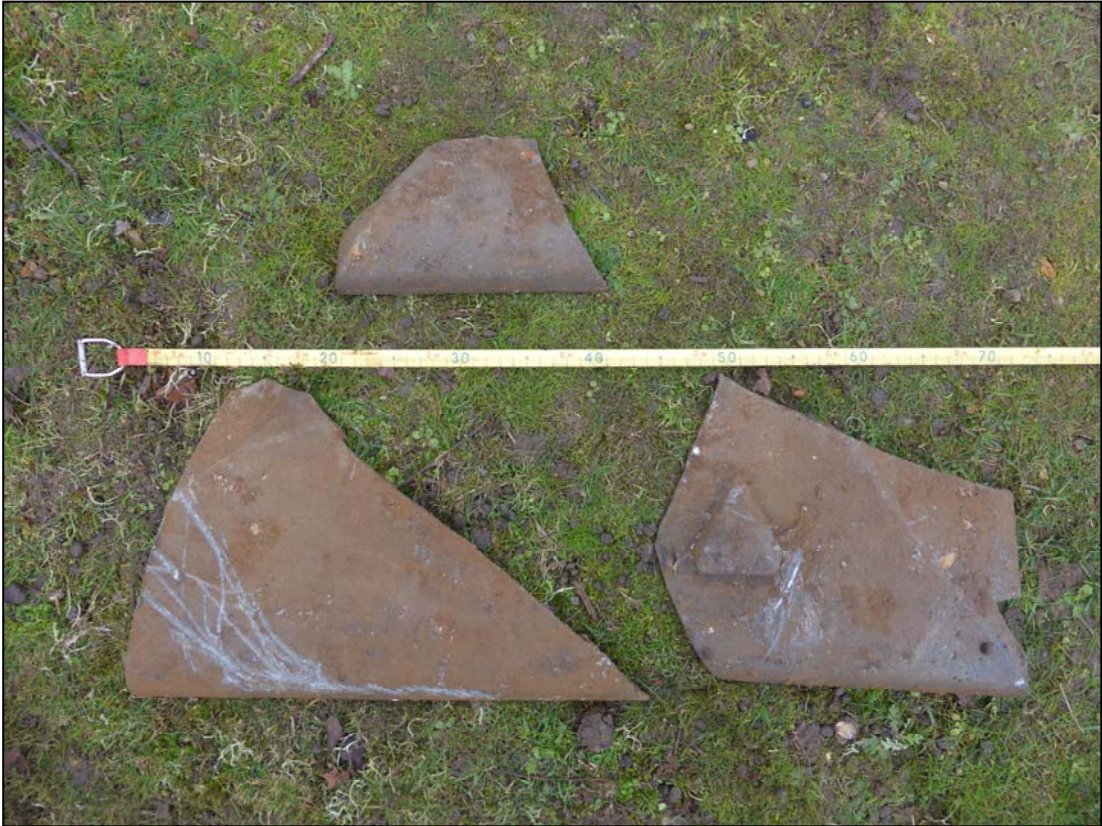
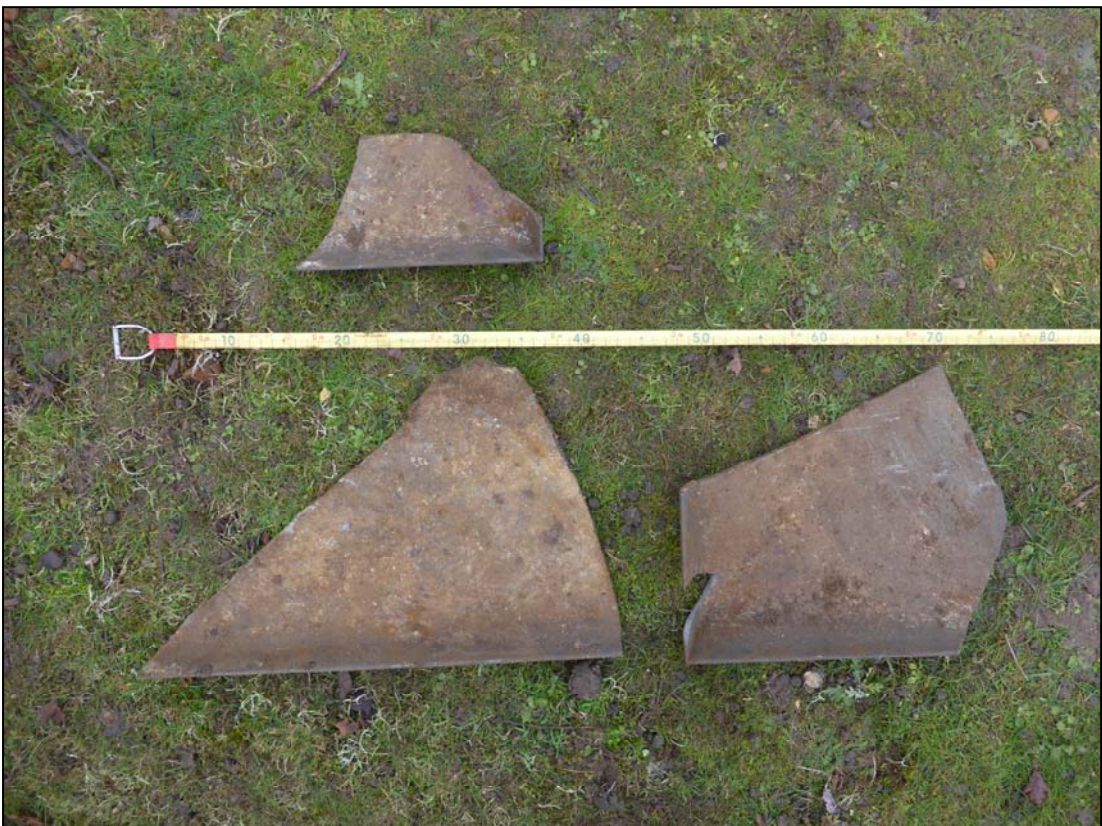
Plate 21. Fragments of steel plate recovered from trench in vicinity of Left Battery

Plate 22. Fragments of steel plate recovered from trench in vicinity of Left Battery showing opposite sides

Sections of steel plate. Clearly broken from a larger item. Presumably some form of cover. A triangular shaped bracket was visible attached to one fragment (plates 21 and 22).

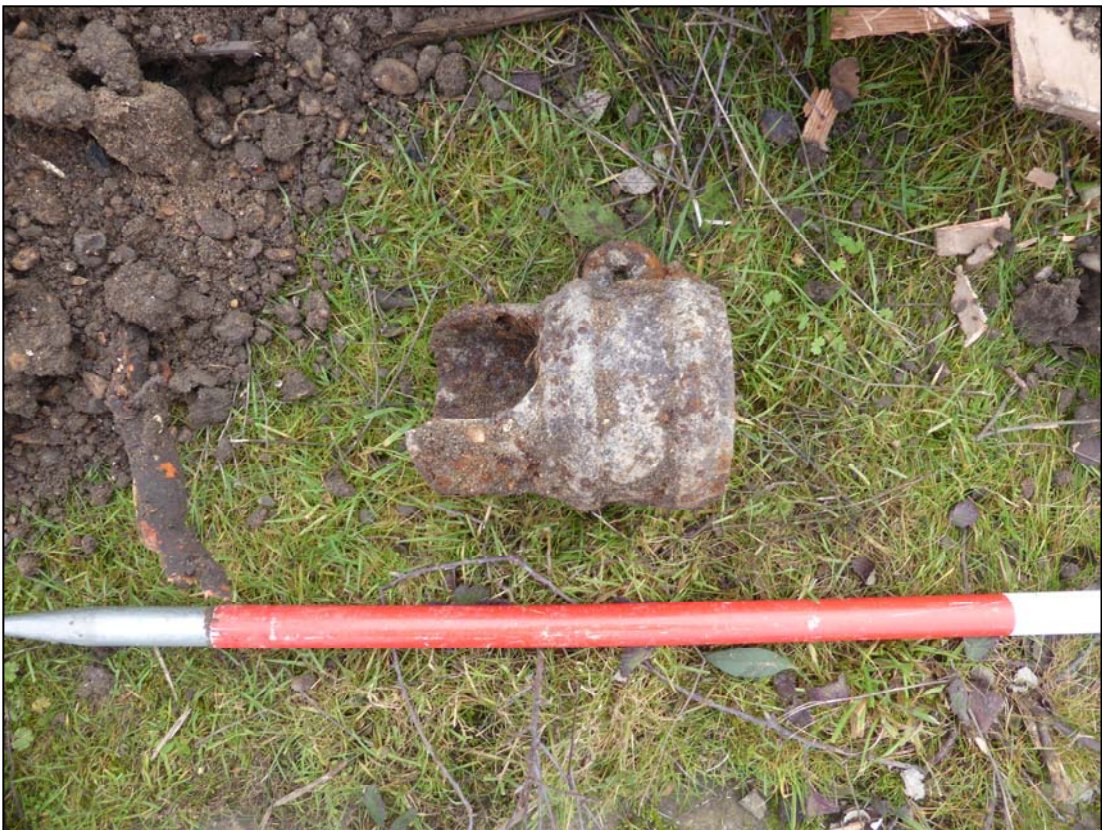
Plate 26. Fragment of cast iron drain pipe recovered from trench in vicinity of Left Battery

Piece of cast iron drain pipe (plate 26).
