# Landguard Point Radar Tower Connection Felixstowe, Suffolk

**FEX 337**

Archaeological Monitoring Report  
SACIC Report No. 2017/004  
Author: M. Sommers  
© SACIC

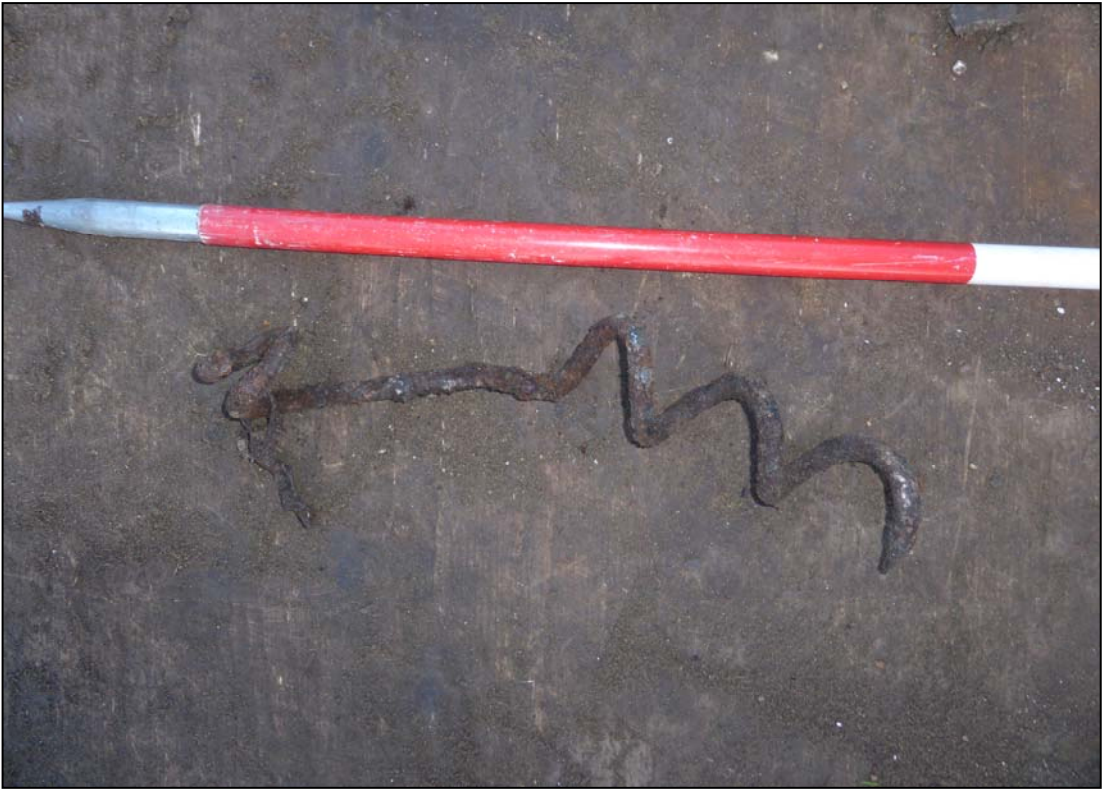
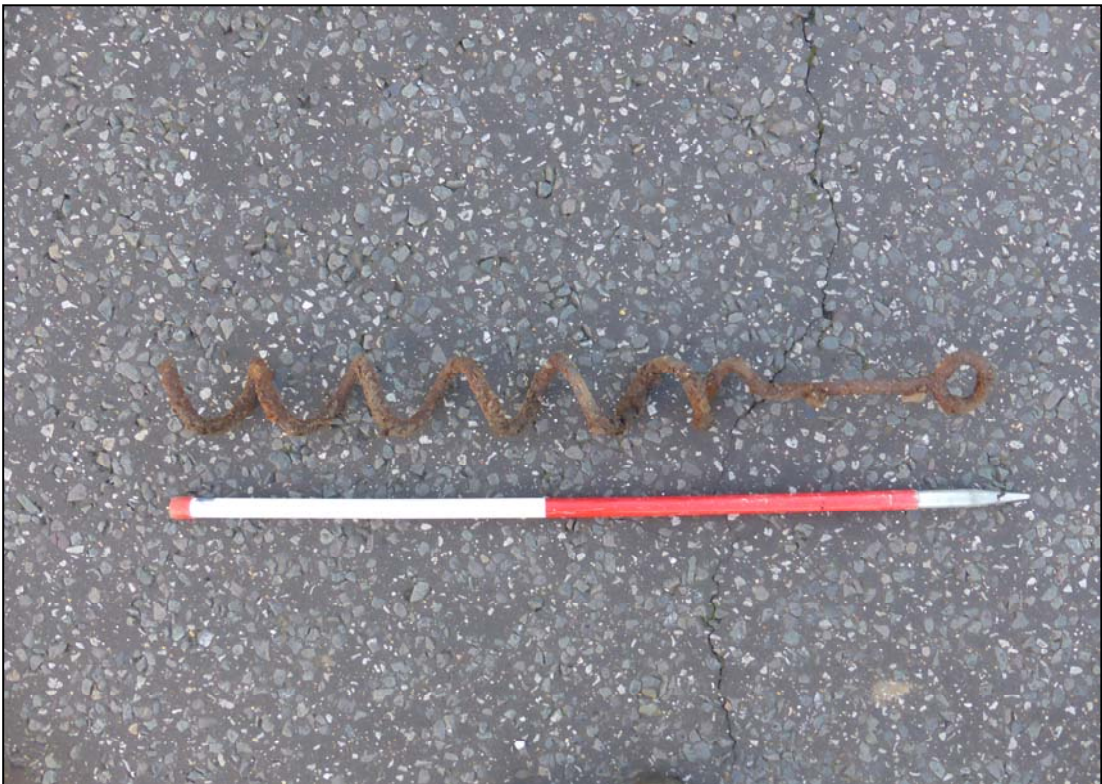
Plate 27. Fencing or ?tethering post recovered from trench in vicinity of Left Battery

Plate 28. Fencing or ?tethering post recovered from trench in vicinity of Left Battery

Two coiled steel rods (similar to a corkscrew), with a point at one end and a straight shank ending in a loop at opposite end (plates 27 and 28). Of differing lengths (c. 0.5m and 1.15m). The shorter rod had a length of wire attached to the loop. Possibly related to fencing or are more likely tethers for large canvas tents.

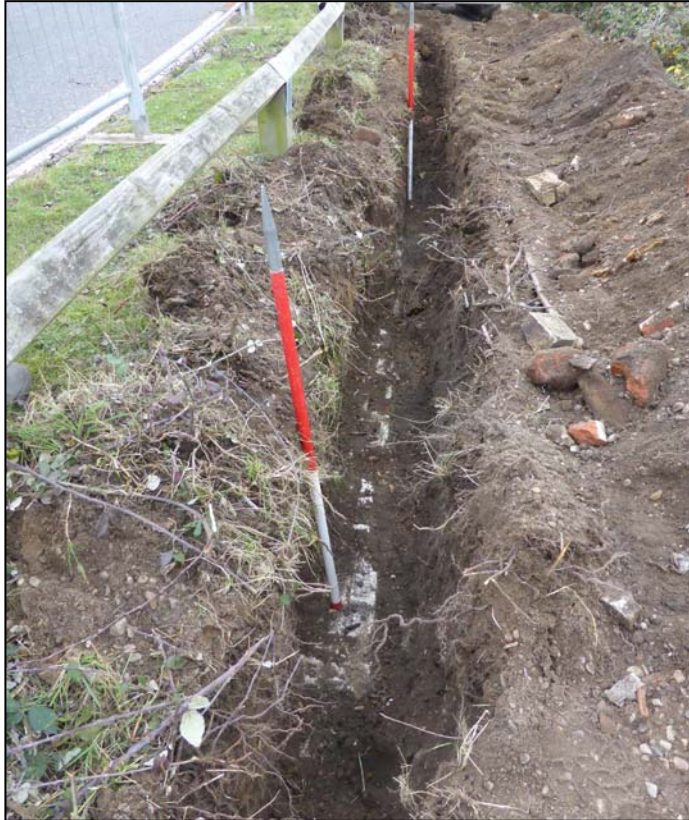
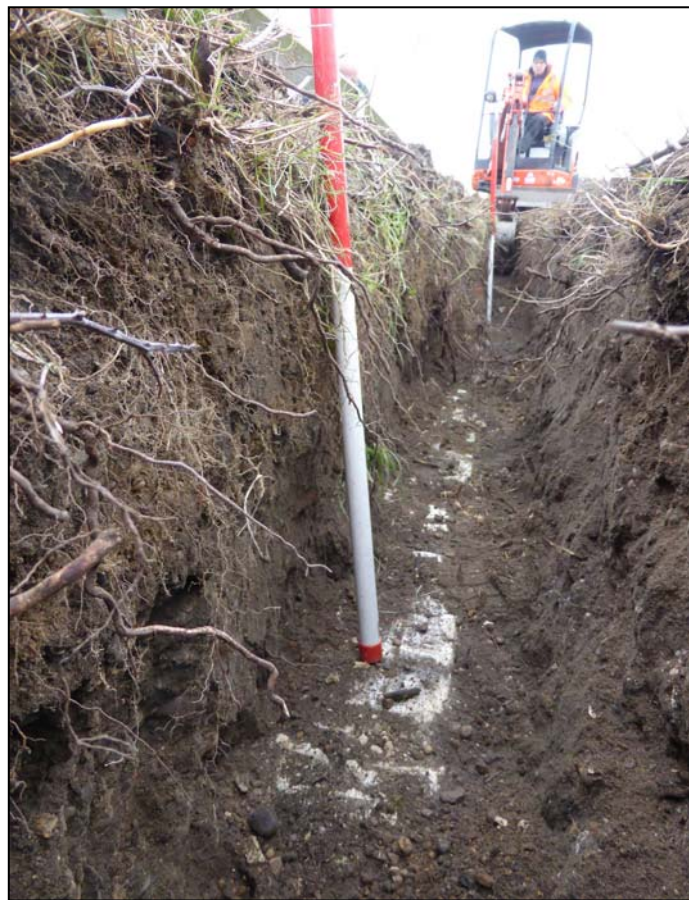
Plate 29. Item 11, length of brick wall running along base of trench (camera facing NE)

Plate 30. Item 11, length of brick wall running along base of trench (camera facing NE)

**Item 11** (fig. 5) A length of brick wall, aligned roughly southwest - northeast, running obliquely along the base of the trench at a depth of 0.65m (plates 29 and 30) beneath an overburden of grey brown sand with occasional lens of yellow sand and gravel. The wall was least two courses wide with a formed corner at the southwestern end. It continued for approximately 6m before running beyond the northwest edge of the trench. The bricks were white in colour and measured 220mm by 105mm by 65mm. All were frogged with unbranded and branded examples present. The marked brands were 'PHORPRES' and 'BURWELL' (plate 31). A twisted steel brick tie was also noted. Within the spoil a number of fragments of asbestos sheeting was noted, probably the remnants of a roof covering. Many of these fragments had a pale green paint adhering to one side (plate 32); probably an attempt to camouflage the structure. *This wall is coincidental with a large building marked on mid and late 20th century Ordnance Survey maps and it is undoubtedly part of the rear, southeast, wall of the building.*

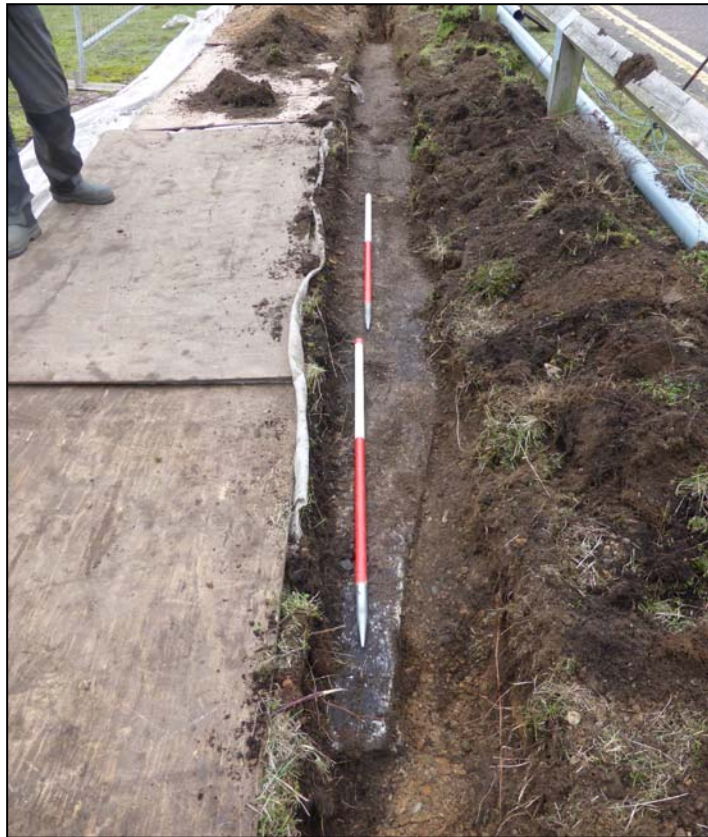
Plate 33. Item 12, exposed section of concrete roadway (camera facing SW)

**Item 12** (fig. 6) Slab of concrete, 6.3m in length and c. 0.23m thick, situated just below the turf (plates 33 and 34). Smooth, finished upper surface, very similar to the surface of earlier fort road present to the east. *Section of earlier roadway, part of a triangular junction as marked on mid and late 20th century Ordnance Survey maps.*

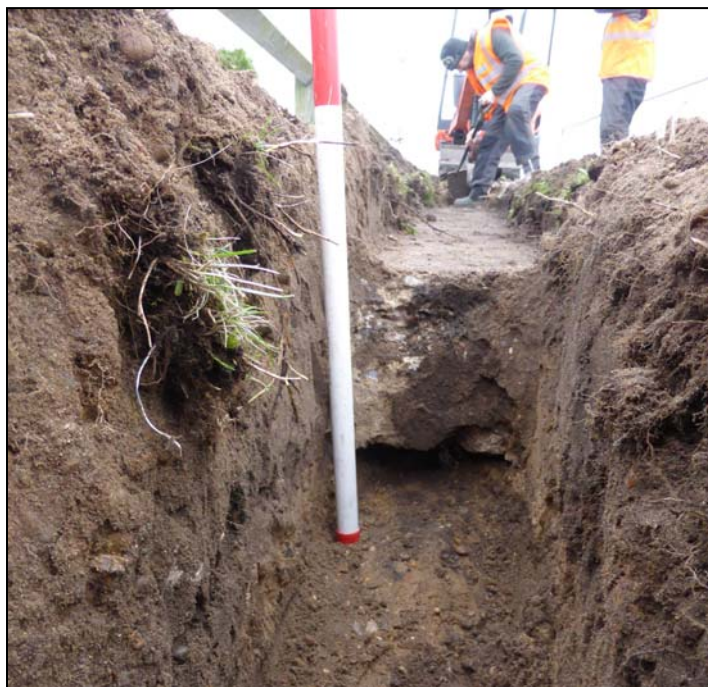
Plate 34. Item 12, cross section of concrete roadway (camera facing NE)

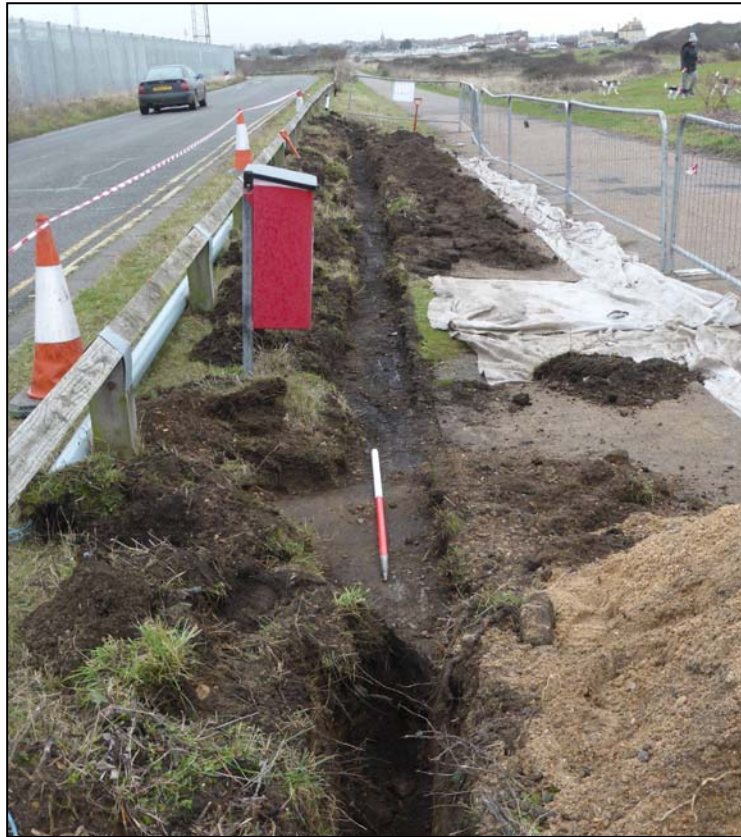
Plate 35. Item 13, concrete slab forming a lay-by adjacent earlier fort road (camera facing NE)

**Item 13** (fig. 7) Slab of concrete, 19.7m in length and c. 0.2m thick, situated just below the turf (plates 35). Cast in five separate slabs resulting in four joints filled with tar. Smooth, finished upper surface, very similar to the surface of earlier fort road present to the east. *Section of earlier roadway, appears as a passing layby on mid and late 20th century Ordnance Survey maps.*
