**Farm Buildings at
Pear Tree Farm,
Fressingfield, Suffolk
FSF 093**

Heritage Asset Assessment

Farm Buildings at Pear Tree Farm, Laxfield Road, Fressingfield, Suffolk

Historic Building Record

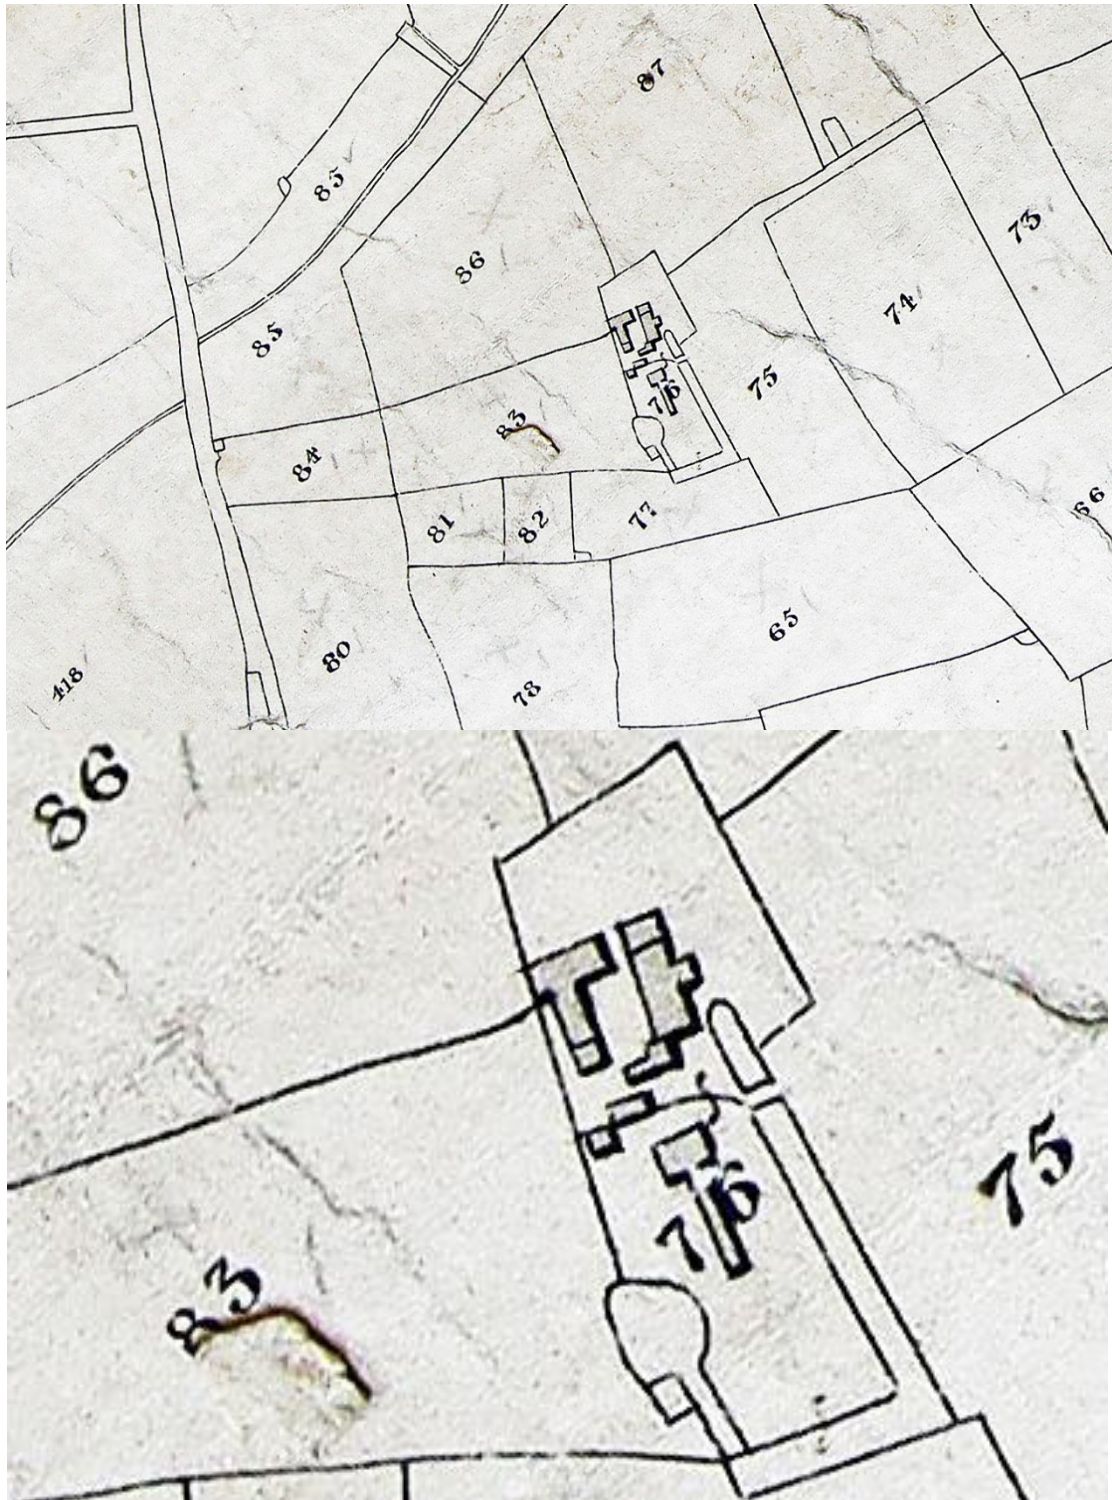
Figure 2. The farm on the Fressingfield tithe map of 1838, with detail below (Suffolk Record Office). The house to the south is shown much as it remains today but the western arm of the moat appears to extend behind the T-shaped timber-framed barn (structure 1 in figure 6) which is shown with its porch slightly to the left of centre and lacks its present brick extensions (2 and 3) – although a smaller shed adjoins its northern gable. The large T-shaped building to the west resembles the surviving granary and shelter-sheds (5, 6 and 7) but must represent their predecessors on the same approximate sites. Plot 76 was named in the apportionment only as ‘homestead’, with ‘front meadow’ on the west (83) and ‘backhouse meadow’ to the east (75). Plots 77, 86 and 87 were ‘colt shed pigstie’, ‘stack yard’ and ‘cart shed field’ respectively.

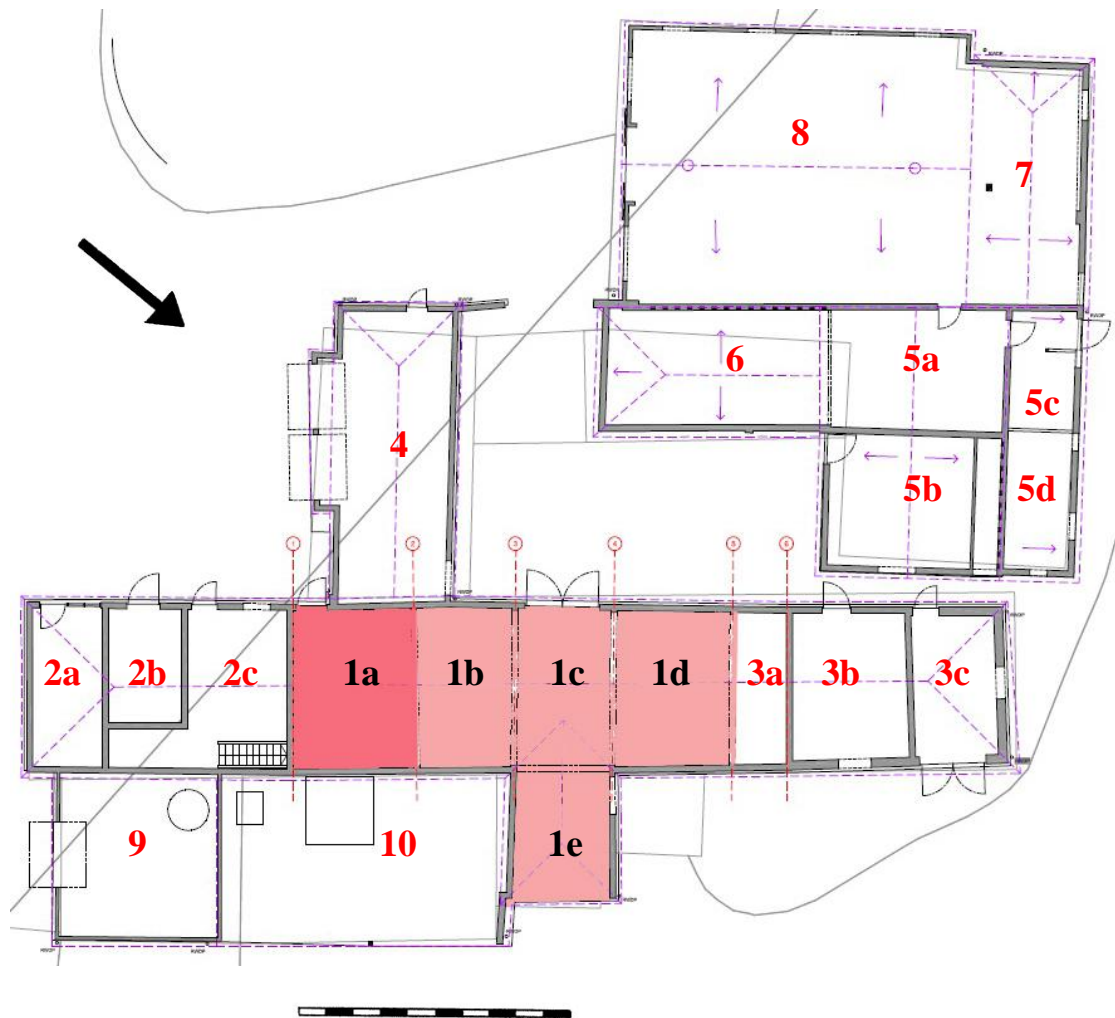
Figure 6

Ground plan supplied by Durrants Building Consultancy adapted to identify each historic structure and compartment of the largely pantiled farm complex for ease of reference in the text and photographic record. Note the change of orientation from the Ordnance Surveys, with north towards the bottom right-hand corner and the house to the left (not shown). The historic timber-framed barn is shaded red with its originally floored stable bay in darker red. Scale in metres.

1. A timber-framed barn of *circa* 1600 in four bays including a former separate stable with a hay loft in the south-eastern bay (1a) and a rare rear porch (1e) that contained a loft and was probably designed as a granary. In the 19th century the barn was re-roofed in conjunction with two brick extensions (2 and 3).
2. A mid-19th century brick coach house (2a) including a stable (2b), a probable tack room (2c) and a chaff box with a first-floor granary.
3. A mid-19th century brick loose box (3b) and cart shed (3c) with a first-floor hay loft accessible from the barn and incorporating a narrow timber-framed extension to the barn (3a).

4. A mid-19th century timber-framed and weatherboarded shelter-shed with a small enclosed brick shed adjoining its south-western gable.
5. A mid-19th century timber-framed and weatherboarded structure containing two loose boxes on its ground floor with corresponding granaries above (5a and 5b). A slightly later brick lean-to on the north-west also operated as a pair of grain stores with a suspended floor and ventilation arches beneath (5c and 5d).

6. A slate-roofed timber-framed and weatherboarded shelter-shed formerly open-sided to the north-east.
7. A brick shelter-shed open to the south-east.
8. A 20th century covered cattle yard with cement-block walls and a corrugated asbestos roof.

9. A 20th century cement-block lean-to with a roof of corrugated asbestos.
10. A mid-19th century lean-to cart or implement lodge now with a corrugated iron roof and protecting 19th century external render to the adjoining barn and porch.

The farm buildings at Pear Tree Farm form a sophisticated complex as illustrated in figure 6 that has altered little since the 1880s. Although it incorporates a much earlier threshing barn this arrangement is typical of the yard-based system of mixed animal husbandry known today as Victorian High Farming. Local farmsteads of the early-19th century normally contained only a barn and stable with perhaps a cart lodge and granary as the high grain prices of the Napoleonic wars stimulated intensive cereal production, but increasing numbers of cattle were introduced as prices fell and new dairy markets were opened up by the railways. Complete Victorian complexes of this kind are now rare in East Anglia, and each structure is described separately below (excepting only the 20th century buildings, 8 and 9, which are not of historic significance and are omitted). The text is intended to be read in conjunction with the descriptive captions to illustrations 1-18 of Appendix 2 (A2. 1-18).

The mid-19th century red-brick structure added to the south-east of the barn extends to 10 m (33 ft) in length and its hipped roof of double butt-purlins with a ridge-board is integral to that of the barn. The lower storey is divided into three original compartments as shown in figure 6 (A2. 13) with a coach house for vehicles to the right (2a, now converted into a farm office), a small central stable (2b) and a compartment on the left that probably operated as a tack room or feed store (2c). The upper storey retains the boarded lateral partitions of ostensibly original grain bins (A2. 14) and is now entered by a secondary internal stair that cuts the ceiling joists. A blocked aperture for its original loading hatch can be seen in the brickwork immediately above the stable door (2b) and coincides with a reinforced area of ceiling immediately inside. The stable is largely unaltered and preserves a wooden manger adjoining a boarded rear wall with hatches on both sides that opened into a narrow chaff box. Its rendered internal walls are still painted with original red ochre. The area to the left (2c) is currently undivided but its walls bear the scars of missing boarded partitions and it was initially entered by two arched doorways, one of which has been converted into a window. The back wall of this space also contains a door, and an original window formerly with horizontal wooden bars lights the loft. The present loft hatches in the gable and front wall are later insertions that cut the Flemish Bond brickwork.

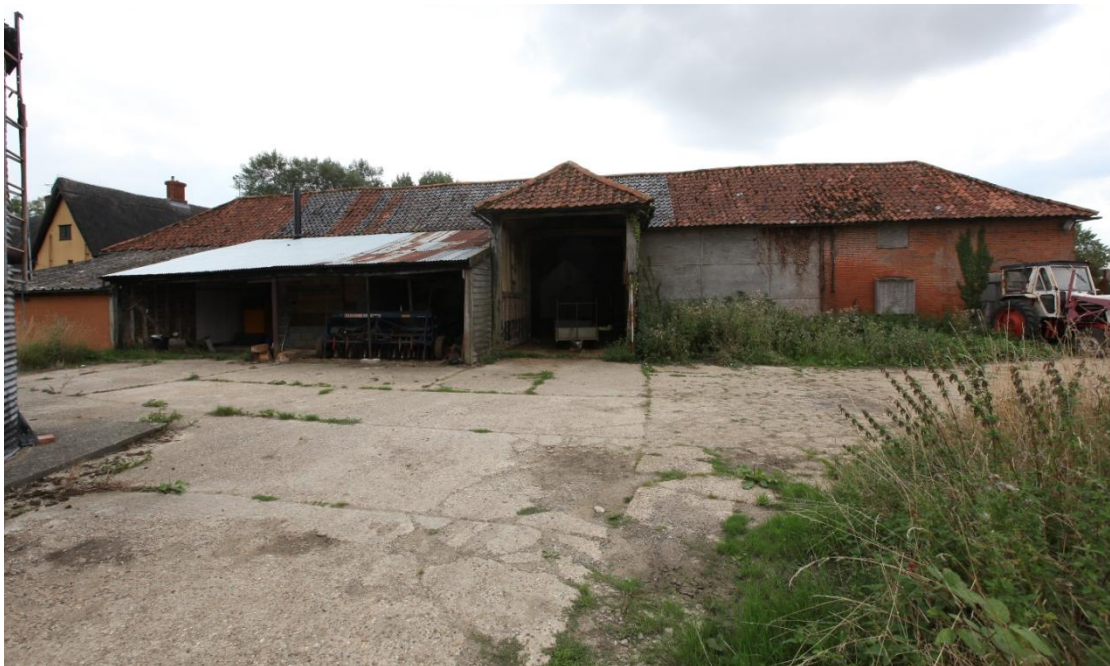
Illus. 2. The farm buildings from the north-east showing the long pantiled and hipped range of the mid-19th century which encompasses contemporary brick extensions at both ends (2 and 3) and a four-bay barn of *circa* 1600 in the centre (1). The hipped porch (1e) projects from the back of the latter's threshing floor and is an exceptional and apparently *in situ* structure of just 3.8 m (12.5 ft) in width that initially contained a loft and was lit by three windows with pegged mullions.

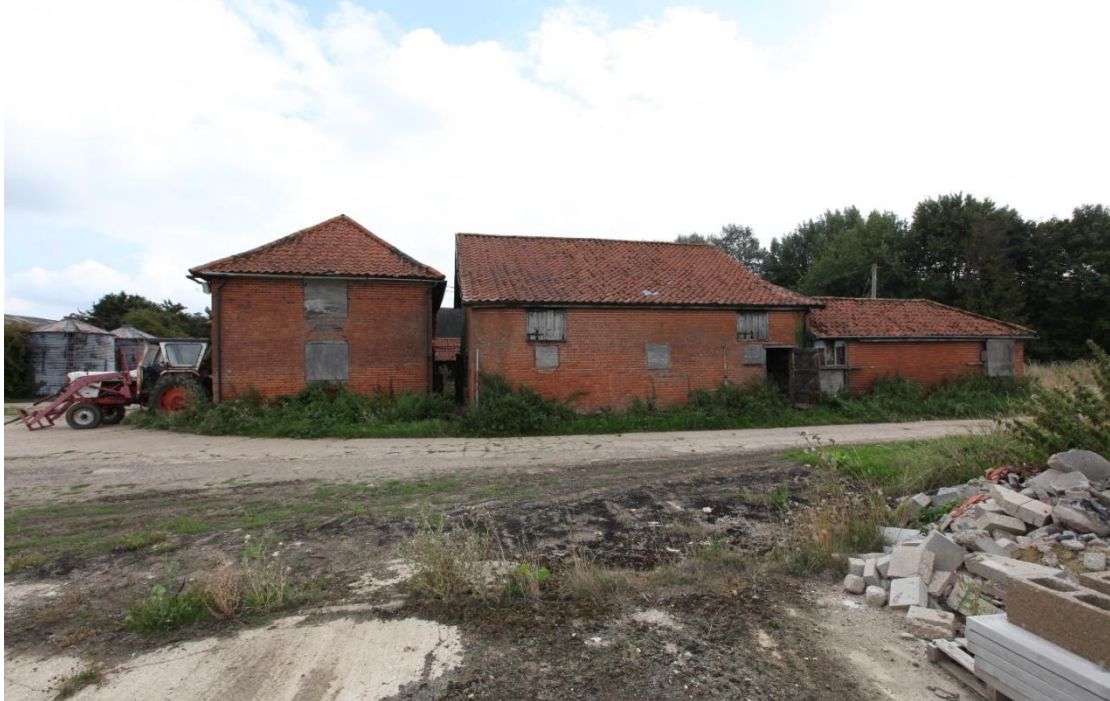
Illus. 3. The buildings from the north-west showing the mid-19th century extension to the barn (3) on the left which contains a cart shed (3c) entered from the rear (north-east) and a loose box facing the animal yard in front of the barn (3b) along with a first-floor hay loft. The contemporary central structure (5) also contains loose boxes with a granary above, and its slightly later lean-to in the foreground provided additional grain storage with a suspended floor and ventilation arches beneath. The single storied right-hand shed (7) is a shelter-shed serving a yard in the rear (8).

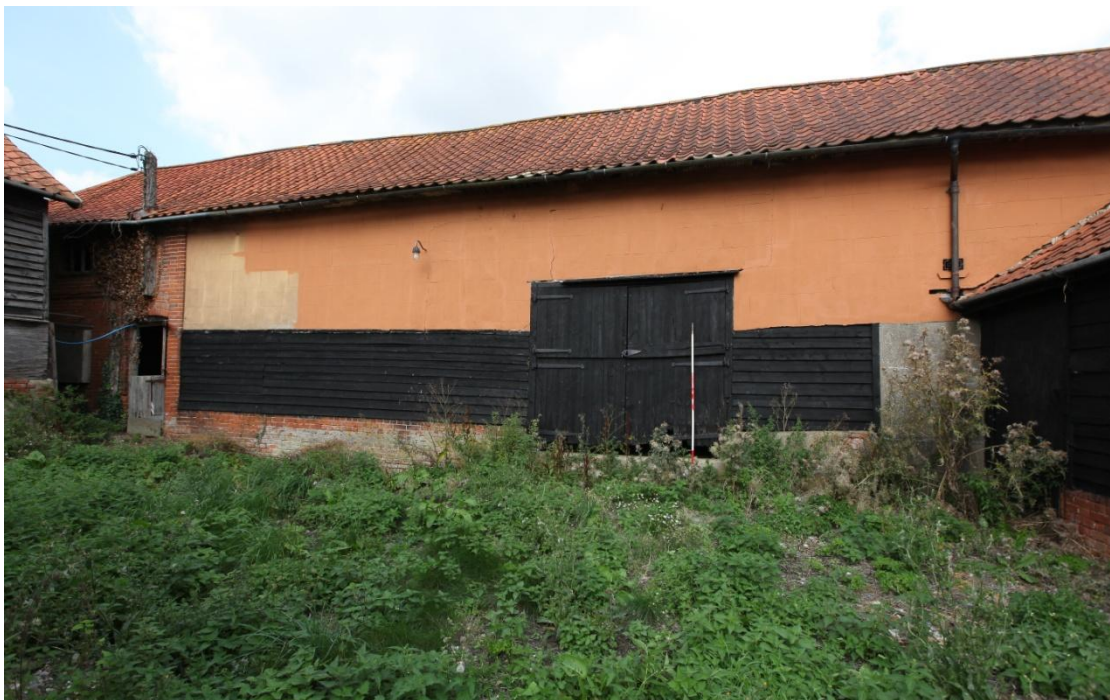
Illus. 4. The barn (1) from the south-west showing its traditional 19th century ‘two-tier’ cladding with ashlar pargeting above tarred weatherboarding. The low doors occupy the position of the original full-height entrance to the barn’s threshing bay. Note that the brick plinth is integral to the extension (3) on the left and was renewed at the same time.

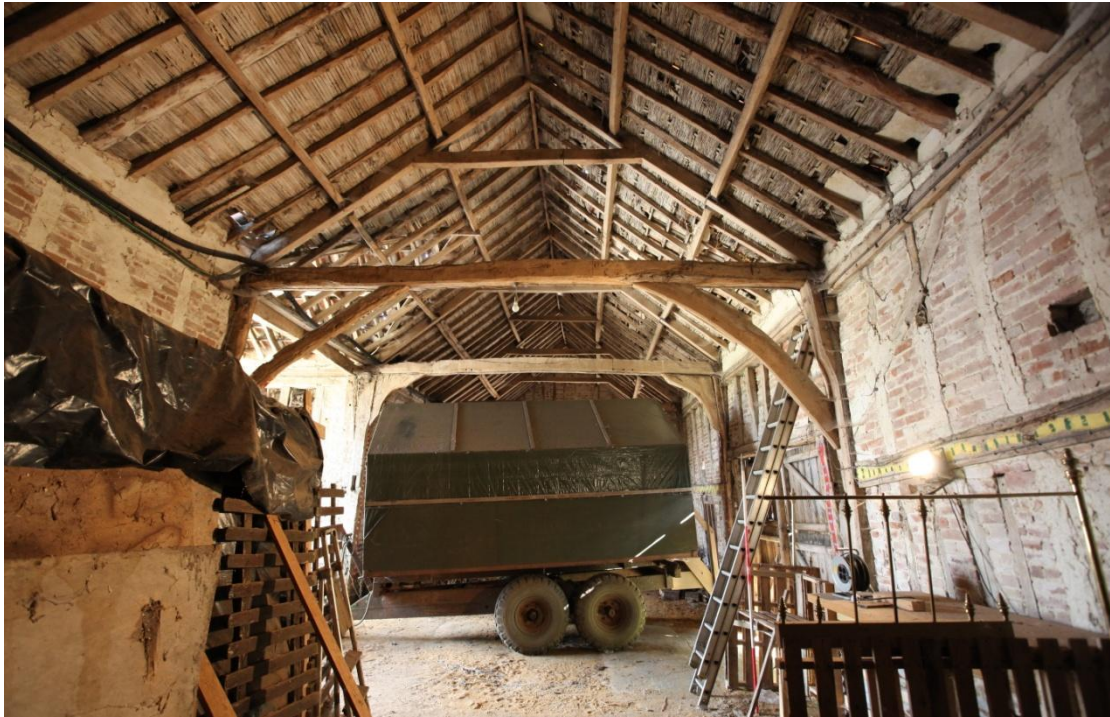
Illus. 5. A general view of the barn (1) from its missing north-western gable showing the intact original arch-braces to the tie-beam between the entrance bay (1c) and the end-bay in the foreground (1d). The butt-purlin roof is a mid-19th century replacement which extends into the brick additions (2 and 3) that are not shown on the 1838 map. The brick infill between the timbers dates from the same period.

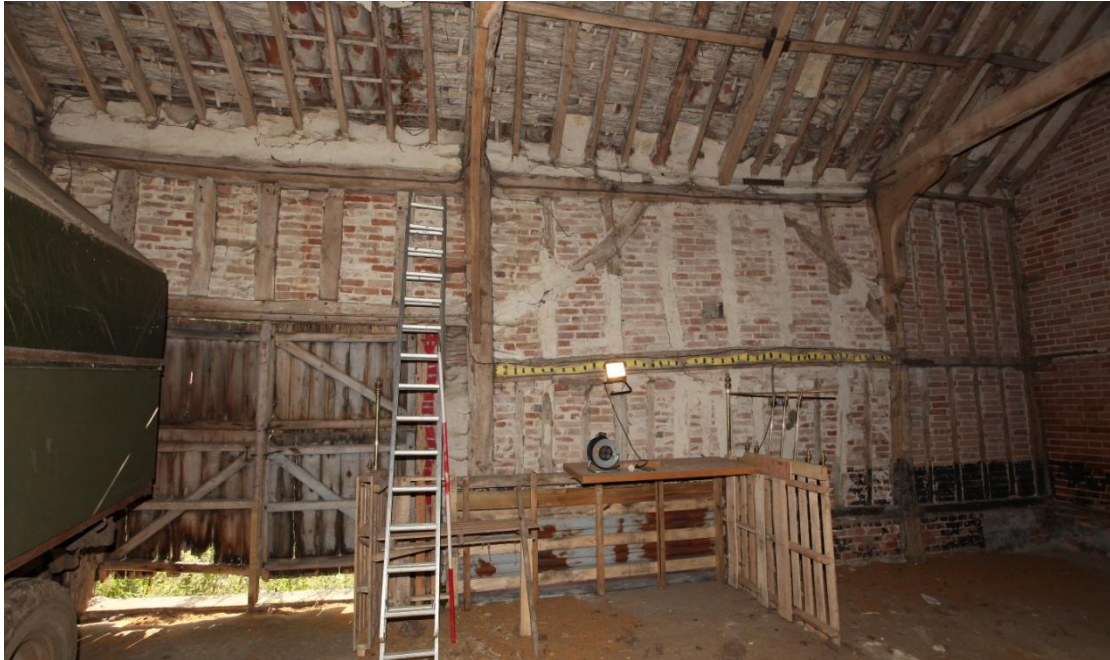
Illus. 6. The south-western interior of the original entrance bay on the left (1c) and the end-bay (1d) to right, with the 19th century extension to the extreme right (3a). The studs and internal wall braces in bay 1d are original but the lintel of the present doors and the short studs above are later insertions that partly block the original entrance. These timbers appear to have been re-used from the porch (1e) and the lintel is a mid-rail with identical pegged mullion mortises for a central window to those in the porch's gable tie-beam and side wall. The floor is of concrete with no trace of a threshing floor.

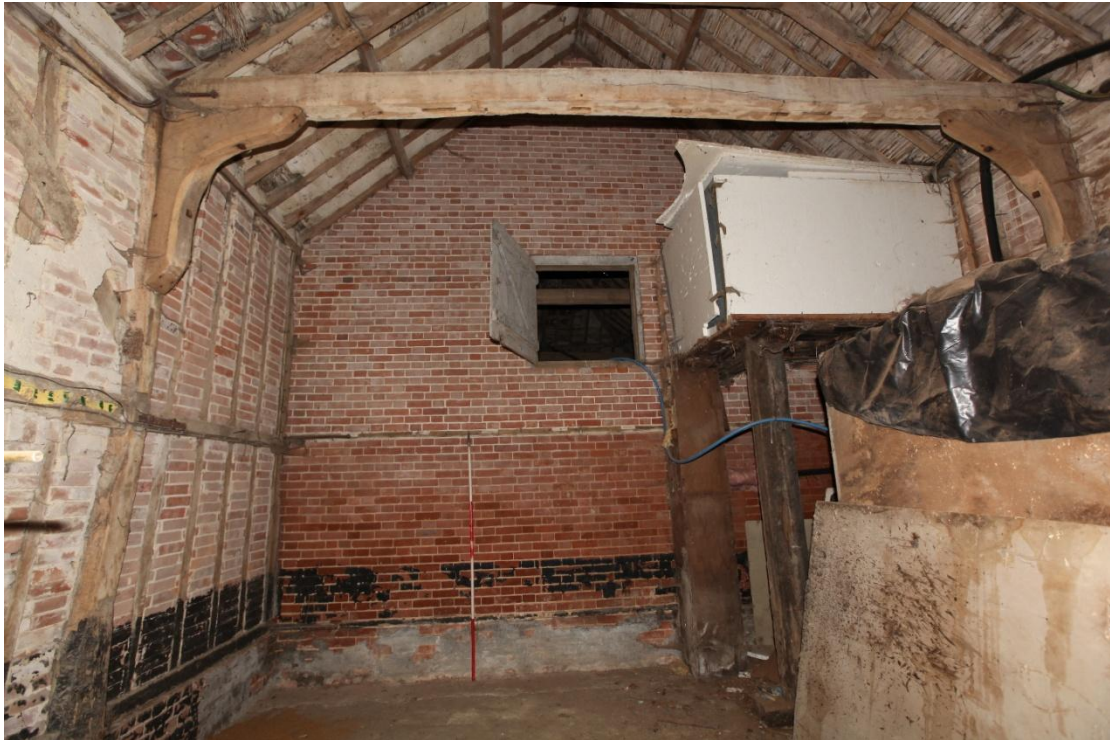
Illus. 7. The original north-western gable of the barn from its final bay (1d) showing empty mortises for a missing solid wall in its tie-beam – which is the only timber now *in situ*. The first-floor hatch opens into the hay loft of the brick extension shown in A2. 15.

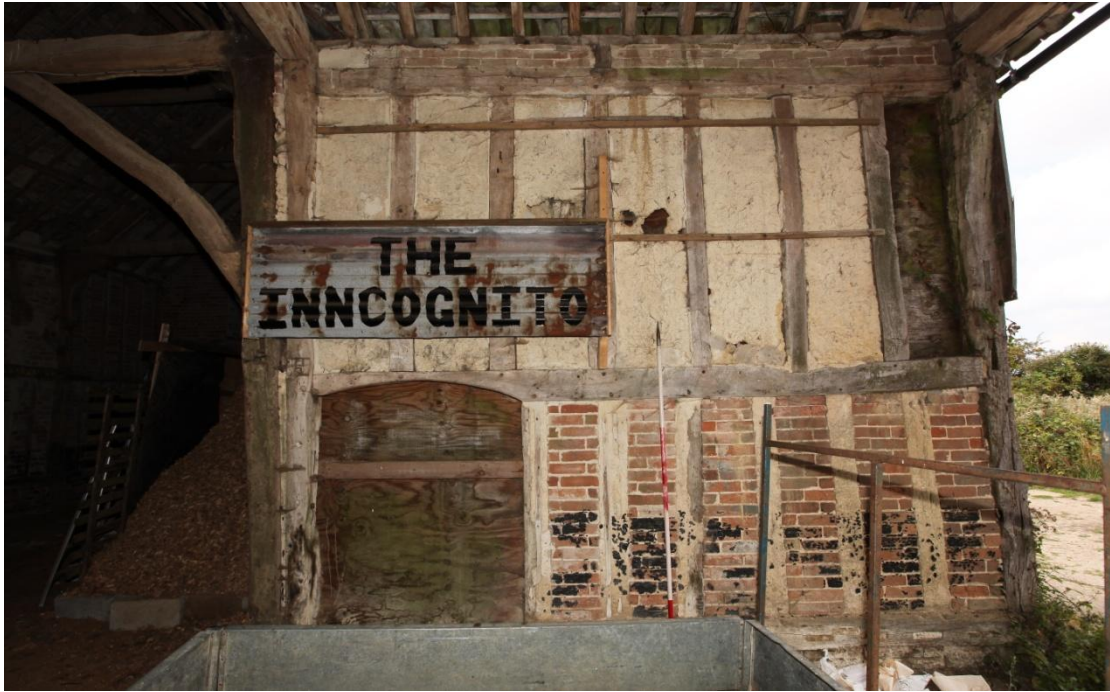
Illus. 9. The north-western interior of the porch (1e) showing its largely intact timber frame with a re-used ground sill. The wide door opened into a demolished lean-to shed, cutting the mid-rail and leaving no obvious evidence of an original door. The upper studs are infilled with original wattle-and-daub with 19th century brick beneath.

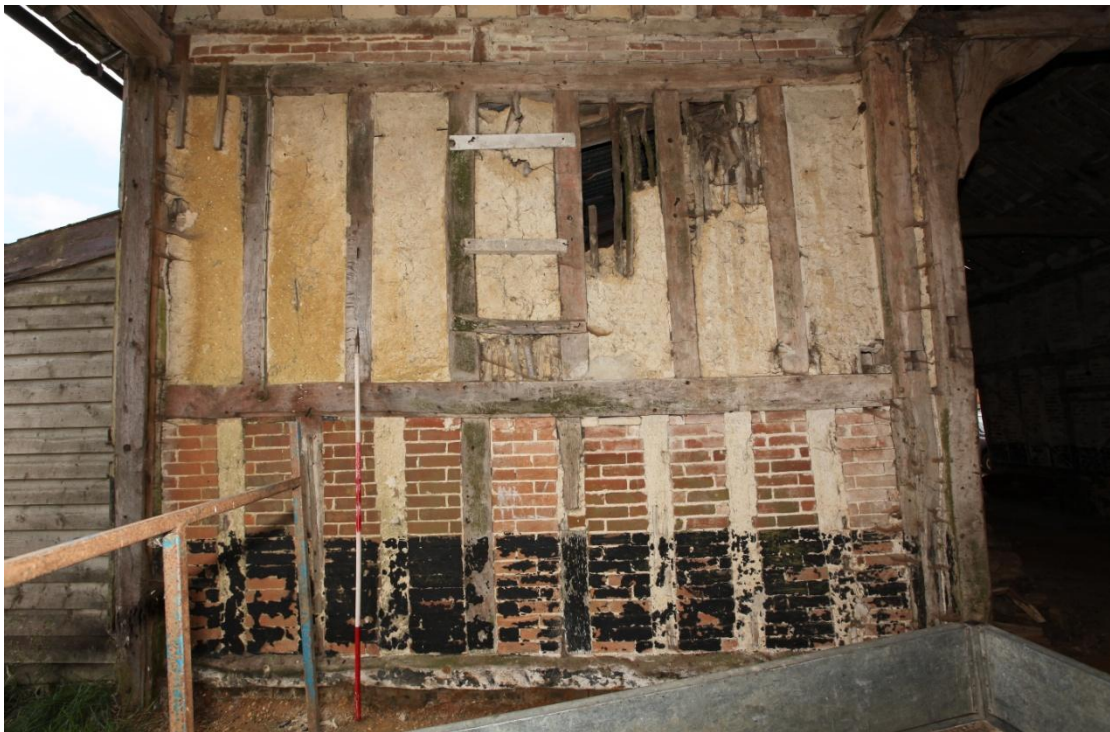
Illus. 10. The south-eastern interior of the porch (1e) showing evidence of a window with a shutter rebate and three pegged mullions on the left and a blocked original door to the right. The right-hand ground-floor stud is an unpegged insertion and the door rebate extends from the mid-rail to the corner post. The structure contained a ceiling of joists lodged on the mid-rails with corresponding pegged mortises in the truss adjoining the barn, but appears to have been open-framed against the barn both above and beneath the loft.

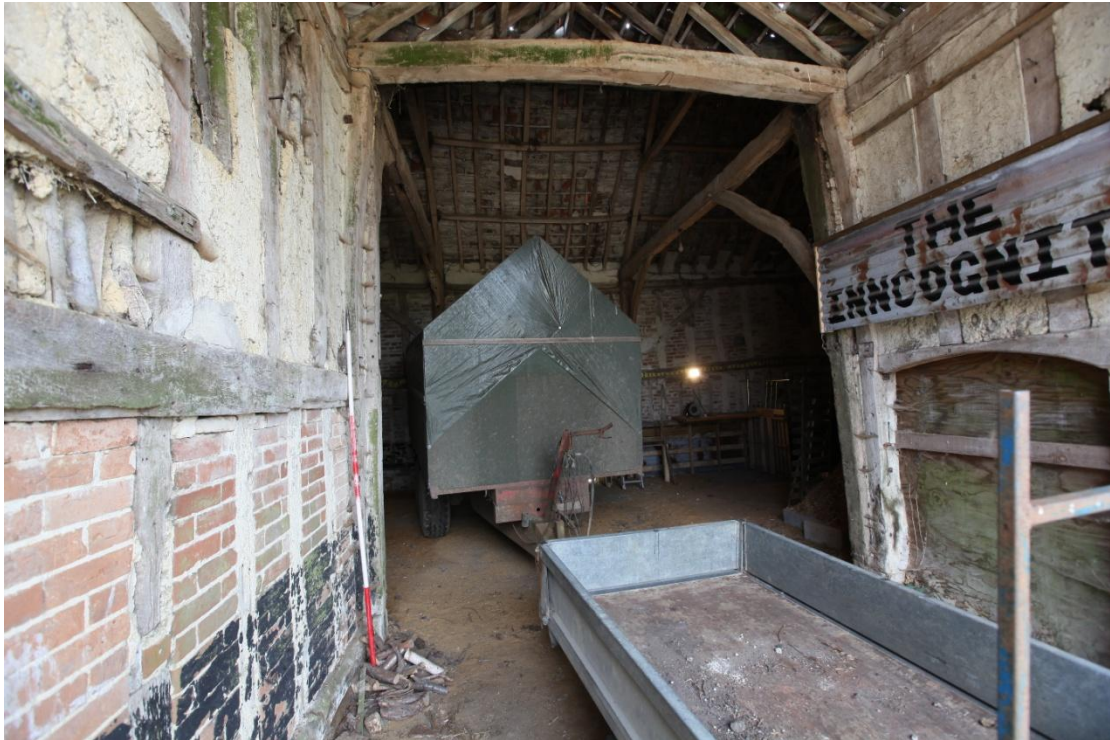
Illus. 11. The south-western truss of the porch (1e) looking towards the barn's original entrance. This bay of the barn contained a mid-rail with a solid wall above and possibly a small door in the usual fashion beneath, but the roof-plate has been cut out. The porch was open-framed against it, with jowled posts but no stud mortises in its intact tie-beam and a binding joist that was smaller than its counterpart in the external gable and is unlikely to have formed part of a ground-floor wall.

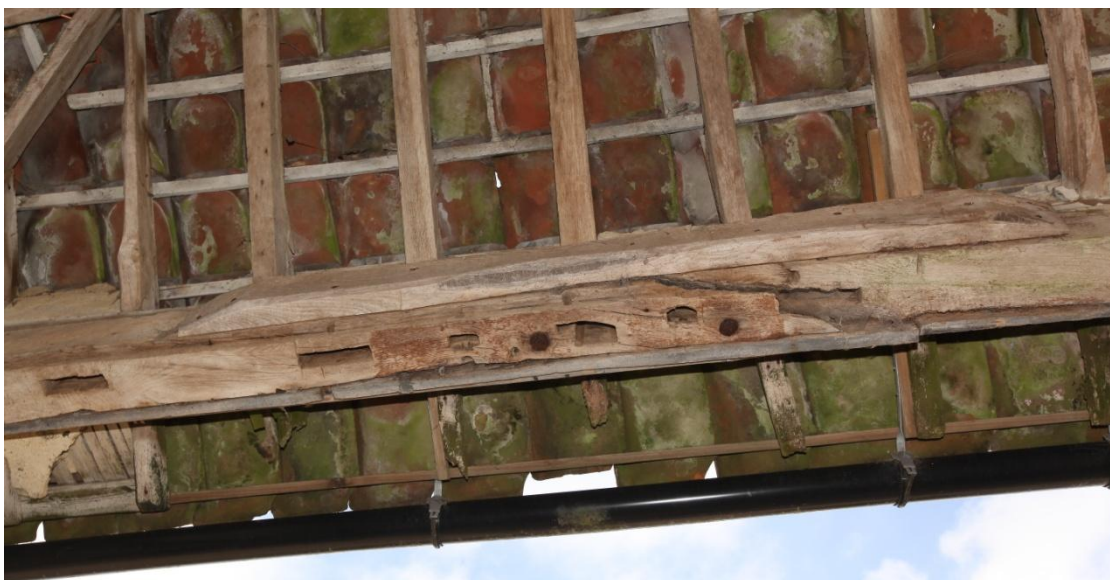
Illus. 12. A detail of the external (north-eastern) tie-beam of the porch (1e) showing empty mortises for studs on both sides of a central window lighting the missing loft with three pegged rectangular mullion mortises cut by a later housing for the locking bar of full-height barn doors. The tie-beam has split and is secured by vertical iron bolts. The corner posts of this gable contain mortises for a mid-rail that probably now forms the lintel of the barn's south-western doors and contains identical mullion mortises (A2. 6). The porch is contemporary or almost contemporary with the barn and probably formed a granary behind the threshing floor but is unique in my experience.

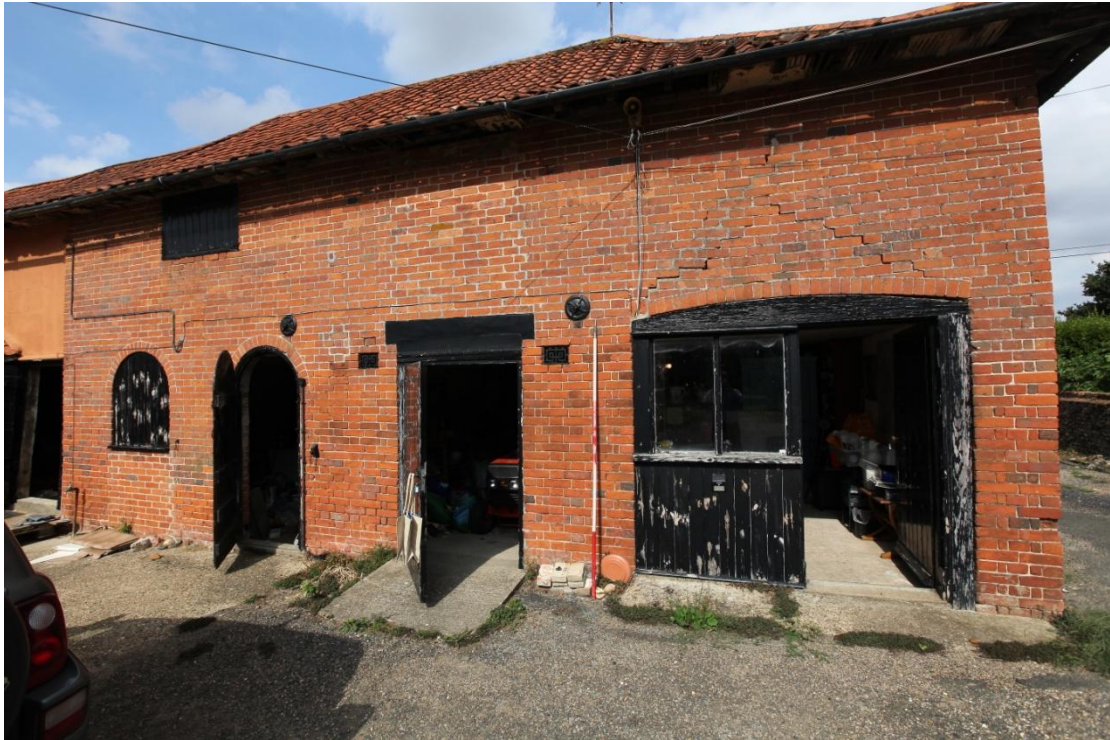
Illus. 13. The south-western facade of the coach house (2) built in the mid-19th century as an extension to the barn. The right-hand doors opened into a vehicle shed (2a) and the large central door into a stable which retains a manger backing onto a chaff box connected by two hatches (2b). The original loading door to the first-floor granary lay above this door but has been blocked. The arched window and door to the left originated unusually as a pair of doors but appear to have opened into a single space that probably served as a tack room (2c).

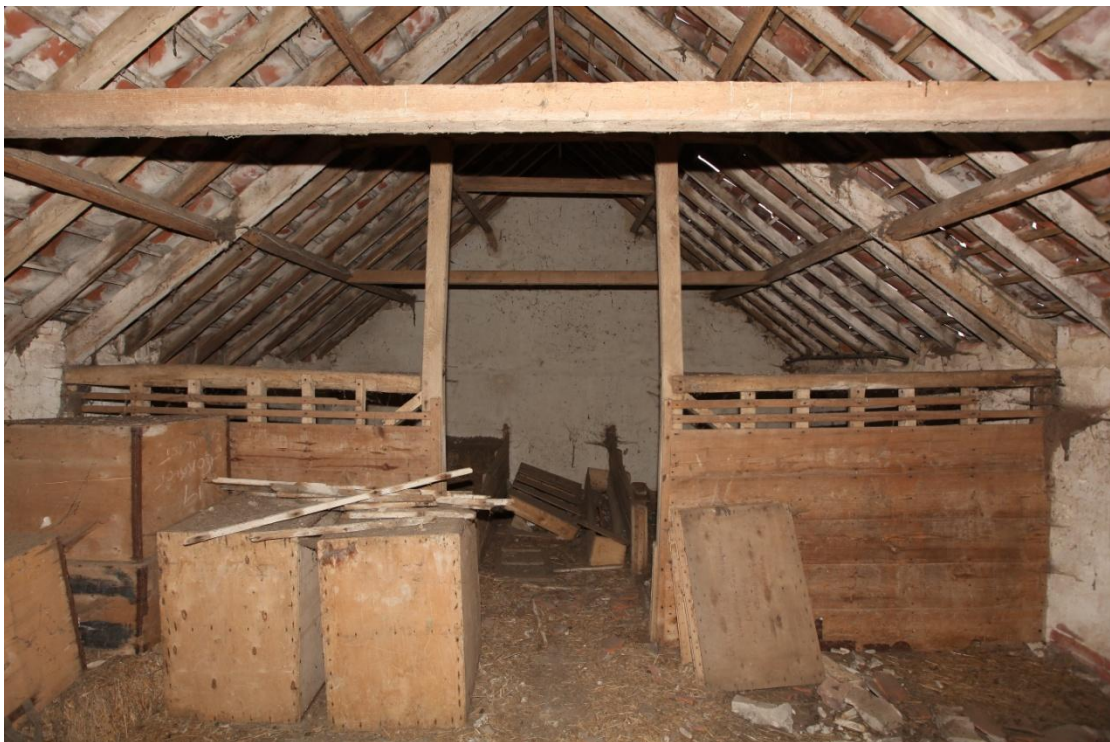
Illus. 14. The granary above the coach house (2) showing the remains of ostensibly original grain bins with an axial passage (as seen from the south-east).

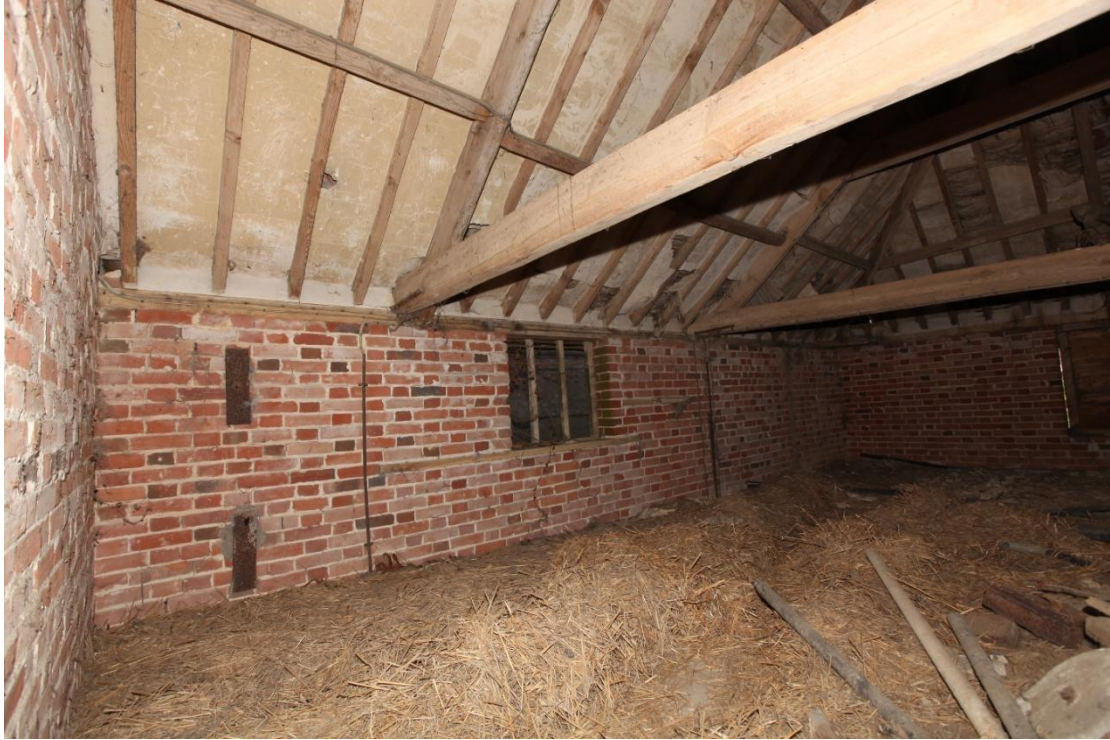
Illus. 15. The south-western internal wall of the hay loft to the north-west of the barn (3) showing an original window with a second window or loading hatch in the gable to the right. This loft is reached by the hatch shown in illus. A2. 7 and replicates the original arrangement of the barn's south-eastern bay (1a).

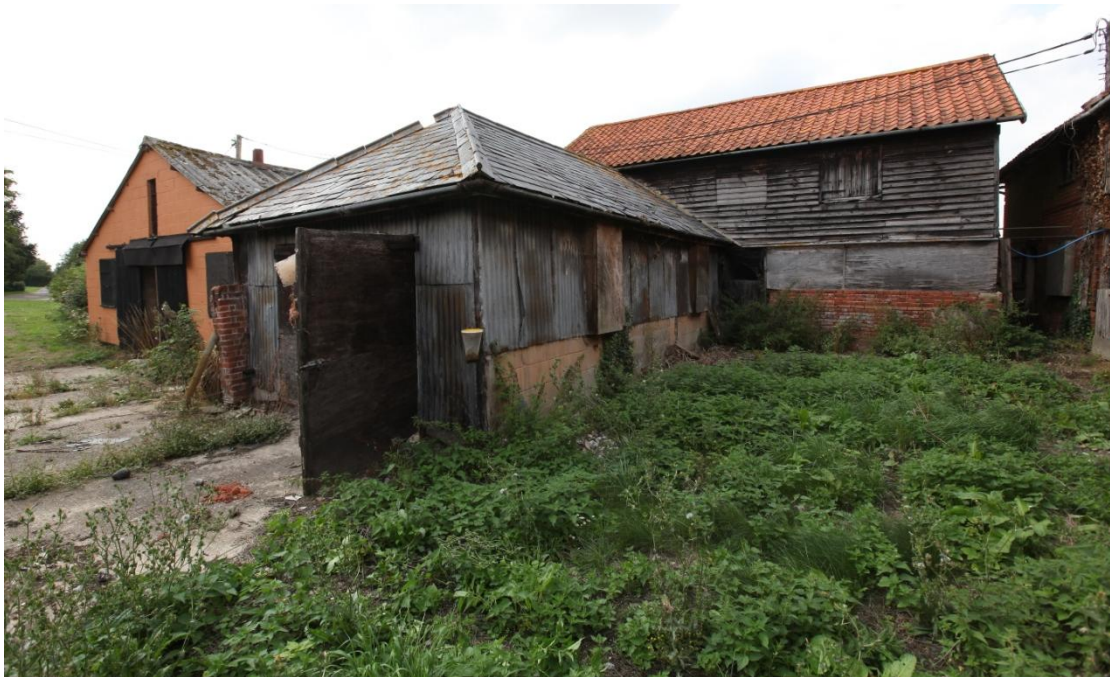
Illus. 16. The animal yard to the south-west of the barn as seen from the south-east with the detached mid-19th century pantiled loose boxes and granary (5) in the rear and the much altered slate-roofed shelter-shed (6) in the foreground (originally open-sided to the right). The 20th century covered cattle yard (8) is shown to the left. The narrow passage between the two loose boxes (3b and 5b) lies to the extreme right. This yard was almost certainly designed for cattle rather than horses but no relevant fixtures or fittings survive.

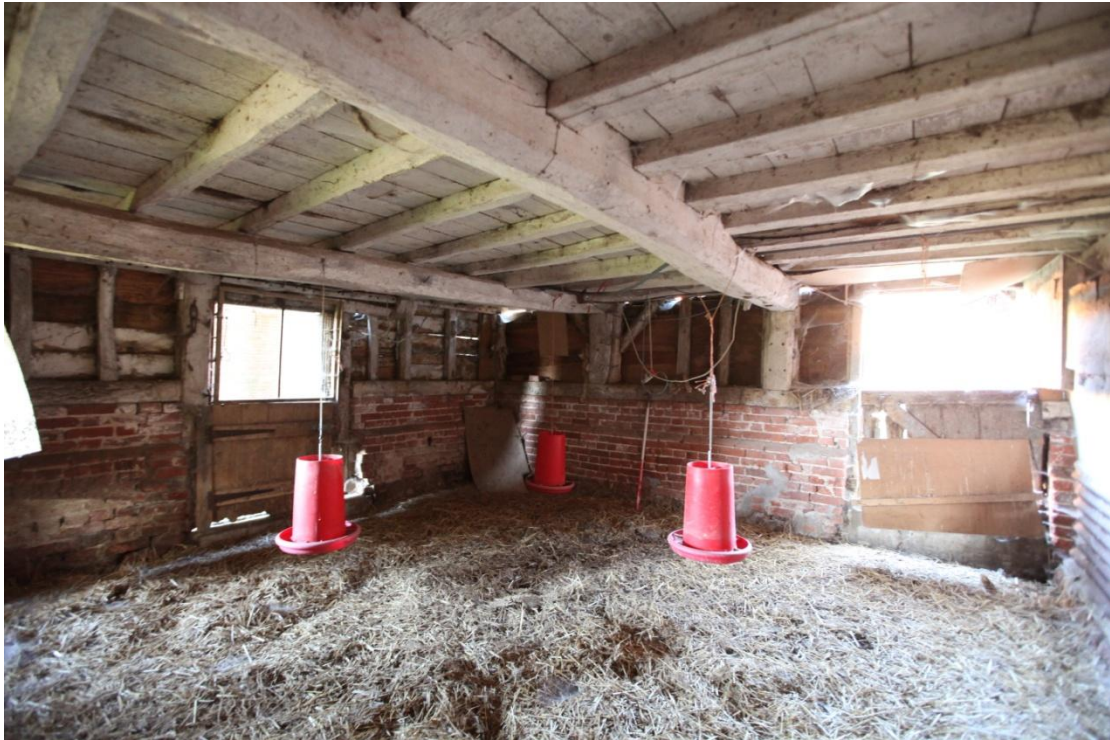
Illus. 17. The interior from the west of the north-eastern ground-floor loose box of the granary (5b) showing its re-used ceiling of partly tenoned and partly lodged joists with a hay drop to the left of the right-hand door (which opens onto the yard shown in A2.16).

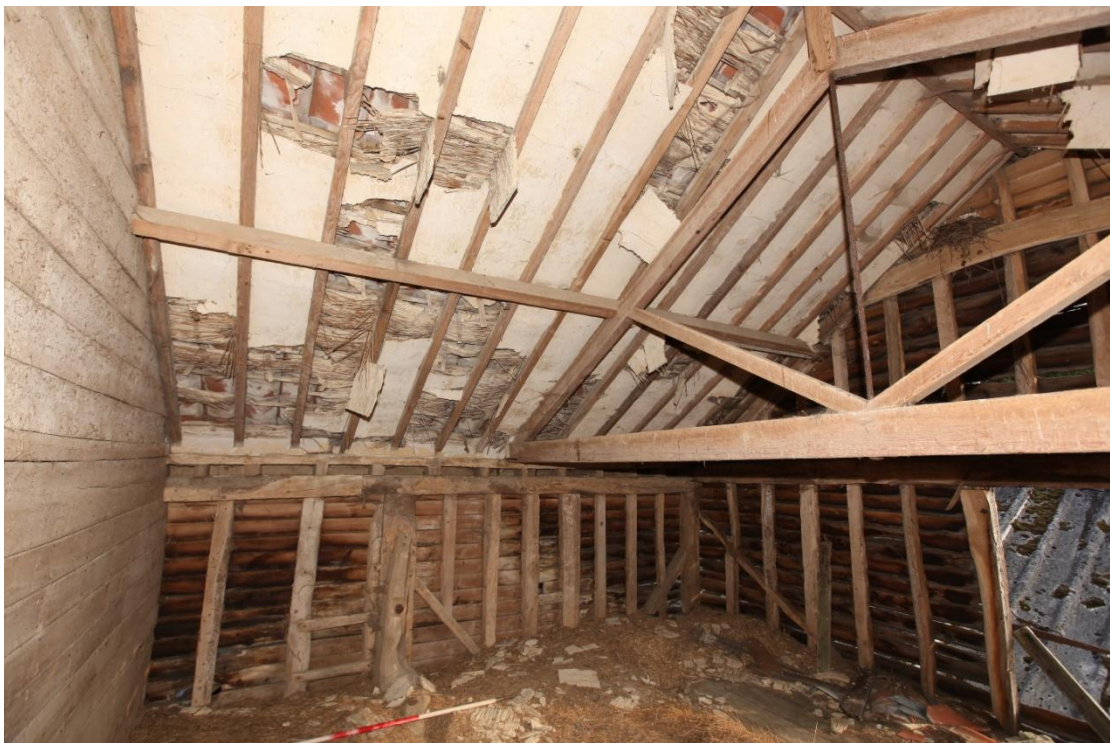
Illus. 18. The south-western compartment of the first-floor granary (5a) seen from the north-west with the gable loading hatch on the right (and the corrugated asbestos roof of the 20th century cattle yard beyond). Note the crudely hewn inverted knee-brace supporting the floor and the original softwood roof with a vertical iron tie-rod – typical of the 1860s and 70s. The original plaster between the rafters is secured by reeds and laths and the boarded wall on the left adjoins the identical north-eastern compartment.
