AN ARCHAEOLOGICAL WATCHING BRIEF AT  
ST. PETER'S CHURCH, CHURCH LANE,  
SCOTTER, LINCOLNSHIRE.

**National Grid Reference: SE 8875 0082**  
**Site Code: PCSC14**  
**Accession No: LCNCC: 2014.65**

PREPARED FOR MR. LEE HOLMES OF LEE HOLMES ARCHITECTURAL DESIGN  
ON BEHALF OF HIS CLIENTS - THE PAROCHIAL CHURCH COUNCIL OF  
SCOTTER AND EAST FERRY

April 2014

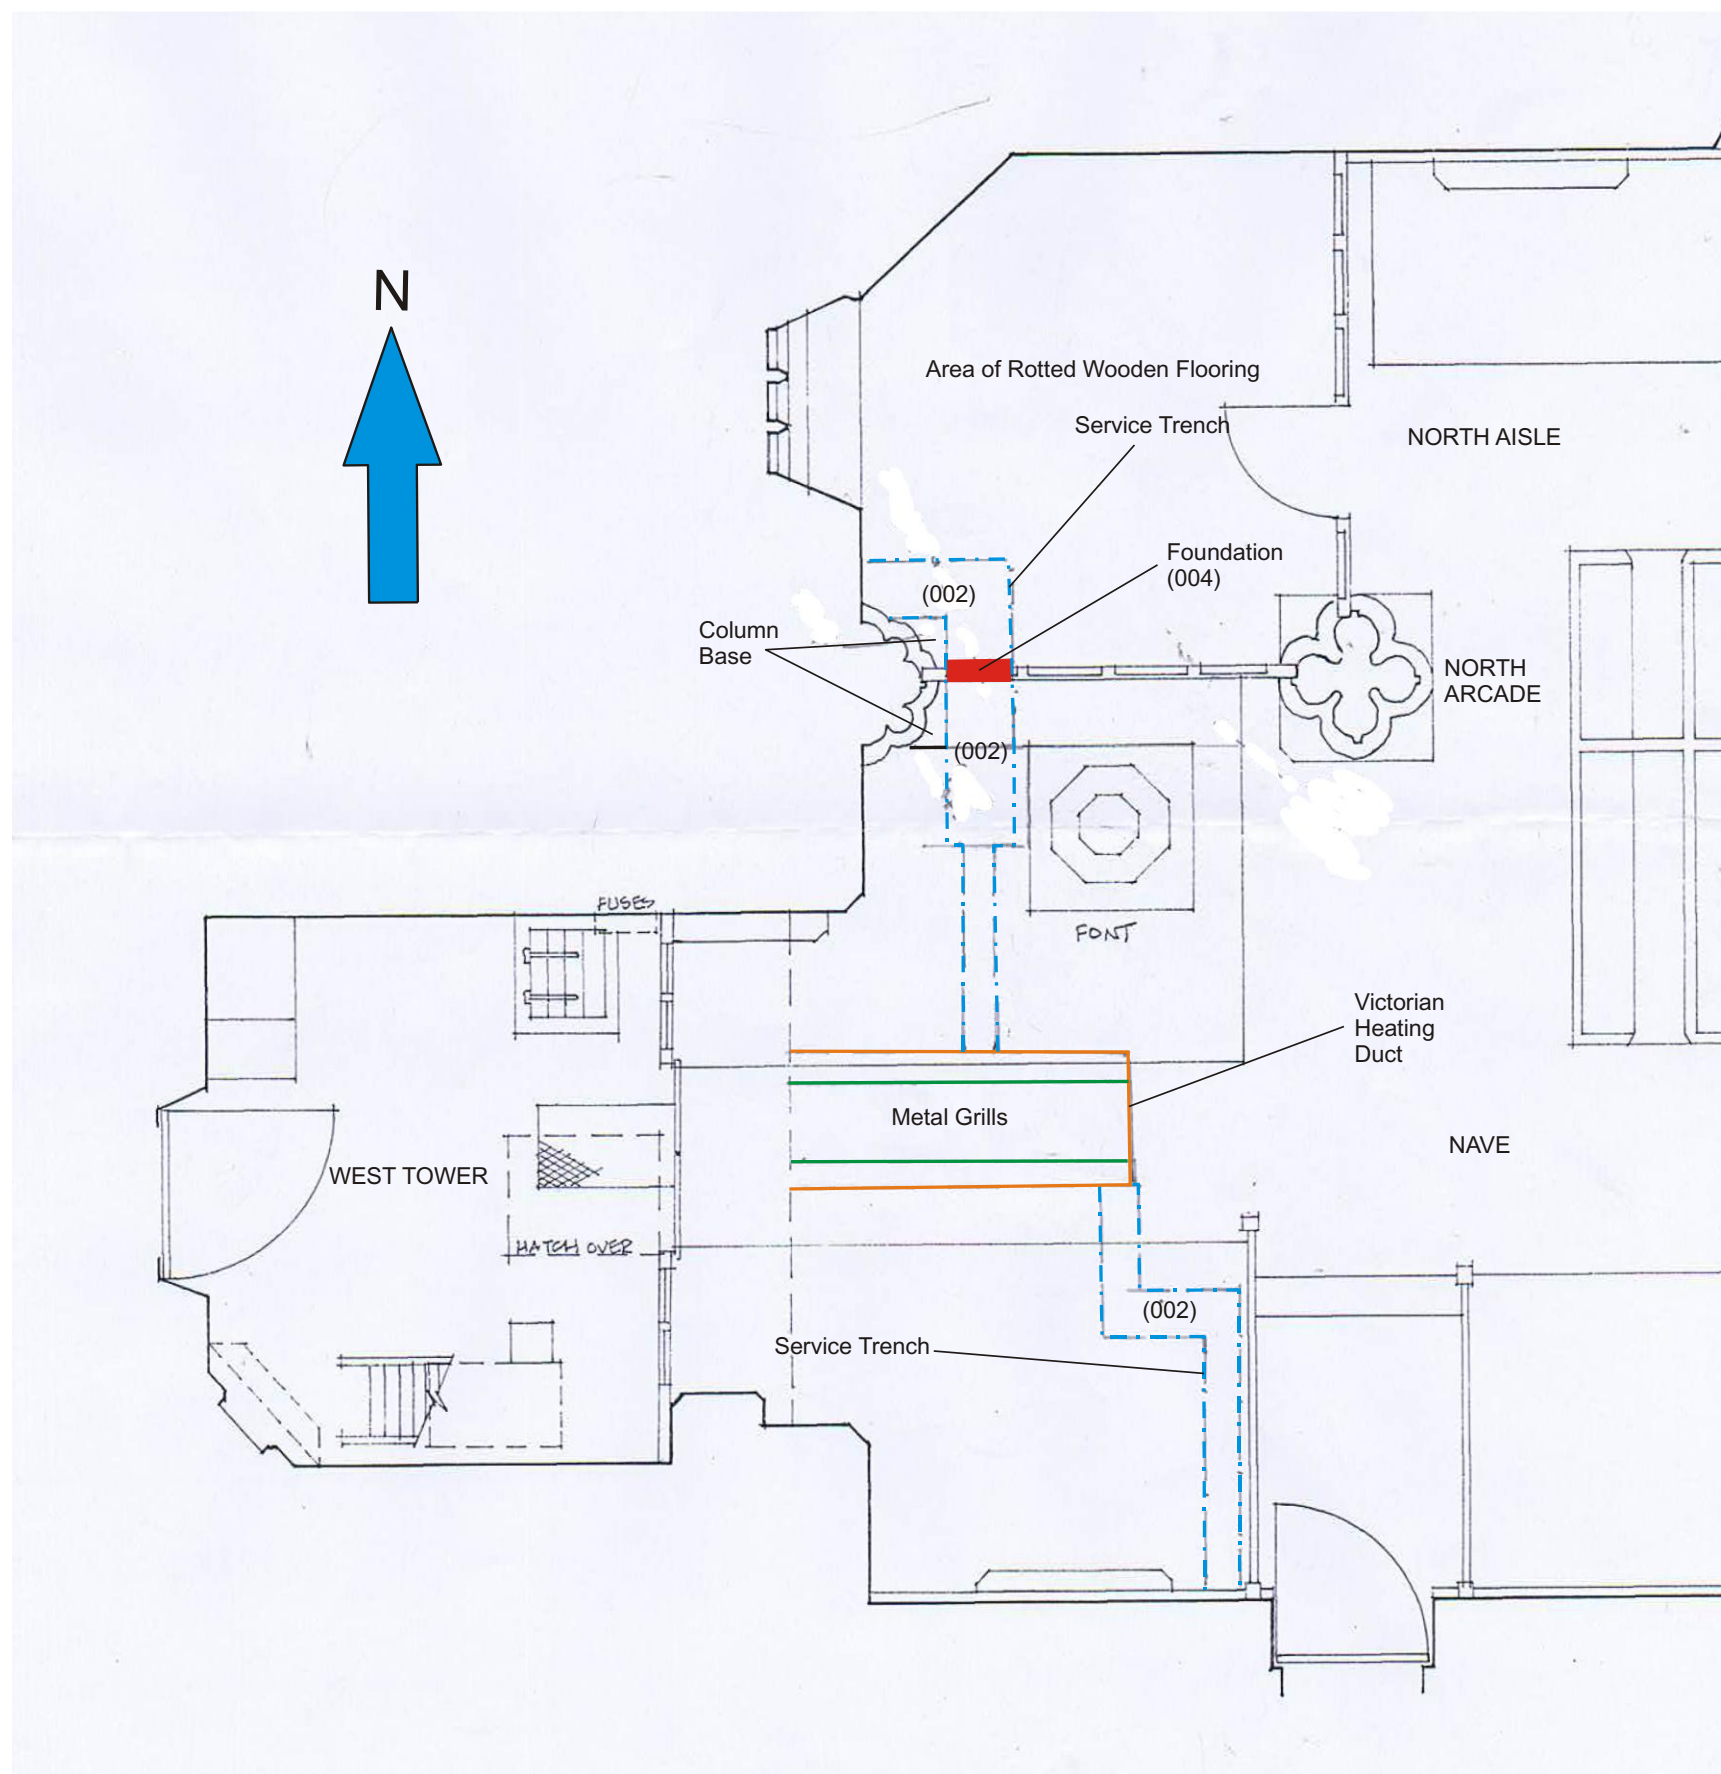
Figure 2: Plan of the Monitored Groundworks in the Church Interior at a scale of 1:50

- 6.2 Where necessary, surfaces were hand cleaned for examination and recording, and the deposit sequence and the structures within and without the Church of St. Peter were recorded on standard *pro-forma* context recording sheets. A plan at a scale of 1:50 was compiled on site of the monitored groundworks within the nave of the church. This plan is reproduced at this same scale as **Figure 2** in this report. A second plan was also compiled on site of the external churchyard groundworks at a scale of 1:50. This is reproduced at a reduced scale of 1:100 as **Figure 3**. A total of three sections of the observed deposit sequence in the churchyard [designated as **Representative Sections 1-3**] were compiled on site at a scale of 1:20. These are reproduced at this same scale as **Figure 4**. A complimentary digital colour photographic record was also maintained, which is reproduced as **Plates 1-56, Appendix 1**. A list of contexts recorded is reproduced in **Appendix 2**.

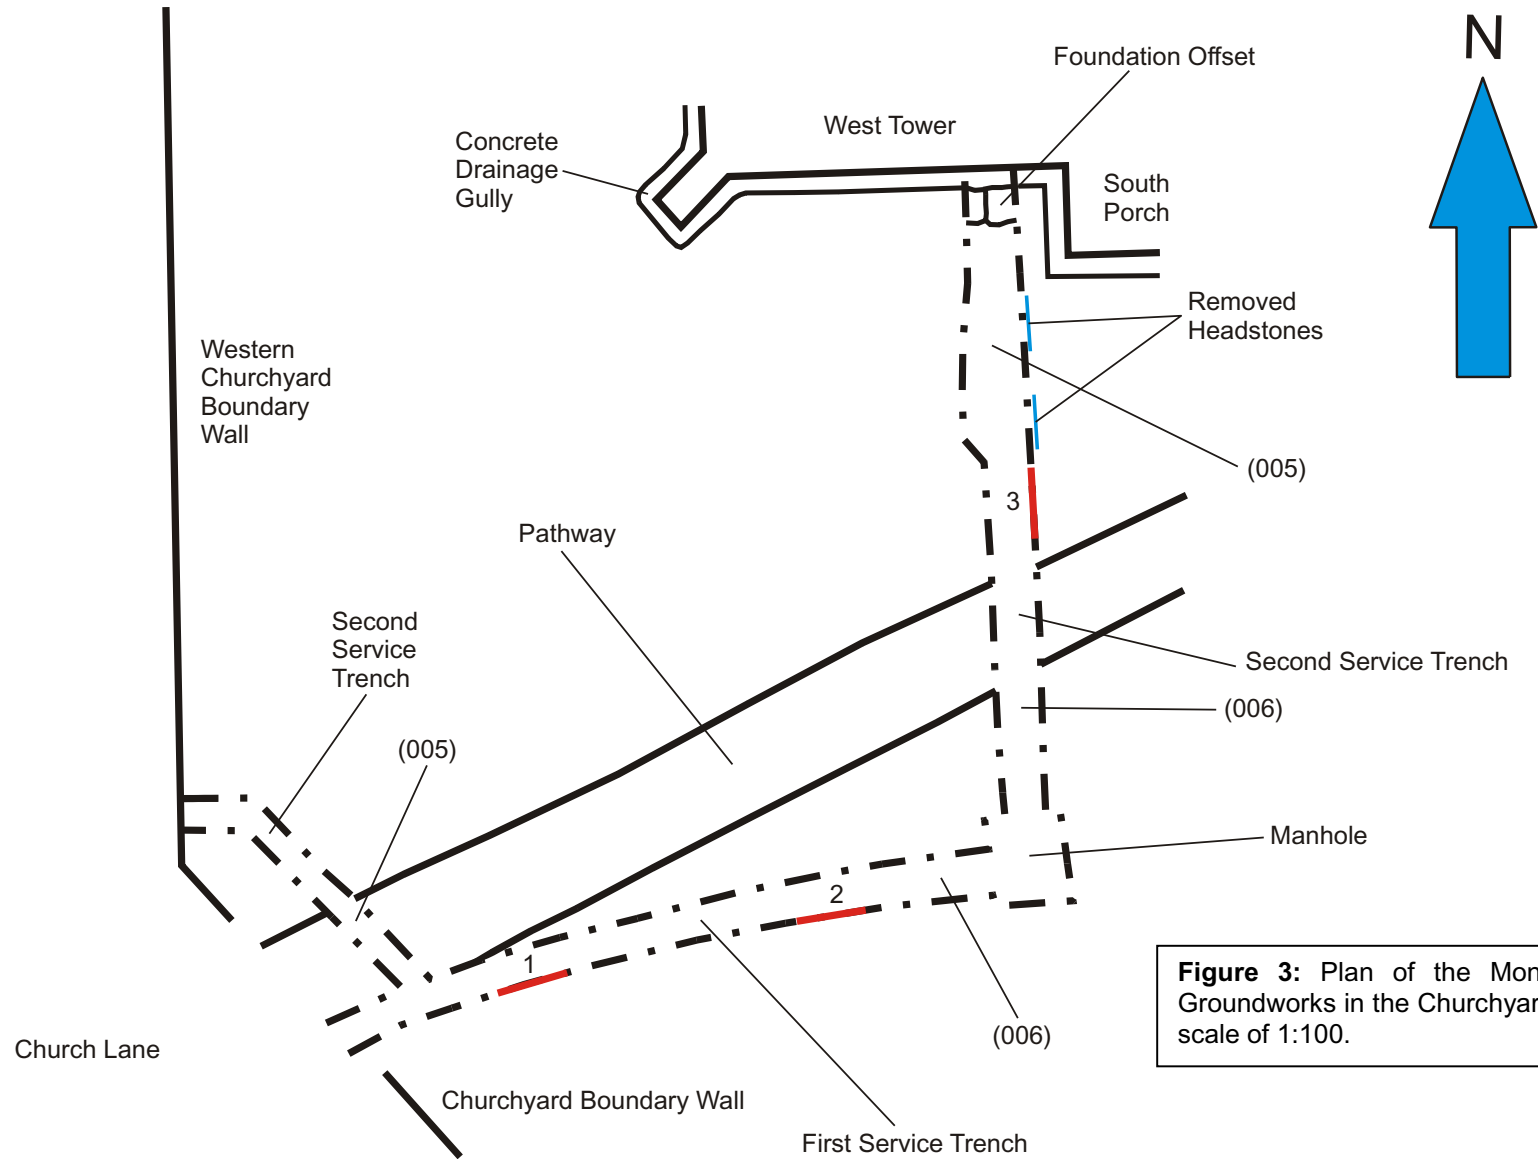
**Figure 3:** Plan of the Monitored Groundworks in the Churchyard at a scale of 1:100.

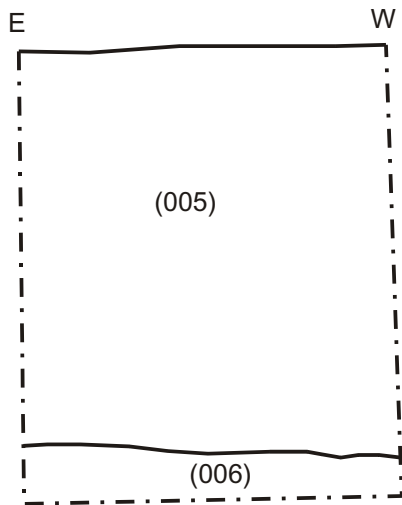
Representative Section 1,  
North Facing Section,  
scale 1:20

**Figure 4: Representative Sections  
1-3 at a scale of 1:20.**

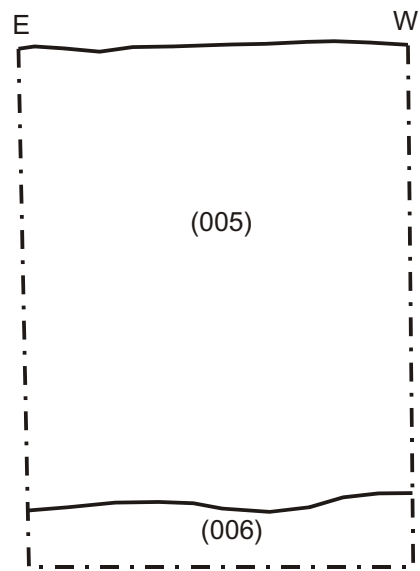
Representative Section 2.  
North Facing Section,  
scale 1:20

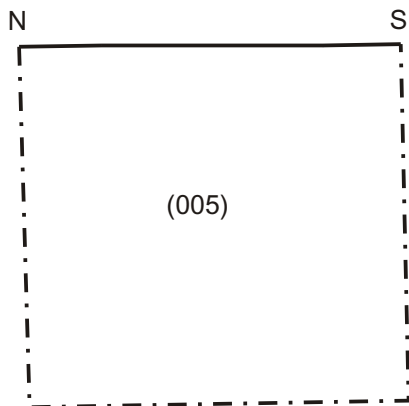
Representative Section 3, West  
Facing Section, scale 1:20

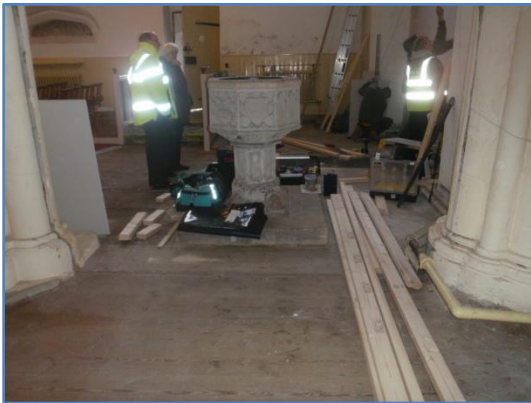
**Plate 1:** Pre interior groundworks, from the north

- 7.1.1 The internal groundworks that were the subject of this archaeological watching brief were concentrated at the western end of the nave [**Plate 1**]. Cement rendering had already

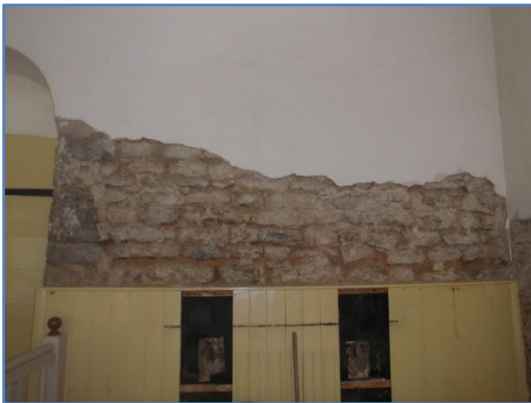
**Plate 2:** Removed rendering from the south wall of the nave, from the north

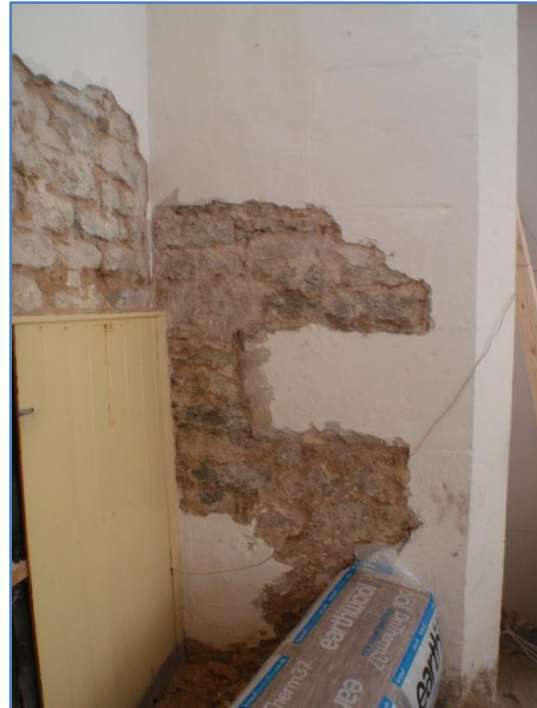
**Plate 3:** Removed rendering from the east wall of the west tower, from the east

been removed on lower sections of portions of the south wall of the nave, of the east wall of the west tower and at the doorway to the south porch. This removal of rendering on the south wall of the nave and at the doorway to the south porch revealed courses of irregularly shaped and roughly faced limestone blocks, which were bonded by a friable, light orange brown sandy mortar with frequent inclusions of very small angular stones [Plates 2 and 4-7]. The removal of this rendering on the east wall of the west tower had revealed similar wall fabric, but a different bonding material, comprising a friable, light buff lime mortar [Plate 3].

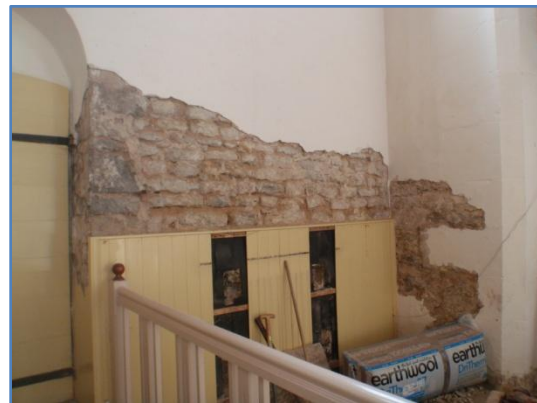
**Plate 4:** View of the south wall of the nave and the east wall of the west tower showing the area where the rendering has been removed, from the north-east

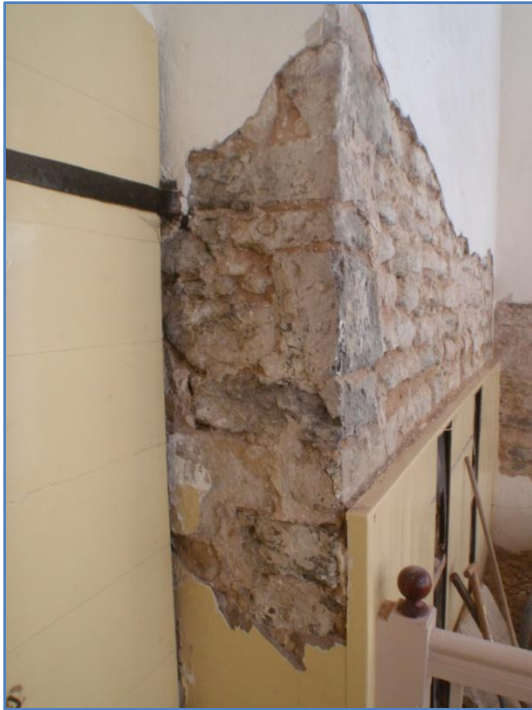
**Plate 5:** Detail: area of removed rendering from the area of the south doorway, from the east

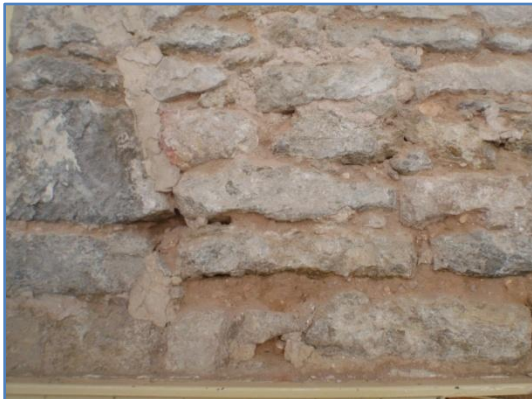
**Plate 6:** Detail: area of removed rendering from the south wall of the nave, from the north

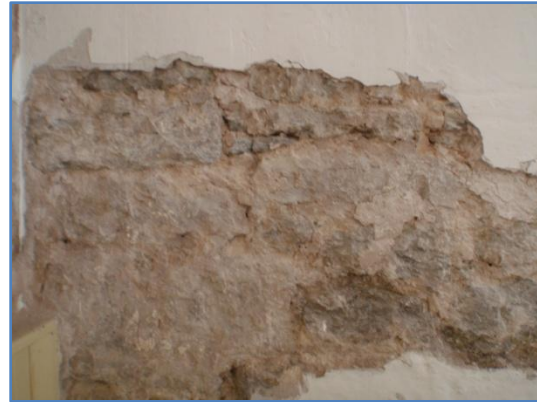
**Plate 7:** Detail: area of removed rendering from the east wall of the west tower, from the east

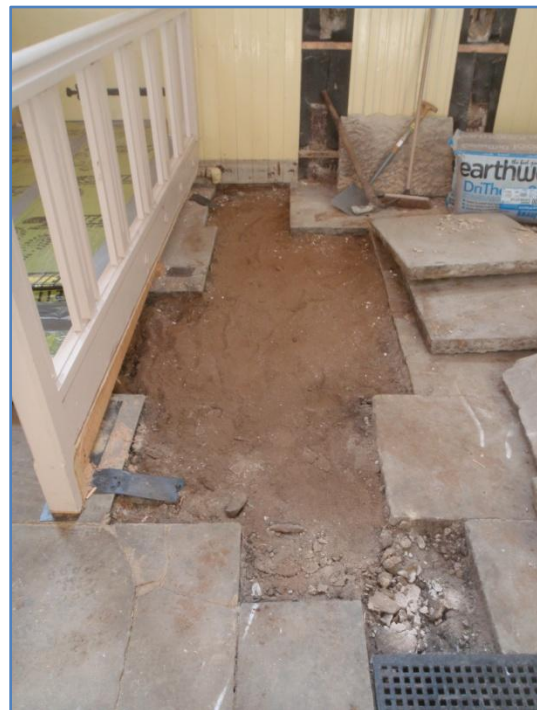
**Plate 8:** Floor area of the western end of the nave, showing the removal of stone floor slabs, from the north

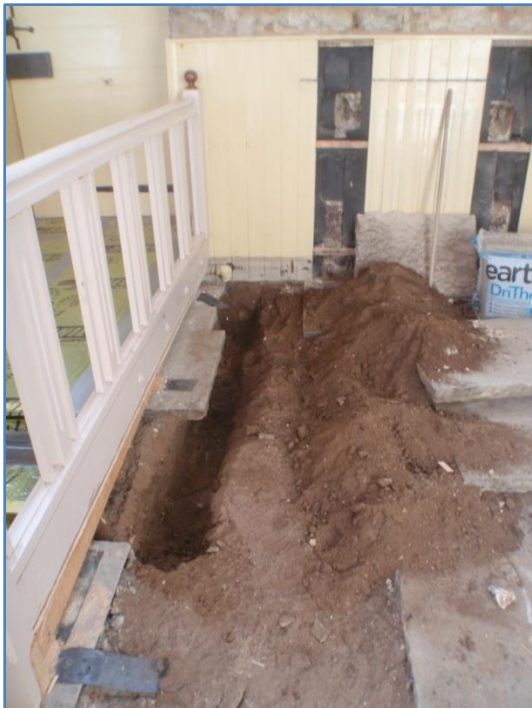
**Plate 10:** Hand excavation of a service trench within the nave, from the north

- 7.1.4 The trench was excavated to a length of approximately 8.0m, to widths of 0.25m-0.50m and to average depths of 0.30m below the floor levels of the nave. The first section of this trench extended from the south wall of the nave and terminated at a Victorian brick lined underfloor heating duct atopped with cast steel grills, which were set into the nave floor [Plates 10-14 and 16-17]. This duct extended to a depth of 1.12m below the nave floor levels [Plate 15]. Beyond this heating duct, the second section of trench extended northwards, to the immediate west of the base of the font, through an area of rotted wooden floor planking in the north aisle and thence westwards to terminate at the west wall of the north aisle. [Plates 18-23 and 28-29]. The same deposit sequence comprising the undated make-up deposit (001) and the undated buried soil horizon (002) were encountered throughout this excavation.

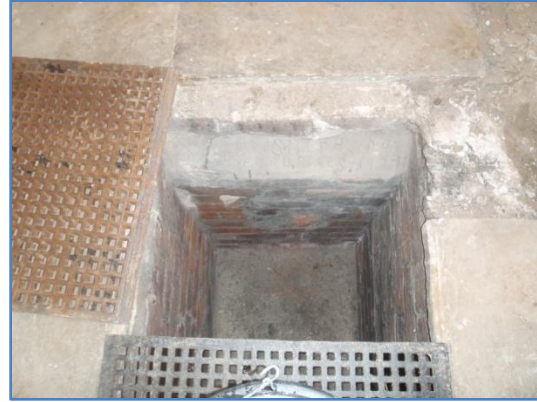
**Plate 15:** Detail: underfloor 19th century heating duct within the nave floor, from the west

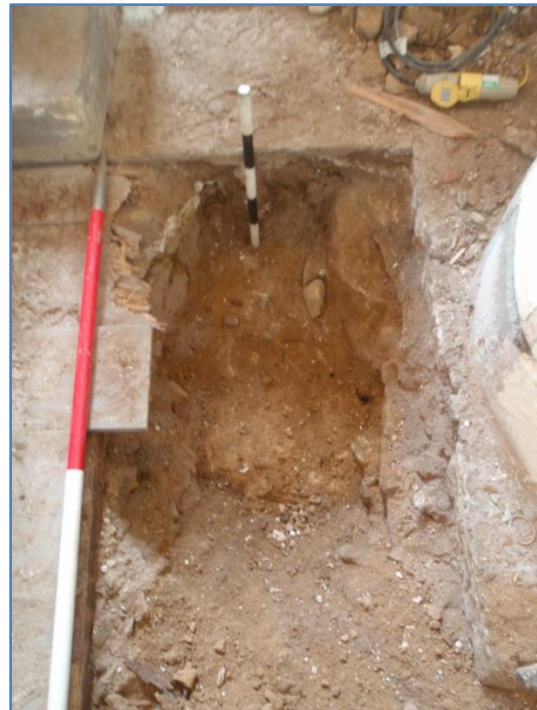
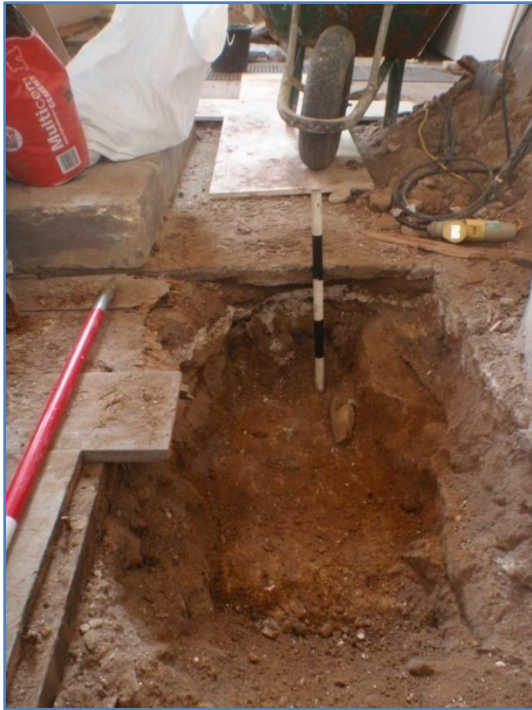
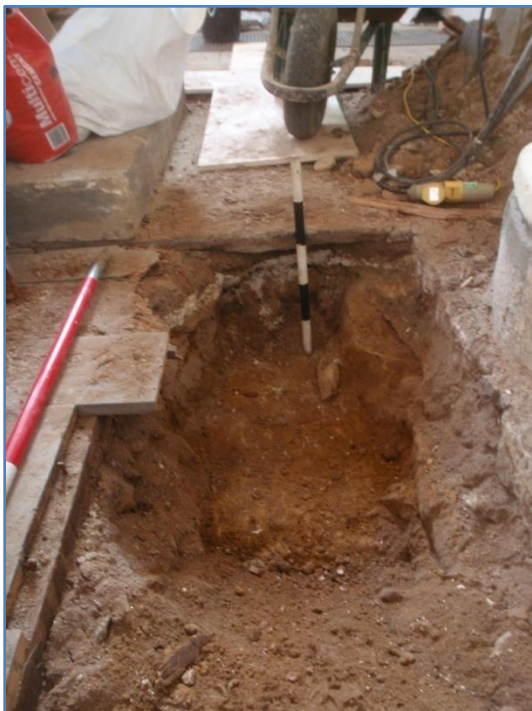
**Plate 24:** View of the rammed chalk floor surface (003) and foundation (004), from the north

- 7.1.6 The earlier floor surface (003) in turn overlay the line of an east-west orientated wall foundation (004), which corresponded to and marked the original east-west orientated line of the north wall of the nave, albeit its truncated and surviving foundation. The foundation (004) was encountered at a relatively high level, (at a depth of 0.12m below the nave floor levels), such that this hand excavation extended through its fabric. This wall foundation undoubtedly pre-dated the construction of the north arcade and north aisle of the church. Up to two courses of the wall foundation (004) were revealed composed of several irregular and faced limestone blocks set within a friable, light orange brown sandy mortar. Included within this wall fabric was one reused circular shaped worked stone or possible capital stone or architectural stone fragment. There was no discernible construction trench for this earlier wall foundation apparent within this excavation [Plates 24-28].

- 8.3 The most significant discoveries from the monitoring of the groundworks within the nave consisted of an undated rammed chalk floor surface, an earlier floor to the nave and below this the remnants of an east-west orientated wall foundation. This foundation was of an earlier north wall to the nave, which preceded and predated the construction of the present early 13th century north arcade and later north aisle of the church and was on the line of this north arcade. It is very probable that this wall foundation is of 12th century origin.

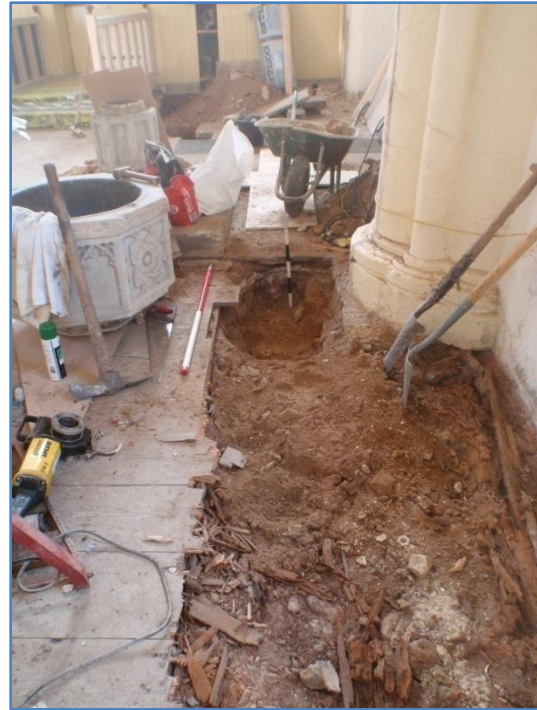
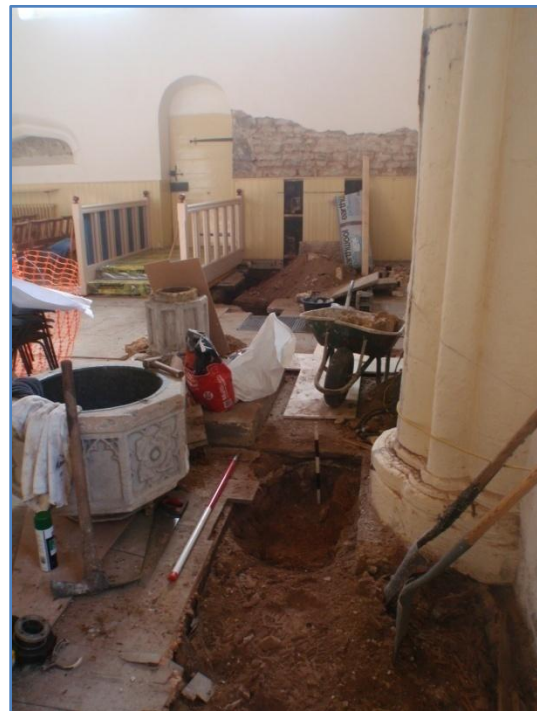
**Plate 27:** Hand excavated service trench in the nave, from the north

**Plate 28:** Hand excavated service trench in the nave, from the north

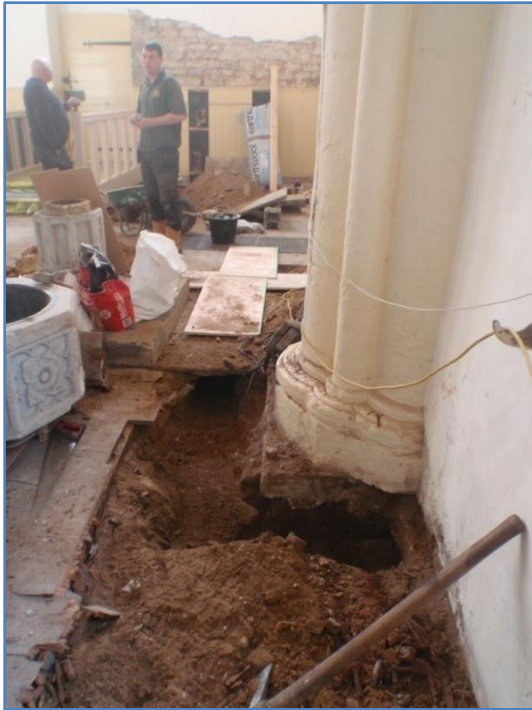
**Plate 29:** Hand excavated service trench in the nave and north aisle, from the north

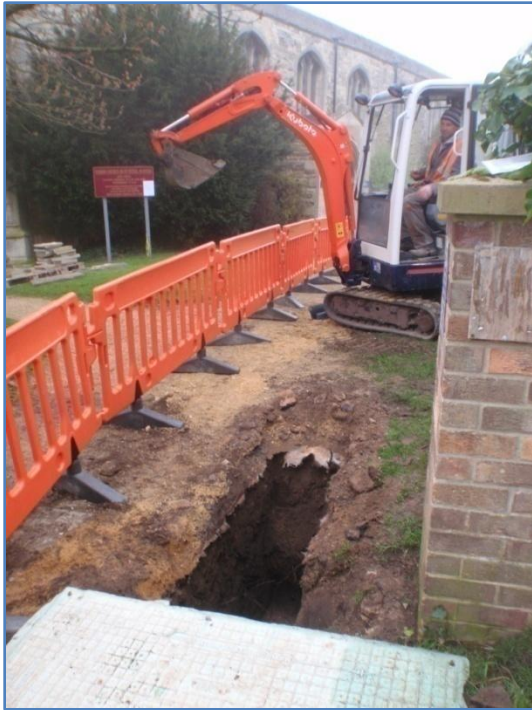
**Plate 34:** Mechanical excavation of the first service trench, from the west

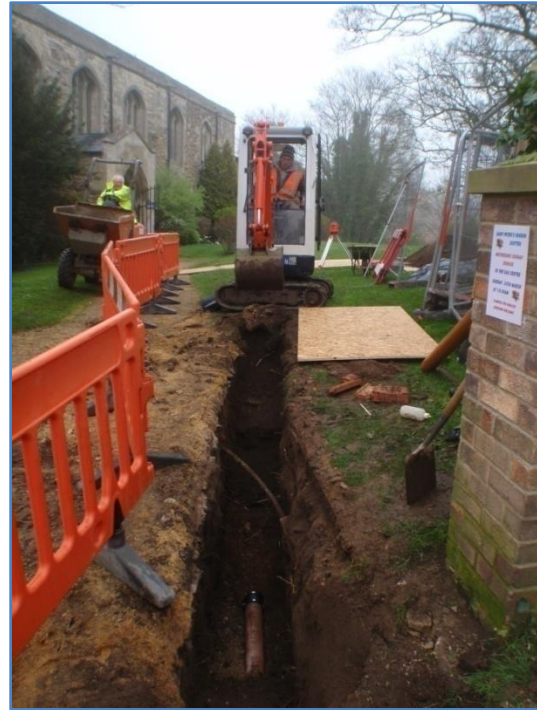
**Plate 36:** Mechanical excavation of the first service trench, from the west

- 7.2.2 The monitored mechanical excavation of the first service trench commenced by the entrance to the churchyard and extended eastwards to a length of approximately 9.0m, to a width of 0.50m, and to depths of 1.30m-1.40m below ground levels [Plates 34-36, 38-41 and 43]. This excavation identified a simple deposit sequence which comprised a very deep and substantial graveyard soil horizon (005). A large number of disarticulated human bones were recovered from this deposit for collection and for eventual reburial. No *in situ* inhumation burials were identified and there were no other finds from this deposit. The graveyard soil horizon (005) overlay a natural horizon (006), which was only encountered at the very base of these excavations. This deposit sequence was recorded within this first service trench within **Representative Sections 1 and 2** [Plates 37 and 42]. One modern disturbance comprising a redundant electricity cable trench traversed the line of this new excavation at a depth of 0.55m below ground levels.

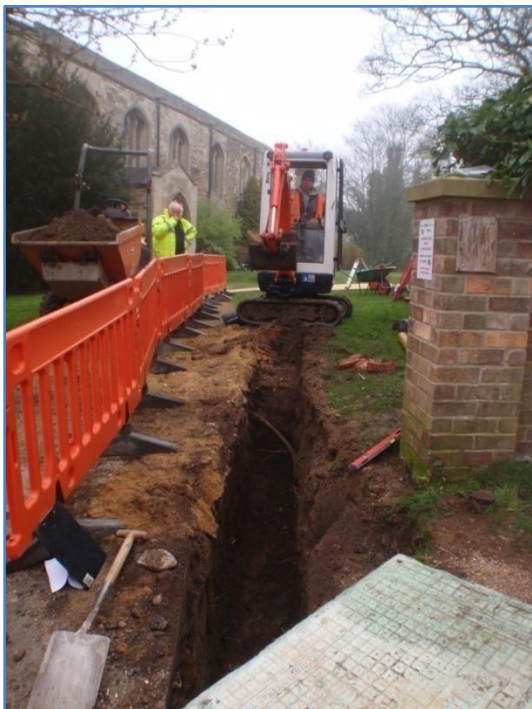
**Plate 35:** Mechanical excavation of the first service trench, from the west

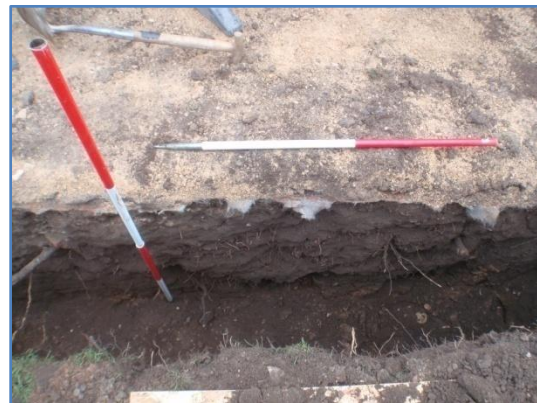
**Plate 37: Representative Section 1,** from the north

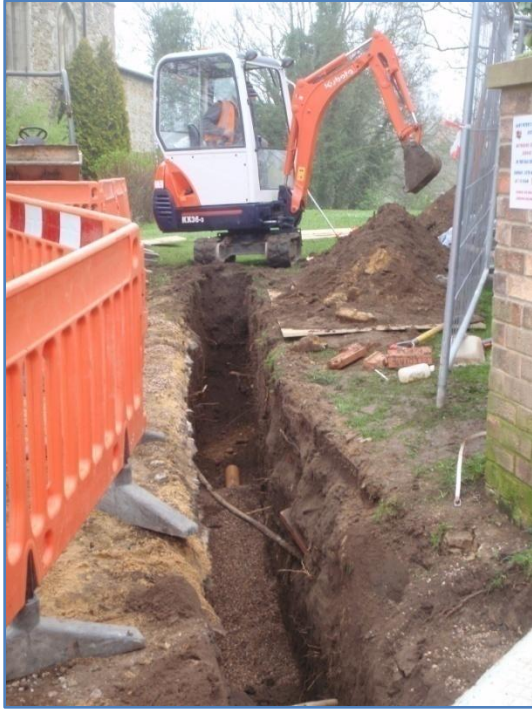
**Plate 38:** Mechanical excavation of the first service trench, from the west

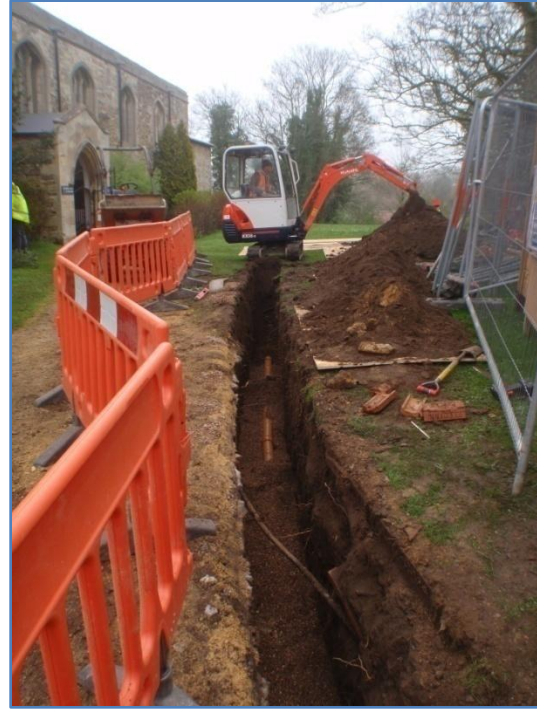
**Plate 40:** Mechanical excavation of the first service trench, from the west

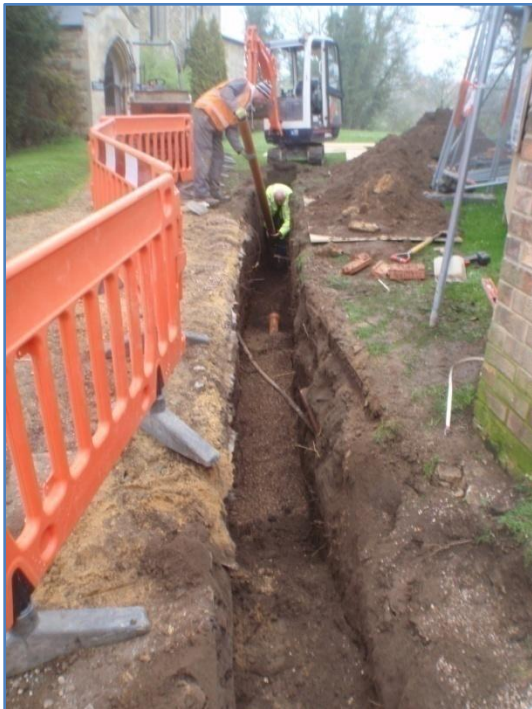
**Plate 39:** Mechanical excavation of the first service trench, from the west

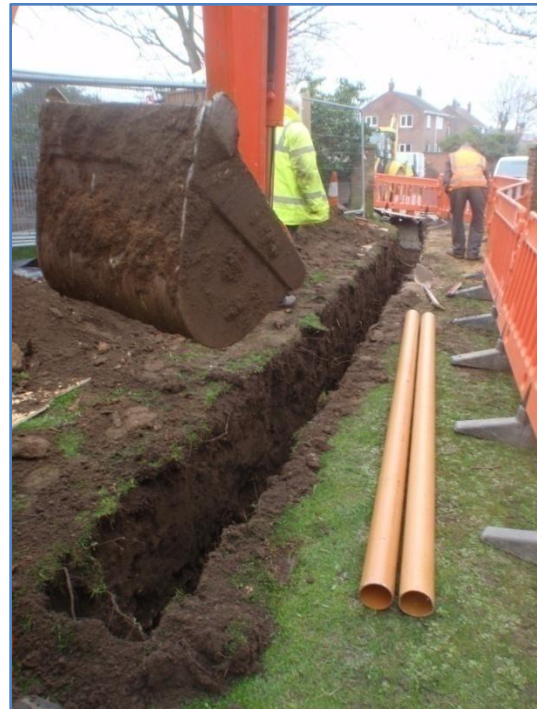
**Plate 41:** Mechanical excavation of the first service trench, from the east

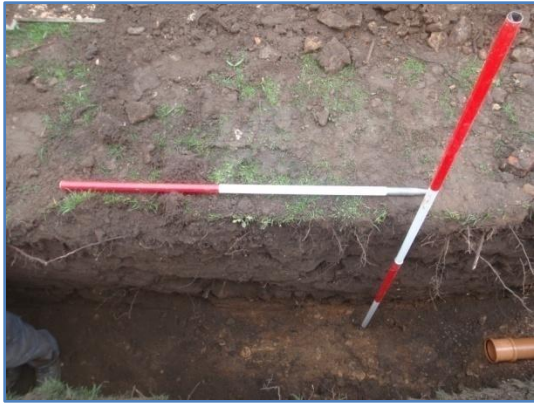
**Plate 42: Representative Section 2, from the north**

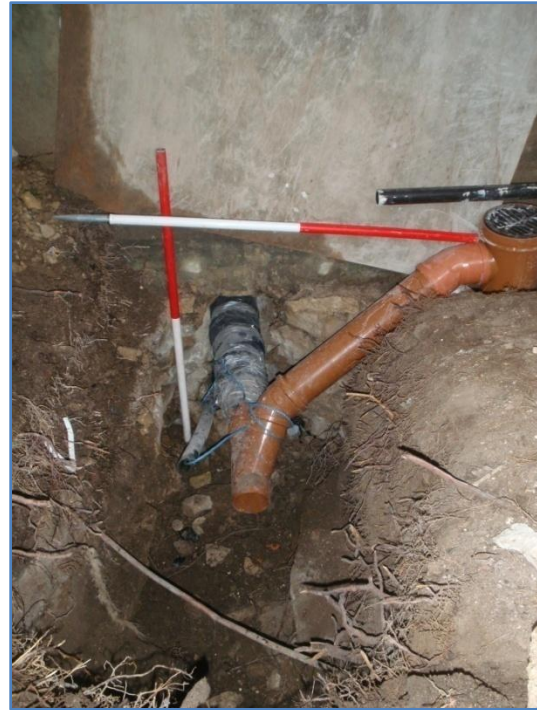
**Plate 44: Exposed foundations of the West Tower & inserted modern services, from the south**

- 7.2.4 The foundations on the southern side of the West Tower had already been exposed and a small section removed by the insertion of modern services (associated with the construction of new toilet facilities within the ground floor of the west tower). The foundations, which were observed to have a relatively shallow depth of 0.80m, was composed of two courses of thickness of shaped and faced limestone blocks, which were bonded by a light buff sandy lime mortar. Below this, and forming the remainder of the exposed foundations was an offset composed of one course of larger rectangular shaped limestone blocks, bonded by the same material. Above this exposed foundation was a layer of modern concrete of some 0.20m in thickness which comprised a curved drainage gully extending around the base of the west tower [Plate 44].

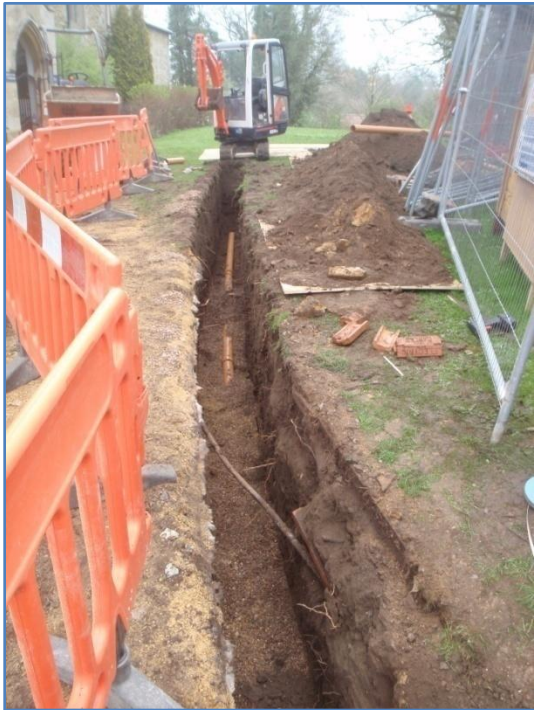
**Plate 43: Mechanical excavation of the first service trench, from the west**

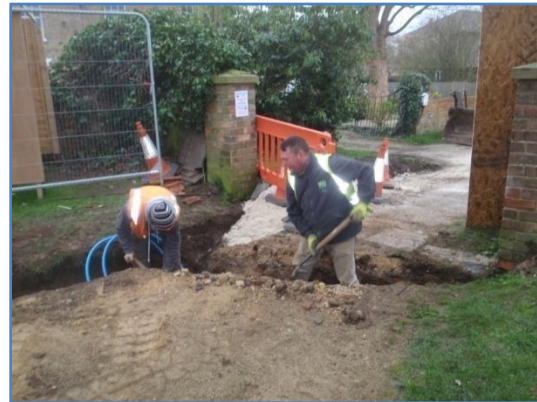
**Plate 45: Hand excavation of a service trench across the churchyard entrance, from the east**

- 7.2.3 A second trench was excavated by hand across and just by the entrance to the churchyard and joined the first service trench at its western end by the churchyard entrance. This trench was excavated to a length of 2.70m, to a width of 0.40m and to an average depth of 0.70m below ground levels [Plate 45]. The purpose of this second excavation was to connect to existing services. This second excavation also extended across the line of the existing modern churchyard pathway of crushed stone, which was found to have a depth of 0.10m. This layer of crushed stone was in turn found to lay on a terram bed. Underlying this terram bed was a modern made ground deposit (007), which was probably associated with the construction of this pathway. The deposit (007) in turn overlay the graveyard soil (005), which extended to the base of this excavation. The deposit (005) did not yield any fragments of disarticulated human bone within this trench excavation.

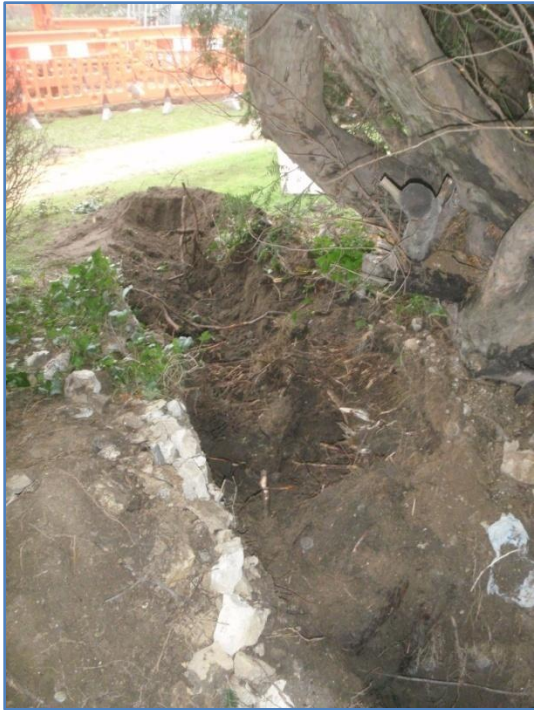
**Plate 46:** Mechanical excavation of the third service trench from the West Tower, from the north

with the depth of this trench gradually increasing to the south [**Plates 46-50 and 52-53**]. The same deposit sequence of the very deep and substantial graveyards soils (**005**) overlying the natural horizon (**006**) was also encountered within this trench. The deposit (**006**) was only encountered towards the south at the deeper levels reached and only at the base of the excavation. This deposit sequence was recorded within a third **Representative Section 3** [**Plate 51**]. A high density of disarticulated human bone fragments were recovered from the deposit (**005**) for eventual reburial, though no *in situ* inhumation burials were encountered.

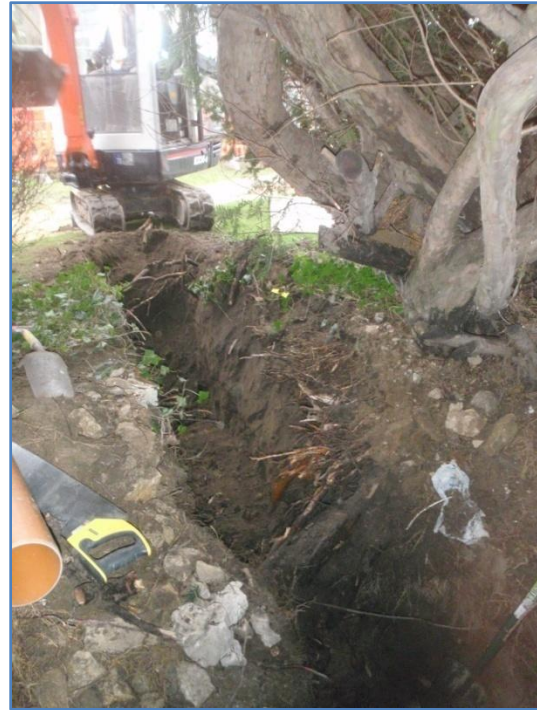
**Plate 48:** As **Plate 46**, from the north

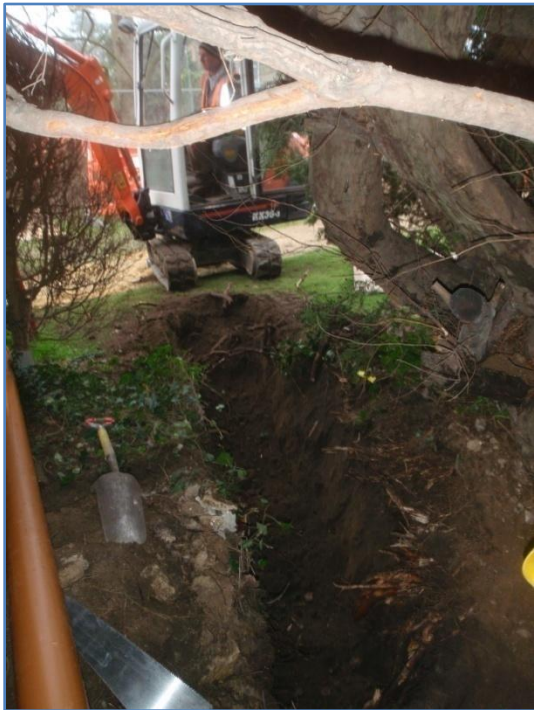
**Plate 47:** As **Plate 46**, from the north

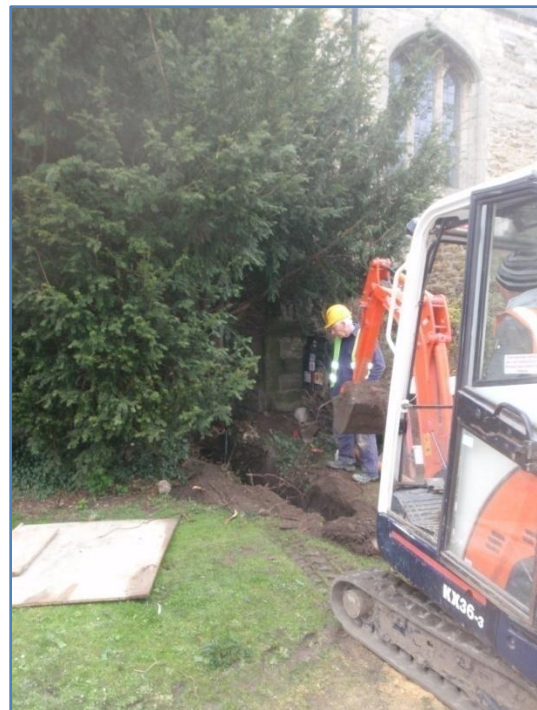
**Plate 49:** As **Plate 46**, from the south

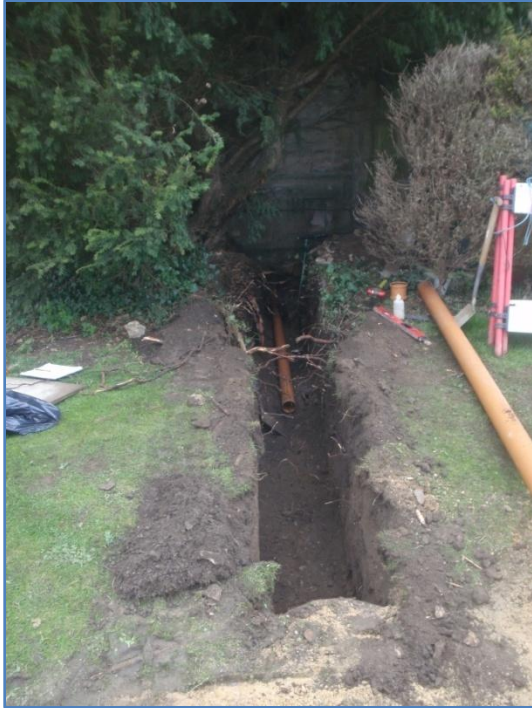
**Plate 50:** As **Plate 46**, from the south

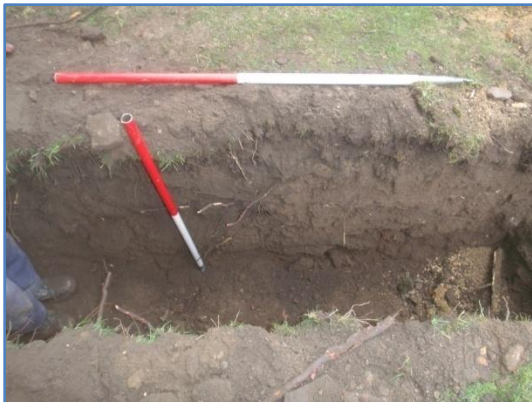
**Plate 51:** Representative Section 3, from the west

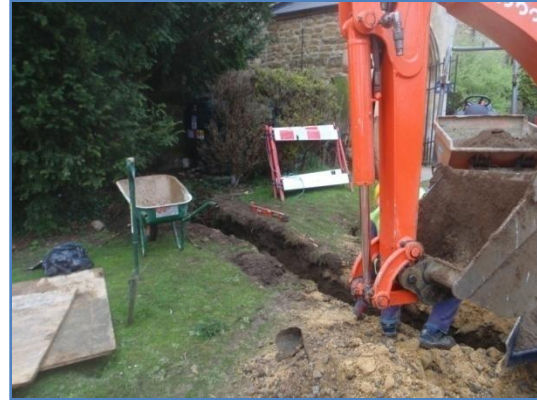
**Plate 52:** As **Plate 46**, from the south

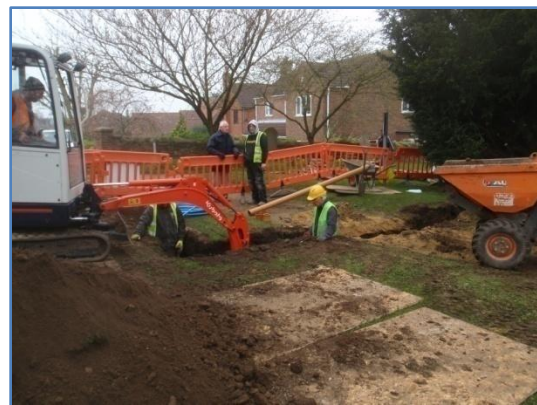
**Plate 53:** As **Plate 46**, from the east

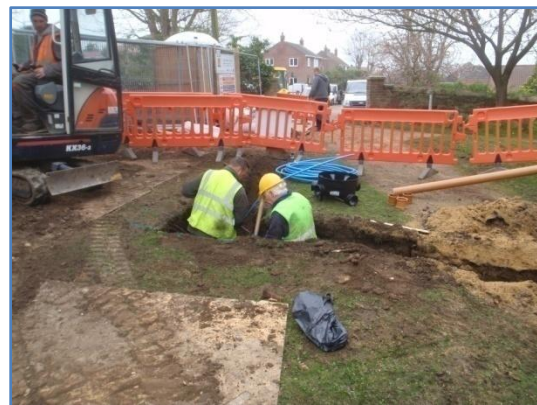
**Plate 54:** Hand excavation of a new manhole, from the east

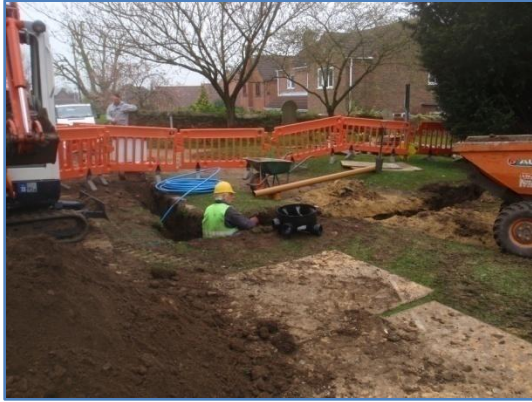
**Plate 55:** As **Plate 54**, from the east

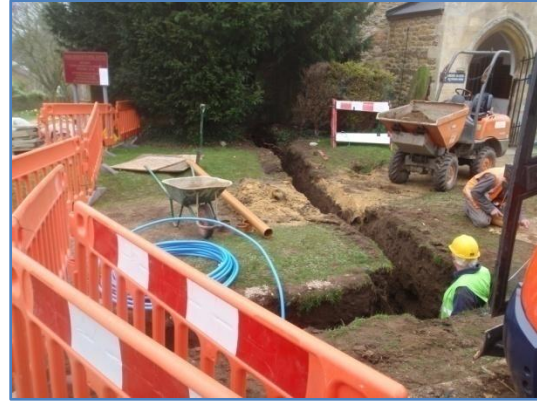
**Plate 56:** Completed service trench and manhole excavations, from the south
