YONSEA FARM, HOTHFIELD, KENT

ARCHAEOLOGICAL ANALYSIS DURING DISMANTLING

Environmental Statement Route Window 31

Oxford Archaeological Unit
August 2000

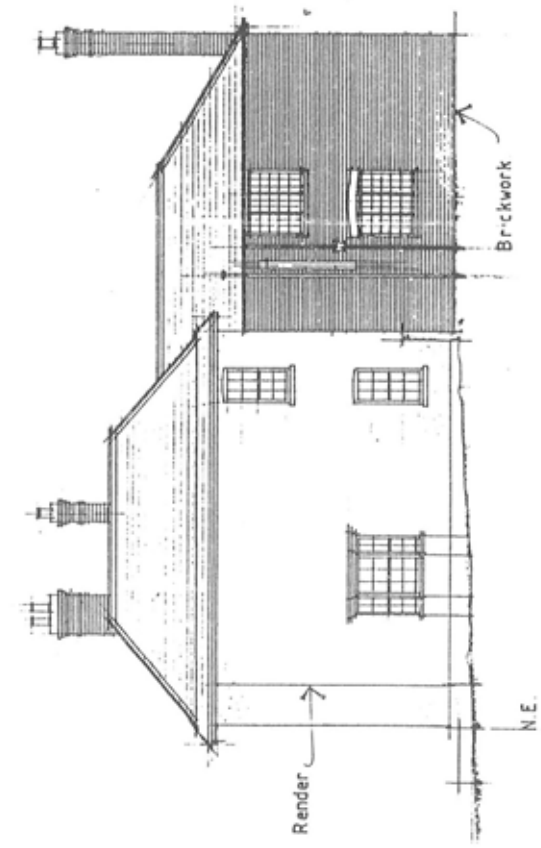
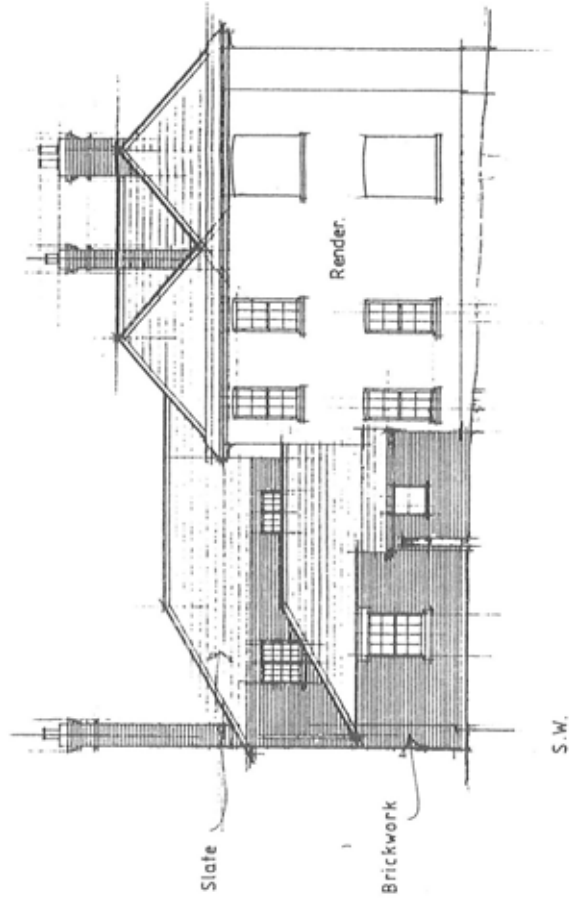
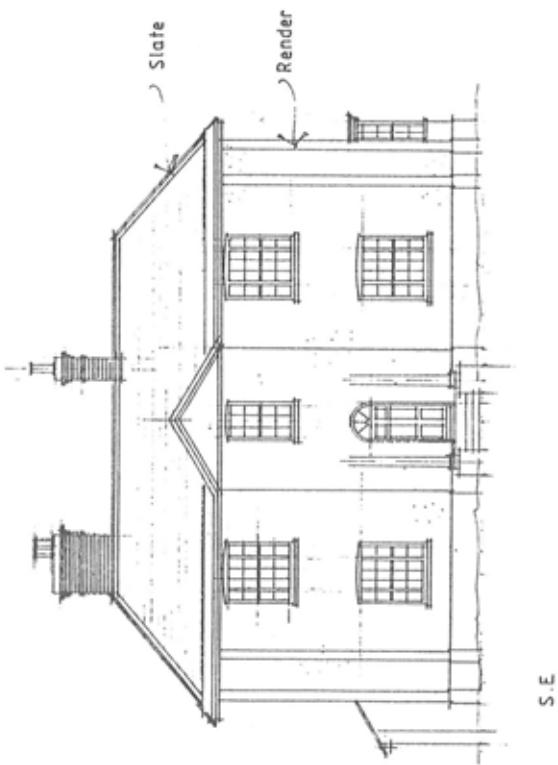
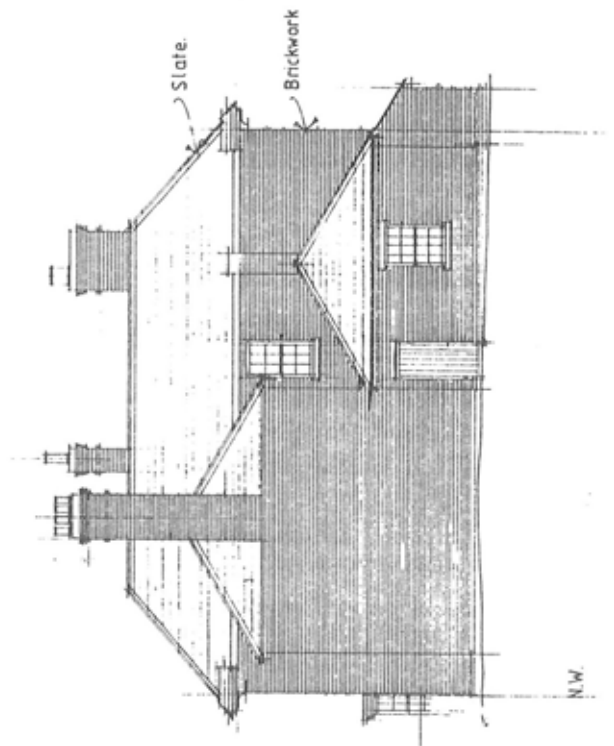
Figure 2: Elevations of the Farmhouse, 1:200 (N J McAnally & Associates)

5.2.3 External Appearance (Figure 2, Plate 1)

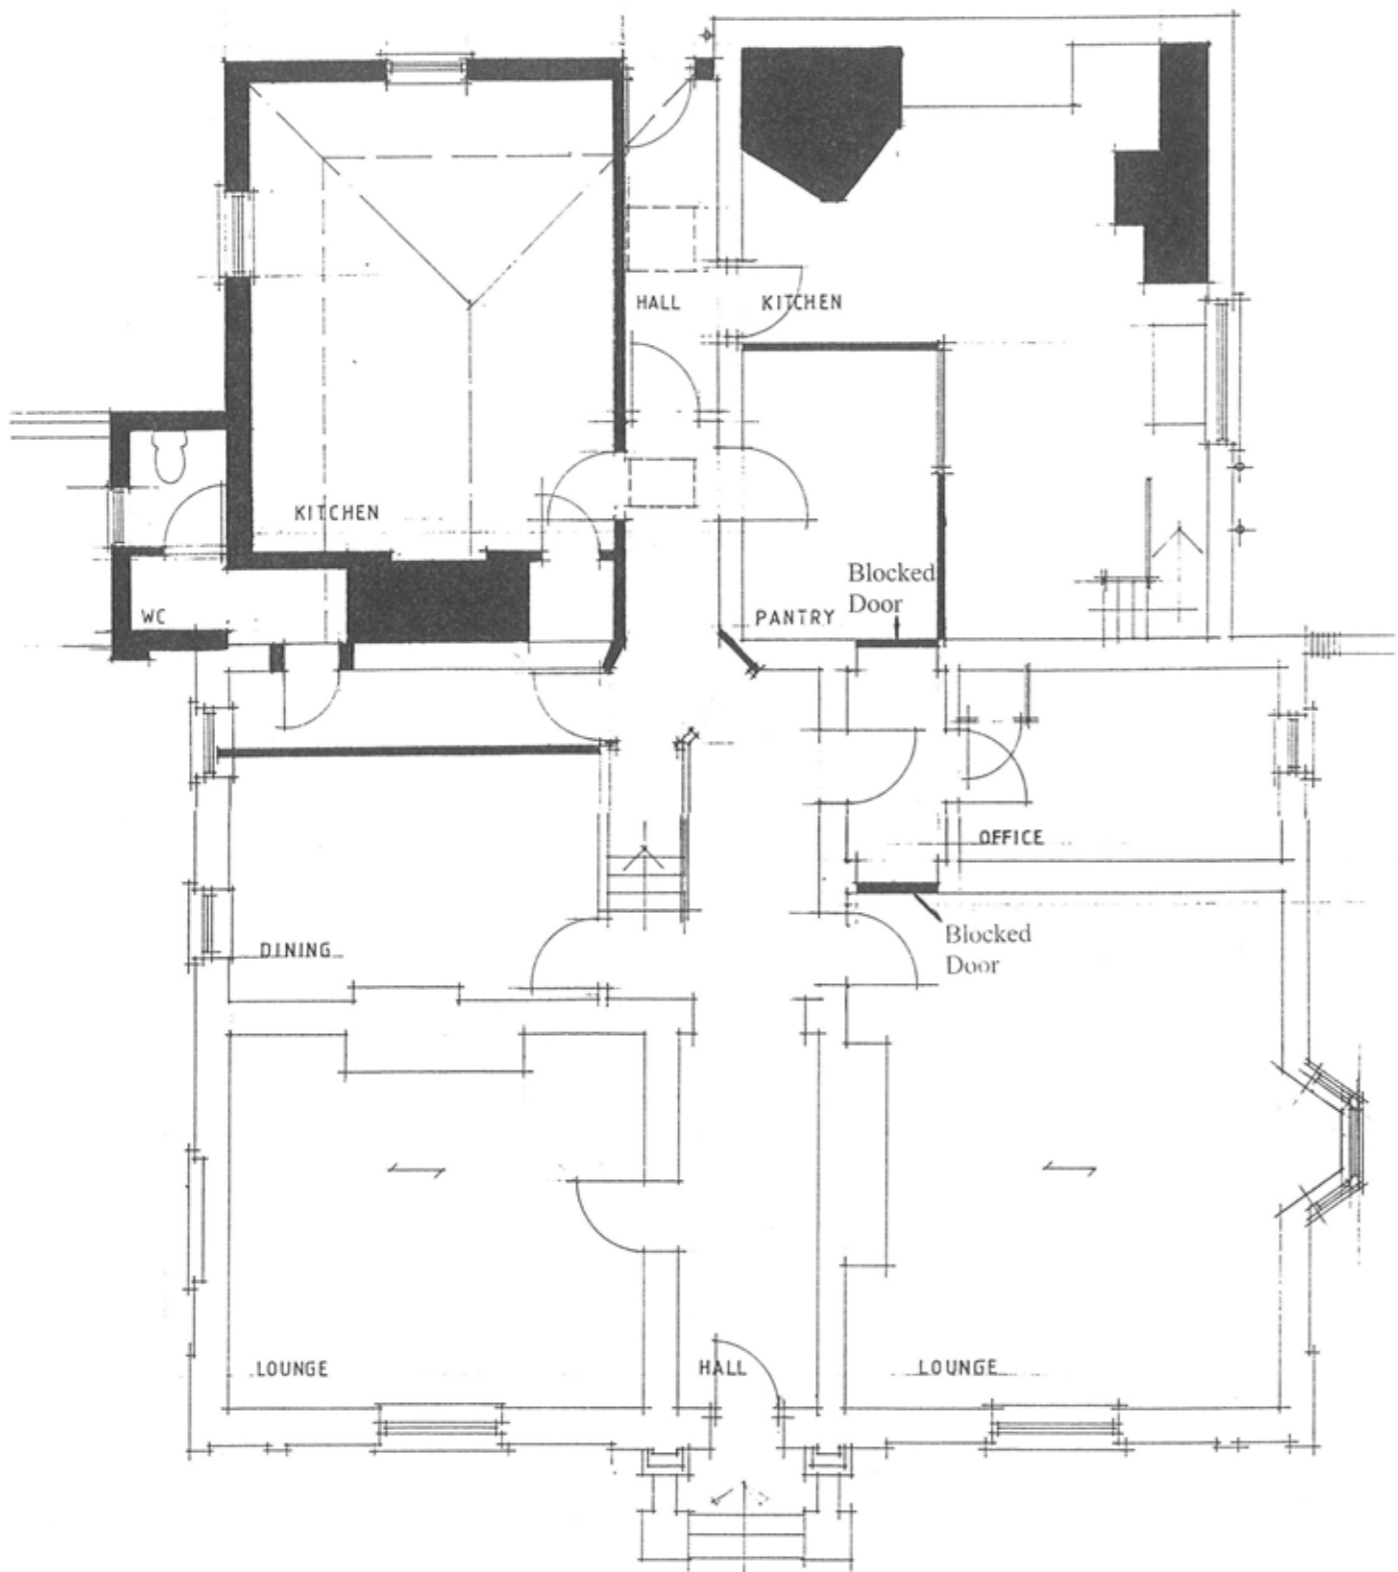
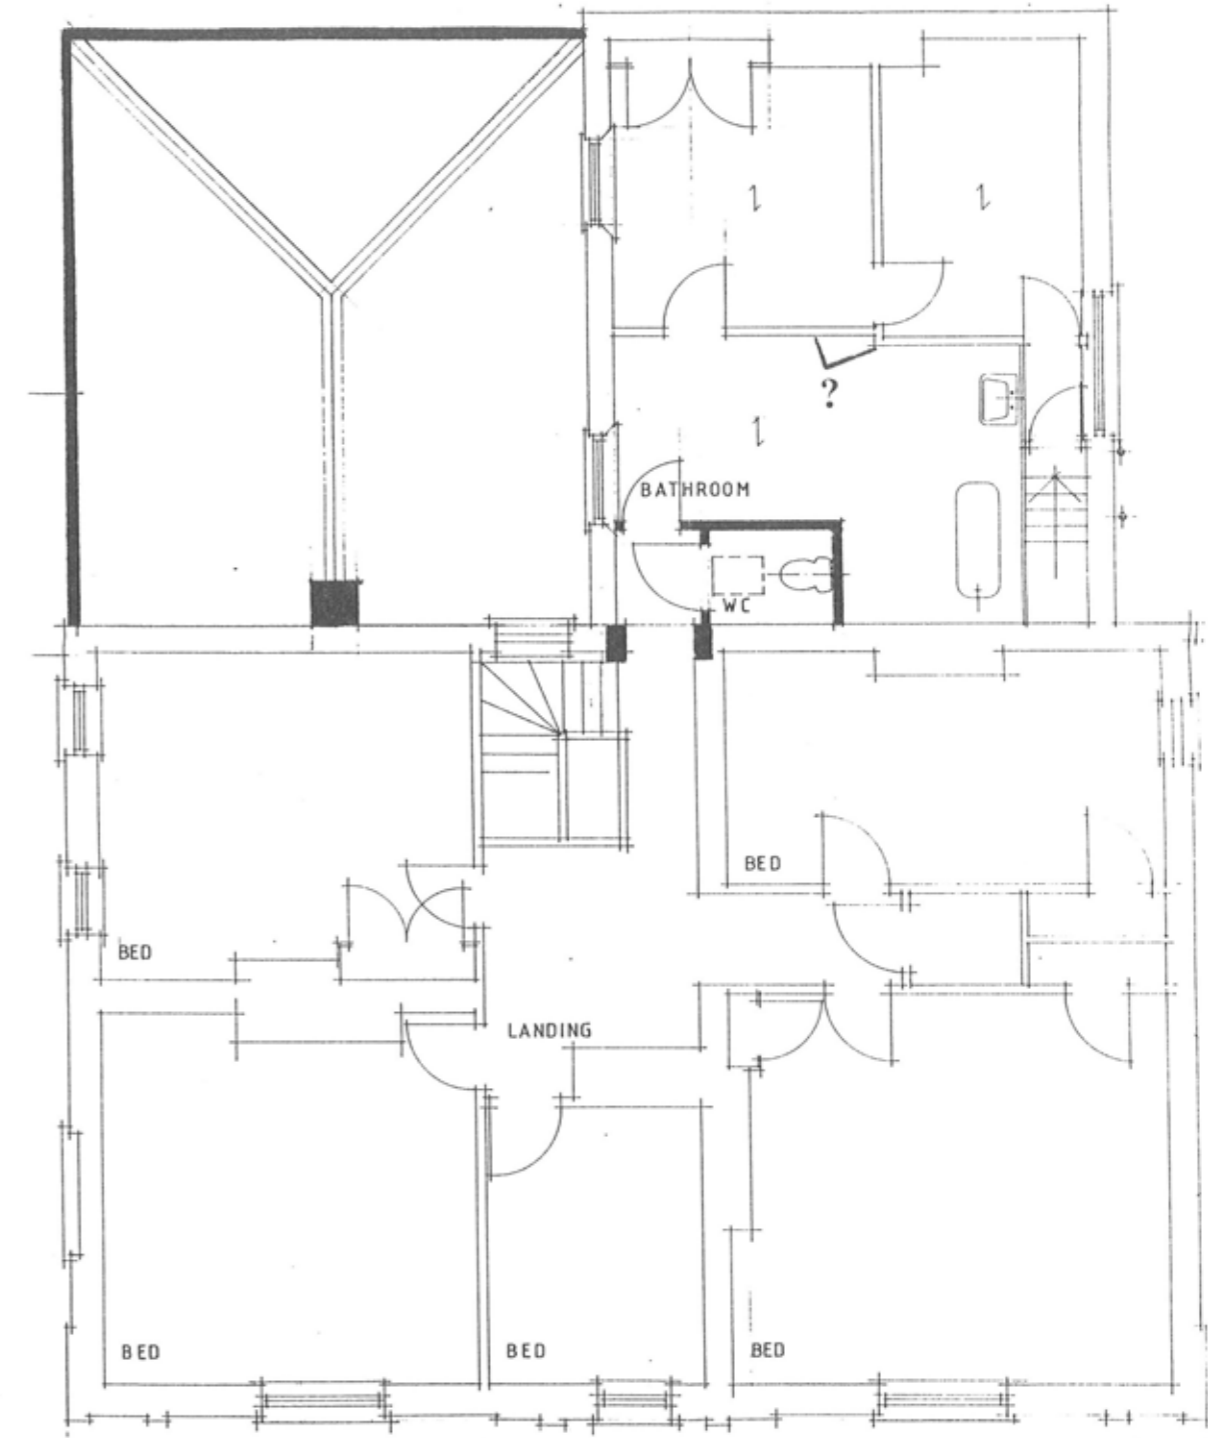
Figures 3 & 4:
Ground and first floor plans of the Farmhouse, 1:100
(Base by N J McAnally & Associates)

5.2.4 Internal Plan and Features - the ground floor (Figure 3)

- 5.2.5.1 The basement of the building is to be retained in situ for the protection of a colony of bats. The area of the basement extends from the east front of the house to the east wall of the kitchen and from the south wall of the building to the north wall of the entrance hall (Figure 3). It is accessed from a brick built stair case under the main stair in the entrance hall. The basement area is divided into three rooms relating to the south front room, the south back room and the entrance hall. The 1850 estate report (Appendix B) states that the basement functioned as a pantry and dairy and some evidence survives for these uses. The entrance hall area is surrounded by drainage channels and has evidence of brick piers, some of which survive, which may have supported stone sinks or work surfaces on which the milk pans could have rested. The floor as in all the basement is of laid bricks. The roof appears to be of reinforced cement and may represent a war-time conversion of the basement to air raid shelter. The two rooms to the south are both lit by semi-subterranean windows in the south wall of the building. The room to the east has no evidence for function. Projecting from the west wall are two brick piers which arch and merge together at ceiling height and support the hearth and stack above, and a similar arrangement is seen on the other side of the wall in the back room basement area. The ceilings in these two rooms are the underside of the wooden floor construction of the ground floor. The central beam onto which the joists are fixed is angled to avoid the hearth but runs approximately east – west with the joists running north-south. In the back room basement area the majority of the walls are lined with the brick piers seen in the corridor area, again presumably for storage space or work surfaces. Some of the piers remain whilst others have been demolished retaining

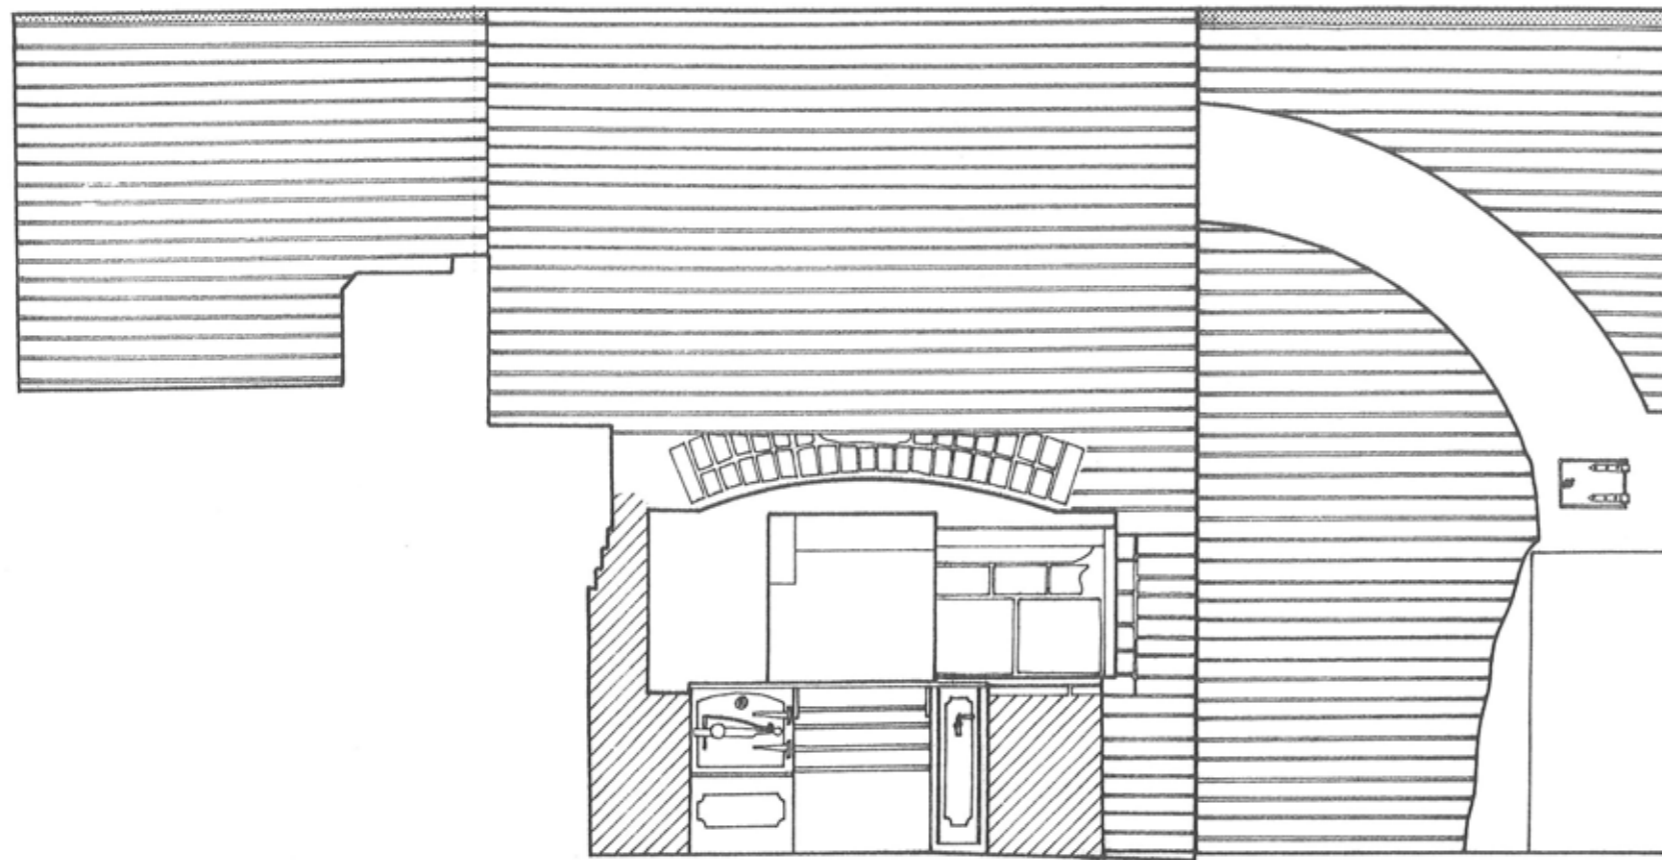
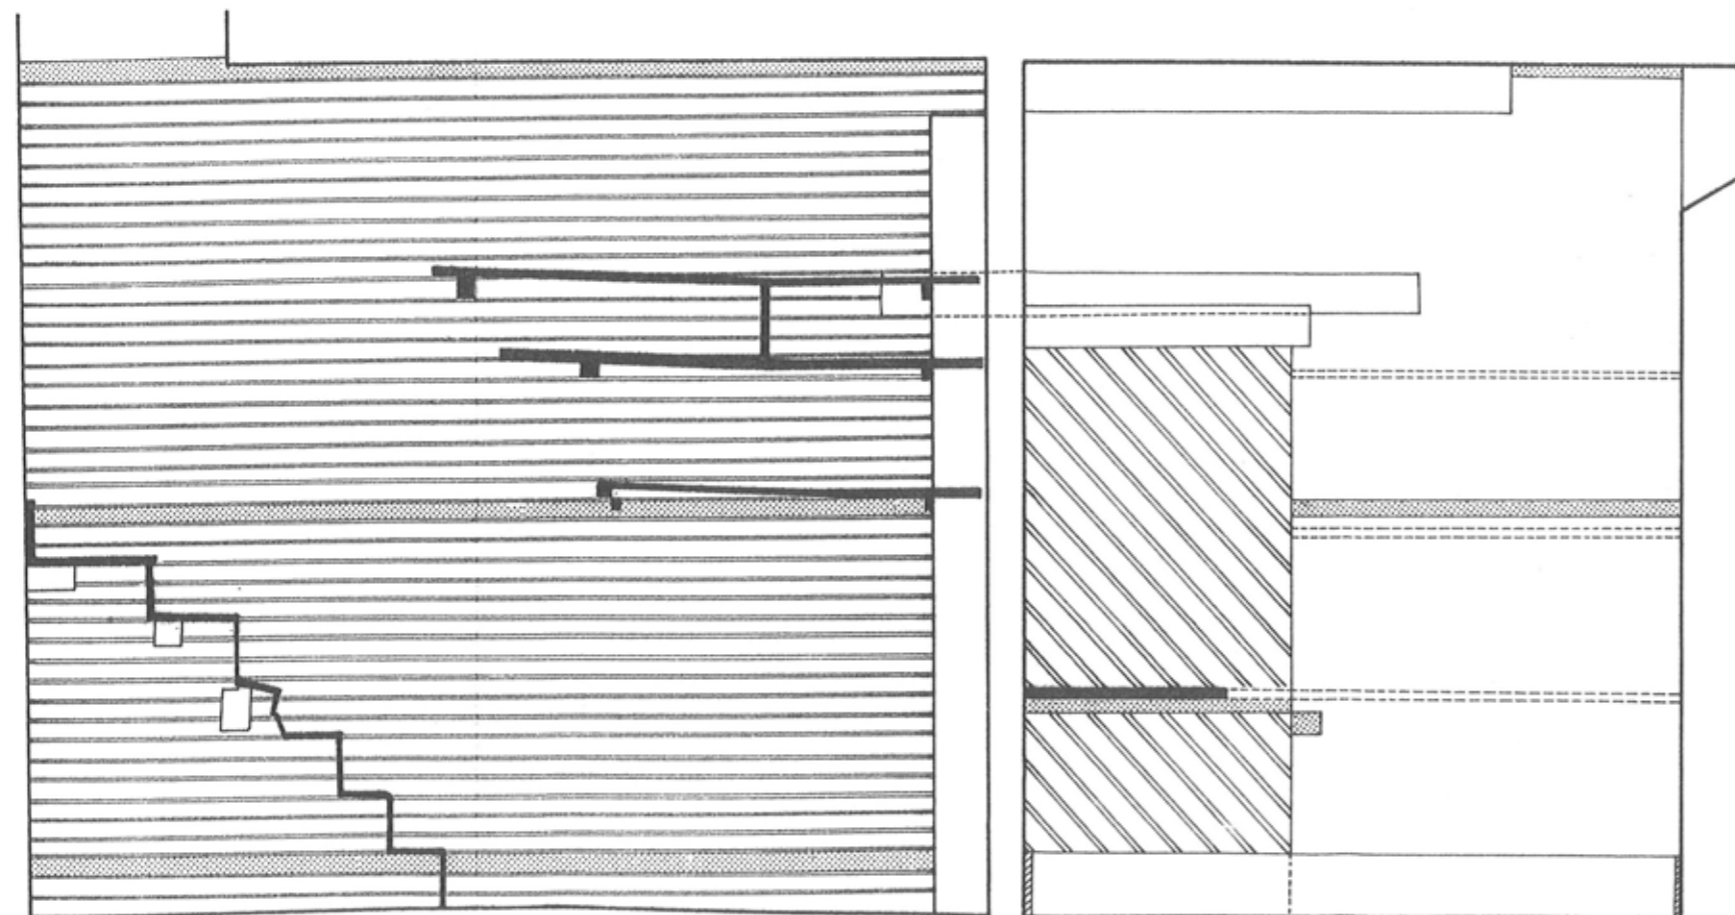
Figure 6: Farmhouse kitchen elevations

Elevation C-C

Elevation D-D

Architectural Survey		
Client:	Rail Link Engineering	
Subject:	Yonse Farm, Ashford, Kent. Farmhouse Kitchen. WALL ELEVATIONS (1 OF 3)	
Survey Date:	October 1998	
Surveyed by:	RDT-KSN	
Drawn by:	RDT	
Scale as drawn:	1:20 (at A2)	
Drawing No.:	ASYON.BS.98/002	
Issue Date:	November 1998

The Northern Kitchen (Figures 6-9, Plate 2)

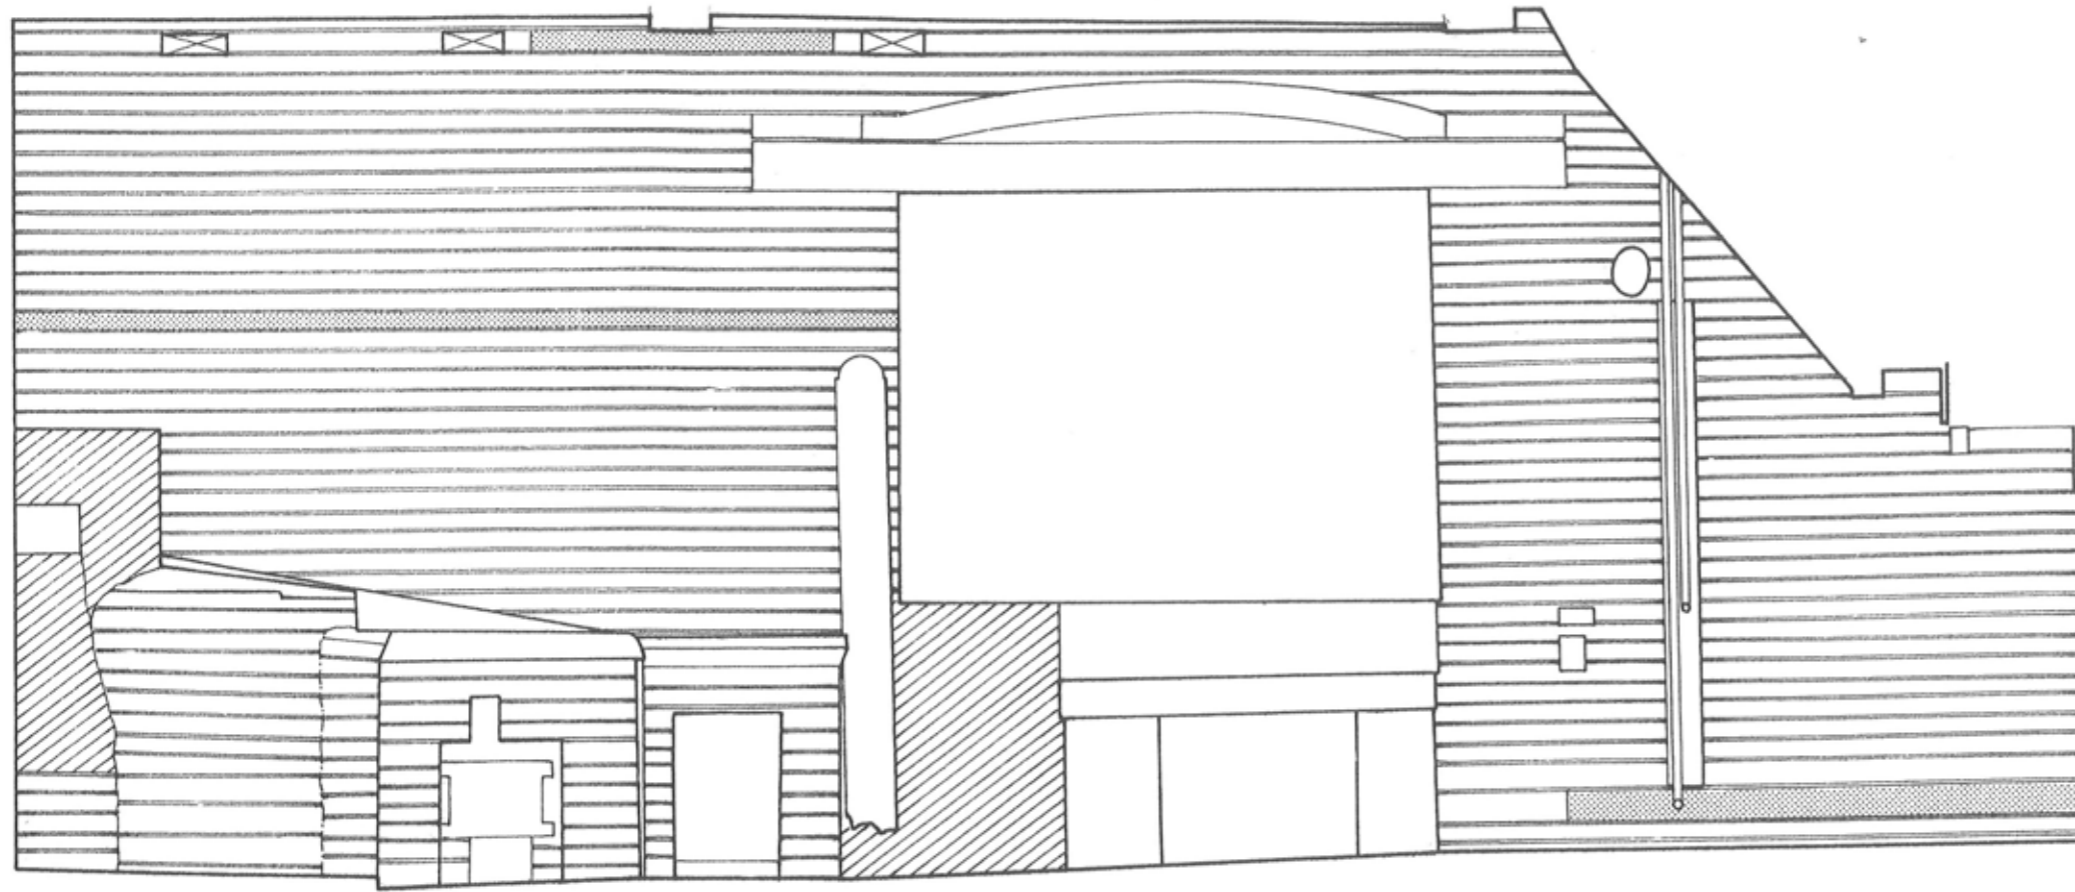
Figure 7: Farmhouse kitchen elevations

Elevation A-A

Elevation B-B

Architectural Survey		
Client:	Rail Link Engineering	
Subject:	Yonseas Farm, Ashford, Kent. Farmhouse Kitchen. WALL ELEVATIONS (2 OF 3)	
Survey Date:	October 1998	
Surveyed by:	RDT-KSN	
Drawn by:	RDT	
Scale as drawn:	1:20 (at A2)	
Drawing No.:	ASYON.BS.98/003	
Issue Date:	November 1998

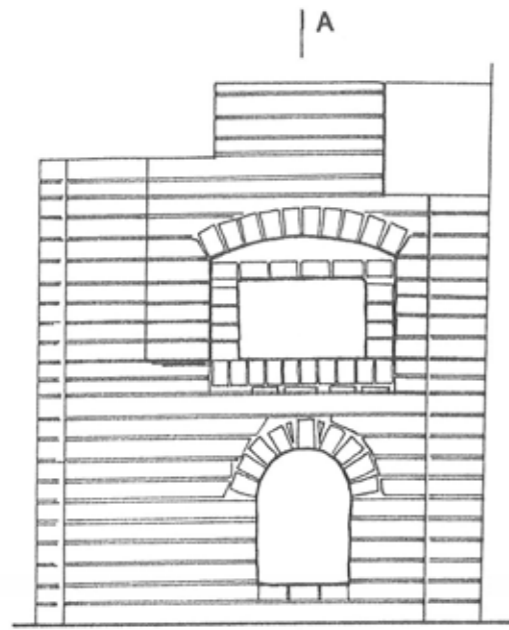
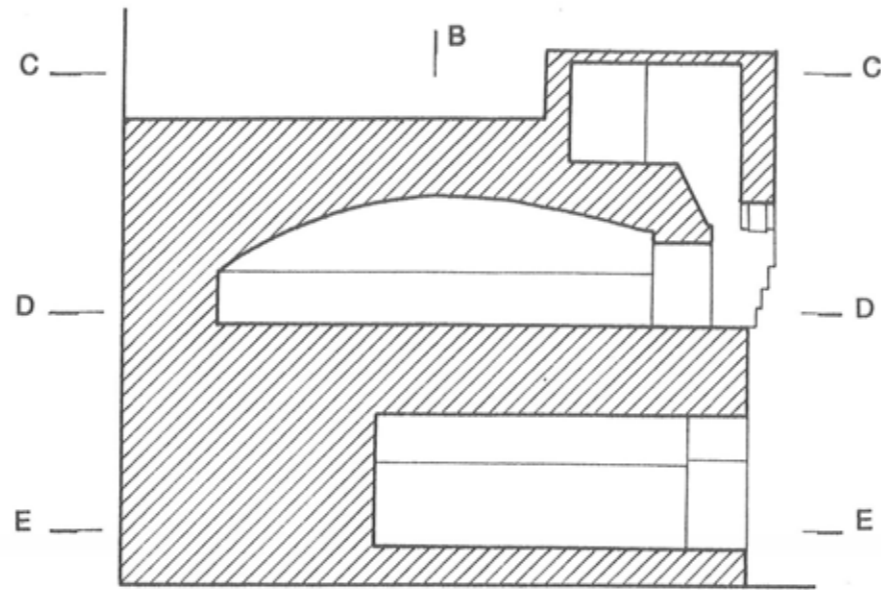
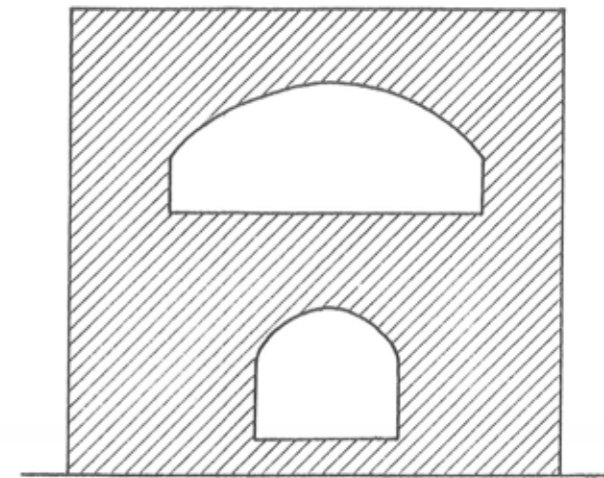
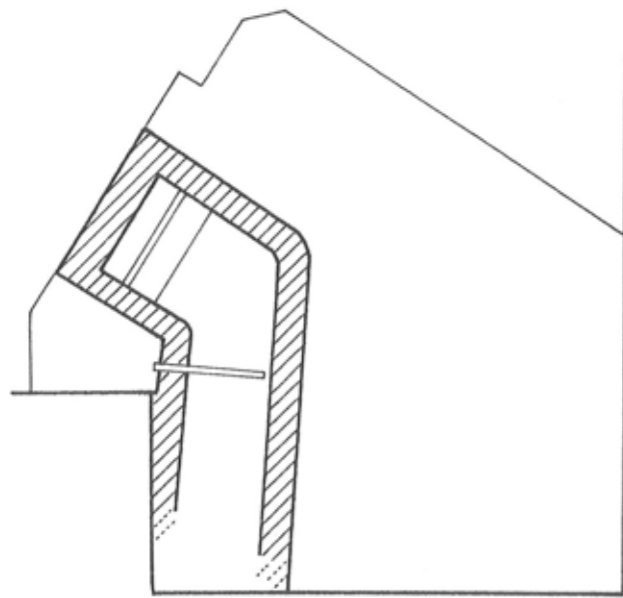
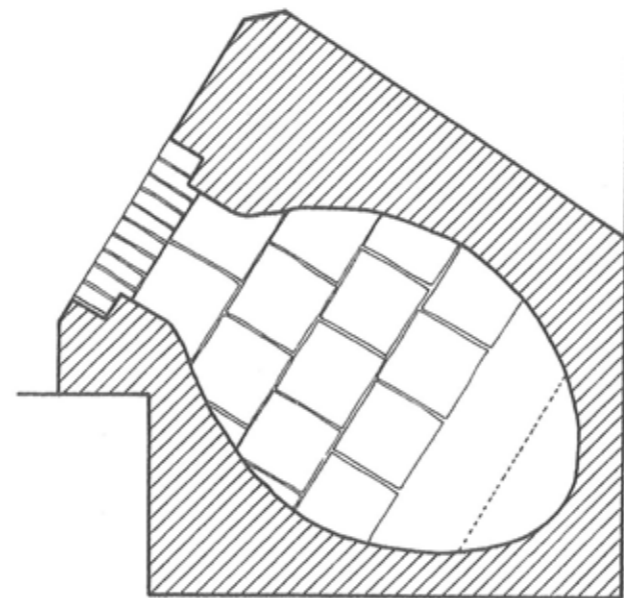
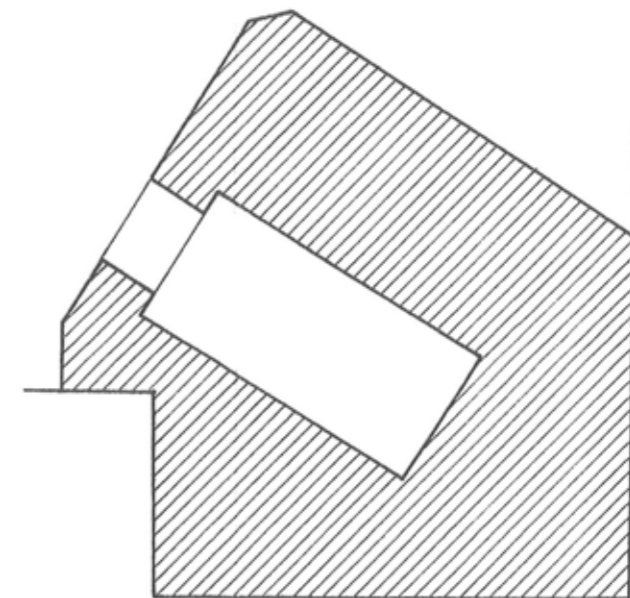
Longitudinal section A-A

Cross section B-B

Figure 9:
Farmhouse kitchen, detail of bread oven, (1:20 at A2)

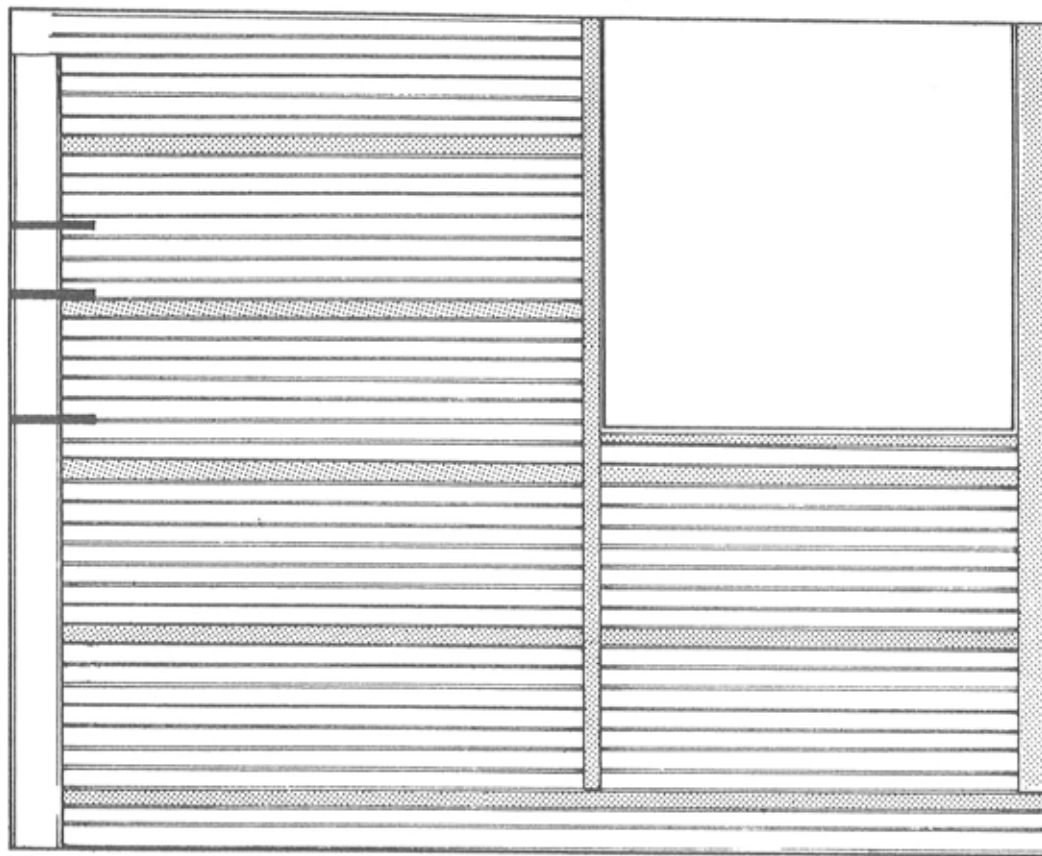
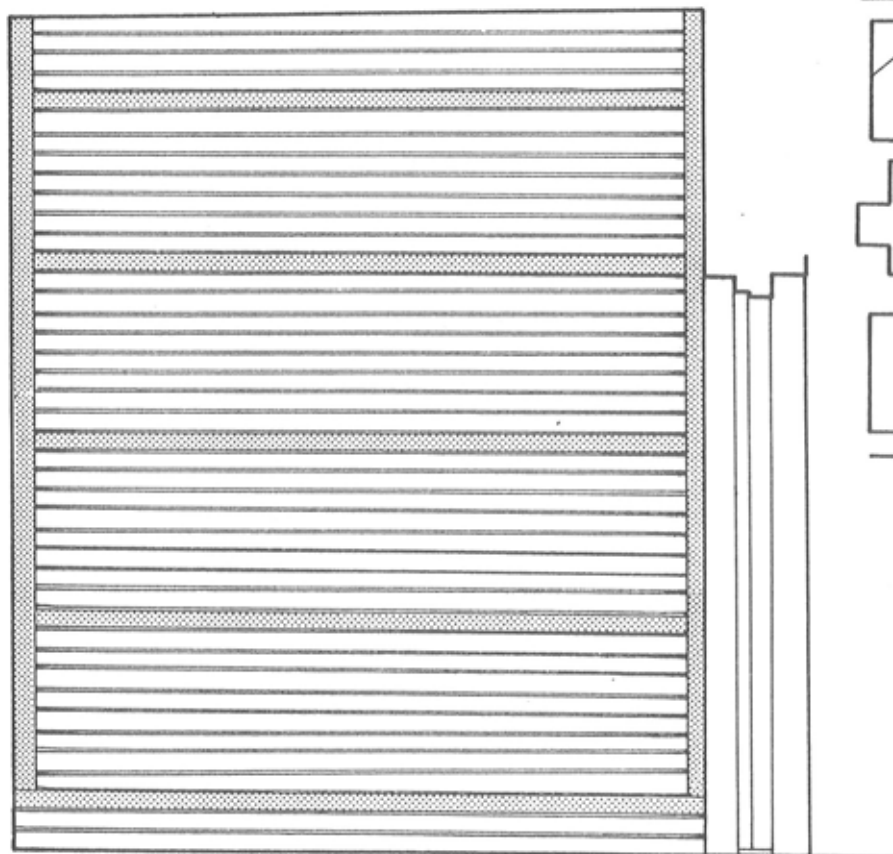
Elevation E-E

Elevation F-F

Figure 8: Farmhouse kitchen elevations, (1:20 at A3)

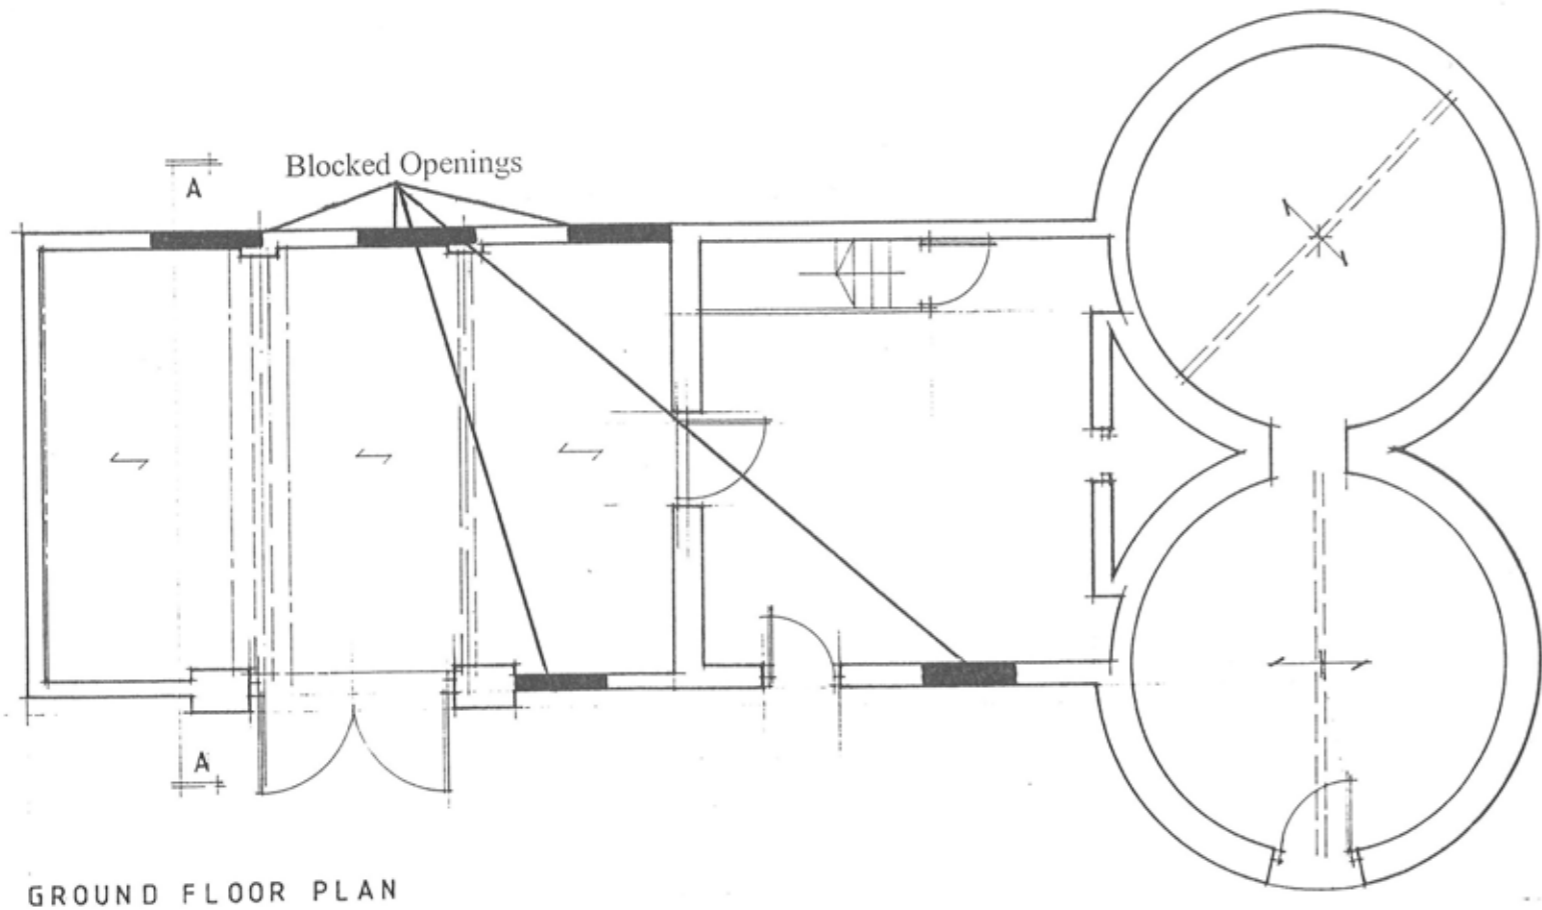
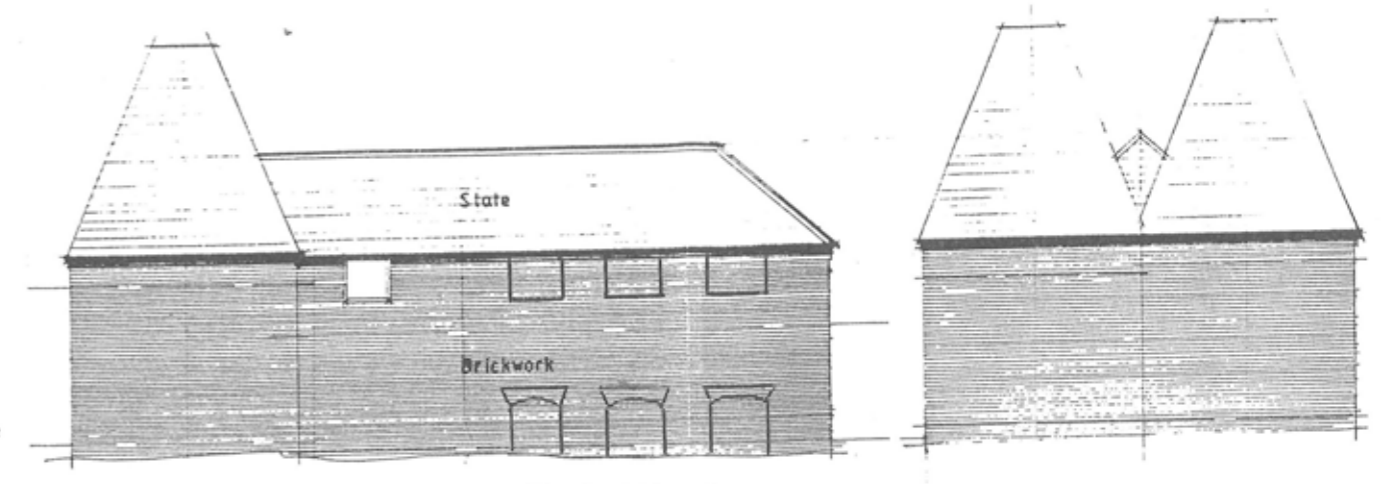
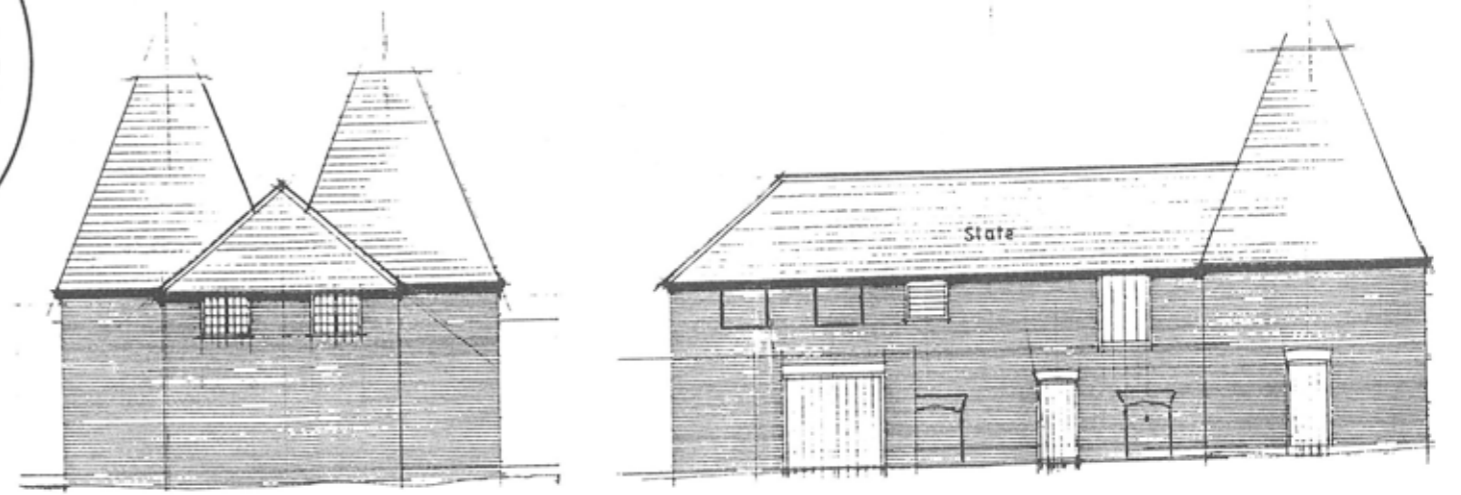
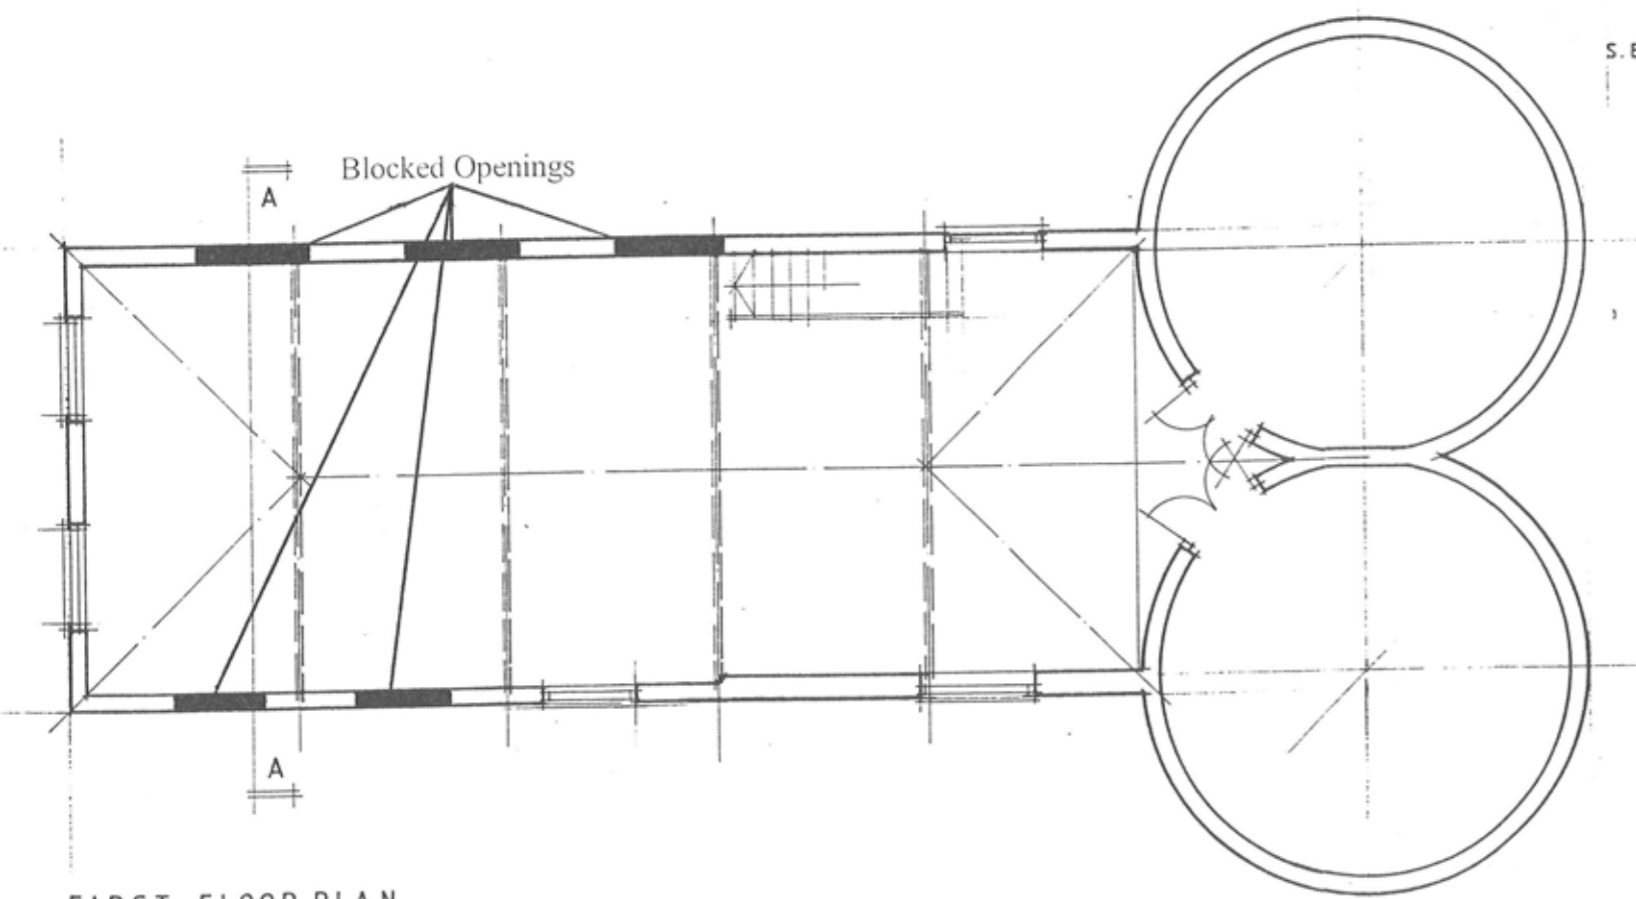
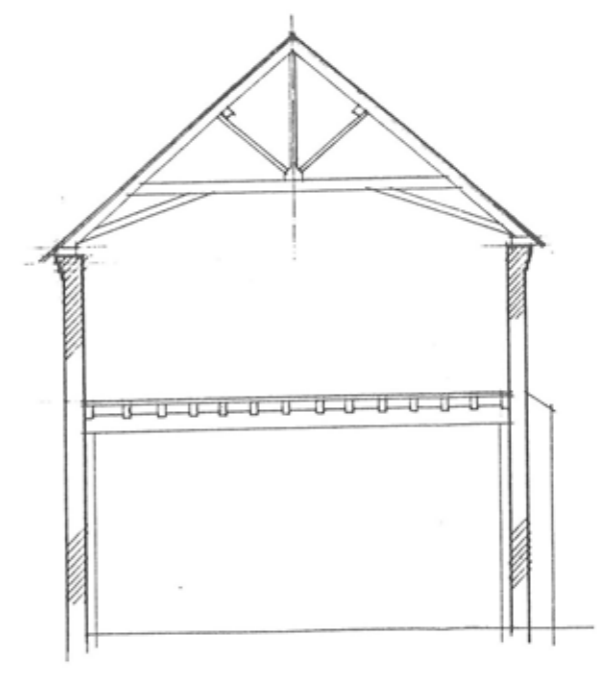
GROUND FLOOR PLAN

Blocked Openings

FIRST FLOOR PLAN
Building n°3

SECTION A-A

Figure 12:
The Oasthouse, 1:100 & 1:200
(N J McAnally & Associates)

5.4 **The Oasts** (Building 3, Figure 12, Plate 7)

- 5.4.4.1 The ground floor area of the building adjoining the roundels is divided into two rooms with an interconnecting door in the brick partition wall. The flooring is of brick tiles. The angle between the two roundels is blocked off at the west end of the western room and used as a storage area. The flight of stairs to the first floor is along the south wall of this room enclosed behind a door and partition. The north and south walls of the room originally had a further 4 openings as shown in Figure 12, presumably to aid ventilation and provide natural light.

- 5.4.4.2 The first floor of the building functioned as one area open to the roof trusses. Unlike the ground floor it has natural light from casement windows in all three external walls, as well as a door in the north wall at the west end. Originally there were a further 5 windows in the north and south walls, shown in Figure 12. The stairs to the south-west of the room have a door and waist height partition around them. The partition is on hinges and can be dropped to floor over the stair opening. The walling of the room is plastered and finished with a faded whitewash. On the north wall an imprint of the 'Strouts' hop pocket stencil was seen under the nail on which the stencil would have hung. Some of the trusses also had number stencil imprints on them. It was from this

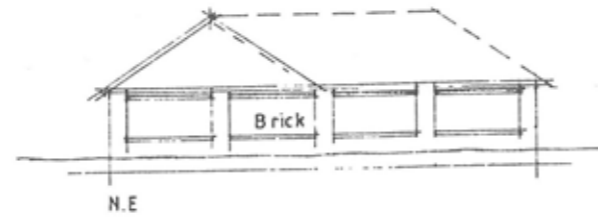
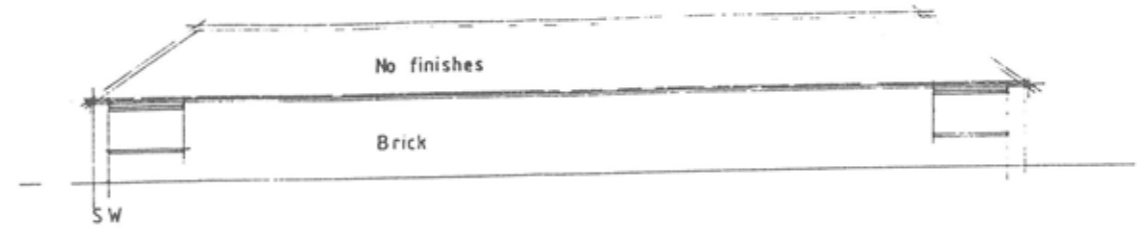
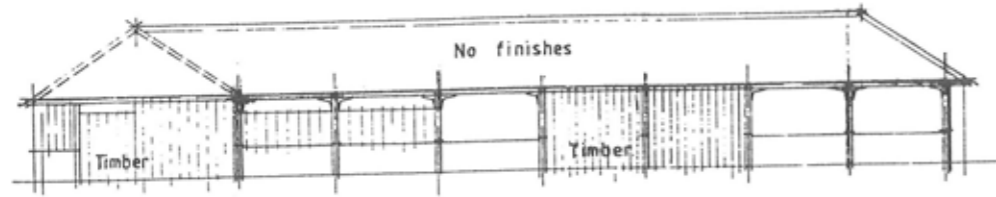
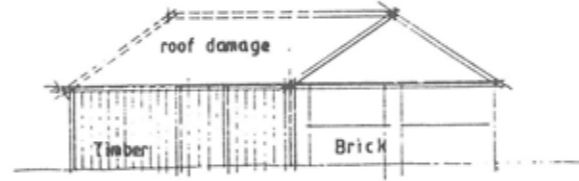
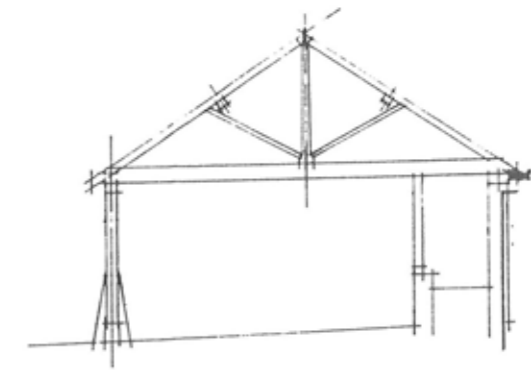
Elevations to building n°7
Scale 1:100

SECTION A-A
SCALE 1:50

DUE TO CONDITION AND NATURE
OF THIS BUILDING THESE DRAWINGS
ARE REPRESENTATIVE ONLY, AND
SHOULD NOT BE READ AS ACCURATE

5.5 **The Loose Boxes and Byres** (Building 7, Figure 13)

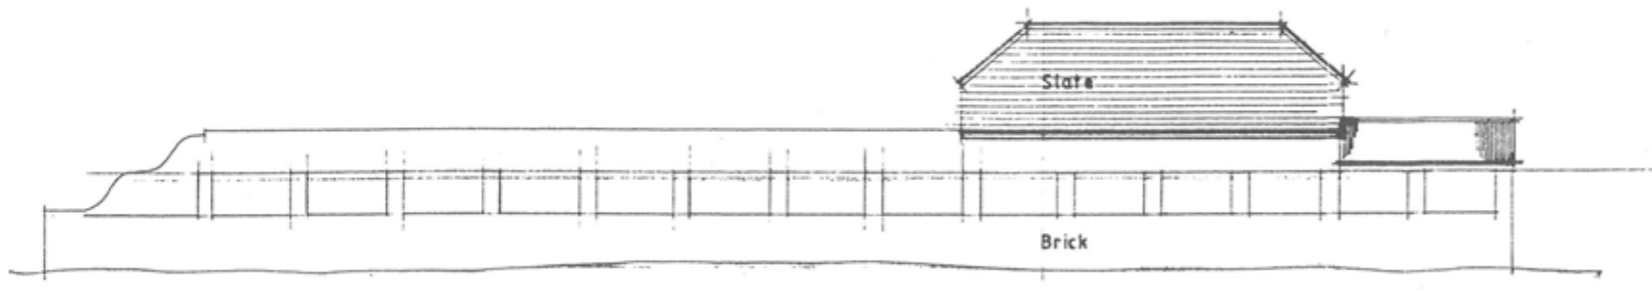
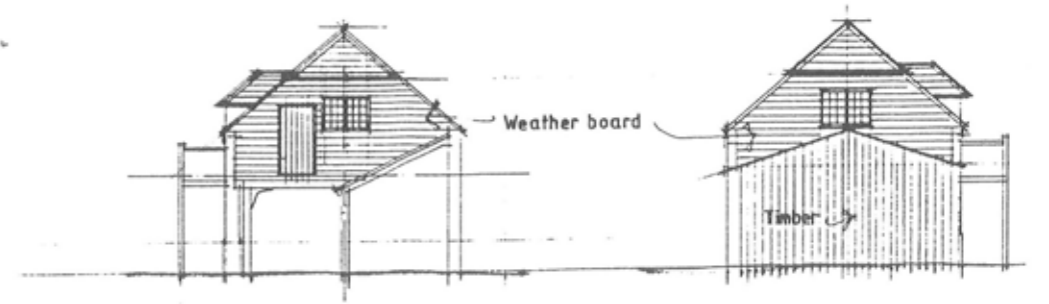
Figure 13:
Loose Boxes and Byres, 1:100 & 1:200
(N J McAnally & Associates)

PLAN
Building n°7
