YONSEA FARM, HOTHFIELD, KENT

ARCHAEOLOGICAL ANALYSIS DURING DISMANTLING

Environmental Statement Route Window 31

Oxford Archaeological Unit
August 2000

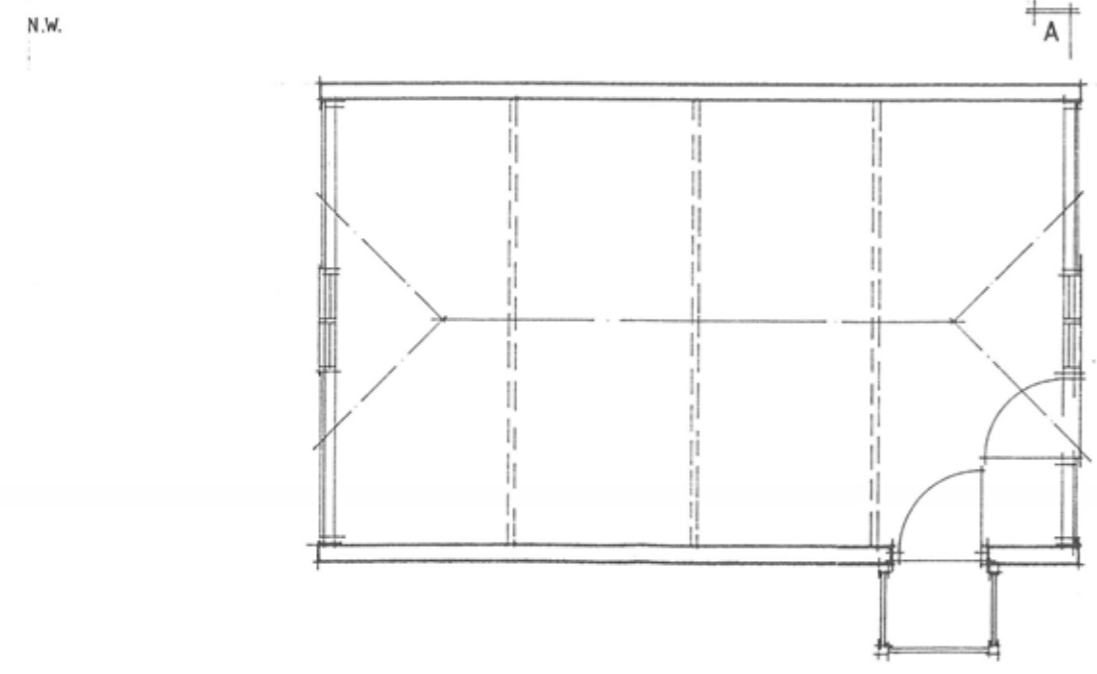
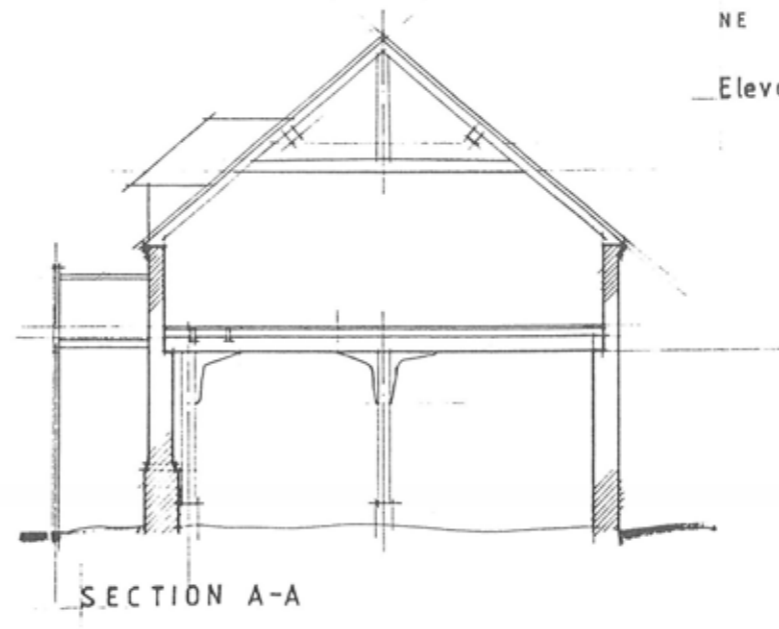
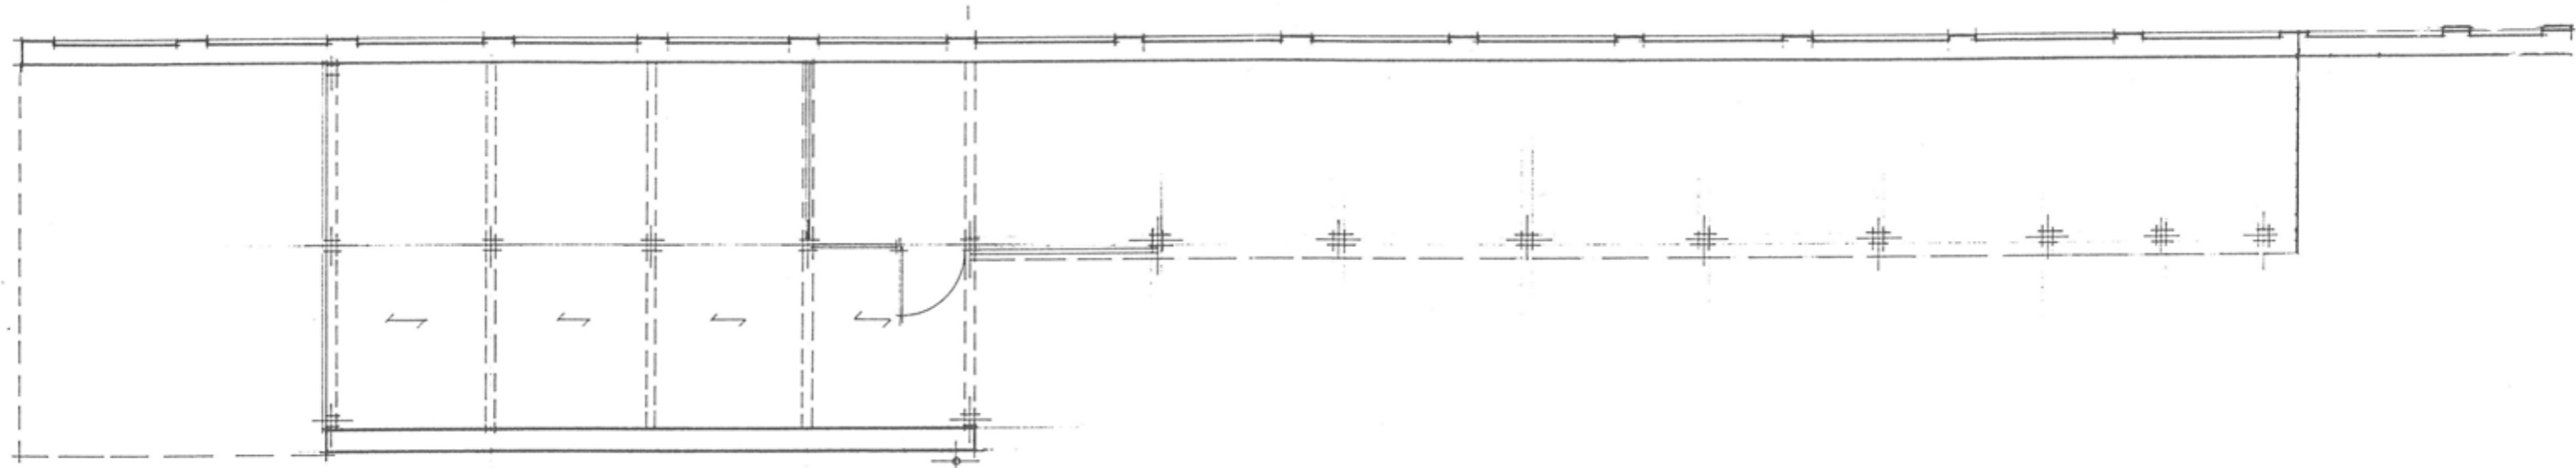
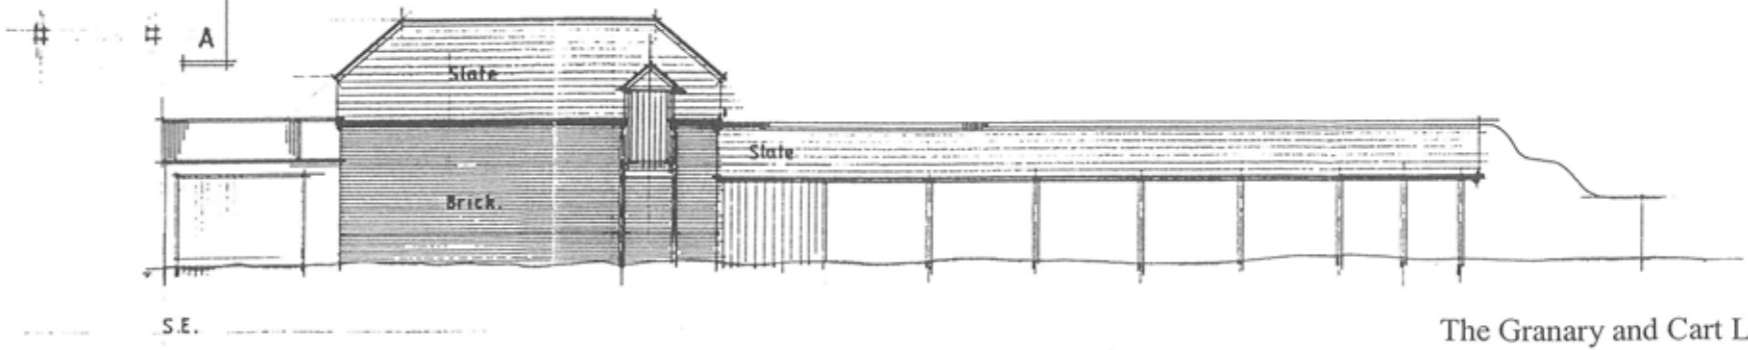
Figure 14:
The Granary and Cart Lodge, 1:100 & 1:200
(N J McAnally & Associates)

NE
SW
Elevations to Granary

GROUND FLOOR
Building n° 6

5.6 **The Granary and Cartshed** (Building 6, Figure 14, Plate 8)

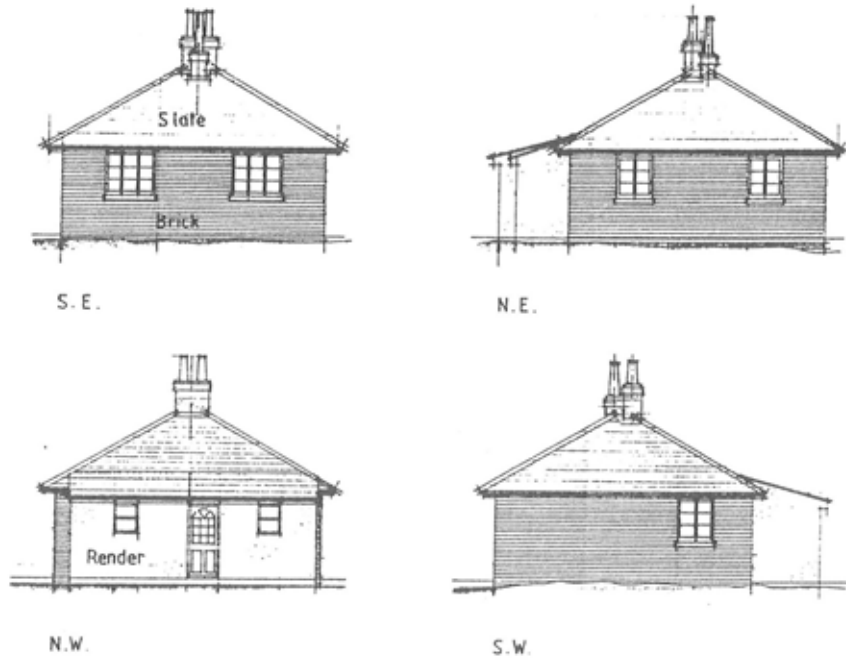
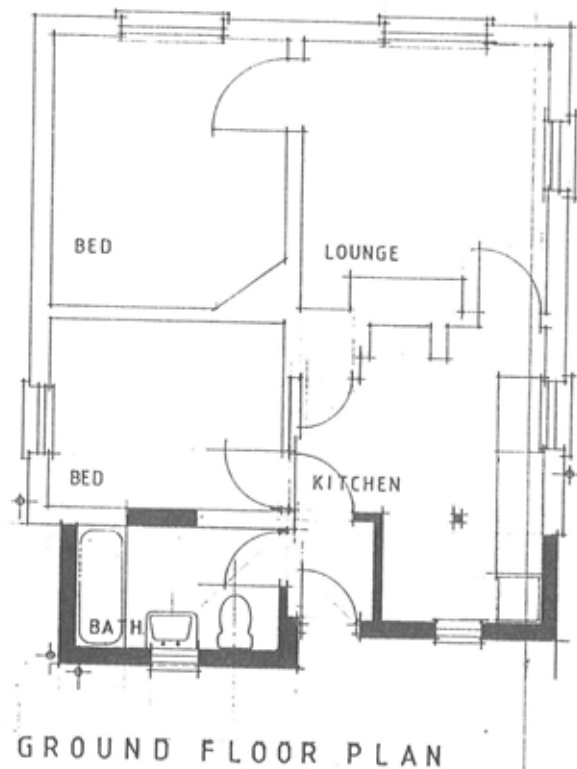
Figure 15: The Toll Cottage. 1:100 and 1:200, (N J McAnally & Associates)

Elevations to Toll Cottage
Building n° 2

5.7 **The Toll Cottage** (Building 2, Figure 15)

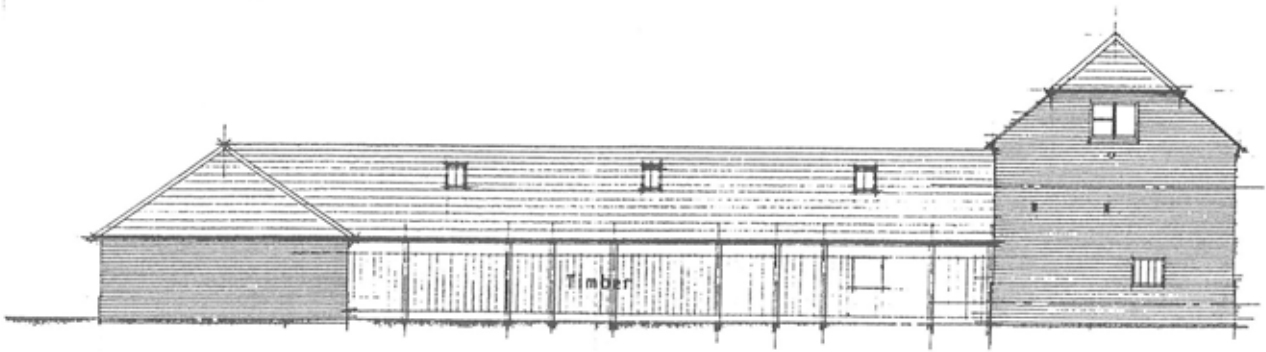
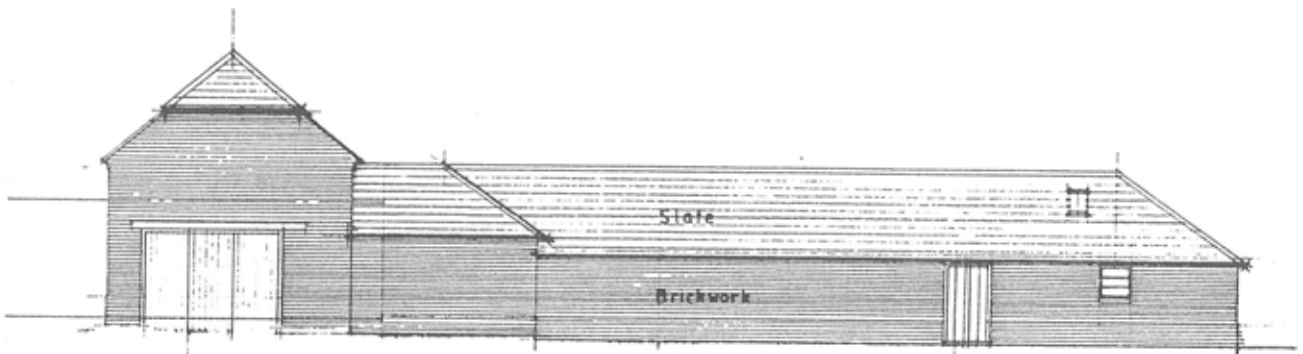
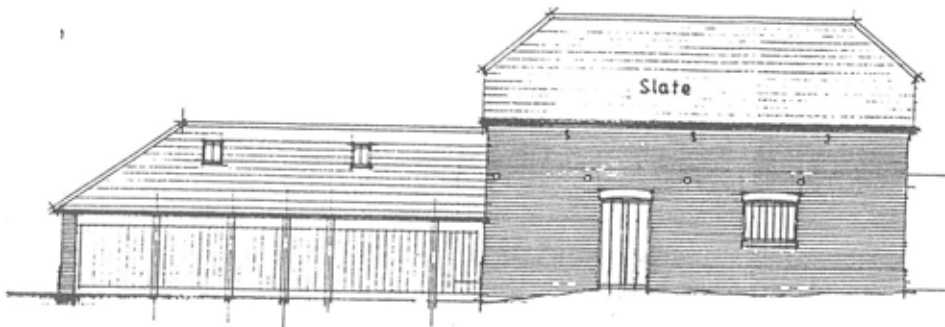
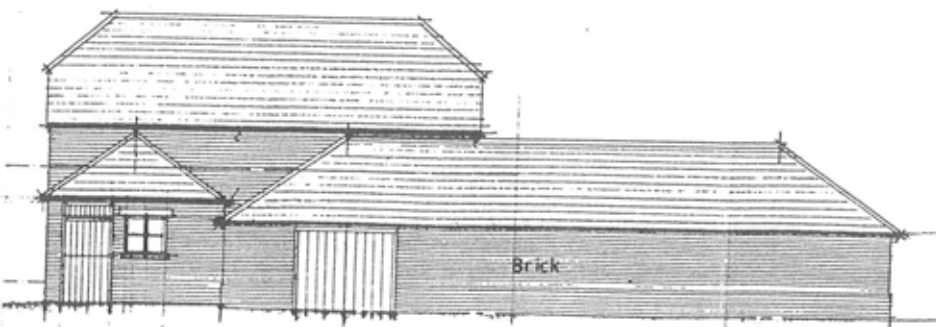
Figure 16: Elevations of the Cowshed and Stable complex, 1:200
(N J McAnally & Associates)

Elevations to Cowshed
Building n° 5

S.E.

N.W.

N.E.

5.8 **The Stable and Cowsheds** (Building 5, Figure 16, Plates 5 & 6)
