Bempton SPS Rising Main Replacement

Archaeological Desk-based Assessment

Yorkshire Water

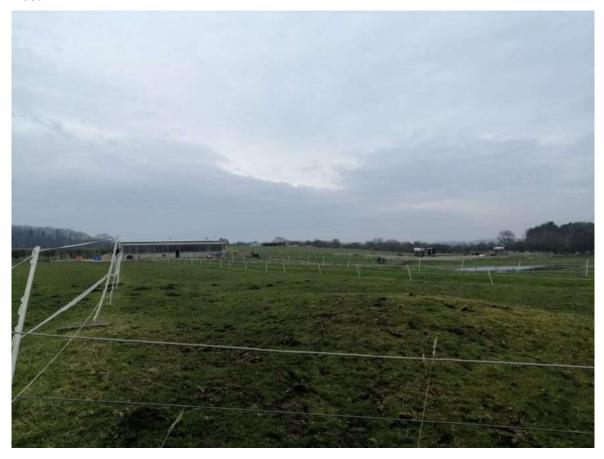
Photo 4.1: View of horse paddocks south of the B1255 Bridlington Road, looking northwest.

The areas between Flamborough Village SPS and the B1255 Bridlington Road mainly consist of horse paddocks associated with a stable along an unclassified track off the Bridlington Road (see Figures 1.1 and 1.2). The rising main replacement then passes through an agricultural field before reaching Bridlington Road. The topography is relatively flat through the horse paddocks at Flamborough Village at approximately 38m AOD (above Ordnance Datum) before climbing slightly towards the stable building and continuing to rise before it reaches Bridlington Road at an approximate height of 41m AOD.

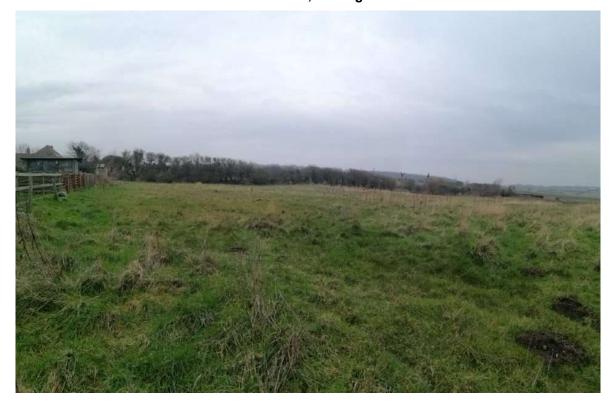
Photo 4.2: Scrub field to the rear of The Crofts, looking north-west.

After the route crosses the Bridlington Road, the land remains relatively level as it passes through a scrub field to the rear of The Crofts fronting the B1255 Bridlington Road at an approximate height of 48m AOD.

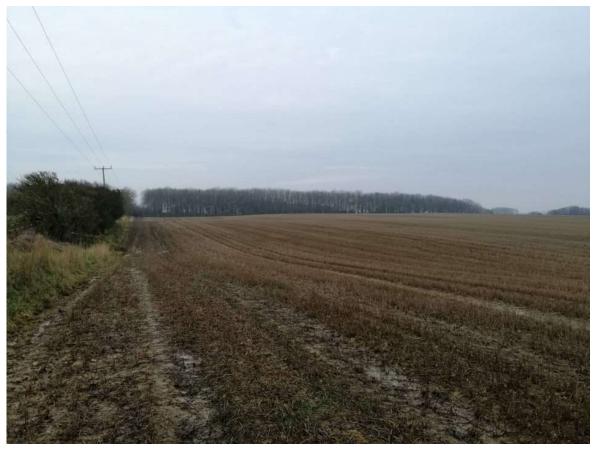
Photo 4.3: Route of Rising Main Replacement through agricultural fields to the east of Dane's Dyke, looking north-west.

The routes continues beyond the scrub field into a mixture of pasture and arable fields. Those in use as pasture contain horses and are to the south of Velvet Stud Farm. The large agricultural field is to the east of Dane's Dyke. The land remains relatively level, which only starts to rise towards Dane's Dyke.

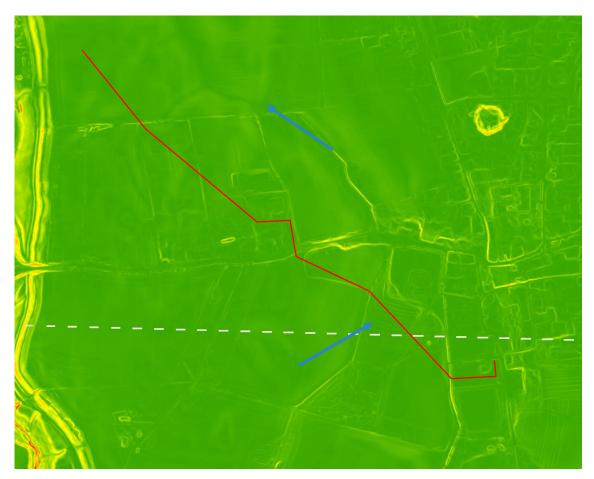
Figure 4.1: LiDAR composite DTM 2m resolution slope model. Indicative replacement rising main route shown in red and areas of interest highlighted by blue arrows.

LiDAR for the entirety of the rising main replacement route was supplied by the Environment Agency at 2m resolution (downloaded in June 2021). The data was then processed and put through various visualisation models using ArcMap in order to aid the interpretation of features. The data is presented in the form of a slope model in Figure 4.3. This visualisation was considered to give the clearest representation of the features discussed below.

The area of ridge and furrow identified during the site walkover in the horse paddocks just east of Flamborough Village is visible on the model. Although now segmented by a public footpath heading towards the Dane's Dyke, the ridge and furrow can be seen running on east to west alignments. A further linear feature is visible in the most northern field where the rising main replacement route runs through. This seems to run on a roughly north-west to south-east alignment before diverging into two separate linears, with one heading off south-eastwards and the other south-westwards. The linears appear to be on different alignments to the current agricultural field boundaries and may suggest they are earlier in date. The 1888 Ordnance Survey map depicts a former field boundary at the location of this linear which was removed to create a larger agricultural field sometime after 1970 and may indicate these are post-medieval in date.
