## PETERBOROUGH CATHEDRAL: THE NAVE CEILING

### PHASE 5: ROWS 0 - 7

CONDITION SURVEY AND CONSERVATION TREATMENT

VOLUME II PLATES

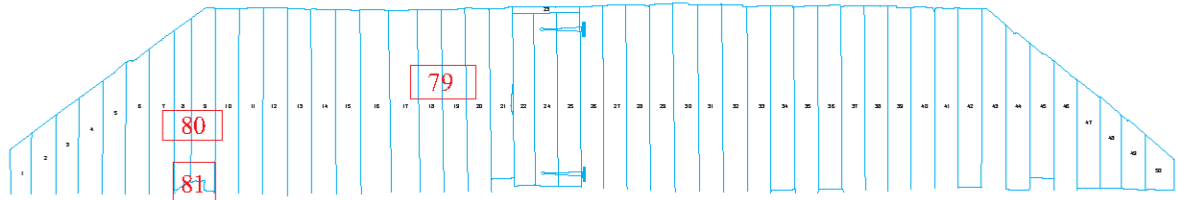
Sheet Number: 2

Plates are in before and after treatment sequence. Ultraviolet (UV) illumination photographs taken before treatment.	TITLE <b>PETERBOROUGH CATHEDRAL - NAVE CEILING                  Conservation Programme Phase 5 (May - October 2003)</b>		PHOTOGRAMMETRY COURTESY OF English Heritage Survey Team & Photarc Surveys Ltd.
STAGE CONDITION SURVEY AND TREATMENT		DESCRIPTION PLATE REFERENCE SHEET	
The Perry Lithgow Partnership 1 Langston Lane, Station Rd., Kingham, Oxon OX7 6UW Tel. 01608 658067
