HISTORIC
CHURCHES
a wasting asset

Warwick Rodwell
with
Kirsty Rodwell

Research Report No 19

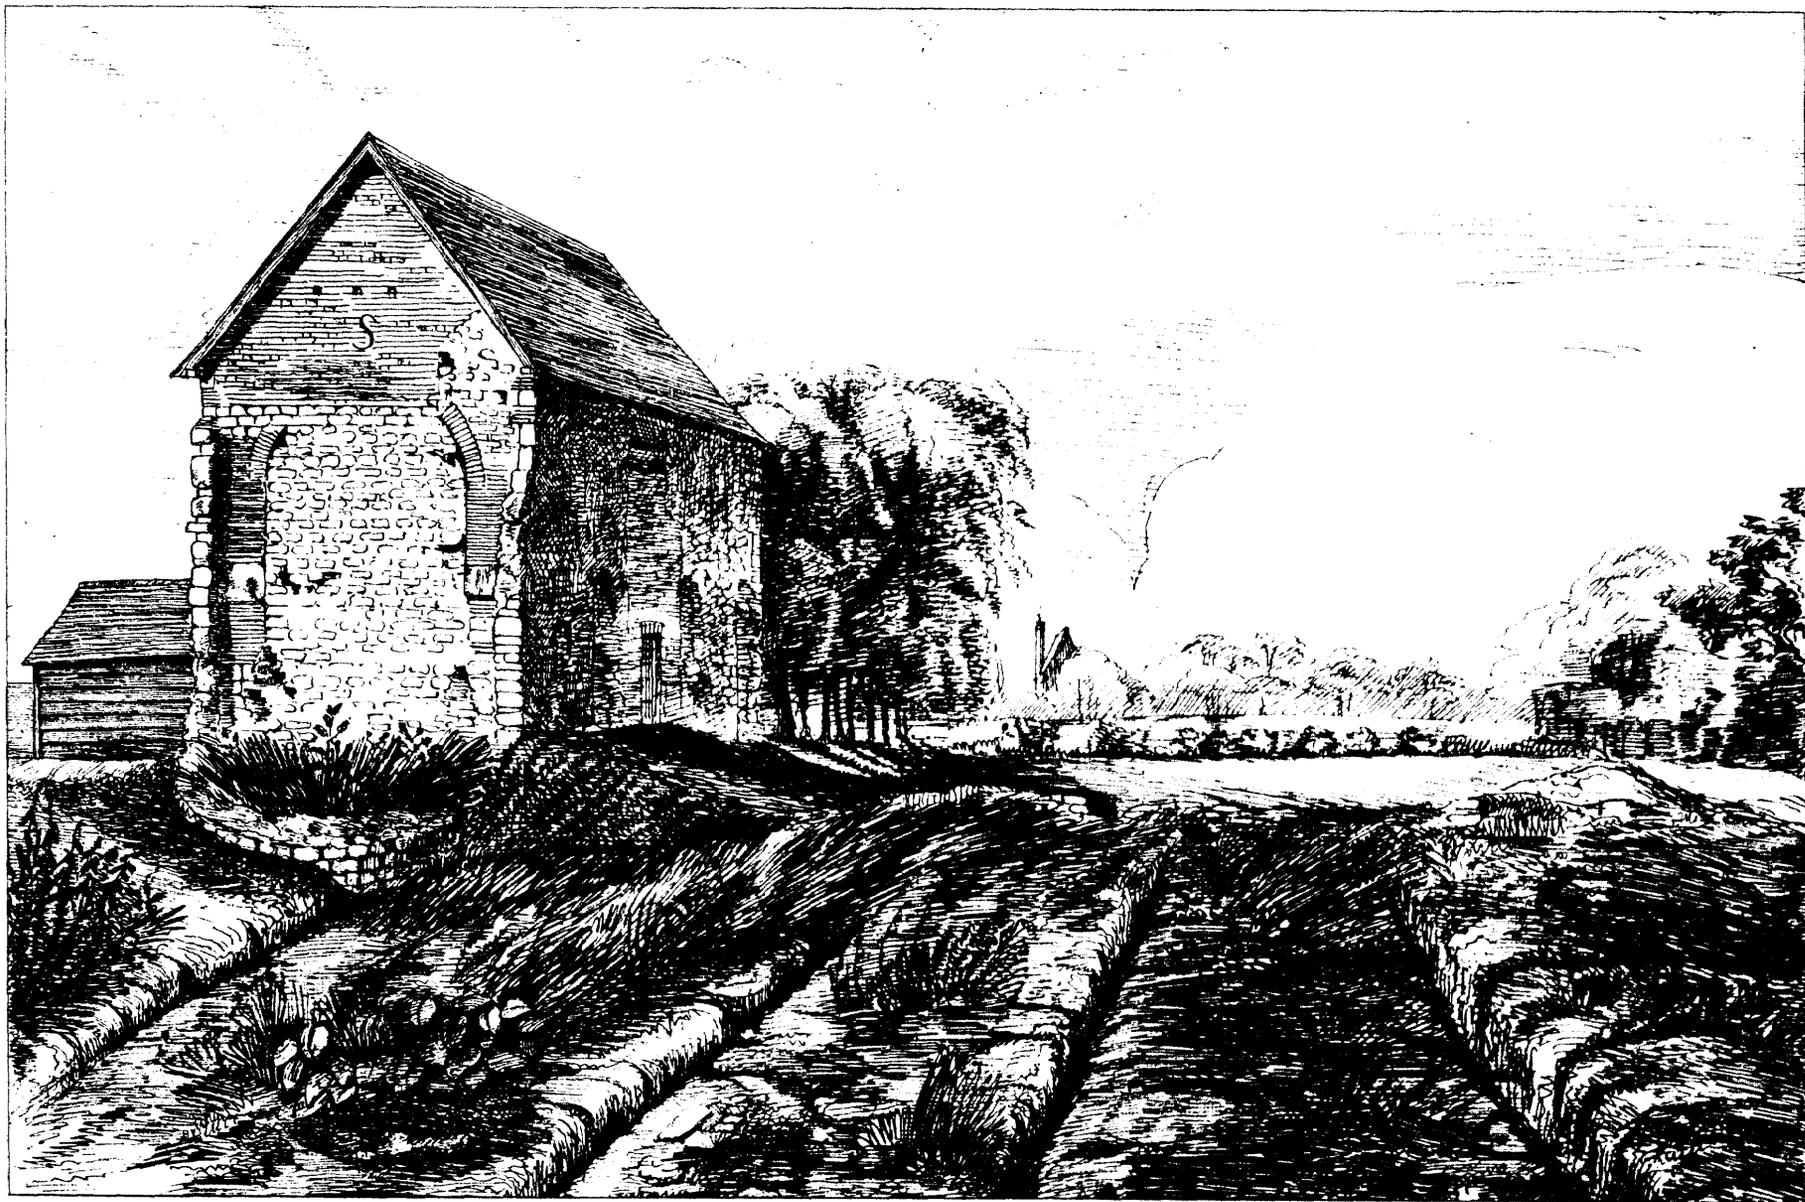
7 *St Peter's church, Bradwell-on-Sea, showing the trenches excavated in 1864*

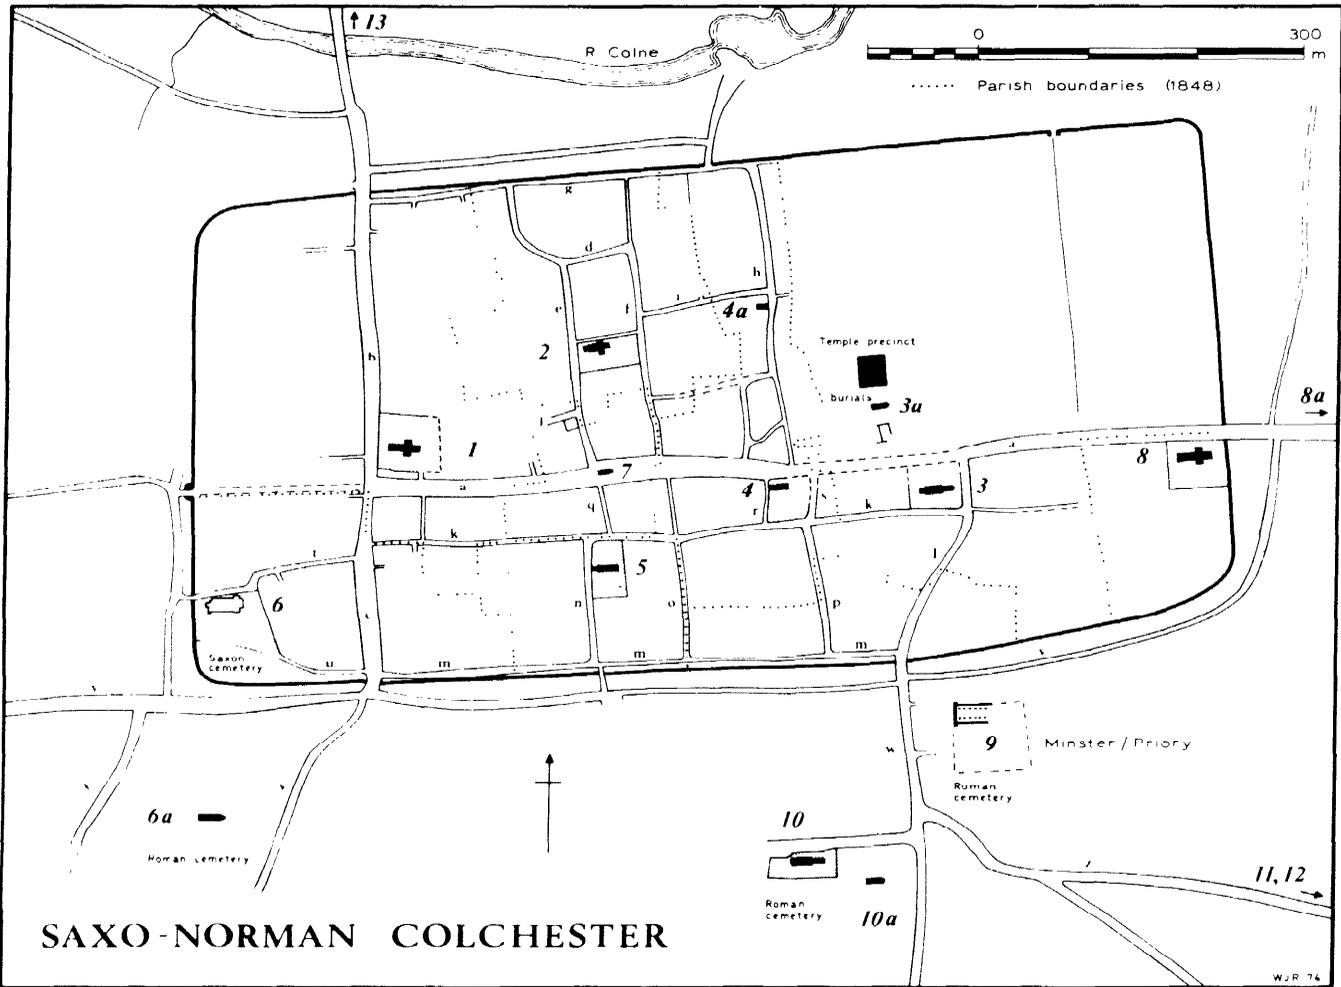
- 1. St Peter's Church
- 2. St Martin's Church
- 3. All Saint's Church
- 3a. Castle Bailey Chapel
- 4. St Nicholas's Church
- 4a. St Helen's Chapel
- 5. Holy Trinity Church
- 6. St Mary the Virgin's (St Mary at the Walls)
- 6a. Roman building in Denmark Street (possibly church)
- 7. St Runwald's Church
- 8. St James's Church
- 8a. St Anne's Chapel
- 9. St Botolph's Priory
- 10. St Giles's Church
- 10a. Church in St John's Abbey grounds
- 11. St Mary Magdalene's Church (and hospital)
- 12. St Leonard's Church (St Leonard at the Hythe)
- 13. St Michael's Church, Mile End

9 Provisional outline map of Saxo-Norman Colchester, showing the positions and alignments of ancient churches, chapels, etc. The town wall is indicated in black outline and ancient graveyards are stippled (when of known extent). The foundation platform of the principal Roman temple is shown as it was prior to erection of the castle around it; and the High Street has been restored to its pre-castle alignment

5.9 Churches numbered 1 to 10 are shown on an outline map of Saxo-Norman Colchester (Fig. 9). Their ground plans (with the exception of no. 6) are shown at a constant scale on Figs. 10 and 11. On Fig. 10 each plan is shown at its greatest extent in the late Middle Ages, while on Fig. 11 an attempt has been made to outline the earliest form of each church, as far as this is discernible from the evidence of the surviving fabric. In all cases this plan is Norman or earlier, but it must not be taken as an indication of the form or date of the *first* church on any particular site, which usually remains unknown or uncertain. For the sake of general consistency, the bibliography, grading, etc.. of Colchester's churches will be found in the Gazetteer.

as was common practice in other parts of the Empire. It is interesting to observe that the 'bailey chapel' and the undated range of masonry buildings to the south of it are aligned not on the Roman structures or on the Norman keep, but on the post-Roman planned street grid, the nearest element of which is Maidenburgh Street (see Fig. 9).

5.91 The building was found by excavation in 1935 and partially explored then and again in 1965 (Hull, 1958, 245; Dunnett, 1971, 78-82). It lies some 200 m south-west of the south gate of the walled town (Fig. 9), close to known Roman cemeteries. The building comprises a long, narrow 'nave', with an apsidal recess at the east end (Fig. 11.6a). There is no evidence to show that it ever served as a Christian church, but its plan, orientation and siting are compatible with such an interpretation. It is highly probable that the building was a religious structure and it is included here on the grounds that it is a potential Roman church. The problems inherent in trying to tie down a religious building to one particular sect in the Roman period, on the basis of ground plan alone, are well known and the pitfalls are great (cf. Toynbee, 1953, 7). While the Denmark Street building could be a church, it could just as easily be a synagogue. To date, no Roman synagogues have been recognized in Britain, but they are well known elsewhere in the Empire, and it is instructive to compare the Denmark Street building with the plan of the period 3 synagogue at Sardis. Although the latter is larger, they both have a nave length-width ratio of 4:1 and a very small unstitled apse at one end (Gutmann, 1973).

5.102 So far the parishes themselves have not featured in our deliberations. The parochial layout is clearly related to the post-Roman re-planning of the intra-mural street grid. It has been suggested that this layout (Fig. 9) was undertaken as a systematic piece of town planning by Edward the Elder in the early C10 (Biddle and Hill, 1971). An alternative and less plausible view suggests that the system grew slowly and mainly at a later period (Crummy, 1974, 33). However, the siting and orientation of the churches and their graveyards in relation to the parish boundaries, streets and other topographical features strongly suggests that the whole system had been laid out, and was even being modified, by the time the castle was added to the townscape in the later C11. St Runwald's appears to be an intrusive church in the market area for which a parish was carved out of the adjacent parishes of Holy Trinity and St Martin's. St Helen's, too, is of particular interest, since it gives the impression of having once been a separate parish which was split longitudinally and divided between St Martin's and St Nicholas's.

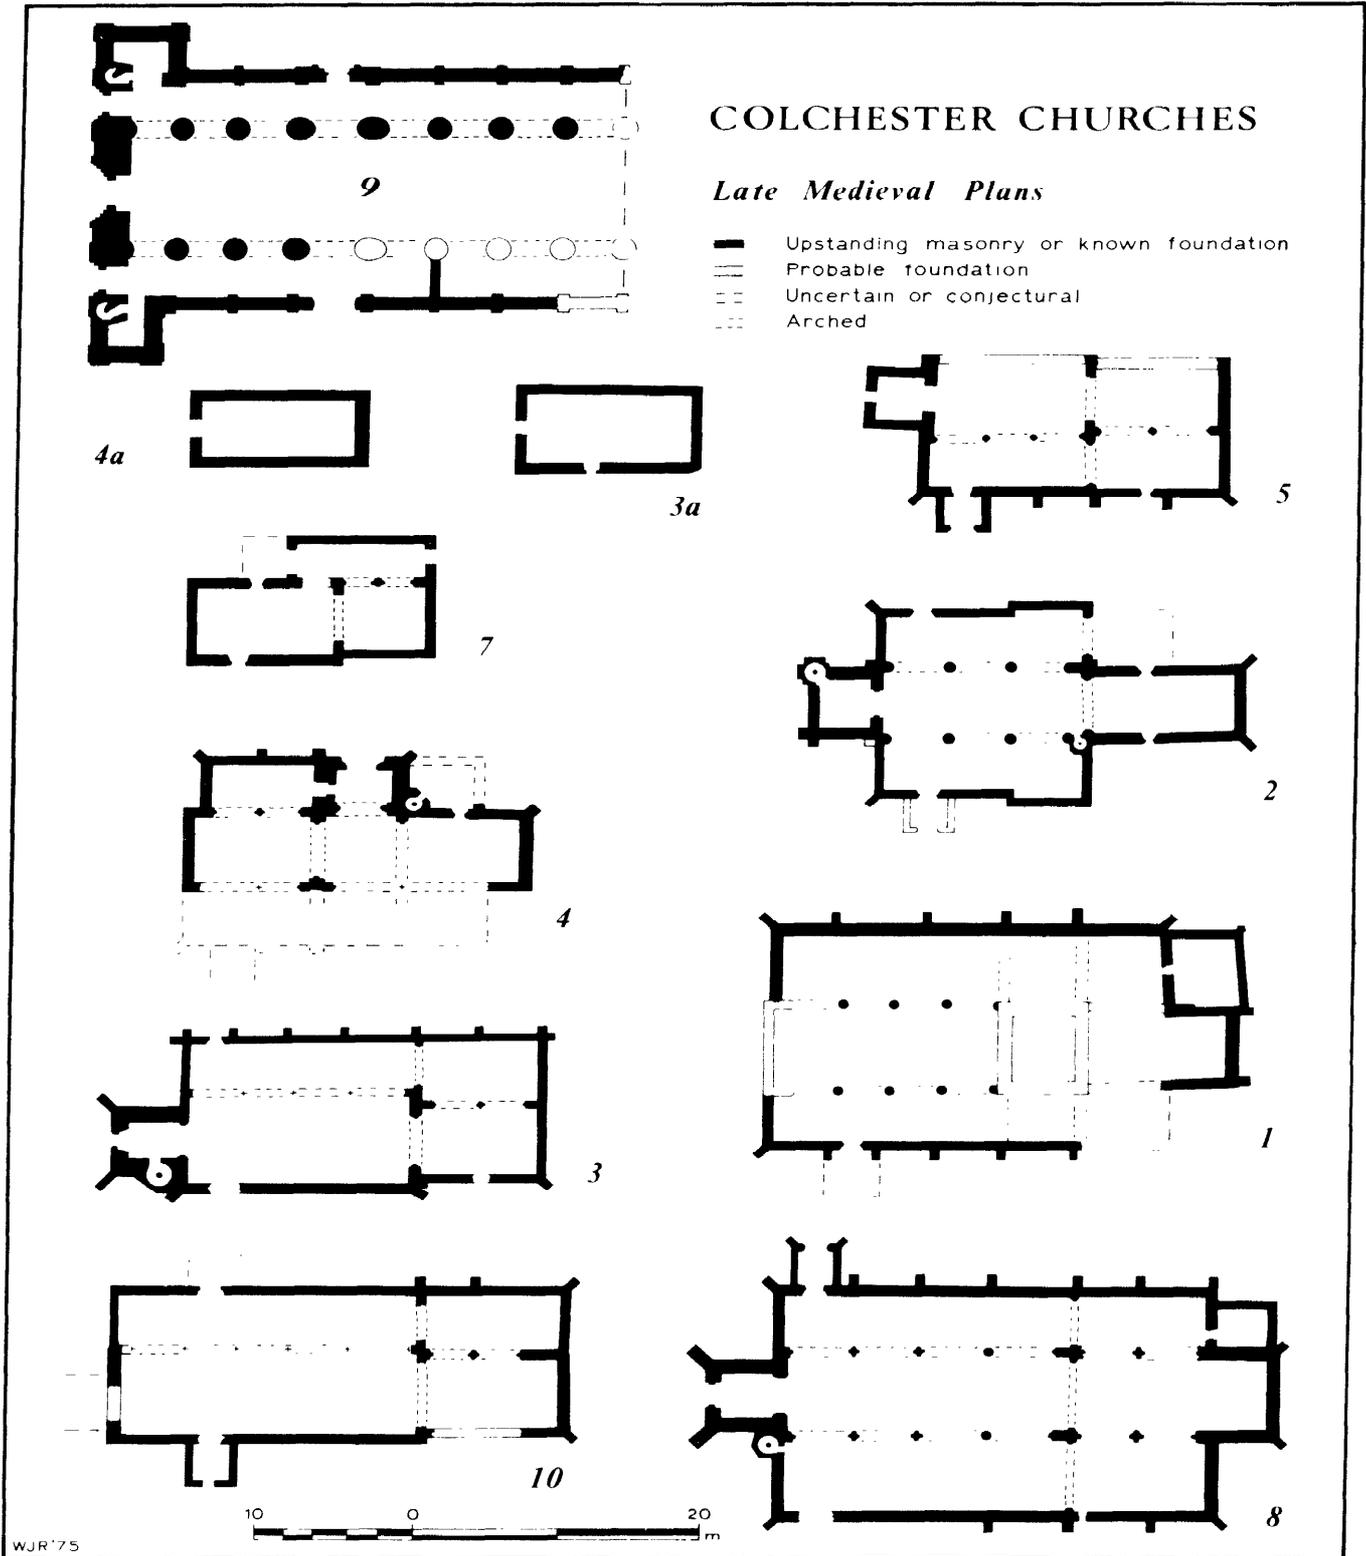
10 *Comparative plans of Colchester churches as they existed in the late medieval period (although incorporating much earlier masonry). Where the exact form of a doorway, etc., is unknown the ends of the abutting walls are shown ragged. For numbered key, see caption to Fig.9*

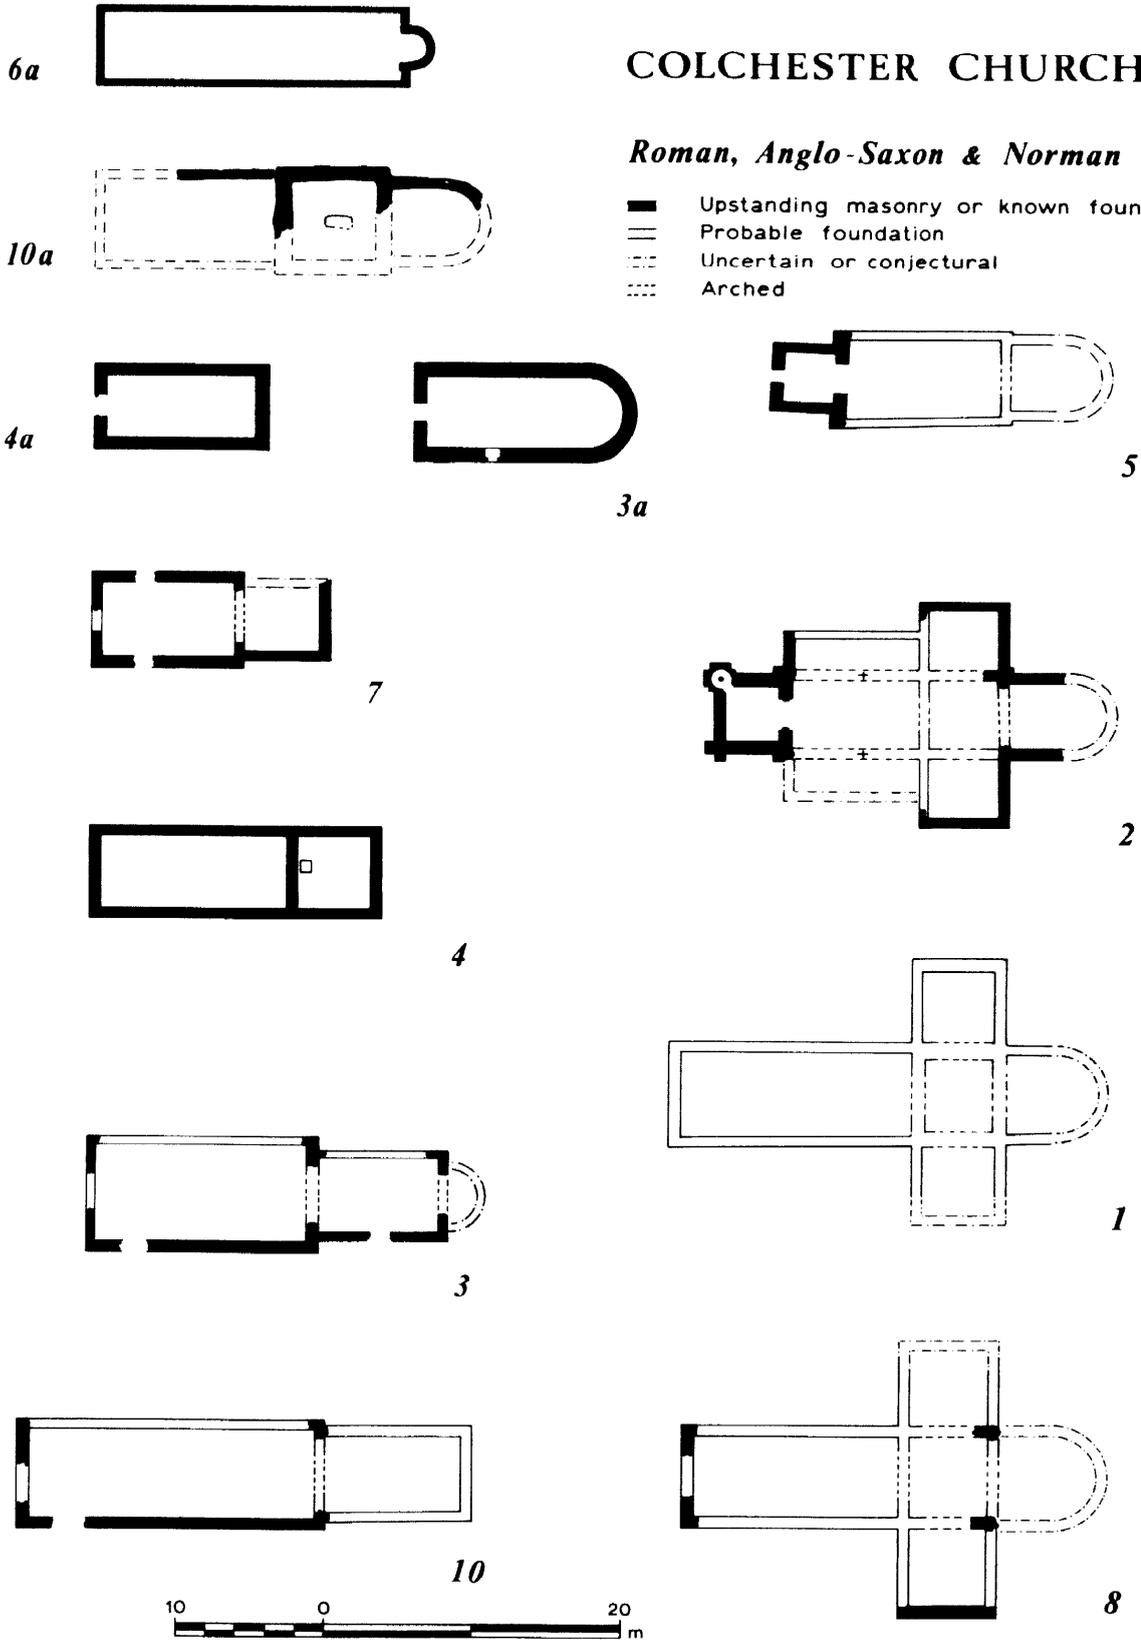
11 The earliest phase plans of Colchester churches which can be reconstructed from the surviving evidence. Most of these plans cannot be dated with certainty, but they are all Norman or earlier. They are shown in the same juxtapositions as the late medieval plans on Fig. 10 (excepting 6a and 10a, which replace 9). For numbered key, see caption to Fig. 9

5.88 Excavation in 1972 in the monastic cemetery of St John's Abbey, a little to the south-east of St Giles's church, revealed part of another unknown church or chapel. It was situated in a late Roman cemetery and overlay some of the graves, but in turn the church had been demolished by the early medieval period, when the area became part of the new monastic cemetery. The church therefore belongs to the Anglo-Saxon era. The discovery is so recent that only plans and a brief note have yet been published (Crummy, 1974, 29; *Med. Archaeol.* 17 (1973), 139) and we must await the final report for discussion of the many important questions which this raises. However, some preliminary discussion may not be out of place here. The church is stated to be of two periods (see Fig. 11.10a): the first comprised a square nave with a stilted apsidal chancel, the full width of which, although not uncovered in the excavation, can be reconstructed geometrically; in the second period the church was converted to a three-cell structure by the addition of a new nave to the west (its length is unknown and on Fig. 11.10a it is shown reconstructed with proportions of 2:1—it is unlikely to have been much shorter).

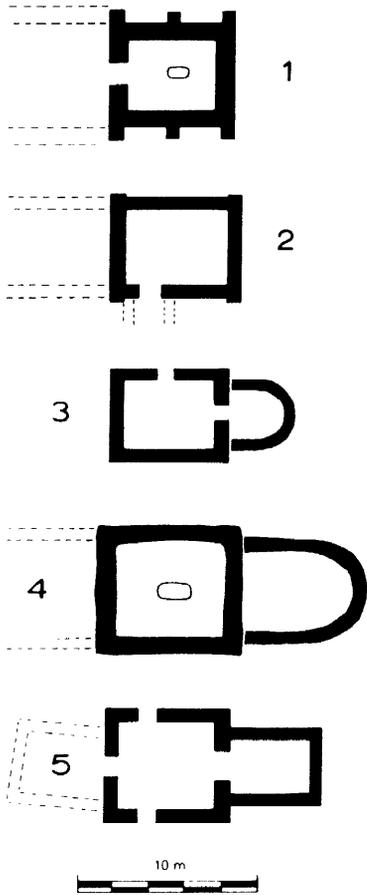
- 1. Stone-by-Faversham, Kent.
- 2. St Martin's, Canterbury
- 3. St Mary's in Tanner Street, Winchester
- 4. Colchester, church 10a
- 5. Barton-on-Humber, Lincs.

12 Comparative plans of reused Roman and Saxon structures in Anglo-Saxon churches.

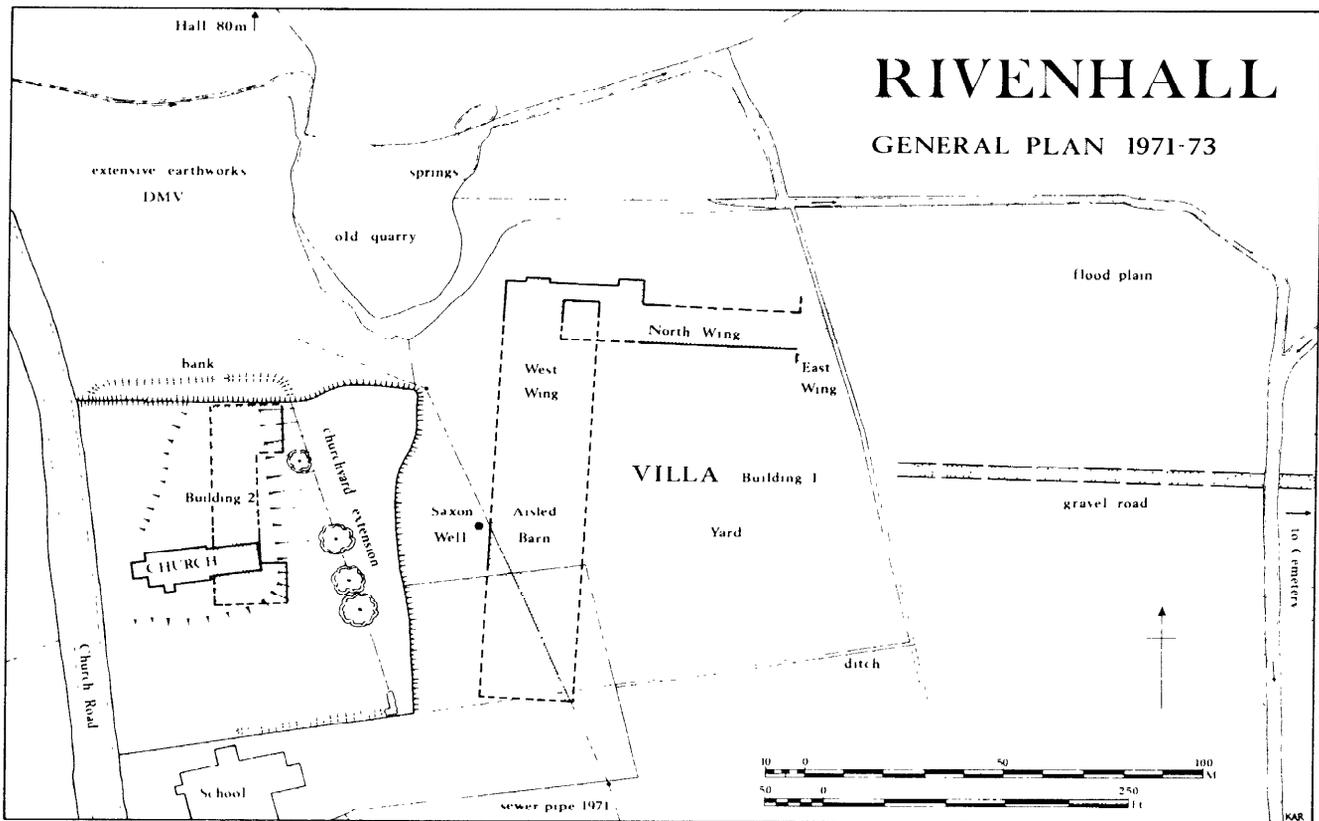
14 Plan of the environs of Rivenhall church, showing the principal archaeological features, graveyard earthworks etc. The known parts of Roman buildings 1 and 2 are stippled

6.5 Work began at Rivenhall in April 1971, when Mrs Kirsty Rodwell undertook a short salvage excavation in a field to the east of the churchyard, for the Department of the Environment. The brief was to rescue part of a Roman villa which lay in the path of a pipeline (Fig. 14). In cutting through rough pasture between the church and the hall, the pipeline revealed the site of an unknown deserted medieval village.

6.7 A careful examination of the churchyard revealed that it comprised three superimposed, but evidently separate earthworks (Fig. 14): first, there is a roughly triangular platform occupying the northern part of the graveyard, upon which the church was built. Secondly, there is an embankment, with an entrance gap, running parallel to the northern boundary of the churchyard but just outside it; the ends of the bank seem to turn into the churchyard. A line of trees and a slight fall in ground level suggested the eastern side of a former enclosure. Thirdly, there is the present churchyard boundary, which stands as a lynchet some 0.5 m to 1.0 m above the surrounding field surfaces. In plan this boundary has a curious excrescence at the north-east corner; modern graves were rapidly advancing in its direction.

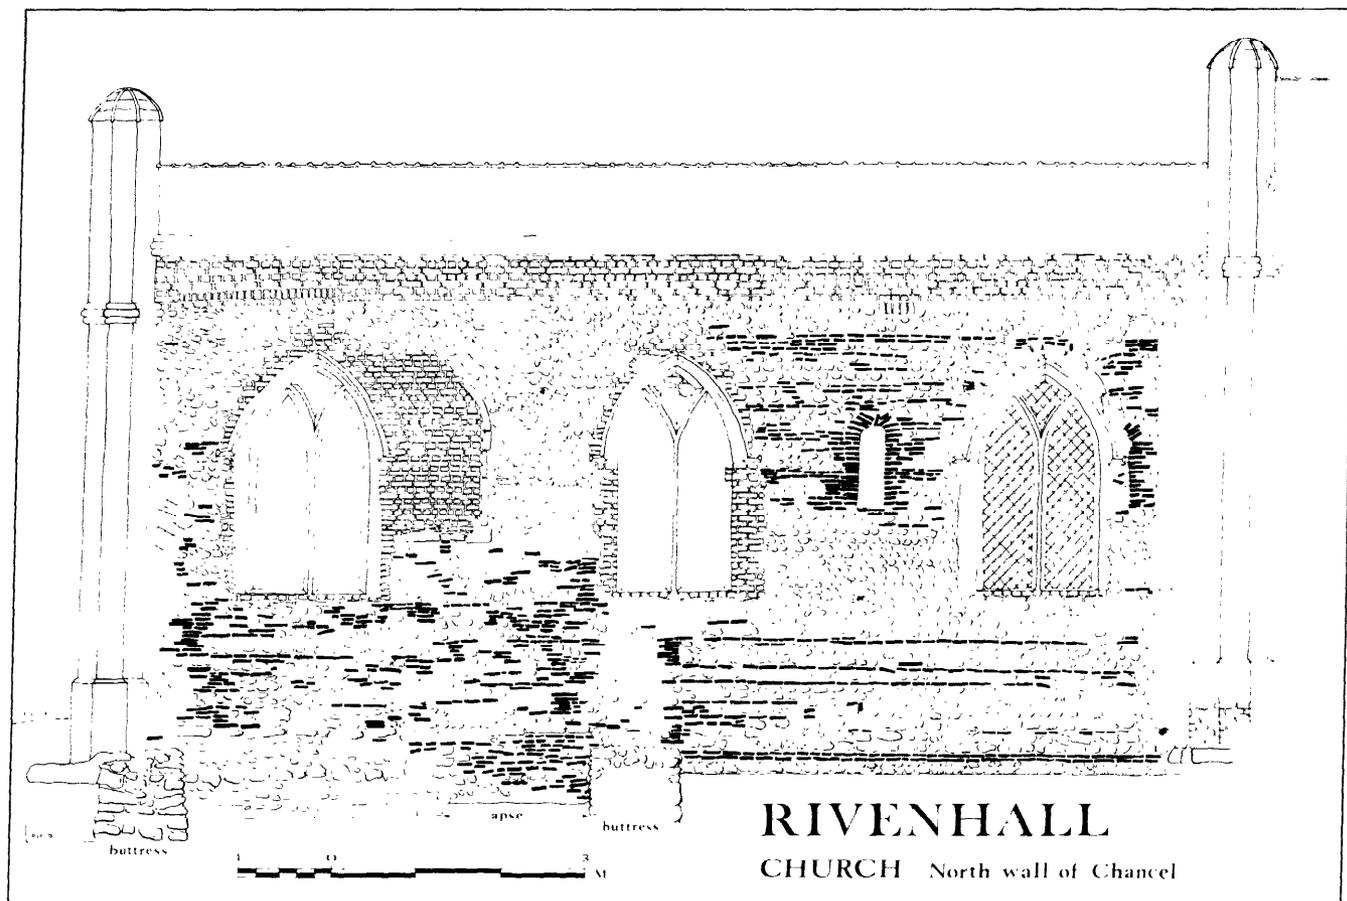
15 *The north wall of the chancel of Rivenhall church, drawn after the stripping of cement rendering in 1972. For interpretation see Fig. 16. (Drawn by Daryl Fowler and Mary Haynes)*

6.12 In addition to excavation, the upstanding structure was examined. Rendering on the north wall of the chancel was badly decayed and it was decided to strip and replace this first. By agreement, the wall was stripped by selected members of the archaeological team. The exposed face, unencumbered by rendering and modern pointing, was a most instructive sight: the 'rebuild' of 1838-9 was shown to have concerned only the parapets, buttresses and windows. The walls themselves were of several builds and periods, ranging from late Anglo-Saxon to late medieval. One complete but blocked Anglo-Saxon window was revealed, together with part of another and traces of two C14 windows. In short, there was as much archaeological stratification in the north wall of the chancel as there was in the ground immediately below it. Recording was undertaken by the normal process of erecting a string-grid on a 0.5 m module and measuring and drawing the wall stone by stone (Figs. 15 and 16). In order that the elevation could be seen, studied and drawn adequately it was necessary to rake-out the mortar joints between the stones and bricks. Such was the interest of this wall and its historic features that the PCC decided not to re-render, but to point the masonry and leave it exposed. Under the direction of the church's architect this has been skilfully done, so that every historic detail is discernible. It was also decided to re-open and glaze the Anglo-Saxon window. This seemingly simple process was soon discovered to have considerable archaeological

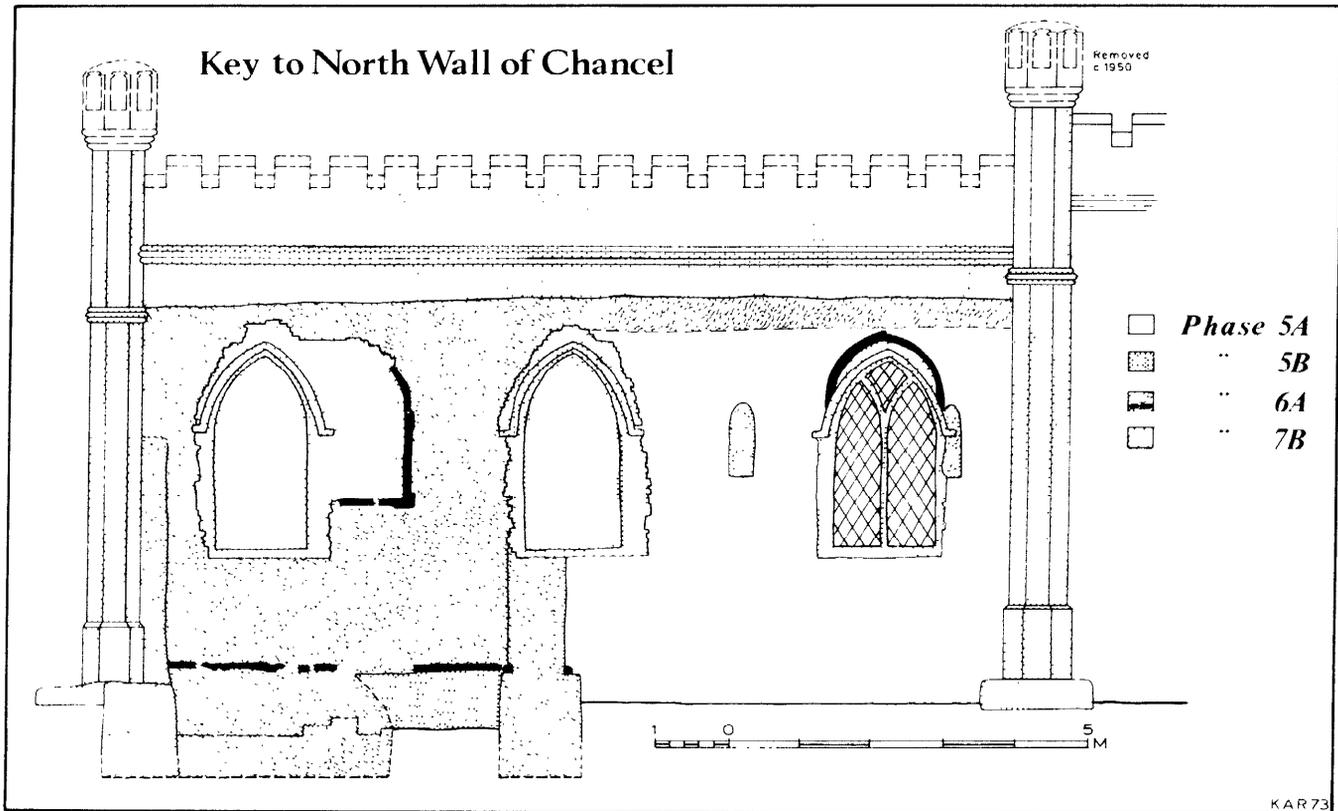
16 The north wall of the chancel of Rivenhall church: interpretation of the detailed drawing, Fig. 15. (For the dating of the building phases, see caption to Fig. 18)

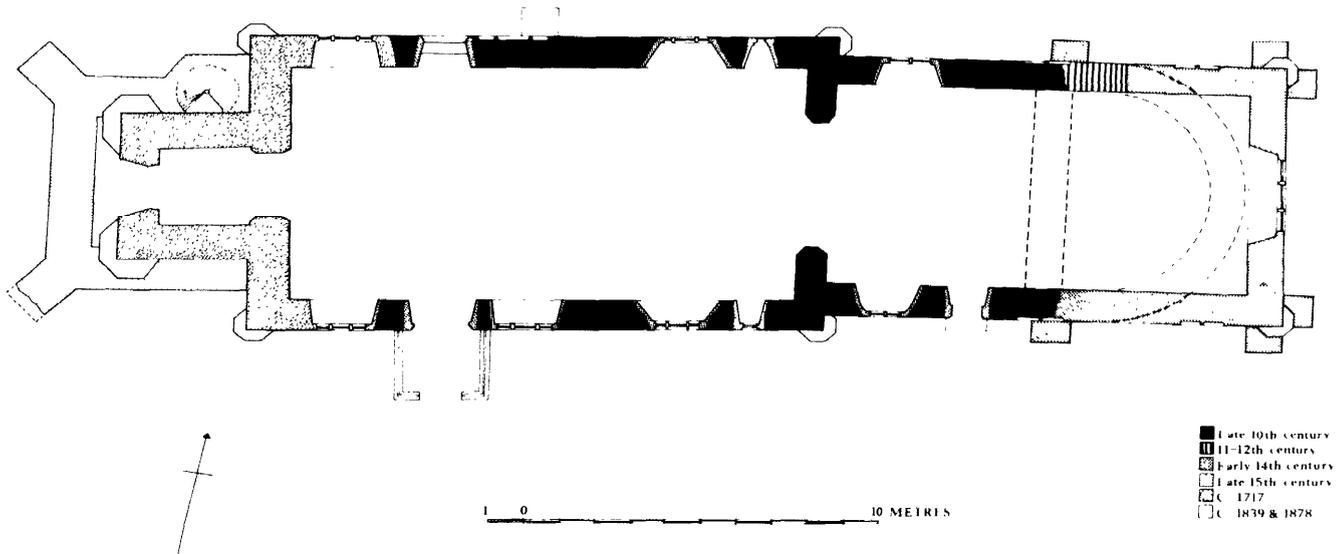
RIVENHALL ST MARY AND ALL SAINTS PLAN

17 *Plan of Rivenhall church, showing an historical analysis of the surviving structure, based on the archaeological investigation of the fabric in 1973*

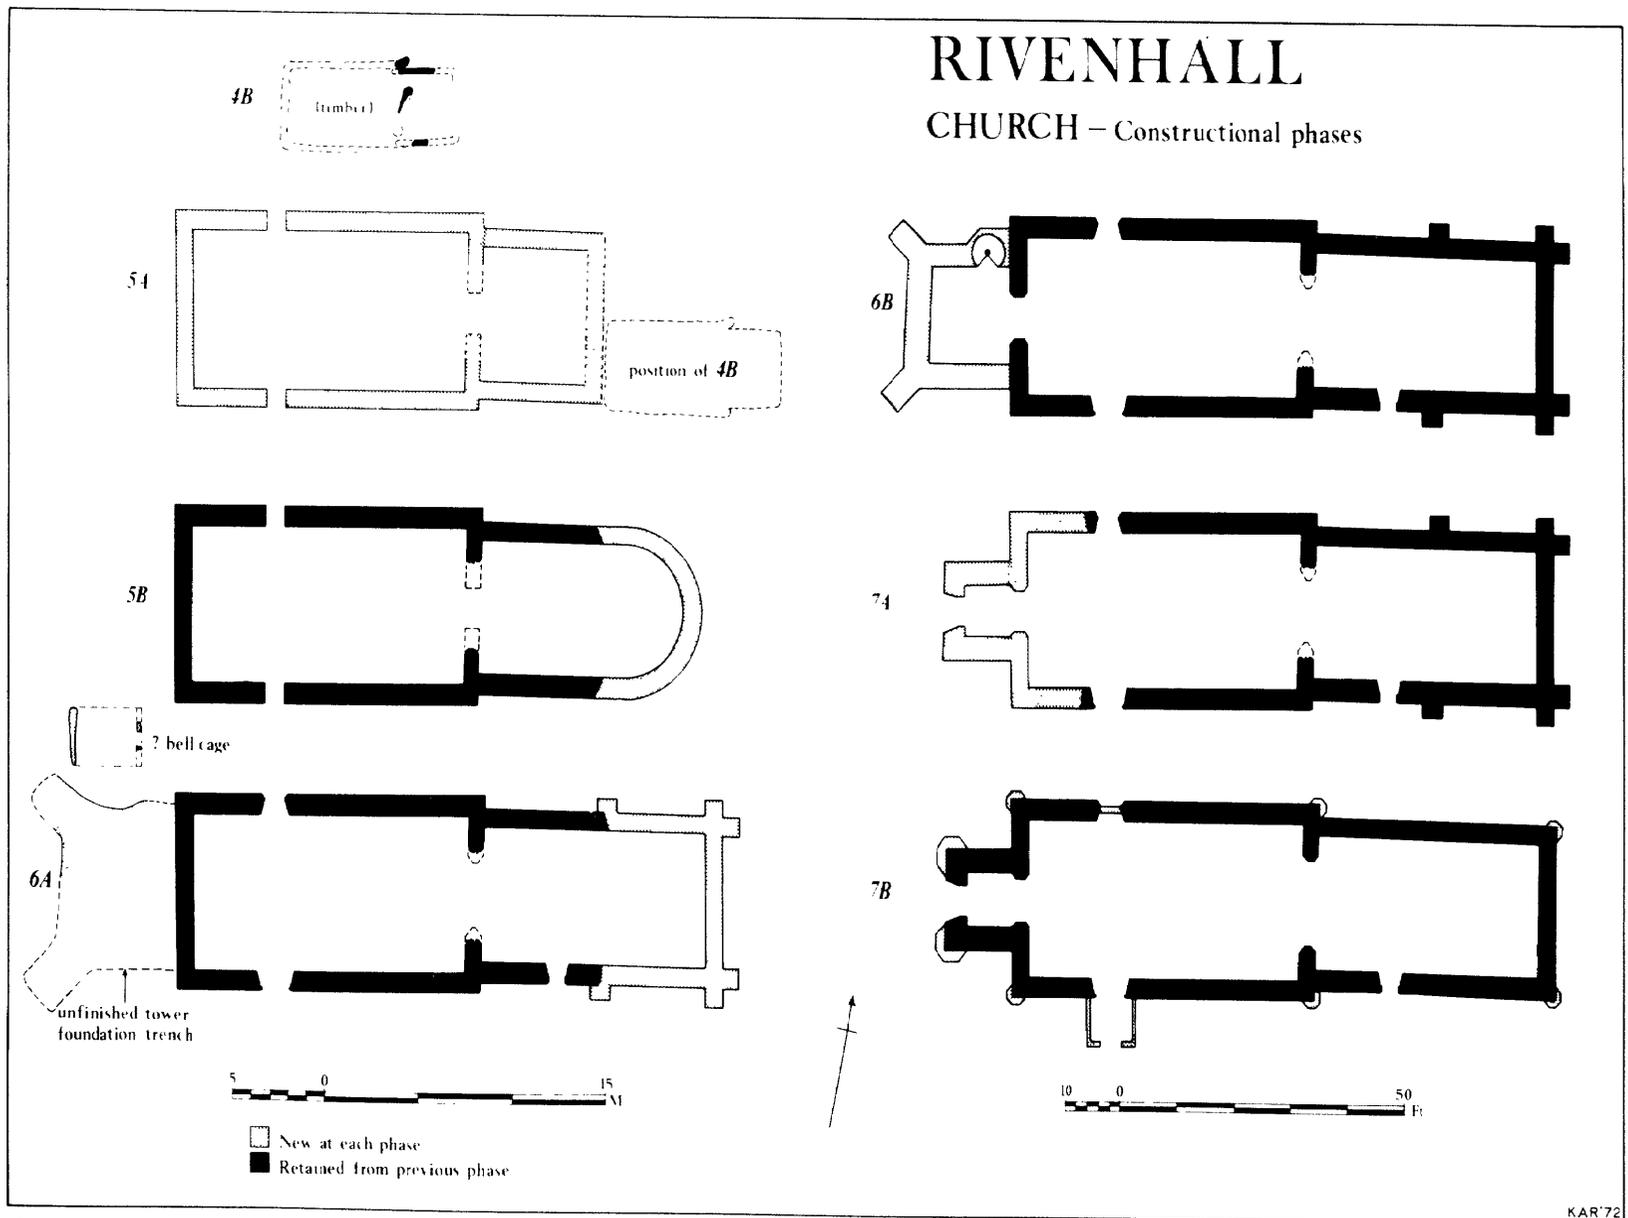
CHURCH – Constructional phases

18 Phase plans showing the development of Rivenhall church from the Anglo-Saxon period to the present day, based upon archaeological excavation outside the building and architectural investigation of the fabric, 1972-73.
Phase 4B: Saxon; 5A: late Saxon (C10 or C11); 5B: Norman (C11 or C12); 6A: Early C14; 6B: Late C15; 7A: Georgian (c. 1717); 7B: Victorian (1839 and 1878)

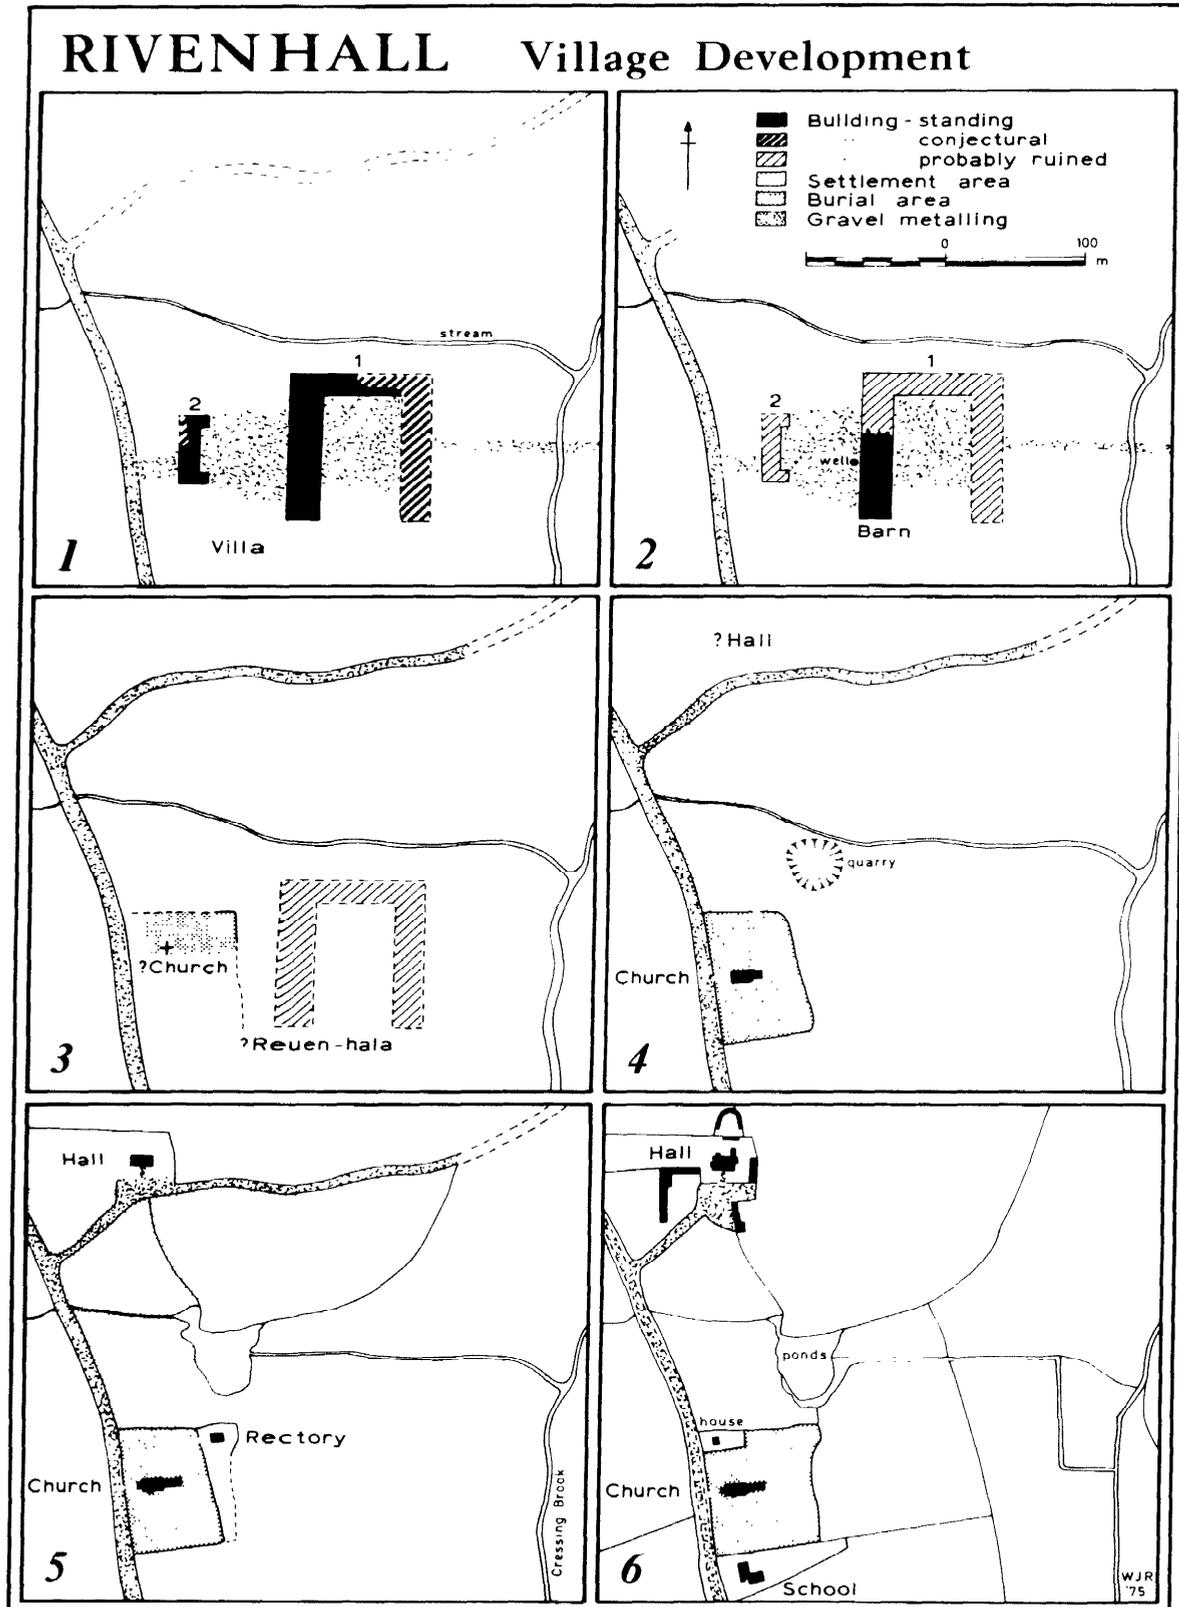
19 Outline plans indicating the development stages of the nucleus of Rivenhall village: 1. Roman. 2. Pagan Saxon. 3. Early Christian Saxon. 4. Later Christian Saxon. 5. Medieval. 6. Victorian

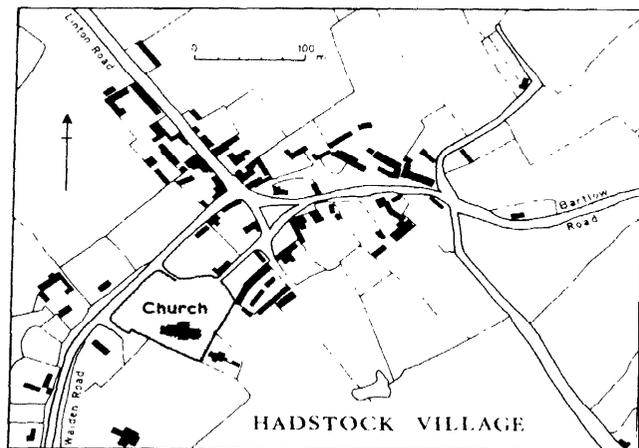
20 Plan of the nucleated village at Hadstock, with the churchyard shown stippled

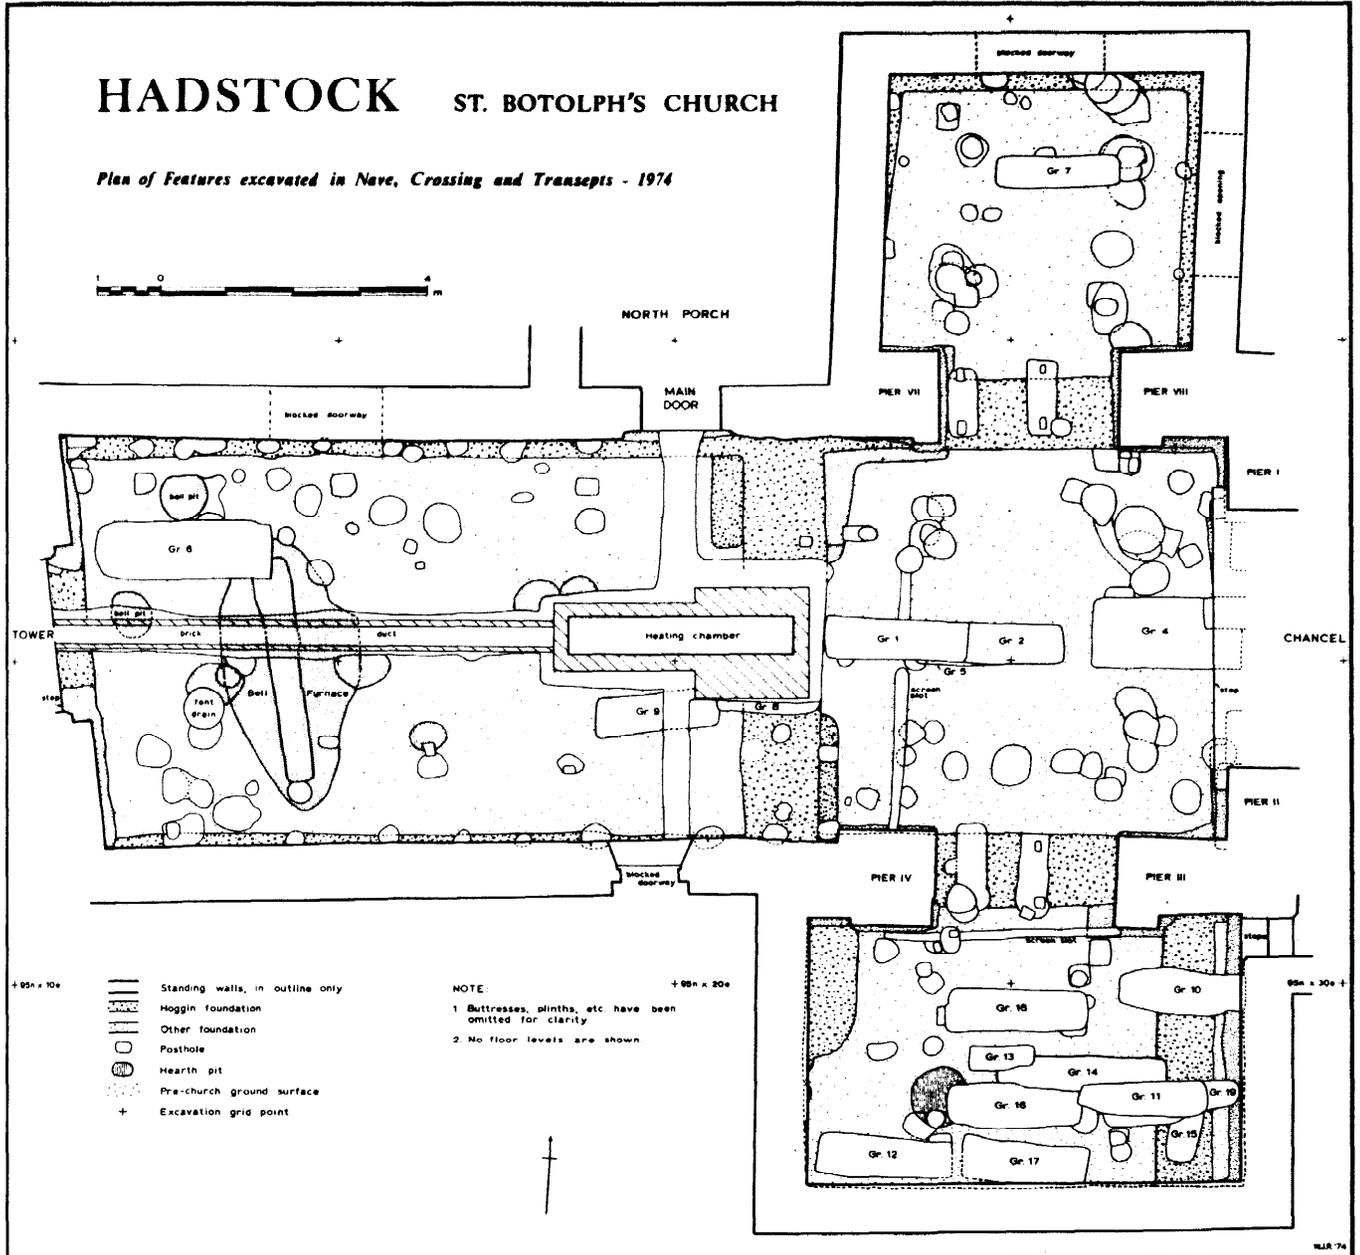
21 Plan showing the archaeological features discovered by excavation inside Hadstock church, 1974

of the nave, crossing and transepts took place in 1974 (Fig. 21). A brief account has already been published (Rodwell (1974a-b); for a technical-interim report see Rodwell (1976b). For present purposes it is the object lesson, as with Rivenhall, in academic revelation which concerns us here. The special problems attending the archaeological investigation of a church which is normally in use for services have been discussed elsewhere (Rodwell, 1976a).
