HISTORIC
CHURCHES
a wasting asset

Warwick Rodwell
with
Kirsty Rodwell

Research Report No 19

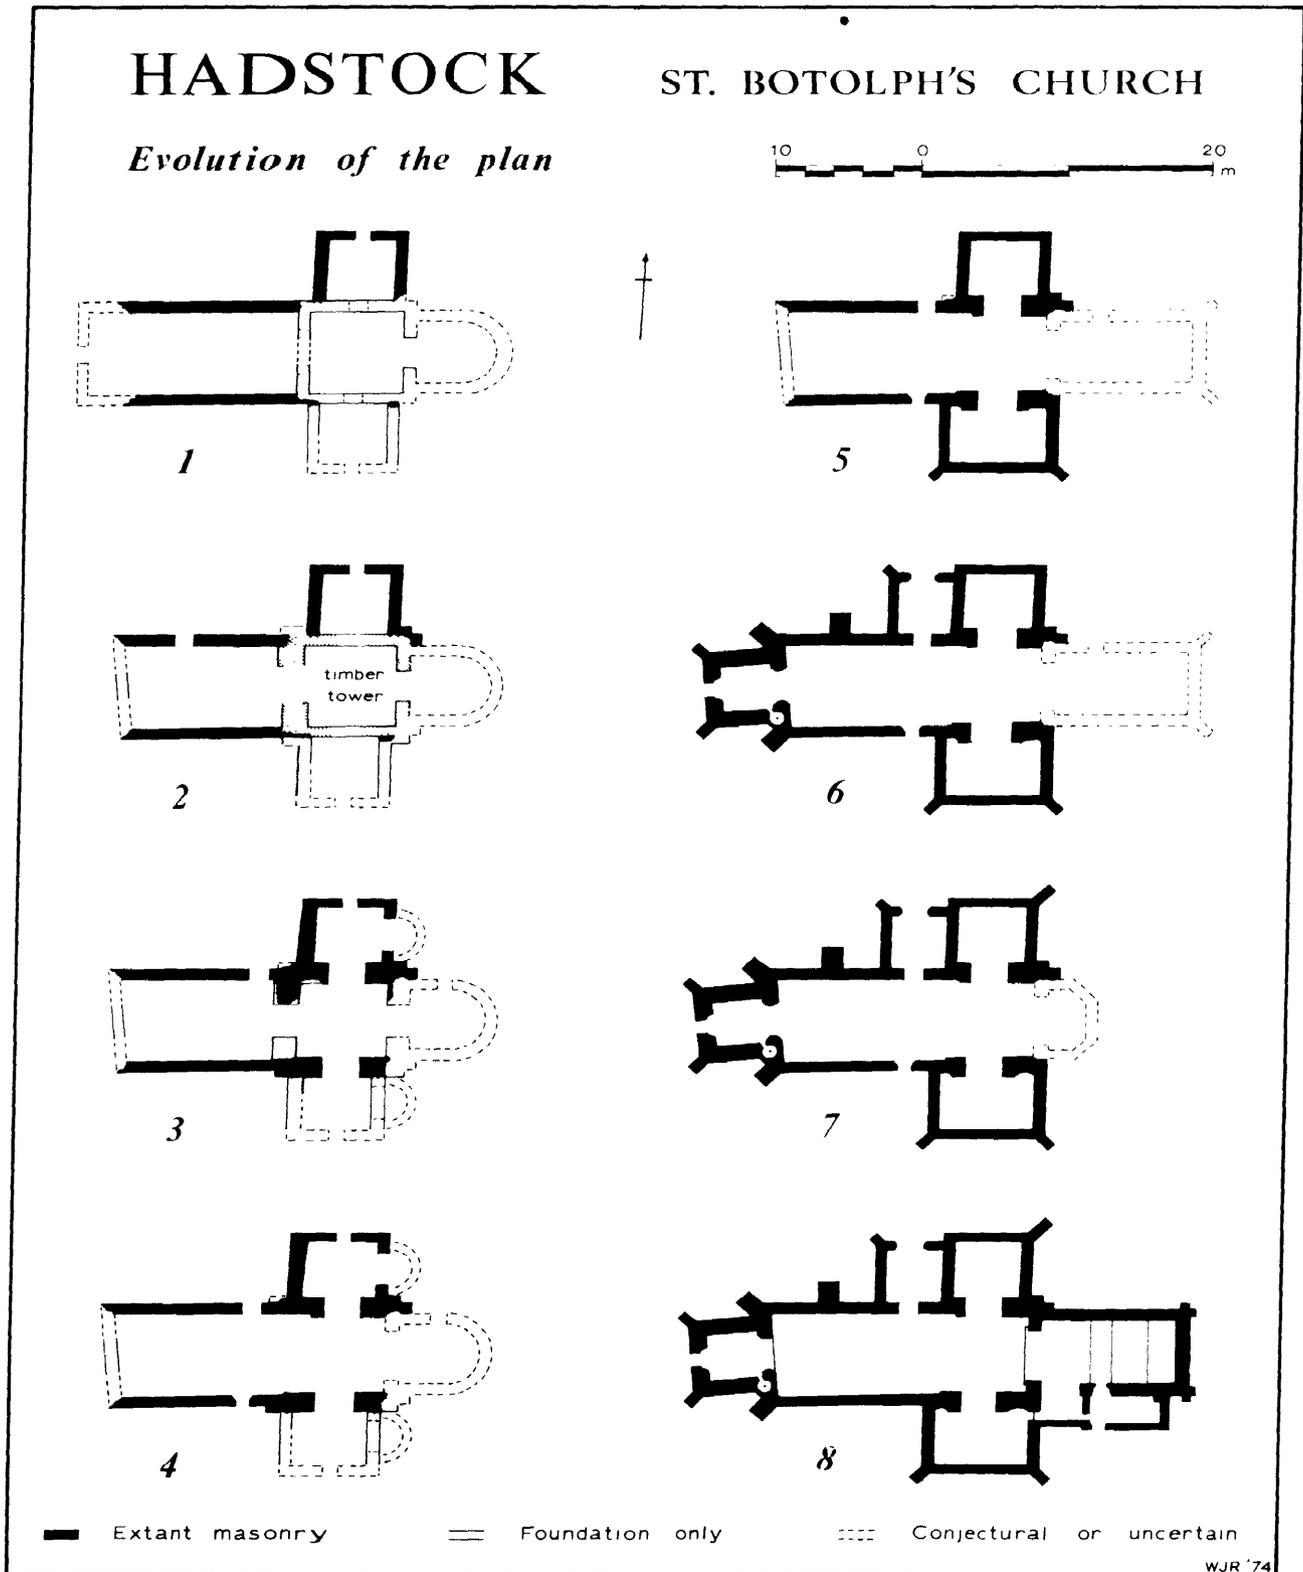
22 *Phase plans showing the development of Hadstock church from the Anglo-Saxon period to the present day, based upon archaeological excavation inside the building architectural investigation of the fabric, 1974.*
 Phase 1: Middle Saxon (possibly C7); 2. Later Saxon; 3. Late Saxon (C11); 4. Later C13; 5. Late C14; 6. Late C15; 7. late C18 (c. 1790); 8. Victorian (c. 1884)

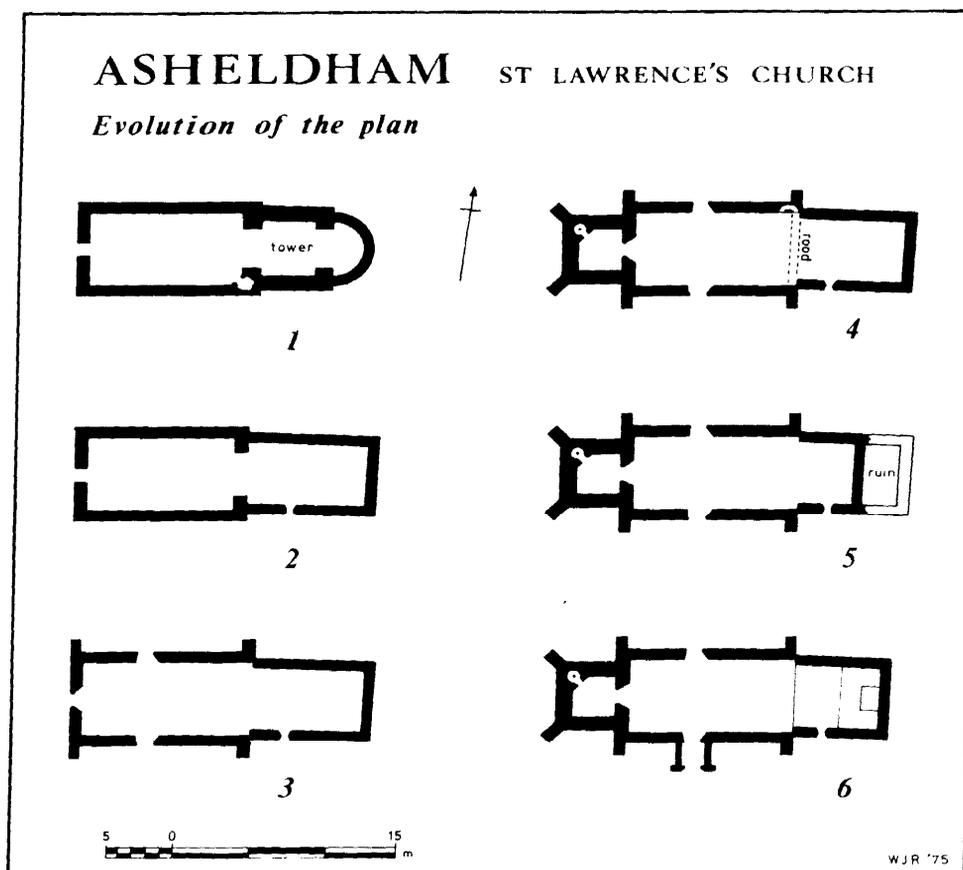
25 *Phase plans showing the development of Asheldham church, based upon an archaeological investigation inside the building in 1975. Phase 1. norman, C11 or early C12. 2. Mid C13. 3. and early C14. 4. Mid or later C14. 5. Undated. 6. Victorian (from c. 1867)*

is fatal to take the present plan of a church and offer that as evidence for the proportions or dimensions used by church builders of any particular date, unless the foundation plan (as opposed to that of the superstructure) can be shown to be cohesive. Thus, taking a very simple example such as Asheldham (Fig. 29, one cannot say that the present plan of the building dated from the C14, or indeed to any historical period at all, even though the nave exhibits a near-perfect 2:1 ratio. The plan form is more an accident than a deliberate implementation. The outline of the Norman church (Fig. 25.1) is the only phase in the development which can be regarded as a consciously laid-out plan, and the sole element of this to survive in the present structure is the width of the nave.

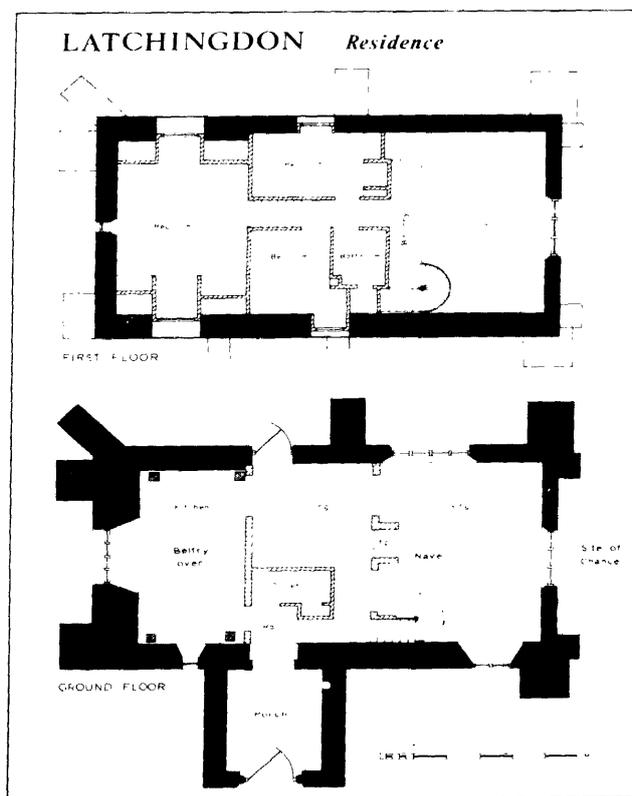
26 Simplified plans illustrating the proposed conversion of Latchingdon church to a domestic residence. The existing church walls are shown in solid black (on the first floor plan they are shown at eaves level). Based on plans by P J Lorimer, by permission of J Dunlop

surprising that no local or community use could be found for it; proposals to maintain it as a disused church (by a local society created for the purpose) were not accepted by the Church Commissioners. The only alternatives were demolition or conversion to a residence and it is perhaps worth noting that it would have been very difficult to argue a reasoned case for the retention of the building, had demolition become a serious threat. Planning permission has been granted for conversion (Fig. 26).

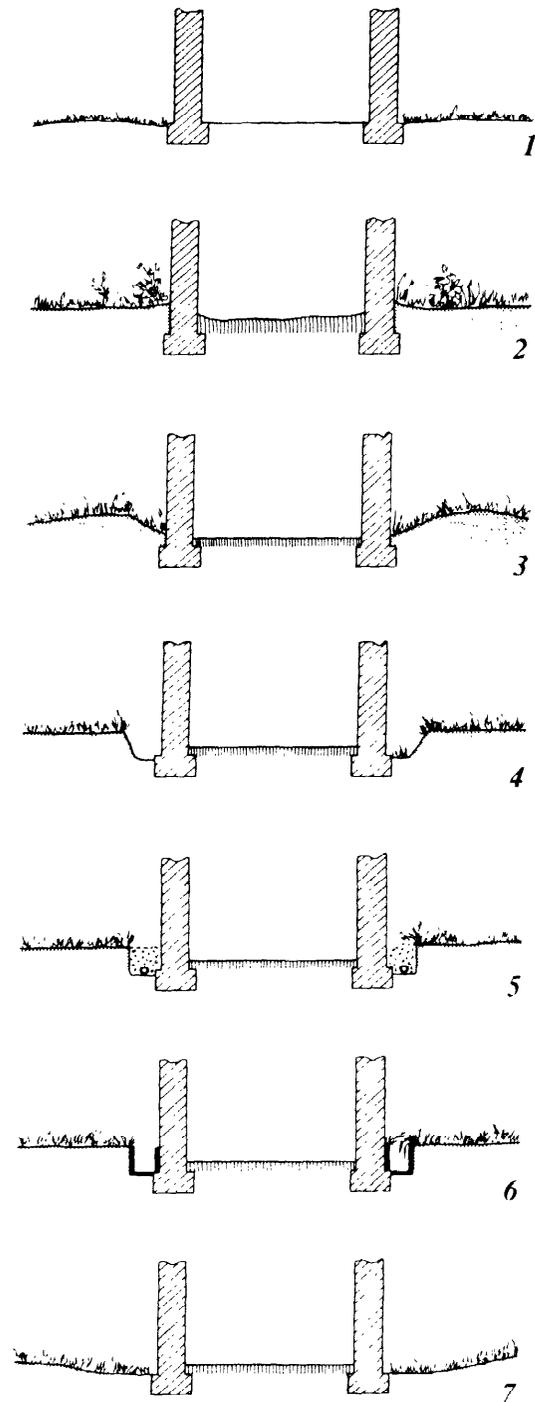
Archaeological Deposits

27 *Diagrams illustrating the accumulation of archaeological deposits in and around churches and how they are affected by the digging of drains and the lowering of ground levels. For explanation, see text, pages 66-9*

9.23 The Victorian restorers made a token effort at controlling the dampness problem, but to a large extent defeated their own ends by lowering floor levels internally (9.54). Their 'remedy' took one of two forms: either the ground around the walls was cut down (Fig. 27.3), or a drainage channel was excavated around the building. Evidence of the first method is common, while at Great Yeldham (136) and Halstead (120) enormous trenches were dug around the churches. The construction of deep drainage channels, usually brick-lined and rendered, was less common until the earlier part of this century. One of the first recorded drainage channels must be that at Layer Breton (73), which was constructed in 1837, and lined with zinc troughing. Over the last few decades the practice of constructing drainage channels has become very common and some architects regard them as a normal part of any restoration programme. Furthermore, concern over the steady loss of, and damage to, wallpaintings since their discovery a hundred or so years ago has led the Council for Places of Worship to issue recommendations regarding the provision of drainage channels. A diagram illustrating how these should be constructed was published in *Maintenance and Repair of Stone Buildings* (1970) and *How to look after your Church* (1970).

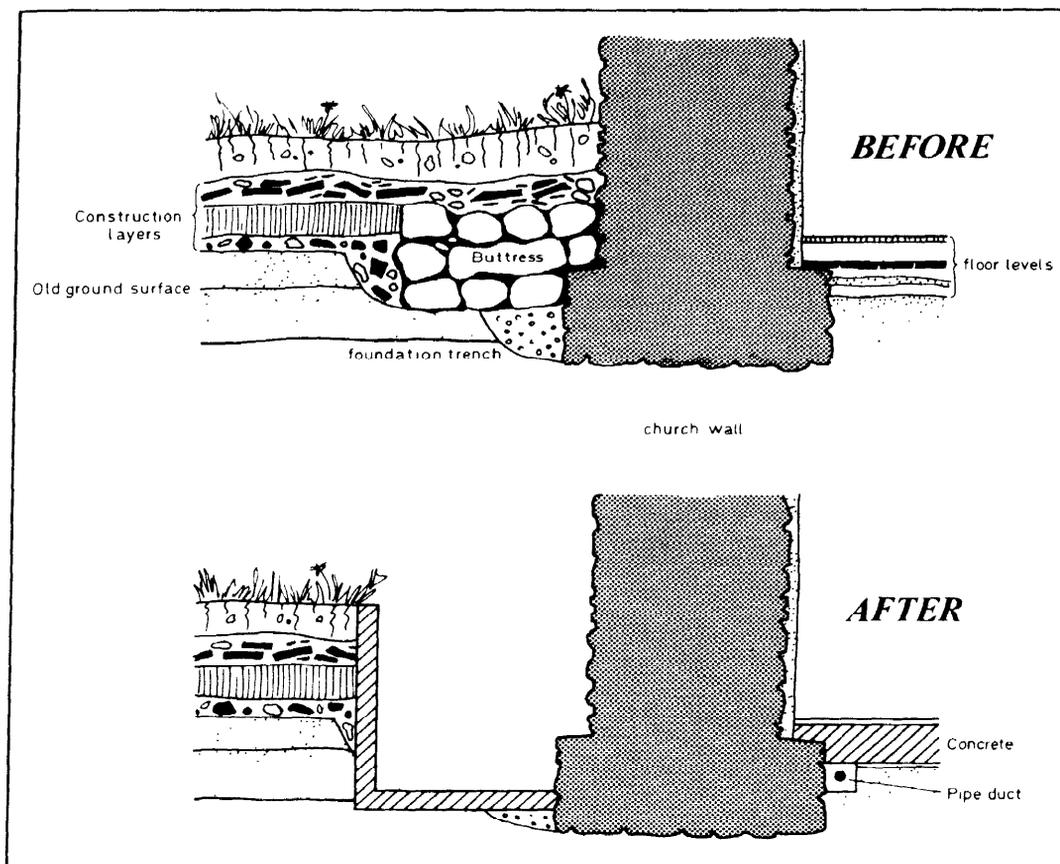
28 Diagrams to illustrate in detail the archaeological effects of constructing an open drain around the base of a church wall, and relaying an internal floor

wall will remove these deposits. Furthermore, if there are any buried foundations of buttresses, chapels, aisles, towers, porches or *porticus*, these will be dug away wherever they cross the path of the trench, and their structural relationship to the main walls of the church destroyed (Fig. 28). Worse still, drainage channels usually run around most, or all of the exterior of a church, so that the archaeological destruction adjacent to the foundations is not partial, but total (Rodwell, 1975a, 38). The Council for Places of Worship has recognized the danger of advocating drainage channels around ancient churches and has produced a supplementary publication on this subject, *Churches and Archaeology: digging operations in and around churches* (1974). We have already seen how extensive the archaeological destruction would have been at Rivenhall, had the proposed drainage operation taken place without prior excavation (6.11).

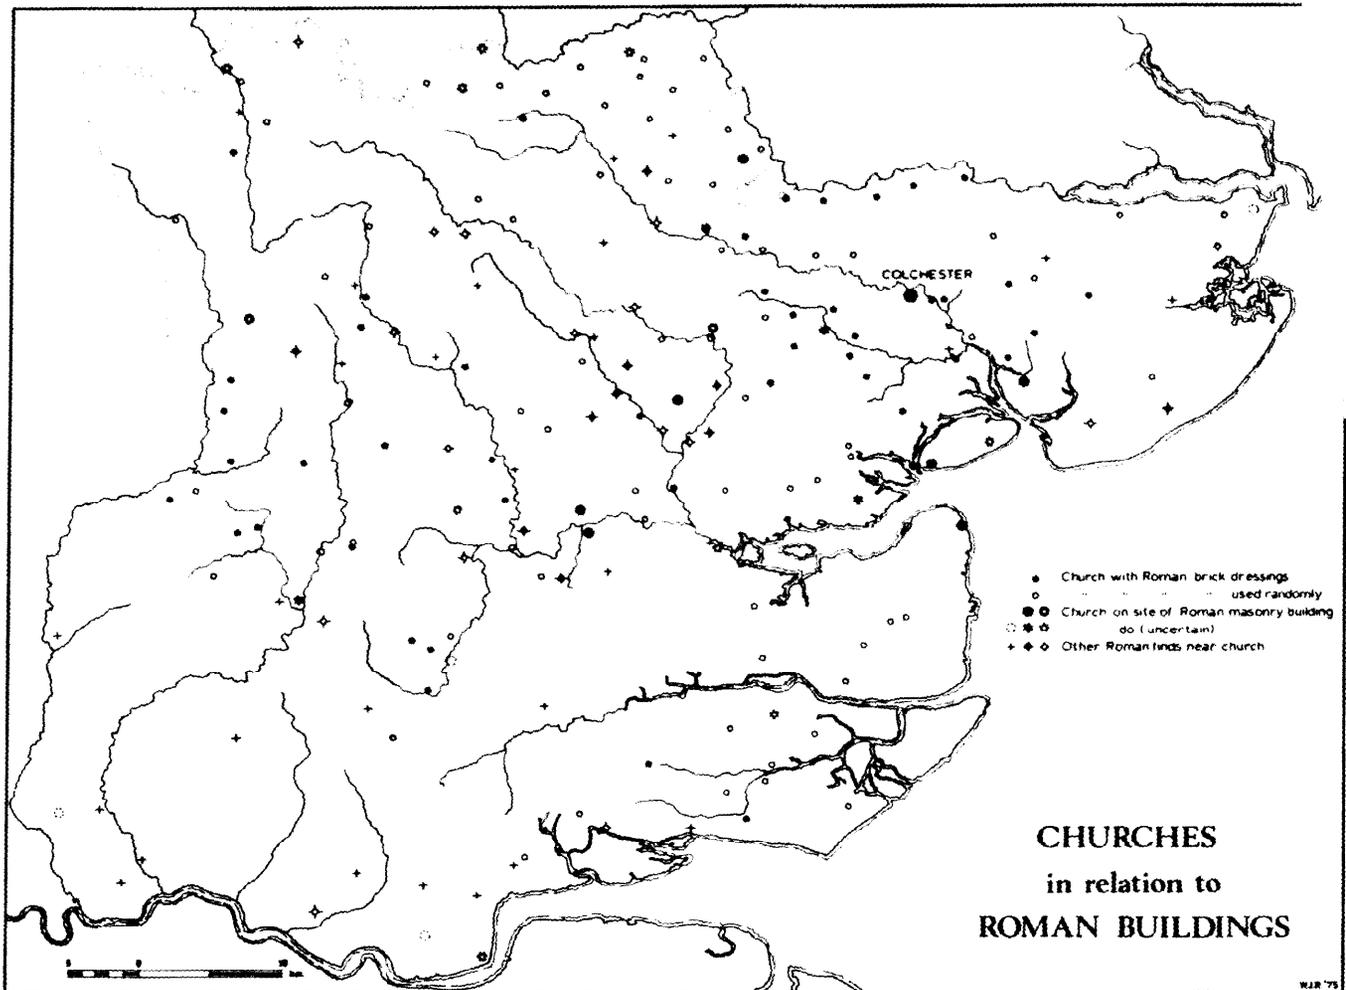
30 Map to illustrate the coincidence of churches with major Roman sites and the occurrence of Roman bricks in Anglo-Saxon and medieval churches

Anglo-Saxon and Norman examples employ Roman brick in place of dressed stone (Fig. 30). Buildings of the Tudor period are often largely or wholly of brick, while the use of earlier (medieval) brick is very rare. Repairs to brickwork tend to be relatively straightforward and, provided that the correct colour, texture, size, bonding and pointing are employed, the archaeologist need not be unduly troubled. There should, however, be provision for the making of an adequate photographic record, especially if large areas of brickwork are to be replaced. Repairs to historically important features, such as early windows and doorways built of Roman brick, should be recorded in careful detail, since the very way in which the bricks are laid may be a crucial piece of dating evidence. There are, for example, several distinct ways of turning an arch in Roman bricks, but to the layman they may all look alike.

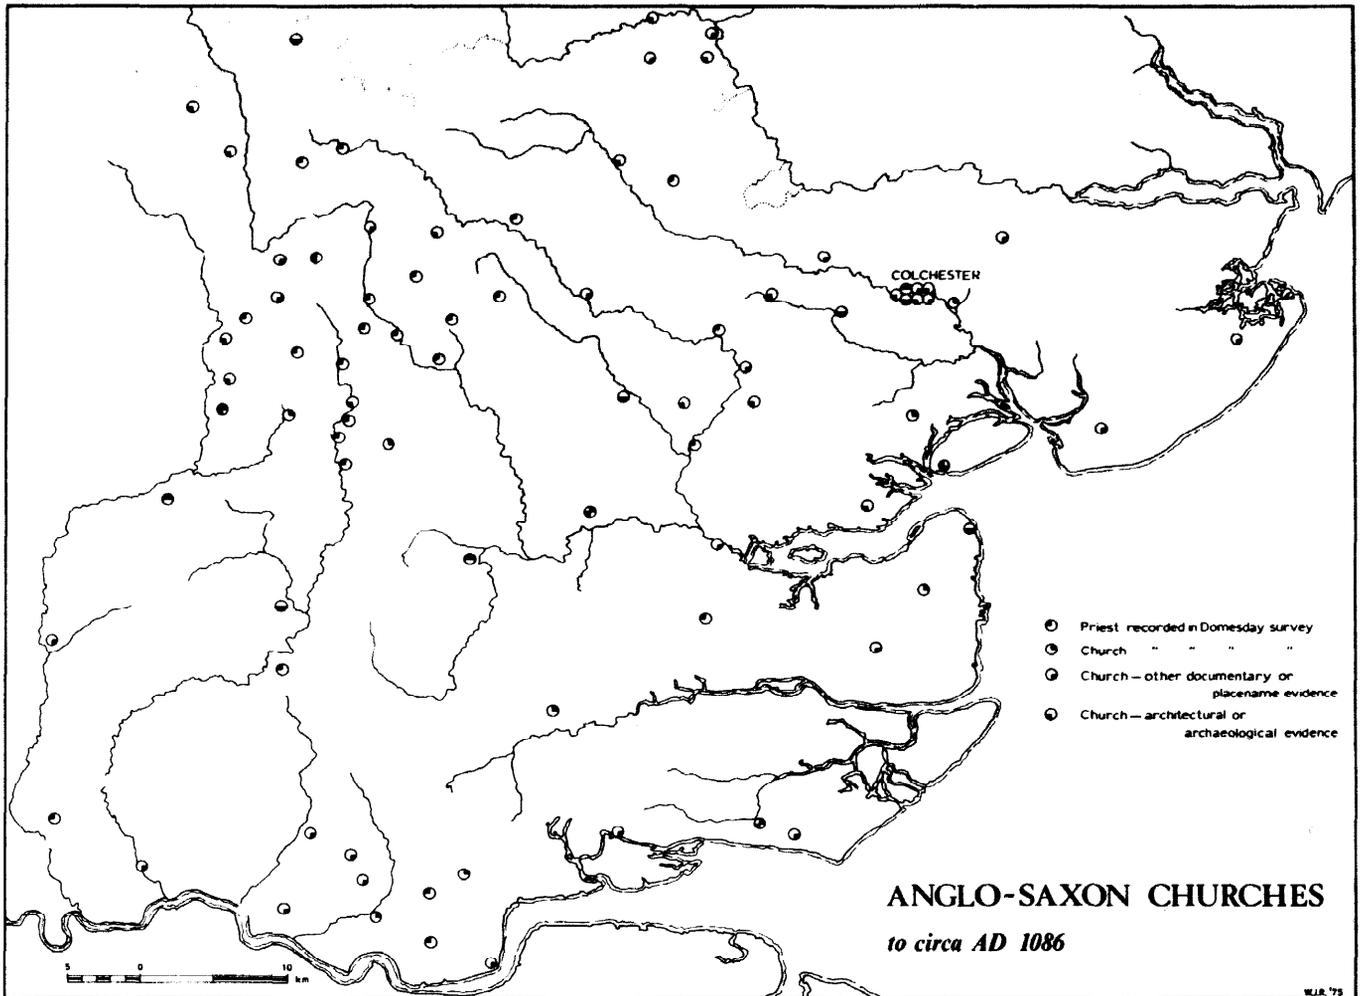
31 Map showing the incidence of churches known to exist prior to c. 1086, based on documentary, archaeological and architectural evidence
