SEAFORD CHURCH.

BY THE LATE J. S. LEE, Esq.

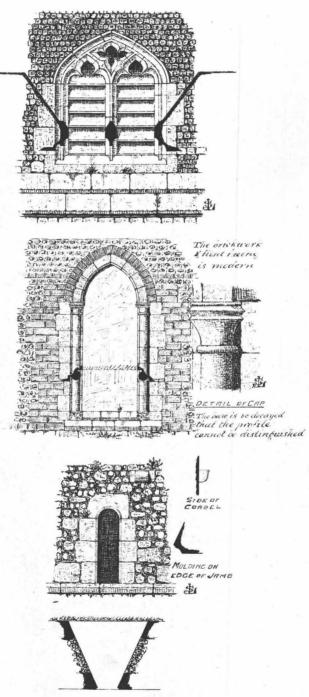
PLAN

Seaford Church consists of a nave, chancel, north and south aisles of nave, tower at west end, vestry north of tower, south porch, and vestry south of chancel. The accompanying plan shows the building as it now exists : the order, in point of time, of the component parts being indicated by different shades.
