# ◆ An early fifteenth-century barn at Charlton Court, Steyning, West Sussex

*A programme of archaeological recording, historical research, and dendrochronological dating, undertaken during a programme of major repairs in 1993–94, demonstrated that the barn at Charlton Court, Steyning, was erected from trees that had mostly been felled in the winter of AD 1404–05, shortly after the manor had passed into private hands in 1403, and it is likely that the barn was prefabricated from green timbers during the summer of 1405 through to the spring of 1406.*

*Originally designed as a three-bay unaisled barn, with canopied porches to the central bay, it has a surviving roof frame comprising kingposts carrying a ridge plate, supported by heavy downswing braces which carry side purlins trenched into their upper edges.*

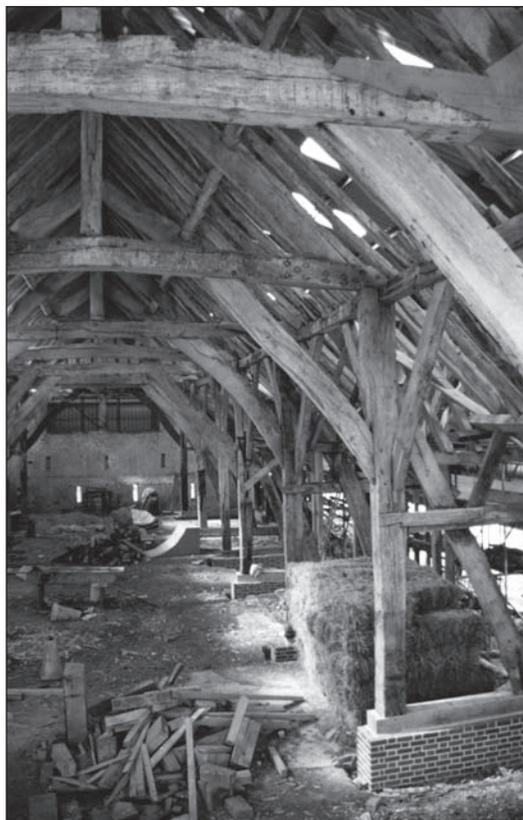
Fig. 3. Interior of the barn during repairs in 1994, looking south, with the west end of Truss 3 in the foreground.

As it survived in 1993, the building was an eight-bay aisled barn, formed by eight oak trusses, including the north wall, which has been numbered *Truss 1* by the author, and a flint and chalk wall with brick dressings at the south end (Figs 2 & 3). The north, east, and west walls were timber clad and the roof covering was Horsham stone slabs in reducing courses. There were two gabled porches on the west side with corresponding entrances on the east side and a further access, probably for carts, had been made at the north end of the east wall.

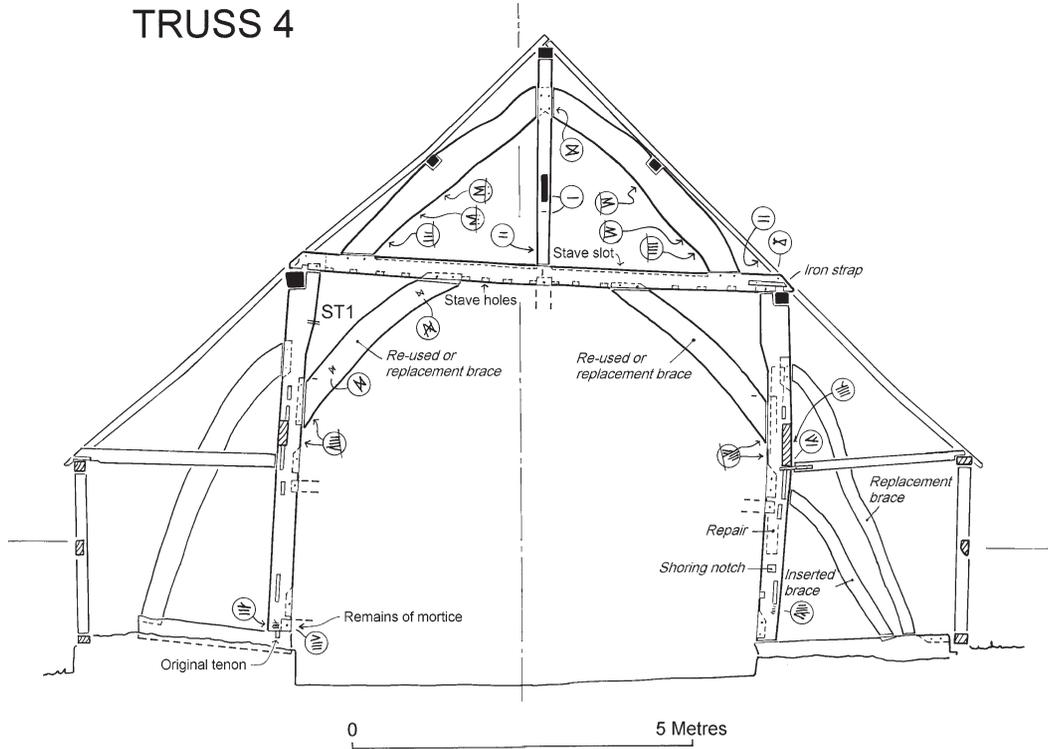
Fig. 4. The south (internal) face of the truss forming the north end of the Phase 1 barn, showing the position from which the dendrochronological sample was taken (ST1) and with the carpenters' marks enlarged for clarity.

The lines of the principal external walls of the earliest building are defined by the main posts on Trusses 4, 5, 6, and 7, though that at the east end of Truss 7 has been replaced, and by mortices for posts and braces as well as notches for staves cut on the underside of, what are now, the arcade plates on the east and west sides of Bays 4, 5 and 6 and the tie beams of Trusses 4 and 7 (Figs 4–13).

A number of hewing marks, of the type described by Dan Miles and Henry Russell occur on both of the principal phases of the barn, usually in the form of a diagonal cross with a horizontal line at the top and bottom (Figs 4 & 8-12).<sup>13</sup> Two examples on the curved underside of the paired downswing braces on Truss 4 were cut in half when the two braces were sawn apart from a single timber (Fig. 4).

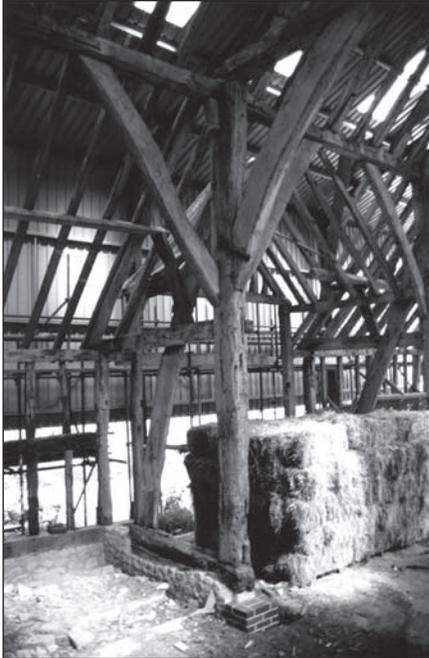
Fig. 5. The main post at the west end of Truss 4, looking northwest. Note the redundant mortices for the soleplate, rail, and braces.

the mortice visible at the west end of Truss 4. The main posts now mostly sit on soleplates inserted for the Phase-2 aisles and these extend to the outer walls. The notches for the shores which may have been necessary to allow their insertion survive, although these do not appear on all the Phase-1 posts and do extend onto the Phase-2 extension, so an alternative function may account for all or some of them (Fig. 15).

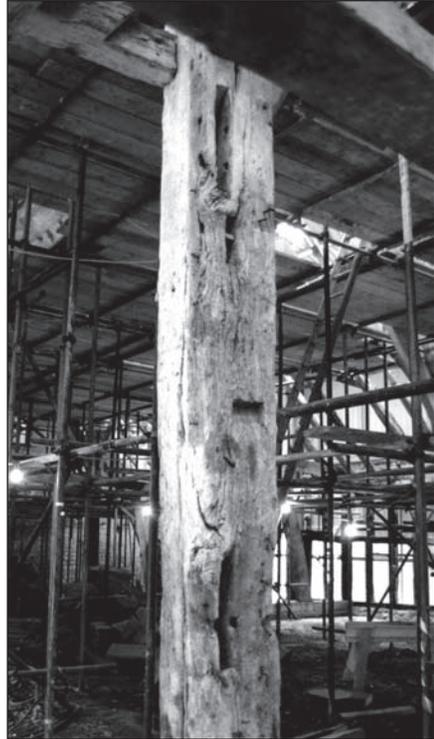
Fig. 6. The main post at the east end of Truss 5, north face, showing the redundant mortices for rail and braces, and a shoring notch.

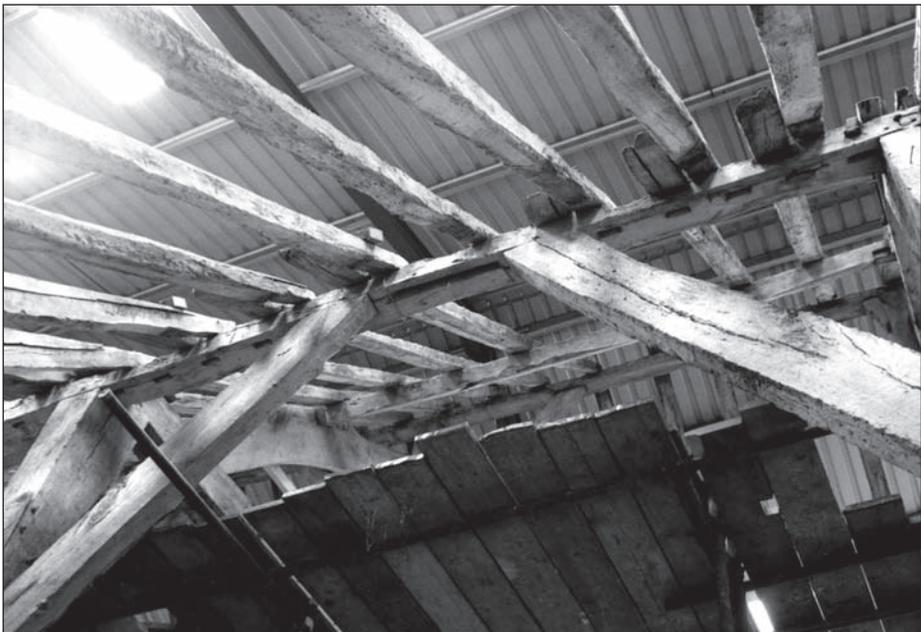
Fig. 7. Underside of the Phase 1 wall plate, showing stave-holes and the redundant mortice for braces.

The stave-holes on the underside of the wall plates and tie beams at either end of the building appear to have been designed to carry wattle and daub panels, as the end stave-holes in each panel are set alongside the principal members of the framing, but there was no evidence which might have existed, for example in the form of broken

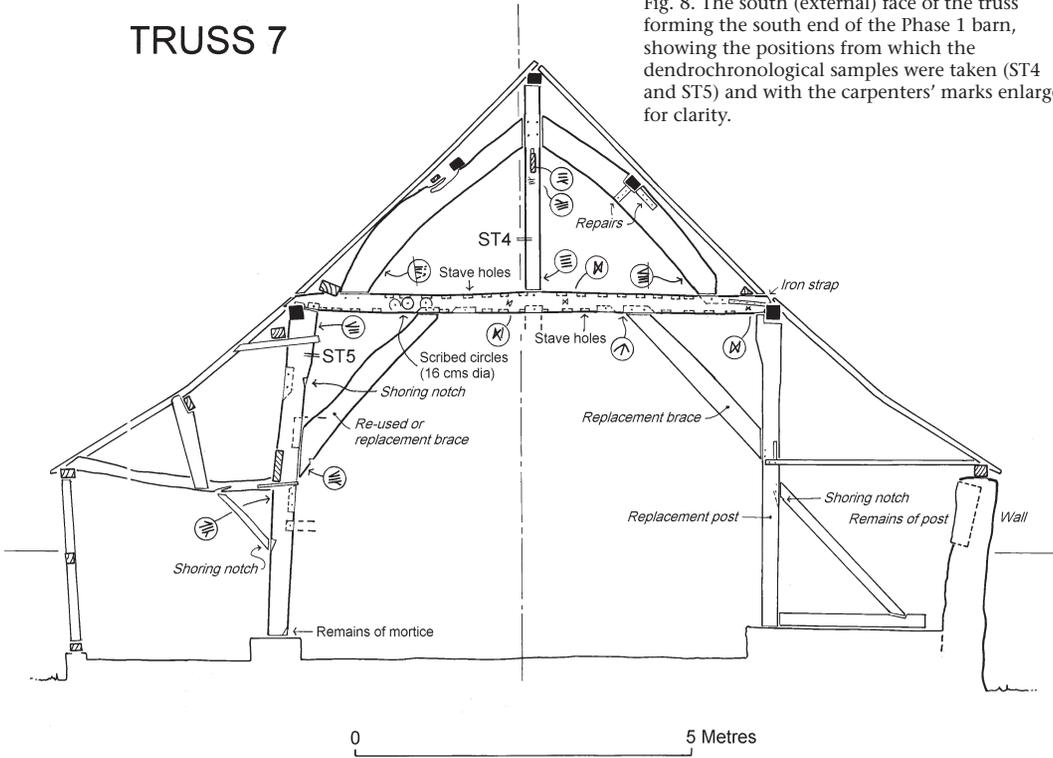
Fig. 8. The south (external) face of the truss forming the south end of the Phase 1 barn, showing the positions from which the dendrochronological samples were taken (ST4 and ST5) and with the carpenters' marks enlarged for clarity.

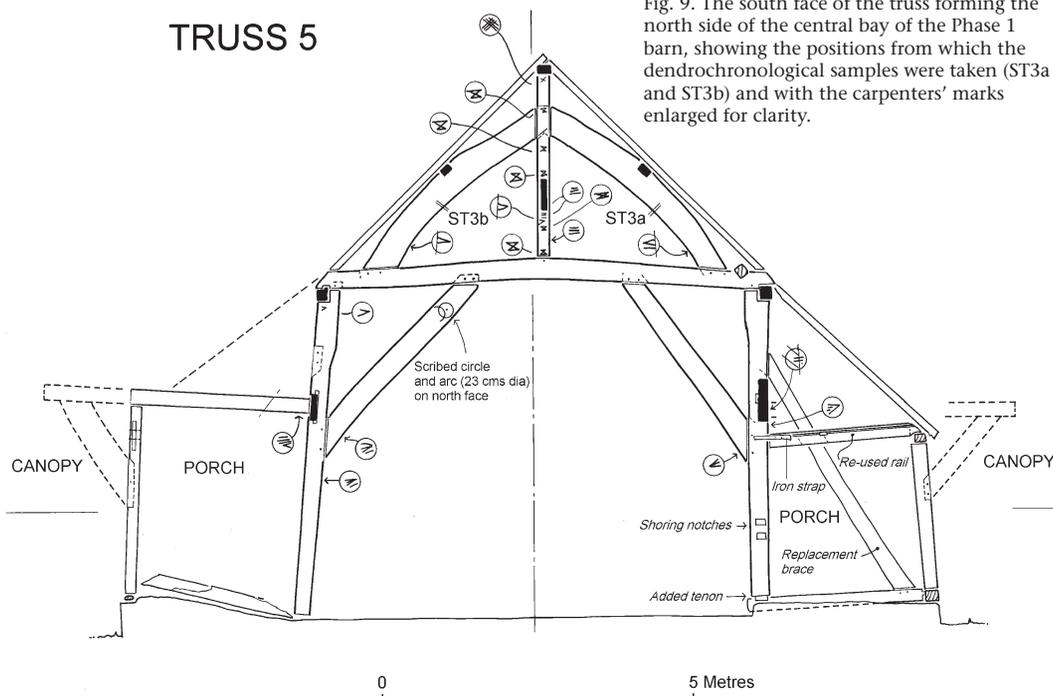
Fig. 9. The north face of the truss forming the north side of the central bay of the Phase 1 barn, showing the positions from which the dendrochronological samples were taken (ST3a and ST3b) and with the carpenters' marks enlarged for clarity.

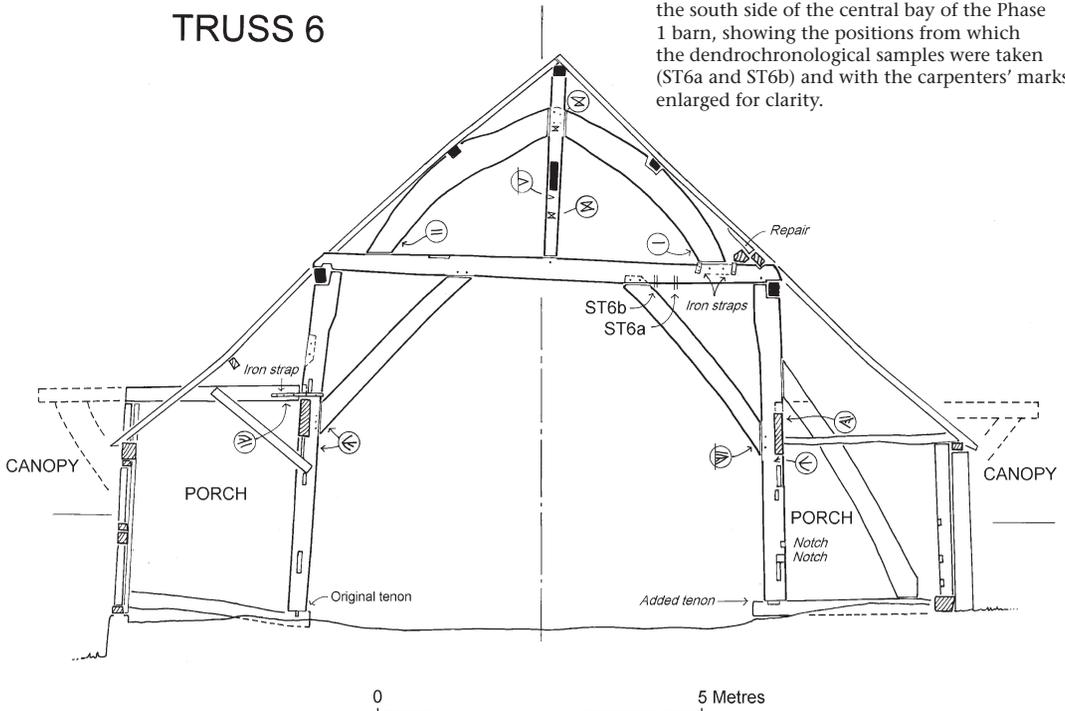
Fig. 10. The south face of the truss forming the south side of the central bay of the Phase 1 barn, showing the positions from which the dendrochronological samples were taken (ST6a and ST6b) and with the carpenters' marks enlarged for clarity.

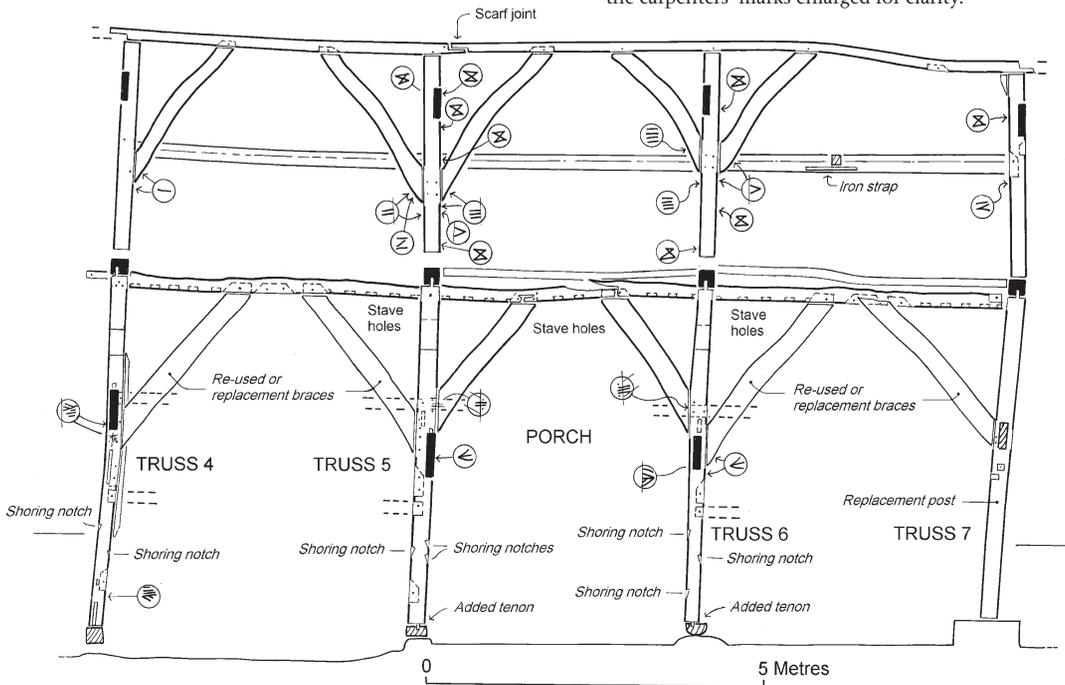
Fig. 11. The west (interior) face of the arcade and roof frame forming the east side of the Phase 1 barn, with the carpenters' marks enlarged for clarity.

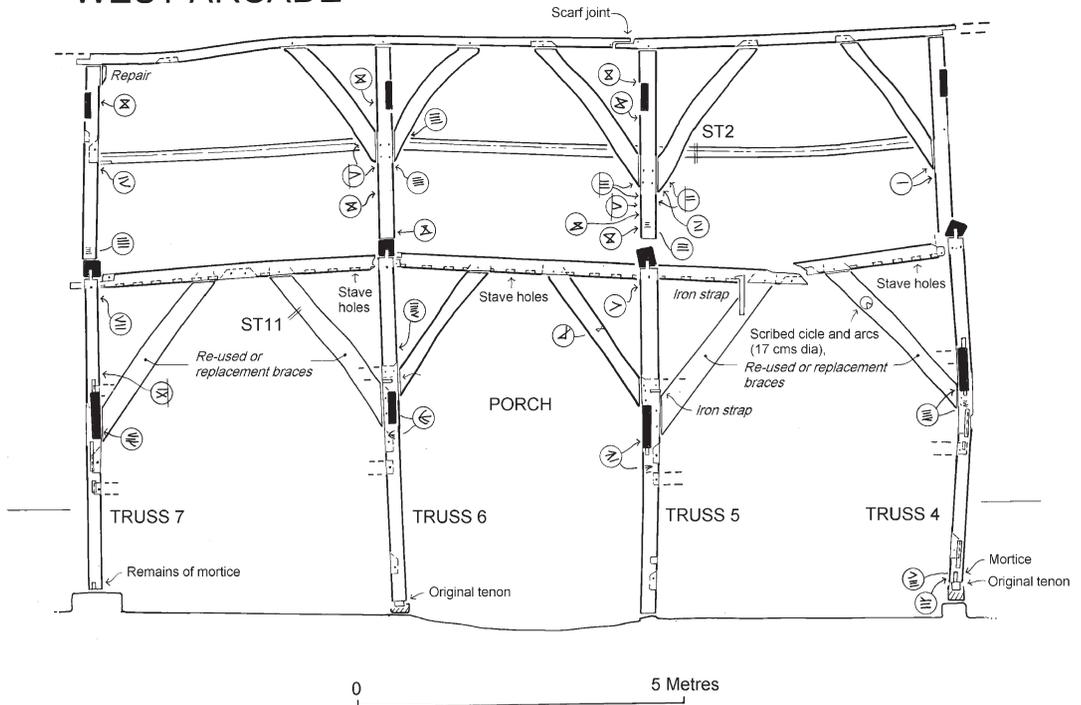
Fig. 12. The east (interior) face of the arcade and roof frame forming the west side of the Phase 1 Barn, showing the positions from which the dendrochronological samples were taken (ST2 and ST11) and with the carpenters' marks enlarged for clarity.

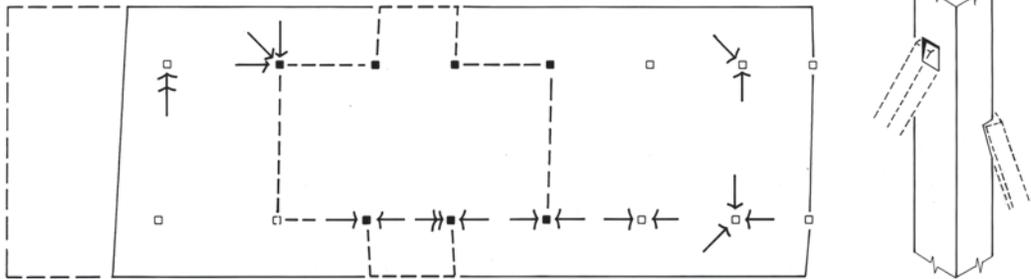
Fig. 15. The locations of the shoring notches, which are mostly also shown on Figures 4 and 8-12.

The sequence of carpenters' numerals on the arcade braces and posts appears to be restricted to the east arcade (Fig. 24b) where the numerals I-VI occur adjacent to Trusses 1-4 with one further numeral adjacent to Truss 6. With the omission of a brace on the north side of Truss 2, this sequence evidently relates to the insertion of braces in Phase 2. It may be of significance that the pattern of this sequence of numbers is similar to the pattern of surviving shoring notches or 'scotches' (Fig. 15).

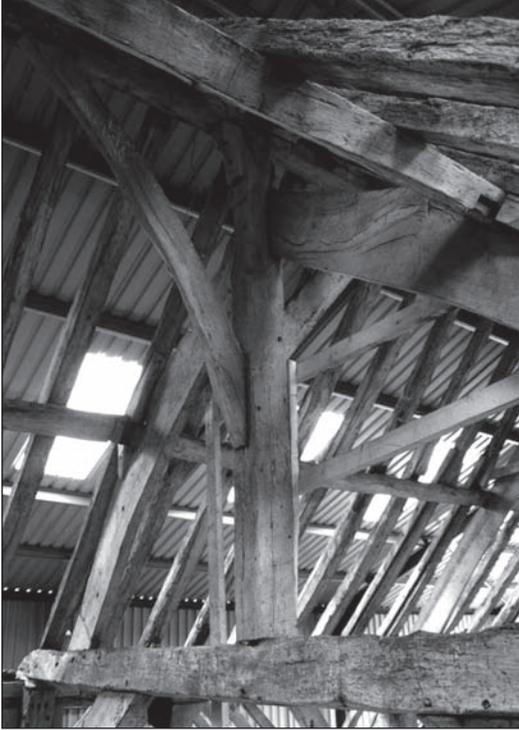
Fig. 16. Kingpost and brace assembly on Truss 4. Note the different levels at which the braces from the ridge plate attach to the kingpost, that to the left (south) is part of the Phase-1 structure, whilst that to the right (north) is part of the Phase-2 extension.

The roof frame currently consists of kingposts carrying a ridge plate and supported by heavy downswing braces which each carry side purlins trenched into their upper edges. The ridge plate is also longitudinally braced to the kingposts, and it is noticeable that the level at which the braces meet the kingposts changes at Trusses 4 and 7 (Fig. 16).

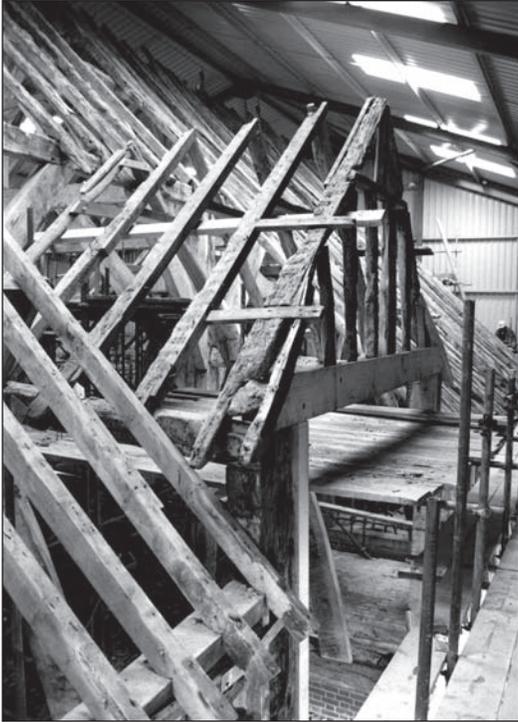
Fig. 19. The west porch, from the north.

The west porch survives, its top plates set just below the level of the upper rail of the side walls. The plates carry five collared rafter couples, including the gabled truss (Figs 18 & 19).

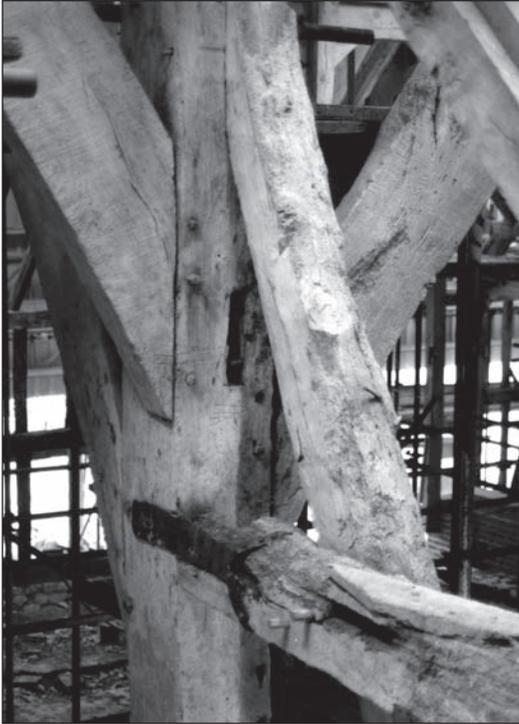
Fig. 21. Redundant mortice for the wall plate on the north side of the east porch, on the post at the east end of Truss 5. Note the remains of a peg which appear to indicate that it had been used.

face of the posts at the east end of Trusses 4 and 5, which both carry broken pegs (Figs 21 & 22), and the redundant peg-holes for valley boards in the rafters, mentioned above. The fact that the feet of the original rafters, with tapered underside and chamfered end, continue through the line of the east porch, suggests that the east porch may be constructionally slightly later than the roof.

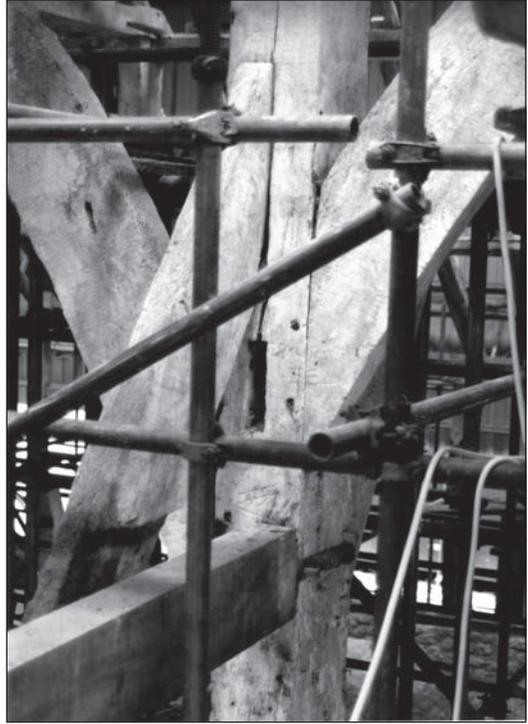
Fig. 22. Redundant mortice for the wall plate on the south side of the east porch, on the post at the east end of Truss 6.

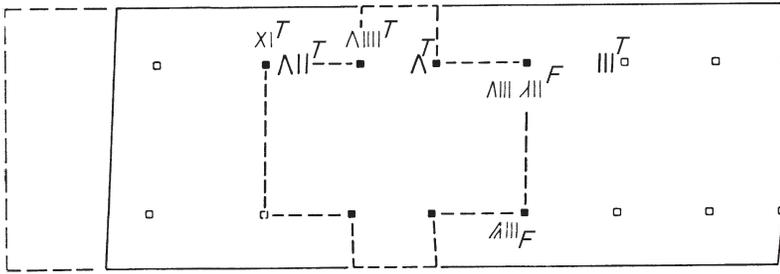
### a. MAIN POSTS

*T* - Number at top of post  
*F* - Number at foot of post

Of limited value for understanding the constructional sequence of the building are a small number which appear on the main posts (Fig. 24a). The numerals III, V and VII at the top of posts at the west end of Trusses 3, 5 and 7 seem to identify these three trusses in the extended eight truss barn of Phase 2. Of the remainder there are a pair at the bottom of the posts at either end of Truss 4, both identified as the numeral VIII, but these are on the lower, south, face of the truss and may belong to the Phase-2 extension.

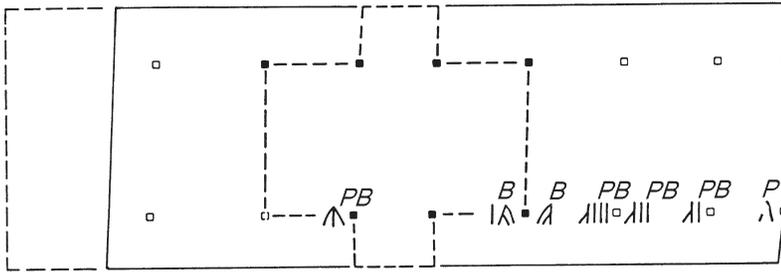
### b. ARCADE BRACES AND POSTS

*B* - Number on brace  
*P* - Number on post  
*PB* - Number on post and brace

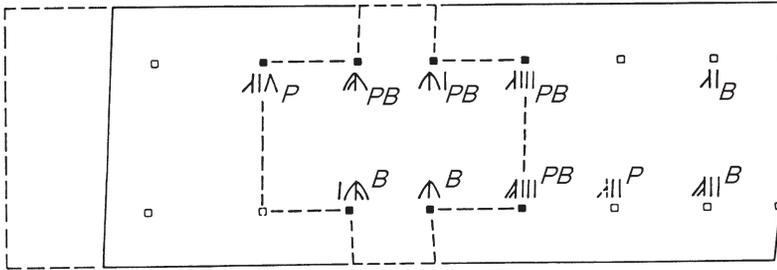
### c. ARCH BRACES AND POSTS

*B* - Number on brace  
*P* - Number on post  
*PB* - Number on post and brace

The sequence of carpenters' numerals on the arch braces, linking posts to tie beams, is more extensive (Fig. 24c) and seems to run in some sort of order from north to south throughout the Phase 2 extended barn, with the numerals II-VII occurring on Trusses 2-7. There are, however, a

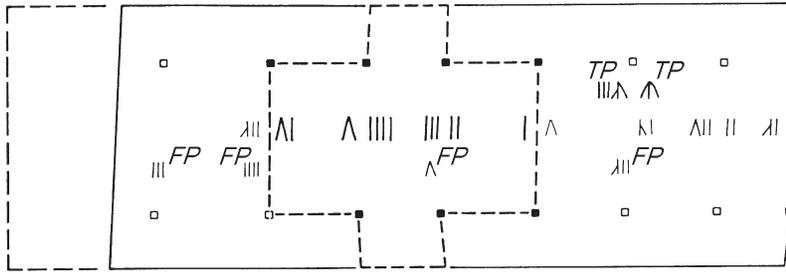
### d. KING POSTS AND BRACES

*TP - Number at top of king post  
FP - Number at foot of king post*

The carpenters' numerals on the kingposts and braces include a significant sequence of numerals from I-VI on Trusses 4-7 which clearly relate to the framing-up of the Phase-1 barn as a separate entity (Fig. 13), but there appears to be no particular pattern to the remainder which link kingposts to braces or are confined to the kingposts themselves (Fig. 25d).

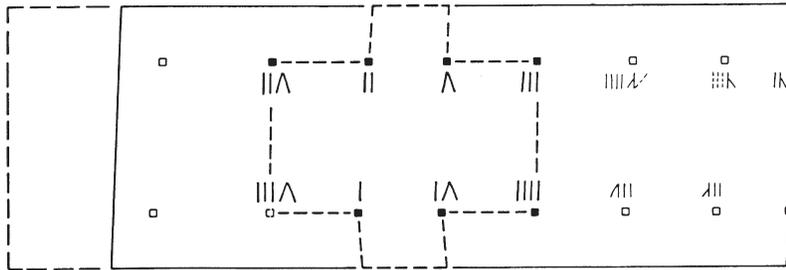
### e. DOWNSWING BRACES

Fig. 25. Carpenters' numerals d-f.

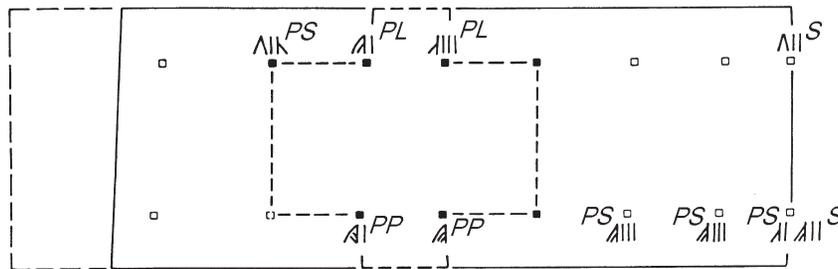
### f. AISLE SPURS, PORCH PLATES AND POSTS

*S - Number on underside of spur  
PS - Number on post for spur  
PL - Number on underside of porch wallplate  
PP - Number on post for porch wallplate*

The carpenters' numbers linking the aisle spurs, porch plates and posts appear to form no particular pattern across the building, although their survival is to some extent affected by subsequent alterations and the re-use of old timbers (Fig. 25f). The numbers identifying the porch wall plates are not sufficiently distinctive to suggest that they belong to Phase 1 and the numbers may have been added in Phase 2.
