Report on Archaeological Monitoring
St Mary's Church, Forncett St Mary, Norfolk

NHER ENF 135133

Prepared for Forncett PCC

Sarah Bates (Report No. 15)
March 2015

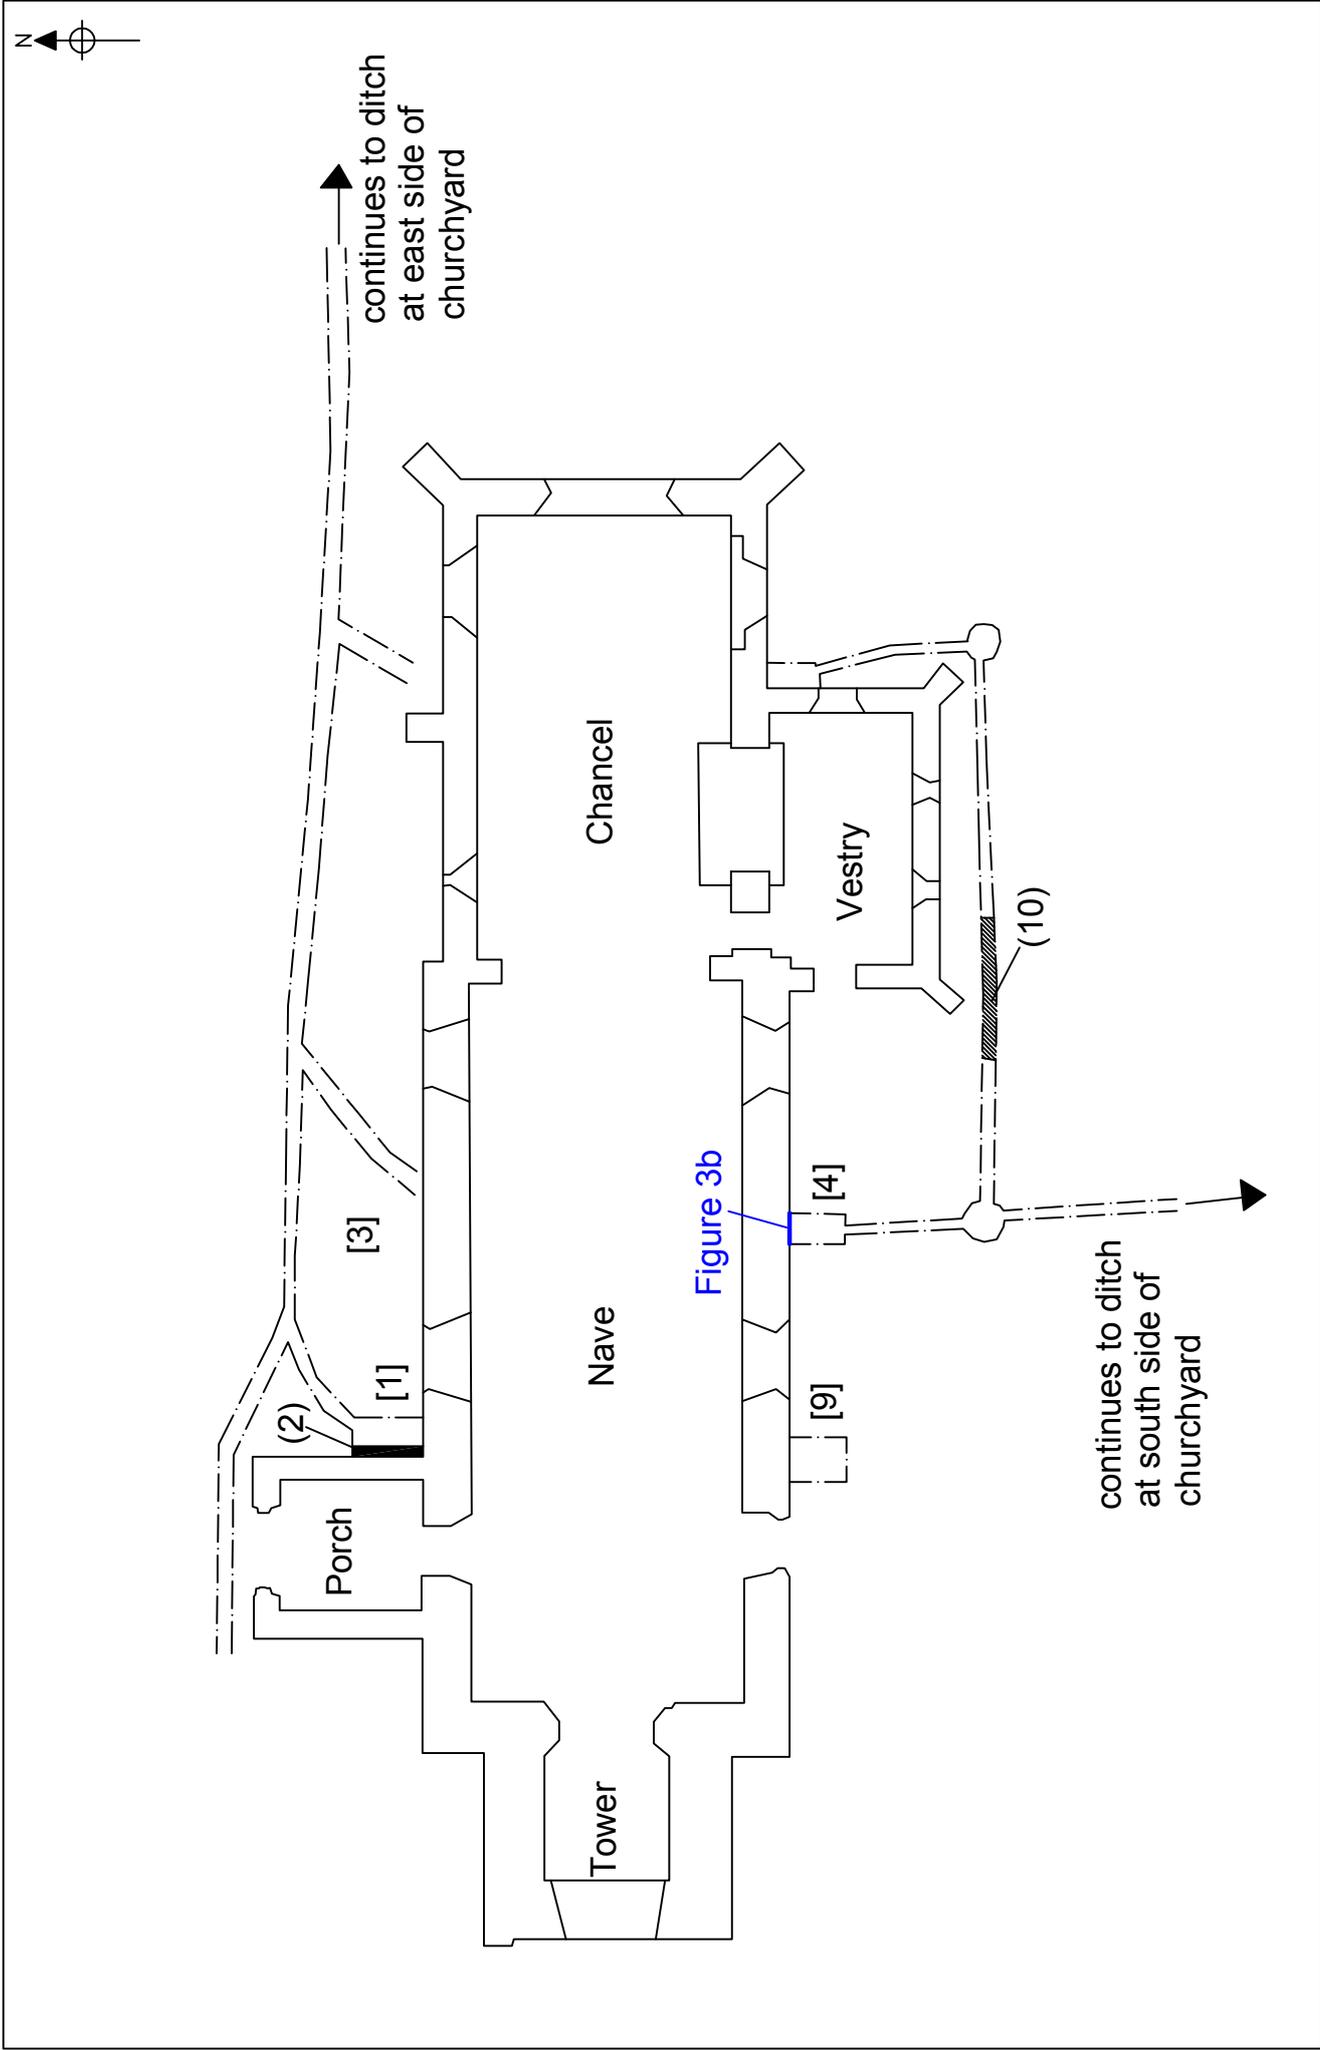
Figure 2. Plan showing location of trenches. Scale 1:150.

5.0 Results (Figs. 2 and 3)

The trenches from all the downpipe gullies ran into two drain runs which ran, due east and south, to drain into ditches at the churchyard boundaries; one at the east side of the churchyard and the other at the south boundary. They were 0.30-0.40m wide and ranged from 0.30-0.90m in depth (being shallower close to the church). The drain running east across the churchyard was up to 0.60m deep and that running to the south was up to 0.90m deep (Plates 6 and 7). Where they extended below the brown sandy loam topsoil they cut into the slightly sandier underlying churchyard soils.

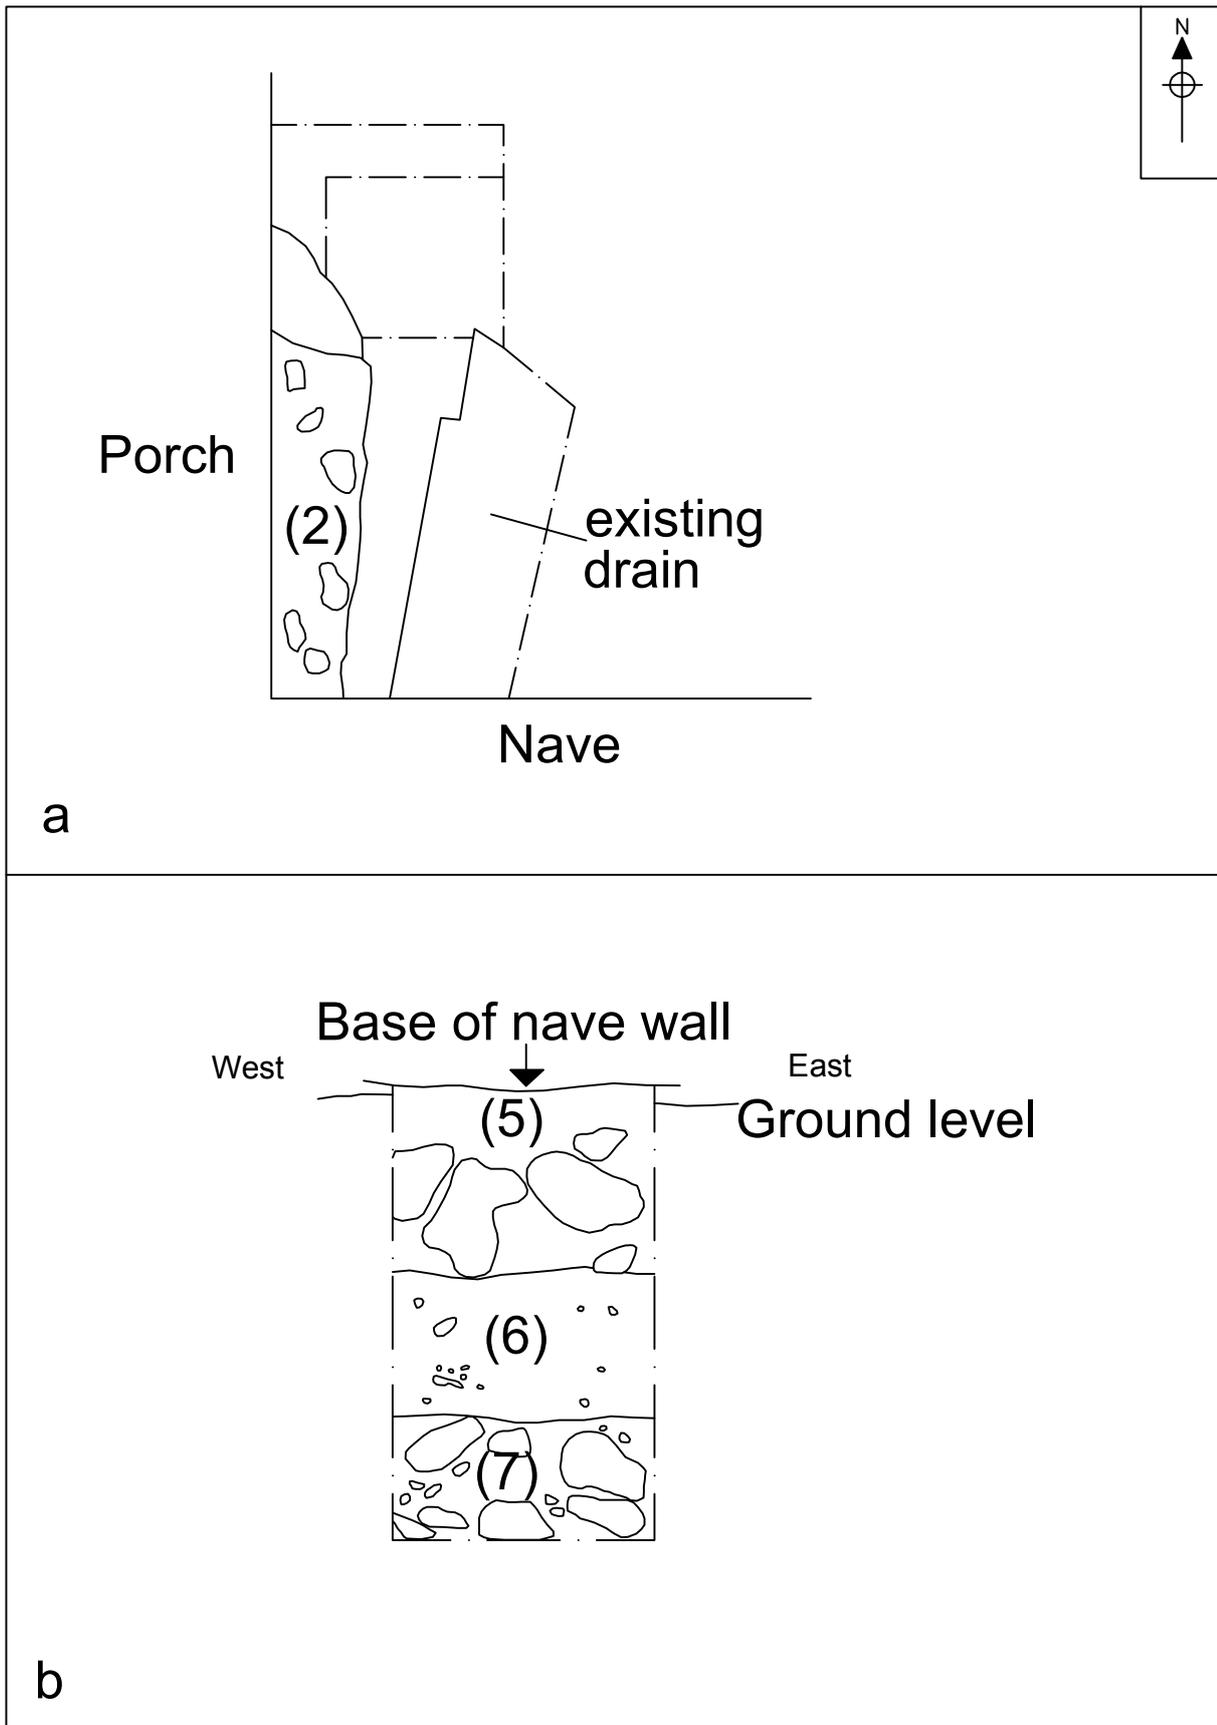
Figure 3. a: Plan of Trench [1] showing footing (2). Scale 1:20.

b: Section through church footing in Trench [4]. Scale 1:10.

Gully trench [1] (Figs 2 and 3a, Plate 2)

Gully trench [4] (Figs 2 and 3b, Plate 4)

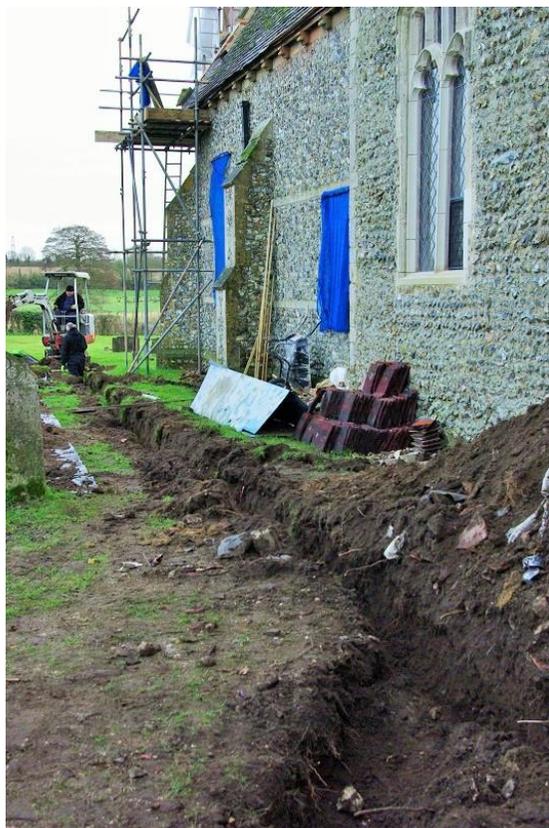
Plate 1: Drain trench N of church, looking E

The trenches were dug, mostly by mini-digger with some hand-digging, by the site contractors (Plate 1).

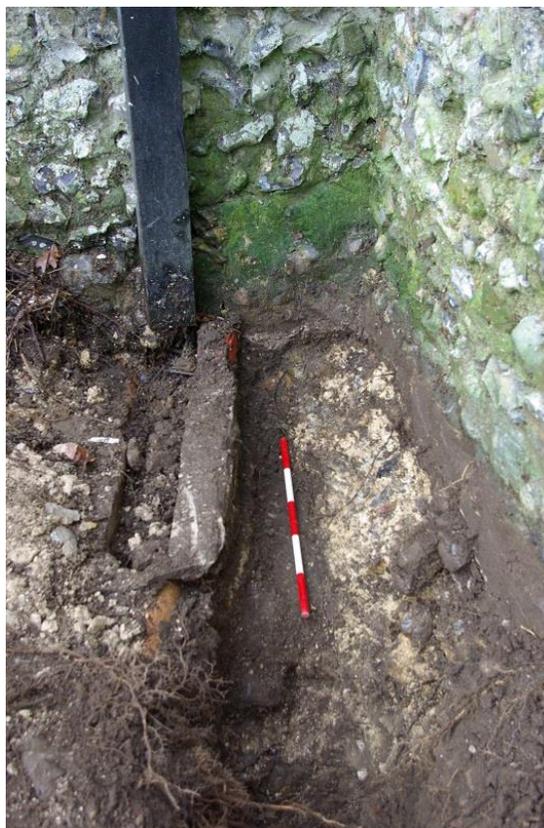
Plate 2: Trench [1], footing [2], looking S, 0.5m scale

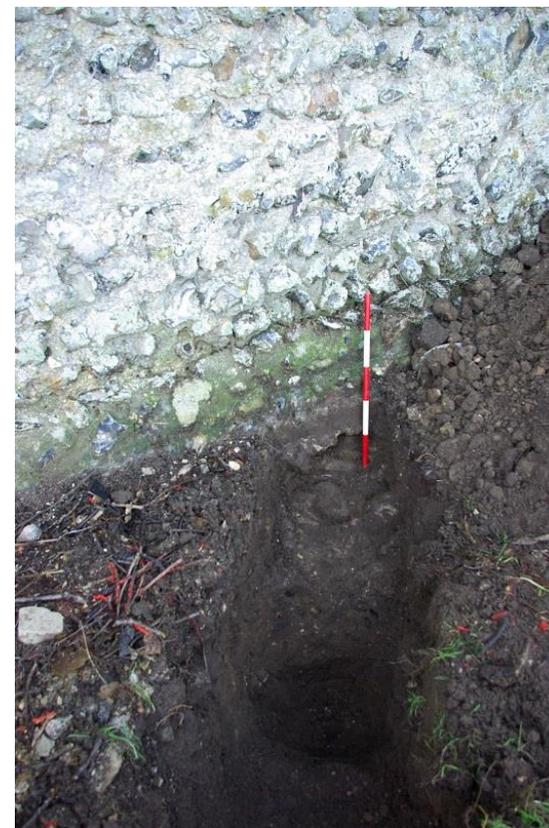
Plate 3: Trench [3], nave wall footing, looking SW, 0.5m scale

Gully trench [3] (Fig. 2) (Plate 3)

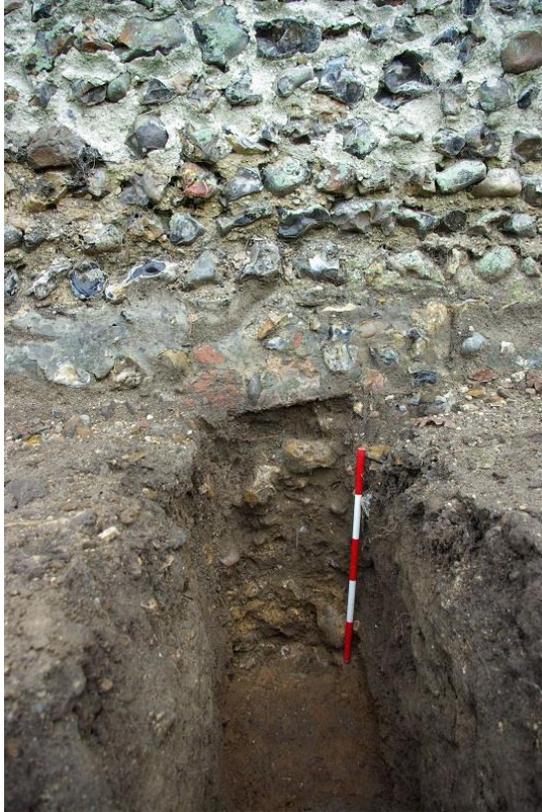
Plate 4: Church footing in trench [4], looking N, 0.5m scale

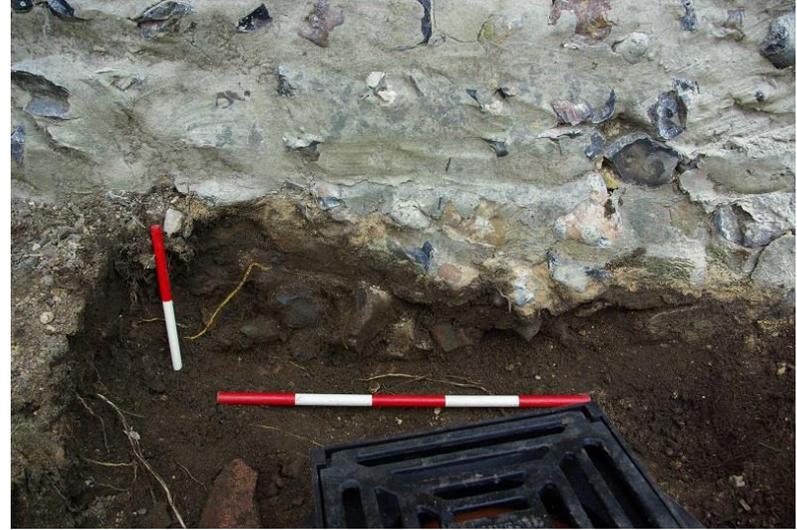
Plate 5: Trench [9] showing base of nave wall, looking N, 0.5m scale

Gully trench [9] (Fig. 2) (Plate 5)

Trench [9] was positioned below the nave wall just to the east of the south doorway. It was 1.10x 0.80m in size and 0.15m deep with a deeper area (0.75m) for the gully pot. The trench was dug to its full depth within slightly orangey brown quite loose sandy silt with occasional small flints. The upper part of the wall footing was exposed and consisted of rough flints which protruded very slightly south from the face of the wall above. Nothing of archaeological interest was seen.

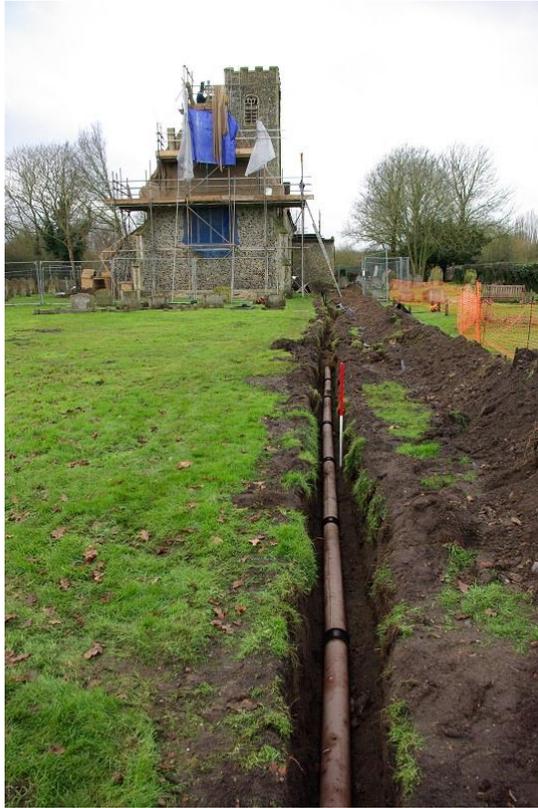
Plate 6: Drain E of church, looking W, 1m scale

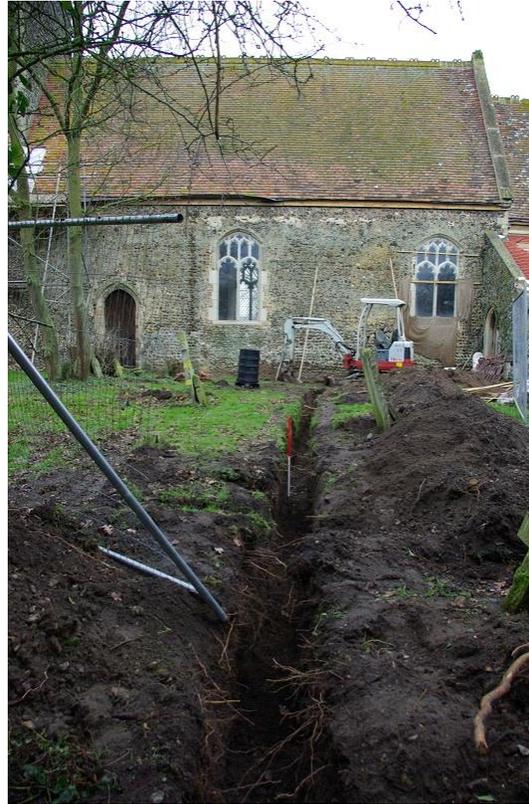
Plate 7: Drain S of church, looking N, 1m scale

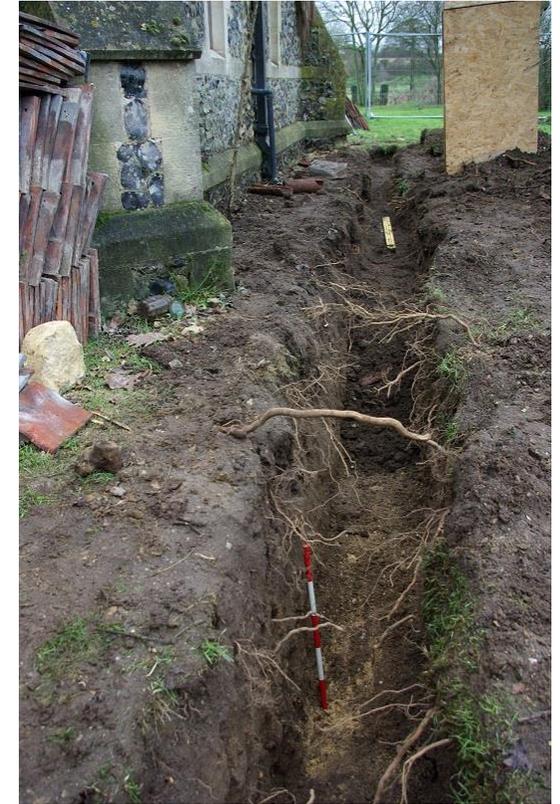
Plate 8: Drain S of vestry, deposit [10], looking E,
0.5m scale

The only area where a deposit of slight interest was seen was just to the south-west of the vestry. Here, a layer of cream mortar was noted in the bottom of the drain at a depth of 0.75m [10] (Plate 8). It extended 1.20m along the trench and was up to 0.10m thick
