Report on Archaeological Monitoring and Excavation

Church of St Peter and St Paul, Honing, Norfolk

Sarah Bates (Report No. 32)
November 2017

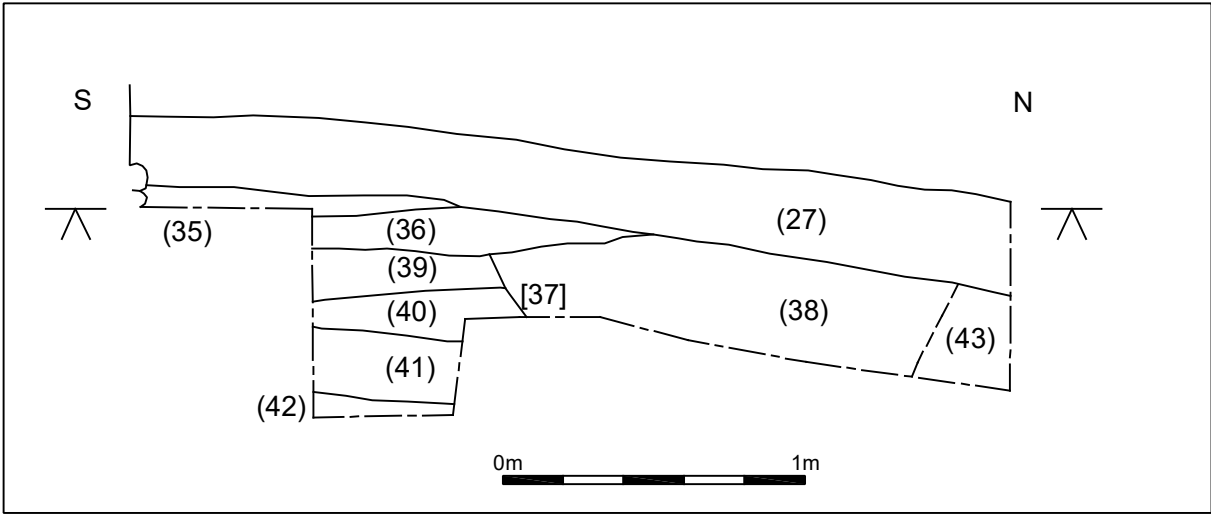
Figure 2. Trench 34; East facing section.

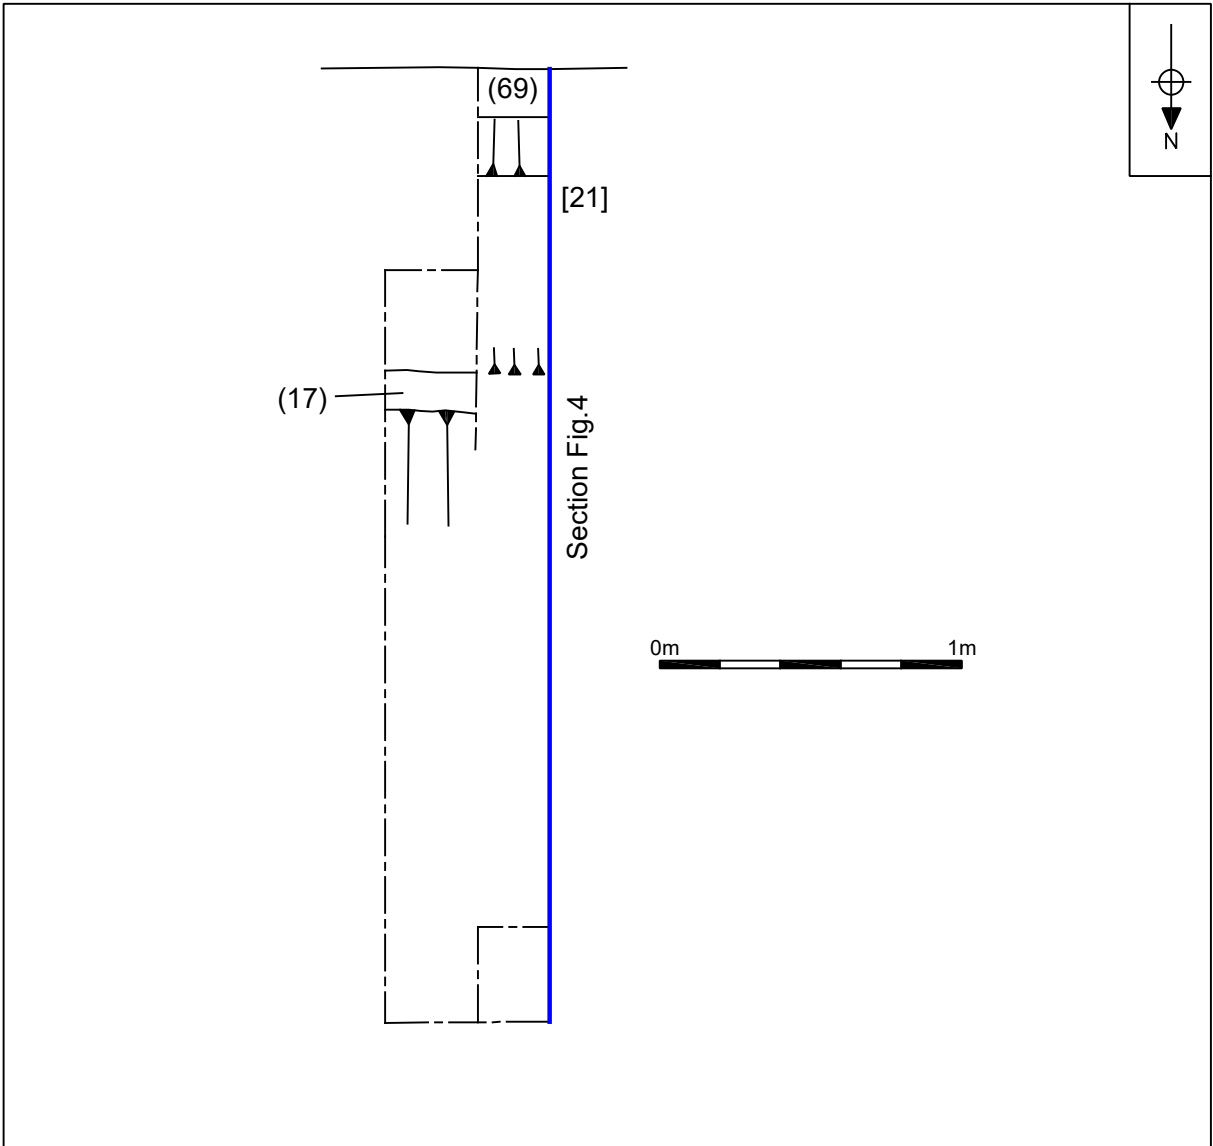
Figure 3. Opening-up Trench 2; plan.

N side of N aisle central/E area, 2.80 x 0.55m x <0.80m (Figs 1, 3 and 4, Plate 3)

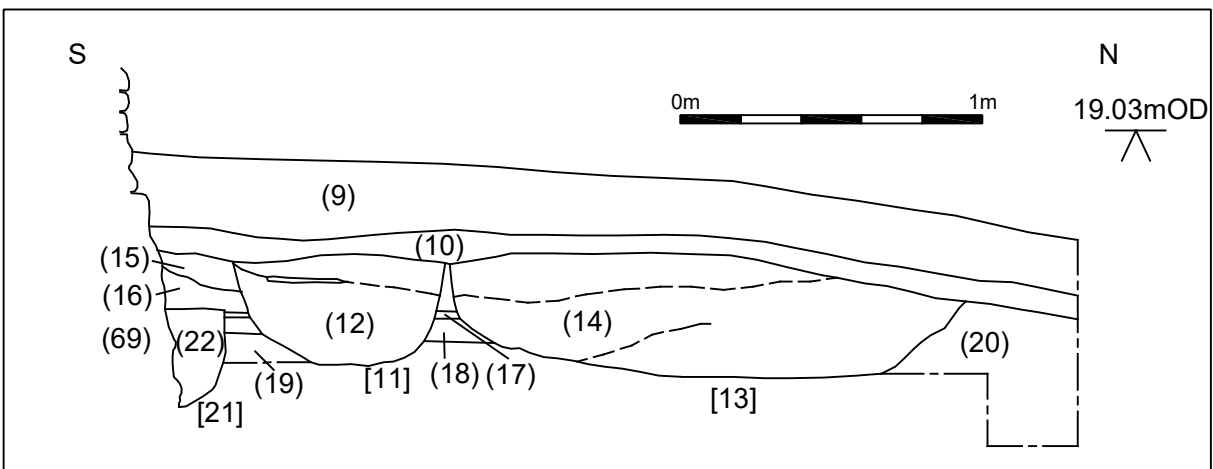
Figure 4. Opening-up Trench 2; East facing section.

The earliest deposits recorded were a very small area of brownish grey fine sandy silt with grey clayey silt patches near the church wall at a depth of about 0.60m from the present ground surface [19], and some churchyard soil at the north end of the trench which was investigated to a depth of 0.75m but appeared to continue downwards [20] (Fig. 4). The grey silt within deposit [19] suggested that that was probably a natural

Absolute levels (mOD) were recorded for the deposits in the opening up trenches (see Figs 4, 7 and 13). In the drain trenches, levels were measured in relation to the church plinth stone and details are held in the site archive. Inside the church the existing floor was recorded as sloping very slightly (40mm) down from chancel to tower but, notably, the tower floor was approximately 0.45m higher than both the threshold to the stairway in its north-east corner and the threshold recorded (outside the church) at its blocked west doorway. The levels recorded for the threshold at the west doorway and the top of the mortar surfaces in opening up trenches 1 and 2 (respectively, 18.57m, 18.64m and 18.45m) show that the mortar recorded to the north (in trench 2) would correspond with a floor level associated with the thresholds seen in the tower. Further interpretation of the levels is difficult although it can be noted that an additional layer of mortar rubble existed below the other deposits in opening up trench 1 (where the upper mortar surface was at a higher level).

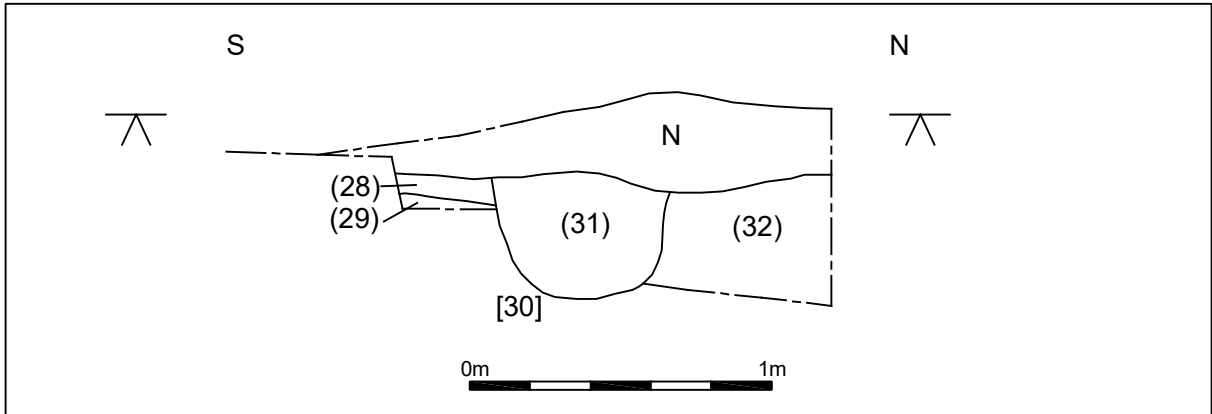
Figure 5. Trench 26; East facing section.

N side of N aisle; E end, 1.30 x 1.30m x 0.90/0.30m (Figs 1 and 5, Plates 4 and 5)

Brown silty sand in the bottom of the pot hole was a subsoil, possibly of natural origin. It was overlaid by a thin layer of light yellow sand and a thicker deposit of dark orange sand (similar to seen elsewhere). The deposits represented make-up material for the former aisle floor (no context numbers were assigned). Above the sand was crushed and moderately compacted cream mortar from the former building, probably including mortar from the floor (the mortar layer is disturbed by machining in Plate 4 but can be seen, prior to excavation of gully pot area, in Plate 5). (These deposit seen in the pot hole in trench [26] are equivalent to [41], [40] and [39] in trench [34] where they were recorded in more detail).

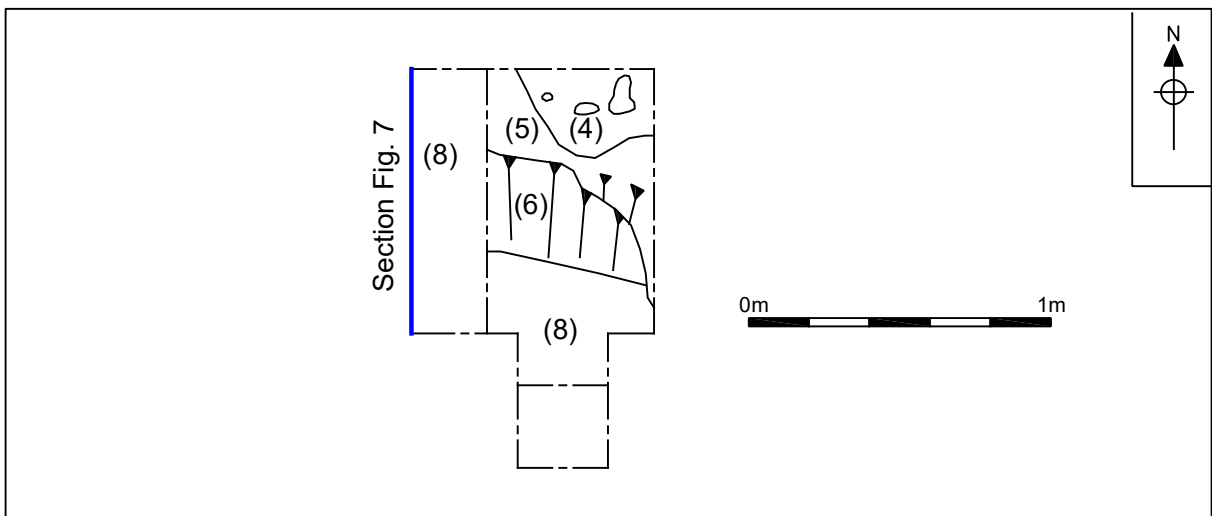
Figure 6. Opening-up Trench 1; plan.

S side of S aisle, W end; 0.90 x 0.80 x 0.90m (with small extension at S end) (Figs 1, 6 and 7, Plate 6)

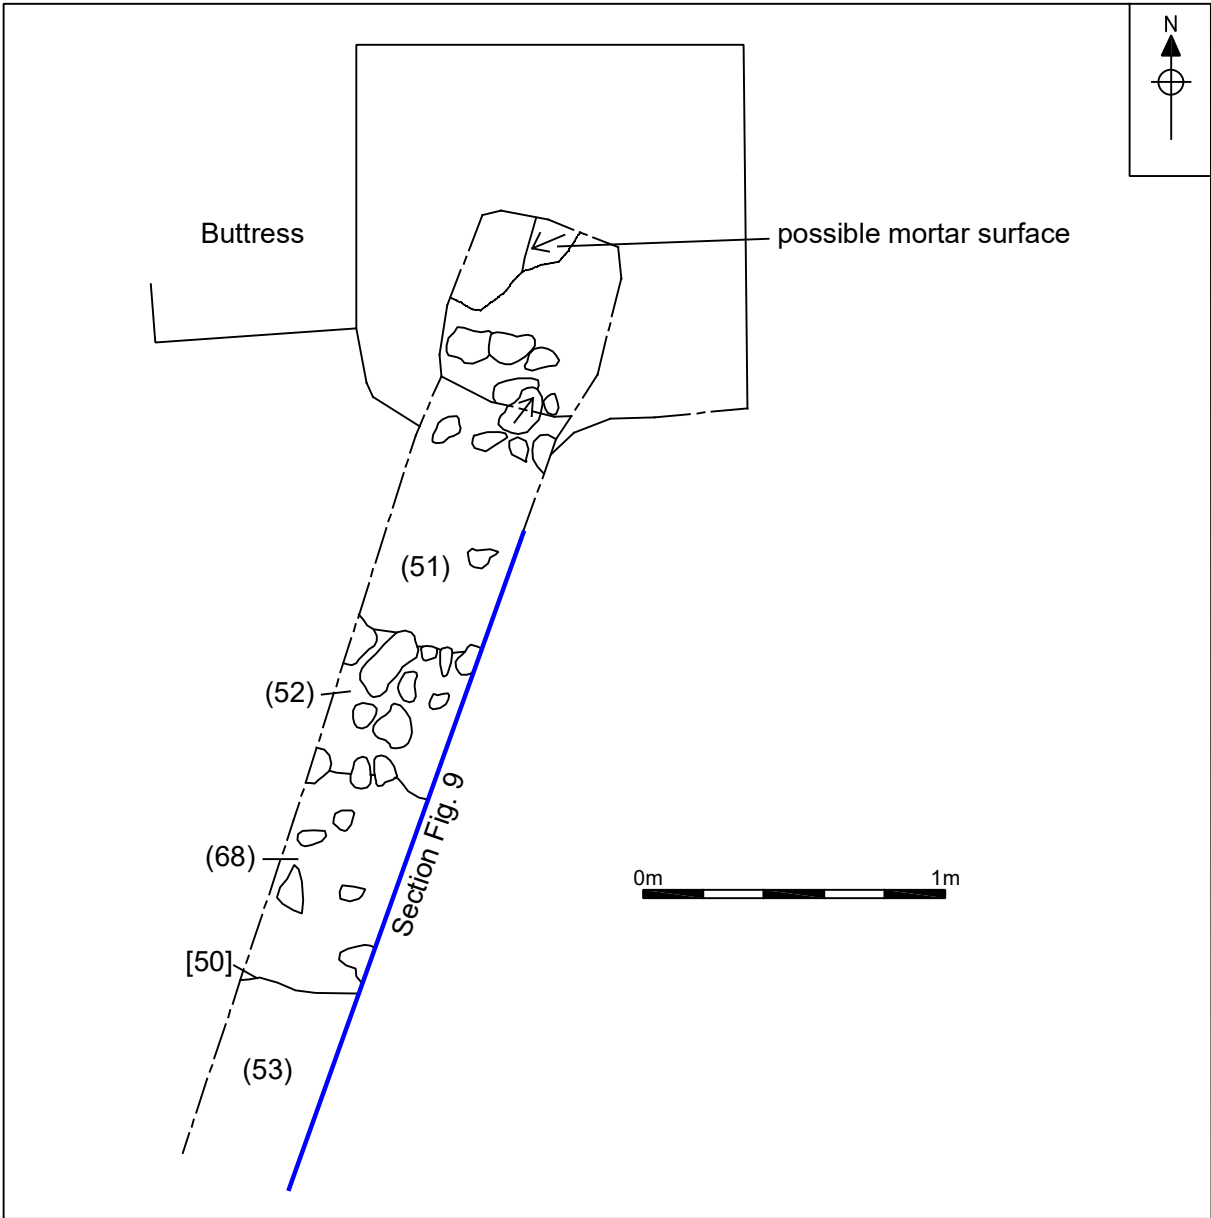
Figure 8. Trench 47; plan.

S side of S aisle, W of porch; 1.40 x 1.30 x <0.70m (Figs 1, 8 and 9, Plate 9)

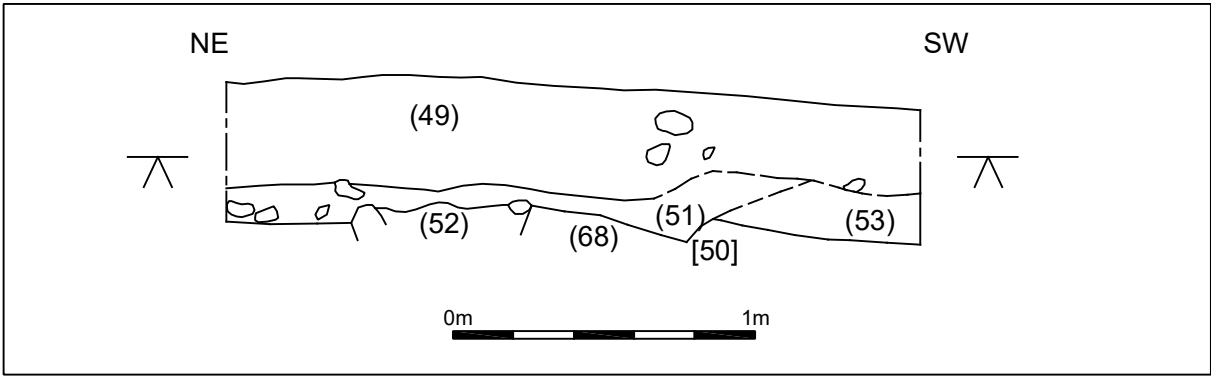
Figure 9. Trench 47; East facing section.

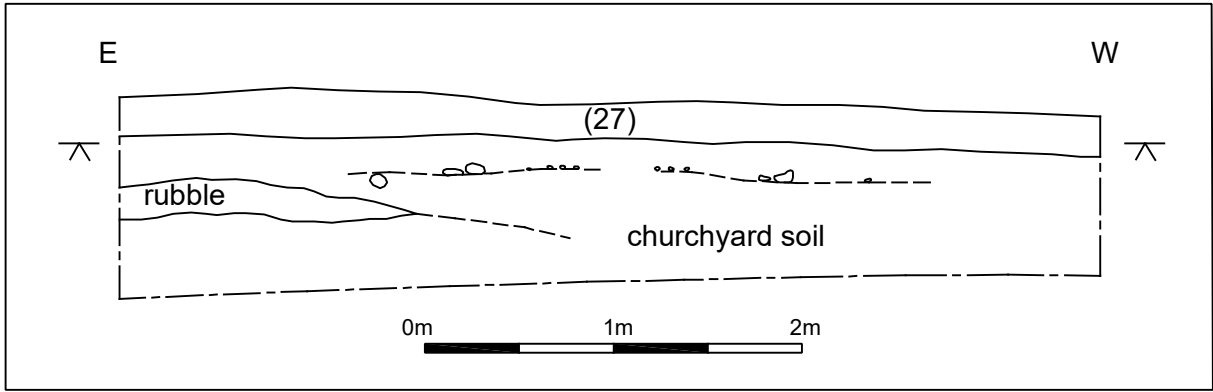
Figure 10. Trench 45; North facing section.

Trench [45]; 5.40 x 1.60 x <1.10m (Figs 1 and 10, Plate 10)

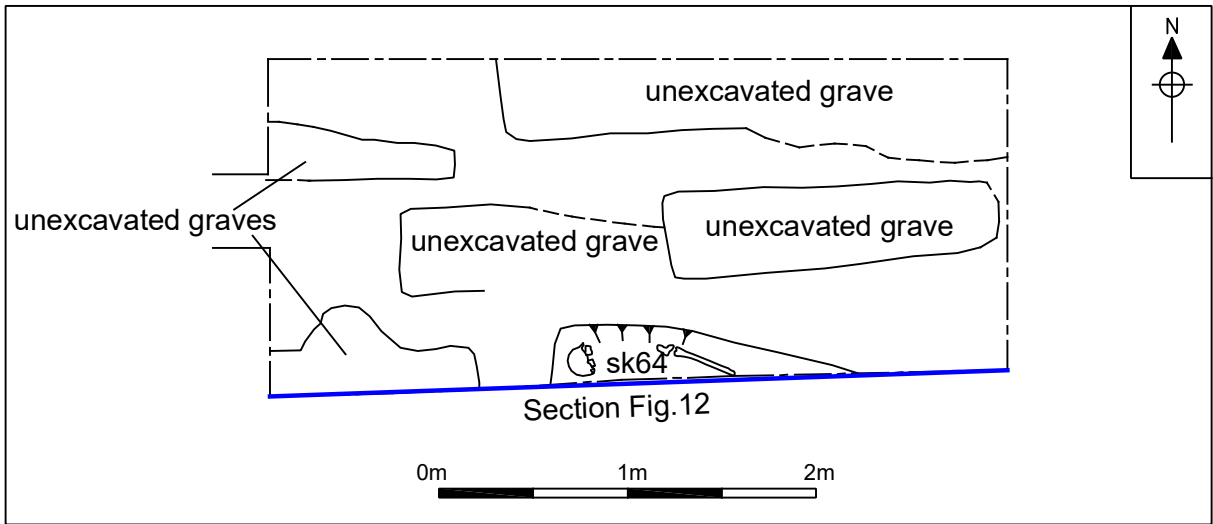
Figure 11. Trench 63; plan.

3.90 x 1.60 x <0.95m (Figs 1, 11 and 12, Plate 11)

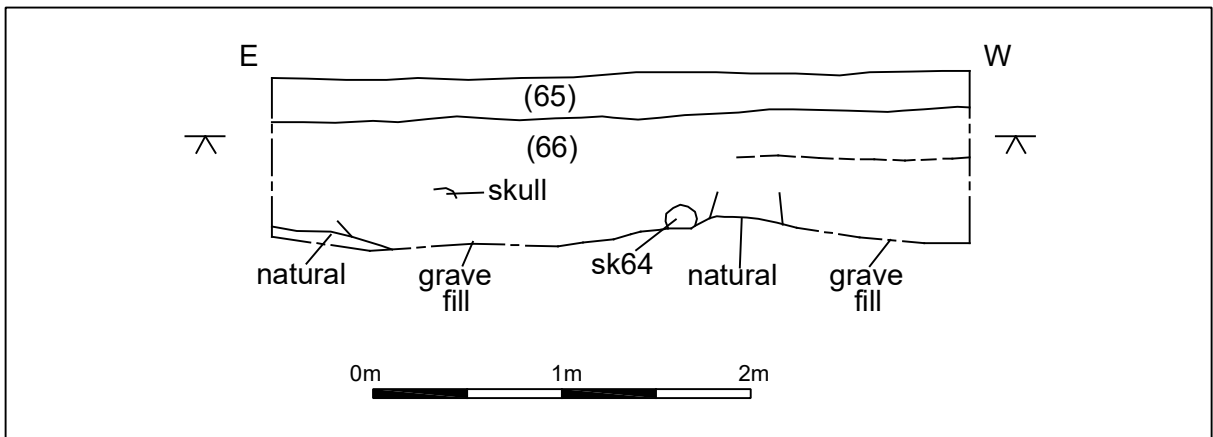
Figure 12. Trench 63; North facing section.

The grave cuts were not well defined in section. Although their approximate positions could be seen in the lowest part of the trench sides, most of the exposed soil could only be described as mixed churchyard soil [66] (brown silty sand with some mottled yellowish more sandy areas reflecting the inclusion of natural sand dug from the graves and redeposited during their back-filling). Part of a disarticulated skull was recorded in the side of the trench (Fig. 12). Above [66] was compacted fine gravel/'pea shingle' [56] – the church path.

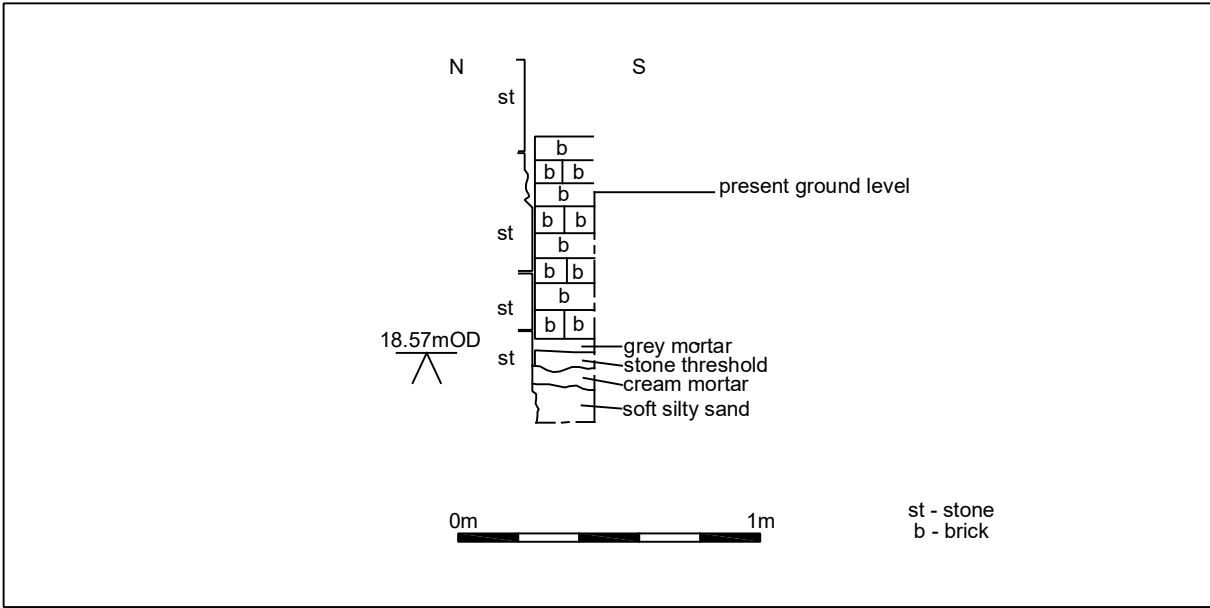
Figure 13 . Investigation at west doorway; elevation.

Investigation at W door (Figs. 1 and 13, Plates 13 and 14)

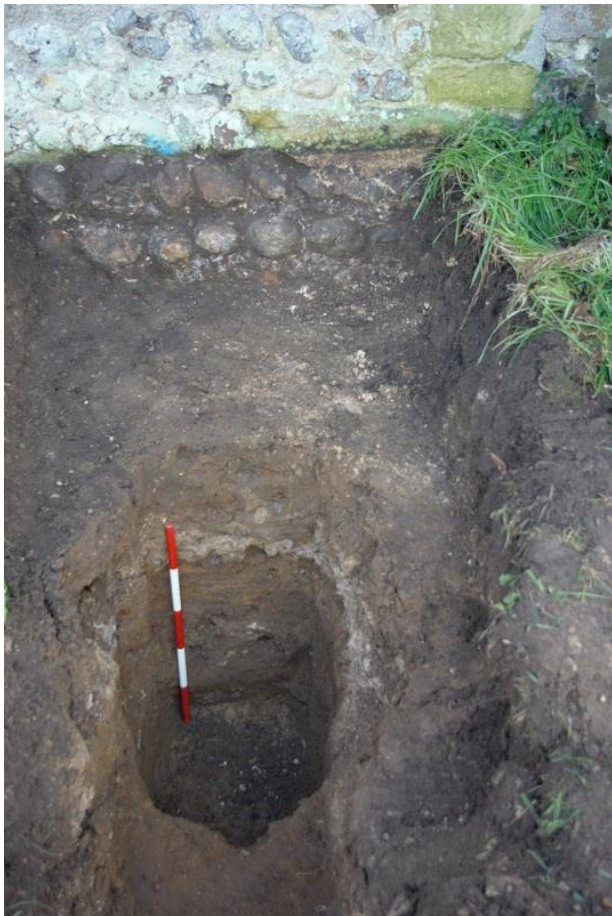
Plate 1: Trench 34; mortar [39] with underlying sand [40], looking S, 0.5m scale

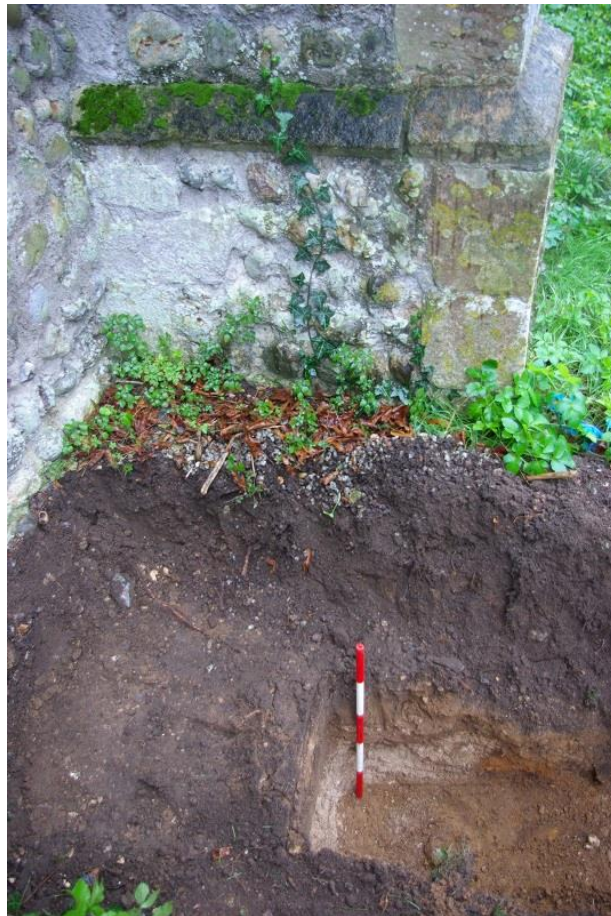
Plate 2: Trench 33; mortar and orange sand deposits, looking W, 0.5m scale

Central N side of N aisle, (Fig 1, Plate 2)

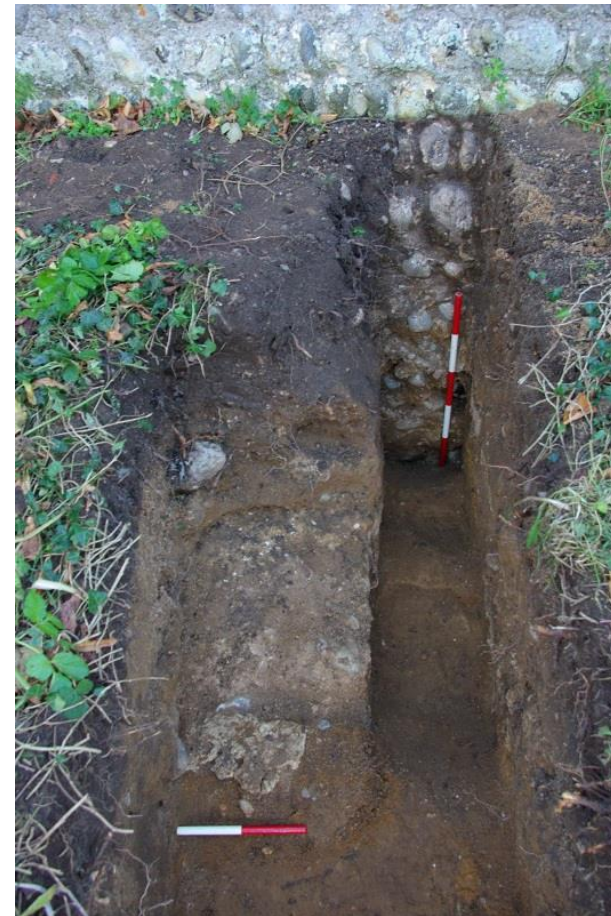
Plate 3: Opening-up trench 2; mortar [17] with underlying sand [18], N aisle footing exposed, looking S, 0.5m and 0.2m scales

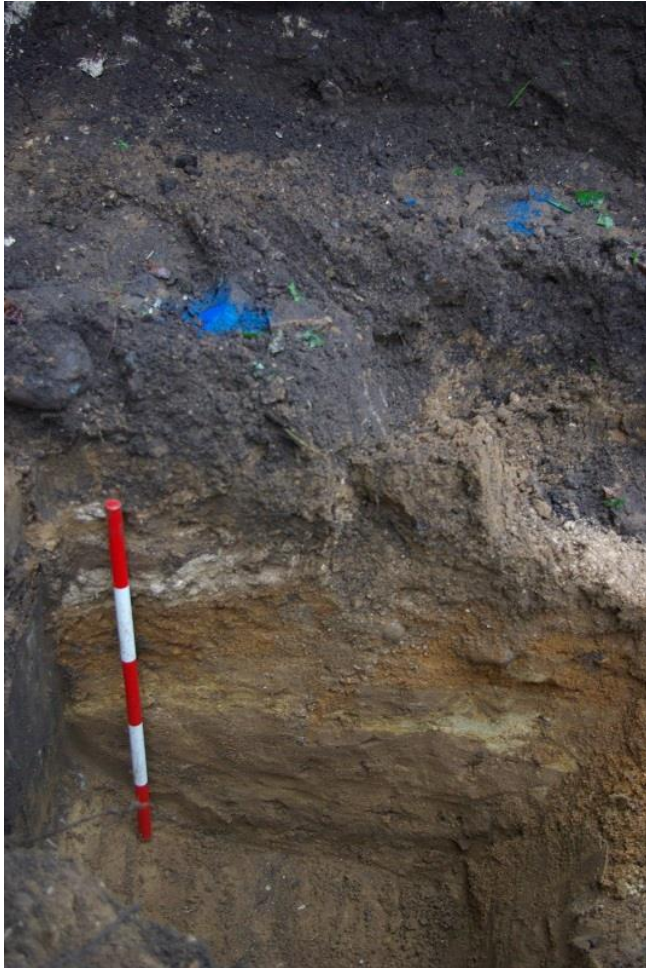
Plate 4: Trench 26 (gully pot hole); orange sand with overlying mortar of former aisle floor looking W, 0.5m scale

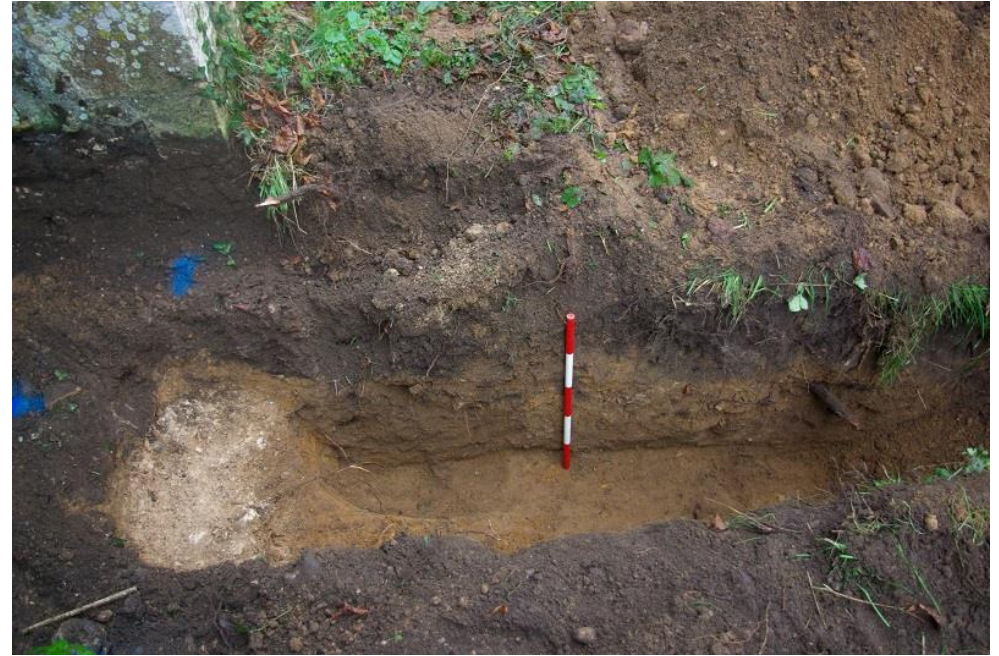
Plate 5: Trench 26 (before gully pot hole was dug); post-hole [30], W, looking SW, 1m scale

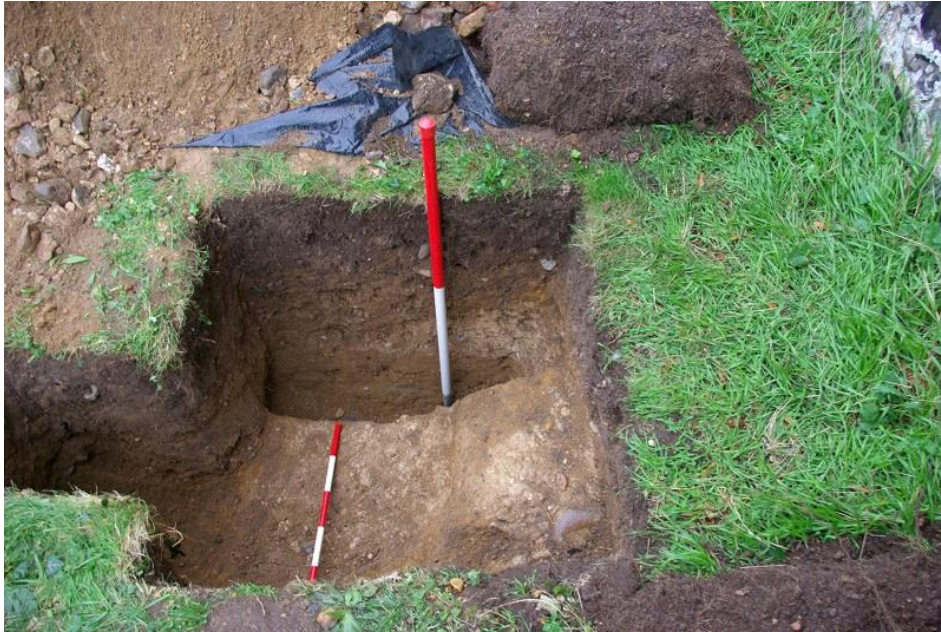
Plate 6: Opening-up trench 1; mortar [6], orange sand [5], mortar surface [4], cut by robber trench [7] looking W, 1 m and 0.5m scale

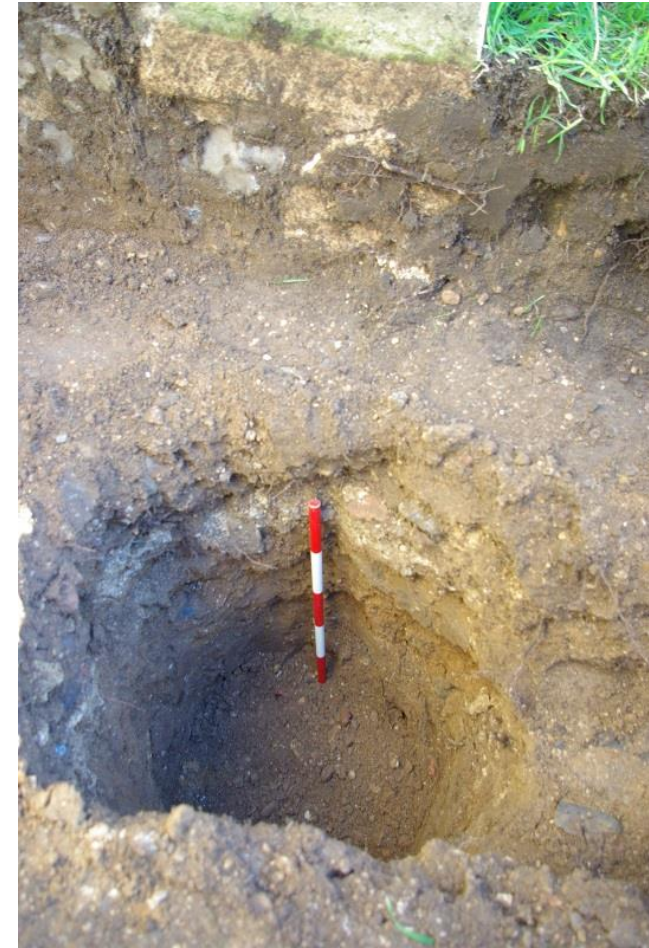
Plate 7: Trench 46; deposits exposed in gully pot hole, looking ENE, 0.5m scale

S side of S aisle, central; 1.20 x 0.80 x <0.70m (Fig. 1, Plate 7)

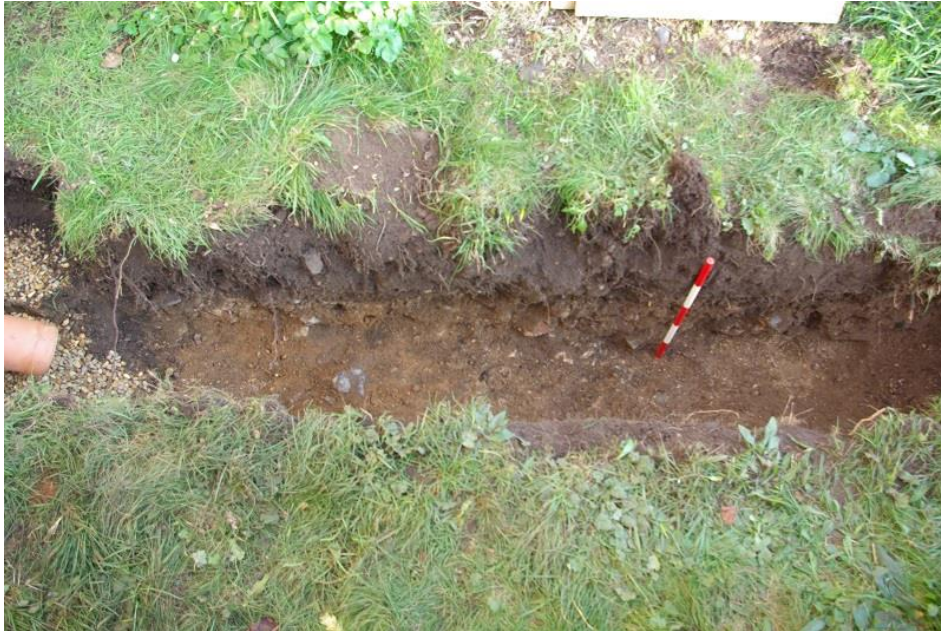
Plate 8: Drain trench S of trench 46; orange sand overlaid by mortar (left) rubble [67] (central) looking E, 0.5m scale

About a metre to the south of [46] light brown silty mortar and sand with moderate amounts of mortar flint and, rarely, brick rubble was seen below the topsoil in the excavated drain trench [67] (Fig. 1, Plate 8). It was thought to be demolition debris relating to the removal of the former south aisle wall - equivalent to the robber trench which was recorded further to the east. However, it seemed rather too far to the south to represent the actual position of the former wall (see below; Conclusions).

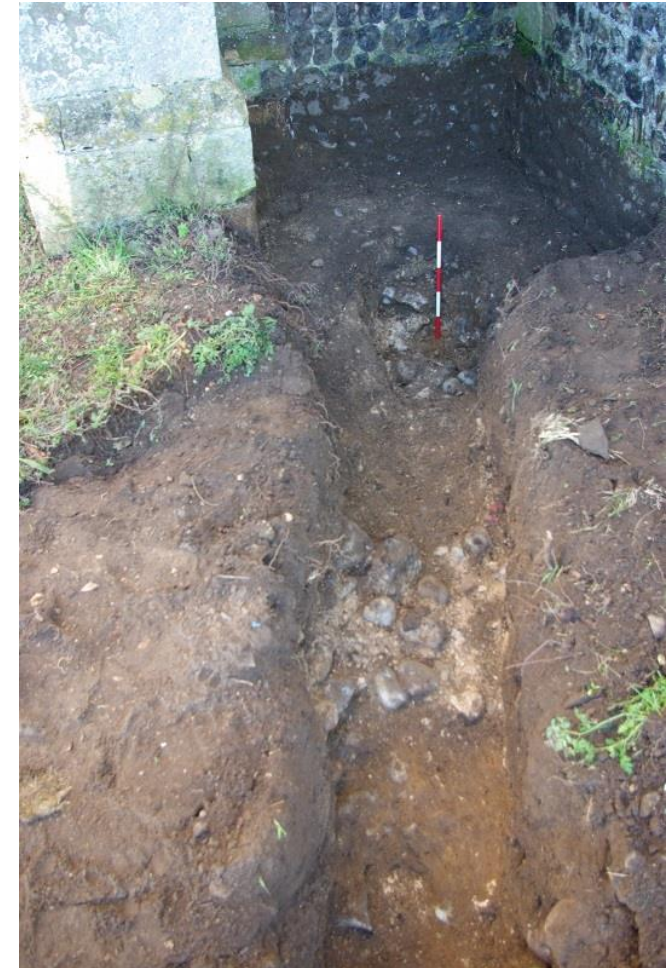
Plate 9: Trench 47/55; rubble [52], looking NNE, 0.5m scale

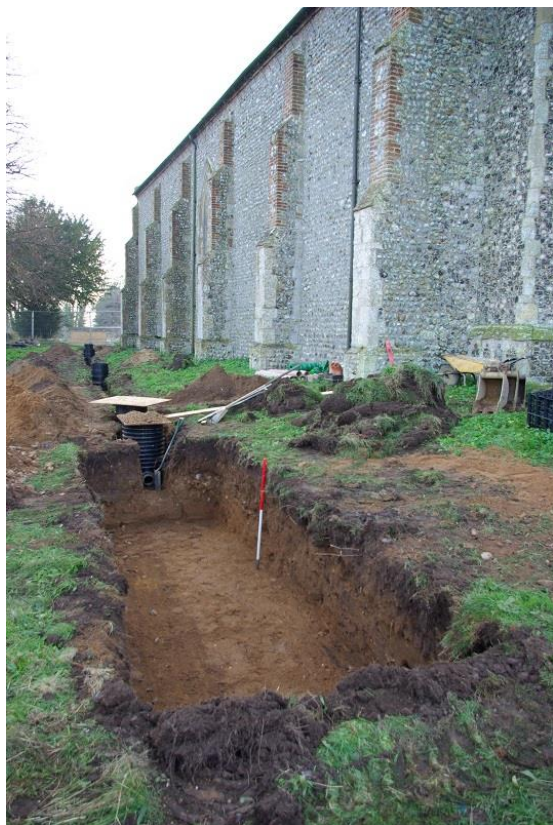
Plate 10: Trench 45; looking E, 1m scale

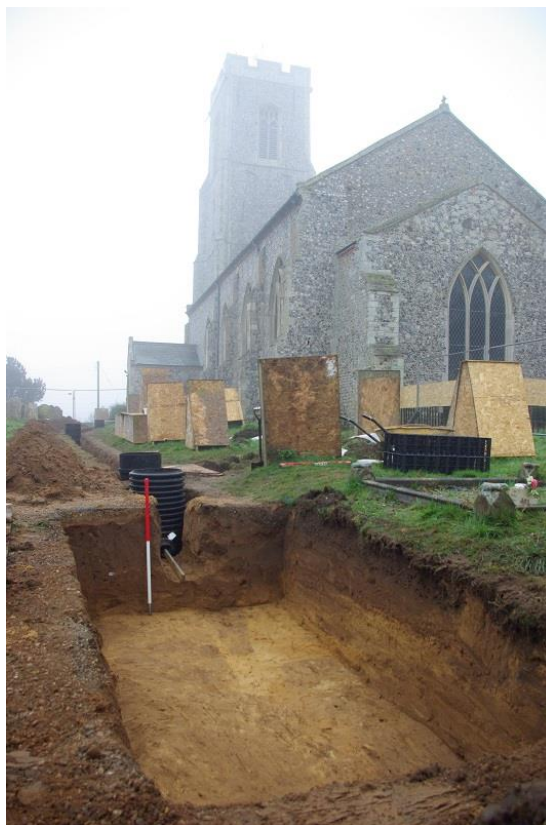
Plate 11: Trench 63; looking W, 1m scale

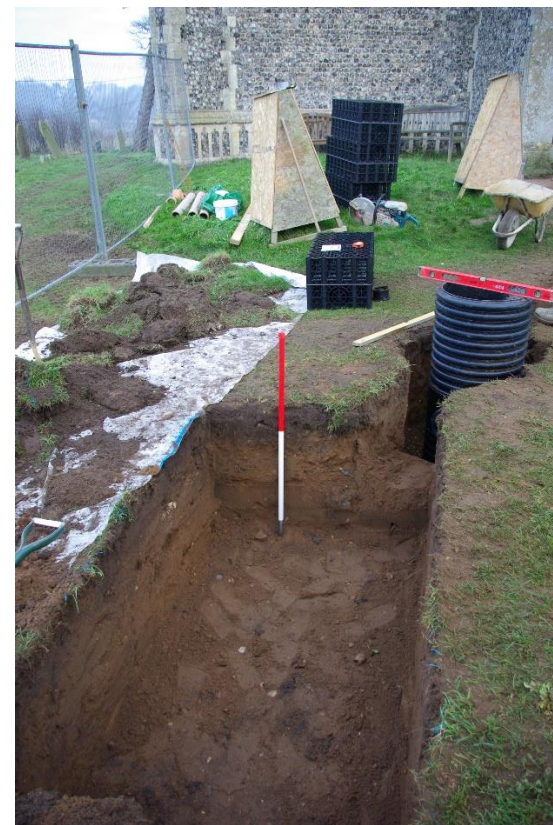
Plate 12: Trench 56; looking N, 1m scale

2.10m x 1.20 x 0.70m (Fig. 1, Plate 12)

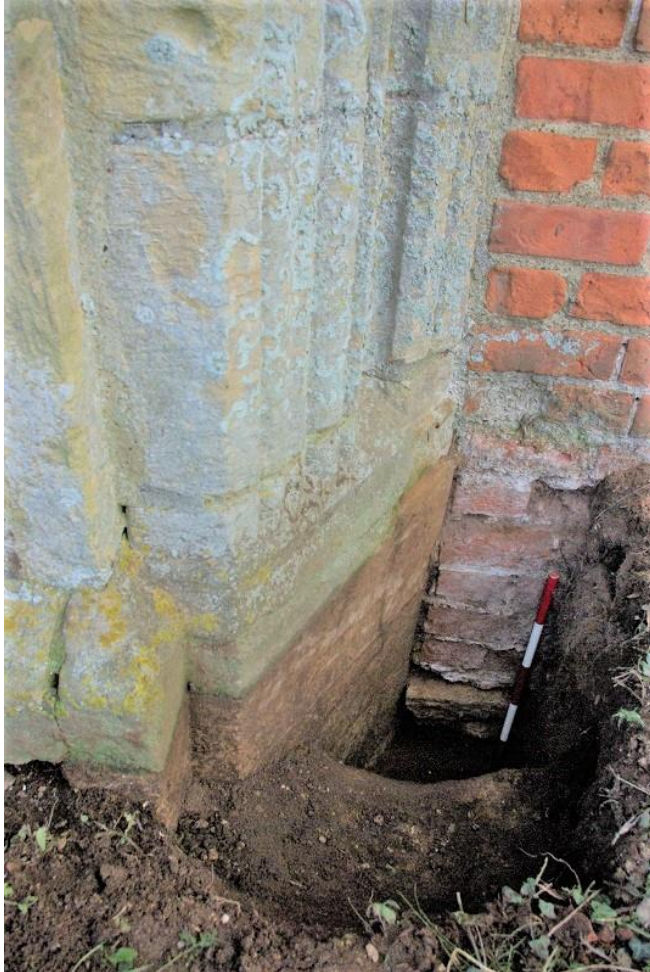
Plate 13: Former threshold at blocked W door,
looking E, 0.5m scale

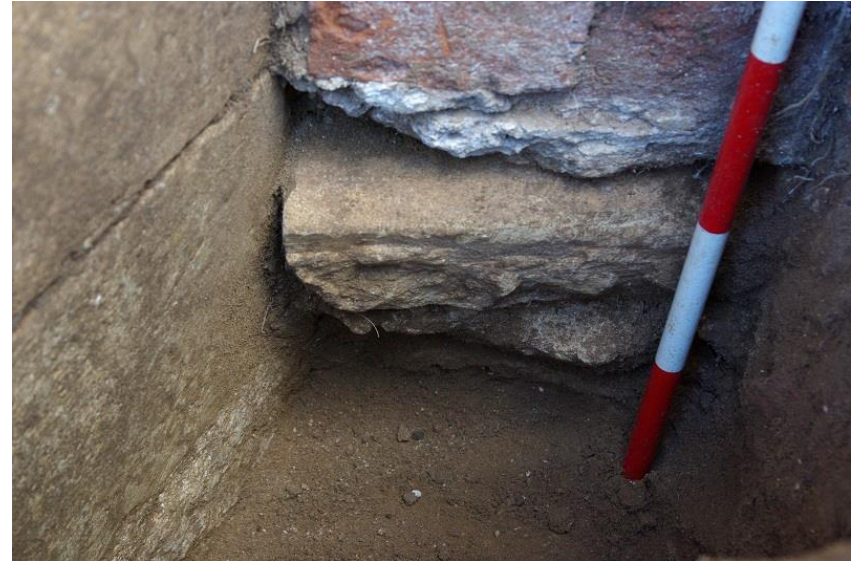
Plate 14: Former threshold at blocked W door, looking E, 0.3m scale
