# **Report of Work under Archaeological Supervision and Control**

## **St Mary's Church, Hickling, Norfolk Installation of lavatory and associated services**

NHER ENF 134189

**Prepared for Hickling PCC**

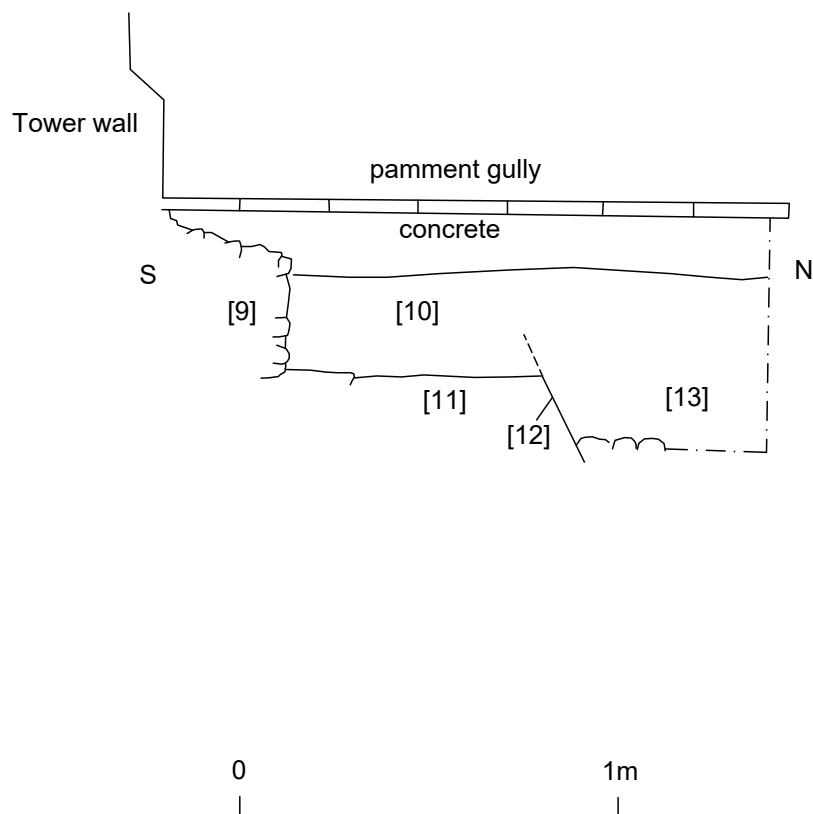
A: Trench 8, E-facing section

Fig. 3: Sections recorded outside A; tower and B; N aisle walls. Scale 1:20 (for locations see Fig. 2)

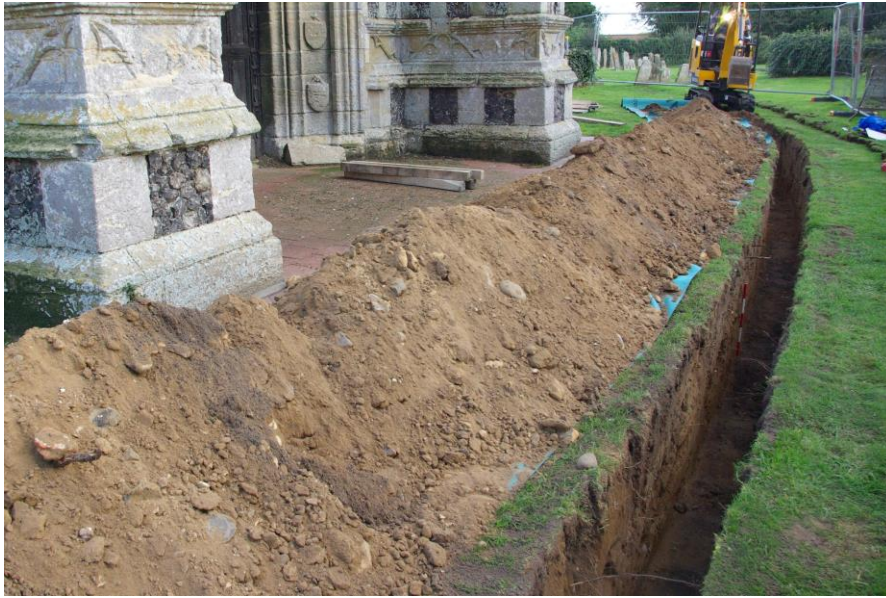
Plate 1: Trench 1, W of tower, looking S, 0.5m scale

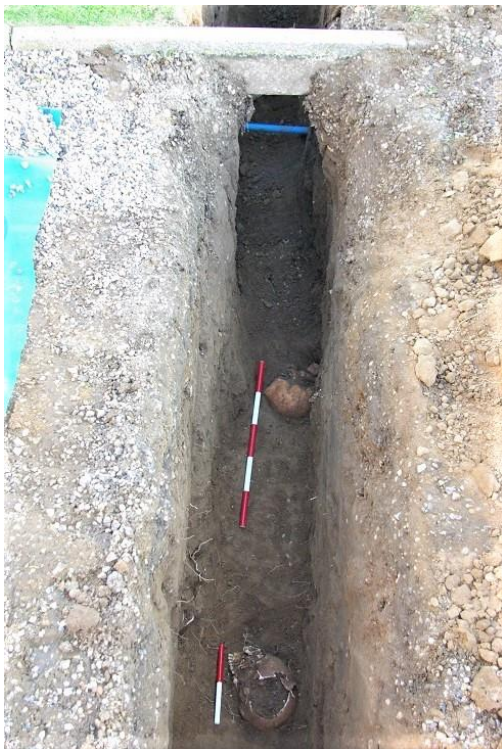
Plate 2: Trench 1, skulls beneath S path, looking E, 0.5m and 0.2m scales

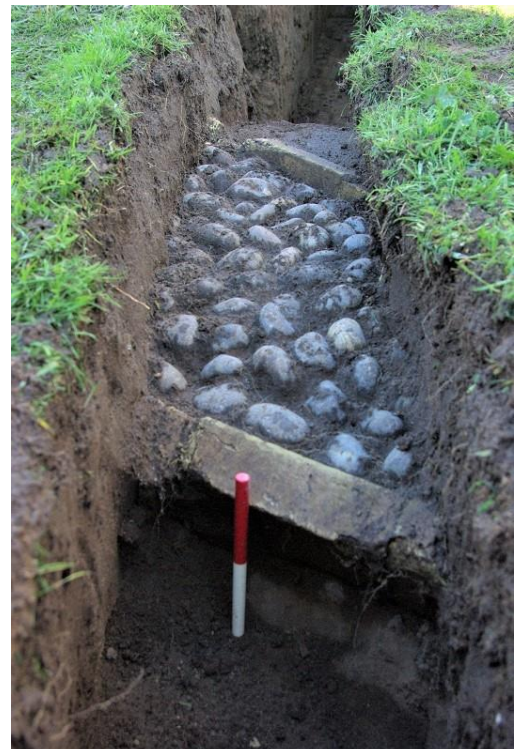
Plate 3: Path or grave marker [4], looking N, 0.2m scale

The churchyard soil was overlaid by brown sandy silty loam topsoil which was soft with relatively few inclusions (rare flints and small fragments of mortar, chalk and brick/tile). The topsoil was 0.30m deep and within it, to the west of the south porch, some flint cobbles were exposed, neatly laid within edgings of yellowish cream-coloured bricks of 19th-century date [4] (Fig. 2, Plate 3). The feature was only 0.12m below the surface and ran from east to west. It was 0.65m wide and the cobbled 'surface' was very slightly convex and comprised a single layer of flints set directly into the soil. The feature might have been a small path – perhaps associated with a grave, or possibly an arrangement overlaying or marking a grave – the alignment of the feature and slightly its convex surface may suggest the latter.

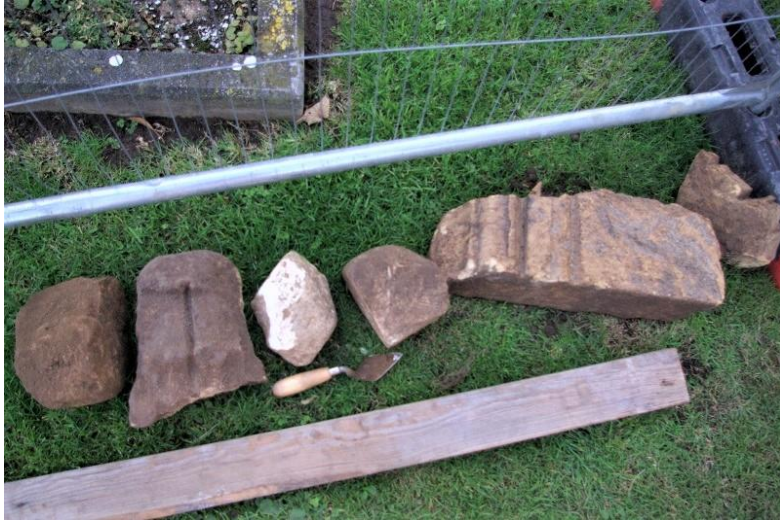
Plate 4: Architectural fragments found during the work in the churchyard, trowel as scale

Several quite large pieces of worked stone were found in the soils from trench 1. They were mostly architectural pieces (Plate 4, detailed photographs in site archive). The fragments of stone were left in the care of the church.

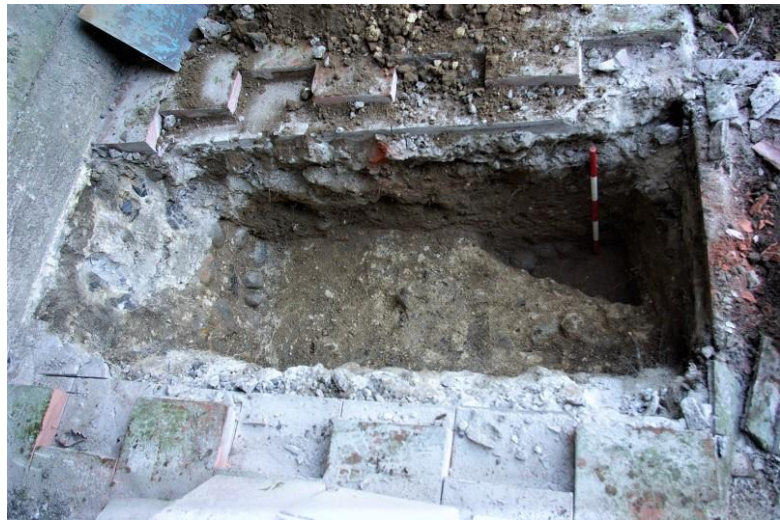
Plate 5: Trench 8, tower footing [9], mortar deposit [11], looking W, 0.5m scale

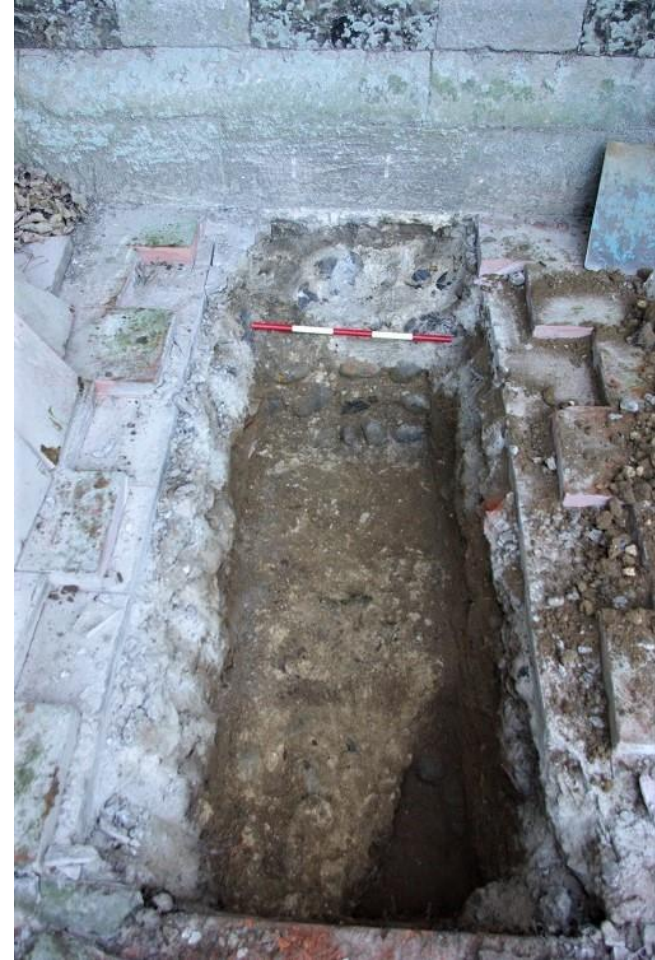
Plate 6: Trench 8, tower footing [9], mortar deposit [11], looking S, 0.5m scale

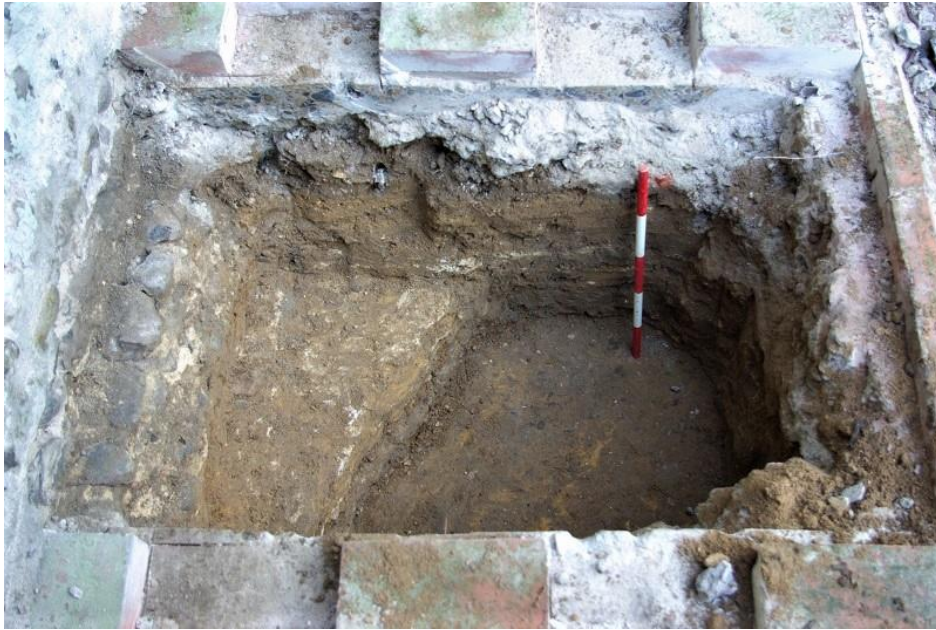
Plate 7: Trench 14, N aisle footing [34], mortar [16], looking S, 0.5m scale

Another small trench was dug by the contractors at the west end of the north aisle to conduct pipes for the proposed kitchenette (Fig. 2). The earliest deposit recorded was some slightly orangey brown silty sand with rare flecks of mortar which was seen in the bottom of the trench [17] (Fig. 3B, Plate 7). Above that, some lenses of cream mortar and brown silty sand [16] represented construction debris at the base of the north aisle wall footing which comprised a slightly gravelly foundation layer [33] and solid mortared flint [34]. Above those was orange brown silty sand churchyard soil [15] which was overlaid by the concrete make up for the tiled gully (as in trench [8], see above).

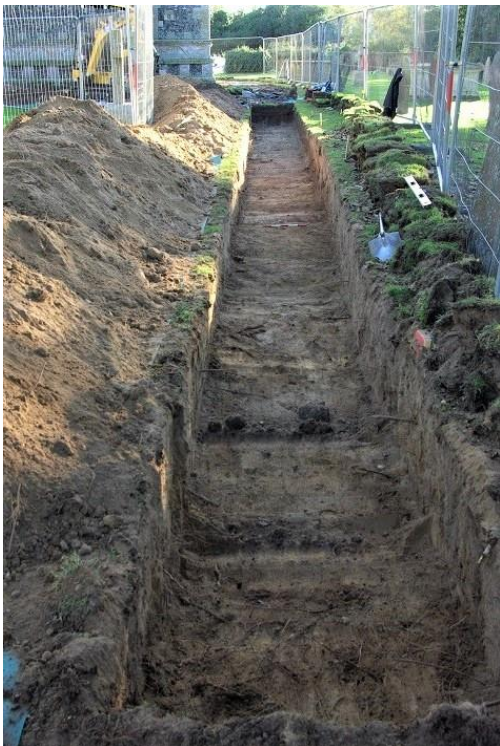
Plate 8: Trench 5, looking S, 0.5m scale

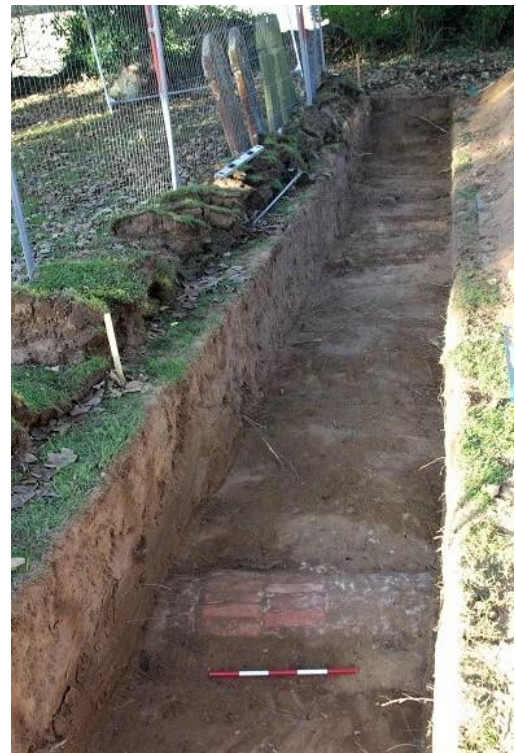
Plate 9: Trench 5, brick tomb [7], looking N, 0.5m scale

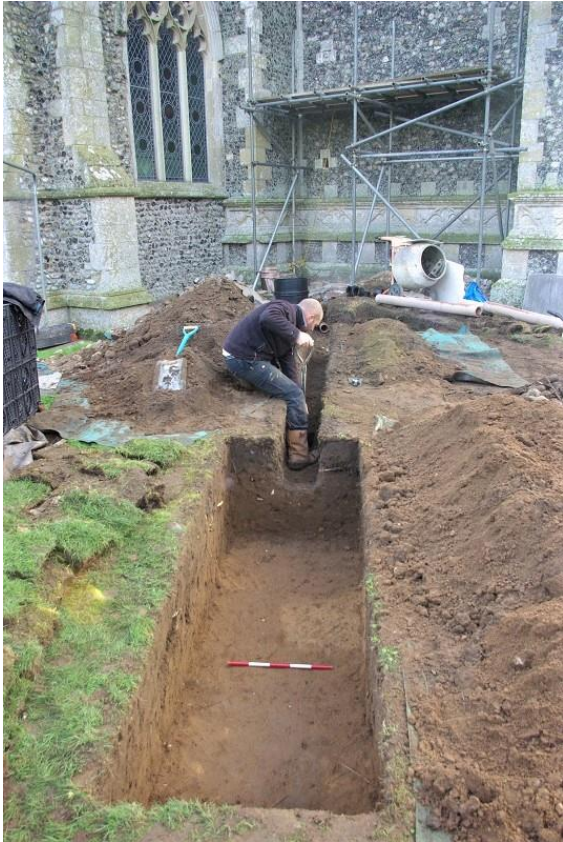
Plate 10: Trench 31, looking SE, 0.5m scale

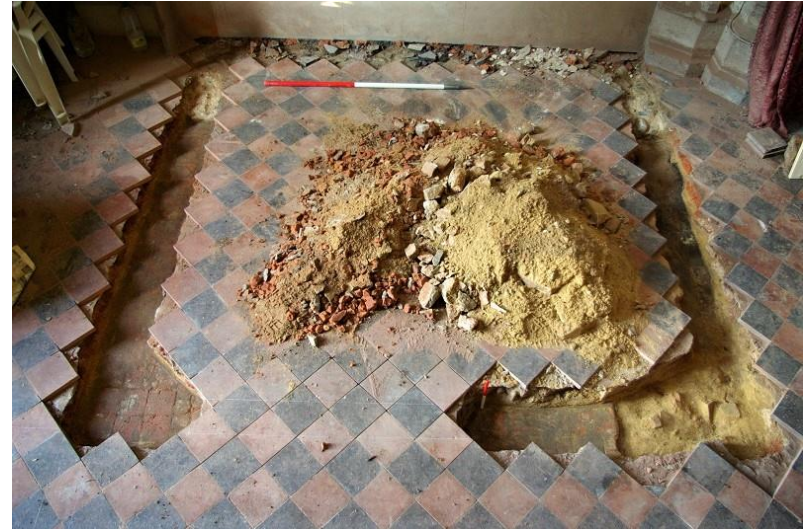
Plate 11: Area of work within tower, looking N, 1m and 0.2m scales

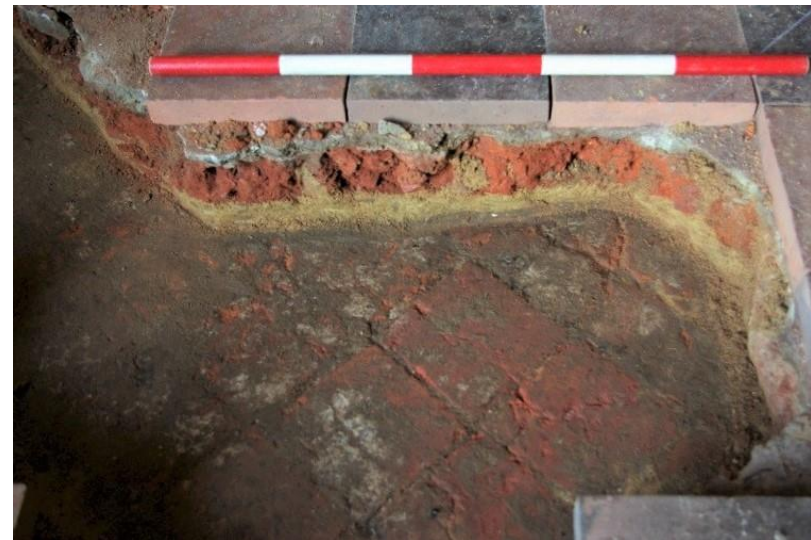
Plate 12: Floor [21], worn tiles in central area, looking NE, 0.5m scale

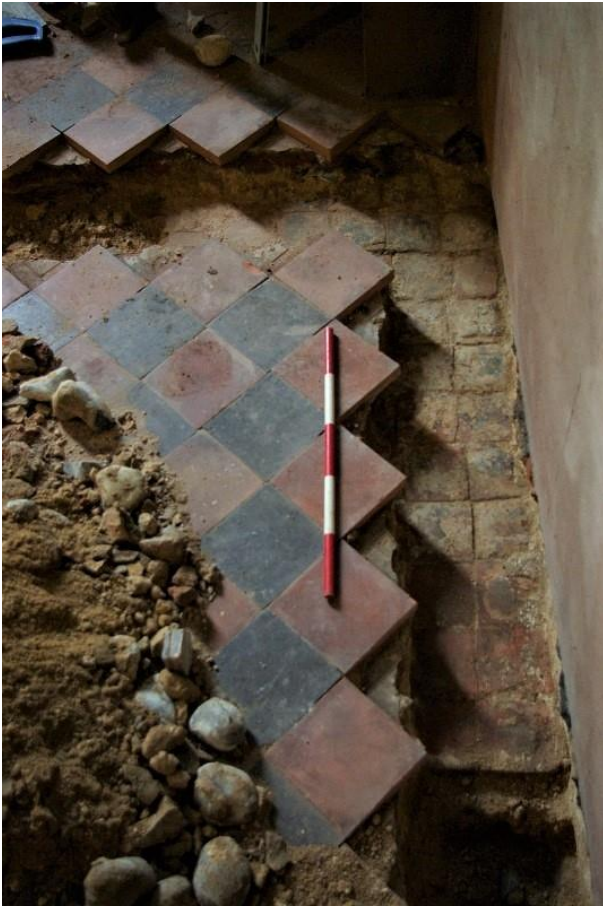
Plate 13: Floor [21] at N wall of tower (and existing floor [18]), looking W, 0.5m scale

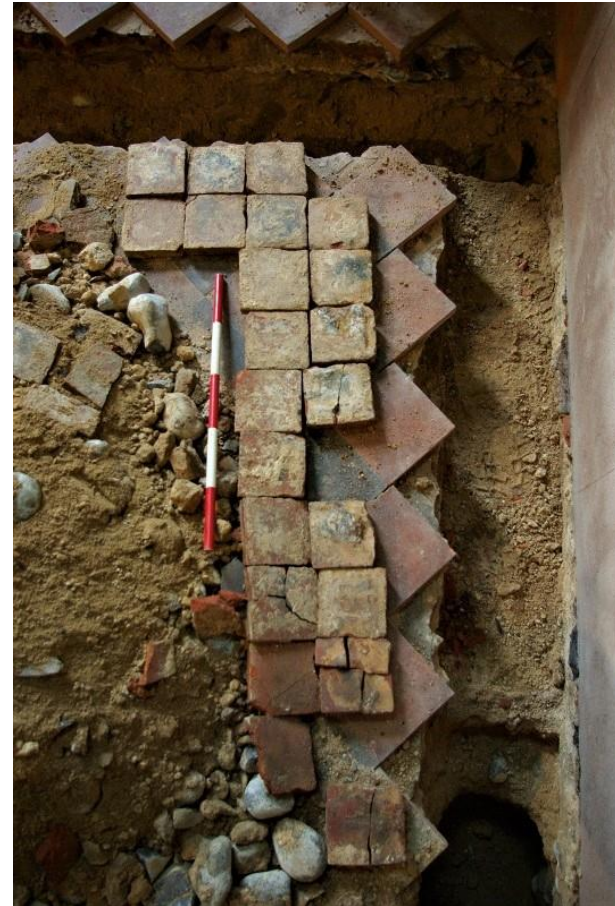
Plate 14: Glazed tiles [21], as lifted from area beside N wall of tower, looking W, 0.5m scale

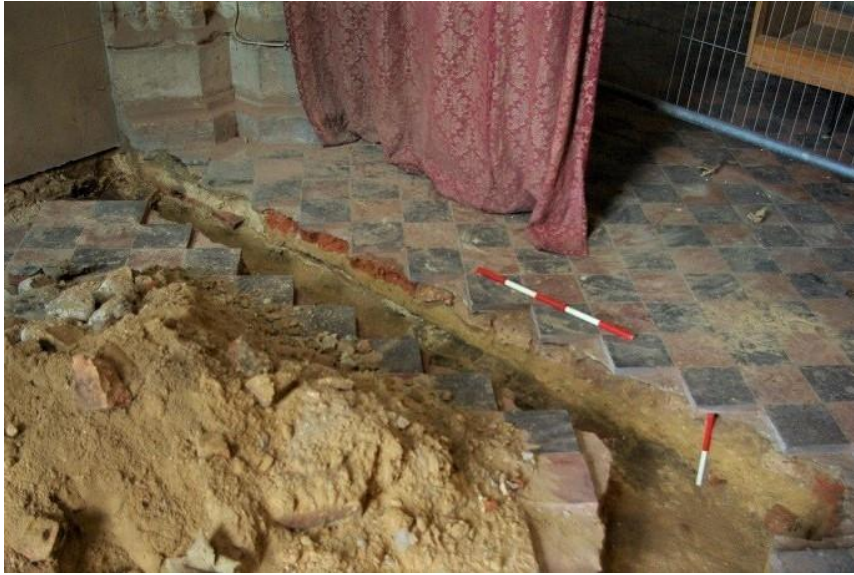
Plate 15: Deposits exposed in eastern footing slot, looking NE,  
0.5m and 0.2m scale

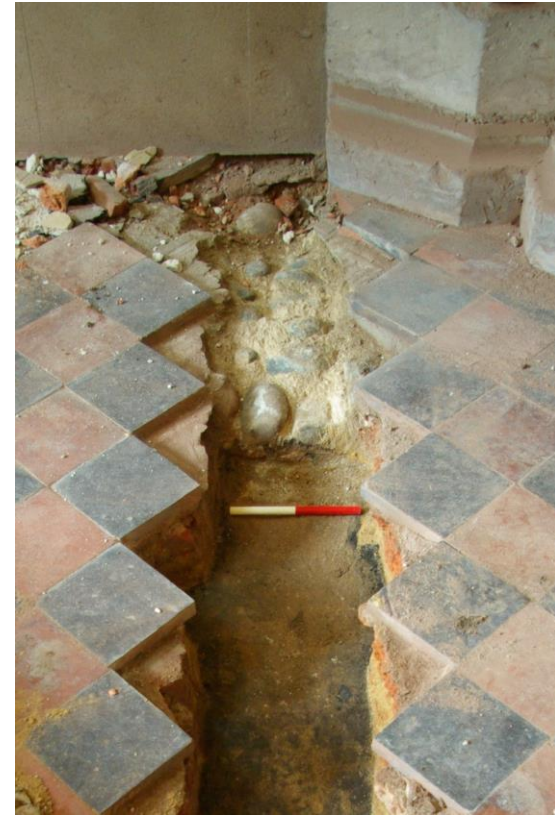
Plate 16: Footing [32] beside N wall of tower, W of tower arch, looking N.  
0.2m scale

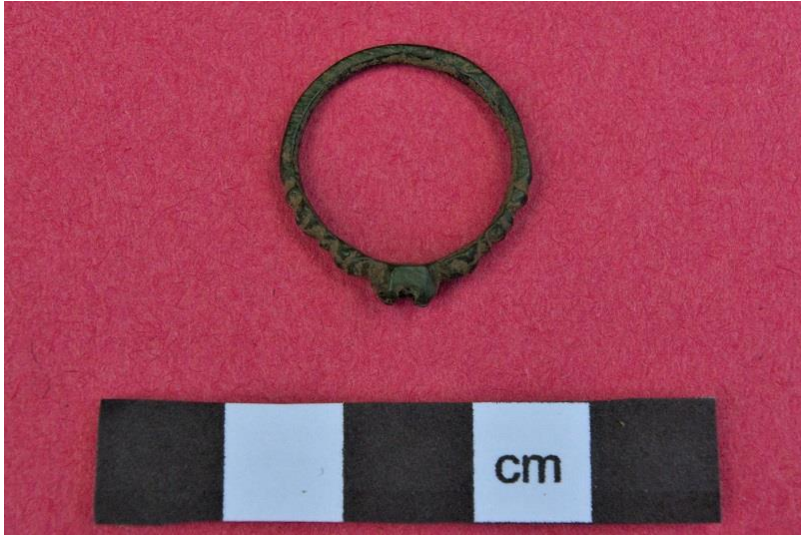
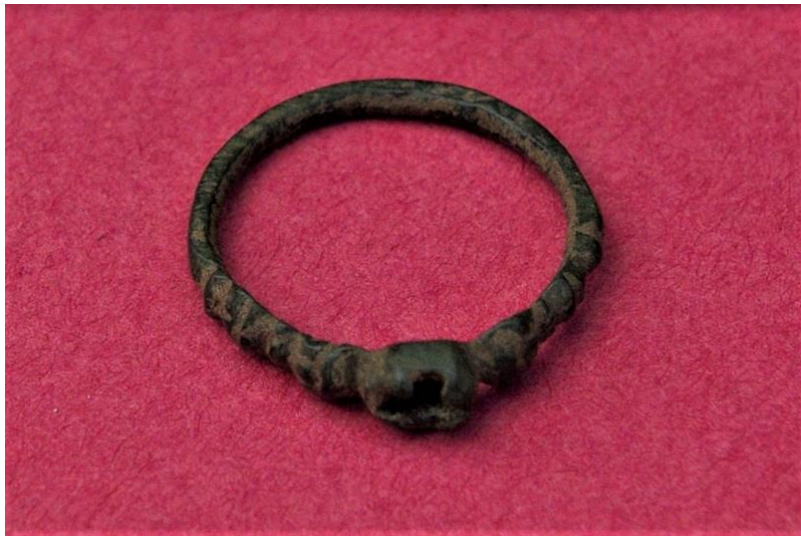
Plate 17A: Copper alloy finger ring [6]

Plate 17B: Copper alloy finger ring [6], detail

A complete finger ring was found and consisted of a slender circular hoop with a raised square bezel once containing a gem or glass setting [6] (Plates 17A and B). The bezel had four 'claws' for holding the missing gem in place. Either side of the bezel there were moulded shoulders, possibly in the form of acorns, however, they are too worn to be certain. This is followed by further mouldings extending around about a third of the ring. The ring measured 20mm in diameter and weighed 1.8g. This ring is likely to be of medieval or early post-medieval date, though no exact parallel has been found. Similar square bezelled rings of medieval date are illustrated by Egan & Pritchard (2013, 328, fig. 216, no. 1617), though they do not have the mouldings to the shoulders that the Hickling example does. Post-medieval examples of similar style are illustrated on the Portable Antiquities Scheme database ([www.finds.org/](http://www.finds.org/)).

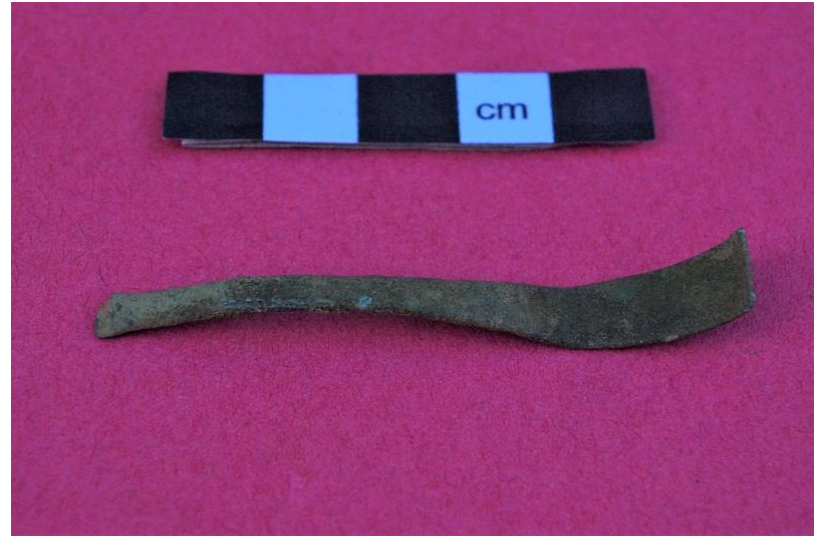
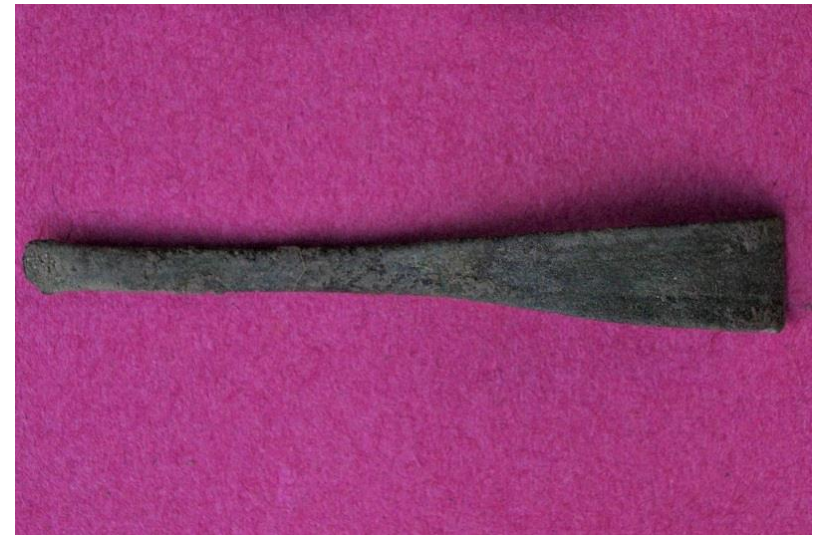
Plate 18A: Copper alloy strip [5], possible tweezers fragment

Plate 18B: Copper alloy strip [5], possible tweezers fragment (incised detail)

A tapering strip was recovered, which may be part of a pair of tweezers or tongs of post-medieval date [5] (Plates 18A and B). The strip had an incised border down its length on its convex face, and the narrow end may have been shaped, but the object was too worn to be certain. The wide end of the piece was broken; this would have been the weakest point of the object. The length of the piece was 62mm and width at the wide end was 10mm. The object weighed 3.5g.
