HEREFORD CATHEDRAL

Archaeological Monitoring of a
Trench in the Vicars Choral,
Hereford Cathedral

*Commissioned by Robert Kilgour Architect Ltd
On behalf of the Dean and Chapter, Hereford Cathedral.*

June 2018

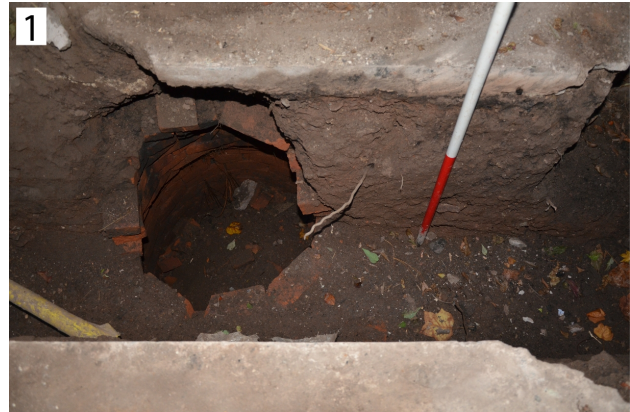
Plate 1, facing west showing (111) section

The structure has an external diameter of approximately 1m. The structure contained a mixed earthen fill with inclusions of brick rubble and concrete debris (112), due to structural considerations the internal cavity was not excavated. (see Plate 1, 2 and Illus 3).

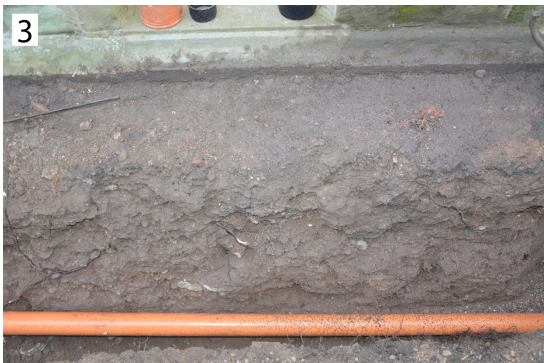
Plate. 3 West facing section Area A 2

The excavation of the service run within area A 2 did not identify any features of archaeological significance. (See Plate 3) the level of the original service run was considered suitable to achieve the necessary fall required by the new service run.

Examination of the stratigraphy identified that the new service run was cut in re-deposited material containing inclusions of bone, brick, and general building debris indicating that the original service run was cut wider than the new works therefore limiting the amount of information that could be ascertained from the current works relating to the formation of the site.

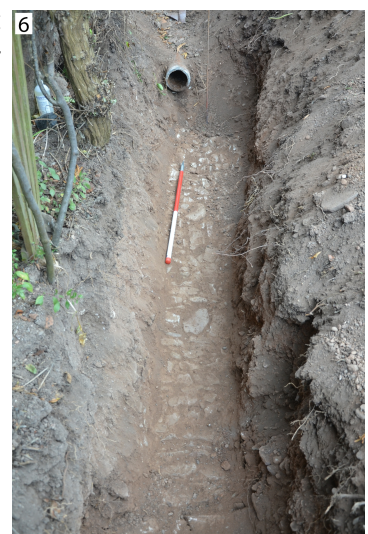
Plate 6. Facing North showing cobbled area (107)

At the base level of the original service run (0.72m BGL) and overlaid by context 106, was a layer of irregular stones and river worn cobbles which formed a possible metallised surface (107).

The original cut of the service trench had stopped at the level of 107, however to achieve the correct fall on the new survive run it was necessary to remove a portion of 107. 107 was laid upon 105, a mid-red-brown sandy deposit similar to 105 but containing fewer inclusions of stones and gravels, no finds were observed to date 107 and no features were observed below 107.

irregular stones and river worn cobbles formed a possible metallised surface (107).

No finds of archaeological significance were observed to allow the dating of 107, however the identification and existence of 107 despite the intrusion of modern services suggests that the potential for archaeological remains to be present at a higher level outside the line of the service run is high.

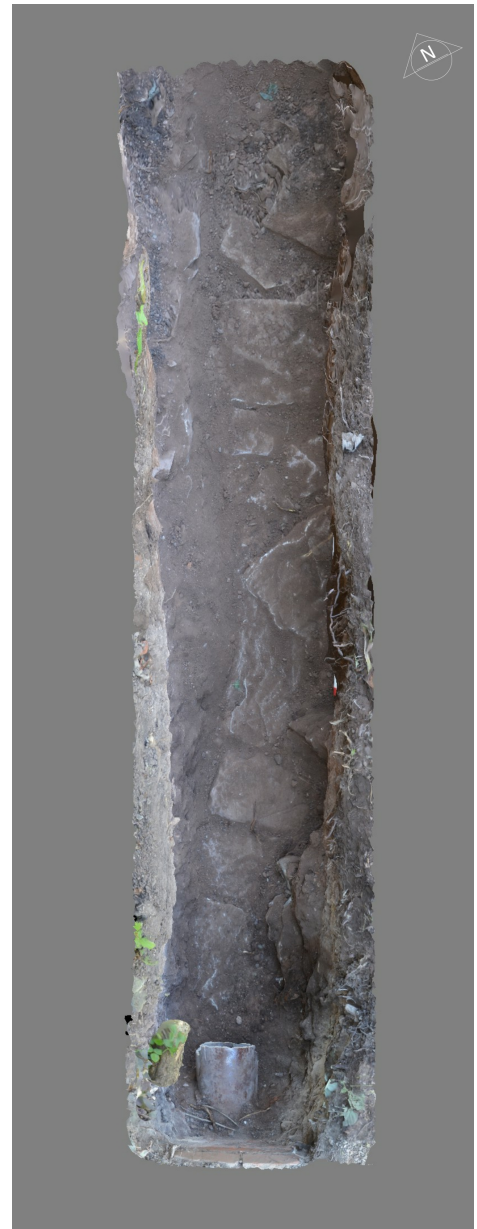
Plate 7 showing (108)- 3D model data

At the junction with of inspection chamber 7 (IC7) at the southern end of the service trench, a stone surface was observed.

108 consisted of both medium and large irregular shaped, yellow sand stones laid flat, in a matrix of mid red brown sandy loam, no indication of bonding was observed.

Continuing the excavation of the service run within the flower bed of the Dean's garden, both area A 4, area A 5 share similar stratigraphy, however at the junction with the modern inspection chamber (IC 7) at the southern end of the service trench, a substantial stone surface or dump was observed.

No finds of archaeological significance were observed to allow the dating of 108.

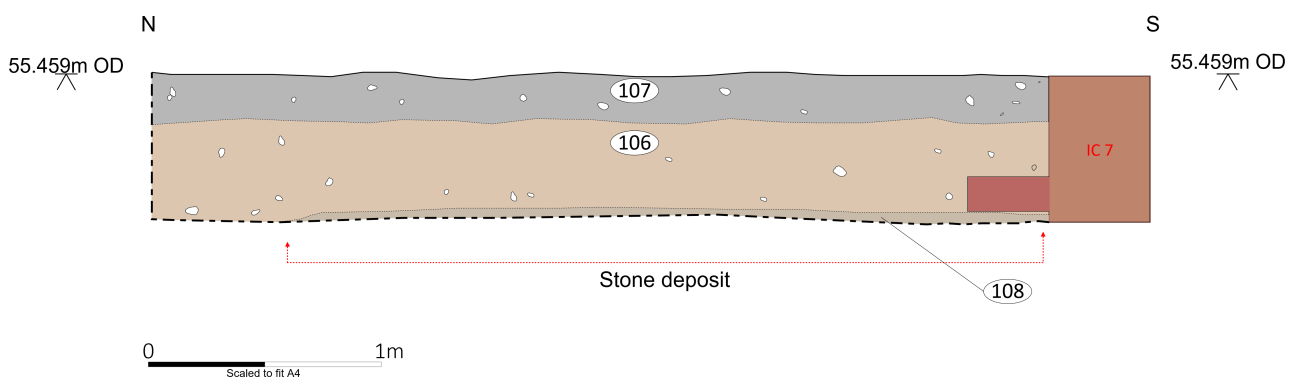
Illus. 7 West facing section over Stone deposit (108)

The depth of the original service pipe excavation was satisfactory to achieve the necessary fall of the new service pipe and excavation was stopped at this level.
