Archaeological investigations at the Church of St Lawrence, Warkworth

Richard Carlton and Peter F. Ryder

SUMMARY

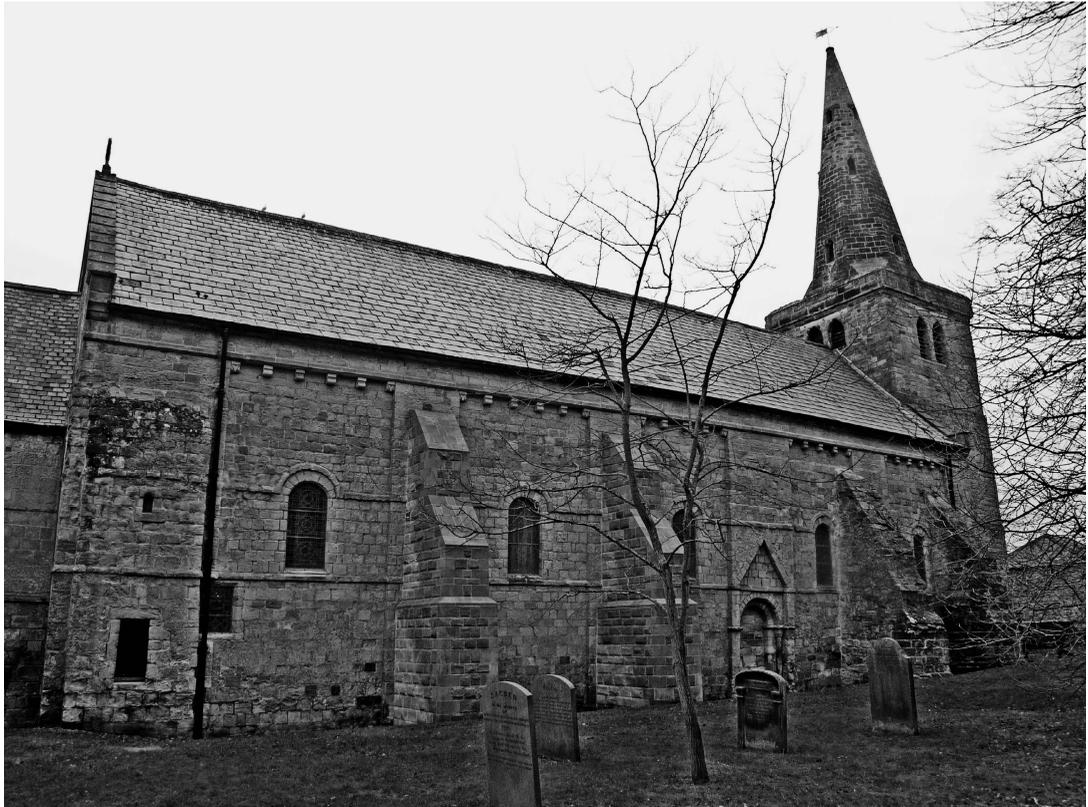
Fig. 1 St Lawrence's: the north wall of the nave, following strengthening work, including the construction of two new buttresses to the left of the blocked north door.

This paper is a summary report on a programme of archaeological work carried out at St Lawrence's between 2008 and 2010,¹ the main focus of which was associated with structural works to stabilise the leaning north wall of the church (figs. 1, 2 and 5). Archaeological investigations associated with the stabilisation scheme were initiated in June 2008 and concluded in March 2009, but subsequently, in 2009–10, additional monitoring was carried out during sub-surface and structural works required for implementation of the wall strengthening scheme, as well as during refurbishment and drainage work in the ground floor of the tower, and during repairs to the roof of the south aisle.

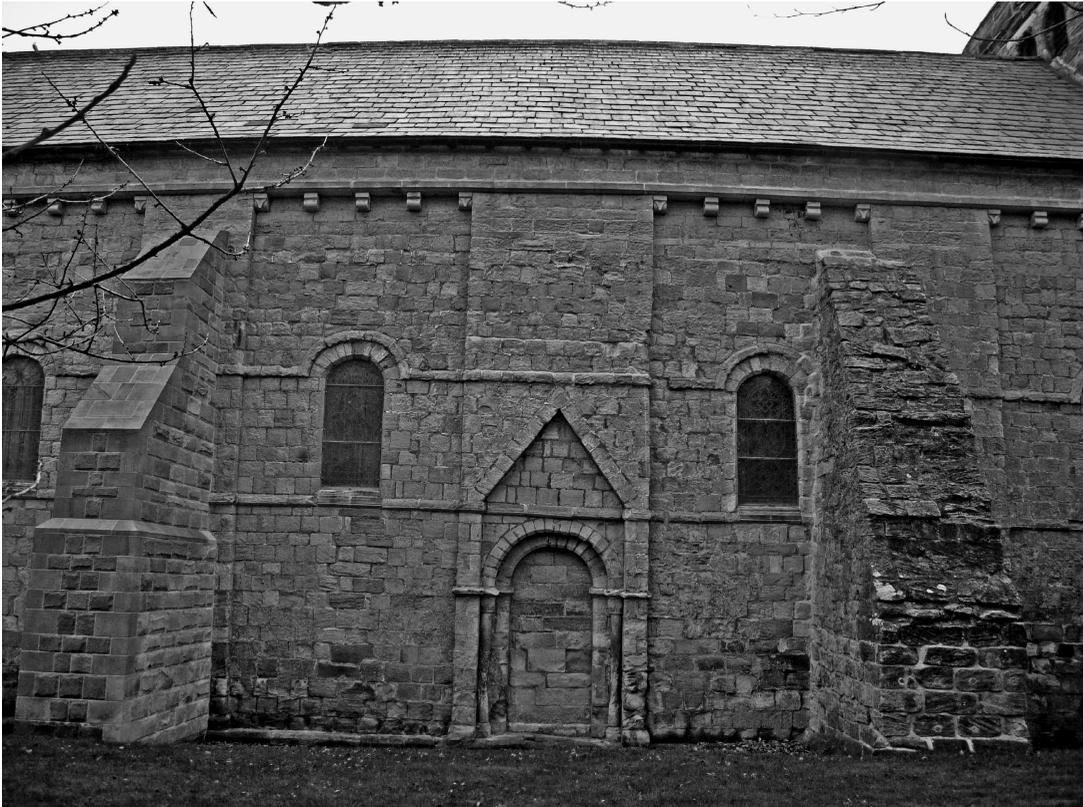
Fig. 2 Part of the north wall, centred on the blocked north door, showing the new and the original buttresses.

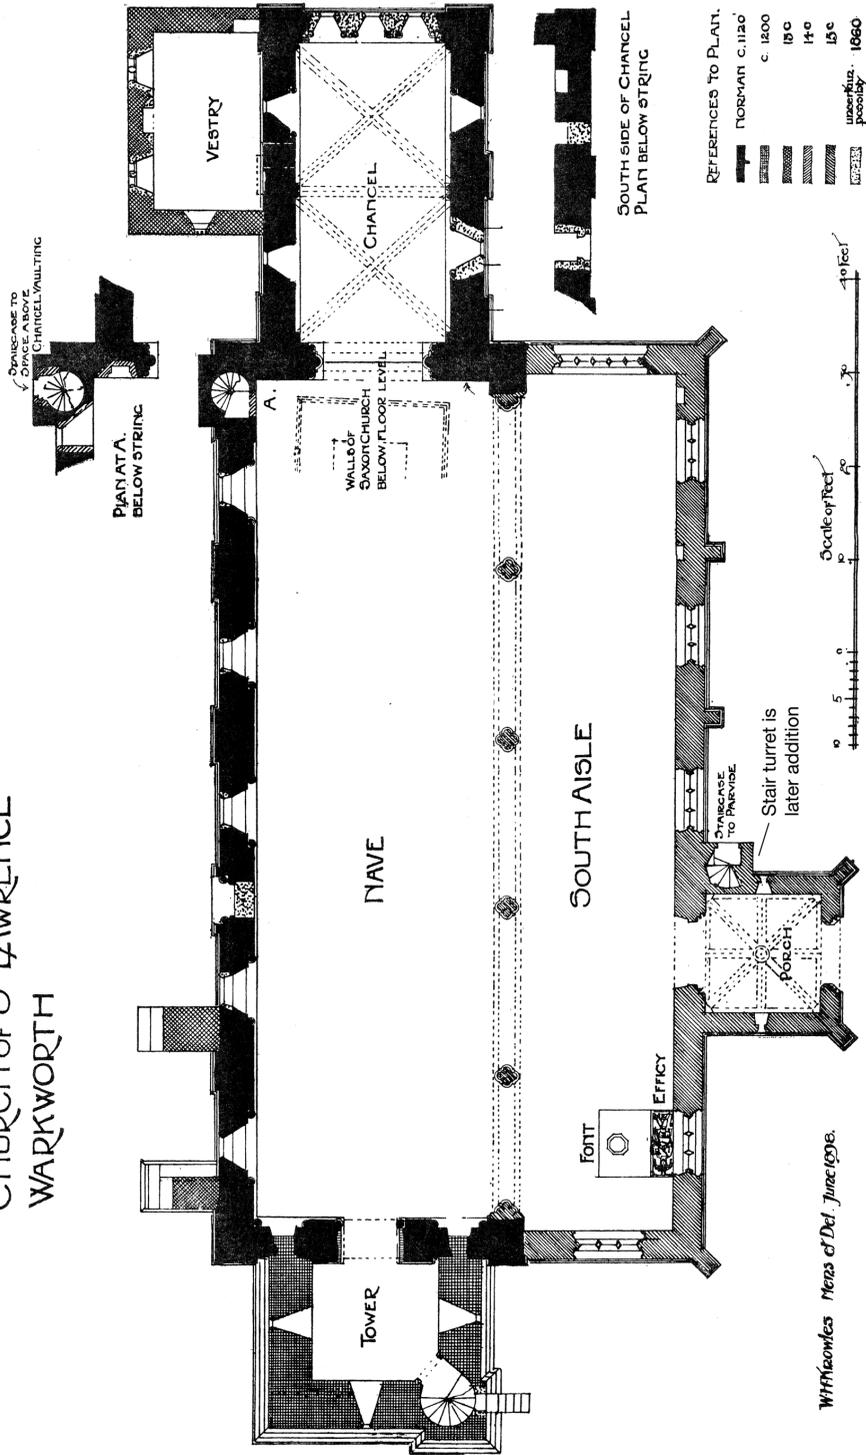
Fig. 4 Knowles' plan of St Lawrence's Church showing the foundations seen in 1860 (Knowles 1899, facing p. 172).

recorded, set at a slightly skew angle to the present building (fig. 4).³ Much later, a 1968/9 survey of the nave by G. E. Charlewood and Curry, Architects, carried out in 1968/9 in relation to structural repairs to the north wall, recorded a 'foundation wall' or off-set around a metre wide seen at two points on the internal face of the wall. It is not clear, however, how this feature relates to the foundations recorded in 1860, and it is unfortunate that specific archaeological recording was not carried out at this time. Another opportunity seems to have been missed in the 1970s or 1980s when the south aisle was re-floored in Caithness stone.

The west tower has been dated to c. 1200, probably replacing an earlier bellcote, which would appear to have been retained as its eastern wall (fig. 4). There is some puzzling evidence of rebuilding in its north wall, and also a hint that the newel stair that now gives access to the fourteenth-century belfry originally continued to a higher level than at present. It would seem reasonable to suppose that the tower of c. 1200 was provided with a proper belfry, although this might conceivably have been of timber.

The final medieval addition came with the addition of the south aisle (fig. 4). There has been some past controversy over its date; some have seen it as a mid-fifteenth-century addition; others (e.g. Bailey *et al.* 1988, 128; Salter 2002, 75) see the arcade as of the fourteenth century and the aisle itself, or at least its windows, as a century later. Hodgson sees the aisle as evidence of the ‘munificence of the third Earl of Northumberland’ and a little later in date than the castle donjon (now seen as c. 1400). Alnwick, another parish church sheltering beneath the umbrella of a great castle belonging to the Percy family, was almost totally rebuilt

The south porch seems to be of one build with the aisle (fig. 4), although it poses some puzzles; the upper chamber or parvise appears part of the original design, yet its stair turret is clearly a later addition; its roof timbers have now been dated to 1443 (Arnold *et al.* 2011). There is no sign of any link between the parvise and body of the church, so access must always have been external, presumably through a doorway in the present position, reached by an external stair or ladder. It is not clear whether the former clerestory (which consisted of five square-headed two-light windows) was coeval with the aisle or of rather later medieval date.

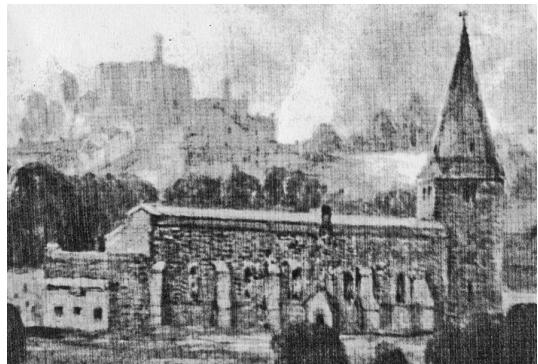
Fig. 5 Print of St Lawrence's Church dated 1837, in the possession of Warkworth PCC and currently hanging in the church, putatively showing five original buttresses against the north wall of the nave.

Inside the church, a minor repair to the stone work infilling the twelfth-century north door opened a hole through into what was revealed to be a flue; this ties in with a chimney shown on the wall-top in a 1837 print (fig. 5, which also shows the ‘dubious’ buttresses now ‘replaced’) and presumably served a stove, probably the first generation of church-heating, prior to successive under-floor systems.

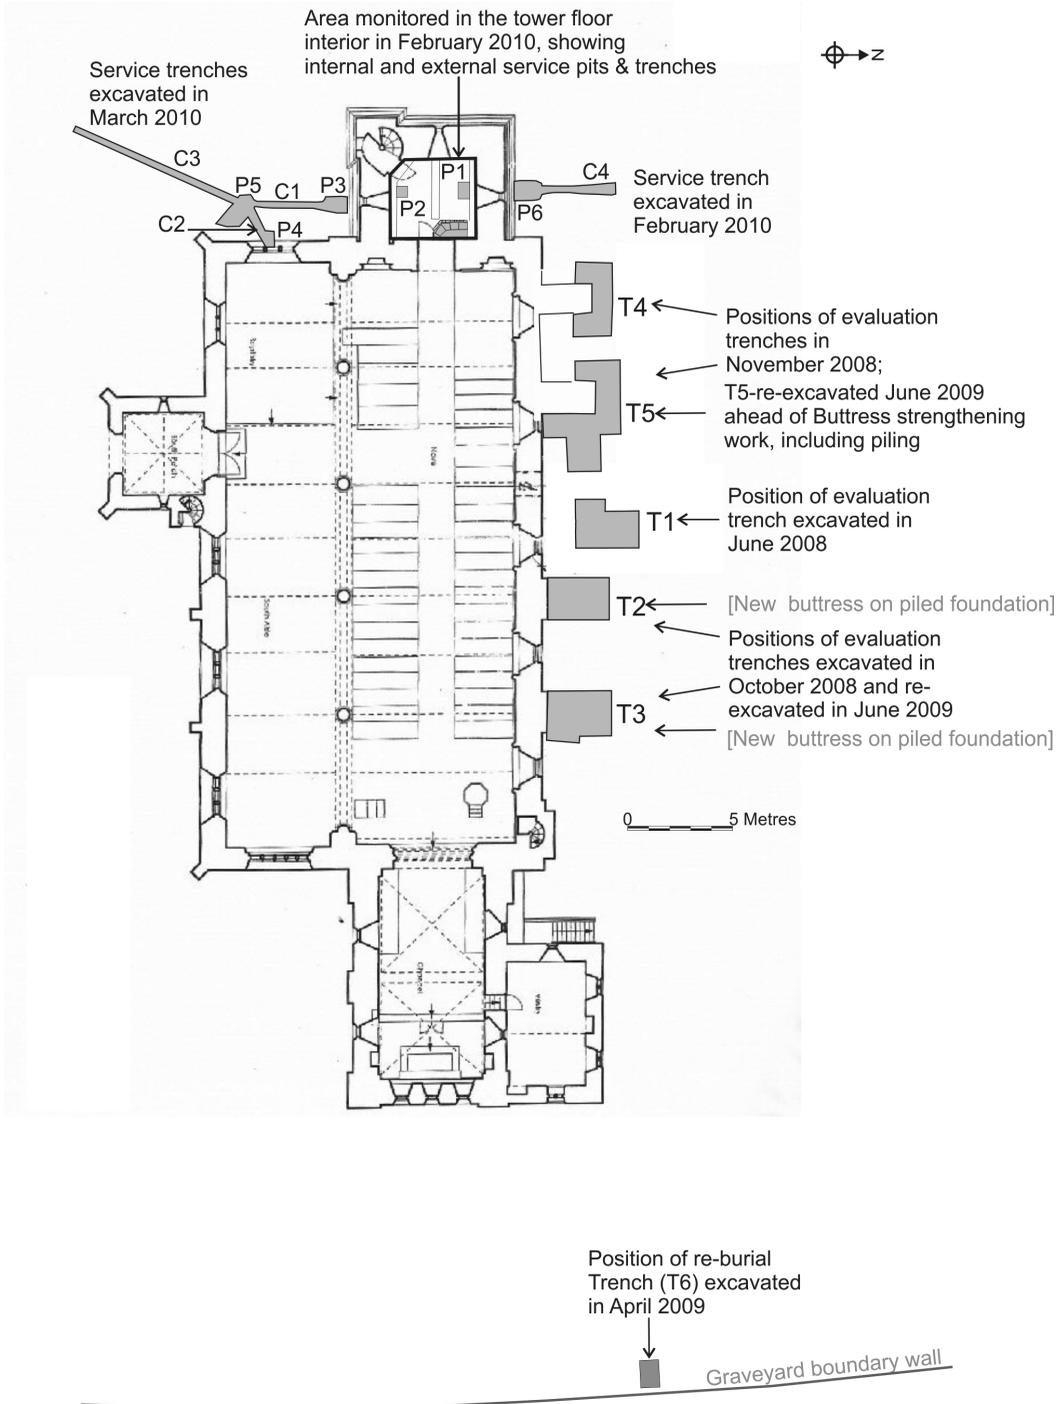
Fig. 6 Plan of archaeological works carried out between 2008 and 2010.

In support of the first part of a programme of works aimed at stabilising and providing structural support to the leaning north wall of the church, trenching was first carried out in June 2008 (T1 in fig. 6) in a location where it was proposed to construct a pile cap to receive the heavy reinforced base of one of a series of massive L-shaped columns to be built into the thickness of the wall behind the flat pilasters between the windows. This scheme was subsequently abandoned in favour of buttressing the North Wall, including building two new buttresses (T2 and T3 in fig. 6) and strengthening existing ones (T4 and T5 in fig. 6) towards the west end of the external north wall; a further scheme of investigation was carried out in October 2008 in connection with that scheme. Subsequently, two of the trenches excavated in support of the revised scheme were re-opened in March 2009, and an additional small pit (T6 in fig. 6) excavated on the eastern edge of the churchyard to receive the disarticulated skeletal material recovered during the works programme. A watching brief was also maintained during the implementation of the north wall strengthening scheme both inside and outside the church. Finally, in early 2010, work to lower the floor of the west end of the church and insert service pipes both inside and outside the building (P1–P5 and C1–C4 in fig. 6) was monitored for finds of archaeological significance and in order to recover disarticulated skeletal material.

In June 2008 a single trench, 3 m by 2.26 m (max) and up to 1.40 m deep, was opened in the churchyard on the north side of the church between two central medieval buttresses, some 1.60 m from the plinth of the north wall (see T1 in fig. 6).

A small trench was excavated on the south side of a brick-built shed at the eastern boundary of the graveyard (fig. 6) in order to rebury the skeletons removed from Trenches 2, 3 and 5. During excavation of this trench no skeletal material was exposed, but several blocks of worked masonry were revealed in the trench bottom and interpreted as the remains of a wall. Examination of documentary sources, historic pictures and maps has failed to provide evidence for buildings on this site, the closest building being a tithe barn which appears on historic maps further south, adjacent to the east end of the church. Therefore it seems likely that the remains excavated relate to a phase of construction and demolition pre-dating the early eighteenth century. No artefacts were recovered to shed light on the origins and character of these remains. The skeletons recovered from Trenches 2, 3 and 5 were reburied in this pit without disturbing the masonry remains.

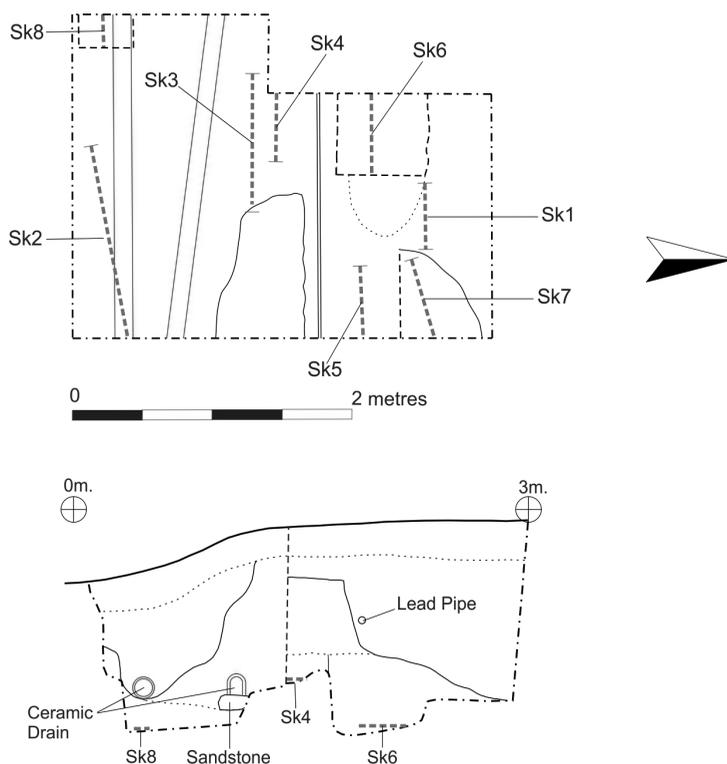
Fig. 7 (upper drawing)
Plan of Trench 1.

Fig. 8 (lower drawing)
East-facing section of
Trench 1.

Immediately below and to the south of the modern services cut, a total of six complete articulated skeletons were exposed at depths between 0.76 and 1.40 m, and two additional skeletons were found to be only partly-articulated (fig. 7). The fully- and partially-articulated

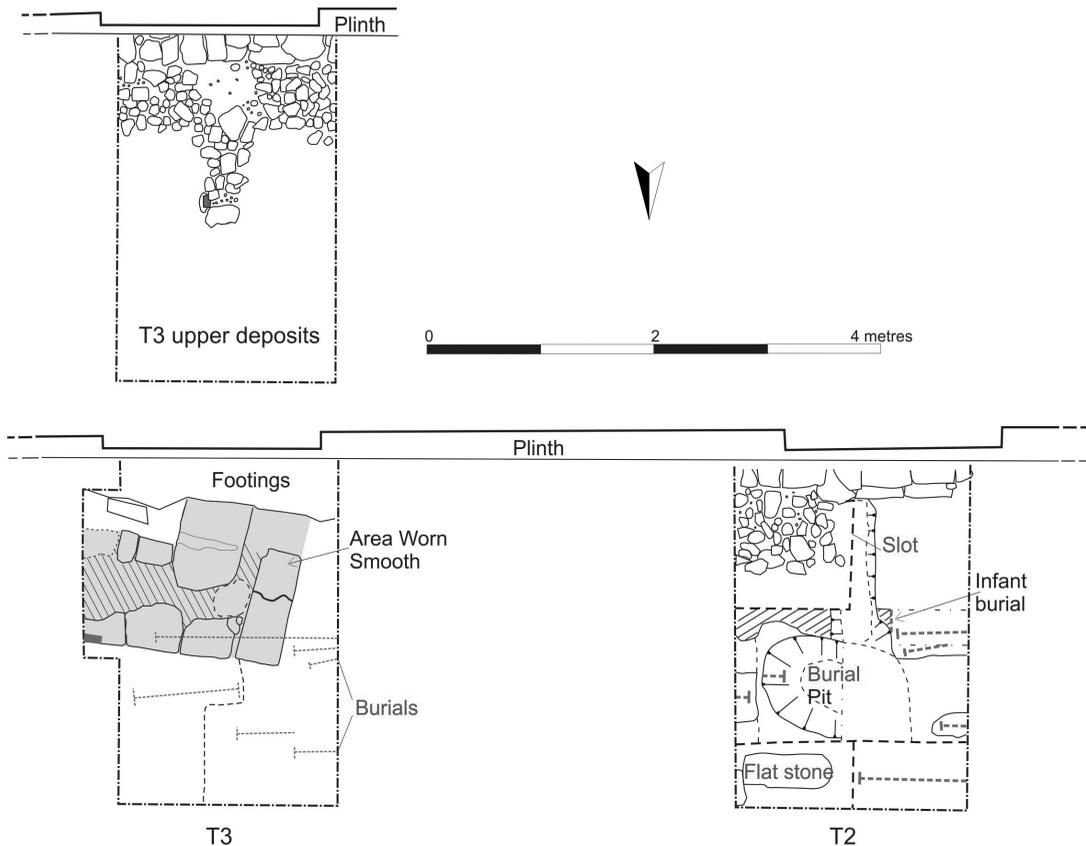
Fig. 9 Plan of Trenches 2 and 3, showing the extent of wall foundations excavated in Trench 3.

In Trench 2 a shallow deposit of rubble was found below the turf layer running next to the church wall footings (fig. 9). Cut through this in the middle of the pilaster was a deep north-south slot, the upper part of which also contained some rubble of probable nineteenth-century origin, including at least one brick fragment.

Excavation of Trench 3 revealed the same T-shaped arrangement of rubble (fig. 9) along the side of the north wall with a central slot, shallower than in Trench 2, cutting it from north to south. The slot was filled with the same kind of rubble as the deposit against the church wall.

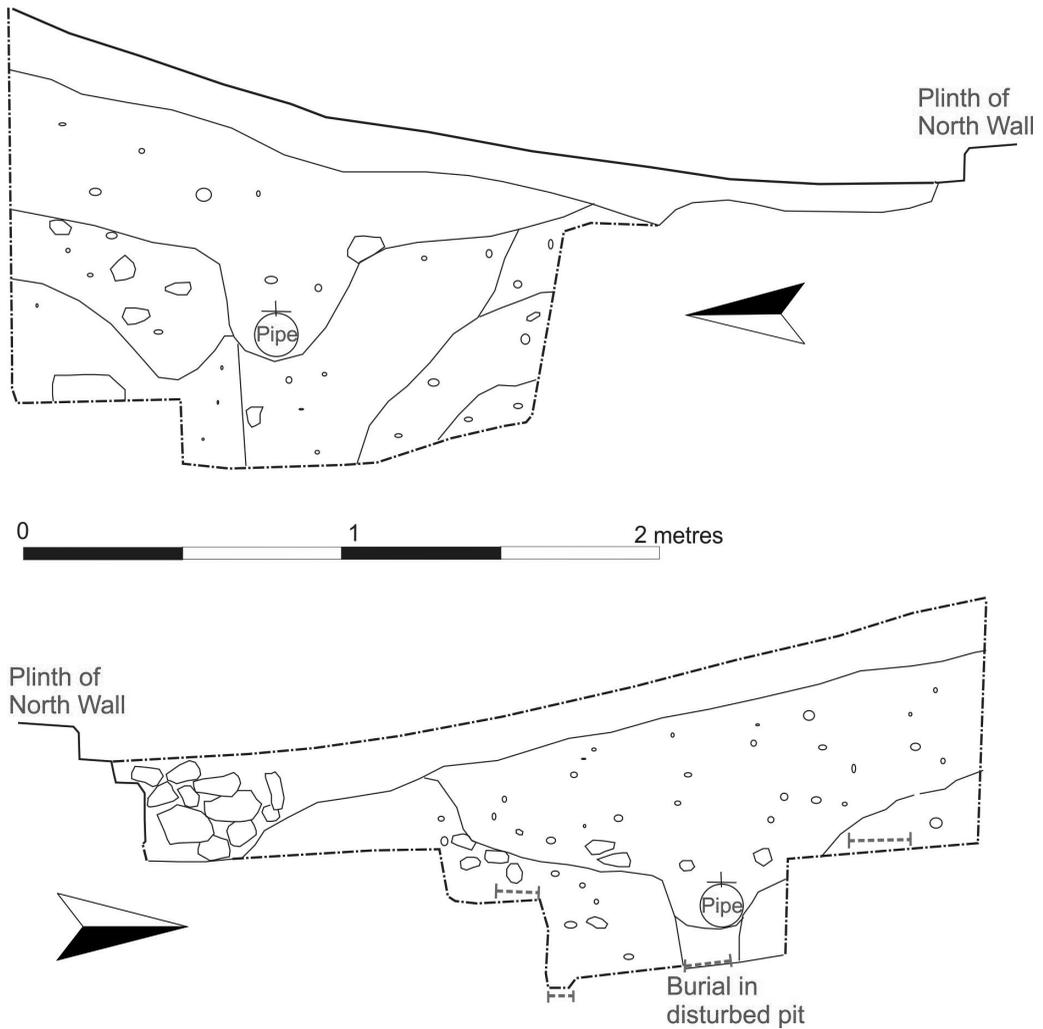
Fig. 10 (upper drawing) West-facing section of Trench 2, showing in-fill deposits.

Fig. 11 (lower drawing) East-facing section of Trench 2, showing in-fill deposits above burials.

the trench, was a shallow, compacted deposit of degraded sandstone (figs. 9–11). In the centre of the trench the deep, oval-shaped pit contained a disturbed burial at a depth of some 1.5 m below the exposed plinth, one of seven skeletons revealed in the trench. At the north end of the trench, parallel with the church wall and at a depth of some one metre below the current ground level at its lowest point, was a long, rectangular stone some 0.75 m long which abutted another in the west-facing section (fig. 10). The possible significance of this is discussed below.

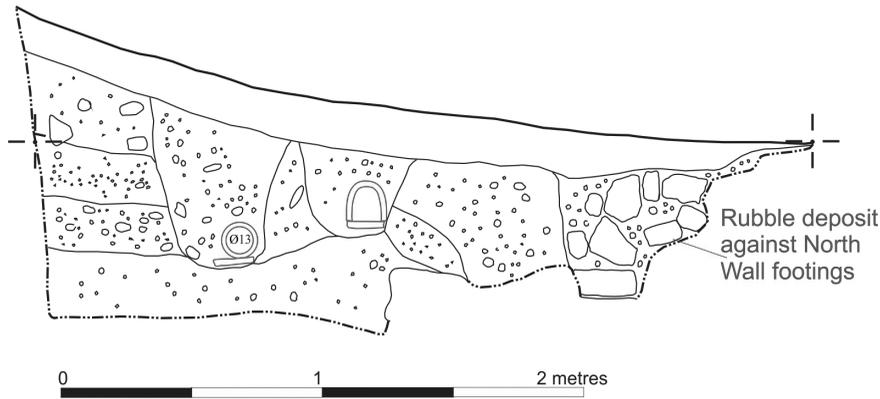
Fig. 12 West-facing section of Trench 3, showing field drains within infill deposits.

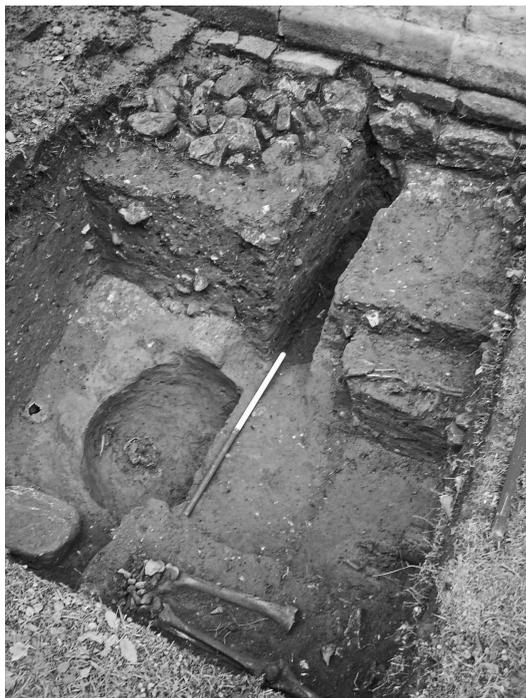
Fig. 13 (above left)
View of Trench 2
from the north.

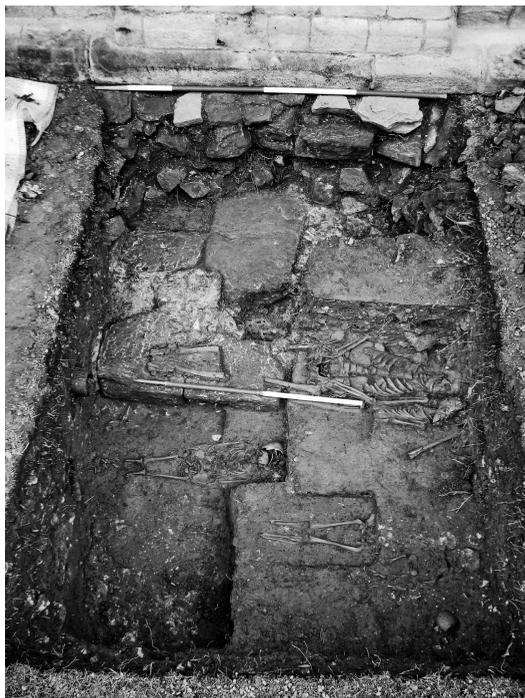
Fig. 14 (above
right) View of
Trench 3 from the
north.

The shallowness of the slot noted above was explained by the presence of substantial wall footings running north-south at a depth of 0.47m below the plinth of the current building (figs. 14 and 15). The top of this wall, 1 m wide, was exposed to reveal that it was constructed of large, squared blocks up to 1.02 m long, apparently clay-bonded with internal voids filled with yellow, sandy rubble. A right-angled return was apparent at the west end of the wall footings, suggesting that the greater part of the structure lay within the area of the current nave. This structure, clearly the footings of a wall that pre-dates the present nave — which probably dates from the 1130s — ran at an angle askew to the nave and was set less than 1 m outside its wall. Its thickness and this misalignment leads to its interpretation as part of a Saxon *porticus* structure forming part of an early pre-Conquest church (see fig. 32).

As well as a charnel pit in the upper deposit, at least six definable complete human burials were uncovered in Trench 3 (fig. 14) — one resting directly upon the north part of the substantial wall footings and partly cut by the central slot — three of which were removed and reburied.

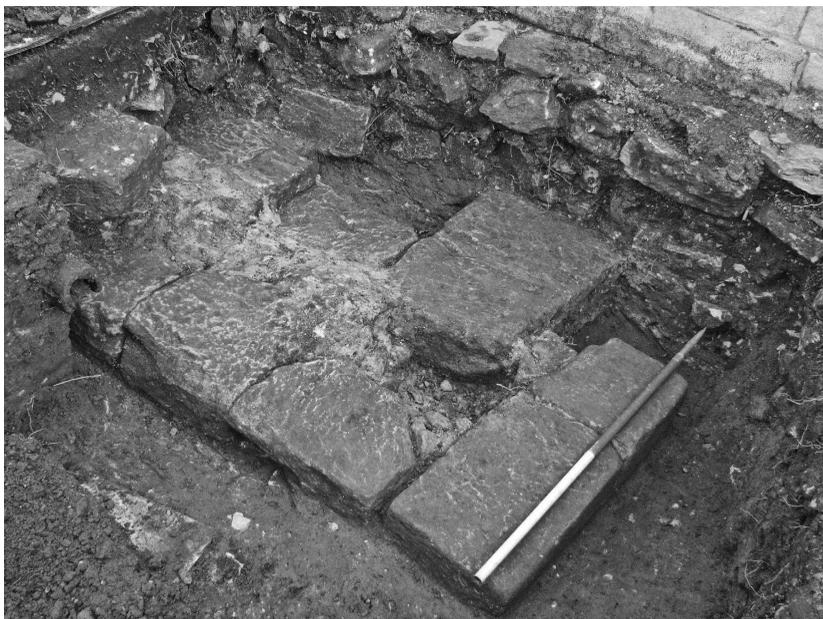
Fig. 15 (right) View
from the north-west
of masonry remains
revealed in Trench 3.

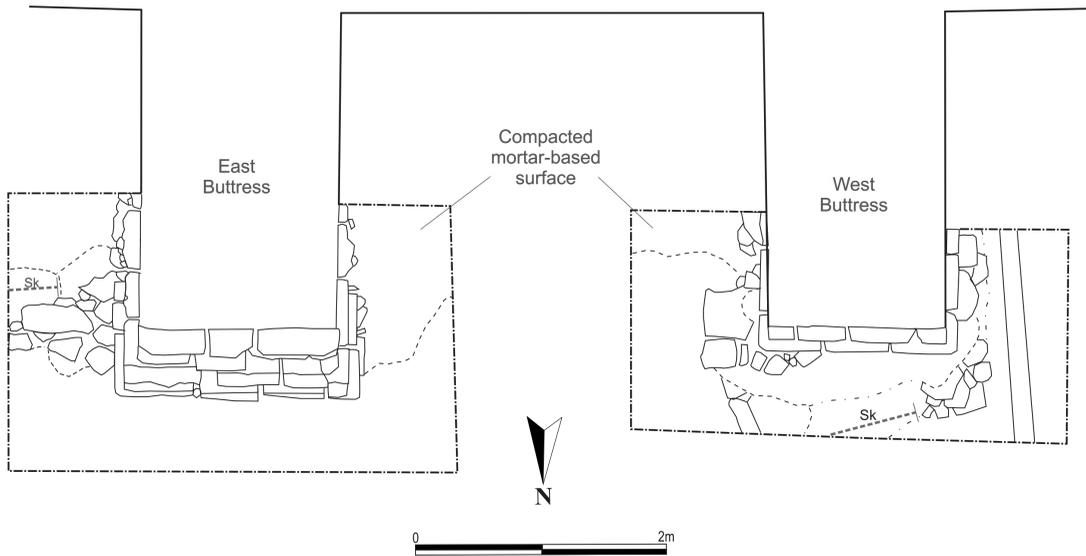
Fig. 16 Plan of excavations carried out against the original buttresses in Trenches 4 and 5.

The excavation of Trench 4 exposed the lower face and footings of the north face and parts of the east and west faces of the western of the two surviving buttresses of supposed medieval date at the west end of the nave (figs. 16–19). The excavation revealed that the lower offset plinth visible above the surface rested upon a rubble base which extended between 0.20 and 0.40 m outwards from the bottom of the plinth on all sides and was up to 0.70 m deep. The topsoil deposits surrounding the buttress and its base had been disturbed by a drainage trench running north-south along the west side of the trench, but on the east side of the trench, where drainage works had not caused disturbance, a very shallow deposit of sand or

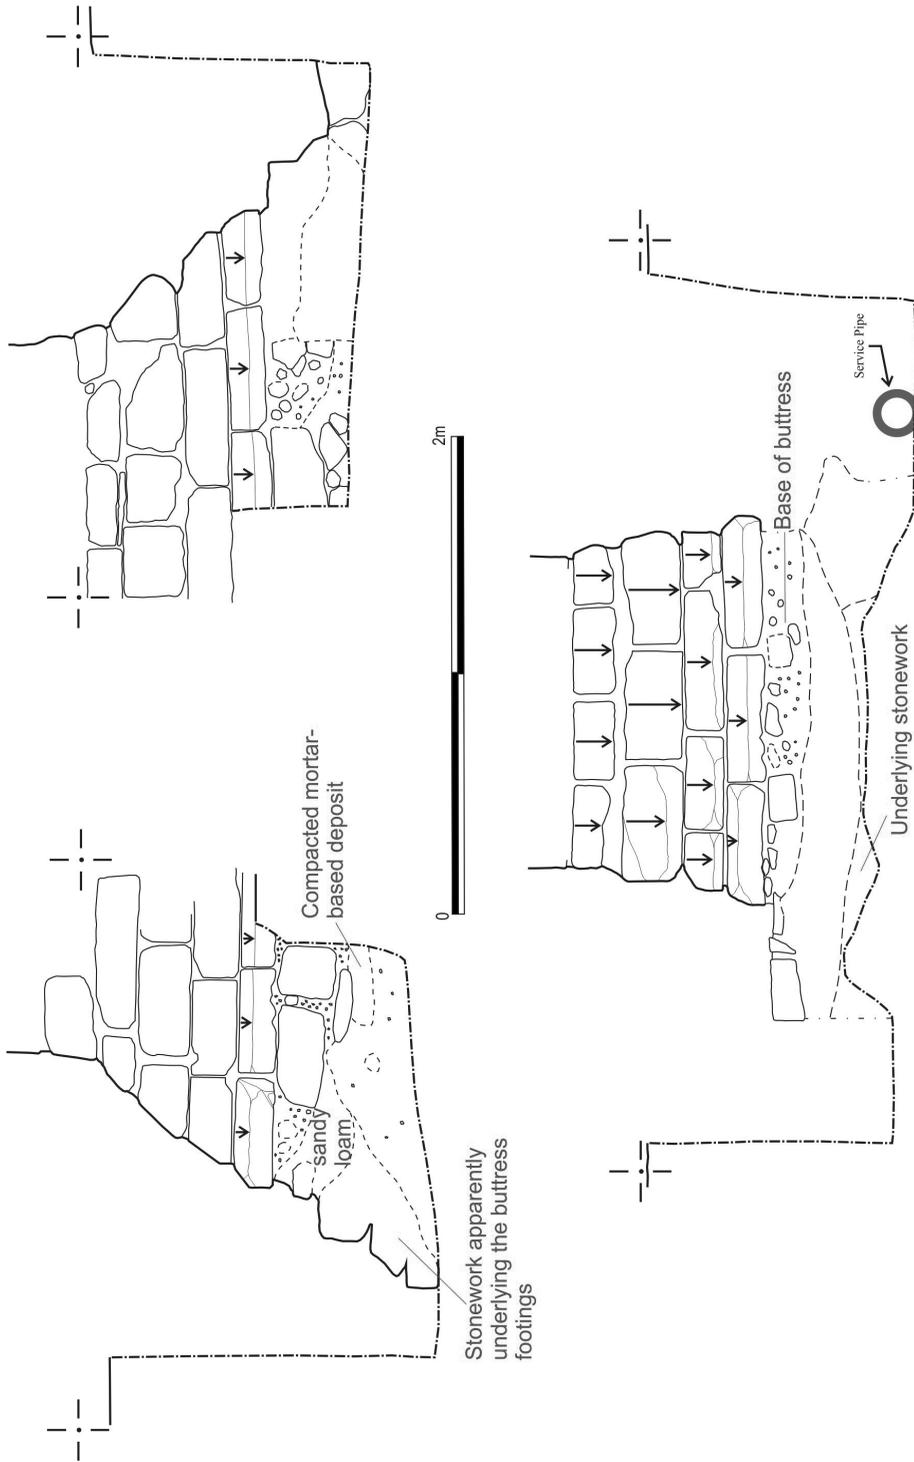
Figs. 17-19 Trench 4 section drawings. Top left (fig. 17): west. Top right (fig. 18): east. Bottom (fig. 19): north.

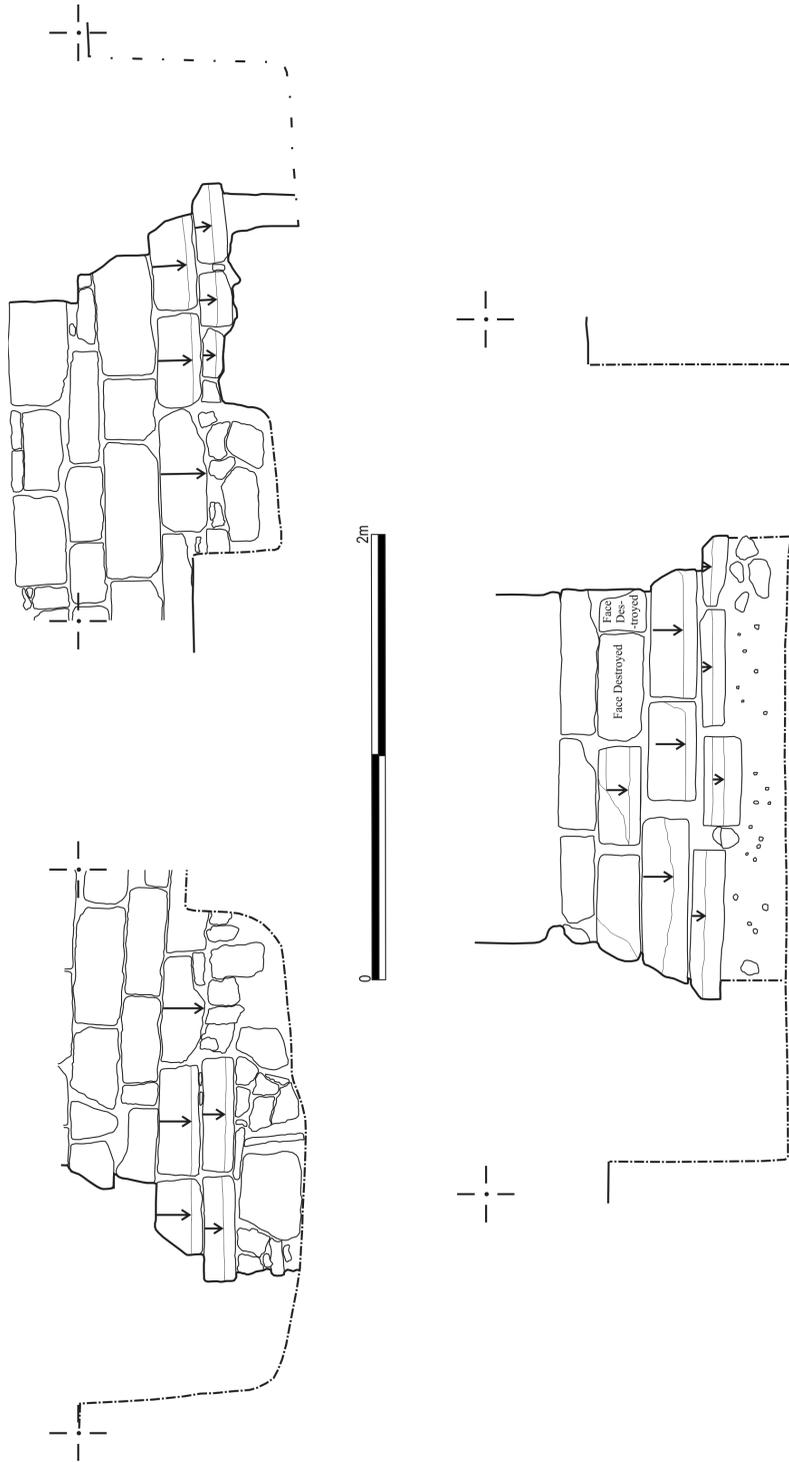
Figs. 20-22 Trench 5, section drawings. Top left (fig. 20): west. Top right (fig. 21): east. Bottom (fig. 22): north.

The excavation of Trench 5 (figs. 20–29), uncovering the north end of the eastern of the two surviving buttresses at the west end of the nave, revealed an offset plinth below the upper plinth. This rested upon an insubstantial rubble base which did not extend significantly outwards from the bottom of the plinth and was only 0.35 m deep. The topsoil deposits surrounding the buttress and its base had been disturbed by a water pipe running east-west along the north side of the trench, whilst on the east and west sides of the trench a very shallow deposit of sand or degraded sandstone, similar to that described in Trench 4 was apparent. Against the east wall of this buttress at foundation level were the apparent remains of an insubstantial stone-built feature. No further structural remains were discovered in the trench, and despite attempts to cut through to underlying deposits it was impossible to establish the depth of the natural subsoil.

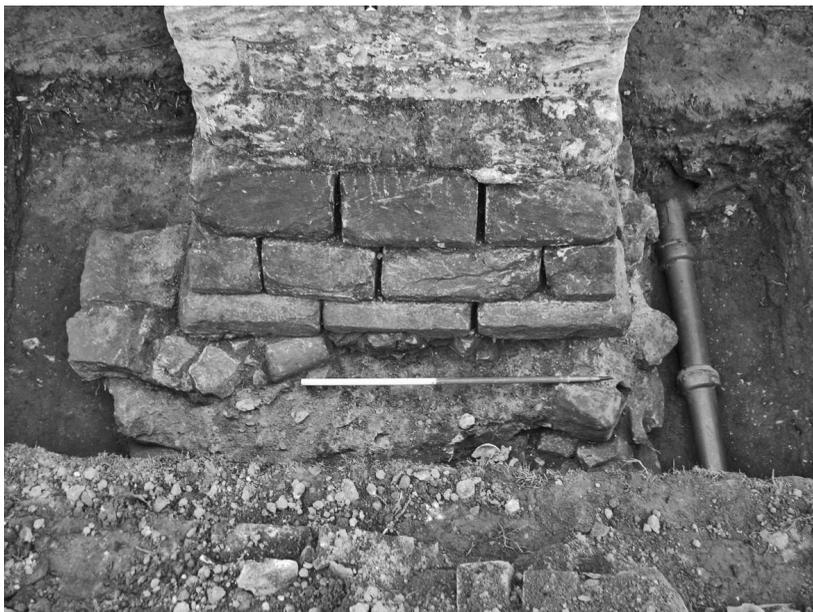
Fig. 23 View from the north of the east buttress following excavation: Trench 5.

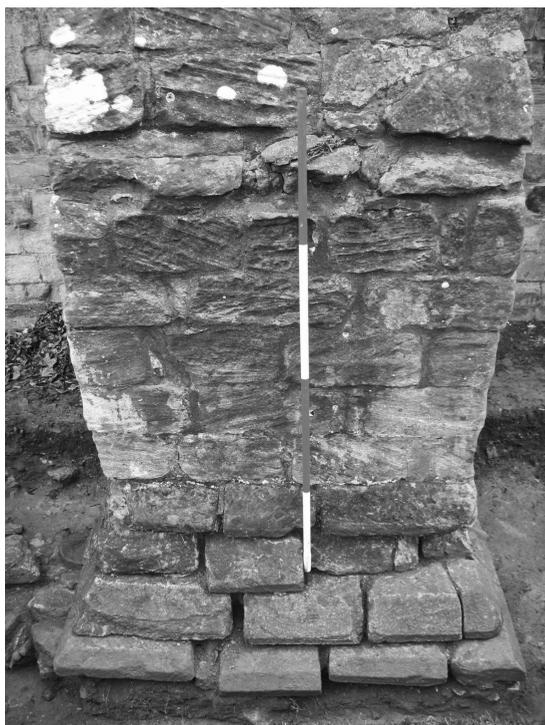
Fig. 24 View from the north of masonry remains revealed against the east side of the east buttress: Trench 5.

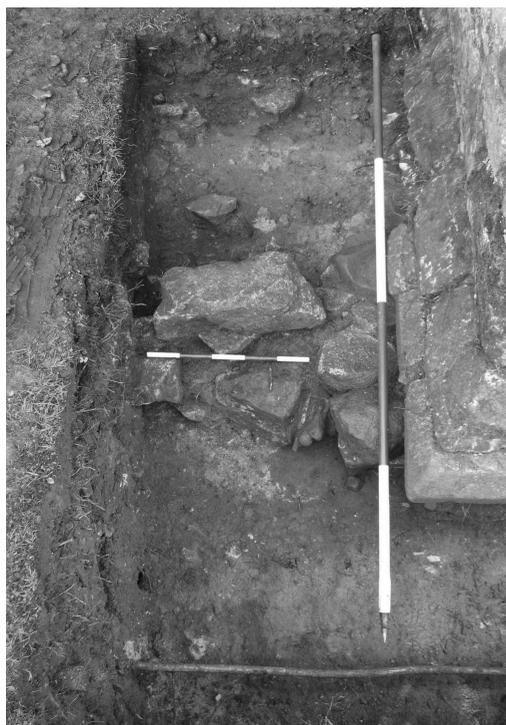
Fig. 25 View from the north of the extension to Trench 5, showing burials.

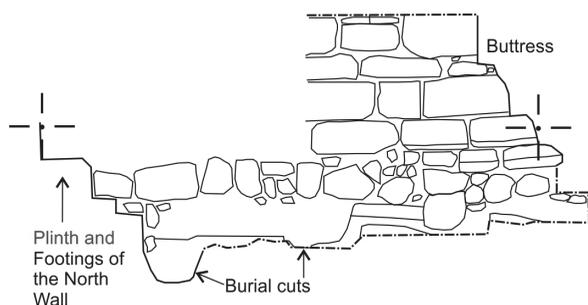
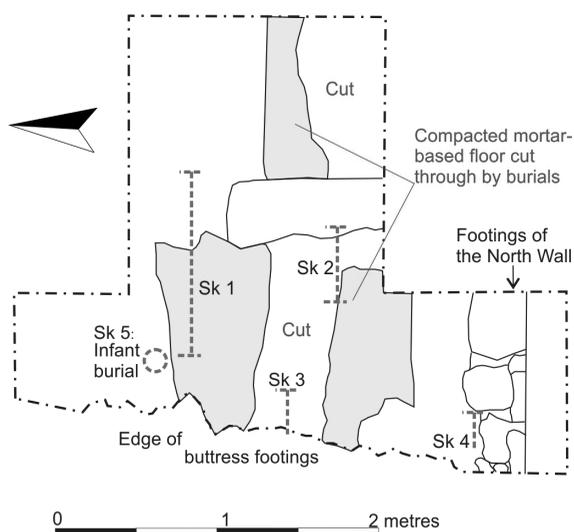
Fig. 26 (top) The east-facing section of Trench 5 following its re-excavation and extension.

Fig. 27 (bottom) Schematic plan of the extension to Trench 5, showing burials which post-date earlier burial cuts through a compacted mortar floor deposit.

The re-excavation of Trench 5 in 2009 (figs. 26–7) involved a slight extension to the trench on the east side, revealing a deposit of crushed sandstone, more substantial and at a deeper level than that previously recorded in Trenches 2–5. This deposit, which underlies the buttress, is interpreted as a structural deposit, possibly associated with the Saxon porticus wall recorded in Trench 3, although no corroboratory evidence in the form of artifacts or dateable ecofactual materials were discovered. A slot apparently cut through this deposit from N–S was tentatively interpreted as a construction trench for the porch which once occupied the position outside the north door of the church (now blocked), although grave-cuts elsewhere in the same deposit (figs. 27–9) suggest an alternative explanation. Two skeletons, one partly

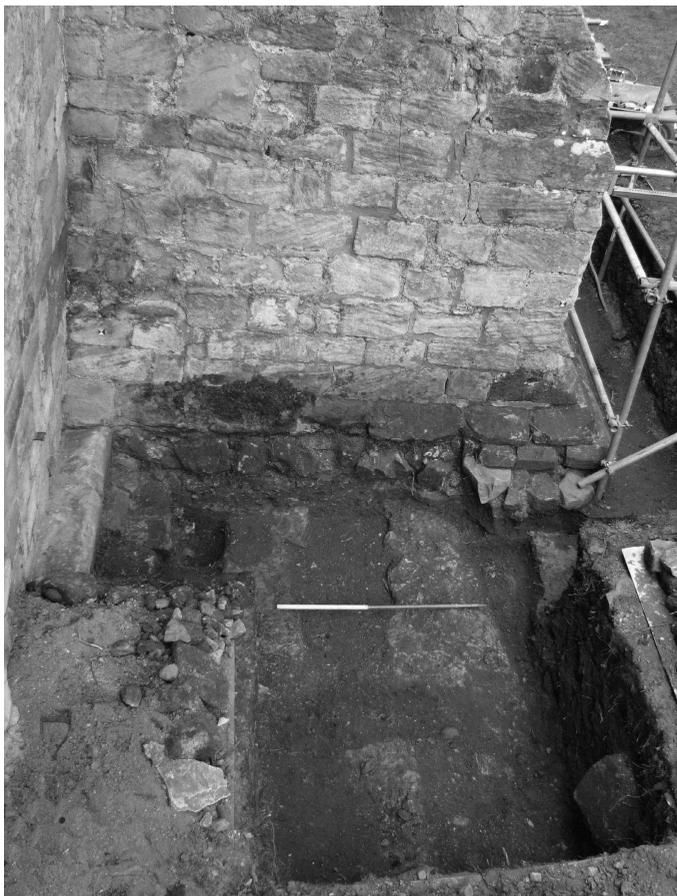
Fig. 28 View from the north-east of burials revealed in the extension to Trench 5.

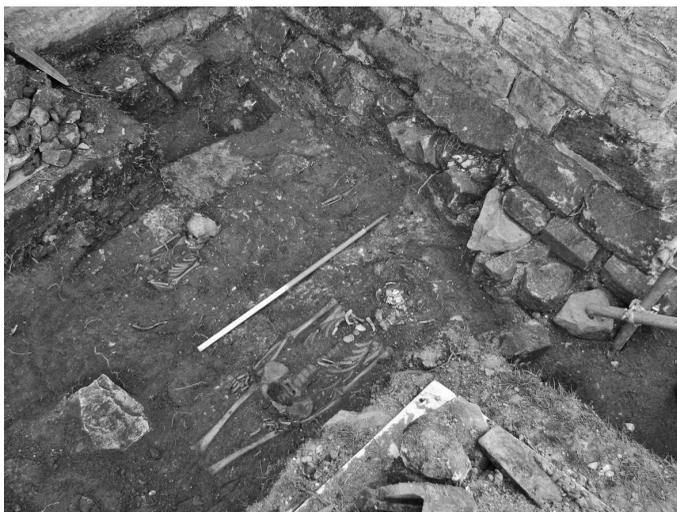
Fig. 29 Vertical oblique view from the east of burial cuts into a compacted sandy floor on the east side of the eastern old buttress in Trench 5.

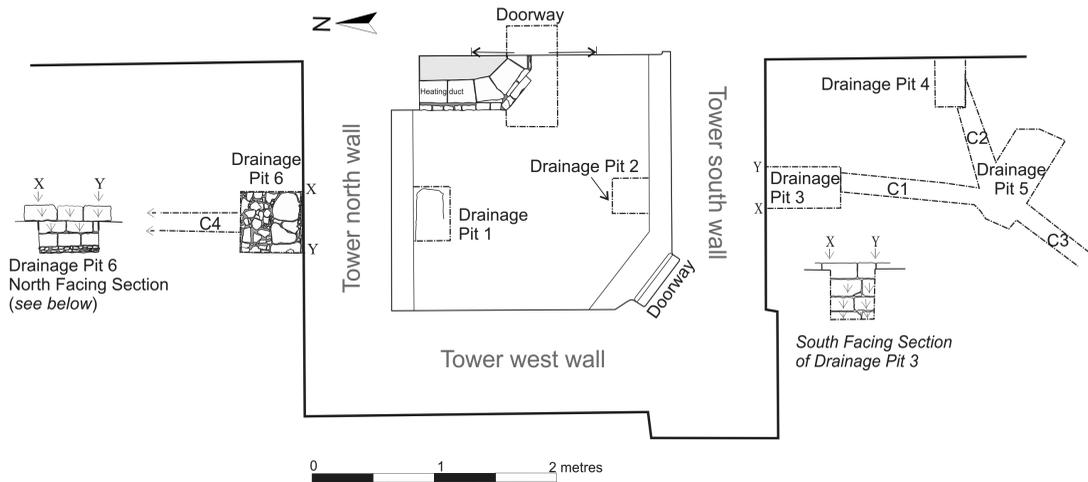
Fig. 30 (above) Plan of works monitored inside the tower.

An archaeological watching brief carried out in 2010 was focused on works related to the installation of a lavatory and kitchen facilities within the fourteenth-century church tower. During these works the wooden Victorian floor of the tower was removed and drainage pits were excavated adjacent to the interior and exterior of the tower walls, with further channels for drainage pipes being excavated within the churchyard (fig. 30).

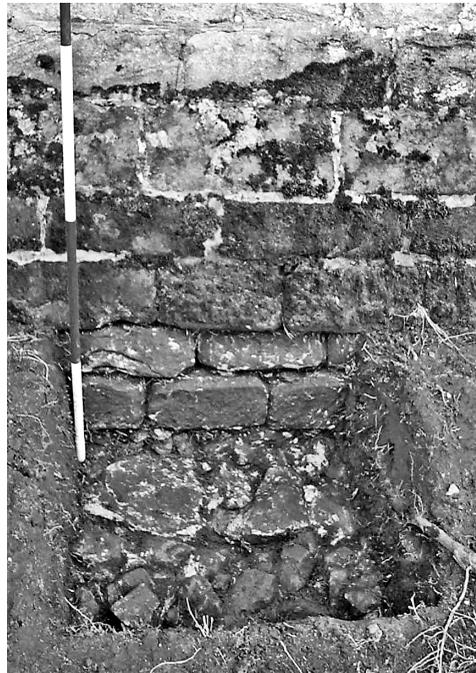
Fig. 31 (right) View of footings revealed in Pit 6 on the north side of the tower.

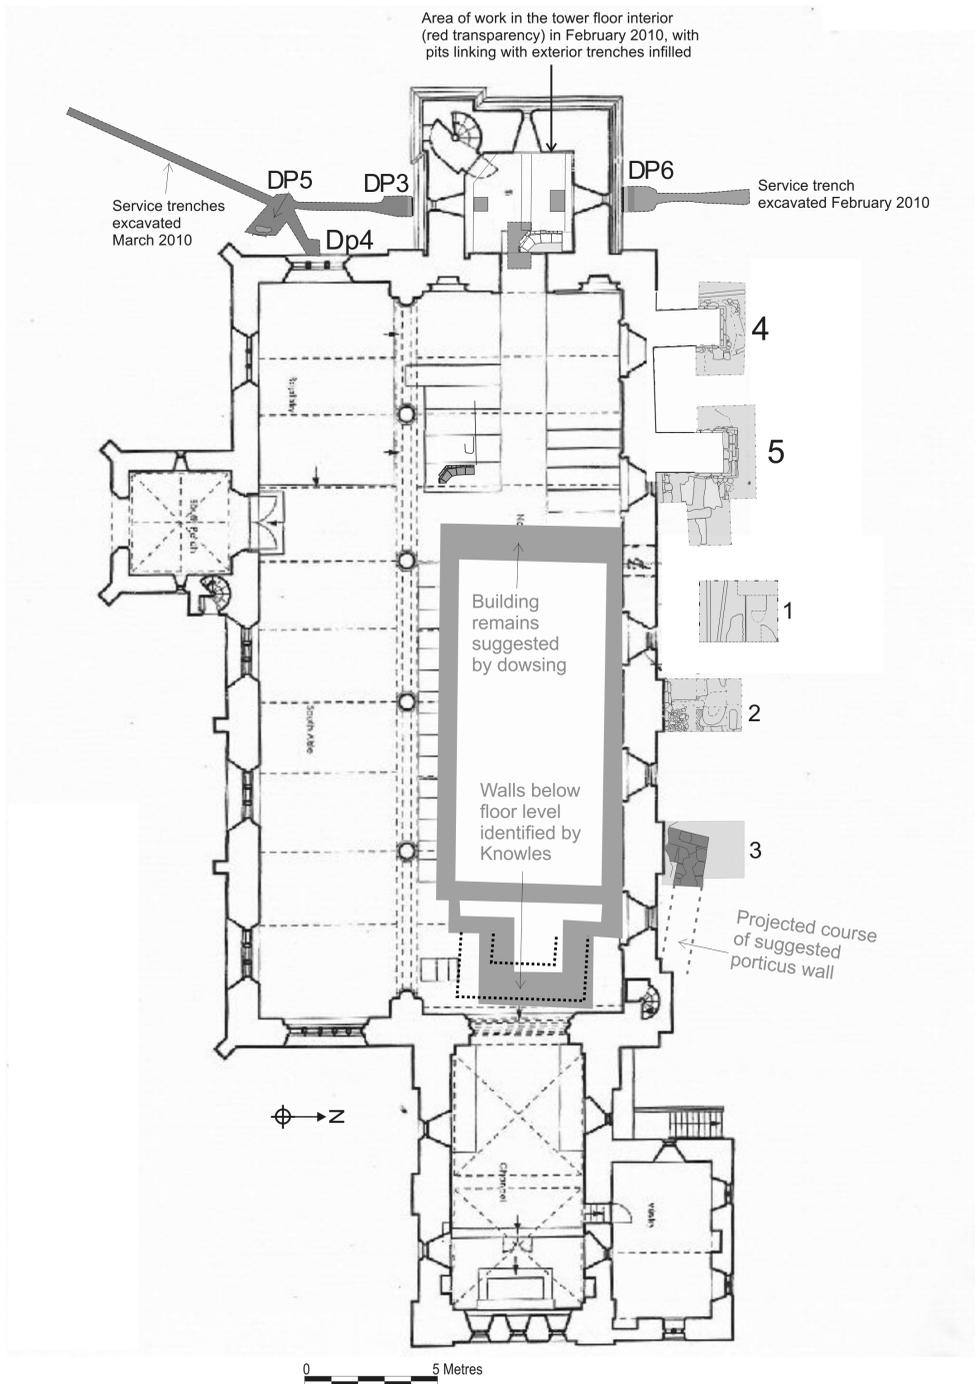
Fig. 32 The position of archaeological interventions and remains discovered, 2008–2010, with suggested interpretations of the evidence.

Also worthy of mention in the context of previous archaeological enquiry is a dowsed survey of the church (Bailey *et al.* 1988) which suggests the footings recorded in 1860 are the thick-walled chancel of an aisle-less church with the north wall of its nave partly underlying that of the present building. (This tallies with the off-set footing recorded in 1968/9.) The survey also recorded a structure on the north of the vestry which might tally with the evidence for a vault there seen in 2001,⁴ and a porch outside the north door. However, the two apsidal east ends shown, one beneath the centre of the chancel and one beyond its east end, appear more doubtful (fig. 32).

Figure 32 sets out the positions of structures and features uncovered during the various phases of archaeological works on the site. It is of some potential interest that a deep, oval pit uncovered in Trench 2 sits in line with the projected extension of the *porticus* wall, as do more ephemeral features in Trench 1. Furthermore, various fragmentary walls and surfaces found in Trenches 4 and 5 lie inside the wall of the *porticus*, as projected, indicating that they were probably not associated with the interior of the putative early church.
