The Ida Wing, Cookridge Hospital  
Historic Building Recording  
ArcHeritage 2019

The Former Ida Wing, Cookridge Hospital, Leeds  
Historic Building Recording

Project Name	The Former Ida Wing, Cookridge Hospital, Leeds
ArcHeritage Project no.	1796
Report status	Final
Type of Project	Photographic Building Recording
Client	Esh Construction
OASIS ID	archerit1-348378
Planning Application ref.	14/02558/LI
NGR	SE 25483 38884
Authors	Christopher Curtis
Illustrations	Christopher Curtis
Editor	Glyn Davies
Report Number and Date	2019/20 05/04/2019
Version and Filename	Version 2: 1796 Ida Wing Cookridge V2.pdf

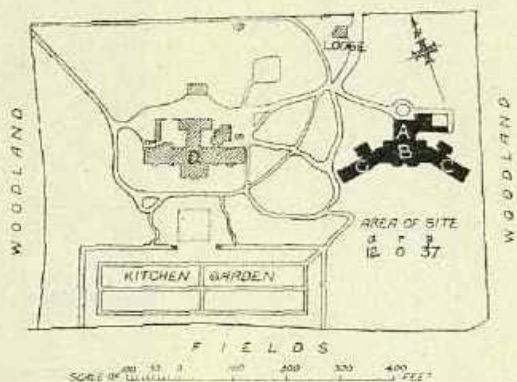
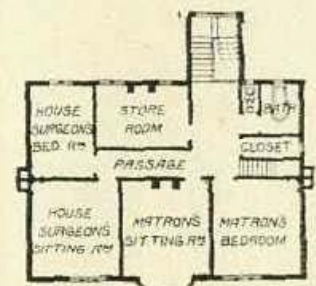
Figure 9: Plan of Ida Hospital from Hospitals and Asylums of the World 1891-3

SEMI-CONVALESCENT HOME COOKRIDGE, LEEDS.

BLOCK PLAN

- A ADMINISTRATION PORTION
- B WARDS & DAY ROOMS
- C WARD
- D EXISTING CONVALESCENT HOME ERECTED IN 1869

ARCHITECTS FOR THE BUILDING  
MESSRS CHOLEY AND CONNOR 1887

THE BUILDING CONTAINS  
GROUND FLOOR  
FIRST - (PART ONLY)

REFERENCE FOR DRAINING  
SOIL DRAINING SHOWN THUS - - - - -  
RAINWATER SURFACE - - - - -  
F.T. FLUSHING TANKS  
A.A. DRAINING CONTINUED TILL THEY MEET  
AND CONNECTED WITH PRECIPITATING  
TANK OF ADJOINING CONVALESCENT  
HOME.

GROUND FLOOR PLAN

FIRST FLOOR PLAN

The Cookridge site was expanded when, in 1885, the hospital committee agreed to build the Ida semi-convalescent hospital for forty patients, on the condition that their upkeep was paid for by the general infirmary. The hospital was completed in 1889 to designs by local architects Chorley and Conon. The use of the arts and craft style was designed to fit in with the main hospital building but its design was more innovative. Chorley and Conon employed the half-butterfly plan, kept all the patients on the ground floor, and made use of different sized wards for different patients. New admissions would typically be kept in the large dormitories in the wing whilst stronger patients who required less supervision could be kept in smaller rooms.

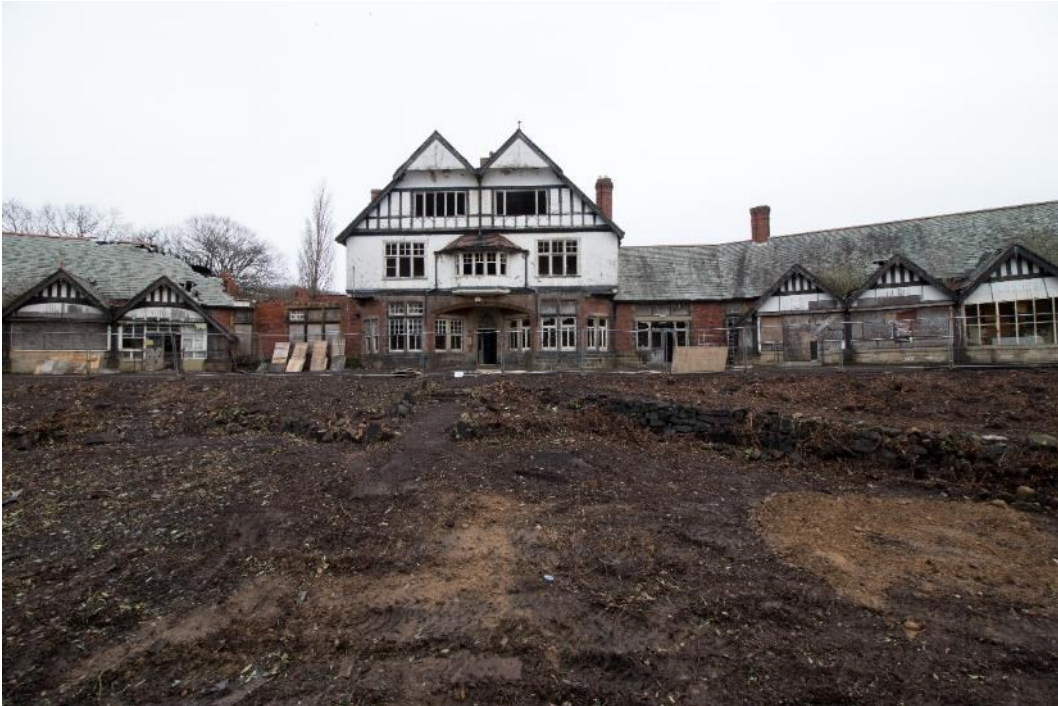
Photo 1: South elevation (1796\_001.TIF)

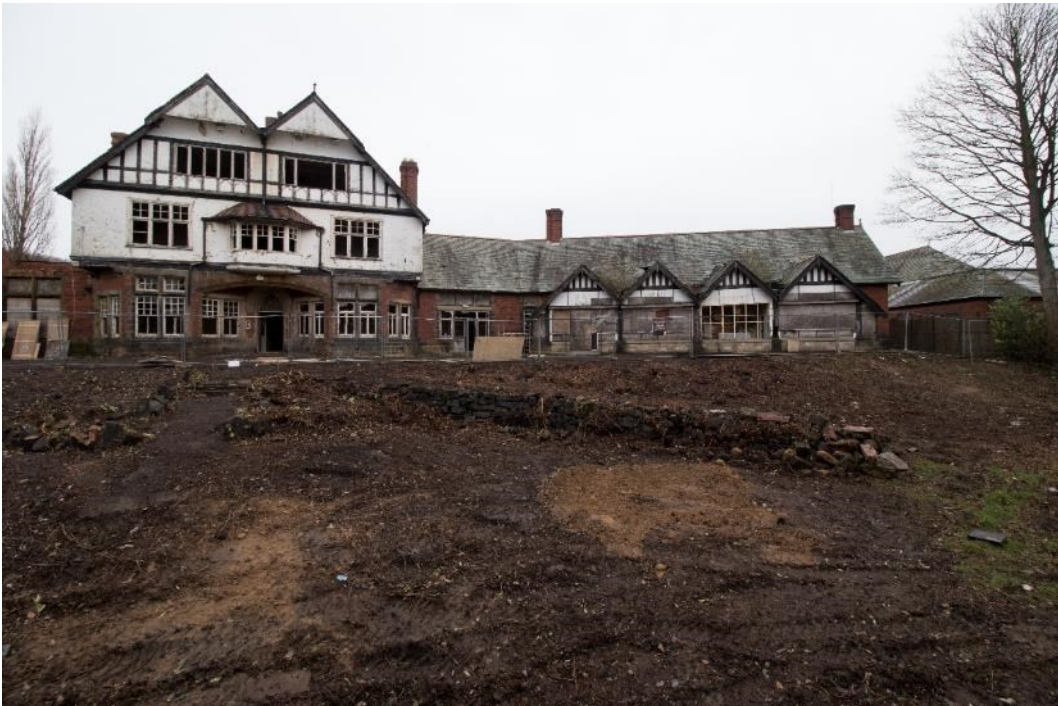
Photo 2: South elevation (1796\_003.TIF)

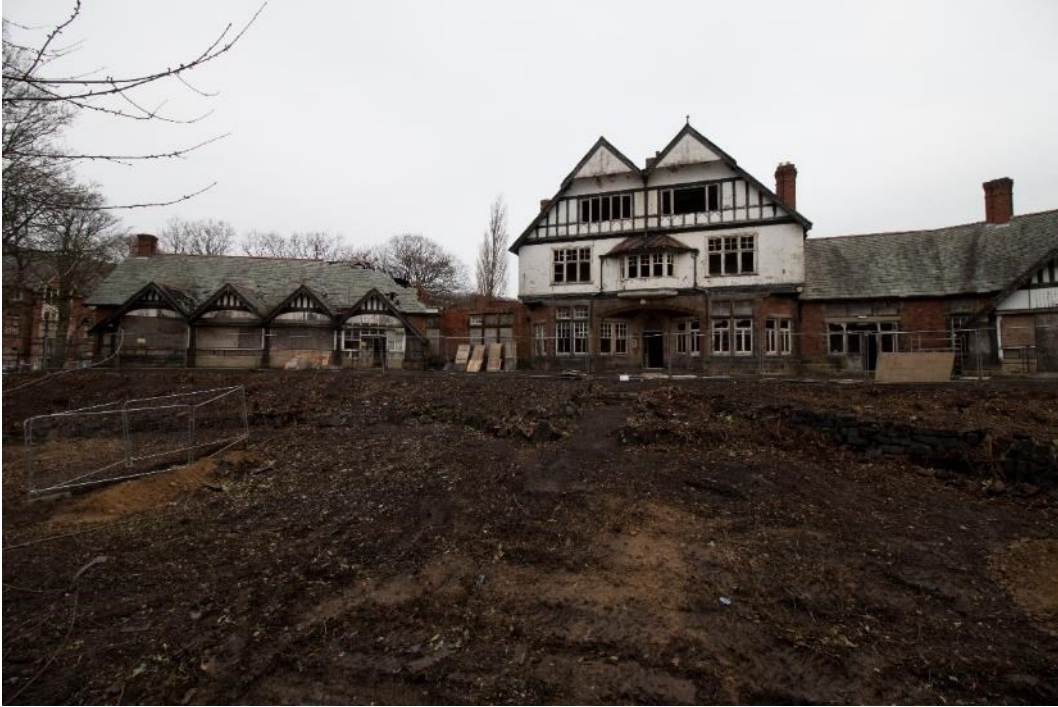
Photo 3: South elevation (1796\_002.TIF)

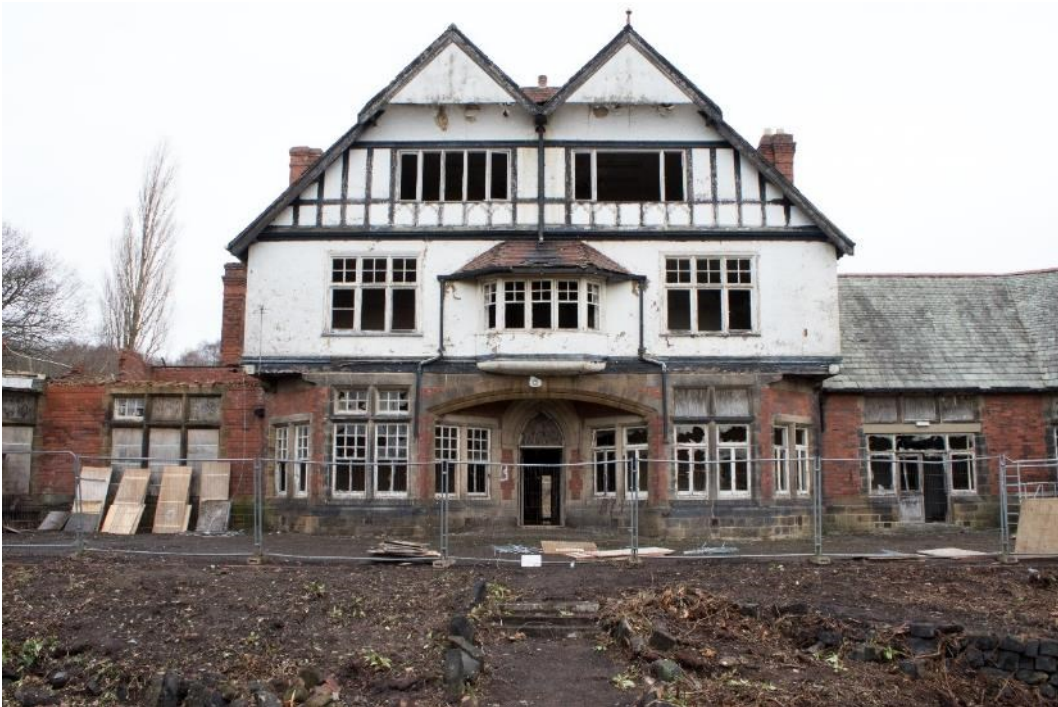
Photo 4 Central block, south elevation (1796\_004.TIF)

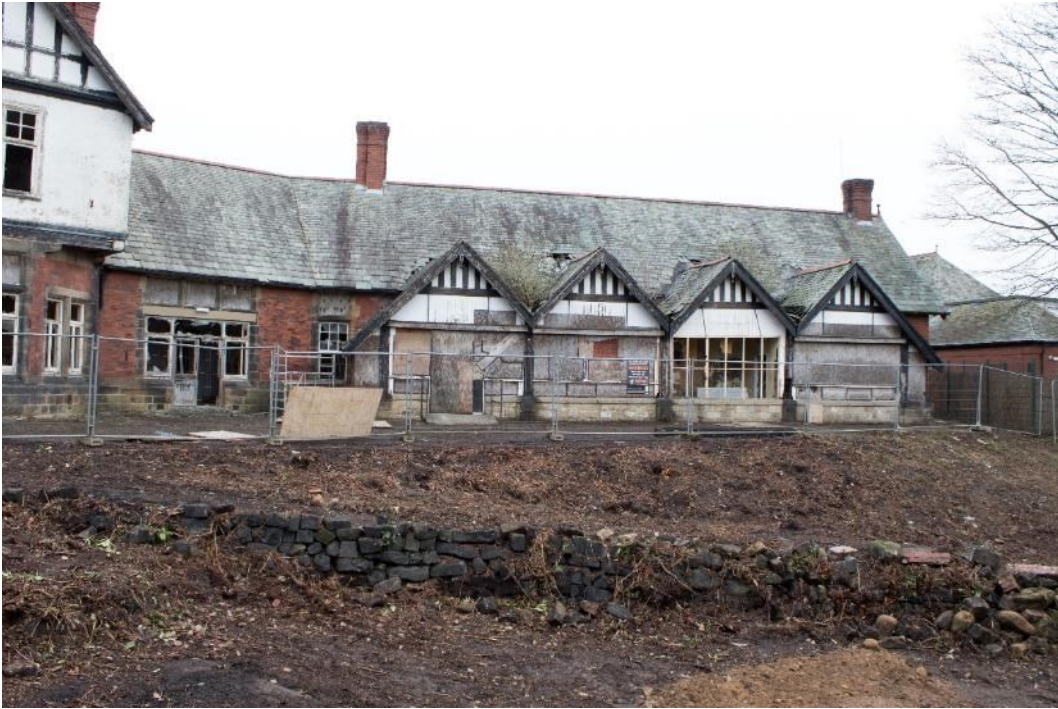
Photo 5: East wing, south elevation (1796\_005.TIF)

The side wings are largely a mirror image of each other and are constructed of brick in the same style as the central block (Photos 5-6). Both wings contain a bay at the same angle as the main block before canting southwards (Photos 19 & 35). The first bay of the west wing contains three sash windows with top-lights, whilst the matching bay of the east wing has been altered to make a double doorway with casements to the side. The canted wings start with a single sash window with top-light close to the main range. The remainder of the elevations are occupied by timber-framed verandas, each with four bays and corresponding gables. The gabled bays comprise posts supporting arch-braced collars, although the collars have been removed from the east wing. The verandas would have originally been open, however, they have since been infilled with timber windows and cladding to the gables. The verandas have also been fitted with rolling awnings, although their placement appears to be a later addition as they obscure the moulded bases of the arch braces (Photos 13 & 14).

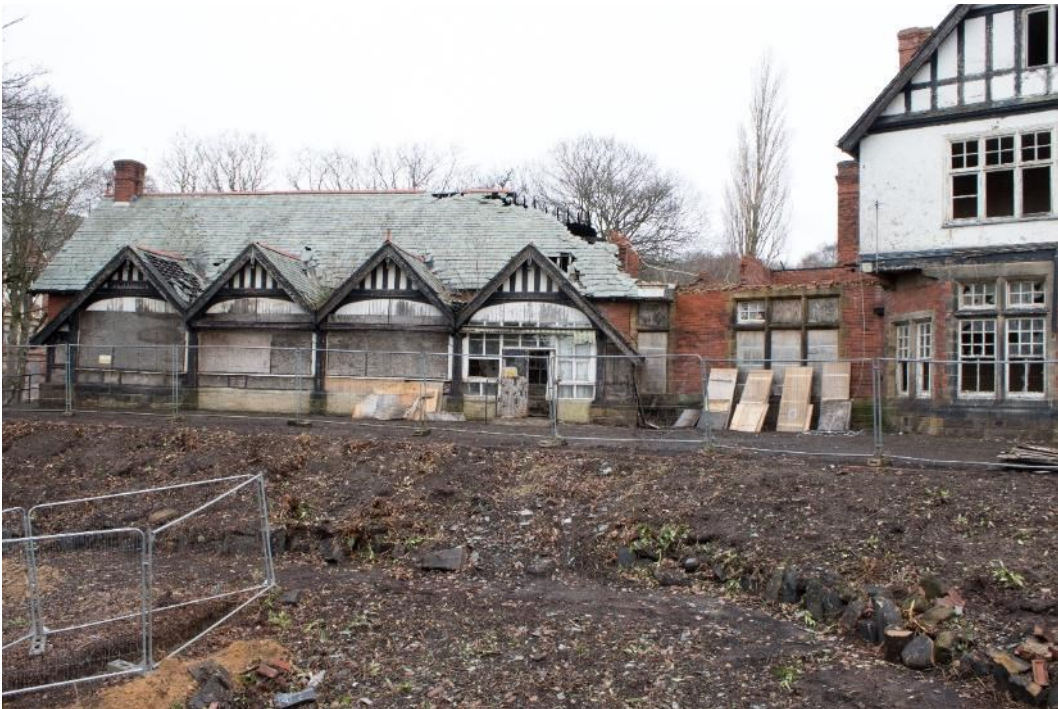
Photo 6: West wing, south elevation (1796\_006.TIF)

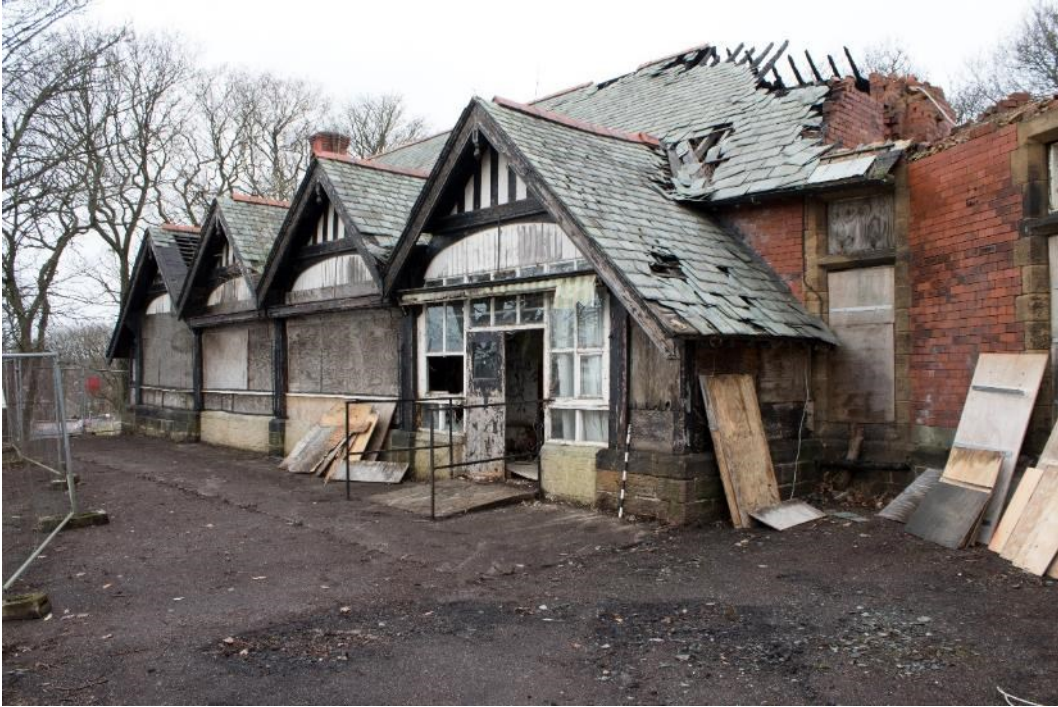
Photo 7: West veranda, facing west (1796\_007.TIF)

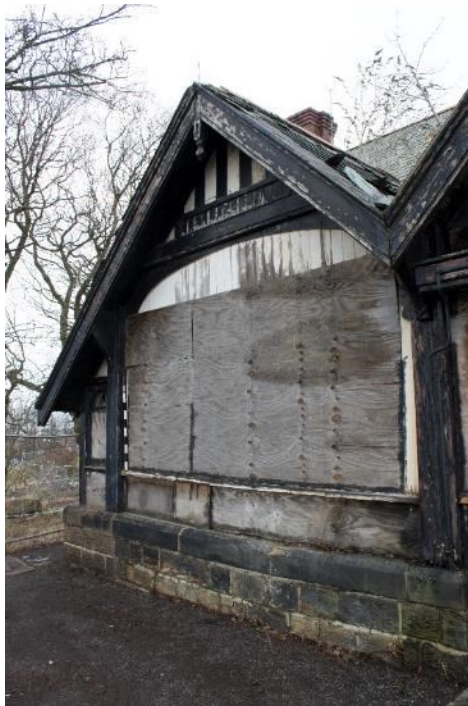
Photo 8: West veranda, facing west (1796\_008.TIF)

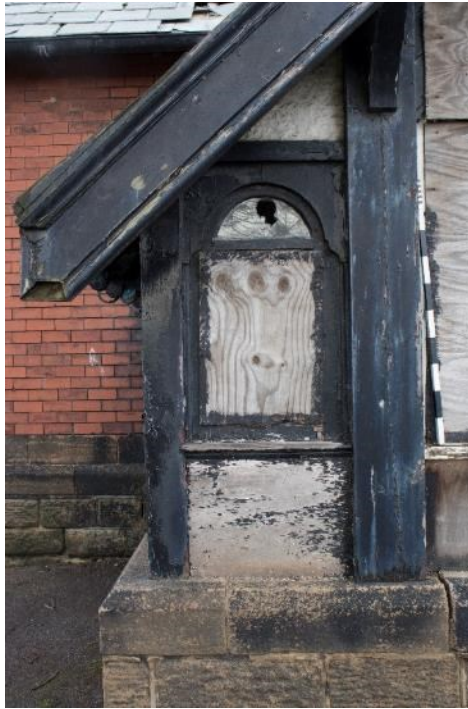
Photo 9: Detail of west veranda, facing north (1796\_009.TIF)

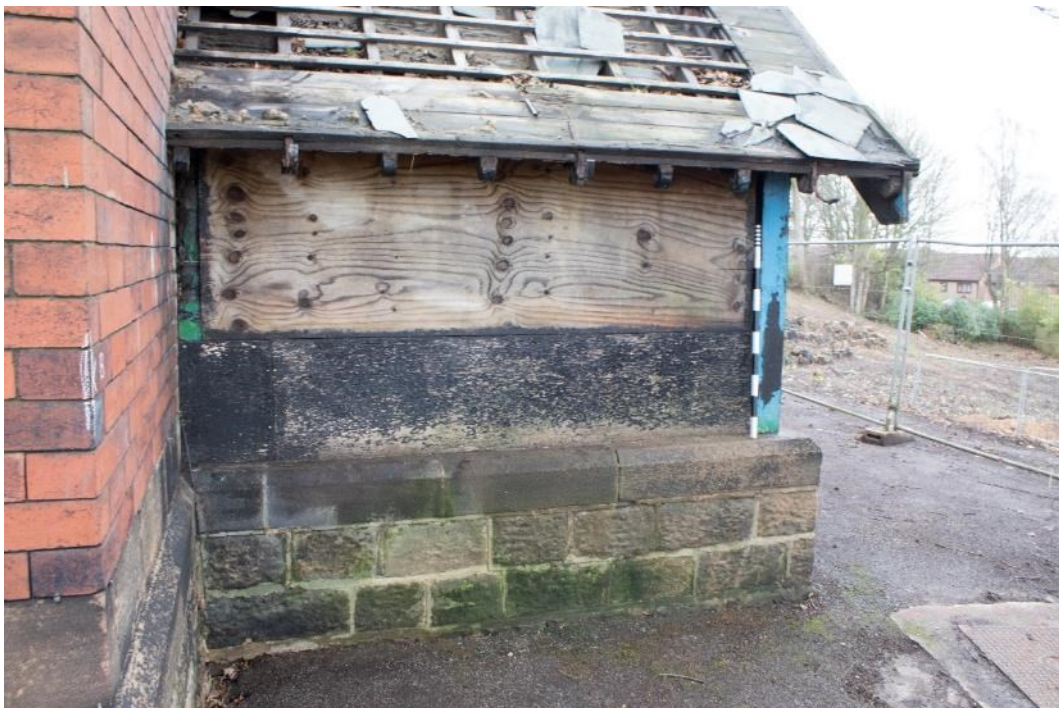
Photo 10: Side elevation of west veranda, facing east (1796\_010.TIF)

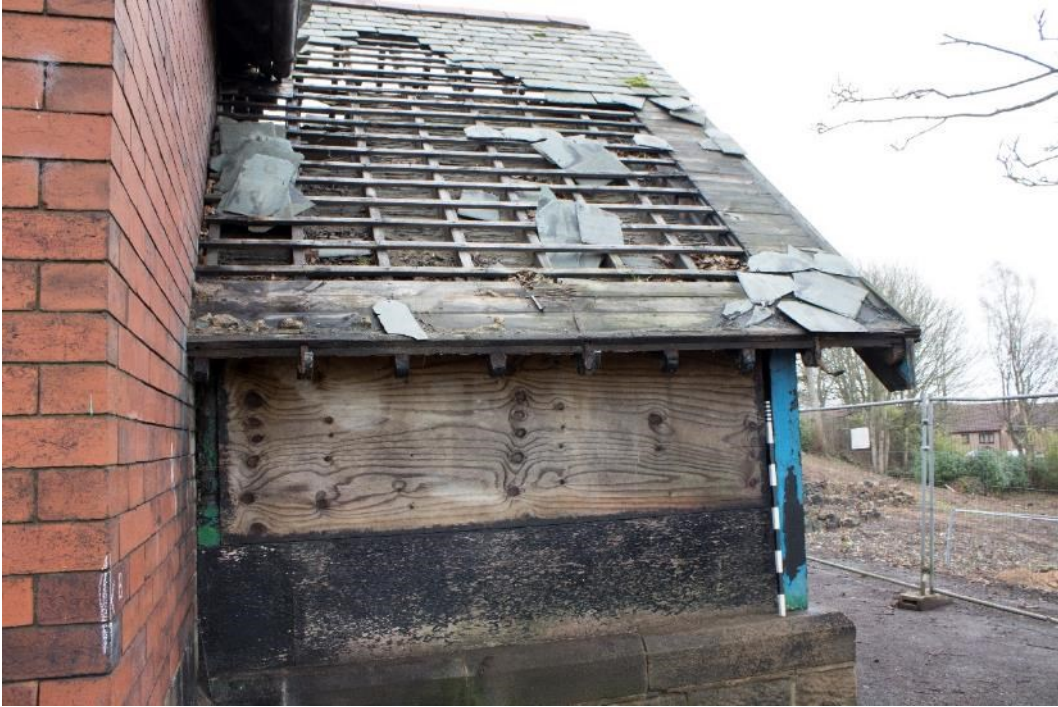
Photo 11: Side elevation of west veranda, facing east (1796\_011.TIF)

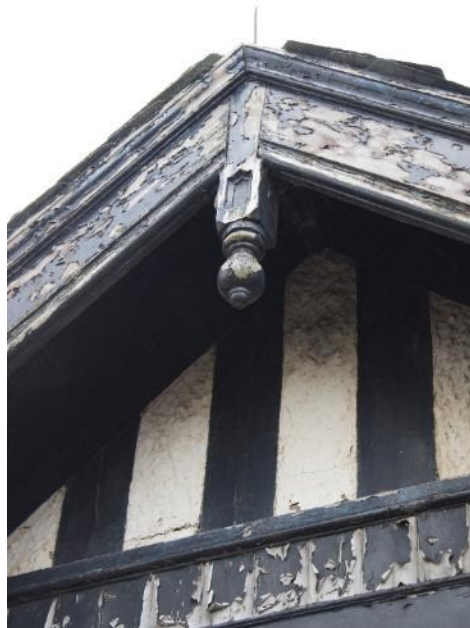
Photo 12: Gable of west veranda (1796\_012.TIF)

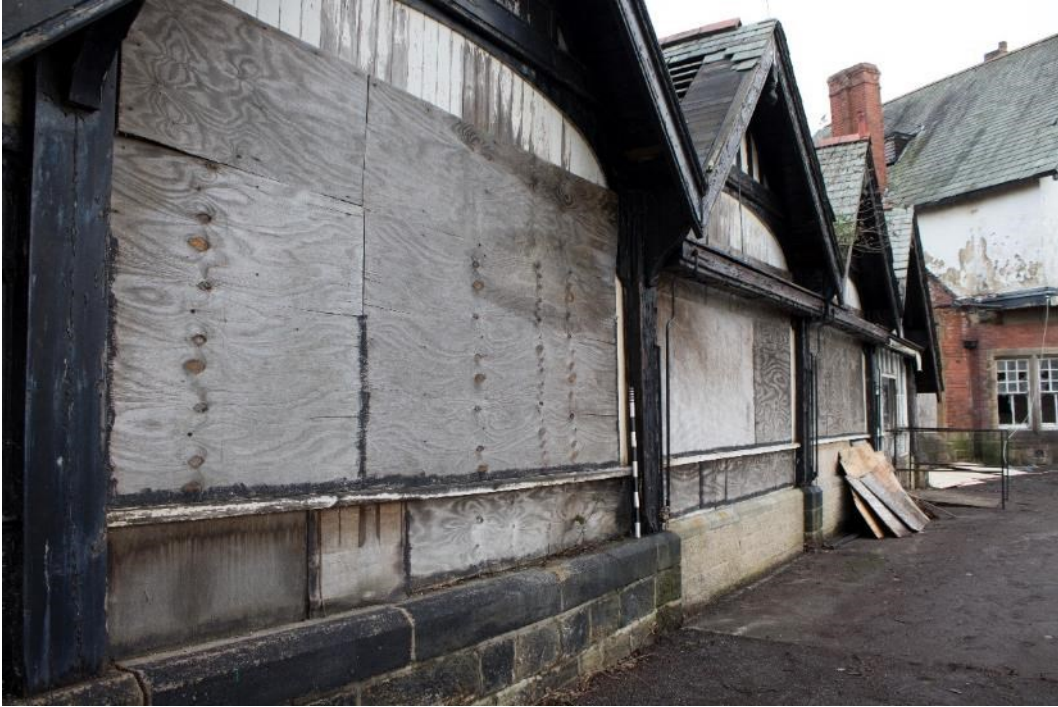
Photo 13: West veranda, facing north-east (1796\_013.TIF)

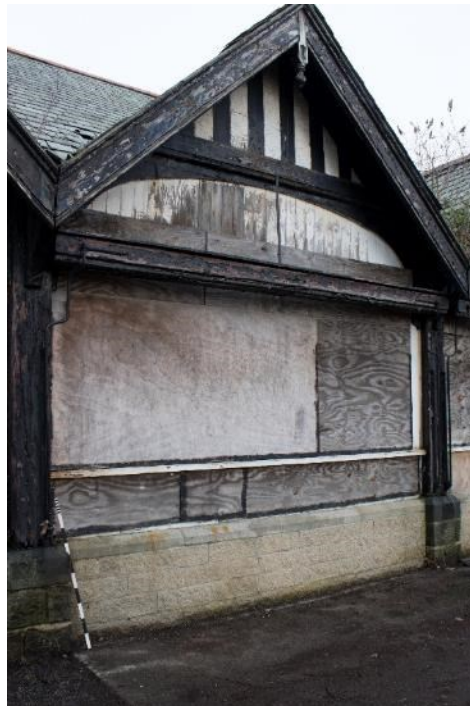
Photo 14: Bay of west veranda, facing north (1796\_014.TIF)

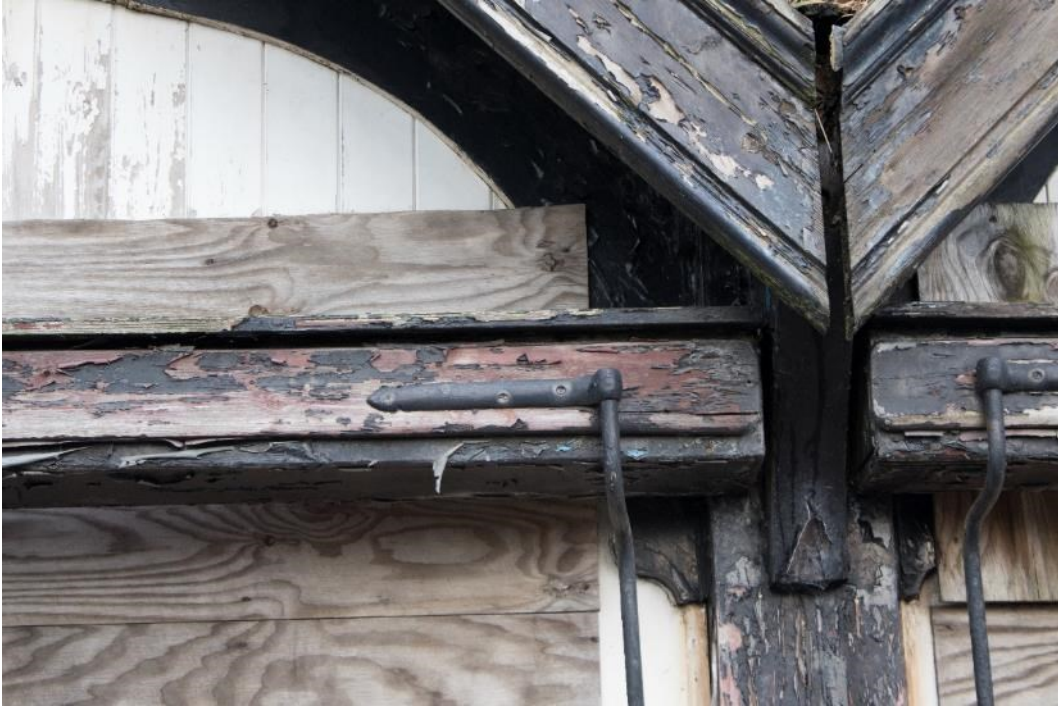
Photo 15: West veranda, awning obscuring arch brace, facing north (1796\_015.TIF)

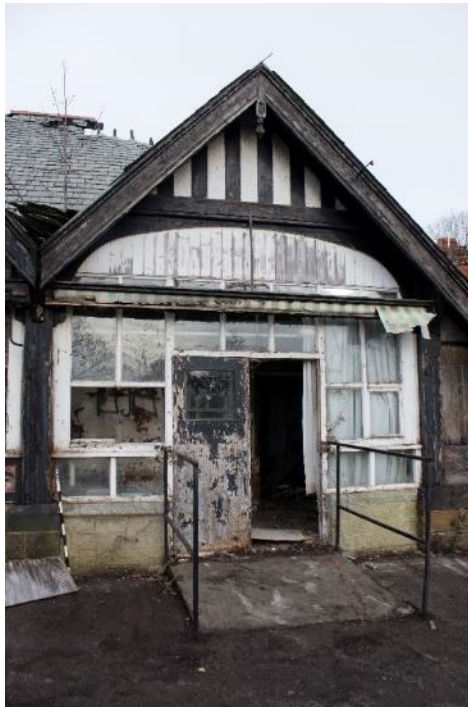
Photo 16: West veranda bay with doorway, facing north (1796\_016.TIF)

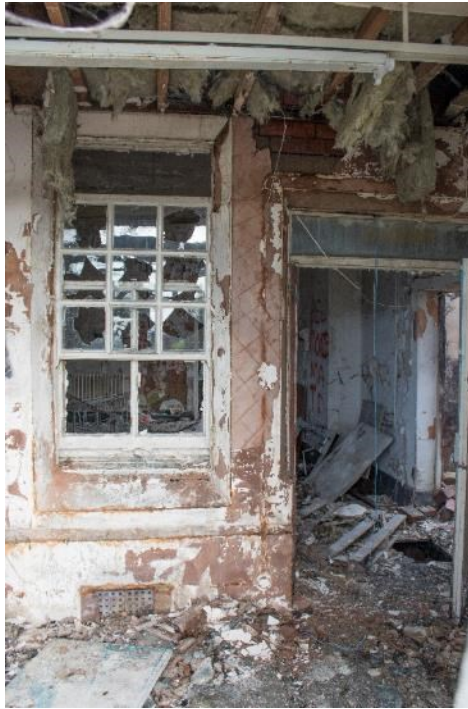
Photo 17: Interior of west veranda, facing north (1796\_017.TIF)

The verandas (59/39) were formerly open structures but the vagaries of the English climate and the need for space saw the insertion of glazing to the bays. The verandas were probably converted in the 1960s or 70s and feature modern softwood windows and a low ceiling, effectively extending the ward space (Photo 17).

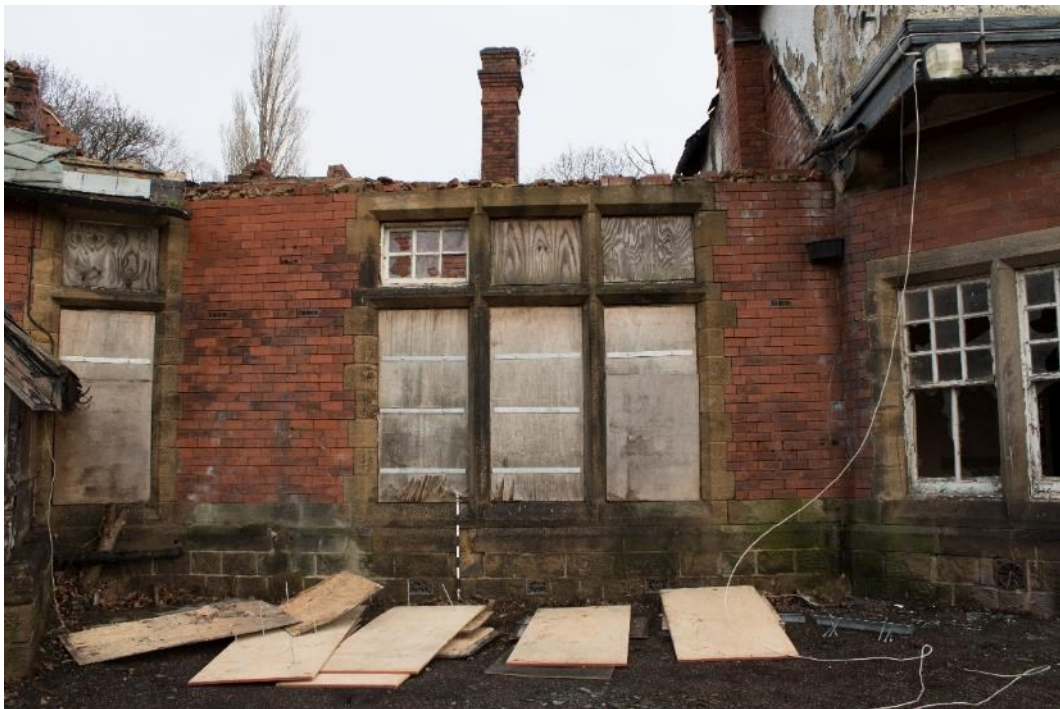
Photo 18: Exterior of room 55, central block, facing north-east (1796\_018.TIF)

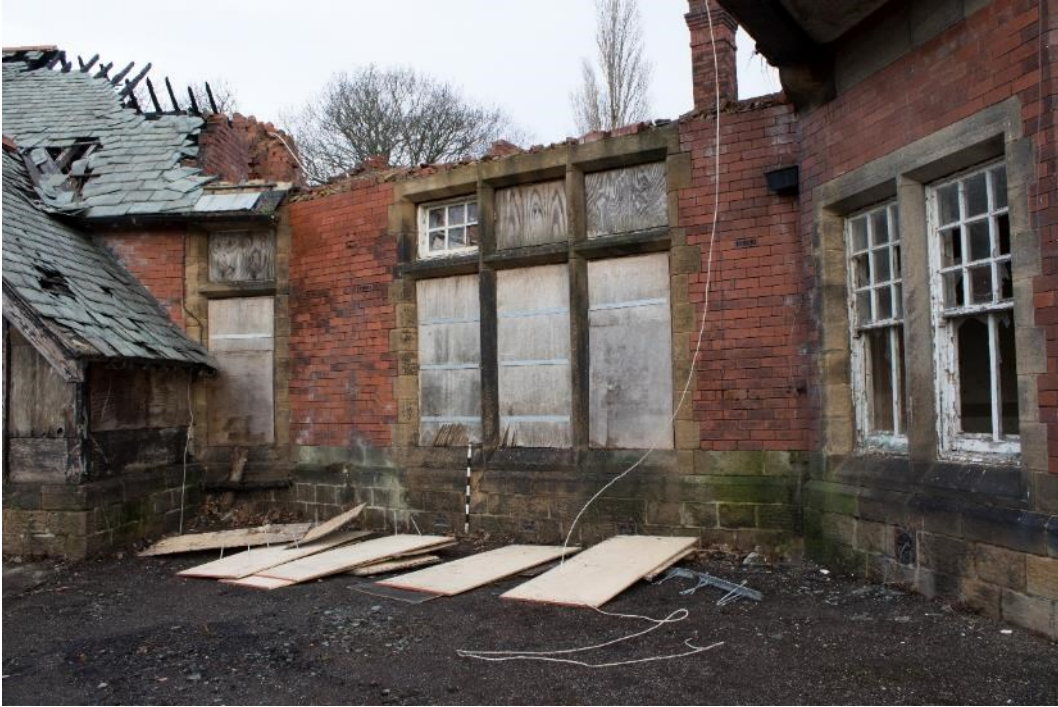
Photo 19: Exterior of room 55, central block, facing north (1796\_019.TIF)

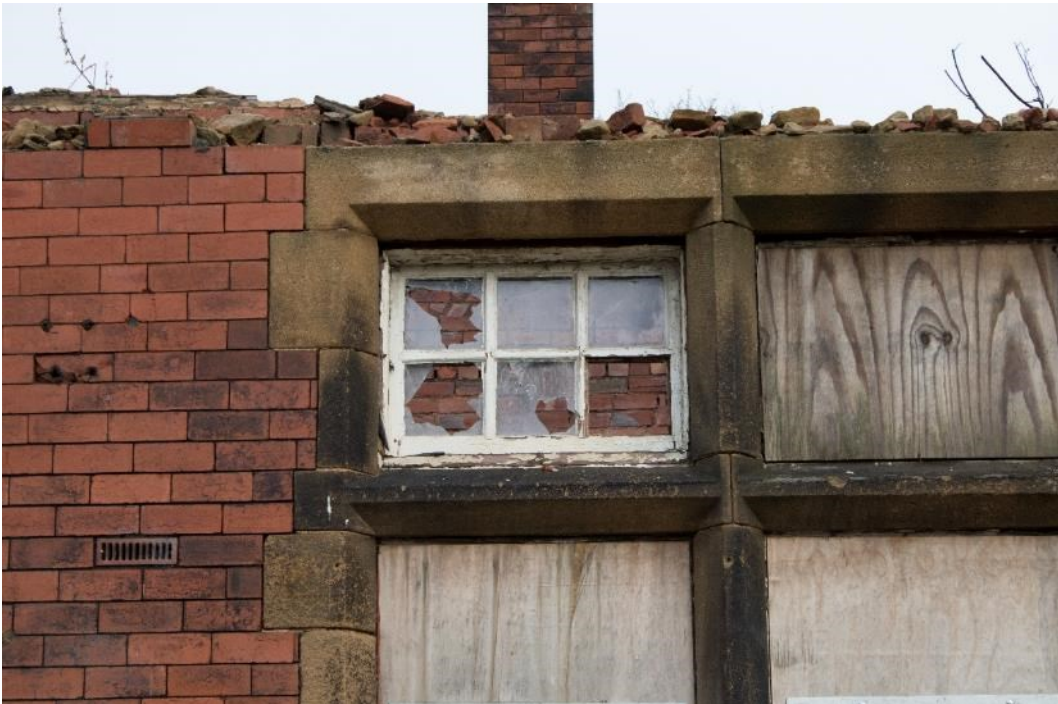
Photo 20: Detail of top-light, facing north-east (1796\_020.TIF)

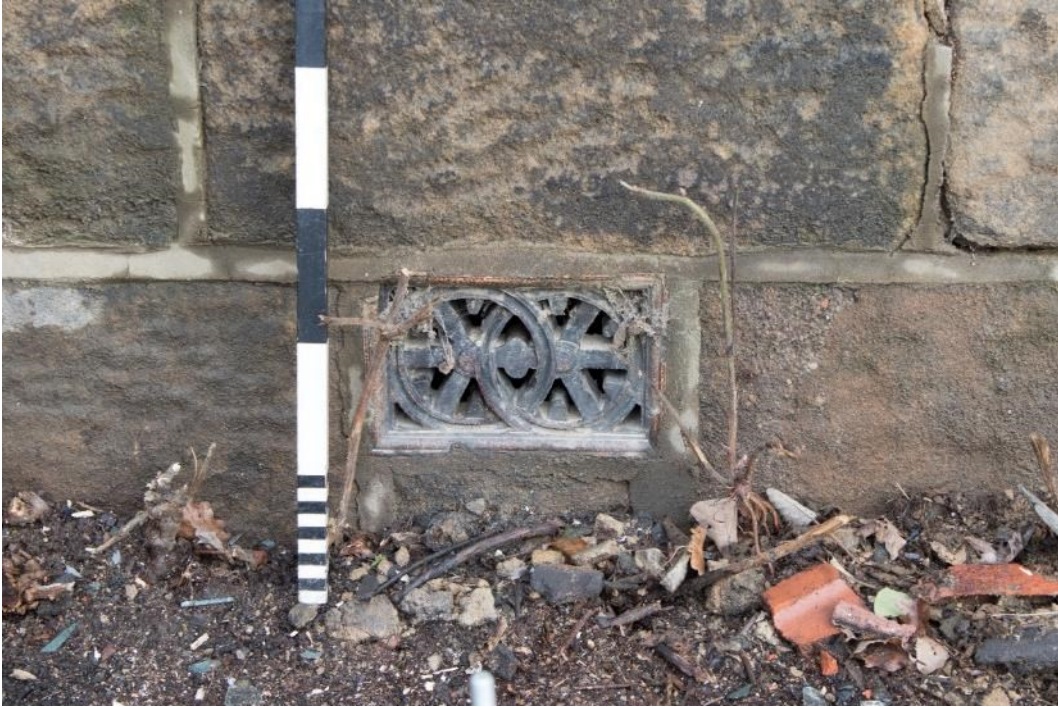
Photo 21: Detail of ventilation grill, facing north-east (1796\_021.TIF)

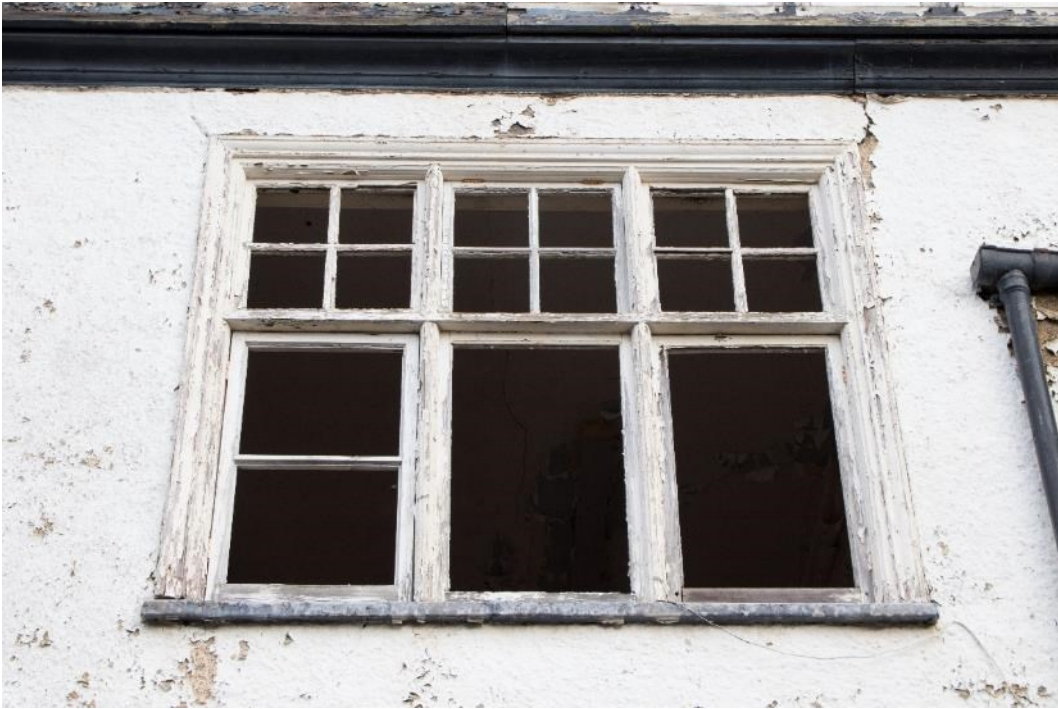
Photo 23: Window to first floor south-west room (45), facing north-east (1796\_023.TIF)

The first floor is lit by three timber casement windows. The two to either side have three large lights and three top-lights whilst the middle five-light window forms a canted oriel and has its own tiled roof (Photos 23 & 28).

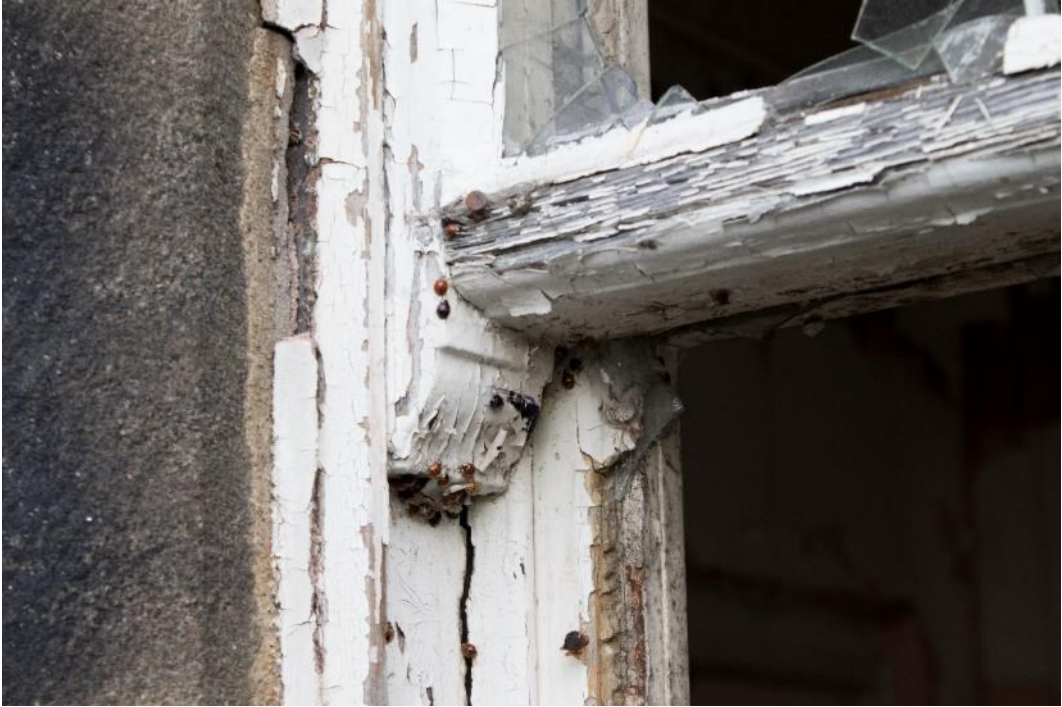
Photo 25: Sash window horn, facing north-east (1796\_025.TIF)

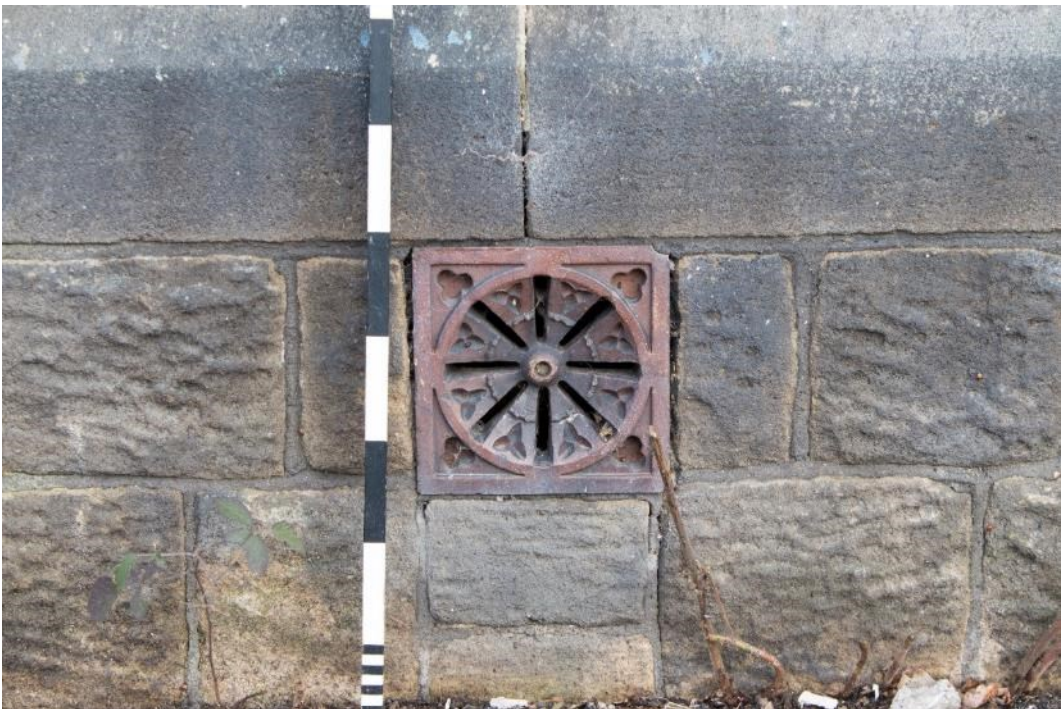
Photo 26: Ventilation grill, facing north-east (1796\_026.TIF)

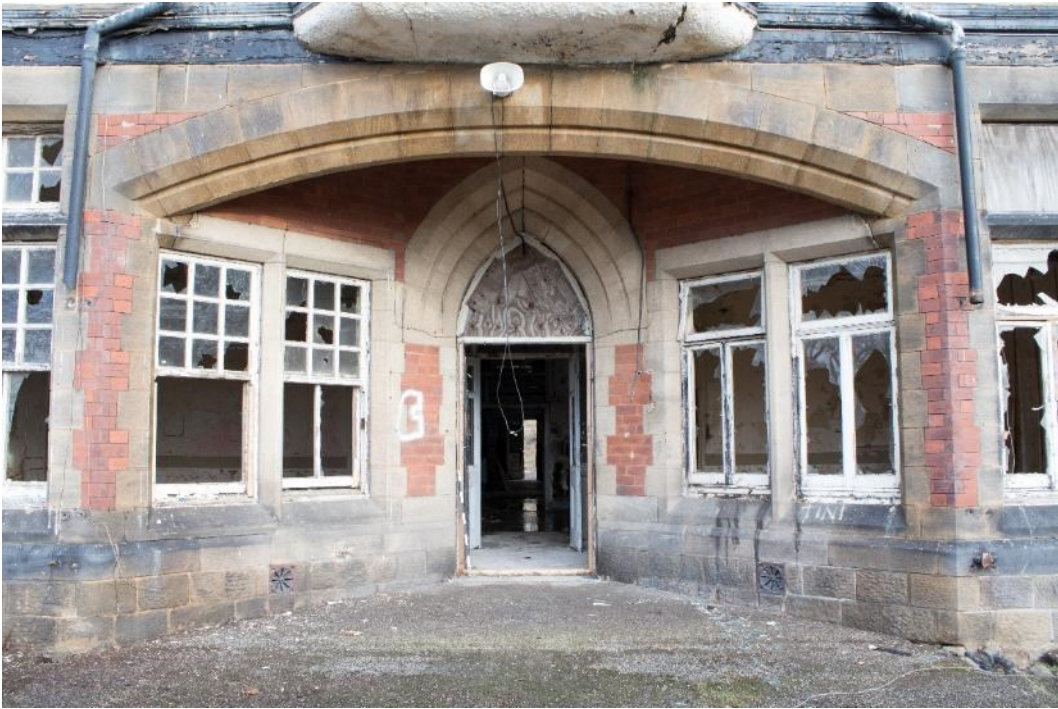
Photo 27: Entrance to central block, facing north east (1796\_027.TIF)

The ground floor is constructed of red brick in stretcher bond, set on top of a sandstone plinth. It has a central recessed entrance over a shallow segmental arch. The doorway itself has a two-centred arched head. The original door survives in poor condition as a two-leaf panelled door, with three panels per door (Photo 239). The top two panels appear to have been glazed, although no glass survives. Either side of the door are two pairs of windows in stone surrounds. Either side of the entrance there are two large canted bays with paired windows with stone surrounds (Photo 22). The windows to the west are typical of the building, consisting of double-hung timber sash windows with 9 over two panes and thick glazing bars. The east windows are timber casements and presumably a replacement (Photo 30).

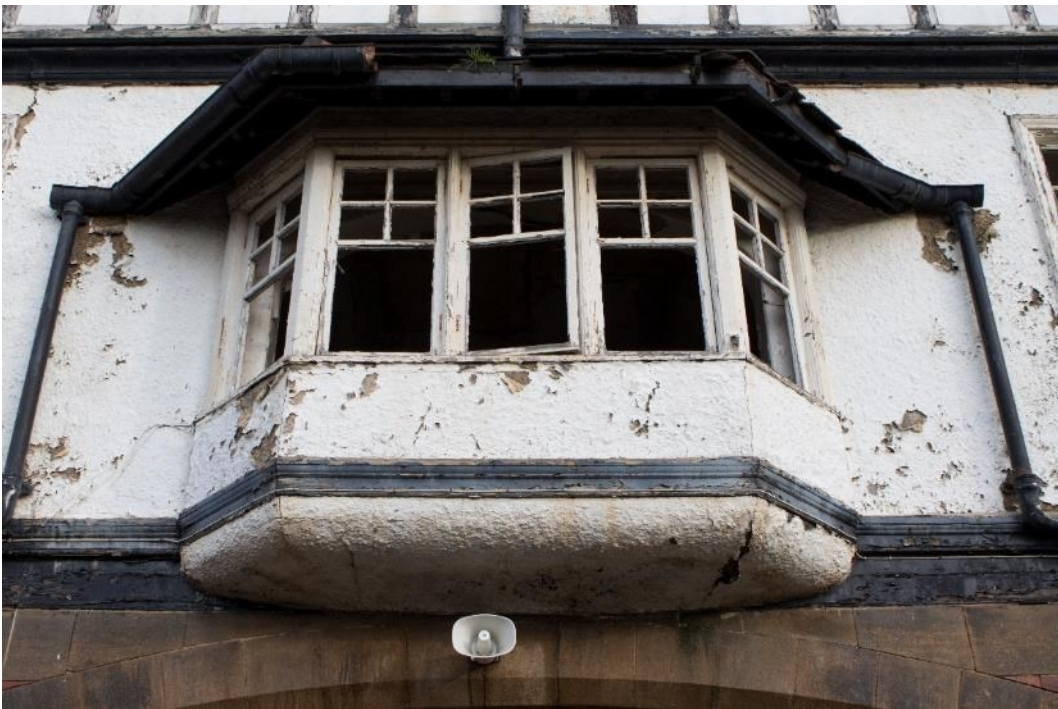
Photo 28: Oriel window to first floor central block, facing north-east (1796\_028.TIF)

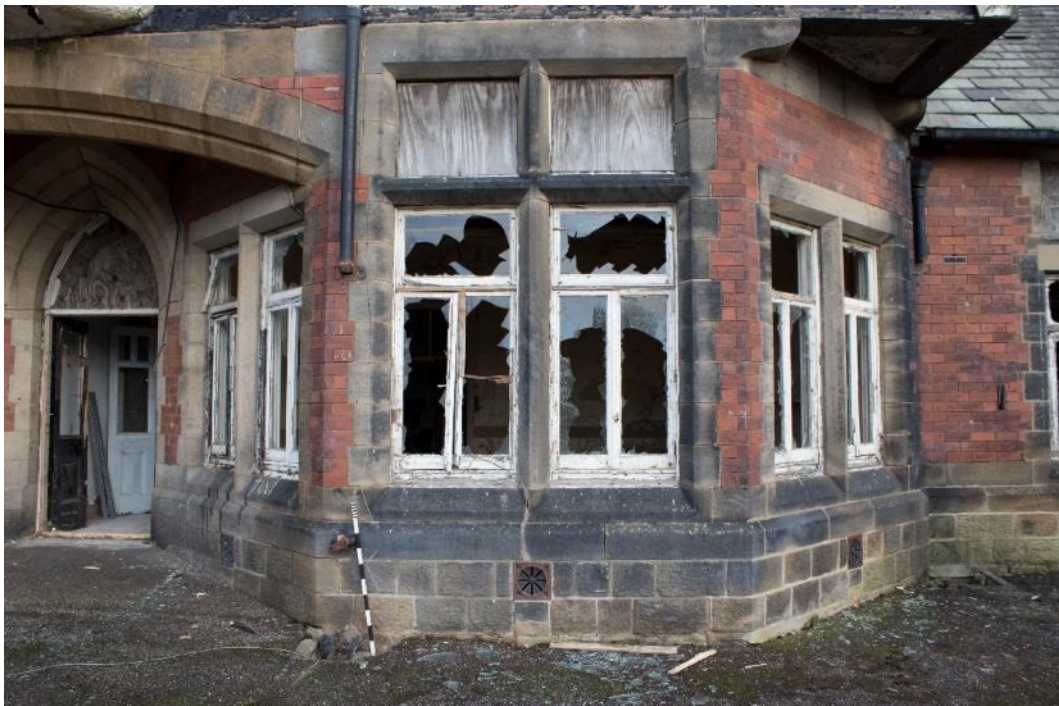
Photo 30: Exterior of east dayroom (16), facing north-east (1796\_030.TIF)

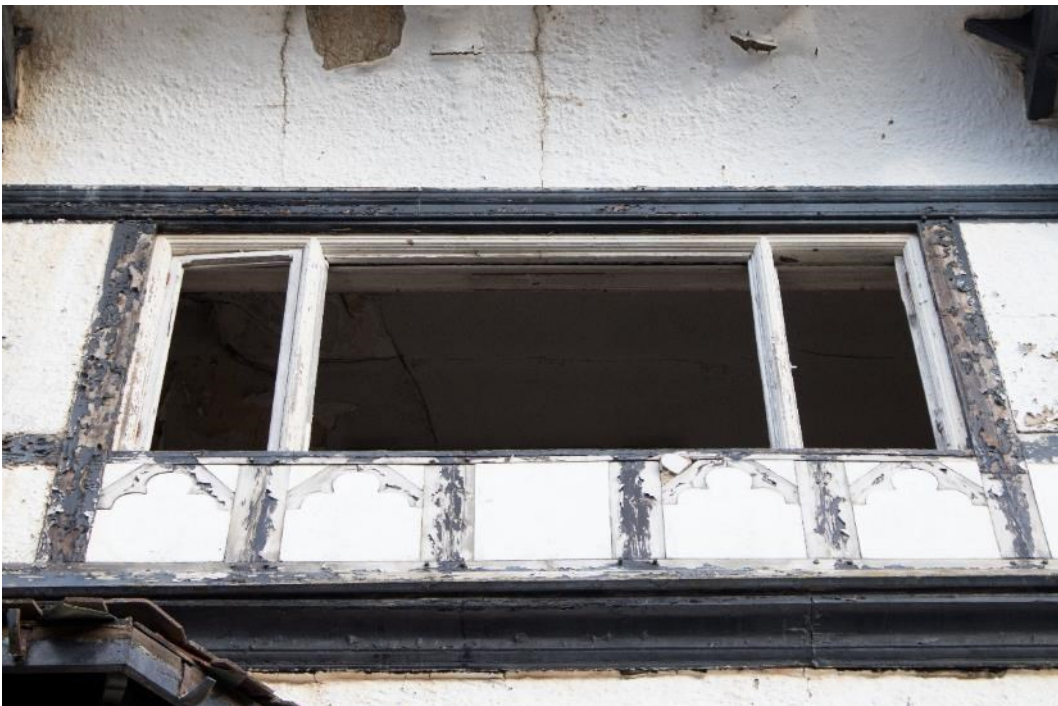
Photo 32: Window to second floor, facing north-east (1796\_032.TIF)

The second floor sits within the gables of the M-shaped roof. It is decorated with fake small-panel framing and cusped braces below the windows forming trefoil heads. The two windows comprise five-light timber casements, although the east window is lacking much of its framing (Photo 32).

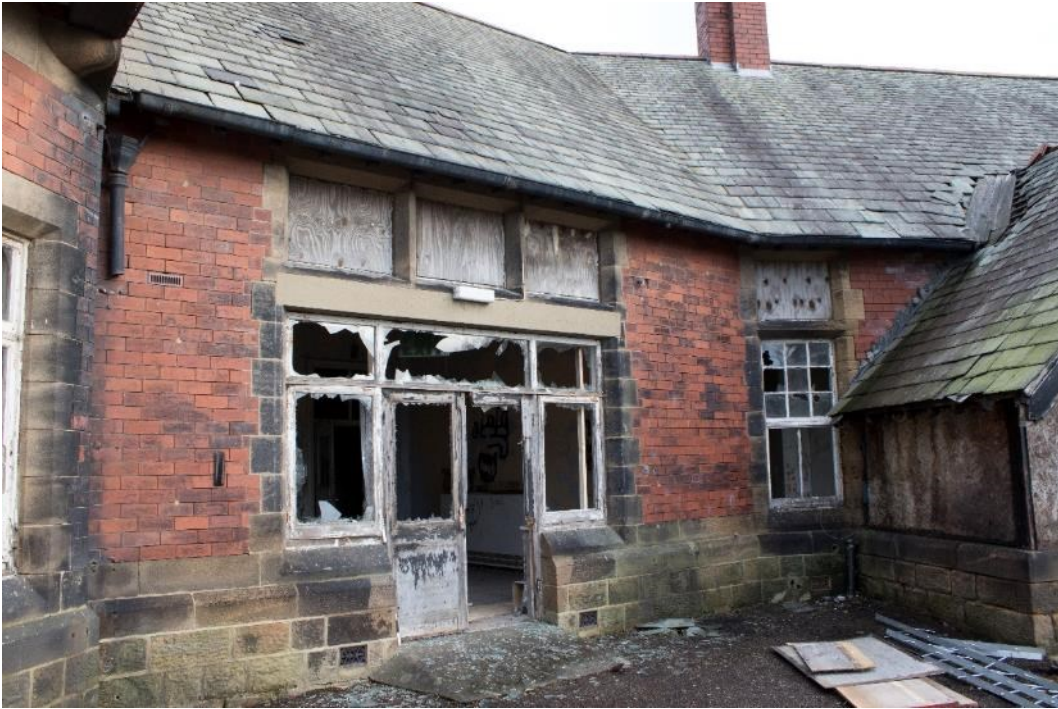
Photo 35: Exterior of room 38, facing east (1796\_035.TIF)

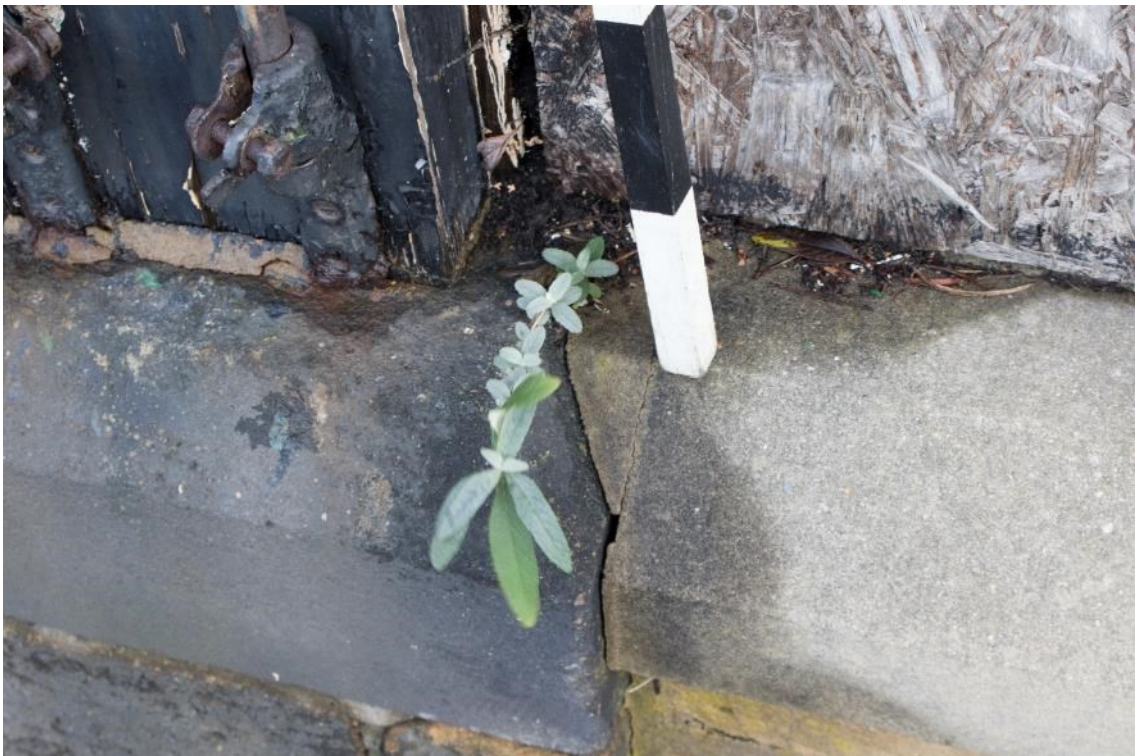
Photo 40: Detail of join on veranda plinth stonework, facing north-east (1796\_040.TIF)

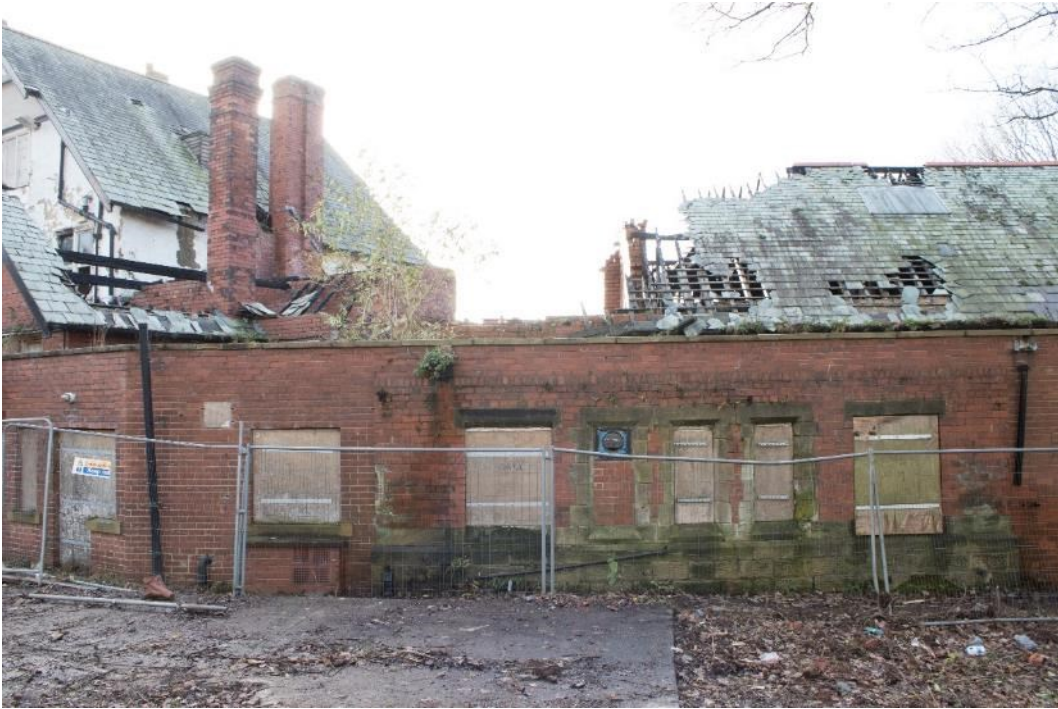
Photo 55: North elevation of west wing wash block (1796\_055.TIF)

have also been extended with flat-roofed, sing-storey toilet blocks (Photo 107). These are built in red brick in stretcher bond and feature steel casement windows. The blocks were probably added in the 1960s, replacing existing, smaller blocks with are shown on the original plans. The west block incorporates a section of the original block in its north elevation, including stone window surrounds and a stone plinth (Photo 55). Both wings join the central block with a small gabled range (Photo 57).
