The Ida Wing, Cookridge Hospital  
Historic Building Recording  
ArcHeritage 2019

The Former Ida Wing, Cookridge Hospital, Leeds  
Historic Building Recording

Project Name	The Former Ida Wing, Cookridge Hospital, Leeds
ArcHeritage Project no.	1796
Report status	Final
Type of Project	Photographic Building Recording
Client	Esh Construction
OASIS ID	archerit1-348378
Planning Application ref.	14/02558/LI
NGR	SE 25483 38884
Authors	Christopher Curtis
Illustrations	Christopher Curtis
Editor	Glyn Davies
Report Number and Date	2019/20 05/04/2019
Version and Filename	Version 2: 1796 Ida Wing Cookridge V2.pdf

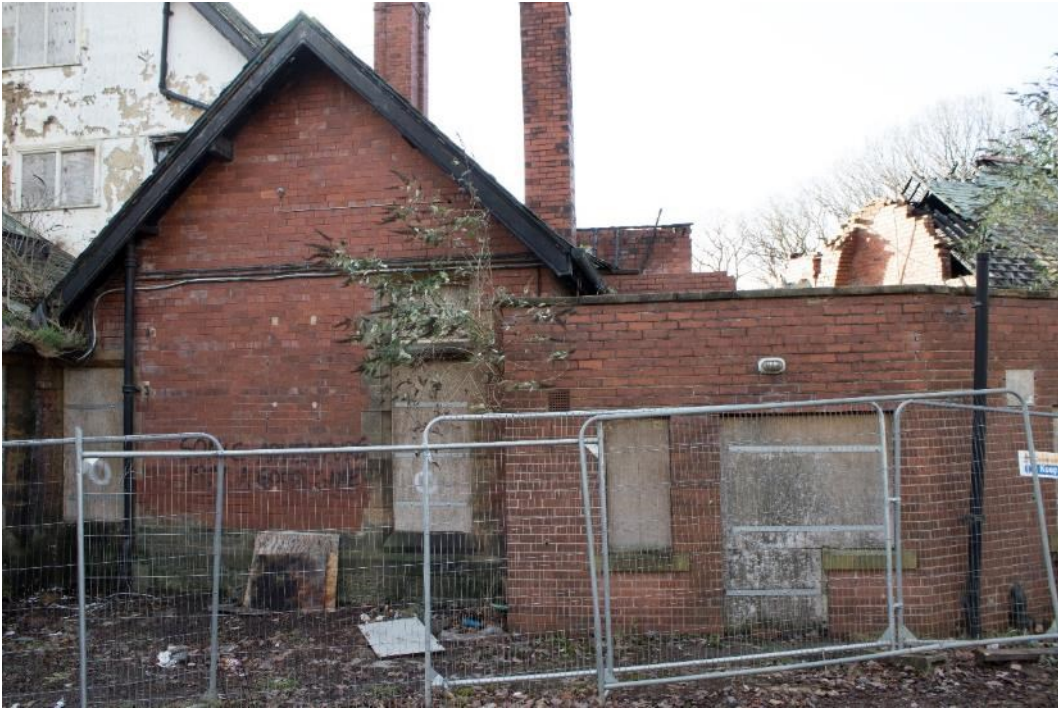
Photo 57: North elevation of west wing and wash block, facing south-west (1796\_057.TIF)

have also been extended with flat-roofed, sing-storey toilet blocks (Photo 107). These are built in red brick in stretcher bond and feature steel casement windows. The blocks were probably added in the 1960s, replacing existing, smaller blocks with are shown on the original plans. The west block incorporates a section of the original block in its north elevation, including stone window surrounds and a stone plinth (Photo 55). Both wings join the central block with a small gabled range (Photo 57).

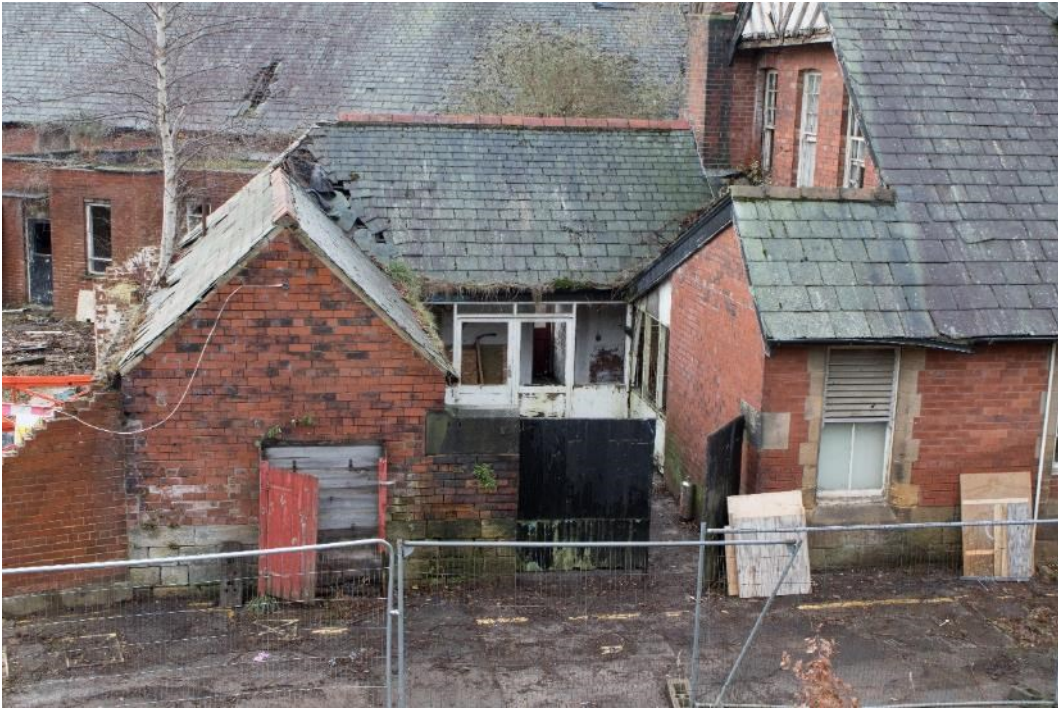
Photo 64: Service range, facing west (1796\_064.TIF)

The kitchen range, attached to the north-east of the rear block, consists of perpendicular gabled ranges and an enclosed yard to the west (Photos 64 & 65). The gabled north elevation of the kitchen contains three sash windows with top-lights. The elevation continues eastwards with two further windows before giving way to a gateway to the kitchen yard. The kitchen block also has an east facing elevation at first floor height overlooking the yard, consisting of three sash windows below a mock-timber gable in the same style as the central block of the hospital.

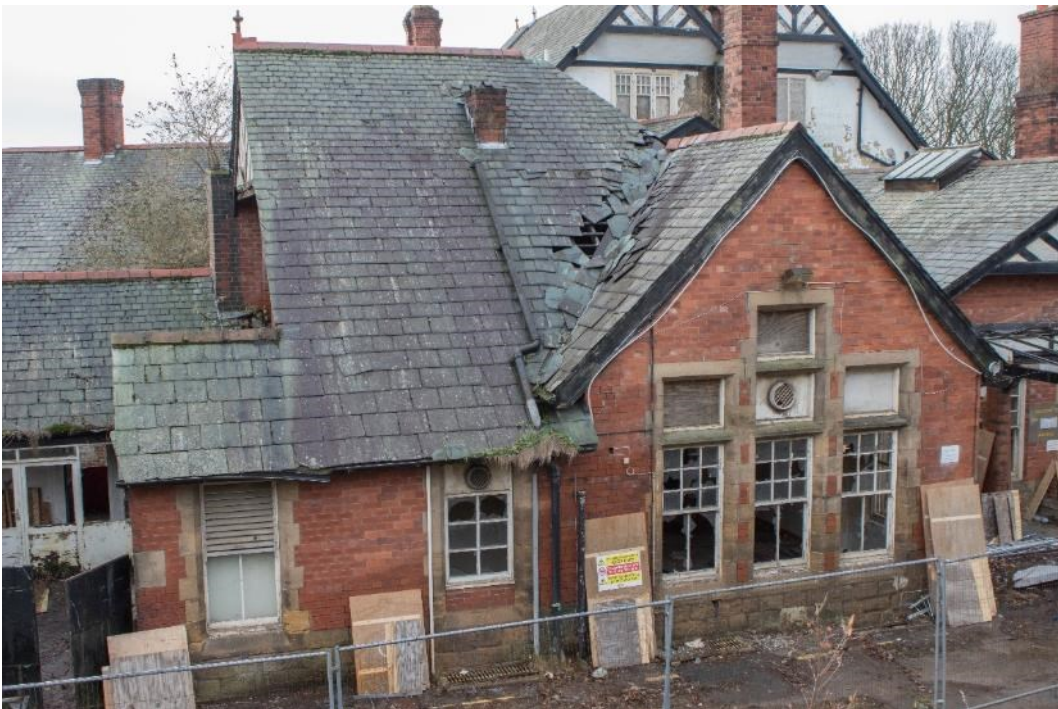
Photo 65: Kitchen courtyard, facing south-west (1796\_065.TIF)

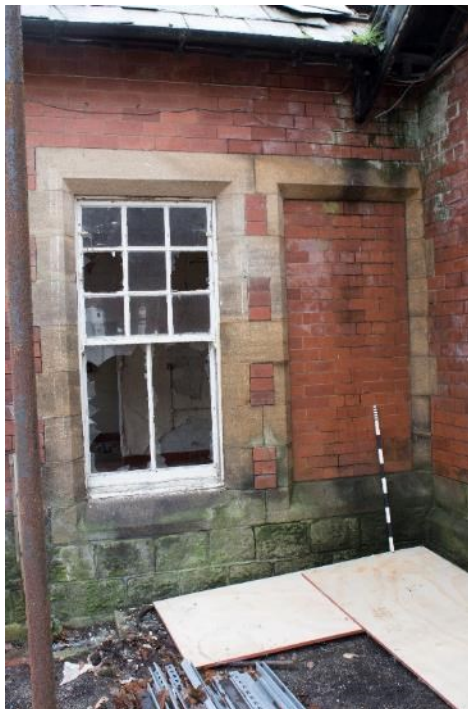
Photo 73: Glazed stub-wall to north of north block, facing south-east (1796\_073.TIF)

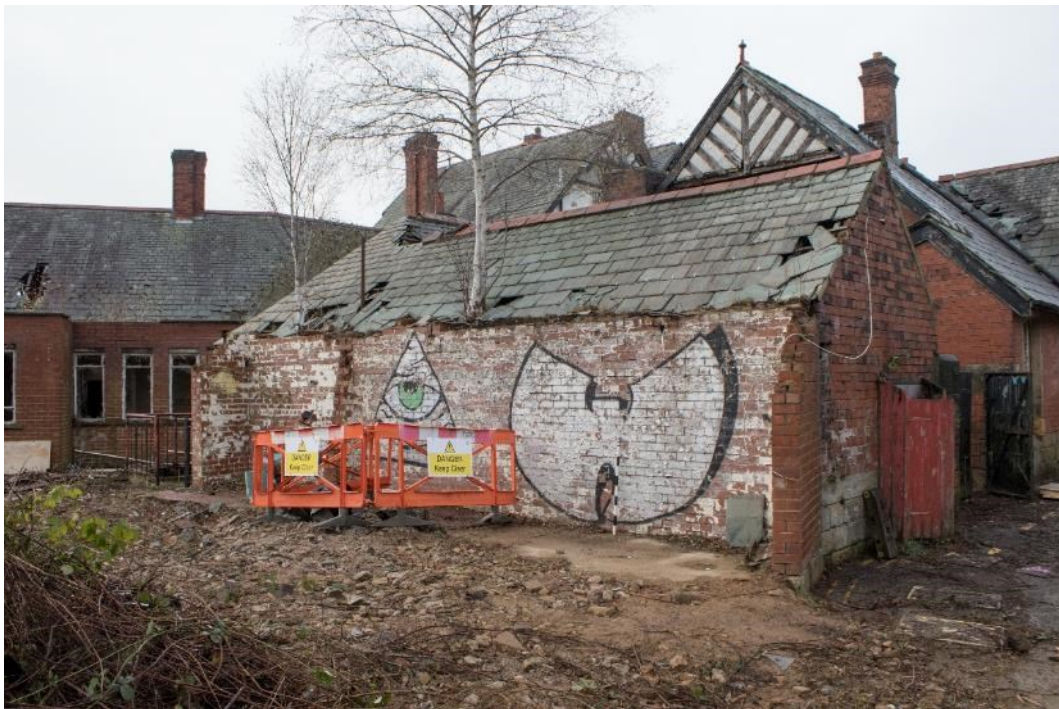
Photo 83: Partially demolished extension to east of service range, facing south-west (1796\_083.TIF)

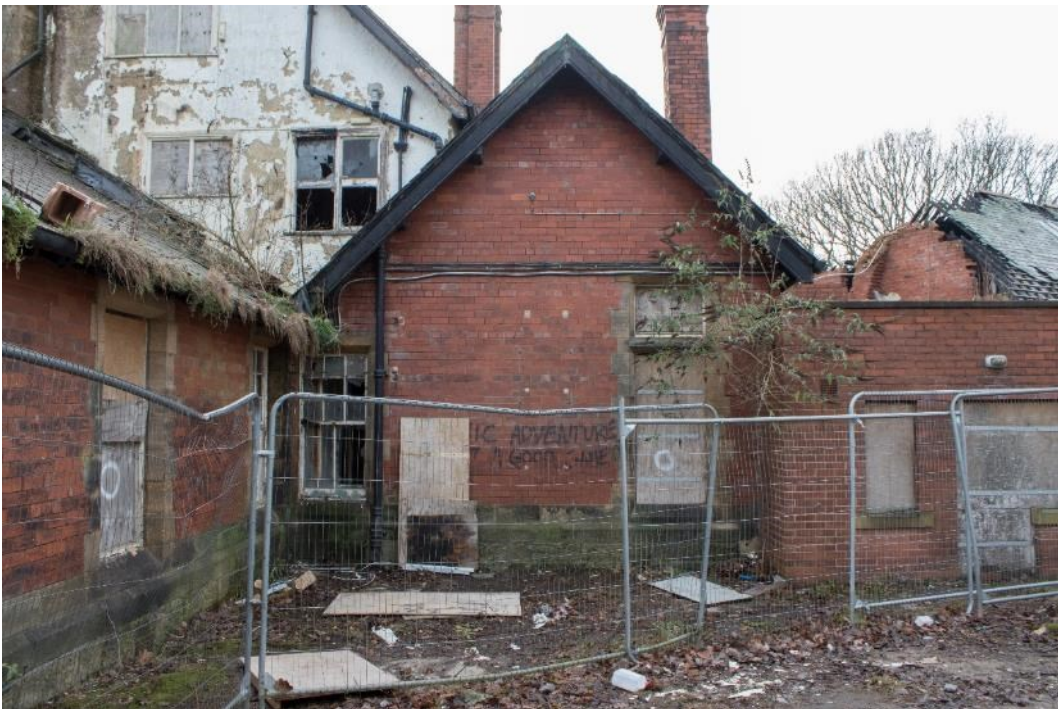
Photo 95: West elevation of north block and north elevation of central block, facing south (1796\_095.TIF)

The upper storeys of the central block present an elevation to the north similar to that of the south, consisting of an M shaped pair of gables projecting over a roughcast façade. The fenestration is irregular but consists of timber casements (Photo 95).

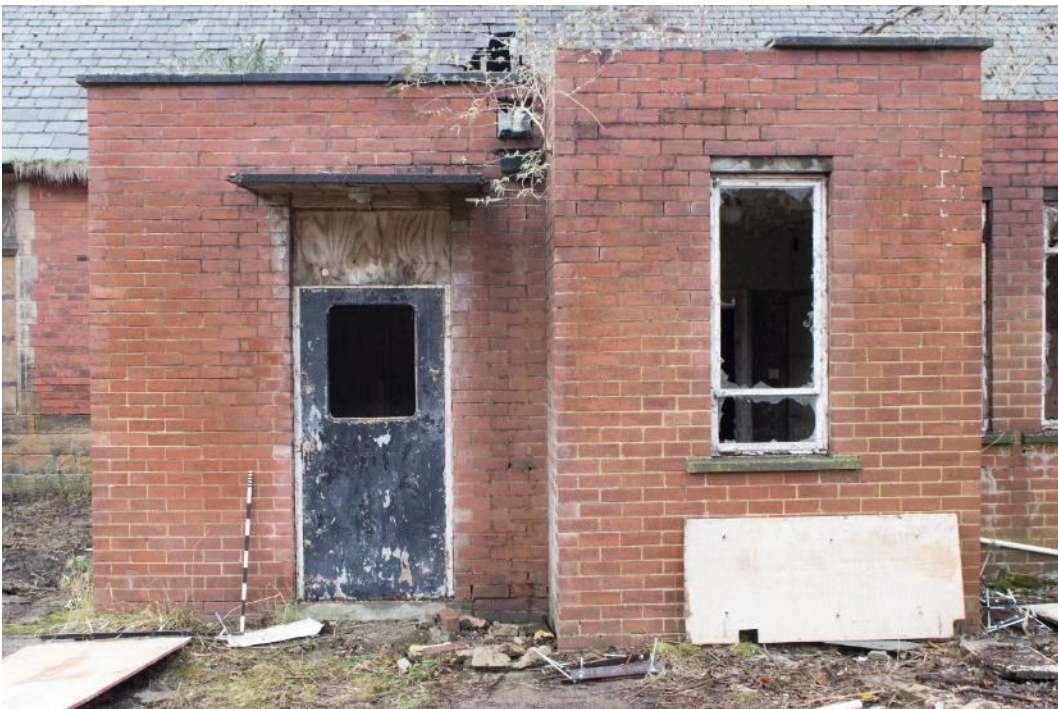
Photo 107: East wing wash block, north elevation (1796\_107.TIF)

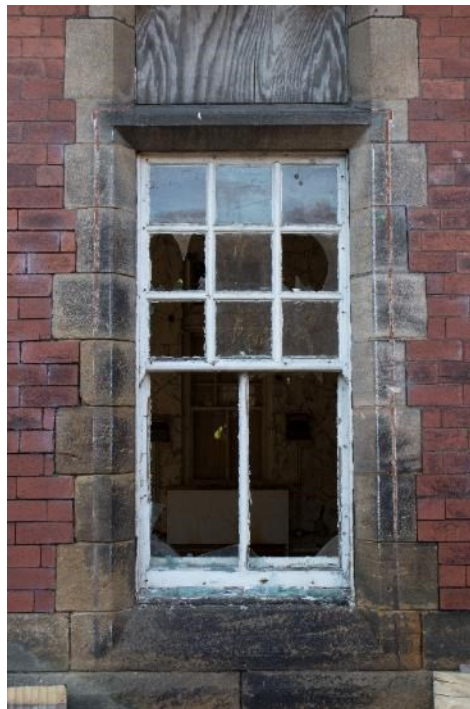
Photo 113: North elevaton of east wing (1796\_113.TIF)

The rear elevations of the wings are broadly similar, consisting of red brick walls on a stone plinth punctuated by sash windows with over-lights (Photo 113). The rear side of the wings

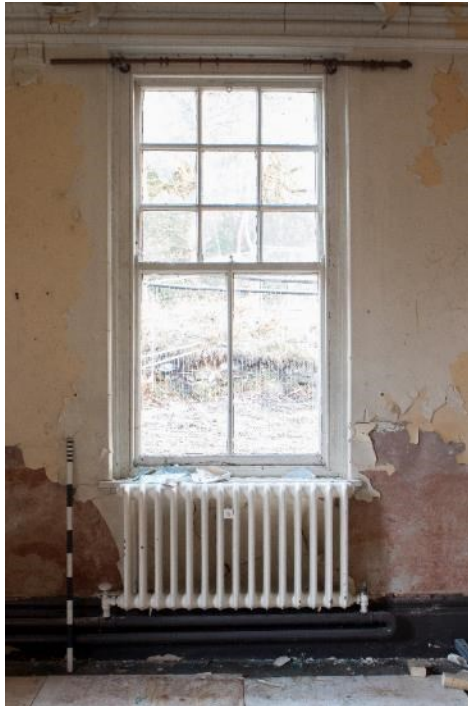
Photo 116: Interior of room 2, facing south (1796\_116.TIF)

The west side of the block contains three rooms, all accessed from the main corridor. The north room (2) is domestic in appearance, featuring a deeply coved cornice and high skirting board (Photo 116). The room is lit with sash windows, has a carpeted floor and a blocked chimneybreast to the south. The historic plan labels the room as the nurses' sitting room.

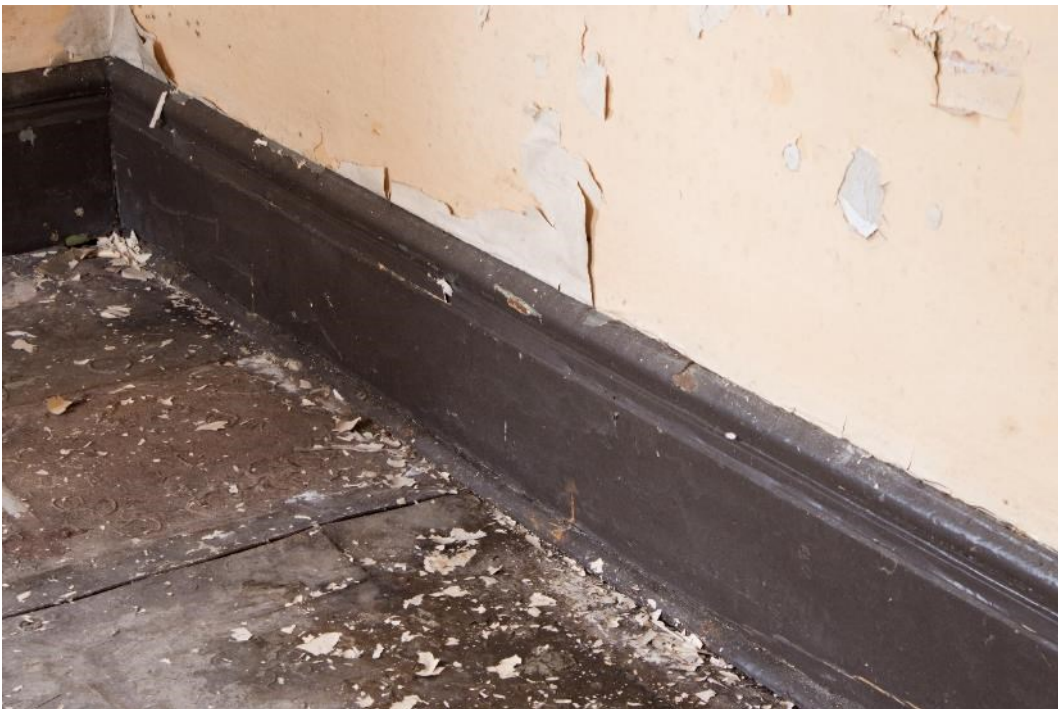
Photo 119: Room 2 cornice, facing west (1796\_119.TIF)

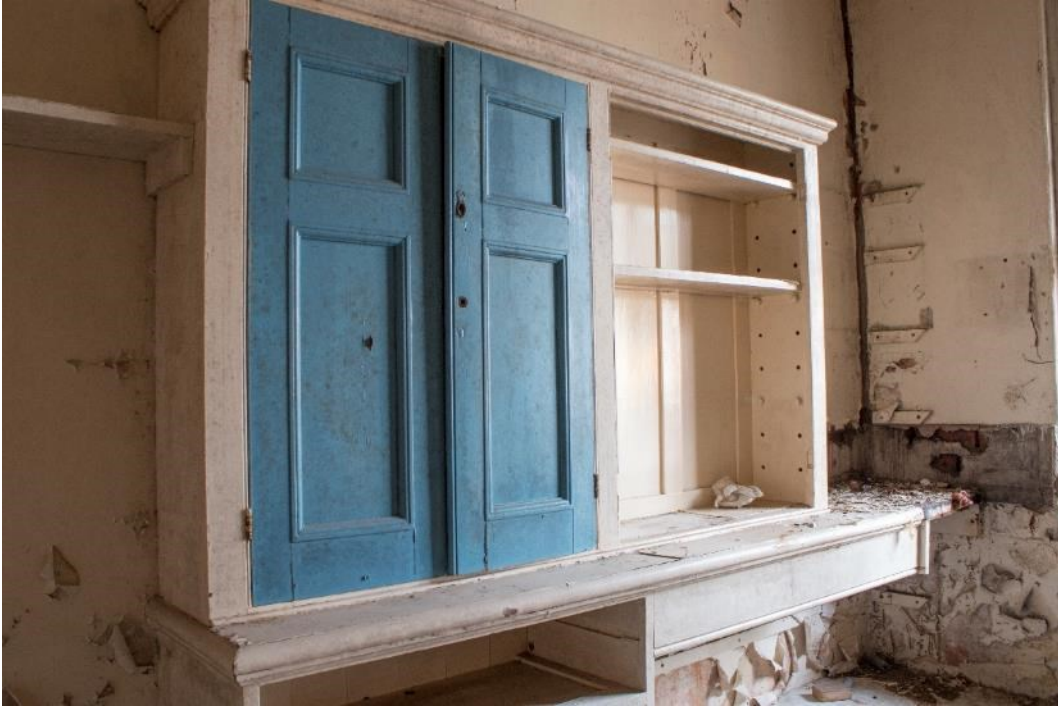
Photo 122: Room 4, facing south-east (1796\_122.TIF)

The narrow southern room (4) is labelled as a dispensary on the historic plans and appears to have most of its original fixtures intact (Photo 122). The room is lined with cupboards, shelves and workbenches built in the same style as the joinery in the rest of the hospital.

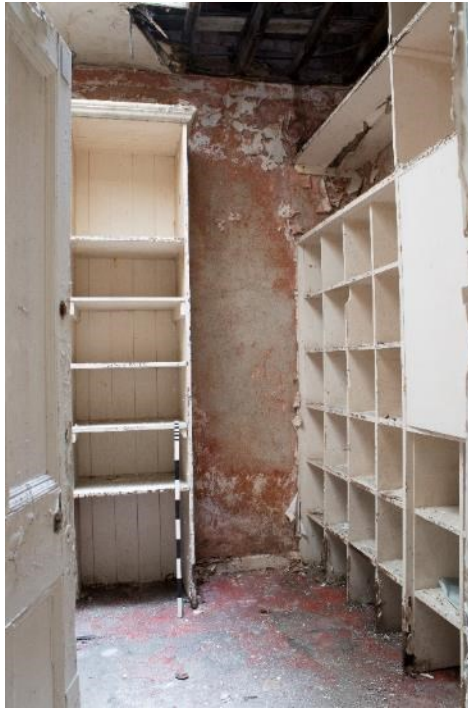
Photo 124: Room 4 cupboards and draws, facing north (1796\_124.TIF)

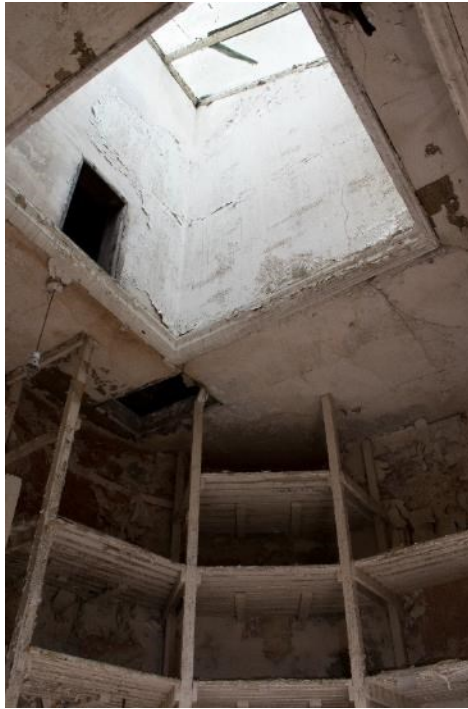
Photo 126: Room 10, facing south-west (1796\_126.TIF)

The central block also contains a set of rooms on the north side of the main east-west corridor. The outer rooms (**56/13**) are presumed to be identical, although the west room has largely been destroyed by fire. The east room (**13**) is plainly decorated and both rooms are marked as one bed wards on the historic plan. The next rooms (**11/12**) in are marked as cloakrooms on the historic plan but appear to have been altered. The eastern room (**12**) is entirely plain and has a modern suspended ceiling (Photo 203), it may have been latterly used as a treatment room. The western room has been converted to a W.C (Photo 129). Either side of the north-south corridor leading into the north block there are two small spaces. To the east the space is occupied by the stairs to the first floor and an electrical cupboard underneath it. The west space contains a storage room with a skylight (**10**). The room is marked as clothes store on the historic plan and contains what is probably a set of original shelves (Photo 126).

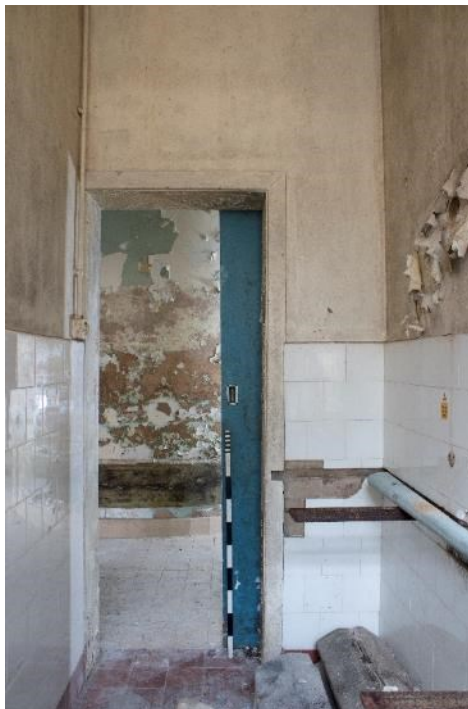
Photo 131: Room 5, facing north-east(1796\_131.TIF)

The east side of the block contains two rooms and a few smaller storage spaces. The north east corner contains a room and a small narrow room next to it. The narrow room (5) is lit by a single sash window and has half-height tiling to the walls and was probably last used as a W.C (Photo 131). The room is accessed from the south via a sliding door in a modern plain architrave. The larger room to the east (6) is accessed via a large opening to the south and is lit by a single sash window (Photos 133 & 134). The room is devoid of any features apart from a series of numbered power sockets midway up the wall. The two rooms are shown as one on the historic plans and labelled as a store. It is likely that they were divided in recent years.

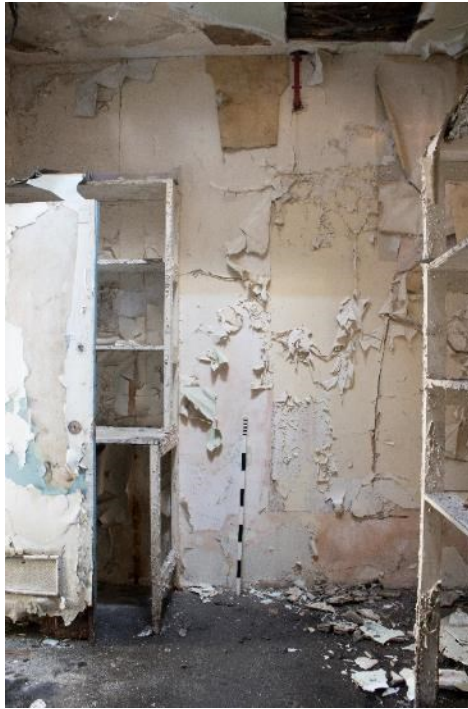
Photo 136: Room 7, facing north-west (1796\_136.TIF)

The central room (7), accessed from the kitchen corridor to the north, is marked on the historic plan as a linen store. This function appears to have remained unaltered as it is still lined with wide shelves (Photo 136). The doorway has a plain modern architrave and door. The room is shown as extending further south on the historic plan; however, now the south of the room is

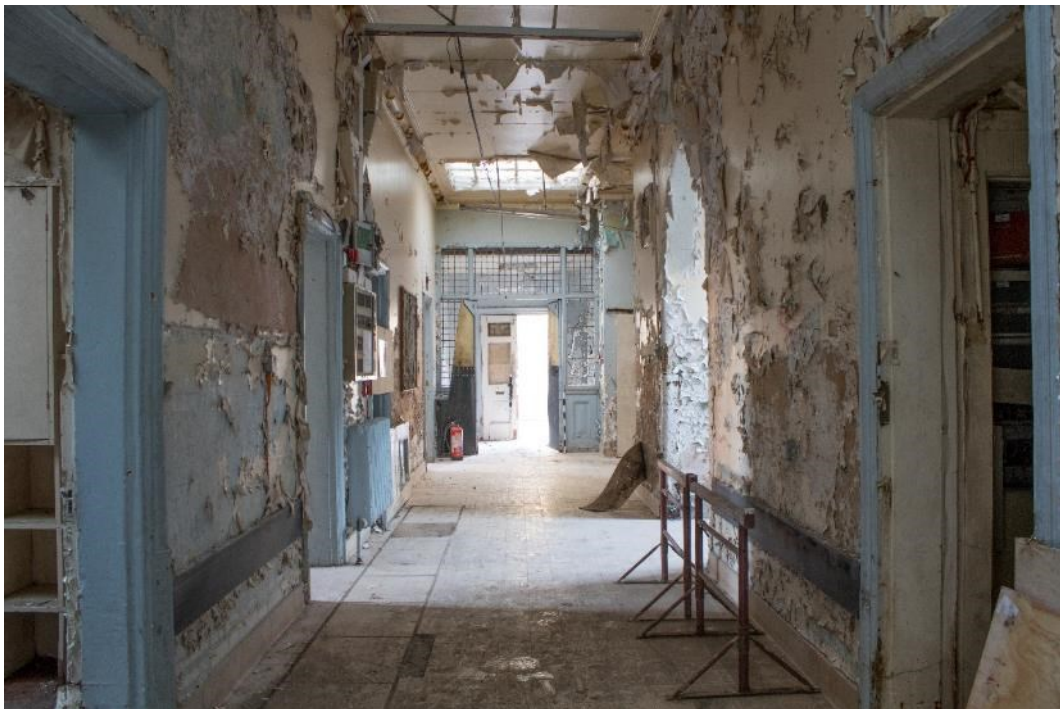
Photo 139: North block corridor, facing south-west (1796\_139.TIF)

The corridor itself (1) has modern plain skirting boards and a modern tiled floor (Photo 139). The walls and ceiling are plain plastered and meet at a deeply coved cornice similar to the corridor in the central block. Access to adjacent rooms is through doorways with moulded architrave and four-panel doors. The space is lit via roof lights in ceiling. A marble dedication plaque on the rounded corner of the corridor commemorates Ida North, the namesake of the hospital (Photo 149).

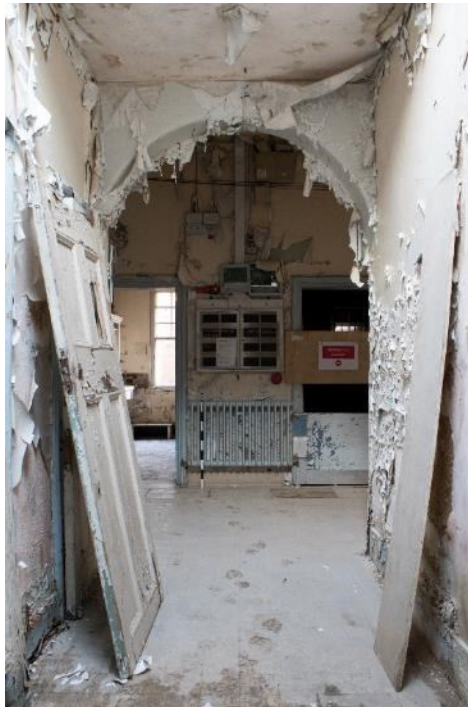
Photo 143: North block corridor to Arthington Hospital, facing south-east (1796\_143.TIF)

occupied by a spur of the corridor leading to a large blocked opening (Photo 143). This would have led to a covered walkway linking the building to the Robert Arthington Hospital. The room was probably truncated not long after being built to make way for the corridor. To the south of the link corridor are two small cupboards (8) and the stairs to the first floor (Photo 151).

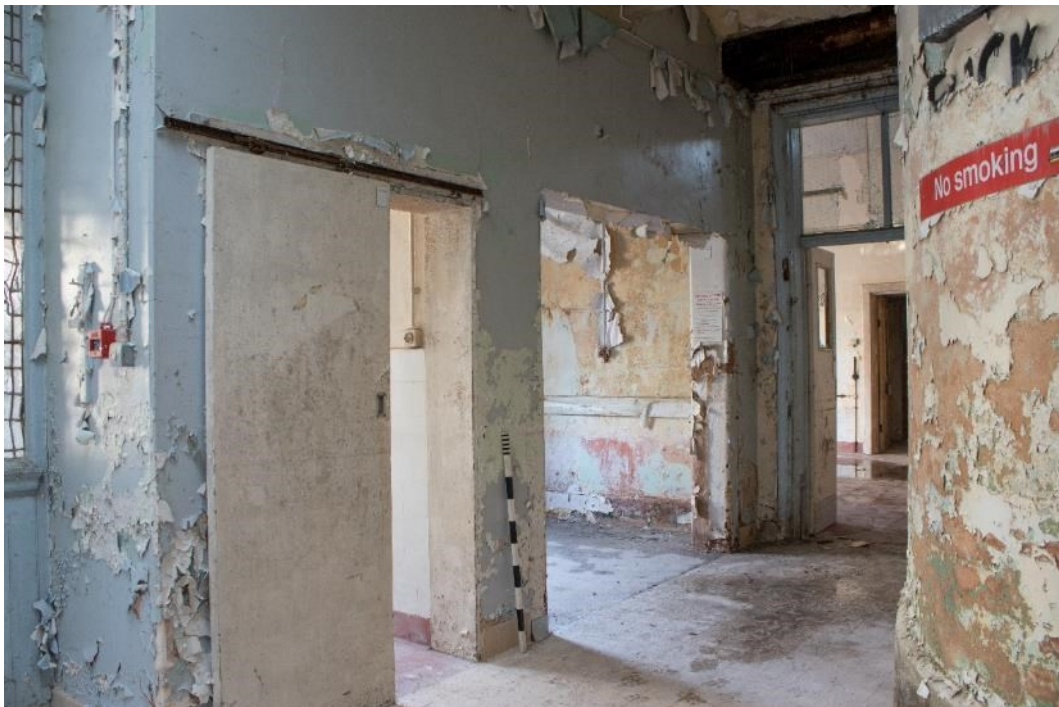
Photo 145: North entrance to north block, facing north-east (1796\_148.TIF)

The main entrance to the corridor is via a set of doors at its north end leading to what used to be a *porte-cochère*. The doors and ante-room are similar in arrangement to the south entrance, although the inner doors have been replaced with a pair of swinging plastic doors, probably in the 1960s (Photo 145). Having better access to the road in and out of the hospital, it is likely that the rear entrance was the most used.

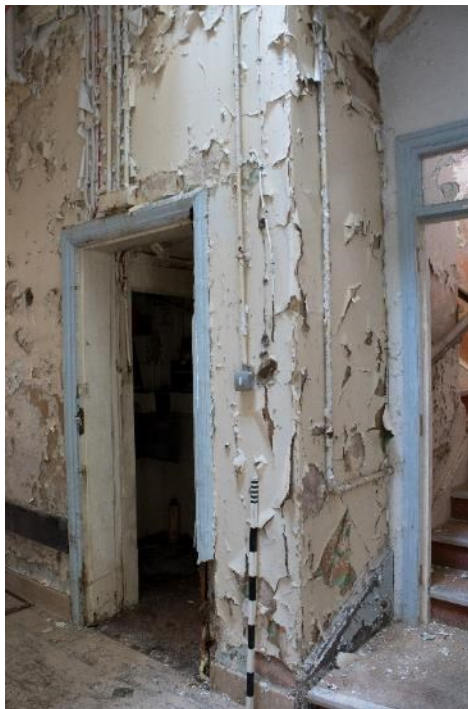
Photo 151: Stairs to first floor, facing south-east (1796\_151.TIF)

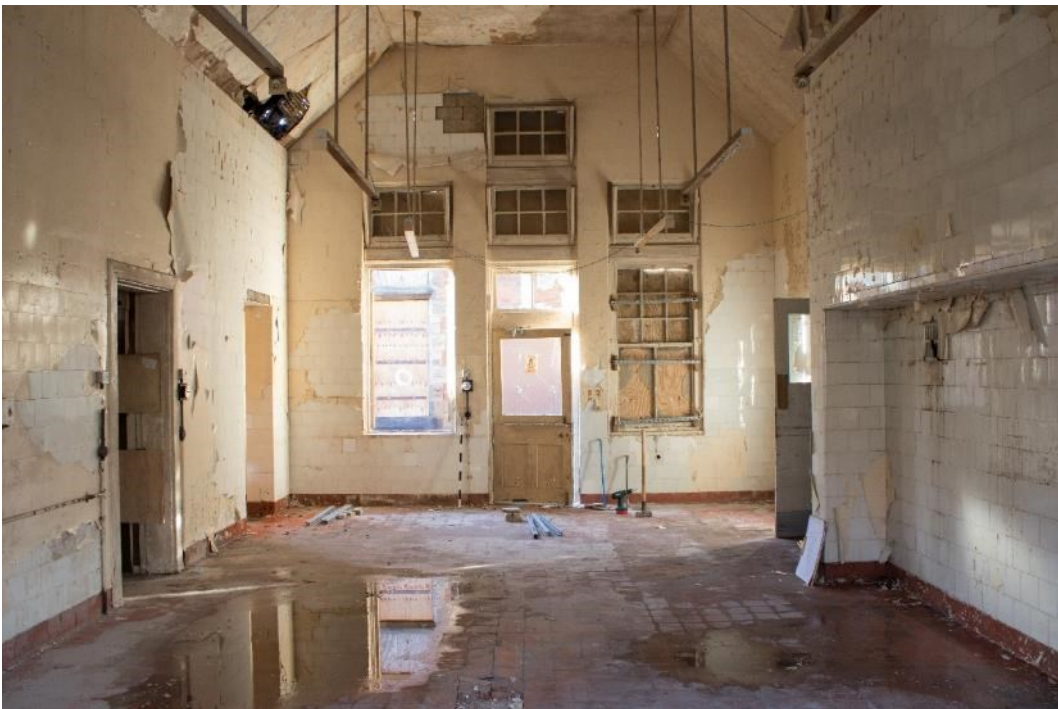
Photo 153: Kitchen, facing, north-east (1796\_153.TIF)

The kitchen (17) occupies the western part of the range and is a double height room orientated north-south and open to the roof (Photo 153). The kitchen is lit at both ends by sets of three sash windows and top-lights, although a doorway has been inserted into the middle south window. The room is accessed primarily from the north block to the west, via a set of modern double doors. The room has been stripped of any furnishings or equipment, although a large fireplace remains on the west wall (Photo 155), where the cooking was presumably originally done with a coal stove. The room walls and floor are entirely clad in tiles.

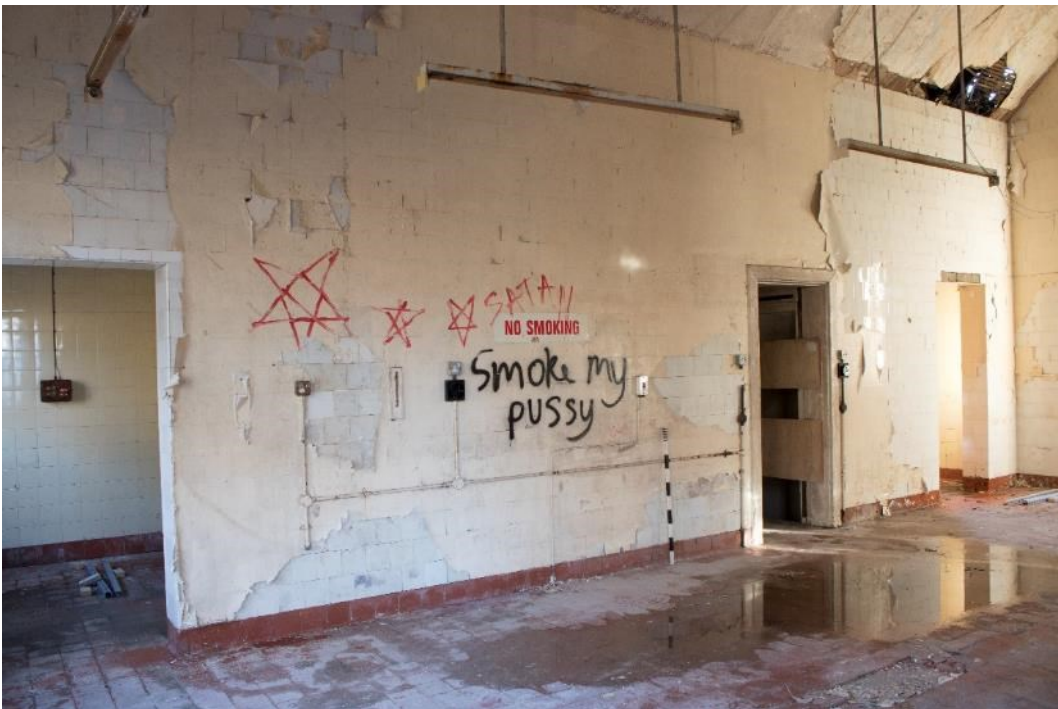
Photo 155: Kitchen fireplace, facing west (1796\_155.TIF)

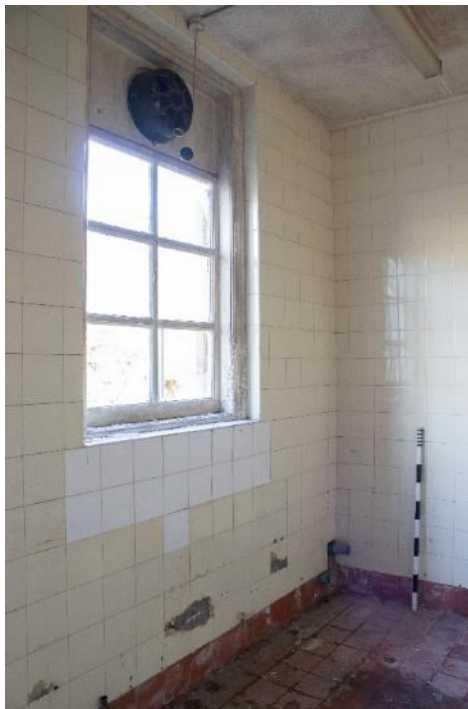
Photo 163: Room 18, facing south-east (1796\_163.TIF)

The kitchen has open doorways to the north and south of the east wall. These lead into similar tiled rooms (18/19) Photos 163 & 165) that appear to have been used most recently for washing dishes. The historic plan shows a slightly different arrangement, with the north room being part of the neighbouring pantry and the northern part of the kitchen being used as a scullery. Judging on the tiles, it is likely that the kitchen was overhauled in the 1960s as technology changed. A doorway in the centre of the east wall leads to a small lobby containing stairs to both the first floor and the basement as well as access to the pantry to its north (Photo 166). The pantry (20) contains slabs set against the wall and a tiled floor and walls (Photo 193).

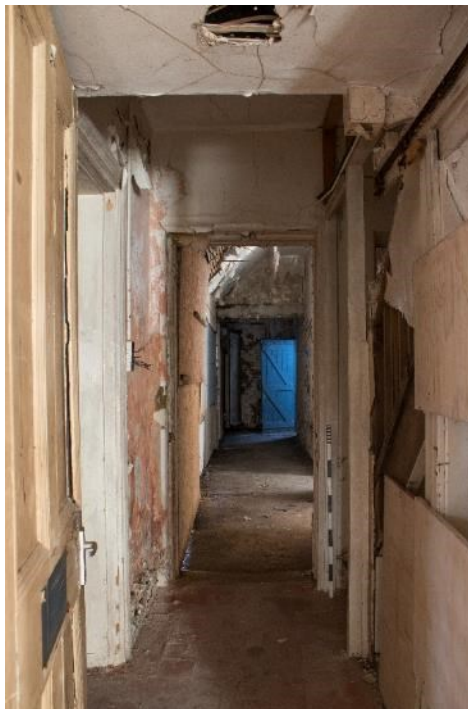
Photo 165: Room 19, facing south (1796\_165.TIF)

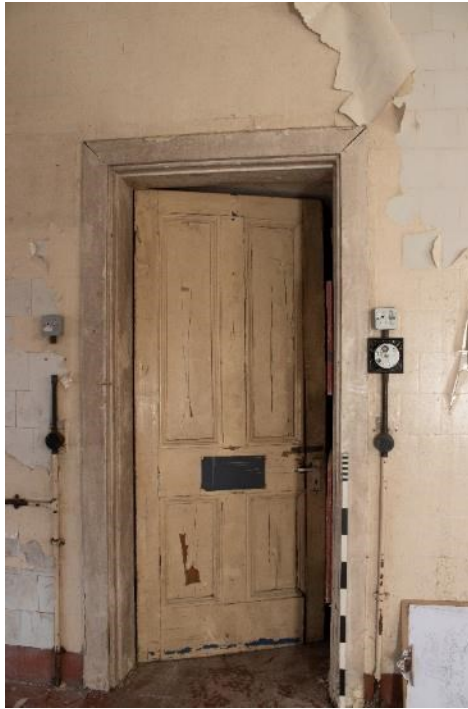
Photo 166: Corridor from kitchen to service range, facing south-east (1796\_166.TIF)

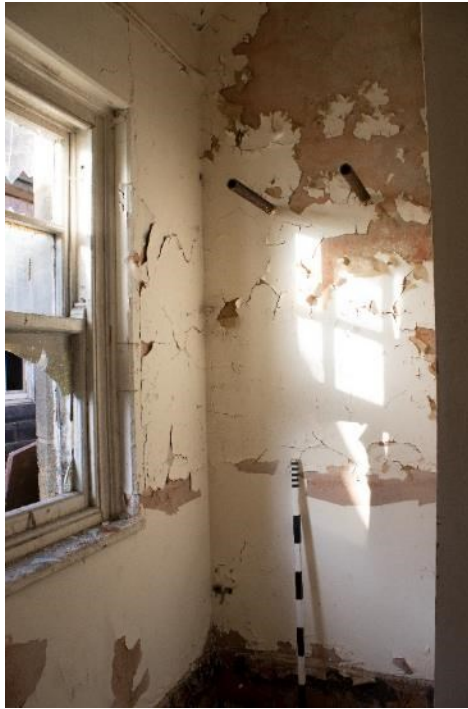
Photo 170: Room 21, facing south-west (1796\_170.TIF)

There are three rooms to the south of the veranda as well as a formerly open passage and a W.C. The westernmost room (21) is a fairly awkward space marked as a boot room on the historic plan. The room is plastered and lit by a sash window to the south (Photo 170). The room is accessed via a moulded four-panel door with matching architrave (Photo 172) and most of its space is taken up by a chimney rising from the location of the former furnace in the basement.

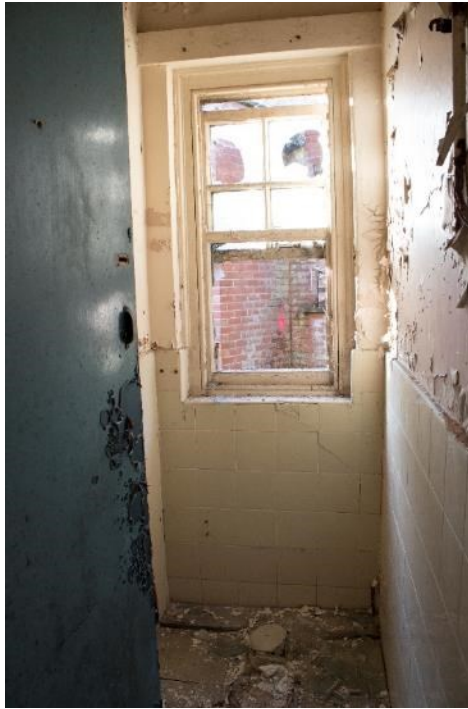
Photo 174: Entrance passage to service range, facing north-east (1796\_173.TIF)

Adjacent to the west room is a through passage (22) providing access to the yard and kitchen range from the south. The passage is lined with brick and has a W.C. to the east. The passage is shown as open on the historic plan but has since been enclosed. To the south the opening has a panelled and glazed door, possibly an early addition (Photo 173). To the north the opening onto the veranda has been filled with a modern partition and door (Photo 174).

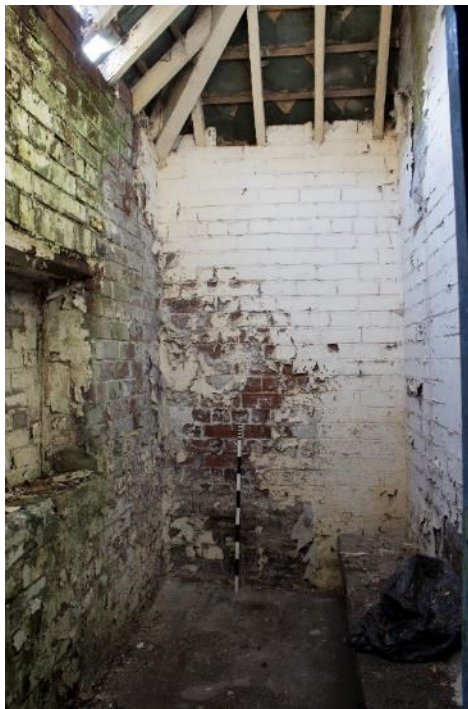
Photo 180: Room 24. Facing south-west (1796\_180.TIF)

The narrow east room (24) is accessed from the end of the veranda via a plank and batten door. The room is open to the rafters and has painted brick walls (Photo 180). The south wall has a blocked window. The room is fairly spartan and is marked as an ash room on the historic plan.

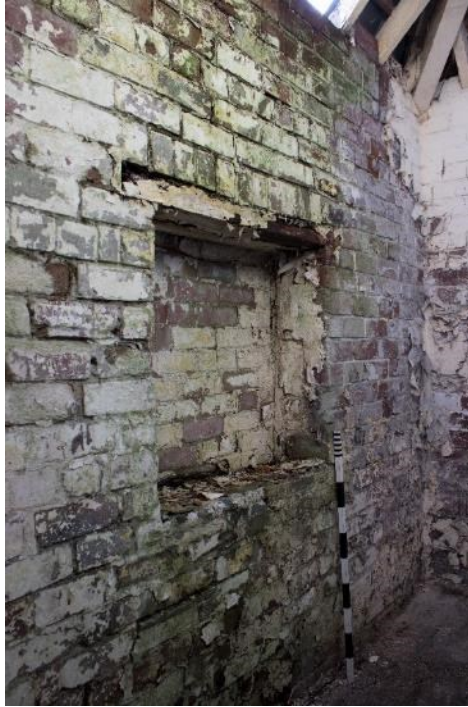
Photo 181: Blocked window in room 24, facing south (1796\_181.TIF)

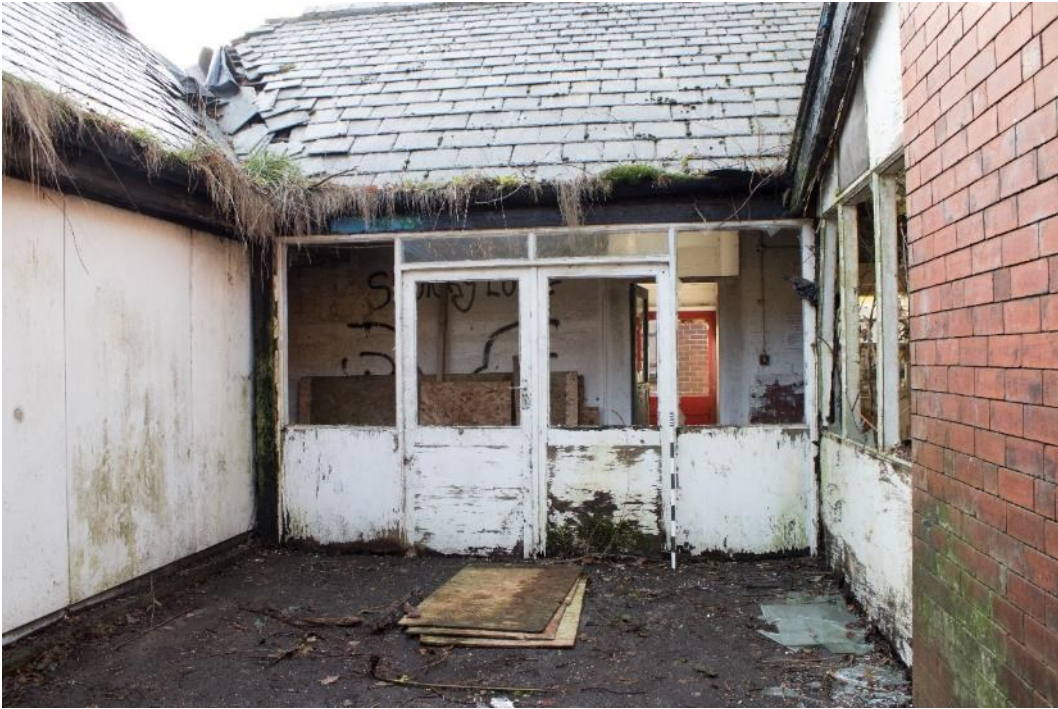
Photo 185: Kitchen courtyard, facing south-west (1796\_185.TIF)

The kitchen and pantry lobby give access to a further range of rooms to the east arranged around a yard and accessed from a semi-open veranda. The two spaces either side of the yard (52/23) are occupied by industrial refrigerators whilst the veranda to the south has been closed in with modern glazing and a set of half-glazed double doors (Photo 185). The main fridge (52) is marked as coal storage on the historic plan.

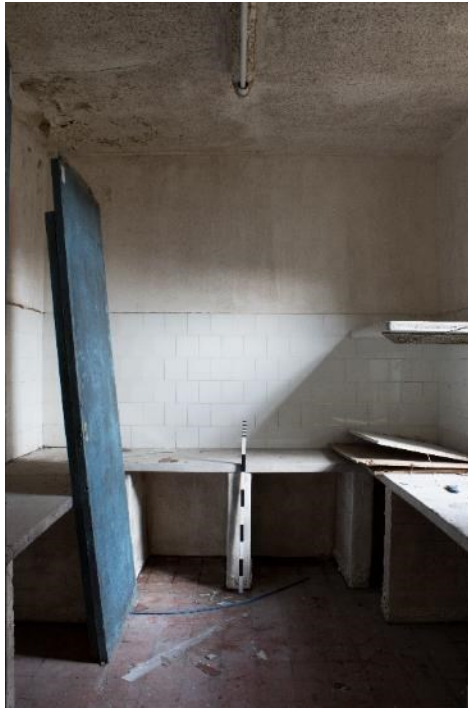
Photo 193: Larder, room 20, facing north-east (1796\_193.TIF)

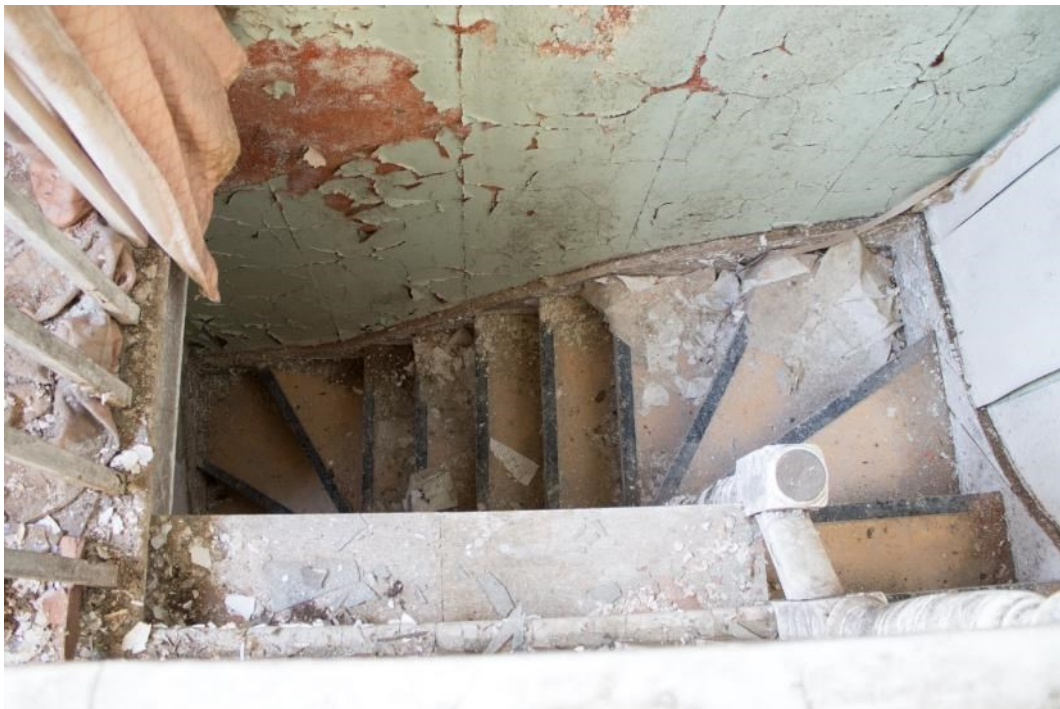
Photo 198: Stairs to first floor of service range, facing south-west (1796\_198.TIF)

The first floor over the pantry and wash rooms is accessed via a narrow set of stairs with turned newel posts and plain balusters (Photo 198). The floor consists of a lobby for the stair landing (53) and a cramped sitting room to the north (54). The room is devoid of any decoration but has a fireplace to the west wall (Photos 199 & 202). The fireplace is modern but the chimneystack is original. The first floor of the kitchen range isn't represented on the historic plan; however, it is likely that it was built as a sitting room for the cook, and appears to have been used as such continuously.

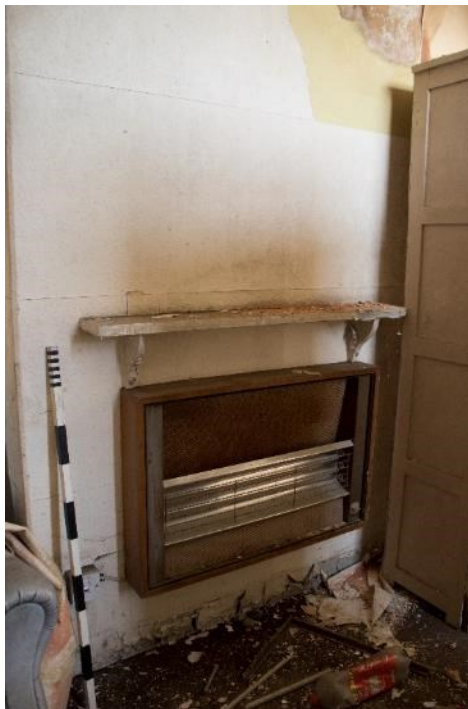
Photo 202: Room 54 fireplace, facing north (1796\_202.TIF)

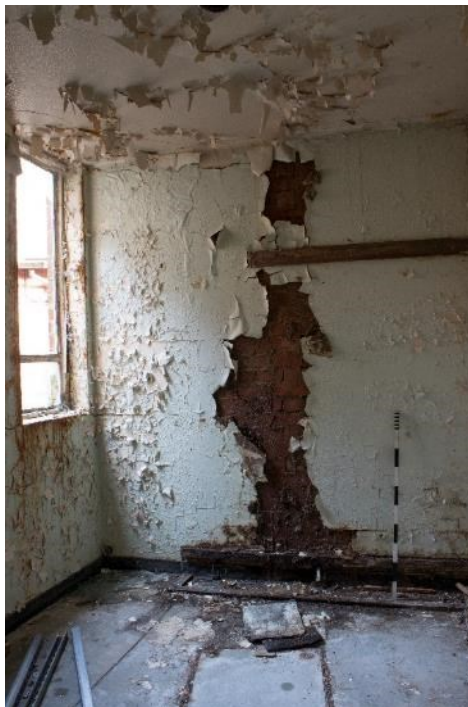
Photo 206: Room 36, facing east (1796\_206.TIF)

The east extension has three small rooms accessed from the main corridor (34-36). The westernmost room (36) is devoid of any features (Photo 206) whilst the central room (35) has pigeon holes and what appears to be the remains of a workbench (Photo 209). It may have been either an office or treatment room. The eastern room (34) has a cupboard and a counter opening into the ward (Photo 212). This presumably served as a dispensary for medication.

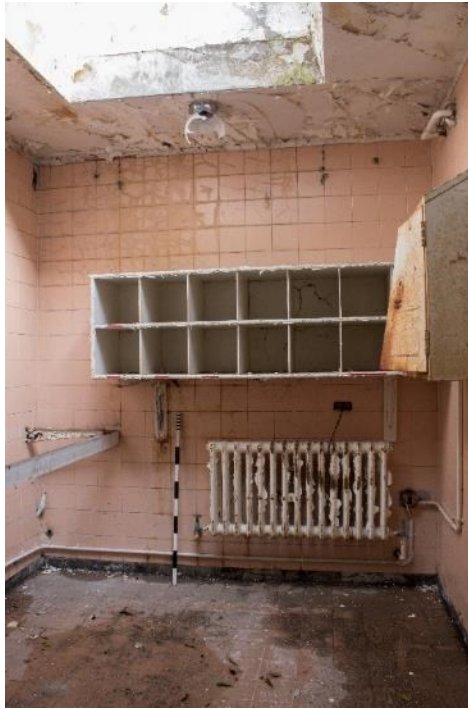
Photo 209: Room 35 facing east (1796\_209.TIF)

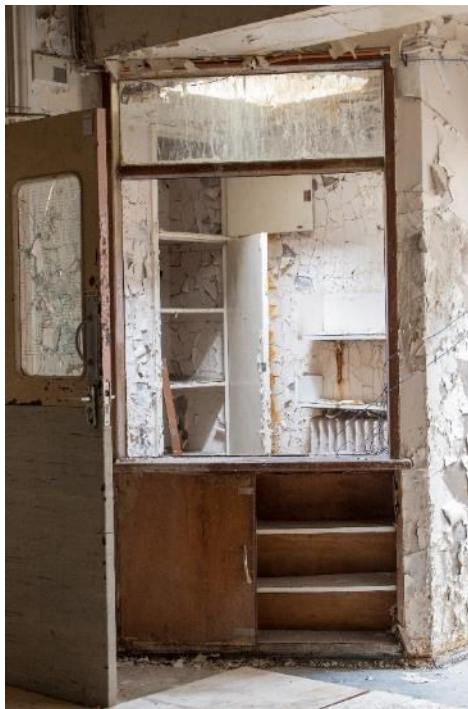
Photo 212: Room 34 as viewed from the east ward, facing north (1796\_212.TIF)

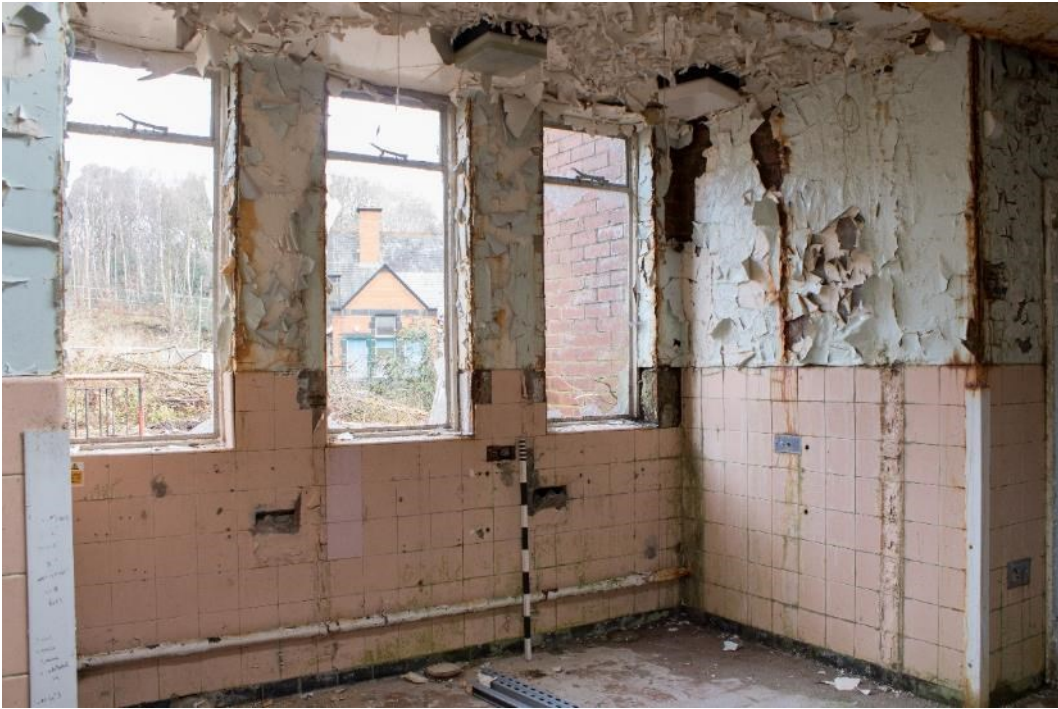
Photo 217: Location of former toilet stalls in room 31, facing south-east (1796\_2107TIF)

The remainder of the extension consists of a wash block with staff rooms. The wide entrance from the ward leads into a central space that once had toilet stalls (31) (Photo 217). To the west this leads to two bath and shower rooms (32/33) (Photo 220). To the east the extension contains a store room (30) and two staff rooms (29/30) (Photos 225 & 228) with external access.

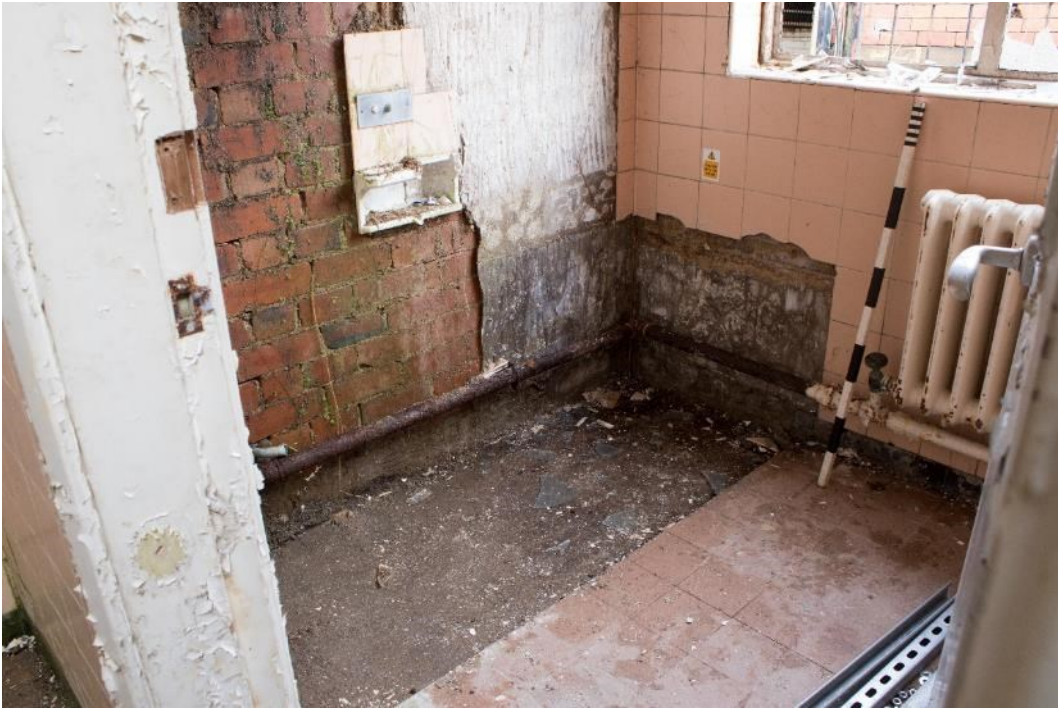
Photo 220: Room 33, facing east (1796\_220.TIF)
