The Ida Wing, Cookridge Hospital  
Historic Building Recording  
ArcHeritage 2019

The Former Ida Wing, Cookridge Hospital, Leeds  
Historic Building Recording

Project Name	The Former Ida Wing, Cookridge Hospital, Leeds
ArcHeritage Project no.	1796
Report status	Final
Type of Project	Photographic Building Recording
Client	Esh Construction
OASIS ID	archerit1-348378
Planning Application ref.	14/02558/LI
NGR	SE 25483 38884
Authors	Christopher Curtis
Illustrations	Christopher Curtis
Editor	Glyn Davies
Report Number and Date	2019/20 05/04/2019
Version and Filename	Version 2: 1796 Ida Wing Cookridge V2.pdf

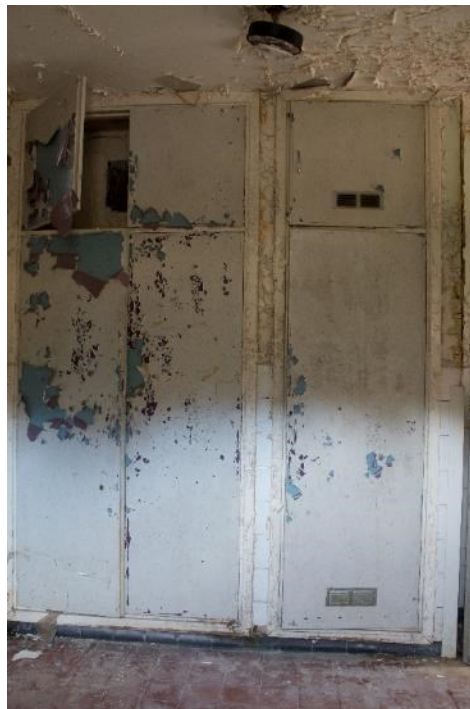
Photo 225: Room 29, facing south-east (1796\_225.TIF)

The remainder of the extension consists of a wash block with staff rooms. The wide entrance from the ward leads into a central space that once had toilet stalls (31) (Photo 217). To the west this leads to two bath and shower rooms (32/33) (Photo 220). To the east the extension contains a store room (30) and two staff rooms (29/30) (Photos 225 & 228) with external access.

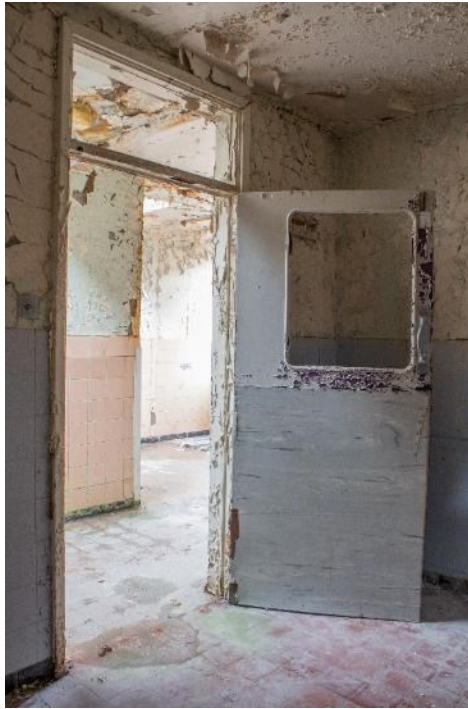
Photo 228: Room 228, facing south (1796\_228.TIF)

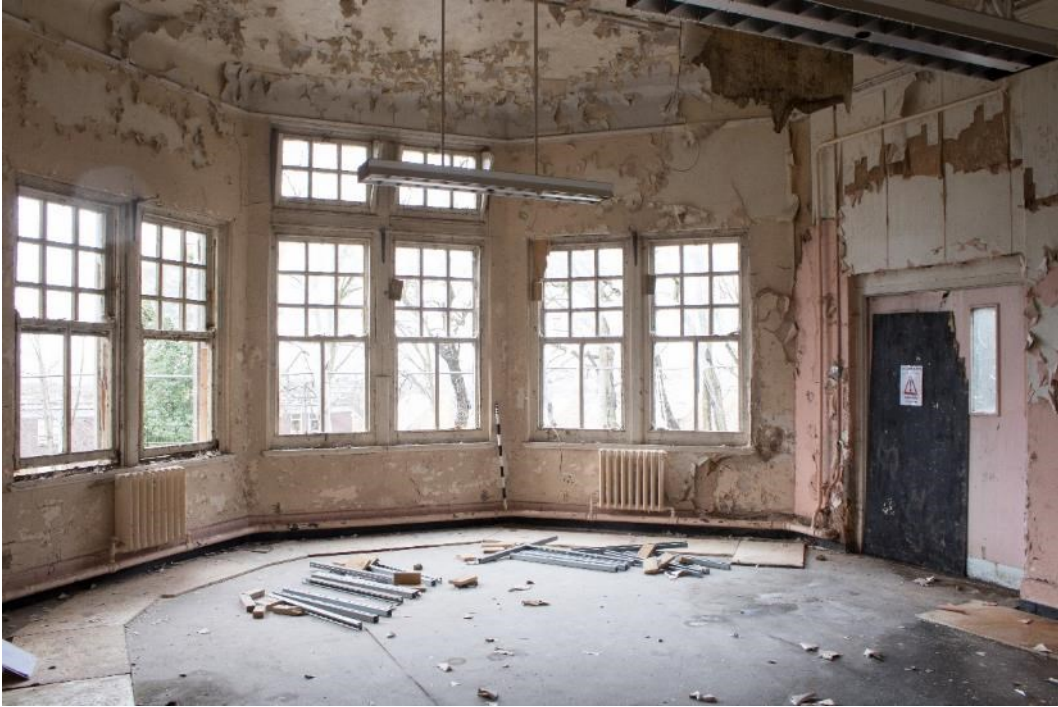
Photo 230: East dayroom (15), facing north-east (1796\_2.TIF)

Either side of the entrance corridor the central block contains an almost identical set of day rooms (**15/16**) (Photos 248 & 230). The rooms are lit from the south with canted bay windows and are accessed from doorways to the north. Each room has a blocked fireplace in its outer wall and they have both had doorways inserted into the adjacent rooms. The rooms have been mostly stripped of any original features, and the sash windows in the east room have been replaced with timber casements.

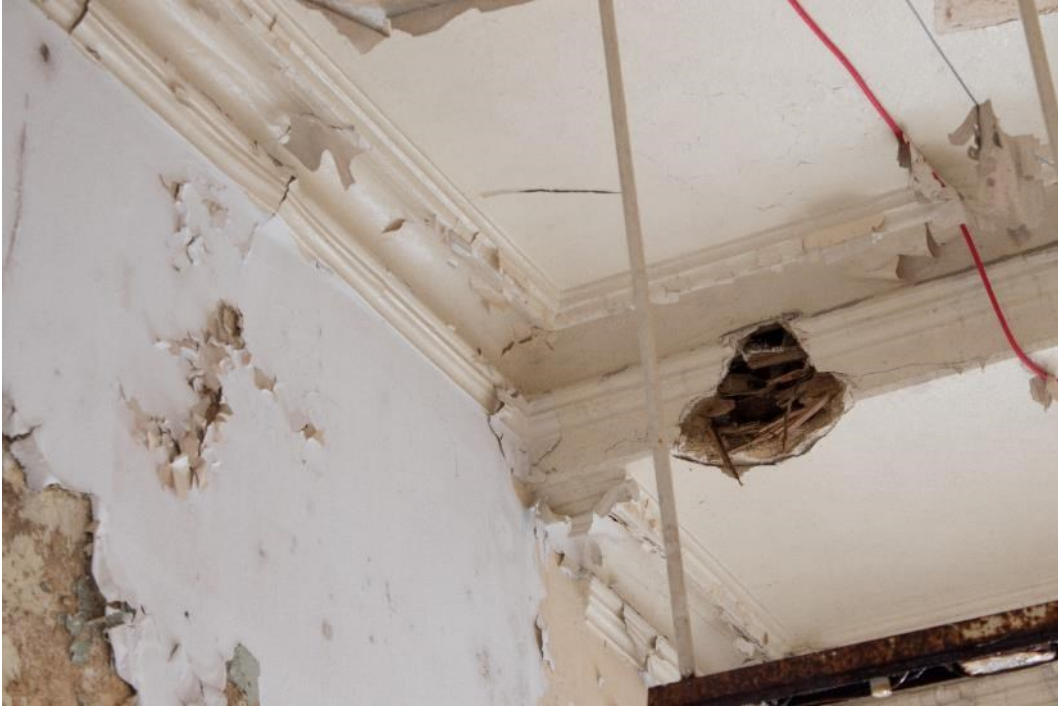
Photo 236: South entrance corridor, facing south-west (1796\_236.TIF)

The ground floor of the central block is almost symmetrical, as it was designed as two identical units for different genders. The main entrance to the building leads into a lobby, separated from the main north-south corridor via a mixed timber panelled and glazed partition with leaded lights (Photo 236). The partition has matching panelled and glazed double doors. The corridor leading from the entrance is decorated with plain plaster walls, a flush-beaded skirting board and a coved cornice to the ceiling. The corridor leads through an arch to the similarly decorated east-west corridor (**14**) and continues into the north block (Photo 238). The east-west corridor appears to have originally been open to the north and to the east and west but has had modern partitions and doorways inserted (Photo 240).

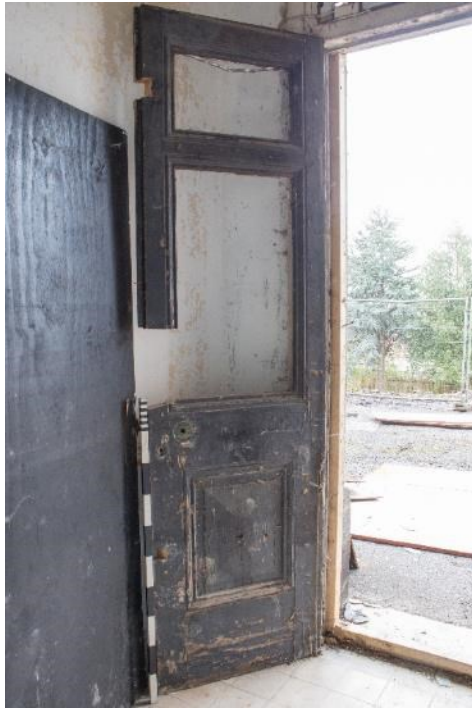
Photo 238: South entrance corridor, facing north-east (1796\_238.TIF)

The stairs to the second floor wind up from the east of the building and while narrower and steeper, are built in the same style as the ground-first floor stairs (Photo 330). The hallway (49) is lit with roof lights and has a partition at either end (Photos 237 & 238). The west partition appears to be original and features a door architrave in the same style as the rest of the floor. The east partition appears to be a modern addition. The west end of the hallway has modern toilet stalls inserted into a projecting part of the building (Photo 329).

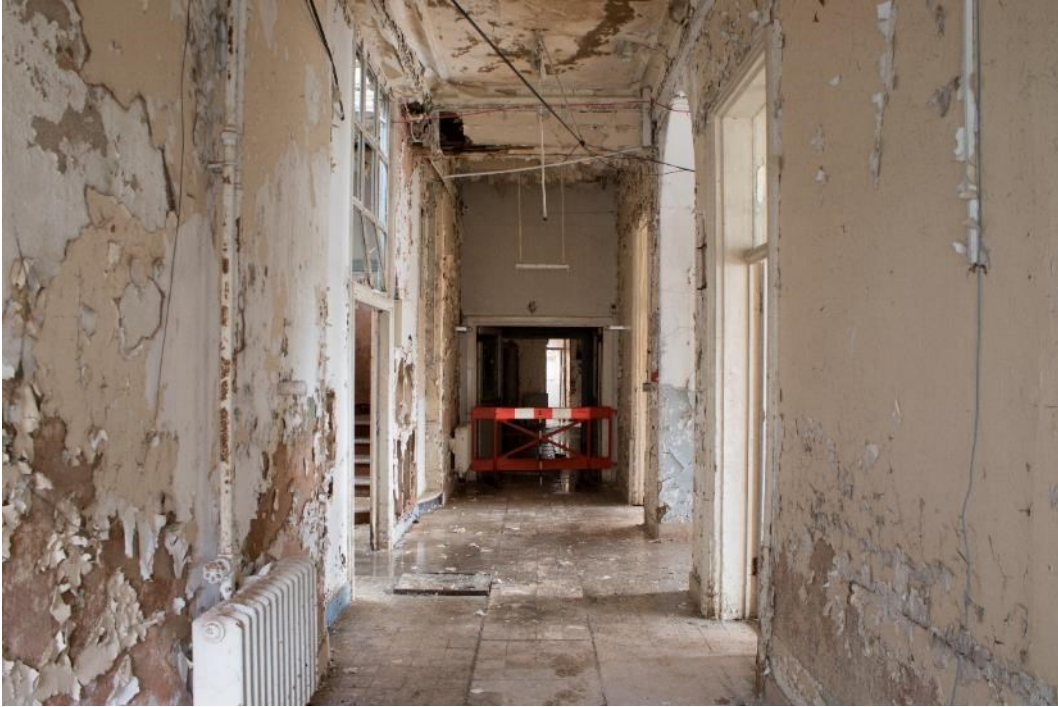
Photo 240: Main east-west corrdior, facing north-west (1796\_240.TIF)

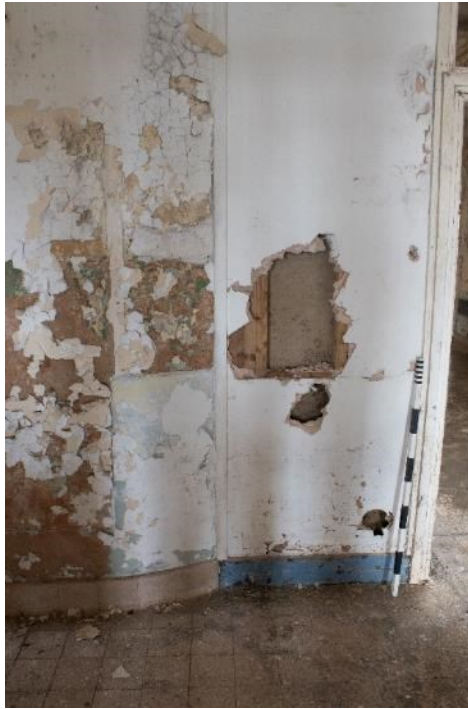
Photo 242: Inserted partition between north and central block corridors, facing east (1796\_242.TIF)

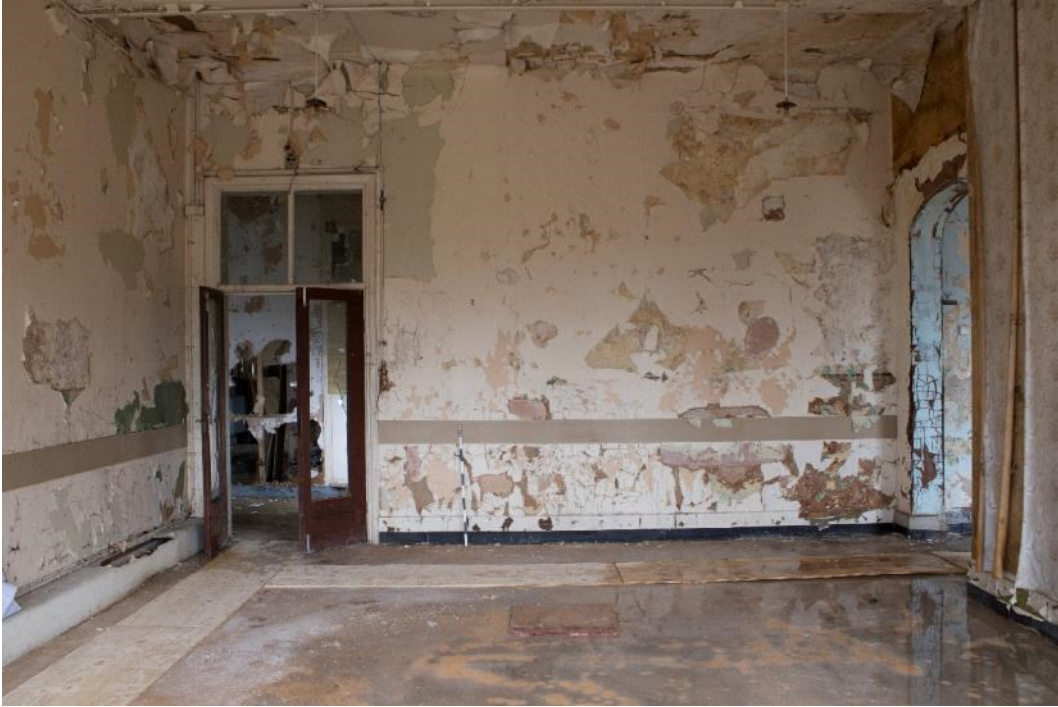
Photo 248: West dayroom (16), facing south-west (1796\_248.TIF)

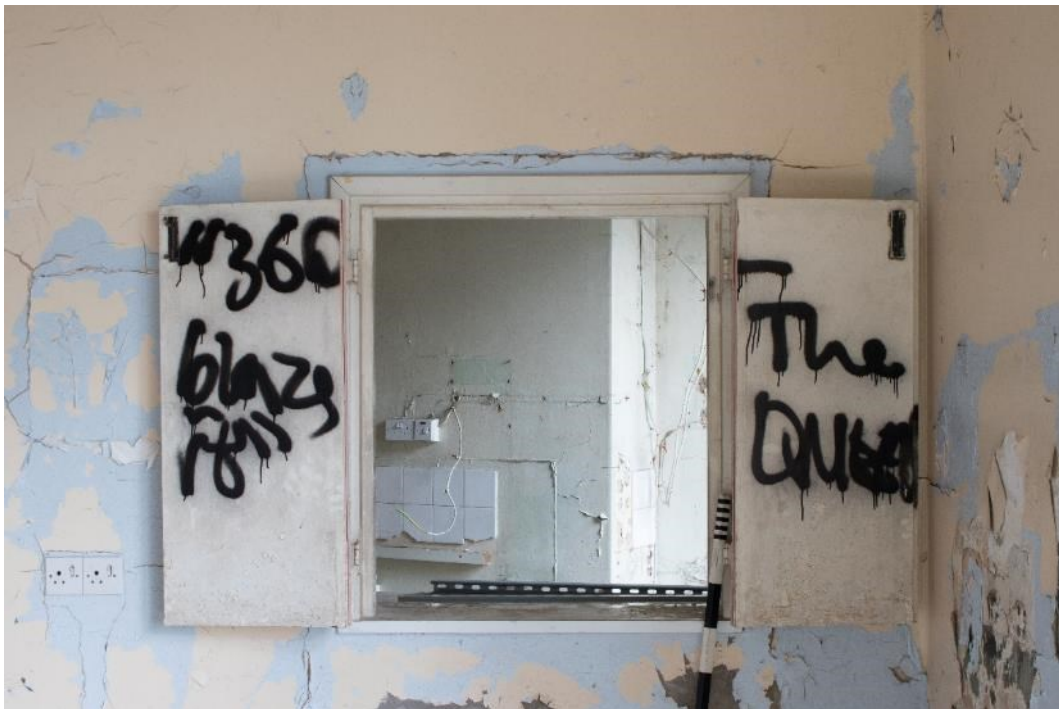
Photo 255: Chimneybreast in room 38, facing north (1796\_255.TIF)

Either side of the day rooms are a further pair of rooms (**55/38**), marked as four-bed wards on the historic plans but now linked to the inner day rooms and presumably used as such in later years. As with the inner day rooms, any historic features have been stripped out, although blocked chimney breasts remain on the inner walls (Photos 253 & 255). The rooms have had service hatches inserted through to the neighbouring outer rooms (**57/26**) and the east room has had its windows replaced with timber casements and a set of modern doors leading outside.

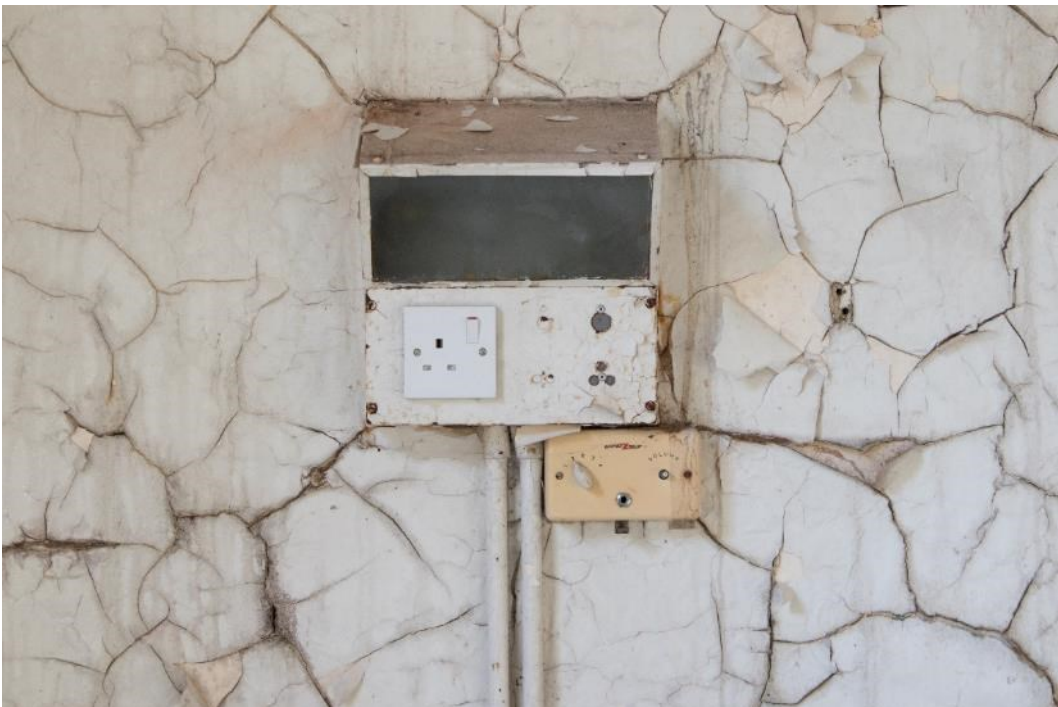
Photo 273: East ward, bedside lamp and headphone socket, facing east (1796\_277.TIF)

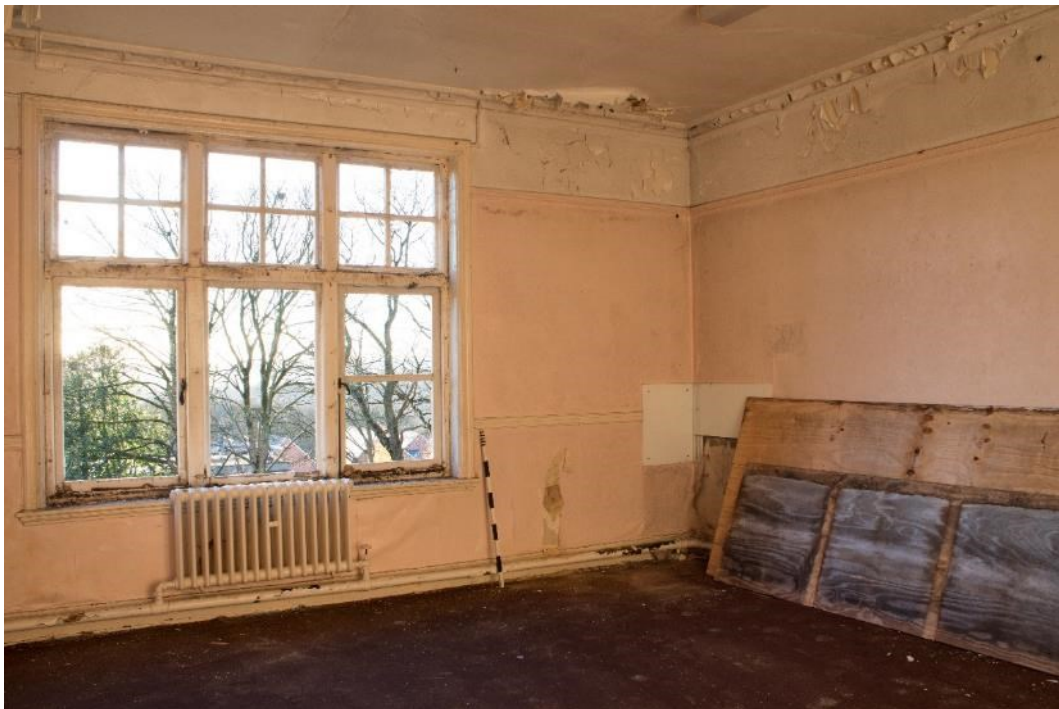
Photo 300: Room 45, facing south-west (1796\_300.TIF)

The south-west room (45), marked as the house surgeon's sitting room on the historic plan, mirrors the south-east room, however it also features a dado rail (Photos 300 & 301). The tiled former fireplace appears to be a 1930s replacement. The original was probably taller as the dado rail is interrupted at this point.

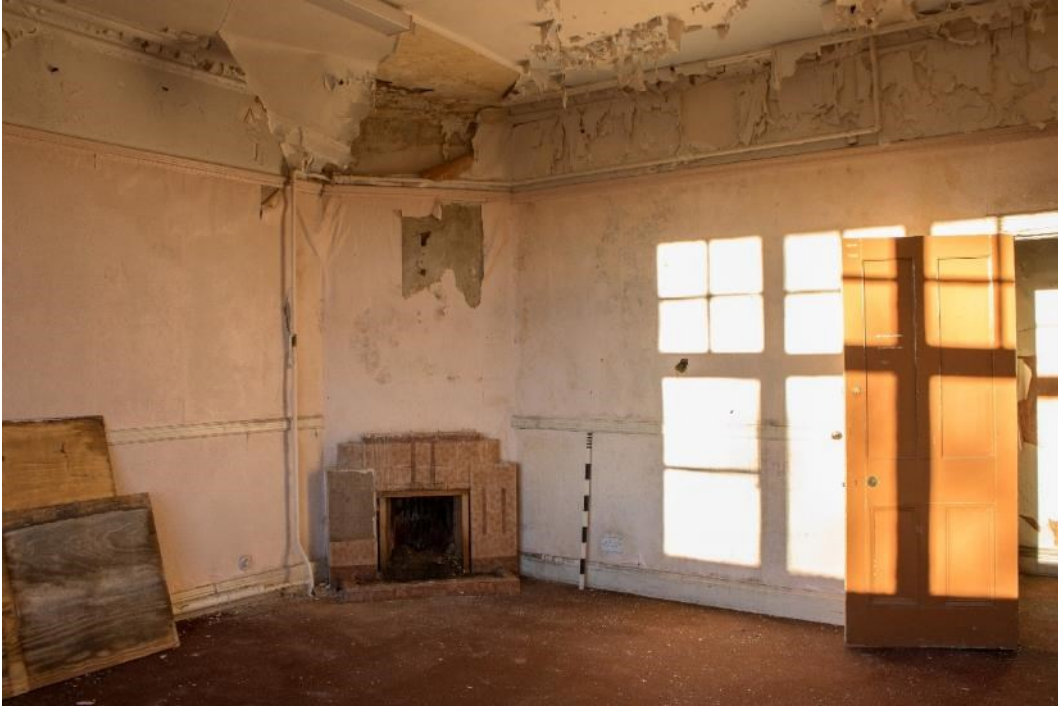
Photo 301: Room 45, facing north (1796\_301.TIF)

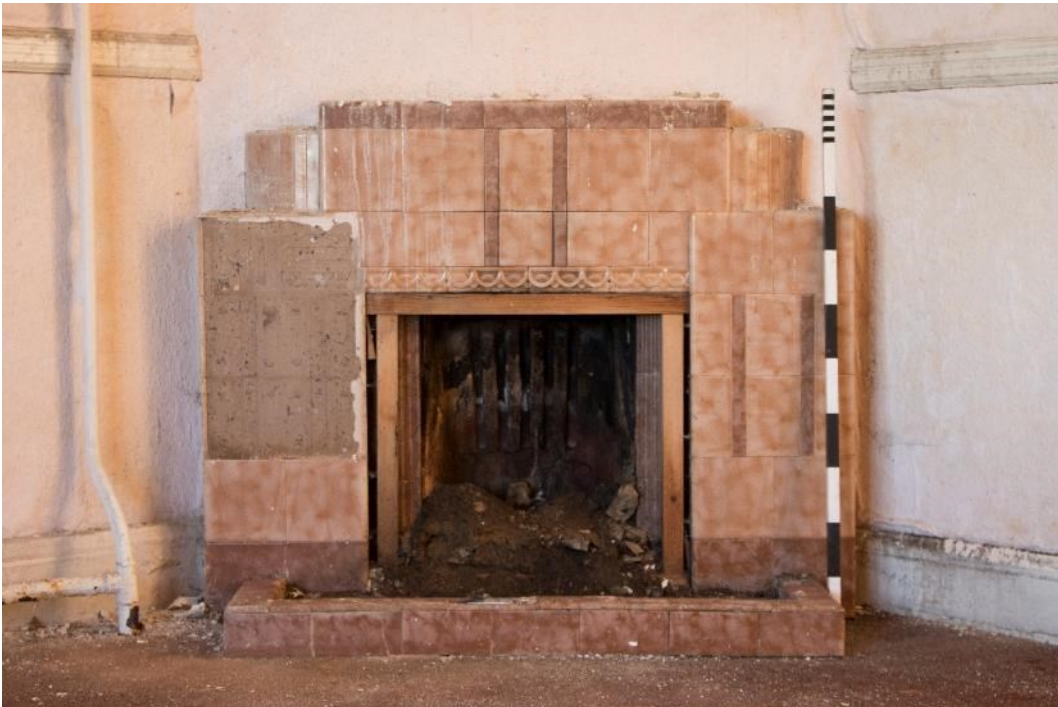
Photo 304: Fireplace to room 45, facing north (1796\_304.TIF)

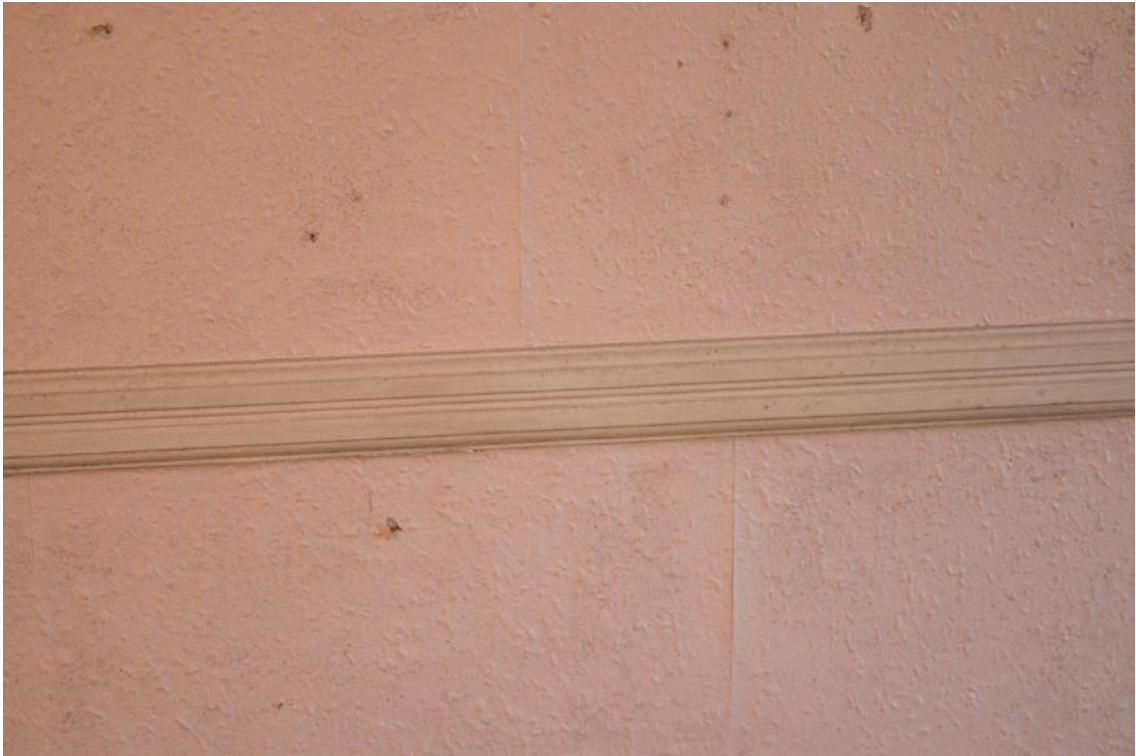
Photo 305: Dado rail to room 45, facing south-east (1796\_305.TIF)

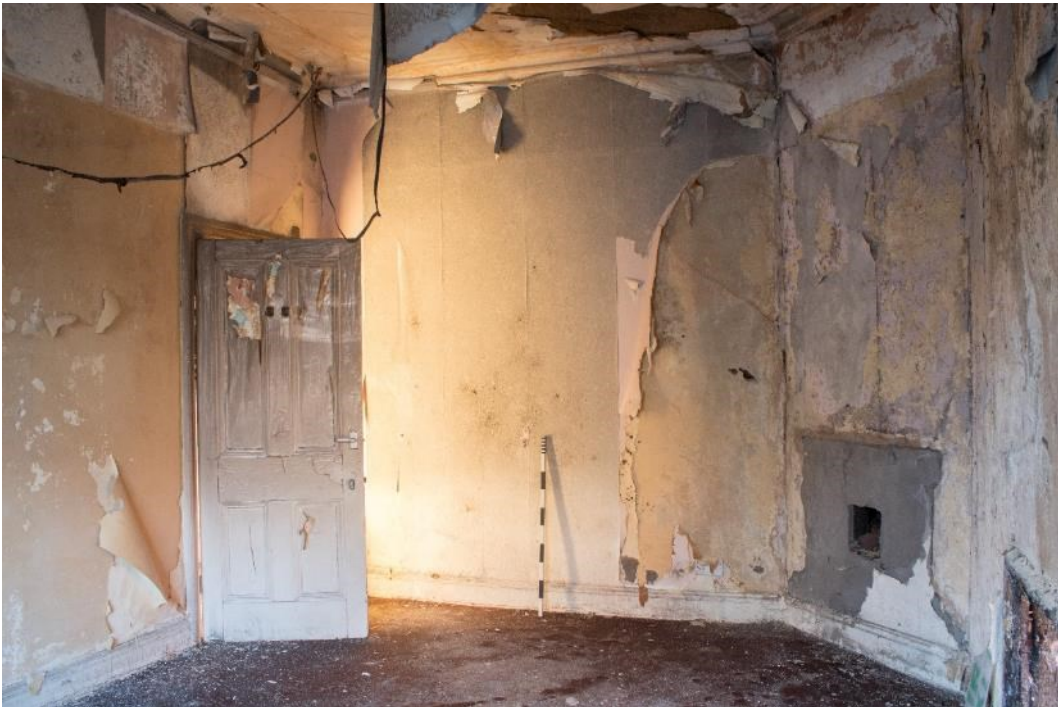
Photo 308: Room 46, facing south-west (1796\_308.TIF)

The north west room (46) consist of a relatively small space decorated similarly to the others but with no picture rail (Photo 308). The room has a corner chimneybreast with its fireplace removed and a hatch in the west wall giving access to the roof structure over the west wing. The room is marked as the house surgeon's bedroom.

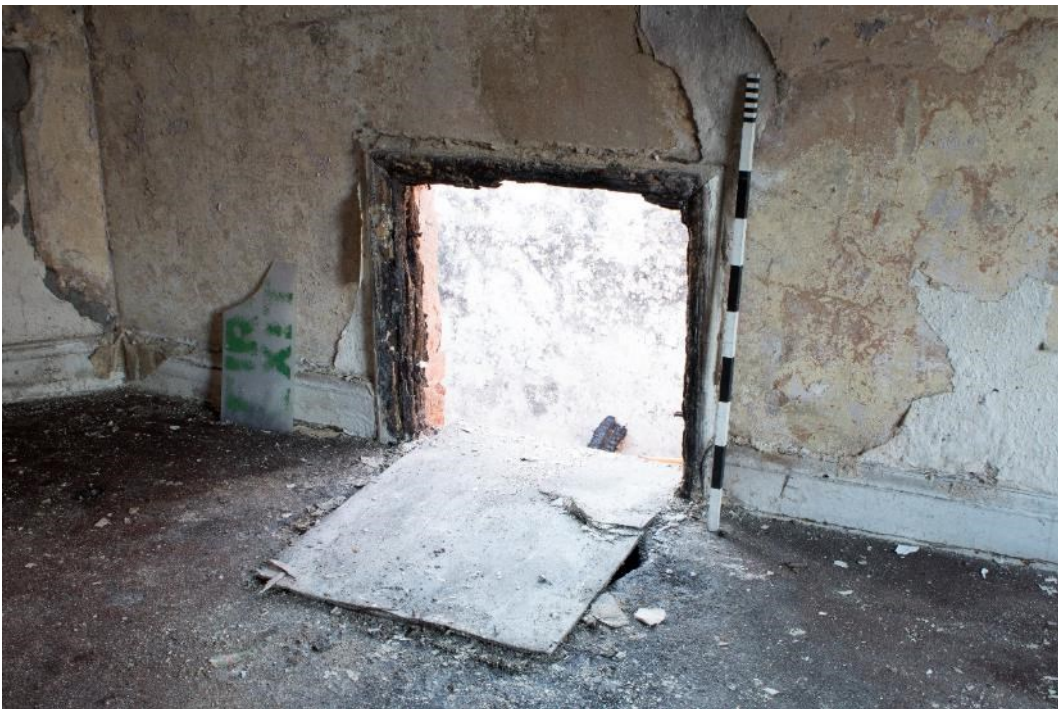
Photo 310: Roof access hatch in room 46, facing west (1796\_310.TIF)

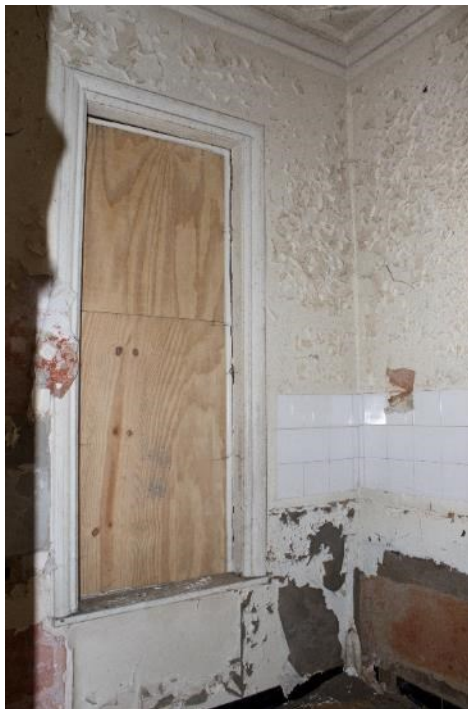
Photo 314: Room 41, facing east (1796\_314.TIF)

The north-east corner of the first floor is occupied by a W.C and bathroom (41) (Photo 314), similarly decorated to the rest of the floor and showing no signs of alteration. The layout is the same as the historic plan.

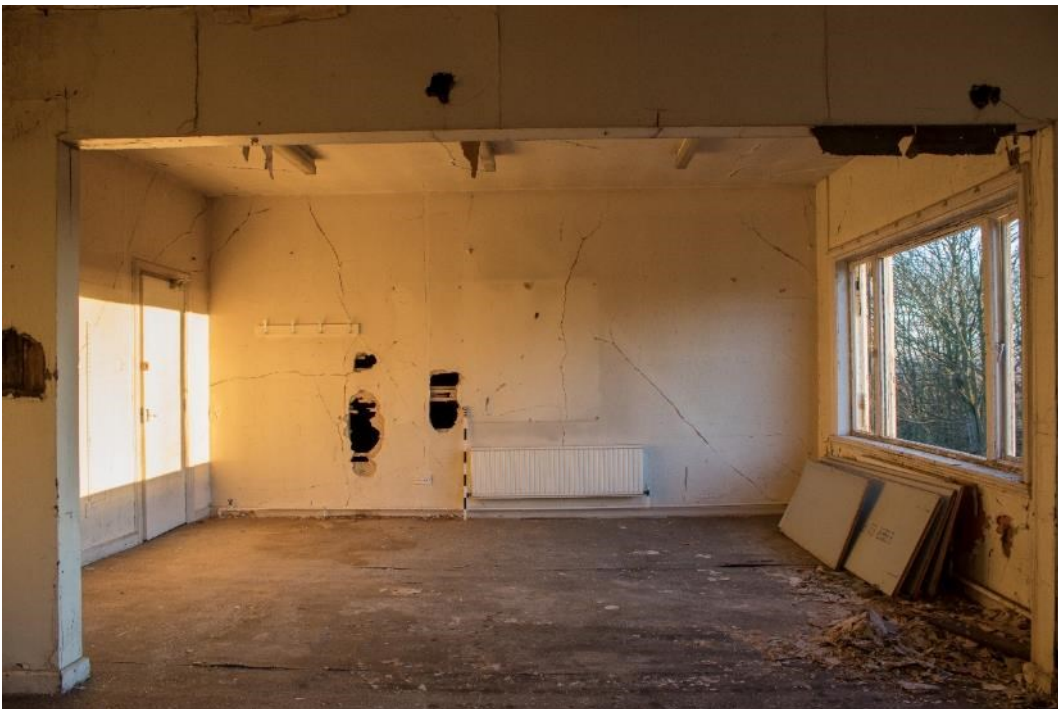
Photo 318: Room 47, facing south-east (1796\_318.TIF)

The partition between the southern two rooms (47) has been knocked through to create a larger space but it is evident that they were originally separate (Photos 318 & 320). The rooms are sparsely decorated with plain skirting boards and have a softwood floor. The rooms are lit with five-light mullion windows and have corner chimney breasts at the northern end of the remains of the partition wall. The fireplaces have been removed.

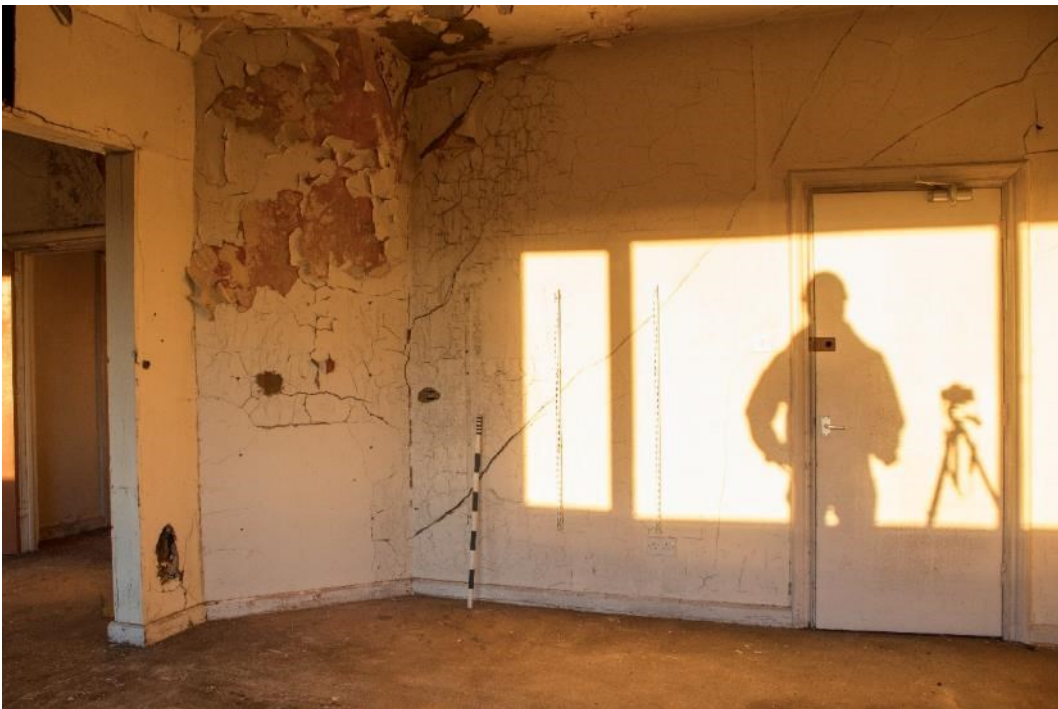
Photo 320: East half of room 47, facing north (1796\_320.TIF)

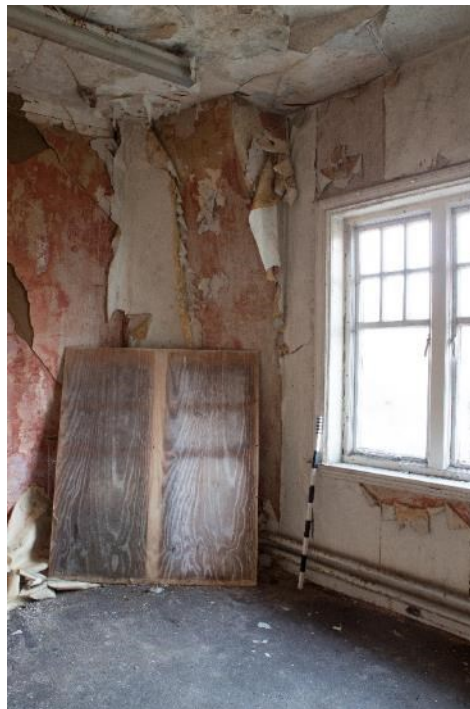
Photo 324: Room 48, facing north (1796\_324.TIF)

The north-east room (48) is fairly small and lit with a three-light mullion window (Photo 324). The north-west room (66) is probably identical but could not be accessed due to safety concerns.

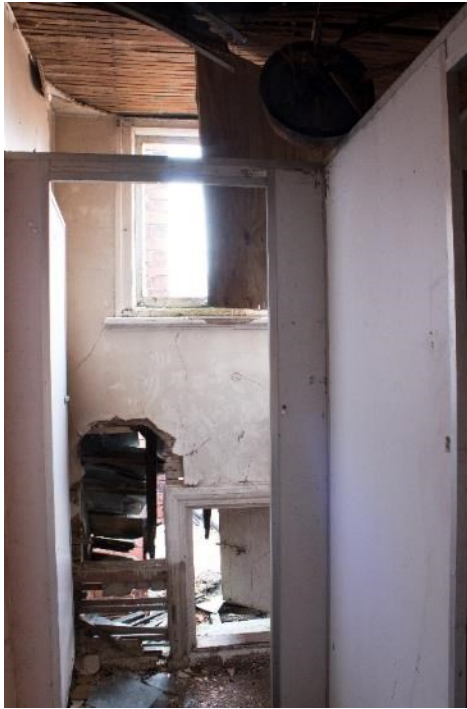
Photo 329: Second floor W.C. (50), facing north-west (1796\_329.TIF)

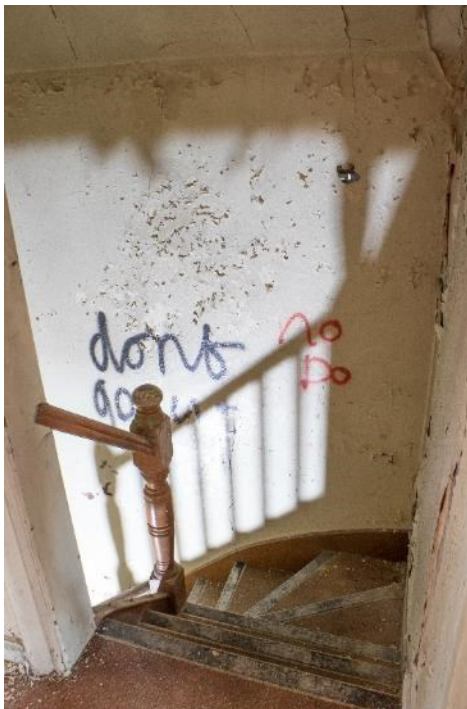
Photo 330: Stairs from first to second floor, facing south-east (1796\_330.TIF)

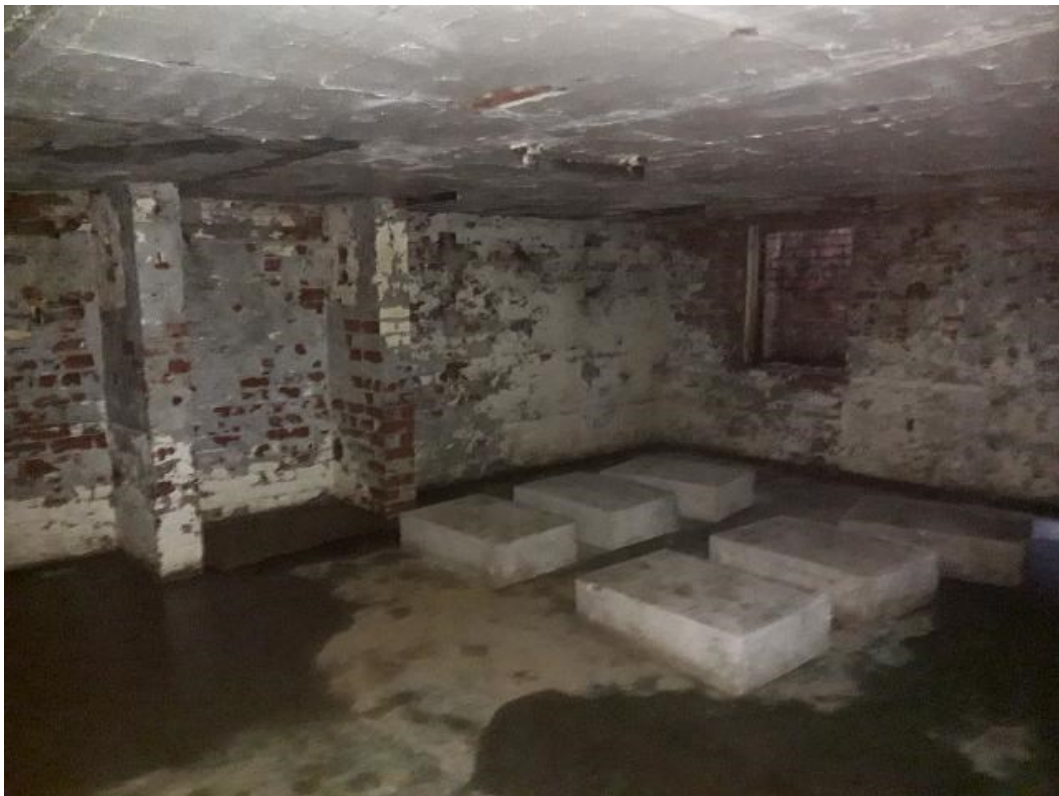
Photo 332: West room in basement (60) facing north (1796\_332.TIF)

The large west room and the smaller central rooms sit under the kitchen block and broadly mirrors its layout. The stone and brick stairs lead into small central lobby (62) which leads north into a small room filled with server racks (63). The central lobby also leads to the large west room (60), built principally of brick but with a concrete floor and ceiling (Photo 332). The room has high level windows on the north and south walls for ventilation and brick stub walls on the west wall supporting the kitchen hearth above. The room contains a series of low concrete blocks that presumably supported machinery. A doorway in the south-east corner of the room leads to a lobby (63) leading to the eastern half of the basement.

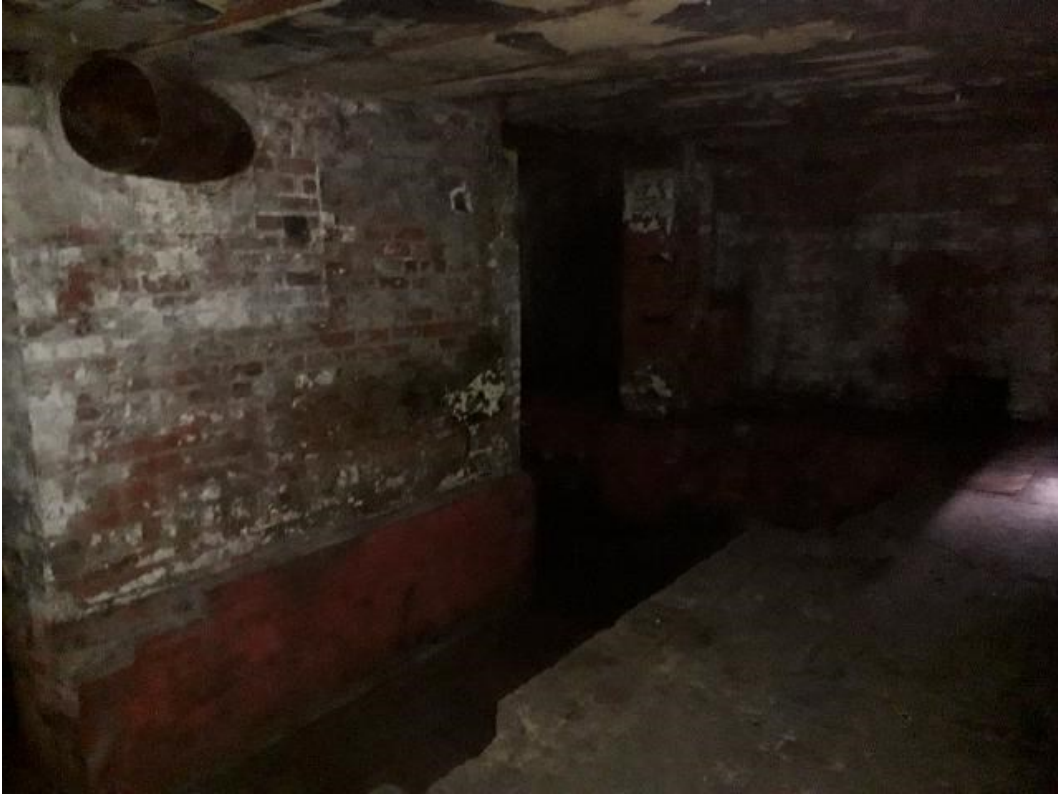
Photo 333: East room in basement (64) facing east (1796\_333.TIF)

The large eastern room (64) (Photo 333) appears to have functioned as the hospital's boiler room, constructed with a brick floor and walls and a concrete ceiling, which may have been added when the kitchen was updated, possibly in the 1960s. The space is divided by a thick spine wall running east-west with openings at either end. The north of the room contains a sunken area approximately one metre lower than the rest of the basement. At the west end of the room there is a large chimneybreast, the chimney itself has been demolished below roof level. At the east end of the room there are two large arched openings for dropping coal, the southern opening has been blocked. A doorway at the east end of the south wall leads to an external set of stone stairs.
