Manor Lodge, Sheffield, South Yorkshire

Archaeological Watching Brief

ARCUS report 1107.7(1)

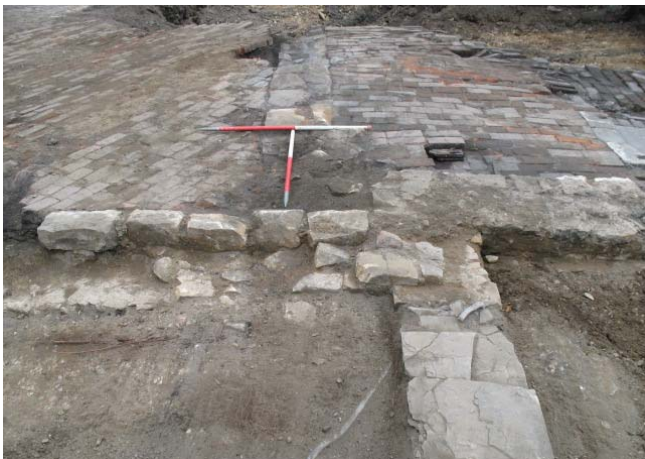
Plate 1 – intersection of walls 1066, 1097, 1098 and 2013
(viewed facing north, 1m scales)

Walls [1011 and 1066], initially recorded during the excavation of evaluation Trench 1, represented the east and west end walls of the original cottage(s) (Phase 1). Both walls continued north beyond the limits of evaluation Trench 1 and keyed into the north wall [1098] of the cottage(s) (**Plate 1**). Wall [1098] was constructed in the same manner as the sandstone foundation walls recorded during the evaluation.

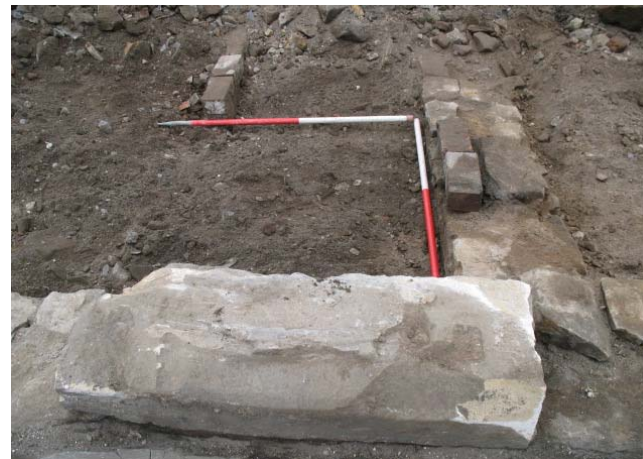
Plate 2 – walls 1099, 1020 and 1022
(viewed facing south, 1m scales)

Walls [1018 and 1099], recorded in the evaluation and watching brief, were stone walls bounding a set of stone steps that descended north from the centre of the cottage(s) toward a small cellar revealed during the watching brief (**Plate 2**). The line of wall [1018] continued north, c.0.90m beyond the limits of evaluation Trench 1 by an extension of brick wall [1020], which terminated at the corner of the steps leading into the cellar. Parallel to wall [1018], wall [1099] lie under (evaluation) wall [1022] and bounded the west of the stairs. The north terminus of wall [1099] abutted the southeast face of wall [1098] where it formed the northwest corner of the cellar. The south of the cellar was bounded by a substantial stone wall [1101] keyed into the north terminus of wall [1018] and the southwest face of wall [1011/1102]. Walls [1099 and 1101] were constructed in the same manner as the sandstone foundation walls recorded during the evaluation. All the internal faces of the sandstone and brick cellar walls were whitewashed. A coal slot was cut into the middle of the east wall [1102] of the cellar, c.0.70m above the cellar floor. The floor of the cellar [1115] comprised of large sandstone flags, measuring c.0.55m x 0.60m, set directly on the underlying natural.

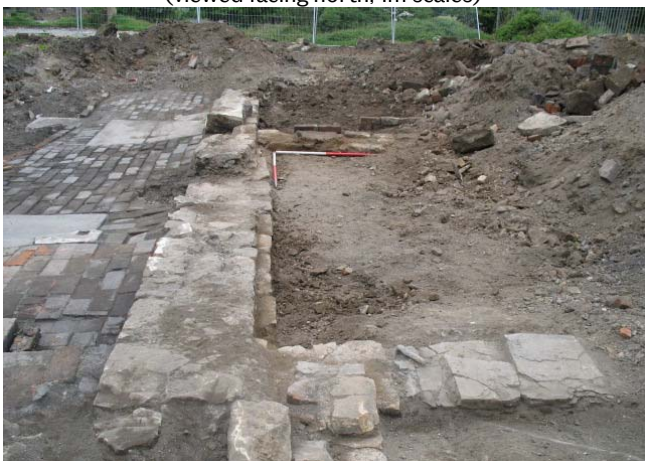
Plate 3 – wall 1098
(viewed facing east, 1m scales)

Slightly offset from wall [1098], wall [1097] formed the north wall of the Phase 2 ancillary structure appended to the west of the cottages (**Plate 3**). Wall [1097] abutted the west and east faces at the termini of walls 1066 and 1074, respectively, and was constructed in the same manner as the sandstone foundation walls recorded during the evaluation.

Red brick surfaces [2017 and 2018], initially recorded in the south end of evaluation Trench 2, continued south beyond the limits of evaluation Trench 2 and abutted the north face of the cottage walls [1097 and 1098] (**Plate 3**).

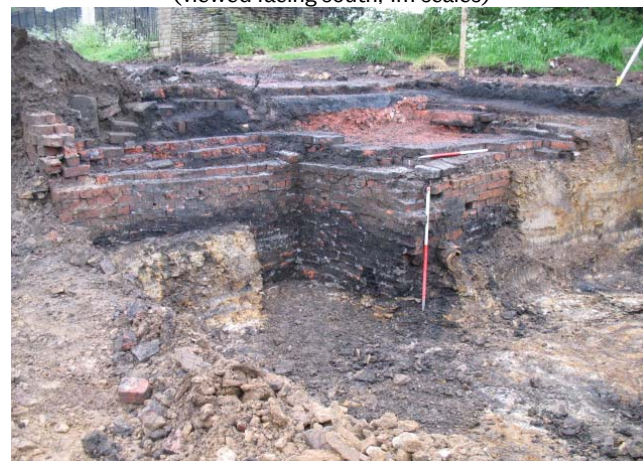
Plate 4 – brick 'soakaway' at west end of cottage
(viewed facing southwest, 1m scales)

At the west of the cottage(s), the composite sandstone flag [1077] and red brick surface [1075], recorded during the evaluation, continued beyond the west limit of evaluation Trench 1. Once fully exposed, it was clear that these small surface areas represented repairs to the former cobbled road following the incorporation of modern water and electric services to the Phase 2 or 3 cottage renovations. A section of the earlier cobbled road had been removed and a substantial red brick drainage/soakaway was cut into the underlying sandstone, then capped with surface [1075] (**Plate 4**).

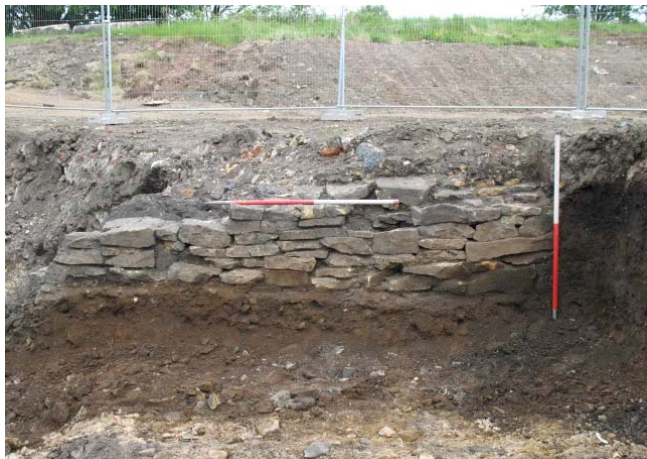
Plate 5 – garden wall 2012
(viewed facing north, 1m scales)

During the evaluation, the intersection of walls [2012 and 2013] defined the northwest corner of the yard associated with the 19th-century cottage. During the watching brief, a further c.3.5m of wall [2012] was recorded to the point where it continued east beyond the limits of the watching brief area (**Plate 5**). South from the limits of evaluation Trench 2, a further c.3.3m of wall [2103] was recorded to the point where wall [2013] abutted cottage walls [1097 and 1098].

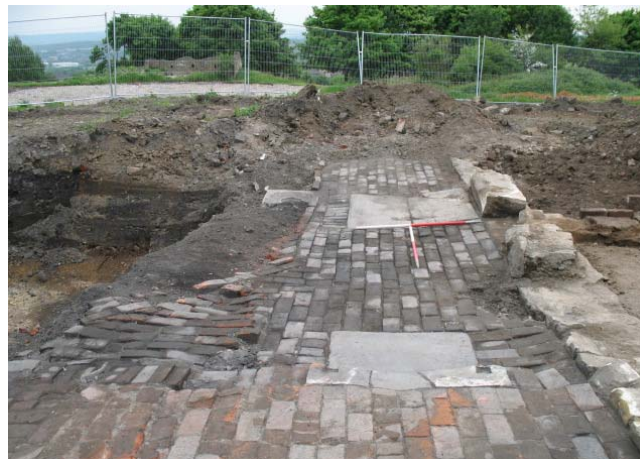
Plate 6 – surface 2025
(viewed facing east, 1m scales)

Bounding the west of surface [2018], a single-skinned red brick wall [2023] with a stone gate threshold [2024] appeared to subdivide the yard surfaces along the north face of the cottages. To the east of wall [2023], another red brick surface [2025] formed what appeared to be a small yard and path along the north of the cottages. Surface [2025] abutted the north face of wall [1098] and was bounded on the north by edging comprised of a single skin of red bricks laid stretcher on edge [2027 and 2029] on either side of a concrete drain [2028] (**Plate 6**).

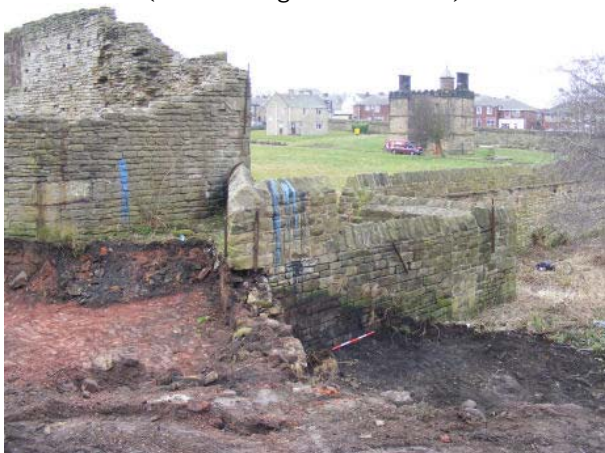
Plate 7 – yard surface 9003 and wall 9002
(viewed facing south, 1m scales)

Structures identified during the groundwork included a red brick yard surface [9003] encountered c.0.35m below the modern ground level and a late 19th-century wall [9002] extending the line of boundary wall section F-G. Yard surface [9003] abutted the east face of wall [9002] and the north face of the boundary wall between points D and G (**Plate 7**). This surface likely continues beneath the topsoil along the north face of the boundary wall to point A, where evidence for a similar red brick surface/road shows through the modern ground cover. A section of wall [9002] has been previously recorded in watching brief Trench 3 from the evaluation stage as a late 19th- to mid-20th-century yard boundary wall associated with the colliery and subsequent yards (McCoy 2007)(**Plate 8**).

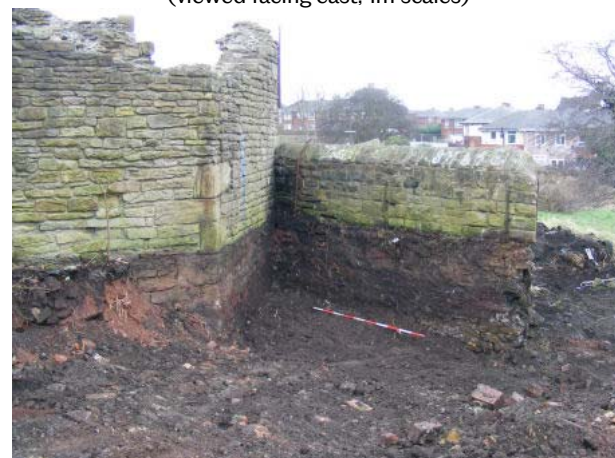
Plate 8 – post-reduction
(viewed facing west, 2m scale)

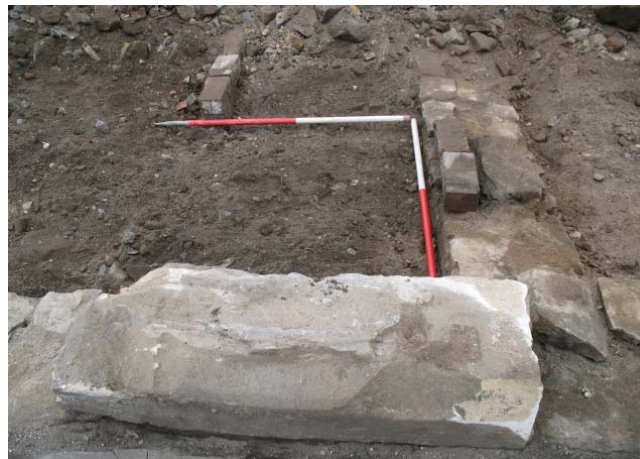
Plate 2 – walls 1099, 1020 and 1022
(viewed facing south, 1m scales)

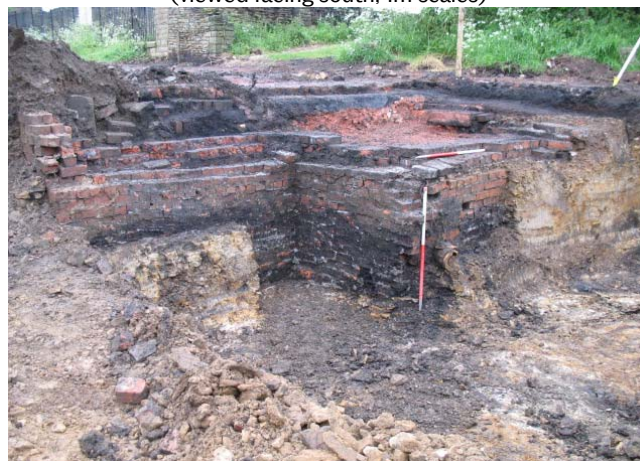
Plate 4 – brick 'soakaway' at west end of cottage
(viewed facing southwest, 1m scales)
