Do Chancels Weep?

Does the often noticed difference between the alignments of nave and chancel actually mean anything?

Ian Hinton

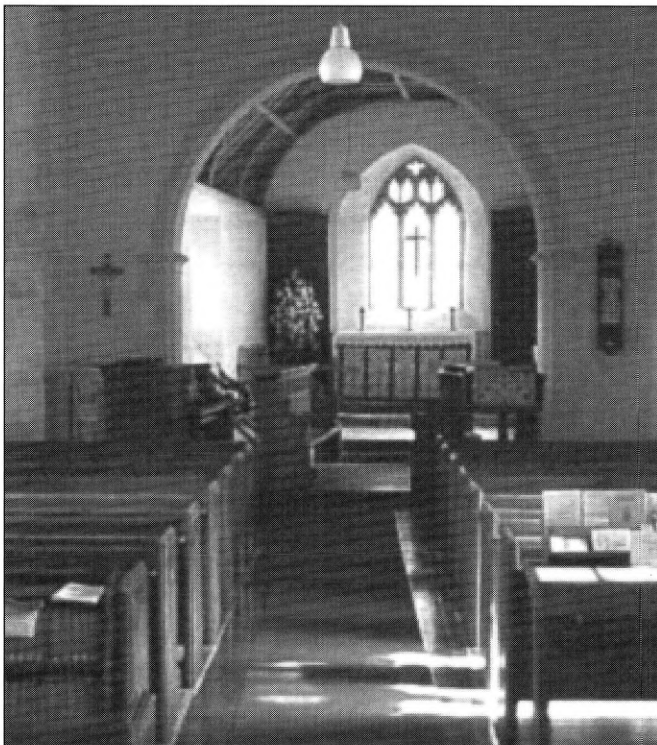
Plate 1 – St Ervan, Cornwall – chancel misaligned right (not weeping) by 7°, improving the alignment from 81° to 88° True

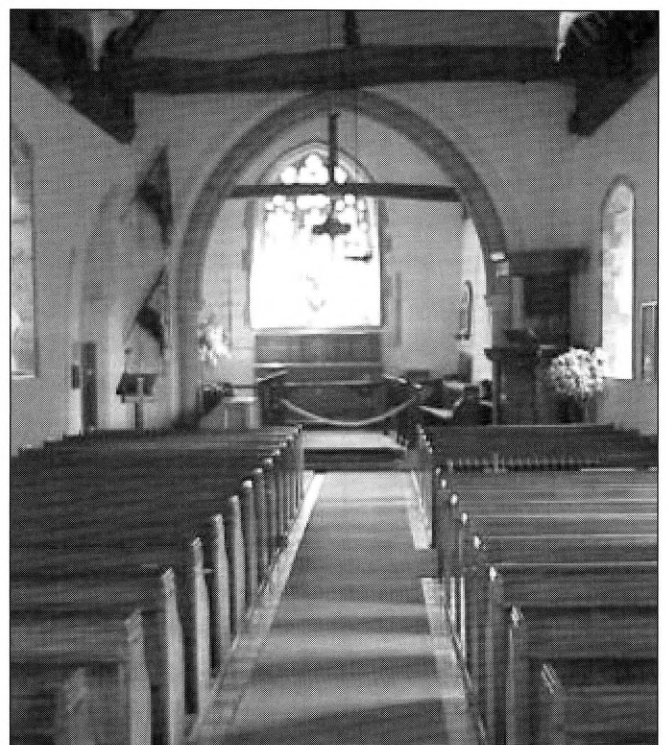
Plate 2 – St Simon, East Dean, East Sussex – with a short chancel, 'weeping' by 14 degrees, but also improving the alignment from 104° to 90° True

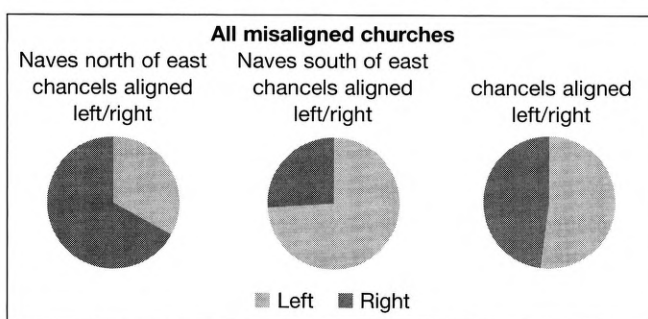
Diagram 2 – Comparative alignment of chancels of all misaligned churches, when nave is aligned north or south of east

If there was no particular reason for the misalignment, then it would be expected that the balance shown in these overall figures would be mirrored in the two groups that make it up.

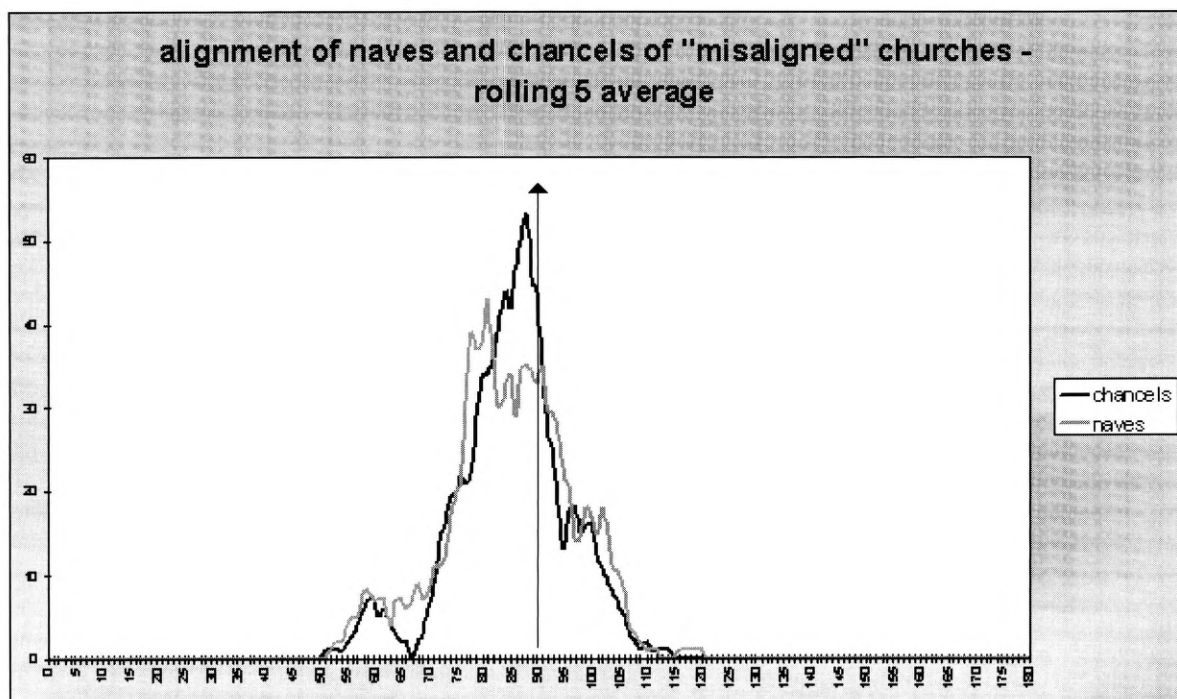
Diagram 3 – Alignments of naves and chancels – demonstrating the improvement in alignment, with chancels close to 90°

The improvement of alignment can be seen in the graph in Diagram 3. The results have been smoothed using a rolling 5 average. Overall, the chancels of the 218 churches are closer to 90° (east) than their naves, demonstrated both by the taller peak of the 'chancel' curve close to 90°, and its narrower shape overall.

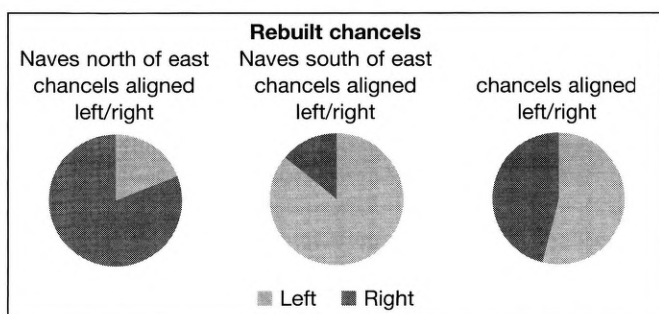
Diagram 4– Comparative alignment of chancel in churches with rebuilt chancels, when nave is aligned north or south of east.

south of east have rebuilt chancels that are aligned left (Case 3) (86:14). When taken together, however, these concentrations all but cancel each other out. The right hand diagram above shows how, overall, the proportions of those misaligned left (weeping) are almost balanced by those misaligned right, 52:48. The variation in figures becomes more marked when those churches with naves aligned close to east (between 88 and 92°) are excluded, rising to 83% improving the alignment (83:17), whilst the overall situation is still almost balanced at 46% aligned left (weeping) and 54% right (46:54).

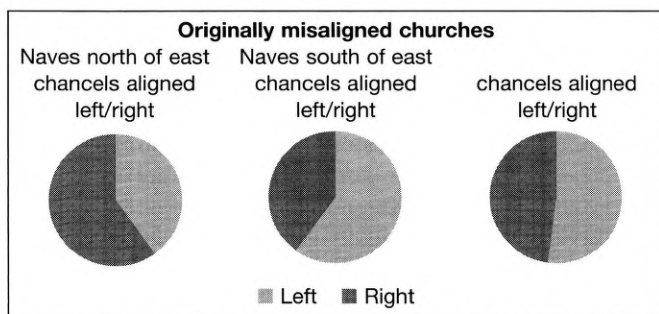
Diagram 5 – Comparative alignment of chancels in churches where nave and chancel are of the same 'period', when nave is aligned north or south of east

When considering churches that do not appear to have rebuilt chancels, it must be assumed that they were originally built misaligned. The results are illustrated in Diagram 5. When those churches with naves aligned close to east are excluded, the misalignment left: right proportions of 49:51 demonstrate that this is likely to be random, but the proportions of cases

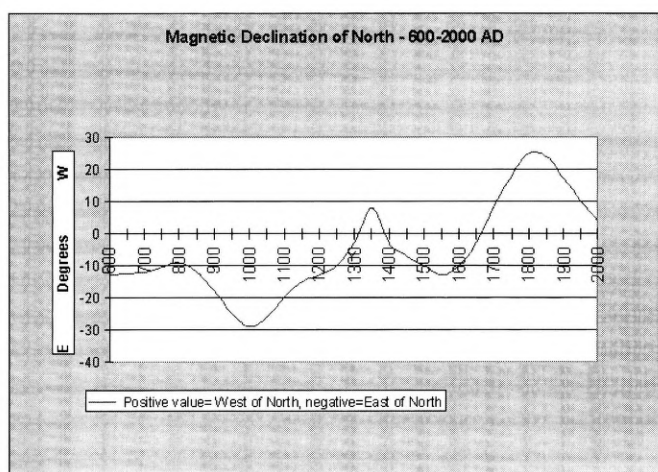
Diagram 6 – Magnetic declination of North between 600 and 2000AD (Author's extract of declination from combined plot of magnetic declination and inclination, after Clark et al p659)

set out the new alignment, then the chancel would have been realigned towards magnetic east rather than True East. Where was magnetic east when the church was realigned? The east-west difference between a magnetic direction and the true direction is known as magnetic declination. It was first measured in London in 1576¹⁰, and has been projected backwards in time by using datable objects which have thermo-remnant magnetism¹¹, enabling a graph of the movement of the magnetic pole to be plotted. Diagram 6 shows the author's extract of the declination from Merrill's combined declination and inclination plot¹².

During the medieval era, apart from a 50 year period between approximately 1325 and 1375, magnetic east was always south of True East, being approximately 20° south of

True East in 1100, 15° in 1200 and 7° in 1300, 7° in 1400 and 14° in 1500, resulting in magnetic easts in these years of 110°, 105°, 97° and 104°, compared with True East (90°). Therefore any realignment using a compass before this date would have been made towards magnetic east, ie towards 100° True or more, rather than to True East at 90°.

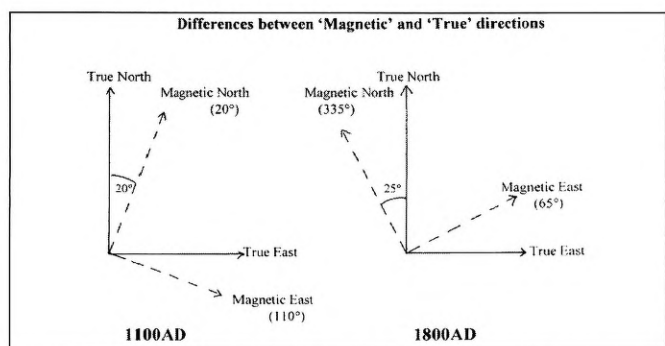
Diagram 7 – Variations between Magnetic and True directions
