Southampton Archaeology Unit

Report 1222

Archaeological Building Recording at 117, 119, 121 and 123 Paynes Road, Freemantle, Southampton SOU1696

Client: Homelife Estates Limited.

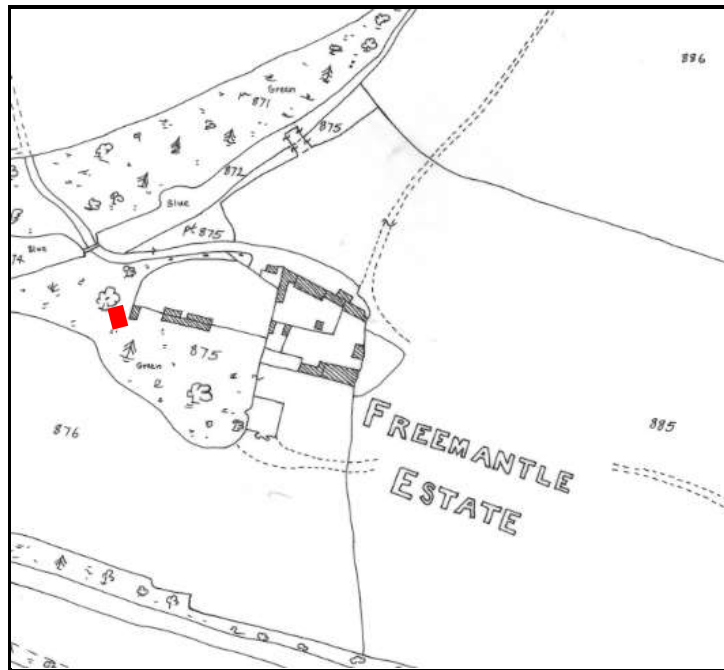
Figure 2. A tracing of the Millbrook Tithing Map of 1843, with the position of No 123 Paynes Road shown as a red rectangle.

6.3 The Millbrook tithe map of 1843 shows Millbrook House facing approximately south-southwest, with a group of buildings to the north of it (fig 2). They are hatched on the map to indicate that they are not dwellings, and

they would have been the *coach-houses stabling, homestead, green and hot-houses, pinery, ice-houses* etc as advertised in the Hampshire Independent of 1848 (<http://sotonopedia.wdfiles.com/local--files/page-browse%3Afreemantle-house/HSi3%2B031.pdf>). The sale plan of c.1852 marks the two buildings in the far west of the complex as 'conservatory' and 'orangery'. It is the conservatory that appears to have been mistaken for No 123 Paynes Road. Figure 2 clearly shows that it No 123 was not in the correct position to be a lodge for the estate

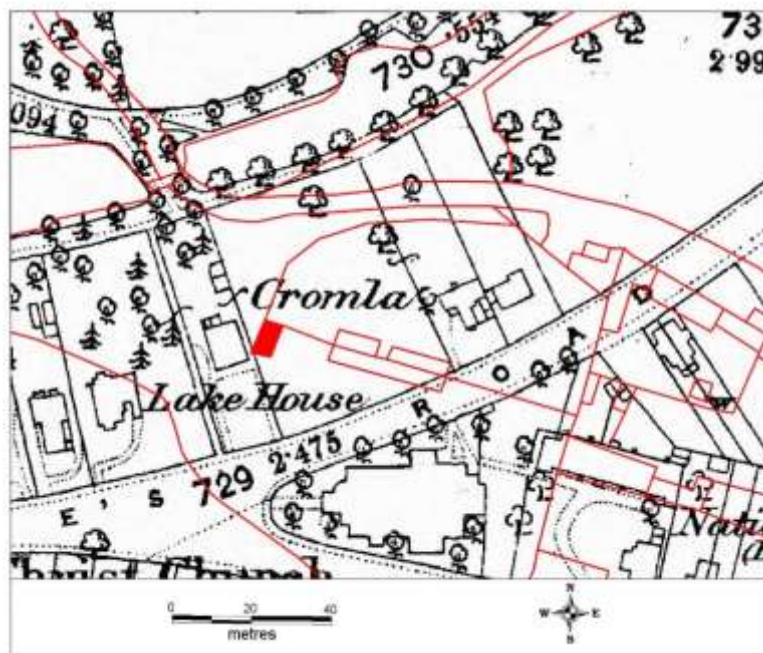
Figure 3. The 1871 (surveyed 1866-69) Ordnance Survey map overlaid on the tracing of the Millbrook Tithing Map. The conservatory is shown in red.

6.4 Figure 3 shows the 1871 (surveyed 1866-69) Ordnance Survey map overlaid on the tracing of the Millbrook Tithe Map, again making it clear that No 123 is not an estate building. The 1871 Ordnance Survey map does show that No 123 was in existence at that date, and that Nos 117, 119, and 121 had not been built. They first appear on the 1895 Ordnance Survey map (fig 4). Later maps (figs 5 and 6) show little change in the layout of the buildings, but there had been alterations and extensions by 2013 (fig 7).

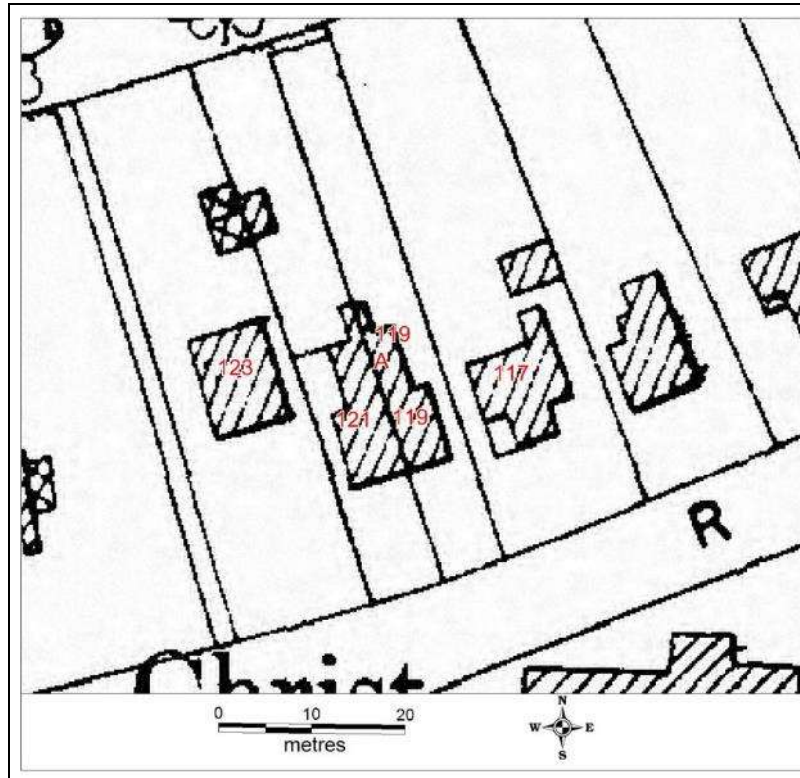
Fig 4. The 1895-6 Ordnance Survey map showing the site; © Crown Copyright. All rights reserved Southampton City Council. LA 1000 19679. 2015.

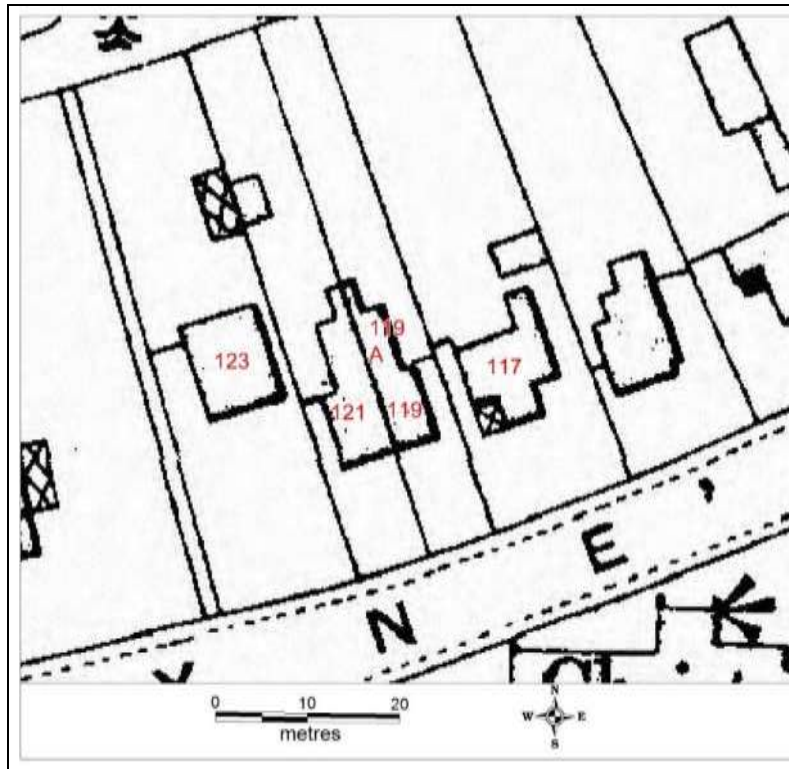
Figure 5. The 1909-10 Ordnance Survey map showing the site.
© Crown Copyright. All rights reserved Southampton City Council. LA 1000 19679. 2015.

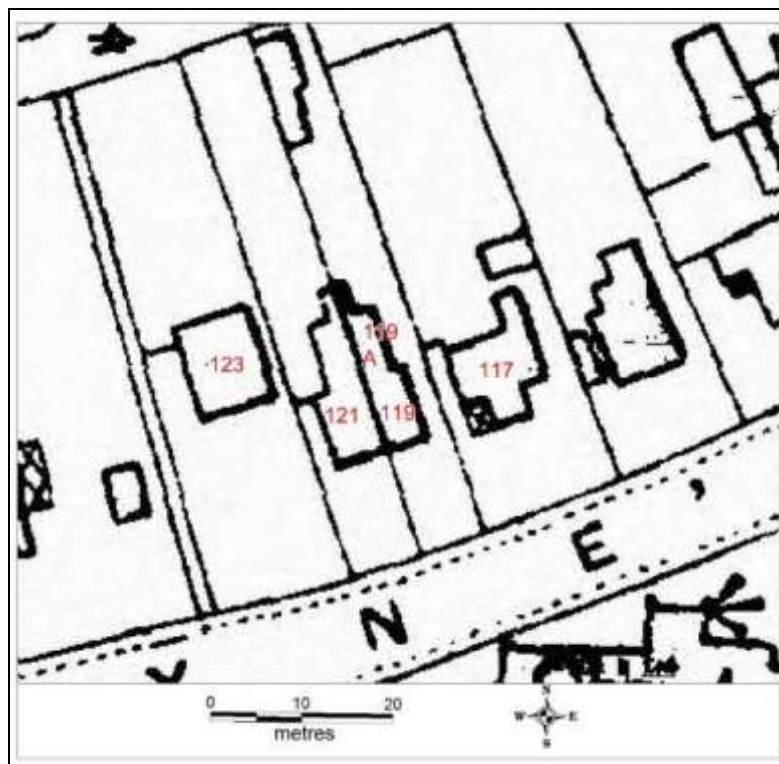
Figure 6. The 1933-46 Ordnance Survey map showing the site.
© Crown Copyright. All rights reserved Southampton City Council. LA 1000 19679. 2015.

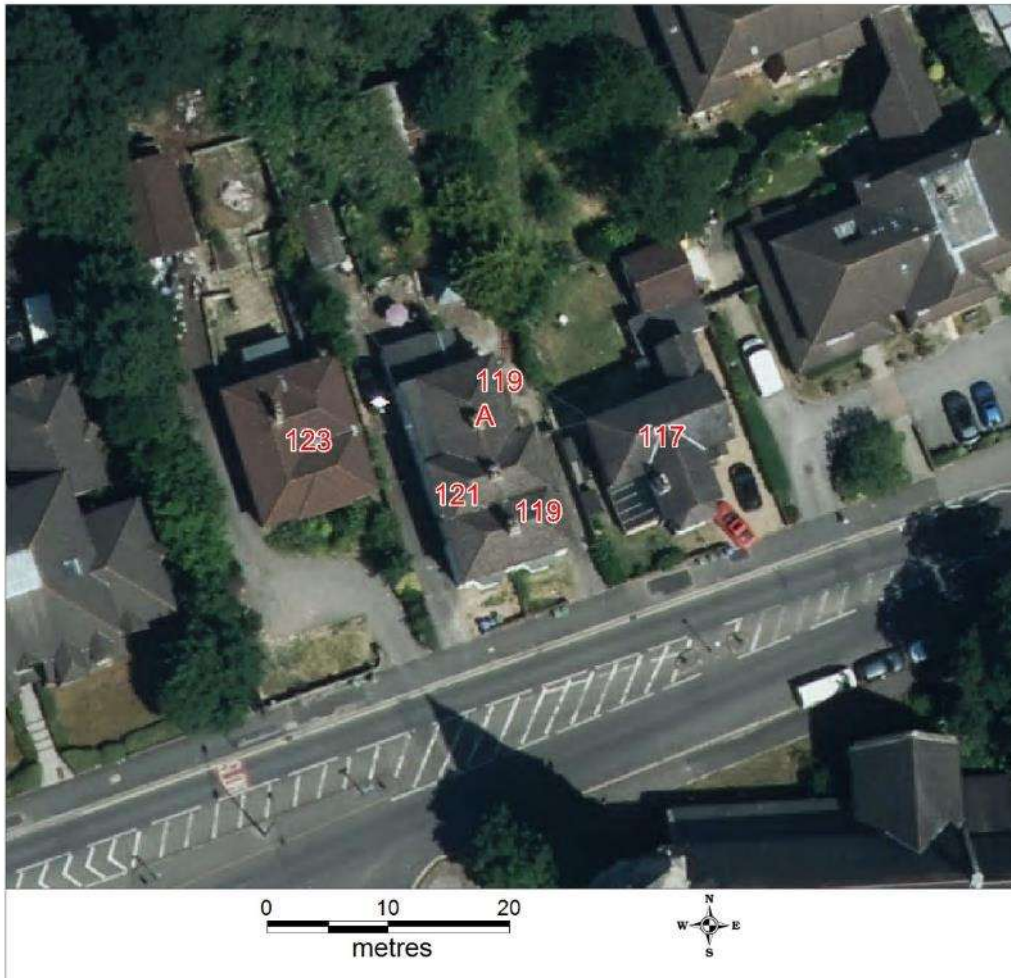
Figure 7. A 2013 aerial photograph showing the site. An extension has been added to the northwest of 123. Extensions have been added to the northwest and southwest side of 121. Further extensions have been added to the north of 117.

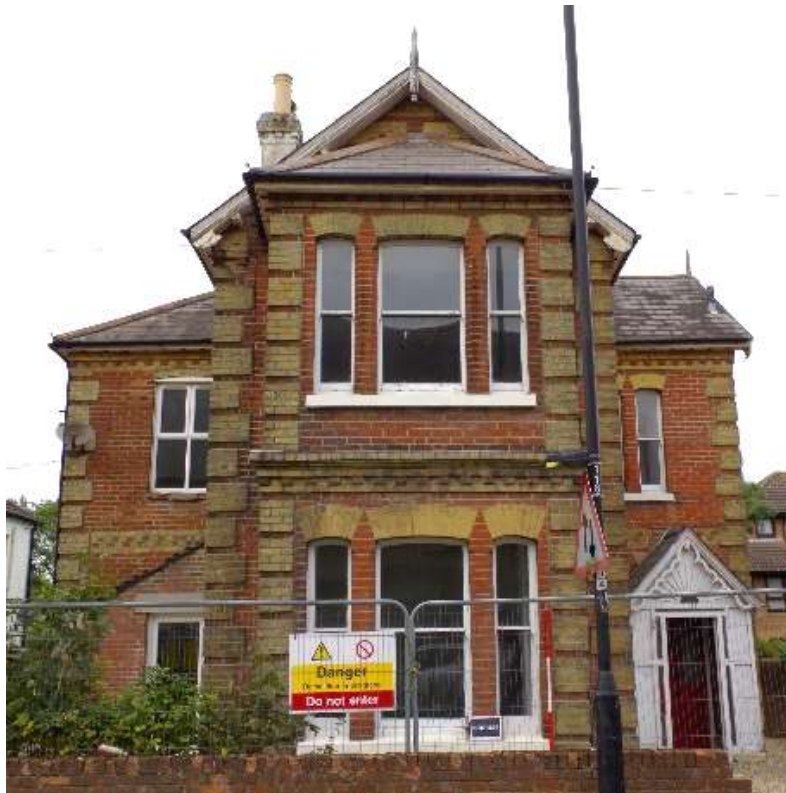
The main SE elevation

The front of the house was built mostly of red bricks, 218mm long, 111mm wide and 69mm deep, in stretcher bond, with decorative elements constructed of yellow bricks. These included the lintels and brick quoins. At first floor level was a decorative string consisting of two courses of alternating red and yellow bricks, bracketed above and below by a single course of yellow bricks. At the top of the building was one course of alternating red and yellow bricks, bracketed by two courses of yellow bricks. The window sills and the lintels at the back of the building were rendered brickwork.

The roof was hipped to the west with gable ends on the south and east arms of the T. It had a slate roof with the ceramic ridge tiles. There were decorative barge boards with pointed finials at each gable. Two chimneys were situated in the west of the roof. At the back of the building a possible chimney breast was visible on the rear outside wall, suggesting that rooms 5 and 8 may have had fireplaces at one point. A small wooden porch was situated in front of the front

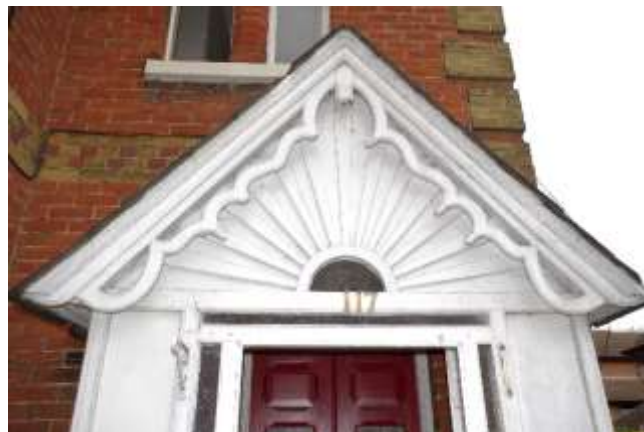
Close-up of SE-facing elevation of porch

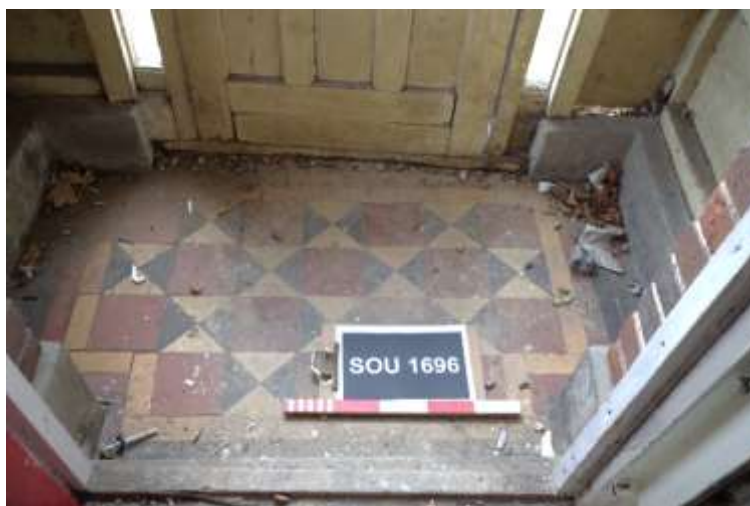
Floor of porch, looking southeast

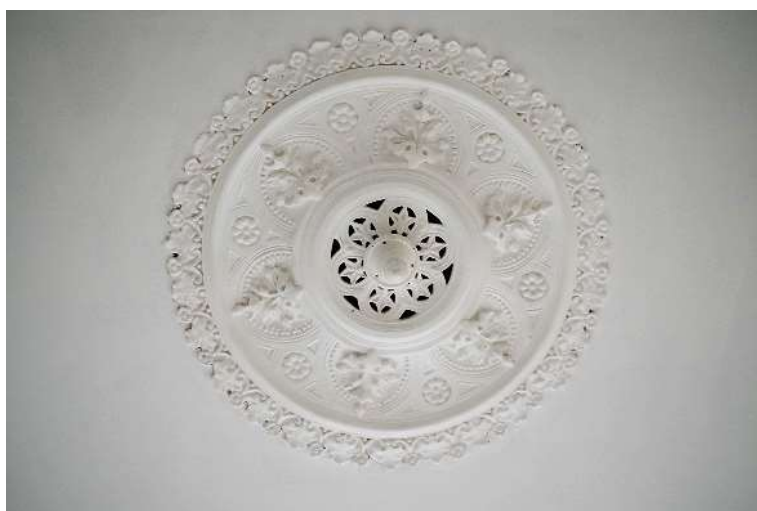
Moulding in centre of ceiling in Room 1

Ground floor front room, Room 1, was situated at the front of the building and would have originally been the living or reception room. This room was part of the original building. A square bay window was situated in the southeast of the room. The front of the bay had 3 original sash windows, one larger in the middle and two smaller to either side of it. Both sides of the bay also contained smaller sash windows. The catches on these windows also seemed to be original. The coving around the wall junction with ceiling was probably original, and was cavetto coving. A decorative ceiling medallion with a floral and leaves motif was

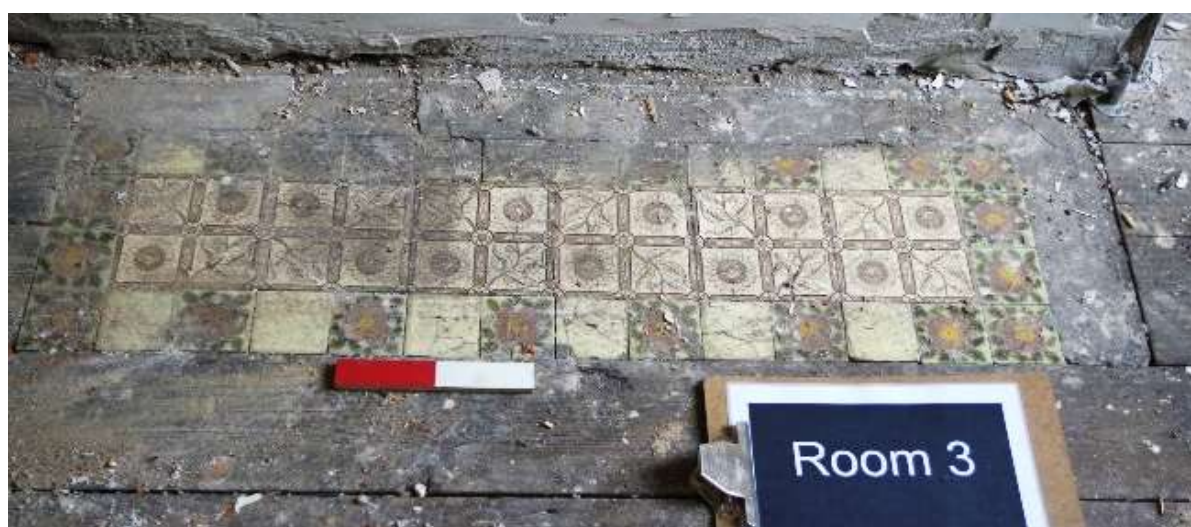
Tiles in front of chimney breast Room 3.

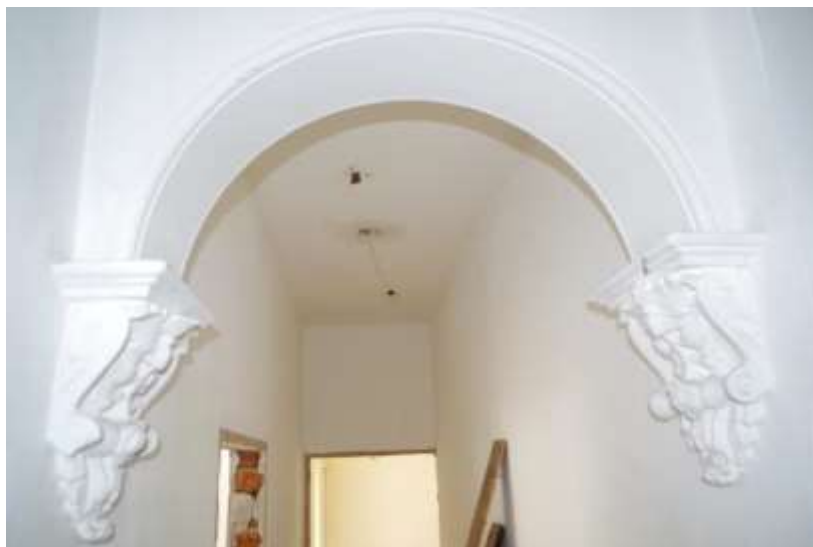
NE-facing elevation of decorative moulded arch room 4.

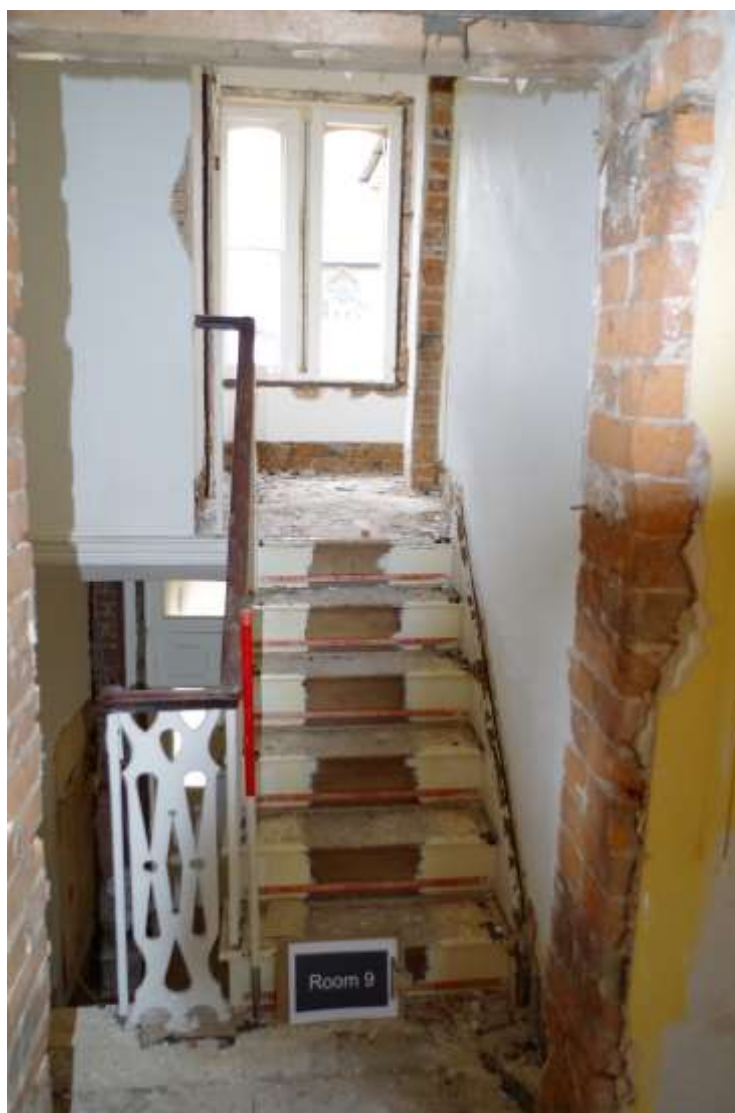
Room 9 general shot, looking southeast upstairs from middle landing

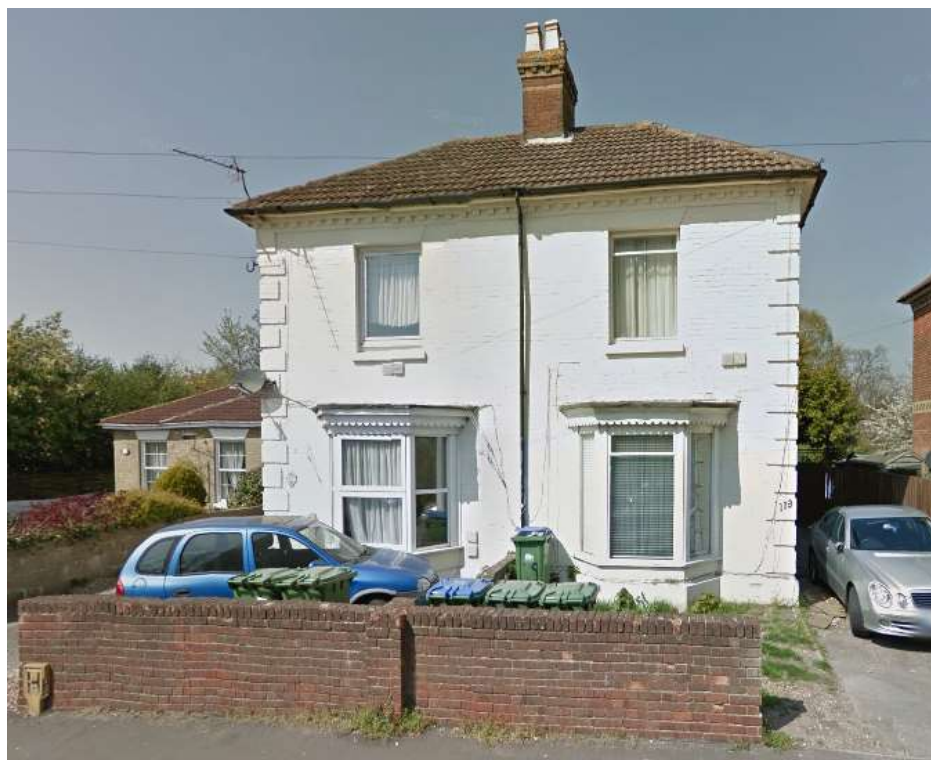
SW-facing elevation of Nos 119 (right) and 121 (left)

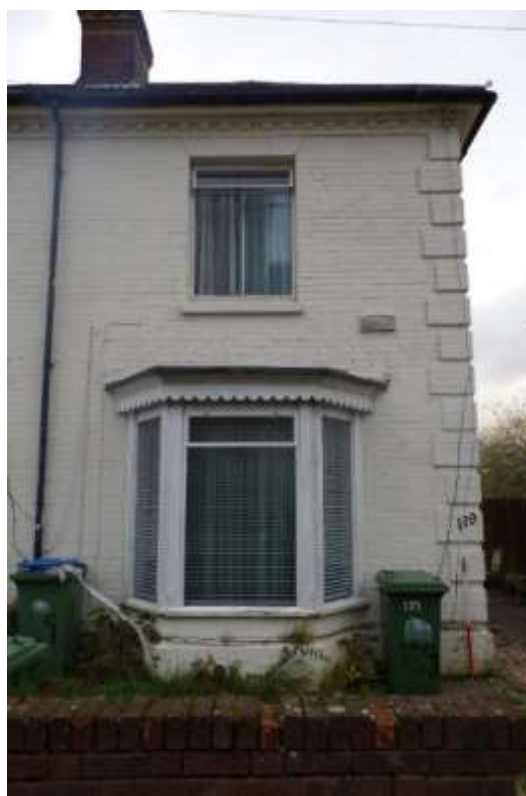
Façade of 119, looking northwest

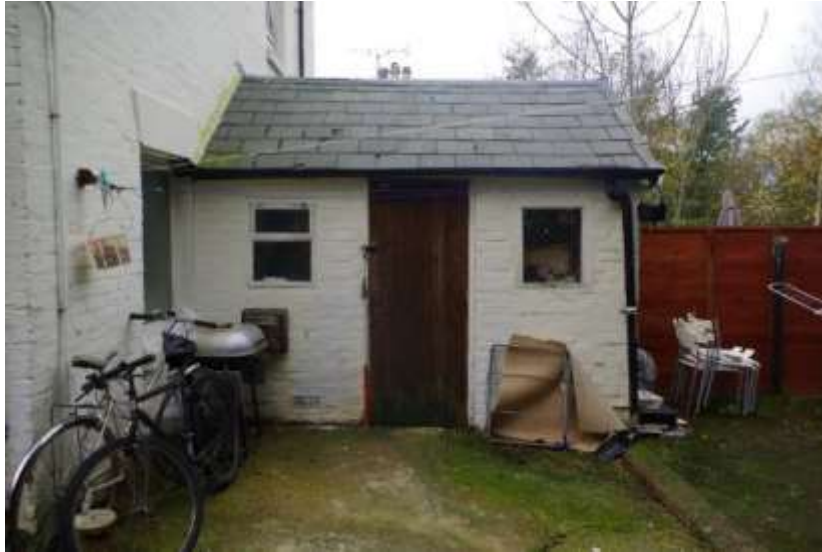
Northeast elevation of outhouse to 119, looking southwest

An outhouse was situated at the rear of 119A. This room could not be accessed.

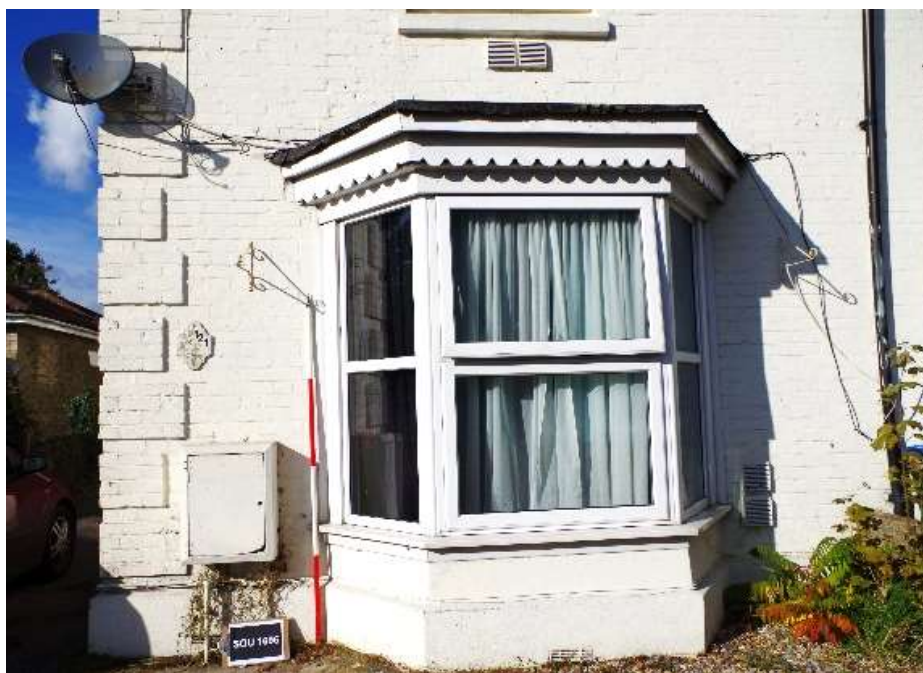
Bay window

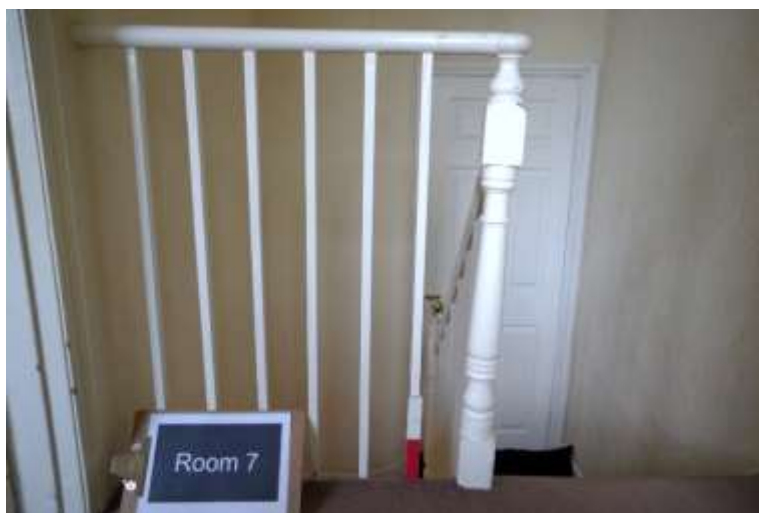
SW-facing elevation of 1st Floor banister Room 7.

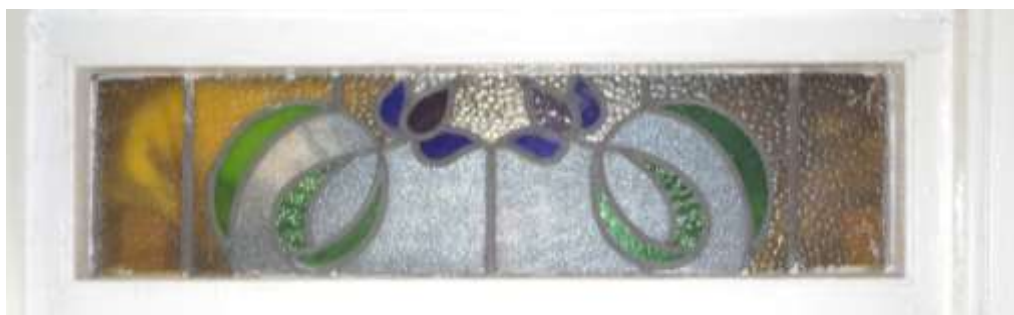
Close-up of NE-facing elevation of stained glass above front door

This was the room number given to the ground floor hallway and staircase. The hall led to rooms 8 and 10, with the southwest door leading out to a modern porch. The front door itself was modern, of aluminium and glass, however above the door was an art nouveau style stained glass window, depicting two tulips. The banister was made of wood with turned wood posts. Two cupboards were situated under the stairs. The coving was cavetto coving, the skirting board was made of wood and was 300mm high.

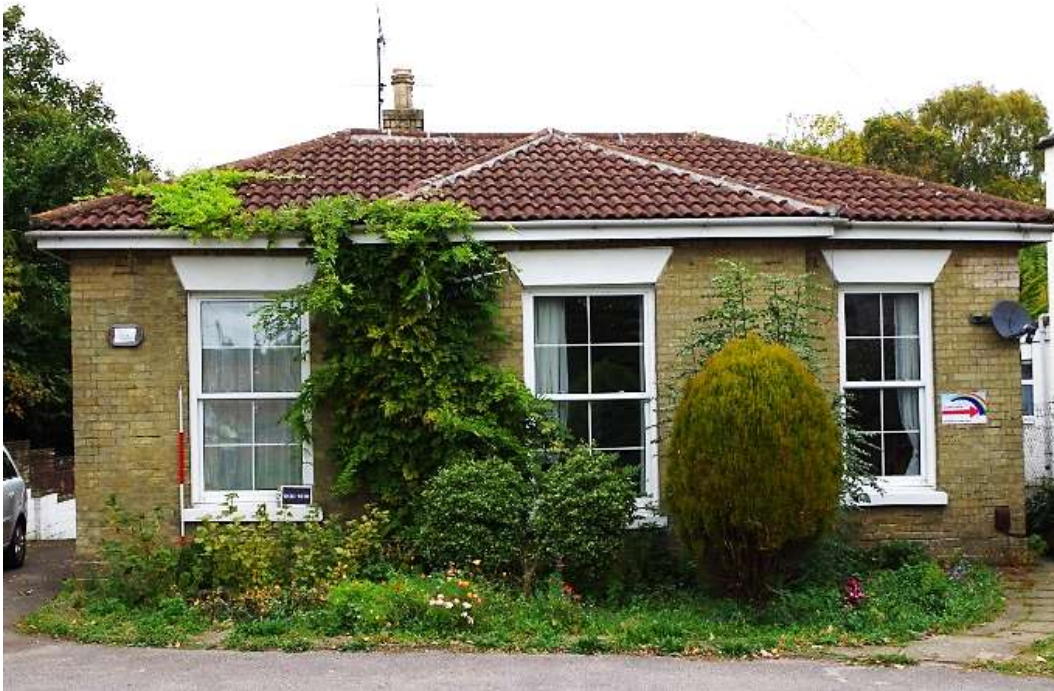
SE-facing elevation

The external walls were built from yellow bricks 225mm long, 107mm wide and 65mm deep in Flemish bond. The sills and lintels of all the windows were made of rendered brickwork and were painted white. The roof was hipped and was covered in concrete roof tiles. One chimney was situated near the rear of the roof. A modern single storey conservatory was situated at the rear of the building. Three blocked windows were visible only from the outside of the property. They were situated in the northeast wall of room 1, the southwest wall of room 2 and the northwest wall of room 6.

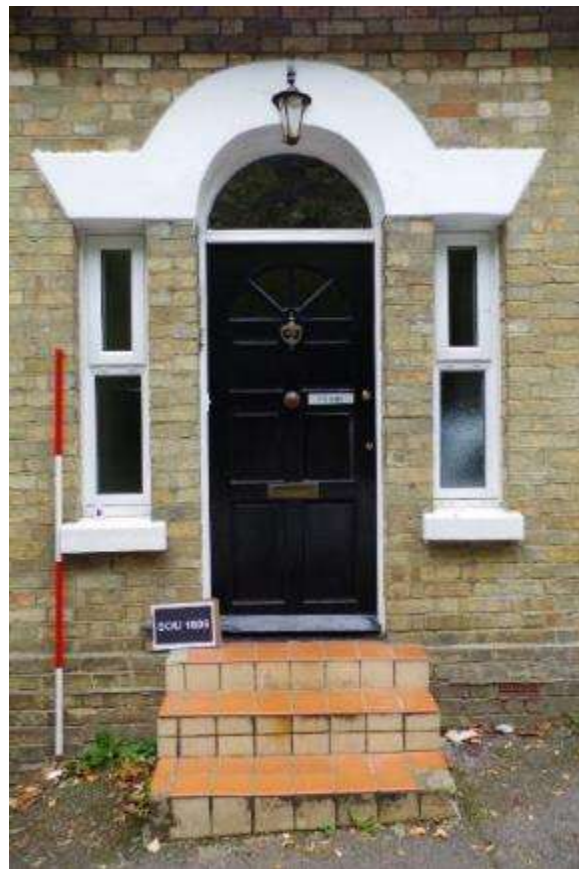
SW-facing elevation of external door and its venetian arch.
