**HISTORIC BUILDING RECORD  
AT  
178 & 182 NEW CROSS ROAD  
LEWISHAM**

*National grid Reference (NGR): TQ 3573 7690*

*Planning applications: 06/61637 & 06/61638/CAC*

SEPTEMBER 2006

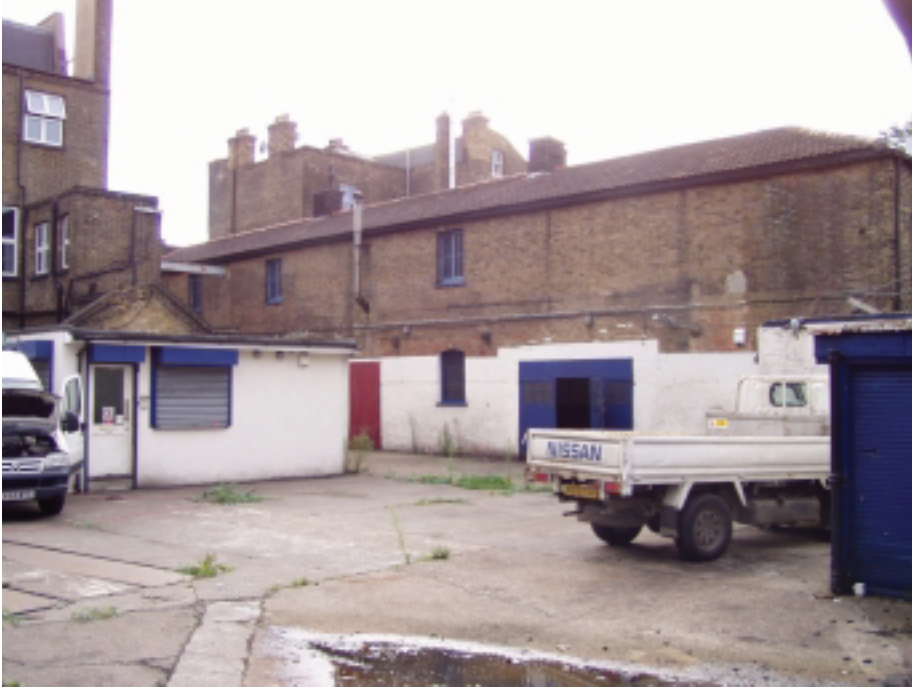
Plate 5: North facing elevation, 182, New Cross Road

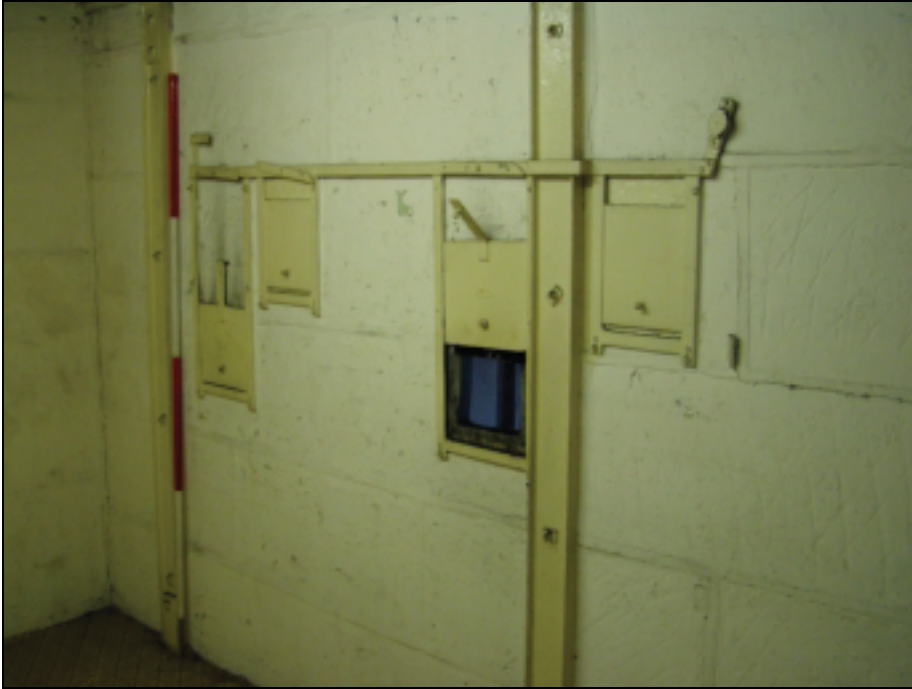
Plate 7: Projector Room

*First Floor Projection Box (1F2) (Figures 7 and 8) (Plate 7)*

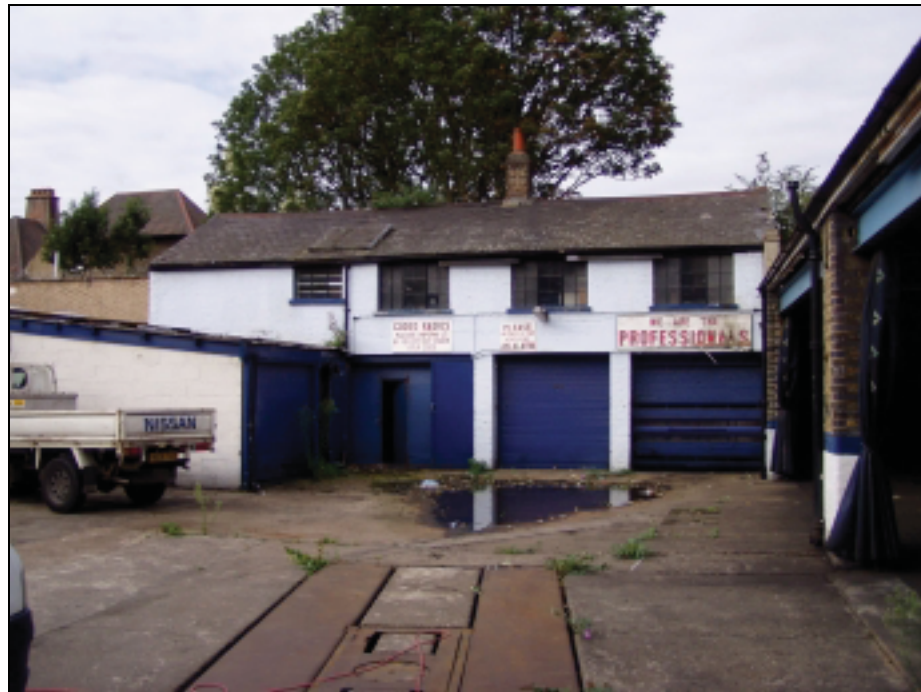
Plate 8: Building B: exterior

*Exterior (Plate 8)*

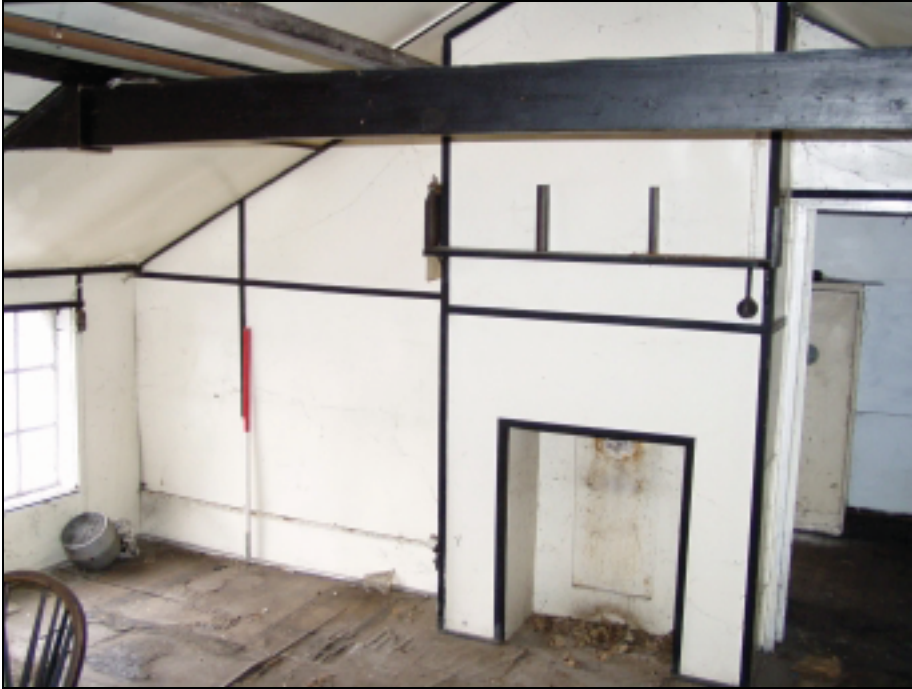
Plate 9: Fireplace First Floor, Building B

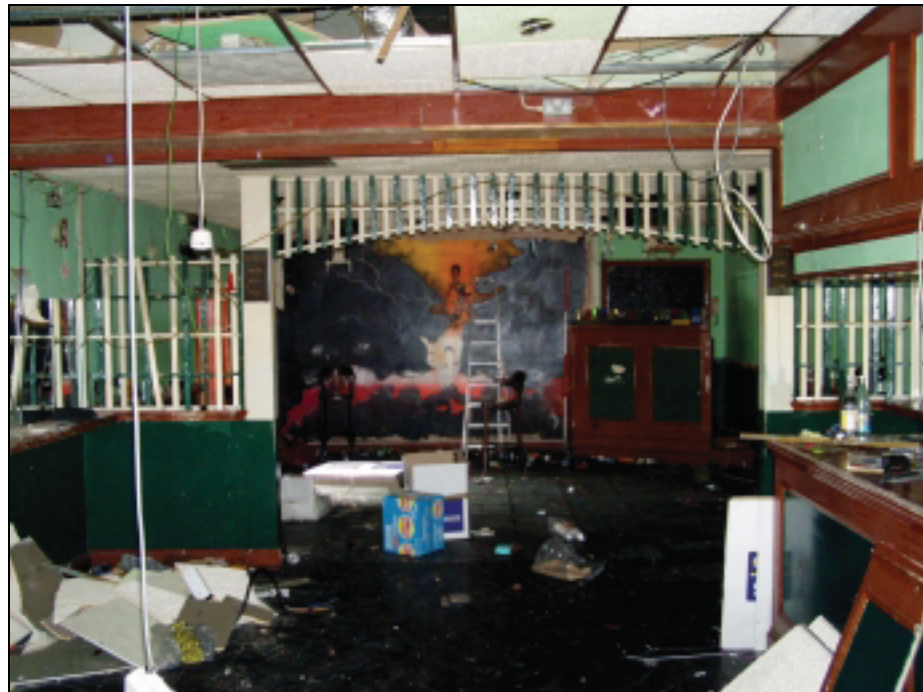
Plate 12: Club area, 178, New Cross Road

- 4.41 The ground floor of the club was split into two spaces by a decorative wood and glass partition (Plate 12). The eastern end, closest to the entrance door contained a long bar along the northern wall, and had mirrors lining the walls (GF2). A blocked fireplace was present, the chimney stack concealed behind the mirror finish. The floor was laminate wooden flooring over a solid base, thought likely to be concrete. The rear room, to the west of the building (GF3) had a small cupboard in the northwest corner, beneath the rear stairs to the second floor.

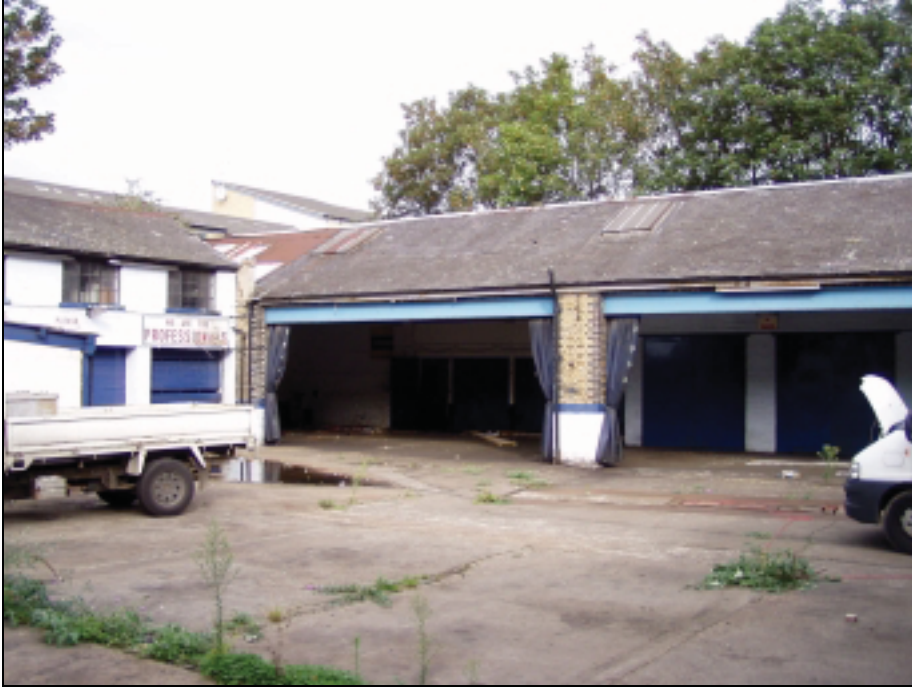
Plate 13: Building D exterior

*General (Plate 13)*

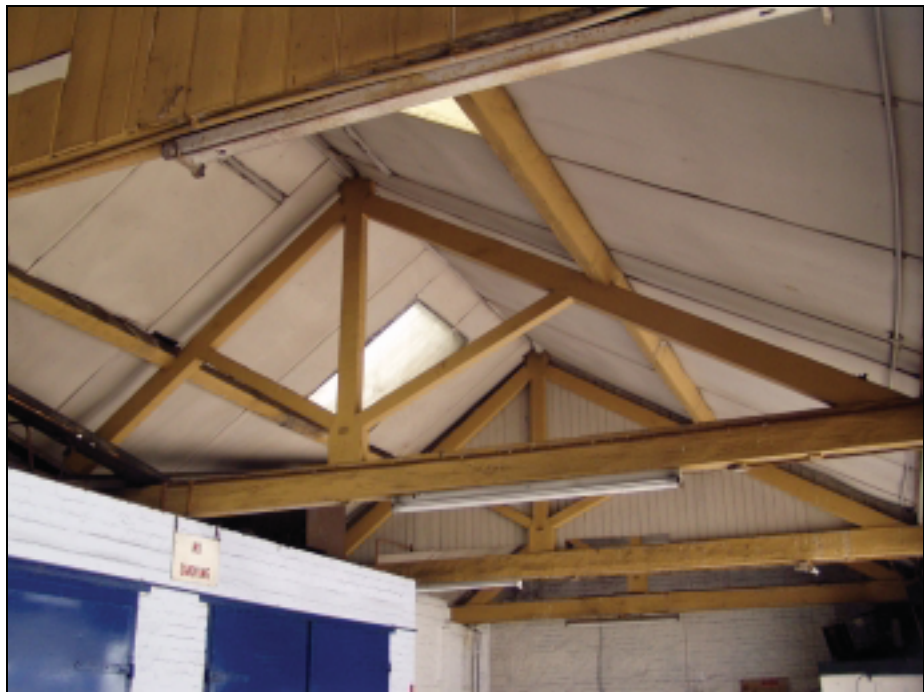
Plate 14: Roof trusses, Building D

- 4.51 The roof was supported by a series of king post trusses spanning between the sides of the building, laying upon piers standing 0.10m proud of the walls, where surviving modification. Each truss had struts between the base of the king post and the principal rafters, just below the level of purlins. Common rafters lay atop the purlins, resting on wall plates at the base and a ridge beam at the top (Figure 14, Plate 14).

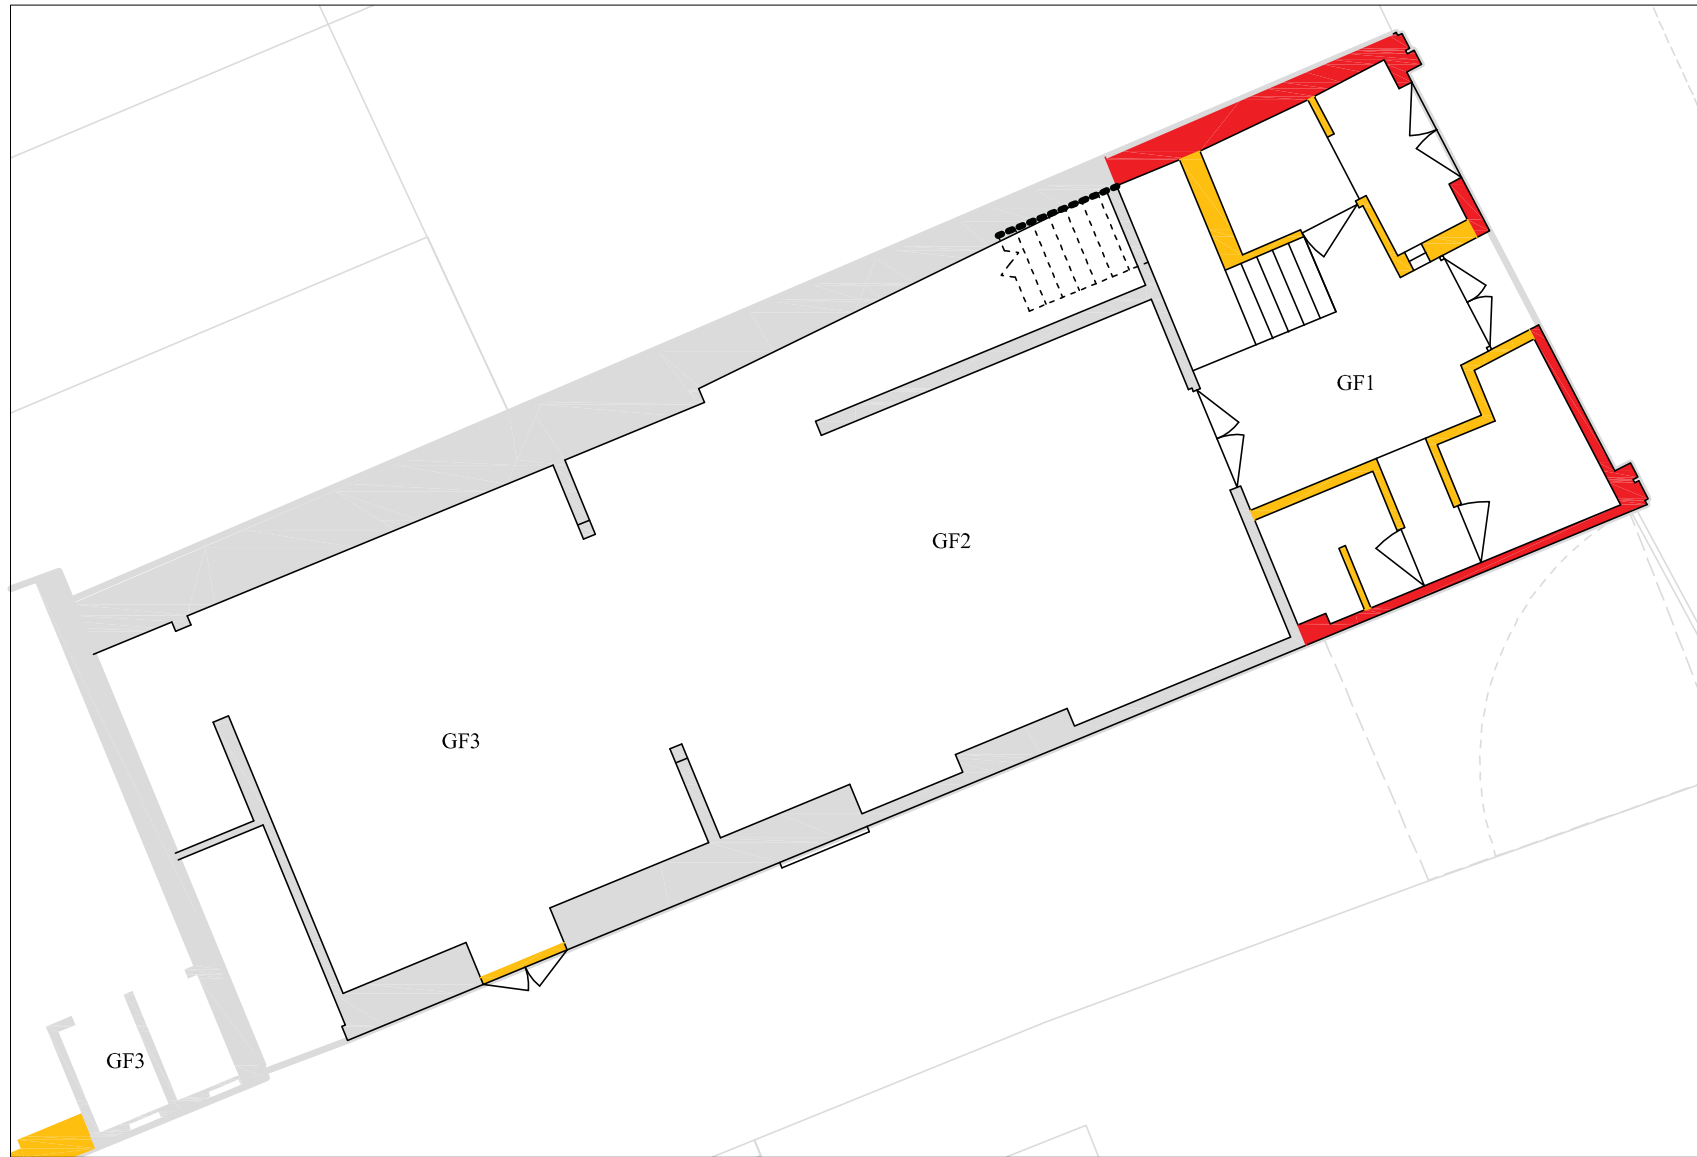
**Figure 11:** Building C 178 New Cross Road: Ground Floor

**BUILDING C: 178 New Cross Road, End of Terrace** (Figures 11 and 12)
