Broomhill House & Steading, Sighthill, Glasgow: Archaeological Evaluation & Excavation Data Structure Report

AOC 23135
21st September 2016

Prepared by: Kevin Paton

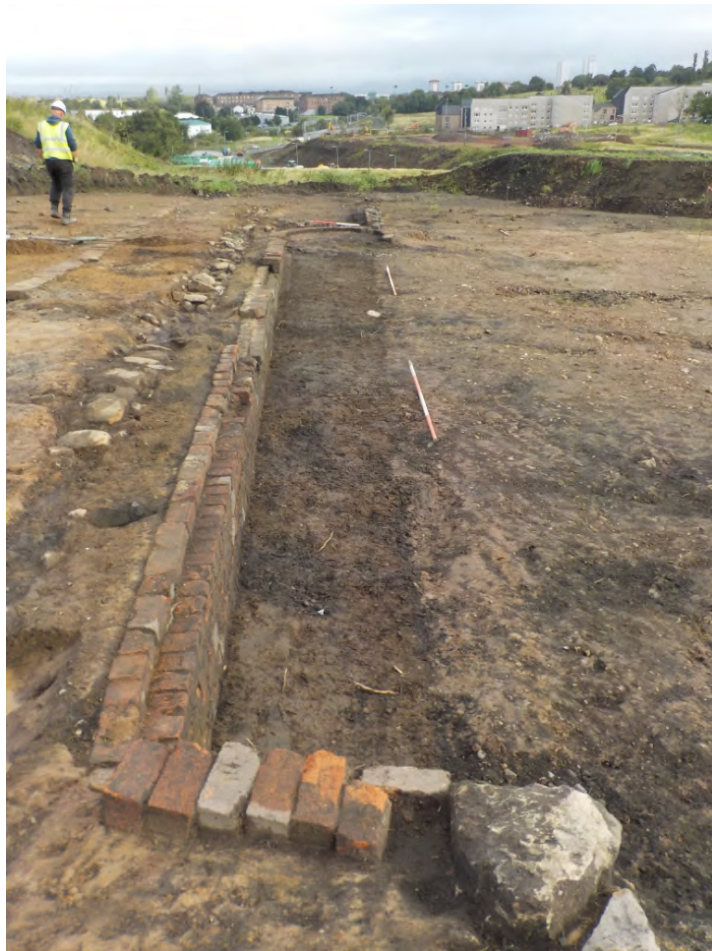
Plate 3: General view of retaining wall [1031]

Plate 3: General view of retaining wall [1031]

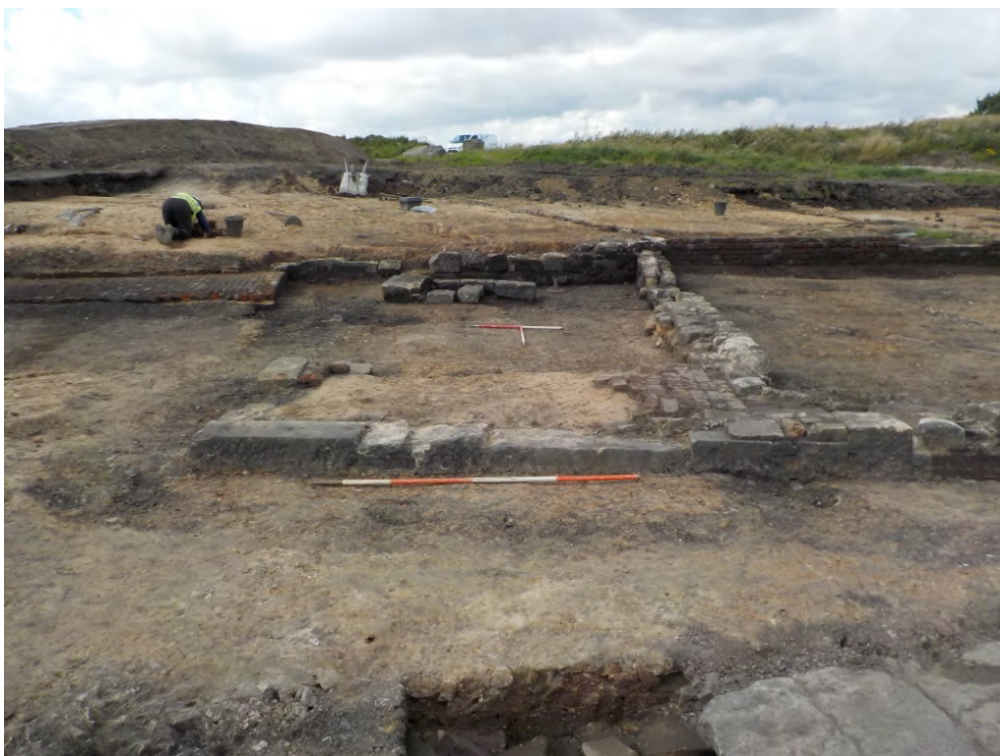
Plate 4: General view of structure [1049]

Plate 4: General view of structure [1049]

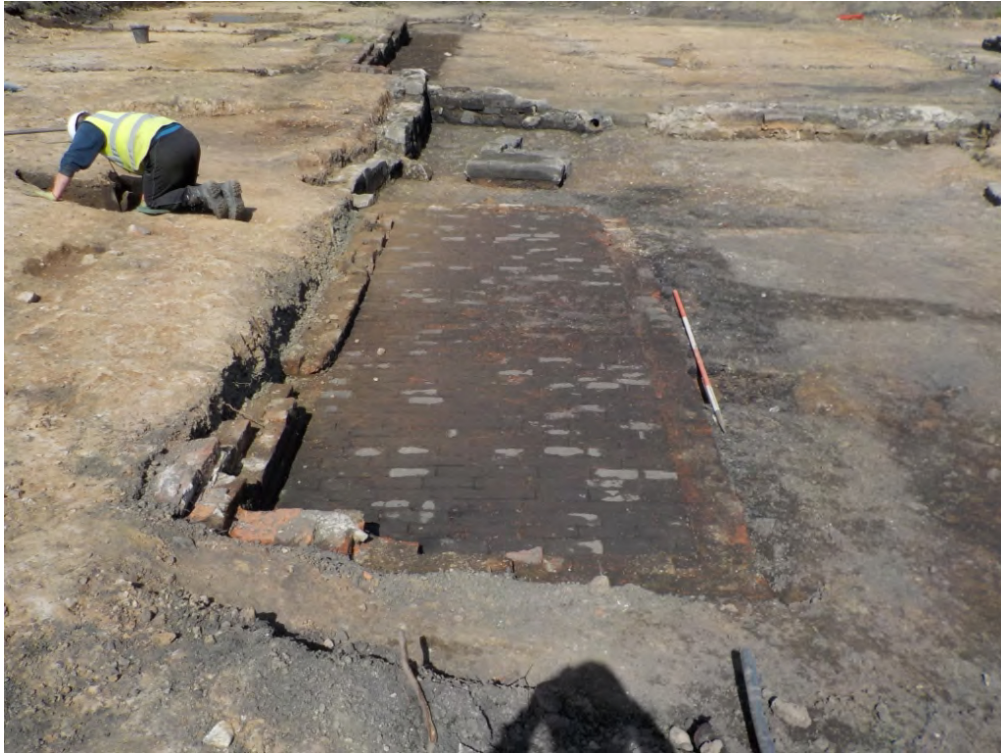
Plate 5: General view of structure [1048]

Plate 5: General view of structure [1048]

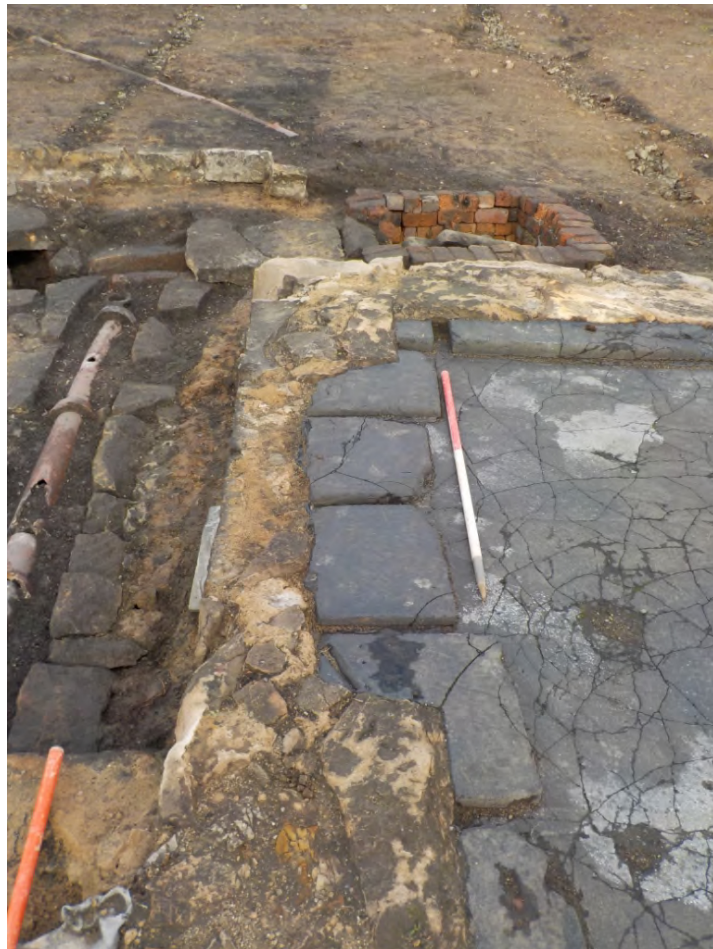
Plate 6: General view of window recess [1089]

Plate 6: General view of window recess [1089]

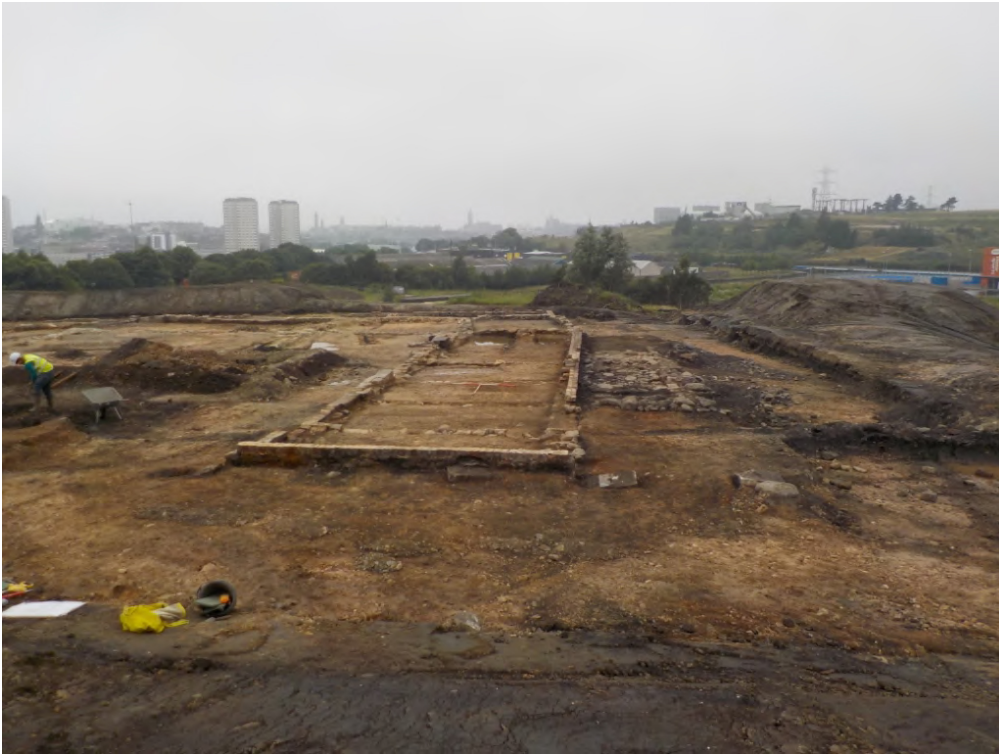
Plate 7: General view of structure [2103]

4.4.2.1 The initial phase of use on the site relates to cartographic evidence from the 18th and early 19th century, but may be earlier in date. This phase consisted of two main structures: a single long house, structure [2103], aligned E-W to the N of the site; and a long farm building, structure [2172], also aligned E-W to the S of the site (Plate 7). This southern structure has not survived later reconfiguration well, and only consists of L-shaped sandstone and boulder wall foundation [2014] that was re-used as part of the 19th century boundary around the site. The structure is approximated to have been 18.2 m long by 7.5 m and contained a central rubble drain [2112].

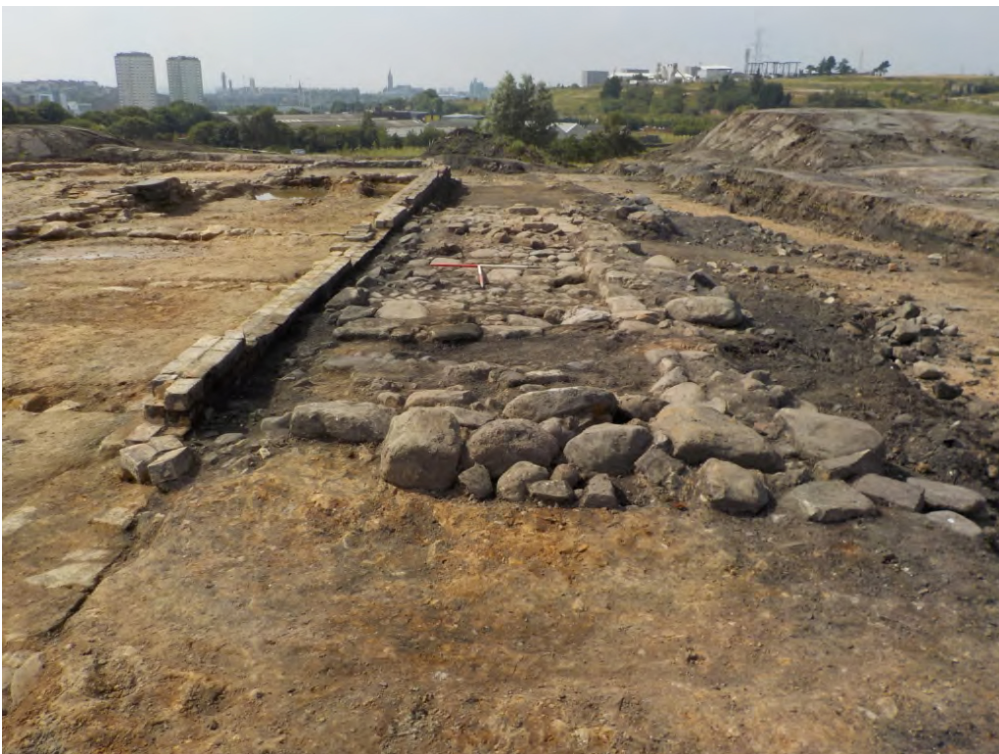
Plate 8: General view of structure [2129]

4.4.2.2 Attached to structure [2103] along its N edge was structure [2129] (Plate 8). This smaller structure did contain floor levels and some internal features, but the relationships with structure [2103] had been removed by the construction cut [2137] for brick wall [2056] in Phase 3. The structure survived as a 10 m by 2.3 m rectangular building, aligned E-W and bounded by walls [2141], [2146], and [2147]. The structure had two rooms divided by wall [2143], with Room 1 containing a flagstone floor [2142] at the W end of the structure and measuring 1.5 m (E-W) by 2.85 m. Access to Room 2 was via doorway [2168], that led into a series of cobbled surfaces [2144], [2148], [2149] and [2151], that varied in size and shape. Two possible drainage gullies [2145] and [2150] were also present within these floor surfaces that were both aligned S to N.

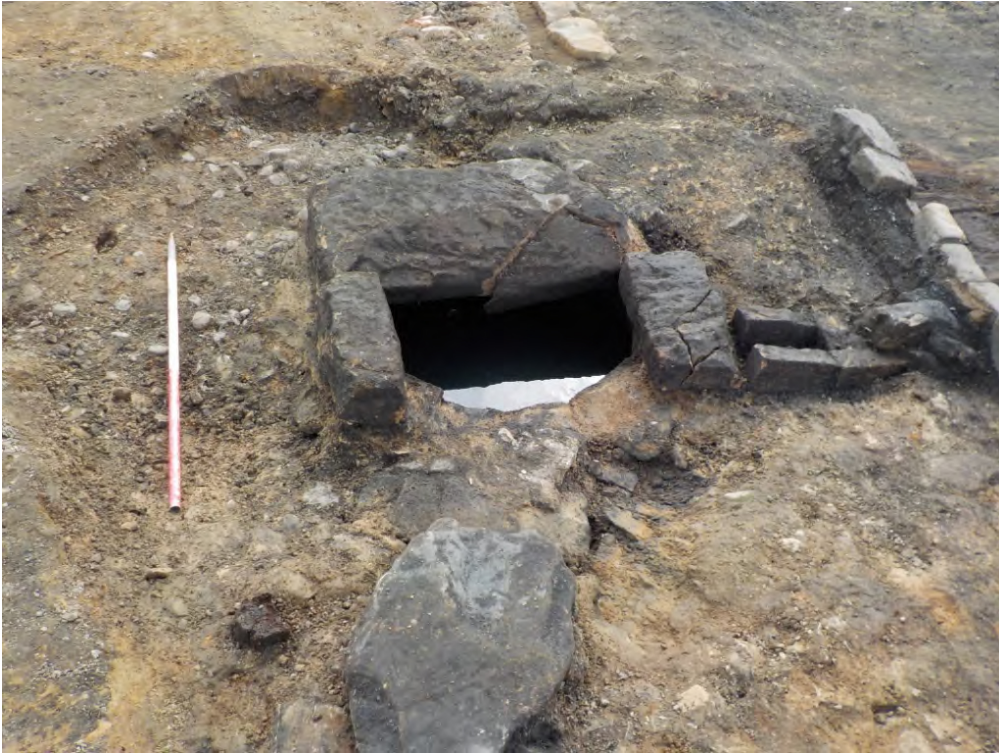
Plate 9: General view of well [2152]

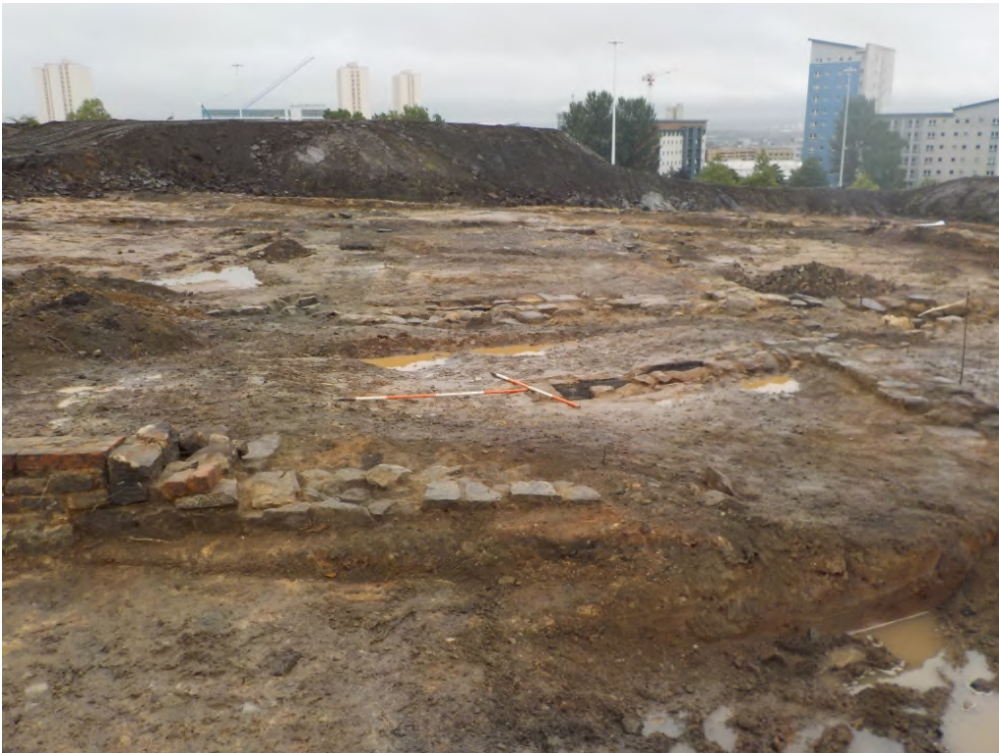
Plate 10: General view of structure [2101] with [2006] in background

- 4.4.3.1 In the early 19th century the cartographic evidence shows the steading changing in shape with the long building [2103] becoming L-shaped. This is evidenced from the excavation by the addition of structure [2101] to the W end of the long house (Plate 10). This structure appears to have been built into structure [2103] by removing the W end of S wall [2121] and replacing it with sandstone wall [2079]. The rest of the structure would have been formed by [2078] to the E, [2105] to the W and [2033] to the S, and contained culvert [2088]. This internal culvert feeds into culvert [2031] to the immediate S of wall [2033] that then feeds into original culvert [2011] via junction [2084]. Culvert [2031] may link into culvert [2156], running W from the edge of well [2152] and truncating/replacing drain [2158]. Another brick lined culvert [2159] also abuts and runs W from the edge of the well, with cobbles [2154] lining the W edge of the well construction cut [2060], with timber raft [2155] further W.

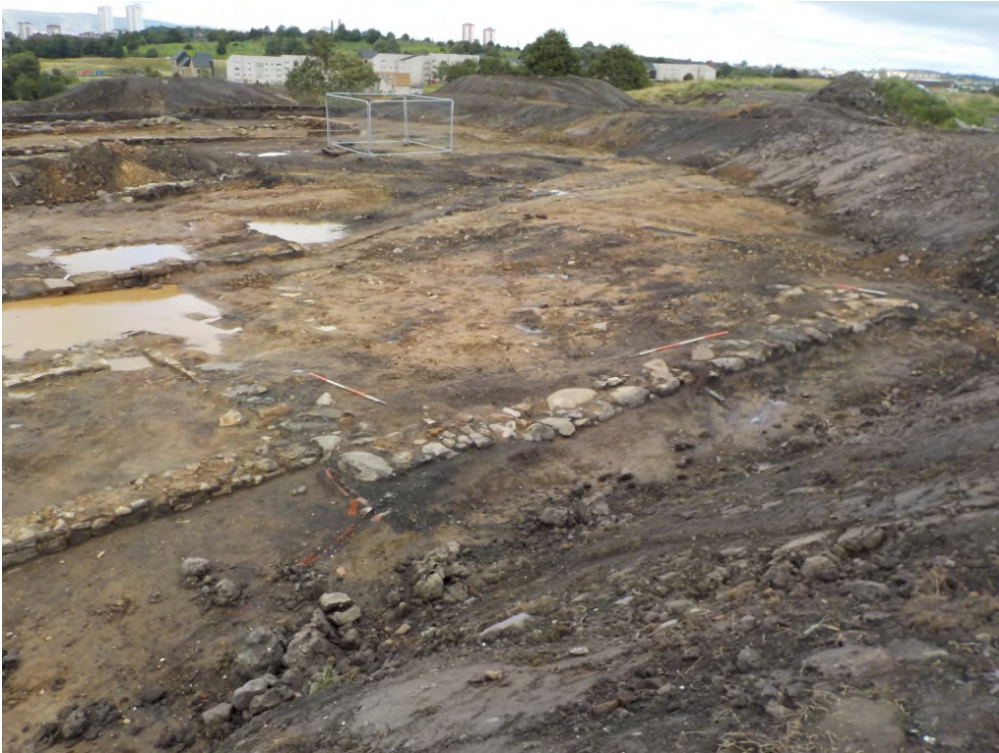
Plate 11: General view of structure [2098]

- 4.4.3.3 This structure contained a rough cobbled surface [2003] consisting of small rounded stones packed into the natural clay. This building also had a small culvert [2008] exiting the S edge into culvert [2032]. To the SE of this addition there is a new structure [2098] that only survives as the southern and western walls abutting the E end of wall [2014] (Plate 11). Structure [2098] consists of walls [2114]-[2116], [2164], and [2165]. A small chute [2163] is also present between the N end of [2116] and the E end of [2164] that may indicate the use of the building at this end. It would have measured approximately 9.3 m by 5.5 m internally.

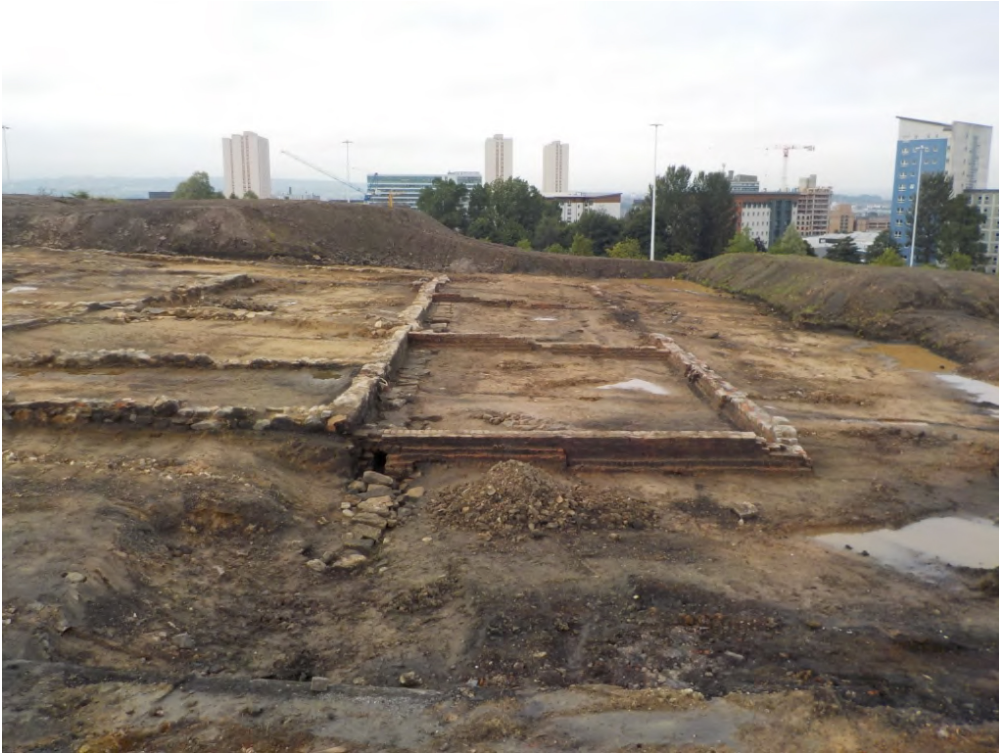
Plate 13: General view of structure [2102]

[2037], manhole [2038], and truncated drain [2019]. Another pipe [2104] is inserted into the top of culvert [2011] and a pipe base [2095] shows where pipes are entering the modern shed [2102].

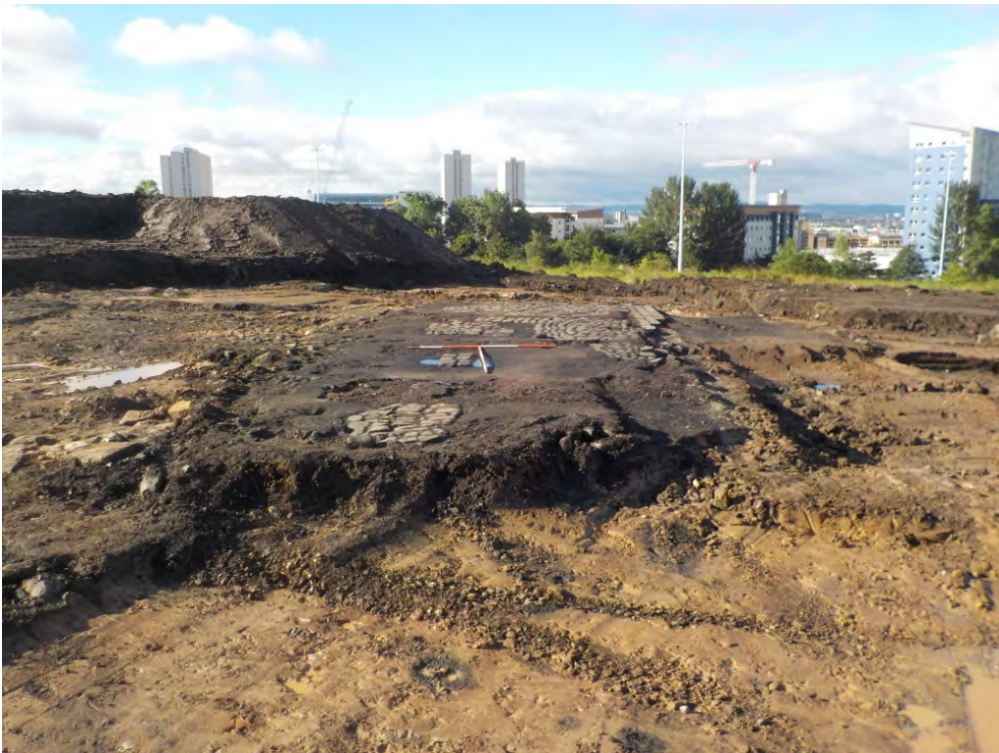
Plate 14: General view of structure [2007]

4.4.4.5 As well as these two large extensions the courtyard area that used to exist between structures [2006]/[2101] and the boundary wall [2012] has also been changed to contain structure [2007] (Plate 14). It is separated into four surviving bays with bitumen and cobbled surfaces [2020]-[2023]. Each bay was separated by thin breaks in the bitumen floor where wooden partitions would once have stood. The surfaces had been truncated to the N and partly to the W, with a cobbled gully [2024] surviving in part at the W and S edge of the structure. Other drainage features were also present in the form of brick drain [2026] in the SW corner of bay 4, and a brick culvert [2009] running off the SE corner of the building.

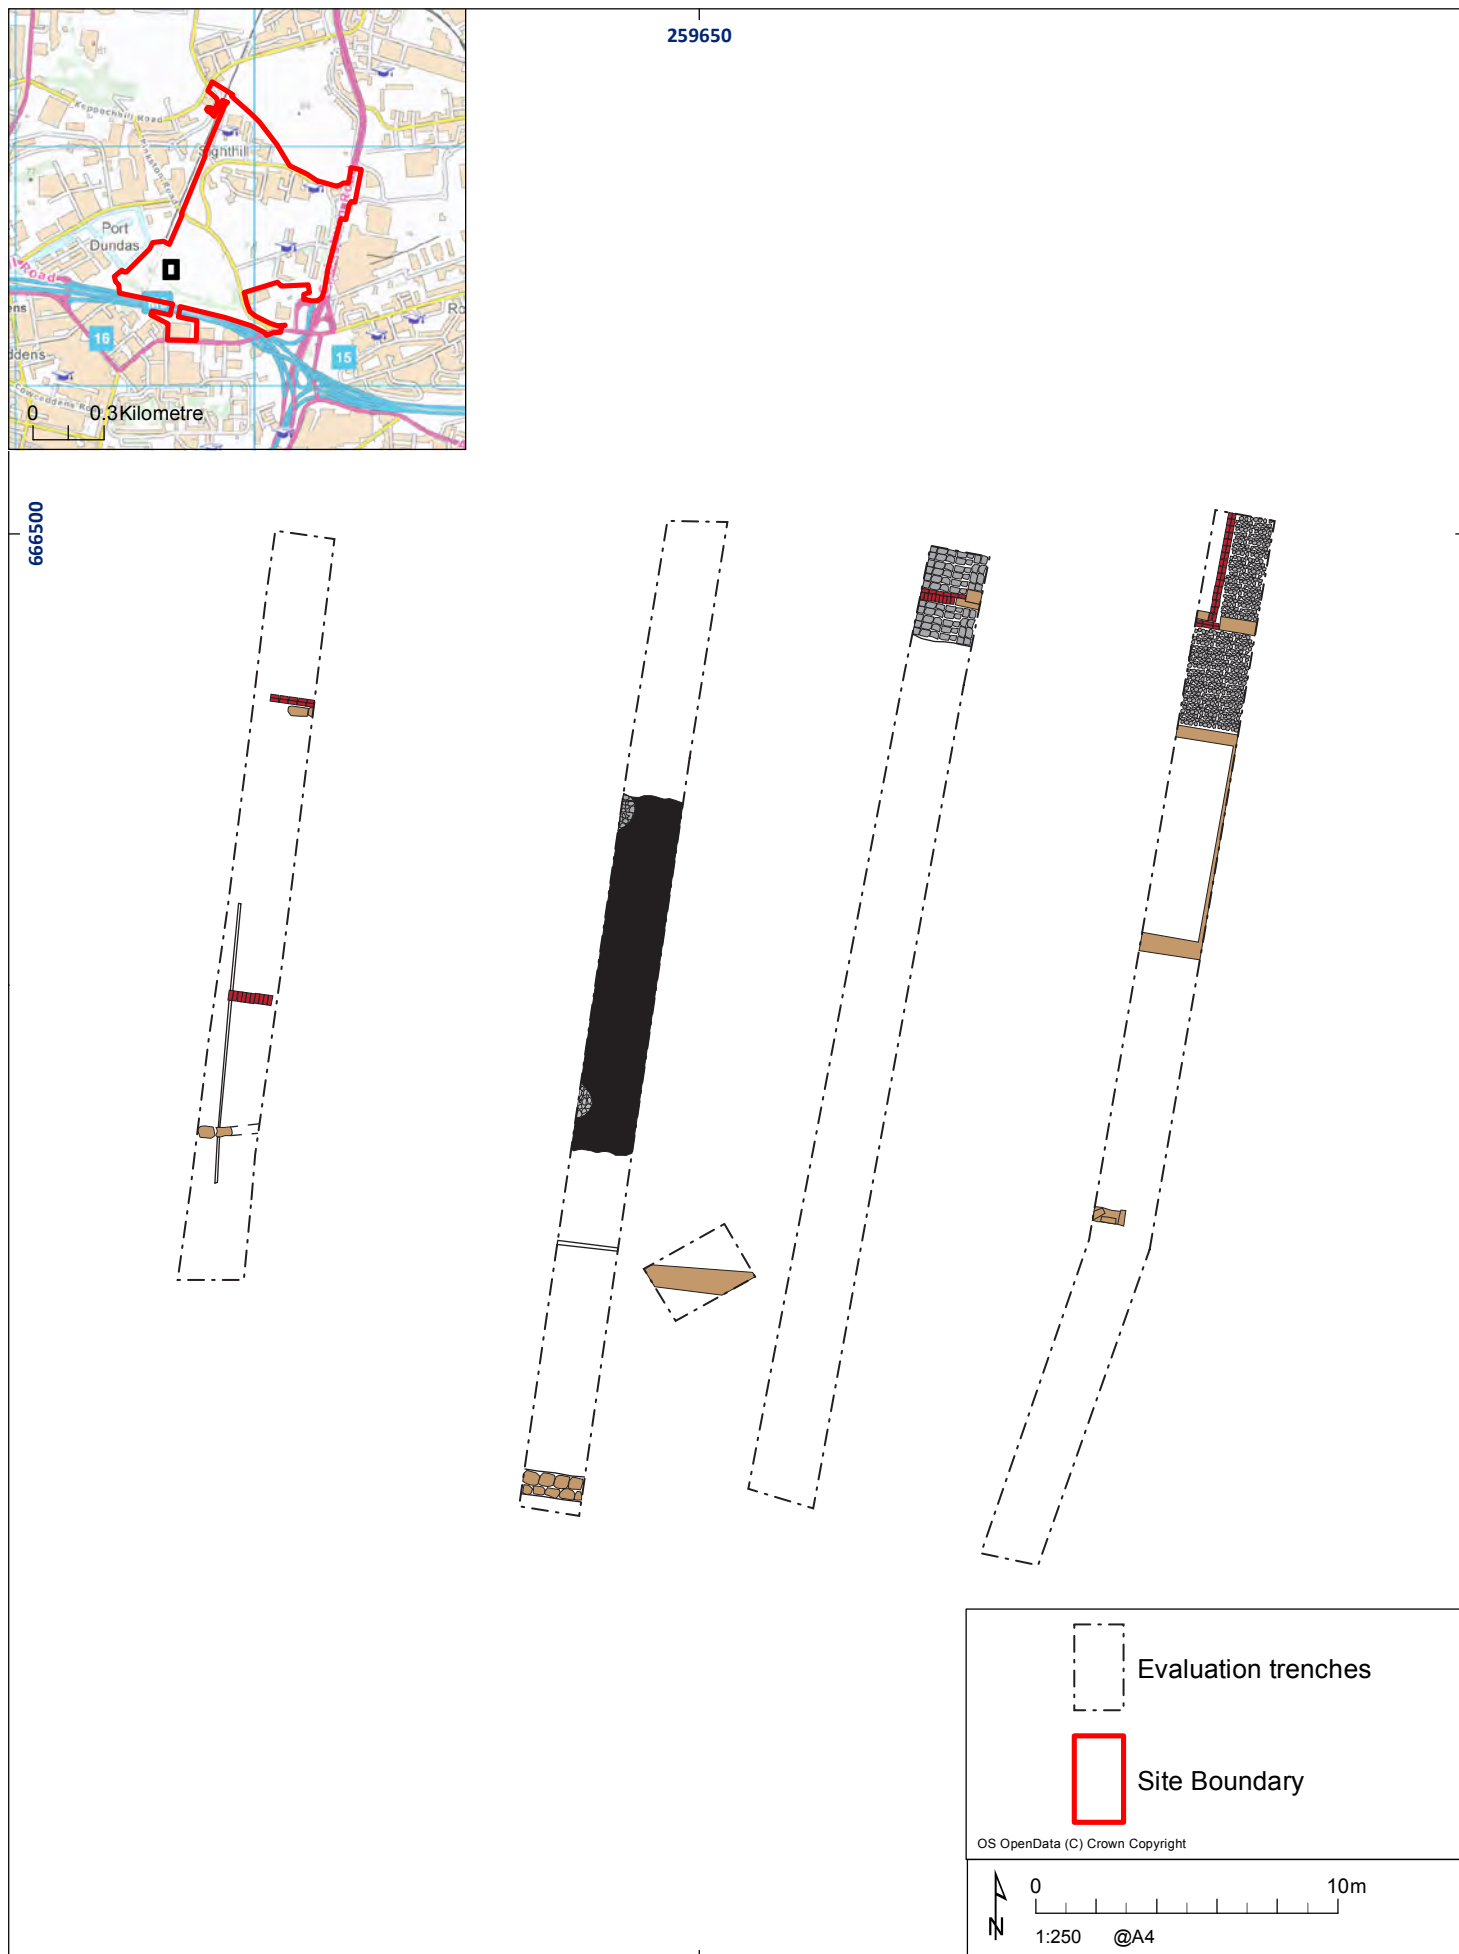
01/23135/REP/9/01

Figure 9: Area 1 evaluation trench locations showing features

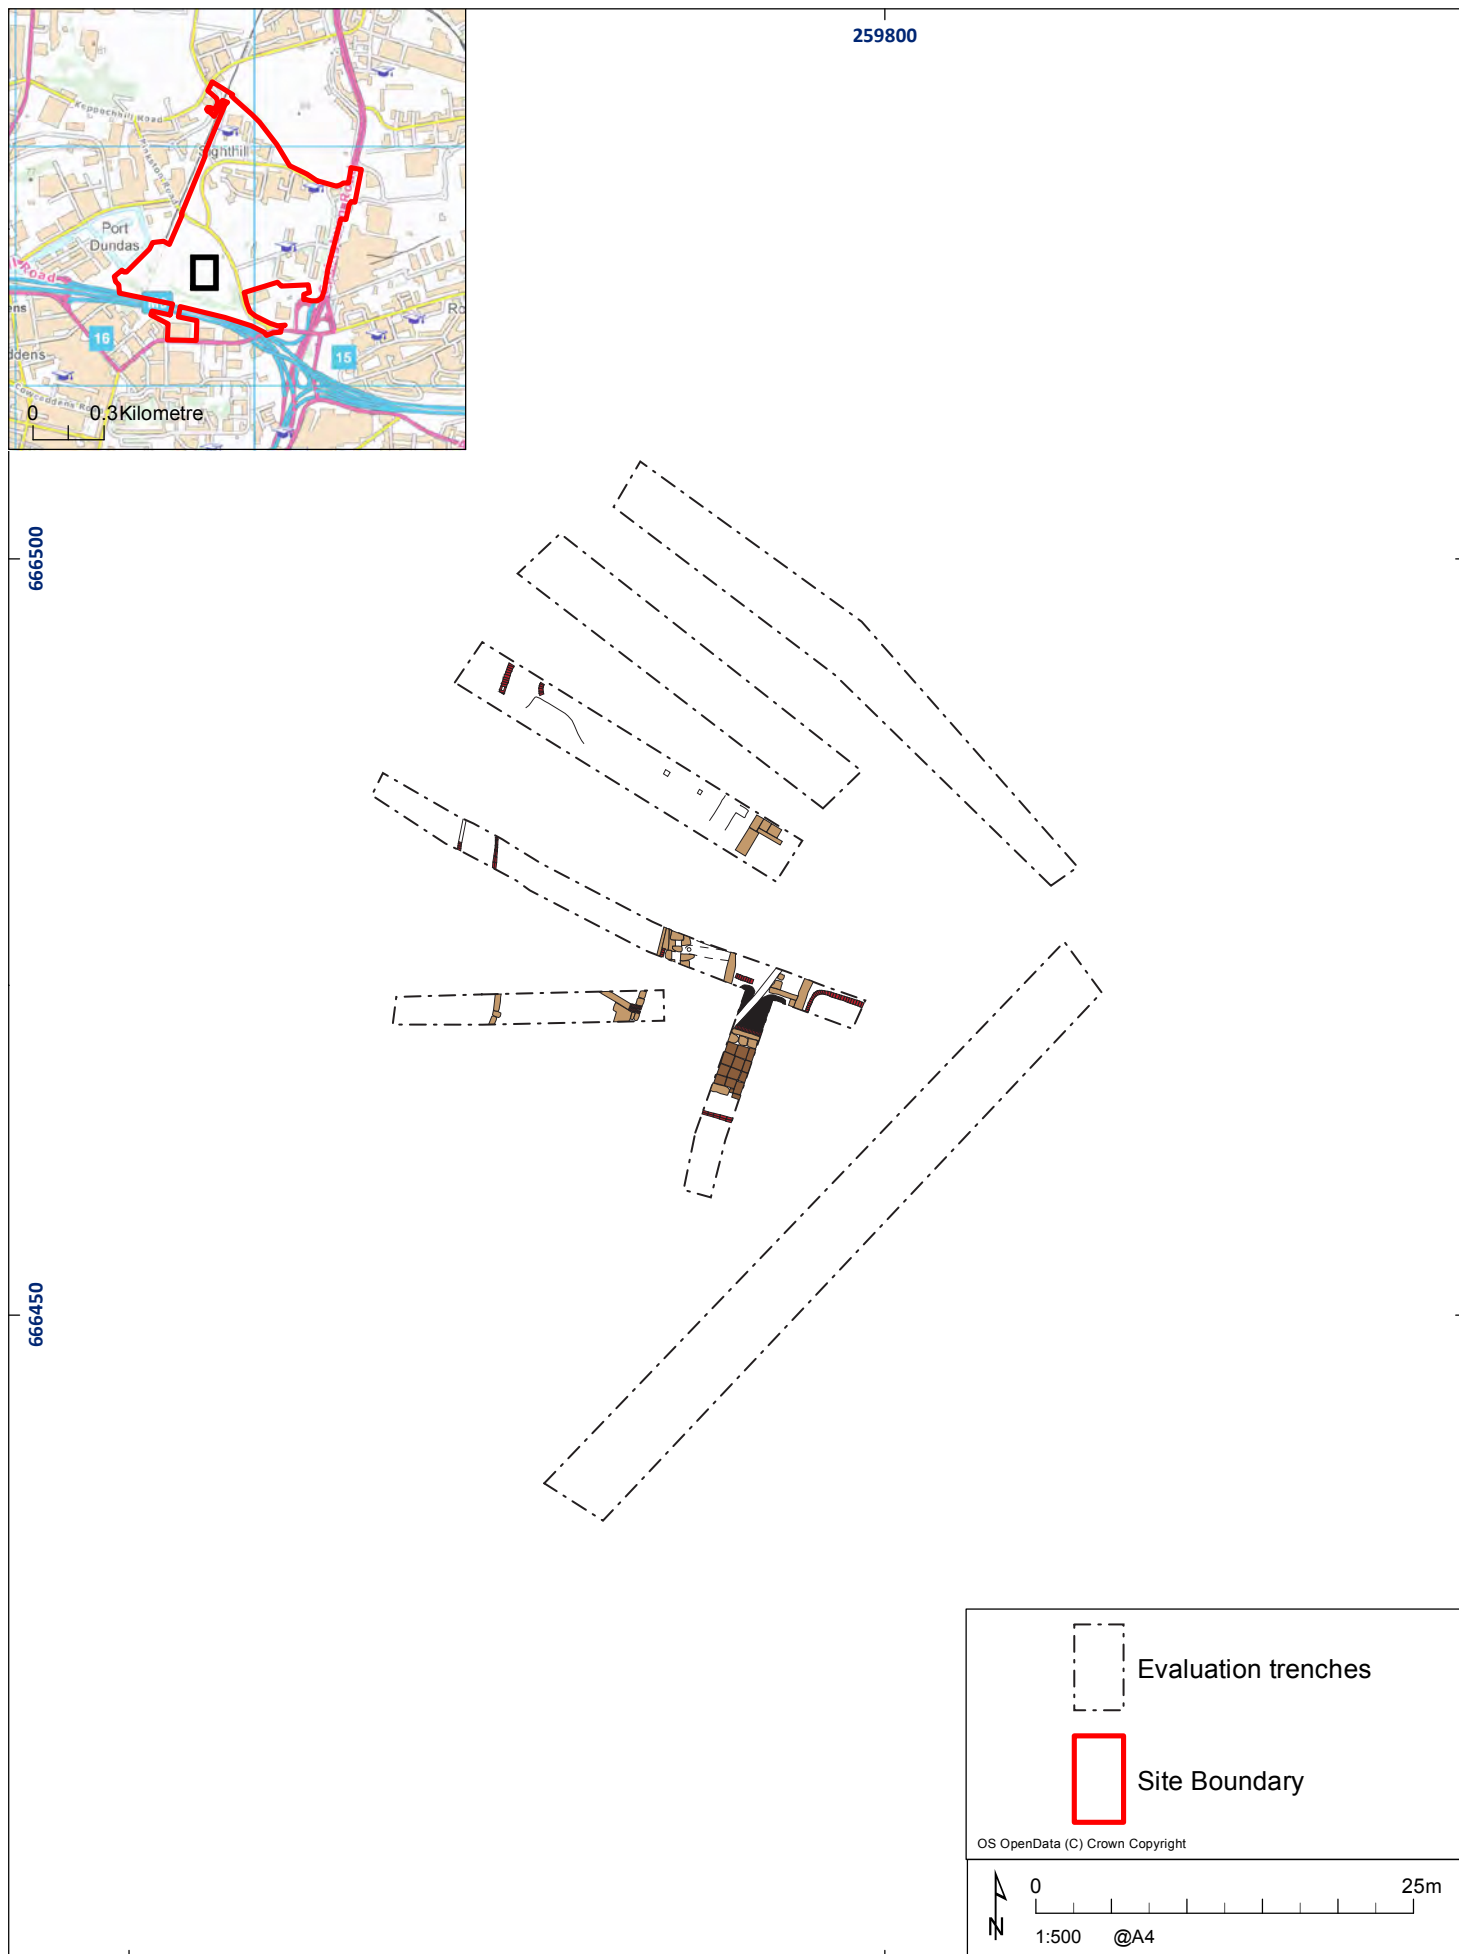
01/23135/REP/10/01

Figure 10: Area 2 evaluation trench locations showing features

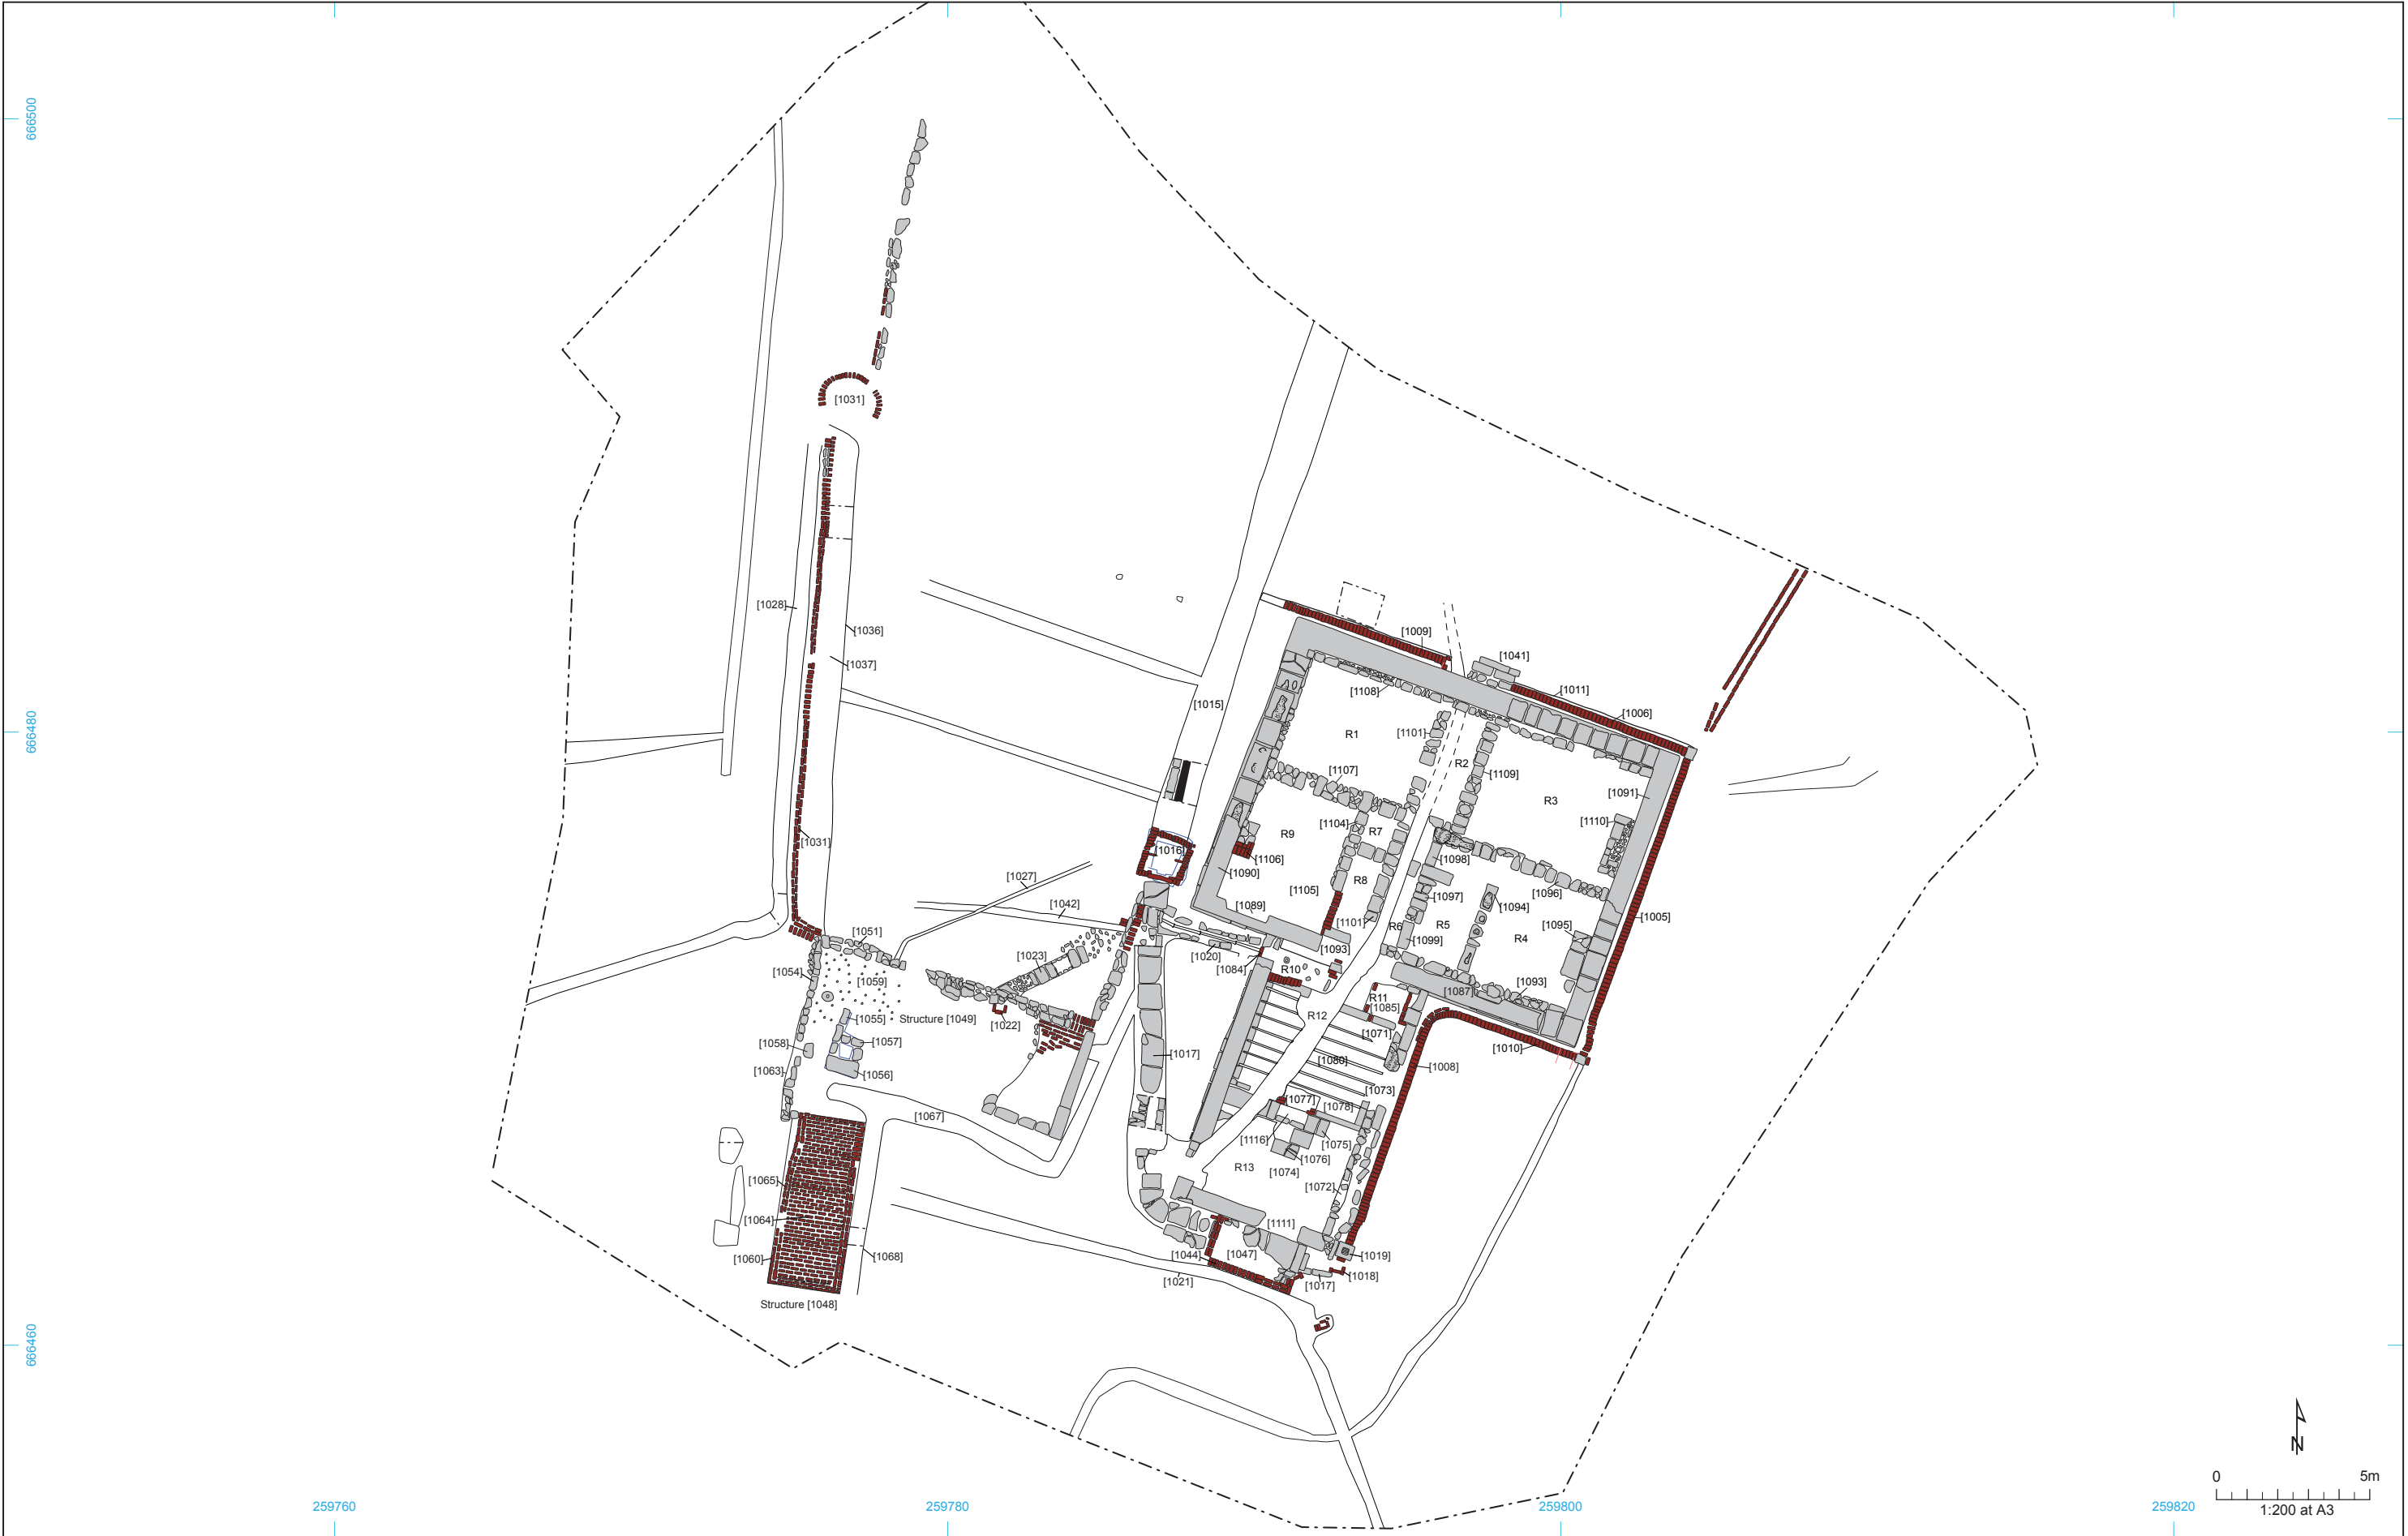
01/REP/23315/12/01

Figure 11: Plan of area 1: Broomhill House

- 4.3.11 Surrounding the outside of the house are a number of drainage features. Brick gully [1008] is a rainwater gully that surrounds the E edge of the house from the SE corner, beginning at down pipe grate [1019], and running N of the house through former brick gully and now ceramic pipe [1007]. A similar brick gully [1009] is seen along the N edge of the house at either side of entrance step [1041], emptying into [1007] to the E and [1015] to the W. Drain [1015] is N-S aligned and begins at brick manhole [1016]. It was formerly a part of sandstone culvert [1017] but was later replaced by a ceramic pipe, similar to drain [1020]. The manhole is also fed into by surviving sandstone culvert [1017] that is aligned NW-SE and wraps around the S end of the house and runs under porch [1045], connecting to the S end of [1008] via brick junction [1018]. The use of ceramic pipes sitting within former culverts is an indication of an upgrade in the drainage for the house at some point in the later 19th or early 20th century.

- 4.3.12 Other drainage around the house is seen in sandstone rubble deposits [1005] and [1006] that are located along the NE edge of the house and they appear to have been constructed within the re-deposited clay to remove water away from the foundations and out through rubble drain [1004] that runs NE away from the NE corner of the house. Furthermore, a ceramic field drain links into culvert [1008] at the SE corner of the northern part of the house.

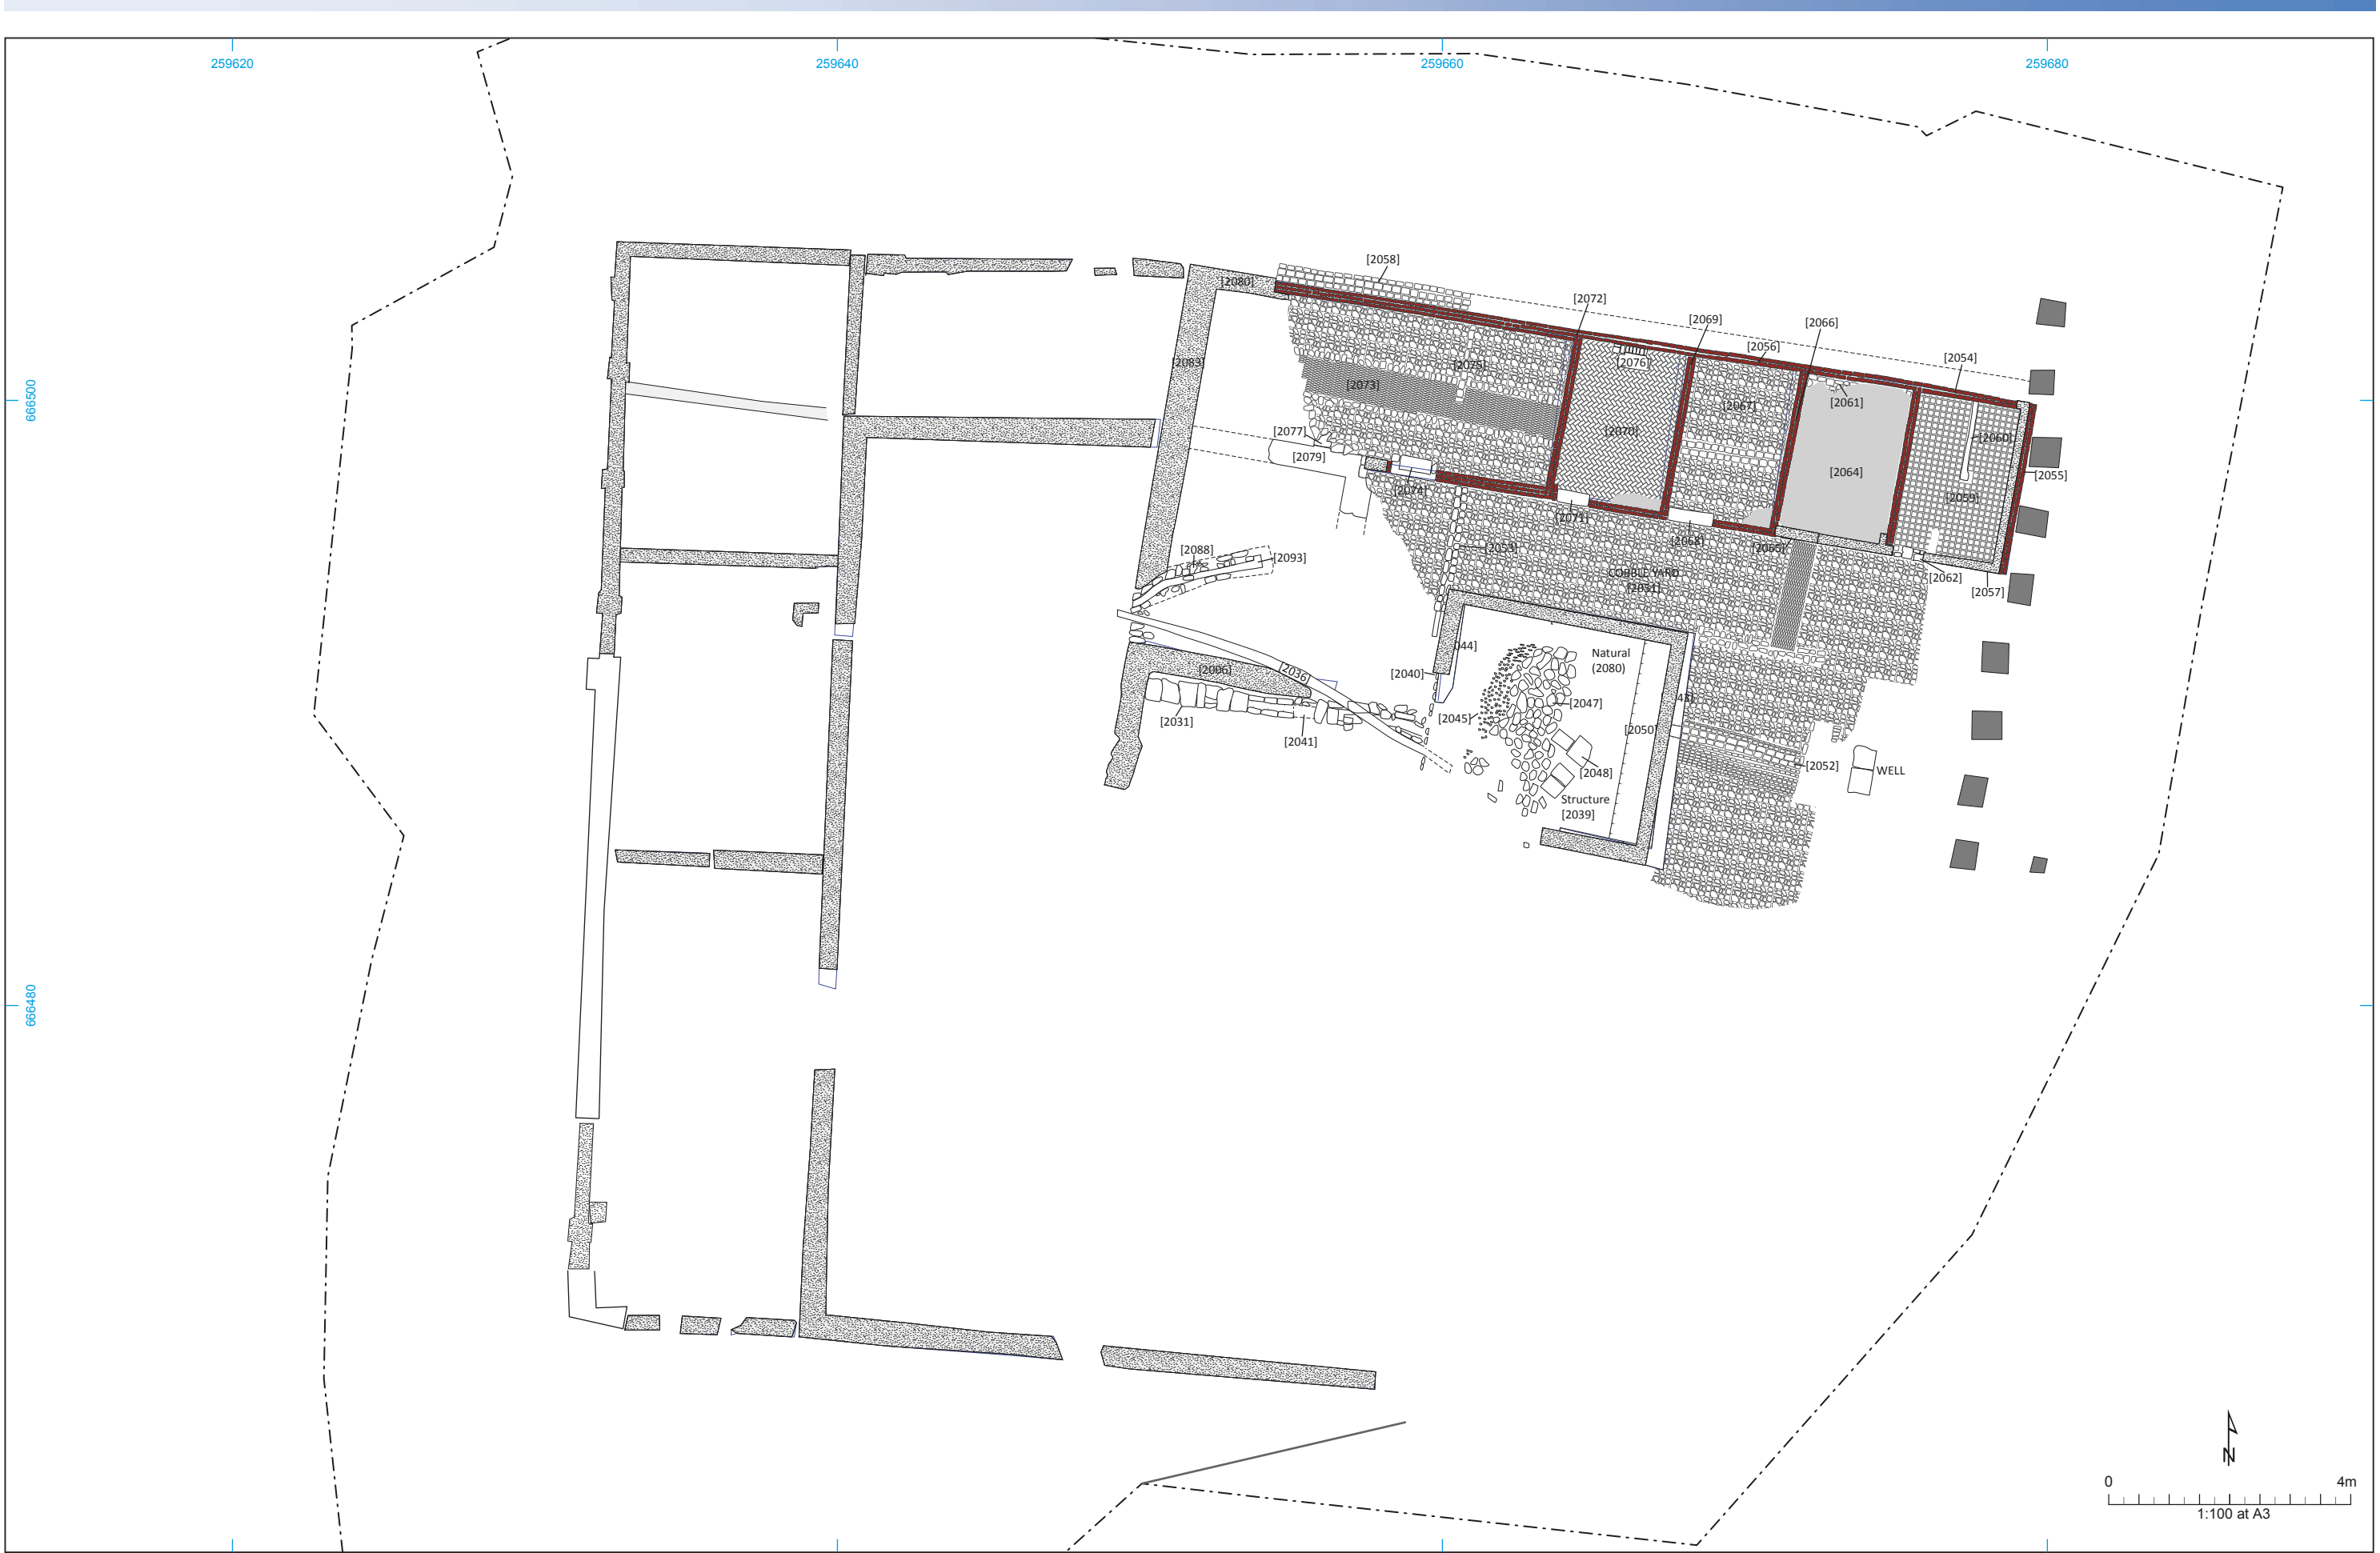
Figure 14: Plan of Area 2 Phases 3 and 4
