Lamer Island, Dunbar, East Lothian: Archaeological Watching Brief & Historic Building Recording Report

On Behalf of: Dunbar Harbour Trust
Cromwell Quay
Shore Street
Dunbar
EH42 1SU

AOC Project No: 20245

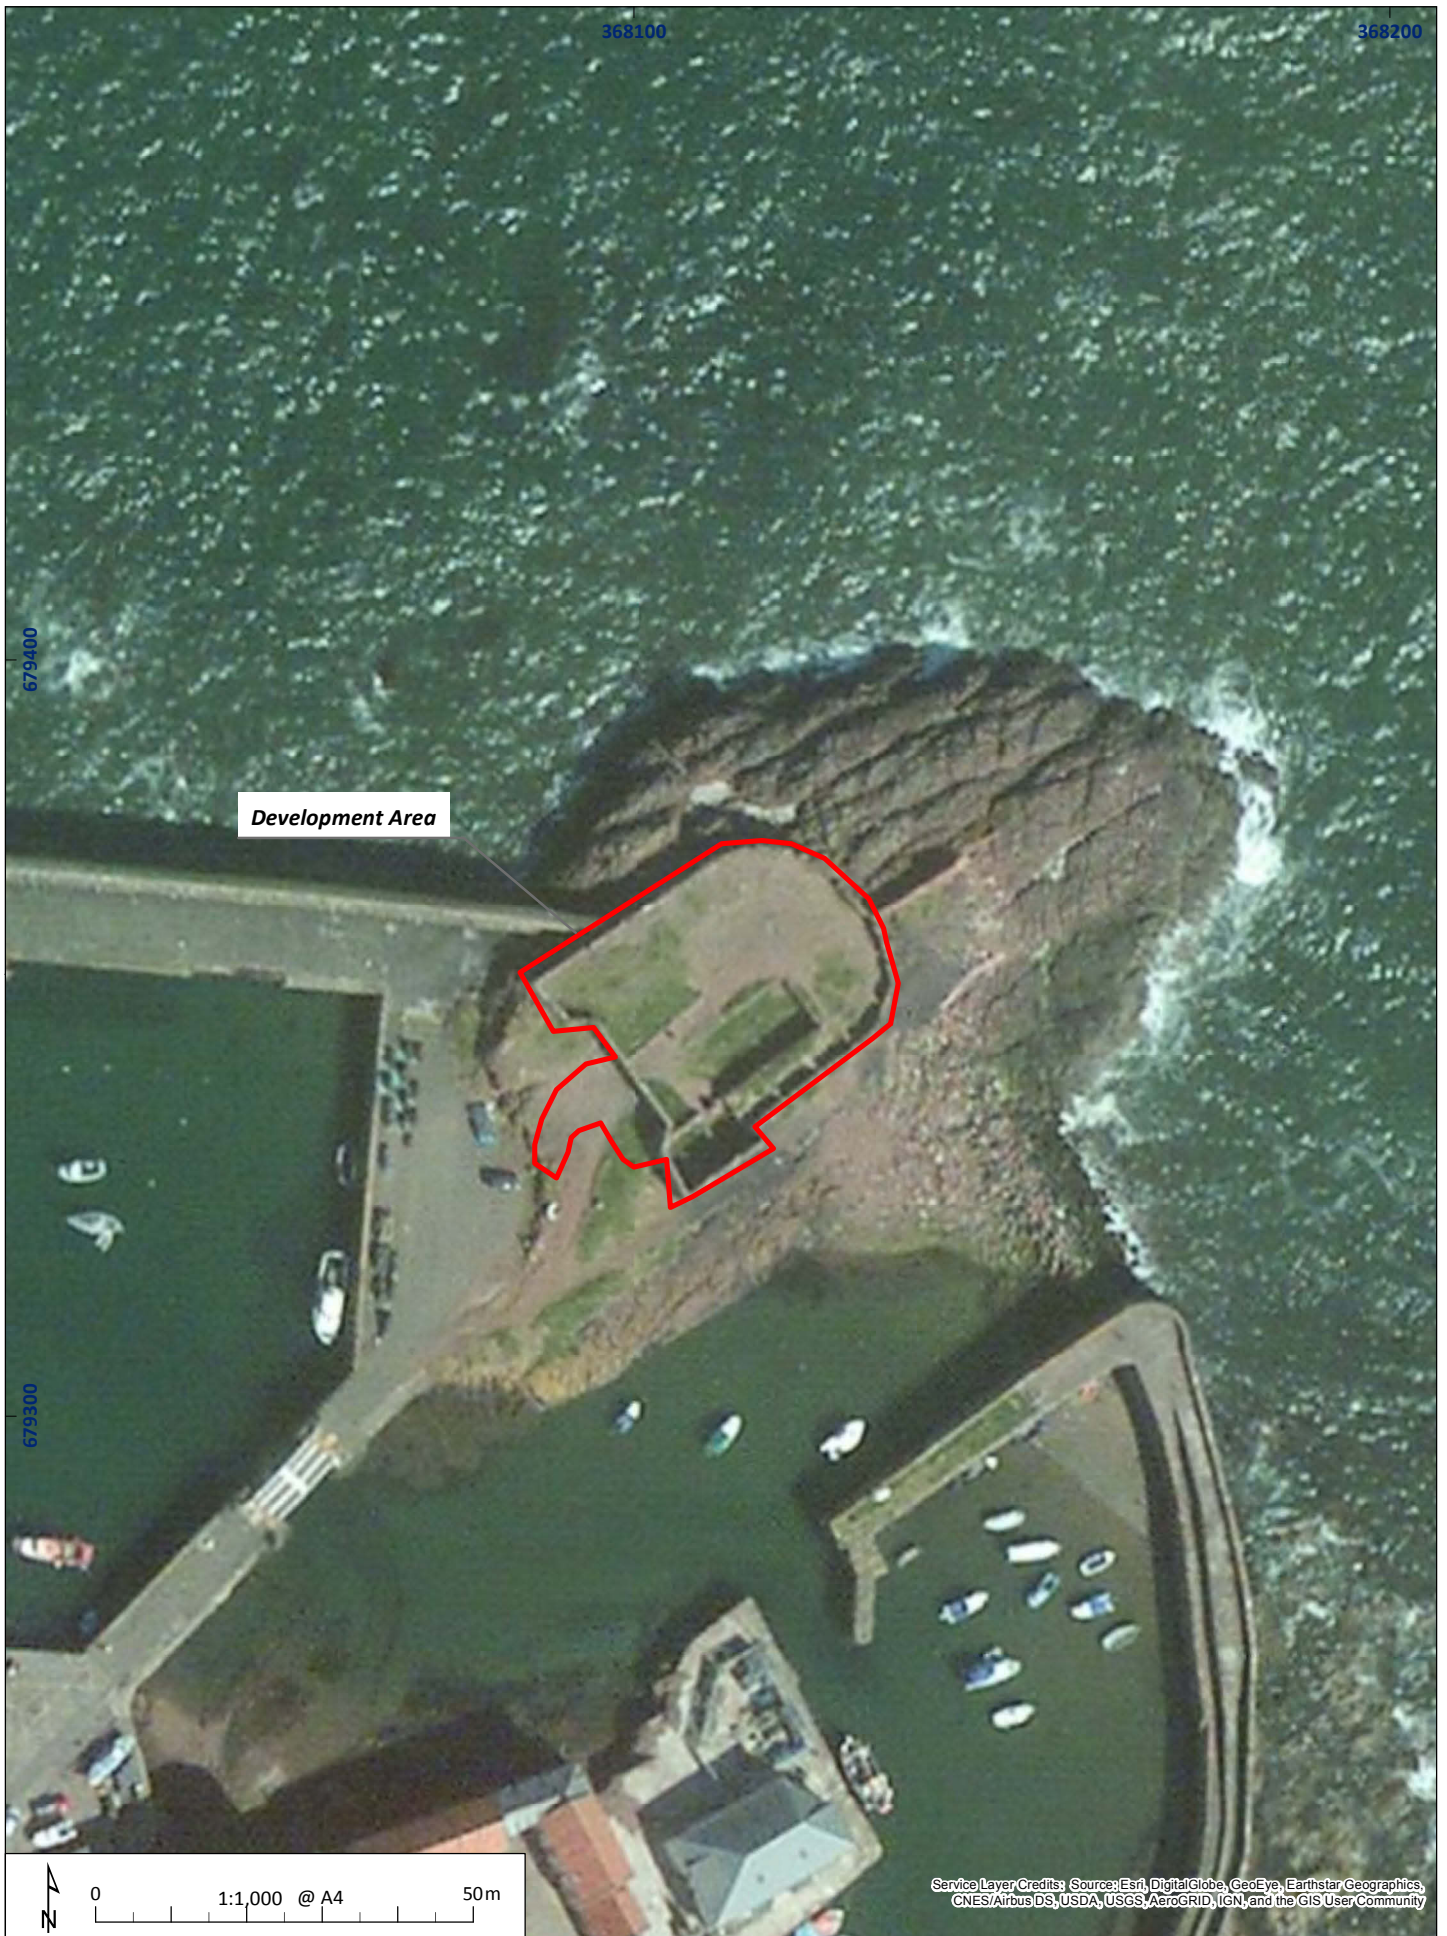
Figure 2: Site plan of Lamer Island showing areas subject to archaeological investigation 01/20245/REP/2a/01

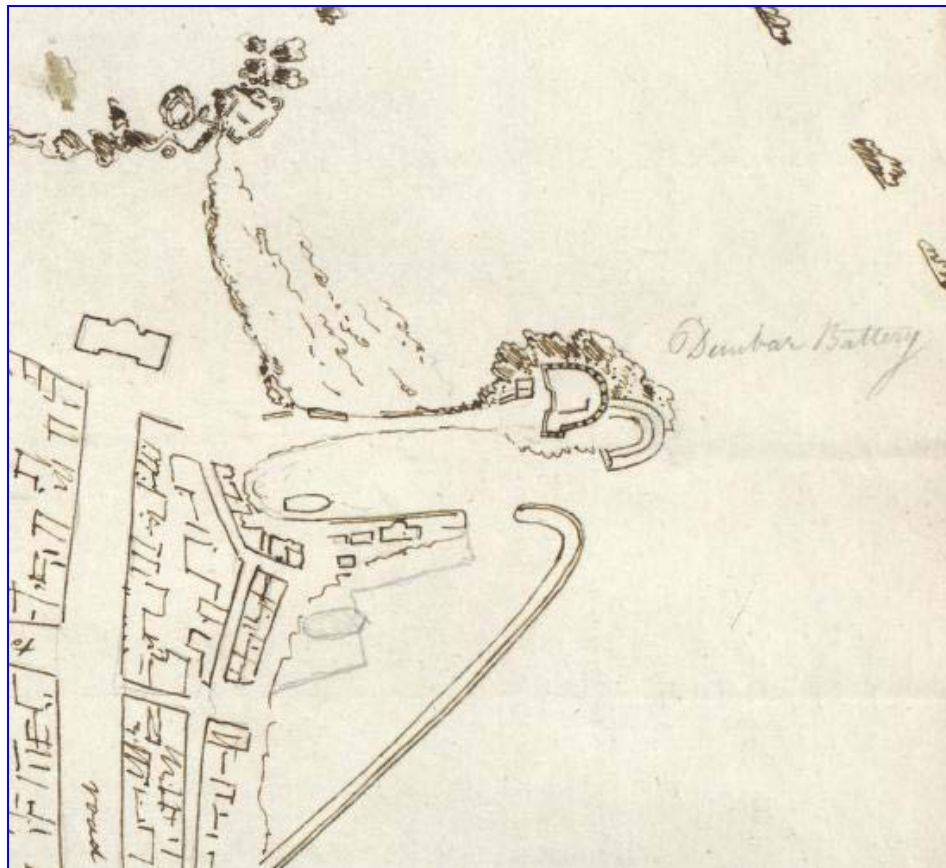
Figure 3: Extract from sketch of 'Dunbar Battery' by William Garrett, 1795

- 4.1 The first mention of Lamer Island was in 1445 in a charter by James II, conferring the privilege of Dunbar (AOC 2007, 10). The charter mentions both the harbour and Lamer Craig, possibly an earlier name for the island. However, it is not mentioned in the known historical record after that until 1781 when Captain Fall, an American privateer, attempted to board and cut a vessel at Dunbar Harbour (*ibid*). 12 pounder guns were transported to Lamer Island in response with an additional two 9 pounders at the nearby castle to try and defend against the privateers. This was enough to make Fall retreat to the Isle of May (Miller 1859). Fall's attempt to steal from the town was the second attempt in as many years (John Paul Jones did the same in 1778) and hence the people of Dunbar were motivated to build a battery to protect themselves from any future attacks. The battery was constructed the same year of Fall's attack in 1781 to plans by Andrew Fraser (AOC 2007, 1). Funded by both the town council and the East Lothian and Merse Whale Fishing company, it was more of a civil undertaking rather than a military one and was therefore of a more traditional fort design as opposed to the latest 'cutting edge' military designs of the late 18th century. It was constructed of local red sandstone and consisted of sixteen embrasures housing six, nine, twelve and eighteen pounder guns along with four carronades (Graham 1967). The magazine, guard and store room were added to the centre of the fort by 1795 according to an assessment of the site by William Garret in that year (AOC 2007, 1). He made a (albeit quite schematic) sketch of the site, which shows the buildings within the fort as a simple L-shaped line which roughly outlines the north-west elevation of the vault (Figure 3).

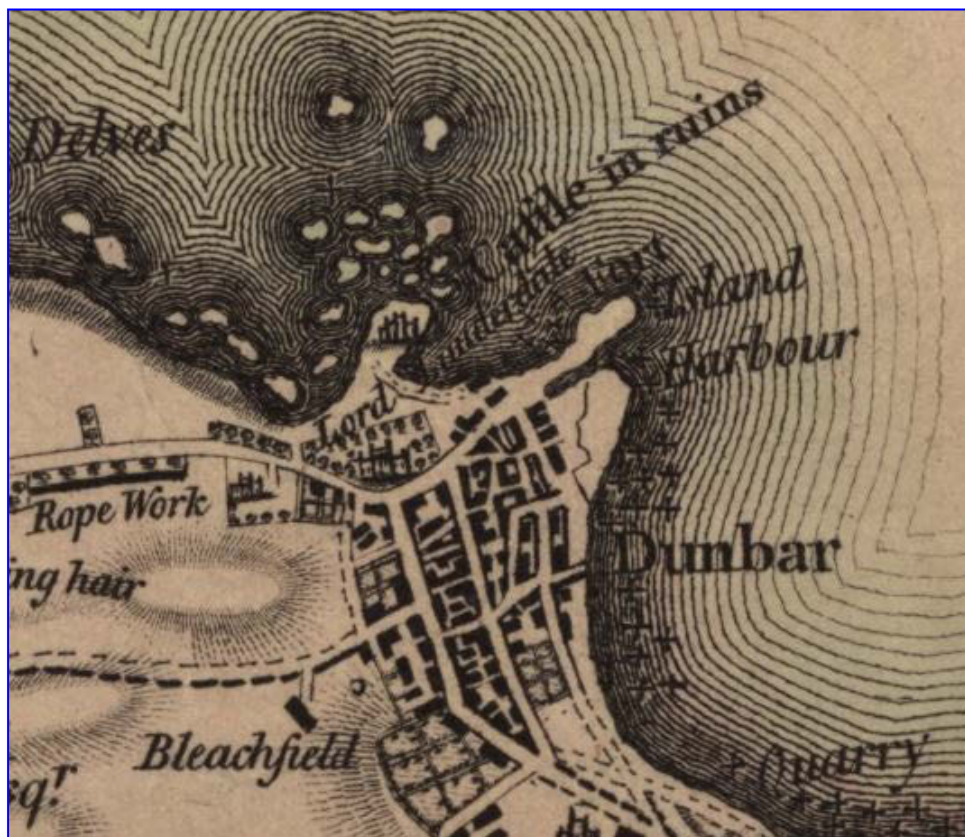
Figure 4: Extract from Forrest's map, 1803

- 4.2 The battery is first represented in the cartographic record by William Forrest's 1803 map where it is simply annotated as 'Fort' (Figure 4). It was in this very year that the main barracks were constructed (which would be converted into a hospital building some 70 years later) in response to a possible threat from the French after the outbreak of war between Britain and France in 1793 (Martine 1999). John Wood's 1830 map shows a little more detail of the battery, and shows the central building within the fort with an additional building to the south corner. There are also two buildings located to either side of the entrance to the battery to the south-west side (Figure 5).

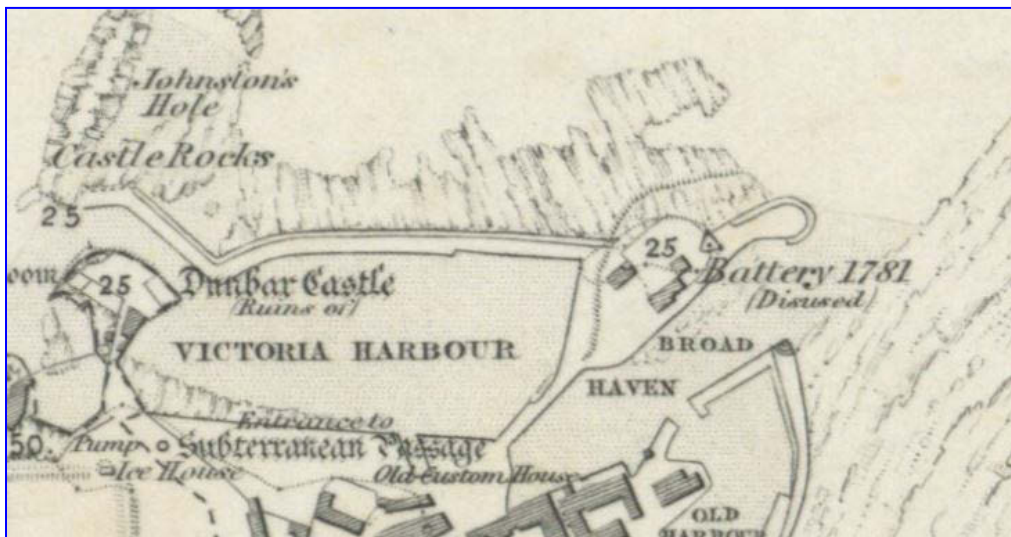
Figure 6a: Extract from Ordnance Survey, 1854

- 4.3 By the middle of the 19th century, the battery fell out of use after never having fired a single shot, as we can see by the annotation on the 1854 Ordnance Survey map (Figures 6a & 6b). The building was in fact preserved in the 1840s whilst the Victoria Harbour was constructed to the north-west side, and the south-west wharf of the harbour became integrated with it. No use could be found for the former battery, although a small causeway was constructed to maintain access to it.

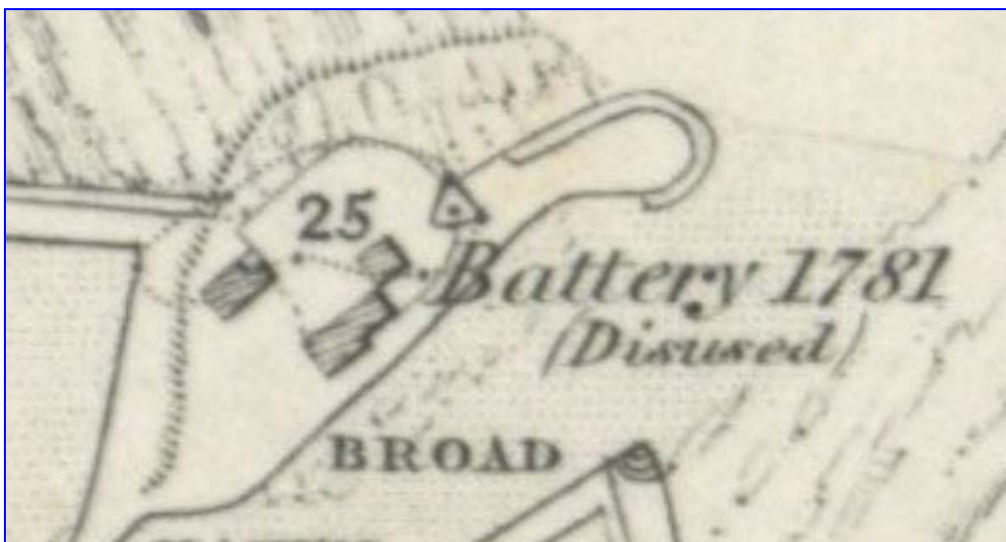
Figure 6b: Extract from Ordnance Survey map, 1854 showing detail of Lamer Island

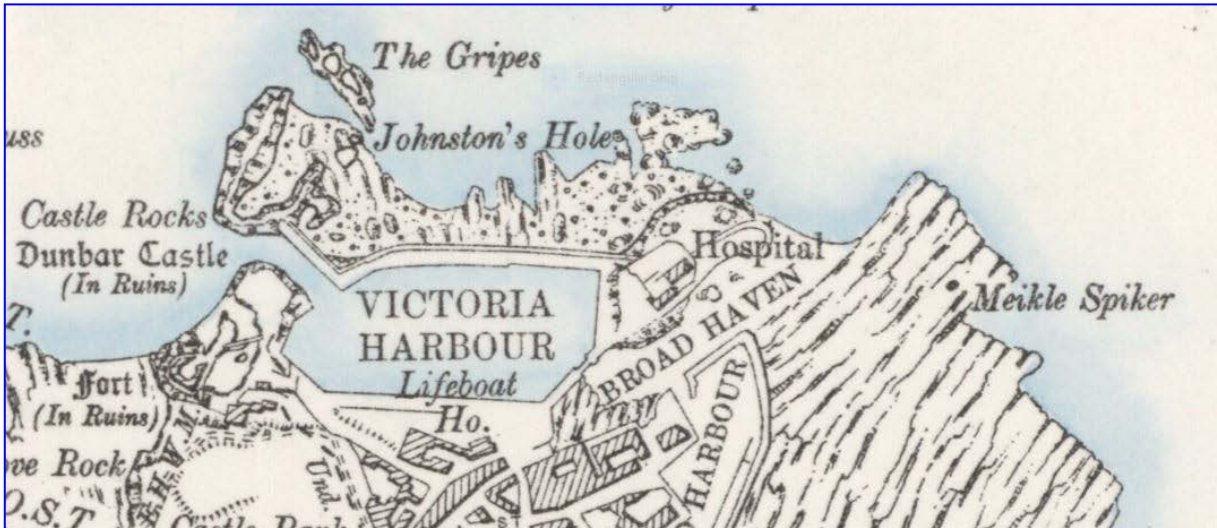
Figure 7: Extract from Ordnance Survey map, 1895

- 4.4 By the 1895 Ordnance Survey map, the fort is annotated as a hospital (Figure 7). The conversion happened in 1874, when it was in fact adapted for use as a fever and isolation hospital, ideally located away from the citizens of the town, in response to the Public Health (Scotland) Act of 1867. The two-storey building to the centre of the fort was the primary hospital wing, only the ground floor of which survives today. The vaults (which were the former magazine store) were also possibly used at this time as part of the ancillary (domestic) functions to the wards. An 1899 sketch shows the layout of the hospital buildings and interior areas at first floor level within (Figure 8). It identifies the partitioned areas within the hospital building, including the area to the south-east that was presumably built over the vaults/magazine store.

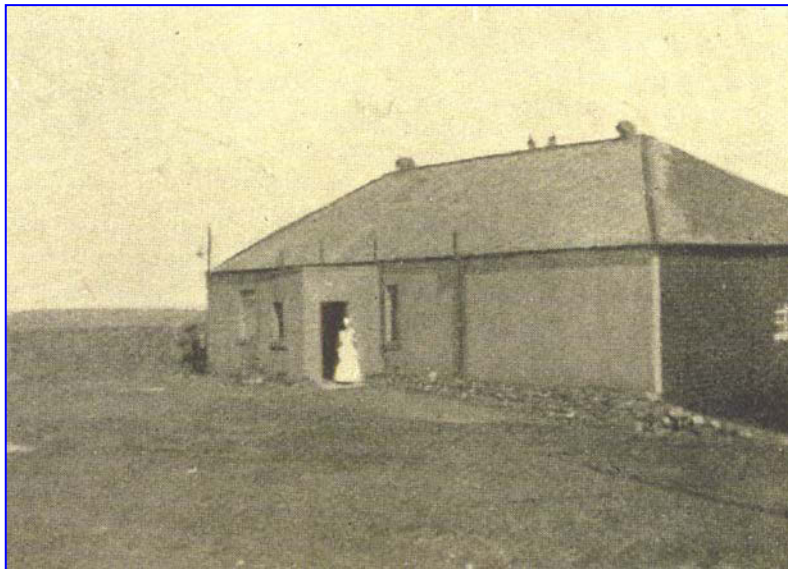
Figure 9a: Photograph of the 1872 hospital building from the west, showing the north-west elevation, 1914

- 4.5 The hospital, probably due to its poor condition and exposed location, was closed down by 1906. However, the battery was brought back into use some 11 years later, again as an infectious disease hospital and a military hospital during the First World War. By this time, the main hospital building had 14 beds, which were all full at the time of war (AOC 2007, 13). The hospital was also described as being in a beautiful but very inhospitable location subject to gales and other extreme weather (*ibid*). Two photographs exist of the hospital building dating from 1914 (Figures 9a & 9b). These show that the building was rendered with roughcast, no doubt to prevent against weathering of the stonework in the inhospitable weather. The north-west elevation (Figure 9a) shows the upper floor of the hospital (the ground floor sunk into the ground level of the rest of the battery against the former magazine store) with a hipped roof and small porch. The view of the hospital from the south shows the upper floor windows of the hospital with a chimney to the centre (Figure 9b).

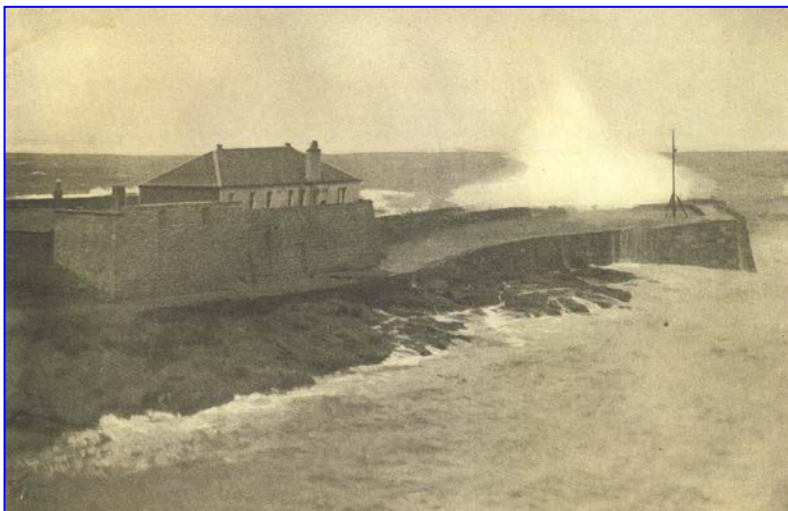
Figure 9b: Photograph of the 1872 hospital building from the south, 1914

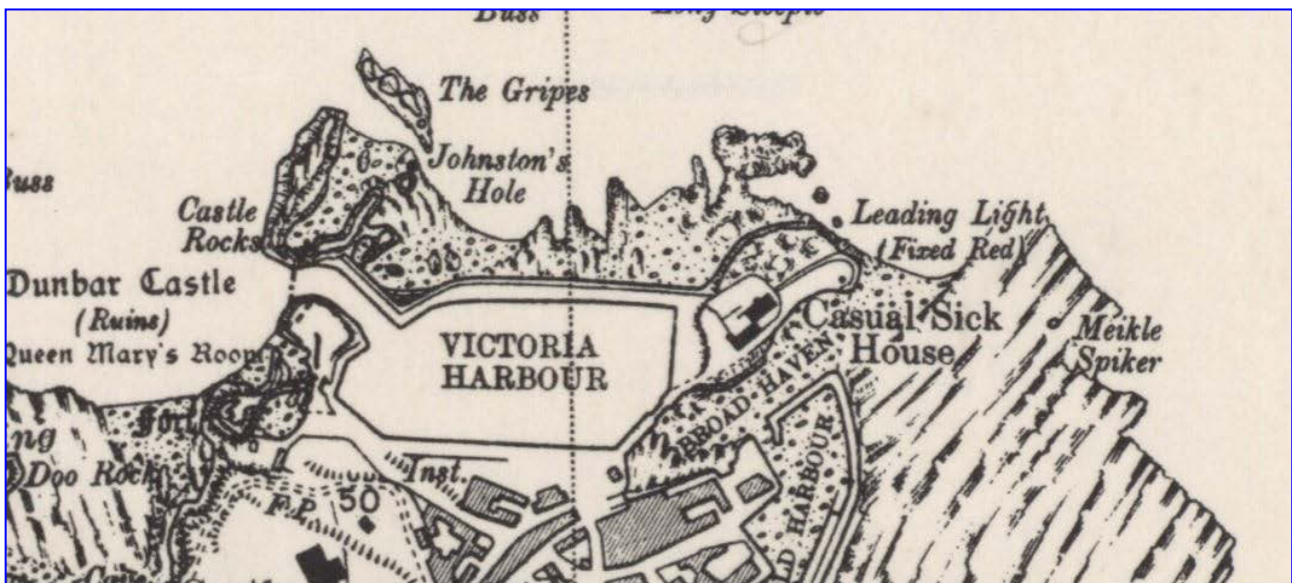
Figure 10: Extract from Ordnance Survey map, 1948

4.6 By the end of the War, the hospital became a cottage hospital and was opened as such in 1919. The cottage hospital was in use for several years and was even visited by the Princess Royal who donated £20 (*ibid*, 14). The condition of the building continued to deteriorate, however, and its roof was eventually blown away in a storm in 1937. A fire in the building also occurred during that year when the battery was the site of a bonfire and fireworks display in celebration of King Edward's coronation (Pugh 2003). The 1948 Ordnance Survey map shows the battery some years after the Second World War, as a disused structure, although the former hospital buildings are still depicted - it is even annotated as a 'Casual Sick House', indicating that some use may have been made of the former structures (Figure 10).

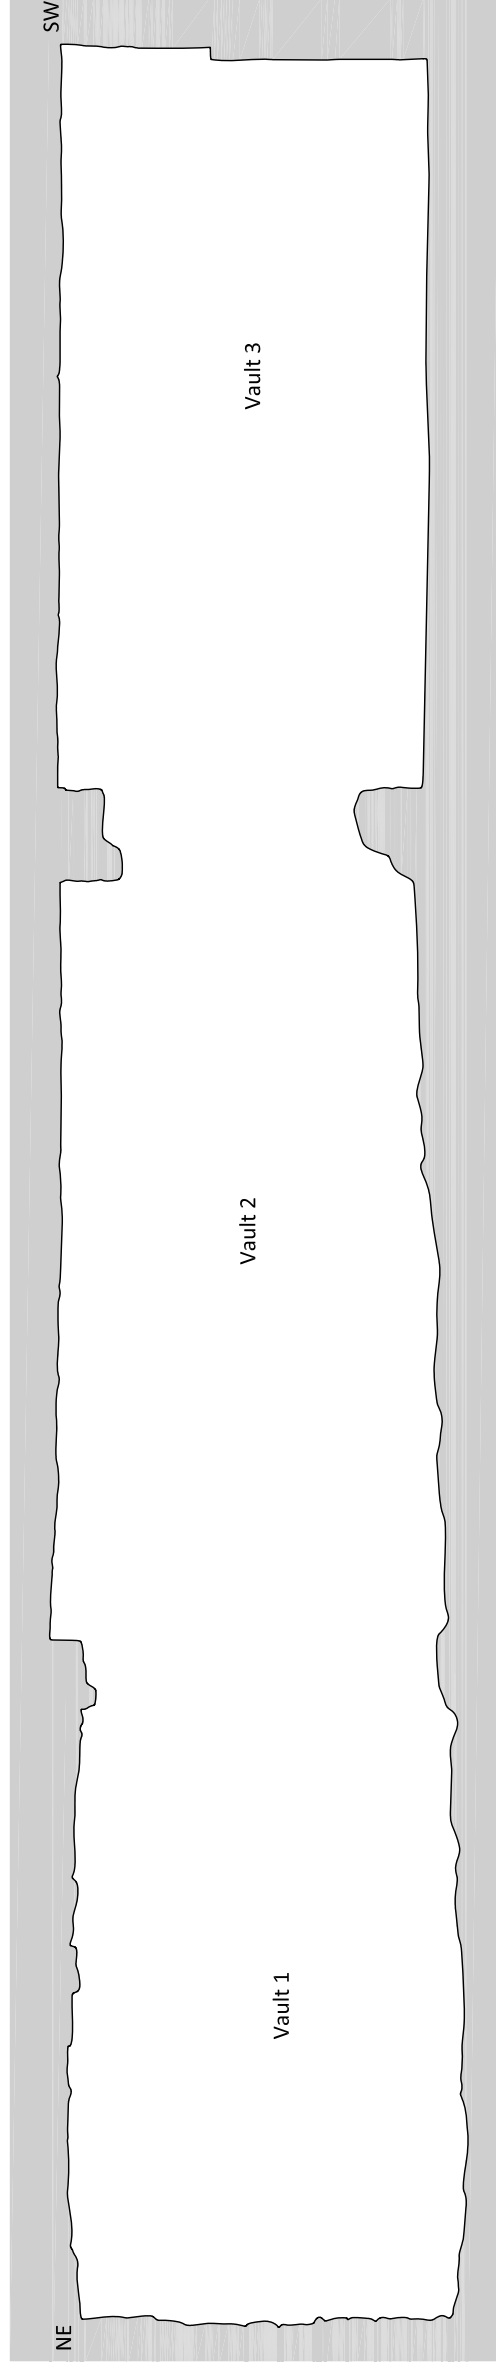
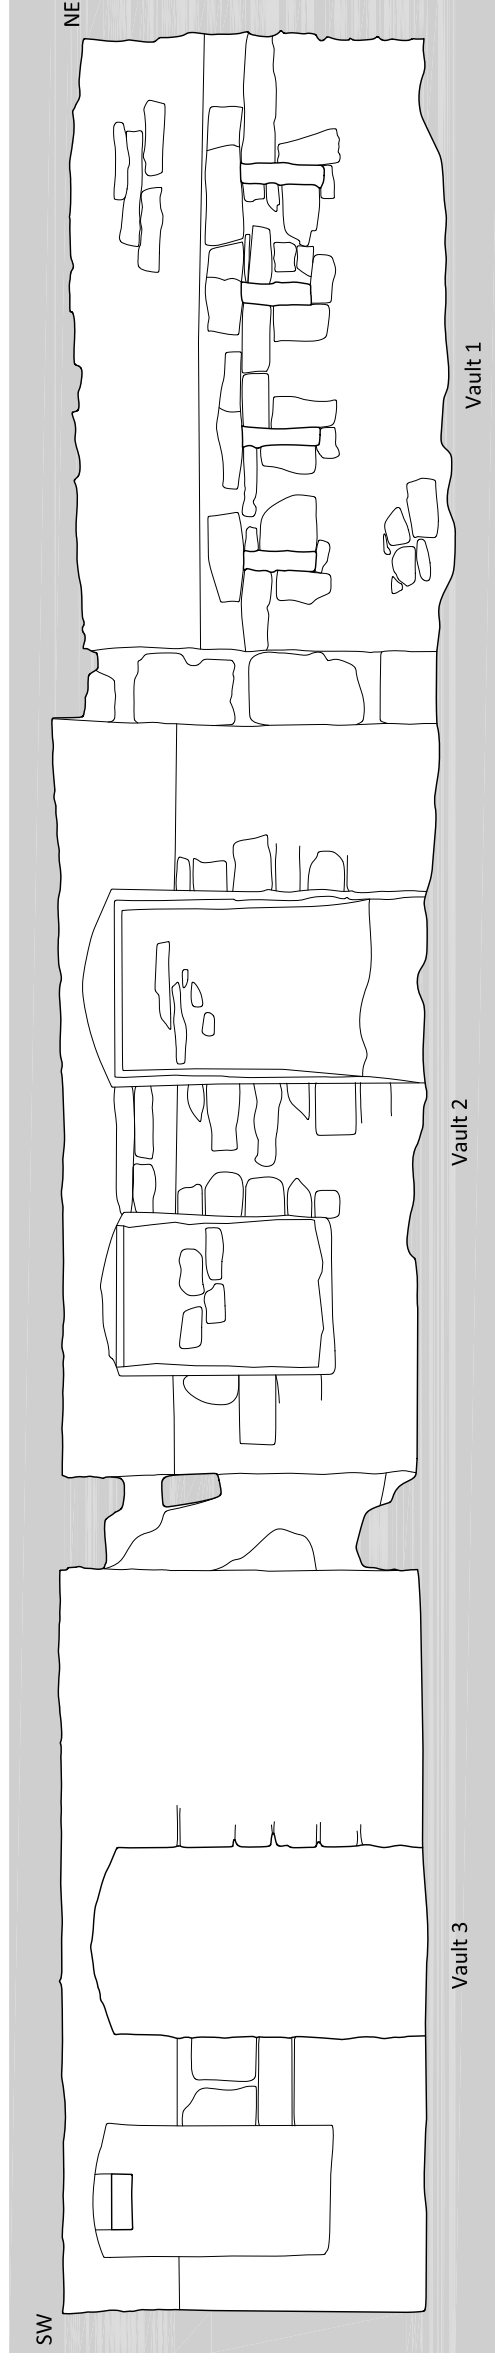
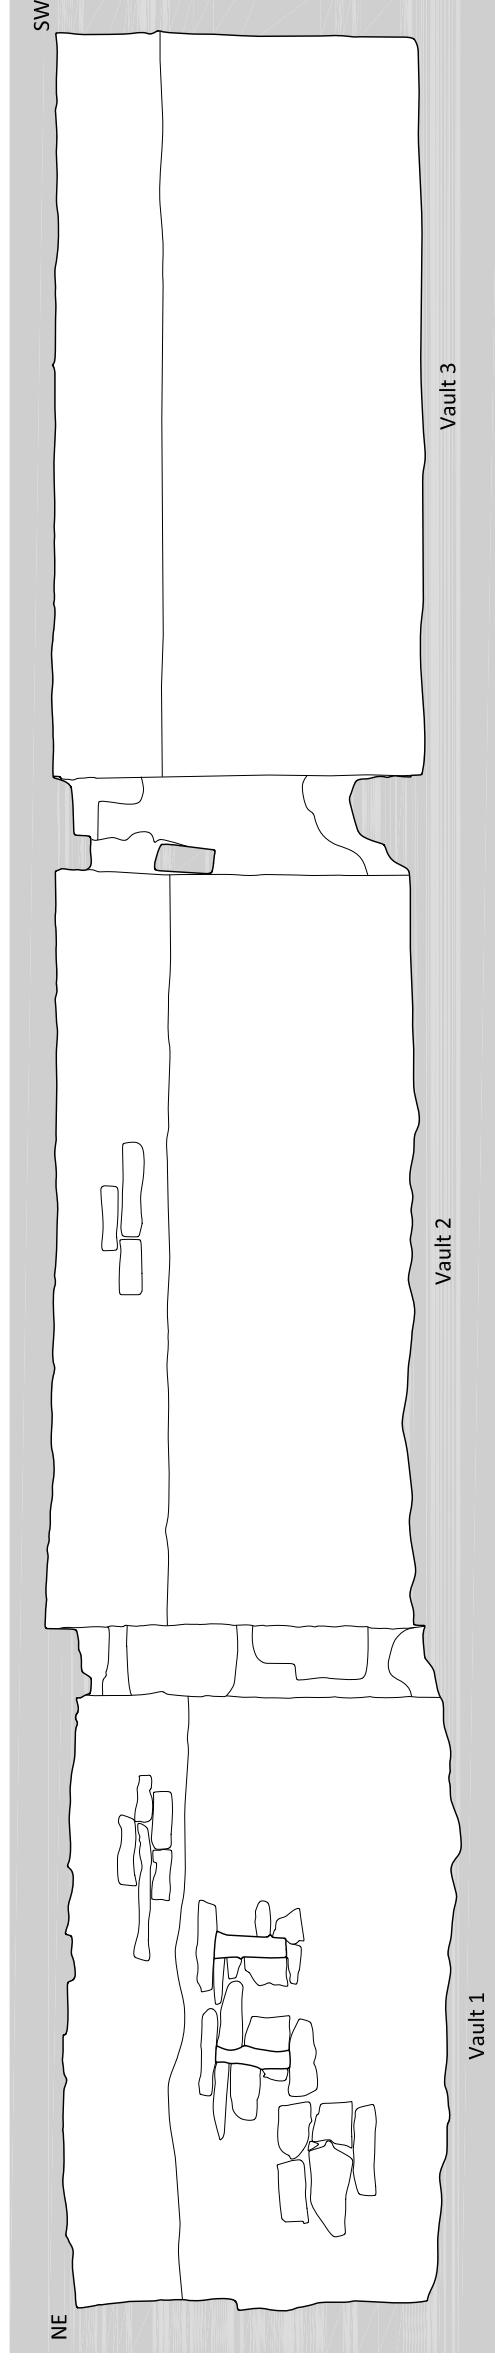
Section through NE-SW centre line of vaults 1-3

NW elevation of Vaults 1-3

SE elevation of Vaults 1-3

Figure 12: Internal Long Elevations and Section

3.1.4 A measured survey of the vaults was undertaken using a Trimble TX-5 3D laser scanner. The entirety of the survey was tied into the National Grid using GPS. 2D external and internal elevations together with a ground floor plan and sections through the vaults have been produced from the laser scanner data, which have been

reproduced as **Figures 11 - 13**. More detailed information on the laser scanner survey can be found in Appendix 5.

- 5.1.2 The following descriptions will look first at the newly exposed vaults, then the hospital building to its north-west and finally the fumigation house to the south corner. It should be read in conjunction with [Figures 11 - 13](#), which provide detailed floor plans, elevations and sections of the relevant areas.

- 5.2.2 Vault 1 to the south-west end consists of a small chamber measuring 4.05m x 3.45m ([Figures 11 & 12](#)). With bare stone rubble walls, carrying through to the vaulted roof, the vault has no features in the north-east elevation ([Plates 1 & 2](#)), although to the north-west and south-east elevations are four slit windows with large lintels and in-out surrounds ([Plates 3 – 5](#)). Access is from Vault 2 to the south-west elevation through a tall square-headed doorway, almost up to the vaulted roof ([Plate 6](#)). All of its fixtures and fittings have been removed. The flooring of Vault 1 consists of cut flag stones [034] of various sizes and is probably the original floor surface.

- 5.2.3 Vault 2 measures 4.95m x 3.45m with the return of the door in the north-east wall through to Vault 1 ([Figures 11 & 12](#); [Plate 7](#)). The north-west wall has two doorways, both stone-blocked, the north-easternmost of which is set much further back into the vaulted roof with a stone lintel ([Plates 8 & 9](#)). The opposite south-east wall has no features ([Plate 10](#)) and access to Vault 3 is to the south-west wall through a low square-headed doorway with a large stone lintel and small feature above it ([Plate 11](#)). Although no excavations took place within the vaults themselves, the flagged stone floor [057] of this chamber to the east and west corners is still *in situ* ([Plates 12 & 13](#)). The floor of Vault 2 is covered by a compact burnt sand layer [035], probably caused by the fire of 1937. A compact sand and stone surface [036] and its foundation layer (038) and possibly (037) were exposed directly below the burnt sand layer.

- 5.2.4 Vault 3 is the largest chamber to the south-west side of the vaults and measures 4.35m x 3.45m ([Figures 11 – 13](#)). The return of the square-headed doorway through to Vault 2 can be seen to the north-east wall, although the lintel and area around the small feature above it has been broken away on this side ([Plate 14](#)). On the opposite south-west wall is a small centrally-placed blocked fireplace with dressed stone surround ([Plates 15 & 16](#)). The adjacent north-west wall contains the main entrance into the vaults today (albeit now blocked once more) which is roughly central to the chamber wall and contains a wide door jamb for an inward-opening door ([Plates 17 & 18](#)). Immediately adjacent to this to the south-west side is another thinner stone-blocked doorway or recess ([Plates 19 & 20](#)). As with Vault 2, the south-east elevation has no features ([Plate 21](#)) and the stone-flagged floor has survived ([Plate 22](#)). The floor consists of a black burnt sand with stones and blocks surface [039].

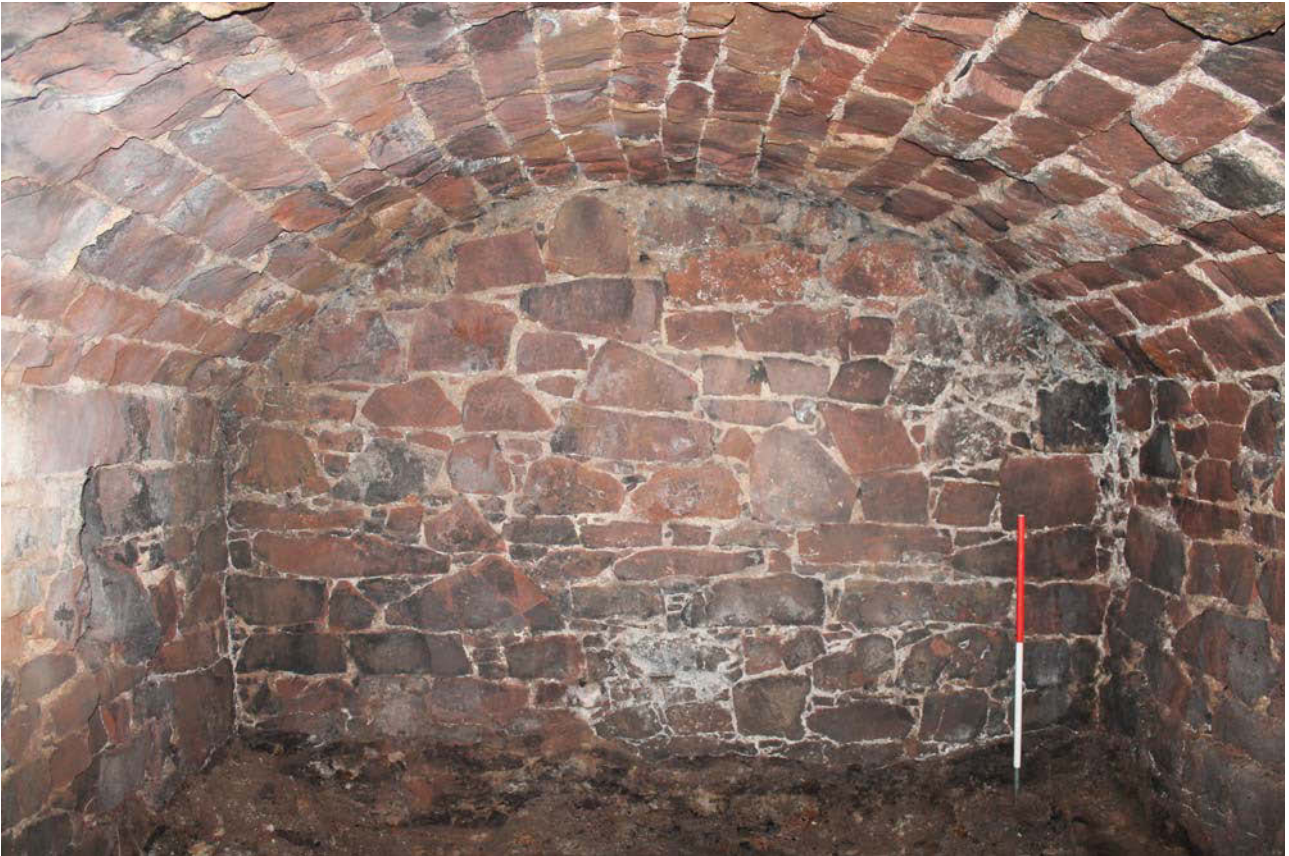
Plate 1: Vault 1, general view of the north-east wall from the south-west

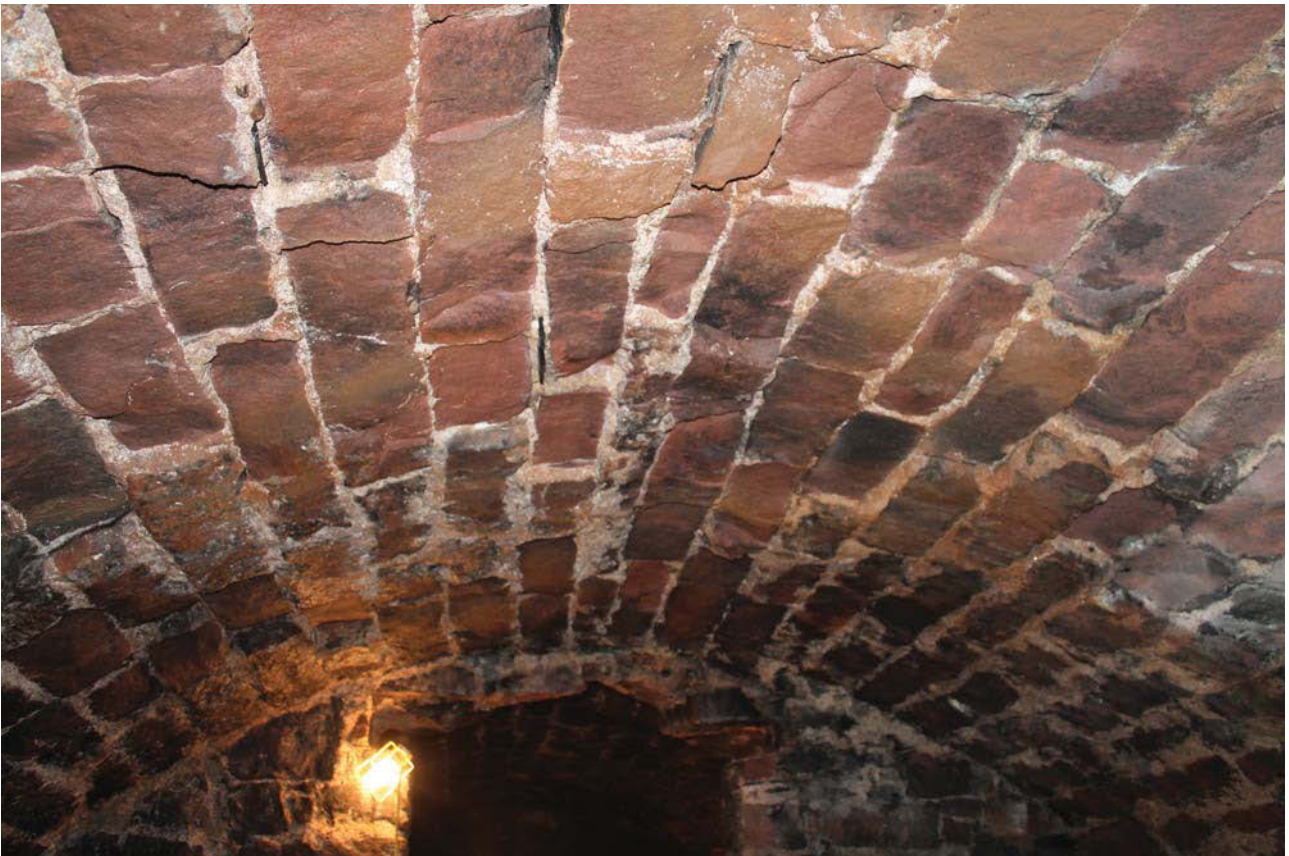
Plate 2: Vault 1, general view of the vaulted roof from the north-east

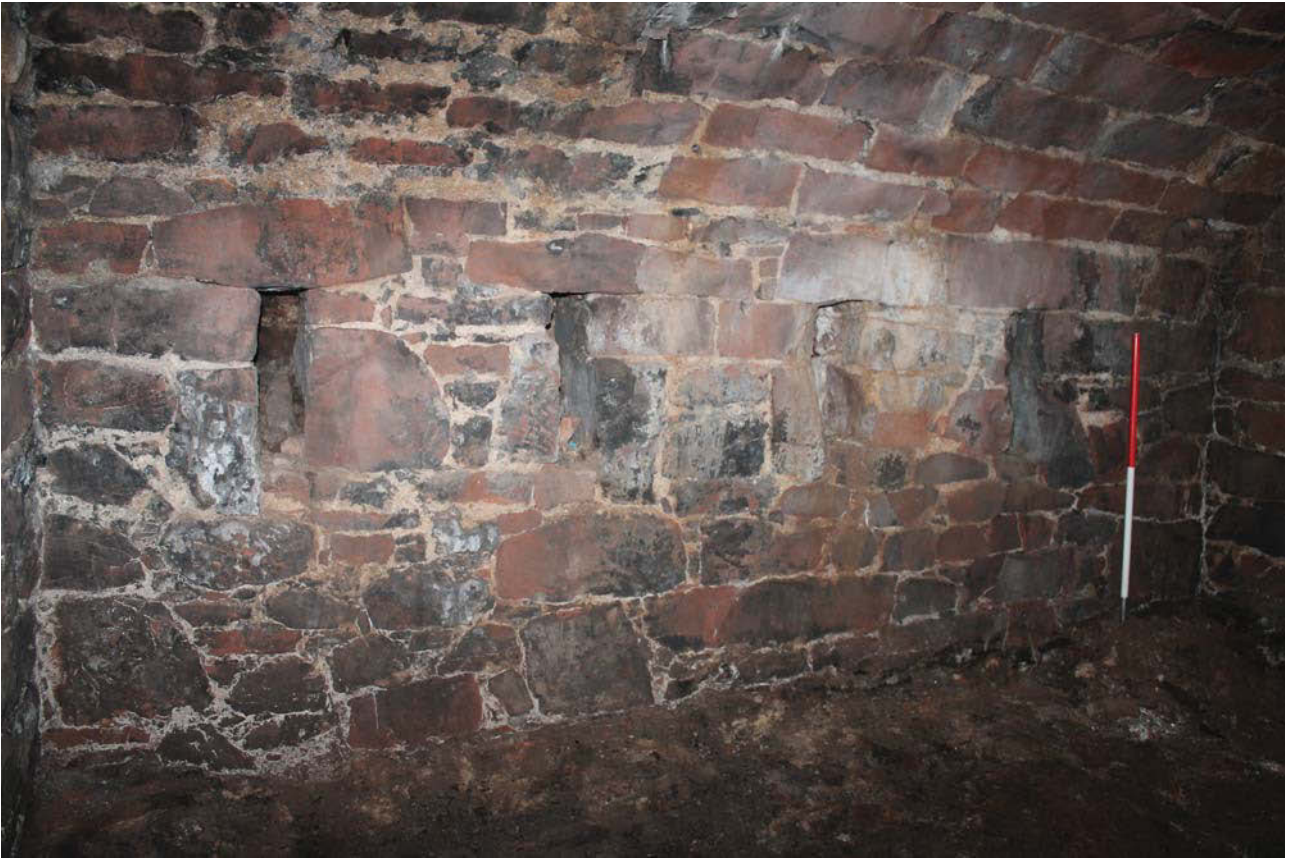
Plate 3: Vault 1, general view of the slit windows in the north-west wall from the south

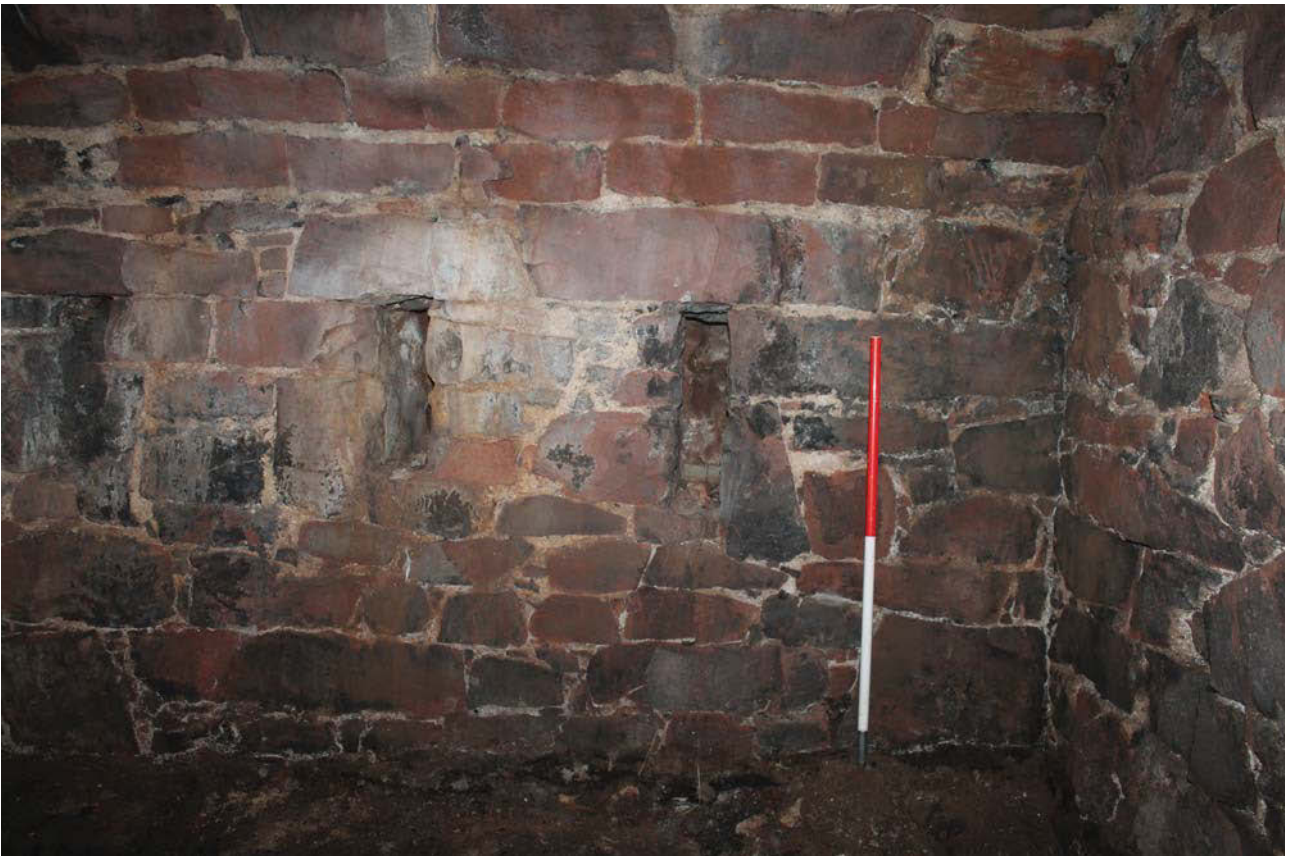
Plate 4: Vault, detail of the two north-eastermost slit windows in the north-west wall, from the south-east

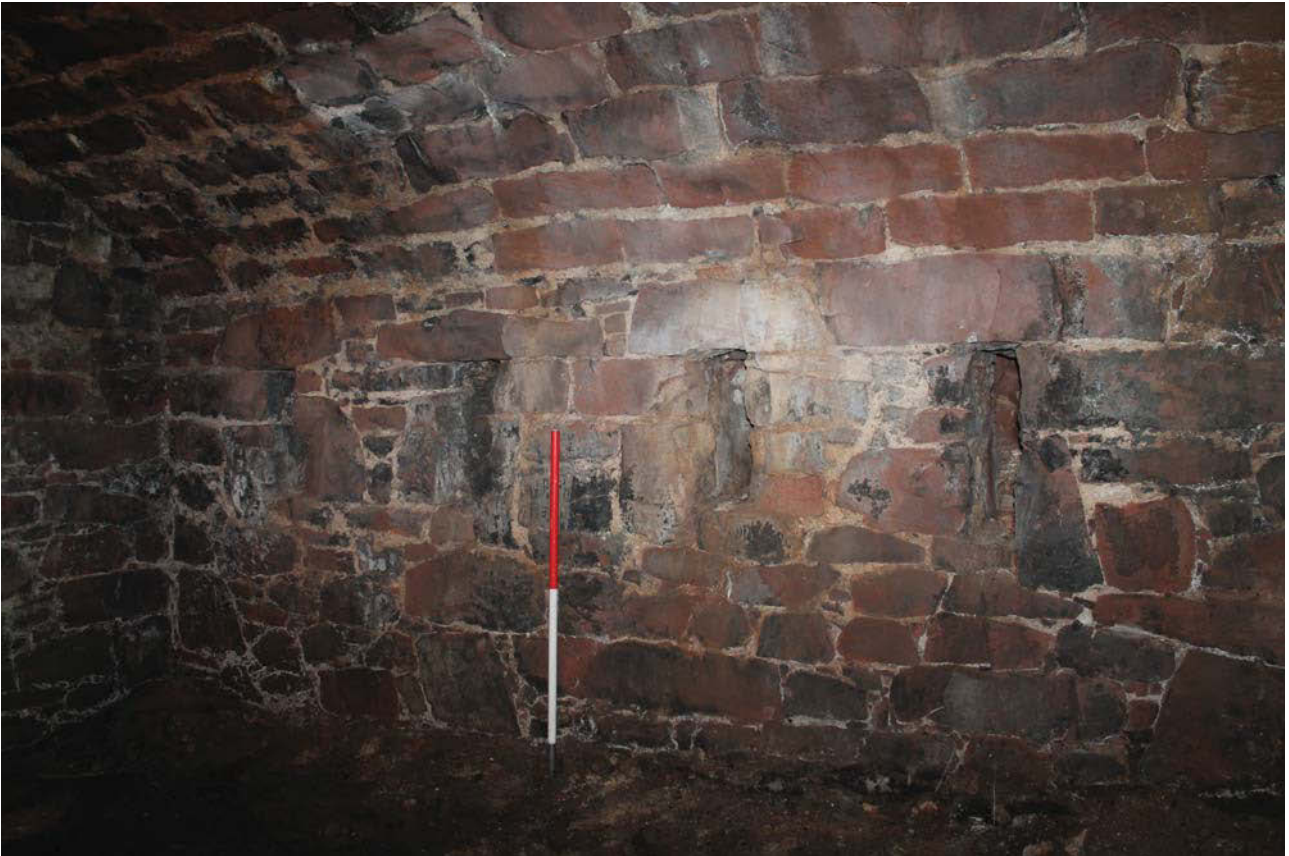
Plate 5: Vault 1, general view of the slit windows in the south-east wall from the north

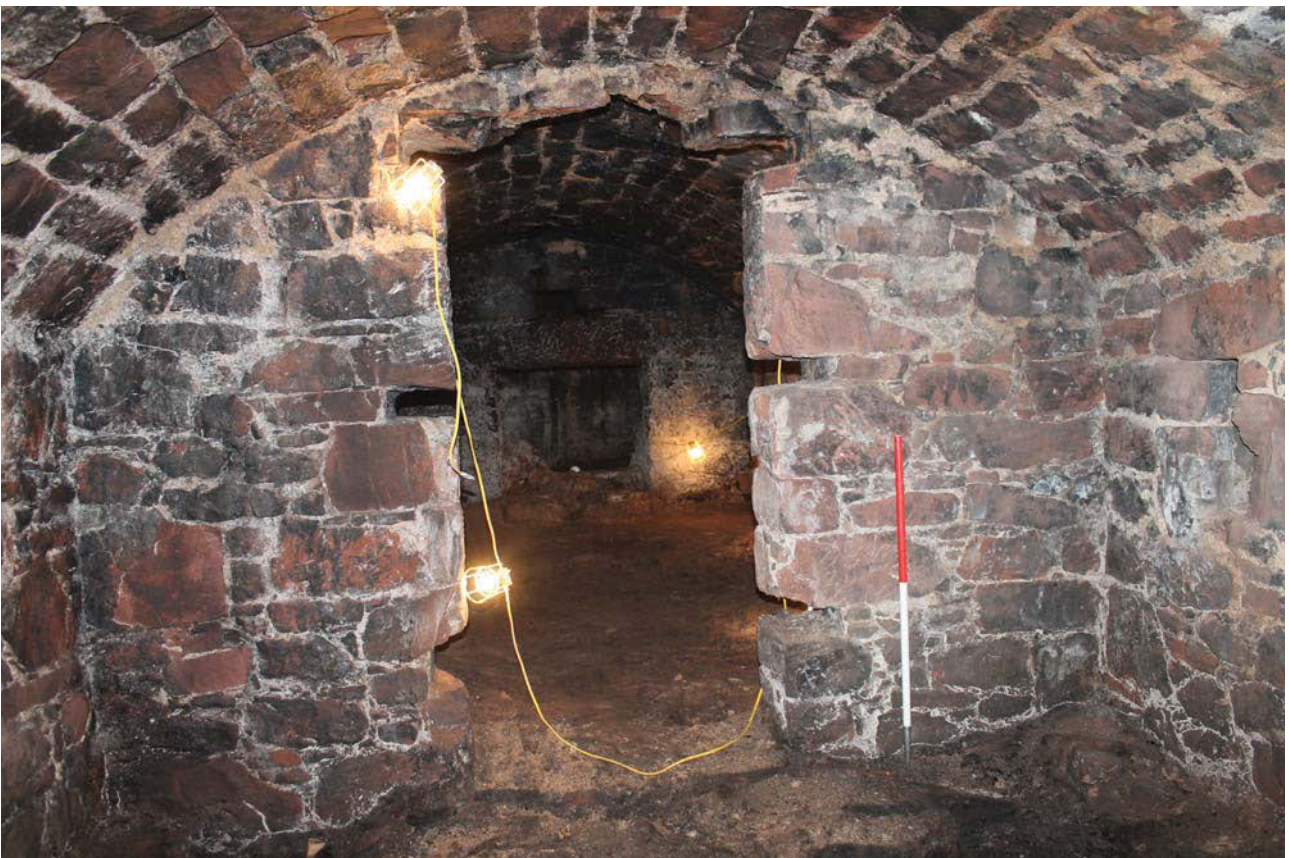
Plate 6: Vault 1, general view of the south-west wall showing doorway to Vault 2, from the north-east

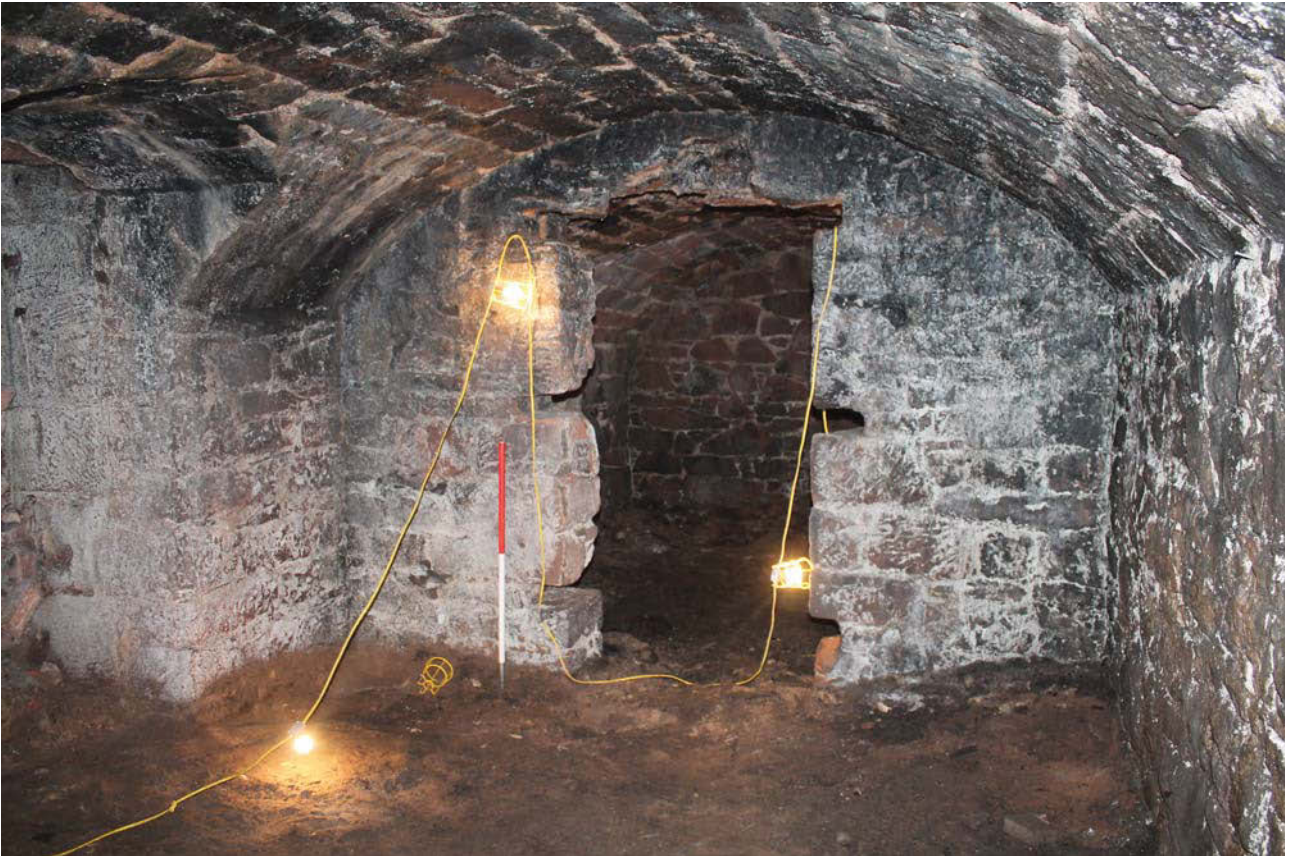
Plate 7: Vault 2, general view of the north-east wall showing the doorway to Vault 1 from the south-west
