Lamer Island, Dunbar, East Lothian: Archaeological Watching Brief & Historic Building Recording Report

On Behalf of: Dunbar Harbour Trust
Cromwell Quay
Shore Street
Dunbar
EH42 1SU

AOC Project No: 20245

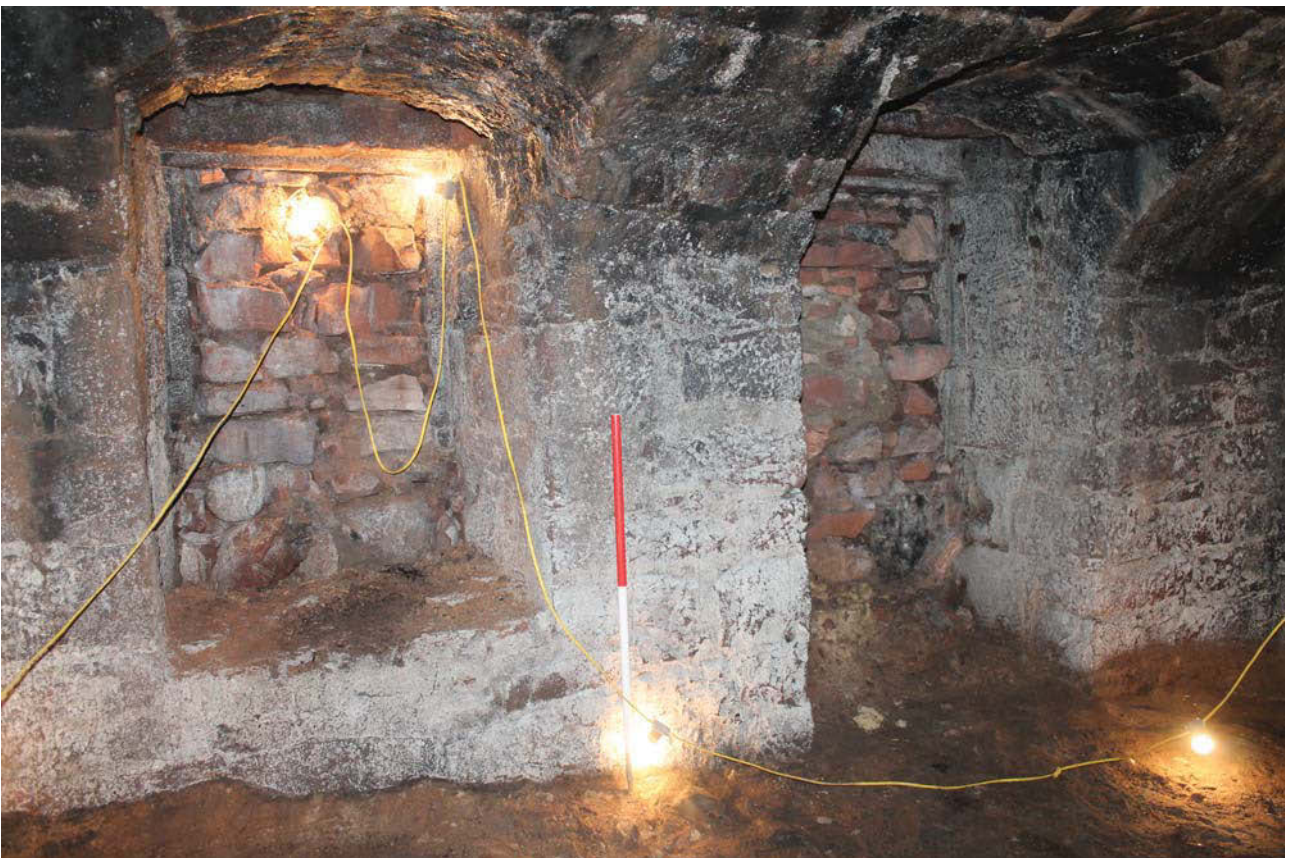
Plate 8: Vault 2, general view of the north-west wall from the south

- 5.2.3 Vault 2 measures 4.95m x 3.45m with the return of the door in the north-east wall through to Vault 1 ([Figures 11 & 12](#); [Plate 7](#)). The north-west wall has two doorways, both stone-blocked, the north-easternmost of which is set much further back into the vaulted roof with a stone lintel ([Plates 8 & 9](#)). The opposite south-east wall has no features ([Plate 10](#)) and access to Vault 3 is to the south-west wall through a low square-headed doorway with a large stone lintel and small feature above it ([Plate 11](#)). Although no excavations took place within the vaults themselves, the flagged stone floor [057] of this chamber to the east and west corners is still *in situ* ([Plates 12 & 13](#)). The floor of Vault 2 is covered by a compact burnt sand layer [035], probably caused by the fire of 1937. A compact sand and stone surface [036] and its foundation layer (038) and possibly (037) were exposed directly below the burnt sand layer.

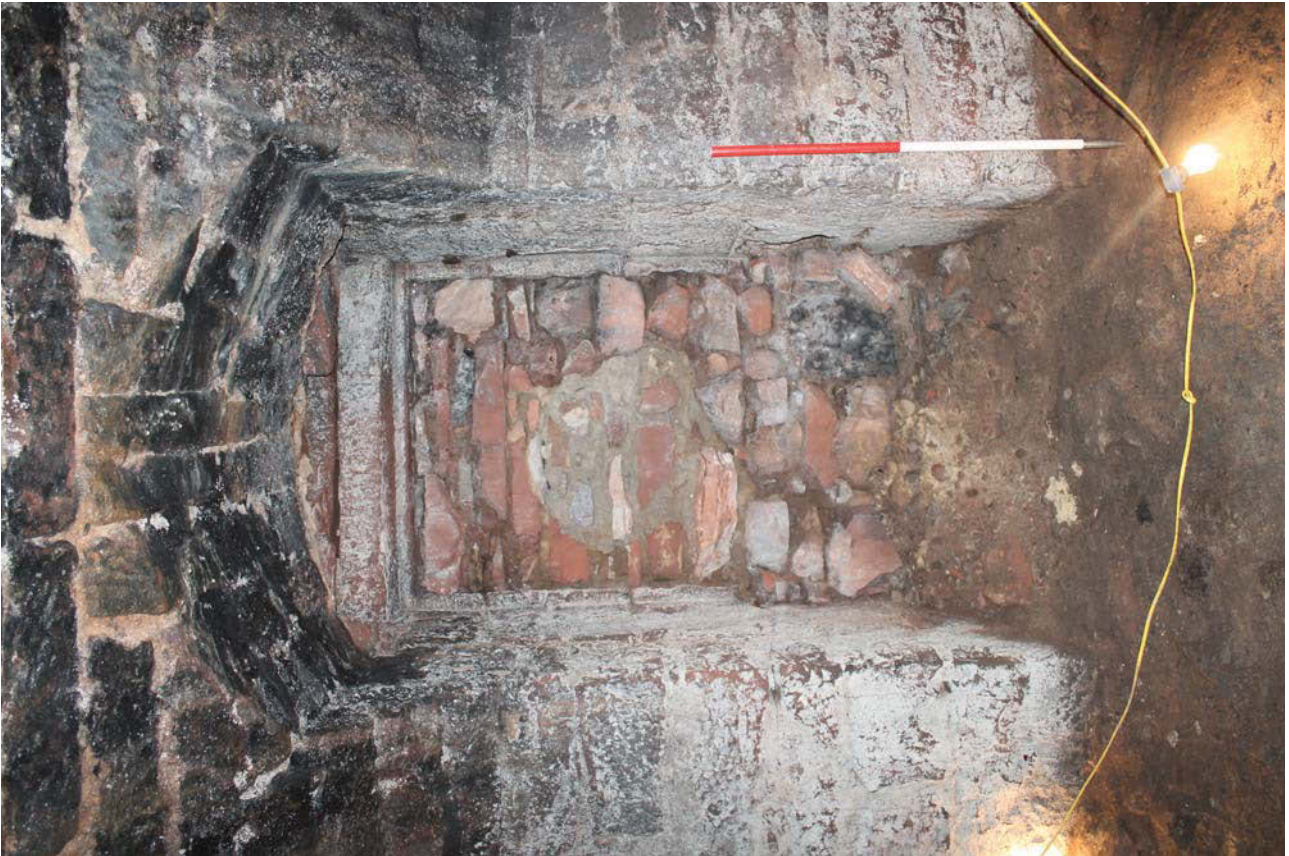
Plate 9: Vault 2, detail of the north-easternmost blocked doorway in the north-west wall, from the south-east

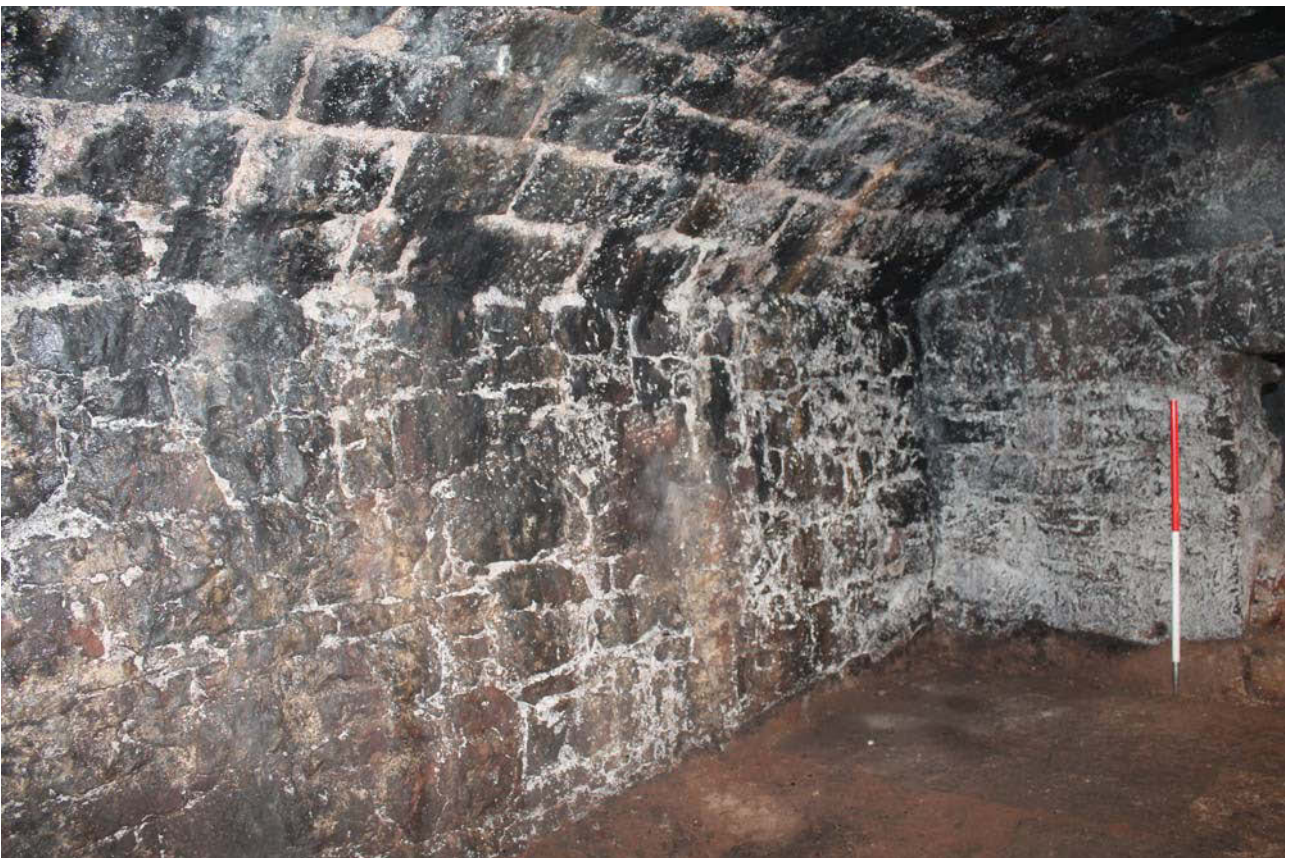
Plate 10: Vault 2, general view of the south-east wall from the north

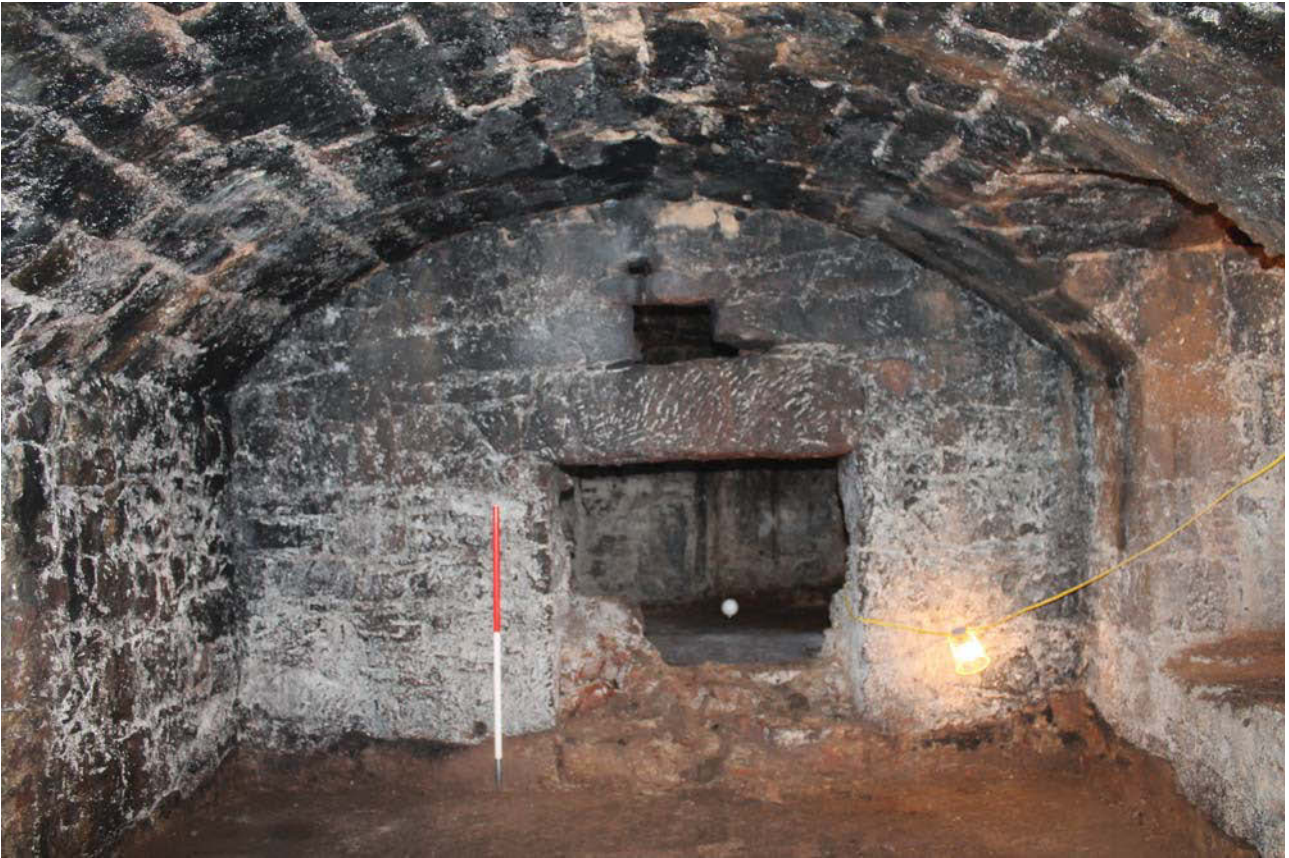
Plate 11: Vault 2, general view of the south-west wall showing the doorway to Vault 1, from the north-east

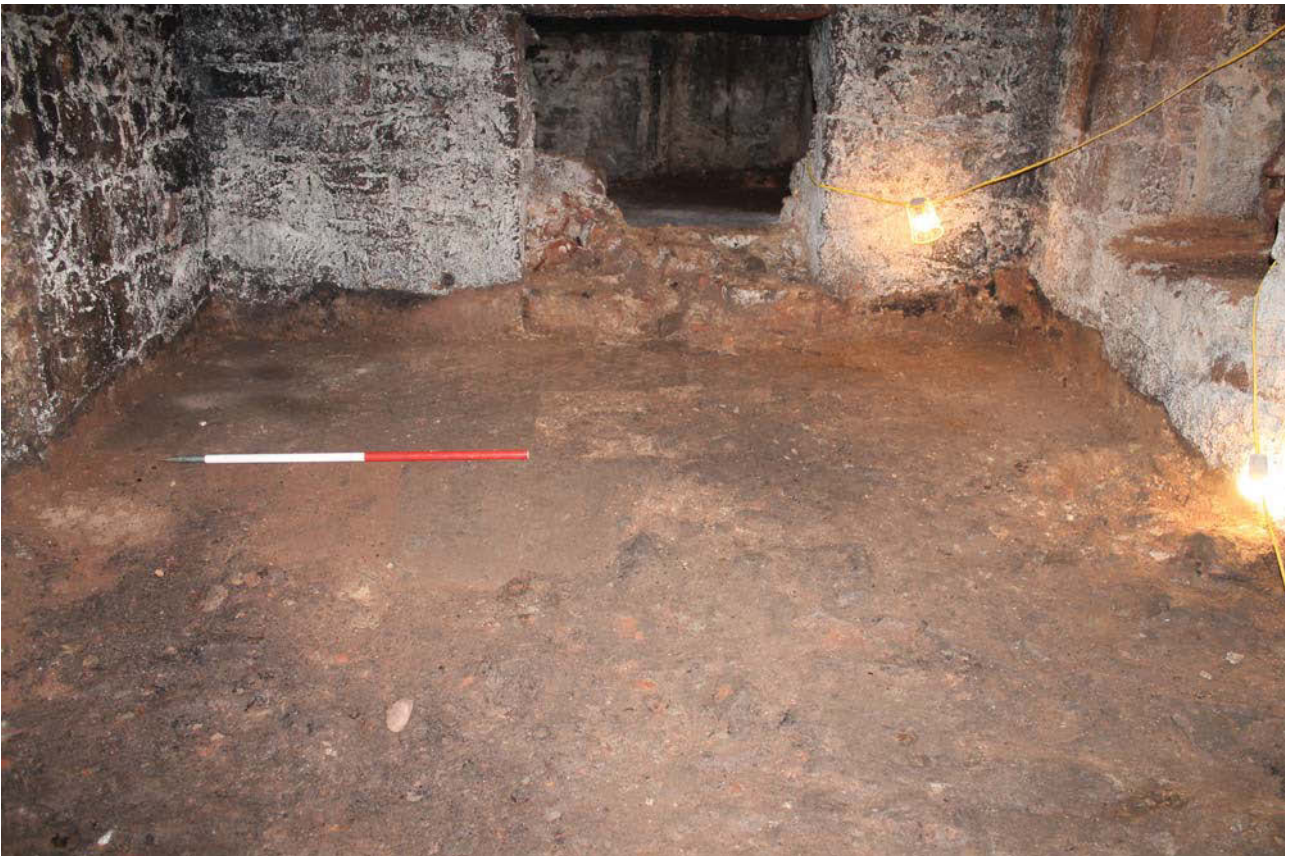
Plate 12: Vault 2, general view of the stone-flagged floor from the north-east

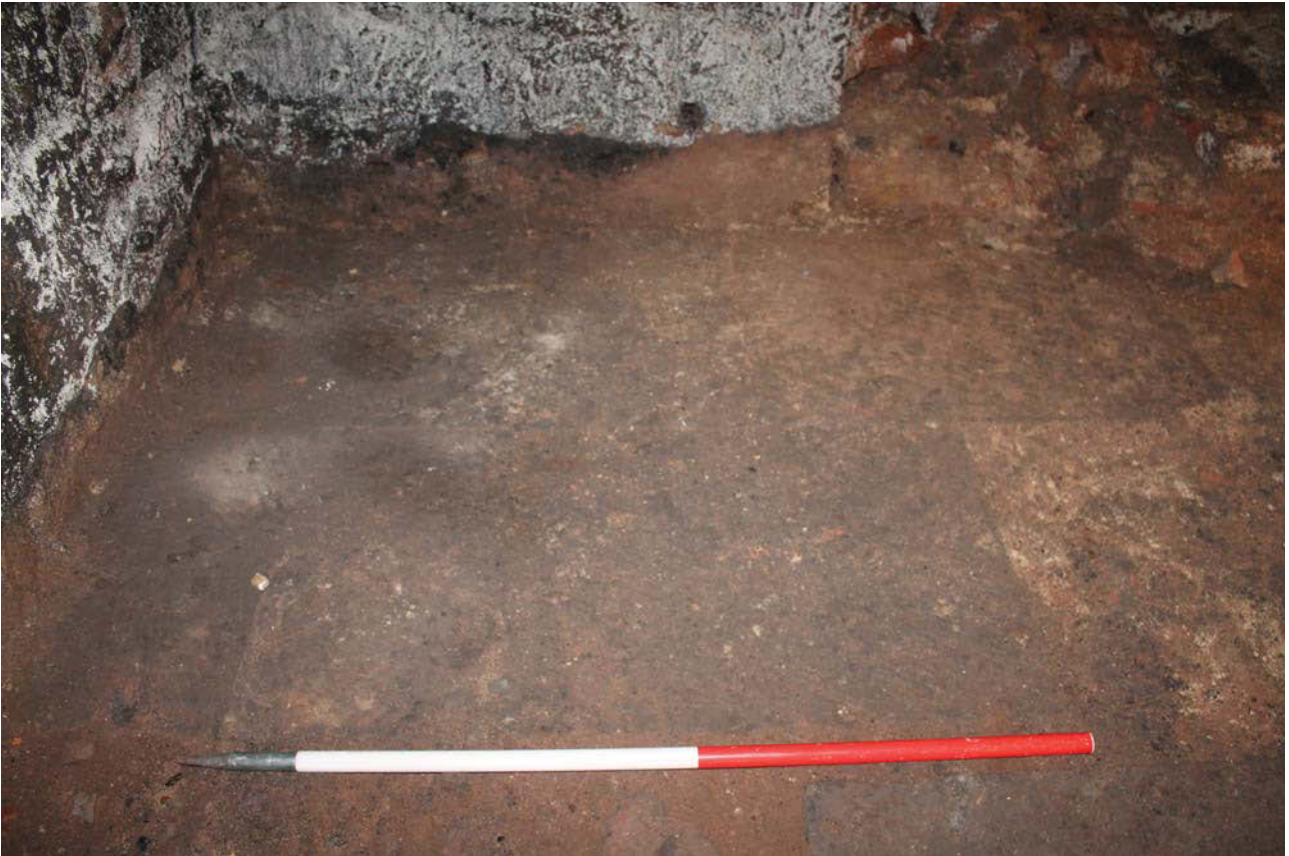
Plate 13: Vault 2, detail of the stone-flagged floor in the south corner from the north-east

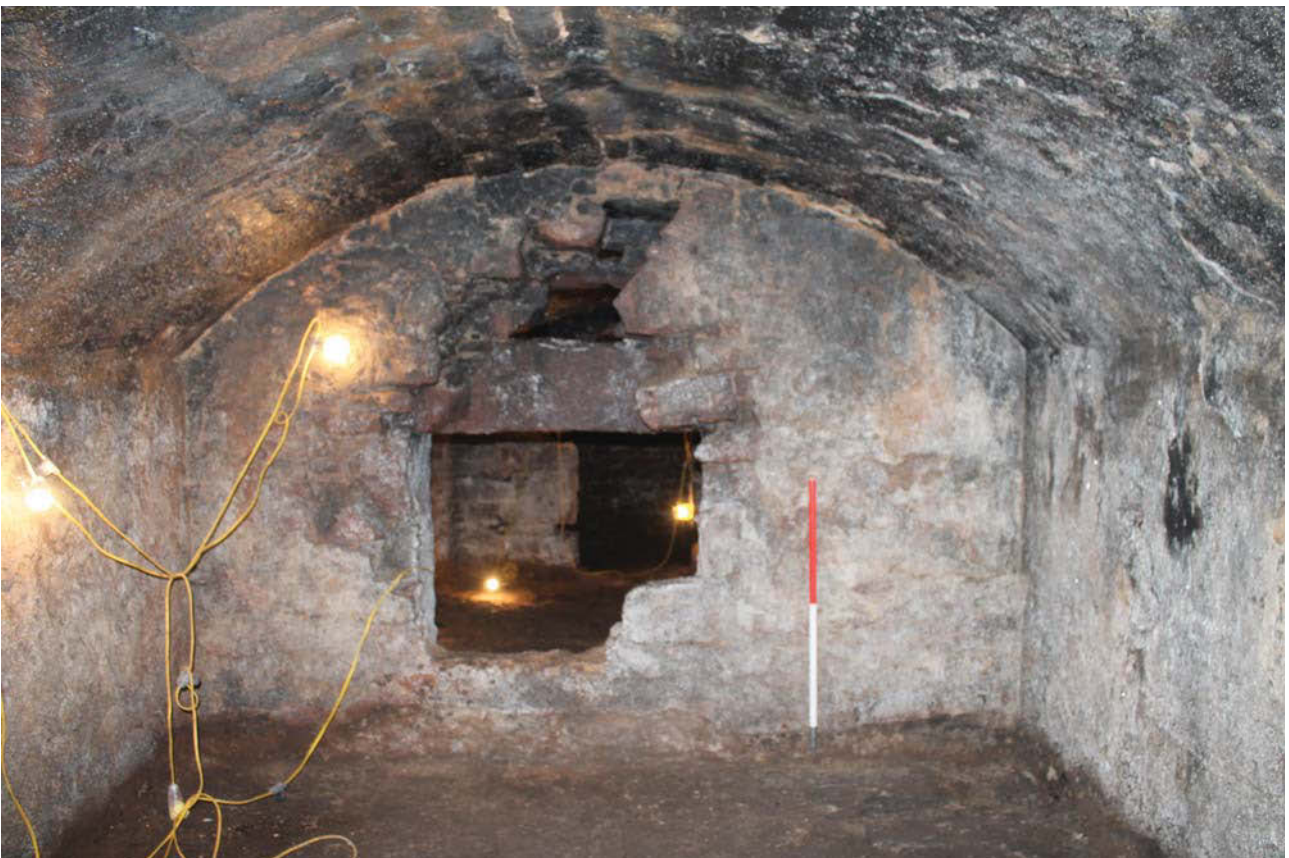
Plate 14: Vault 3, general view of the north-east wall showing the doorway to Vault 2, from the south-west

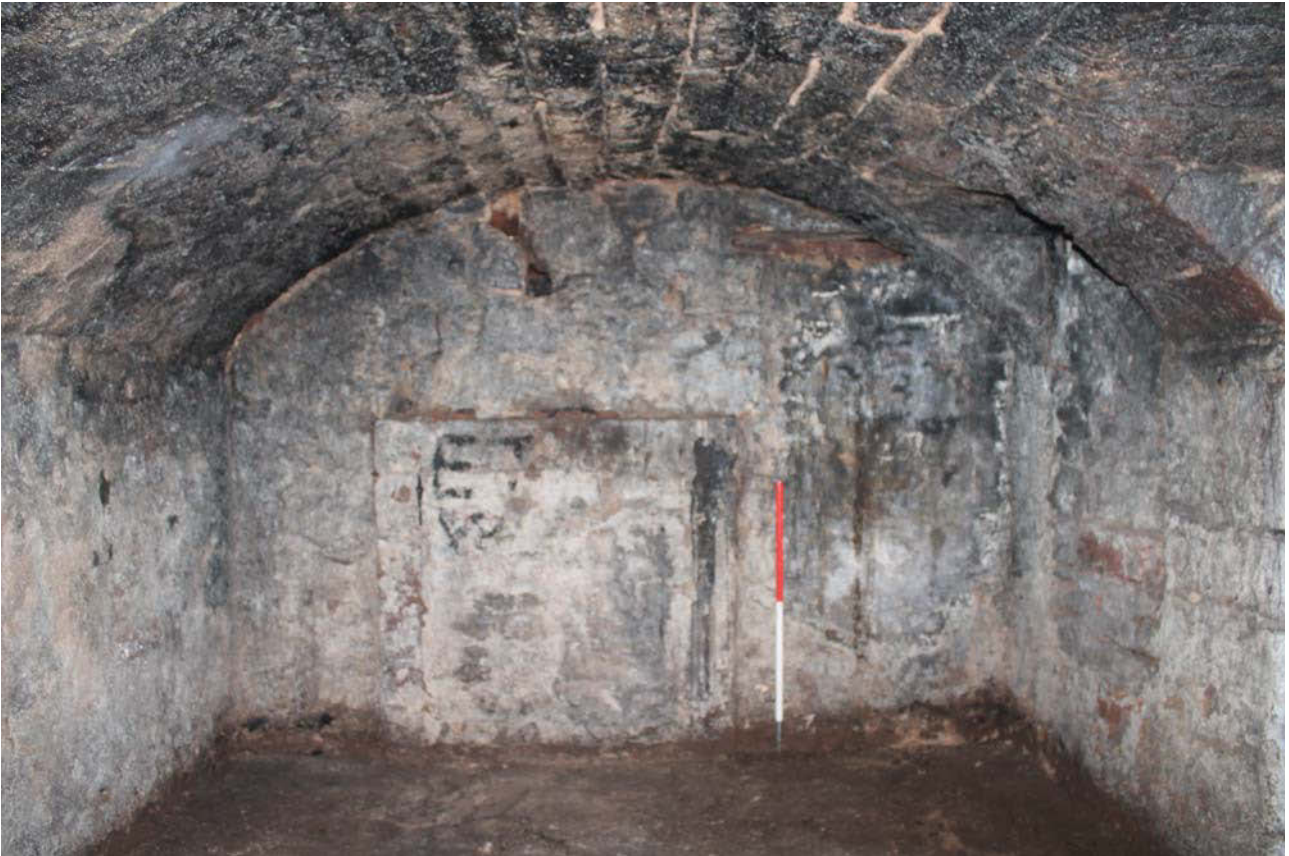
Plate 15: Vault 3, general view of the south-west wall from the north-east

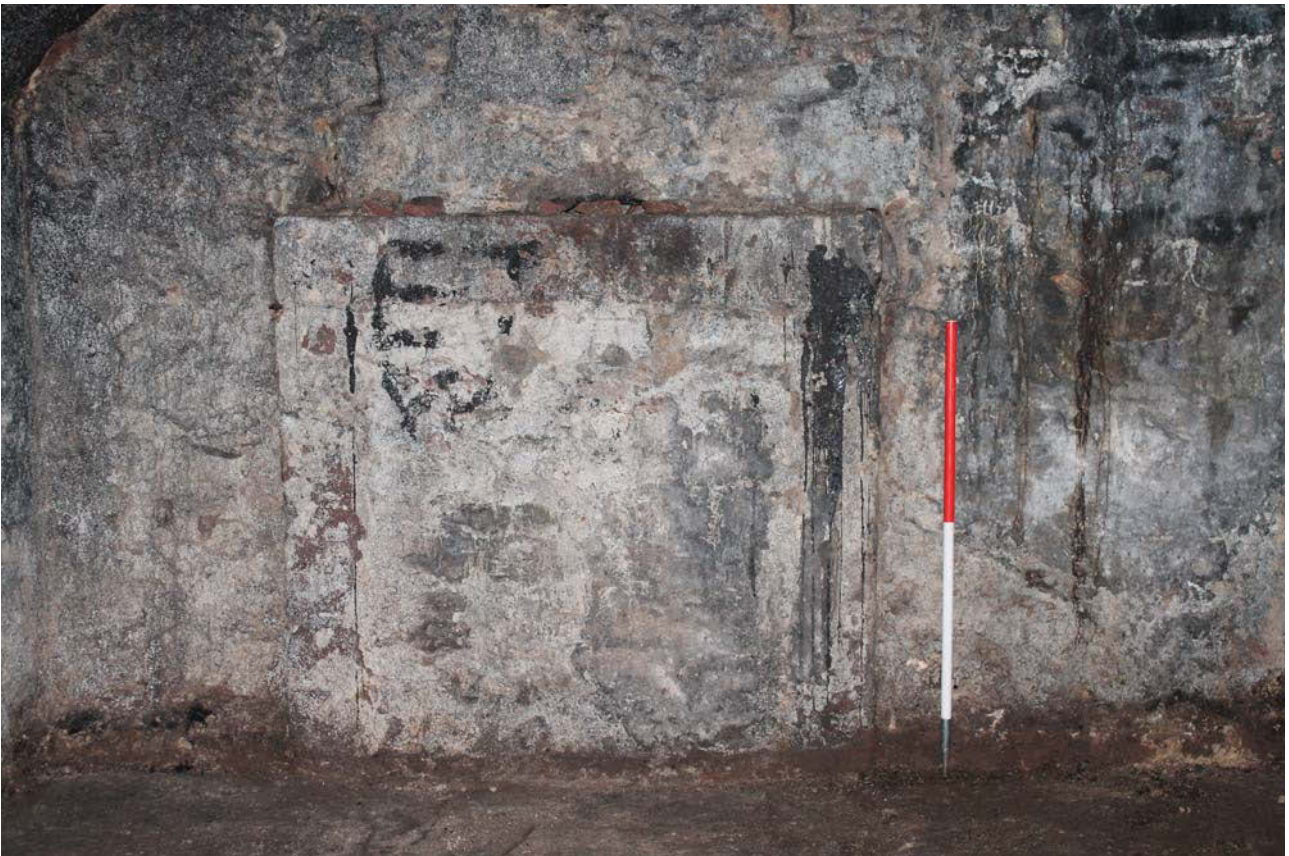
Plate 16: Vault 3, detail of the blocked fireplace in the south-west wall, from the north-east

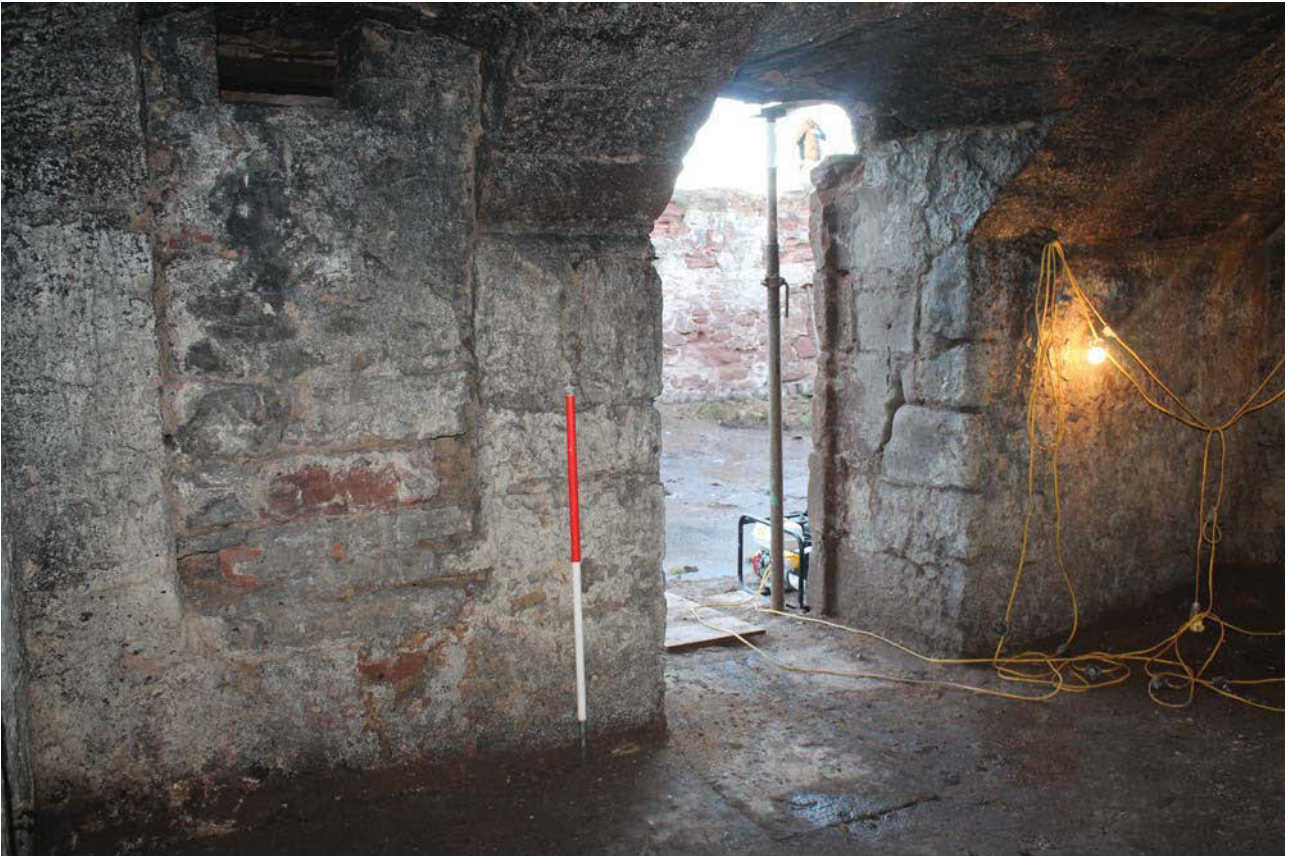
Plate 17: Vault 3, general view of the north-west wall from the south

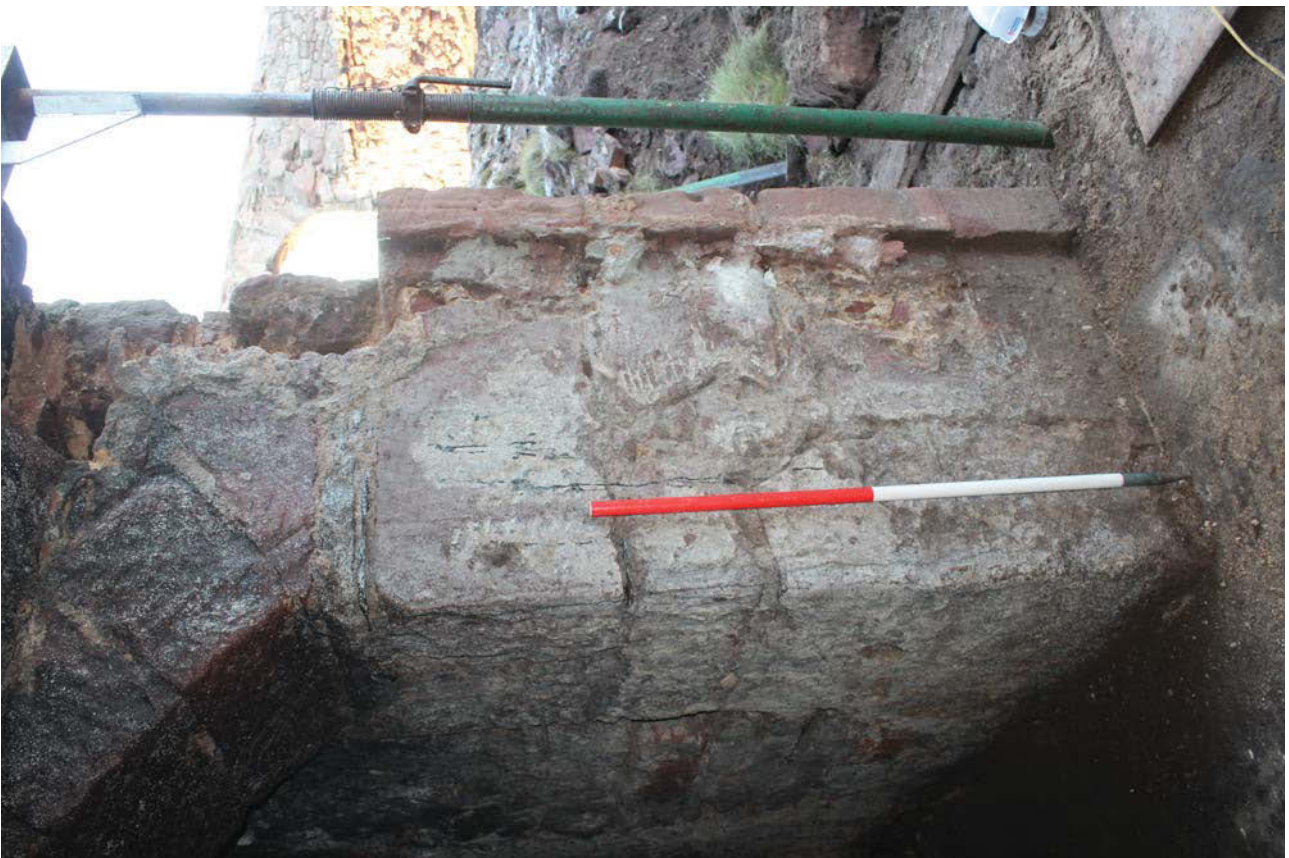
Plate 18: Vault 3, detail of south-west soffit of central doorway in the north-west wall, from the east

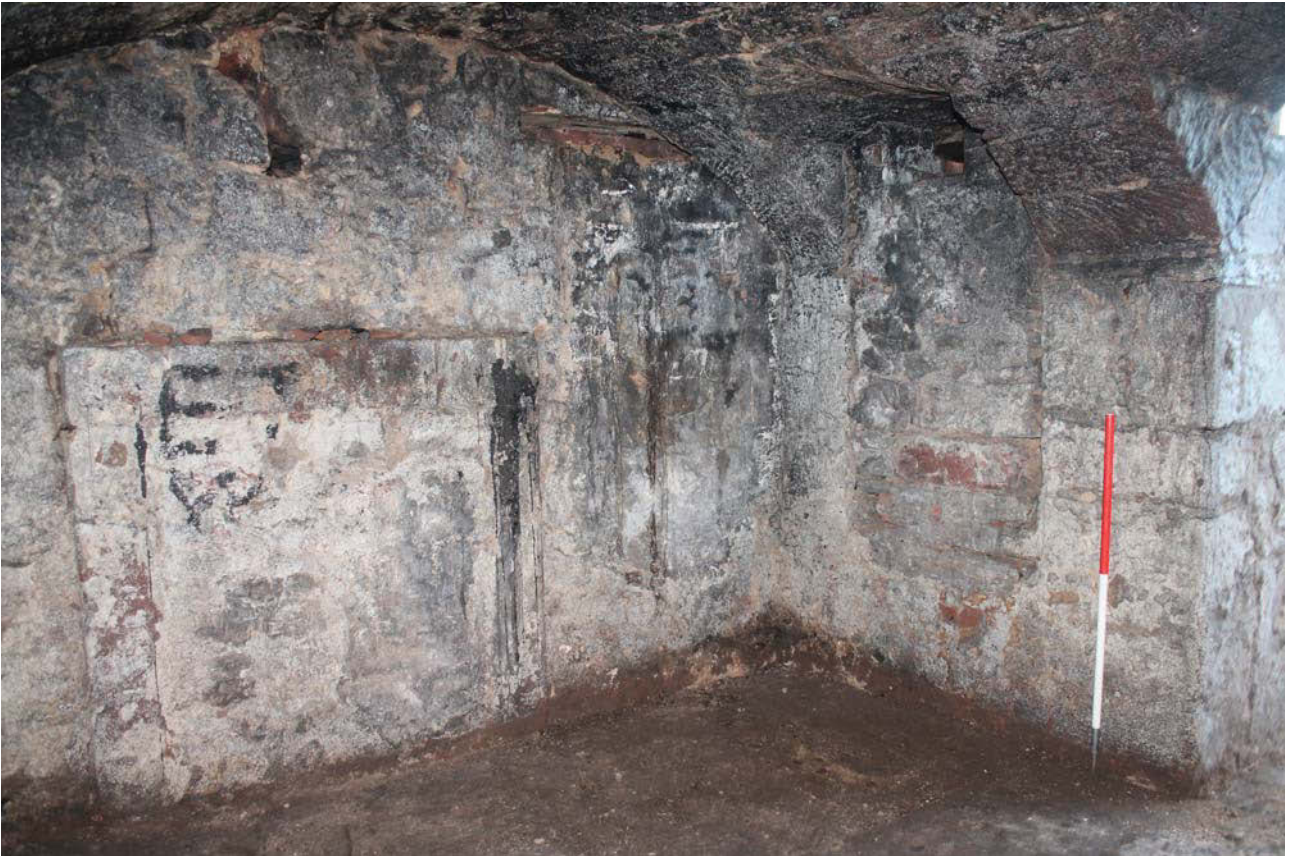
Plate 19: Vault 3, general view of the north corner from the south

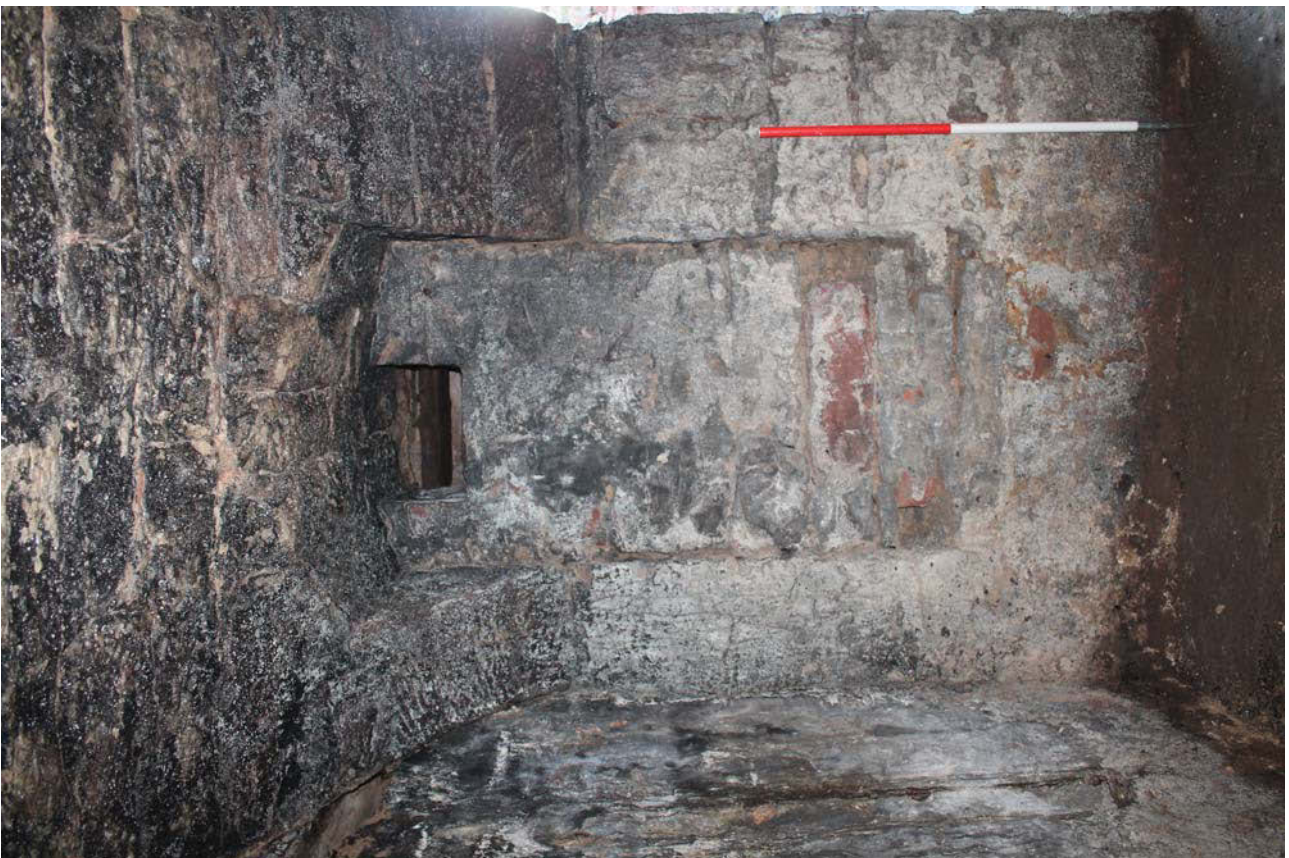
Plate 20: Vault 3, detail of the blocked doorway to the south-west side of the north-west wall from the south-east

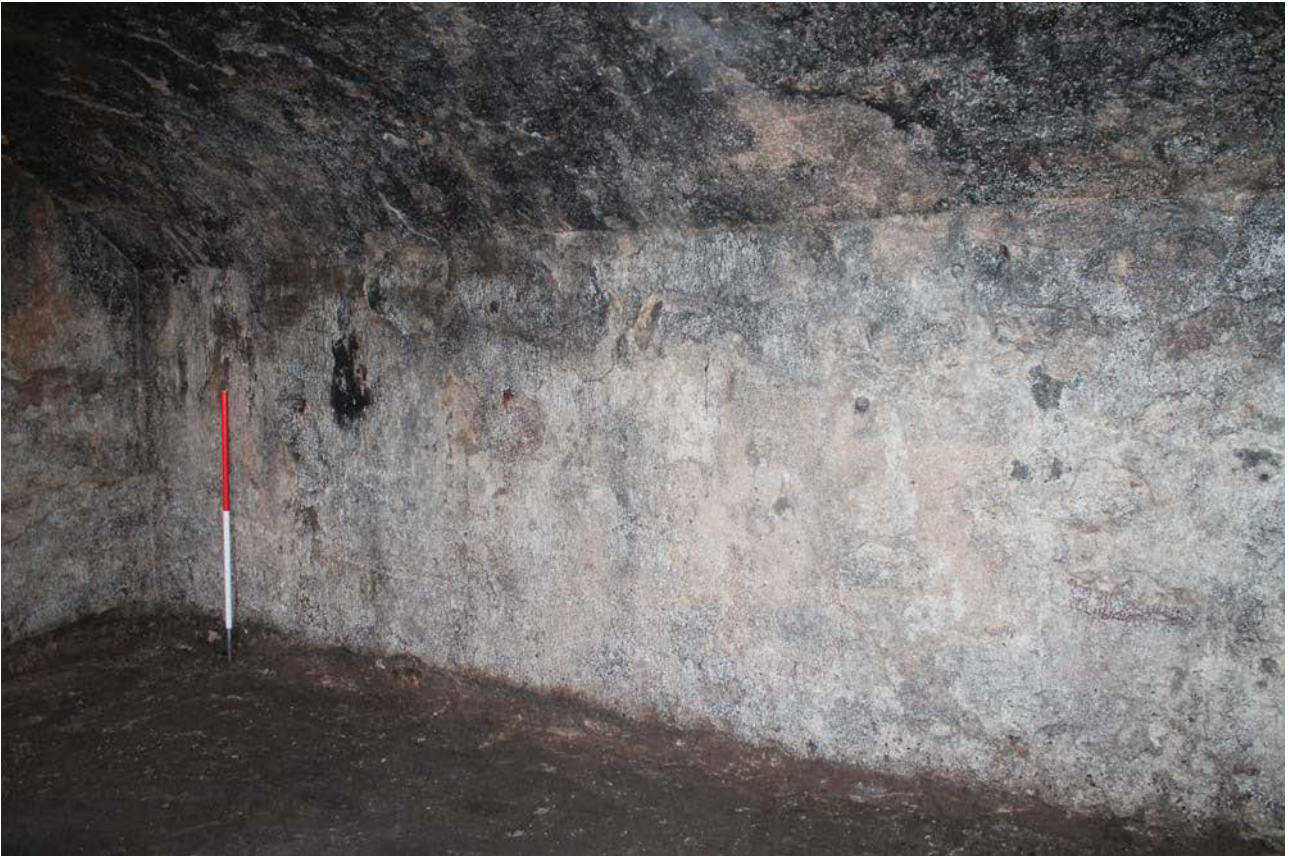
Plate 21: Vault 3, general view of the south-east wall from the north

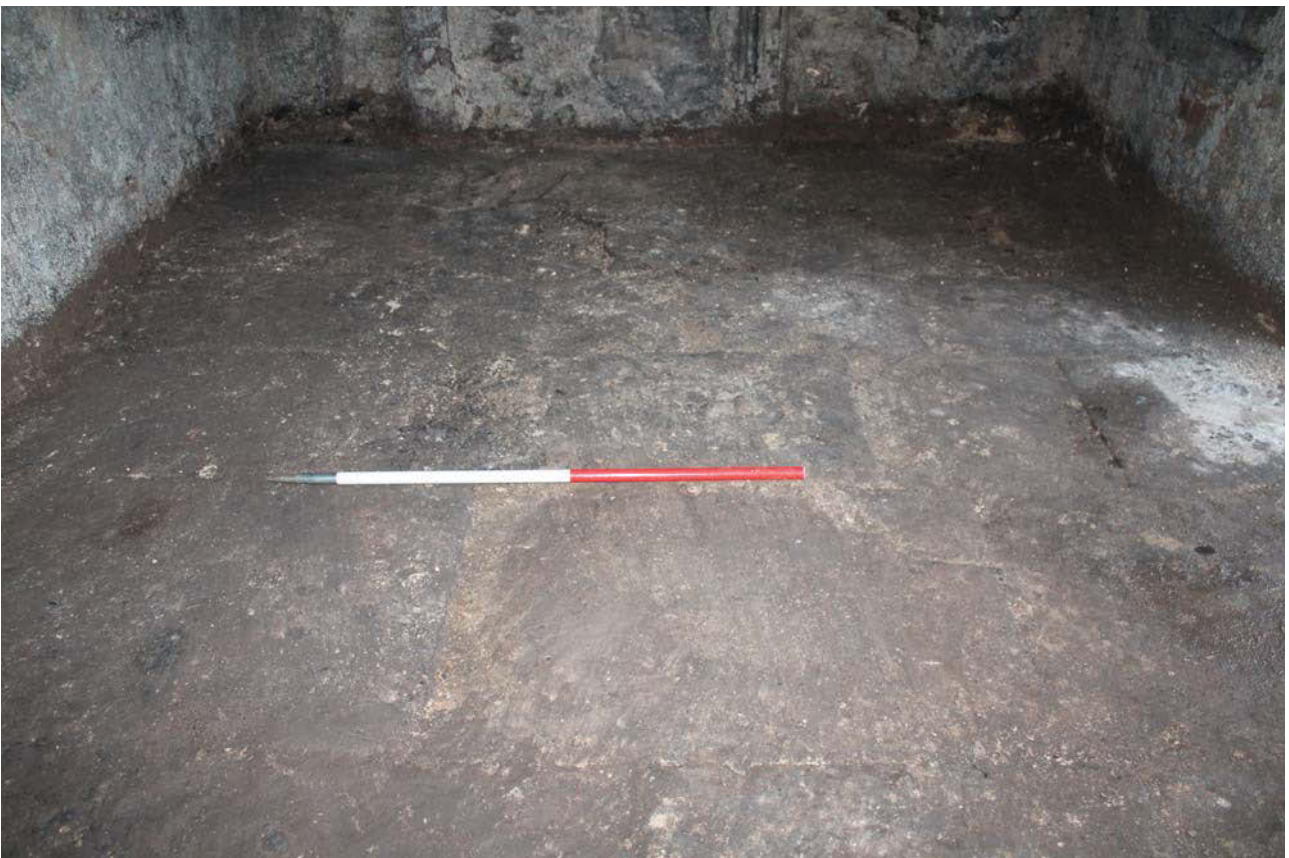
Plate 22: Vault 3, general view of stone-flagged floor from the north-east

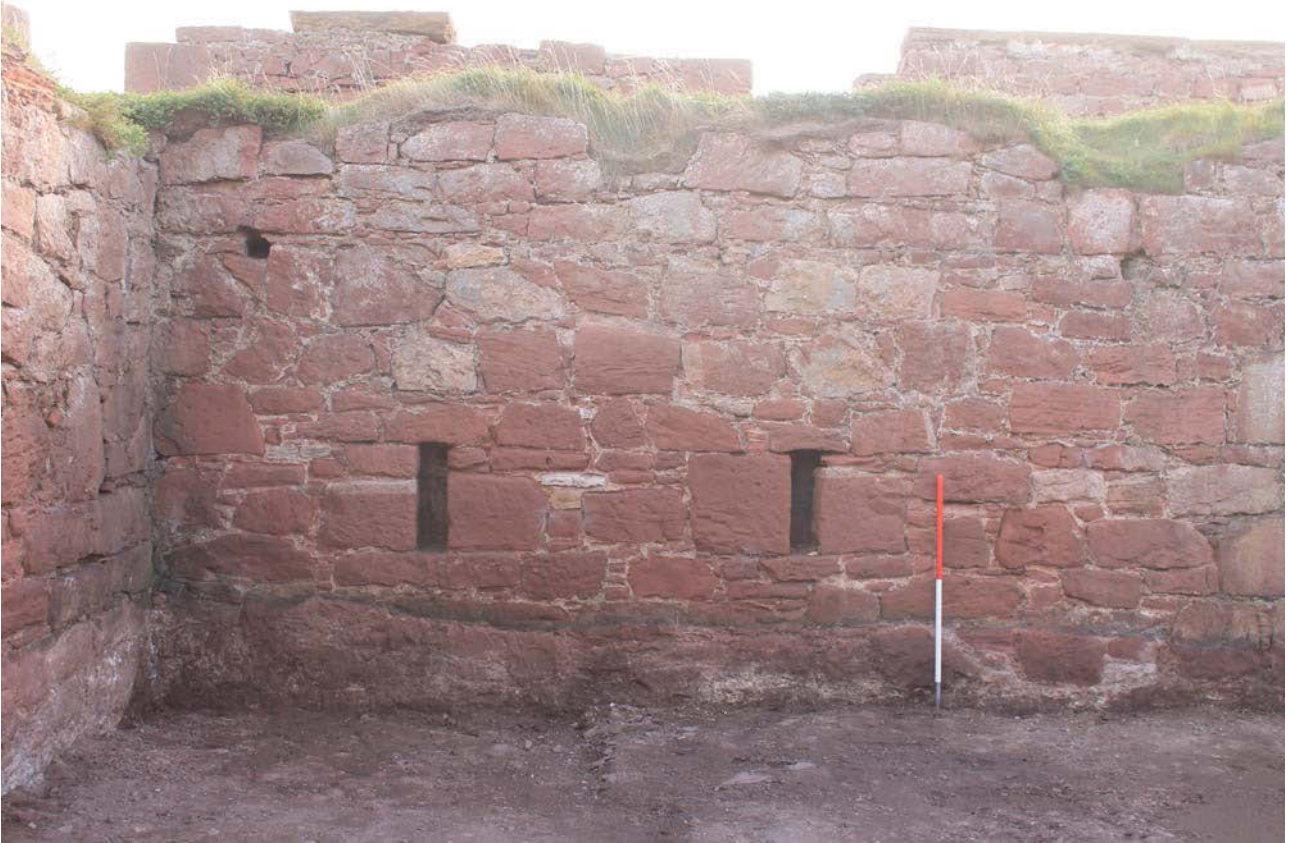
Plate 23: The Hospital building, south-east elevation, detail of the slit windows to the north-east side, from the north-west

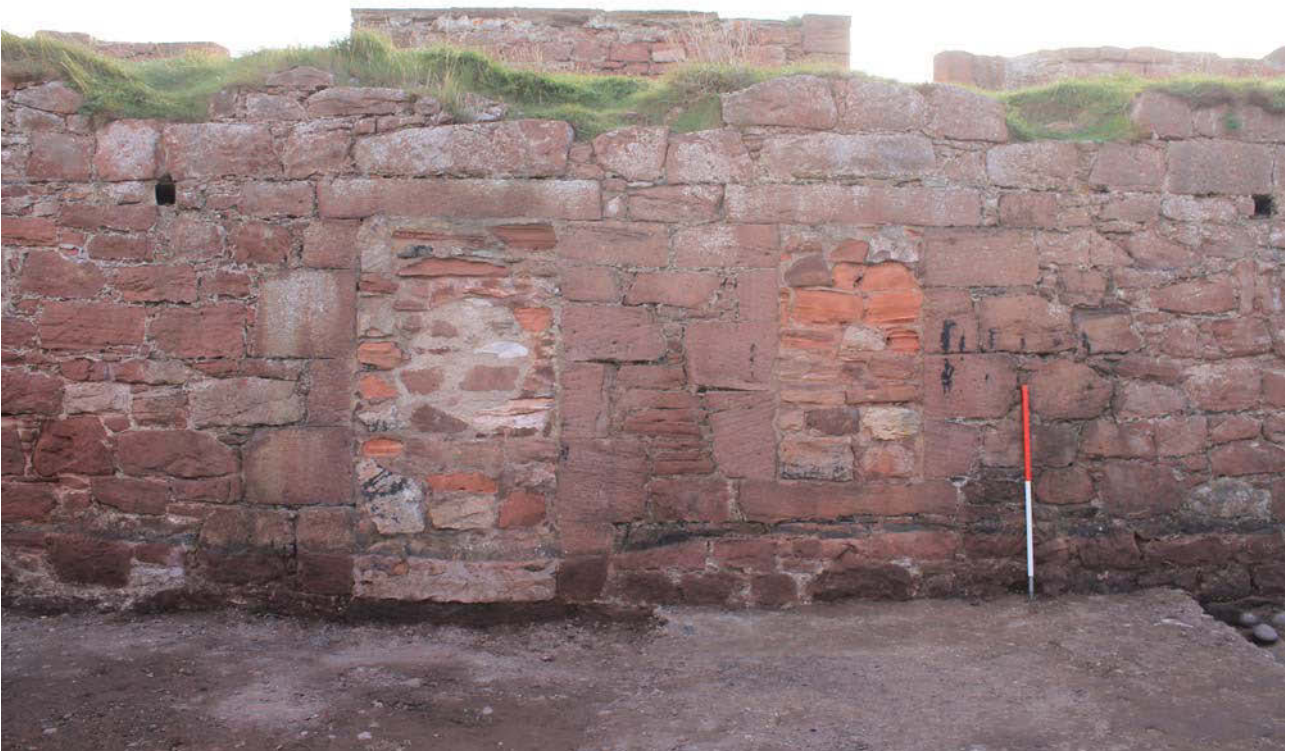
Plate 24: The Hospital building, south-east elevation, detail of the central blocked doorways from the north-west

- 5.3.1 The external elevation of the vaults comprises the north-west elevation of the vaults and the south-east internal elevation of the hospital building. The features identified in the interior north-west elevations of the vault also appear here, stone-blocked in red sandstone, including two of the four slit windows to Vault 1 to the north-east side (Plate 23), the two central doorways to Vault 2 (Plate 24) and the main entrance and adjacent blocked doorway to Vault 1 (Plate 25).

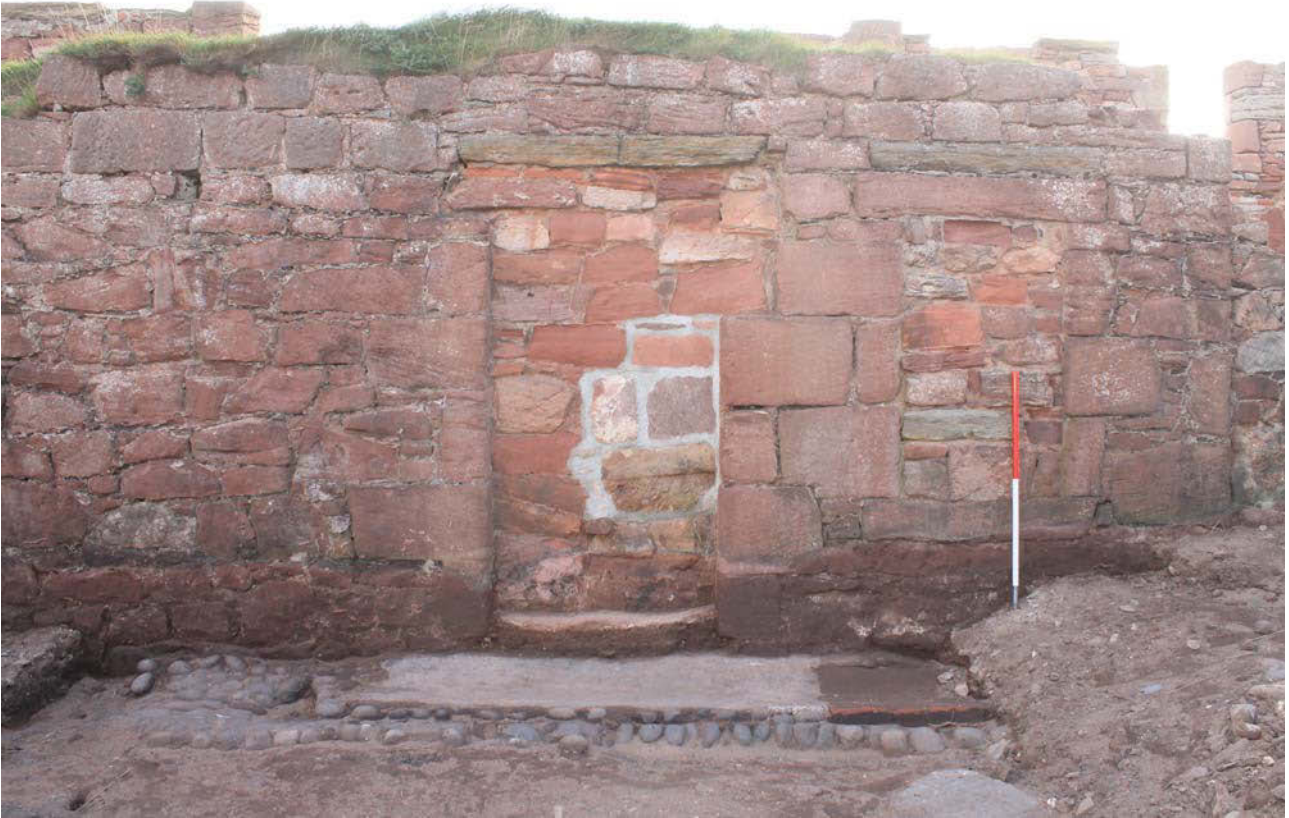
Plate 25: The Hospital building, south-east elevation, detail of blocked doorways to the south-west side, from the north-west

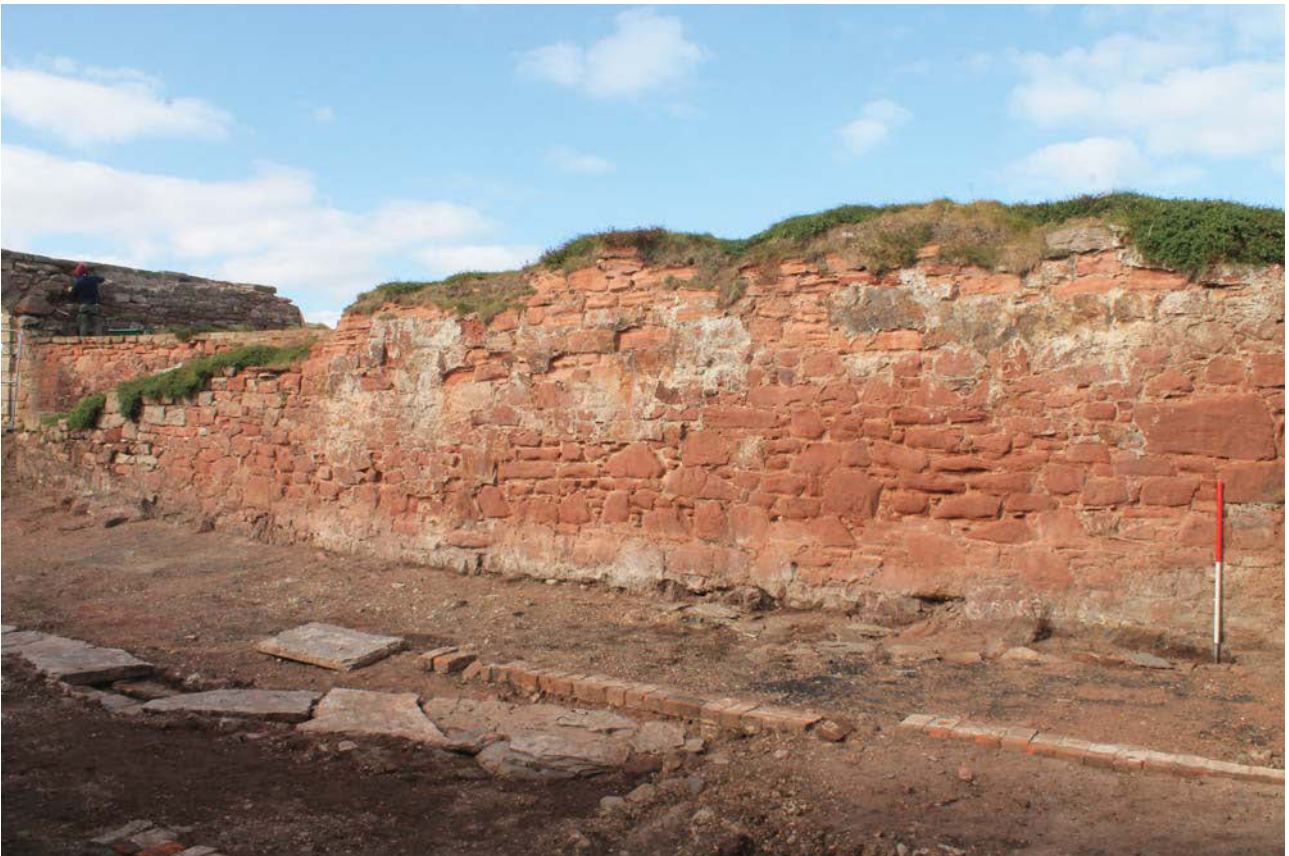
Plate 26: The Hospital building, north-west elevation, general view from the east

- 5.3.2 The opposite north-west and north-east internal elevations of the former hospital building have no features (as they were built below the ground level), and are constructed of red sandstone rubble (Plates 26 - 29). The single course of a north-east elevation [076] was exposed abutting the north-west interior elevation of the former hospital, in line with the north-east internal elevation of the hospital and extending to 2.43m to the north-west with a 1.0m return to the east.

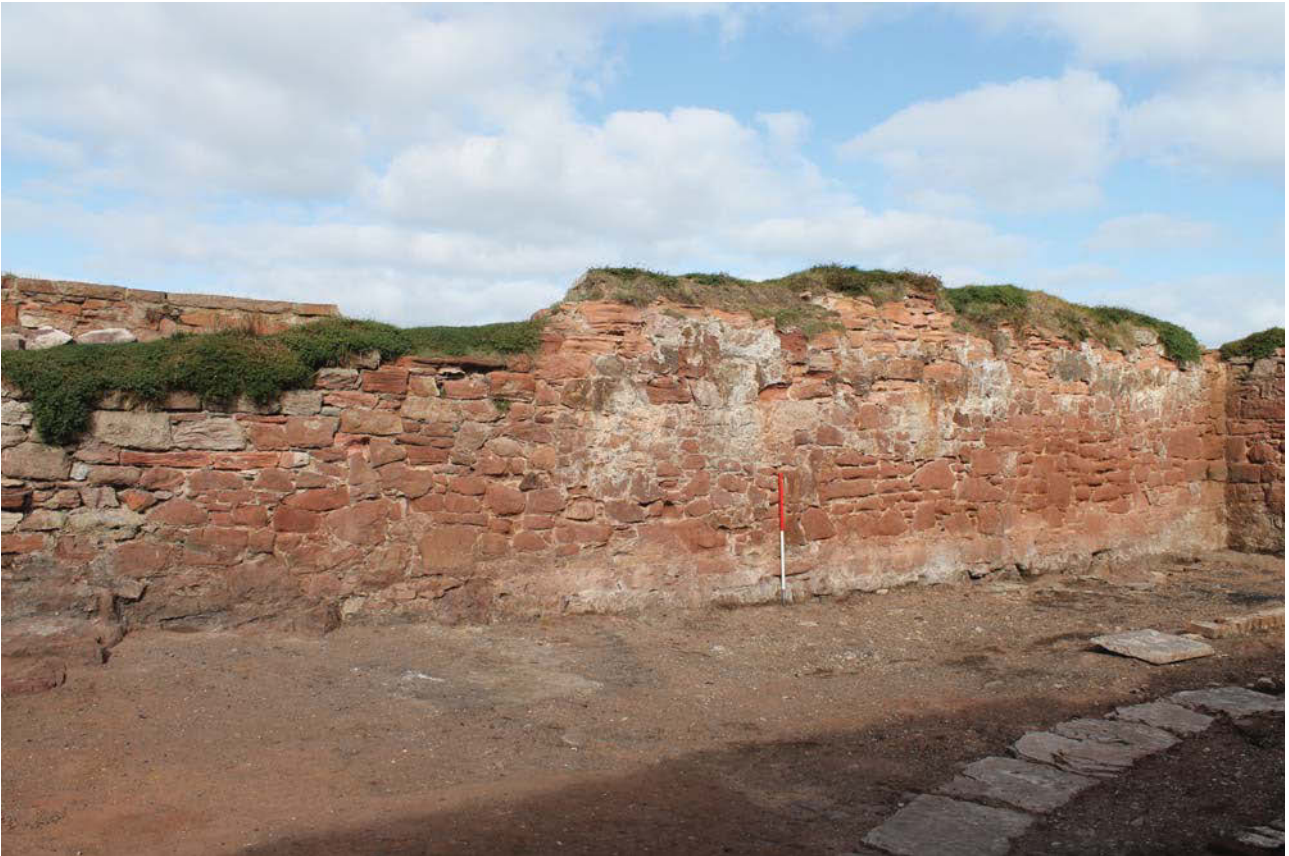
Plate 27: The Hospital building, north-west elevation from the south
