Lamer Island, Dunbar, East Lothian: Archaeological Watching Brief & Historic Building Recording Report

On Behalf of: Dunbar Harbour Trust
Cromwell Quay
Shore Street
Dunbar
EH42 1SU

AOC Project No: 20245

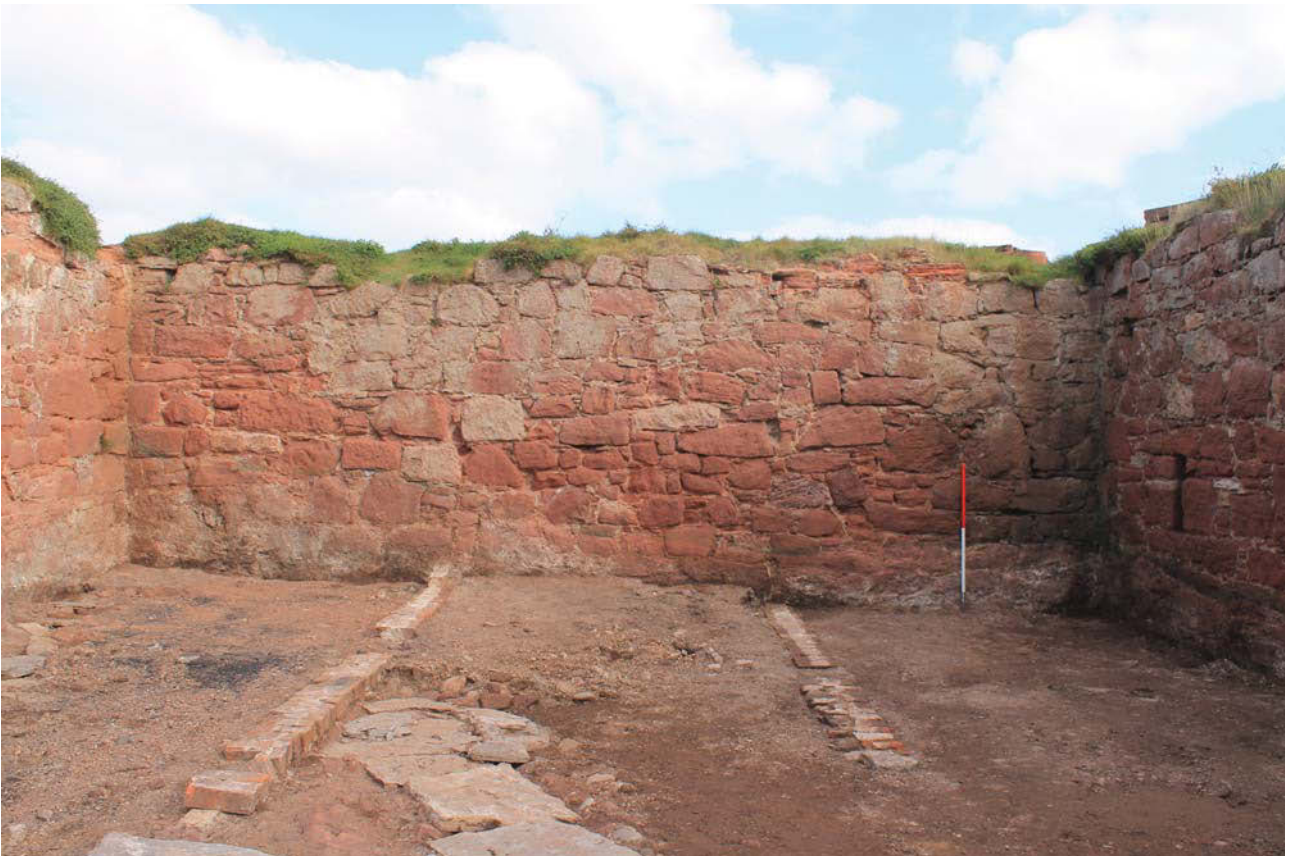
Plate 28: The Hospital building, north-east elevation, general view from the south-west

- 5.3.2 The opposite north-west and north-east internal elevations of the former hospital building have no features (as they were built below the ground level), and are constructed of red sandstone rubble (Plates 26 - 29). The single course of a north-east elevation [076] was exposed abutting the north-west interior elevation of the former hospital, in line with the north-east internal elevation of the hospital and extending to 2.43m to the north-west with a 1.0m return to the east.

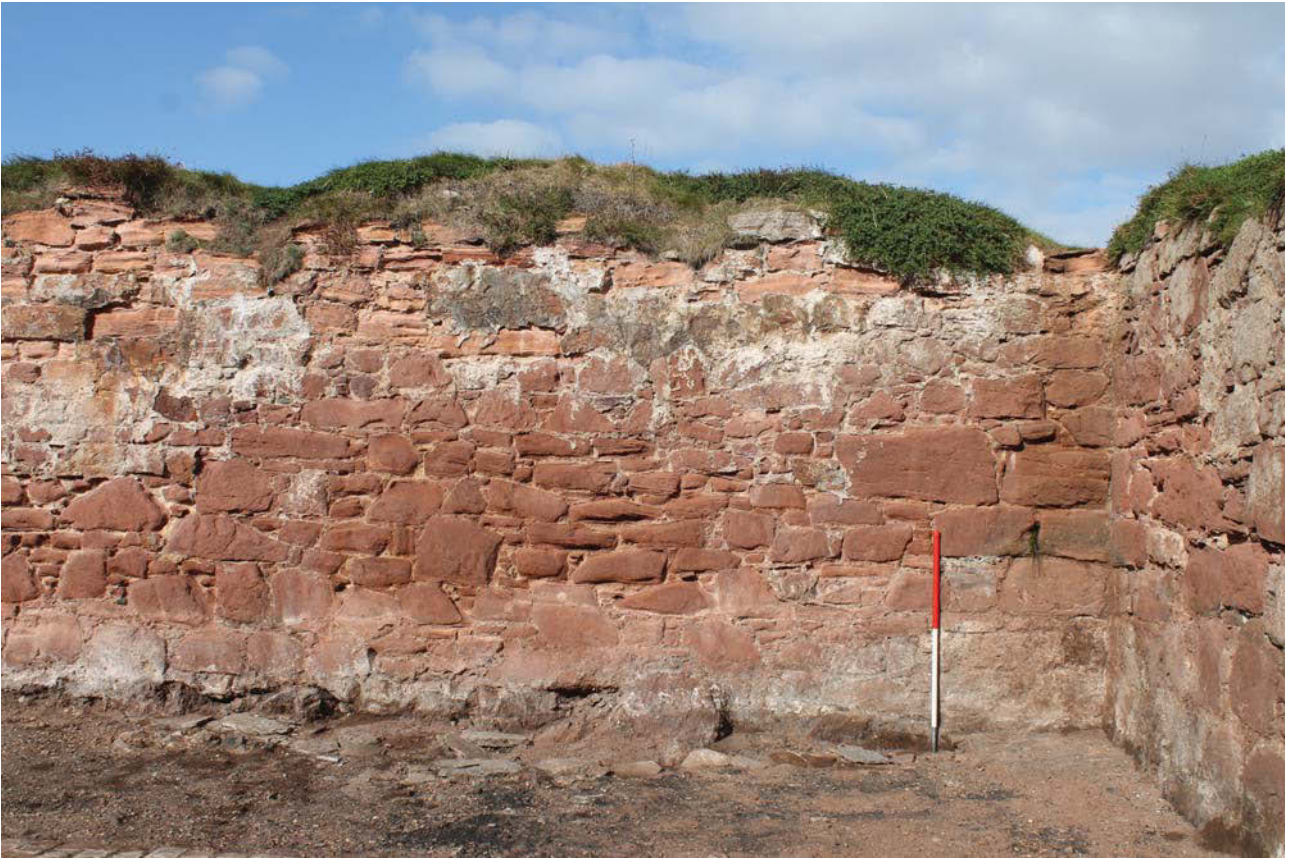
Plate 29: The Hospital building, north-east elevation, general view of the south-east side from the south-west

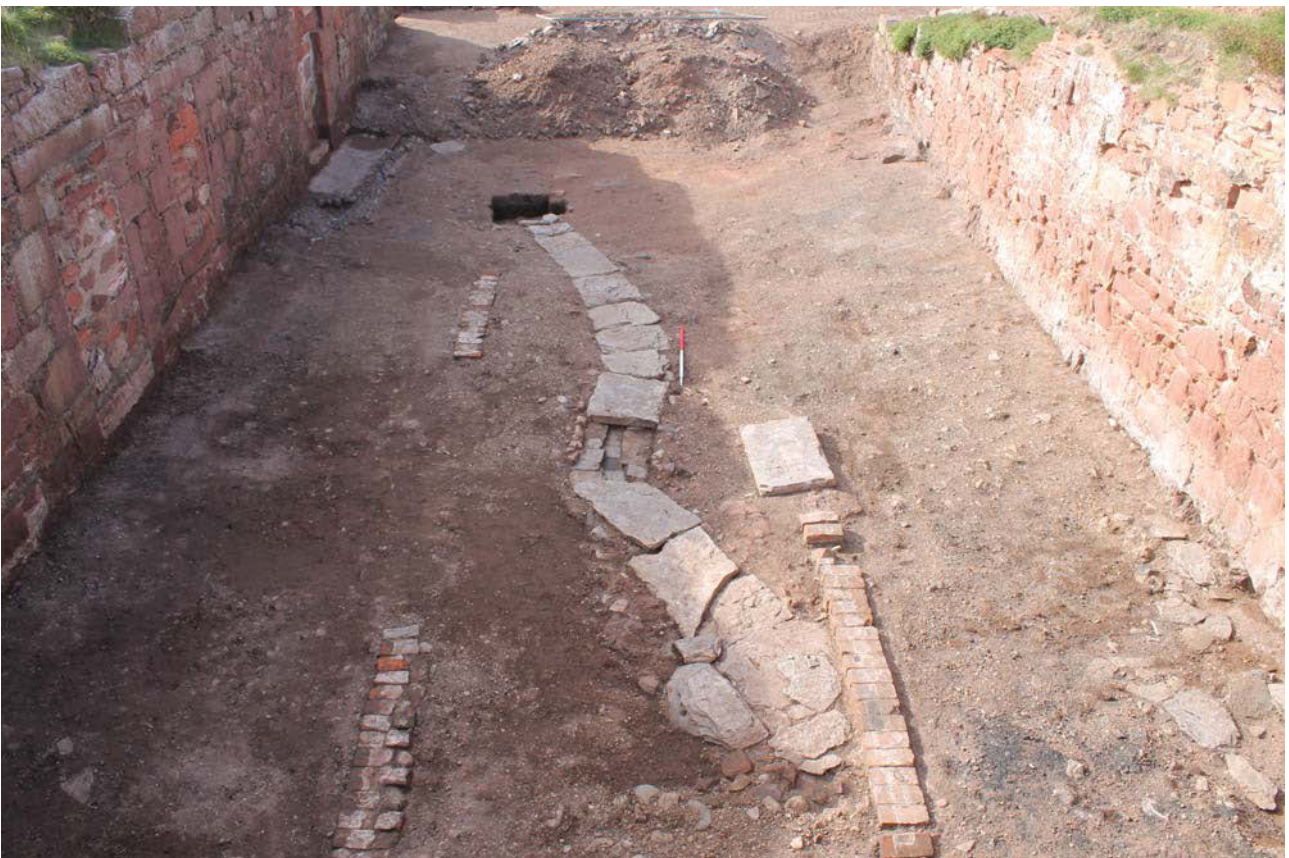
Plate 32: The Hospital building, general view of the internal brick partition [020], from the north-east

- 5.3.3 The archaeological watching brief of the ground floor of the former hospital building exposed approximately 0.9m more depth than had previously been exposed and identified the original floor structures and other features of the battery building which was later converted into a hospital in the later 19th century (Figure 14; Plates 30 & 31). Turf, topsoil and made ground were removed to reveal the remains of two red brick walls orientated north-east/south-west ([019] and [020]) and a slate lined culvert [021] covered with paving stones (Plates 32 & 33). Both red brick walls [019] and [020] were a later addition to the battery and are likely to relate to the hospital structure as partition walls. Culvert [021] was truncated to the south by an oval-shaped, steep-sided pit [022], which was possibly a soak away pit. A north-west/south-east aligned linear feature [024] merged into a pit [022] slightly to the west of culvert [021]. Also steep sided, the function of feature [024] is unclear, although it may have been contemporary with culvert [021]. A shallow cobble and mudstone topped gully [027] was also exposed to the north-west of wall [020].

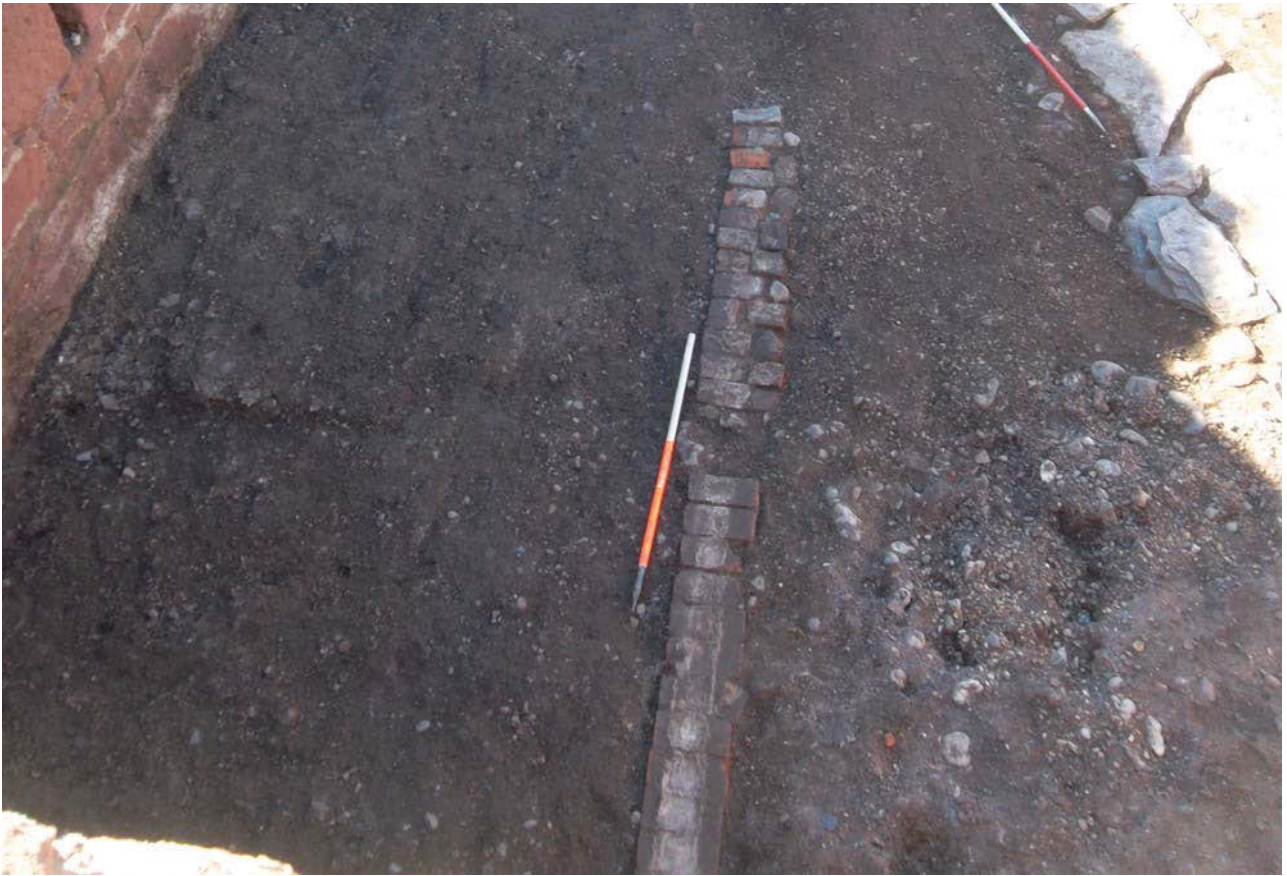
Plate 33: The Hospital building, detail of the internal brick partition [019] from the north-east

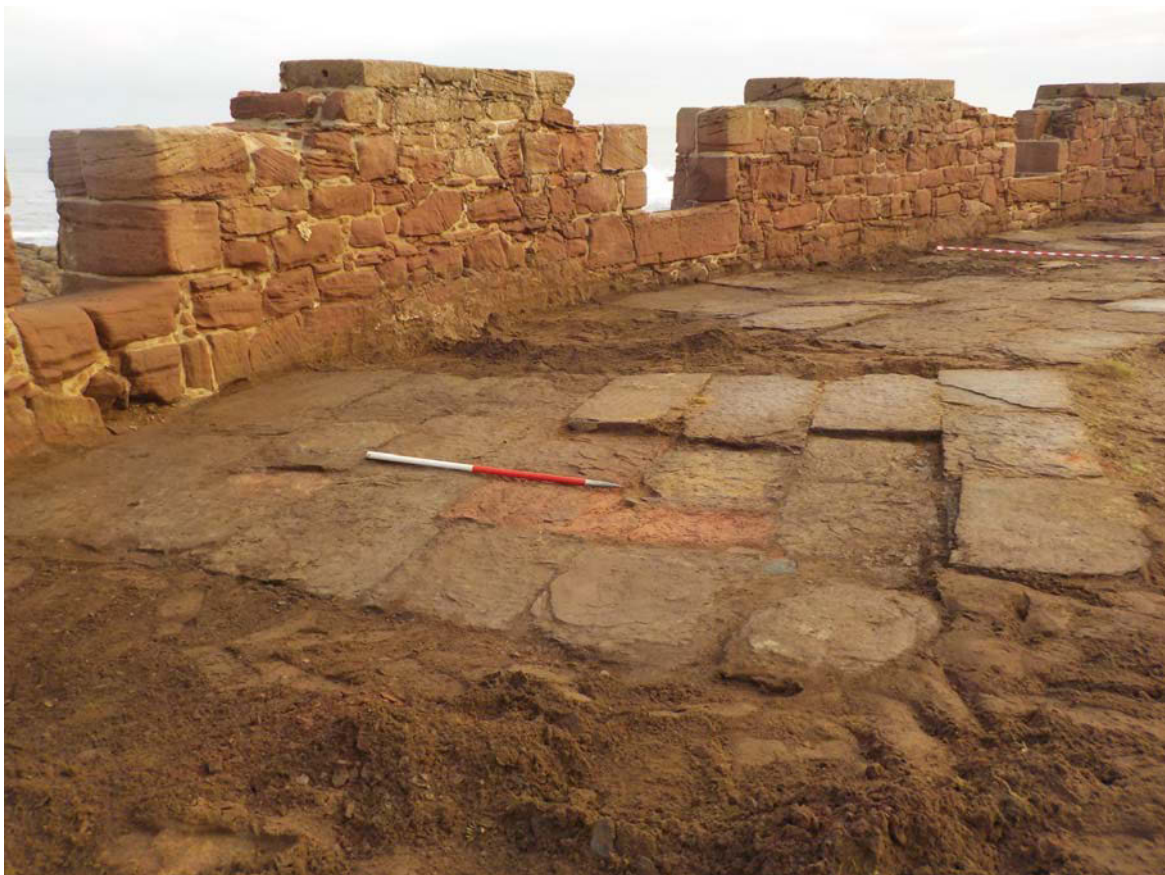
Plate 34: The Hospital building, general view of flagstone surface [052]

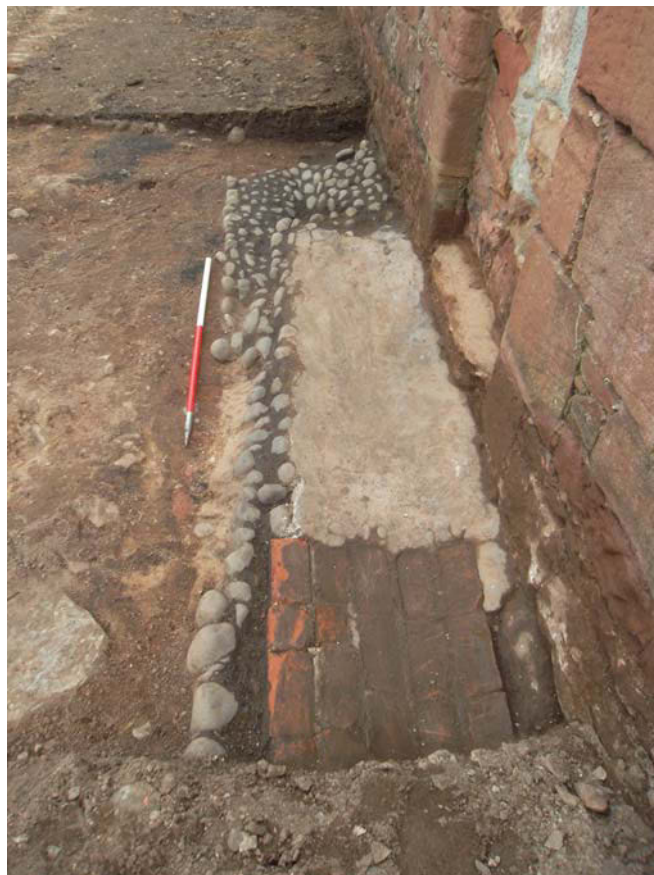
Plate 36: The Hospital building, general view of feature [018]

- 5.3.4 A rectangular area of set cobbles [018] partially overlain by a mortared surface, extended 0.9m from the north-west elevation of the vaults. The mortared surface was set against the red sandstone wall and the vaulted entrance. This was probably a cobble lined threshold to Vault 1 as indicated by the concave groove showing wear (Plate 36). The surface continued to the south as a red brick set also displaying a worn concave groove and was excavated to a length of 3.60m.

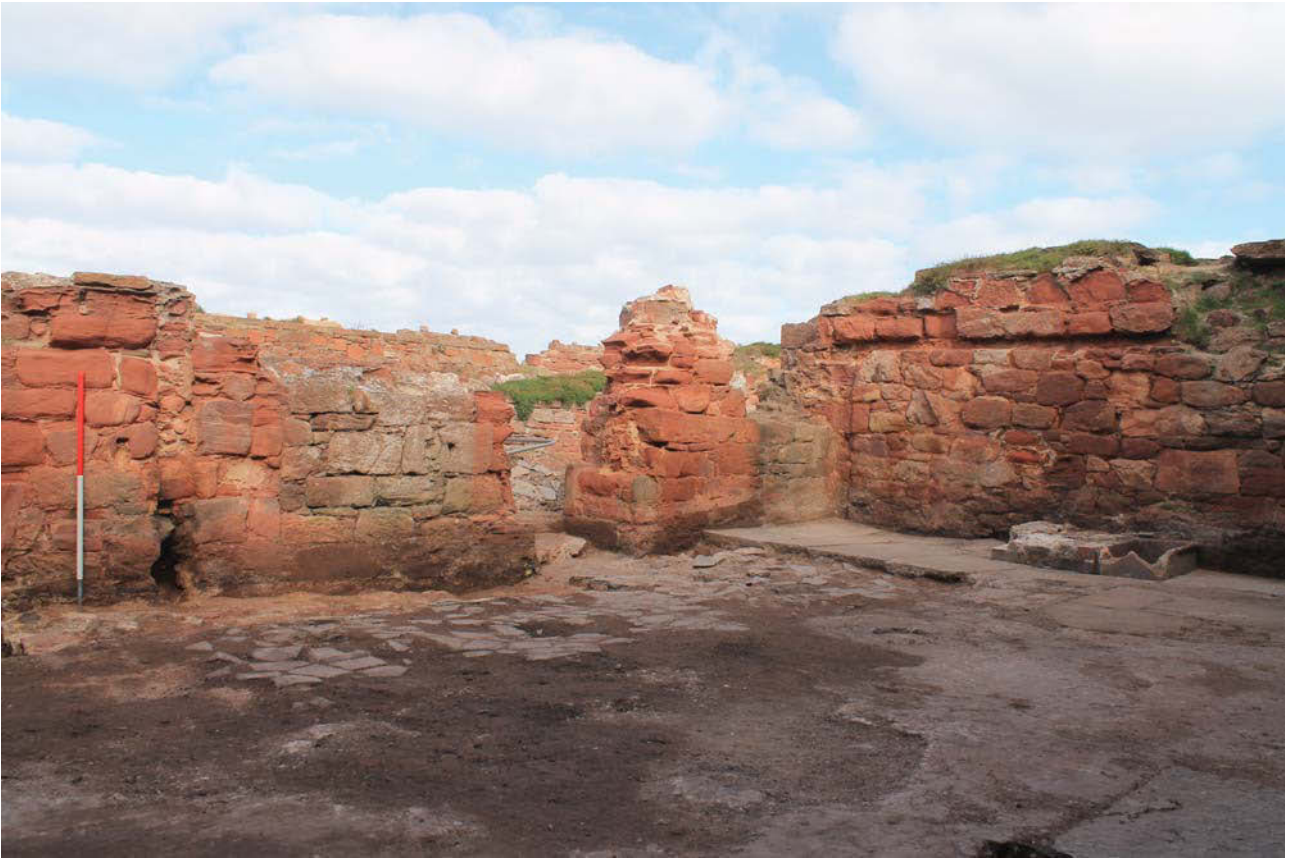
Plate 37: The Fumigation House, general view from the south

- 5.3.2 The main entrance into the building was through the north-west wall through a small doorway, little of which survives (Plate 37). Flanking the entrance are two areas which have a greyer tinge to the stonework, and this may indicate where a partition or other piece of equipment/feature rested against the walls (Plate 38). The south-west side of the wall then angles forward slightly and there is a round-headed drainage feature at ground level (Plates 39 & 40). It consists of an arched opening with neat on-edge voussoir stones standing in front of a square drainage feature cut into the stone slab flooring [002]. The end south-west side of this wall survives to a much greater height and has the slot at head height indicating a former floor level here, or roof storage (Plate 41). A small rectangular beam slot is located within it. There also appears to be two phases of build to this stretch of wall, with the lower construction being of larger red sandstone blocks, with the area above this in a more randomly coursed lighter beige sandstone. The scar for the former lean-to roof here can also be seen (Plate 42). The red sandstone build, recessed floor level and roof scar continue around to the south-west end wall of the fumigation house (Plate 43). Above this, more phases of construction can be seen, possibly two phases with a smaller stone randomly course and heavily rendered build above and set back from the lower construction and an additional phase of build above it. There is a large platform to the south corner of the room along this wall (Plate 44).

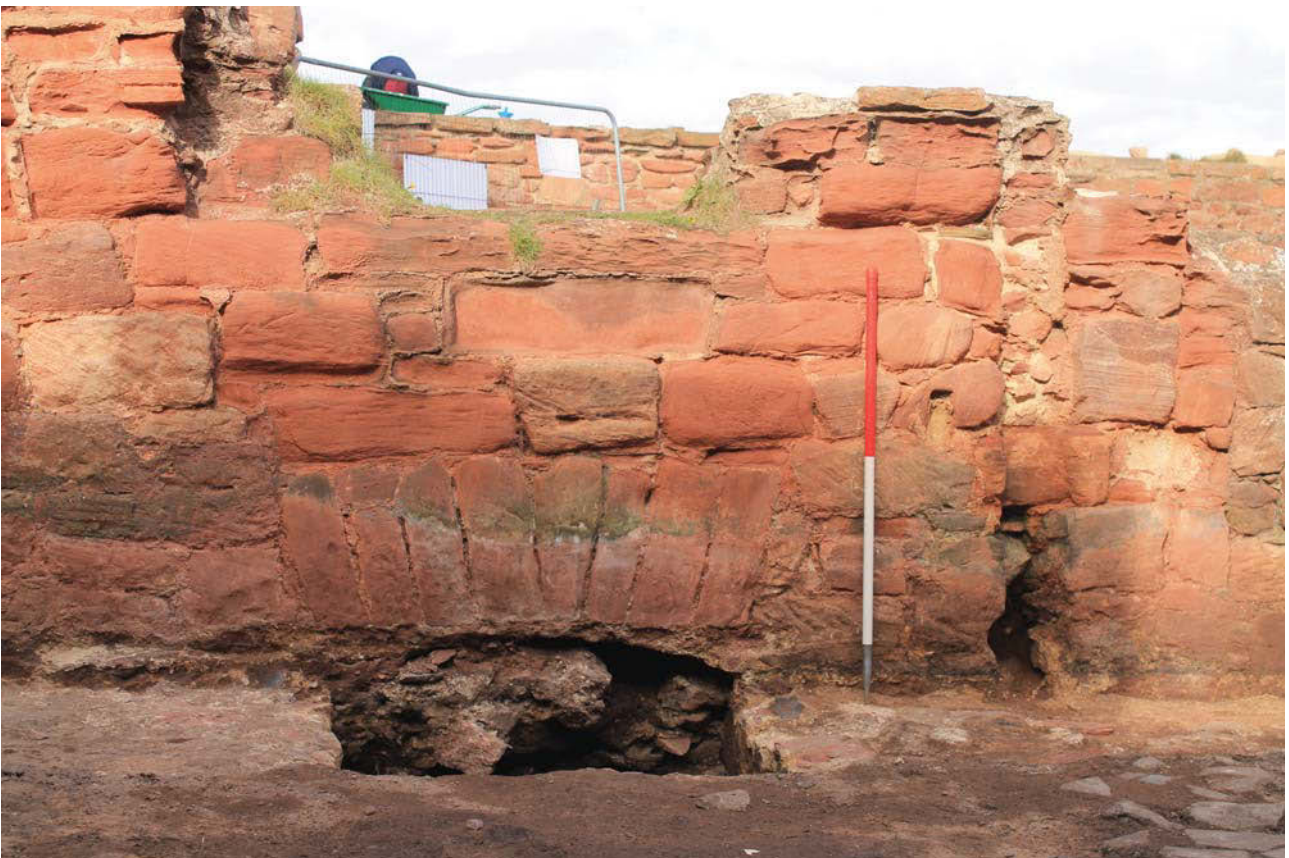
Plate 40: The Fumigation House, north-west elevation, detail of small drainage feature from the south-east

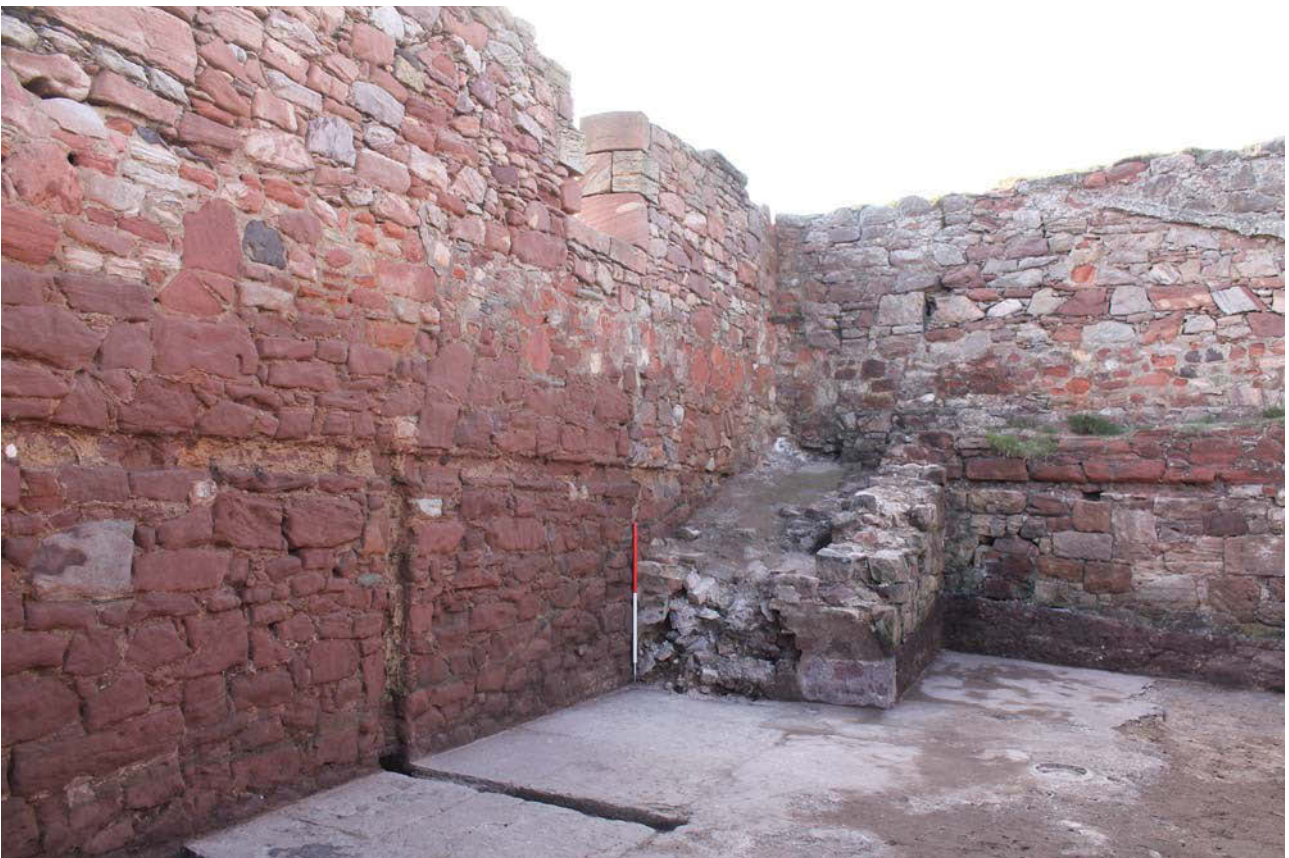
Plate 44: The Fumigation House, general view of the south corner from the NEE

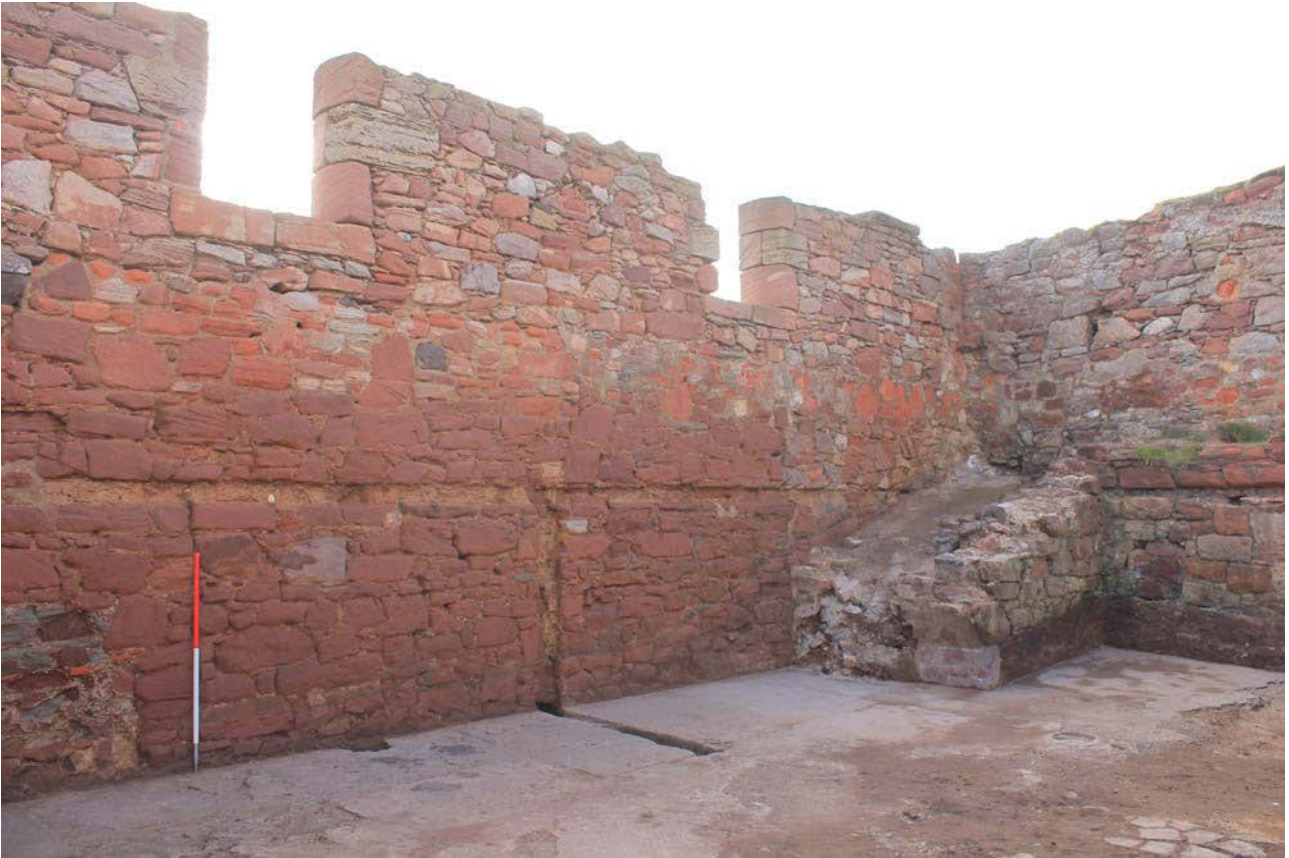
Plate 45: The Fumigation House, south-east elevation, general view from the north

- 5.3.3 Moving round to the south-east wall of the fumigation house, the red lower sandstone build and the recess for the upper floor continues, although there are few features along this wall in general (Plate 45). The possible two later phases of build as described from the south-west wall also continue, and two first floor windows have also survived up to at least two-thirds of their height. Another slot to the centre of the wall indicates the position of a former partition wall here. To the north-east side of this wall is also a crudely blocked low-set opening (Plate 46). This feature does not appear to have any definite surround, so may be an inserted opening for a pipe or ventilation that has been later blocked up.

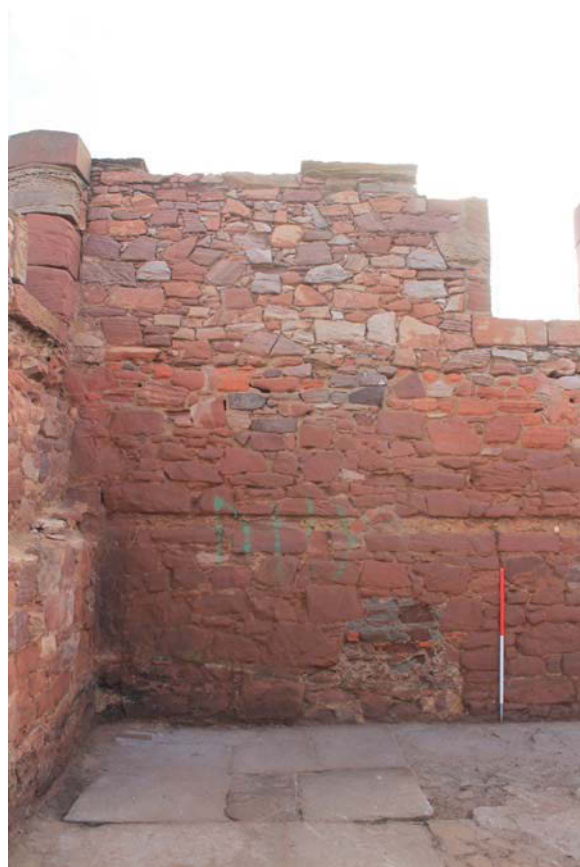
Plate 46: The Fumigation House, south-east elevation, detail of the blocked feature to the north-east side, from the north-west

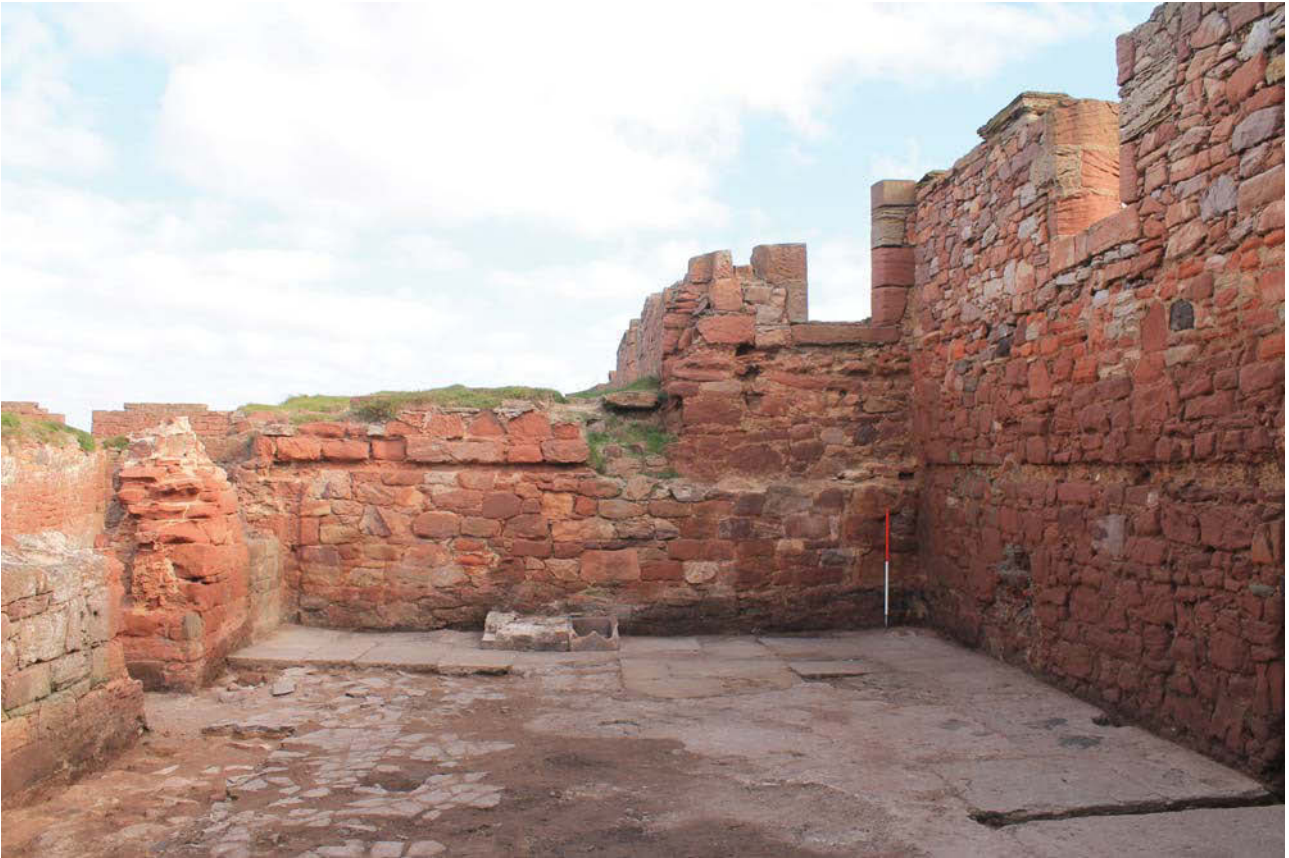
Plate 47: The Fumigation House, general view from the south-west

- 5.3.4 The north-east elevation of the interior of the fumigation house survives only to the height of the adjacent north-west wall to the north-west side and then to almost first floor level to the south-east side (Plate 47 & 48). The slot once again continues round to this wall and a first floor window survives to the south-east, again surviving only to two-thirds its height.

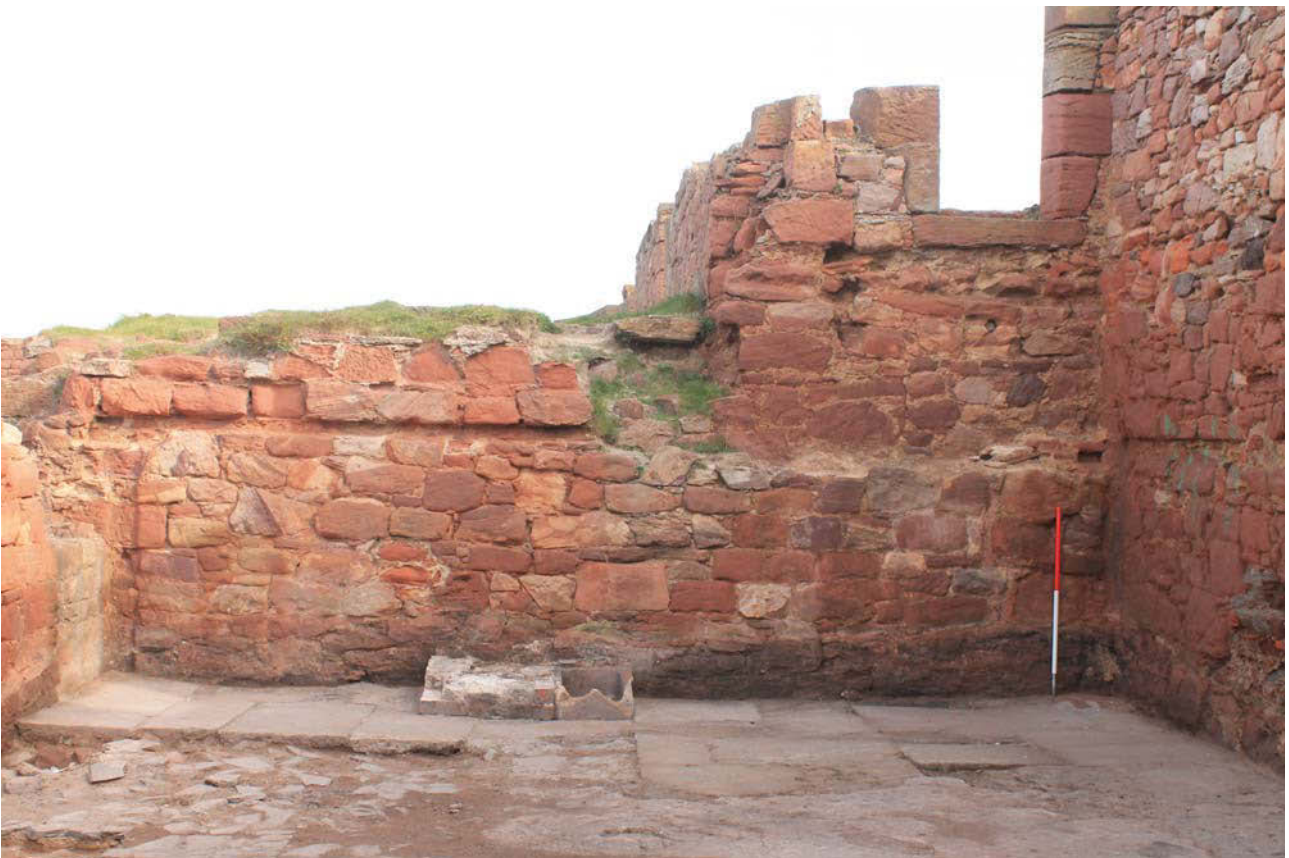
Plate 48: The Fumigation House, general view of the north-east wall from the south-west

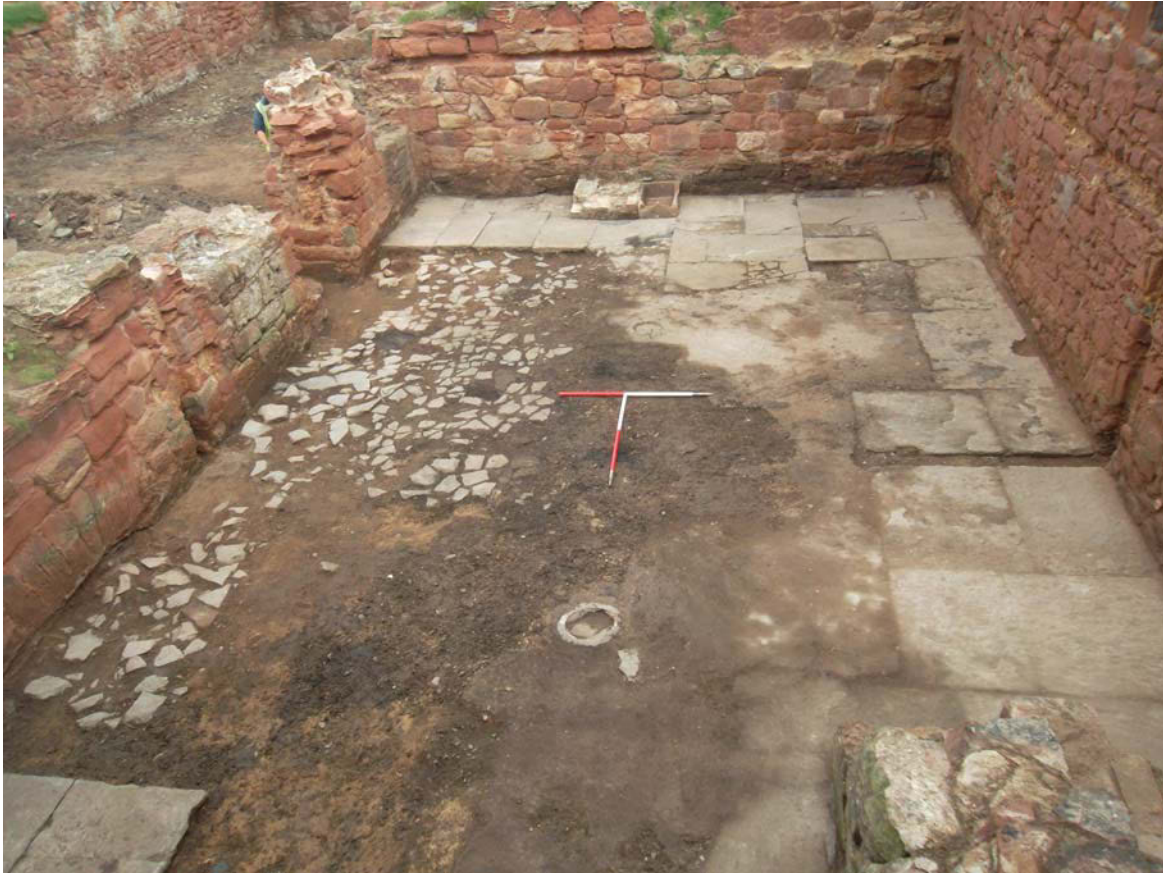
Plate 49: The Fumigation House,, general view of Fumigation House after excavation from the south-west

- 5.3.5 The excavations to the original floor levels also exposed a number of features (Figure 15; Plate 49). A square, faced draining feature [029] was cut into the stone slab flooring at a depth of 0.67m and filled with an upper rubble fill (030) and a sandy clay lower deposit (031), below a round-headed drainage feature at ground level in the north-west elevation. The upper rubble fill (030) contained fragments of 19th and 20th century pottery and animal bone. Moving to the west, six concrete slabs [002] are located in the north-west corner of the with a 0.12m x 0.12m square-cut into the middle slab, [003]. A structure 0.80m in height and covered with a flat concrete layer was also exposed after the removal of the rubble which was set over a slightly vaulted brick roof. This roof extended 2.4m from the external south-east wall and a north-east/south-west aligned red sandstone block wall to the north.

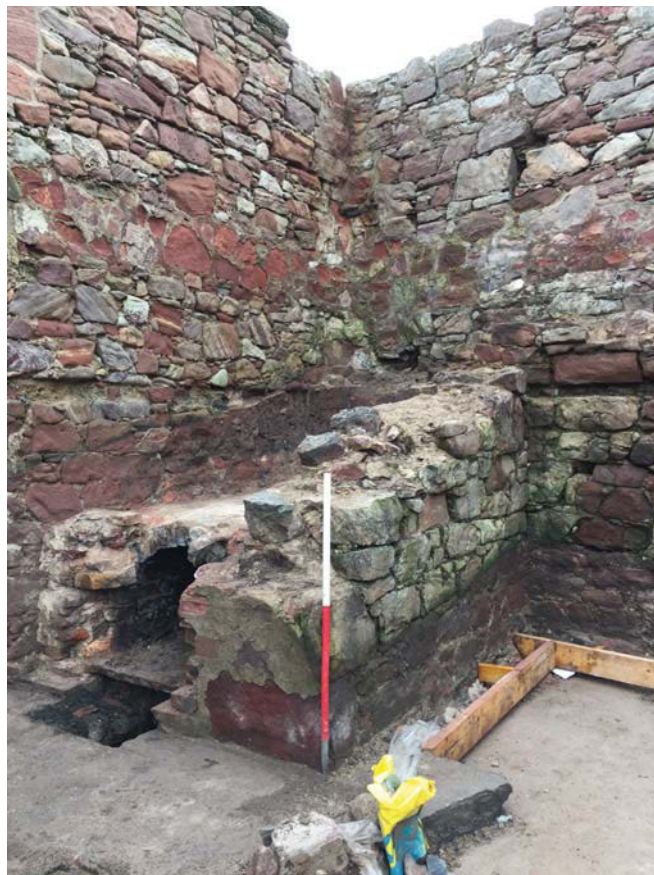
Plate 52: The Fumigation House, general view of excavated platform in the west corner exposing drain feature, from the east

- 5.3.7 The final excavations saw the reduction of the large platform in the south corner. This exposed a drainage feature within it with a stone slabbed base (Plates 52 & 53).

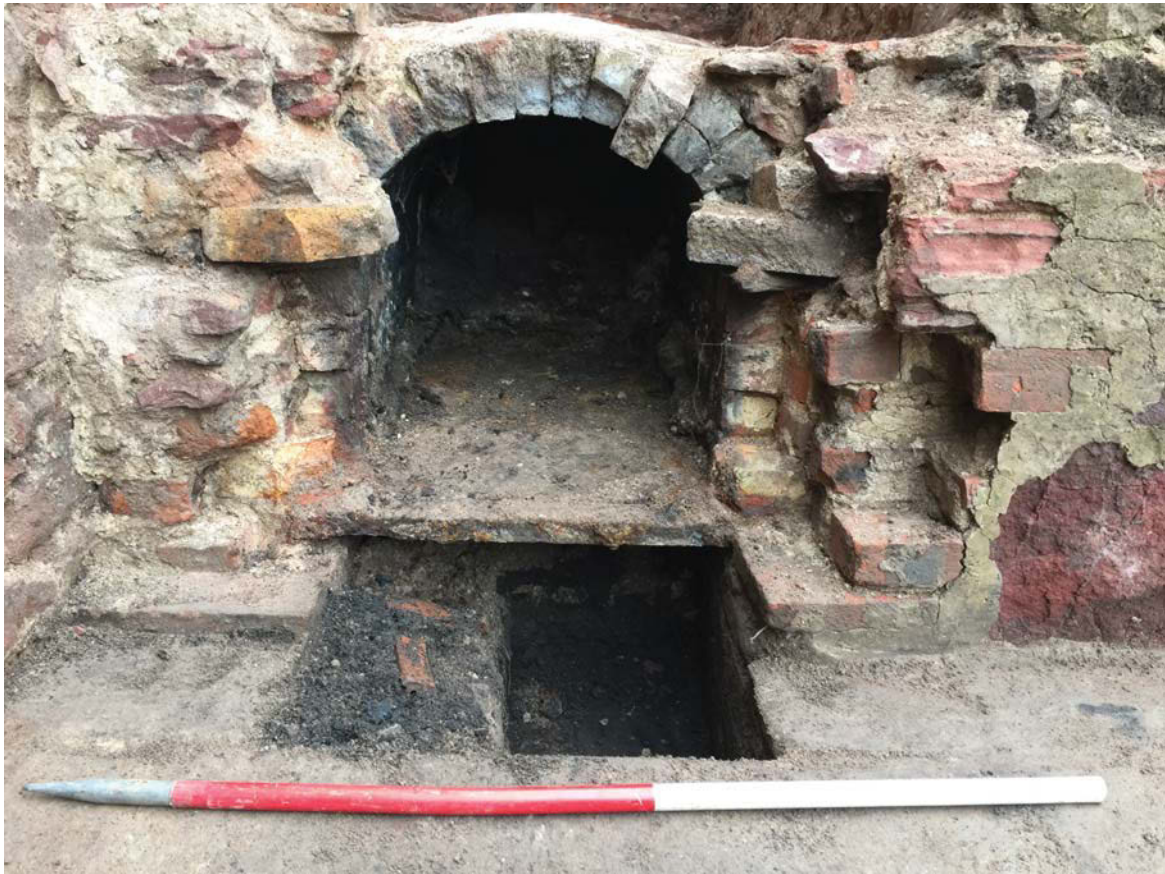
Plate 53: The Fumigation House, detail of the drain feature exposed after the excavation of the platform in the west corner, from the north-east

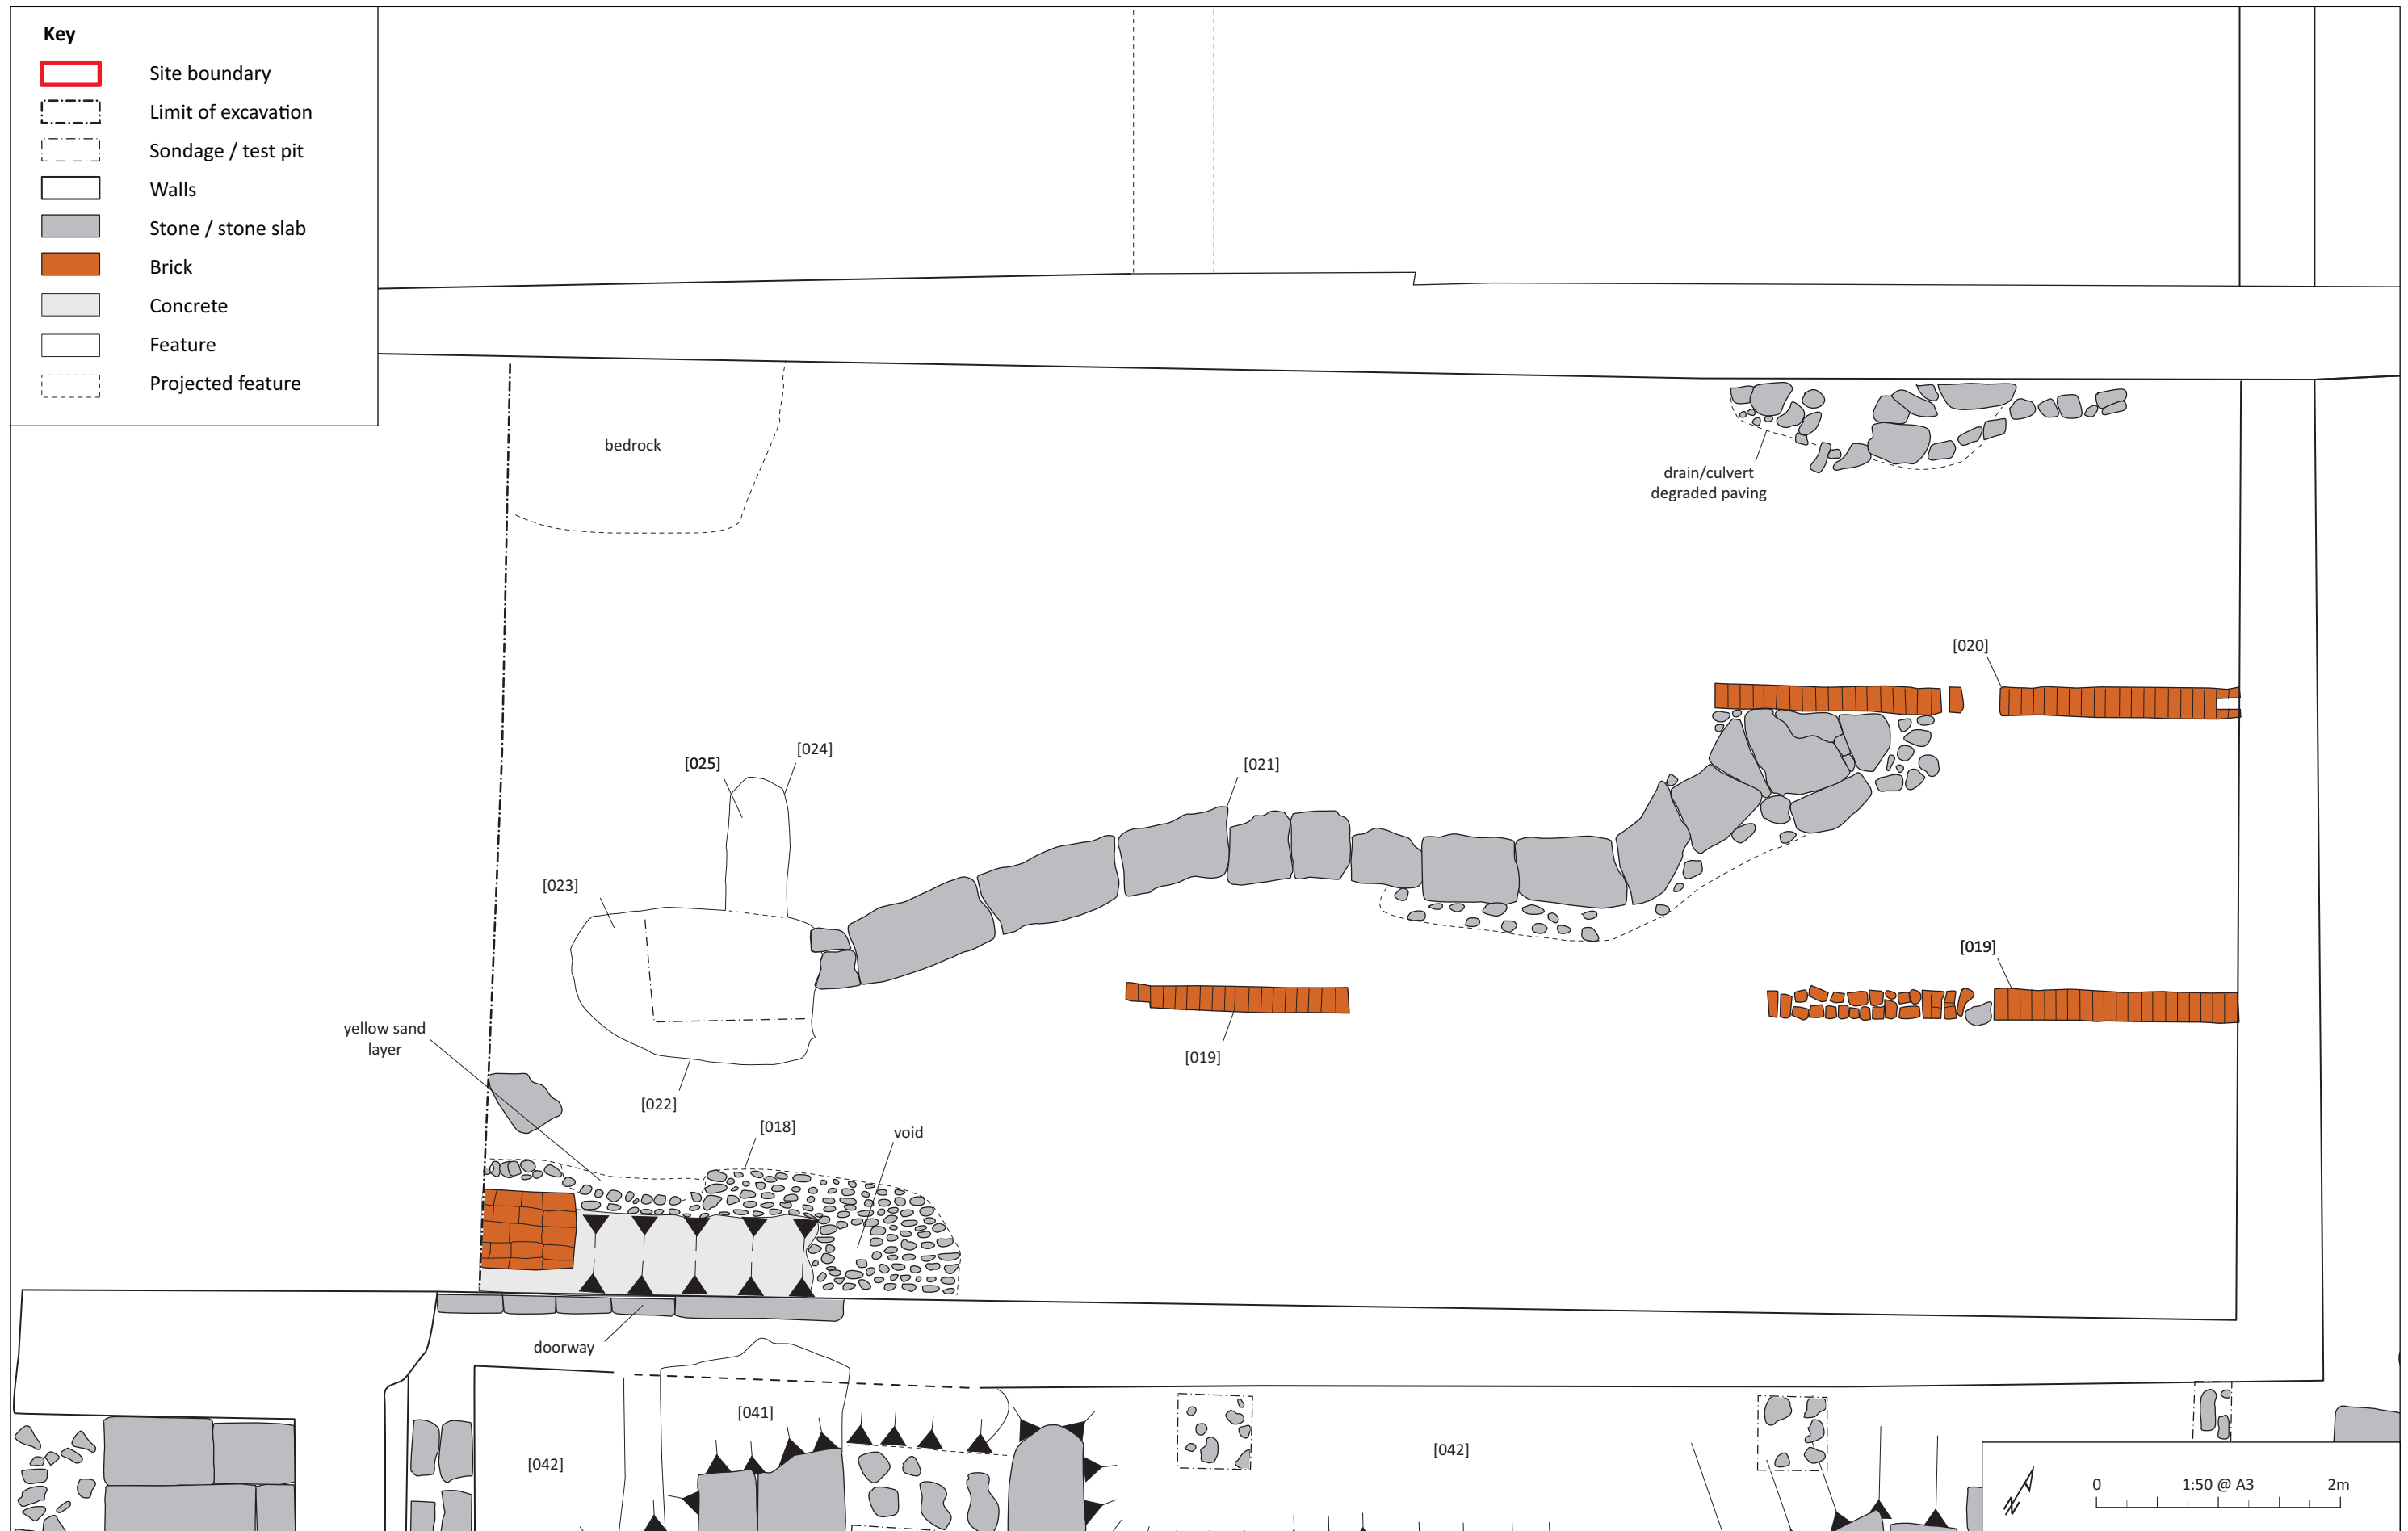
Figure 14: Hospital post-excavation plan
