Lamer Island, Dunbar, East Lothian: Archaeological Watching Brief & Historic Building Recording Report

On Behalf of: Dunbar Harbour Trust
Cromwell Quay
Shore Street
Dunbar
EH42 1SU

AOC Project No: 20245

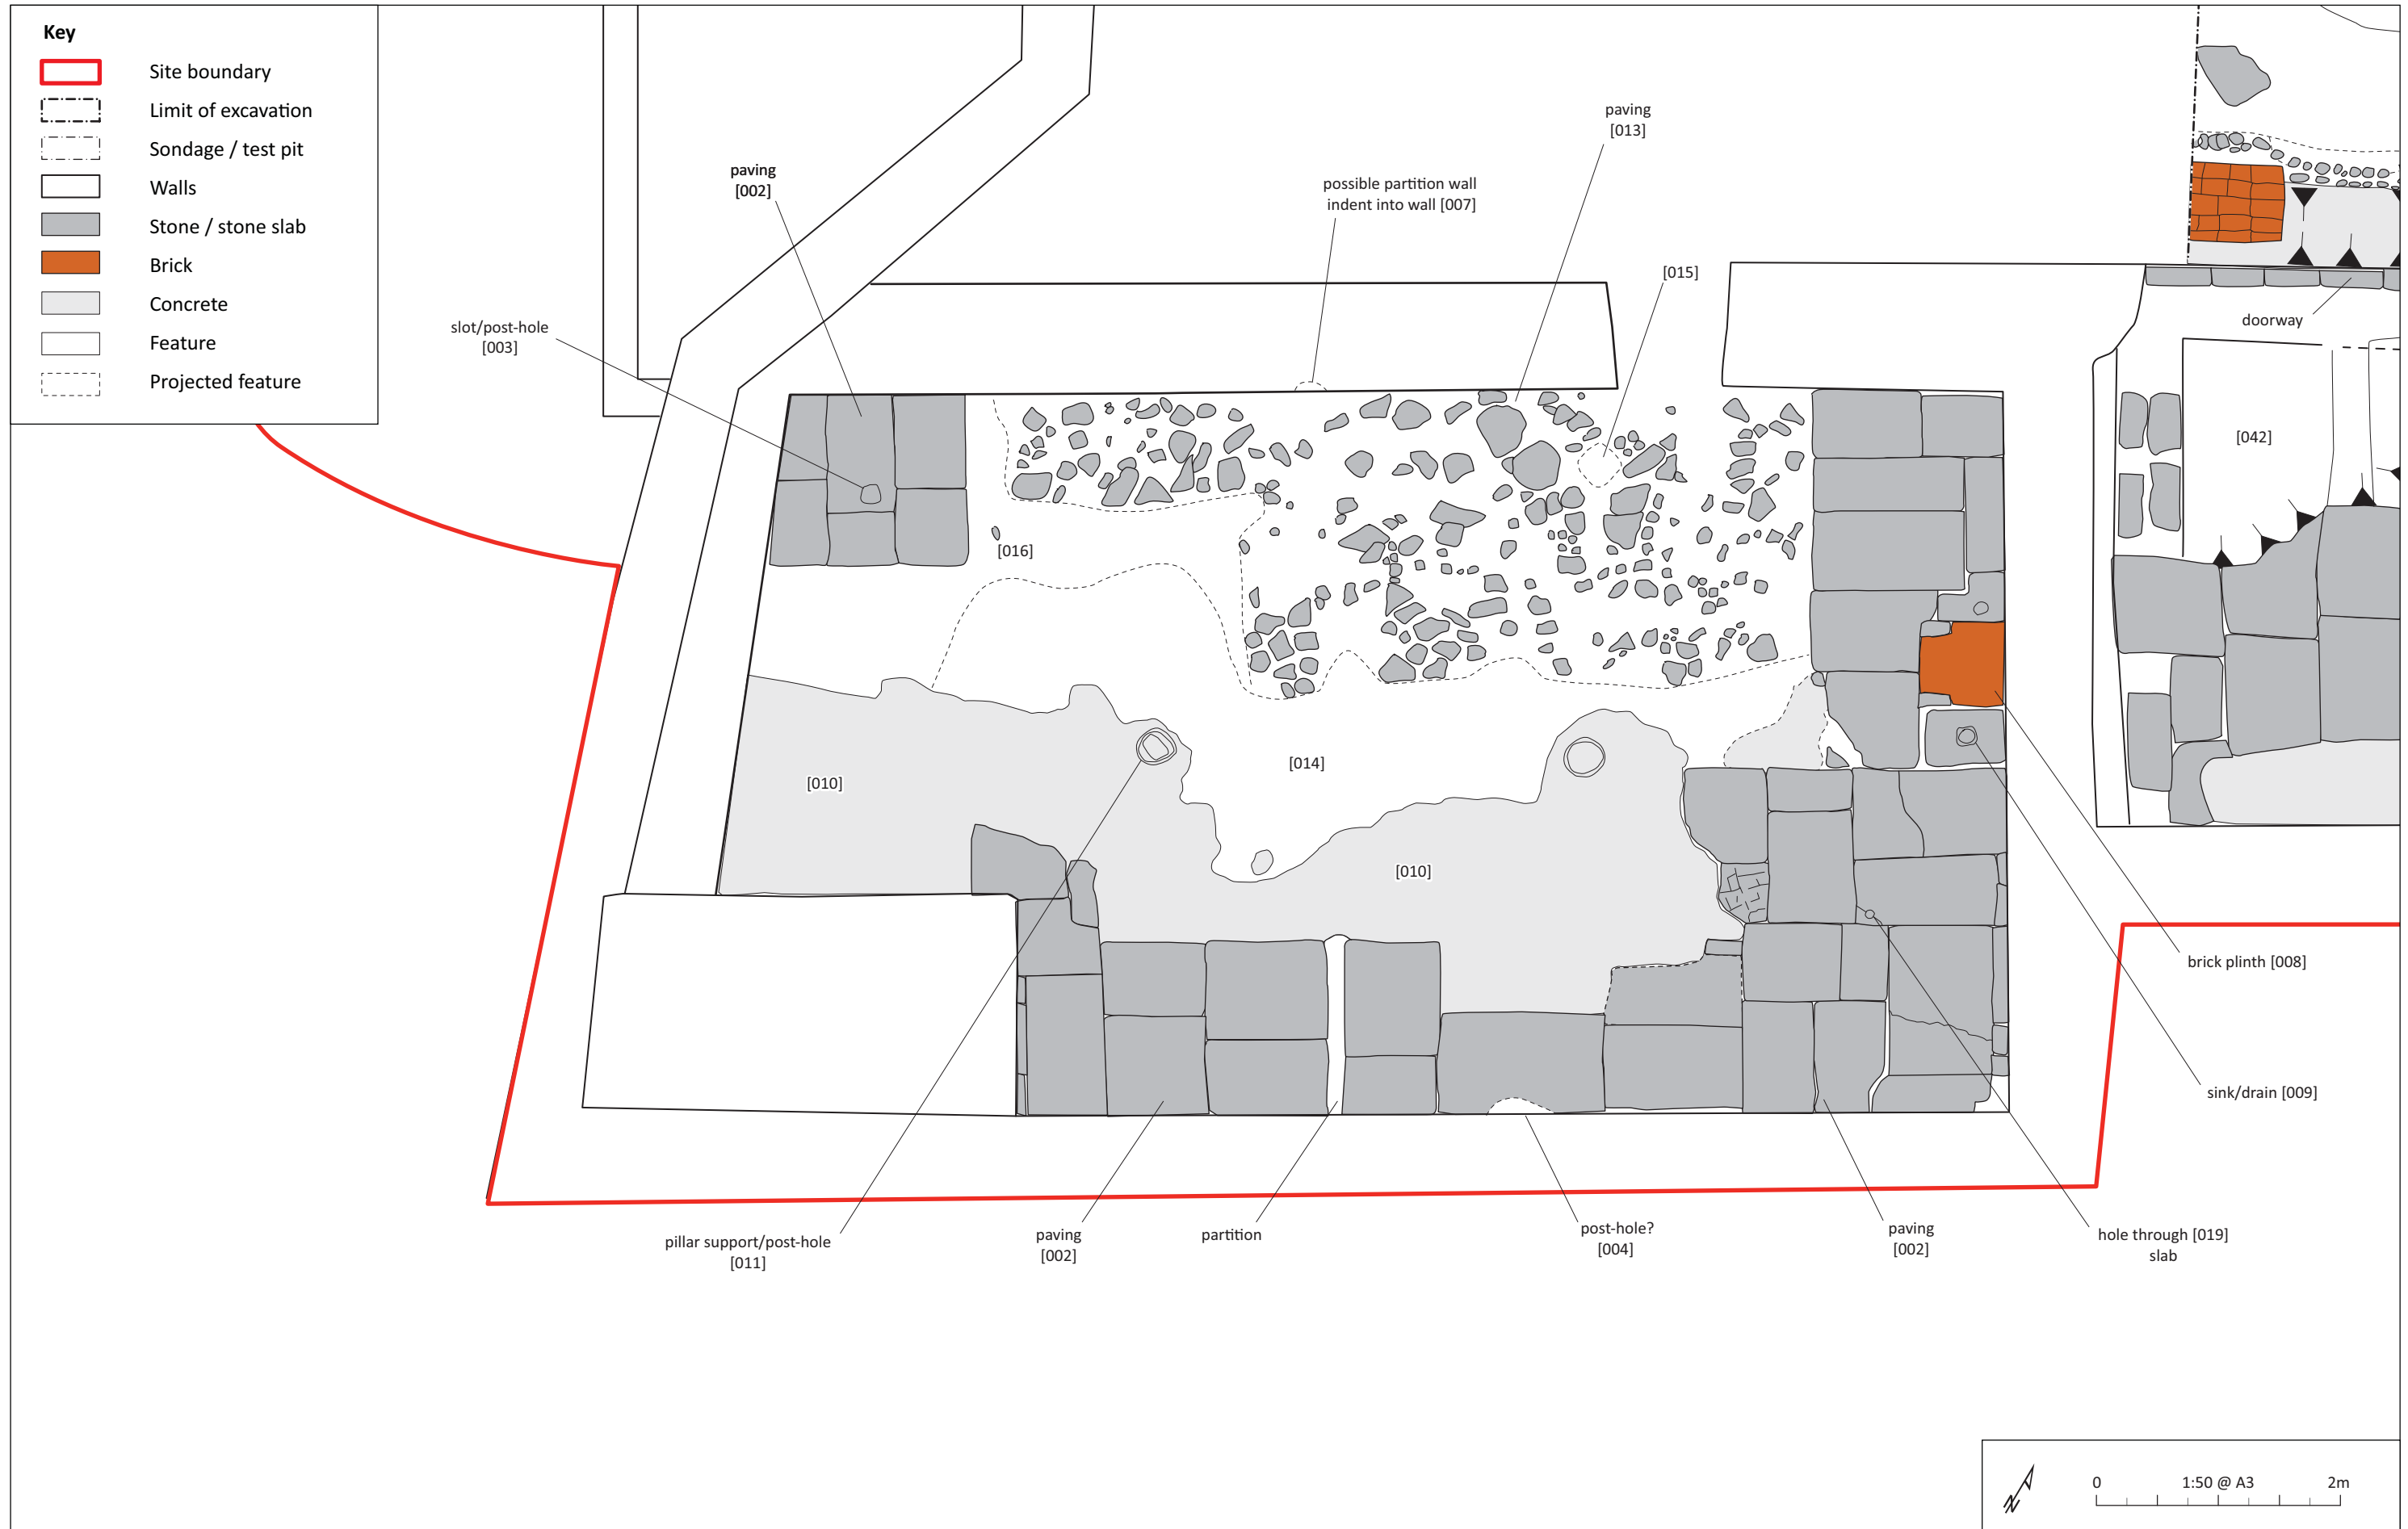
Figure 15: Fumigation House, post-excavation plan

- 5.3.5 The excavations to the original floor levels also exposed a number of features (Figure 15; Plate 49). A square, faced draining feature [029] was cut into the stone slab flooring at a depth of 0.67m and filled with an upper rubble fill (030) and a sandy clay lower deposit (031), below a round-headed drainage feature at ground level in the north-west elevation. The upper rubble fill (030) contained fragments of 19th and 20th century pottery and animal bone. Moving to the west, six concrete slabs [002] are located in the north-west corner of the with a 0.12m x 0.12m square-cut into the middle slab, [003]. A structure 0.80m in height and covered with a flat concrete layer was also exposed after the removal of the rubble which was set over a slightly vaulted brick roof. This roof extended 2.4m from the external south-east wall and a north-east/south-west aligned red sandstone block wall to the north.

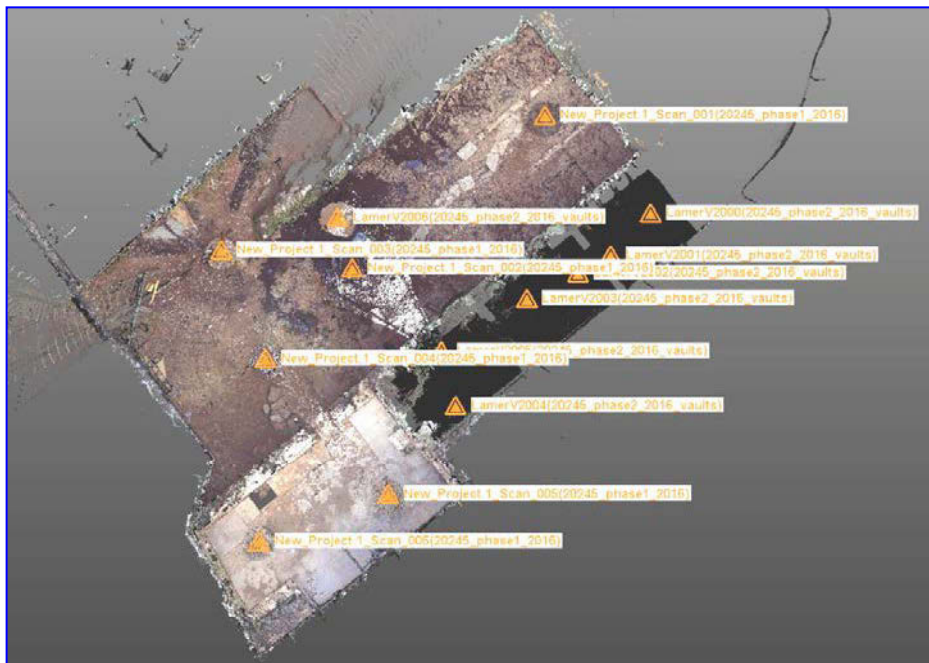
Key plan showing the location of laser scan survey stations

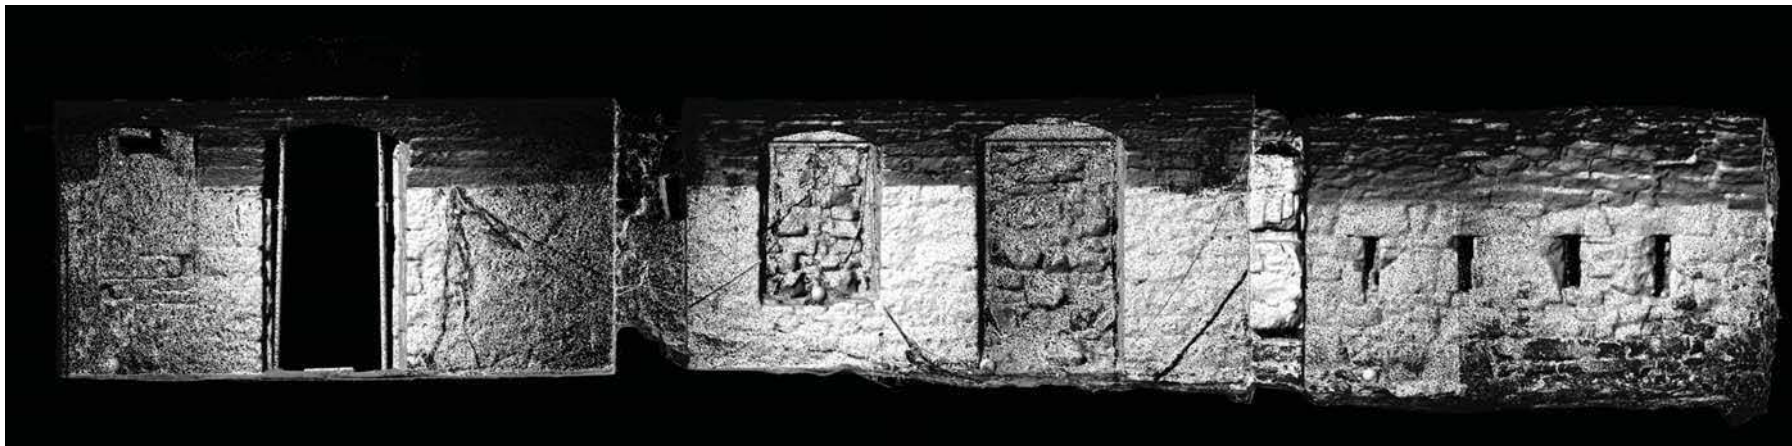
Ortho-image of the north-west vault Interior elevation, using intensity values and lighting

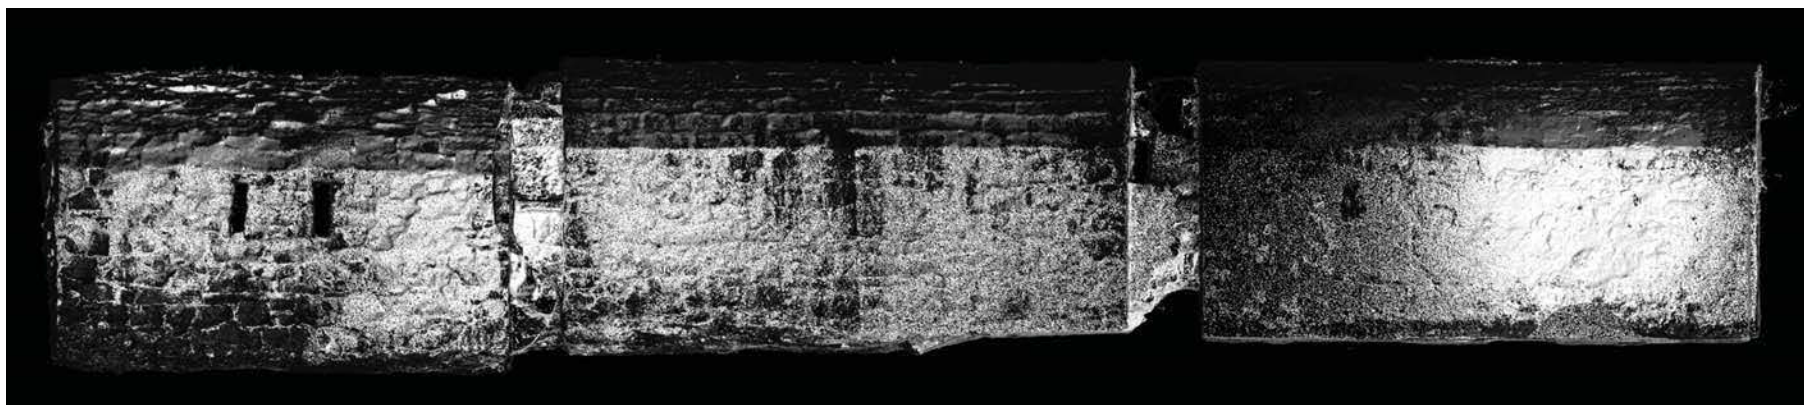
Ortho-image of the south-east vault interior elevation, using intensity values and lighting
