**Barns at  
The Rookery,  
Wilby, Suffolk  
WBY 024**

**Heritage Asset Assessment**

# **Barns at The Rookery, Worlingworth Road, Wilby, Suffolk**

## **Heritage Asset Assessment**

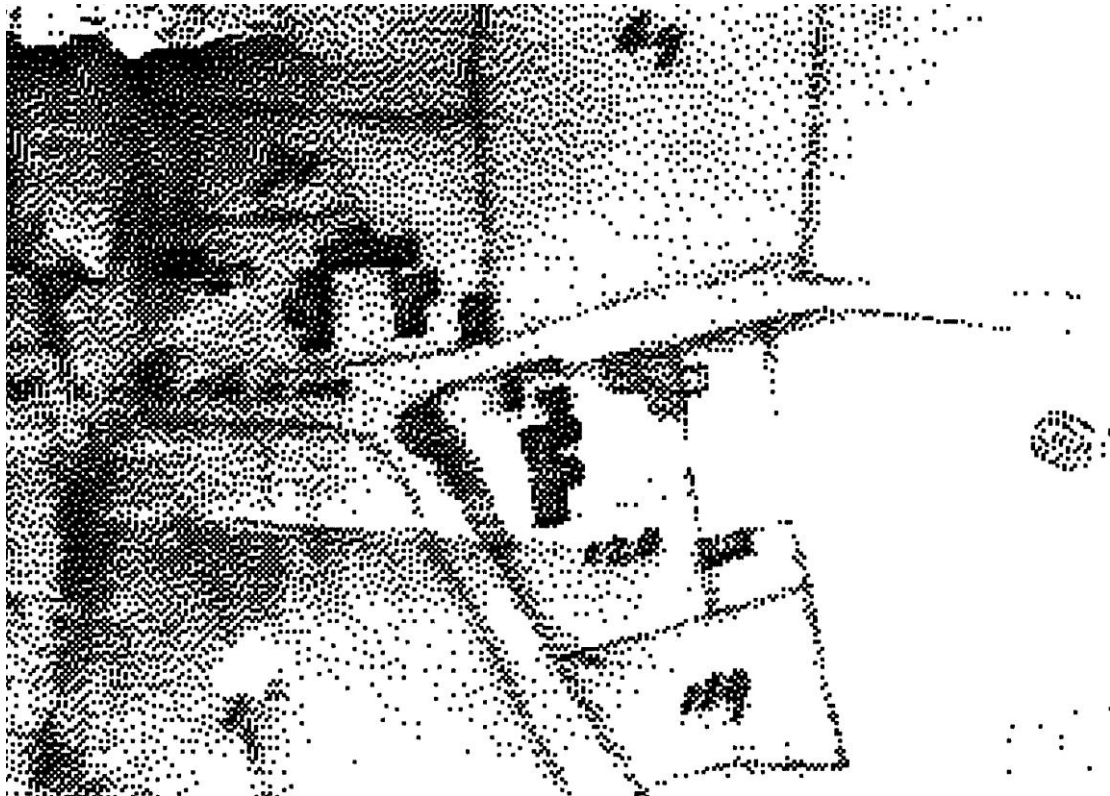
Figure 2

The Wilby tithe map of 1838 (from a copy of the original in the PRO, kindly supplied by the owners). The two 16<sup>th</sup> century barns (buildings 1 and 2 in figure 5) are shown with rear porches to the west and north of a courtyard along with a third structure to the east that no longer survives. The stable (4) also appears to be shown to the east, but the cart lodge (3) and the rest of the present farm complex had yet to be built.

The tithe map of 1838 shows both timber-framed barns forming the western and northern sides of a broad yard together with an additional structure that no longer survives to the east (figure 2). The latter was presumably demolished when the present dairy shed was built in front of the northern barn in the mid-19<sup>th</sup> century (i.e. no. 7 in building) and may have extended onto the sites of the present yards to the east (nos. 5 and 6). The two barns appear to adjoin each other corner to corner, and while this may be an error on the part of the surveyor the map seems highly accurate in other respects: it is entirely possible that the northern barn (no. 2) was moved by several metres during the extensive 19<sup>th</sup> century refurbishment that included the replacement of its ground sills and plinth. The stable (no. 4) also appears to be shown in the south-eastern corner of a large rectangular enclosure but the rest of the modern complex, including the cart lodge and granary to the west (no.3), is conspicuous by its absence. Both barns are depicted with rear porches much as they remain (although the northern porch has since been rebuilt). The relevant area of the tithe map in the Suffolk Record Office has been damaged and the version reproduced here was kindly supplied by the owners from a copy of the original in the Public Record Office at Kew.

and the hip rafters, purlins and collars have also been lost. This supports the cartographic evidence that the barn was moved further to the north between 1838 and 1885 (figures 2 and 3) – and its rafters are more likely to have been dismantled and re-erected accordingly. Surprising as it may seem, it was not uncommon for substantial timber framed buildings to be moved over short distances without completely disassembling their main structures, but common rafters would have been more difficult to retain *in situ*. The upper part of the western gable appears to have been rebuilt in the 20<sup>th</sup> century but was impossible to survey at close quarters due to the presence of a modern wire-mesh hay loft in the two western bays, which are divided by a 20<sup>th</sup> century boarded partition from the rest. The entrance bay was moved in the 19<sup>th</sup> century from its original position in bay 2B to the more central adjoining bay to the east (2C), and a rear (northern) porch was provided. This porch was almost completely demolished in the late-20<sup>th</sup> century when a large corrugated iron lean-to shed was added to the entire length of the same elevation, but a section of its wall and plinth remains intact to the west – along with the scar of its roof where the corrugated asbestos has been patched with tin. The tie-beam of the original internal partition is intact (unlike its thatched counterpart) and contains six empty stud mortises but none in the collar – although the partition clearly rose into the roof as there are stud mortises in the upper surface of the same tie-beam (and the studs were presumably nailed to the collar). The open truss of the two-bay hay loft lacked arch-braces as there are no mortises in its tie-beam, yet two brace mortises were cut into the storey posts as if they were initially intended but not installed (they were scarcely necessary given the narrow length of the bays).

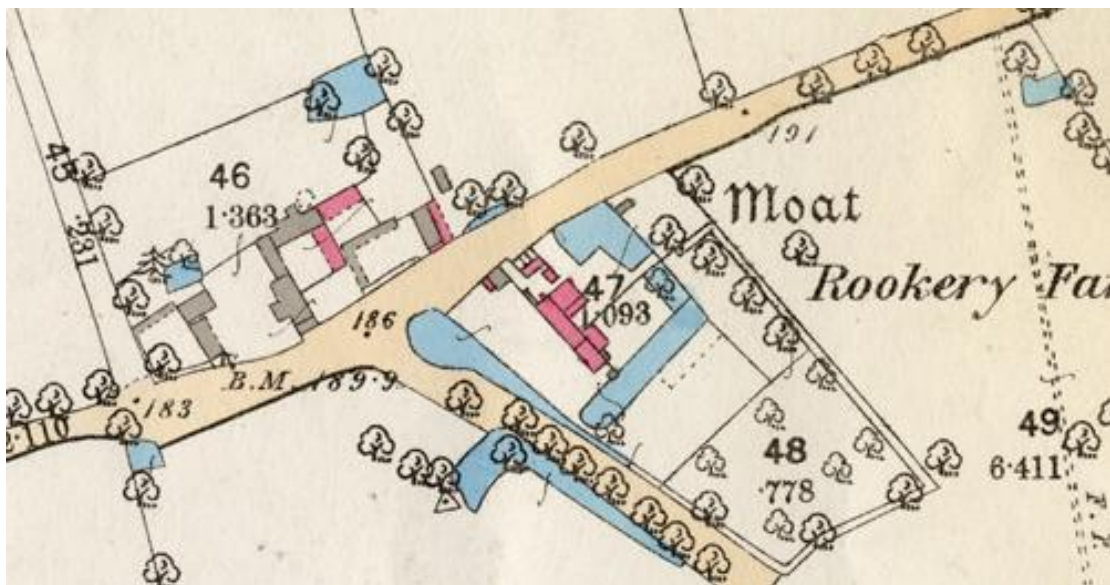
Figure 3

First Edition 25 inch Ordnance Survey of 1885.

The principal elements of the complex are now shown much as they remain, with the open-sided elevations of the cart lodge (3) and the various shelter-sheds adjoining the yards indicated by broken lines.

By the time of the Ordnance Survey of 1885 the principal elements of the modern farm complex were already in place, and the site had evidently undergone a dramatic transformation of the kind seen on most East Anglian farms during the middle decades of the 19<sup>th</sup> century. These changes reflect the agricultural revolution of the period which saw the introduction of a system of yard-based mixed animal husbandry known today as Victorian High Farming. The arrival of the railways in the 1840s dramatically increased the market for

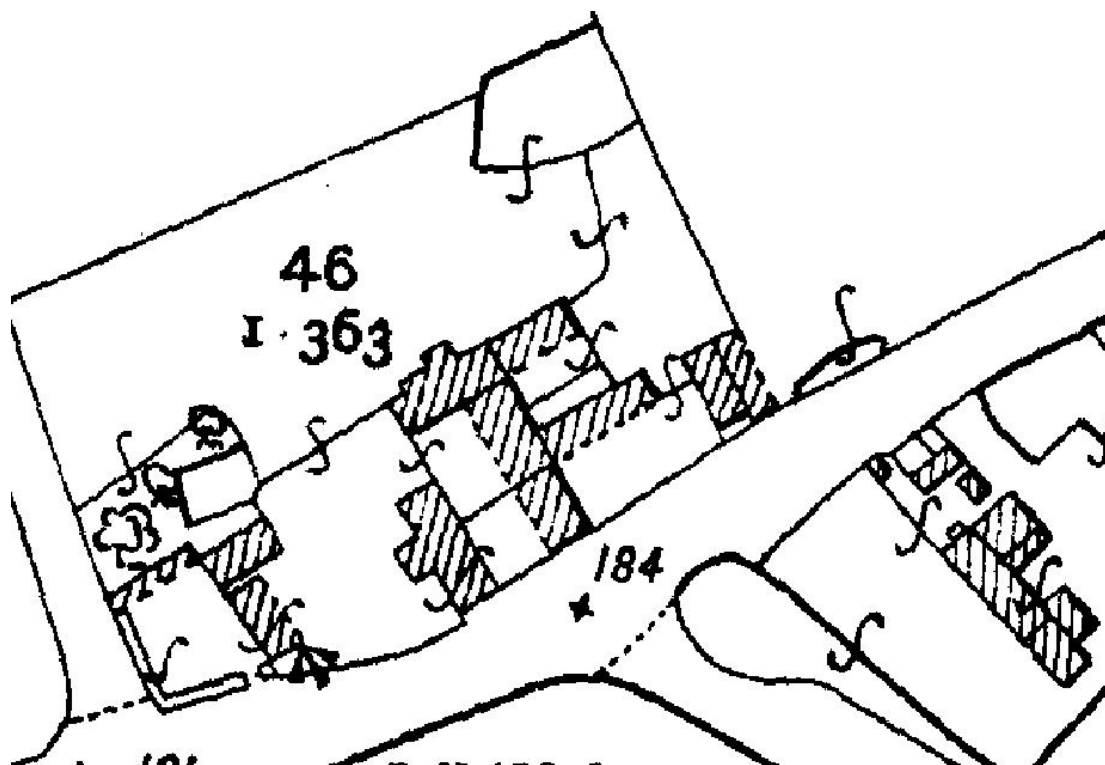
Figure 4

Second Edition 25 inch Ordnance Survey of 1904.

The complex had undergone further modification since 1885, with the replacement of the L-shaped range of open-sided sheds to the south-east (shown in grey in figure 3) by the present brick ranges adjoining the wood yard (5) (i.e. the southern end of the present dairy range (7) and the yard's northern shed). Apart from its mid-20<sup>th</sup> century additions the complex shown here is still recognisable today.

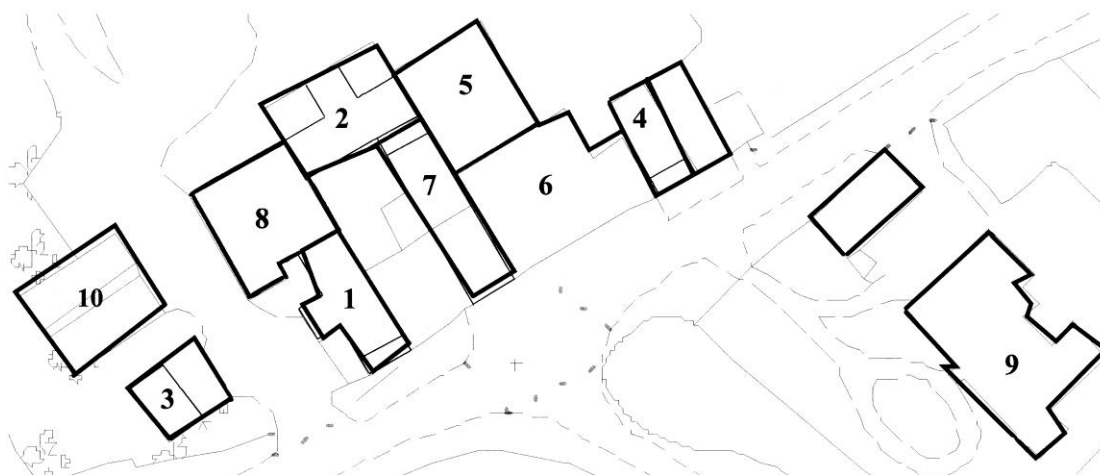
Figure 5

Block plan of the site, identifying each historic element with a number for ease of reference in the text and photographs. Based on the Ordnance Survey.

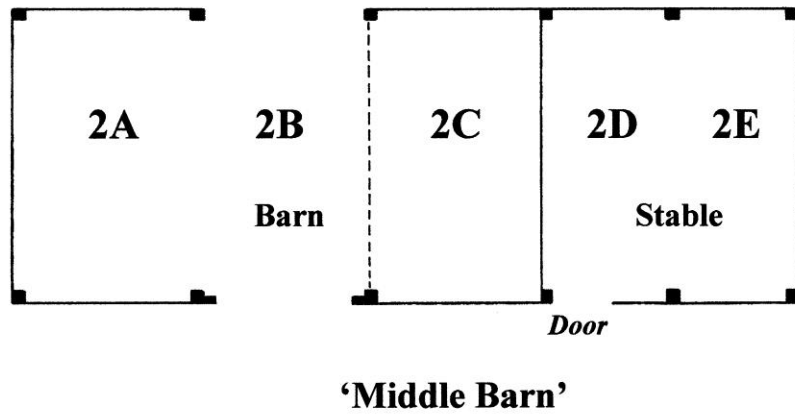
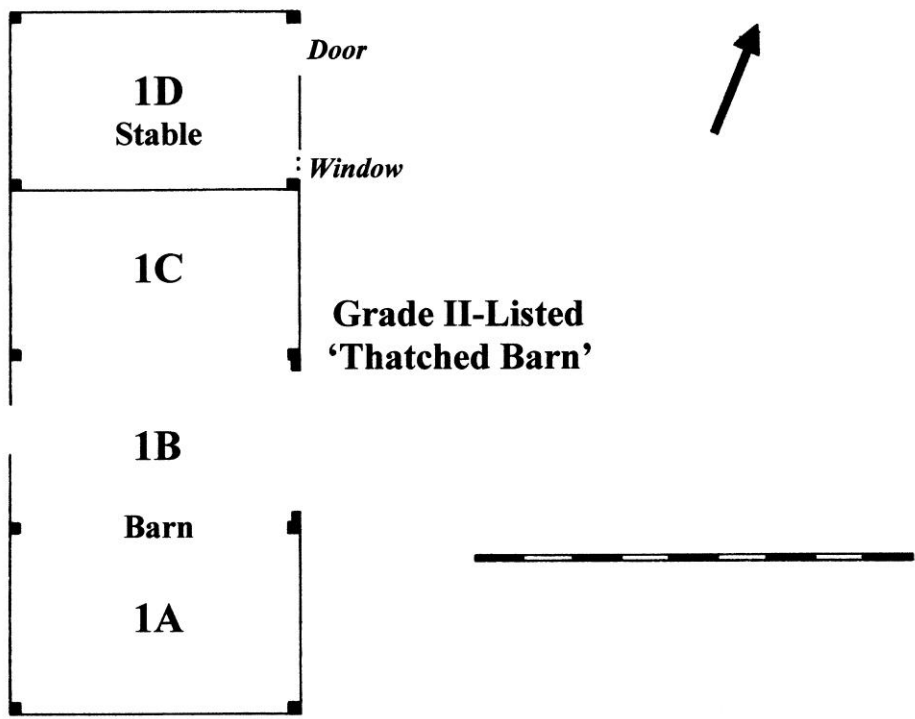
Figure 6

Schematic ground plan of the 16<sup>th</sup> century barns showing their original layout and identifying each bay for ease of reference in the text and photographs. Scale in metres. The broken line between bays 2B and 2C indicates a possible half-height barrier for which mortises survive in the storey posts.

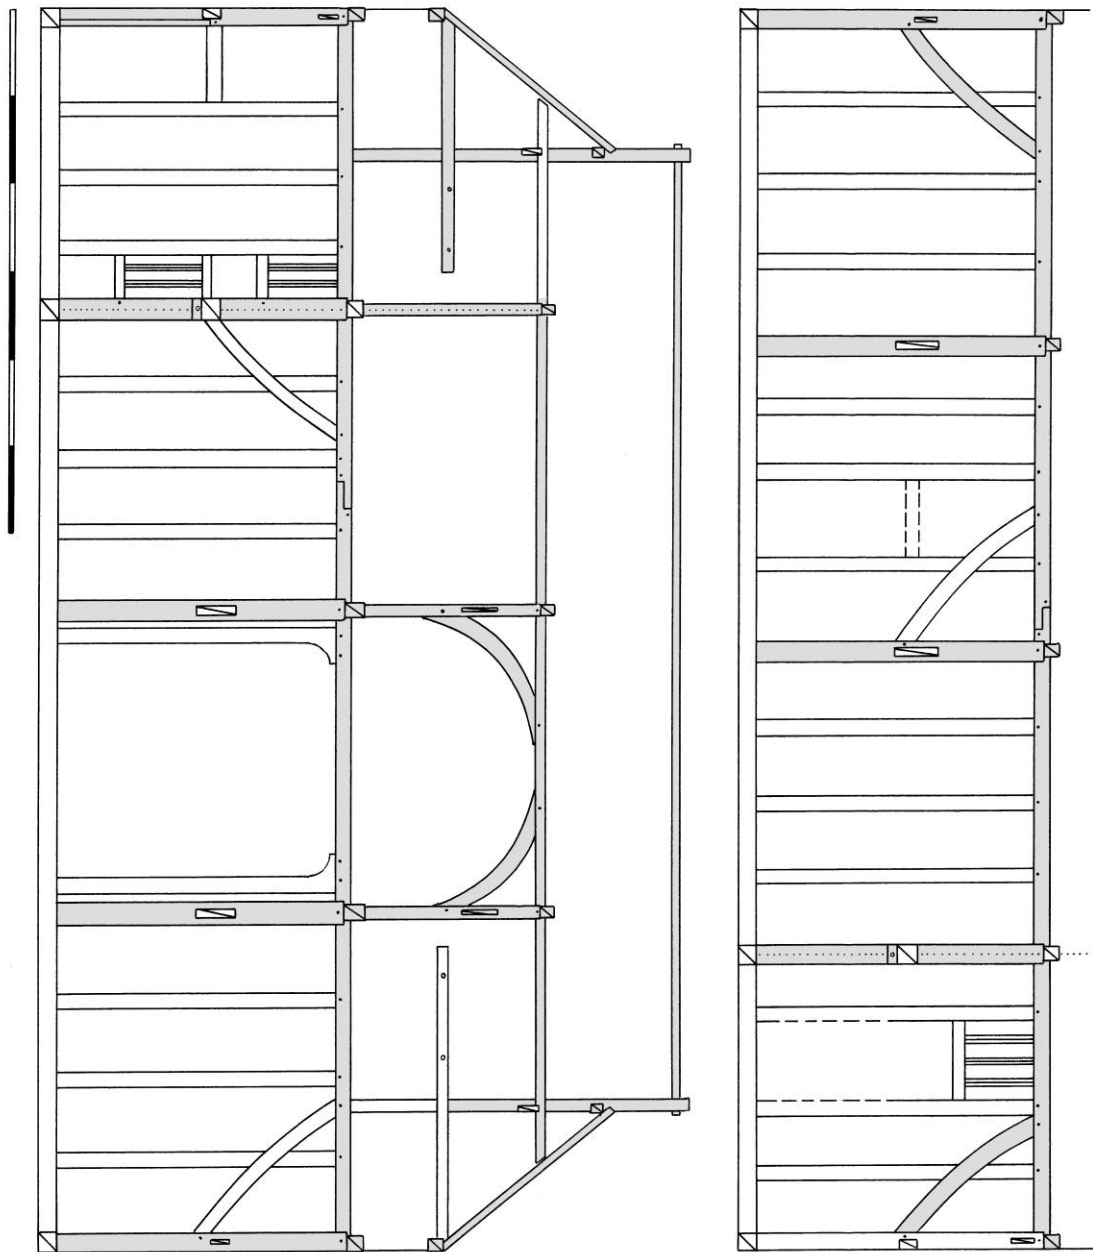
***Reconstructing the original arrangement of the framing and highlighting the remaining original timbers in grey. The inserted 19<sup>th</sup> century ground sills are shown (since the height of the original sills is uncertain) but the 19<sup>th</sup> century studwork is not. All scales in metres.***

**Figure 7**  
**Thatched Barn (Listed)**  
**The internal eastern (front) elevation with its half-hipped queen-post roof structure (below) and the internal western (rear) elevation. The lofted stable bay is shown to the left and right respectively.**

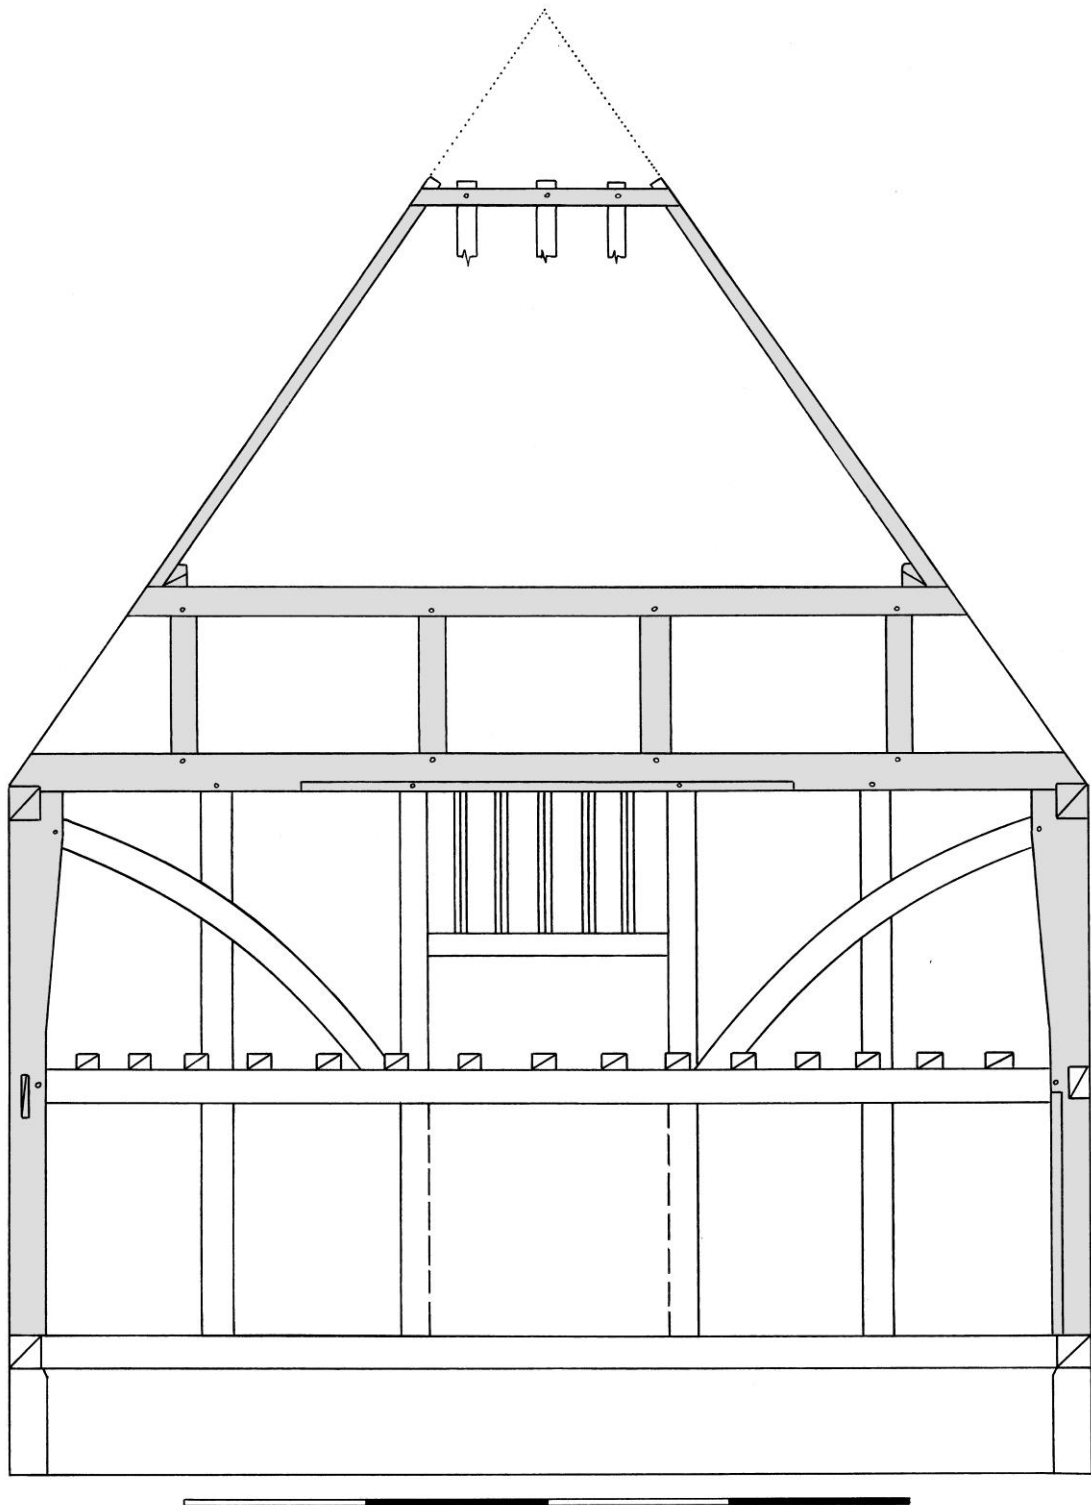
**Figure 7**  
**Thatched Barn**

The internal northern gable showing the arrangement of the half-hip with the (missing) joists of the original hay loft supported by a mid-rail. The north-eastern corner post to the right shows the rebate and lintel of the stable door.

61. Barn 1. Northern internal gable showing hip rafters & all studs replaced below tie-beam with diamond mullion mortises and shutter rebate.
62. Barn 1. Detail of northern tie-beam soffit showing stud & diamond mullions mortises with shutter rebate for hay loft window.

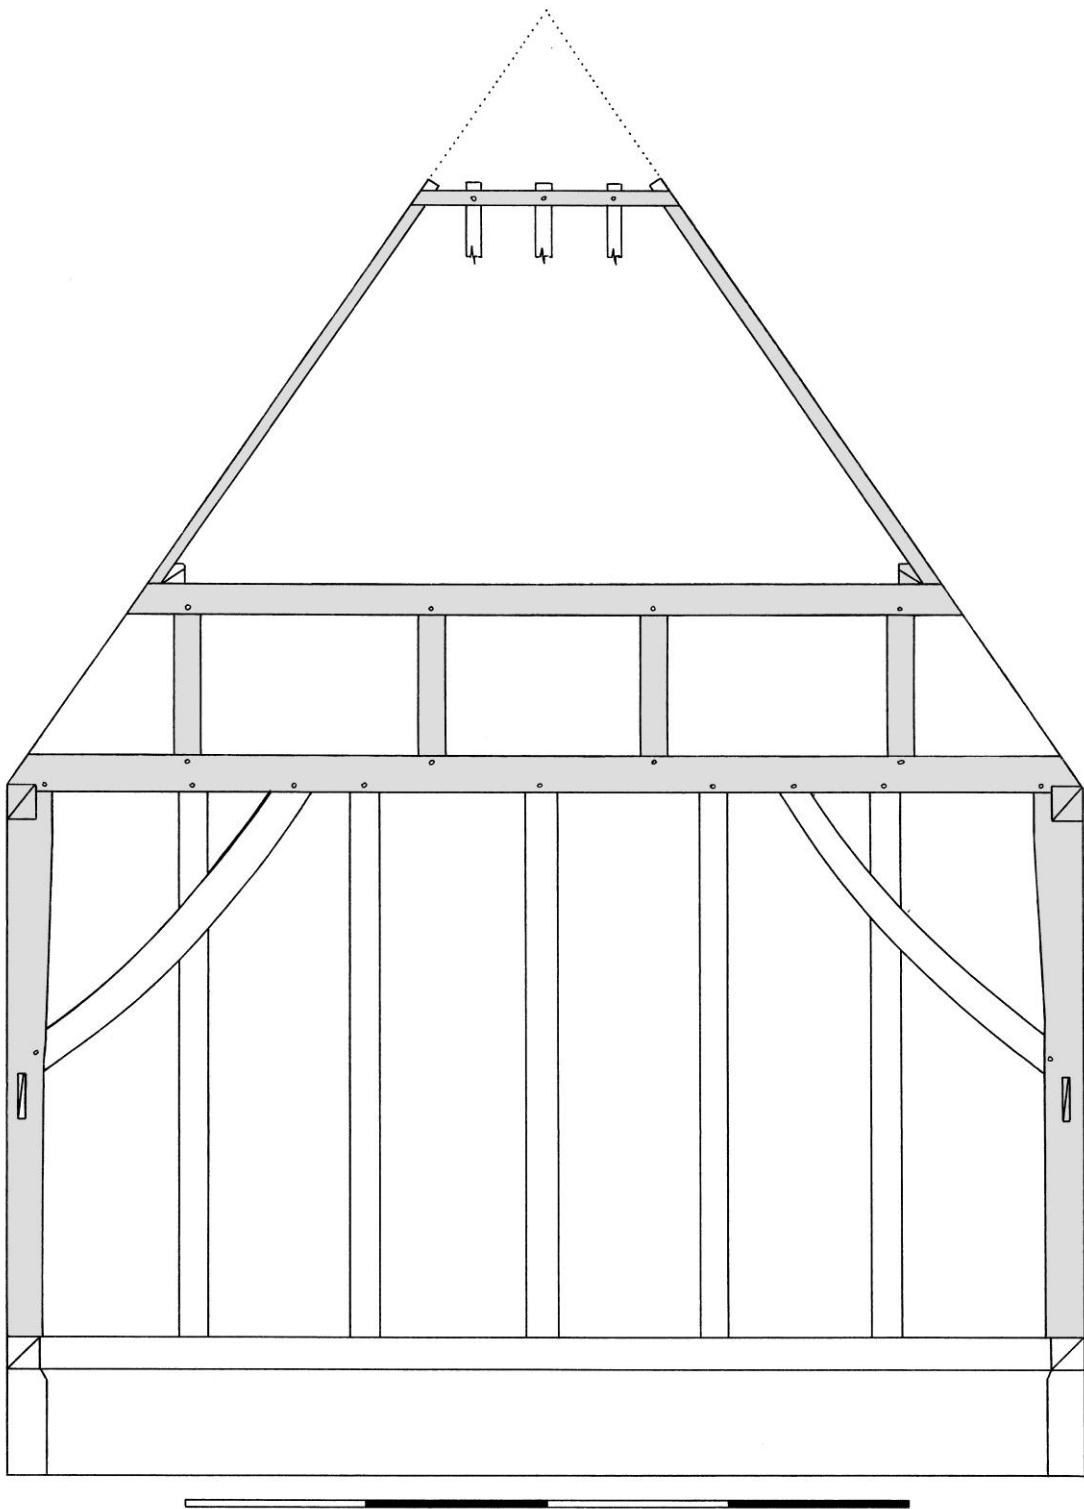
**Figure 8**  
**Thatched Barn**  
**The internal southern gable showing the arrangement of the half-hip with pegged purlins securing the ends of the upper tie-beam to the rafters.**

47. Barn 1. Detail of southern internal gable showing original half-hip tie-beam, purlins and collar with three pegs for hip rafters.
48. Barn 1. Western interior of southern bay (1A) showing all common timbers replaced except reverse-curved internal corner brace to left.

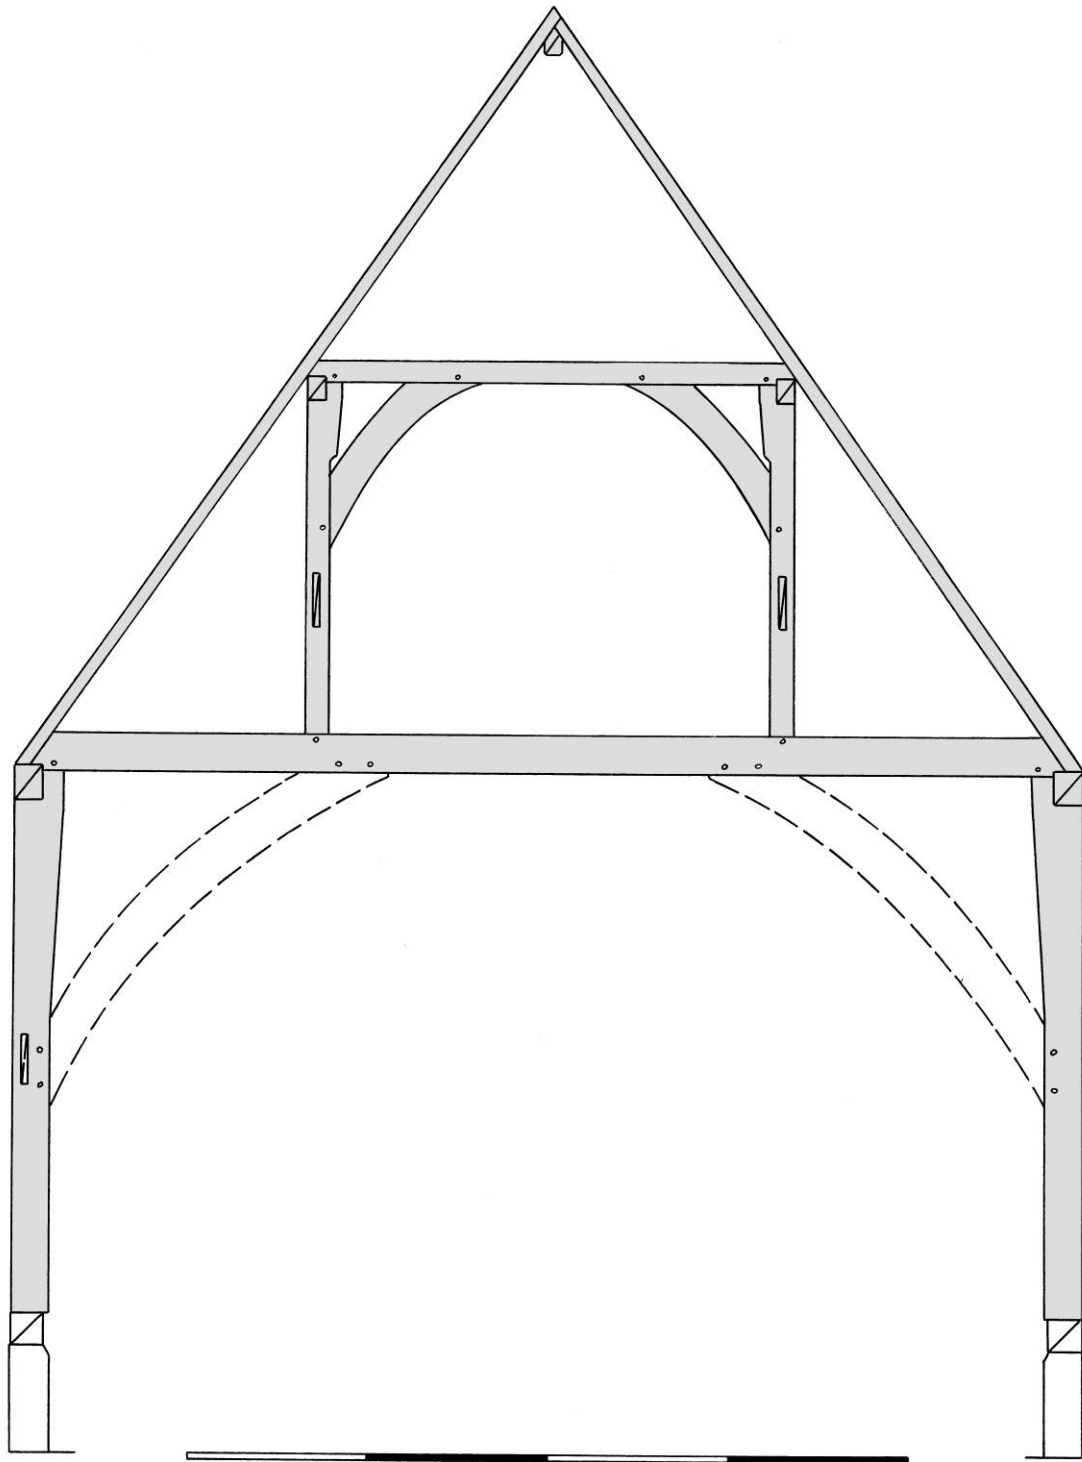
**Figure 7**  
**Thatched Barn**

The queen-post open truss between bays 1B and 1C seen from the south. The trusses of the Middle Barn are almost identical but with smaller collar and purlin braces.

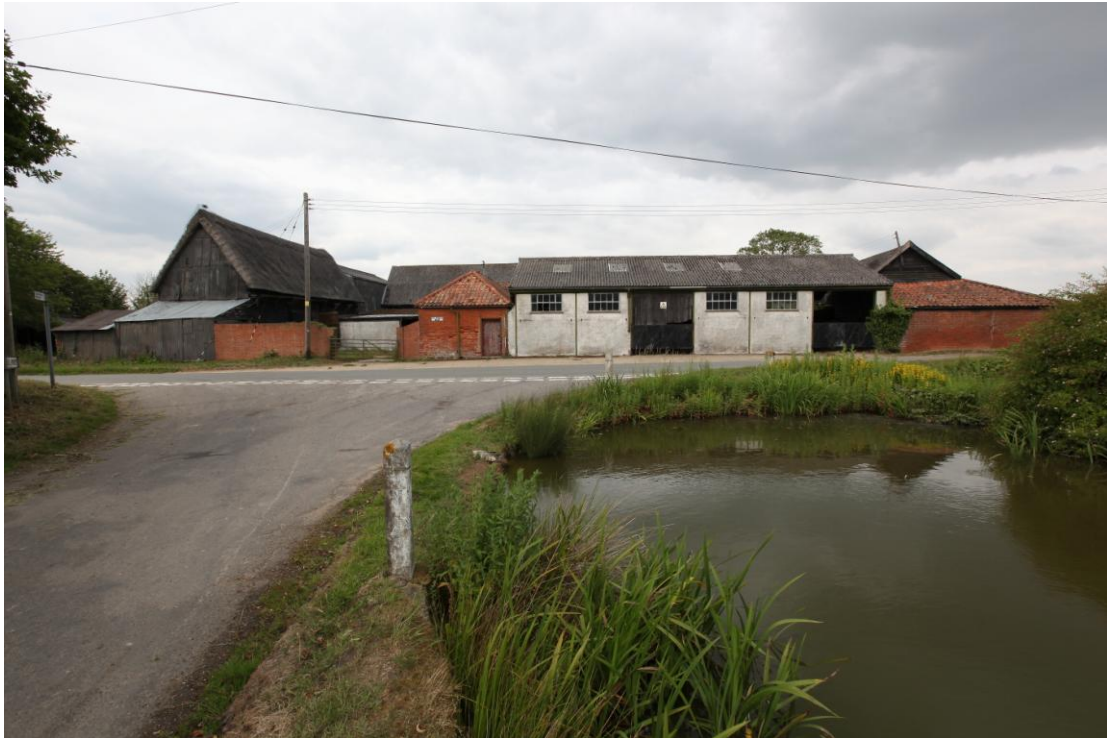
**Illus. 1** General view of the farm complex from across the farmhouse moat to the south, showing from left to right the grade II-listed 16<sup>th</sup> century thatched barn (1) with the contemporary ‘middle barn’ (2) in the rear, the brick dairy range (7) and 20<sup>th</sup> century covered yard (6) in the centre and the 19<sup>th</sup> century weatherboarded stable (4) with its brick southern lean-to to the right.

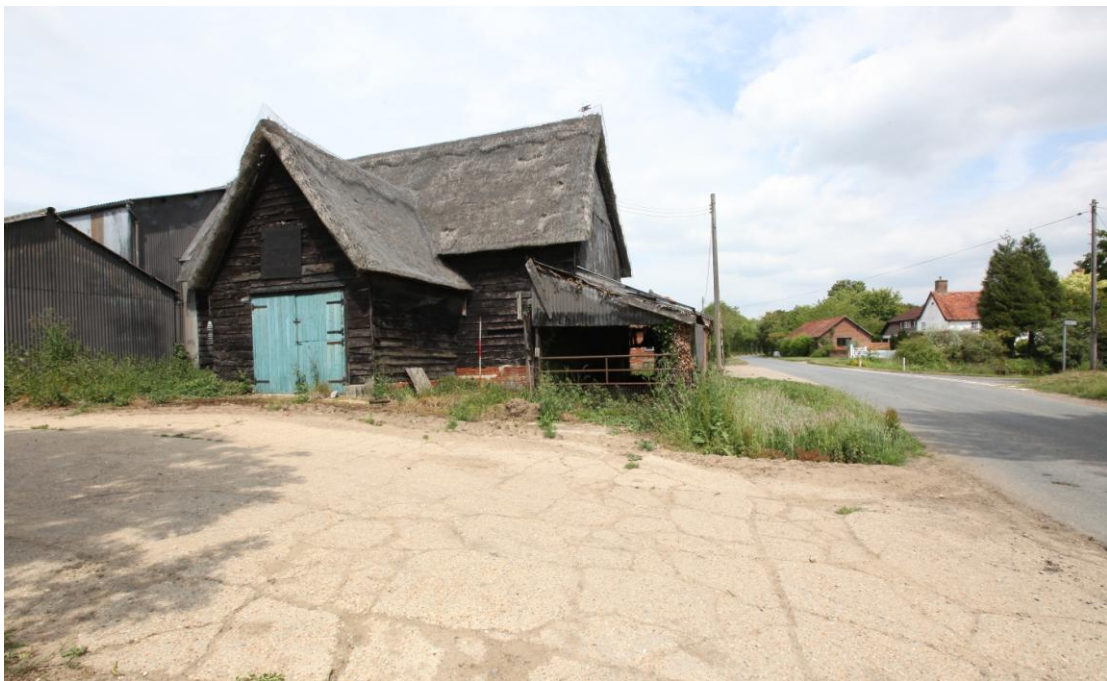
**Illus. 2** The exterior of the thatched barn (1) from the west showing its 19<sup>th</sup> century gabled porch and southern lean-to shed. The grade II-listed 16<sup>th</sup> century farmhouse is visible on the opposite side of the Woodbridge Road to the right.

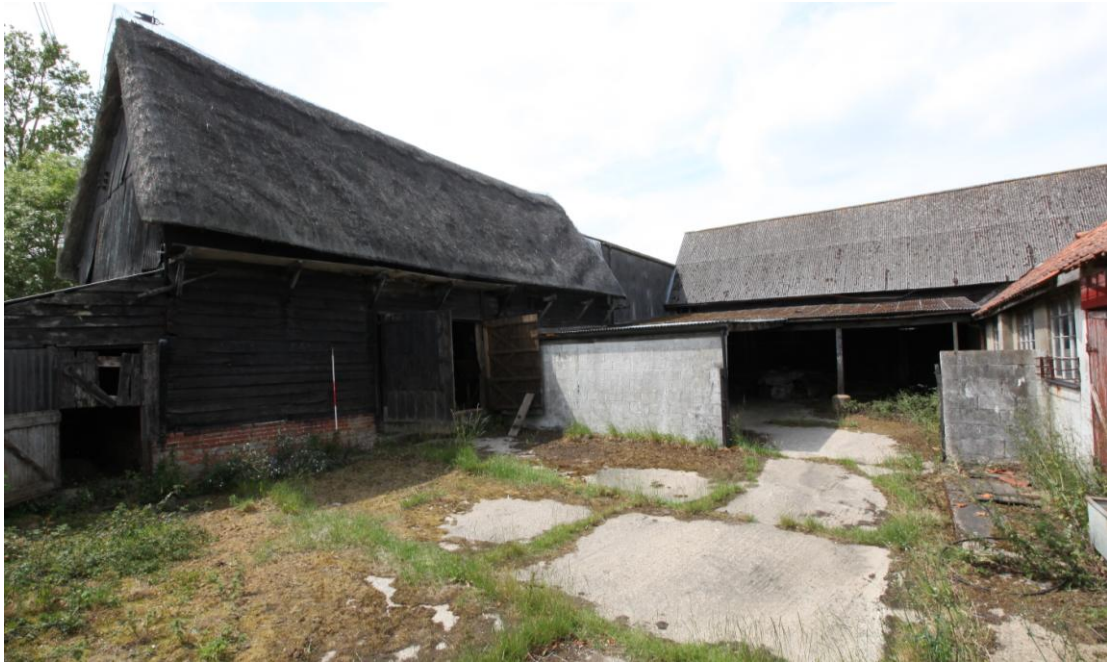
**Illus. 3** The eastern exterior of the thatched barn (1) from the adjoining yard showing its close proximity to the contemporary middle barn to the right. Note the unusual guttering of corrugated iron supported on wooden brackets beneath the thatch eaves. The framing and condition of the two barns are almost identical but the thatch of the middle barn has been replaced with corrugated asbestos.

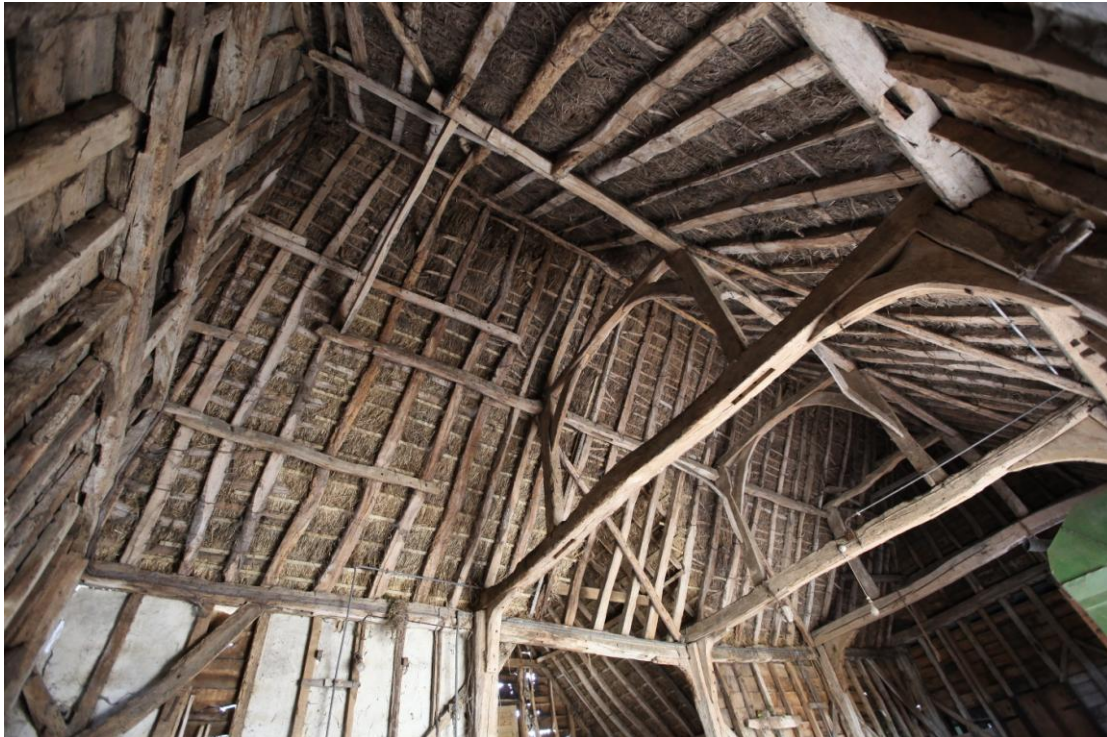
**Illus. 4** Thatched barn (1). The fine late-16th century queen-post roof structure from the south-east, showing the evidence for an original half-hip with a gablet to the southern gable. The present vertical gable is part of an extensive 19<sup>th</sup> century refurbishment which included the insertion of a new ground sill and brick plinth, along with the replacement most of the original wall studs. Note the empty mortises of the arch-braces to the tie-beams replaced with knee-braces at the same time.

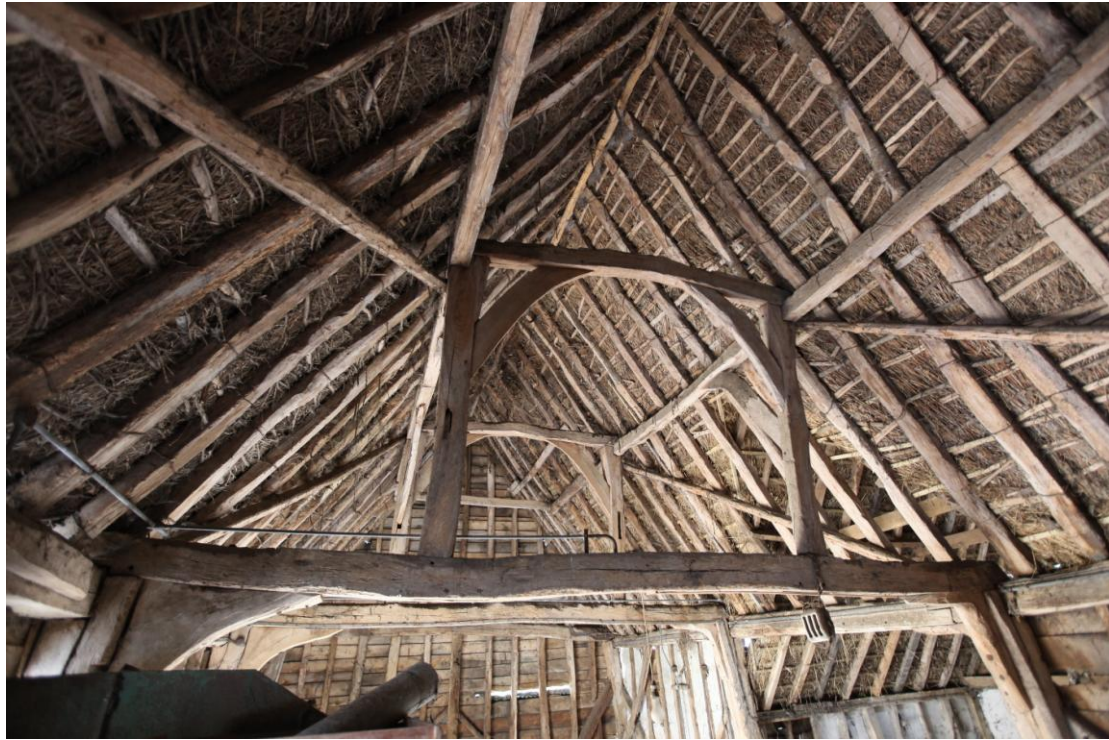
**Illus. 5 Thatched barn (1). The queen-post roof structure from the south showing the original ridge-piece and the purlin braces that are confined for decorative effect to the threshing bay (1B). The middle barn (2) is identical in this respect.**

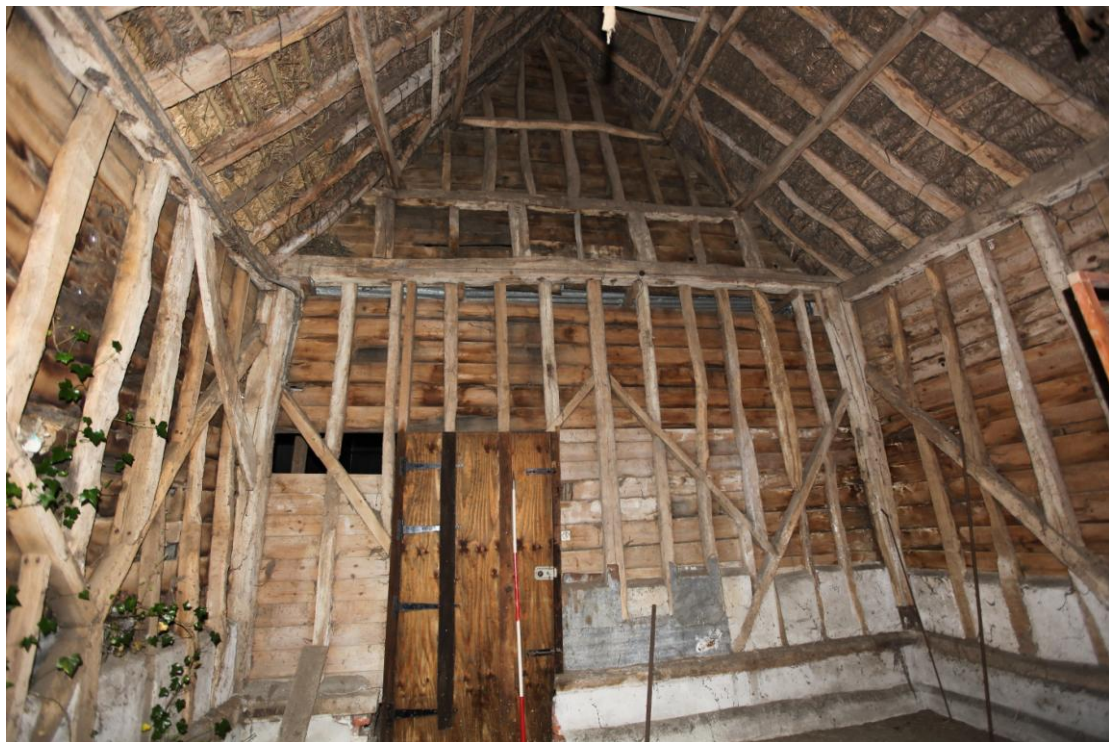
**Illus. 6 Thatched barn (1). The interior of the northern gable showing the 19<sup>th</sup> century studwork with nailed primary braces. The short studs between the upper tie-beam of the half-hip are original, as are the diagonal hip rafters and purlins. This bay was built as a stable entered by a door against the corner post to the right and evidence is visible here of three diamond-mullion windows to its loft (to the extreme left and right, and in the centre of the tie-beam).**

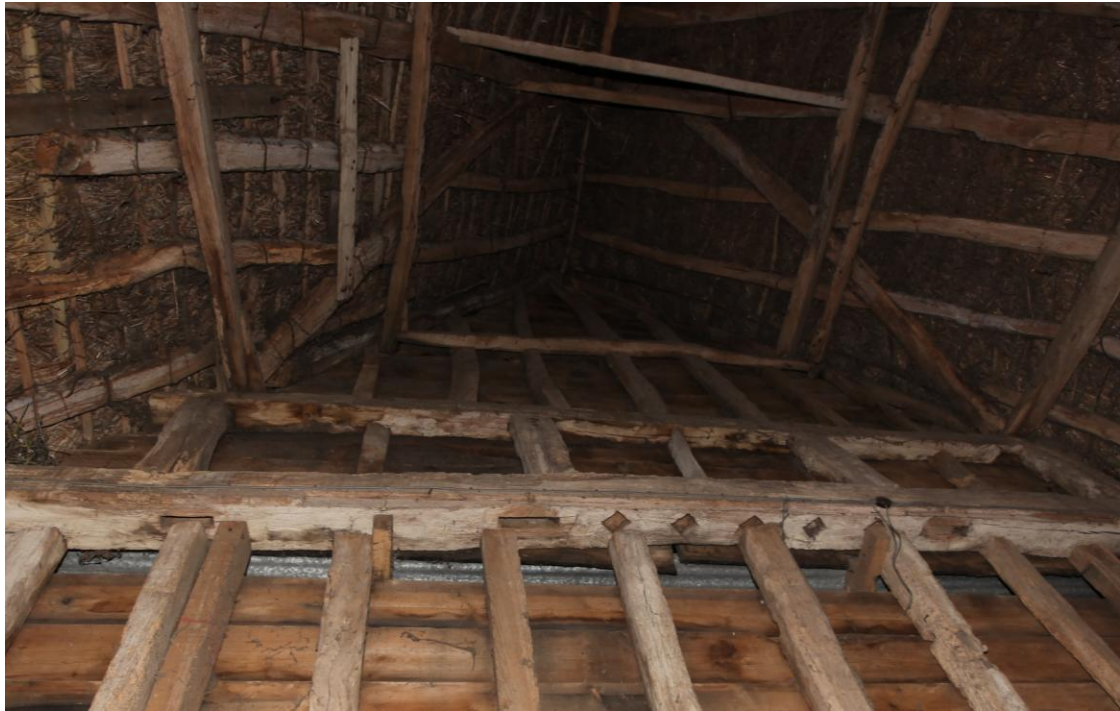
**Illus. 7 Thatched barn (1). Detail of the underside of the northern gable tie-beam showing a series of empty mortises for studs and the diamond-mullions of a central six-light window with sliding shutters on both sides. The hip collar at the top of this image contains three peg holes for original rafters.**

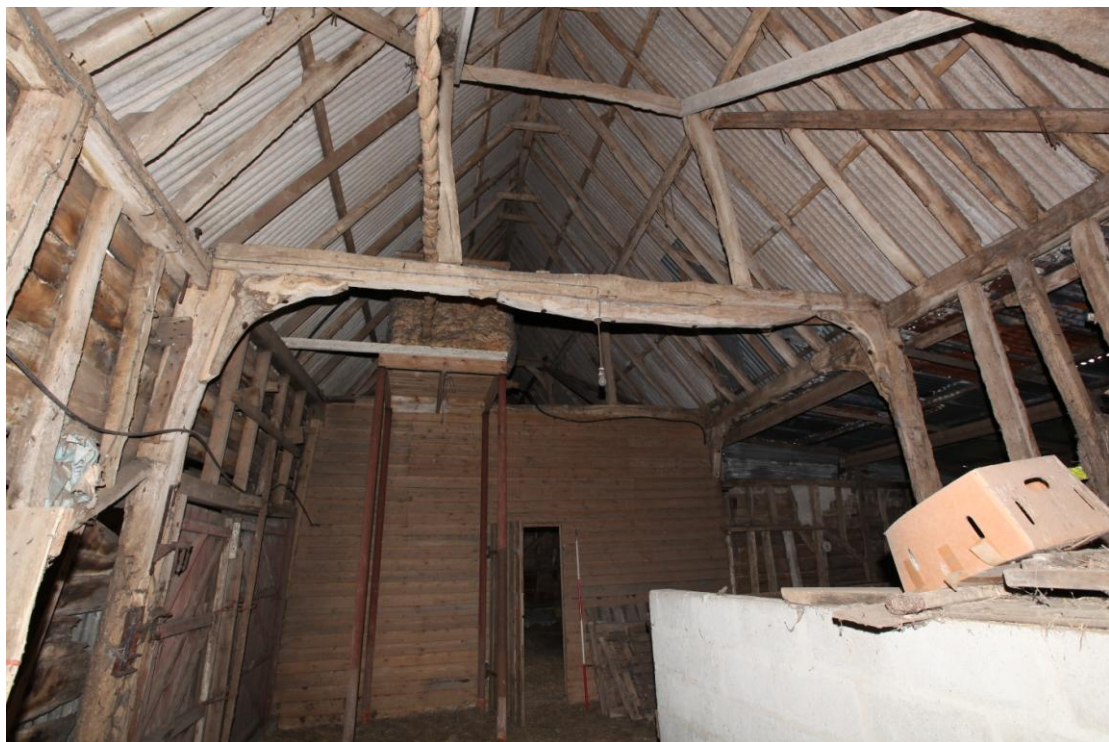
**Illus. 8 Middle barn (2). The interior from the east showing the intact queen-post roof structure, which is less visible than that of the thatched barn due to the presence of the 20<sup>th</sup> century boarded partition visible here and a wire-mesh hay loft in the two western bays (2A and 2B). The tie-beam in the foreground contains the empty stud mortises of an original partition which divided a three-bay threshing barn to the west from a two-bay stable and loft to the east.**

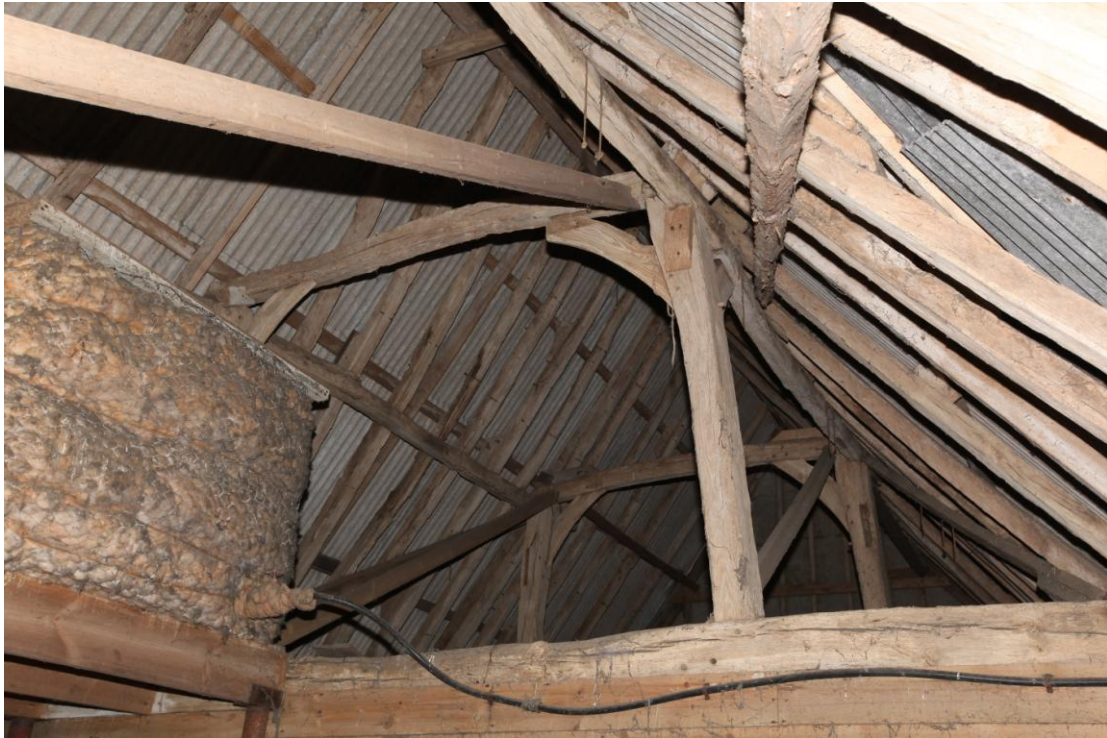
**Illus. 9 Middle barn (2).** The queen-post roof above the two eastern bays, seen from the east (but hidden from beneath by a wire-mesh loft). Like the thatched barn, only the threshing bay (2B) was provided with braces, of which three have been lost.

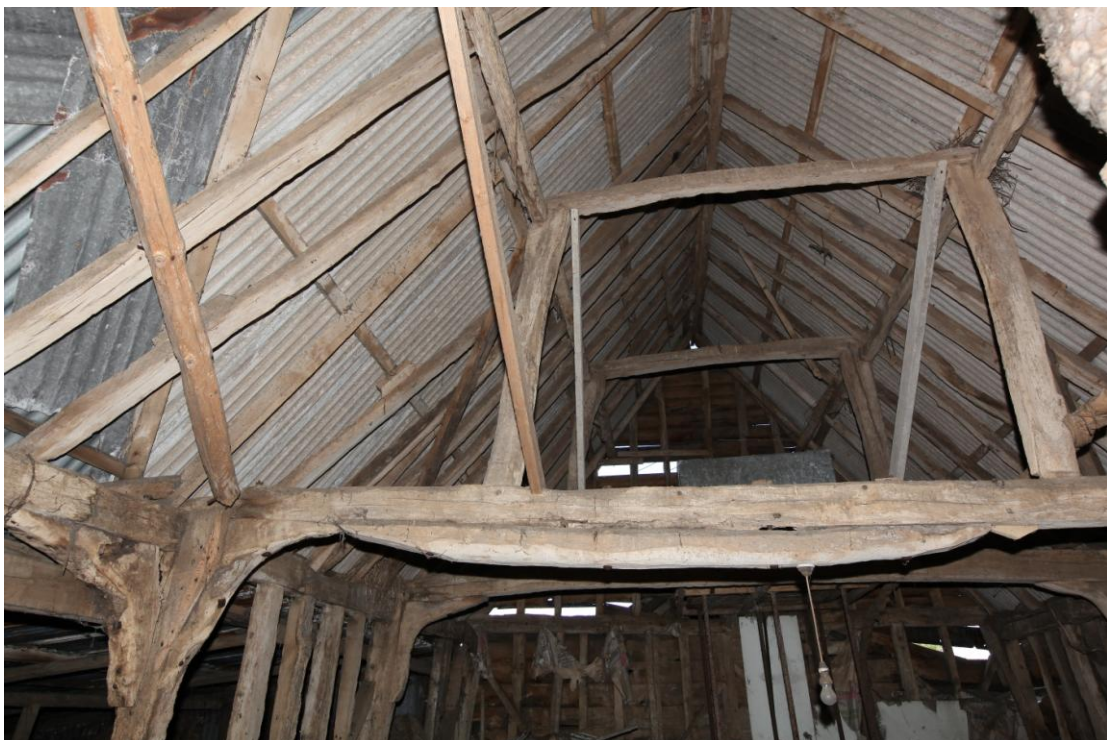
**Illus. 10 Middle barn (2).** The roof trusses of the eastern bays which lack braces to either the purlins or collars. There is evidence of a half-hip at the eastern gable but (like that of the thatched barn) it was converted into a vertical gable in the 19<sup>th</sup> century.

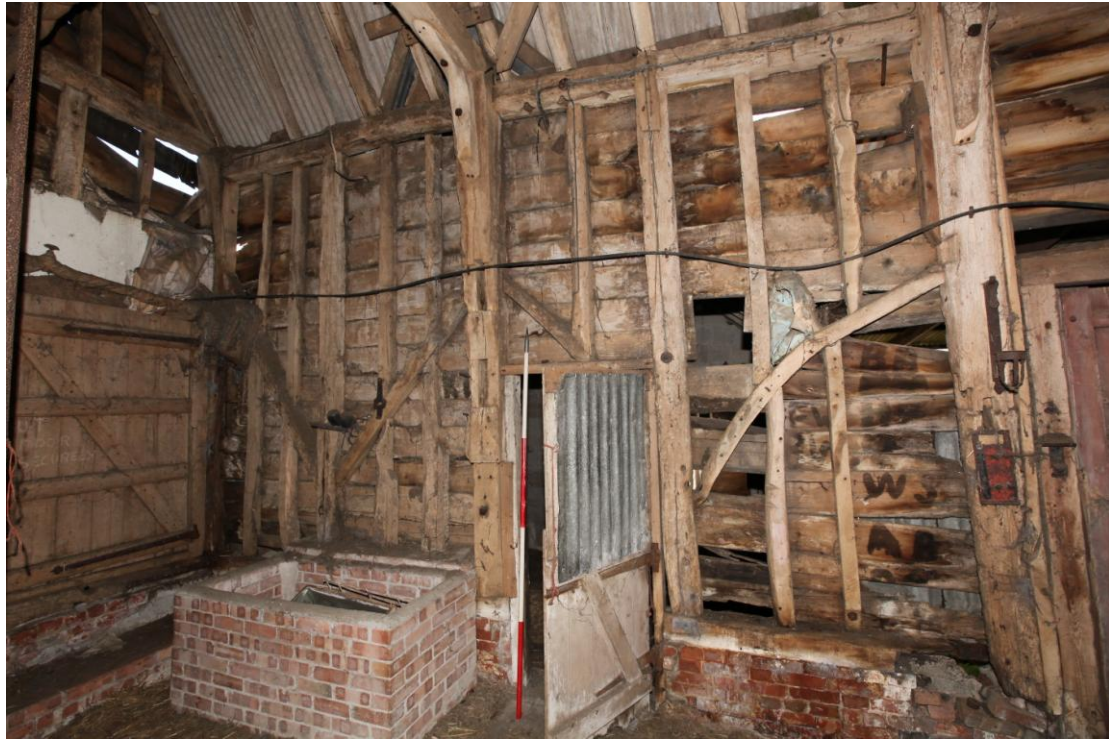
**Illus. 11 Middle barn (2). The southern interior of the two eastern bays (2E and 2D) which originally formed a stable with a loft. The present door and the main entrance to the extreme right (bay C) are secondary, the latter replacing the previous thoroughfare in bay B in the 19<sup>th</sup> century. The majority of the common studs are 19<sup>th</sup> century replacements but the stud to the right of the central door is original and contains the mortises of a diamond-mullion loft window sill to its left and the lintel of a blocked door to its right.**

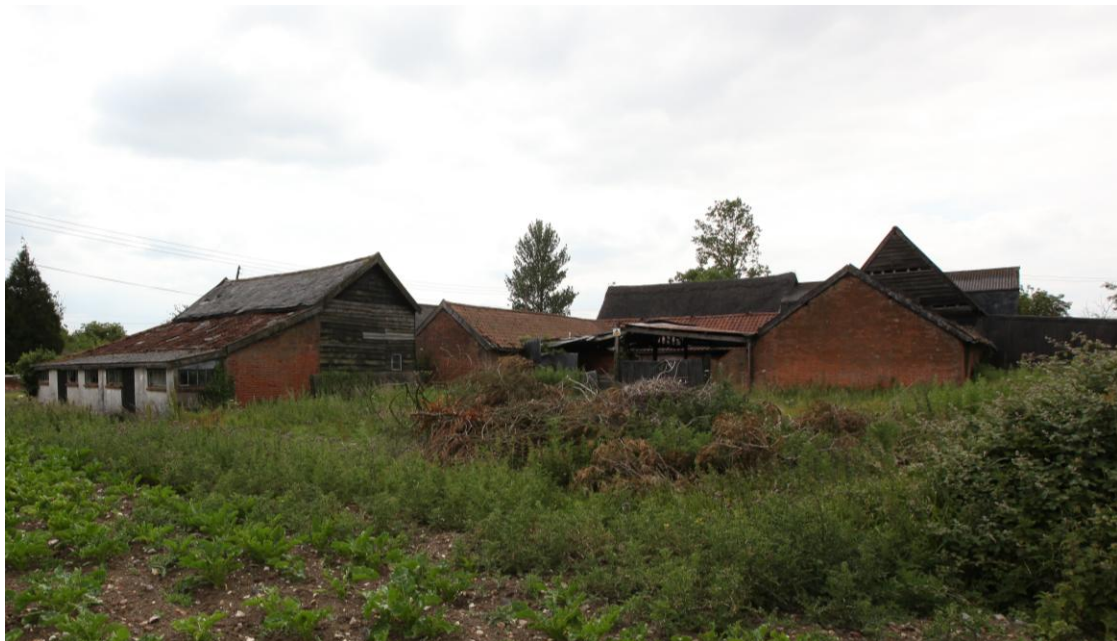
**Illus. 12 The farm complex from the north-east showing the 19<sup>th</sup> century brick shelter-sheds of the two eastern yards (5 and 6) with the two barns in the rear and the well preserved 19<sup>th</sup> century weatherboarded stable to the left.**
