**Barns at  
The Rookery,  
Wilby, Suffolk  
WBY 024**

**Heritage Asset Assessment**

# **Barns at The Rookery, Worlingworth Road, Wilby, Suffolk**

## **Heritage Asset Assessment**

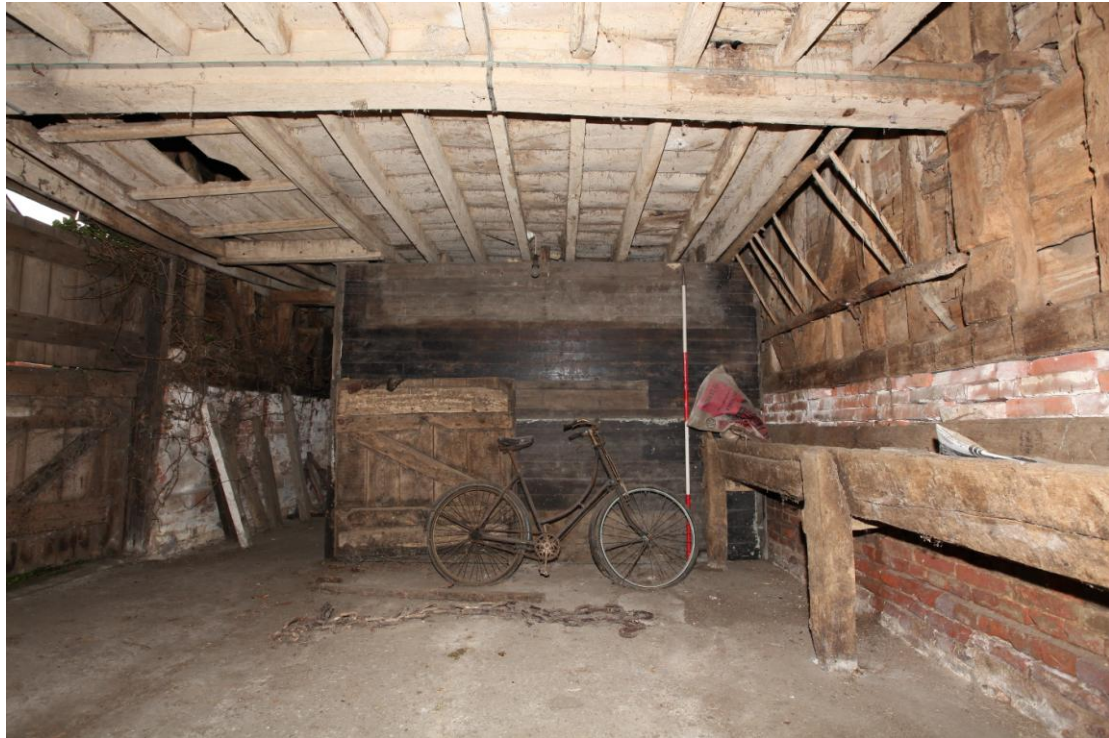
**Illus. 13** Stable (4). The southern section of the interior from the southern gable, showing the intact 19<sup>th</sup> century boarded manger and hay rack beneath a hay drop in the loft ceiling to the right. The manger continues into the northern section beyond the boarded partition.

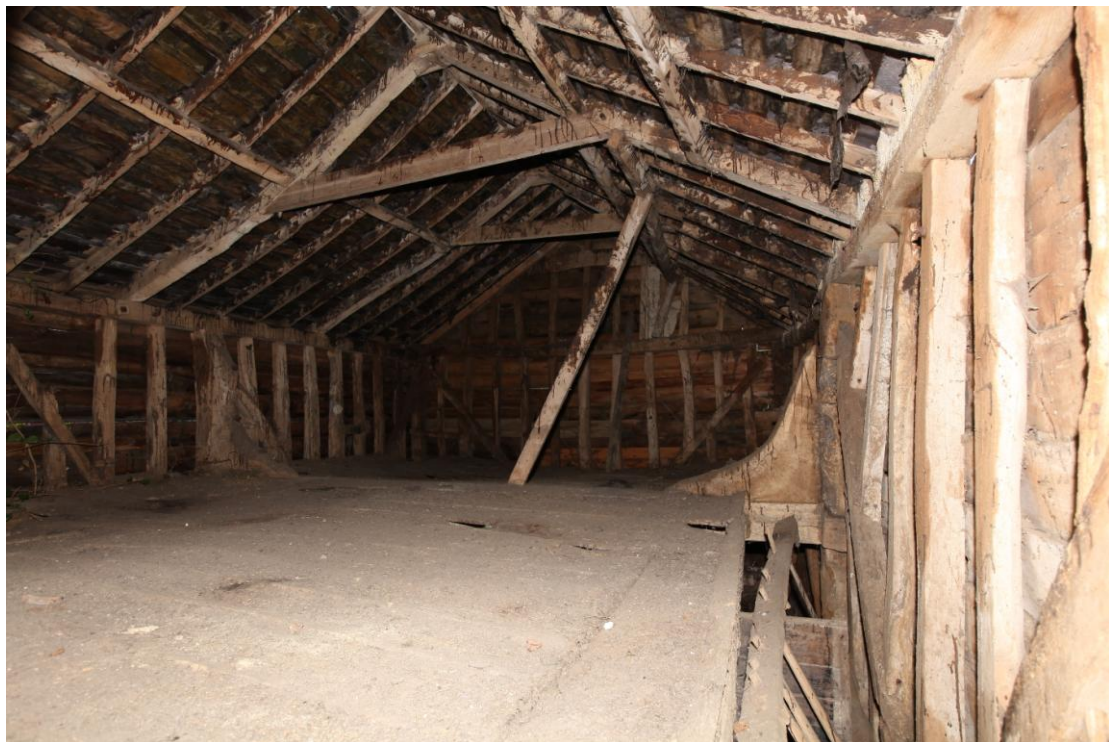
**Illus. 14** Stable (4). The interior of the hay loft from the south showing the butt-purlin roof structure with re-used timber and the hay drop above the rack to the right.
