## St. Margaret's, Leiston (LCS 018), A Record of Archaeological Work Associated with the Insertion of a New Underfloor Heating System

Report No. 2005/166

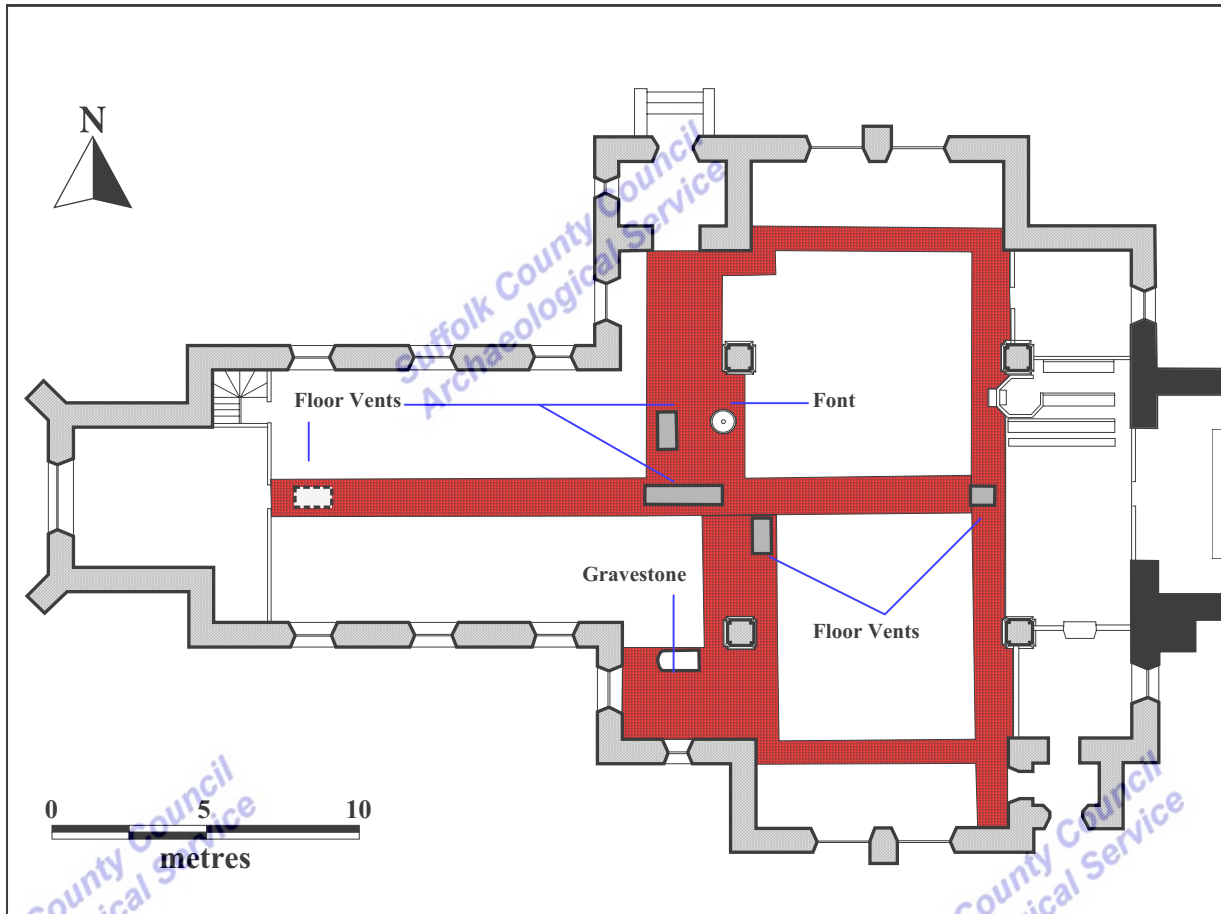
Fig. 2 1:250 Scale Plan Showing Tiled Floors

The pews and wooden flooring were all removed from the church leaving the tiled aisles intact (Fig. 2). The material encountered beneath the pew floors varied considerably throughout the church. In the north and south transepts and the two large areas in the crossing the layer comprised relatively unconsolidated flint and mortar rubble while in the south side of the nave the composition was dominated more by mortar. However, in the north side of the nave the layer was far more consolidated as a formally lain slab.

Designed by the somewhat controversial architect Edward Buckton Lamb, the new church was cruciform in plan with two small chambers in the angles of the cross on its eastern side (Fig. 2).

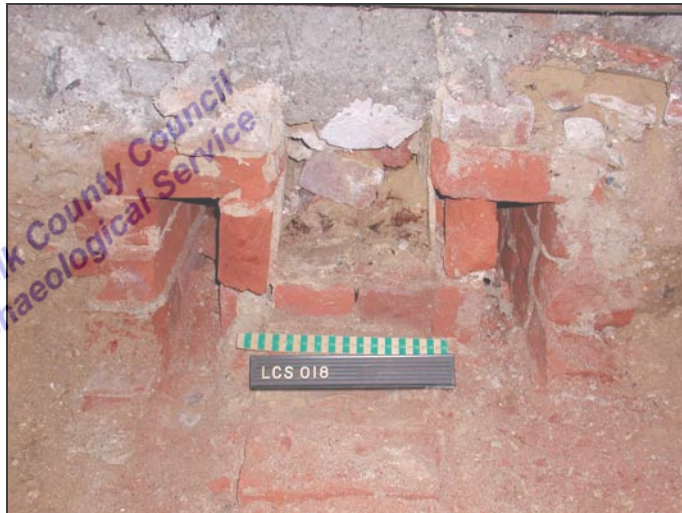
**Plate 1:** Section Through Brick-Built Heating Duct

At this level, two parallel lines of bricks separated by a *c.*0.24 metre wide void, later found to represent part of the Victorian heating system (see pages 4-7), were recorded running down both sides of the nave and around the north and south transepts.

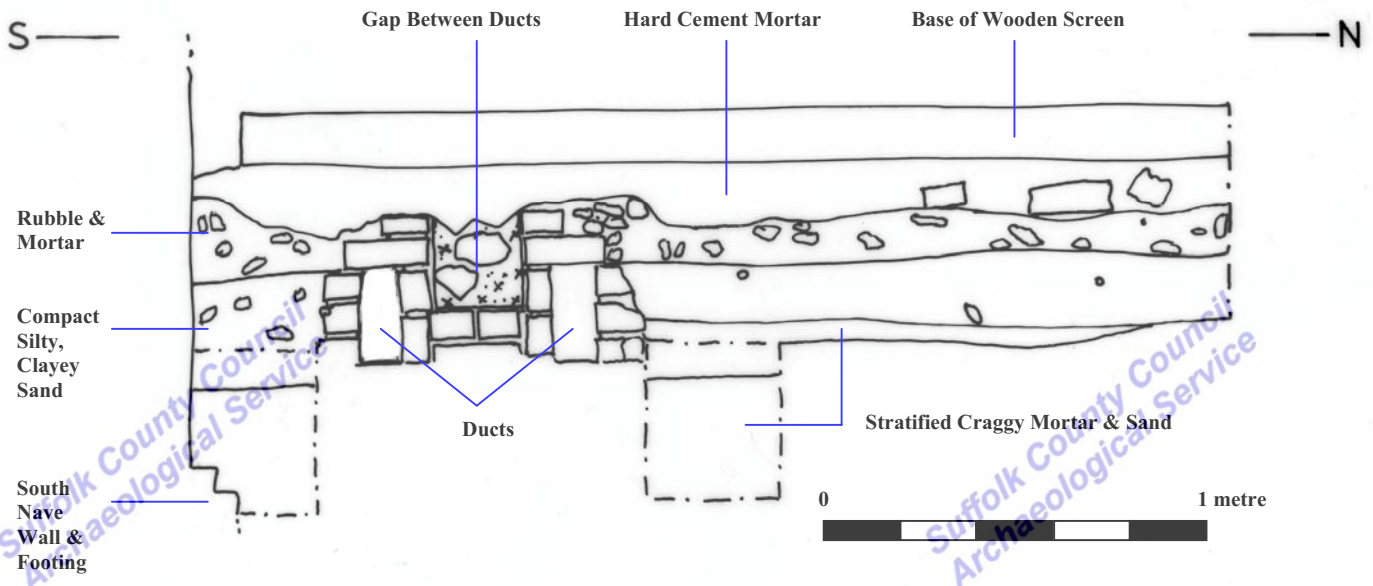
**Fig. 3** 1:20 Scale Section Drawing Through Heating Duct

excavation, parallel to the wooden screen at the western end of the nave (Fig. 3). At this juncture, three layers were recorded; a relatively consolidated 0.1-0.15 metres thick layer of mortar (forming a base for the screen) overlay a c.0.1 metre thick layer of unconsolidated mortar and rubble which in turn overlay a c.0.2 metres thick compact layer of mid brown clayey sand. The base of the latter effectively coincided with the reduced level strip. Two small

test-holes (Figs 3 & 4) were excavated for a further 0.4 metres through stratified deposits comprising predominantly of coarse lime mortar and mortar covered flints. At no stage was naturally occurring subsoil encountered and all of the layers appeared laterally extensive and representative of those observed throughout the church. The two test-holes had been excavated with the aim of finding vestiges of the earlier medieval walls or their associated footings. None were identified in the test-holes and were certainly not seen anywhere else within the 0.4 metres of the reduced level strip. However, one of the test-holes, that excavated against the standing wall, revealed the stepped out base of the brick-built footing. There was no obvious cut for the wall or its footing and the fill layers appeared to abut the wall rather than be cut by it.

Attention then turned to recording the Victorian underfloor heating system (Figs 3 & 4). A series of brick-built ducts ran around the entire church. These had been constructed on a hard mortar base, effectively acting as a footing. The mortar base

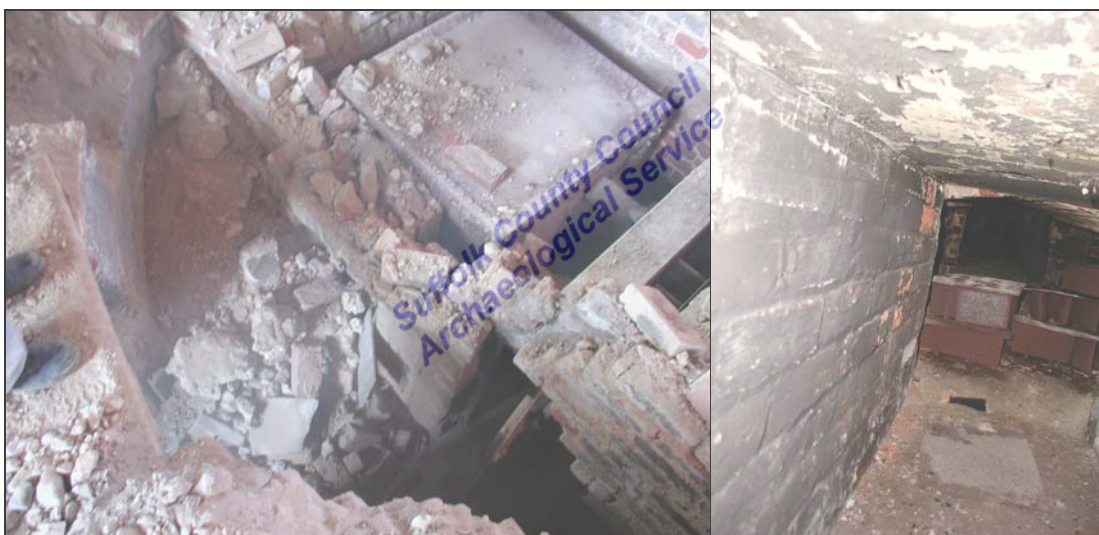
**Plate 2** Firebox in Pit & Top of Firebox Seen From Vent

The hot air for the ducts was generated in a firebox situated in a circular (*c.*3.3 metres in diameter) pit located in the crossing, effectively the centre of the church (Fig. 4). This pit, which was roofed in brick supported by two iron girders, had previously housed the boiler for the earlier hot water heating system. Heat from the firebox was transferred by conduction to the air and was then drawn through the system. The brick ducts heating below the pews with the main body of the church heated through floor vents. Three substantial brick built passages lead away from the firebox, one to the east and two, one on top of the other, to the west. The lower of the two on the west side serviced two floor vents, while the others appeared run to one vent each. The only other floor vent recorded (access was not gained to the chancel or north chapel) was serviced by the smaller floor ducts and was located at the western end of the nave (Fig.s 2 & 4).

The firebox was situated north of centre in the circular pit behind an inserted brick wall with heavy iron doors providing access for fuel, stoking and raking out (the tools for which were still present in the pit). Ventilation to the outside of the building was

provided by two ducts, one to the north wall (constructed from masonry from a substantial medieval arch, possibly a window or door) and the other to the south built in brick. In addition, further ventilation was supplied by the curving entrance passage and a flue located at its eastern end that exits through a small, decorated turret.

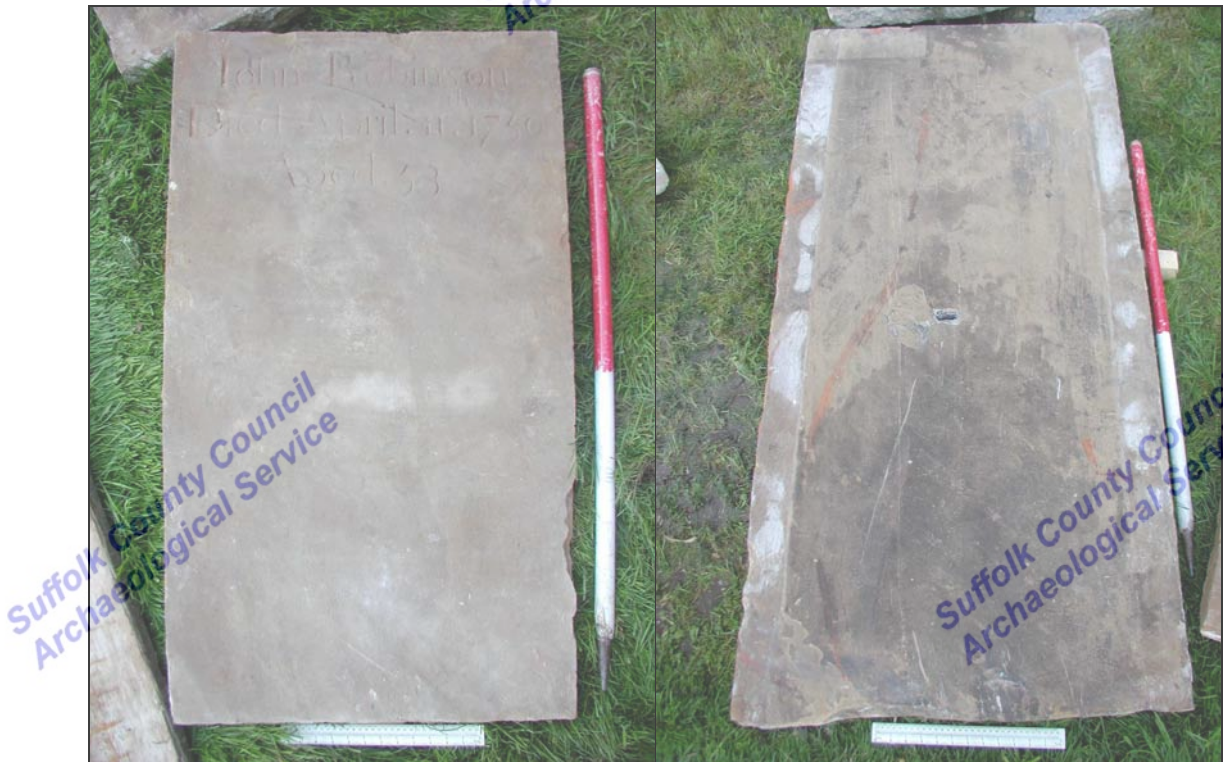
Plate 4: Grave Slabs Recorded Below Tiled Floor (No.s 3 & 4)

No. 3 John Robinson

No. 4 John Grimsby

No.	Location	Dimensions	Inscription	Description
1	Set in tiled floor S.side of church (Fig.s 2 & 4)	1.35 x 0.65 m	SACRED TO THE MEMORY OF ANNA MARY DAUGHTER OF EDWARD AND SARAH DEWING OF THIS PARISH WHO DEPARTED THIS LIFE SEP <sup>R</sup> . 30 <sup>TH</sup> 1834 AGED 2 YEARS AND 11 MONTHS ALSO OF WILLIAM DEWING WHO DIED AN INFANT SUFFER THE LITTLE CHILDREN TO COME UNTO ME AND FORBID THEM NOT FOR OF SUCH IS THE KINGDOM OF GOD. MARK CHAP 10 ??????	Gravestone, probably originally set upright in ground. Simple curved top. Would be replaced in same position in new floor
2	In Rubble in bottom of S.most floor vent	?	G . R 1873	Small, brown york-type sandstone. Would have been set vertically at foot of grave.
3	South Transept under tiled floor, W.most of three (Fig. 4)	1.07 x 0.61 m, 0.07 m thick	JOHN ROBINSON DIED APRIL. 11 <sup>TH</sup> . 1750 AGED 53	Grave slab, brown york-type sandstone (Fig. 4 & Plate 4)

4	Under tiled floor, re-used as roof for passage immediately E. of firebox pit	1.58 x 0.76 m, 0.08 m thick	IN MEMORY OF JOHN GRIMSBY SON OF JOHN AND SUSAN GRIMSBY WHO DEPARTED THIS LIFE APRIL 30 <sup>TH</sup> 1770 AGED ?? YEARS	Grave slab, brown york-type sandstone. Has socket with lead in centre of stone below inscription (Fig. 4 & Plate 4)
5	Re-used in roof over tunnel entrance to firebox pit	Irregular; ends 0.26 & 0.48 m, sides 0.84 & 0.69 m, 0.08 m thick	Present but illegible	Fragment of grave slab (2 real edges), brown york-type sandstone
6	Re-used in roof over tunnel entrance to firebox pit	Irregular; ends 0.3 & 0.54 m, sides 0.44 & 0.8 m, 0.08 m thick	IN ME?????? SUSAN ???? WHO DIED J?????? AGED?????	Fragment of grave slab (2 real edges), brown york-type sandstone
7	Re-used in roof over tunnel entrance to firebox pit	Irregular; ends 0.37 & 0.55 m, sides 0.76 & 0.94 metres, 0.07 m thick	None visible	Fragment of grave slab (2 real edges), brown york-type sandstone, painted at least once

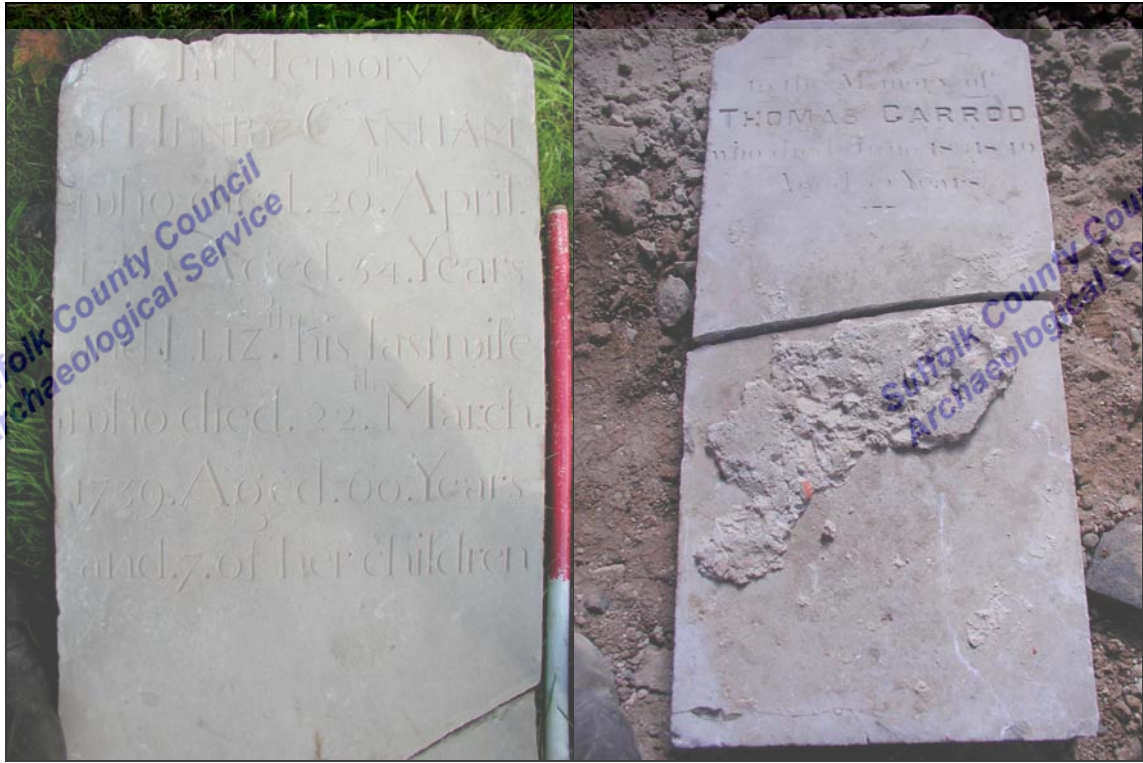
Plate 5: Grave Slabs Recorded Below Tiled Floor (No.s 17 & 18)

No. 17 Henry Canham

No. 18 Thomas Garrod

15	Re-used in roof over tunnel entrance to firebox pit	0.8 x 1.76 m, 0.07 m thick	None visible	Complete grave slab, Purbeck Marble. Indent for brass, 2 figures (Fig. 5)
16	Re-used in roof over tunnel entrance to firebox pit	0.88 x 1.8 m, 0.09 m thick	None visible	Complete grave slab, Purbeck Marble. Indent for 4 brasses, includes 2 figures (Fig. 5)
17	South Transept under tiled floor, middle of three	0.61 x 1.27 m, c.0.08 m thick	IN MEMORY OF HENRY CANHAM WHO DIED. 20. <sup>TH</sup> APRIL. 1728. AGED. 54. YEARS AND ELIZ. <sup>TH</sup> HIS LAST WIFE WHO DIED. 22. <sup>TH</sup> MARCH. 1739. AGED. 60. YEARS AND .7. OF HER CHILDREN	Complete grave slab, brown york-type sandstone, broken corner (Fig. 4 & Plate5)
18	South Transept under tiled floor, E. most of three	0.61 x 1.29 m, c.0.07 m thick	SACRED TO THE MEMORY OF THOMAS GARROD WHO DIED JUNE 18 <sup>TH</sup> 1819 AGED ?39 YEARS	Complete, although in 2 pieces. White limestone (Fig. 4 & Plate 5)

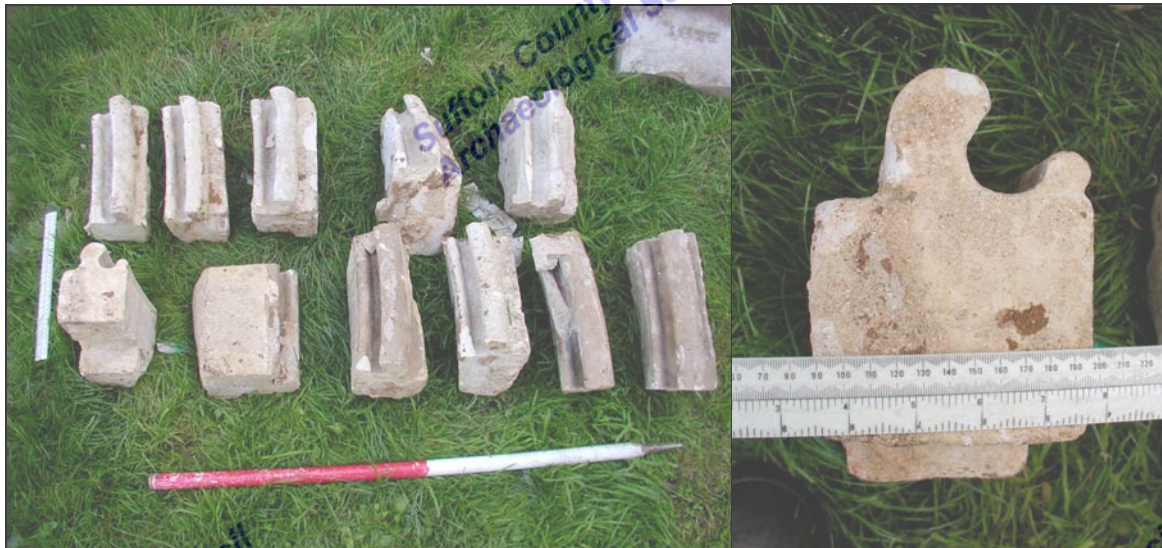
Plate 6: Medieval Masonry Re-Used in Vent

Selection of pieces

Detail of moulding

In addition to the gravestones and slabs, nineteen pieces of limestone moulding (Plate 6), from at least one arch forming part of either a medieval (?14<sup>th</sup> century) window or doorway, were found to have been used in the construction of an air vent running diagonally from the firebox pit to the north transept wall.
