**Wood Farm,
Iken, Suffolk
IKN 111**

Historic Building Record

Wood Farm, Iken, Suffolk

Heritage Asset Assessment

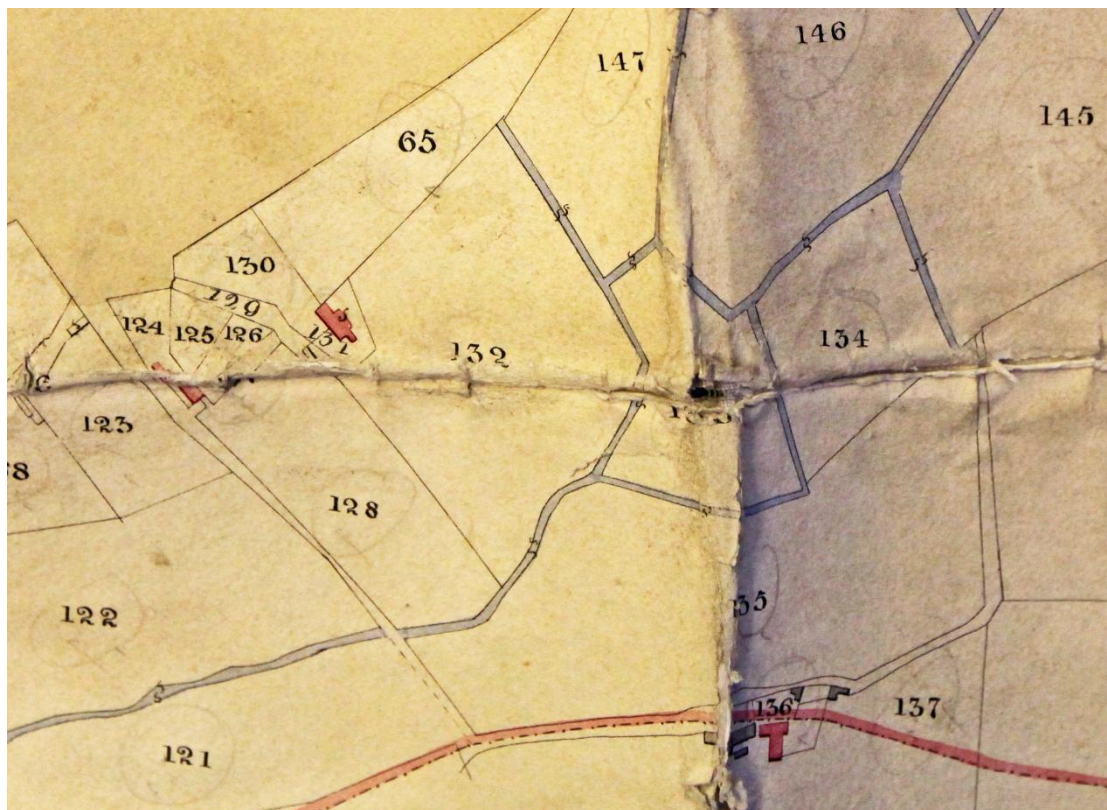
Figure 2. The Iken tithe map of 1840 showing Wood Farm at bottom right and the south-eastern corner of Iken Heath (shaded) at top left.

The Iken tithe map (figure 2) shows a T-shaped farmhouse in red with a large outbuilding in close proximity to the west. The similarly T-shaped outline of the outbuilding suggests it formed a barn with a south-facing porch, but the map is damaged by a vertical tear which has destroyed some detail. Two additional outbuildings lie to the north-east of the house on the Iken side of the boundary. The tithe apportionment records 69.25 acres in Iken and notes that George Eastaugh was the farm's tenant. The site was described only as 'Barn and Yard' (plot 136) and the adjoining field on the east was named as 'Back House Field' (plot 137).

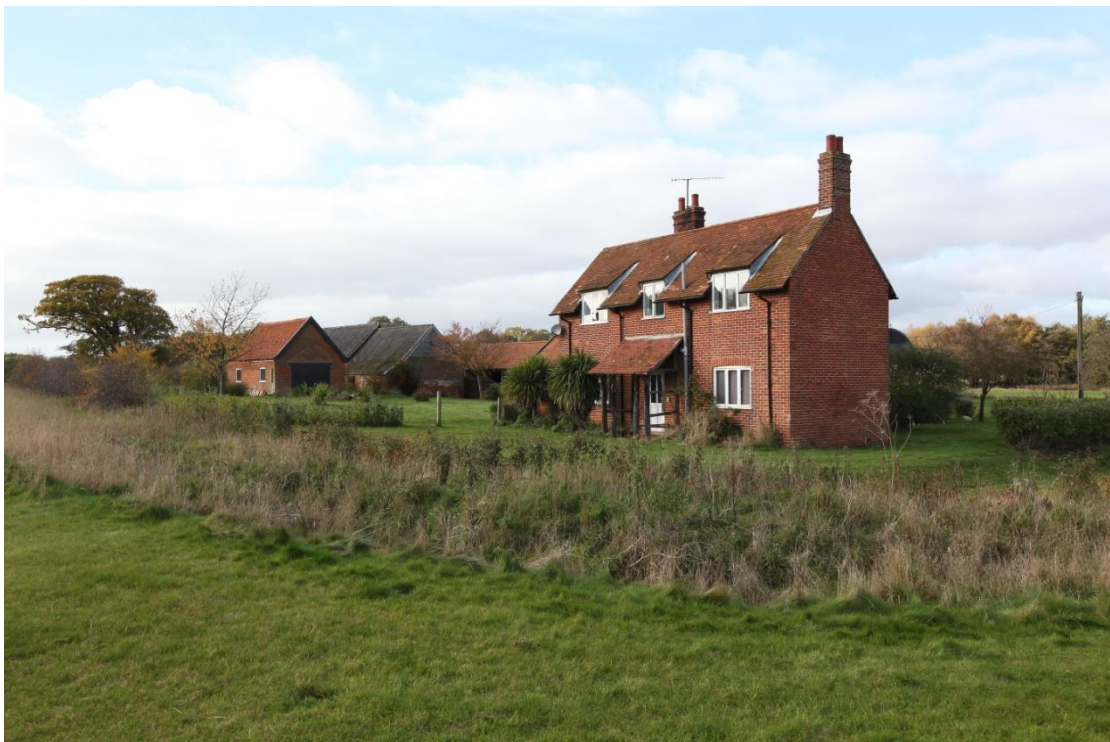
Illus. 2. A general view from the south-east showing the early-20th century red-brick farmhouse (7) to the right with the late-19th century vehicle shed (5) to the left and the mid-19th century stable (4) in the centre.

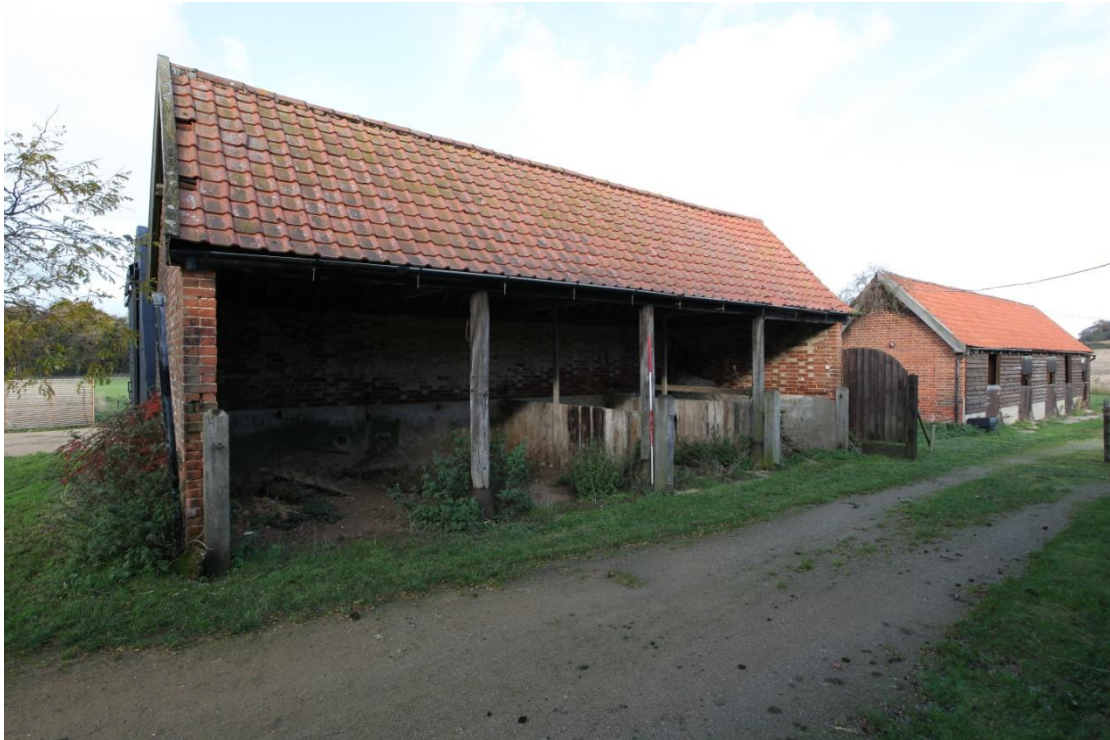
Illus. 3. The open-sided southern exterior of the late-19th century western shelter-shed (2) which initially served the stable (4) immediately opposite. The contemporary eastern shelter-shed (6) to the right was converted into a stable in the late-20th century. The parish boundary between Iken and Sudbourne runs along the track in the foreground.

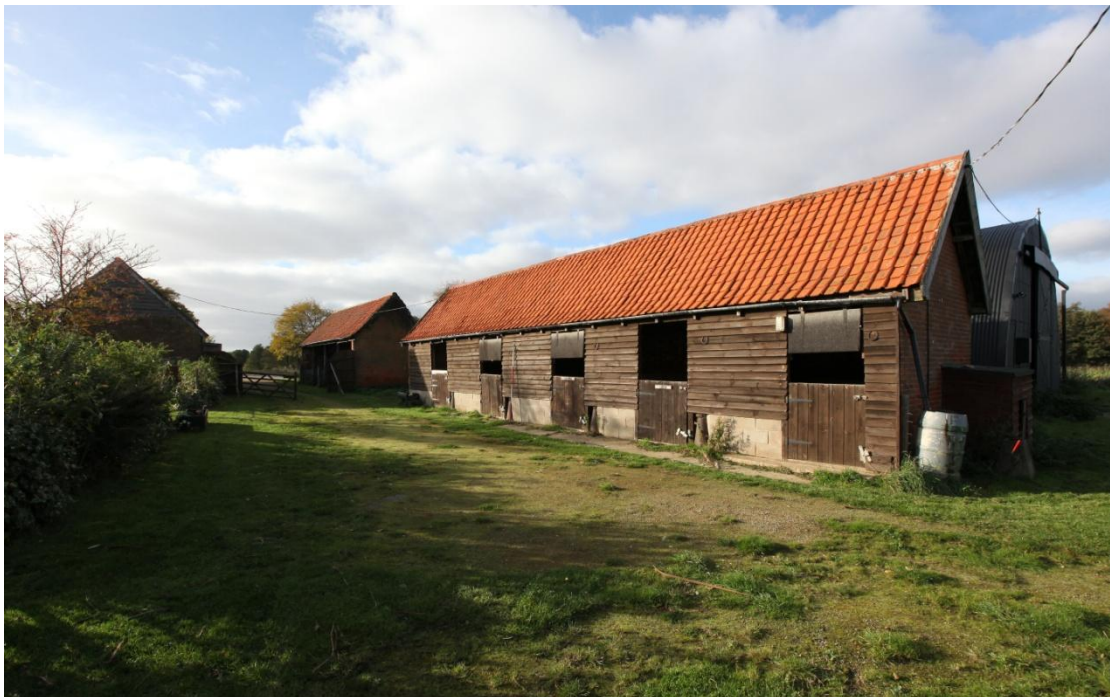
Illus. 4. The late-19th century eastern shelter-shed (6) seen from the east, with the Nissen hut (1) in the rear to the right and the stable (4) and western shelter-shed (2) on the left. The buildings to the north (right) of the track are in Iken but the farmhouse and other structures lie in Sudbourne parish. The southern elevation of the shelter-shed was originally open to match its western counterpart but was enclosed in the late-20th century to form a stable consisting of five loose boxes.

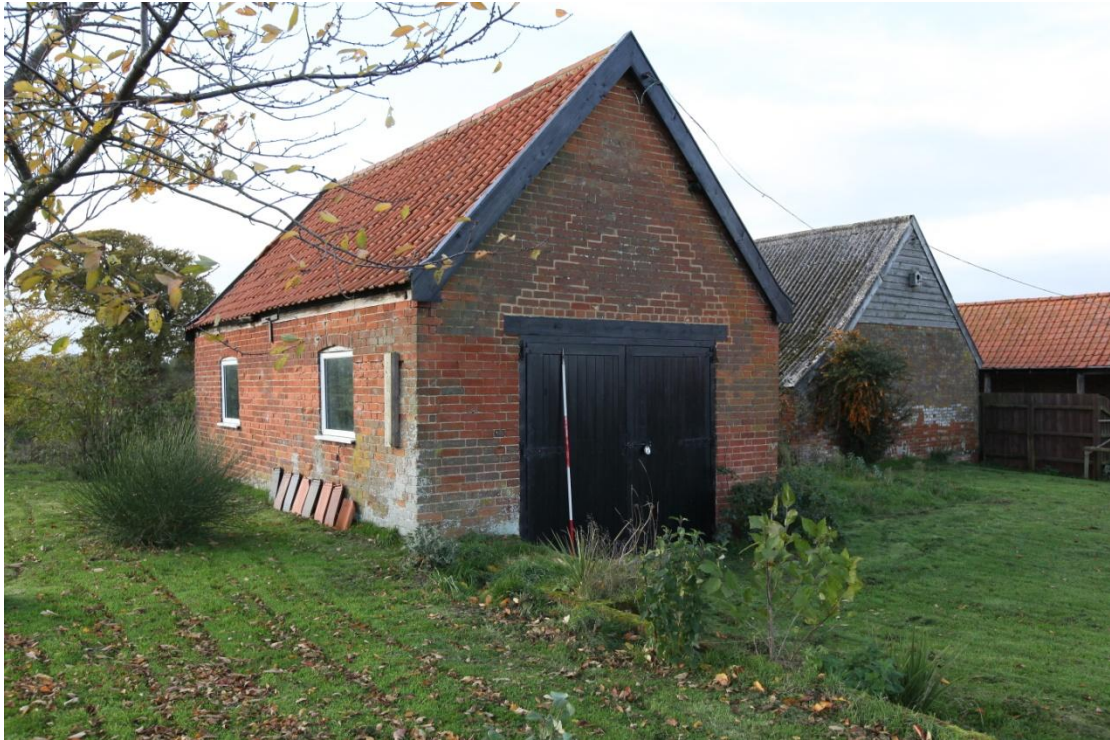
Illus. 5. The late-19th century brick vehicle shed (5) from the east showing the replaced doors occupying its original gable entrance and two original window apertures in the southern elevation. There is evidence of a narrow original door in the opposite western gable (now converted into a window). The stable (4) with its integral southern lean-to is visible to the right.

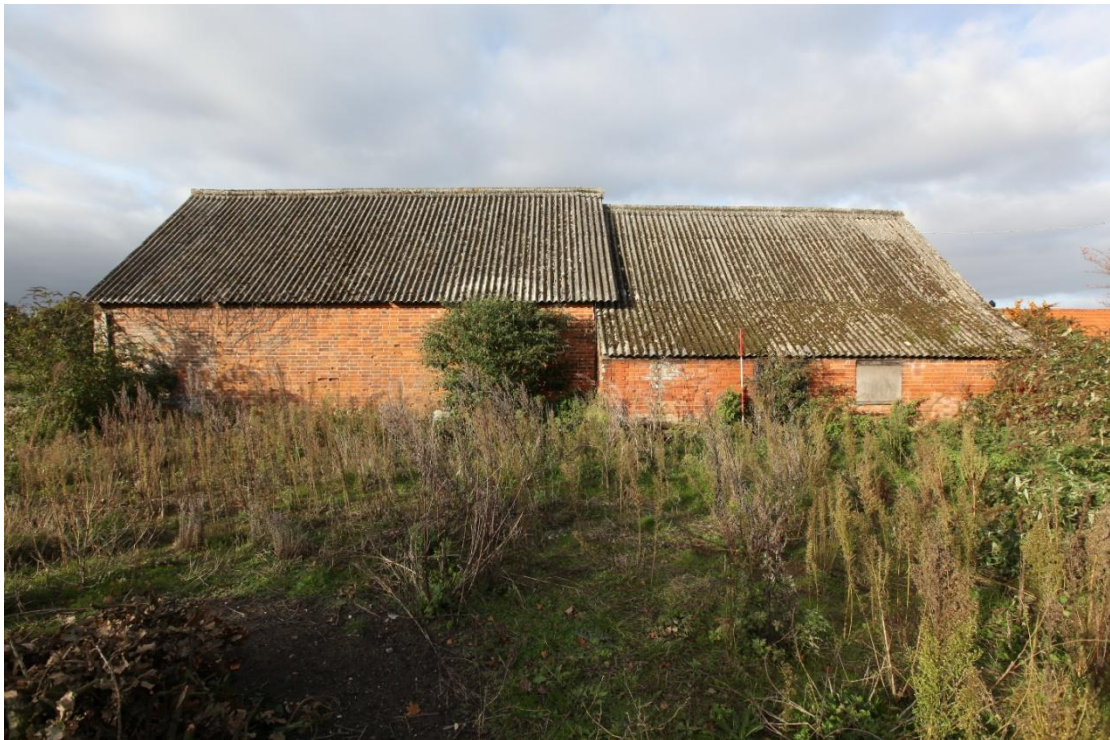
Illus. 6. The rear (southern) exteriors of the cart lodge (3) to the left and the mid-19th century stable (4) with its integral lean-to on the right. Both roofs are clad in 20th century corrugated asbestos.

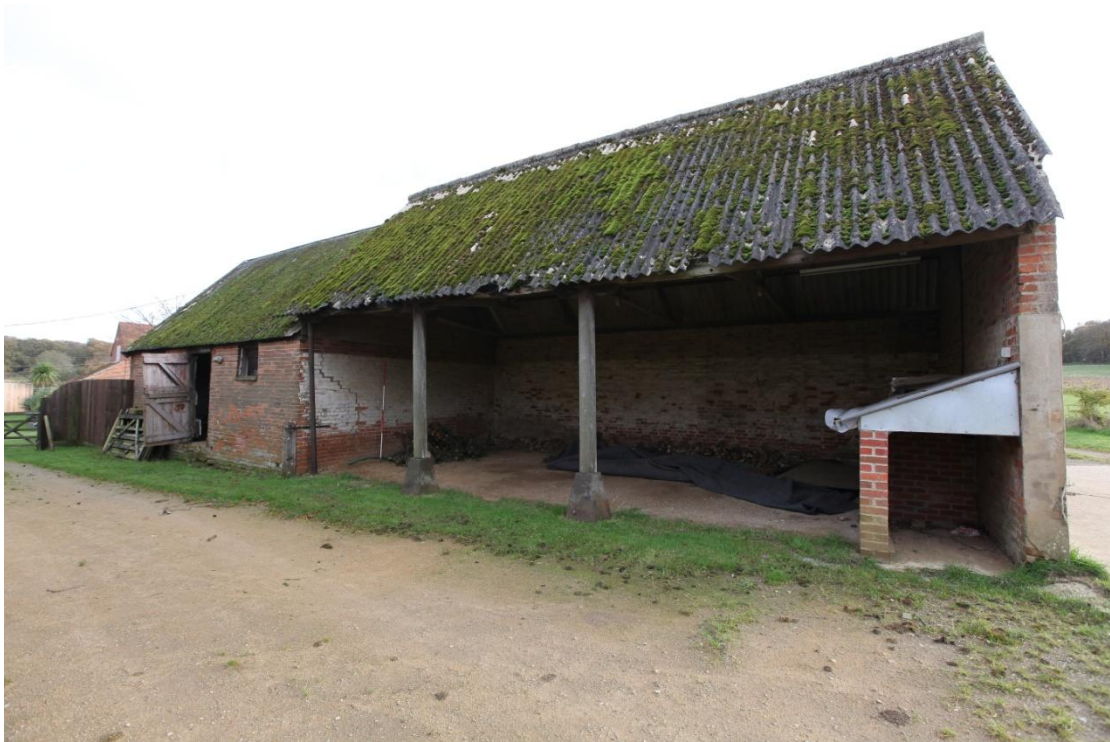
Illus. 7. The 19th century cart lodge (2) at the entrance to the site as viewed from the north-west and showing its original open arcade with the contemporary or slightly earlier stable (4) on the left.

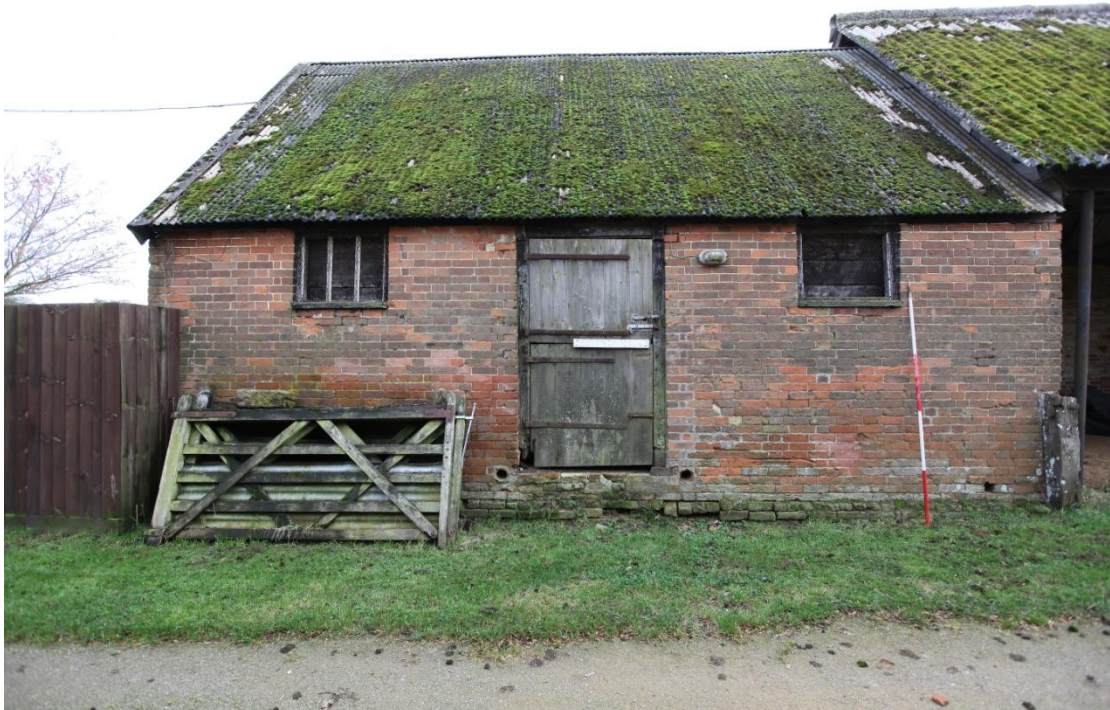
Illus. 8. The northern facade of the original 19th century stable (4) showing its central half-hung door flanked by shuttered windows - all respected by closer bricks. Note the circular drain apertures marking the internal floor level.

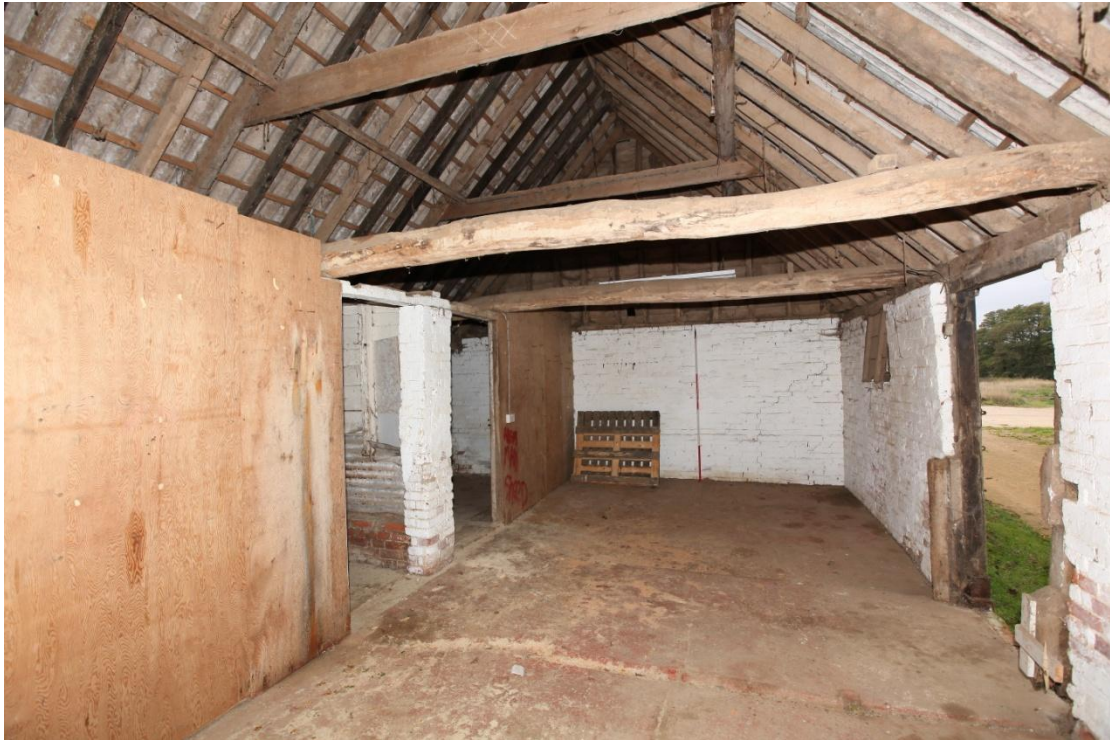
Illus. 9. The interior of the 19th century stable (4) from the east, showing its central entrance to the right and the twin central doors opening into the two compartments of the integral rear lean-to on the left. The roof was rebuilt in 1923 as dated by an inscription on the further of the two roof collars shown here. The horses were presumably stalled against the gables, although no evidence survives, with the lean-to containing a tack room and chaff box.

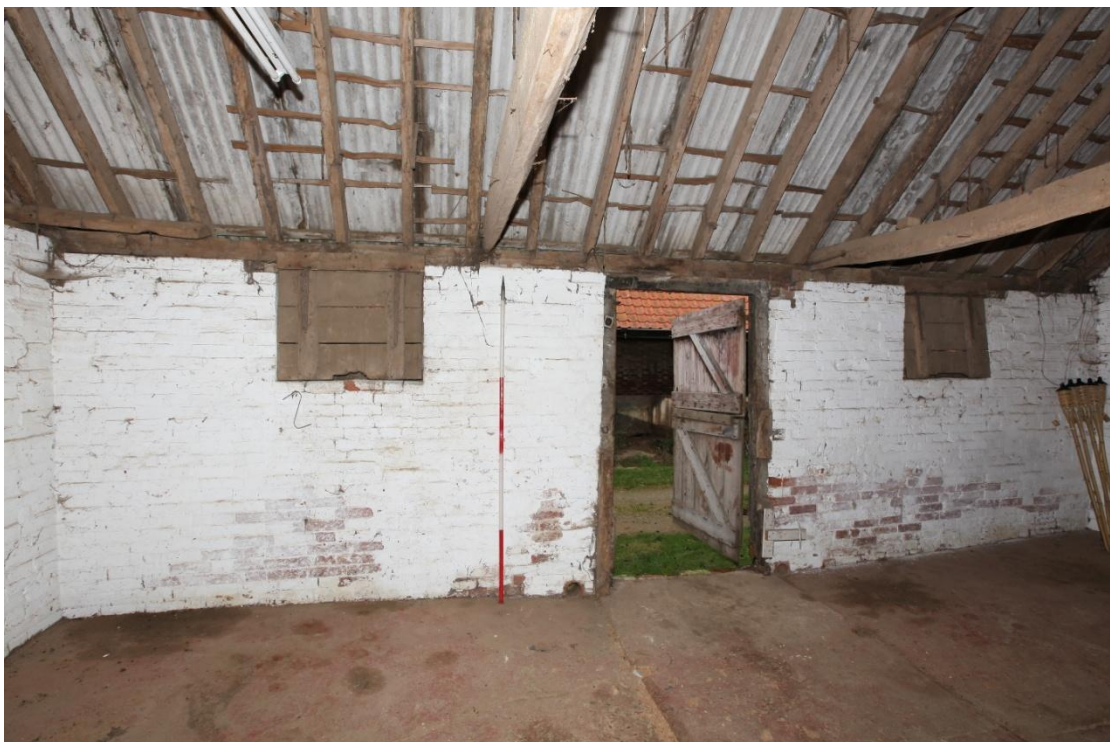
Illus. 10. The northern interior of the 19th century stable (4) showing its original central entrance flanked by vertically hinged shuttered windows with floor drains.

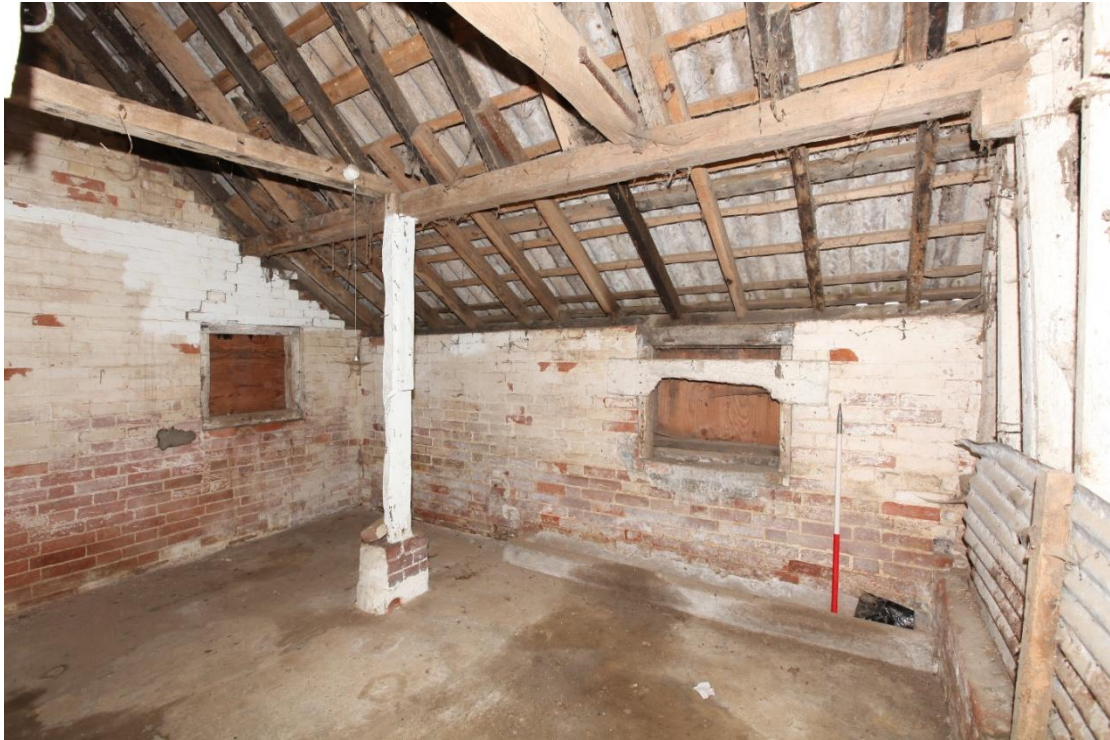
Illus. 11. The interior from the north-west of the easternmost lean-to compartment of the 19th century stable (4) showing two original windows or loading hatches with a late-20th century concrete cattle trough. Part of this space may have served as a chaff box.

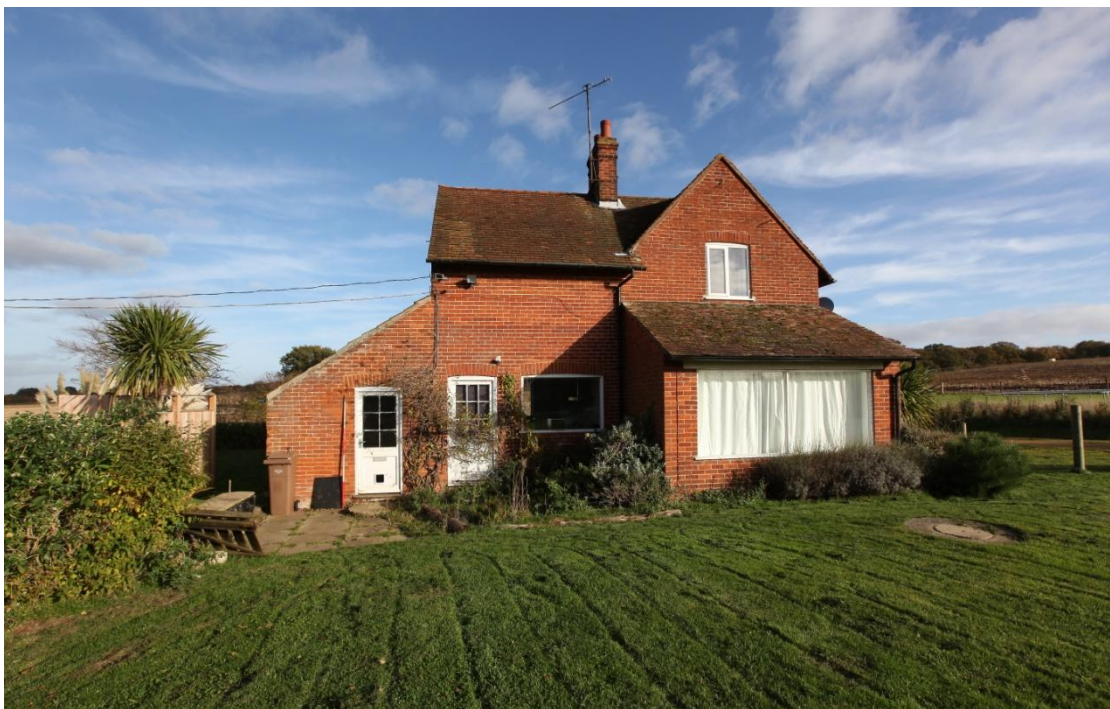
Illus. 12. The early-20th century farmhouse (7) from the west. The northern lean-to on the left is an original feature but that to the right is a late-20th century addition. A pair of mill stones serves as door steps and may have been used to grind animal feed on the farm. The present house appears on the Ordnance Survey of 1927 but not that of 1904 and appears to date from *circa* 1910. It may, however, be contemporary with the re-roofing of the stable (4) in 1923.
