## Crows Hall, Debenham (DBN 124); Record of an Archaeological Evaluation & Monitoring

SCCAS Report No. 2006/125; Oasis No. suffolkc1-20302

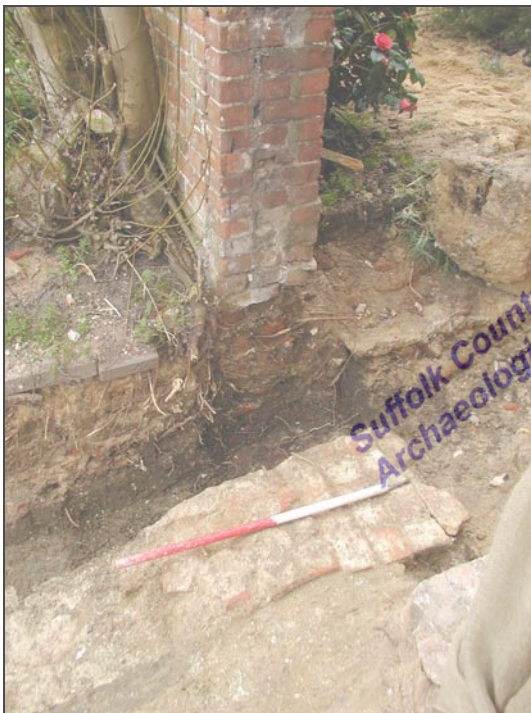
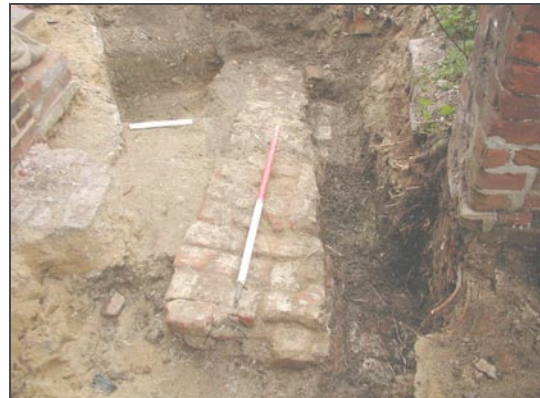
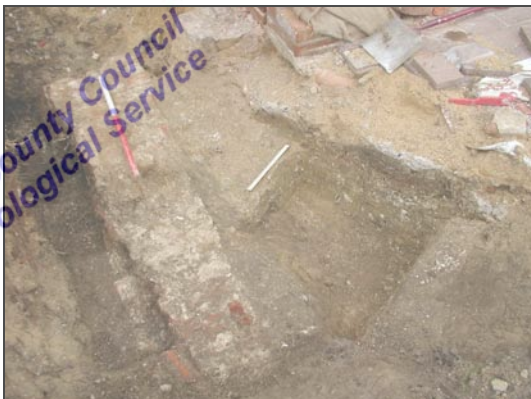
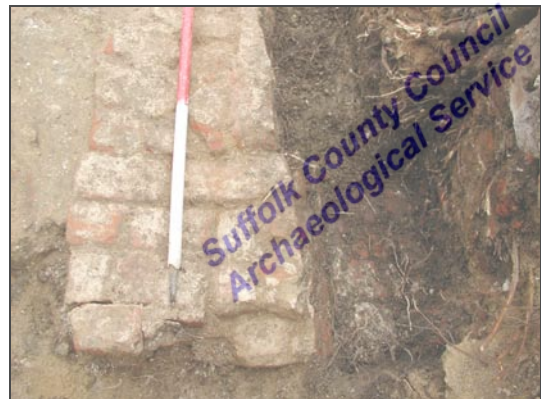
Plate 3 Trench 2; wall 0029 from the north

Plate 4 Trench 2; wall 0029 from the west

Plate 5 Trench 2; wall 0029 & feature 0033

Plate 6 Trench 2; detail of wall corner 0029

On its north side, concrete footing 0026 could be seen to cut a ceramic pipe (0028) comprising interlocking sections, flared at one end, of a type usually used to remove surface water and run-off. The trench excavated to accommodate the pipe itself cut a brick-built wall stub (0029) (Plates 3-6). The wall stub formed a corner (Plate 6) turning at 90° from its north-north-east to south-south-west alignment, coinciding with the extant garden wall (Plates 3 & 4), to the east-south-east and on beyond the eastern end of the trench. While the above-ground garden wall at that juncture was constructed from frogless red bricks measuring 9 x 4 ½ x 2 ¾ inches, the below-ground wall stub comprised 9 x 4 ½ x 2 inch 'Tudor-type' bricks and was considered to represent the footing for the east range. It was similar in width (0.48 metres) to other 16<sup>th</sup> century walls seen at the site and was itself 0.48 metres from the corner of the standing building. This width of wall essentially accommodates two stretchers or a stretcher and two header widths. The base of the wall was not seen in the trench, but it survived to at least six courses and in excess of 0.4 metres below the existing ground surface. Where ceramic pipe 0028 cut the wall, a single course of bricks had been removed to accommodate it. A section of the wall had also been partly truncated by the insertion of a concrete set gate-post (0030) at the northern end of the standing garden wall (Plates 3 & 4). The east-south-east component of 0029 could be seen to be cutting a layer of grey/brown chalky clay (0032) which may represent the upper weathered surface of the naturally occurring boulder clay subsoil, although there was no direct evidence to confirm that it had not been re-deposited.

Clay layer 0032 was also partly truncated by an ill-defined feature which, within the trench, had a relatively straight sided cut (0033), but beyond the north side of the trench curved round, almost surrounding the south-east corner of the standing building (Plate 5). The fill (0034) comprised stiff yellow

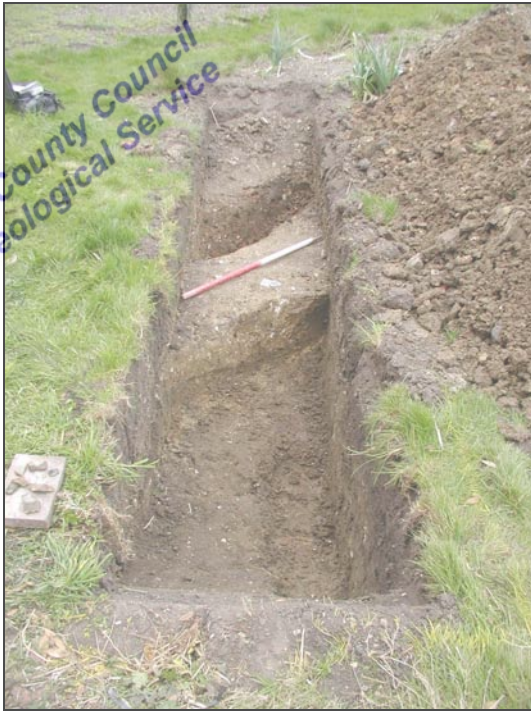
Plate 7 Trench 3; from the south-west

Removal of 0.4 metres of dark grey topsoil revealed naturally occurring clay subsoil in the centre of the trench with large pit-like features at each end (0016 & 0018) (Plate 7).

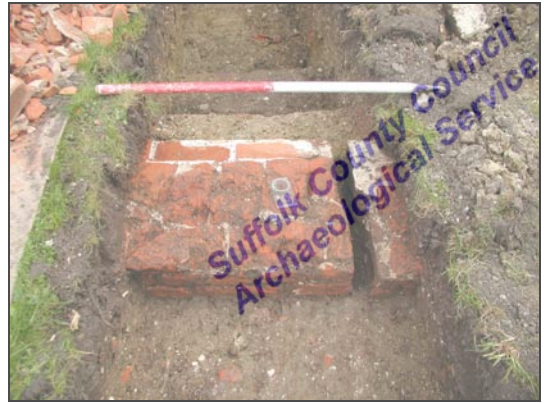
Plate 8 Trench 4; wall 0036 from the north

The stub of a brick built wall (0036) was recorded running approximately east to west across the approximately north to south component of the trench on the same alignment as the north wall of standing building (Plate 8). The bricks were all 'Tudor-type' measuring 9 x 4 ½ x 2 inches. The wall was 0.48 metres wide with, in its top course, stretchers on the outer face with another brick across the wall in the middle. The lime mortar bonding was very light in colour with frequent inclusions of chalk.

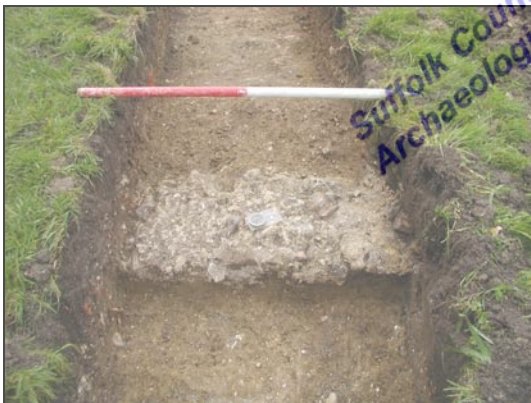
Plate 9 Trench 4; wall 0037 from the east

A second wall (0037) was recorded in the east to west component of the trench running in a north to south direction. Totally different in character, this wall was constructed in flint and lime mortar, was 0.40 metres wide with an unknown depth (Plate 9).

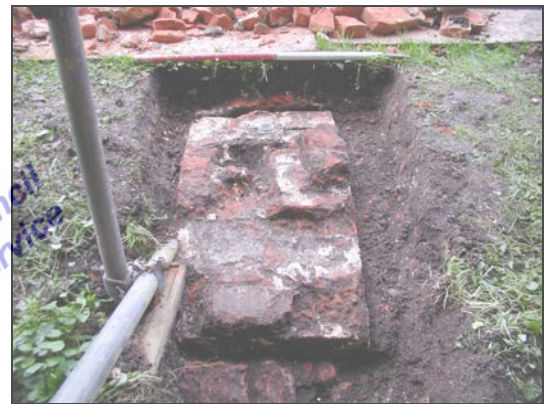
Plate 10 Trench 4; wall 0038 from the south

Another brick wall stub (0039) of similar character to 0036 was visible as a truncated end in the contractors excavation c.2.00 metres from the standing north wall and continuing in a northerly direction, although not reaching the evaluation trench some 5.00 metres to the north (Plate 10). The base of this wall was clearly not as deep as that of the standing building as there was no evidence for it adjacent to its north wall. If it had ever continued up to the existing wall, it must have butted against it. There was some evidence that this was the case; if the line of the wall stub was continued to the north wall of the standing building, it coincided with a vertical line on the wall face marking the boundary between exposed brickwork to the east and a rendered surface to the west (Plate 11). This rendered face was clearly an external surface as it had horizontal lines, at 3 ½ inch intervals and vertical lines scored on its face designed to imitate brick (Plate 12). The rendered face also had hints of red colour surviving. It has been suggested (Philip Aitkins *pers. comm.*) that this technique was common during the 18<sup>th</sup> century.

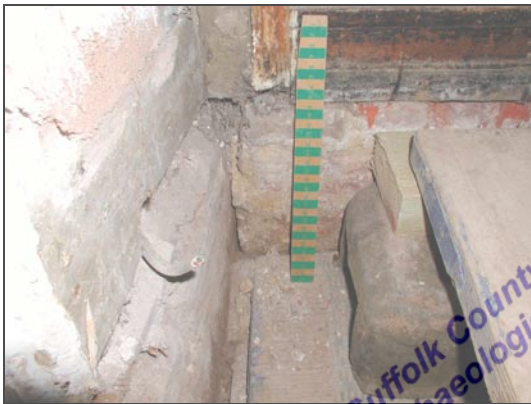
Plate 15 Wall 0007 butting against 0011

It was clear then that the extant room was a secondary development of the original structure and there was ample evidence to support this interpretation. Firstly, at its northern end, the eastern wall of the room (0007) was only butted against the south wall of the north range (0011) and was therefore, almost certainly, later in date (Plate 15). This wall was also continuous with an east

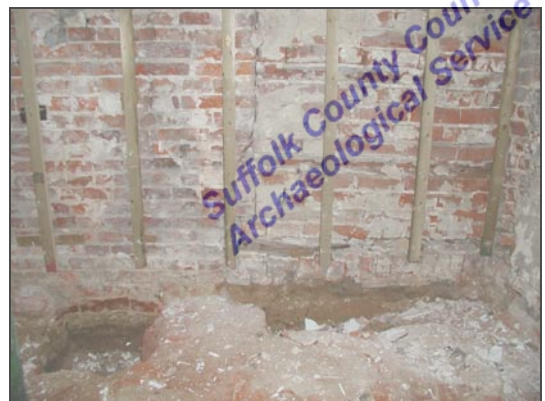
Plate 18 Junction between walls 0015 & 0012

The rebuilt south wall was also a phased structure with two distinct elements (0012 & 0015) with a vertical junction occurring within the area where the north-south component of gatehouse wall 0002 continues on to the south (Plate 18). Following the removal of the modern internal wall covering (plaster over plasterboard attached to vertical batons) the detailed structure/character and interrelationship of these walls became more apparent. The two phases were butted against each other with no tying in between them. A vertical crack seen in the rendered face of the external wall within the gatehouse arch also coincided with the junction between the two walls (Plate 17).

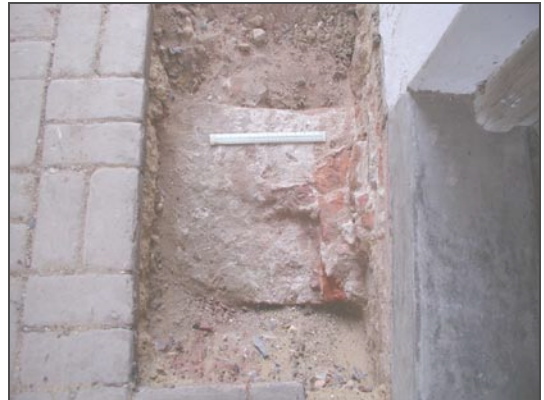
Plate 22 Wall 0040

While evidence for the early phase of the gatehouse was not seen within the room itself, its 0.56 metres wide east wall (0040) was exposed as a stub in a new service trench on the south side of the existing entrance way passage where it continued on under the standing wall (Plate 22).

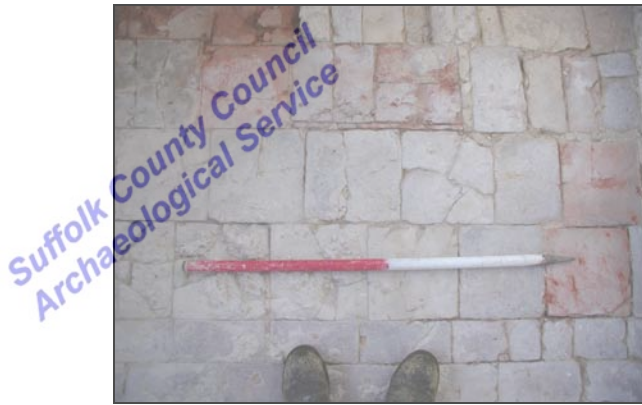
Plate 25 Tile floor 0043 & 0044

- To the south of a straight junction with brick floor 0042 there was an area of pammments (0043) consisting of  $9 \times 9$  inch tiles of fawn to red colour, the majority of which were in poor, badly cracked condition (Plate 25). Where these were disrupted close to the east wall clay/earth could be seen below with an area of concrete (0046) associated with the blocked doorway in the diagonal section of wall to the south-east.

- In the south-west corner of the room there was a rectangular area of floor (0044) measuring c.0.45 metres by c.0.90 metres, effectively that covered by eight floor tiles, where bricks and on-edge tiles had been used to for the surface (top of Plate 25).

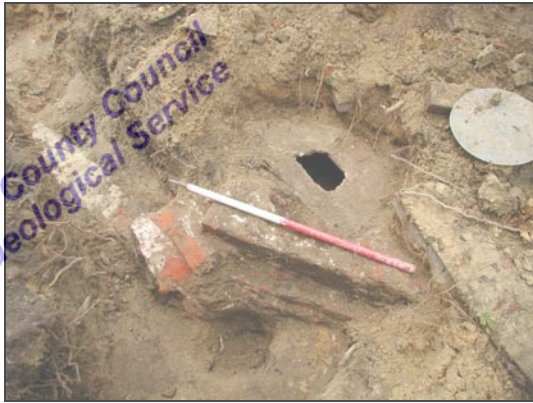
Plate 31 Capped soakaway 0051

On the southern side of the same trench a circular brick-built soakaway (0051) was uncovered (Plate 31). Constructed with red unfrosted bricks measuring  $9\frac{1}{4} \times 4\frac{1}{2} \times 2\frac{3}{4}$  inches, those forming the sides were unmortared while those in the vestiges of its domed top were bonded with lime mortar. The dome had previously been breached and replaced with a concrete and steel capping formed at c.0.20 metres below the existing brick patio surface with a, probably contemporary squared brick structure (0053) protruding to the south joining it with drain 0054. While still being able to function as a soakaway, the presence of a considerable quantity of rubble and pieces of wood in it suggest that it may have become redundant (Plate 32). It was unclear if brick drain 0054 was an earlier feature discharging into the moat which had subsequently been diverted into the soakaway or whether they were contemporary. The drain cut across what would have been the line of the east wall of the west range (the presence of which is indicated by a wall stub 0055, see next paragraph) and as such would appear to be a later insertion. However, the drain, which was encountered at 0.4 metres below the existing patio surface, was constructed primarily using 2 inch 'Tudor-type' bricks, although these could have been re-used (Plate 33). Bricks were lain lengthways along its base, with others lain on edge to form the sides with bricks lying crossways to form the top. A line of peg-tiles had then been place

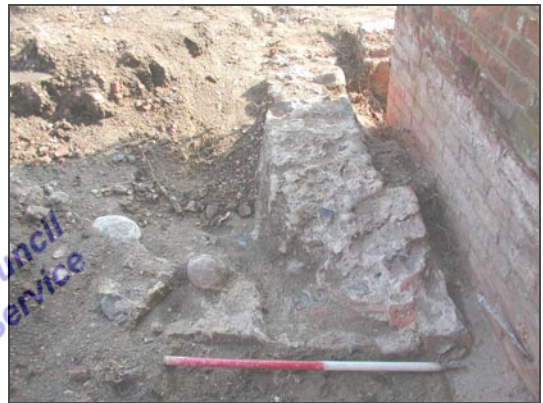
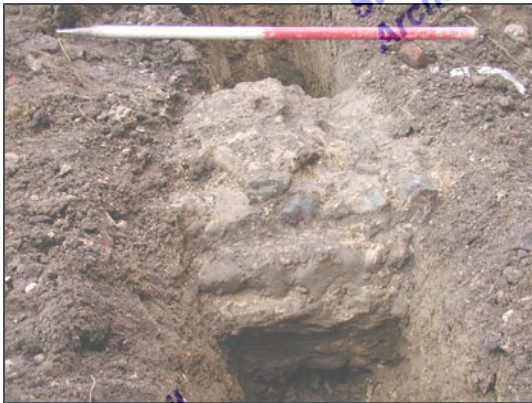
Plate 42 Wall 0065 from the south

Plate 43 South side of wall 0065 in trench

Immediately to the west of the north-west corner of the standing building an L-shaped length of flint and lime mortar wall (0065) was uncovered measuring 3.75 metres from north-north-east to south-west and then turning to the west-north-west and continuing for 2 metres (Plates 42 & 43). While generally quite substantial, the northern end of the wall did comprise less well consolidated material that seemed peter out somewhat. The wall included flint cobbles of up to 0.15 metres in diameter. It was first thought that wall 0065 had originally continued beyond its corner towards the east where a protruding stub was recorded, having been truncated by the footings (0072) for the existing extension. However, on closer inspection, this seemed to be a genuine end with stacked roof-tiles included in what may have been a buttress. The concrete footing (0072) for the extension had actually been modified to avoid wall 0065, both narrowing and stepping down by two brick courses. Wall 0065 was not on the same alignment as the standing buildings on the site and while it could have been related to the other flint and lime mortar wall (0037) in Trench 4 some 4.00 metres to the west, its orientation was slightly different. Clearly this represented a different build to the Tudor building and while dating evidence was absent, there was no reason to suggest that this was not related to an earlier, possibly medieval structure.
